Greater Yellowstone Rural ITS Project

Work Order II-2C Dynamic Warning VMS Evaluation of Idaho Sites

Western Transportation Institute
Montana State University
Bozeman, Montana

September 2003

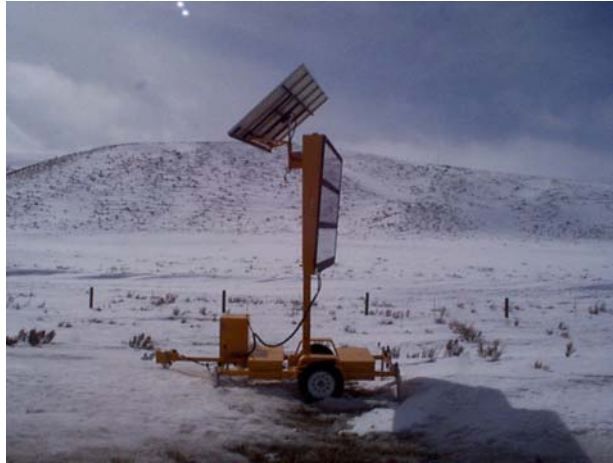
Figure 2: VMS Unit

This section describes the components, locations, costs and challenges of the Idaho Dynamic Vehicle Message System (DVMS). The system consists of eight (8) portable variable message signs (Figure 2) that perform multiple functions throughout the year. During the winter months the signs are positioned along the priority corridors at six (6) locations to allow for the warning of dangerous conditions that exist along the roadway. During the summer months Idaho Transportation Department (ITD) can use them as traffic control devices in work zones.

The signs are approximately 8x5 feet and allow for the display of three lines of text up to 8 characters long. Letter height is 18 inches. The signs utilize light emitting diode (LED) technology. They allow for multiple sets of information to be displayed in a repeating flash mode display. Although the signs are capable of displaying any user specified message, approximately 300 messages were preprogrammed into the signs for this project (Appendix A). Batteries, a solar panel, and a cellular connection allow them to operate self sufficiently in any conditions provided the messages are updated on a regular basis.

The Idaho Transportation Department is able to program and monitor each sign from its office computer by using the cellular connection. This is accomplished using the Portable Changeable Message Sign Software (PCMS) developed by Display Solutions Inc. for this project. Each sign can be monitored for existing message, brightness, battery life, and solar power. Ideally these factors would be checked and changed if necessary twice each day; however other obligations do not allow for this level of monitoring.

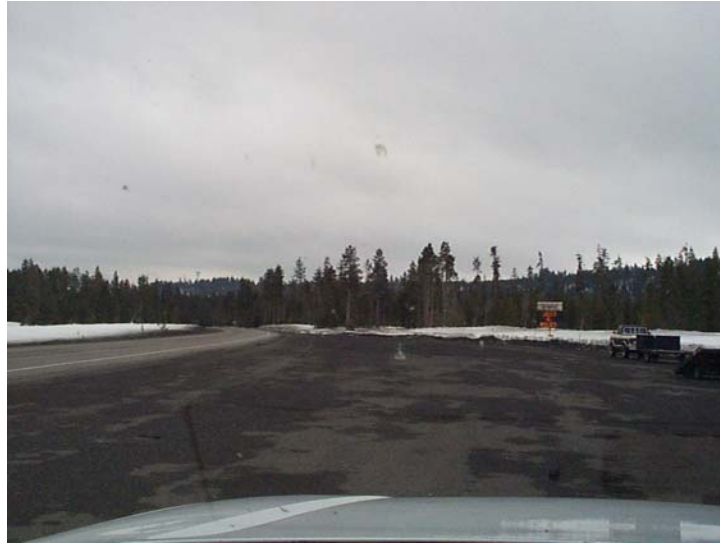
Figure 4: Example of Distance from Traveled Way

Sign Placement: When using portable VMS in semi-permanent locations, they should be placed far enough away from the road to be out of the clear zone and not a safety hazard. Additionally, they must be positioned at locations that are accessible, stable and relatively level. Figure 4

shows the sign at location 3 that is the farthest off the roadway. This limits the visibility of the sign especially since the LED's have a specific light cone.

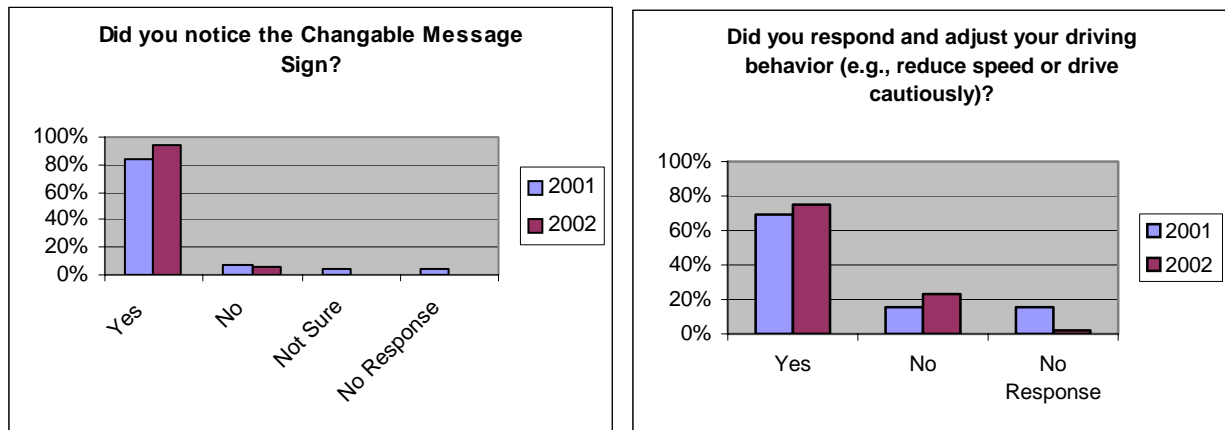
Figure 9: Did Motorists Notice VMS and Respond

Motorists were asked the questions on the survey shown in Appendix B. The response was generally positive. 91% of the motorists noticed the dynamic warning VMS (Figure 9). Of those that noticed the sign, 79% reported that they adjusted their driving behavior.

There were minimal differences in response across different demographic groups such as age, vehicle type, and familiarity. As seen in Figures 9-11, there is also little difference in the response between the two different surveys. This suggests that the reported response is similar across locations (i.e., US 20 vs. I-15) and time (i.e., first year after installation vs. second year after installation).

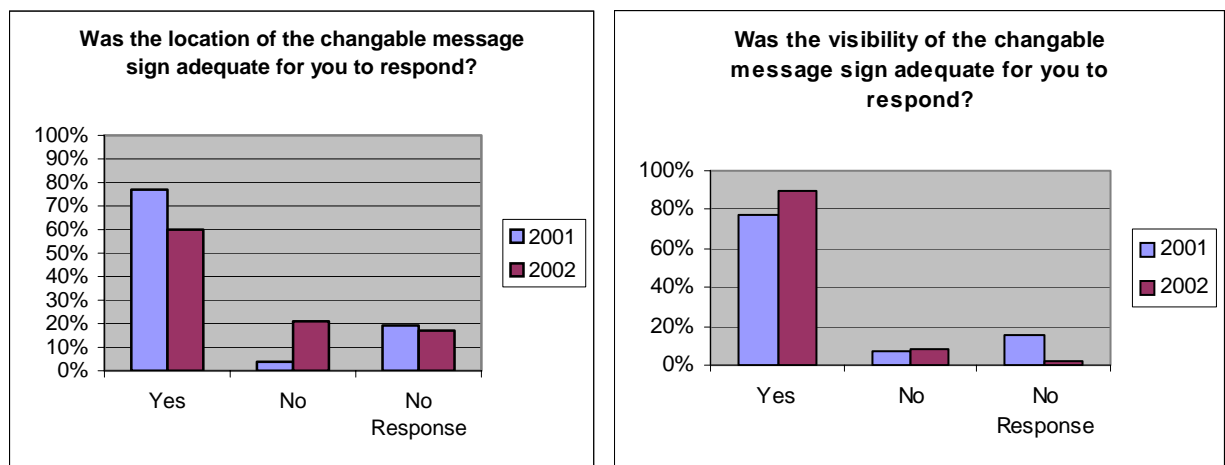
Figure 10: Was VMS Visible and Correctly Located

The motorists were asked if they felt the location and visibility of the sign were adequate (Figure 10). Of those that noticed the sign, 94% felt the visibility was adequate and 73% felt the location was adequate. Motorists that felt that the sign was difficult to see commented that the sign should be a little brighter at night, it might be difficult to see in the fog, and the messages were flashed too quickly to read.

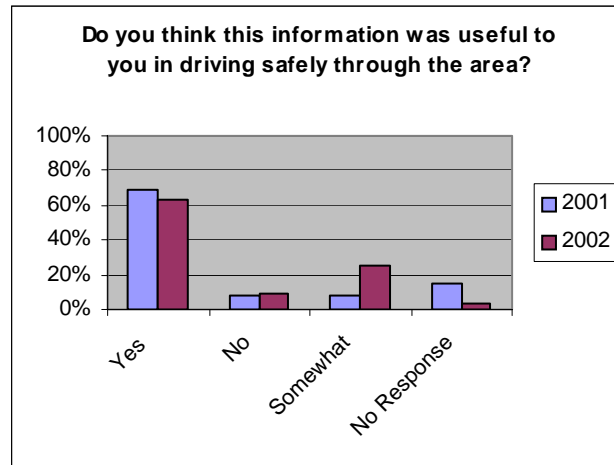
Figure 11: Was Information Useful

Of those that noticed the signs, 72% thought the information was useful and an additional 21% thought it was somewhat useful (Figure 11). Several of the comments made by motorists echoed this response. Motorists commented that they appreciated the efforts to improve safety and liked the signs.
