Greater Yellowstone Rural ITS Project

**Work Order II-2C Dynamic Warning VMS
Evaluation of Wyoming Site**

Western Transportation Institute
Montana State University
Bozeman, Montana

October 2003

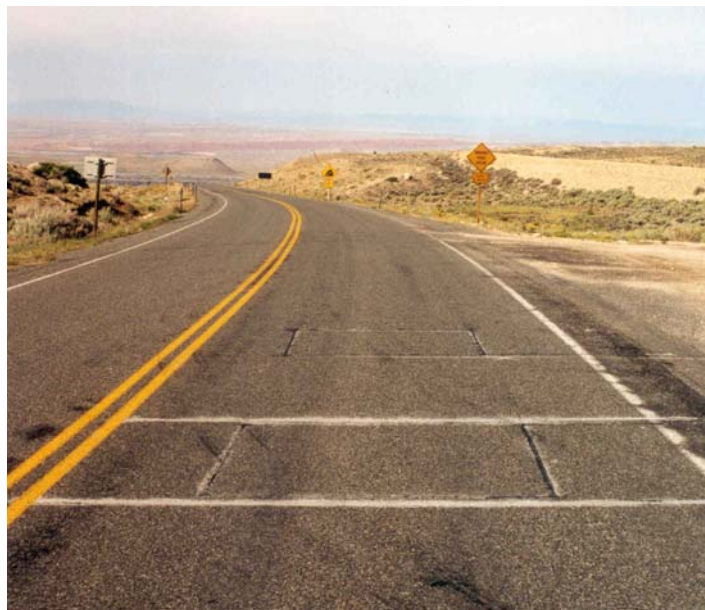
Figure 2: Inductive Loops

In order to trigger the sign to display a warning message, inductive loops (Figure 2) are used to detect the vehicle size and speed. These sensors have been installed in the roadway, conforming to the road profile, giving a clean, easy-to-read signal that translates into accurate vehicle counts and speed data.

This section describes the components, locations, costs and challenges of the Wyoming Dynamic Vehicle Message System (DVMS). The Dynamic Warning VMS was purchased from Skyline Products, Inc. and installed by Modern Electric Co. in August of 2001. The sign is located at approximately milepost 68.5 and is programmed to turn on when a westbound vehicle traveling too fast passes over the inductive loops located approximately 0.3 miles east of the sign.

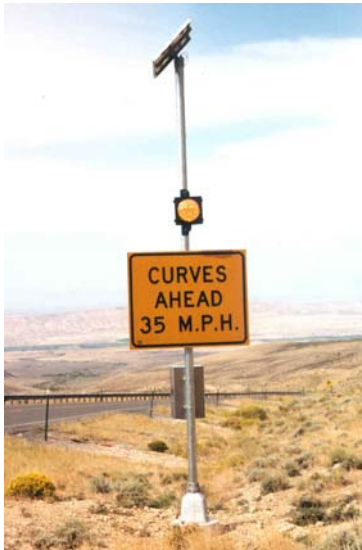
Figure 3: Static Sign

The sign is approximately ten feet wide, four feet tall, and two feet deep. The LED matrix sign consists of two lines of up to eight characters with a text height of 12 inches. The Dynamic Warning VMS is located approximately one half mile before the sharp curves in order to provide the driver adequate response time. An additional static sign (shown in Figure 3) with a solar-powered continuous flasher was placed directly in advance of the curves (shown in Figure 4).

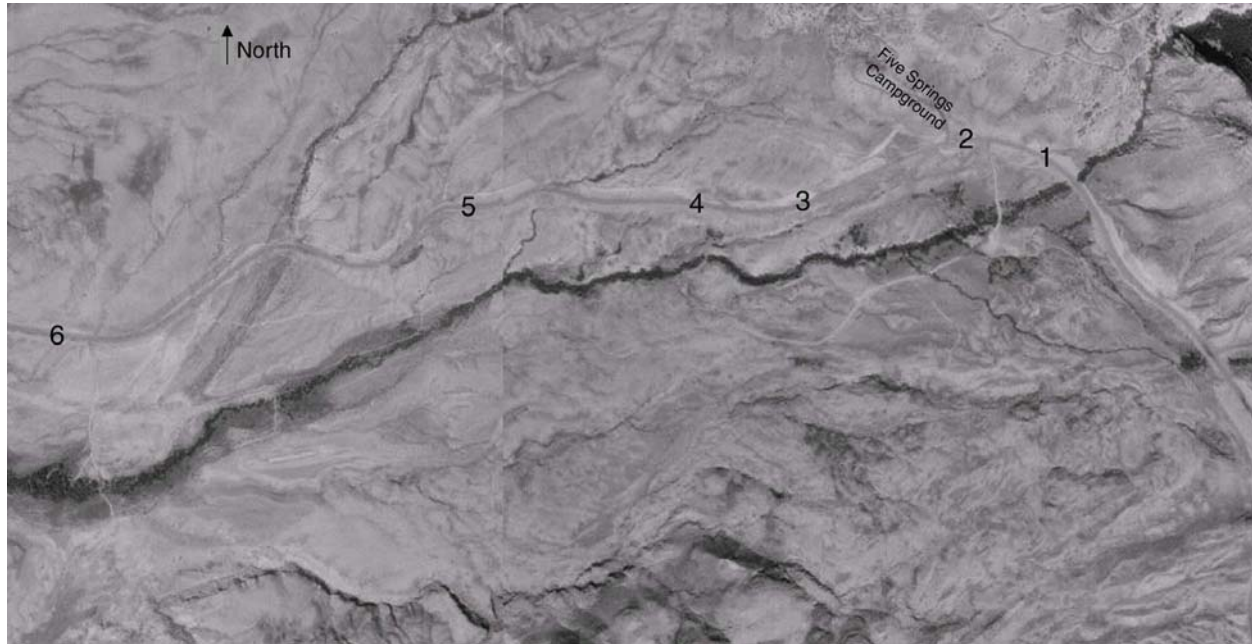
Figure 6: Locations of Speed Data Collection

The mileposts and mile-markers were changed between the pre and post installation. This made the precise locations of the speed data collection difficult to find. There is a possibility the road tubes collected data at slightly different locations. However, because of landmarks identified, the pre and post installation data collection locations should not differ by more than 1/10th of a mile. The traffic counters were placed in the westbound lane at six locations. The locations are as follows (see also Figure 6).

- Location 1: Adjacent to the road closure gate (MP 68.75). This gives a speed in the horizontal curve and steep downgrade previous to the potential sign location.
- Location 2: Just east of the Five Springs Campground intersection (MP 68.63). This gives a speed at the beginning of the tangent section.
- Location 3: Adjacent to the 35-mph curve warning sign at the end of the tangent section (MP 68.35).

- Location 4: At the beginning of the less sharp horizontal curves following the tangent section (MP 67.95). This shows the progression of speeds approaching the hazardous curves.
- Location 5: At the beginning of the hazardous curves, precisely the third delineator into the guardrail (MP 67.80). This displays the speeds when entering the hazardous curves.
- Location 6: Following the final hazardous horizontal curve (MP 66.80).

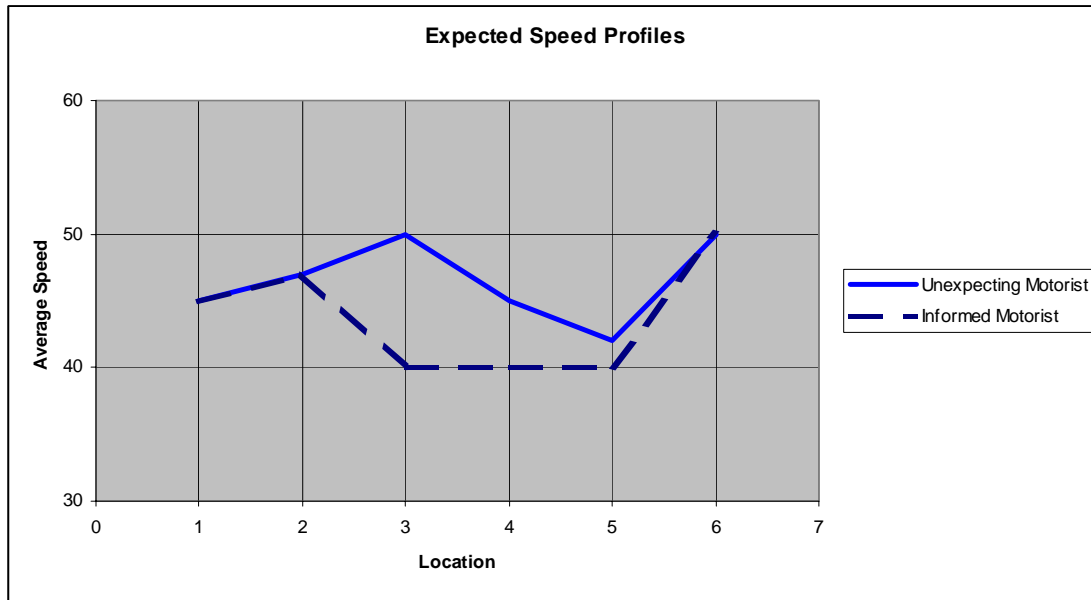
Figure 7: Hypothetical Speed Profile Along 6 Data Locations

To better understand the challenge of driving this segment of road, consider an uninformed motorist that would be surprised by the curves and an informed motorist that would see the dynamic warning sign and slow accordingly. Figure 7 shows the expected profiles of vehicle speeds of these two types of vehicles. Location 1 is at the end of a steep grade (approximately 8%), and vehicles would be coming off a steep grade. When the vehicle reaches Location 2, it comes to a less severe grade and has the false appearance of being out of the steep grades. At this location the dynamic warning sign first comes into view. The view shown in Figure 2 is at this location. At location 3 (just beyond the location of the sign) an informed motorist would see the sign and slow down in anticipation of the curves. An uninformed motorist would continue to speed up until reaching location 3 where the grade again changes to a steep grade. Between locations 3 and 4 the uninformed motorist would slow down or maintain speed. At location 4 the s-curve at location 5 would come into view and the motorist would realize they were in trouble and continue to slow. At location 6 the motorist is truly in the valley bottom and would increase speed.

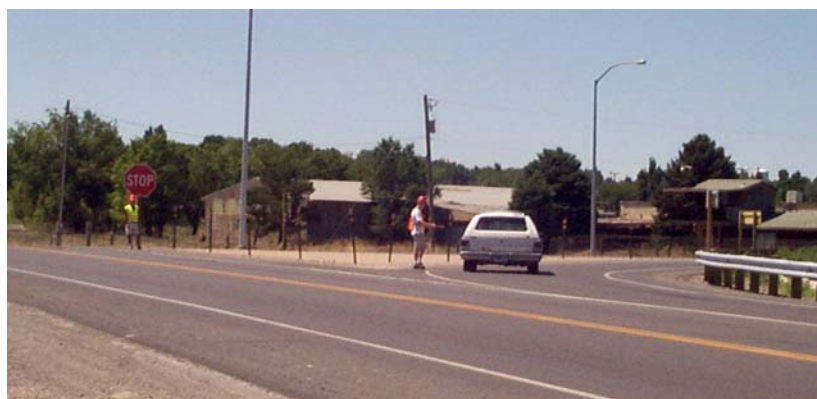
Figure 8: Distribution Survey

A motorist survey was conducted for the purposes of assessing motorist reported response to the DVMS. Motorists were asked if they saw the sign, how they adjusted their driving behavior and if they thought the signs were useful. On July 11, 2002 two surveyors distributed motorist surveys (see Figure 8). Mail-in surveys were distributed at the stop sign (left turn) and the yield sign (right turn) where Federal Highways 14A and 310 intersect.

The survey distribution site was located approximately 20 miles west of the Dynamic Warning VMS. A “Survey Crew” sign was placed upstream and vehicles were flagged to stop. However, approximately 20% of the vehicles did not take a survey. Additionally, this intersection was near Lovell, so some of the traffic may have been local drivers who had not just passed the sign.

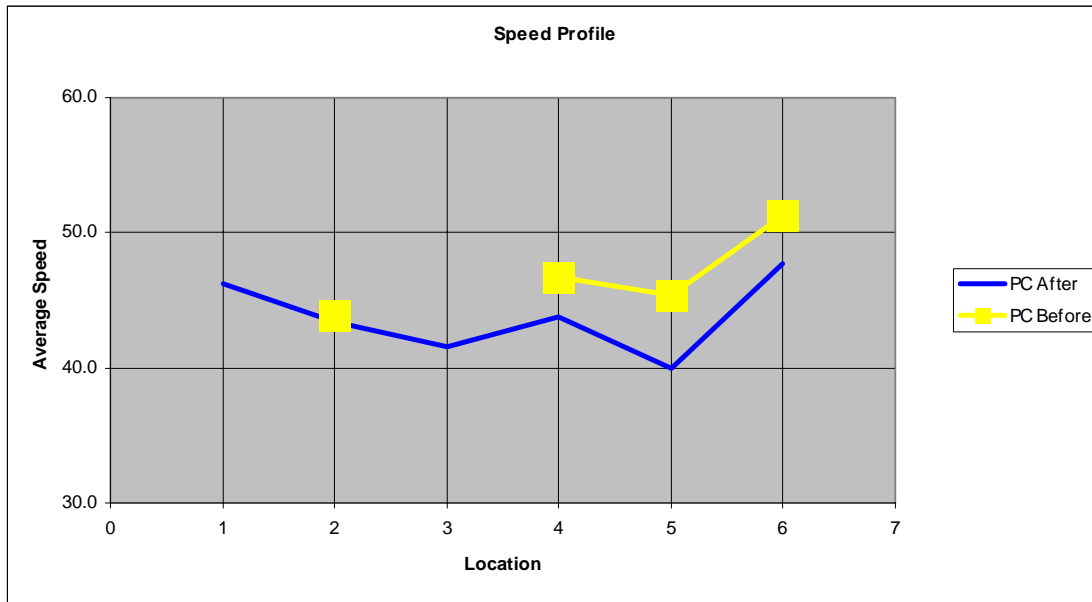
Figure 9: Speed Results for Passenger Cars

Table 3 and Figure 9 show the results of the speed data analysis for passenger cars. Location 2 is approximately where motorists first see the sign. If there is a significant change in speed at or before Location 2, it cannot yet be due to the sign. Location 4 and 5 are of key concern as a reduction in speed at these locations could mean increased safety. The NC-97 speeds are adjusted by -1.5 mph as discussed previously. Considering the adjusted t-test, this is exactly what researchers expected to see. There is little difference at location 2, where motorists first see the sign, and a significant decrease at all locations downstream.

Although some speed comparisons did not see a significant decrease in speed after the DVMS was installed, there was in all cases a significant decrease at location 5. Since location 5 is the beginning of the sharp curves, the DVMS seems likely to have a positive impact on safety at this site.

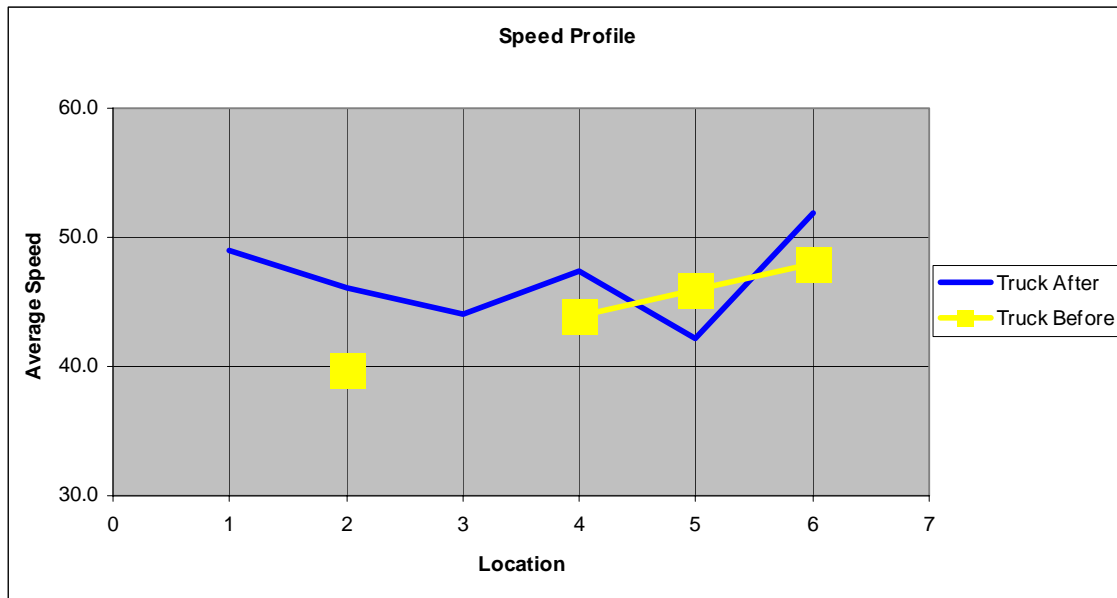
Figure 10: Speed Results for Trucks

Table 4 and Figure 10 show the results for Trucks, which are different from those of passenger cars. Although there is a significant decrease in speed at location 5, there is a significant increase at location 4. It is clear that the overall speeds have increased due to some other factor, since the sign should not affect speeds at location 2. One can see by Figure 10 that although the overall speeds have increased, vehicles appear to be slowing down in the curves.

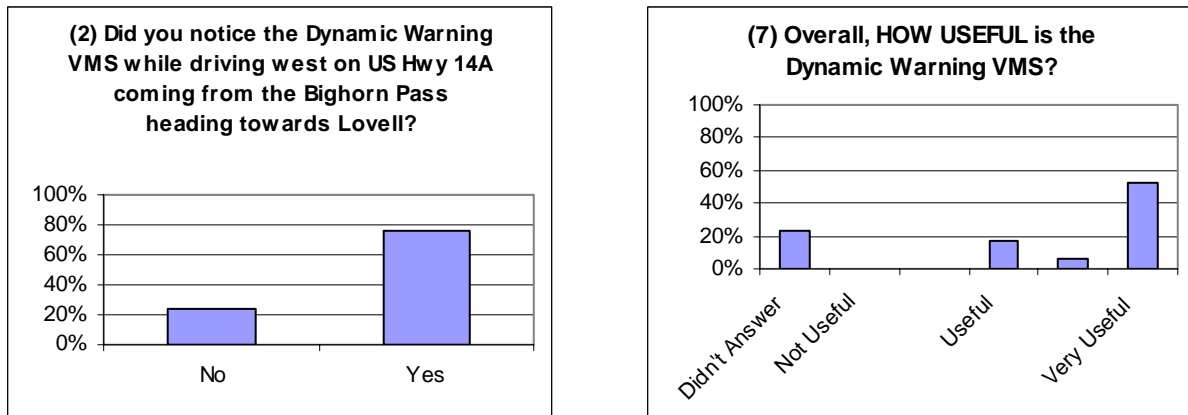
Figure 12: General Response

Based on the surveyed population, seventy-six percent of the motorists noticed the sign. Those that did not notice the sign did not respond to the remaining questions. The response to the DVMS was generally positive. Of those that noticed the sign, all respondents thought it was useful to very useful (Figure 12).

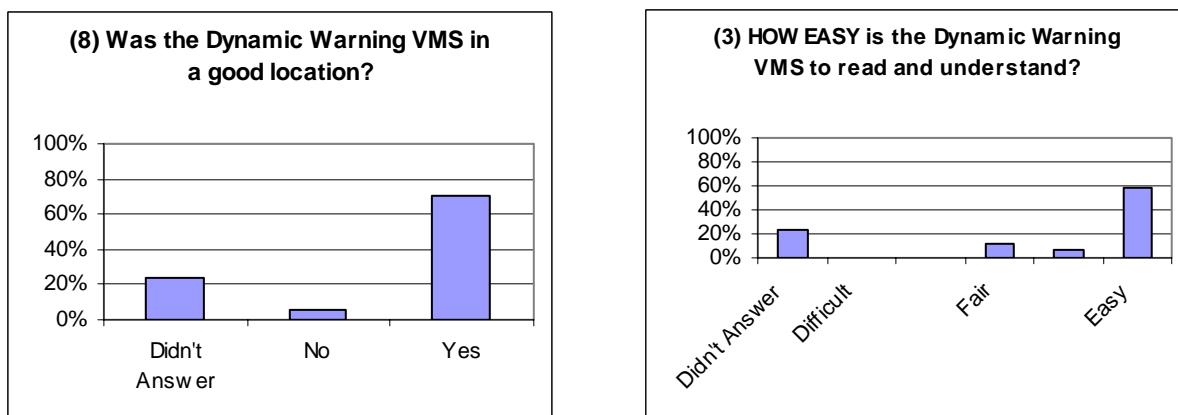
Figure 13: Location and Visibility

Motorists generally felt the sign was in a good location and was easy to read (Figure 13). There appears to be no difficulty in reading and responding to the DVMS. Of those that noticed the sign, 92% thought it was in a good location and 77% thought it was easy to read.

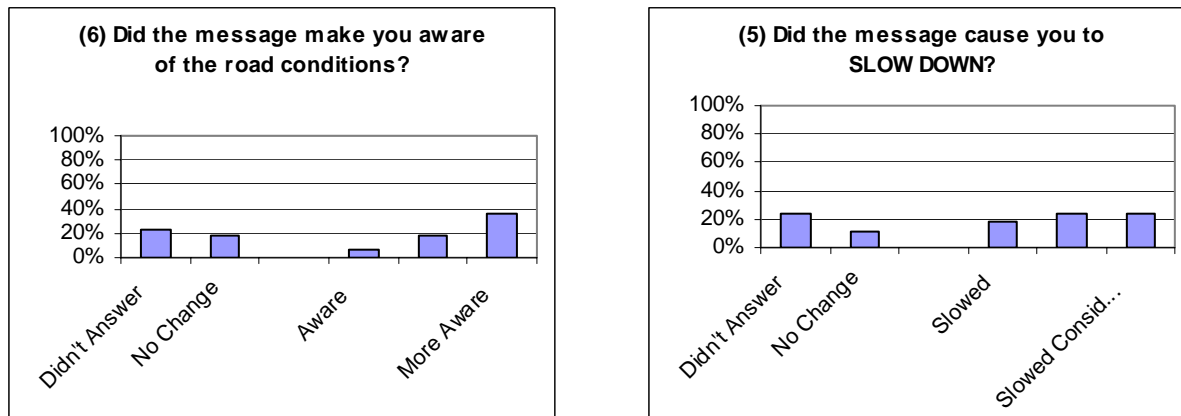
Figure 14: Motorist Response in Behavior

The primary purpose of the motorist survey was to measure motorists' reported change in driving behavior after seeing the DVMS. Regarding a change in their awareness of the road conditions, 23% of respondents who noticed the sign reported no change, 46% reported more awareness and 31% reported some change in awareness. Regarding a change in speed, 15% reported no change, 23% slowed somewhat, 31% slowed (between somewhat and considerably), and 31% slowed considerably.

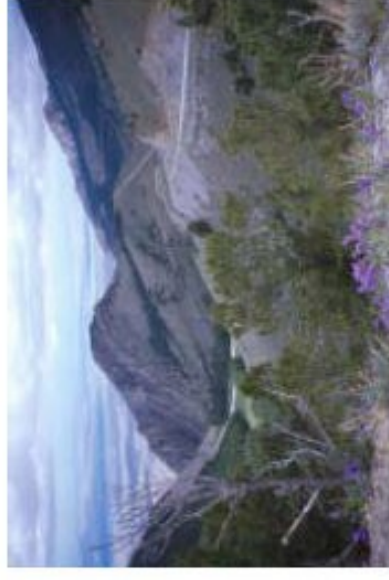
The U.S. Highway 14A Dynamic Warning Variable Message Sign (VMS)

On the Westbound
(downhill) lane of U.S. 14 Alt.
Approximately 20 miles
East of Lovell, WY
