An Evaluation of Dynamic Curve Warning Systems in the Sacramento River Canyon

Final Report

California Department of Transportation
New Technology and Research Program
Sacramento, California

April 2000

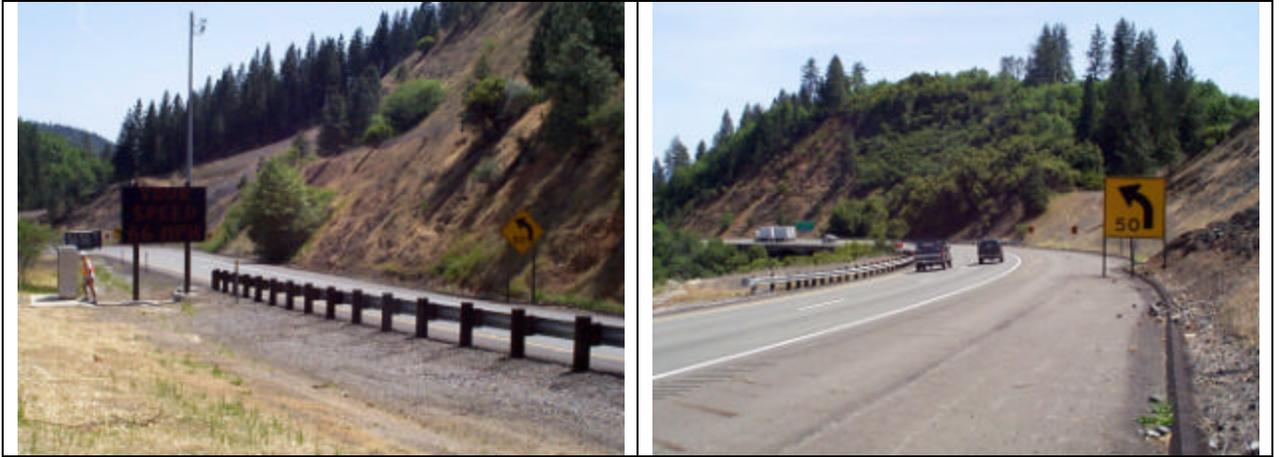
Figure 2: Sidehill Viaduct Site Location

Figure 2 shows the Sidehill Viaduct site and Figure 3 shows the layout of the curve at this site.

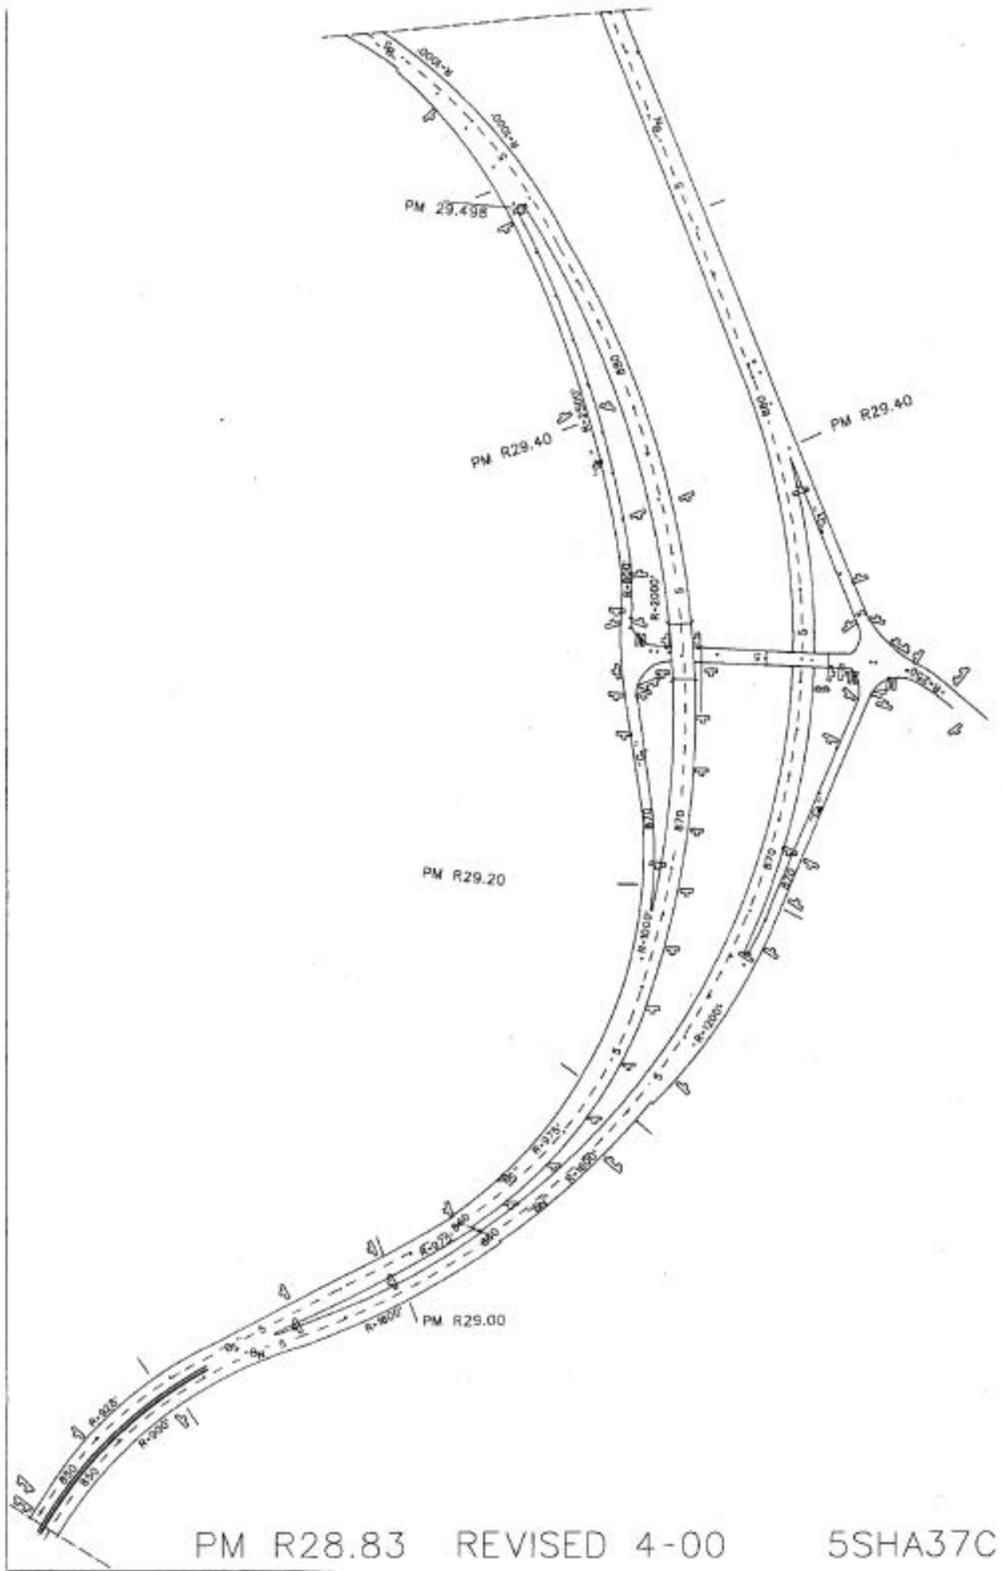
Figure 3: Sidehill Viaduct Curve Layout

At the time of pre-installation data collection, this area had a speed limit of 55 mph. When the second set of data was collected, the speed limit had been increased to 65 mph for passenger cars; the speed limit for commercial trucks remains at 55mph. The advisory speed for the curve has remained at 50 mph.

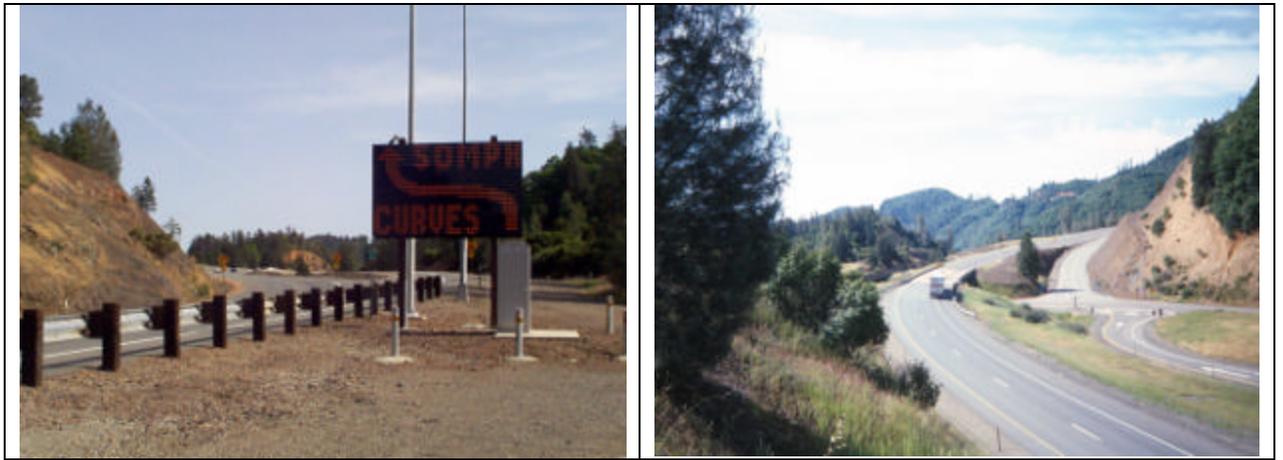
Figure 4: O'Brien Site Location

The O'Brien site is located facing southbound traffic on Interstate 5. The signed right-hand curve is located preceding a diamond interchange. The photograph in Figure 4 is the O'Brien site, and the layout of the curve can be seen in Figure 5.

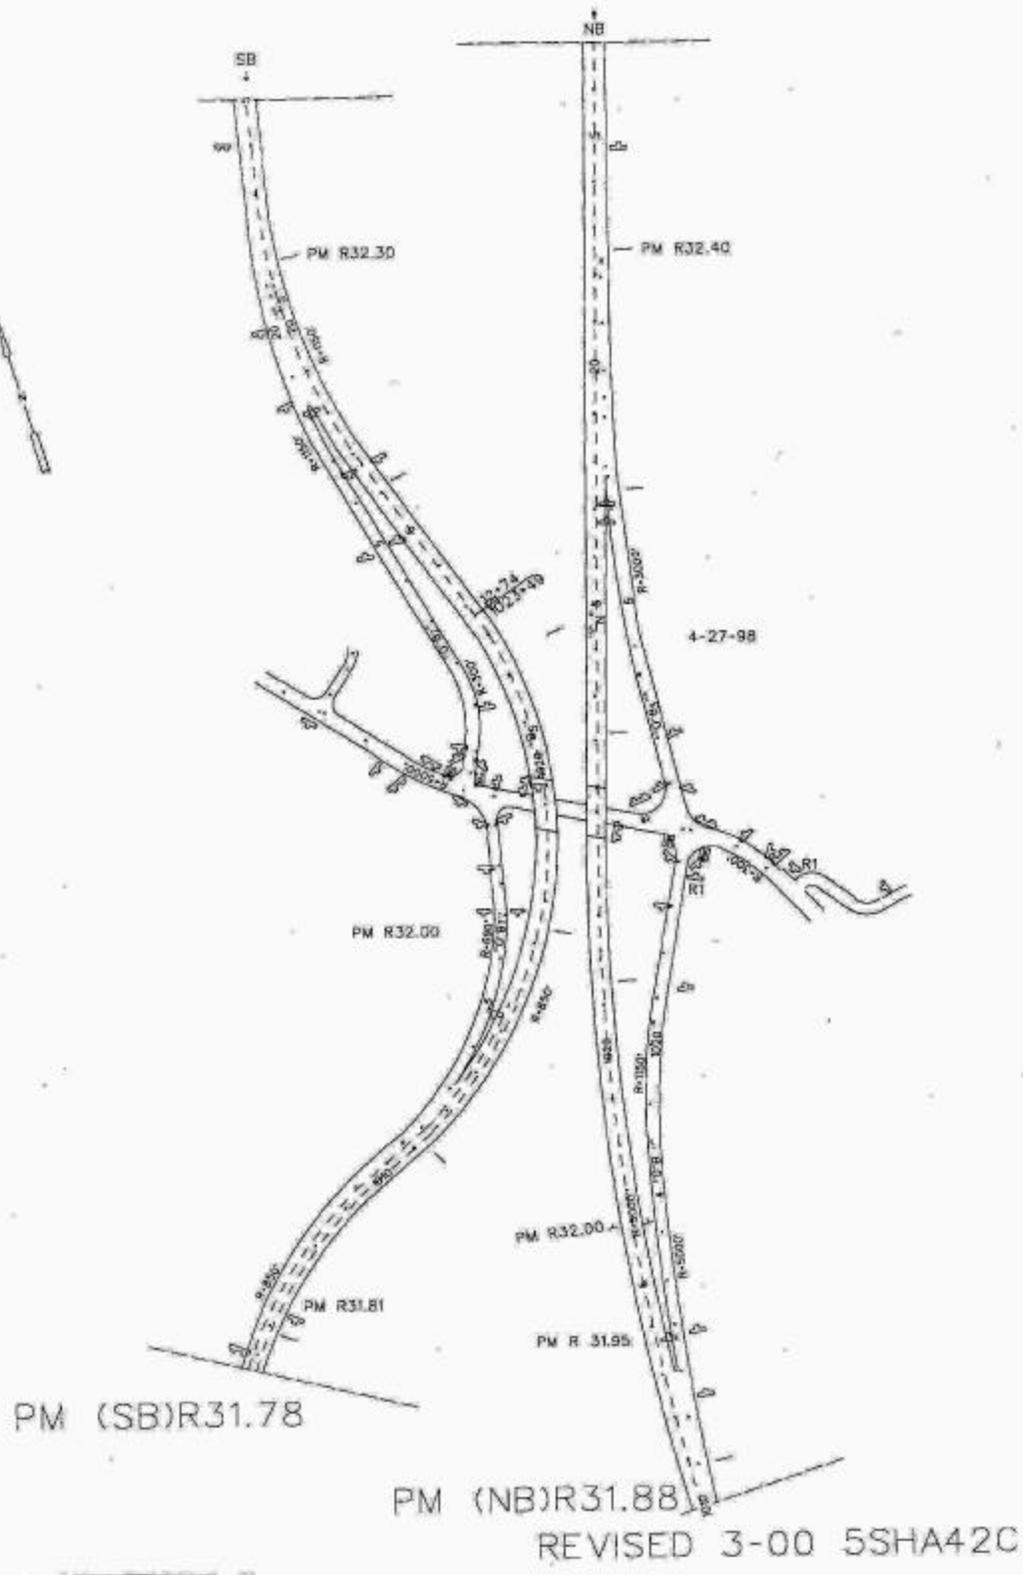
Figure 5: O'Brien Curve Layout

An advisory speed of 50 mph has been maintained throughout the course of the curves at the O'Brien Interchange. Although this area had a 55 mph speed limit at the time of the first data collection trip, it since has been raised to 65 mph for passenger cars. The truck speed limit remains at 55 mph.

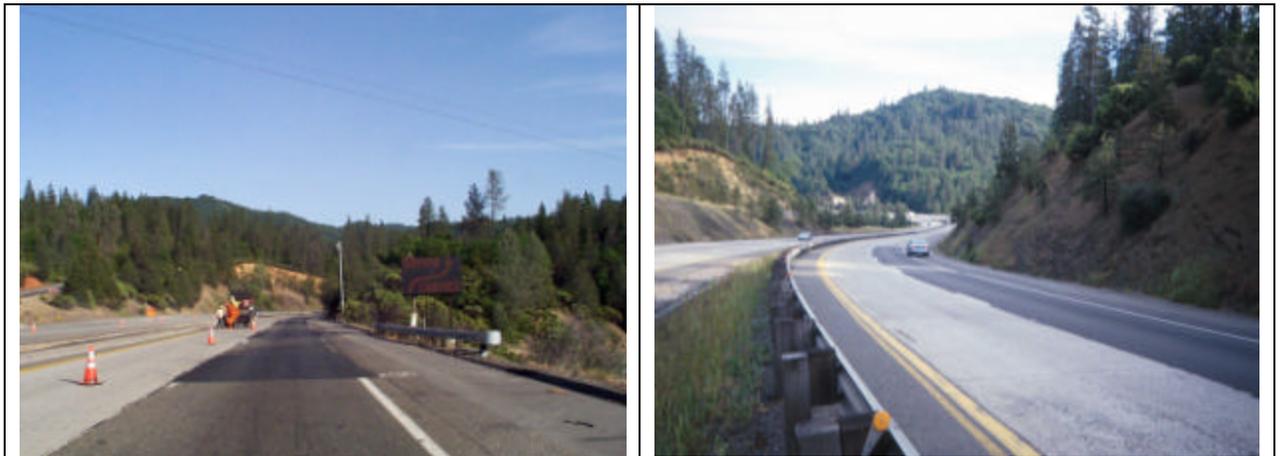
Figure 6: Salt Creek Site Location

This site is on Interstate 5 southbound, following the Salt Creek Interchange. Of the two curves following the dynamic curve warning system (shown on the right in Figure 6), the second curve is the principal reason for placing the dynamic curve warning sign in this area. Placing the dynamic curve warning system between the two curves would not have allowed adequate sight distance for motorists to respond prior to entering the second curve; therefore, the dynamic curve warning system was placed before the first curve. A fairly steep downgrade exists prior to and within the first curve. The second horizontal curve coincides with a vertical curve changing from a grade of -5% to $+6\%$ (13). The site location at Salt Creek is shown in Figure 6 and the horizontal drawing of the curve is in Figure 7.

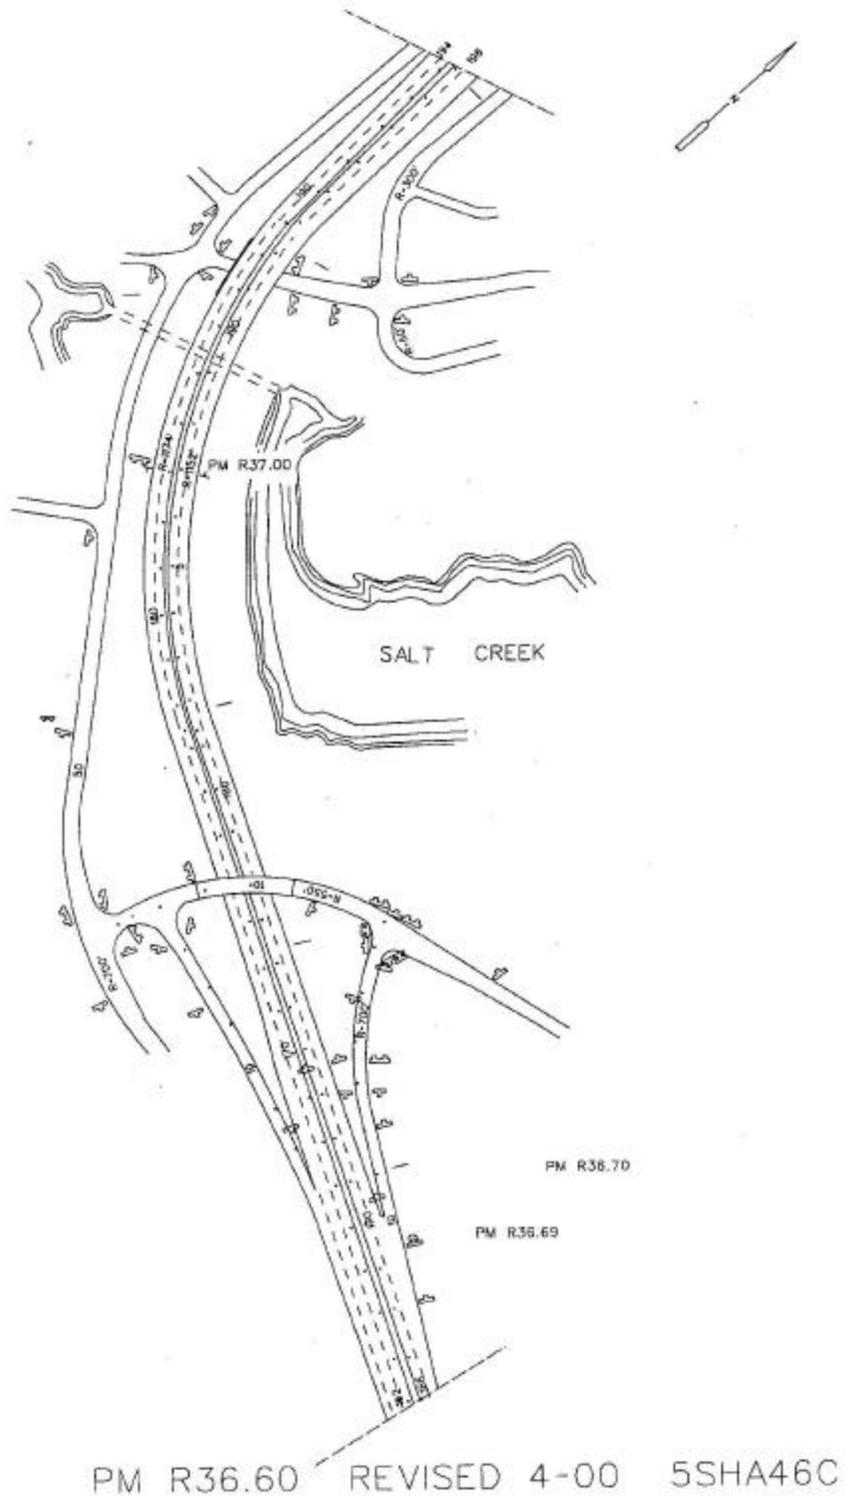
Figure 7: Salt Creek Curve Layout

At the time of the first site visit, this area had a 55 mph speed limit that has been increased to 65 mph for passenger cars. The speed limit for trucks remains at 55 mph, and the curve advisory speed remains at 50 mph.

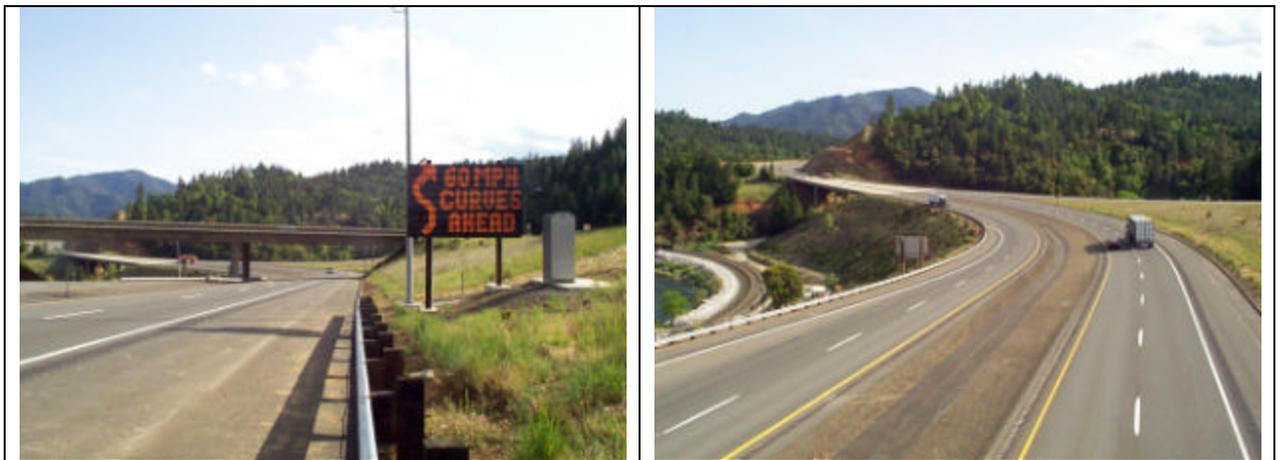
Figure 8: La Moine Site Location

This dynamic curve warning system is located on the southbound side of Interstate 5, near the La Moine Interchange. Following the interchange, the freeway enters an S-Curve (left then right). Although both curves are being signed for, it was assumed that the first curve would better show the direct impact from the dynamic curve warning system message. Speeds at the following curve(s) may be influenced by the vehicle traveling speeds in the previous curve(s). Therefore, data were collected only for the first curve. Figure 8 depicts the La Moine site and curves, and Figure 9 shows the layout of the curve.

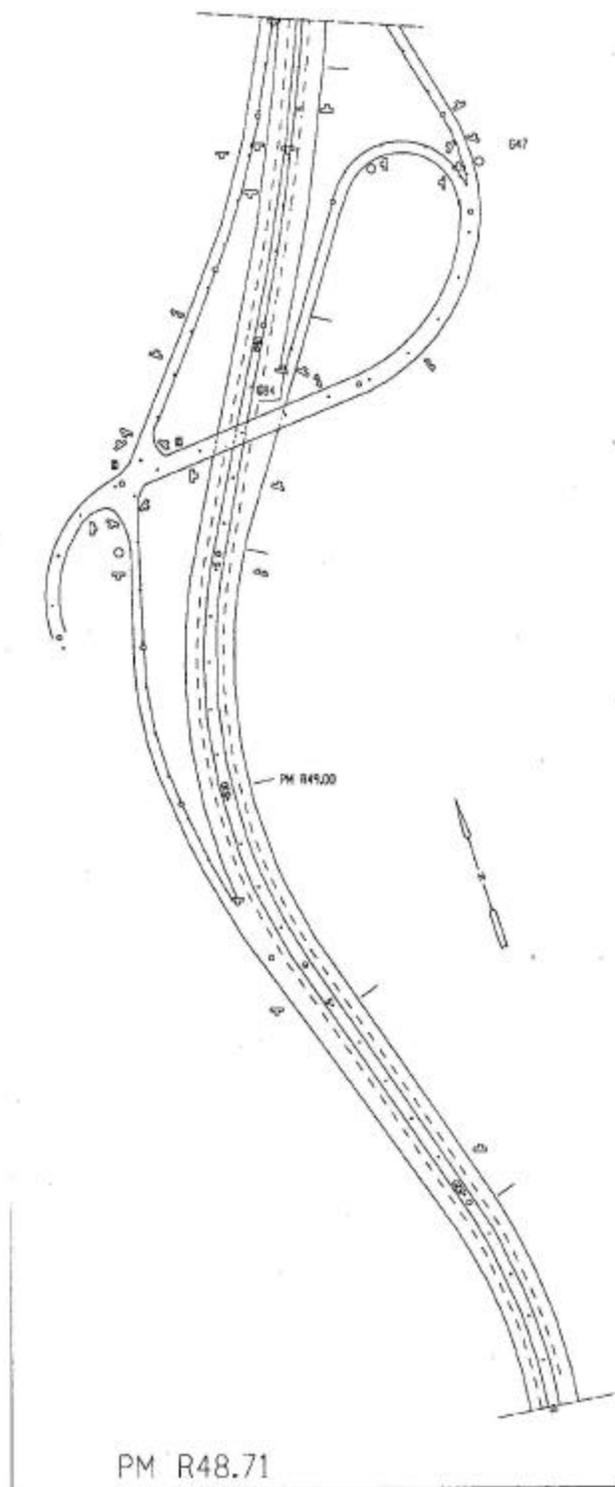
Figure 9: La Moine Curve Layout

Since the study began, this area has maintained a 65 mph speed limit for passenger cars and 55 mph speed limit for trucks. This is the only curve among the five study sites with an advisory speed of 60 mph.

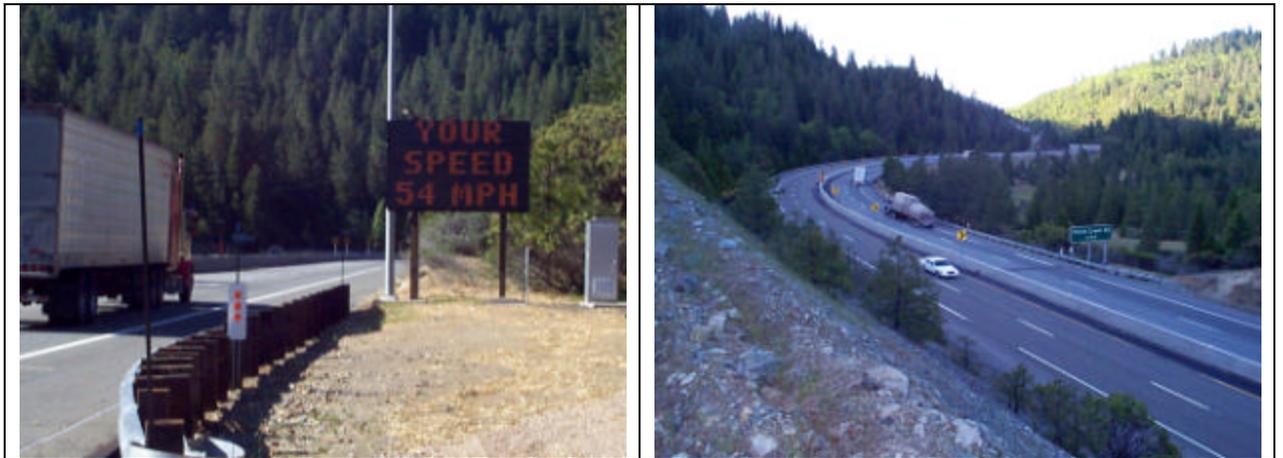
Figure 10: Sims Road Site Location

The Sims Road dynamic curve warning system is the only northbound study site on Interstate 5. The signed curve is a right hand curve, which is pictured in Figure 10 and drawn in Figure 11.

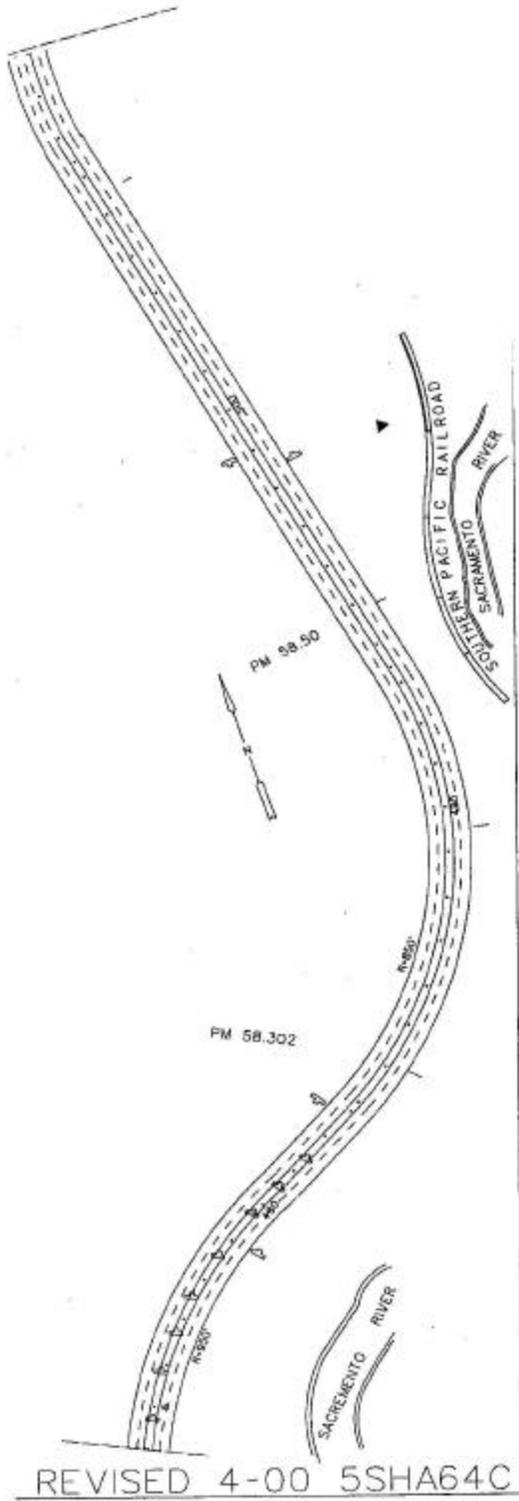
Figure 11: Sims Road Curve Layout

This area also has had a 65 mph speed limit for passenger cars and a 55 mph speed limit for commercial trucks throughout the study period. An advisory speed of 50 mph exists for the curve.

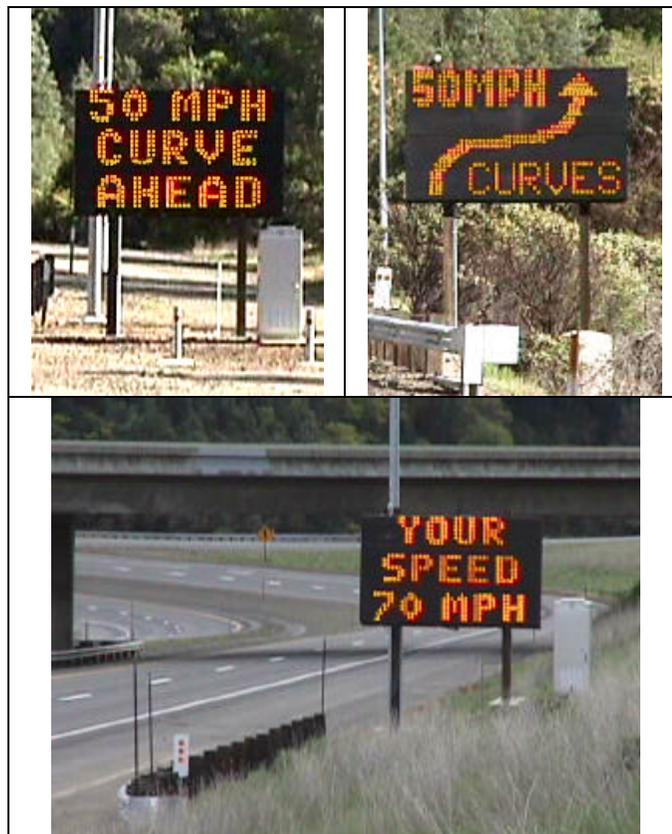
The dynamic curve warning system includes the following elements at each site: a changeable message sign (CMS), a radar speed-measuring device, two cameras, video detection software for one of the cameras, and control/communications equipment. This report includes the evaluation conducted on the effectiveness of the CMS and radar unit on driver behavior, and does not include an evaluation of the camera and software functions. The CMS at each location is a 10-foot by 7-foot full matrix light-emitting diode (LED) sign supplied by American Signal Company that allows for 50 columns and 28 rows of lights (12). Each CMS has specific messages and graphics that can be displayed and rotated every three to four seconds. Some of the standard messages are shown in Figure 12.

Figure 12: Some Standard Sign Messages

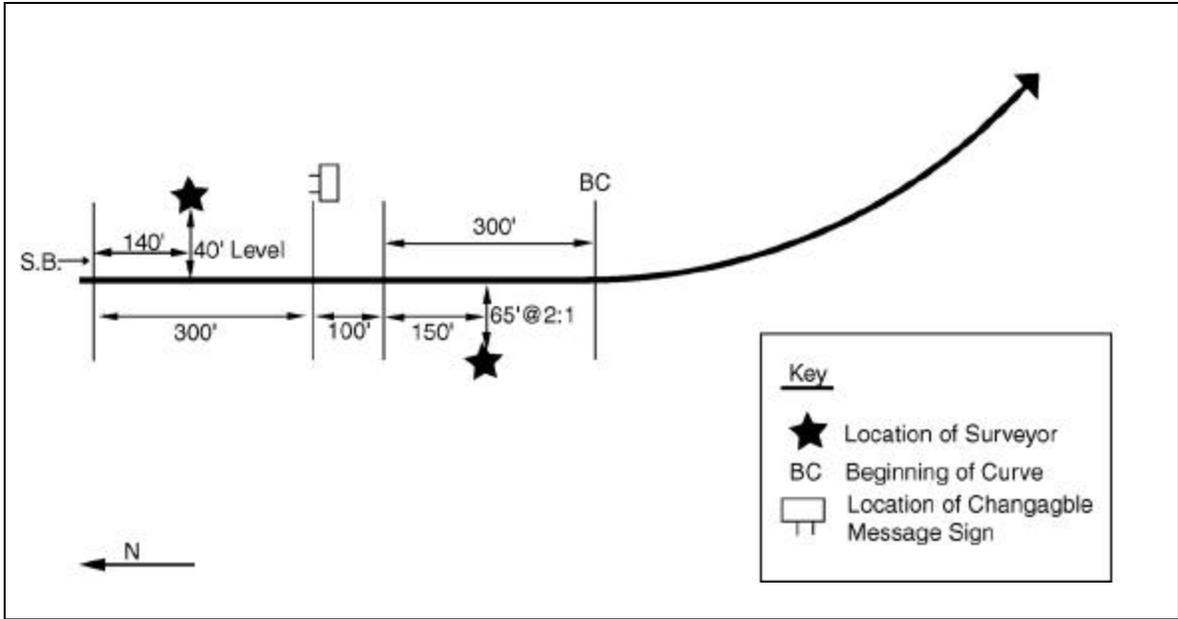
The first speed measurement section was measured from the CMS location to 300 feet upstream, and the second section was measured from the approximate beginning of the curve to 300 feet upstream. Brightly colored paint was used on the laneline to mark the beginning and endpoint of each speed section. To observe the vehicles and record the requisite information, data collectors sat between the two points. Because a tire from each vehicle could be followed as it crossed the painted marks, parallax error was negligible (14). Figures 13-17 display site diagrams from each site, showing the speed measurement section setup and positioning of the data collectors.

Figure 13: Site Diagram: Sidehill Viaduct

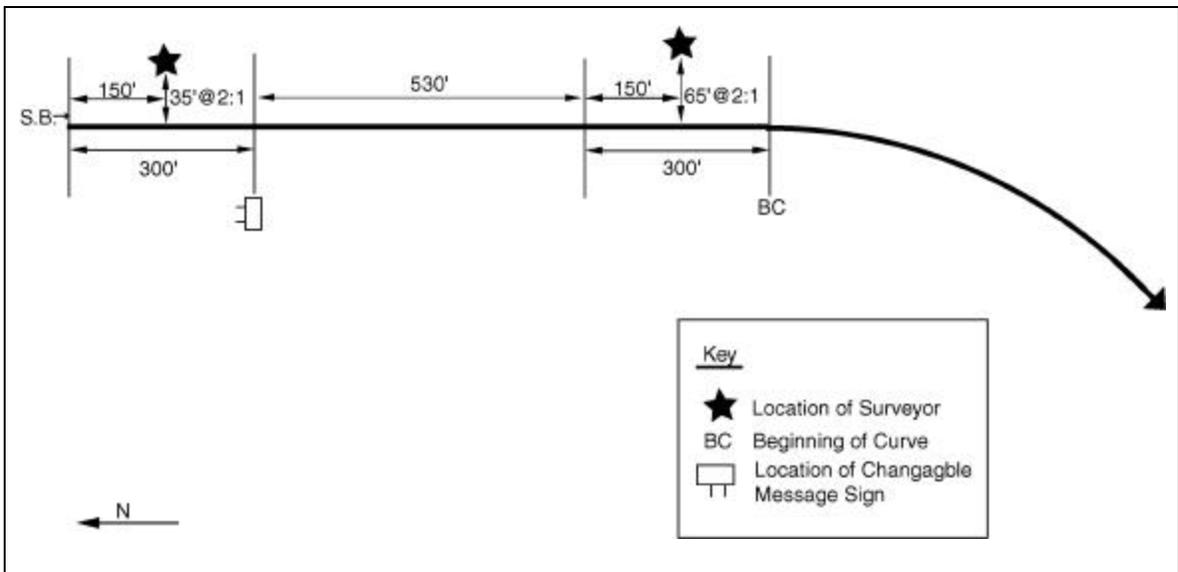
Figure 14: Site Diagram: O'Brien

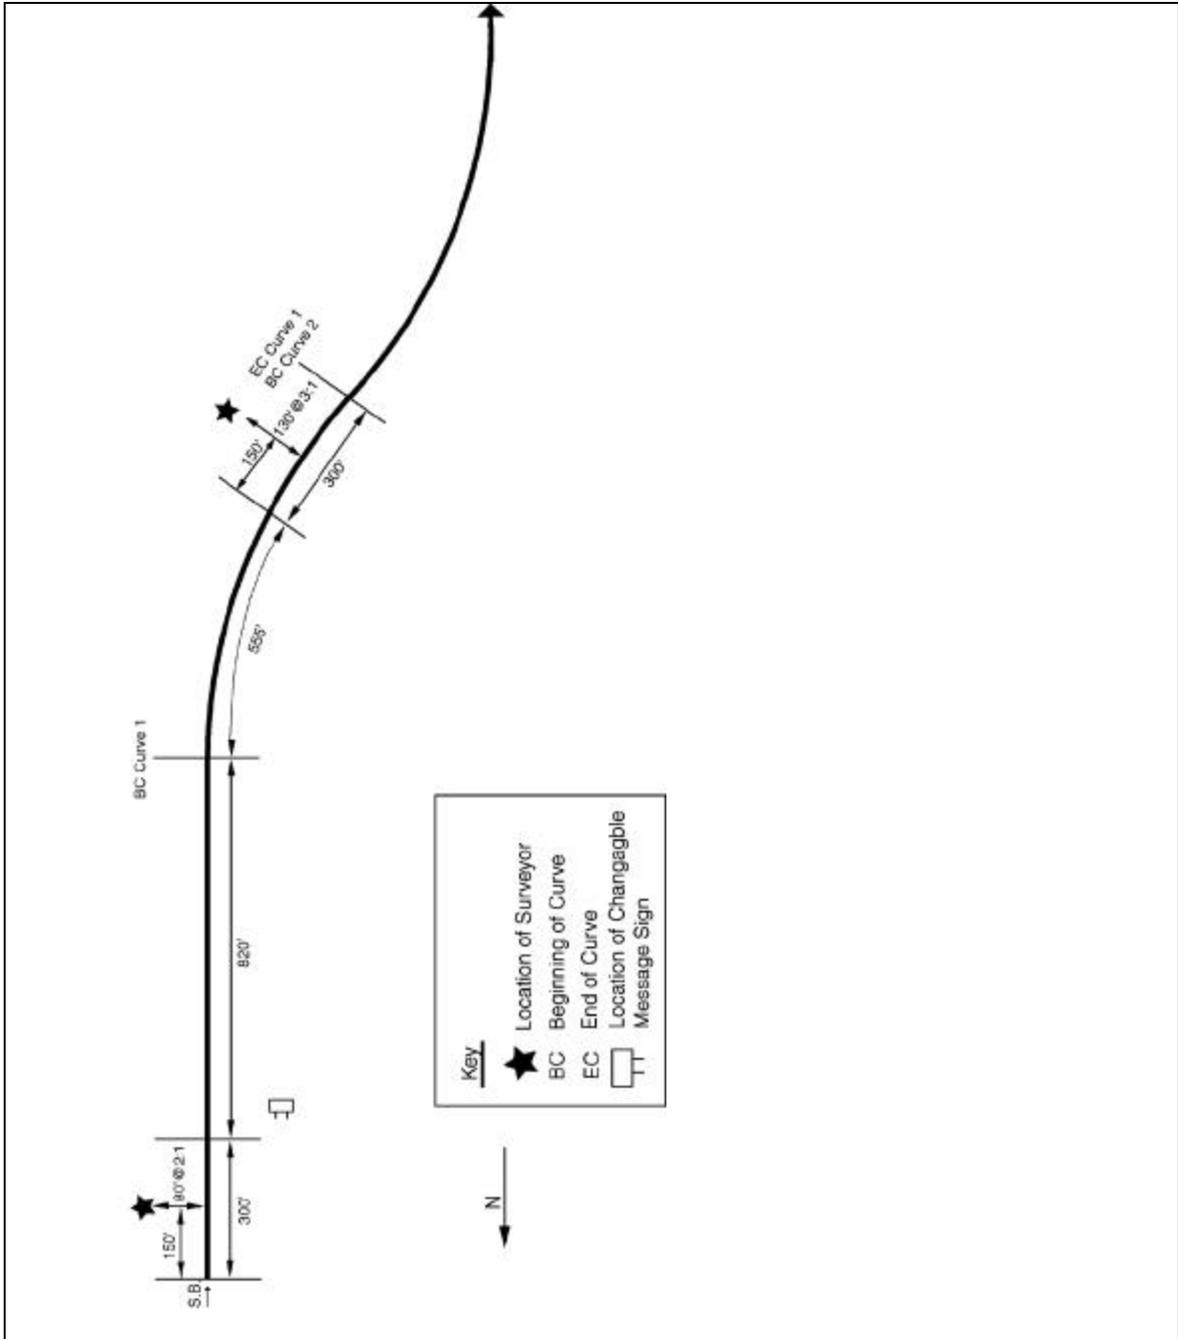
Figure 15: Site Diagram: Salt Creek

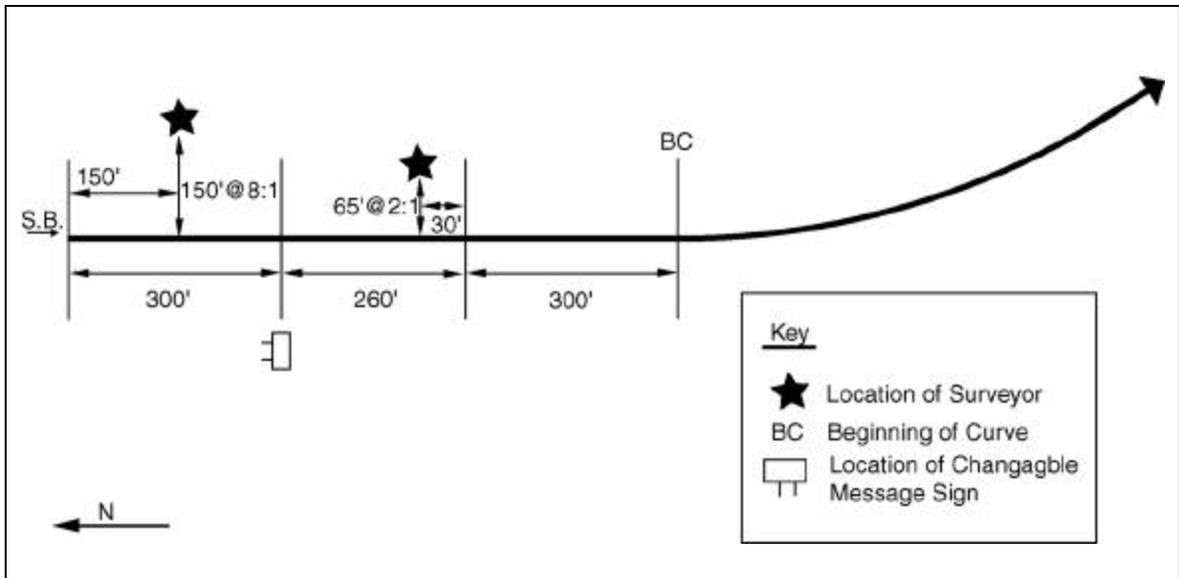
Figure 16: Site Diagram: La Moine

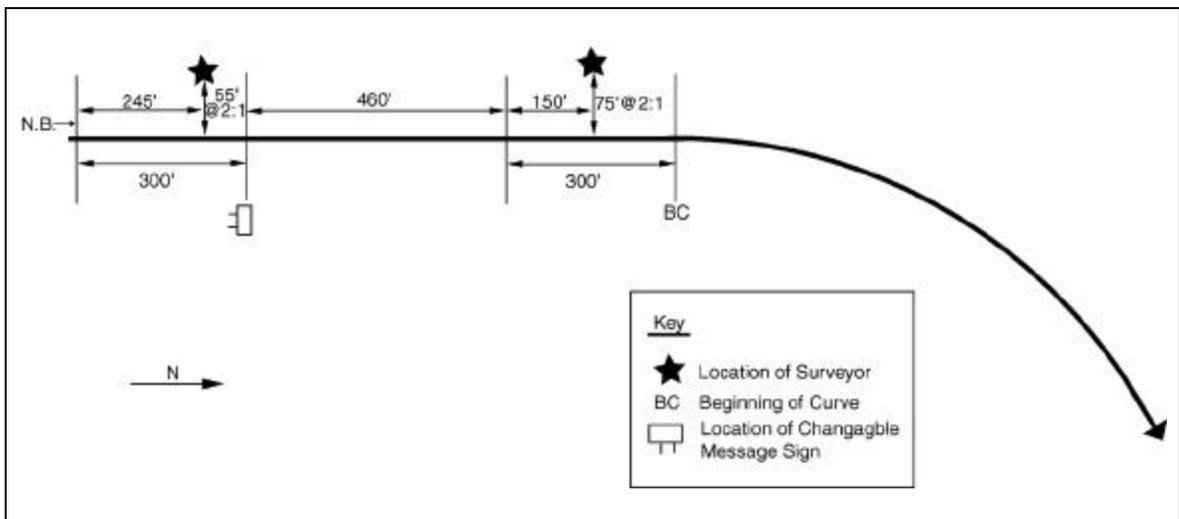
Figure 17: Site Diagram: Sims Road

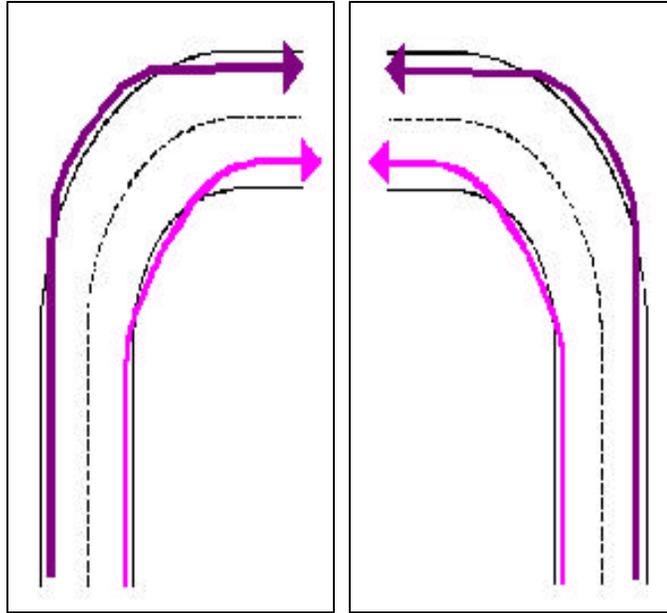
Inside/Outside Edgeline: This particular type of maneuver occurred when the vehicle crossed the painted stripe with two wheels from the inside or outside lane and then returned to the travel lane (Figure 18).

Figure 18: Erratic Maneuvers – Inside/Outside Edgeline

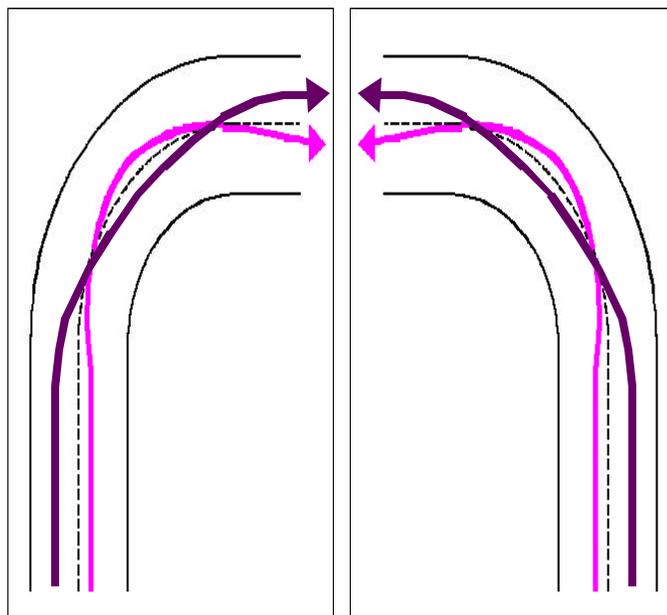
Cross Laneline: Records were kept when the vehicle crossed the laneline to the other lane and then returned to the original lane (Figure 19).

Figure 19: Erratic Maneuvers – Cross Laneline

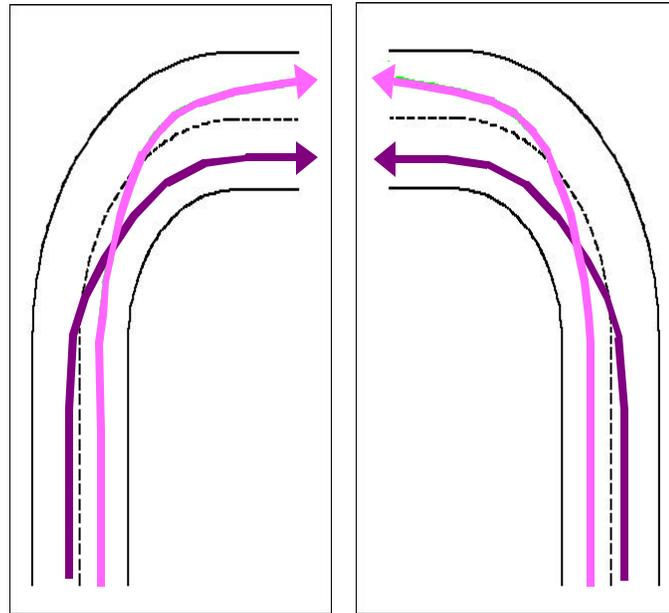
Lane Change: If a vehicle was performing a full lane change during the curve, this was classified as a “Lane Change” maneuver (Figure 20).

Figure 20: Erratic Maneuvers – Lane Change

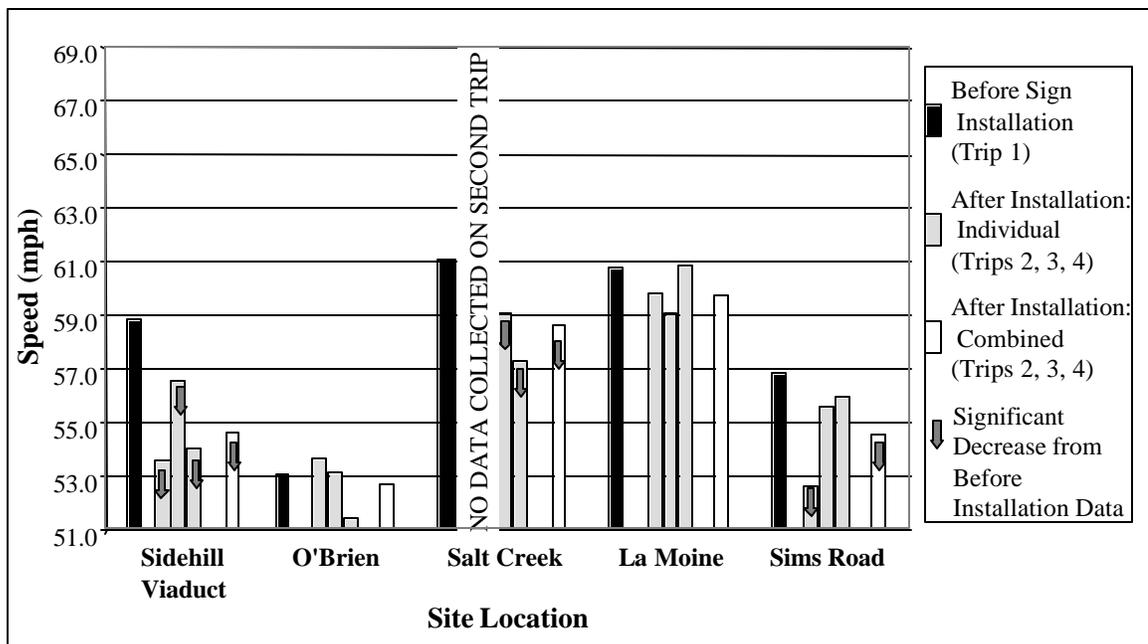
Speeds were measured and recorded as the vehicles were traveling through the speed measurement section at the beginning of the curve at each site. A mean speed was found for each data collection trip at each site; Figures 21 and 22 graphically depicts the mean speeds. The speed data were separated by vehicle type: Figure 21 shows the speed data collected for commercial vehicles, vehicles towing trailers, and recreational vehicles; Figure 22 shows the speed data for passenger cars. The black columns signify the average speeds found at each study site during the trip made prior to the dynamic curve warning system installation. The gray columns are the speeds observed after the dynamic curve warning systems were in place, and correspond specifically to the second, third, and fourth trips from left to right. The white column for each site represents the average of the speed measurements obtained on the second, third and fourth trips (i.e., all the data collected after the dynamic curve warning system was installed). The gray arrow appearing in some of the columns indicates a significant decrease in speed ($\alpha = 0.05$)

when these data were compared with the data collected on the first trip (i.e., before the dynamic curve warning system). If no arrow is present, there was either no significant change or there was an increase in mean speed from before to after the installation of the dynamic curve warning system. An increase in speed or no change in speed between the before and after the dynamic curve warning system installation data (denoted by no arrow in the corresponding column) suggest the dynamic curve warning system may be ineffective at reducing speeds at the specific location.

Figure 21: Mean Truck Speeds At the Curve At All Five Sites

As can be noted in Figure 21, there were significant decreases in speed at the curves at the Sidehill Viaduct, Salt Creek, and Sims Road sites. Sidehill Viaduct and Salt Creek both showed significant decreases in all post-installation periods. An examination of roadway characteristics reveals that these two sites are the only curves located on steep downgrades exceeding a 5% grade. The speeds at the Sims Road site significantly decreased initially (64.1 mph to 61.9 mph), but then continued to rise over time. Overall,

mean post-installation truck speed was significantly lower than the corresponding pre-installation speed at Sims Road, but given the increases in speed noted in the data collected on the third and fourth trips, it would appear that desensitization to the dynamic curve warning system is a possibility at this site. The truck speeds collected at the O'Brien and LaMoine sites did not show any significant decreases after the dynamic curve warning system was in place.

During the fourth data collection trip, there were wet weather conditions at the Sidehill Viaduct and O'Brien sites, which could have had some effect on the speed measurements. When roadways are wet, drivers may reduce their travel speeds, thereby affecting the measured speeds at these sites.

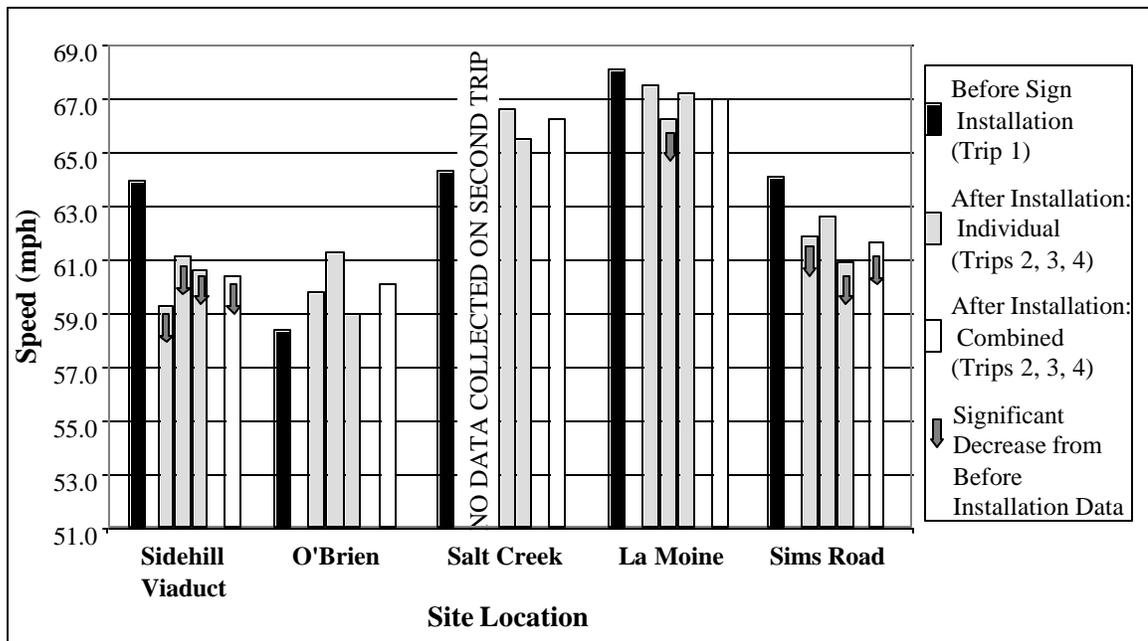
Figure 22: Mean Non-Truck Speeds At the Curve At All Five Sites

The results of the passenger car speed analyses indicate the Sidehill Viaduct and Sims Road sites have experienced significant speed decreases. The speeds collected on all three of the post-installation trips at Sidehill Viaduct showed statistically significant decreases. There was one statistically significant reduction in mean speeds at the La

As mentioned previously, weather also could have had some contributing effects on the data. Conditions were clear and dry for the majority of the data collection trips, with the exception of the fourth trip to Sidehill Viaduct and O'Brien where it was raining and/or the roadway was wet. Reductions in speeds at these two sites may have been due, at least in part, to drivers slowing their speeds because of the roadway conditions. Again, however, the discrepancy between the two sites remains unexplained.

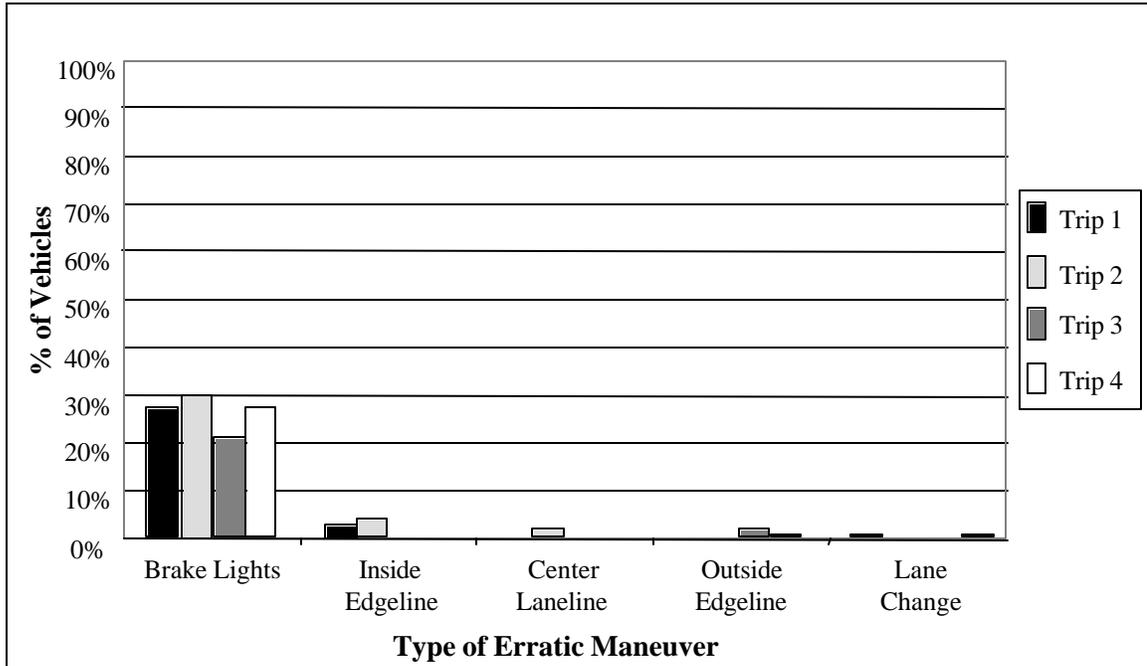
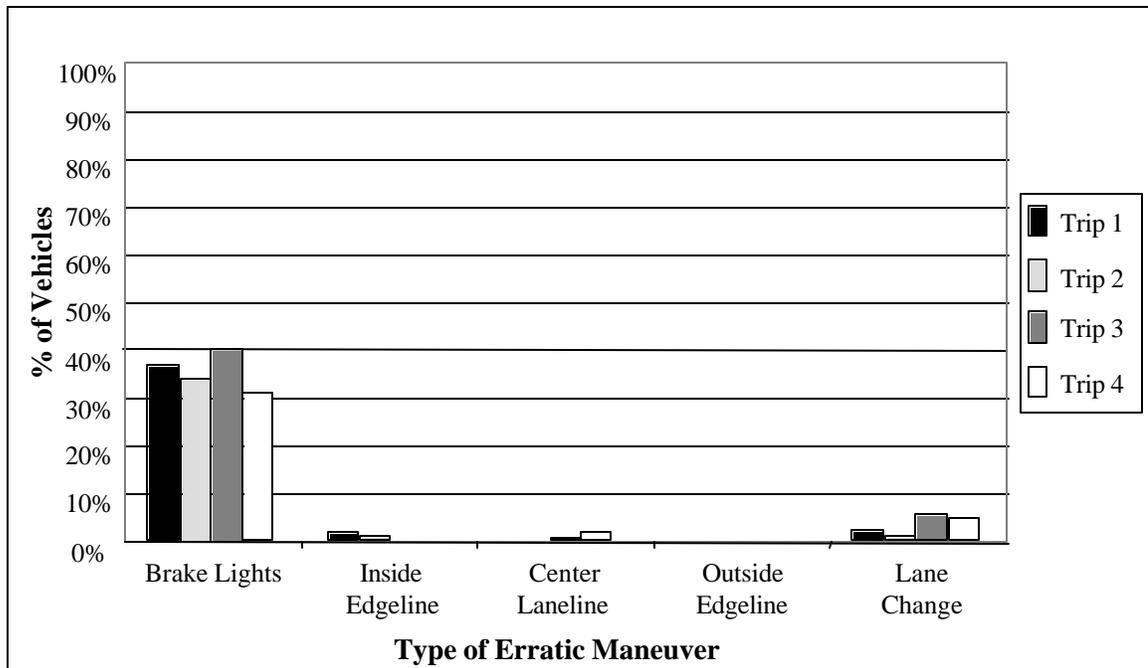
Figure 23 and 24 displays the erratic movements or use of brakes by truck and non-truck drivers during data collection at the Sidehill Viaduct site, respectively.

Figure 23: Sidehill Viaduct: Types of Erratic Maneuvers Performed by Trucks

Figure 24: Sidehill Viaduct: Types of Erratic Maneuvers Performed by Non-truck Drivers

Figures 23-32 include erratic maneuver information recorded at each site during each data collection trip. Although statistical analysis was not conducted by vehicle type, the figures show data broken up by trucks (commercial vehicles, automobiles with trailers, and recreational vehicles) and non-trucks (passenger cars and pickups). While lane encroachment categories are mutually exclusive, it is quite possible for a driver to apply his brakes and cross the boundaries of the travel lane during his negotiation of the curve. Therefore, some drivers are double-counted in the following figures.

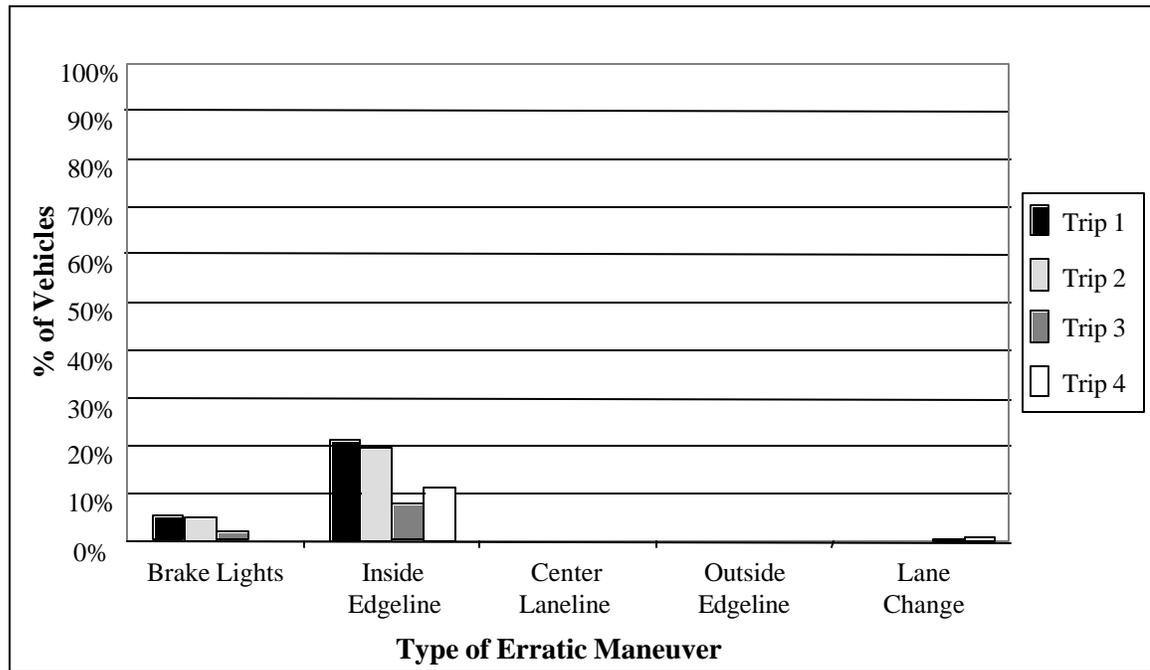
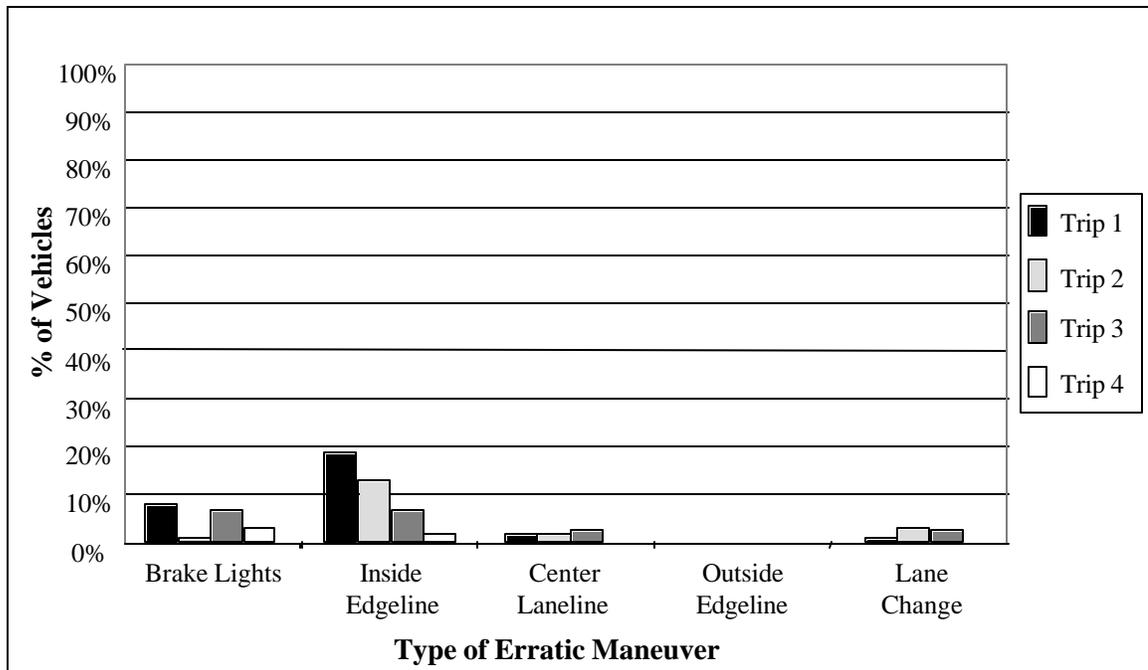
The types of erratic movements performed at the O'Brien site during each of the data collection trips are shown in Figure 25 and 26.

Figure 25: O'Brien: Types of Erratic Maneuvers Performed by Truck Drivers

Figure 26: O'Brien: Types of Erratic Maneuvers Performed by Non-truck Drivers
