An Evaluation of Dynamic Curve Warning Systems in the Sacramento River Canyon

Final Report

California Department of Transportation
New Technology and Research Program
Sacramento, California

April 2000

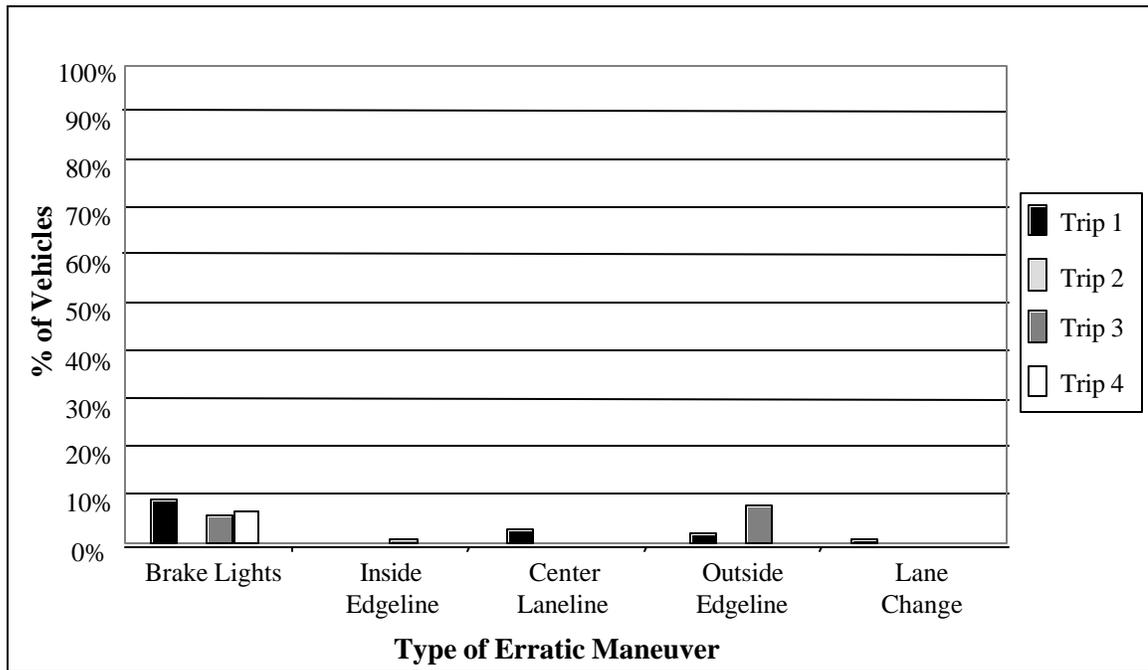
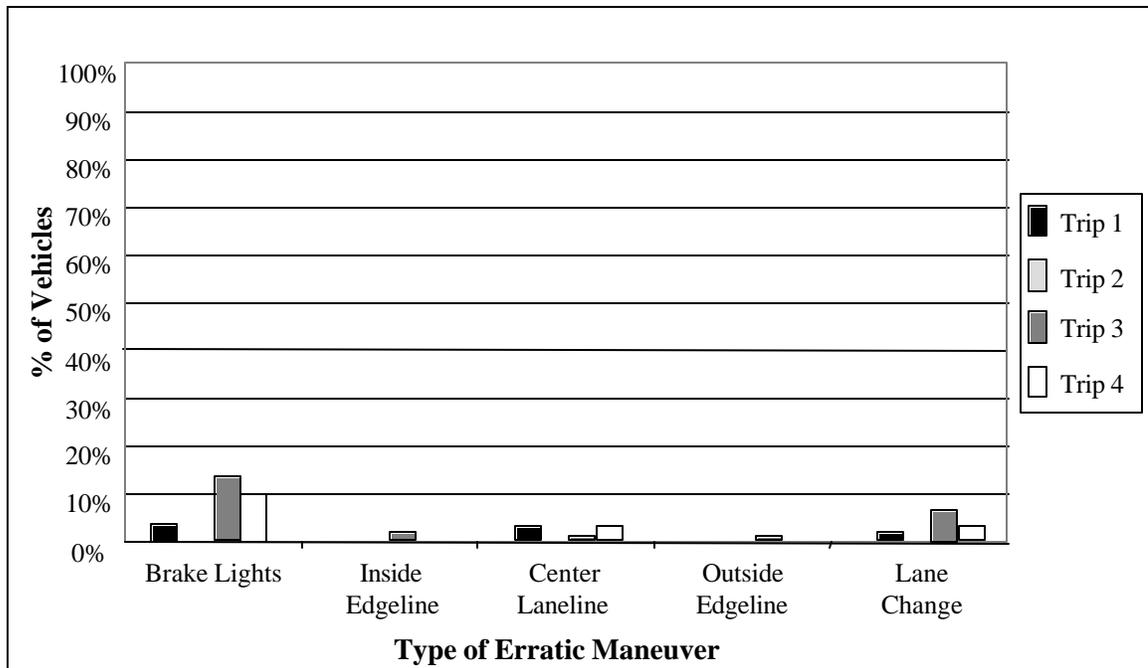
Figures 27 and 28 illustrate the fact that less than 10% of the vehicles were observed making any type of lane line encroachment at the Salt Creek site.

Figure 27: Salt Creek: Types of Erratic Maneuvers Performed by Truck Drivers

Figure 28: Salt Creek: Types of Erratic Maneuvers Performed by Non-truck Drivers

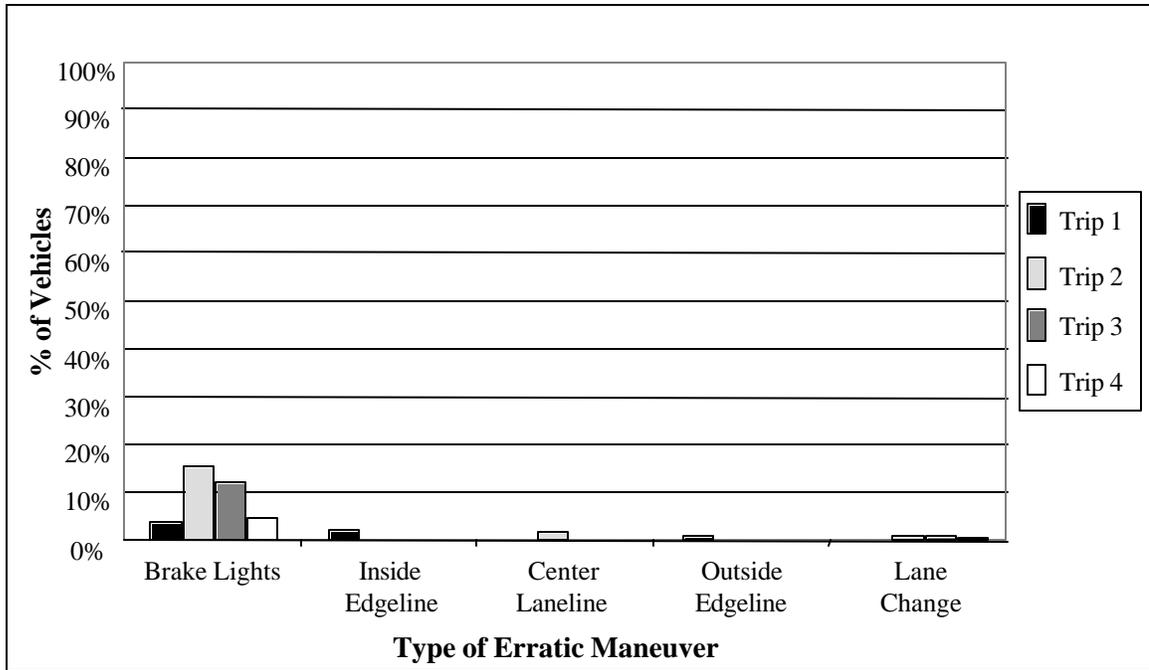
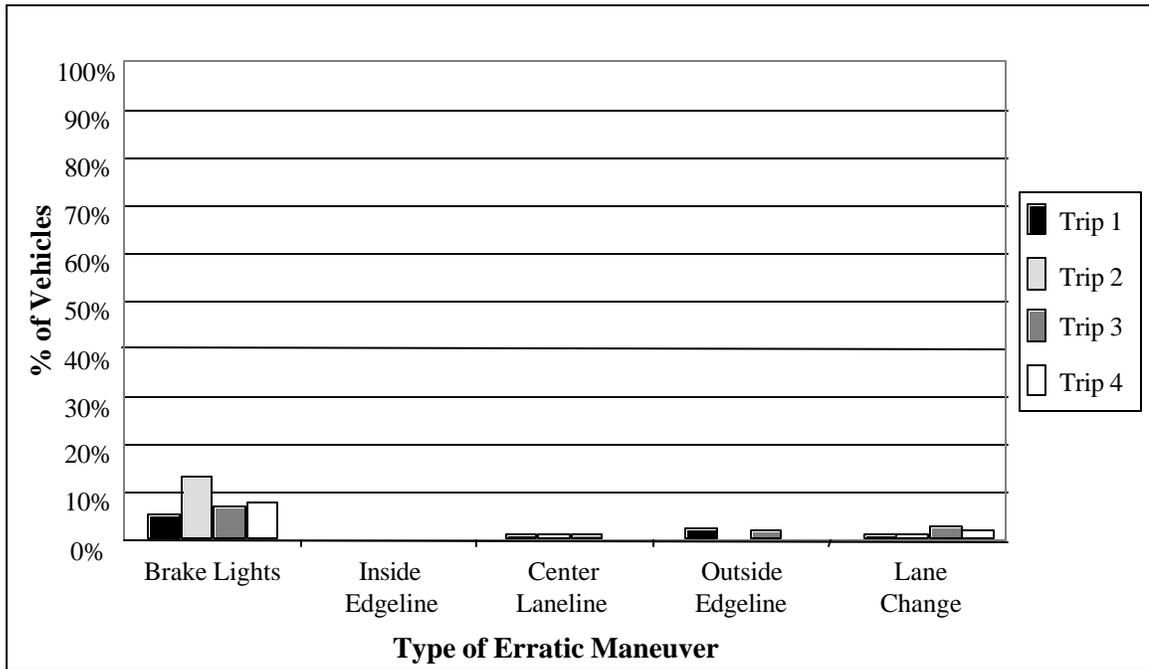
During each data collection, the majority of drivers viewed at the LaMoine site (over 90%) did not perform any lane line encroachments, as can be seen in Figures 29 and 30.

Figure 29: La Moine: Types of Erratic Maneuvers Performed by Truck Drivers

Figure 30: La Moine: Types of Erratic Maneuvers Performed by Non-truck Drivers

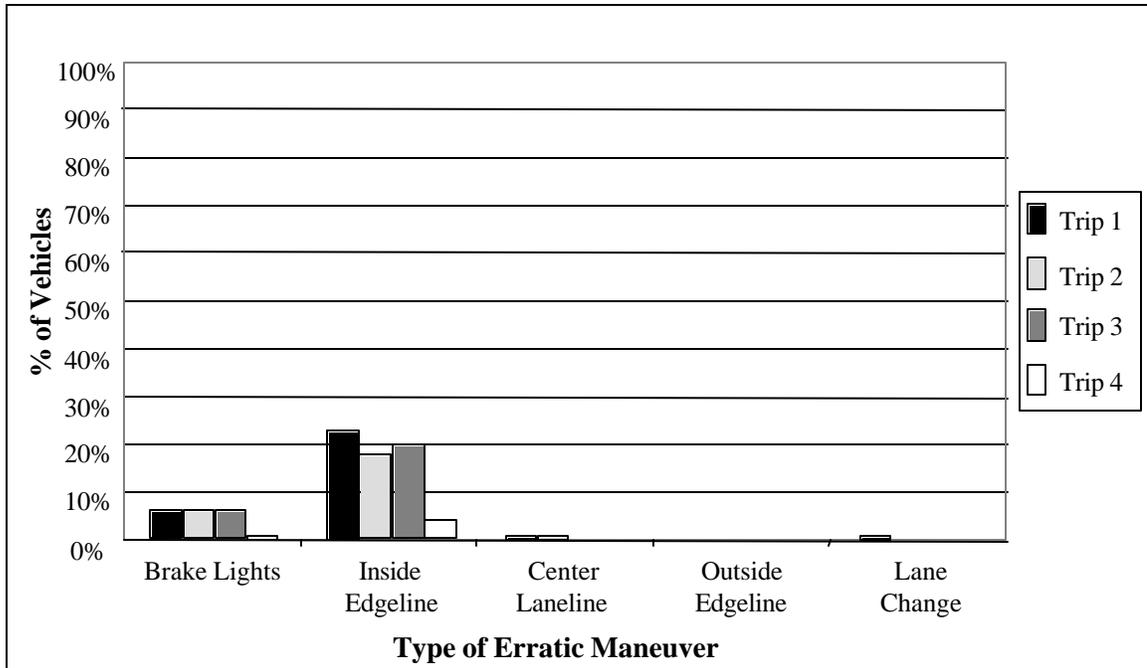
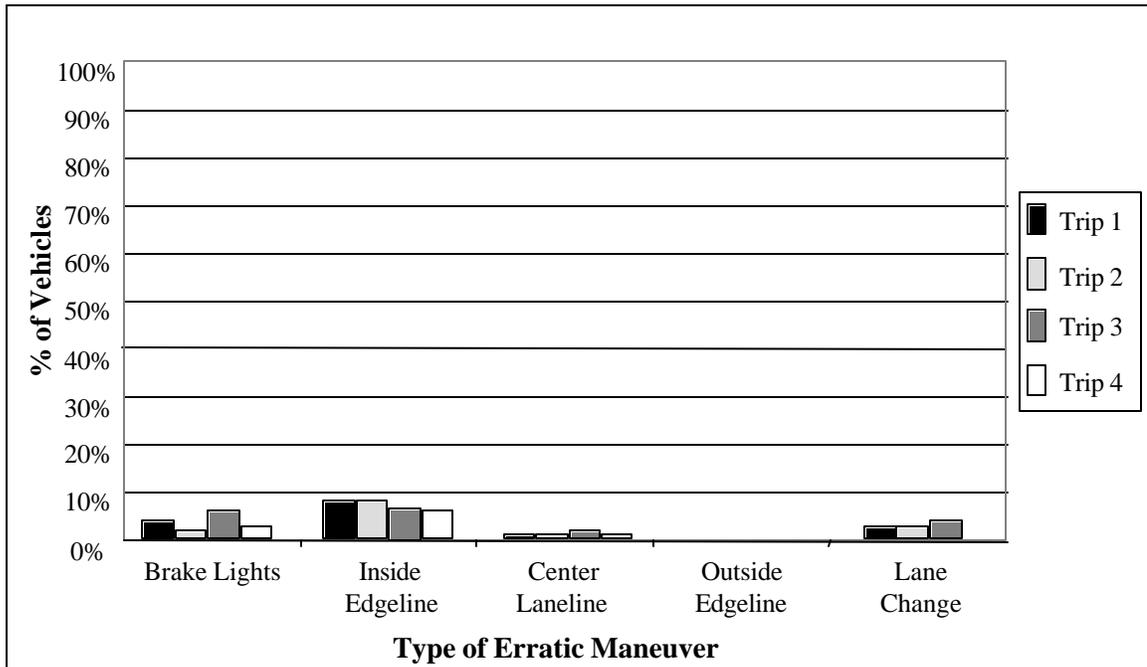
Figures 31 and 32 display the different ways in which vehicles left the lane boundaries at the Sims Road site and the percentage of drivers who used their brakes while traveling the curve.

Figure 31: Sims Road: Types of Erratic Maneuvers Performed by Truck Drivers

Figure 32: Sims Road: Types of Erratic Maneuvers Performed by Non-truck Drivers
