**Effects of Four-Lane Highways on Desert Kit Fox and Swift Fox:  
Inferences for the San Joaquin Kit Fox Population**

**Report number CA10-1095**

**Final Report**

**State of California, Department of Transportation  
Division of Research and Innovation, Office of Materials and Infrastructure Research**

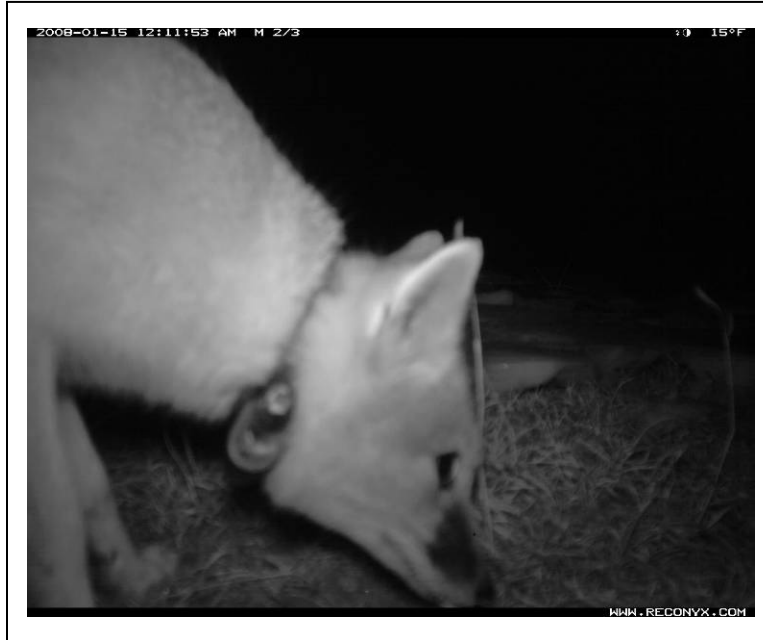
**Figure 4.** Remotely triggered image taken on 15 January 2008, eight days past programmed drop-off date. After several attempts, this fox was not recaptured.

Attempts at UHF tracking during pre-programmed beacon times were almost completely unsuccessful with the exception of obtaining a weak signal from one collar (Channel [CH] 54) on two occasions in the entire three-month period. Both detections were on the side of the highway that the animal was collared. Collars failed to drop off in 90 days as programmed by the manufacturer. Images of two collared individuals were obtained days after the factory programmed drop-off date, illustrating the collars did not drop off as intended (Figure 4 and Figure 5).

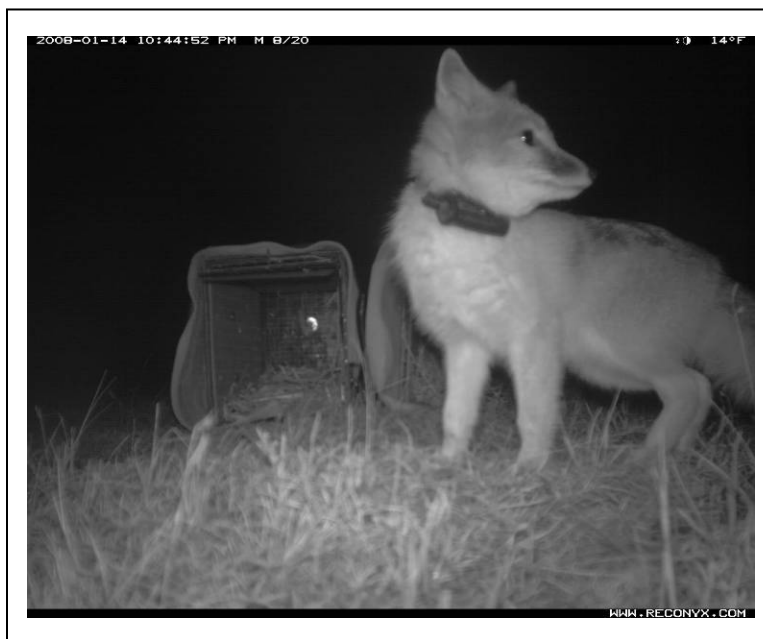
**Figure 5.** Remotely triggered image taken on 14 January 2008, four days past programmed drop-off date. This female fox (CH66) was recaptured on 18 January 2008.

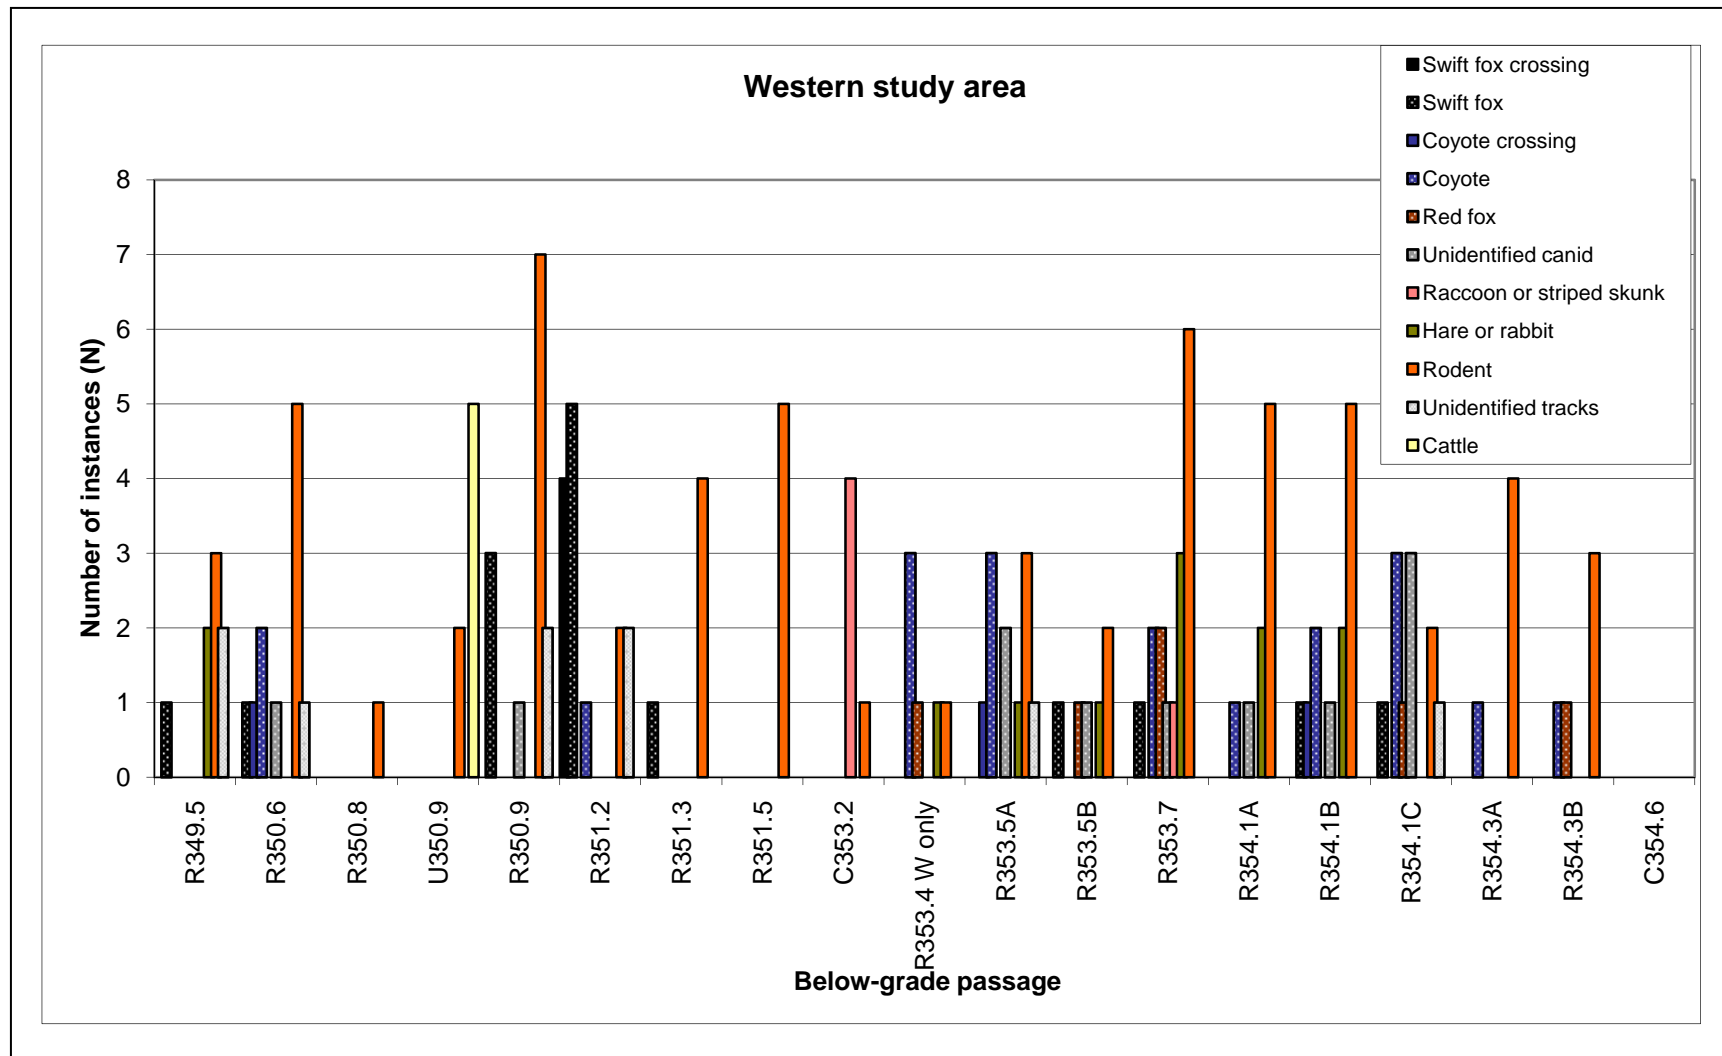
Figure 7. Number of instances of species (or groups) detected in or near entrances of below-grade passages in western study area.

Twenty-four below-grade passages at 19 different locations were monitored 21 times between 29 October 2007 and 10 January 2008. In addition to swift fox, birds—including an accipiter hawk (*Accipiter* sp.), small rodents (e.g., mice), hares or rabbits (family *Leporidae*), raccoon (*Procyon lotor*), striped skunk (*Mephitis mephitis*), red fox (*Vulpes vulpes*), coyote (*Canis latrans*) and domestic cattle were detected in or near entrances of passages by their tracks or camera images (Figure 7 and Figure 8). In some cases, tracks could not be identified.

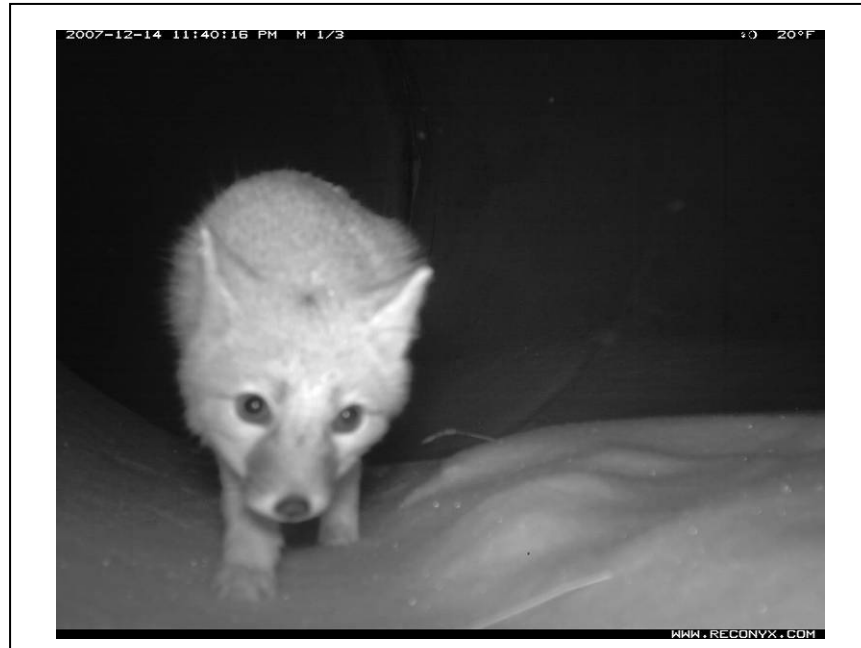
**Figure 10.** Swift fox documented inside reinforced concrete pipe culvert (R351.2) confirms a crossing occurred via the culvert. Snow can be seen in foreground.

Probable swift fox tracks were originally detected at R351.2 (western study area) on 7 November 2007 and again on 13 November 2007; both sets of tracks indicated the fox moved just inside or around the entrance of the culvert but not through. On 21 November 2007, swift fox tracks were found at both ends of the culvert heading in the same direction indicating a complete crossing through the culvert. On several other occasions swift fox tracks were found only on one side or the other. To confirm tracks at R351.2 as swift fox tracks, a temporary camera was placed at one entrance on 28 November 2007. On 14 December 2007, an unmarked swift fox was documented on camera (Figure 10) and tracks at both ends were heading in the same direction. It is speculated that this fox may have been hunting rodents that have been detected in this structure (Figure 11).

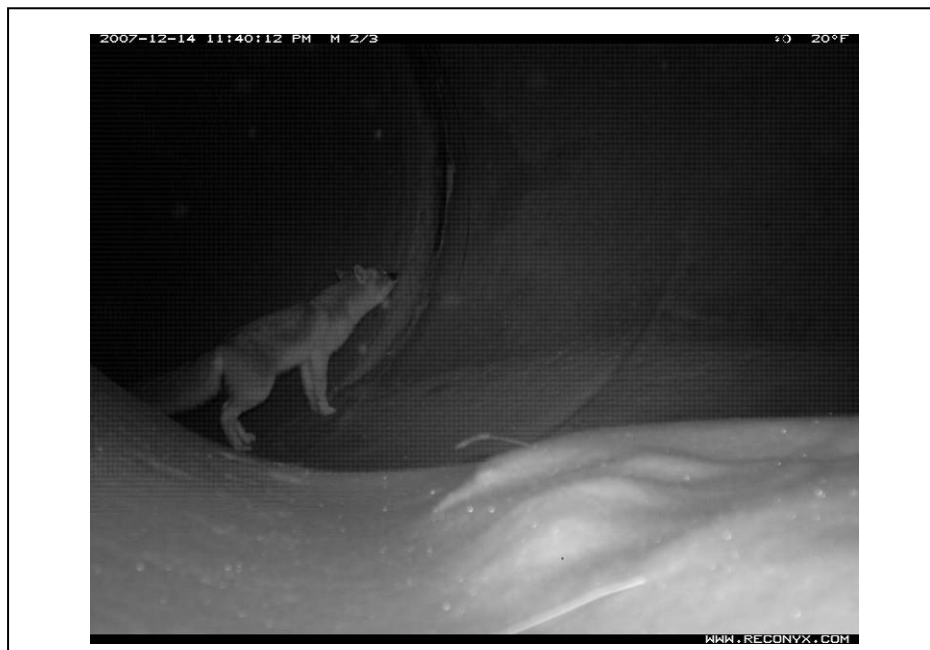
**Figure 11.** Another view of the individual in Figure 10 confirms it is an unmarked fox. This individual appears to be attracted to the seam where a rodent might live.

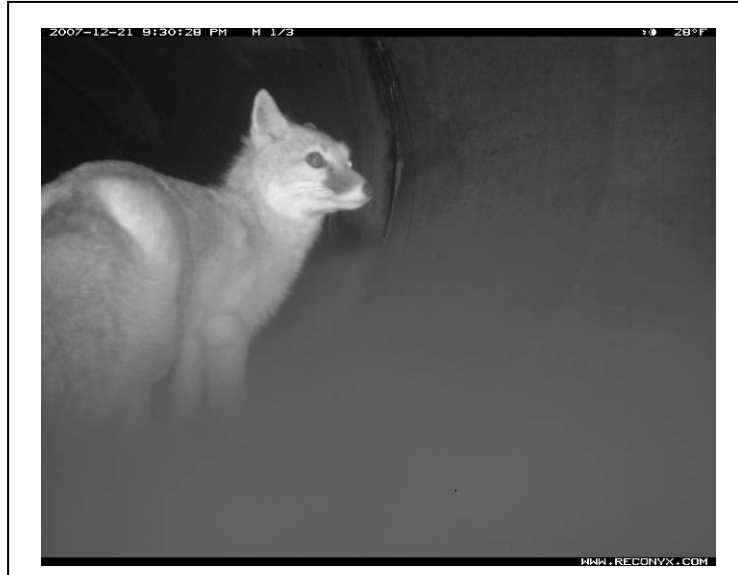
**Figure 12.** A second instance of a swift fox documented crossing via R351.2.

On 21 December 2007, an unmarked fox was documented on camera in R351.2 (Figure 12) and tracks at both ends indicated it was a complete crossing. It is unknown whether the foxes documented on 14 December and 21 December 2007 is the same individual.

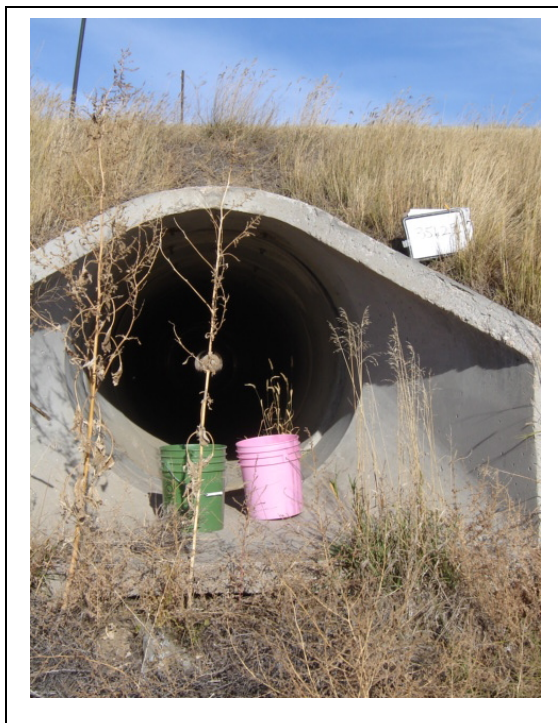
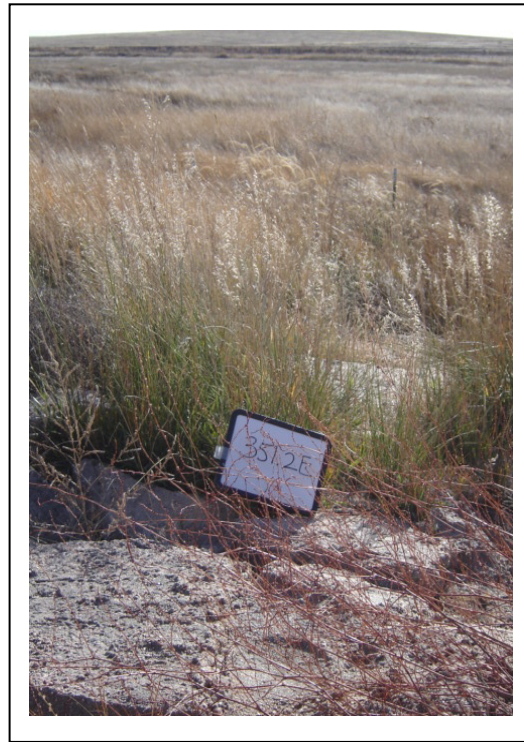
**Figure 13.** View of R351.2 entrance (152 cm [60 in] in diameter (left) and adjacent landscape (right).

One more complete crossing by a swift fox was noted in R351.2 on 6 January 2008. The R351.2 structure and adjacent landscape are pictured in Figure 13.

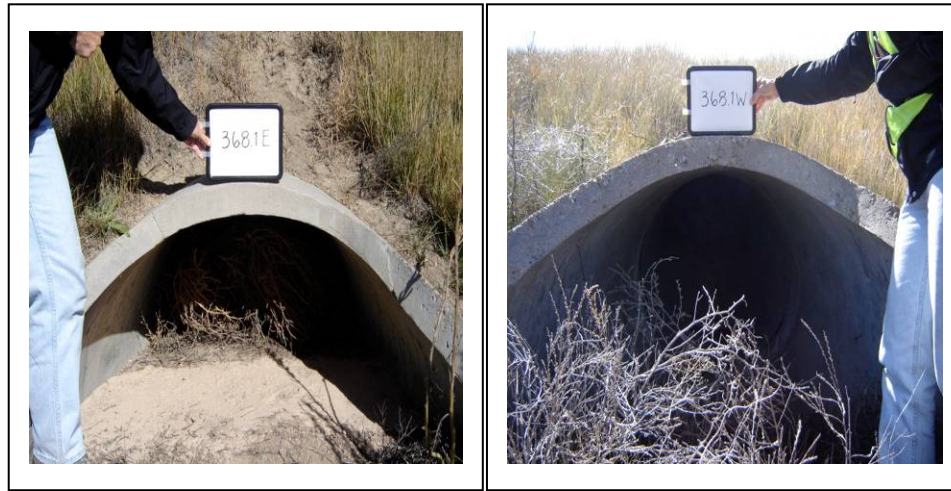
**Figure 14.** View of both entrances of R368.1; 52 x 104 cm (20.5 x 41 in; height x width) at eastbound entrance (left) and 93 x 118 cm (36.5 x 46.5 in) at westbound entrance (right).

The only other possible complete crossing by swift fox was detected in R368.1 (eastern study area) on 19 November 2007. R368.1 spans a two-lane unpaved frontage road in addition to the four-lane divided highway (Figure 14).

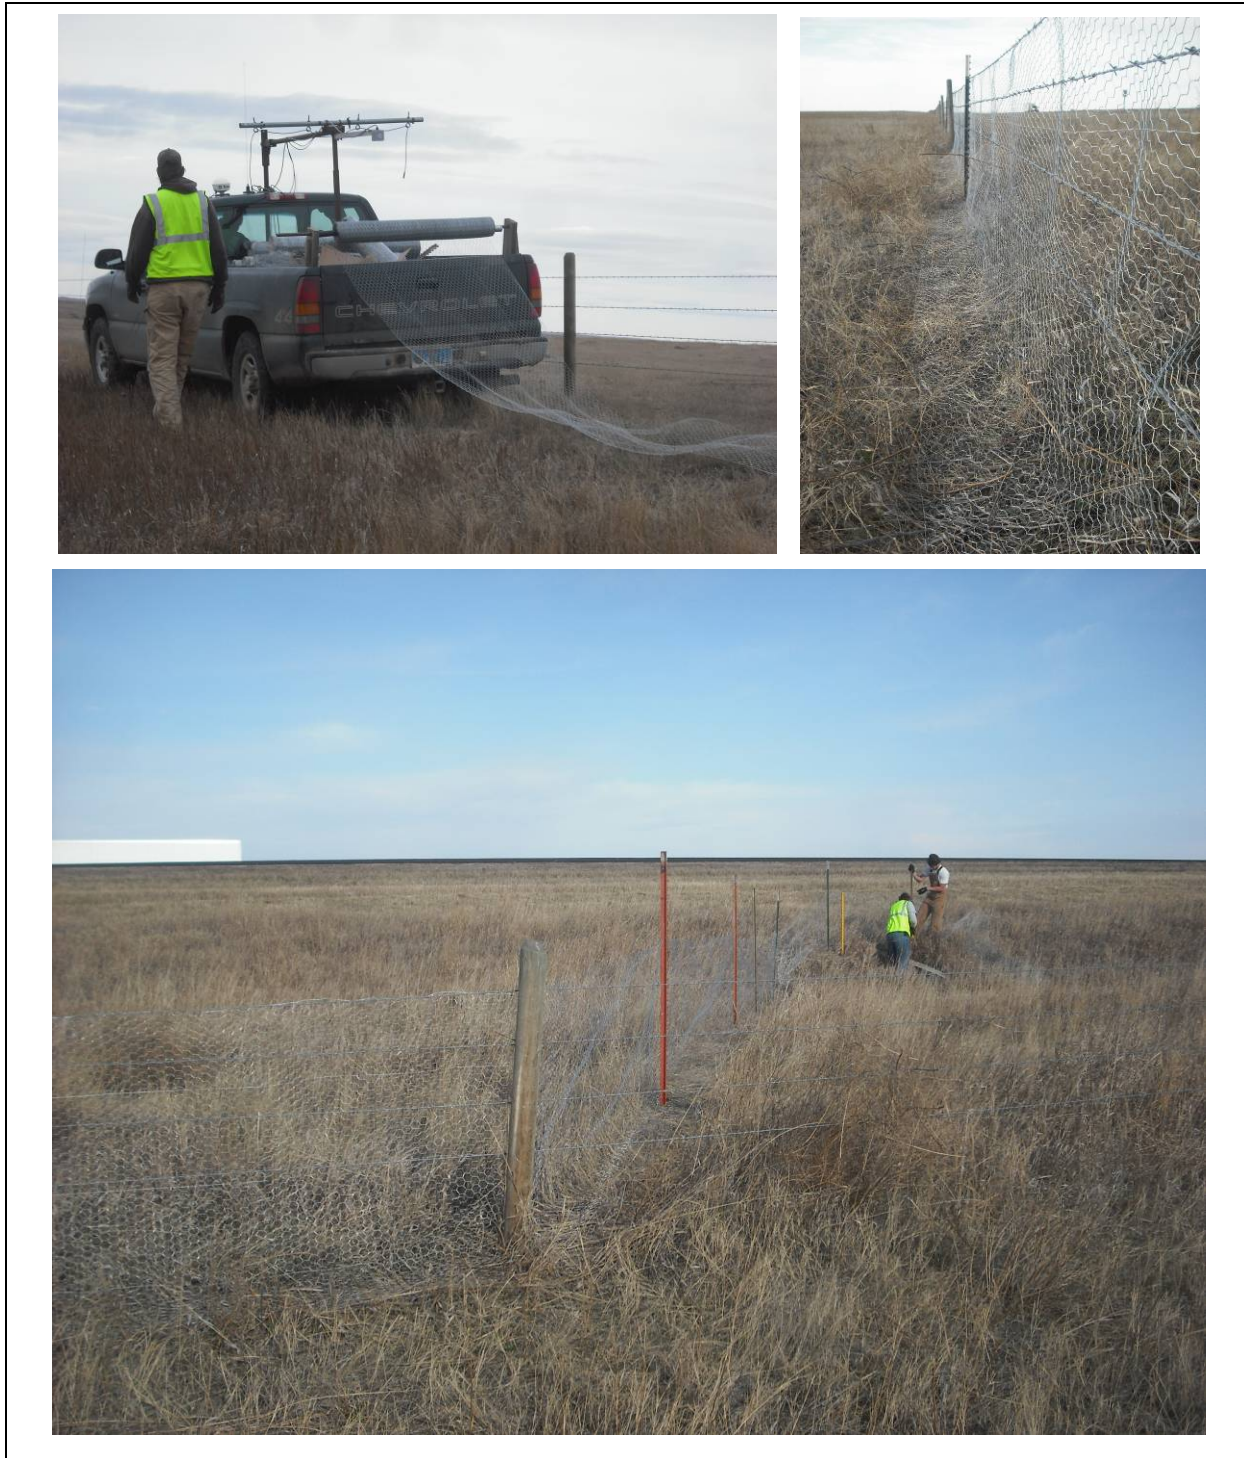
**Figure 17. Fence installation (clockwise from top left: a vehicle-mounted spool aids in laying out ~5.6 km (3.5 mi) of fencing; several inches of mesh stapled to the ground creates a barrier to digging under the fence line; t-posts enable angling the mesh away from the right-of-way fence line (foreground) to the culvert entrances (location of workers in the mid-ground)).**

The fenced area included two reinforced concrete pipe culverts, one that spans all four lanes (R128A) and one that is a two-lane pair opening into the median (R128B). A chicken-wire tunnel connected culvert entrances of the two-lane culvert pair in the open median.

Cameras were installed at all six culvert entrances in the fenced section. Nocturnal VHF tracking was conducted within the fenced area and up to 3.2 km (2 mi) in either direction multiple times per week, weather permitting. All known frequencies were scanned during each session to determine if new collared foxes were in the area. Emphasis was put on tracking those collared foxes known to be in the area. The plan was to monitor fox movements for two months, commencing after installation was completed in late November 2009. Local wisdom indicated that the greatest snow accumulations typically occur in February.

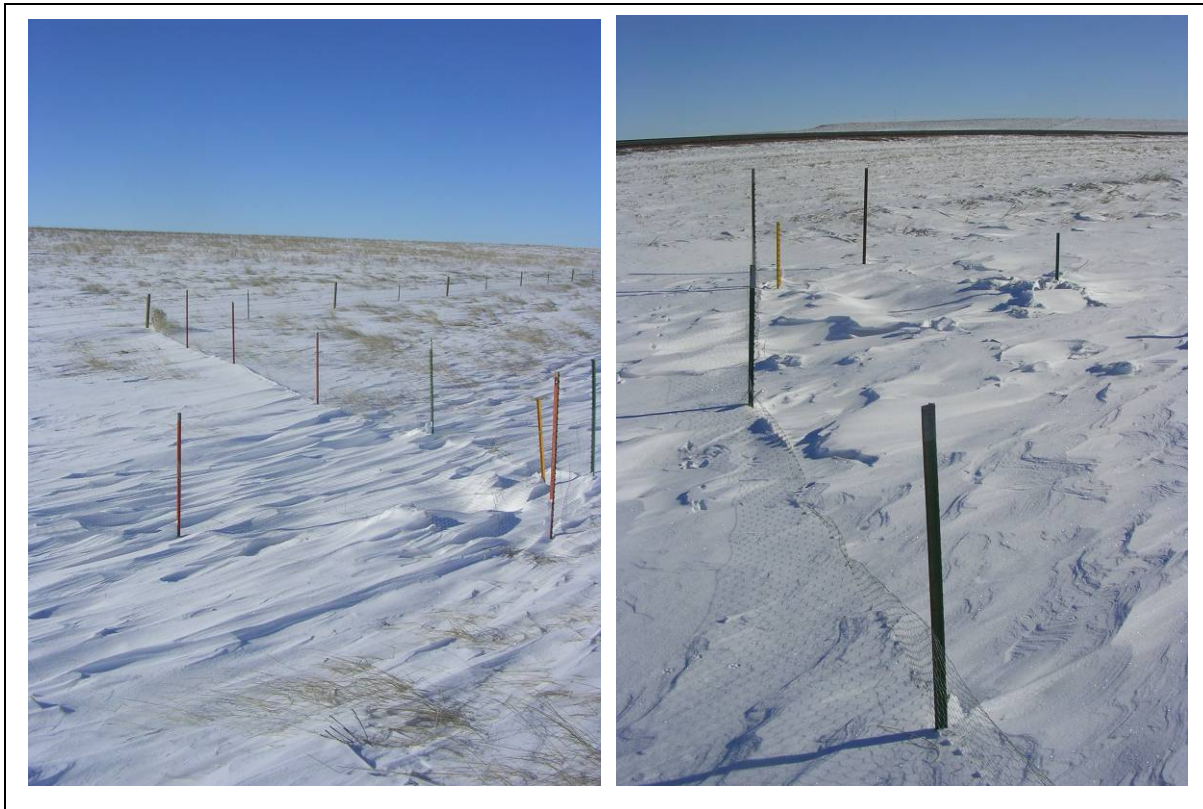
**Figure 18.** Snow filled culvert entrances and negated the effectiveness of the fencing. T-posts delineate where chicken wire fencing funneled to culvert entrances.

The post-fencing monitoring began on 30 November 2009 but was terminated prematurely due to a massive blizzard that affected the study area on 25 December 2009. I-90 was shut down and safe travel was not possible for several days. The snow sealed off culvert entrances and buried the chicken wire fence, destroying some sections (Figure 18). It was not feasible to dig out the fenced study area to allow for culvert use. Travel conditions continued to be unsafe and, therefore, precluded regular radio tracking. During the second week of January the decision was made to terminate data collection given that the study area would likely continue to be affected by winter weather issues.

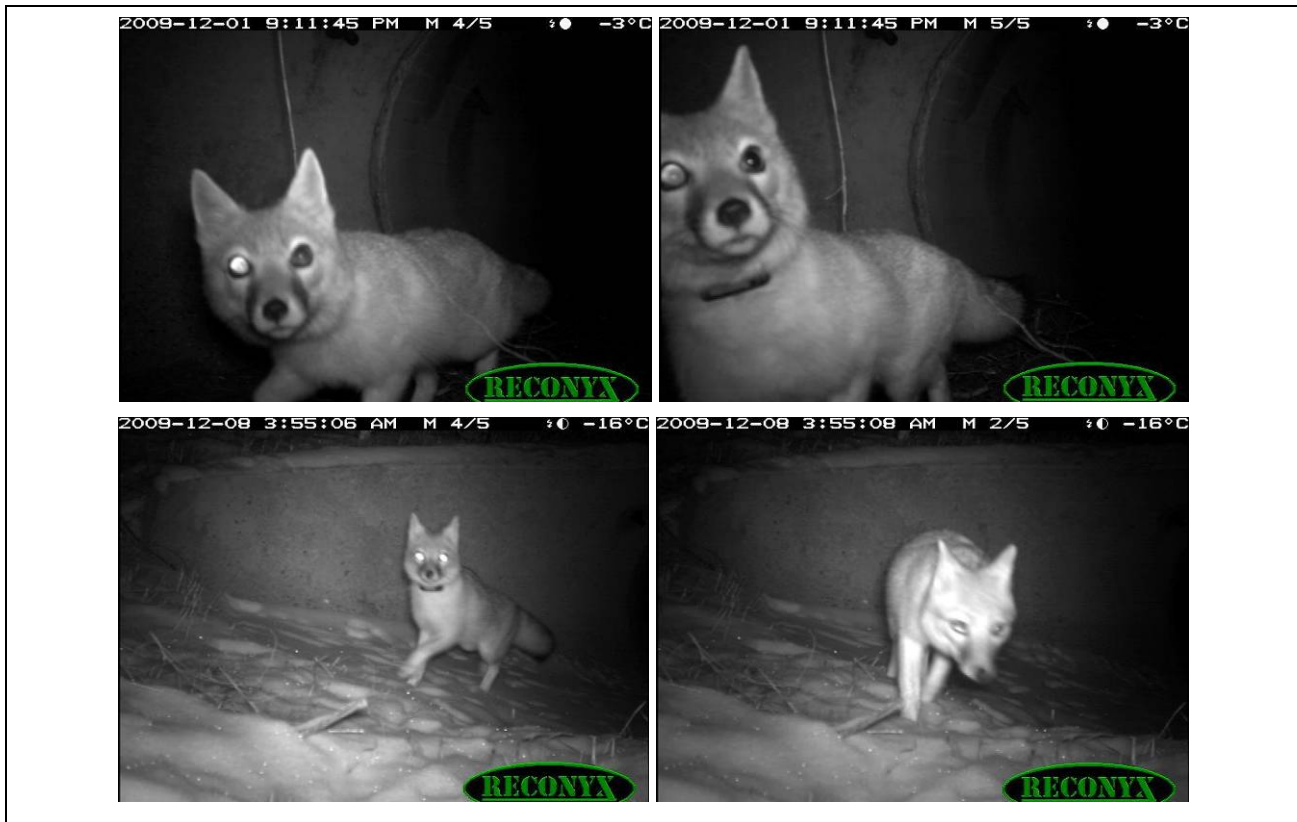
Figure 19. Top two images feature an individual with unequal eye shine and no visible antenna, presumably 701 (adult female). Bottom two images feature an individual with equal eye shine and an obvious antenna even from a distance, presumably 953 (pup of the year).

There were six series of crossing activities via R128B, the two-lane culvert pair system connected by a chicken-wire tunnel in the median (Table 8). All events appear to involve only 701 or her pup 953, based on two visual cues (i.e., eye reflectivity and collar antenna condition). One fox has conspicuously unequal reflectivity in its eyes and it is sometimes difficult to ascertain the presence of a collar. We surmise this is 701, an adult whose antenna could have been chewed off. The other fox has a prominent antenna consistent with that of a newly collared juvenile (953). See Figure 19 for comparison.

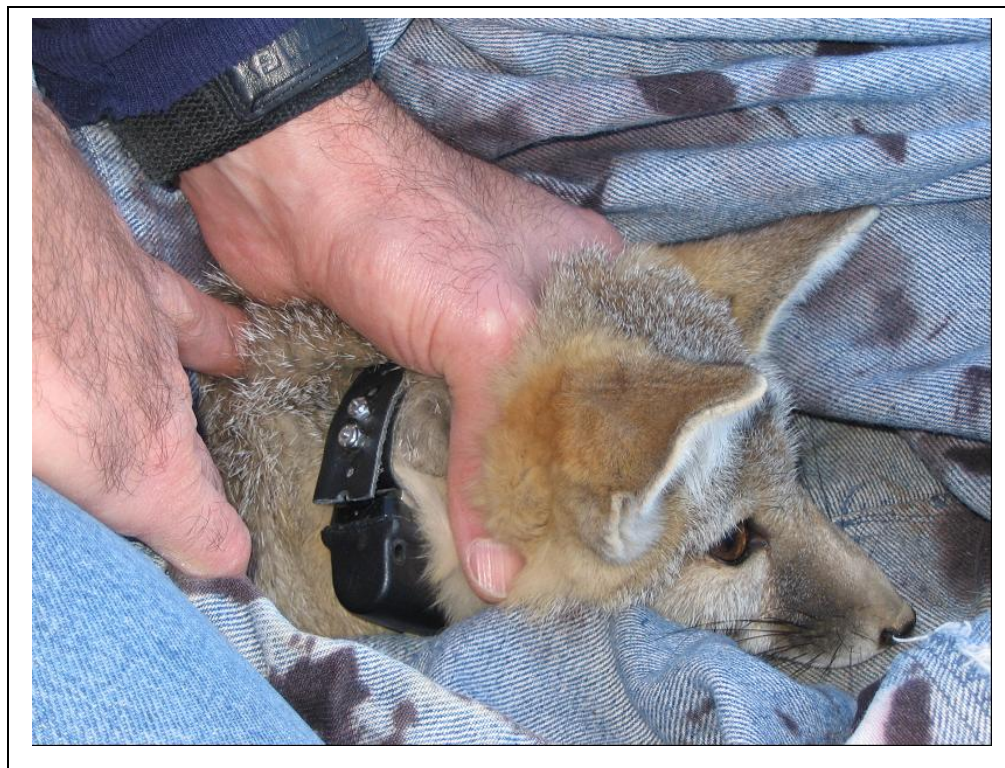
Figure 21. Desert kit fox with a GPS collar at the Hwy 58 study site, California.

Between 30 October and 28 November 2007, five individual desert kit foxes were captured (one female and four males) and fitted with GPS collars at the Mojave Desert field site (Figure 20 and Figure 21). One fox (Male 6503), initially trapped on the south side of Hwy 58 on 30 October 2007, was recaptured on the north side of the highway on 15 November 2007 (Figure 20), thus providing initial evidence of successful crossing of Hwy 58.
