# EVALUATION OF ORGANIC MATTER ADDITION AND INCORPORATION ON STEEP CUT SLOPES: *PHASE II TEST PLOT CONSTRUCTION AND PERFORMANCE MONITORING*

FHWA/MT-07-001/8176

*Final Report*

*prepared for*  
THE STATE OF MONTANA  
DEPARTMENT OF TRANSPORTATION

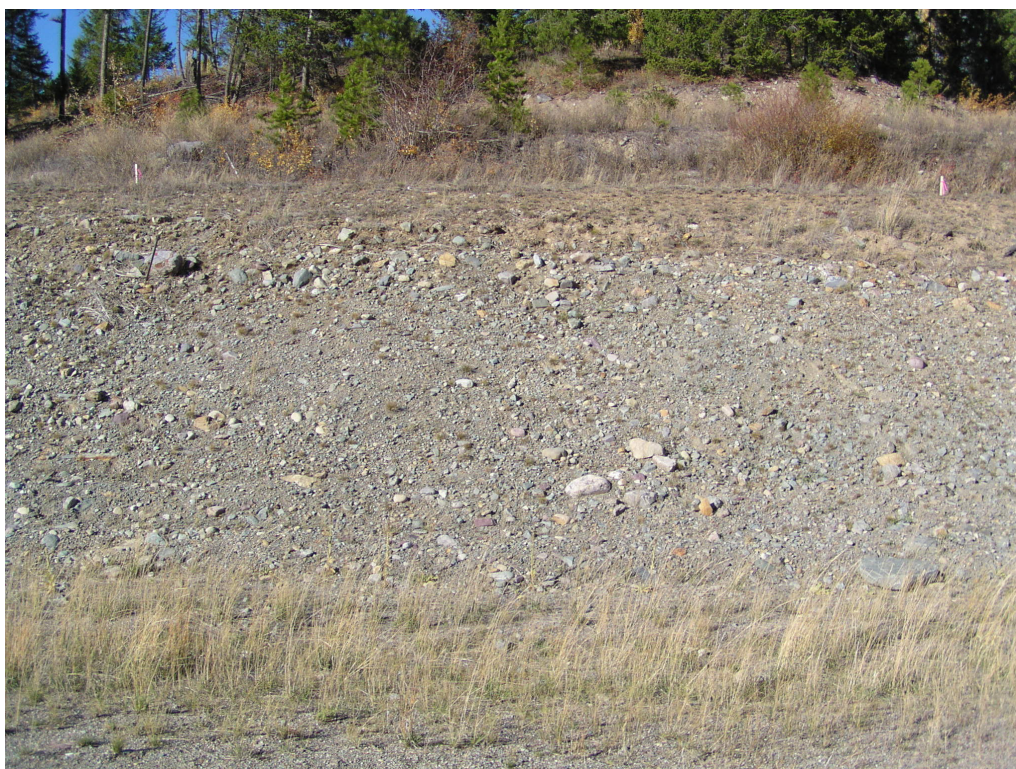
Figure 6. MP 69 (Loon Lake) research area preconstruction conditions, Plot 8.

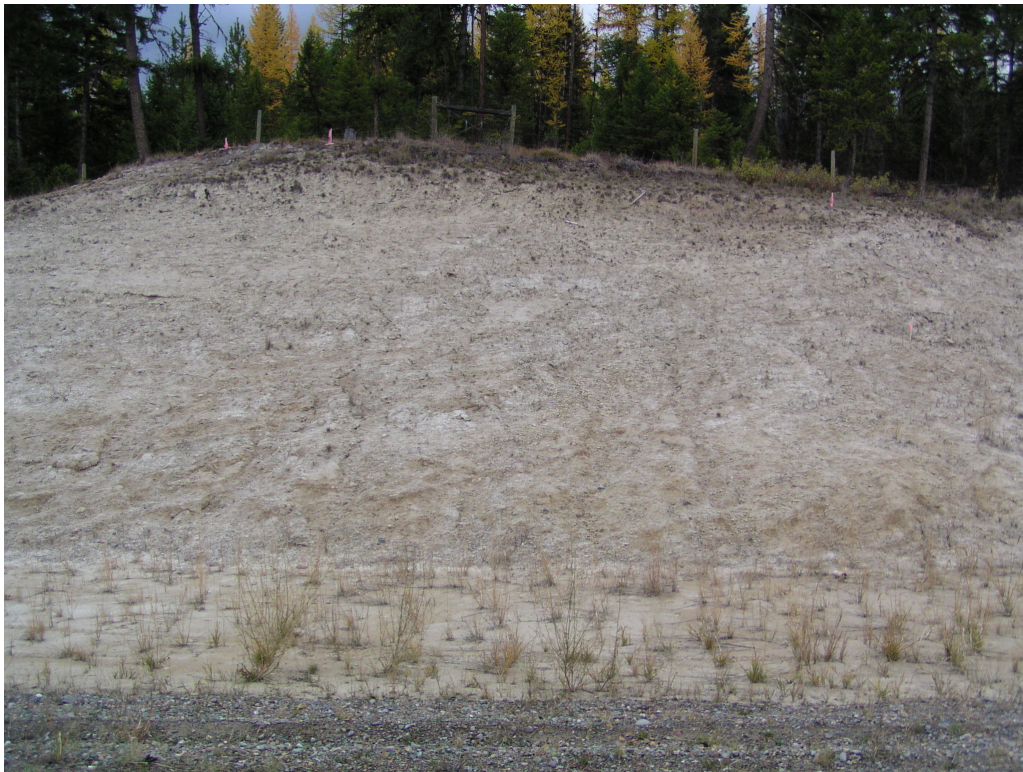
Figure 9. Research Plot 1 at the MP 77 site prior to plot implementation. Note accumulated sediment in ditch, rills and the general lack of vegetation cover.

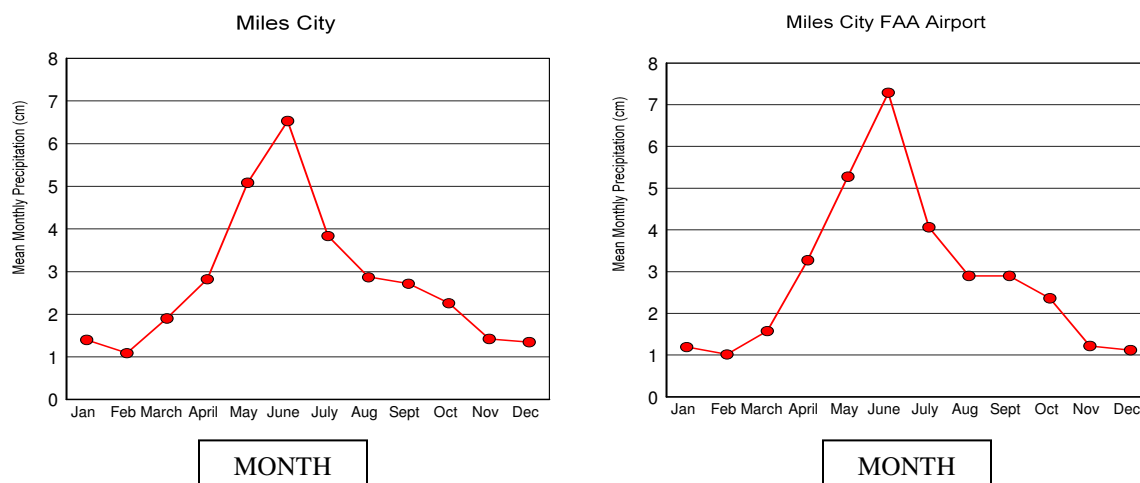
Figure 12. Monthly precipitation for NOAA stations 245685 (Miles City) and 245690 (Miles City FAA Airport).

Climatic data is available from two stations near the research sites: 1) Miles City (Station 245685), and 2) Miles City FAA Airport (Station 245690). These stations are approximately 5.4 (8.7 km) and 4 miles (6.3 km) southwest of the research sites, respectively (Figure 11). Elevations at these stations (719.3 [0.45 miles] and 799.8 m [0.5 miles], respectively) bracket the elevation of the research plots. The period of record for Station 245685 is January 1, 1893 through July 31, 1982. The record for Station 245690 extends from January 16, 1937 through the present. The overall amount and distribution of average monthly precipitation at the two stations is very similar, with the airport receiving slightly more total annual precipitation (34.2 versus 33.3 cm; 13.5 versus 13.1 inch) likely due to the 80.5 m (264 feet) elevation difference between the stations (Figure 12). The annual distribution of precipitation is typical of Eastern Montana. Approximately 75 percent of the precipitation occurs during the growing season from April through September with the month of June receiving the greatest amount.

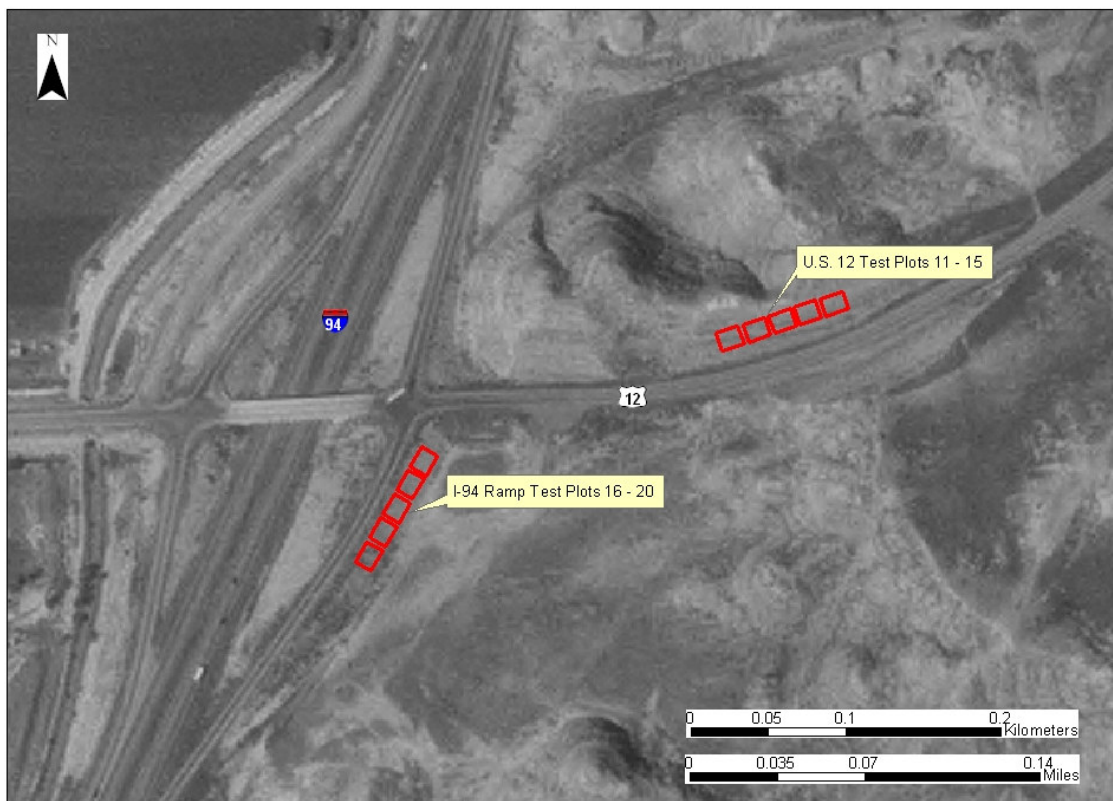
Figure 15. Miles City research plot locations. (*Interchange of US 12 with Interstate I-94 approximately 2 miles east of Miles City*).

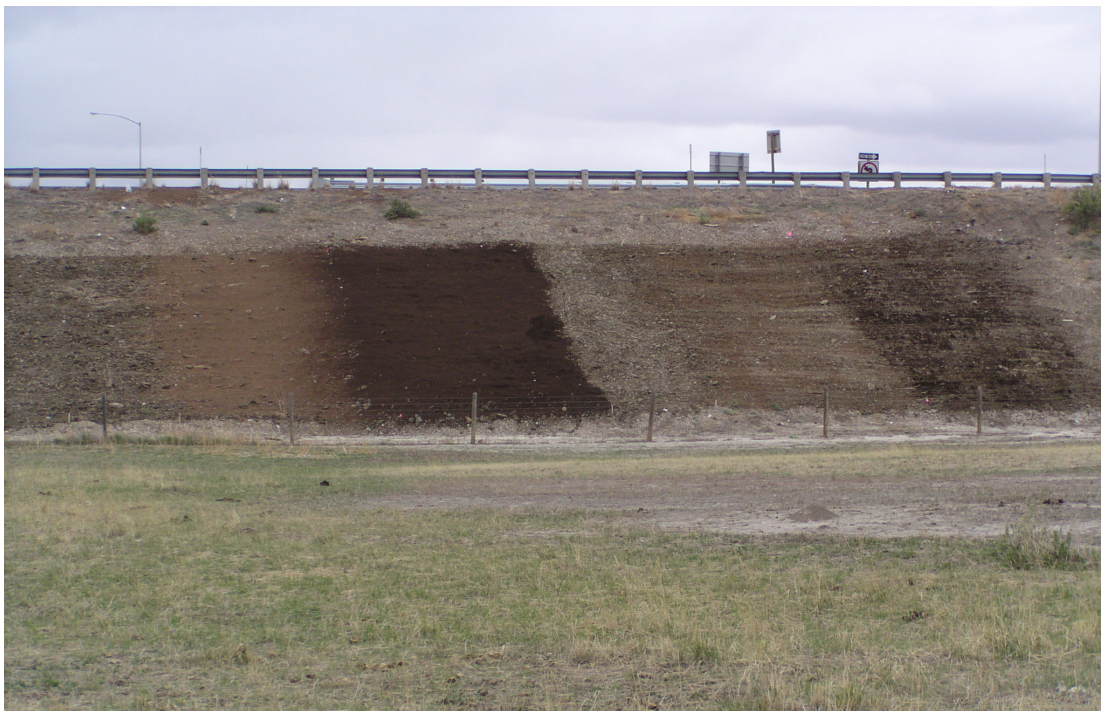
Figure 16. Plots 19 (compost blanket) and 20 (incorporated compost), I-94 off-ramp area, showing Rocky Mountain compost on the left (light-colored) and Earth Systems compost on the right (dark-colored).

The vendor loading equipment problems resulted in delivery of only 45.9 m<sup>3</sup> (60 cy) of Earth Systems compost rather than the 58.9 m<sup>3</sup> (77 cy) ordered, with delivery at 11:00 pm the night before application was to begin. There was insufficient time for shipping an additional load of Earth Systems compost. Arrangements were made for the blower truck to load the additional 13 m<sup>3</sup> (17 cy) at Rocky Mountain Compost in Billings, Montana. To maintain the integrity of the experimental design, plots 16 through 20, located on the off-ramp shale fill, were split vertically with Rocky Mountain compost applied to the southwest side and Earth Systems compost applied to the northeast side (Figure 16). Even with the acquisition of the 13 m<sup>3</sup> (17 cy), compost application was short on plot 12, the last plot constructed. This plot was divided vertically with only the west half receiving compost. The experimental design was identical to plots constructed at the Happys Inn sites and included four treatments and a control at each site (Table 7). Following soil sample collection, all plots were contour tilled across the slope.

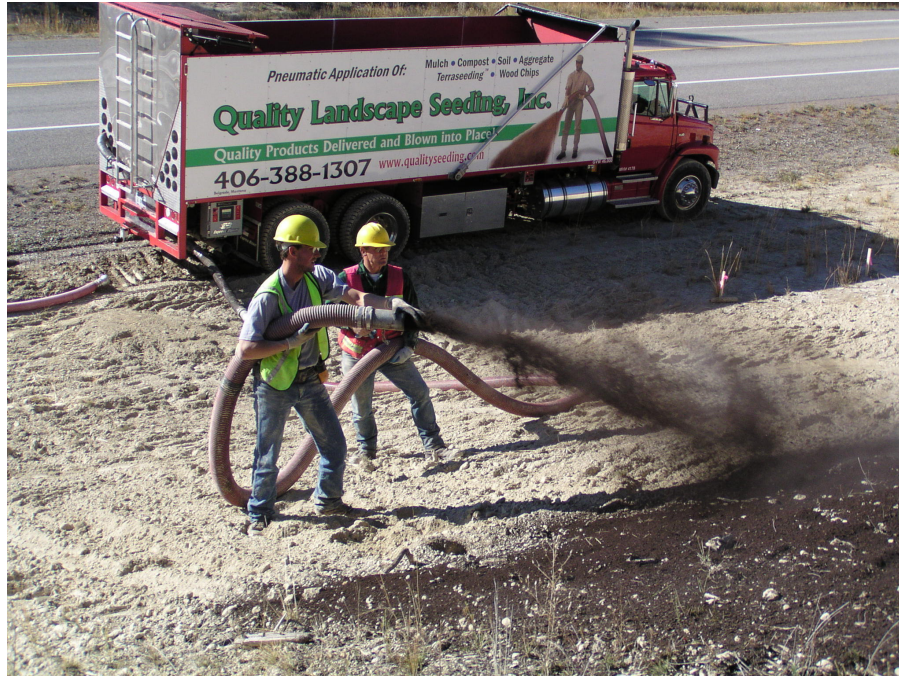
Figure 19. Express Blower Model EB-30 applying compost at the MP 77 site.

The blower truck experienced no difficulties applying compost to the research plots (Figure 19). The maximum length of the research plots was only 10 to 20 percent of the capability of the truck (standard hose length is 111.6 m or 366 feet) and no clogging of feeders or blower hose occurred. Minor hand shoveling inside the truck box was required to feed compost to the walking floor when the unit was near empty. This was apparently caused by the tilt of the unit produced by stationing it partially in the borrow pit to maintain a clear traffic lane. Compost application was timed for several plots. Approximately 10 minutes was required to apply a controlled 1.3 cm (1 inch) compost layer on each plot and an additional 15 to 20 minutes to apply the remaining 3.8 cm (1.5 inch) of compost on the 5.1 cm (2 inch) treatments for an approximate rate of 0.05 ha/hr (0.02 acre/hr) (Table 13). These rates should not be construed as the expected rate on a full scale project. Due to the size of the research plots, more time was required to ensure the applied compost was within plot boundaries. The application of two specific compost layers increased application time by about 10 percent. Manufacturer literature suggests normal application rates of 0.76 to 1.53 m<sup>3</sup> (1 to 2 cubic yards) per hour. At the higher rate, a 5.08 cm (2 inch) compost blanket would be applied at 0.18 ha/hr (0.07 acre/hr).

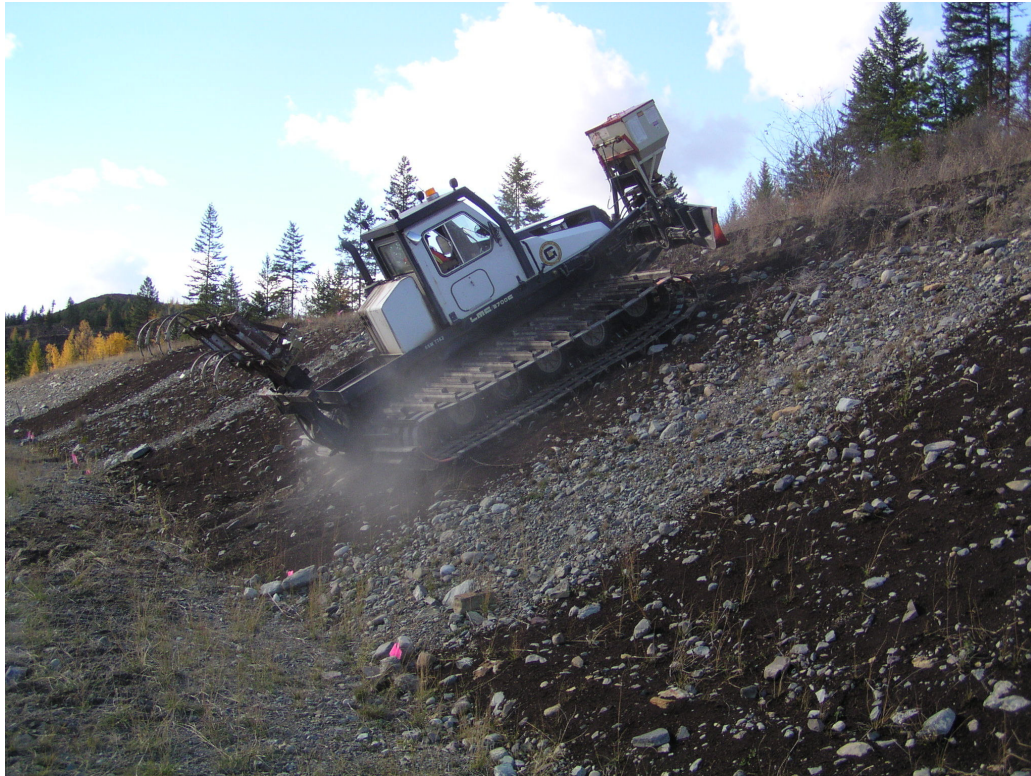
Figure 20. Modified LMC 3700C initiating tillage on plot 8, MP 69 site.

- Reinforced undercarriage;
- Upgraded cooling system;
- Pisten Bully drive sprockets and 2.5 m wide steel tracks;
- Rear 3-point quick hitch;
- Front 3-point brackets to mount broadcast seeder; and
- MSHA certified ROPS canopy.

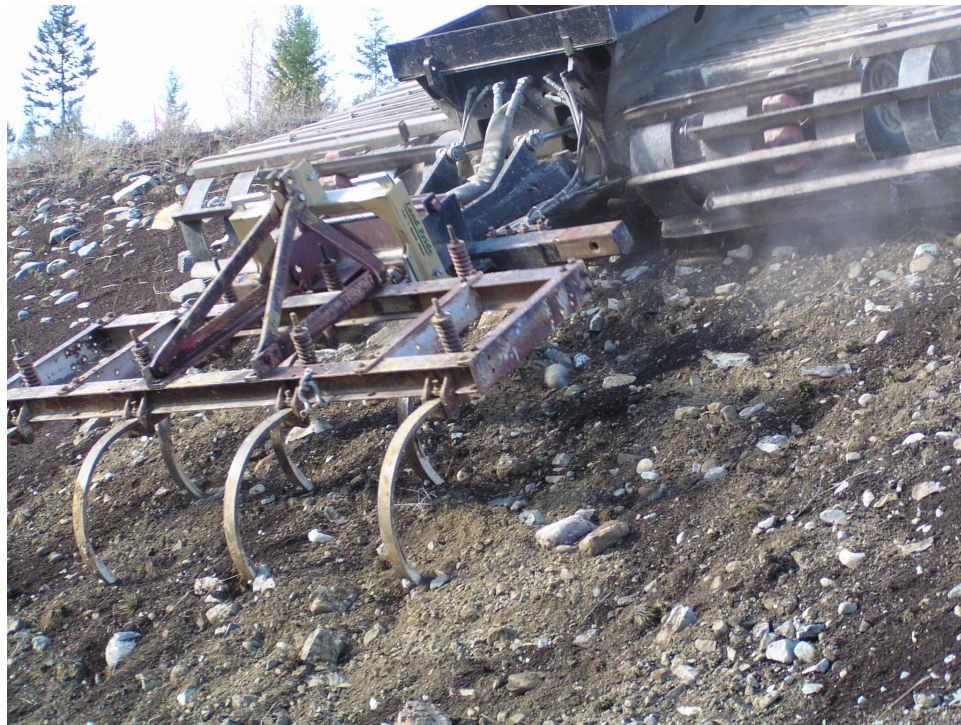
Figure 21. Graham Hoeme 2.4 m (8 ft) spring-shanked chisel plow at the Loon Lake site.

The Graham Hoeme chisel plow utilized for this study worked equally well in both coarse and fine textural classes of material (Figure 21). Shank spacing was set at 0.35 m (1.1 ft) for the 2.4 m (8 ft) wide implement. Potential tilling depth was well in excess of the specified 10.2 cm (4 in) compost incorporation depth for this project. No breakage or other problems were encountered with this unit. It is likely that a wider implement of similar design could have been utilized, especially at the MP 77 site.

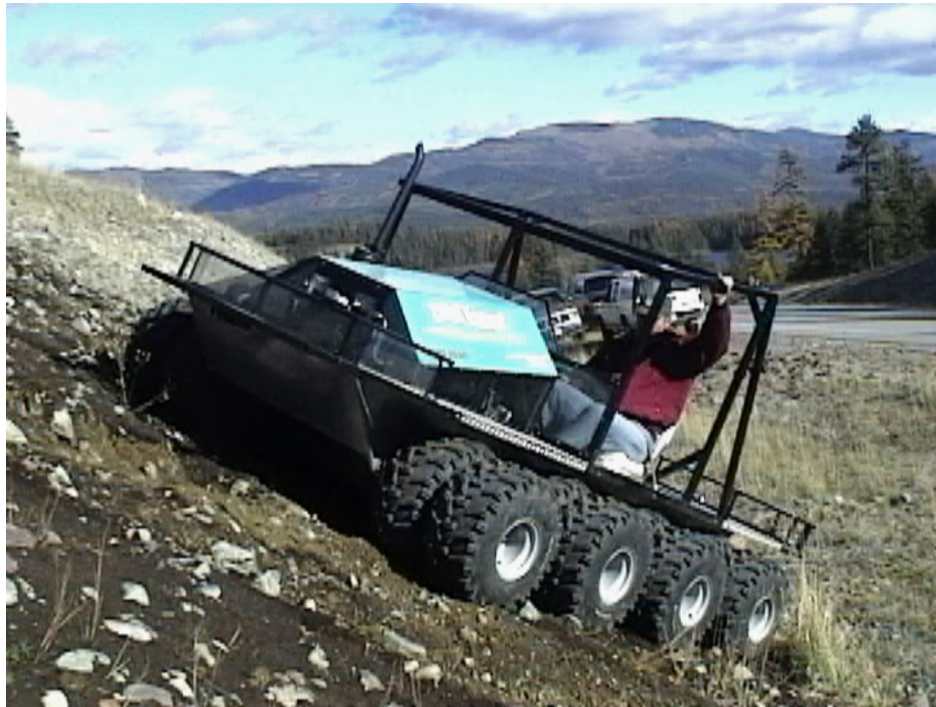
Figure 22. Land Tamer industrial model LT adjacent to Loon Lake research site.

PFM Manufacturing provided a standard industrial LT model for demonstration purposes at the MP 69 site (Figure 22). This unit is a diesel powered eight-wheeled vehicle utilizing a hydrostatic drive. While this machine had no trouble traversing the 50 percent slopes at MP 69, either on the contour or at an angle, it suffered from problems similar to the snowcat. Its rigid suspension limited wheel contact when riding over large cobble and boulders. The resulting loss of traction was sufficient to prevent direct traverse up slope at this site even without any tillage implements. The Land Tamer was not demonstrated at the MP 77 site. It is the authors' opinion that this unit would have performed acceptably well on the silt-dominated materials using a small tillage implement.

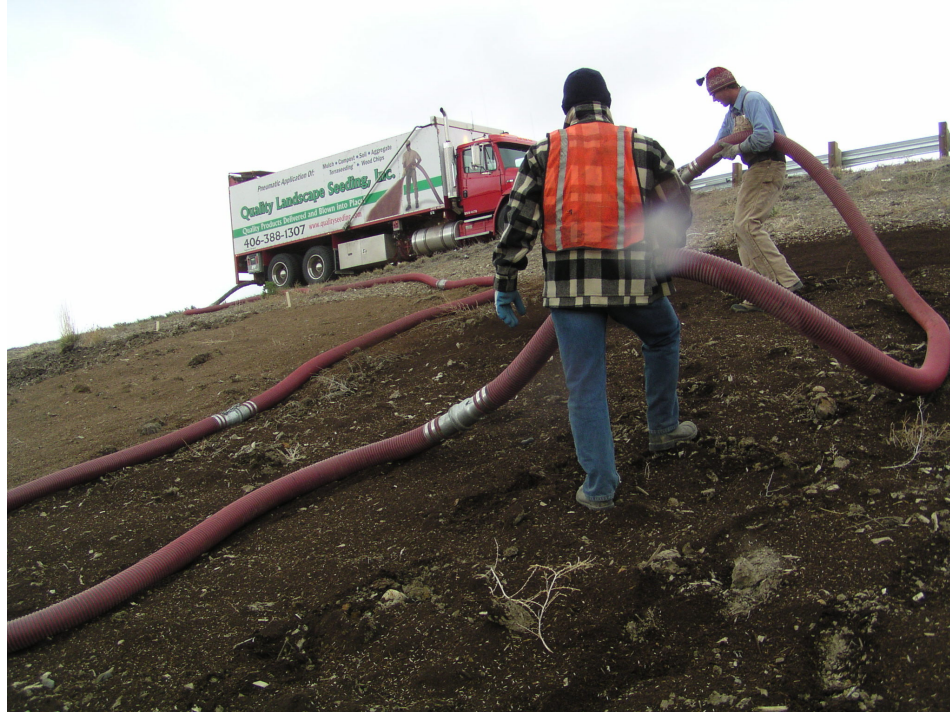
Figure 23. Express Blower (Rexius) blower truck model EB-30 applying Earth Systems compost to Plot 17.

The blower truck utilized for the Miles City plot construction was the same unit used for the Happys Inn sites (Figure 23). No problems were encountered using two additional compost sources that exhibited two very different moisture contents. Production rates were similar to that chronicled at the Happys Inn sites.

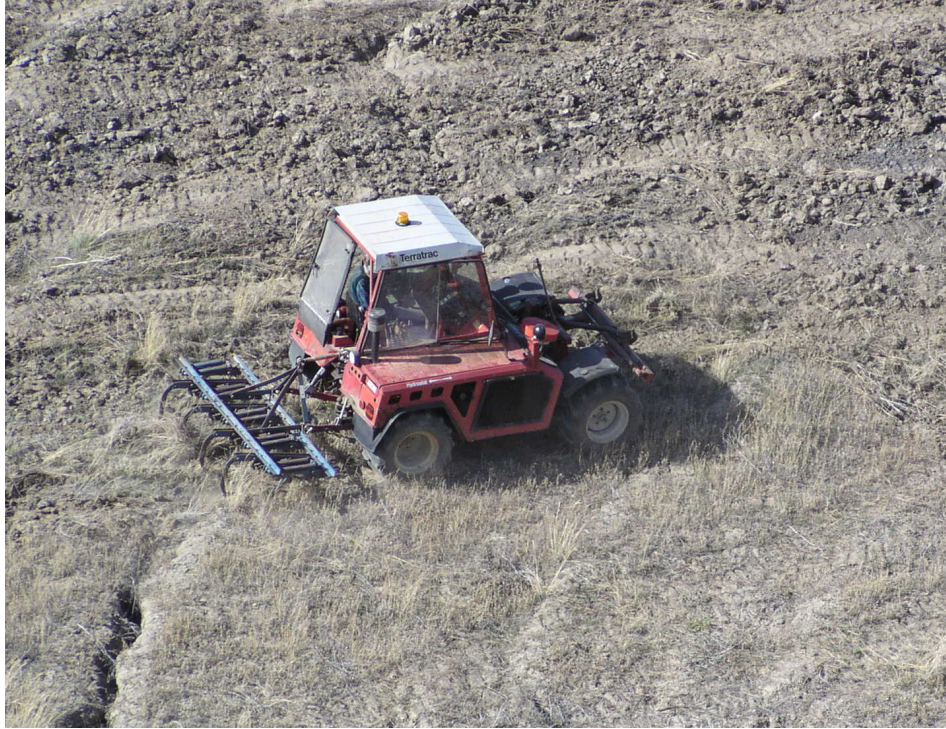
Figure 24. AEBI Terratrak TT88 tilling on the contour along U.S. Highway 12.

The tractor employed for this work was an older (1990) AEBI Terratrak model TT88 equipped with a hydrostatic drive (Figure 24). This unit was rented from the Bridger Bowl Ski Area near Bozeman, Montana where its main use is mowing ski runs. The Phase I report for this research project identified the AEBI tractors as good candidates for compost incorporation on steep cut slopes. The Phase I report (Jennings et al., 2003) contains a listing of all current and past AEBI Terratrak models produced. The TT88 used shares the dual 3-point system and dual PTOs (front and back) common to most Terratrak models, had a EROPs type enclosed cab, and a 44 kW (60 hp) diesel engine. While the slope steepness of the Miles City research plots fell somewhat short of the desired 50 percent, the abilities of the TT88 were not seriously challenged working on these plots (30 to 40 percent range). Tillage both across and up-down slopes was completed easily.

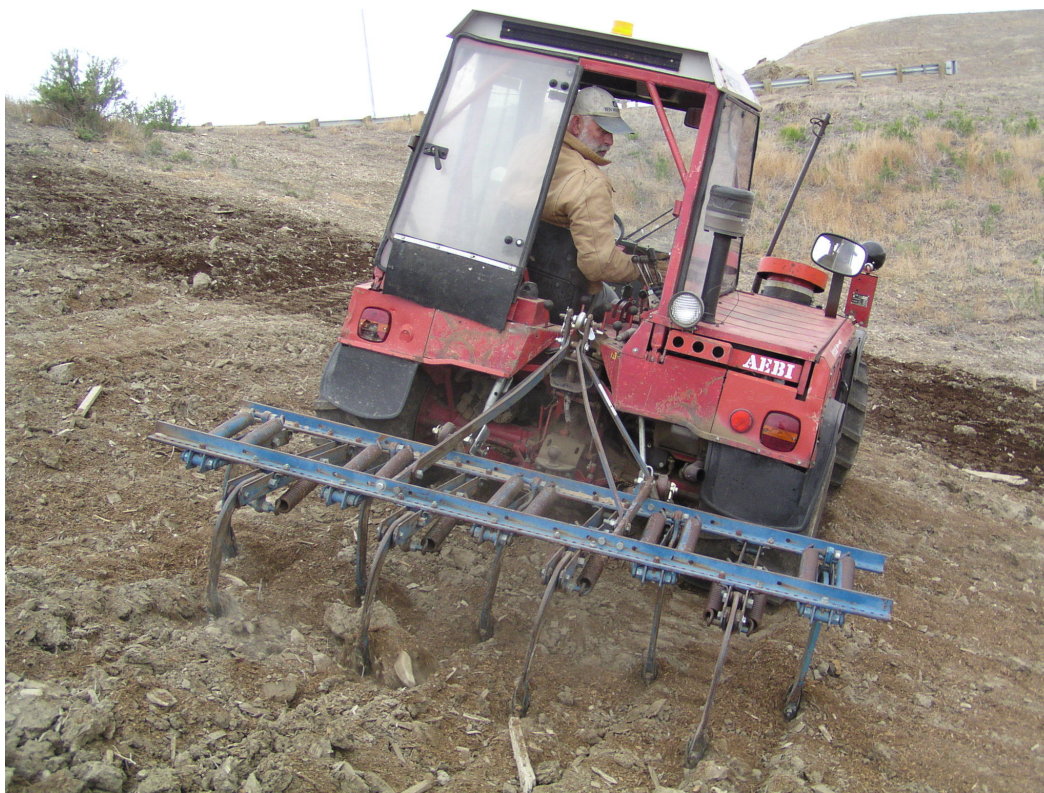
Figure 25. Ford spring-shanked tiller on Plot 20 (Rocky Mountain compost in foreground, Earth Systems material in background).

The Ford tiller used for this work had 9 shanks mounted at 0.30 m (1 foot) centers (Figure 25). All shanks were spring-loaded which allowed passage over several large boulders encountered when tilling plots 11 through 15. All shanks were equipped with chisel points. All initial plot tillage was across the slope. Compost mixing was initially up-down the slope followed by a second pass across the slope. The AEBI TT88 had little difficulty obtaining the desired 10.2 cm (4 inch) tillage depth and was capable sinking the shanks 0.3 m (1 foot), especially when tilling down slope.

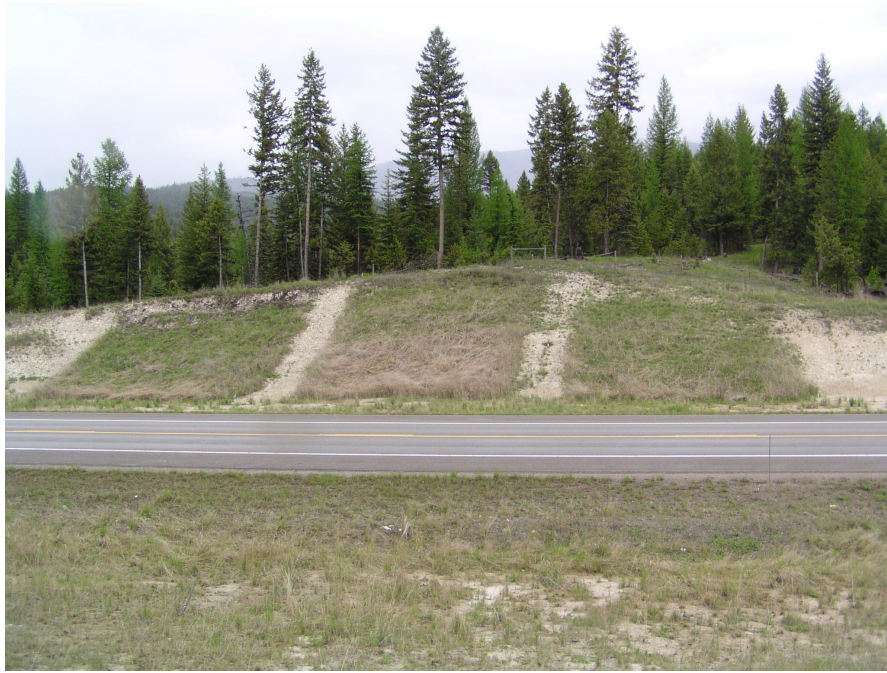
Figure 26. Happys Inn research plots near Middle Thompson Lake, U.S. Highway 2, Spring 2005.

Pre-treatment vegetation at all of the research sites was very poor with some areas completely void of vegetation. After two growing seasons, desirable perennial grasses were thriving at all of the research sites (Figures 26 and 27). At the same time the adjacent control plots where no compost was applied exhibited very limited vegetation development. At the Happys Inn site (Figure 26) the control plot (not shown in the image) exhibited vegetation cover very similar to the unvegetated strips between the compost treated plots. At Miles City the control plot is visible as the middle plot shown in the 5 plot sequence. Detailed vegetation data are presented in Appendix B.

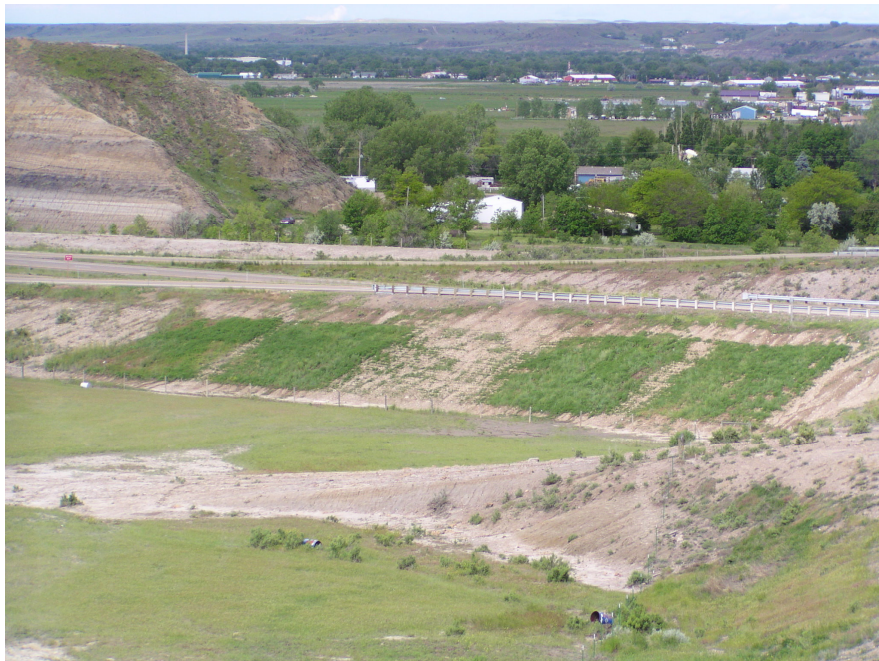
Figure 27. Miles City research plots constructed on the I-94 off-ramp near the U.S. Highway 12 junction, Spring 2005.

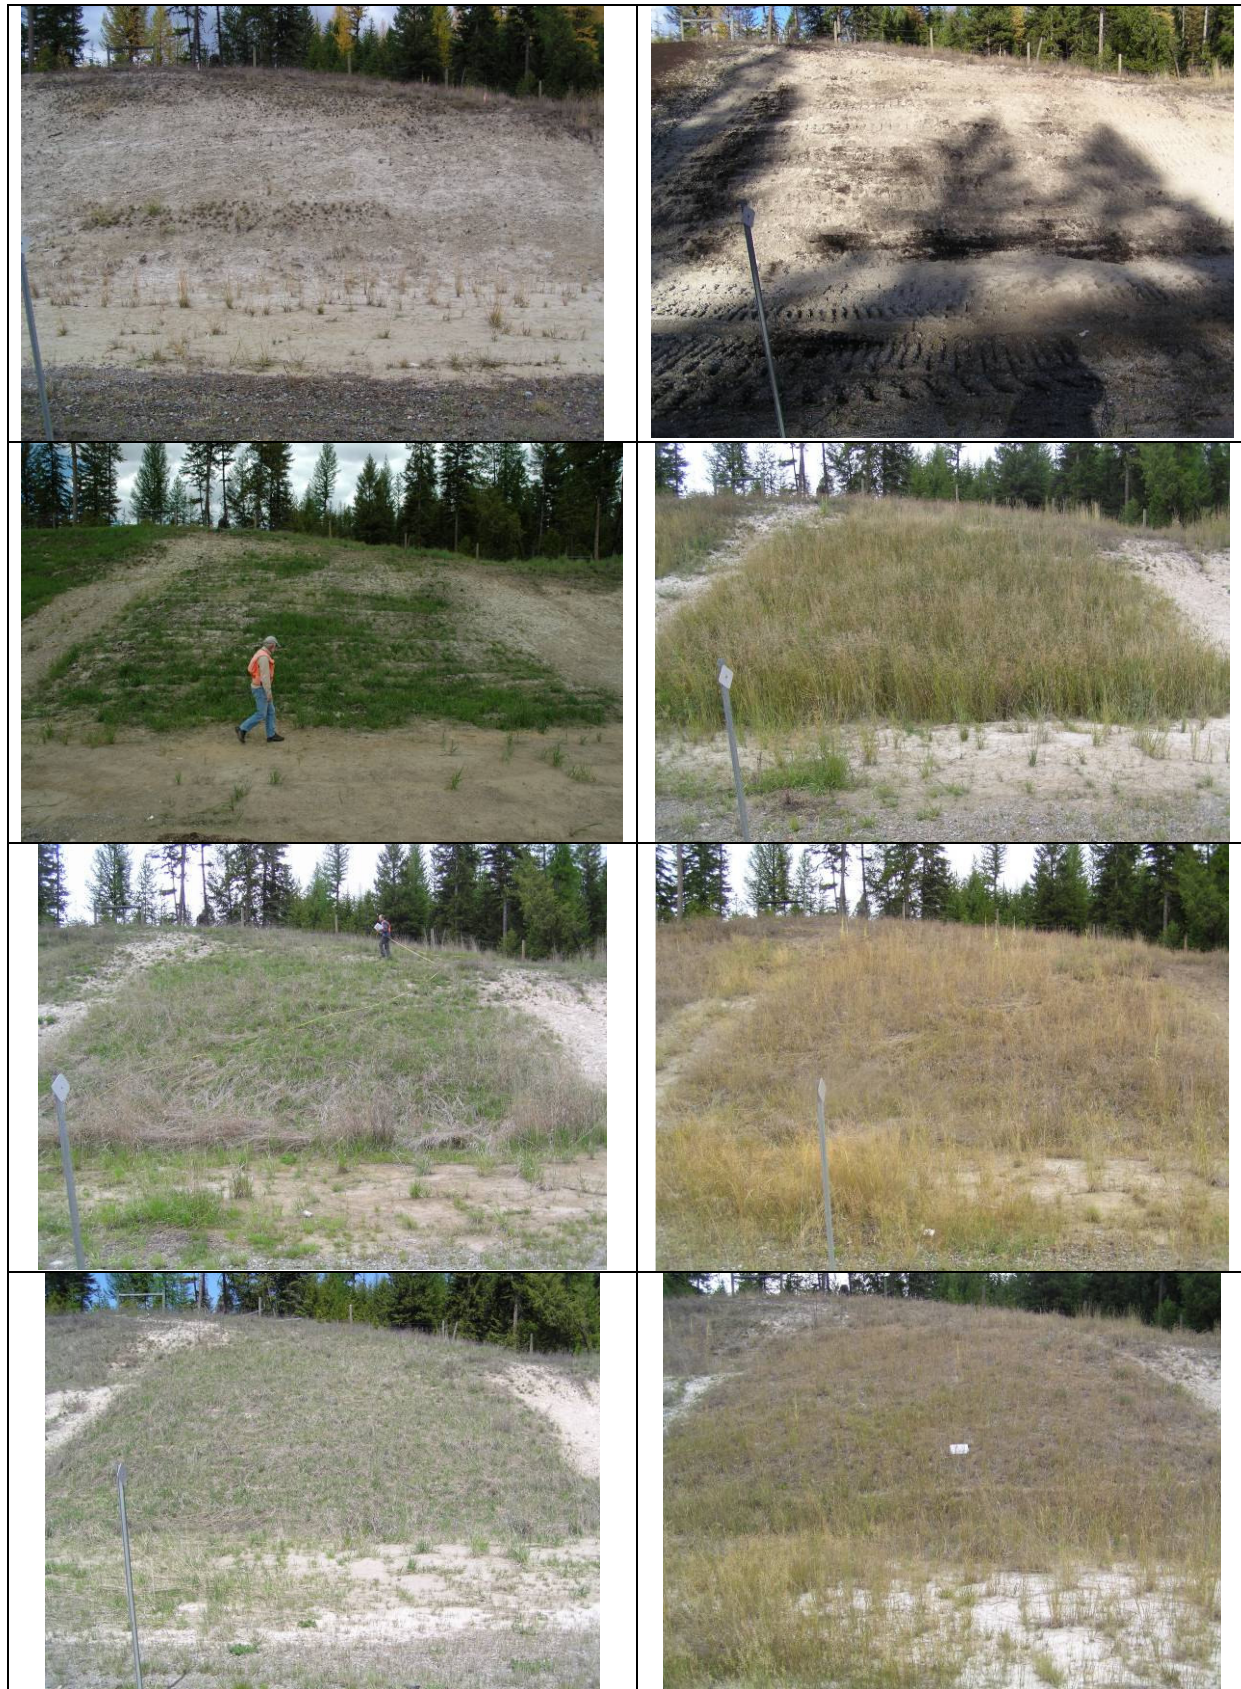
Figure D1. Photo chronology from Plot 3, glacial silt site near Happys Inn, 5 cm incorporated compost treatment from upper left to lower right: before and after construction (2003), spring and fall monitoring, 2004, 2005 and 2006.
