THE RELIABILITY AND EFFECTIVENESS OF AN ELECTROMAGNETIC ANIMAL DETECTION AND DRIVER WARNING SYSTEM. FINAL REPORT.

STUDY NO: 32.42

**COLORADO DEPARTMENT OF TRANSPORTATION
APPLIED RESEARCH AND INNOVATION BRANCH**

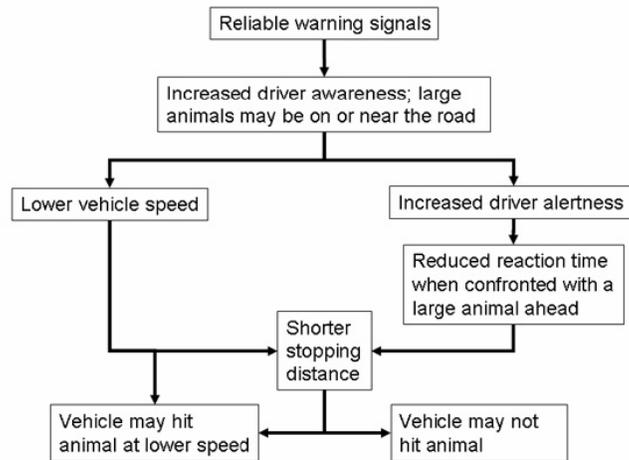
Figure 1.1: Concept of operations

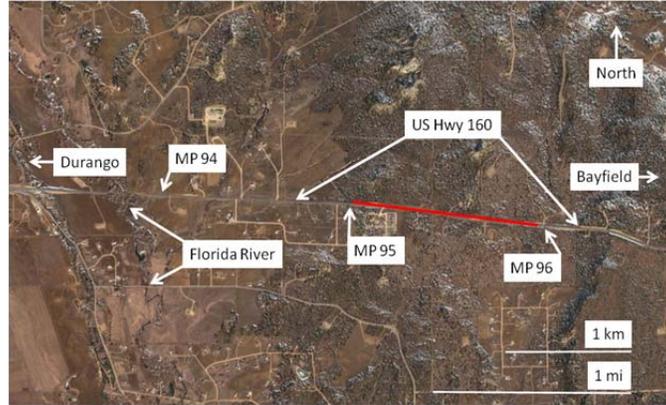
Figure 1.2: Location of the animal detection and driver warning system (red line) along US Hwy 160 between Durango and Bayfield, Colorado, USA.

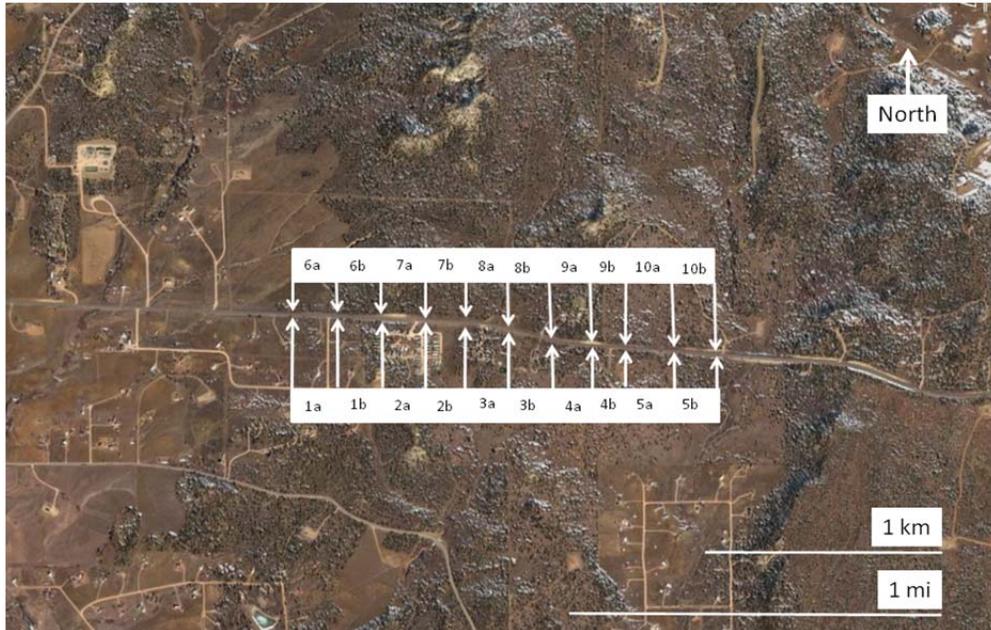
Figure 2.1: Location and name of the detection zones.

The system is divided into 20 detection zones (Figure 2.1), each about 161 m (528 ft) long, and detects large mammals when they move across the cable. The system is manufactured by Senstar Corporation, Carp, Ontario, Canada, and it is the exact same technology as installed in the test-bed for animal detection systems near Lewistown, Montana, USA. System installation took place in early fall of 2008 and was fully operational by September 29, 2008. The system generates an invisible electromagnetic field and when a large animal crosses the cable it causes a disturbance in this electromagnetic field. The electrical conductivity, size and speed of the animal all affect the magnitude of the disturbance. However, the threshold that needs to be met to declare an “alarm” or “detection” is adjustable and can be set depending on the size of the animal one may wish to detect. Detection messages are transmitted to a computer placed in a cabinet on the south side of the road (between detection zones 1a and 1b). The detection messages are saved in files for later analysis. The detection files can be accessed on site as well as from CDOT’s office in Durango.

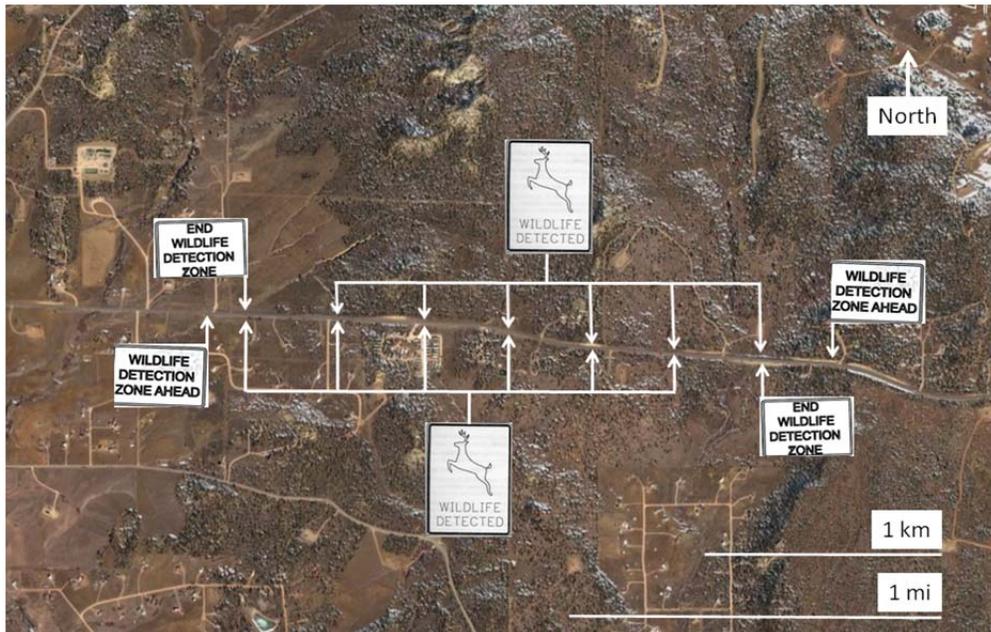
Figure 2.2: Location of the warning signs.

The warning signs are about 366 m (1200 ft) apart (Figure 2.2). The warning signs are fiber optic blank-out signs and do not display any message when no detection is reported (black sign). In addition, there are signs that alert the driver to the upcoming road section with the animal detection system, and signs that mark the end of the road section with the animal detection system (Figure 2.1)

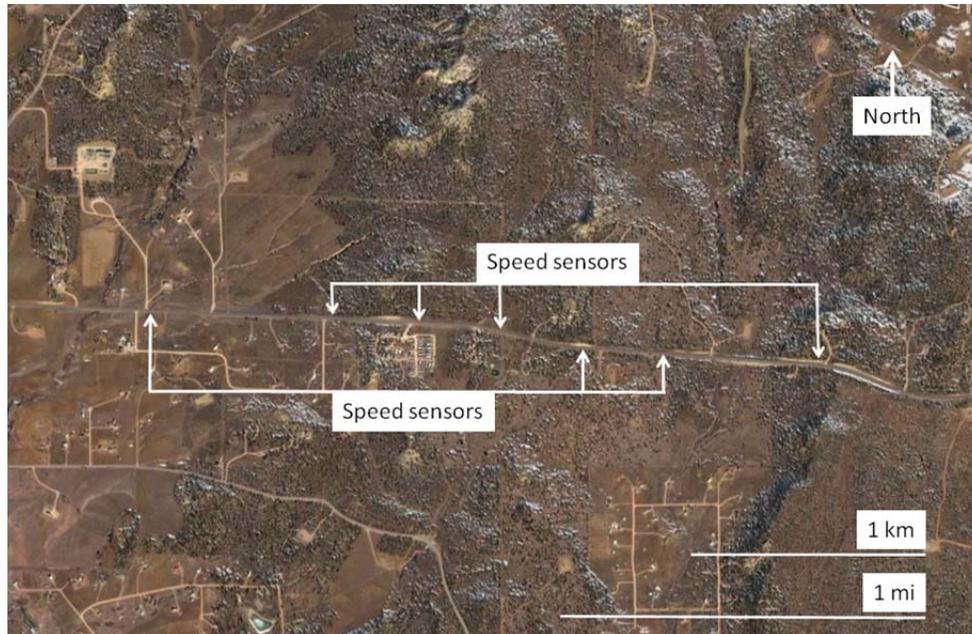
Figure 2.3: Location of the speed sensors.

There are seven speed sensors (radar detectors mounted on posts) associated with the animal detection system (five inside the road section with the system, and one on each side, outside of the road section with the system) (Figure 2.3). The speed data are collected through a communication link to CDOT's office in Durango. If one sensor at a time is collecting data, data on individual vehicles are saved. If data are collected from multiple sensors (up to seven) at a time, only binned data are available.

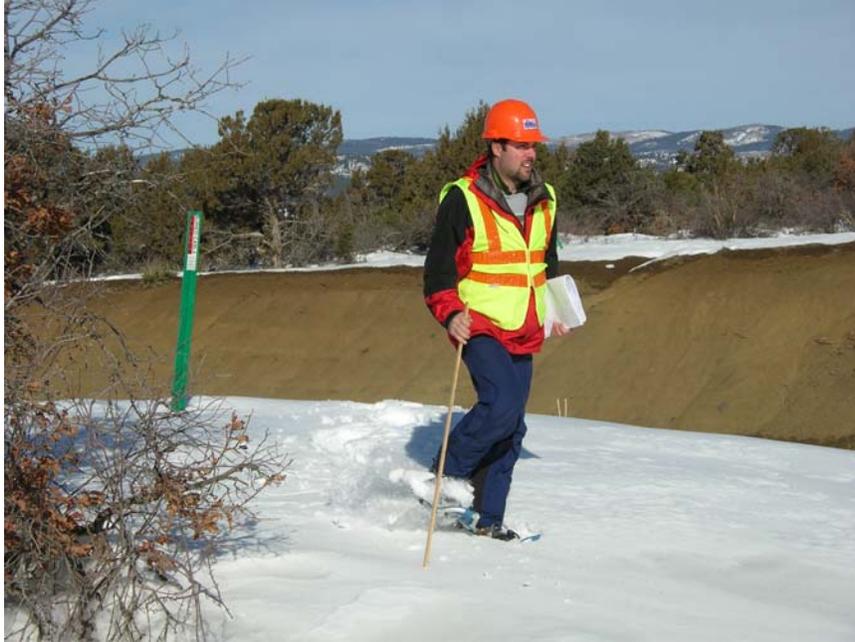
Figure 3.1: Example of a researcher crossing the buried EM cable. The green post in the background represents the location of the buried EM cable (cable extends left to right in photo). Tracks left in the snow by the researcher indicate the nature of the crossing activity by the researcher: perpendicular to the buried EM cable.

While the researcher crossed the buried cable at regular intervals (Figure 3.1), the system continuously logged the signal strength for the different detection zones. A detection occurred when the signal strength exceeded a specific threshold. This threshold value is adjustable to accommodate different species (e.g. smaller species require a lower threshold) and environmental conditions (e.g. greater snow depths require lower thresholds).

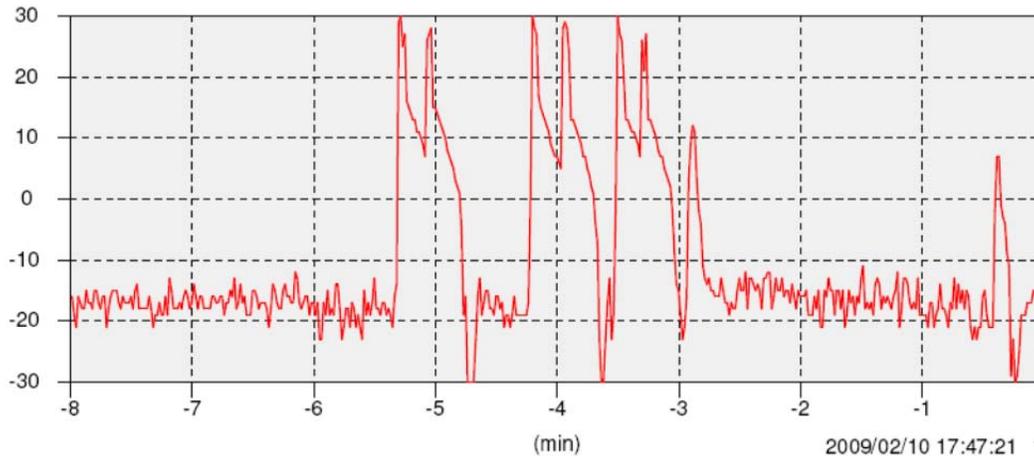
Figure 3.2: Example of a plot generated during reliability testing (x-axis = time; y-axis is signal strength (dB)). In this example, six peaks were identified between 3:00 and 5:30 minutes before the plot was ended. These peaks coincided with a researcher crossing the buried cable at 3 locations (each pass triggered two peaks as the researcher crossed the cable).

Upon completion of the reliability test survey, comparisons were made to the plots with the signal strength for the different detection zones. A pass across the buried cable by the researcher had to be associated with an increase in the signal strength in the detection zone concerned, and the increase in signal strength had to reach or exceed the threshold for a detection to be declared and to activate the warning signs. If the threshold was not met or exceeded with a pass across the buried cable the researchers declared a “blind spot” as the system appeared to have failed to detect the researcher, and potentially a large wild ungulate. An example of how detection events were identified is presented in Figure 3.2.

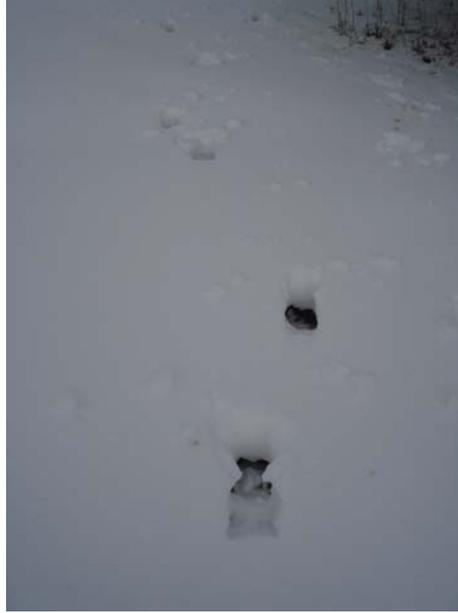
Figure 3.3: Example of a track left by a mule deer. Tracks were identified to species and subsequently “erased” by raking snow over the tracks in preparation for the next day of sampling.

Upon completion of the snow tracking survey, comparisons were made to the detection log and the plots generated by the systems. Correct system functioning should result in cable crossings, as measured through snow tracking, and matching events in the detection logs based on detection zone and time (within the past 24 hours). Detections by the system were identified by spikes in the signal that exceeded either the threshold set for that zone or a substantial increase (greater than 40 dB) in the baseline readings detected along the EM cable, as discussed in Section 3.1.2.

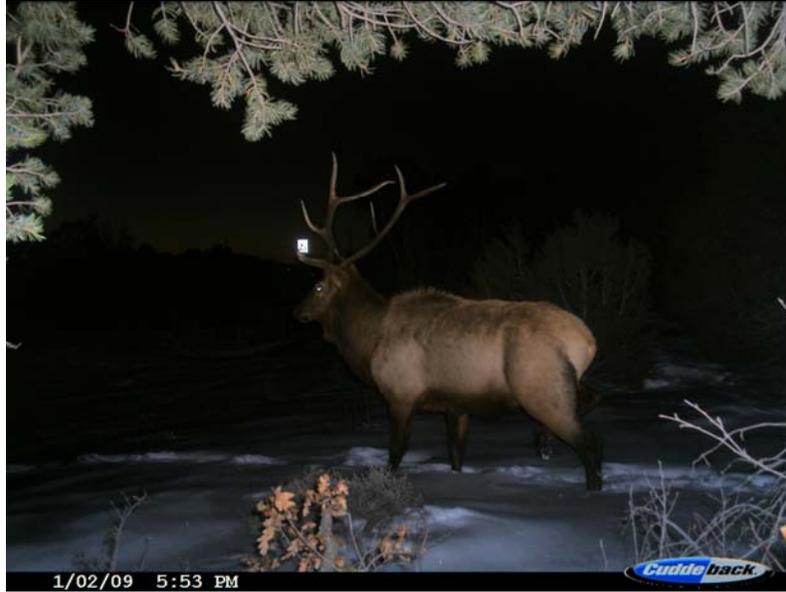
Figure 3.4: Example of photo taken at camera station. Cameras were positioned so as to capture any animals crossing the buried EM cable.

During the 2009 camera session the cameras captured a total of 110 crossing events over the cable, including 92 deer and 1 elk; additional species detected at camera stations included coyote (6 camera detections), red fox (1 camera detections), rabbit (5 camera detections), domestic dog (1 camera detections), and domestic cat (4 camera detections). None of these events were captured by the system log. Of the zones surveyed, camera detections were highest in Zones 10A (25 deer; 1 elk), 4A (20 deer), and 3A (18 deer).

During the 2011 cameras captured a total of 6 crossing events over the cable, all of which were mule deer; additional species detected at camera stations included a domestic cat (1 camera detection). None of these events were captured by the system log. Of the zones surveyed, camera detections were highest in Zone 3A (5 deer).

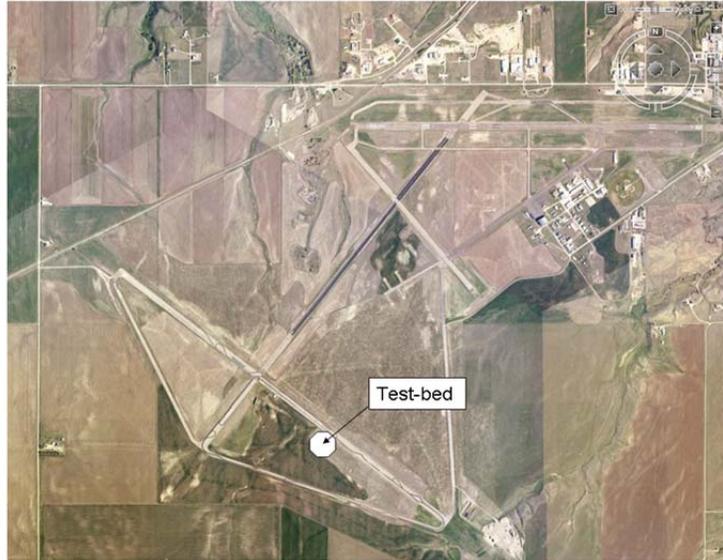
Figure 4.1: The location of the test-bed along a former runway at the Lewistown Airport in central Montana, USA. The current municipal airport is located on the upper right of the photo.

The RADS test-bed is part of the TRANSCEND cold region rural transportation research facility and is located along a former runway at the Lewistown Airport in central Montana. The test-bed location experiences a wide range of temperatures, and precipitation ranges include mist, heavy rain, and snow; the topography is flat, and the rocky soil does not sustain much vegetation that may obstruct the signals transmitted or received by the sensors of some types of animal detection systems. The test-bed consists of an animal enclosure, space for multiple animal detection systems, and six infrared cameras with continuous recording capabilities (Figures 4.1 through 4.4). The distance covered by the system tested for this project was about 50 m (164 ft) (from the left to about the middle of the enclosure). The animal enclosure includes shelter, water, and an area alongside the fence that was designated for feeding. These three resources are located in different parts of the enclosure to maximize animal movement through the detection areas.

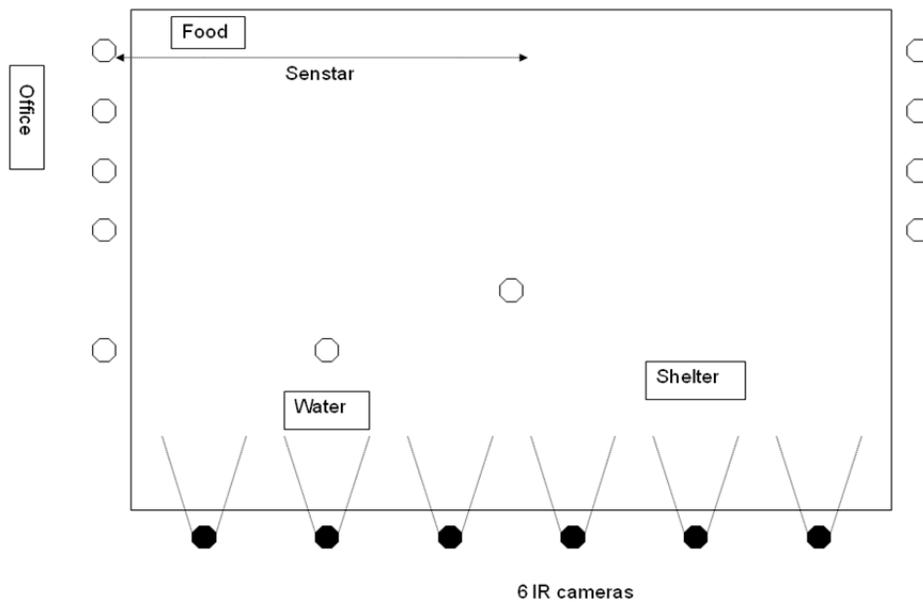
Figure 4.2: Test-bed design including an animal enclosure, the Perimitrax® animal detection system manufactured by Senstar Corporation tested for this project (open circles represent poles on which sensors can be attached), the six infrared (IR) cameras aimed at the enclosure from the side (solid circles), and the office with data recording equipment.

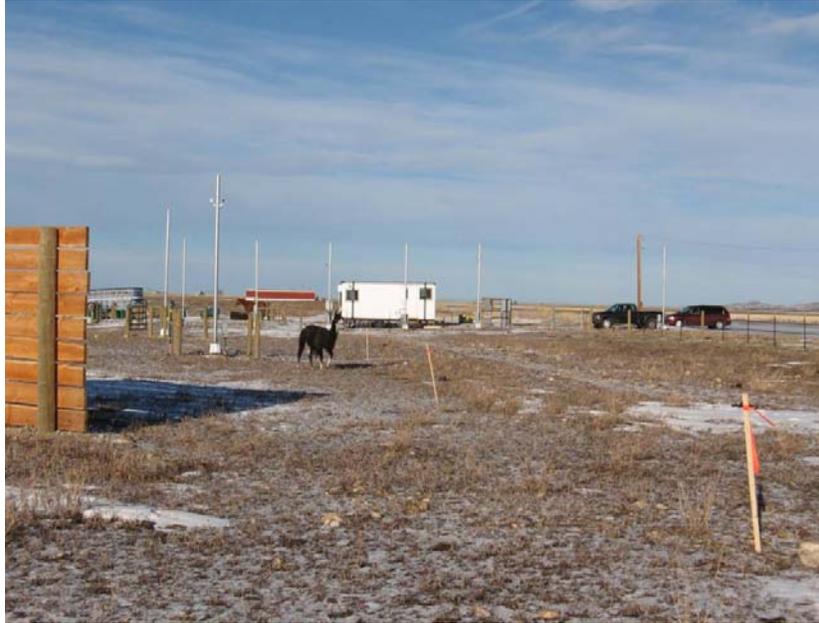
Figure 4.3: The test bed with the remote office, poles on which sensors can be attached, the shelter, and a llama (Photo: Marcel Huijser, WTI/MSU).

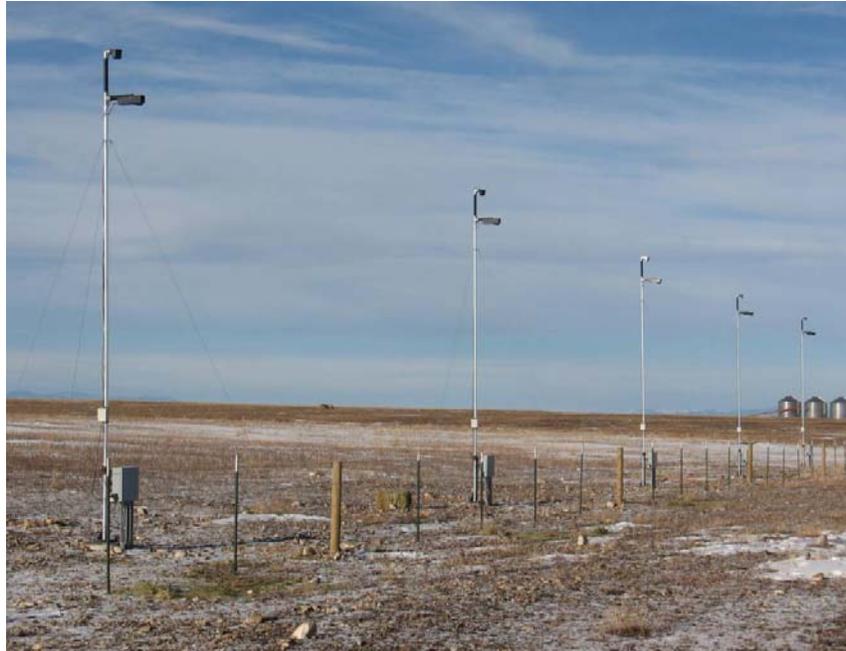
Figure 4.4: The infrared cameras that monitor animal movements in the enclosure (Photo: Marcel Huijser, WTI/MSU).

Six infrared cameras (Fuhrman Diversified, Inc.) were installed perpendicular to the detection system (Figure 4.4). These cameras and a video recording system record all animal movements within the enclosure continuously, day and night. The Senstar Perimitrax® system saved its individual detection data with a date and time stamp. These data were compared to the images from the infrared cameras, which also had a date and time stamp, allowing the researchers to investigate the reliability of the system. Orange cones marked the location of the cable on the images (Figure 4.10).

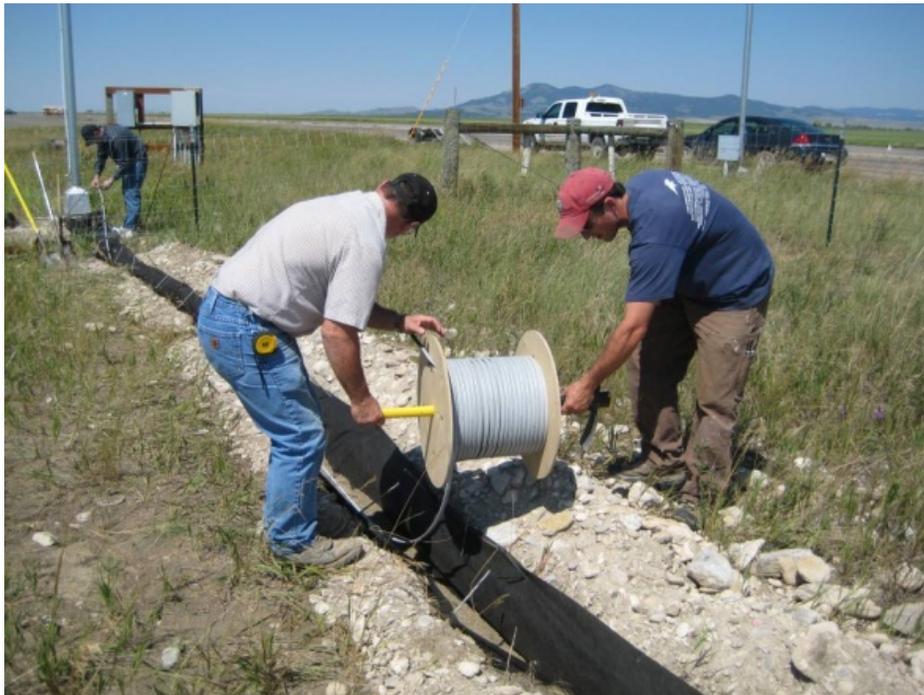
Figure 4.5: The installation of the Senstar Perimitrax® cable. The cable is embedded with sand and wrapped in geotextile (Photo: Marcel Huijser, WTI/MSU).

The system tested for this project is a buried cable (Perimitrax®) that detects large mammals when they move across the cable (Figures 4.5 through 4.9). The system is manufactured by Senstar Corporation, Carp, Ontario, Canada, and it is the exact same technology as originally installed along US Hwy 160 near Durango, CO, USA. The buried cable was placed in a trench and wrapped in sand and geotextile nine inches below the surface. System installation took place on 11 and 12 August 2009. The system generates an invisible electromagnetic field and when a large animal crosses the cable it causes a disturbance in this electromagnetic field. The electrical conductivity, size and speed of the animal all affect the magnitude of the disturbance. However, the threshold that needs to be met to declare an “alarm” or “detection” is adjustable and can be set depending on the size of the animal one wishes to detect. Detection messages are transmitted to a computer in the research trailer at the test-bed where they are saved in files for later analysis.

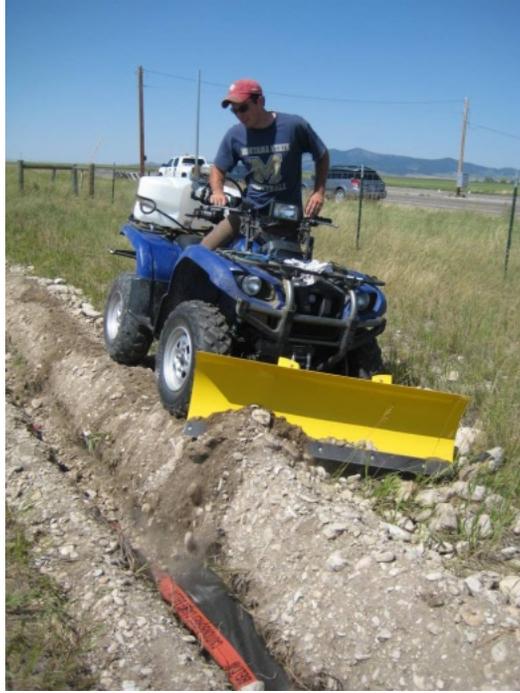
Figure 4.6: The installation of the Senstar Perimitrax® cable. Filling up the trench (Photo: Marcel Huijser, WTI/MSU).

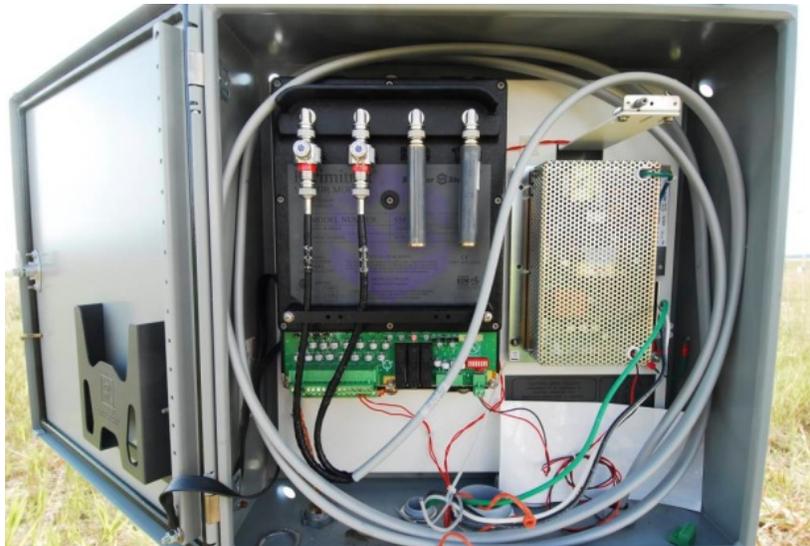
Figure 4.7: The Senstar Perimitrax® sensor module at the pole where the cable comes up from the ground (Photo: Marcel Huijser, WTI/MSU).

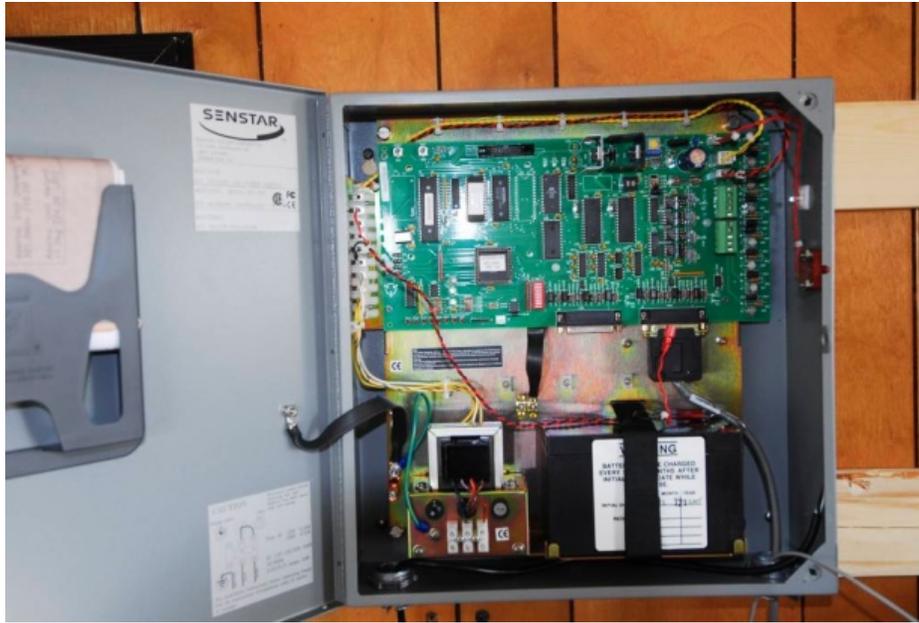
Figure 4.8: The Senstar Perimitrax® Network Controller inside the research trailer (Photo: Marcel Huijser, WTI/MSU).

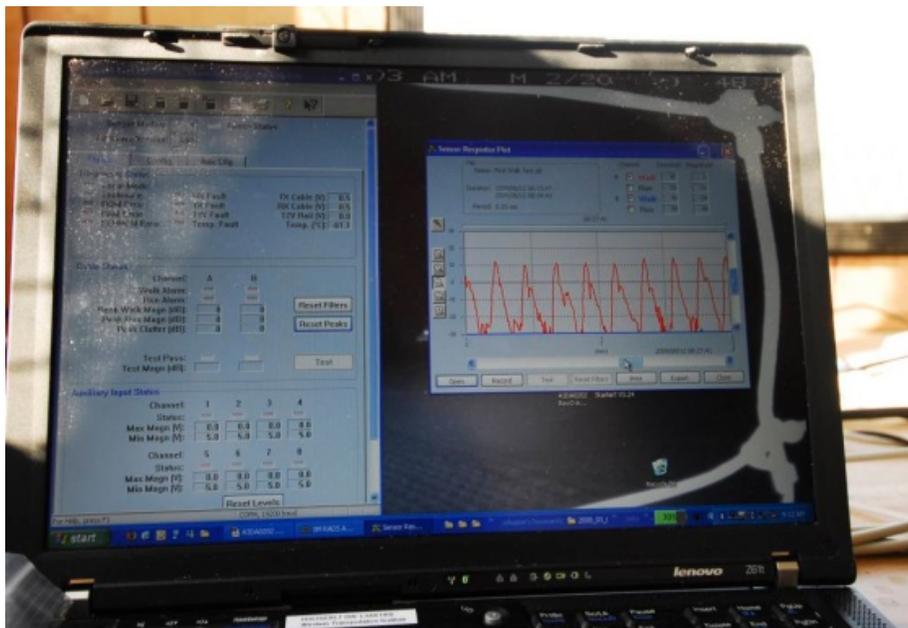
Figure 4.9: The Senstar Perimitrax® interface on a PC in the research trailer during a “walk” test by a human (Photo: Marcel Huijser, WTI/MSU).

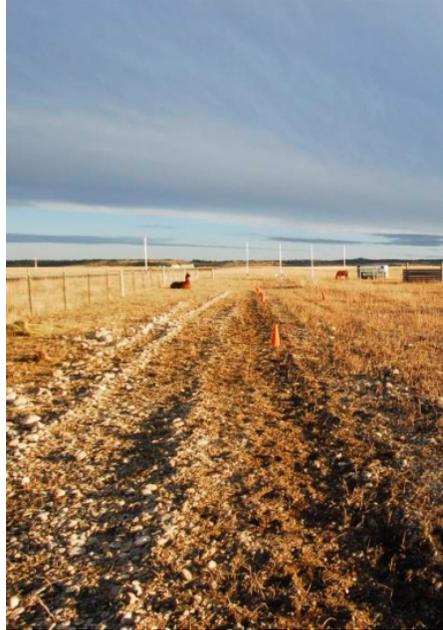
Figure 4.10: The orange cones mark the location of the Senstar Perimitrax® buried cable. These cones are visible on the IR video images (Photo: Marcel Huijser, WTI/MSU).

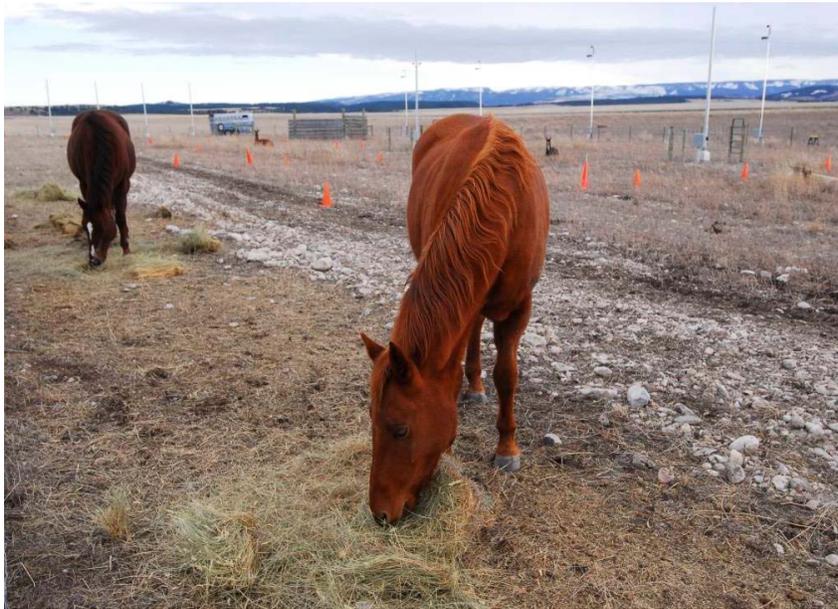
Figure 4.11: The two horses that were used in the test (Photo: Marcel Huijser, WTI/MSU).

In a North American setting, animal detection systems are typically designed to detect white-tailed deer (*Odocoileus virginianus*) and/or mule deer (*Odocoileus hemionus*), pronghorn (*Antilocapra americana*), elk (*Cervus canadensis*) or moose (*Alces alces*). In Montana, it is not legal to have deer, elk or moose in captivity. Therefore the researchers used domesticated species as a model for wildlife. For this study, which took place within an enclosure, two horses, two llamas, and two sheep were used as models for these wildlife target species. Horses are similar in body shape and size to moose, llamas represent deer and elk, and sheep represent small deer (Tables 4.1 through 4.3). The body size and weight of the individual horses, llamas, and sheep used in this experiment are shown in Table 4.3. Some of the test animals are shown in Figures 4.11 through 4.13.

Individual	Height at shoulder	Weight
Horse 1 (Bubba)	5' (152 cm)	1130 lbs (513 kg)
Horse 2 (Buster)	5'2'' (157 cm)	1450 lbs (659 kg)
Llama 1 (Sparkle)	3'9'' (114 cm)	350 lbs (159 kg)
Llama 2 (Cocoa)	3'9'' (114 cm)	470 lbs (213 kg)
Sheep 1	2'4" (71 cm)	170 lbs (77 kg)
Sheep 2	2'5" (74 cm)	225 lbs (101 kg)

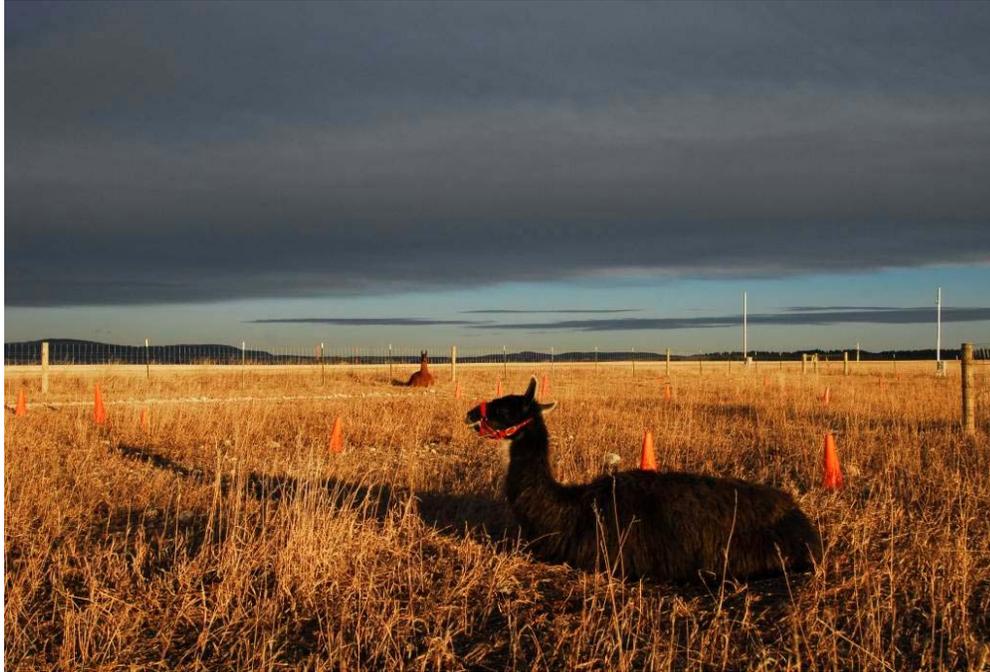
Figure 4.12: The two llamas (foreground and background) that were used in the test (Photo: Marcel Huijser, WTI/MSU).

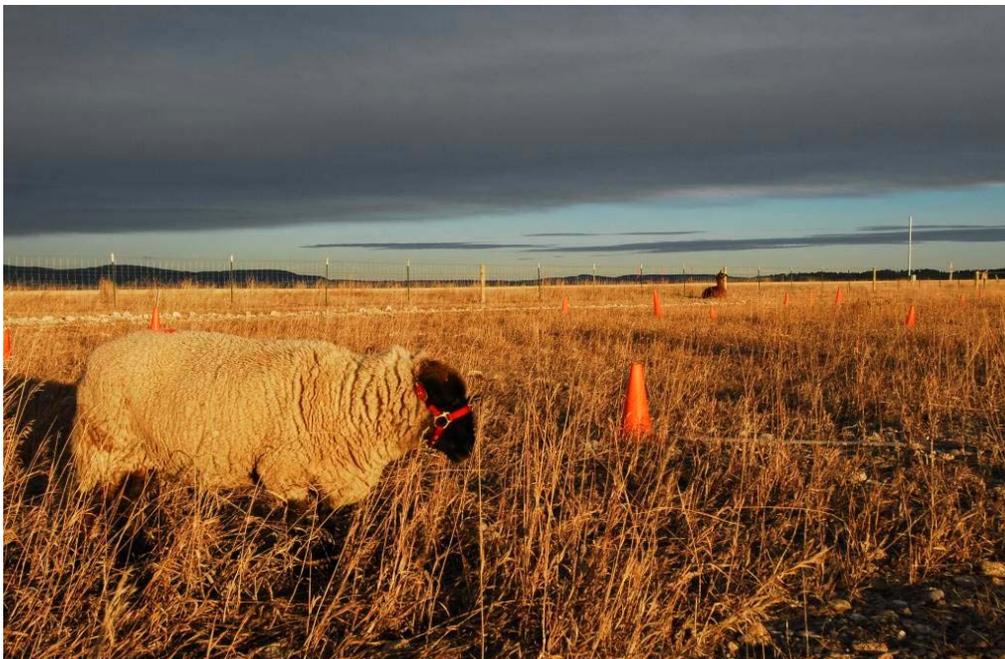
Figure 4.13: One of the two sheep that were used in the test (Photo: Marcel Huijser, WTI/MSU).

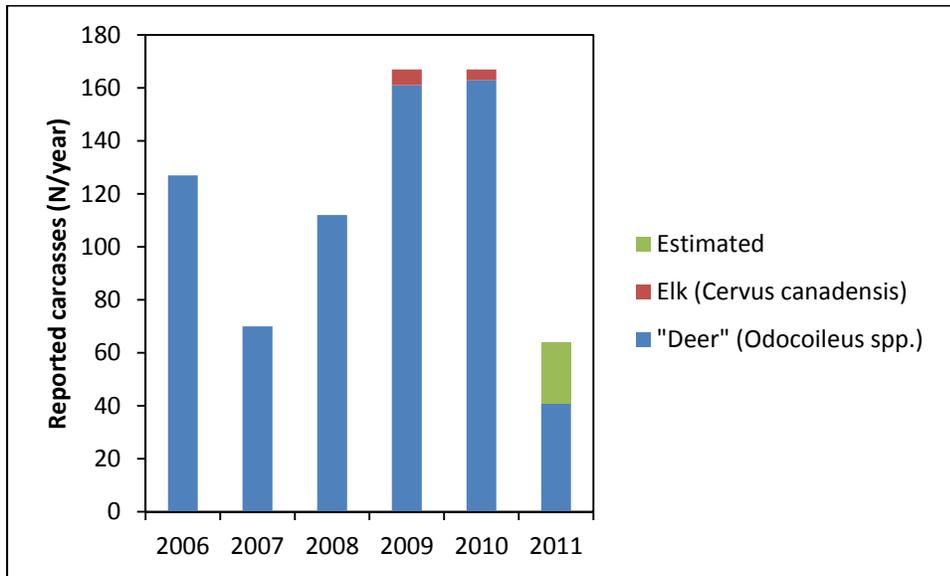
Figure 8.1: The number of reported large mammal per year between 2006 and 2011 for the road section along Hwy 160. Note that the 2011 data included an estimate for the carcasses for the months October through December.

The number of reported large mammal carcasses was highly variable for the different years (between 64 and 167) (Figure 8.1). The treatment road sections (animal detection systems and vegetation clearing in the right-of-way) only related to relatively short road sections of about 1 mile (1,609 m) while the data relate to the entire road section of 19.2 mile (30.9 km). Therefore the relatively low (estimated) number of large mammal carcasses in 2011 is not likely related to

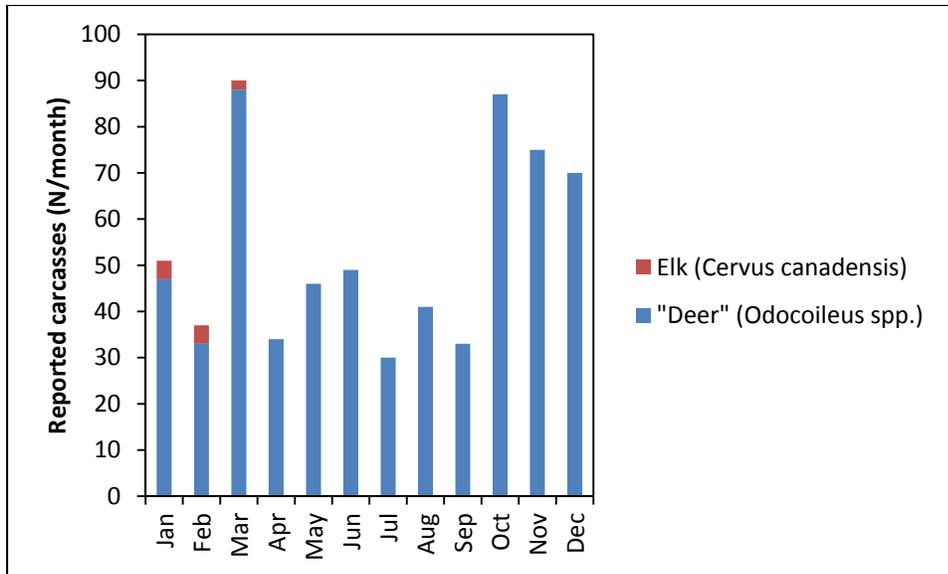
Figure 8.2: The number of reported large mammal per month between 2006 and 2010 for the road section along Hwy 160.

The average number of reported large mammal carcasses was also highly variable for the different months (between 30 and 90) (Figure 8.2). Peaks (March and October-December) may relate to spring and fall migration of primarily mule deer.

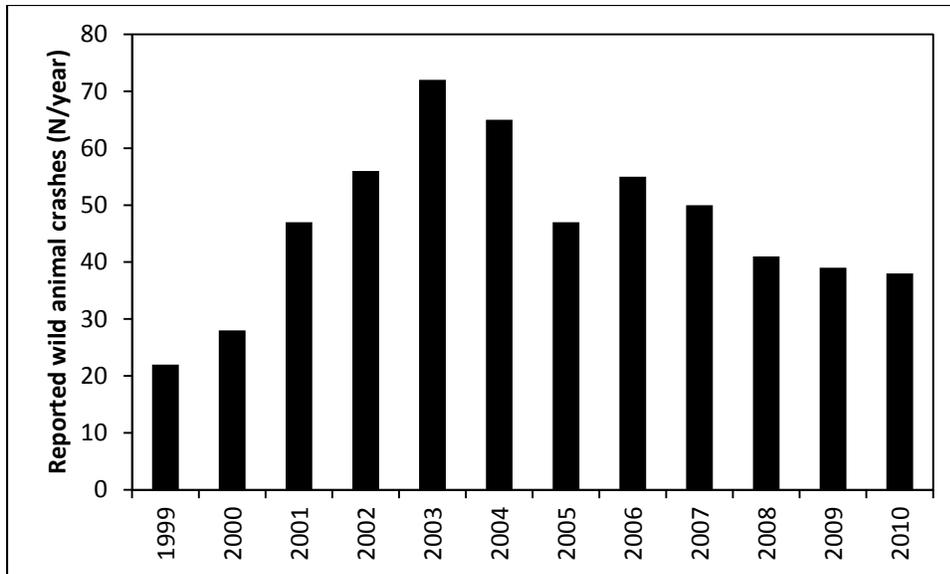
Figure 8.3: The number of reported large mammal per year between 1999 and 2010 for the road section along Hwy 160.
