# SEVEN-YEAR EVALUATION OF THREE INSTRUMENTED BRIDGE DECKS IN SACO, MONTANA

*Final Report*

**Western Transportation Institute**  
College of Engineering  
Montana State University – Bozeman

November 2010

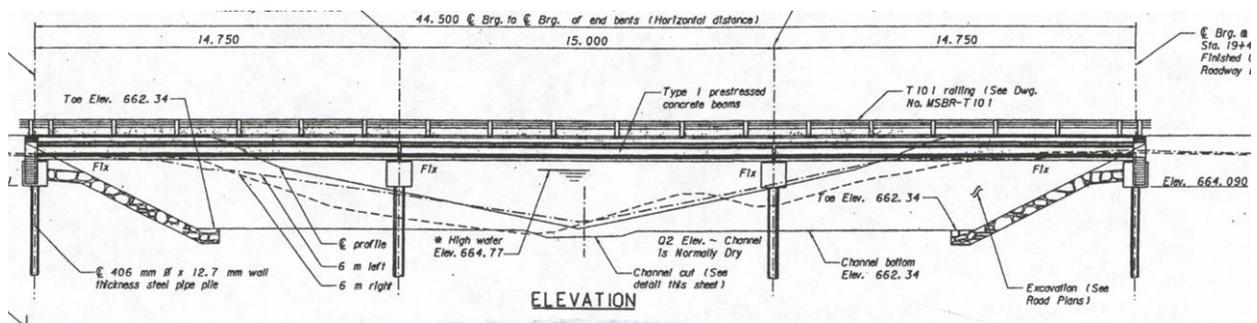
All three bridges are 44.5 meters long and 9.1 meters wide (146 feet long and 30 feet wide). The superstructure consists of three spans, as shown in Figure 1. The stringers that support the deck are standard, Type-I prestressed concrete I-beams spaced at 2.4 meters (7.9 feet) on center, as shown in Figure 2. The thickness of each deck is 210 mm (8.3 in.). Design specifications for the bridge decks required 31 MPa (4,500 psi) strength concrete.

Figure 1: Elevation view of one of the bridges.

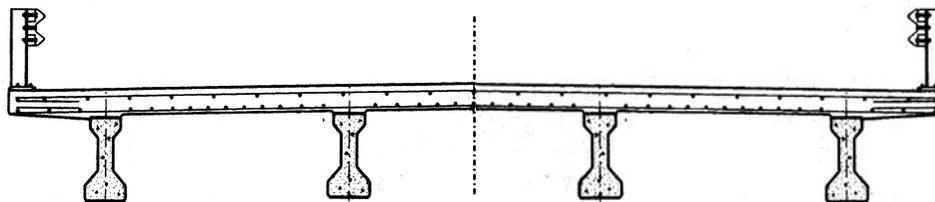
Figure 2: End view of Conventional bridge deck.

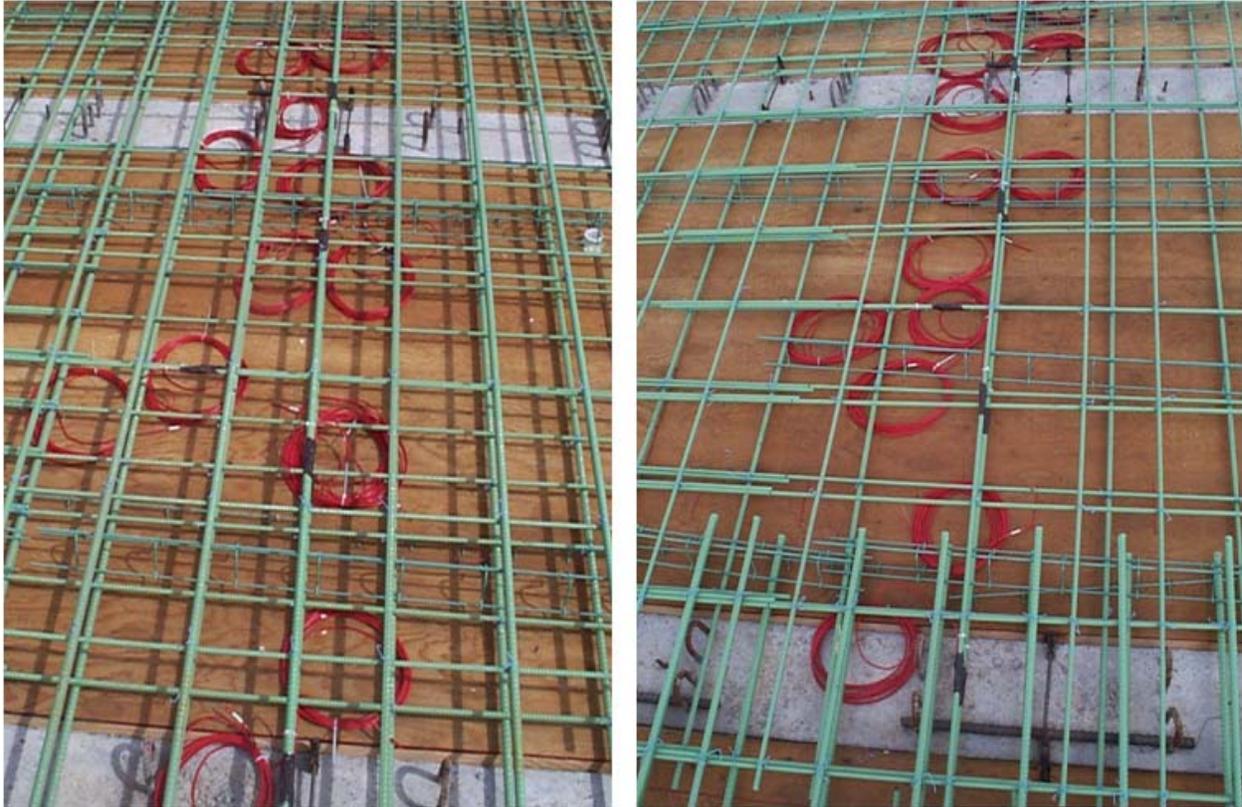
While all three decks use epoxy coated reinforcing steel, the layout of the reinforcing steel varies between the three decks. The conventional and HPC decks were designed using the traditional strength approach described in the AASHTO specifications (AASHTO, 2000). The traditional strength design method treats the deck as if it were a beam in flexure spanning the stringers. This design results in the primary reinforcement oriented transversely to the span of the bridge.

The empirical design approach, which requires no formal analysis, is permitted by the AASHTO specifications for monolithic concrete bridge decks that satisfy specific conditions. Using this design method, reinforcement ratios for the top and bottom mat in both the longitudinal and transverse directions are simply functions of the depth of concrete and length of span. AASHTO specifies a minimum reinforcement ratio equal to  $3.8 \text{ cm}^2/\text{meter}$  ( $0.18 \text{ in.}^2/\text{ft}$ ) in each direction in

the top mat, and  $5.7 \text{ cm}^2/\text{meter}$  ( $0.27 \text{ in.}^2/\text{ft}$ ) in each direction in the bottom mat. The reason for the increased amount of steel in the bottom mat is for better crack control in the positive bending regions of the slab. Comparatively, in the construction drawings for the decks constructed as part of this research project, the Conventional and HPC decks require 3667 kg (8084 lb) more steel than the empirical deck (a 31 percent increase). Figure 3 shows the difference in the density of the reinforcement between the two deck designs, taken at the same place in the deck. Reducing the amount of steel in the empirical deck, especially in the top layer, decreases the opportunity for, and the affects of reinforcement deterioration.

**Figure 3: Typical reinforcement densities of the Conventional and HPC Decks (left), and the Empirical Deck (right).**

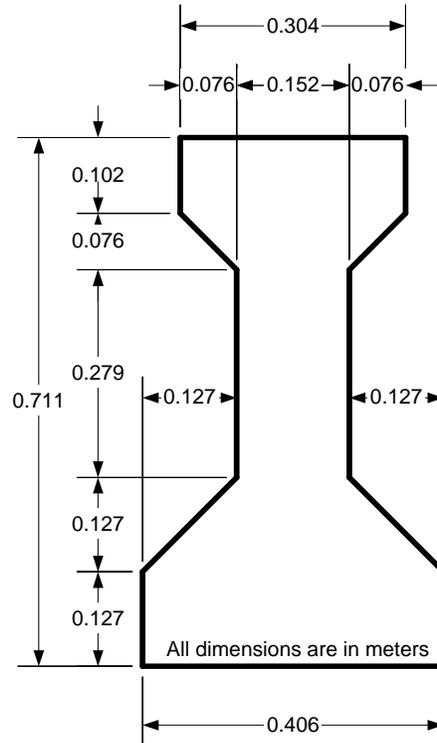
Type I prestressed concrete beams were used to support the bridge deck. The dimensions and sectional properties of these beams are shown in Figure 4. The results of the concrete compressive strength tests for the prestressed girders (obtained from MDT) were averaged and are summarized in Table 3.

Figure 4: Dimensioned cross-sectional view of bridge girders.

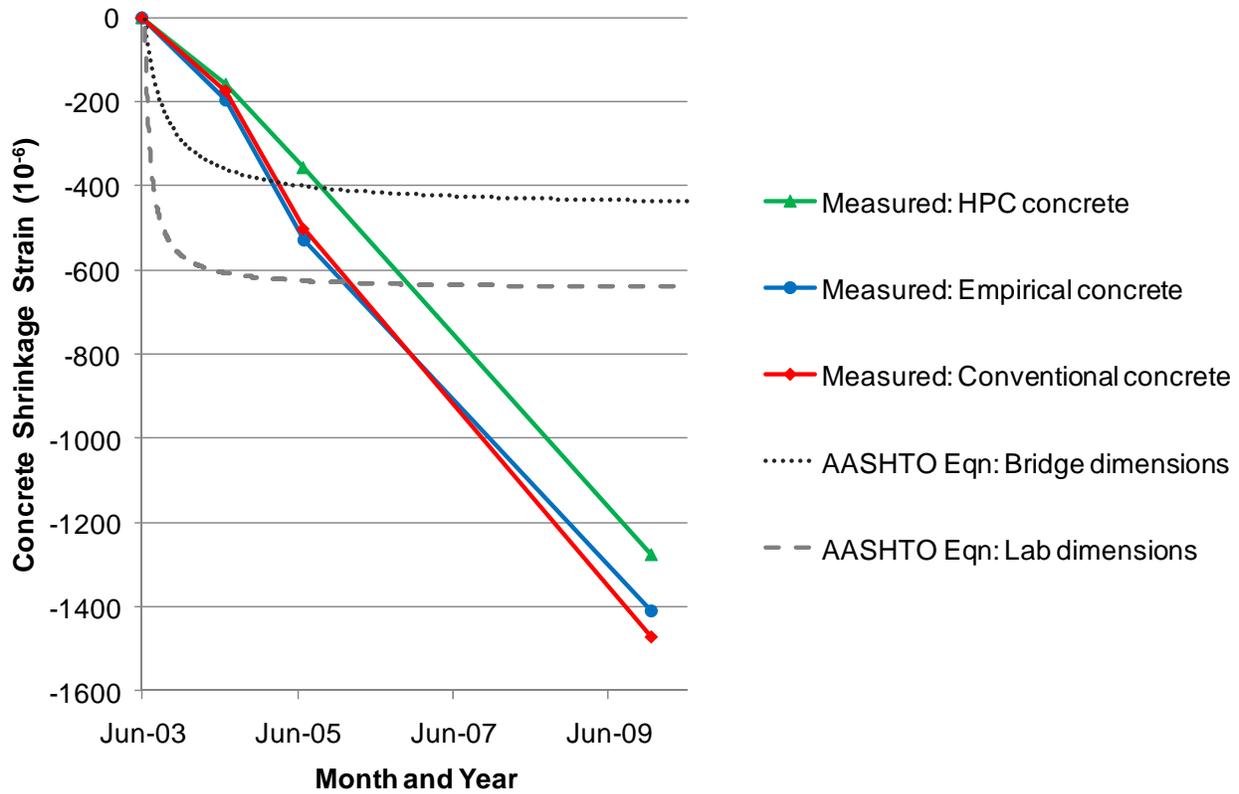
Shrinkage of the concrete was monitored using small beam specimens cast during each deck pour. Some of the shrinkage beams were cured in a moist environment while the remainder were cured and stored on site. Shrinkage is highly dependent upon humidity; therefore, the shrinkage beams cured and stored with the bridge decks should most closely represent true shrinkage of the deck concrete. A milling machine equipped with an edge finder was used to precisely measure the lengths of the shrinkage beams periodically over the seven year interval since the bridge decks were cast. The resulting shrinkage strains (calculated as change in length divided by original length) are presented in Figure 5. Reported values are the mean values for measurements made on three shrinkage beams from each bridge deck.

**Figure 5: Concrete shrinkage of laboratory specimens compared to the AASHTO equation.**

Referring to Figure 5, the shrinkage strains in the deck concretes have steadily increased since the specimens were cast during deck construction in 2003, reaching 1200 to 1400 microstrain in 2009. This result is unexpected, as typically the majority of concrete shrinkage occurs within the first year after construction, with long term values eventually reaching between 200 and 800 microstrain (ACI, 2008). Thus, both the nature and magnitude of the shrinkage strains measured in 2009 are unusual, with the cause for these unusual behaviors being uncertain. These measurements are exceptionally sensitive to the specific operator and equipment used, both of which changed between 2005 and 2009. That being said, the shrinkage of the HPC deck concrete has been noticeably less than that of the Conventional and Empirical deck concretes since 2005, by approximately 150 microstrain. Shrinkage in concrete is influenced by a myriad of factors, and thus it can be difficult to make a general statement about the relative shrinkage of high performance compared to traditional concretes. In this case, the specific concrete used in the HPC deck had a lower absolute volume of water in the mixture than was used for the Conventional and Empirical deck concretes (refer to Table 1), and thus it would be expected to exhibit less shrinkage than those concretes (Zia et al., 1997).

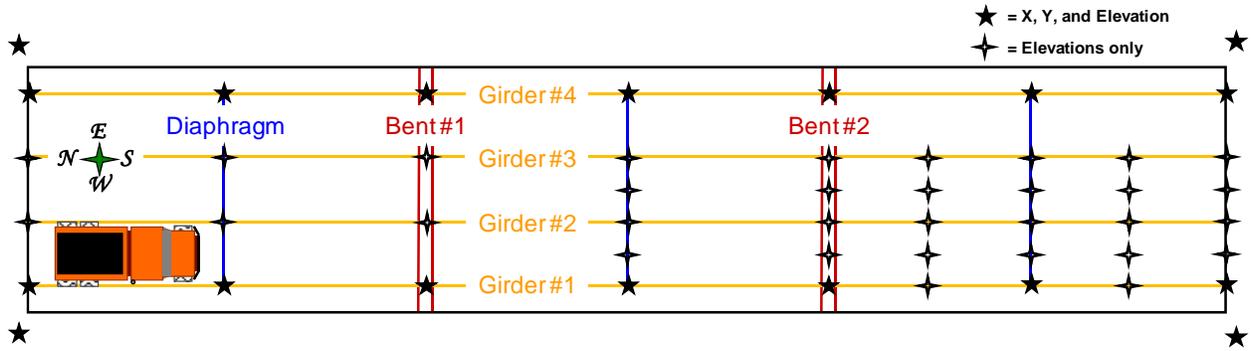
Topographic surveys were conducted to measure relative changes in the elevation and the horizontal position of various points on the surface of each deck. The same reference points were used in all surveys and are shown in Figure 6. Horizontal position was measured with an accuracy of about 3 mm and elevation was measured with an accuracy of approximately 1 mm.

**Figure 6: Survey points on a plan view of a bridge deck.**

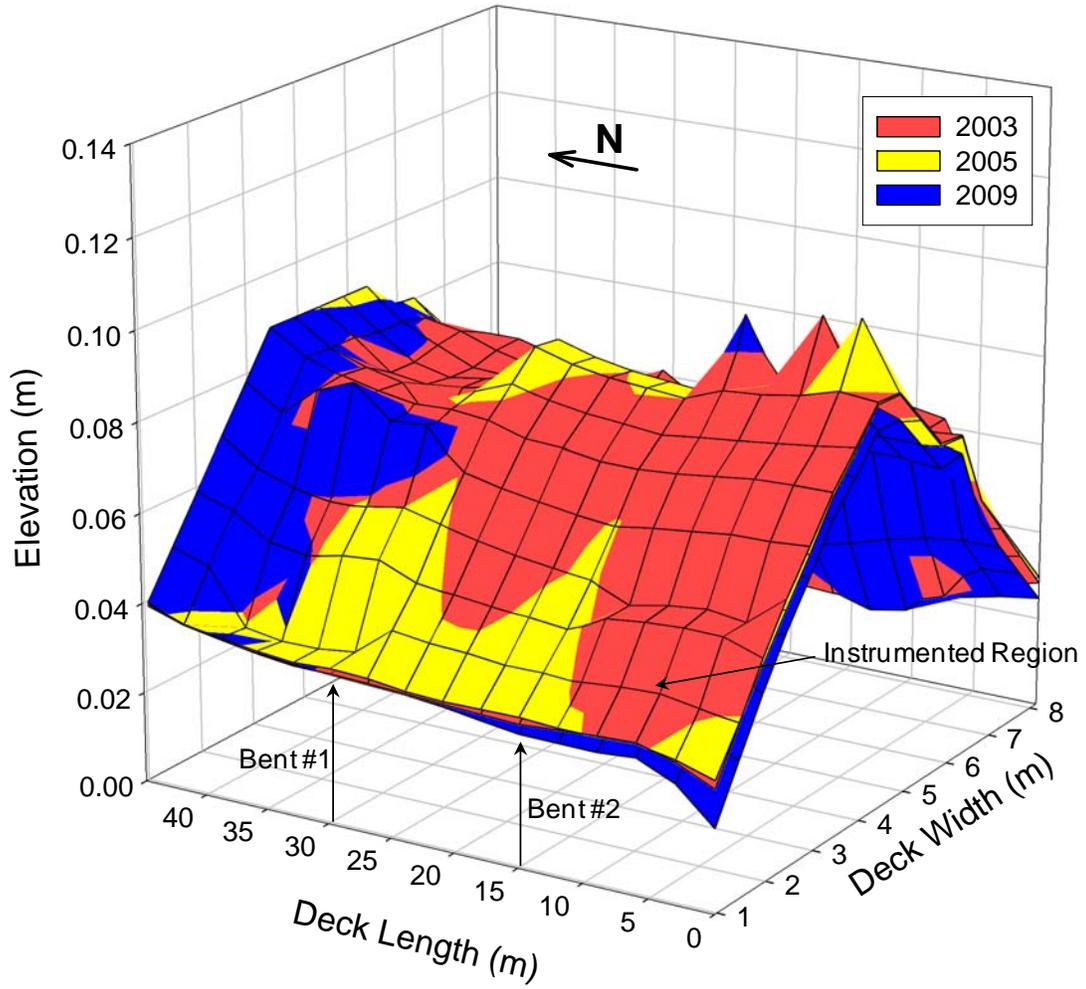
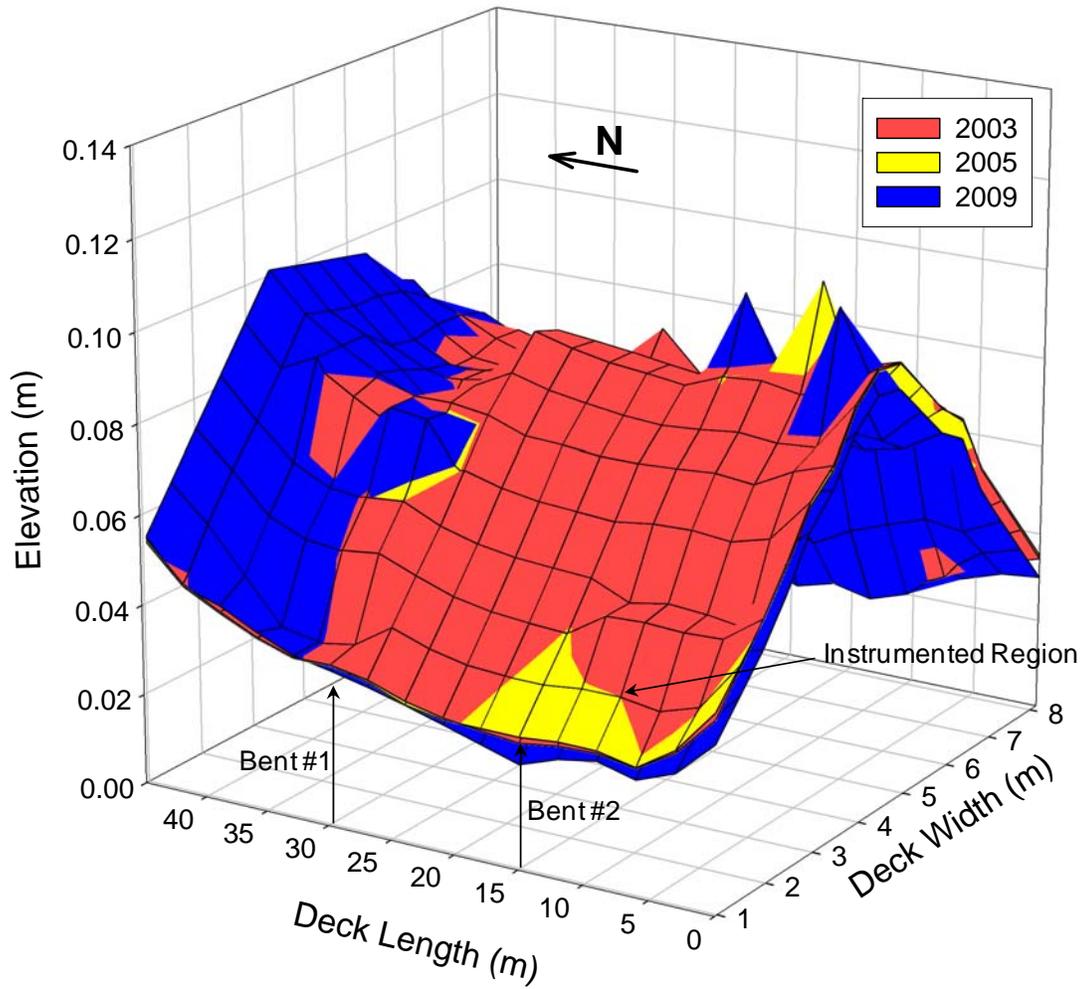
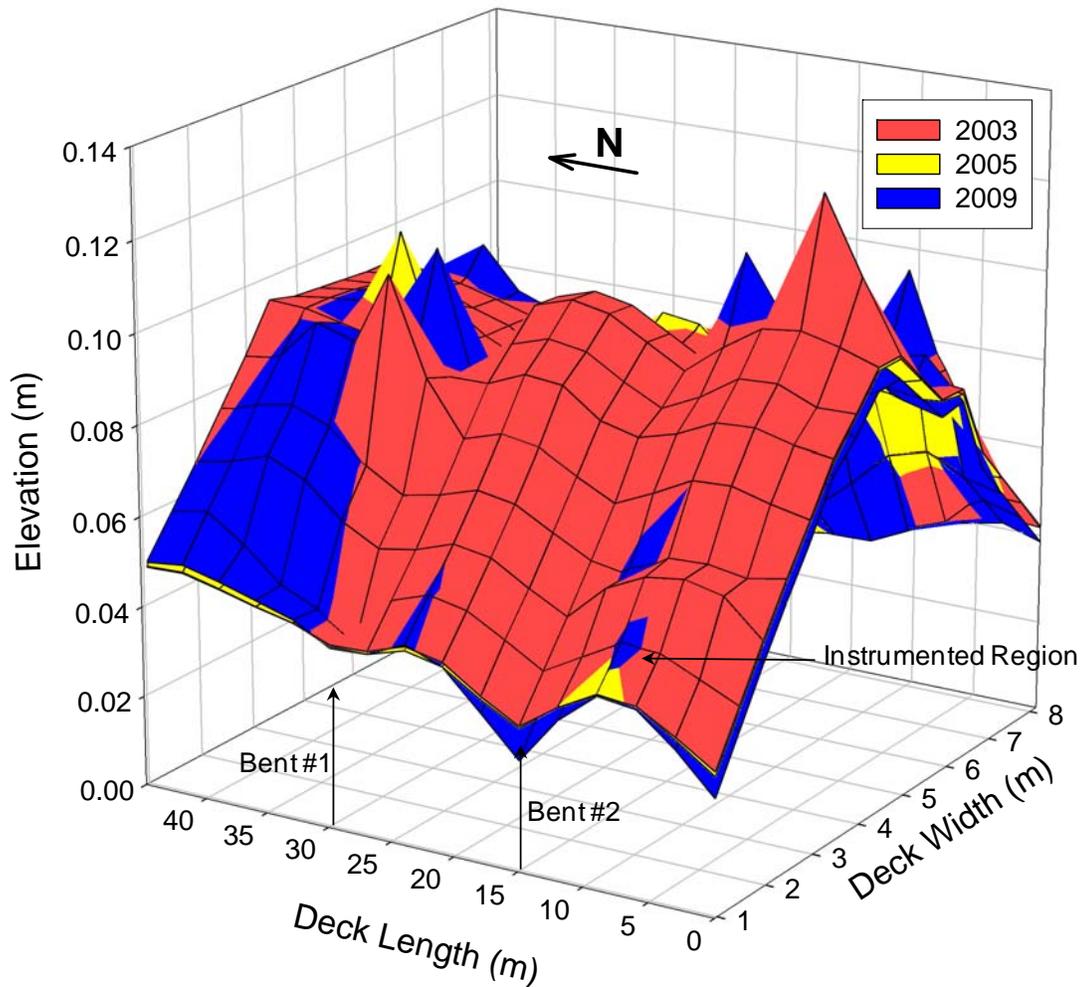
The results of the elevation surveys conducted in 2003, 2005, and 2009 are overlaid for each bridge in Figure 7, Figure 8 and Figure 9 for the Conventional, Empirical, and HPC decks, respectively. The geometry of the surfaces of all the decks was similar, consisting of a basic crown down the centerline of the bridges (measured as approximately 1.5 percent) and some longitudinal camber (upward deflection) between the bents, most notably in the HPC bridge. Elevation changes over time were small, although the survey conducted in 2009 showed some “tilting” of all the bridges along their longitudinal axis, with a small increase in elevation of approximately 0.5 mm (0.02 in.) on the north end, and a decrease of about 5 mm (0.2 in.) on the south end.

Figure 7: Topographic map of Conventional bridge deck surface.

Figure 8: Topographic map of Empirical bridge deck surface.

Figure 9: Topographic map of HPC bridge deck surface.

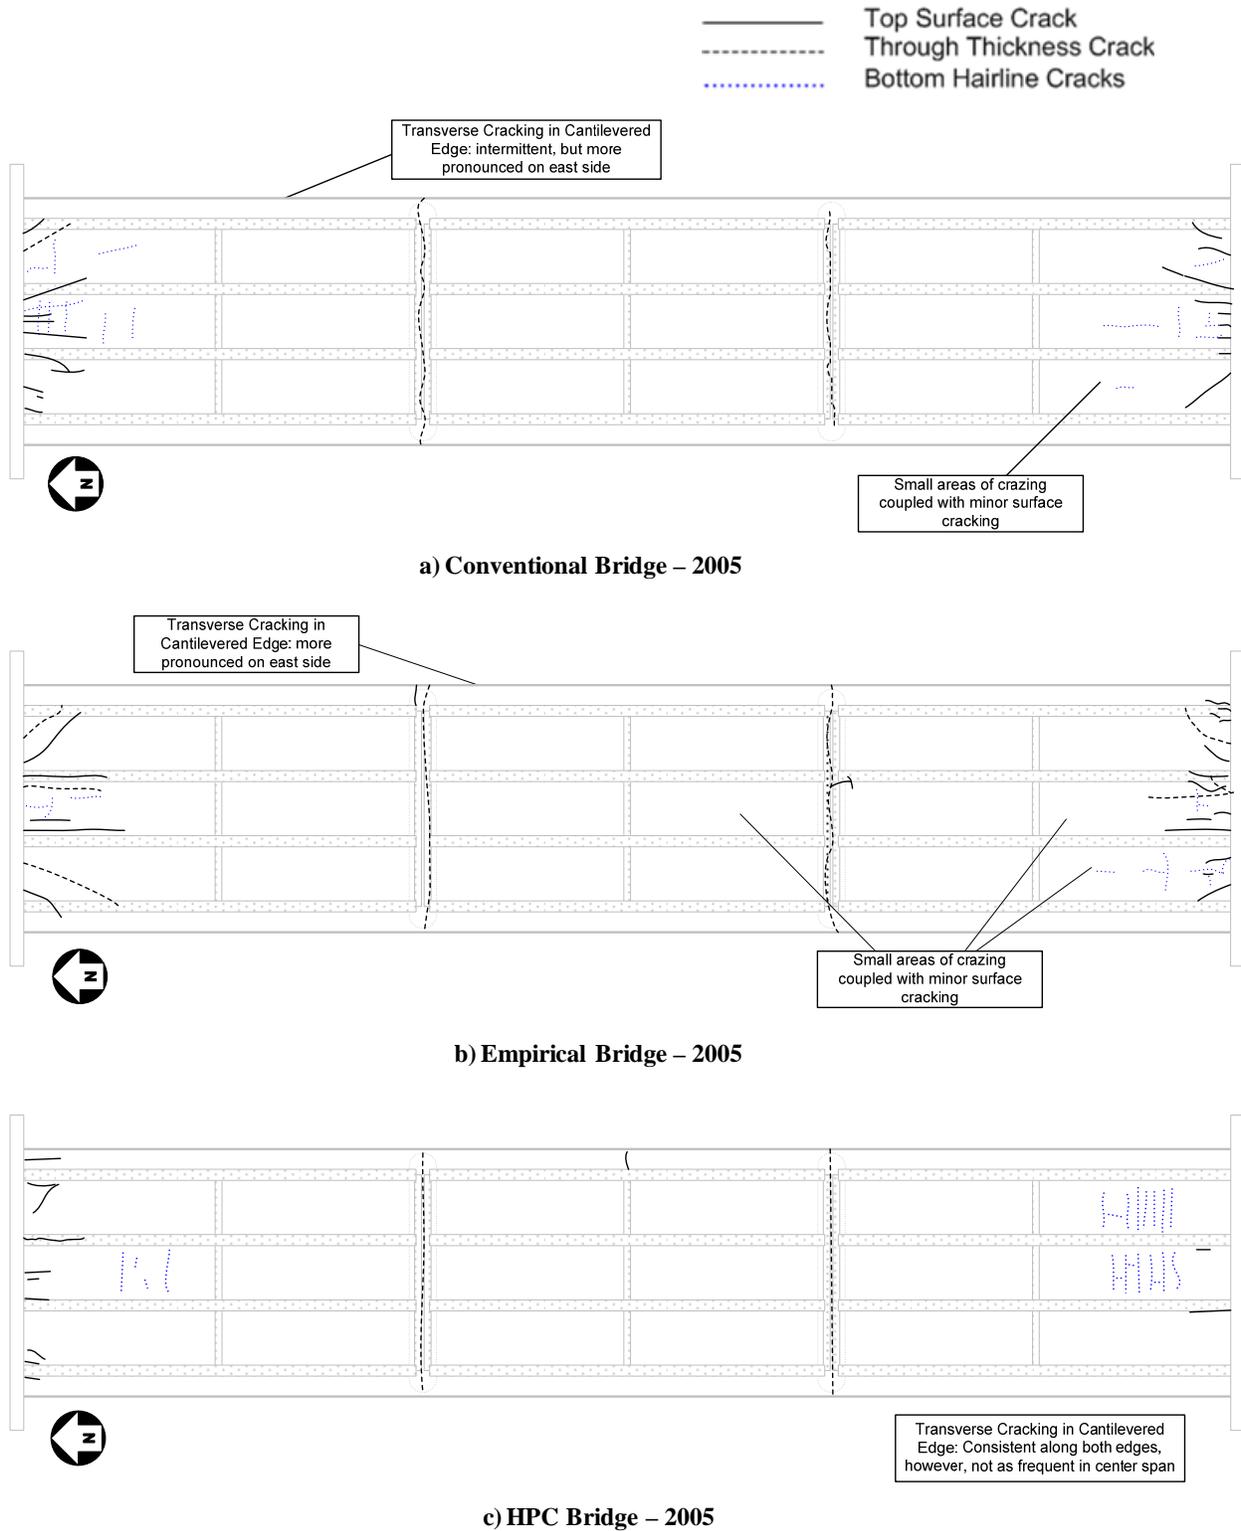
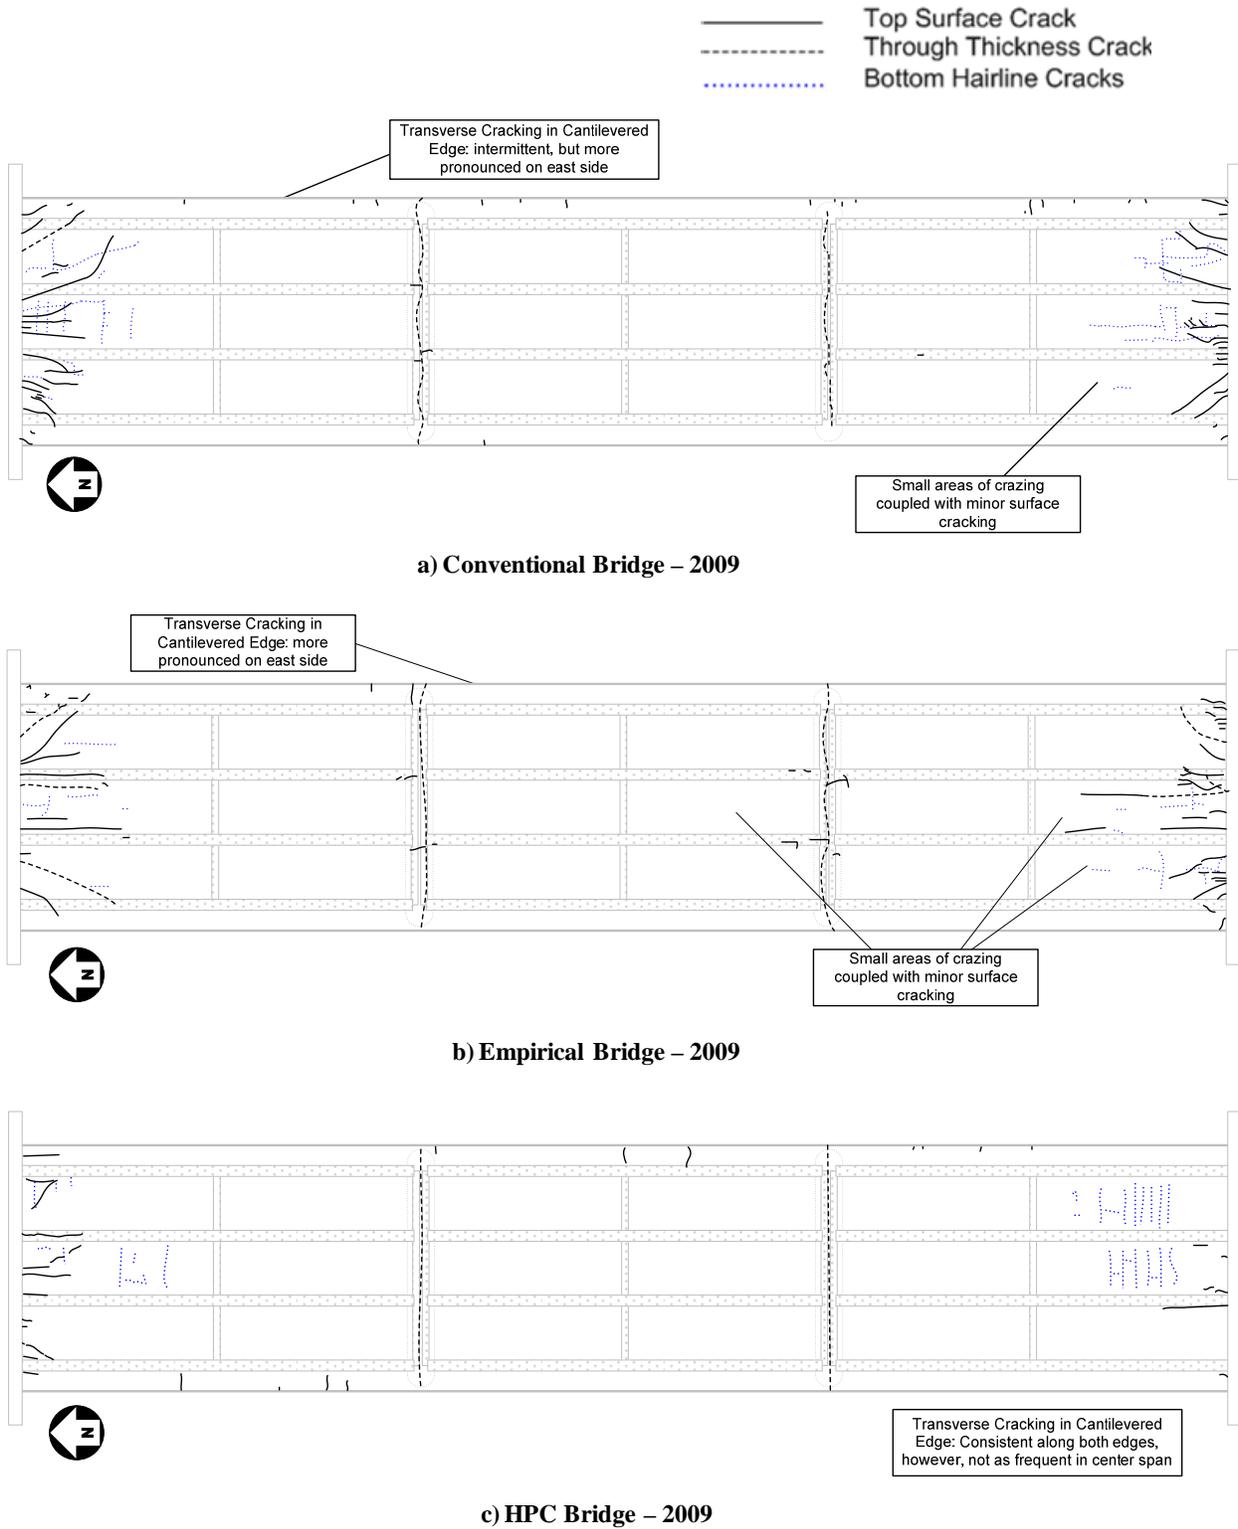
The three bridge decks were closely inspected to monitor the development of cracks, irregularities and delaminations. Acoustical soundings using a chain drag revealed no delaminations in the deck surface. Visible cracks were highlighted with a black marker and photo-documented. Consistent with the Phase I surveys, the entire top surface of the deck was inspected, whereas only about one-third of each end span toward the abutments was examined on the underside. A comprehensive survey of the underside of the bridge decks was not possible without special equipment. Thus, only the portion of the underside readily accessible from below the bridges was examined. Crack maps were generated and compared with visual distresses in 2005 (the last time visual distresses were surveyed). The 2005 and 2009 distress surveys are shown in Figure 10 and Figure 11, respectively.

Figure 10: Visual distress survey maps of the Saco bridge decks – 2005.

Figure 11: Visual distress survey maps of the Saco bridge decks – 2009.

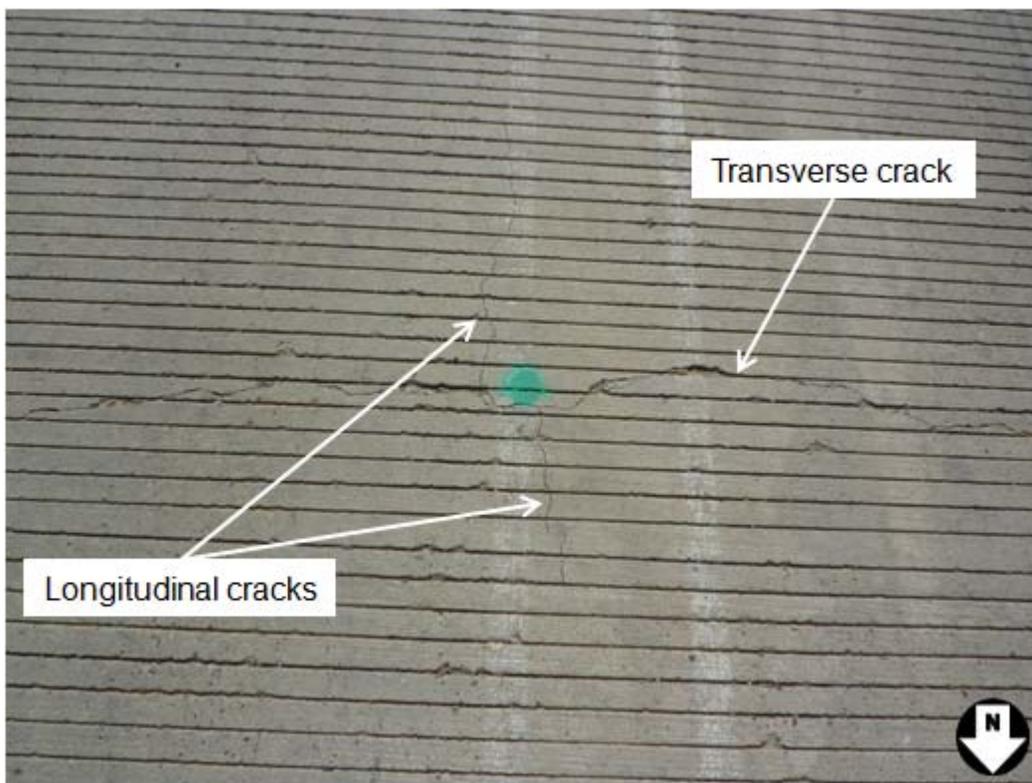
Transverse cracks developed over each of the bents within days after the deck concrete was placed, as described during the Phase I study. Generally, these cracks had not changed dramatically in 2009, other than further cracks developing in the Conventional and Empirical decks in the longitudinal direction initiating at the transverse cracks. Some of this type of cracking was already evident on the Empirical deck in 2005, but by 2009 more cracks had formed over both bents (Figure 11). By 2009 the Conventional deck also exhibited some longitudinal cracks propagating from the northern (non-saw-cut) bent as shown in Figure 12. Overall, the longitudinal cracking coincident with the transverse cracking over the bents was most prominent in the Empirical deck, present in the Conventional deck, and was not found in the HPC deck.

**Figure 12: Longitudinal cracking propagating from the transverse crack over the northern bent of the Conventional deck.**

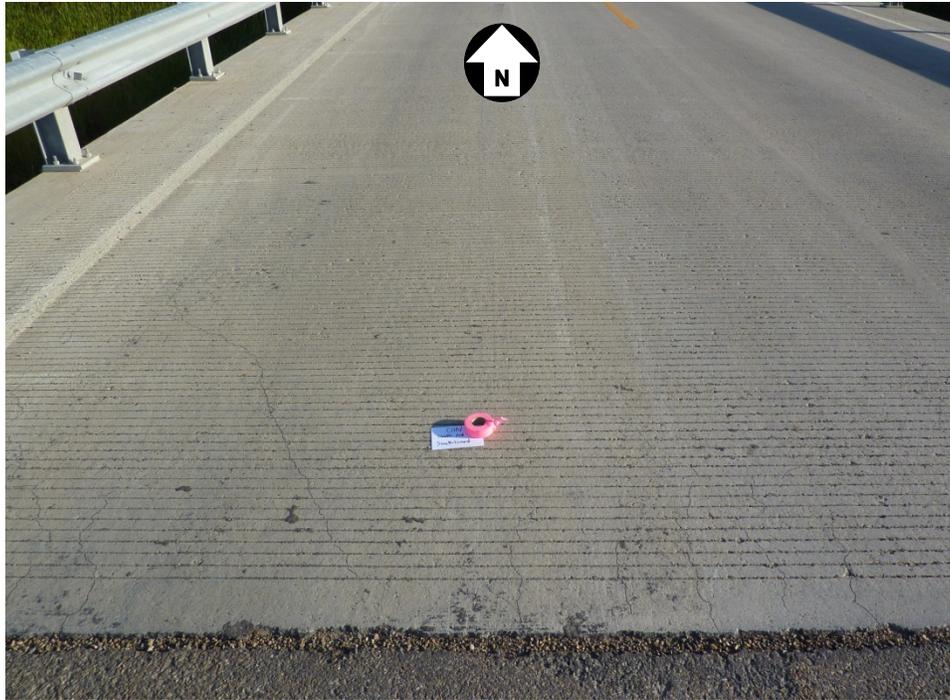
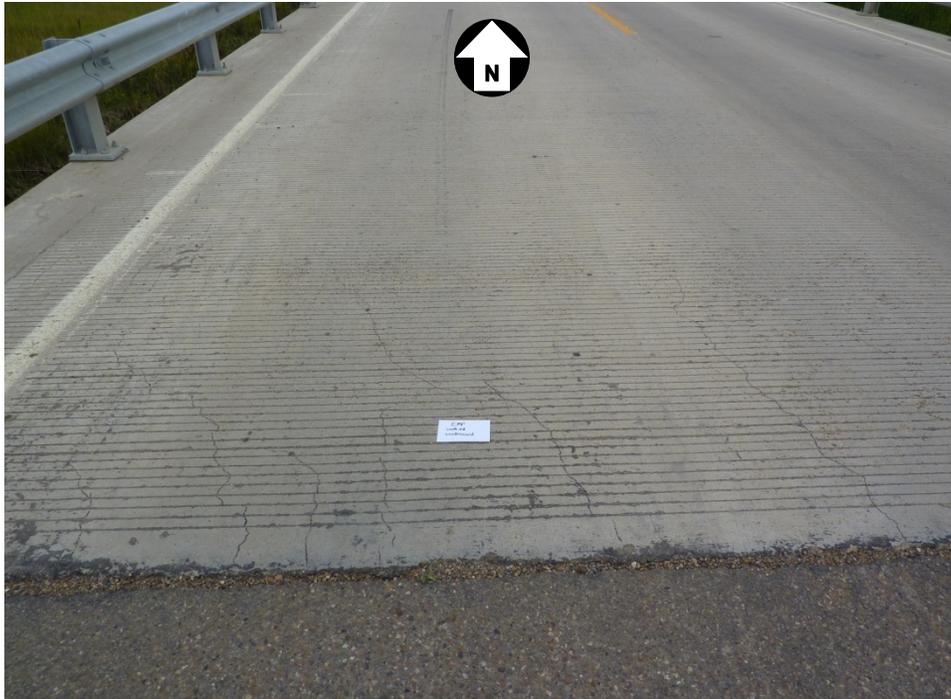
The majority of the cracking on all three bridge decks has occurred on the ends near the abutments. By 2005, fairly significant cracking was evident in this area, but was even more pronounced in 2009 with an increase in the number of cracks and length of existing cracks. The HPC deck still showed less cracking in these areas than the Conventional and Empirical decks. The southwest end of the Conventional and Empirical decks is shown in Figure 13 and Figure

- The level of cracking distresses in the Conventional deck was more similar to the cracking distresses in the Empirical deck than during previous assessments.
- The Empirical deck had more full-depth cracking near the abutments.
- On the north end, the Conventional deck had a larger number of cracks on the top surface of the deck, but they were generally shorter than the cracks in the Empirical deck.

**Figure 13: Cracking on the southwest end of the Conventional deck in 2009.**

**Figure 14: Cracking on the southwest end of the Empirical deck in 2009.**

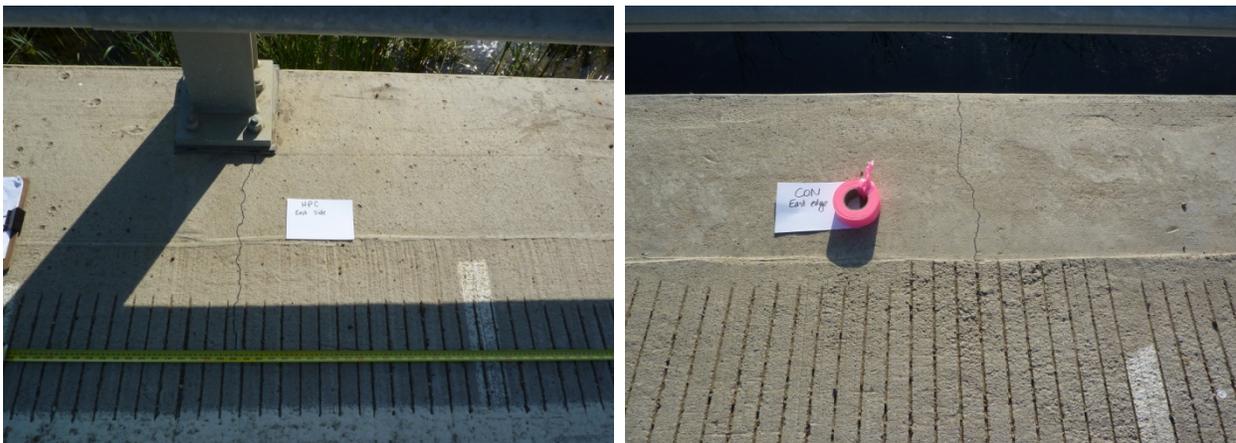
The cantilevered edges of all the decks exhibited short full-depth transverse cracks. This cracking was first noticed on the HPC deck in 2004, but by the end of Phase I each bridge exhibited some cracking in this area. The Conventional and Empirical decks had more cracking on the east edge, while the HPC deck had similar cracking on both edges. As shown in Figure 11 and Figure 15, the cracks were generally longer in the HPC deck, but more numerous in the Conventional deck. The cantilevered edge cracking was least severe in the Empirical deck.

**Figure 15: Cantilever edge cracking, eastern edge, HPC–left, Conventional–right, in 2009.**

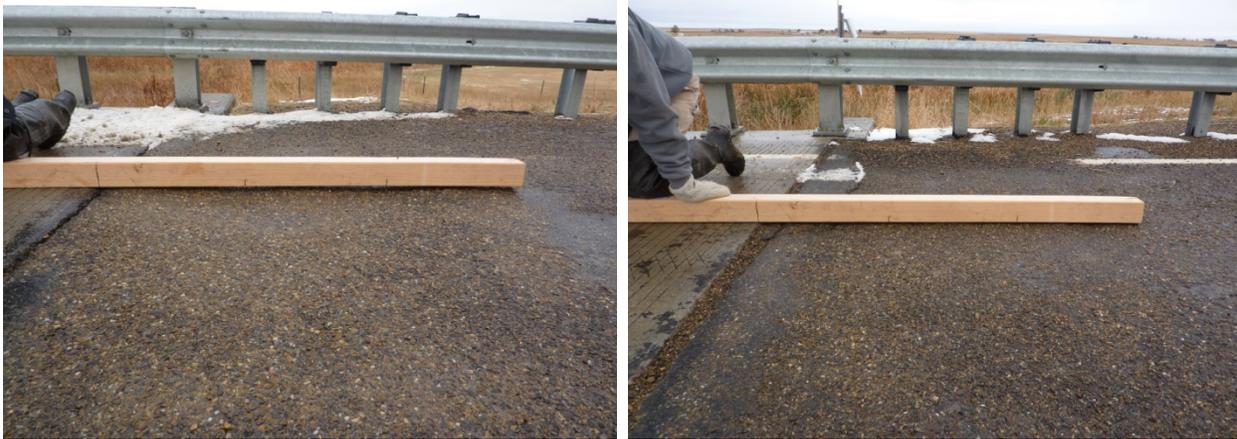
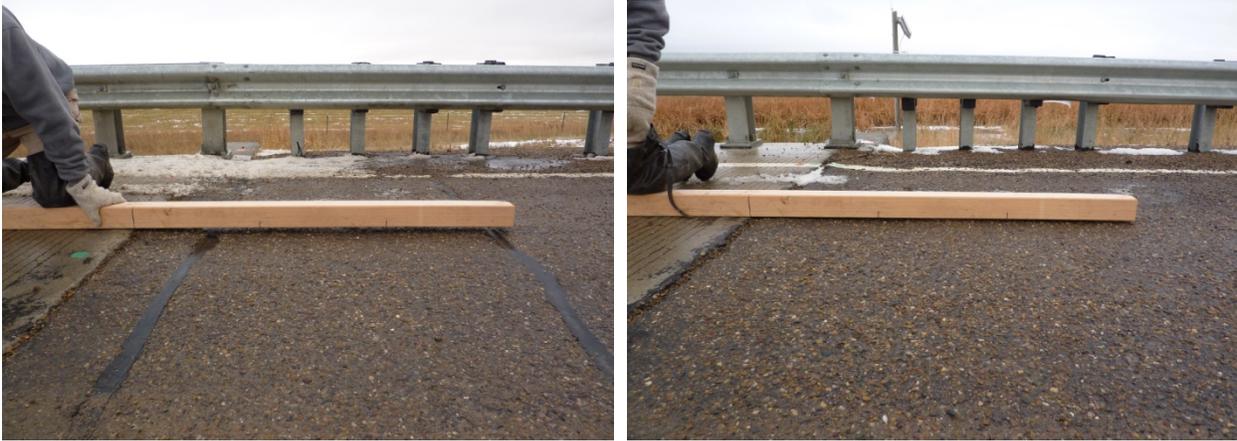
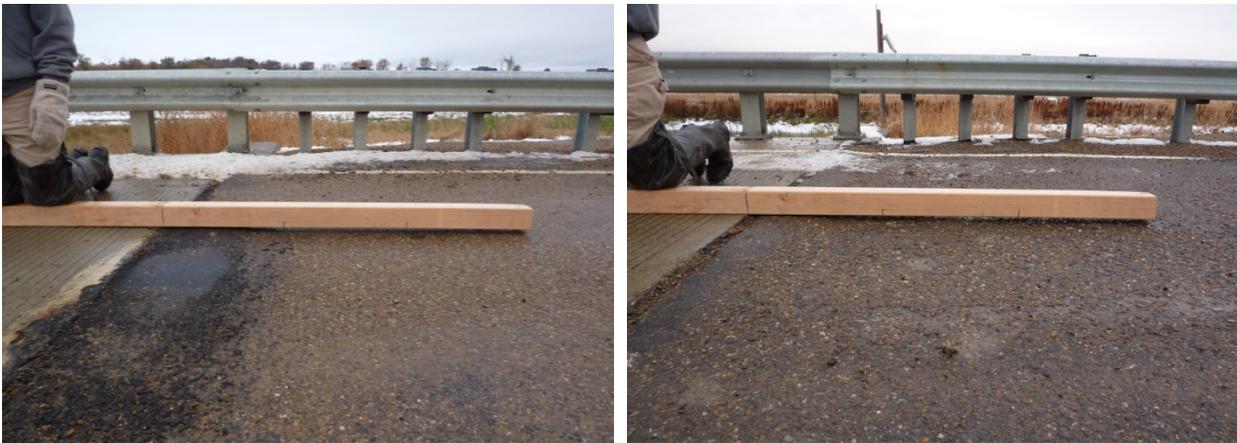
Settlement of the bridge approaches was qualitatively assessed in 2005 by placing a straight edge along the bridge deck with one end cantilevered over the paved approach. Northbound traffic approaches the bridge decks on the southeast (SE) end; likewise, southbound traffic approaches the bridge decks on the northwest (NW) end of the bridge. Pictures taken from the side allowed a qualitative comparison of the settlement that has occurred in the paved approaches. The same procedure was used in Phase II (Figure 16 to Figure 18), although in addition to photographs, measurements of the gap between the straight edge and the pavement were recorded. For northbound traffic, the gap is largest in the HPC deck (2 cm), followed by the Empirical deck (1.5 cm), and finally the Conventional deck (1 cm). For southbound traffic, the gap is very similar for all the bridge decks (2–2.5 cm). This is notably different than the findings in 2005 in which the Empirical deck showed large settlements on this approach (Figure 19).

**Figure 16: Paved approaches of the Conventional deck (NW-left, SE-right) in 2009.**

Figure 17: Paved approaches of the Empirical deck (NW-left, SE-right) in 2009.

Figure 18: Paved approaches of the HPC deck (NW-left, SE-right) in 2009.

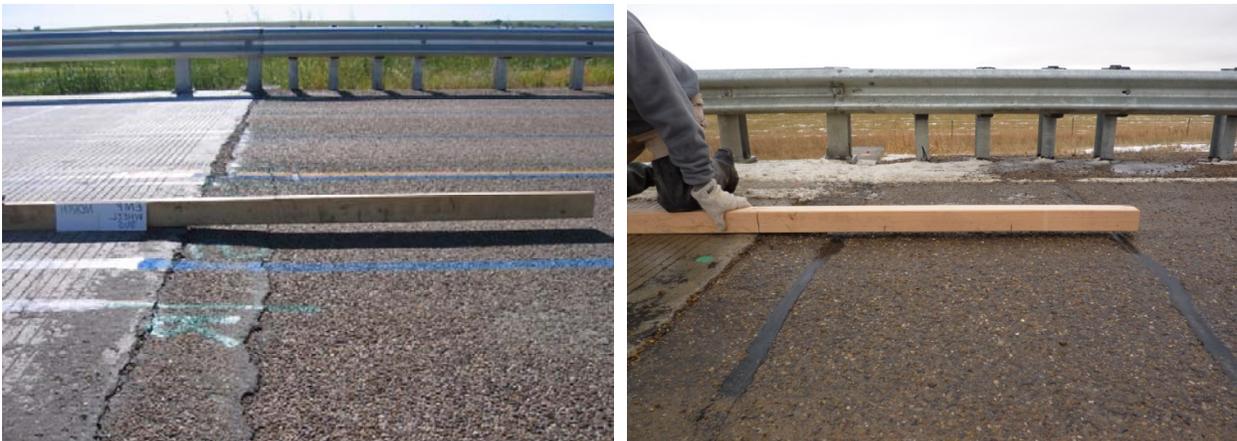
Figure 19: Paved approaches of the Empirical deck (NW) in 2005 (left) and 2009 (right).

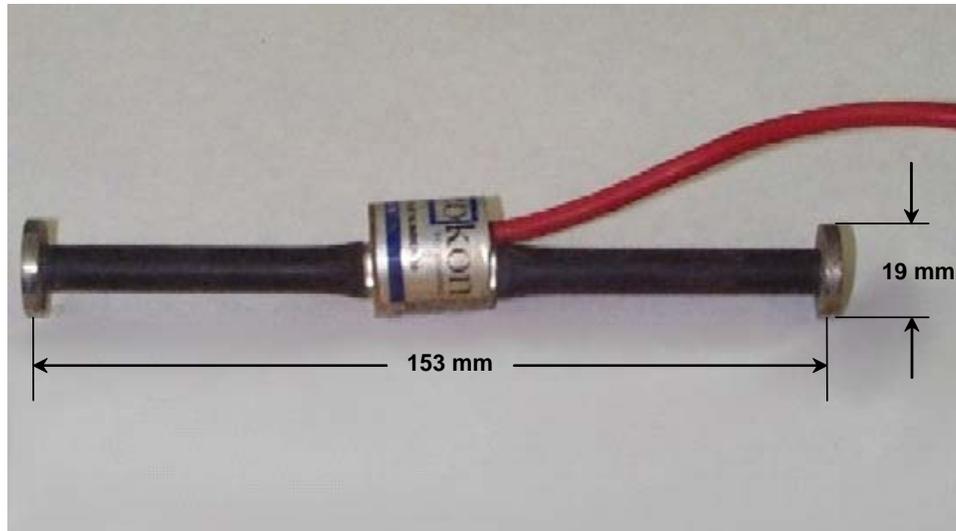
**Figure 21: Vibrating wire strain gage.**

The gages use a steel wire in tension between two circular end plates to measure length changes in the concrete. As the concrete contracts or expands, the wire responds accordingly, thereby changing its resonant frequency of vibration. The wires are excited by electromagnetic coils, which also detect their resonant frequencies of vibration. Frequencies detected by the coil are converted to a DC voltage using a vibrating wire interface unit. Each vibrating wire gage is also equipped with a thermistor to record temperature. Temperature measurements are used to apply temperature corrections to measured strains, necessitated by differences between the thermal expansion coefficients of steel and concrete.

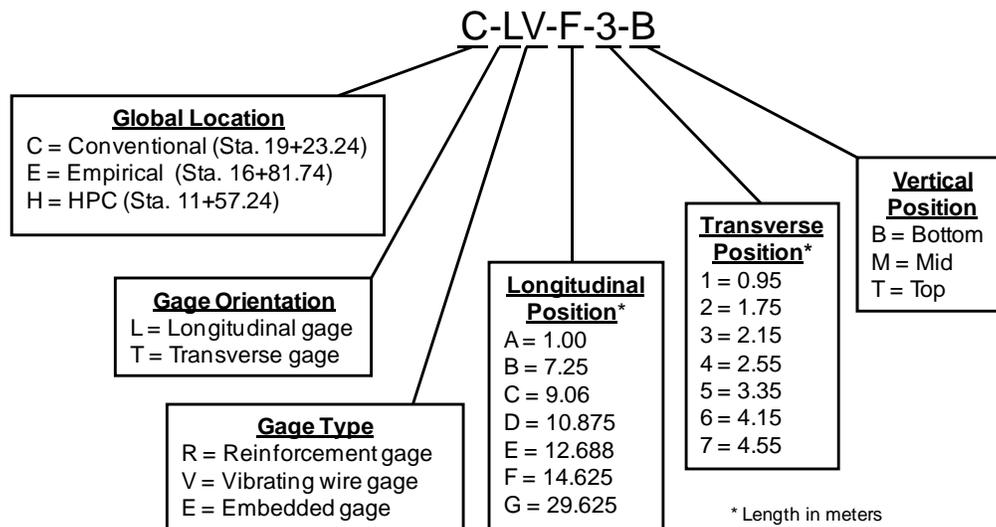
A reference numbering system was created to help organize and distinguish each gage based on its location, orientation, type, and relative position. Altogether, the gage numbering system consists of six characters, as illustrated in Figure 22. The global location indicates which bridge the sensor is embedded in: Conventional (C), Empirical (E), or HPC (H). Gages are oriented either longitudinally (L) or transversely (T) with respect to the direction of traffic. Gage types are either strain gages bonded to the reinforcement (R), vibrating wire gages (V), or embedded concrete gages (E). The analysis in this follow-on study focused on the vibrating wire sensors. Positions of the gages are referenced from the southwest corner of the bridge. Longitudinal distances from the south end of the bridge are denoted by the letters A through G. Transverse positions of the gages from the west side of the bridge are denoted by the numbers 1 through 7 (these correspond to the letters and numbers in Figure 20). Finally, the vertical position of each gage within the deck is described as bottom (B), middle (M), or top (T). The example in Figure 22 (C-LV-F-3-B) corresponds to a Longitudinally oriented Vibrating wire gage in the Conventional bridge deck, located at Gage Line F, transverse position 3, and in the plane of the Bottom mat of reinforcement. These unique reference numbers are used throughout the remainder of the report.

**Figure 22: Gage reference numbering system.**
