# SEVEN-YEAR EVALUATION OF THREE INSTRUMENTED BRIDGE DECKS IN SACO, MONTANA

*Final Report*

**Western Transportation Institute**  
College of Engineering  
Montana State University – Bozeman

November 2010

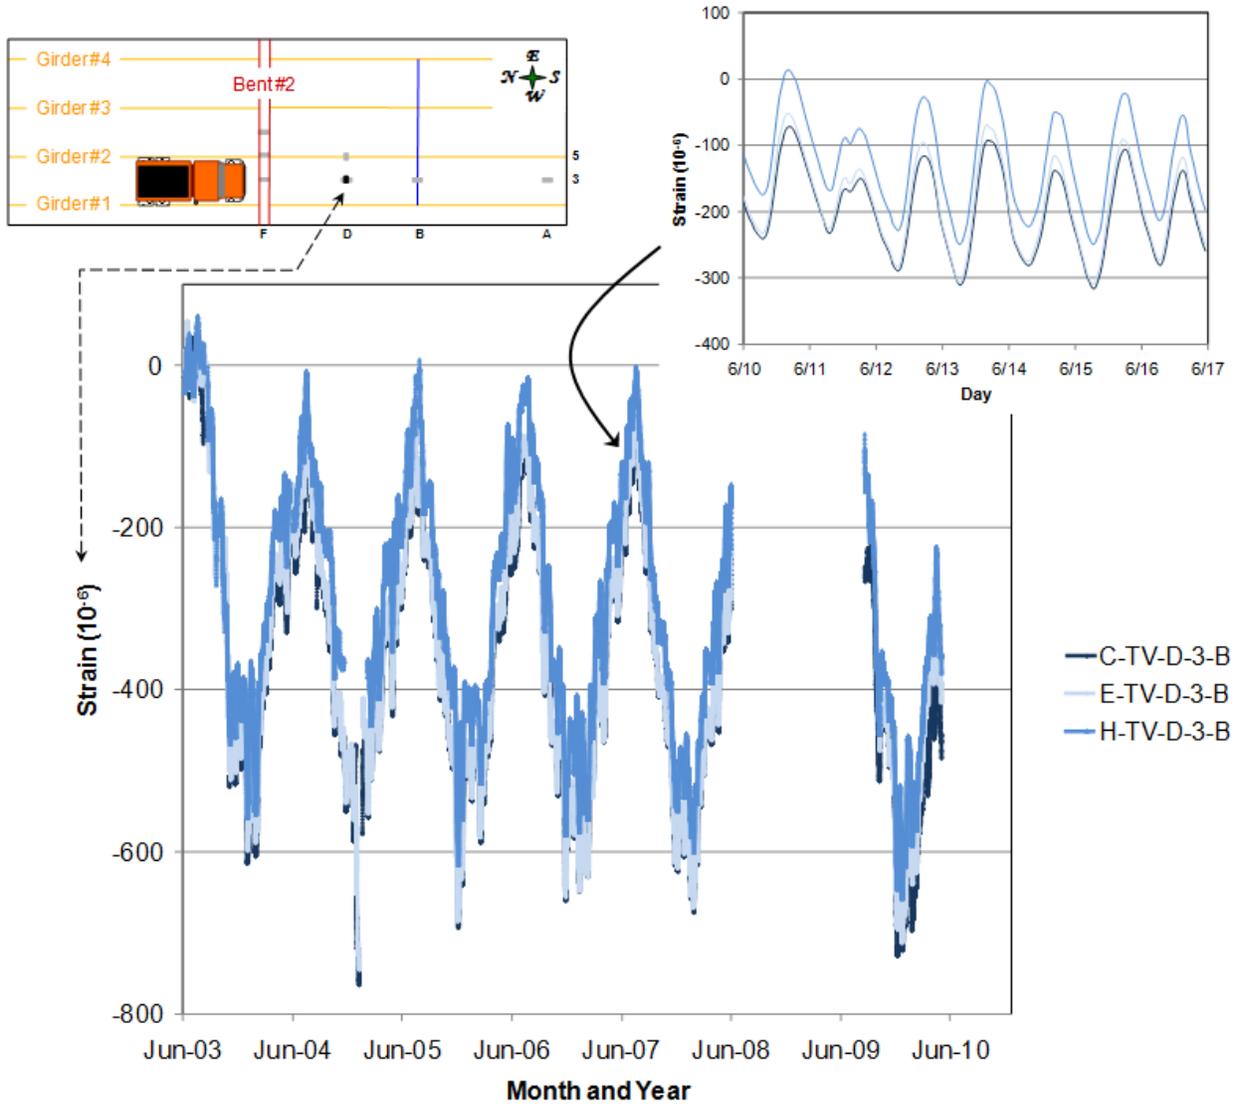
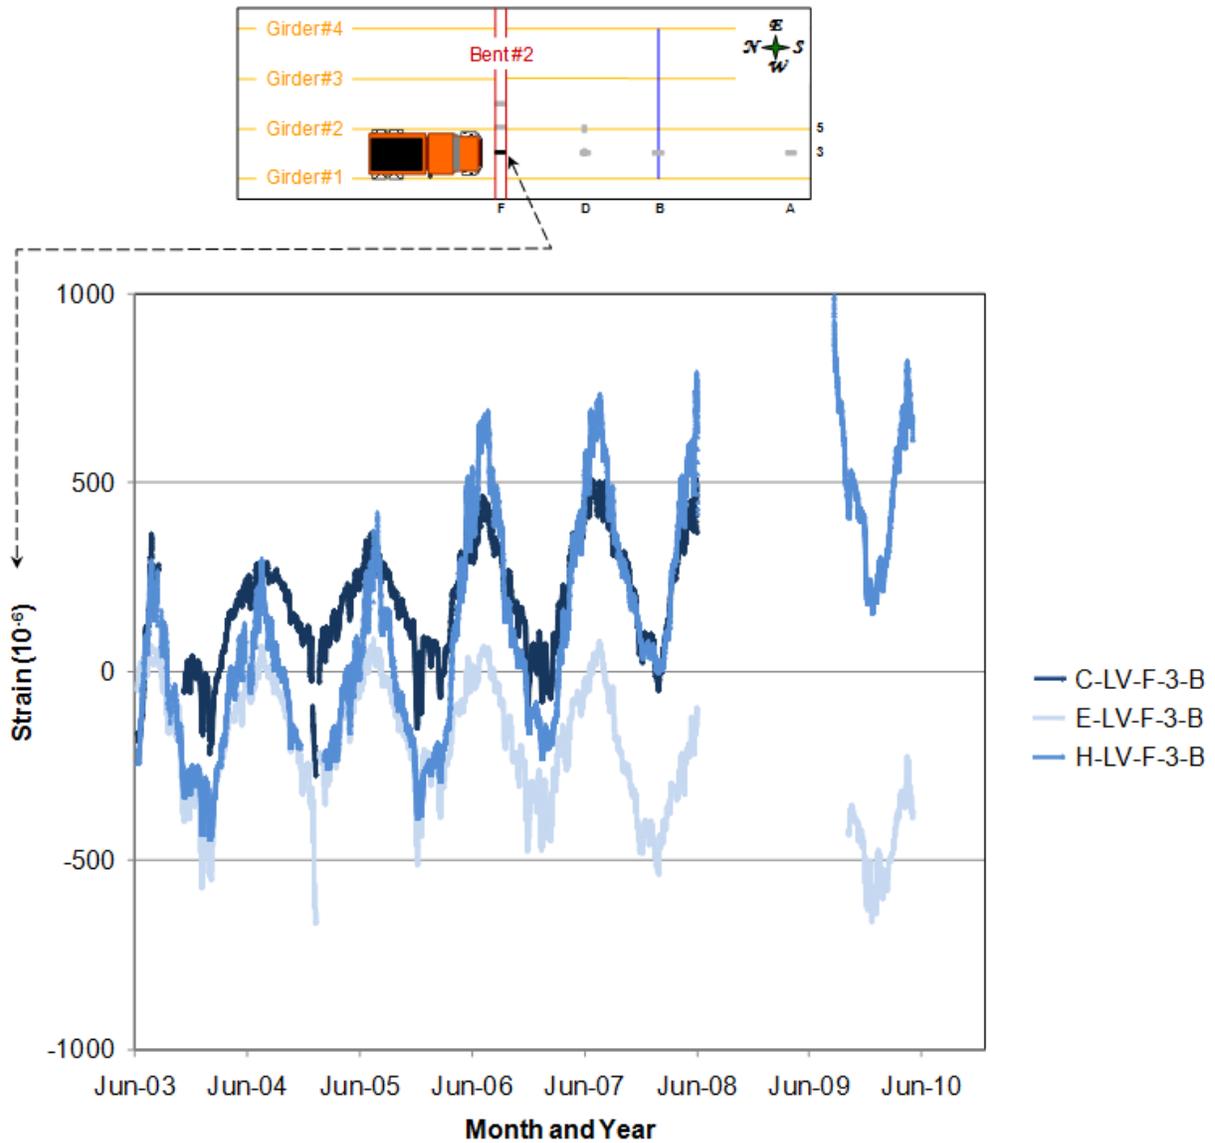
Plots of long term total strain data from the beginning of Phase I of this project through the end of Phase II were created to qualitatively analyze general behaviors at each location in the deck. The bridge decks experience both diurnal and seasonal temperature cycles. The strain response in the concrete to these frequent temperature cycles was evident in the data and to a certain extent interfered with formulating comparisons of the average values and seasonal fluctuations in the strain response between bridges (see insert in Figure 23). In order to more easily observe differences between the bridge decks, the strain data was smoothed using a 1-week moving average, as was done in the Phase I investigation. A representative example of this smoothed data is shown in Figure 23, and Appendix B contains plots of the smoothed strain response for all gages that were monitored. In general, plots of strain over time along the A-, B- and D-lines were similar to one another; nevertheless, small changes over time were also observed as detailed below. The long-term strain levels along the F-line, however, were less similar to one another, as illustrated by the strain response at position F-3-B, where the strains differed from one another at a given point in time and continued to diverge over time (Figure 24). Strain responses along the F-line were known to be heavily influenced by local behaviors of the transverse cracks that developed in this region. The ability of the instrumentation along the F-line to reflect the development of such distresses was substantiated during phase I by showing 1) a shift in the absolute magnitude of strain, and 2) the increase in diurnal temperature related strain fluctuation (Cuelho et al., 2006).

Figure 23: Strain history at all three bridge decks at gage location TV-D-3-B (smoothed).

**Figure 24: Strain history at all three bridge decks at gage location LV-F-3-B (smoothed).**

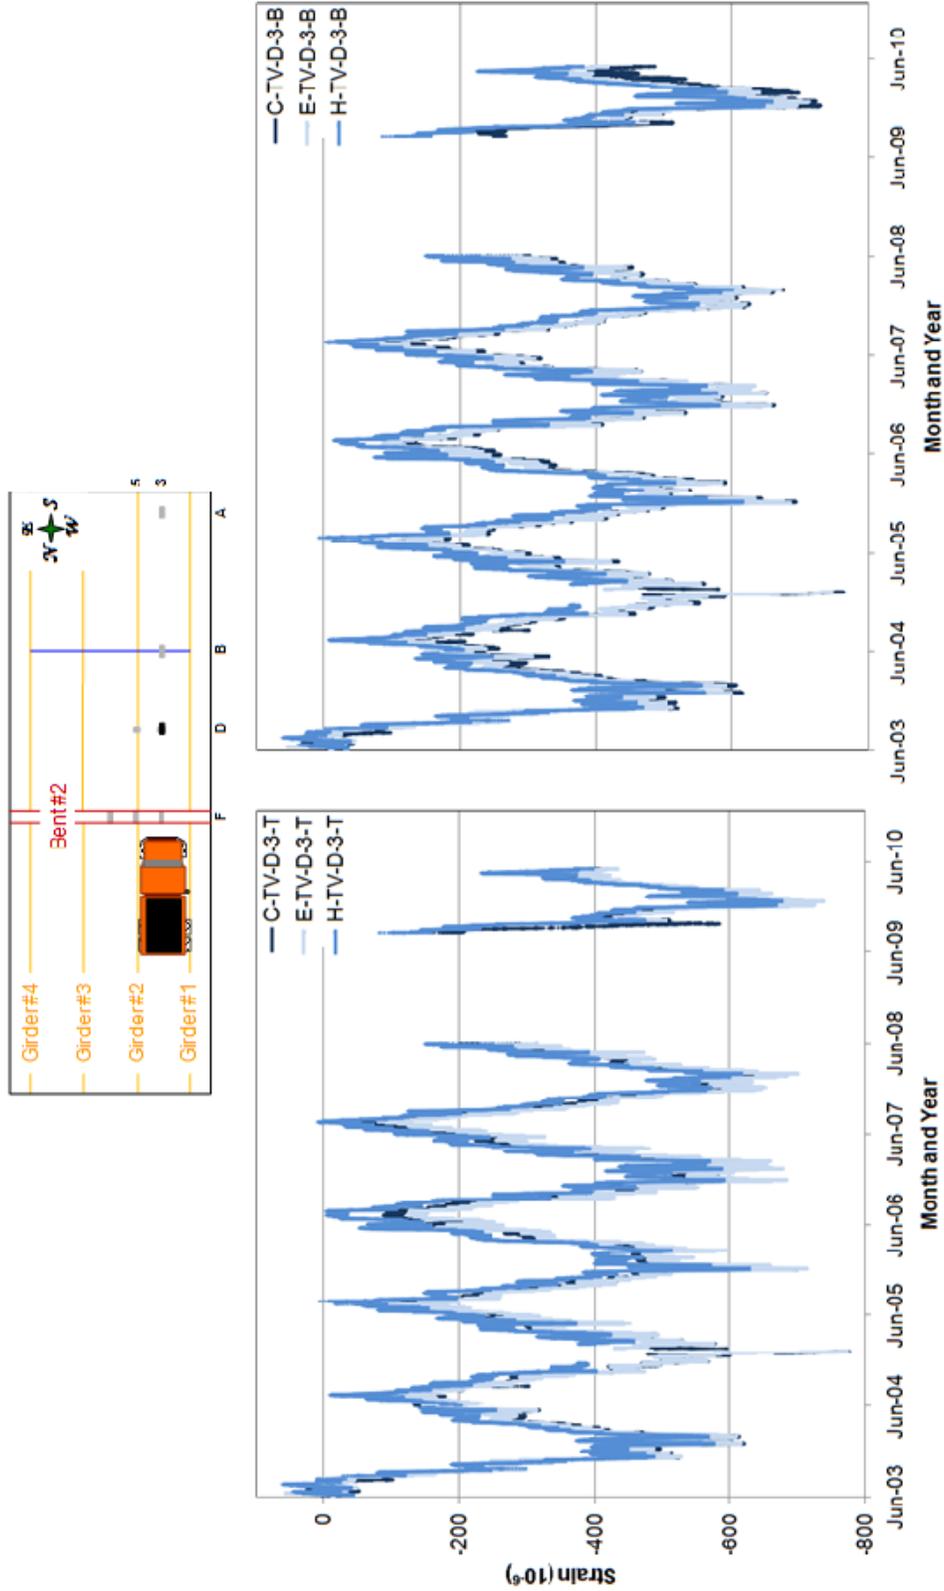
Transverse strains were available at positions D-5 and D-3 in each of the decks. In general, the strains at these two locations were similar to each other and similar between the three bridges, consisting of large seasonally related in-plane expansion and contraction of the decks (reaching -600 to -700  $\mu\epsilon$  in the winter, and returning to about 0  $\mu\epsilon$  in the summer) superimposed on a relatively constant shrinkage strain of approximately -350  $\mu\epsilon$  (negative signs indicate contraction). This strain is of the same order of magnitude as the shrinkage strain of -430 microstrain previously calculated for the decks using the AASHTO concrete shrinkage equation. Further, the magnitude of the seasonal strain cycles (600 to 700 microstrain) are generally consistent with the expected change in thermal strain calculated using the coefficient of thermal expansion of the deck concrete and the difference in temperature mid-summer to mid-winter temperatures. The distribution of strain through the depth of the deck at position D-3 was fairly uniform (indicating predominantly in-plane response), and showed the typical response to temperature and shrinkage described above (Figure 26).

Figure 26: Strain in response at position D-3 near the top and bottom.

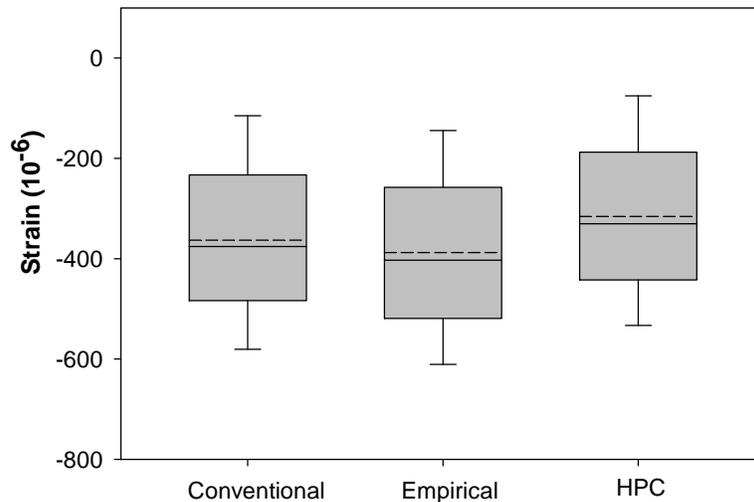
To represent the global behavior of the decks in the transverse direction, a single mean strain was calculated from all the data collected from the transverse gages (located at D-5 and D-3) throughout the monitoring period. The resulting mean transverse strain values were -370, -390, and -320 microstrain for the Conventional, Empirical, and HPC decks, respectively, as shown in the box plots in Figure 27. Statistical comparisons of these mean strains showed that the HPC deck was dissimilar to the other decks (p-values of 0.31 and 0.11 when compared to the Conventional and Empirical decks, respectively, as presented in Table 6). In other words, the p-values indicate in this case that the mean strain response in the HPC and Conventional decks have a 31 percent chance of being the same ( $p = 0.31$ ), and the mean responses of the HPC and Empirical decks only have an 11 percent probability of being the same ( $p = 0.11$ ). A further statistical analysis of the mean transverse strain by individual years (Table 7) showed the mean strains were most similar during Year 1, and that the Empirical and HPC decks are the least similar to one another from Year 2 through Year 7. Overall, this analysis showed that the magnitude of the mean strain in the transverse direction is lowest in the HPC deck, which corresponds to shrinkage measurements made on collected concrete samples, and the mean strain in the transverse direction is similar in the Empirical and Conventional decks, which are both higher than in the HPC deck.

Figure 27: Box plots for each deck based on strain from all transverse gages.

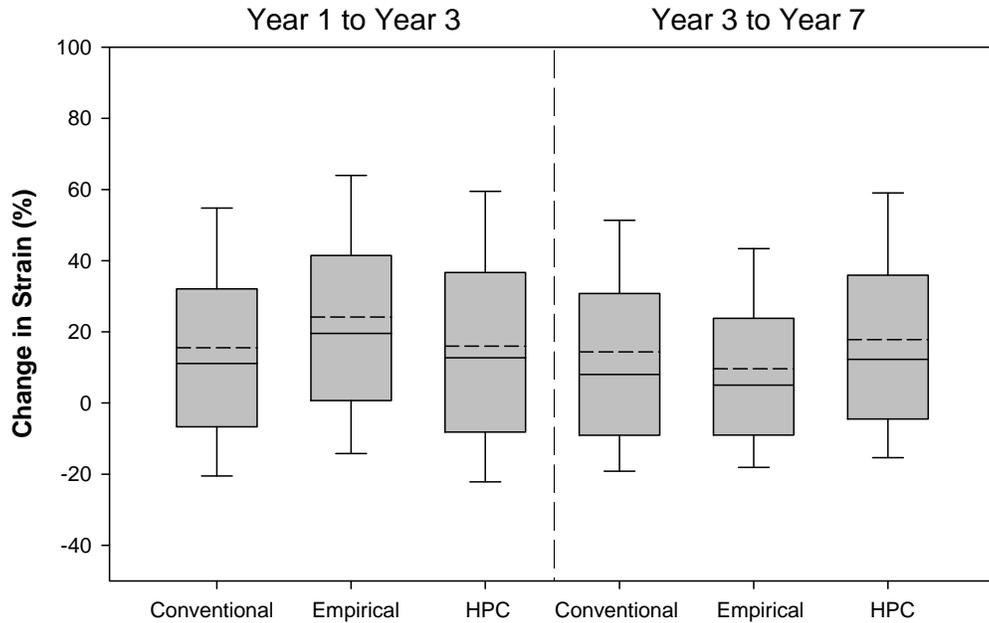
The transverse strains were also analyzed to assess the rate of change in the mean response from Year 1 to Year 3 to Year 7, as described above. If a particular deck exhibited a reduction in the rate of change of strain relative to the other decks, this would indicate a relative stabilization in its behavior, which in turn could be related to an extension in its service life with respect to the other decks. Referring to the box plot in Figure 28, the average percent change in strain from Year 1 to Year 3 was slightly higher than from Year 3 to Year 7 in the Conventional and Empirical decks, and similar in both time periods for the HPC deck, but the data “boxes” in all cases overlap significantly. Even at seven years of age, the bridge decks are still relatively young, and it is more logical to assess the rate of change in the strains over the entire 7 year period rather than the shorter periods. As such, the average percent change from Year 1 to Year 7 was around 30 percent (Table 8). The p-values associated with the comparisons of these mean rates of change are all above 0.9, indicating that they were all very similar to one another.

**Figure 28: Box plot of the percent change over time between the transverse gages.**

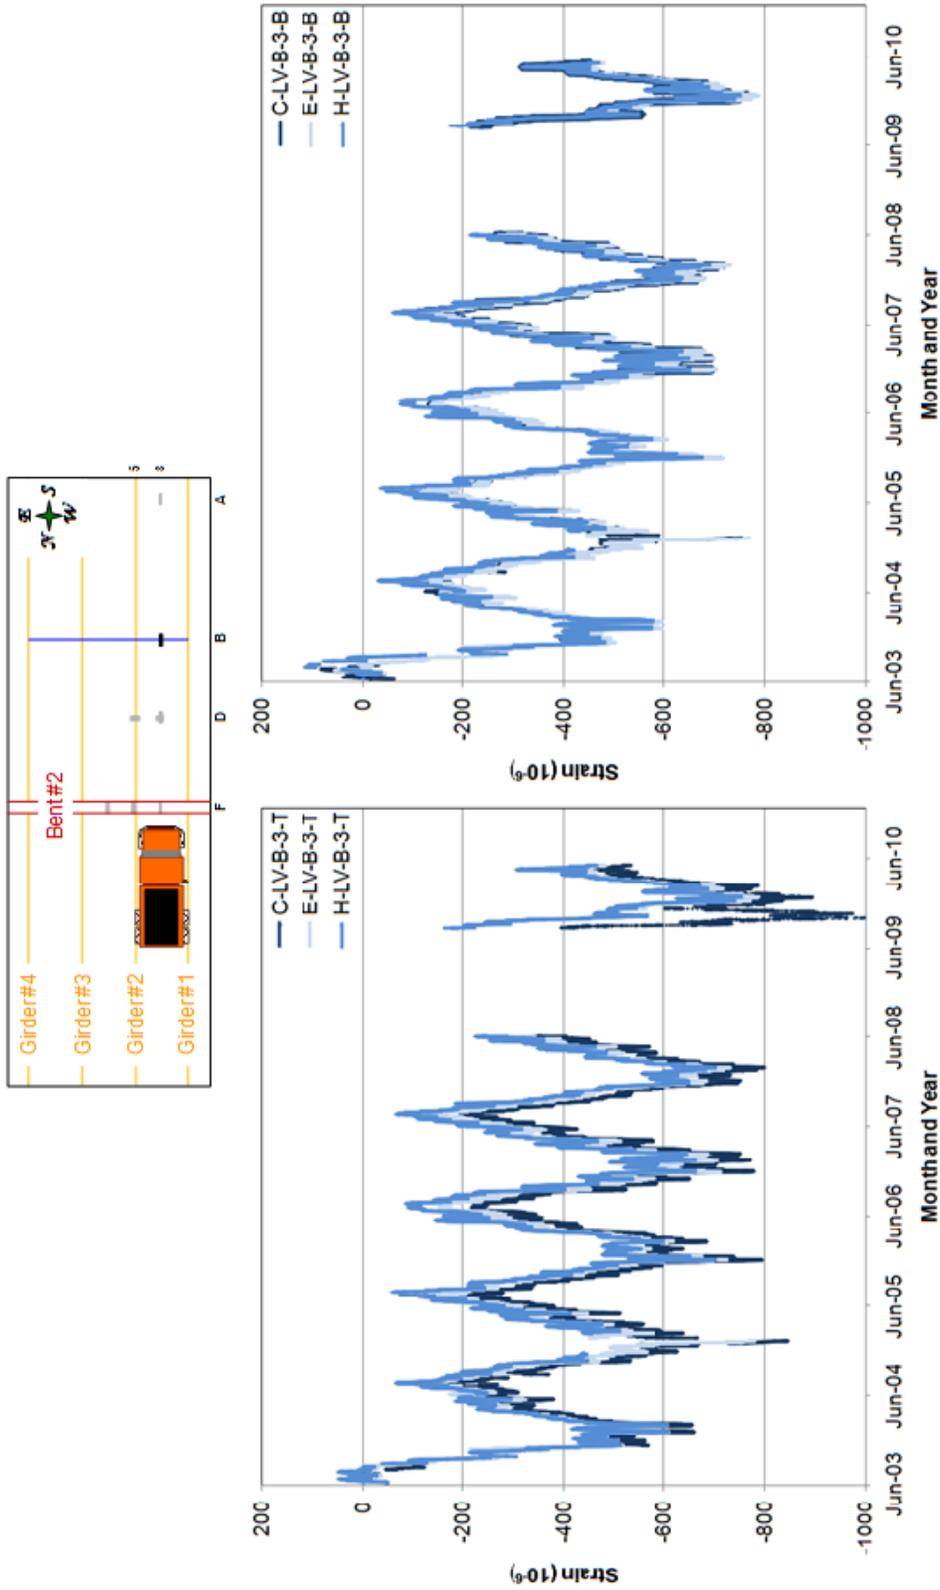
Longitudinal strains in the bridge deck were measured at transverse gage lines A, B and D along longitudinal gage line 3 between the girders (i.e., A-3, B-3 and D-3). The general longitudinal strain response has the same prominent features as in the transverse direction, with large seasonally related expansion and contraction (reaching  $-600$  to  $-700 \mu\epsilon$  in the winter and returning to about  $-100 \mu\epsilon$  in the summer) superimposed on a shrinkage strain of approximately  $-400 \mu\epsilon$  (Figure 29).

Figure 29: Strain response at position B-3 near the top and bottom of the deck oriented longitudinally.

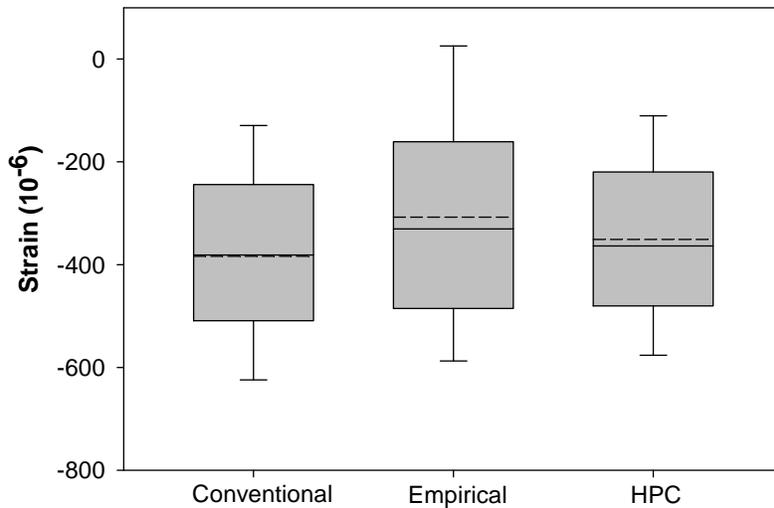
In the longitudinal direction a mean strain analysis was also conducted to investigate possible subtle differences in behavior between the bridge decks not apparent in the qualitative visual comparison provided in Figure 29. The mean strain responses calculated from all the longitudinal gages (from the A-, B- and D-lines, and not the F-line) in each deck for the entire data monitoring period were about -310 to -390  $\mu\epsilon$  in magnitude and ranged from about -160 to -510  $\mu\epsilon$ , as shown in Figure 30. A statistical analysis of these means, however, found that the p-values associated with these comparisons are all lower than 0.5, as shown in Table 9. When a more specific analysis was done with respect to gage line, the differences in the mean values were found to be most clearly evident in the A-line (Table 10), where it was seen that the Empirical deck was clearly different than the Conventional and HPC decks (p-values = 0.01 and 0.03, respectively). As previously described, values along the F-line were not included in the global analysis because the behaviors in this area were known to be heavily influenced by transverse cracking in the decks coincident with the intermediate support and, therefore, may not be representative of global deck behaviors. The p-values associated with the strain measurements taken along the F-line are shown in Table 10.

Figure 30: Box plots for each deck based on strain from all longitudinal gages.

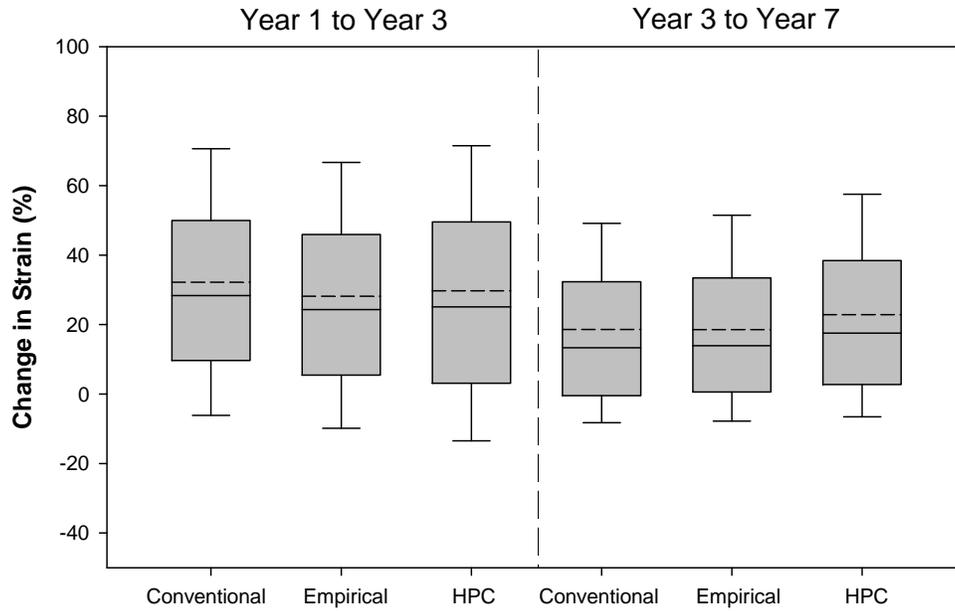
The comparison of the typical responses in the transverse and longitudinal directions revealed a noticeable and continuous decrease in the magnitude of the mean longitudinal strains over time (compare Figure 26 to Figure 29). The cause for this gradual and continuing increase in deck contraction in the longitudinal direction over time is uncertain, although deck shrinkage in the longitudinal direction will be affected by the girders, which may be shrinking more slowly than the deck above primarily due to their sheltered position under the deck. The rate of change in the mean strains was evaluated to determine the significance of this difference. This analysis revealed that the rate of change in the mean strains in the longitudinal direction appeared to be greater between Year 1 and Year 3 than between Year 3 and Year 7, as illustrated in Figure 31. The mean percent changes over the entire evaluation period (Year 1 to Year 7) were relatively similar between decks—55 percent for the Conventional and HPC decks and 49 percent for the Empirical deck (Table 11). The p-values associated with the comparison of these mean rates of change are greater than 0.9 indicating that the rates of change within the decks were similar. Overall, greater changes occurred in the longitudinal relative to the transverse strains (approximately 50 percent compared to 30 percent, respectively).

**Figure 31: Box plot of the percent change over time between the longitudinal gages.**

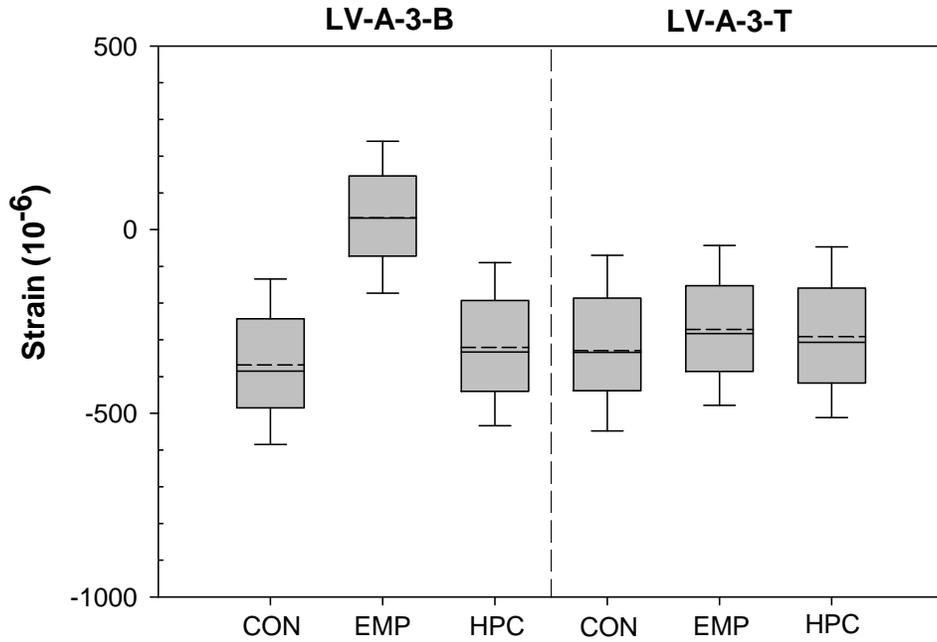
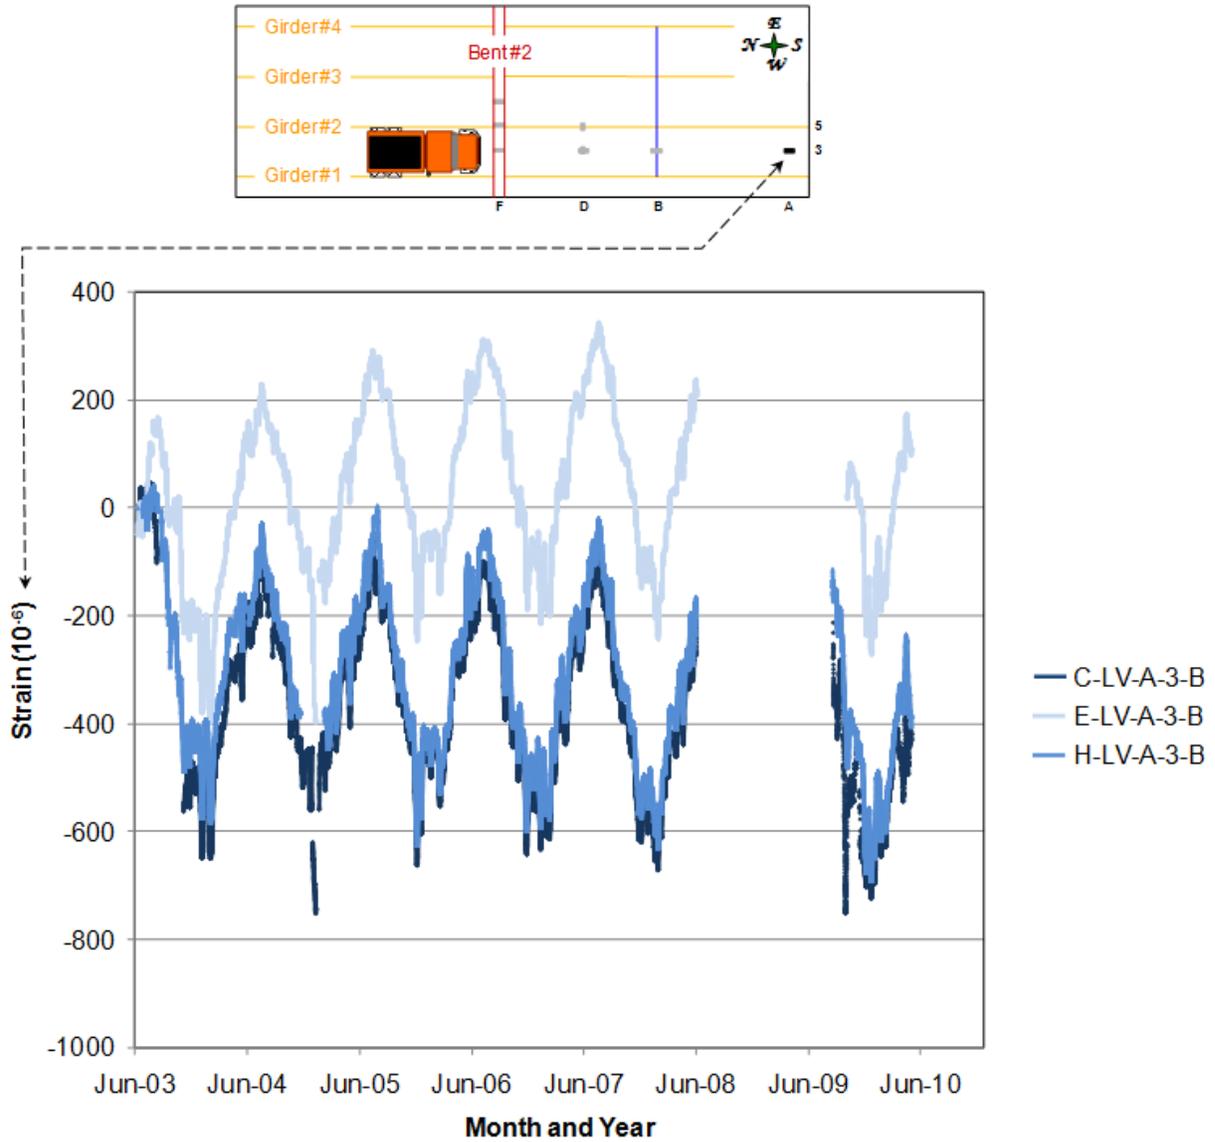
The A-line was instrumented with two longitudinal gages: one near the top of the deck and one near the bottom. While the strain responses at LV-A-3-T were similar between the three decks, the strain response for the bottom gage (LV-A-3-B) was different in the Empirical deck, as illustrated in Figure 32 and Figure 33. The p-values all increase to values greater than 0.5 (Table 12) when the strains associated with gage A-3-B are removed from the analysis. The strains in the Empirical deck are routinely expansive at LV-A-3-B in the summer, with peaks above 300  $\mu\epsilon$ . In addition, the visual distress survey revealed a hairline crack on the underside of the Empirical deck in the vicinity of A-3-B, which may have developed due to these tensile strains. Differences at this location within the Empirical deck may be due to the behavior of the integral abutment in this region.

Figure 32: Box plots for longitudinal gages at the A-line.

Figure 33. Strain history at all three bridge decks for longitudinal gage located at A-3-B (smoothed).
