# **Evaluation of an Animal Warning System Effectiveness Phase Two - Final Report**

**California PATH Research Report  
UCB-ITS-PRR-2012-12**

**June 2012**

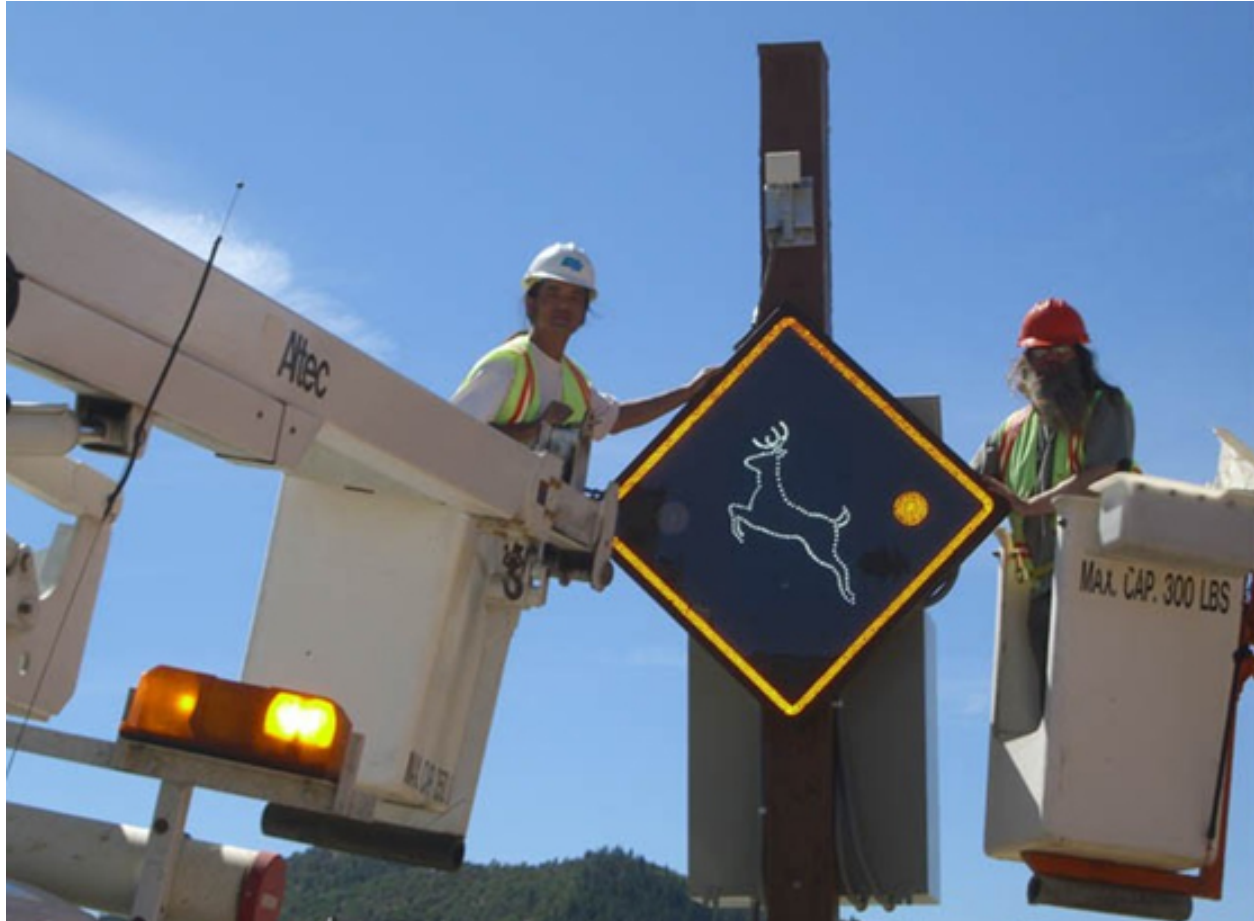
Figure 3.3: Installation of an Animal Warning Sign.

The four animal warning signs were designed and manufactured by Electro-Tech. Two animal warning signs (see Figure 3.3) were installed for each road direction: on Poles B and G on one direction and poles H and C on the other direction of diagram 5 above. The acceptance tests were done by PATH staff on location.

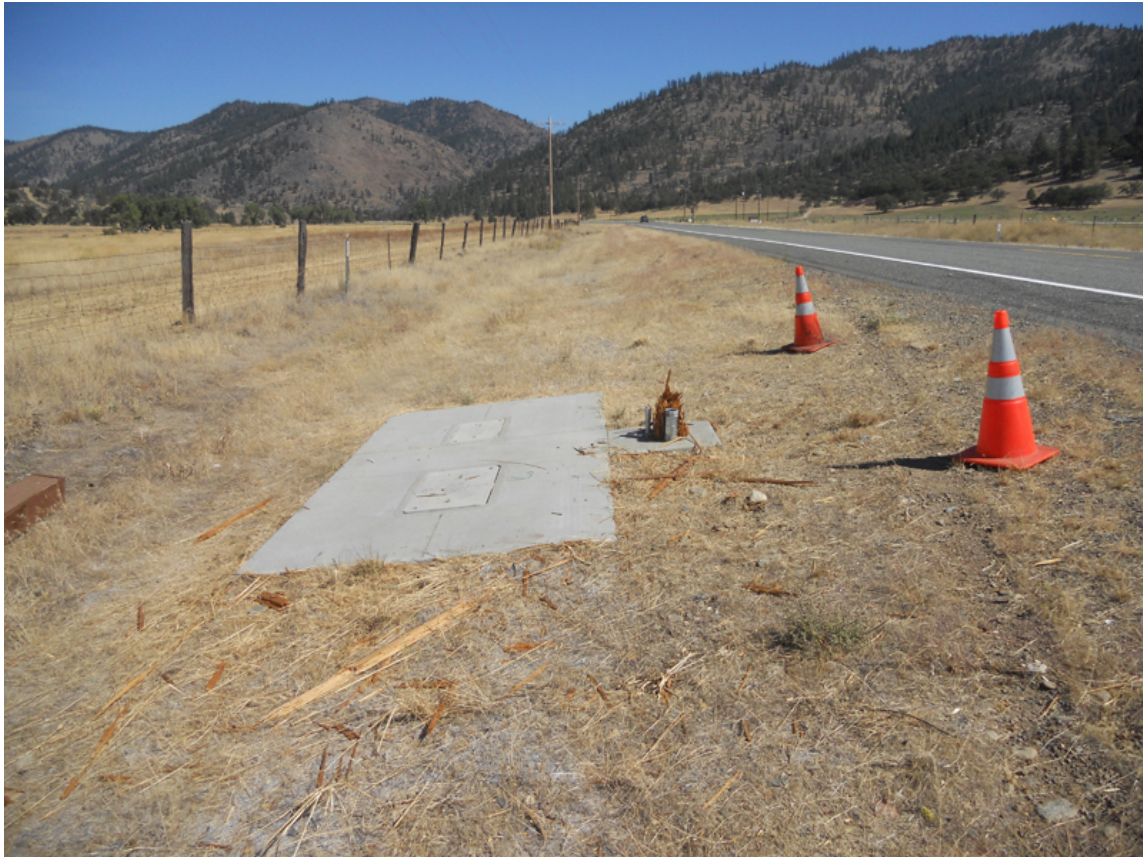
Figure 3.6: Pole H after Being Struck and Removed.

On July 16, 2011, Pole H was hit by a car and fell on the ground. The equipment on Pole H included one SMS radar head, one animal warning sign, one STS animal detection transmitter, one NEMA box, one network switch, one power supply, and one circuit breaker that controls the power to Poles H and I. With the support from Caltrans D2, Pole H was re-installed, and broken parts including the power supply, the network switch, and the circuit breaker were replaced. However, a new STS transmitter could not be procured. The original inventor of the device and the company that currently owns it are in an intellectual property conflict, and a replacement could not be procured.

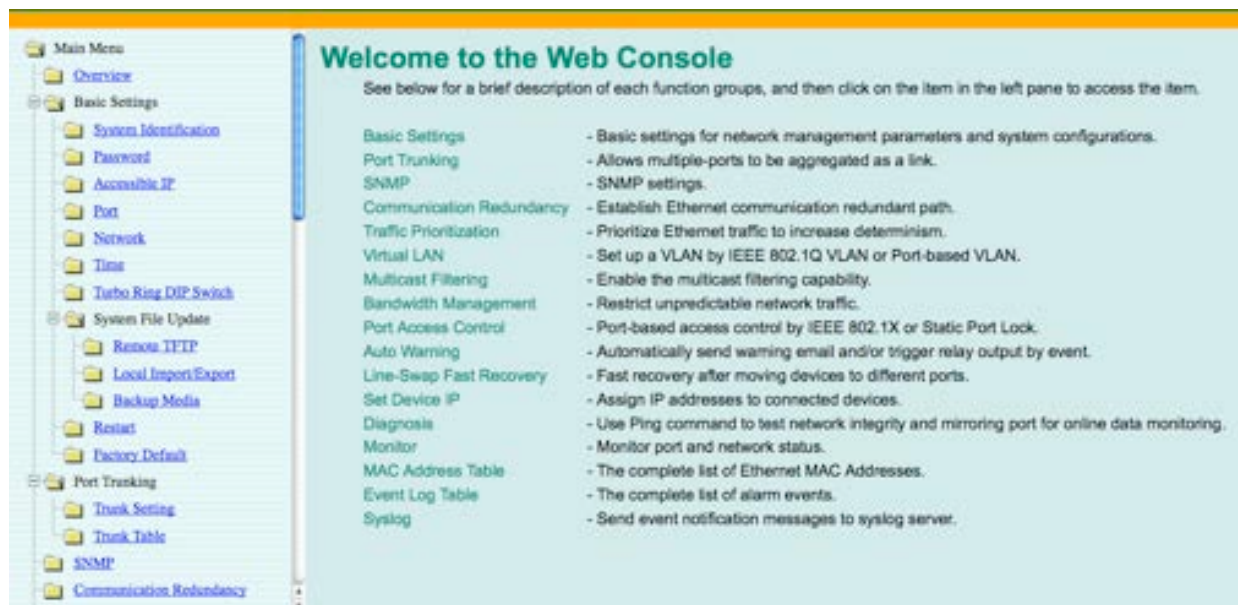
Figure 4.1: Switch Management Menu.

Managed network switches were chosen when the project's network infrastructure was designed. Managed network switches provide a lot of diagnostic information that is not typically available in non-managed network switches, as can be seen in Figure 4.1.

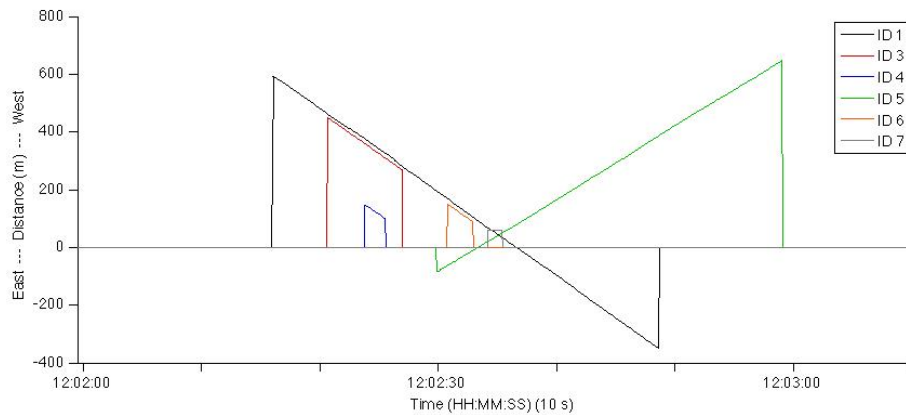
Figure 5.2: SMS radar spurious target filtering.

Similarly target ID 7 appeared right as the two vehicles passed each other, indicating a ghost reflection generated by the crossing of the vehicles. After some investigation, target 4 was a spurious target generated by a bug in the SMS radar system. It seemed to occur frequently at the same location when tracking some eastbound vehicles. The high frequency of ghost targets was likely due to the fact that there was very little overlap in the coverage of the 7 SMS radar heads. While this allowed the system to cover the entire 1070 m test site, it also degraded the target recognition when transitioning between radar heads. Fortunately, most of the false targets only appeared in the data for about 10 seconds or less, allowing them to be filtered out by a simple time-based filter.

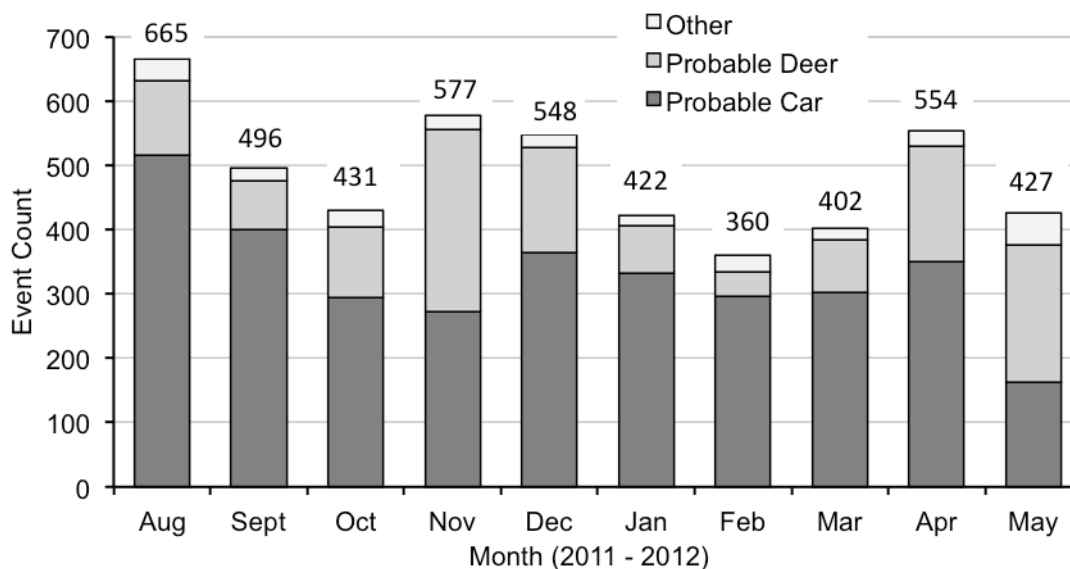
Figure 6.1: PAWS events by month.

As shown in Figure 6.1, the total number of PAWS events varied from as high as 665 in August to as low as 360 in February. Approximately 67.4 percent or 3292 of the events were labeled as most likely being triggered by turning vehicles, while 27.4 percent or 1335 cases were labeled as probable deer or other wildlife. This averaged to 11.4 car events and 4.6 wildlife events being generated each day. Interestingly, the ratio between the number of car events and the number of wildlife events did not remain constant each month. The highest number of car-generated events occurred in August (516) and September (400). From October to April, the number of car-generated events averaged between 10 and 11 per day, while August and September average 17.8 and 14.2 car-generated events per day. Mostly likely, this activity corresponded to increased farming and harvesting activity.

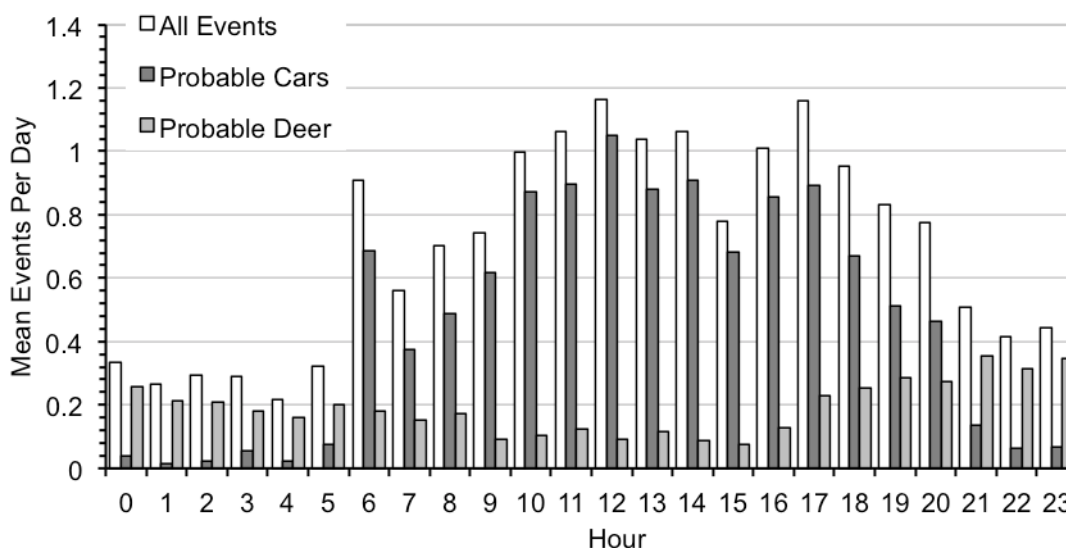
Figure 6.4: PAWS events by hour.

The pattern of PAWS events per hour, shown in Figure 6.4, also corresponds with expectations. PAWS events that were likely triggered by turning vehicles were mostly clustered during the daytime hours of 6 AM to 8 PM. PAWS events that were suspected of being due to wildlife activity were more frequently noted from about 4 PM until midnight, when animals are known to be most active. From about 10 AM until about 6 PM, there was almost one event per hour per day. Between 10 PM and 6 AM, there was only a mean of 0.33 events per hour per day, or put another way, during any given night, there was only about a 33 percent chance of an event in any given hour.

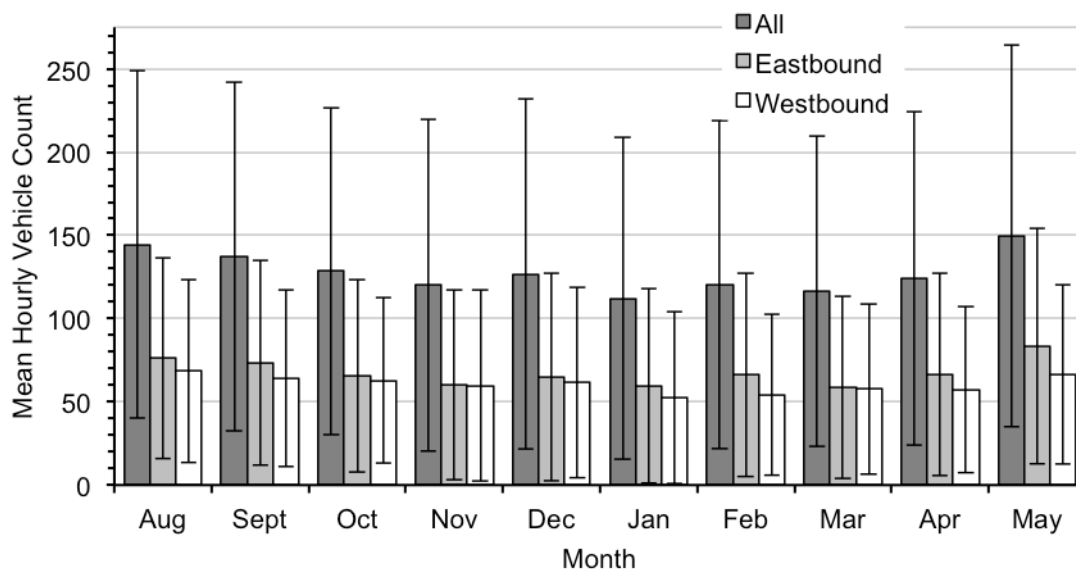
Figure 6.6: Mean hourly vehicle count by month.

As shown in Figure 6.6, monthly variations in the vehicle counts tracked typical travel patterns, showing decreases in the mean number of vehicles per hour through the winter months as compared to spring and fall. Figure 6.7 depicts the mean hourly vehicle counts by day of the week. The mean hourly vehicle counts were 30 to 53 percent less on weekends as compared to week days, although this is not particularly surprising since in general, weekend travel tends to be lighter. Additionally, the mean hourly vehicle counts did not appear to differ much by direction of travel, either by day of the week or by month.

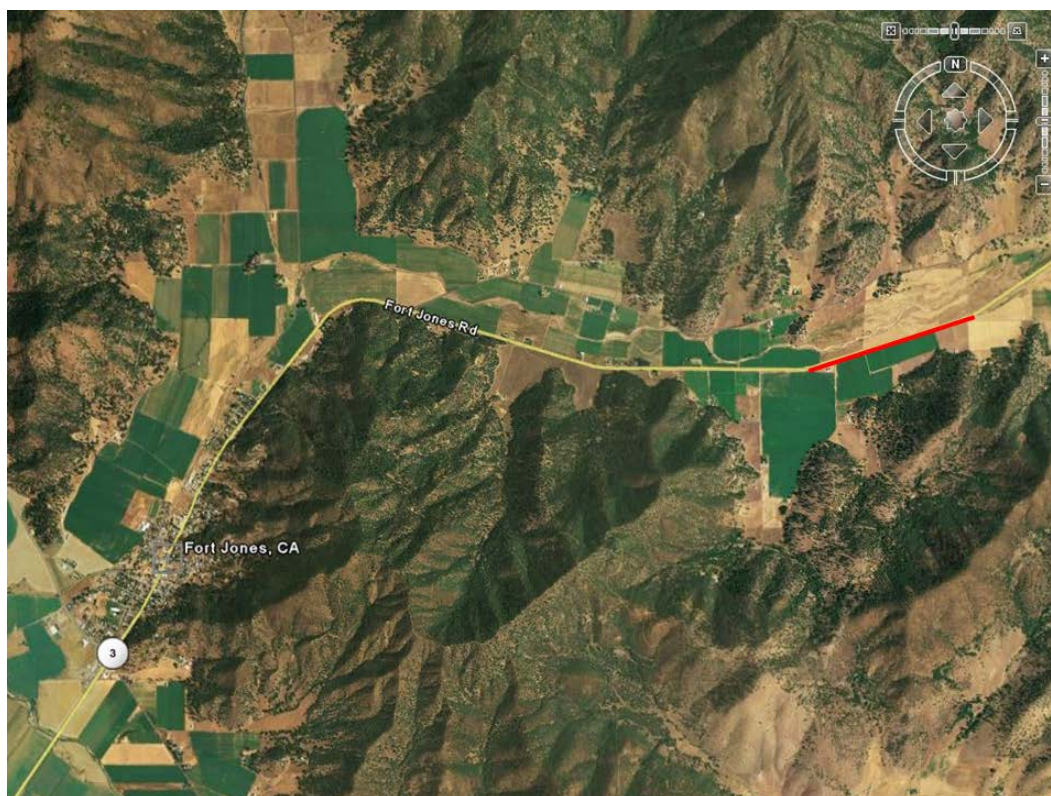
Figure 2.1. The road section (in red, about 1,030 (0.64 mi) long) with the location of the animal detection system along SR 3 (Ft. Jones Rd.) near Ft Jones, CA.

Originally, an animal detection system was scheduled to be installed along Hwy 1, near Orick, CA (Cody & Huijser, 2005). However, that site was abandoned and, after review by PATH and discussion with WTI-MSU, a new site was selected section along SR 3 (Ft. Jones Rd.), near Ft Jones, CA (Figure 1). The section that had the animal detection system installed was about 1,030 m (0.64 mi) long between mi marker 36.6 and 37.3 (Sharafsaleh et al., 2010).

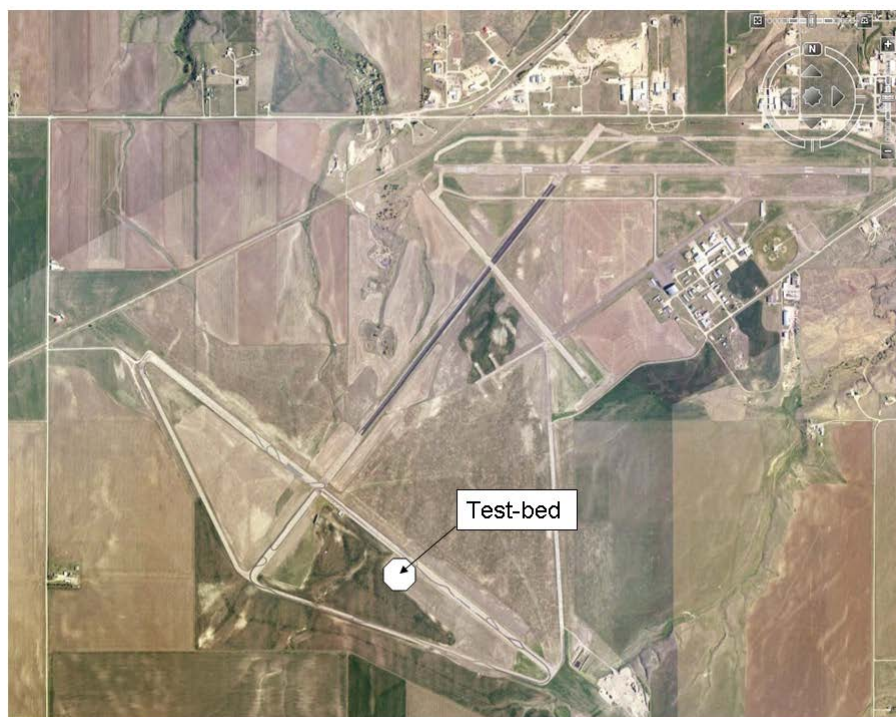
Figure 4.1. The location of the test-bed along a former runway at the Lewistown Airport in central Montana. The current municipal airport is located on the upper right of the photo.

The RADS test-bed is part of the TRANSCEND cold region rural transportation research facility and is located along a former runway at the Lewistown Airport in central Montana (Figure 2). The test-bed location experiences a wide range of temperatures, and precipitation ranges include mist, heavy rain, and snow; the topography is flat, and the rocky soil does not sustain much vegetation that may obstruct the signals transmitted or received by the sensors. The test-bed consists of an animal enclosure, space for multiple animal detection systems, and six infrared cameras with continuous recording capabilities (Figures 2 through 5). The distance covered by the system tested for this project was 91 m (300 ft) (from the left to the right side of the enclosure). The animal enclosure includes shelter, water, and an area alongside the fence that was designated for feeding. These three resources are located in different parts of the enclosure to maximize animal movement through the detection areas.

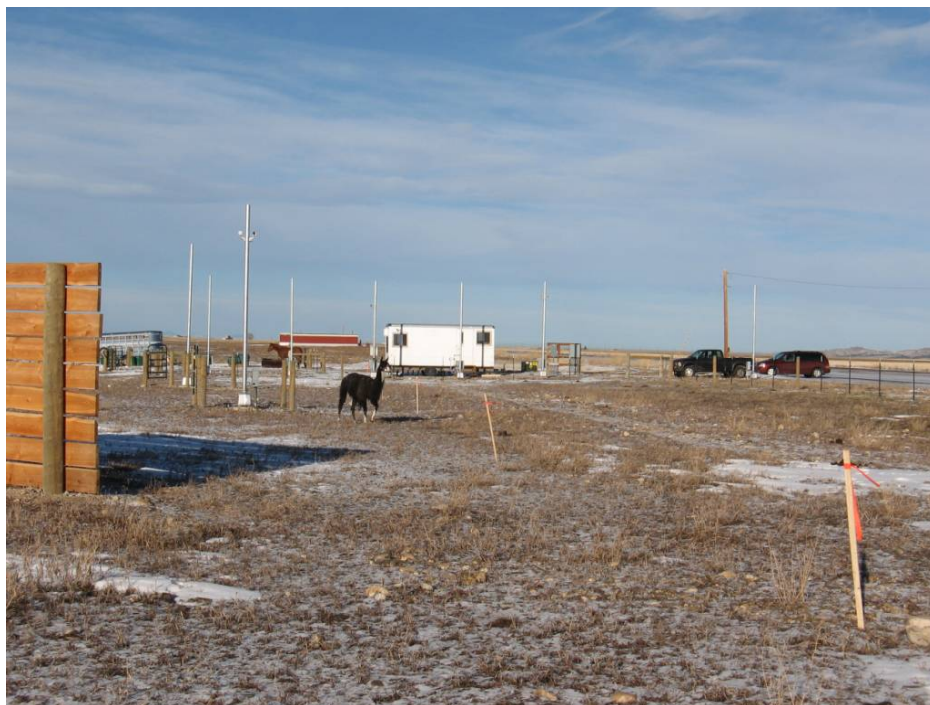
Figure 4.3. The test bed with the remote office, poles on which sensors can be attached, the shelter, and a llama (Photo: Marcel Huijser, WTI/MSU).

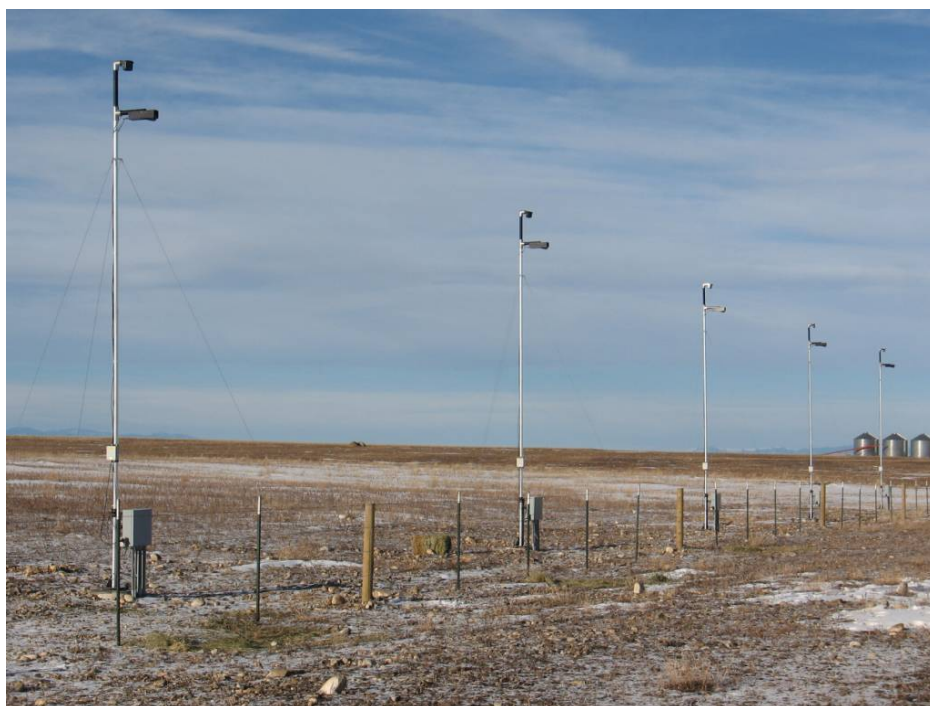
Figure 4.4. The infra-red cameras that monitor animal movements in the enclosure (Photo: Marcel Huijser, WTI/MSU).

The six infra-red cameras (Fuhrman Diversified, Inc.) were installed perpendicular to the detection system. These cameras and a video recording system record all animal movements within the enclosure continuously, day and night. The RADS III animal detection system saved its individual detection data with a date and time stamp. These data were compared to the images from the infra-red cameras, which also had a date and time stamp, to investigate the reliability of the system.

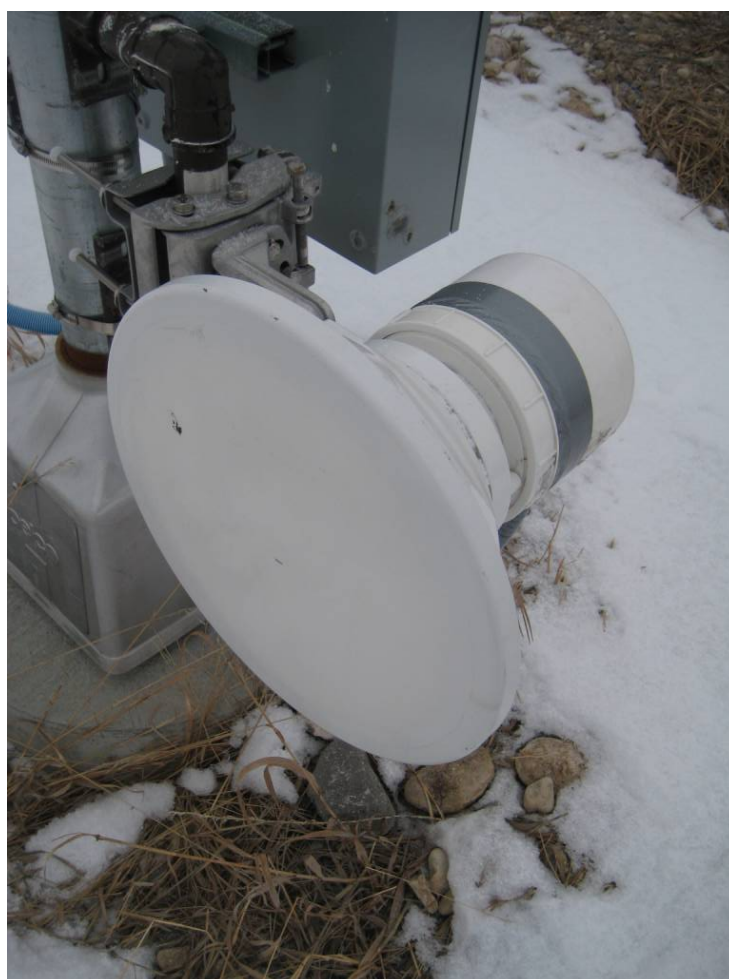
Figure 4.5. The receiver of the third generation break-the-beam system manufactured by ICx Radar Systems. Note: the transmitter looks similar to the receiver.

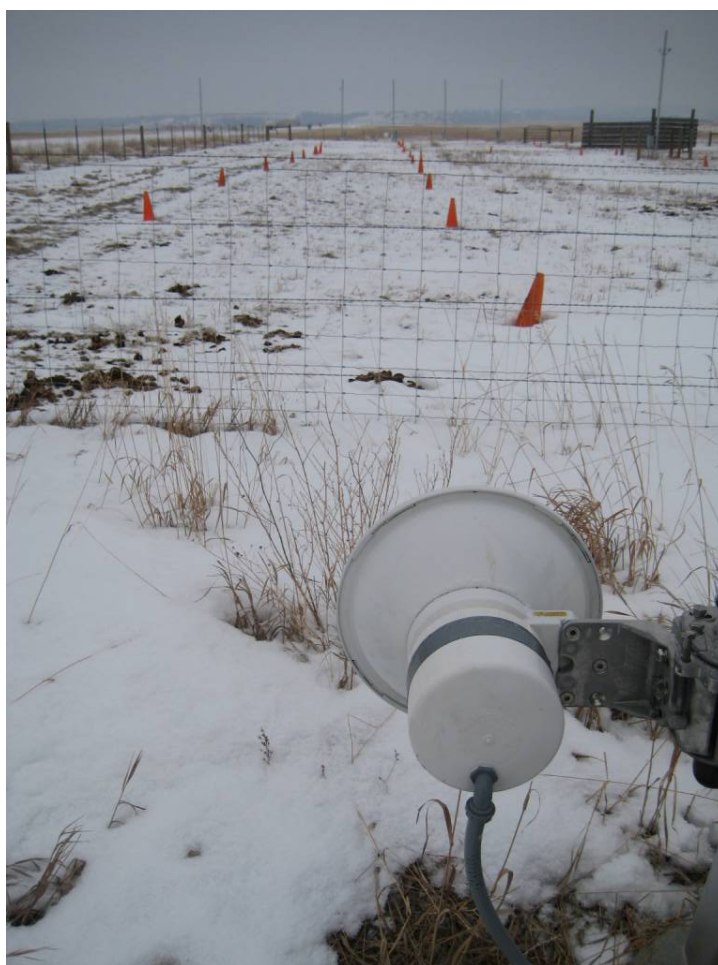
Figure 4.6. The detection line was marked with cones to be able to record the position of the animals (Photo: Marcel Huijser, WTI/MSU).

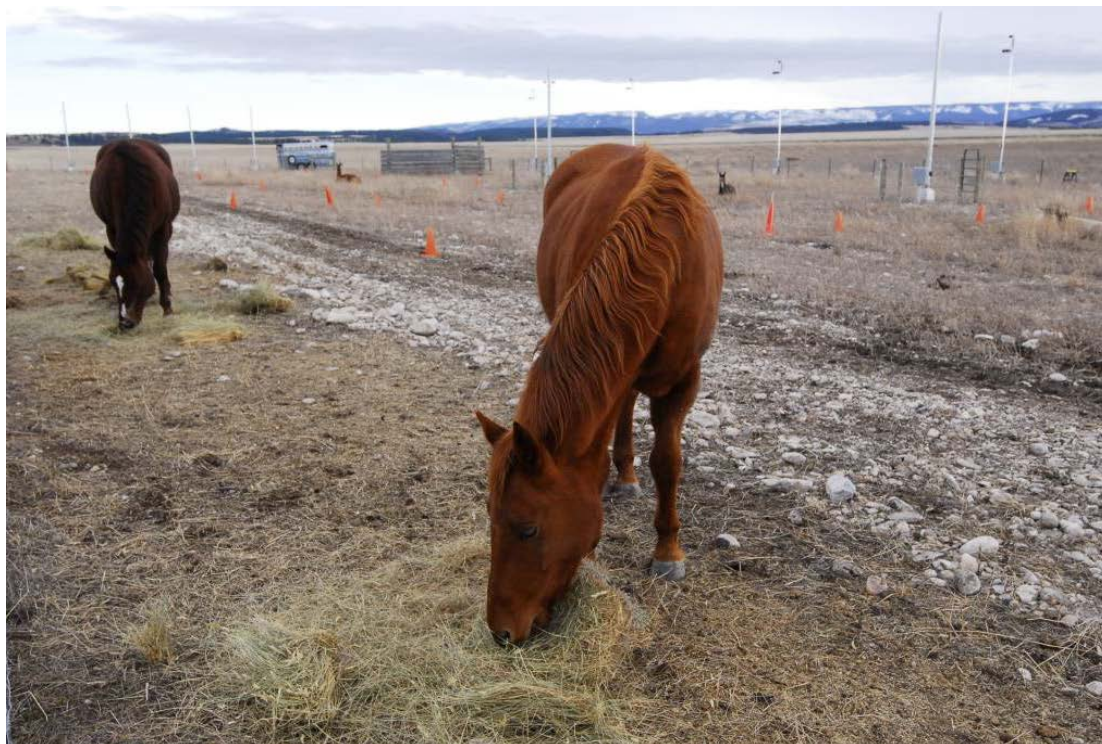
Figure 4.7. The horses that were used in the test.  
(Photo: Marcel Huijser, WTI/MSU.)

In a North American setting, animal detection systems are typically designed to detect white-tailed deer (*Odocoileus virginianus*) and/or mule deer (*Odocoileus hemionus*), pronghorn (*Antilocapra americana*), elk (*Cervus canadensis*) or moose (*Alces alces*). In Montana, it is not legal to have deer, elk or moose in captivity. Therefore the researchers used domesticated species as a model for wildlife. For this study, which took place within an enclosure, two horses, two llamas, and two sheep were used as models for these wildlife target species. Horses are similar in body shape and size to moose, llamas represent deer and elk, and sheep represent small deer (Tables 4.1 and 4.2). The body size and weight of the individual horses, llamas, and sheep used in this experiment are shown in Table 4.3. Some of the test animals are shown in Figure 4.7 to 4.9. The horses that were used in the test.

Individual	Height at shoulder	Weight
Horse 1 (Bubba)	5' (152 cm)	1130 lbs (513 kg)
Horse 2 (Buster)	5'2" (157 cm)	1450 lbs (659 kg)
Llama 1 (Sparkle)	3'9" (114 cm)	350 lbs (159 kg)
Llama 2 (Cocoa)	3'9" (114 cm)	470 lbs (213 kg)
Sheep 1	2'4" (71 cm)	170 lbs (77 kg)
Sheep 2	2'5" (74 cm)	225 lbs (101 kg)

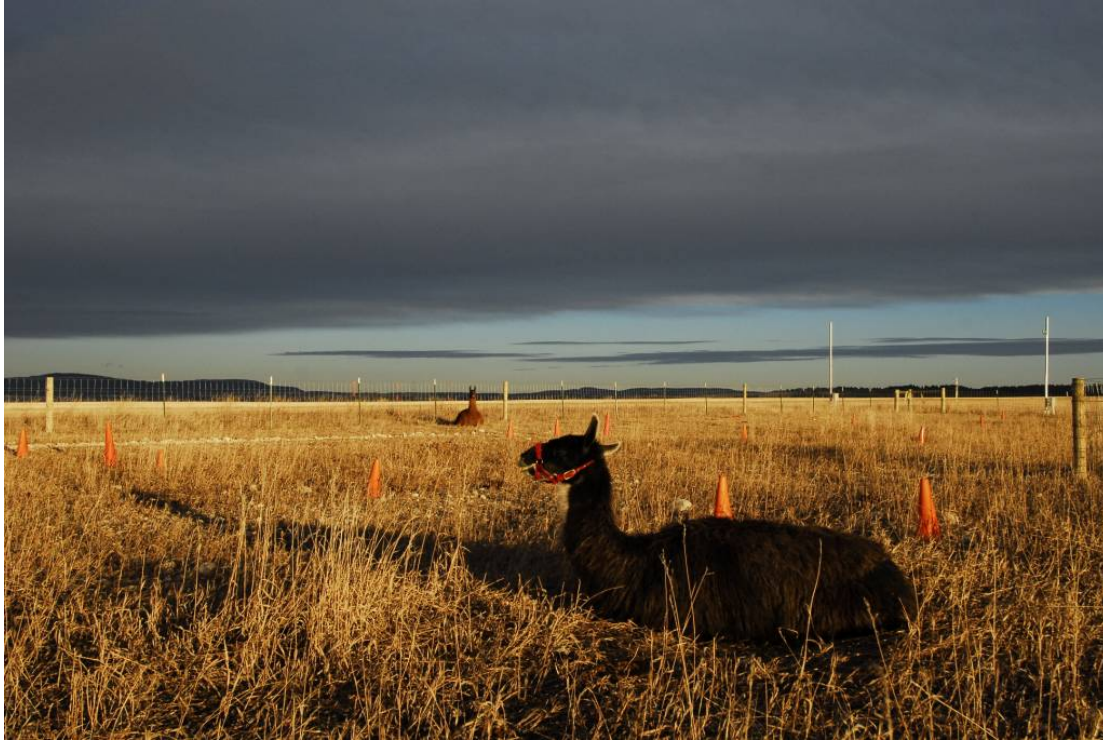
Figure 4.8. One of the two llamas that were used in the test.  
(Photo: Marcel Huijser, WTI/MSU.)

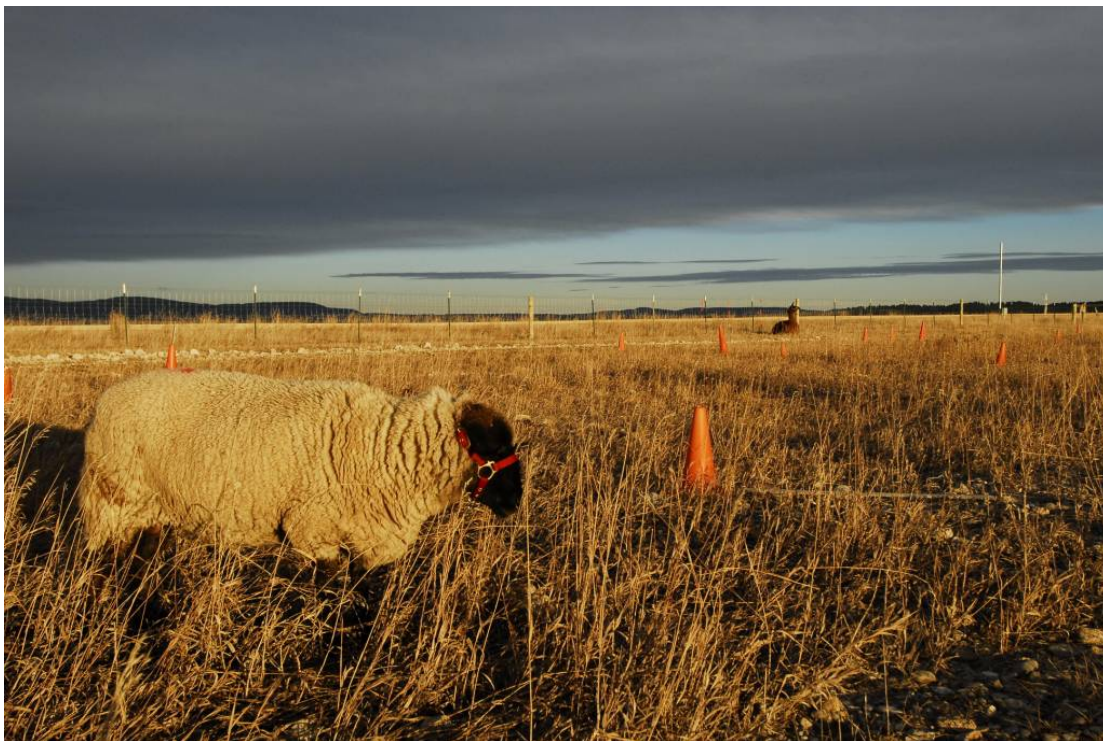
Figure 4.9. One of the two sheep that were used in the test.  
(Photo: Marcel Huijser, WTI/MSU.)

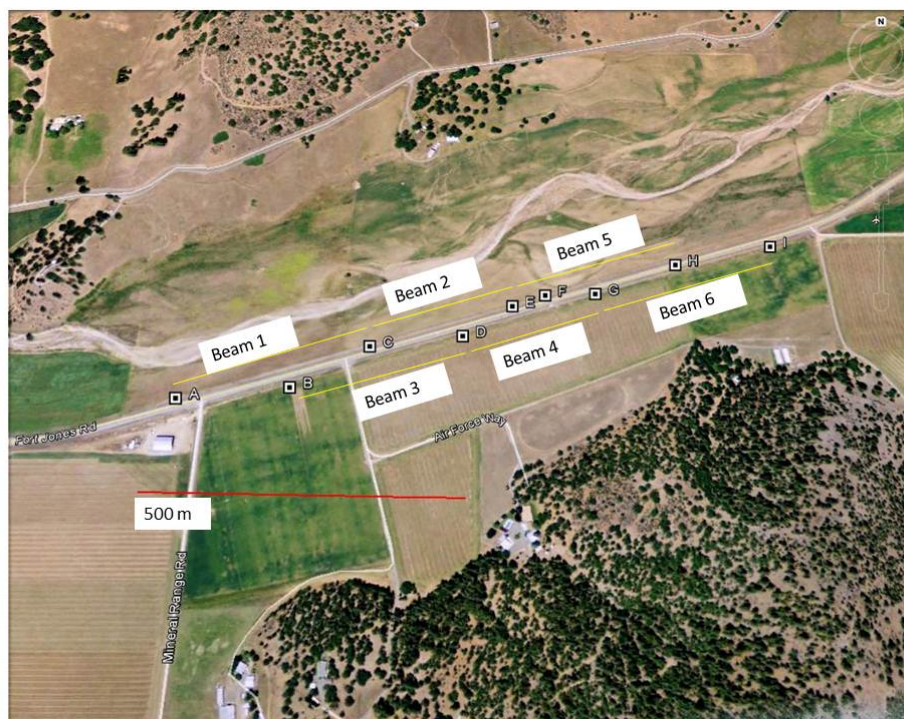
Figure 6.1. Layout of the animal detection system along SR 3 near Ft Jones, CA. Letters indicate poles, numbers and yellow lines indicate beams.

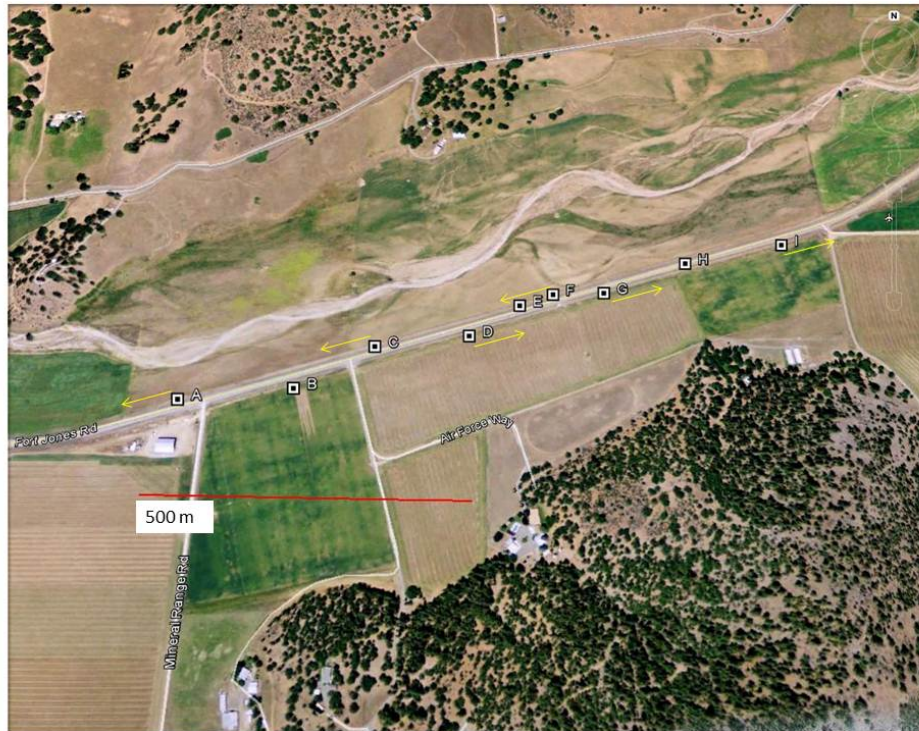
Figure 6.2. The location and direction (yellow arrows) of the video cameras associated with the animal detection system along SR 3 near Ft Jones, CA.
