RP 247

The Reliability and Effectiveness of a Radar-Based Animal Detection System

Idaho Transportation Department
Research Program, Contracting Services
Division of Engineering Services

September 2017

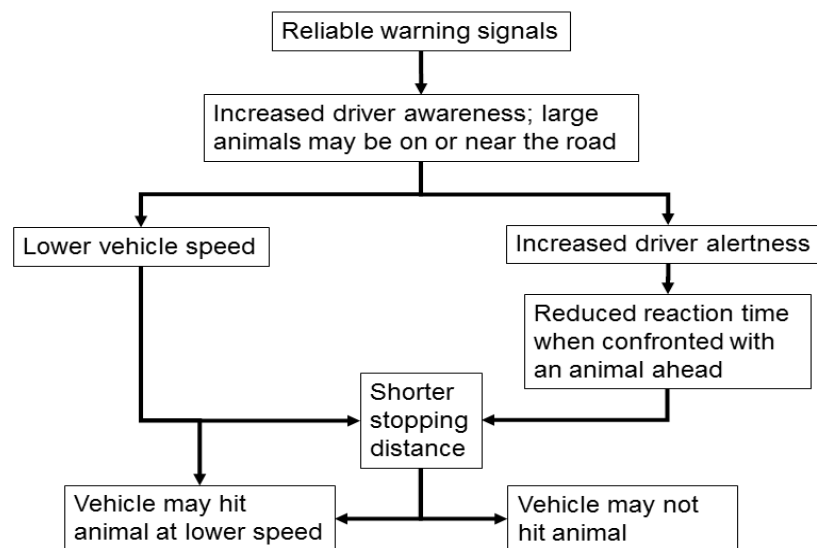
Figure 1. Warning Signs Must Be Reliable Before They Can Be Effective.

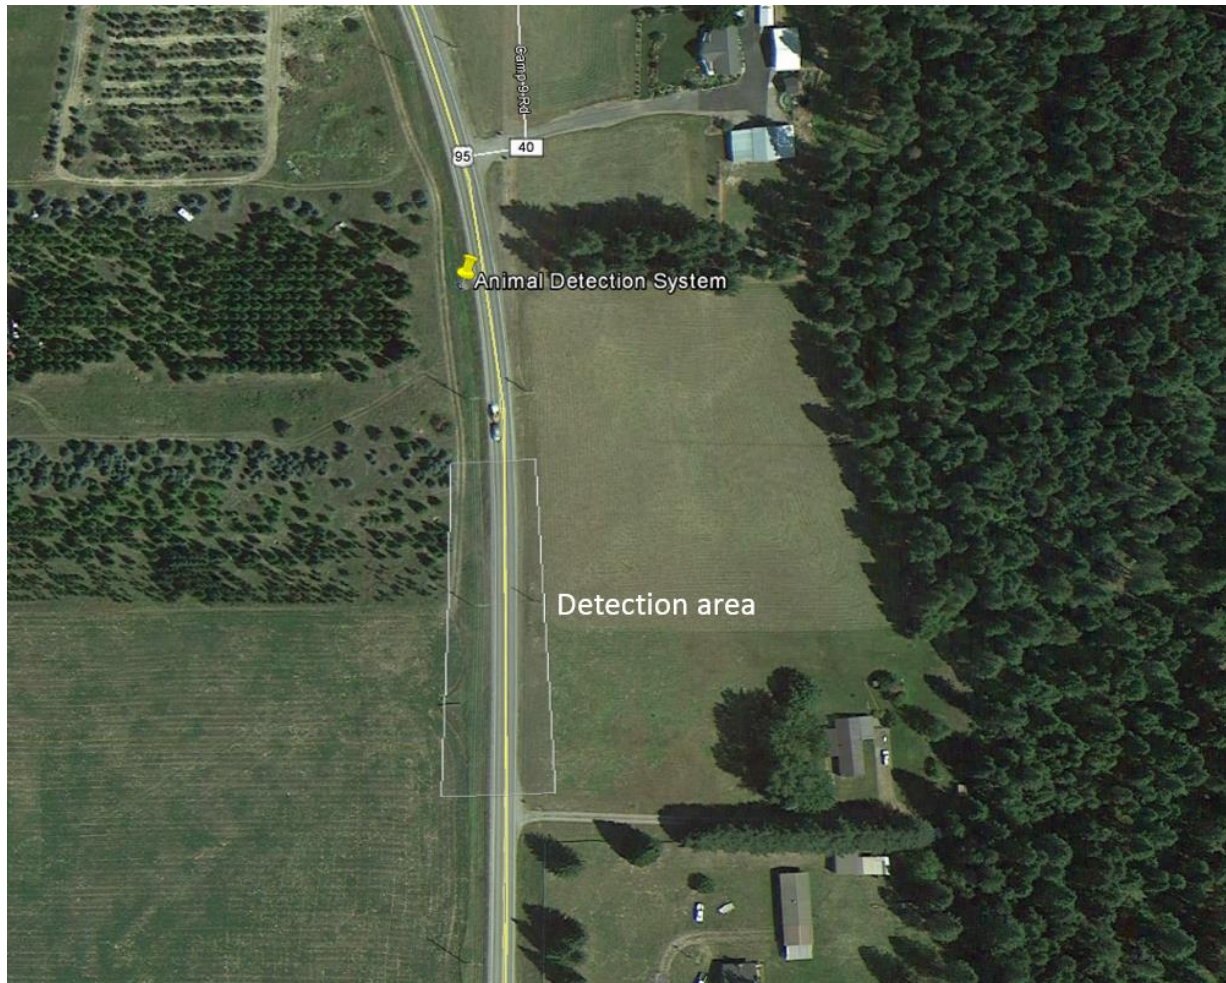
The system used a Doppler radar to detect large mammals along a 371 ft (113 m) long road section (Figure 3). The detection area was between 22 and 37 m wide and included the paved road and a zone adjacent to the paved road. However, the Doppler radar can be programmed to detect large mammals over much longer distances (about 1312 ft (400 m); Pers. Com. Brice Sloan, Sloan Security Technologies).

Figure 3. The Location of the Doppler Radar System and the Detection Area.

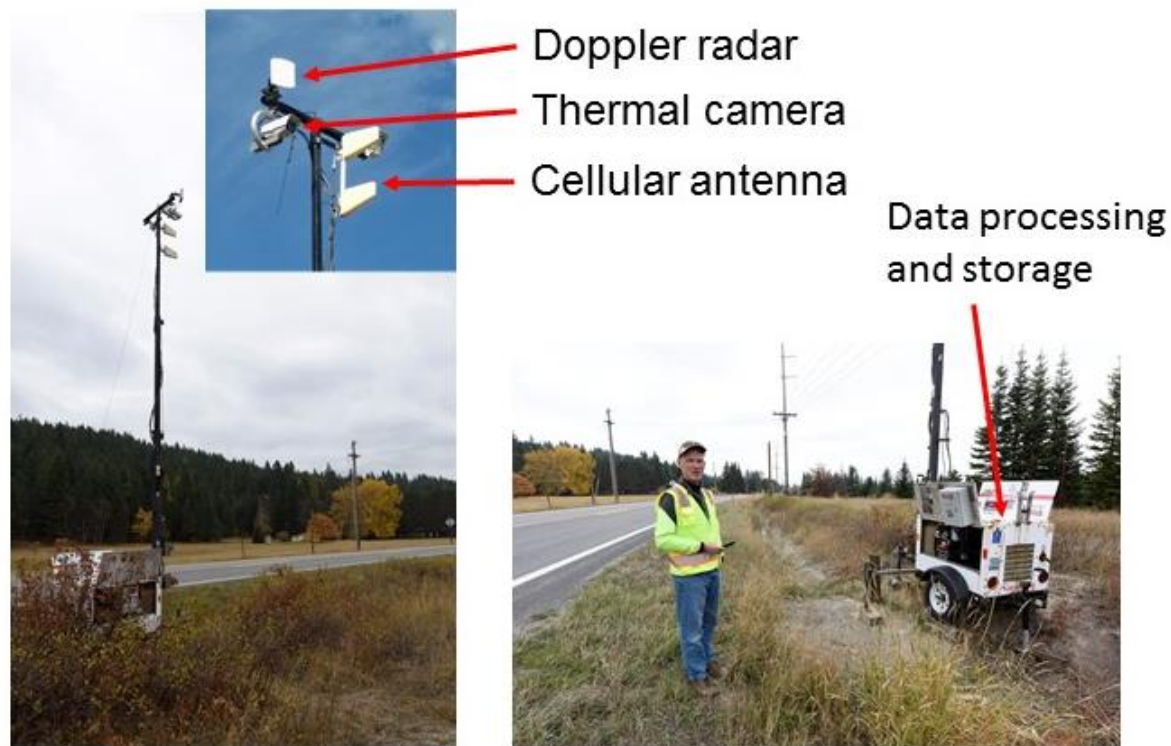
The sensor that detected large mammals consisted of one Doppler radar mounted on a 24 ft (7.3 m) pole (Pers. Comm. Brice Sloan, Sloan Security Technologies, Inc.) (Figure 4). The height allowed the sensor to “look over” semi-trucks to detect large animals on both sides of the highway and on the road, for several hundreds of meters, even if vehicles were on the road. The high location of the Doppler radar also reduced the risk of theft, vandalism or accidental damage and certain types of false alarms (e.g., caused by spray from snow plows).

Figure 4. Detection and Research Equipment.

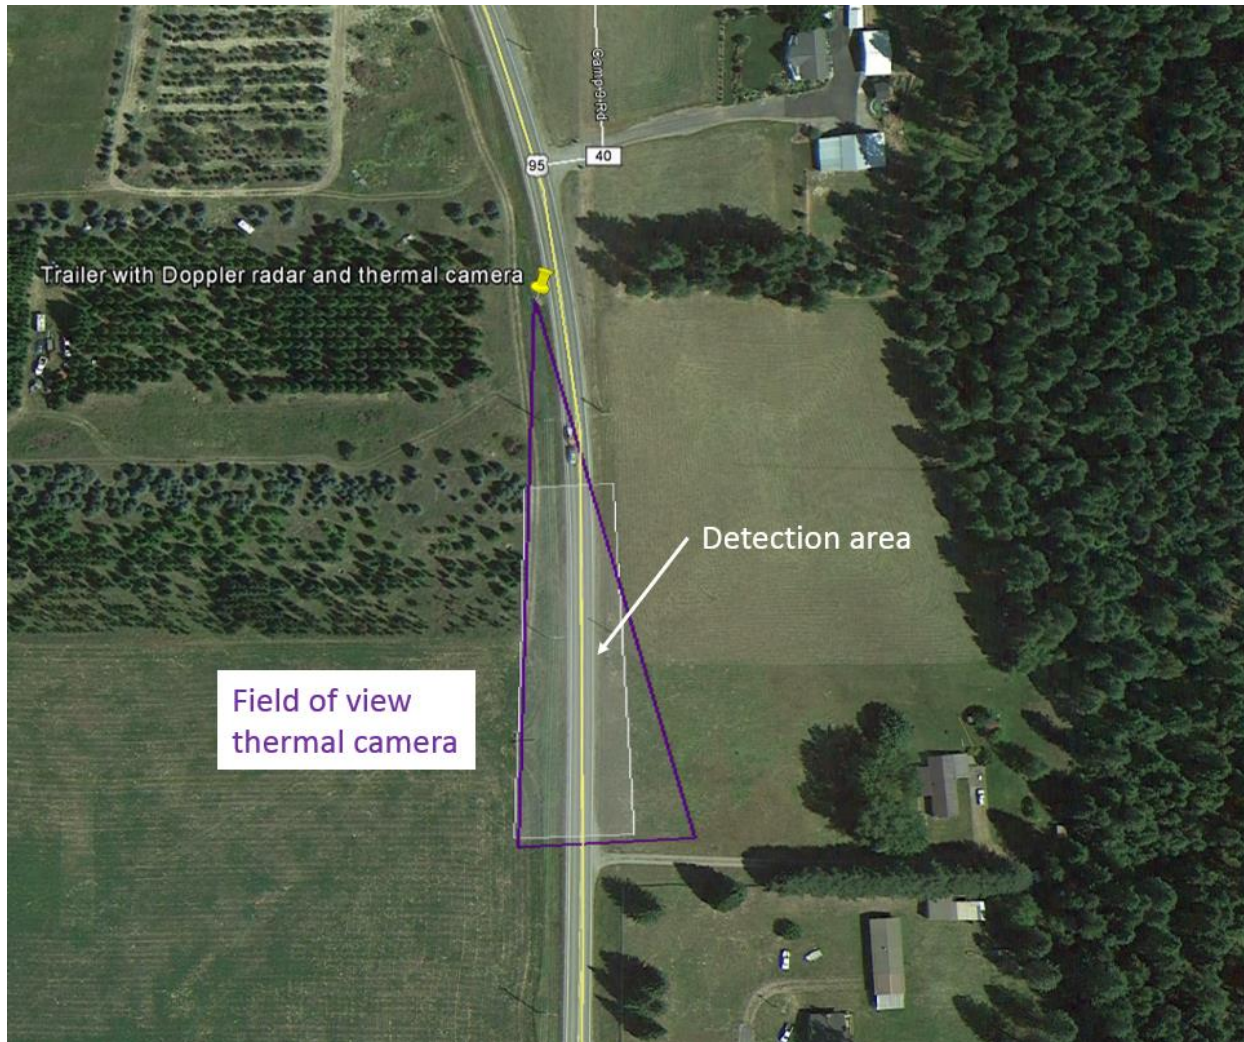
To evaluate the reliability of the radar in detecting large mammals, a thermal video camera was used to monitor wildlife in and around the detection area (Figure 5). Note the two small areas that were part of the detection area that were not covered by the thermal video camera (a narrow strip west of the highway and a small area in the northwest corner of the detection area (Figure 5). Every detection by the system was associated with a thermal image (1 image every 3 seconds) when the radar was detecting an object that matched the “large mammal” profile (Pers. Comm. Brice Sloan, Sloan Security Technologies, Inc.). The images of the thermal camera were continuously recorded and temporarily saved. When a detection occurred, the images were saved starting 3 seconds before the detection and ending 3 seconds after the detection. The video images had a date and time stamp, and also showed whether the Doppler radar detected an object that was presumably a “large mammal” (Figure 6). This

Note: Detection area delineated by the white line, thermal camera view delineated by the purple line.

Figure 5. The Detection Area of the Doppler Radar and the Thermal Video Camera.

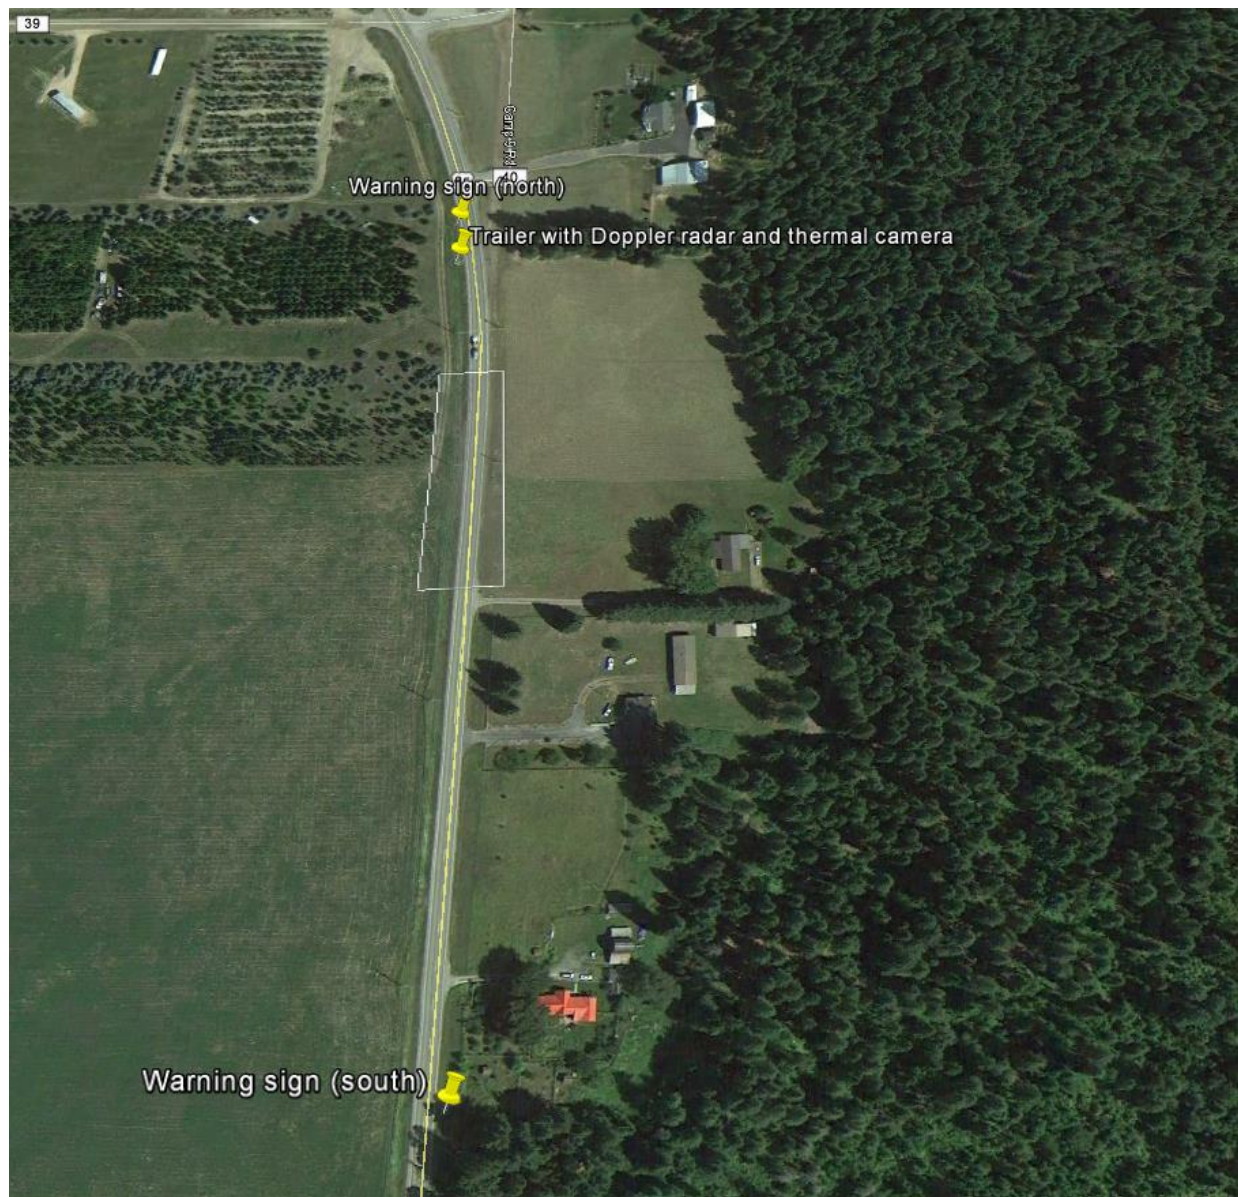
When the system detected a “large animal”, warning signs were activated. There were two warning signs: one was located 285 ft (87 m) north of the detection area (northern edge, mile reference post 514.45) for south bound traffic, and one was located 735 ft (224 m) south of the detection area (southern edge, mile reference post 514.38) for north bound traffic. (Figures 7, 8) for north bound traffic.

Note: The detection area covered by the Doppler radar is delineated by the white line.

Figure 7. The Detection Area and the Location of the Two Warning Signs.

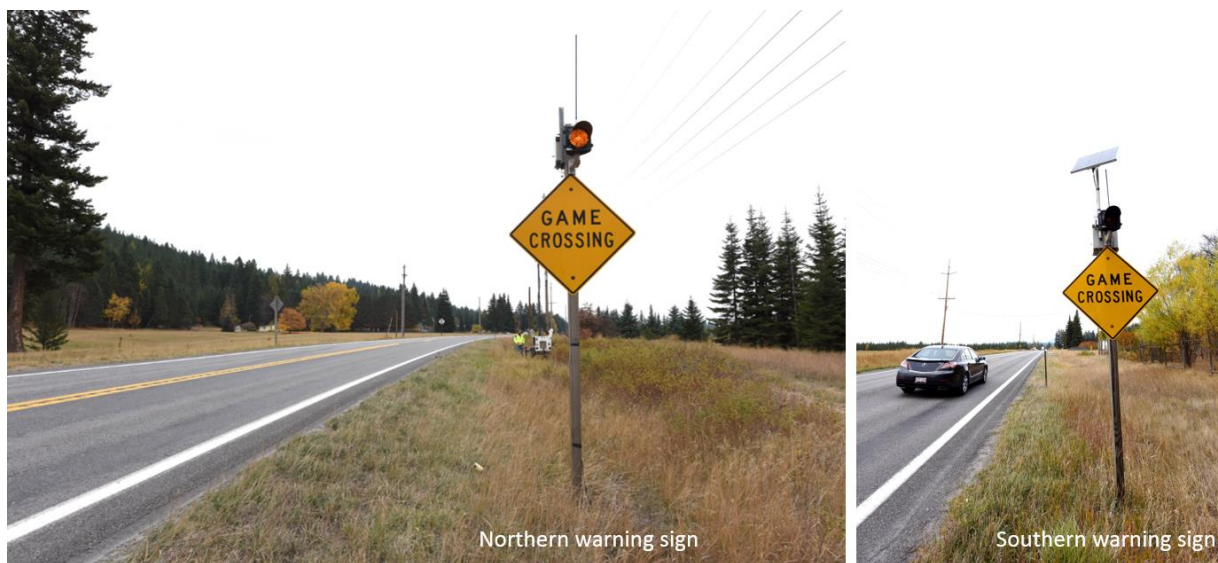
The warning signs displayed the text “GAME CROSSING” (always visible), and an amber flashing light was present above each warning sign. The amber flashing lights were activated only when detection of a “large mammal” was ongoing, and it remained on for about 40 seconds after the detection stopped. Should another detection occur before the 40 seconds were up, the clock resets and the amber lights remained active until 40 seconds after the last detection. The amber flashing light was “off” when there was no ongoing detection of a “large mammal” or if at least 40 seconds had passed since the last detection. The warning lights were activated through radio signals (2.4 GHz). The northern light was hooked up to the electric grid, but the southern light was powered by a solar panel and a battery.

Figure 8. The Warning Signs.

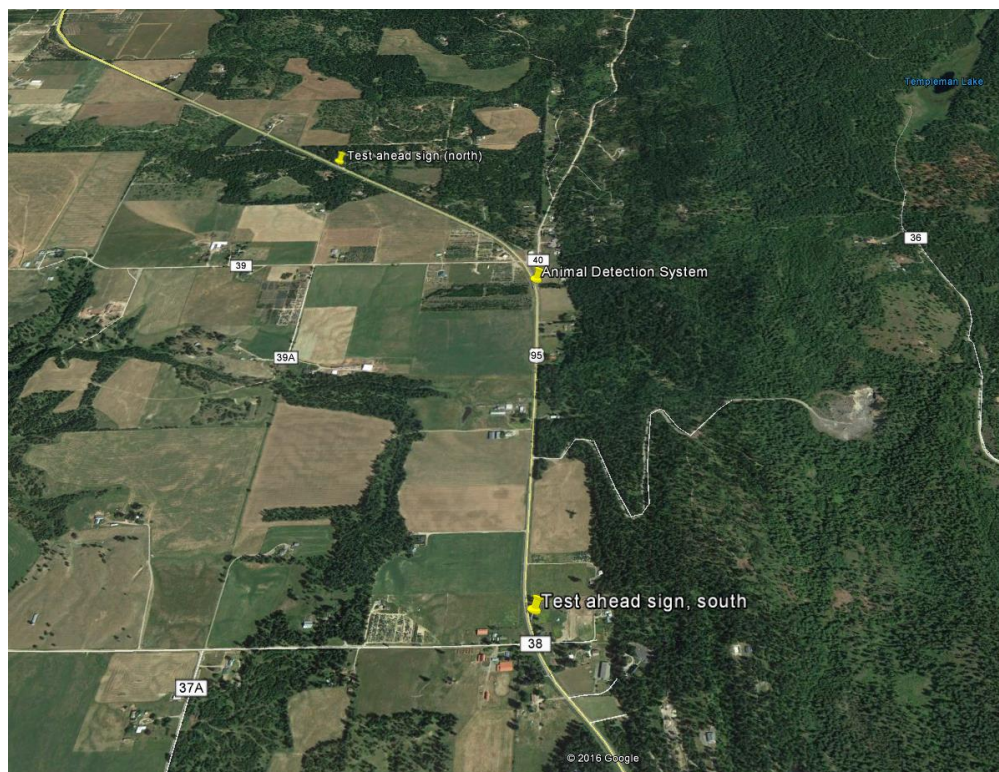
Drivers were informed about the detection zone and associated warning signs through signs stating “WILDLIFE DETECTION TEST AHEAD” (Figures 9 and 10). The southern informational sign (mile reference post 513.62) was located 3,248 ft (990 m) south of the southern warning sign. The northern informational sign (mile reference post 515.22) was located 3,773 ft (1,150 m) north of the northern warning sign.

Figure 9. The Location of the Signs Stating, “WILDLIFE DETECTION TEST AHEAD.”

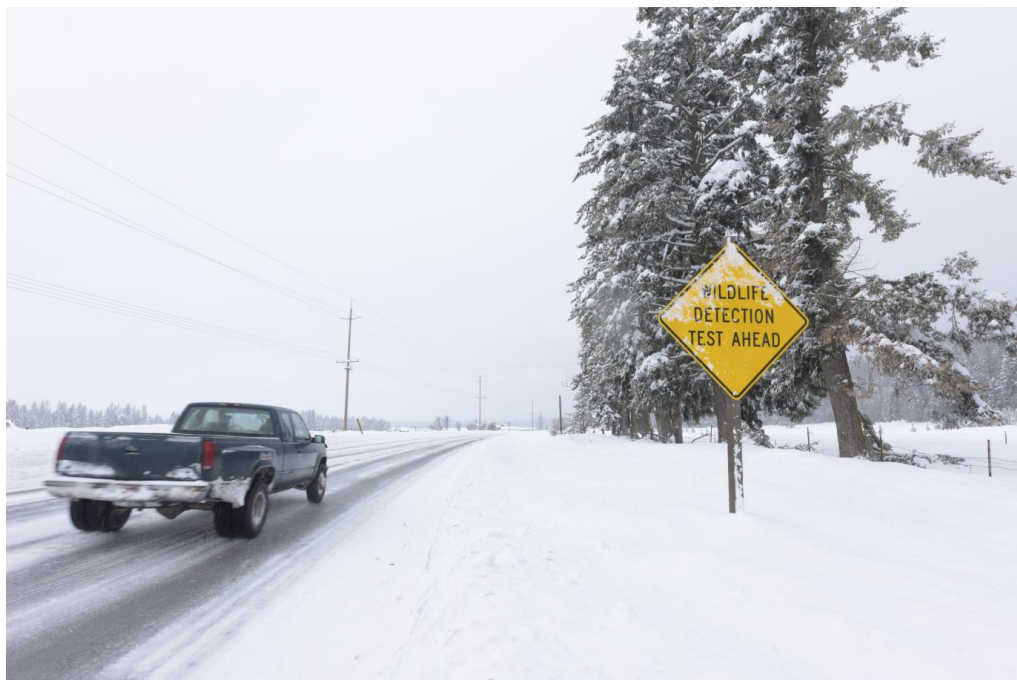
Figure 10. The Southern Sign Stating, “WILDLIFE DETECTION TEST AHEAD”.

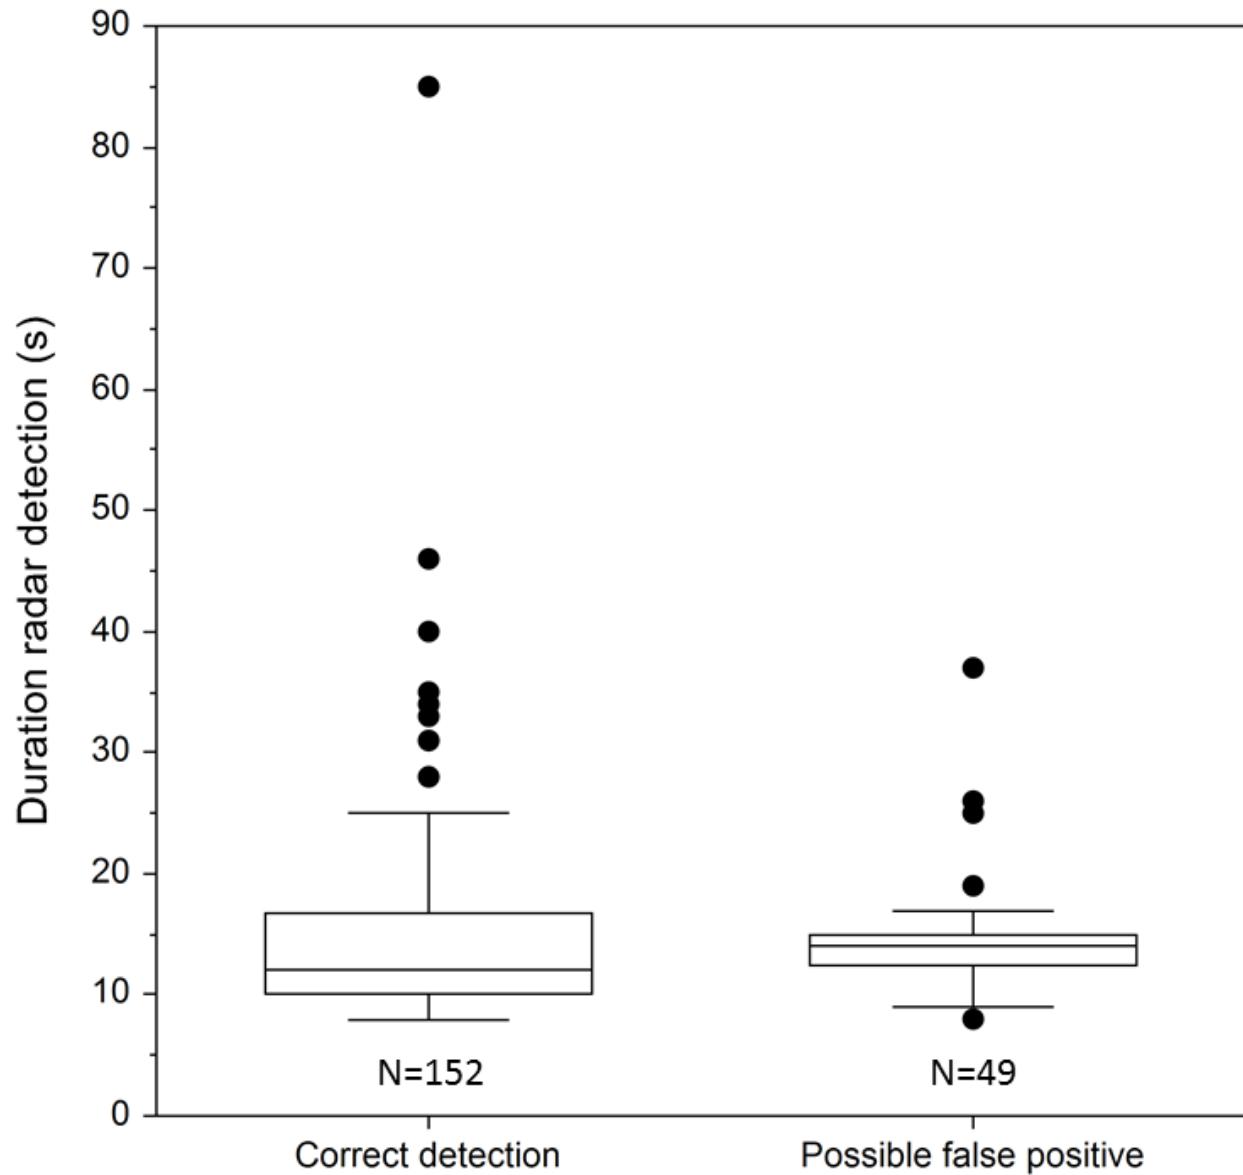
The average radar detection lasted 14.85 seconds (SD = 7.75, N = 201). There was no significant difference between the duration of the radar detections for correct detections and possible false positives (Mann-Whitney U-test, Z-value = 1.270, P = 0.204; Figure 12).

Note: The data relate to correct detections and possible false positives. Box: Middle 50 percent of the data (25–75 quartile); Horizontal line: Median; Whisker boundaries: 1.5 times inter-quartile range; outliers: Over 1.5 times inter-quartile range.

Figure 12. The Duration of the Radar Detections.

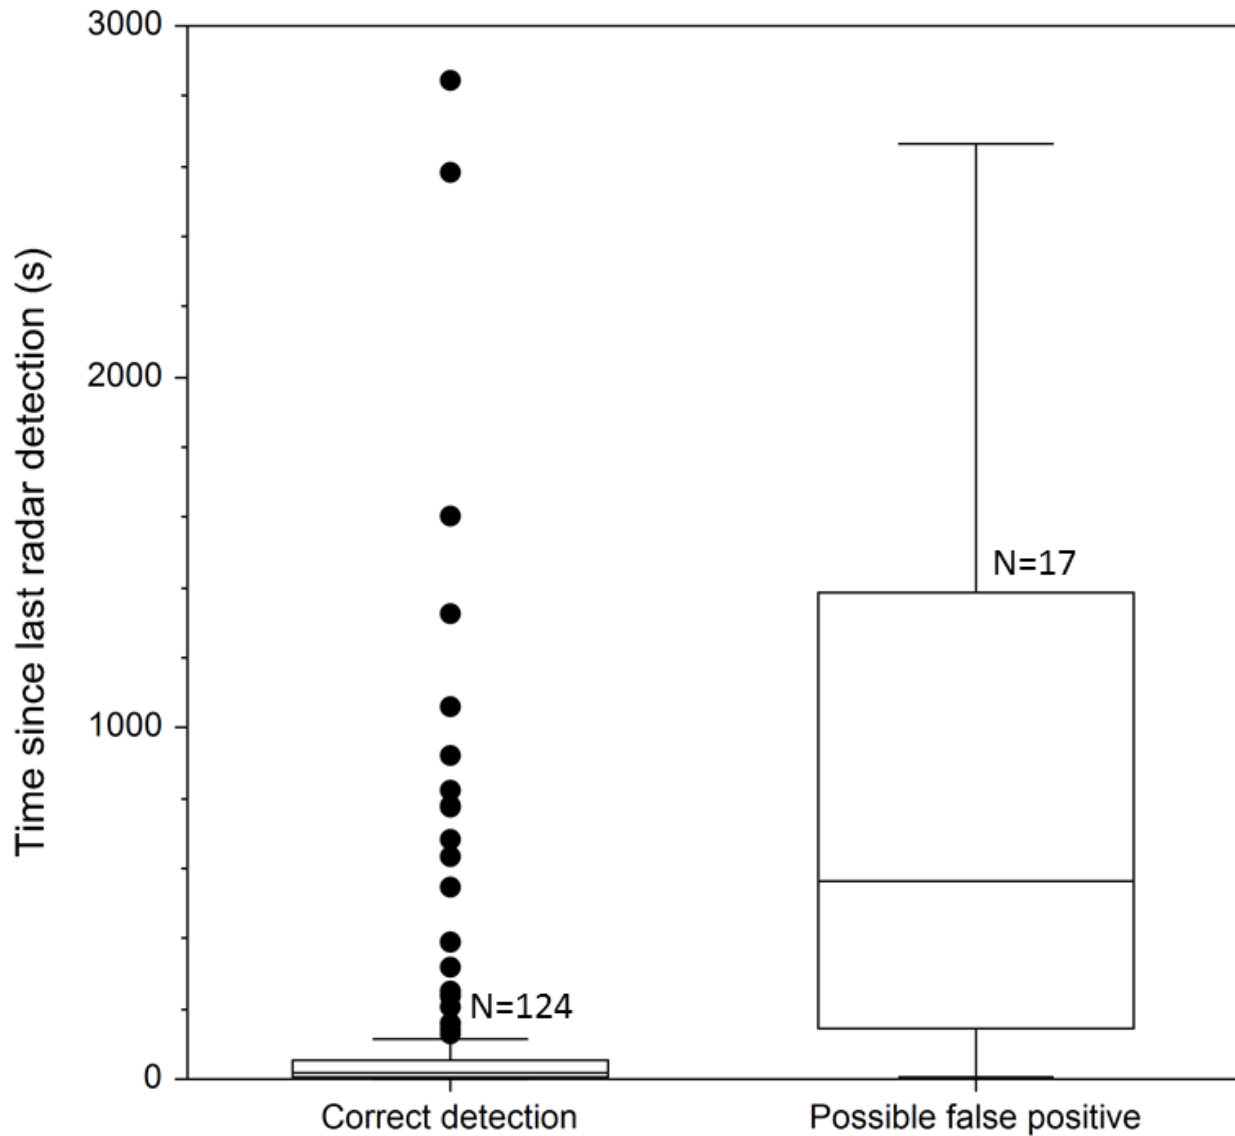
since the previous radar detection for correct detections and possible false positives (Mann-Whitney U-test, Z-value = 4.3171, $P < 0.0001$; Figure 13). For correct detections, the average time since the last detection was 155.52 seconds (SD = 422.28, N = 124, Median = 16). For potential false positives, the average time since the last detection was 830.47 seconds (SD 845.33, N=17, Median =563).

Note: The data relate to correct detections and possible false positives. Box: Middle 50 percent of the data (25–75 quartile); Horizontal line: Median; Whisker boundaries: 1.5 times inter-quartile range; outliers: Over 1.5 times inter-quartile range.

Figure 13. The Time Passed Since the Previous Radar Detection.

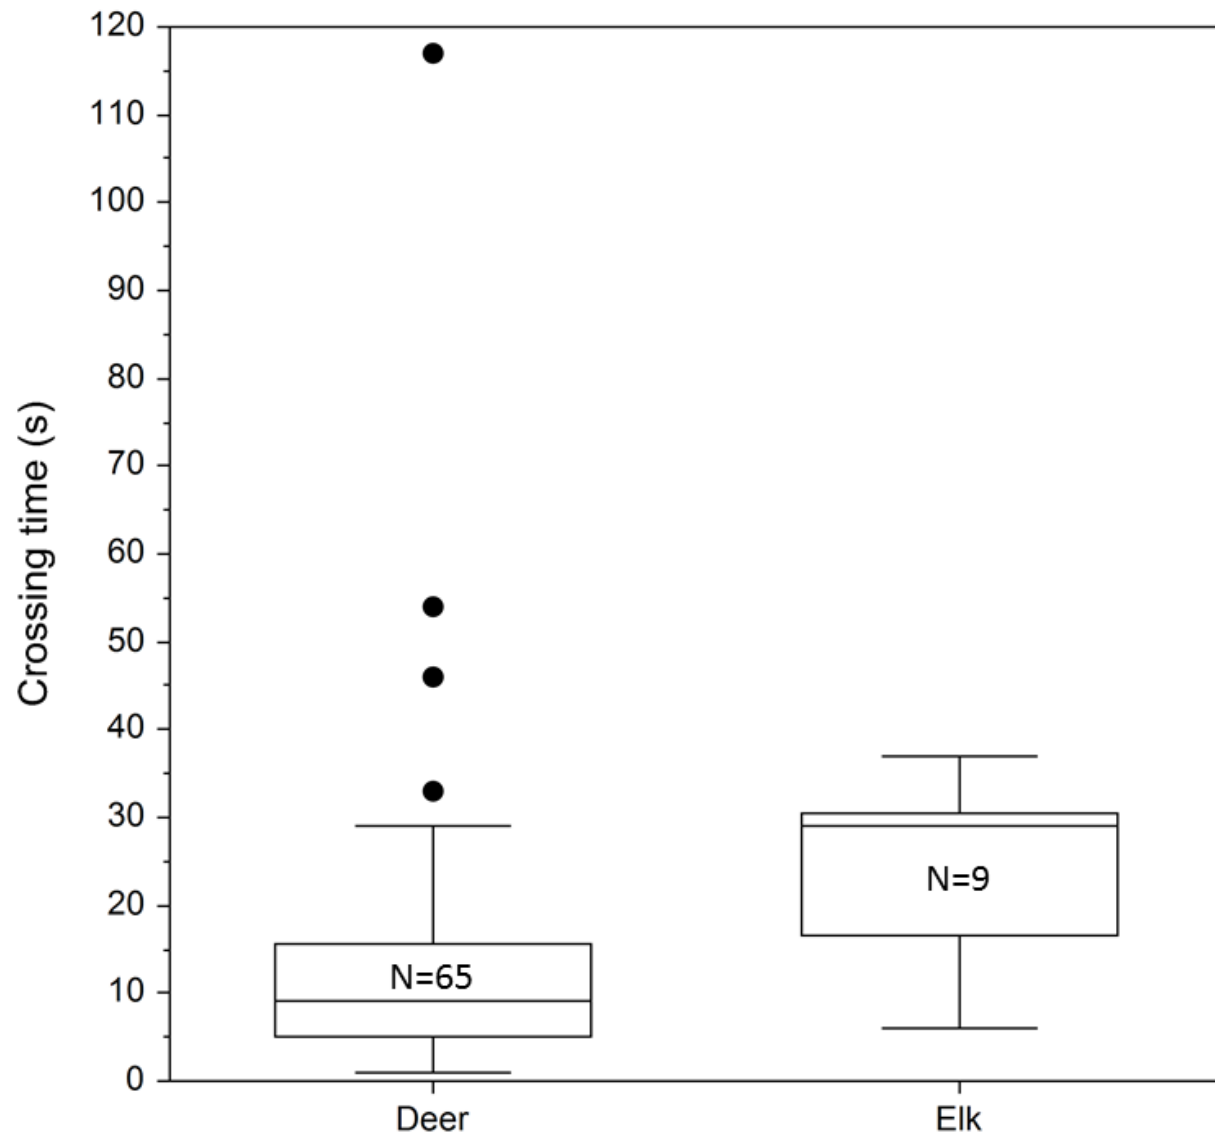
The average crossing time for large ungulates (elk or deer) that successfully crossed the highway was 14.91 seconds (SD = 16.27, N = 74). There was a significant difference in crossing time for deer and elk (Mann-Whitney U-test, Z-value = 3.1221, P = 0.002; Figure 14). For deer, the average crossing time was 13.60 seconds (SD = 16.62, N = 65, Median = 9). For elk, the average crossing time was 24.33 seconds (SD 9.62, N=9, Median = 29).

Note: The data relate to successful crossings only. Box: Middle 50 percent of the data (25–75 quartile); Horizontal line: Median; Whisker boundaries: 1.5 times inter-quartile range; Outliers: over 1.5 times inter-quartile range.

Figure 14. The Crossing Time for Deer and Elk.

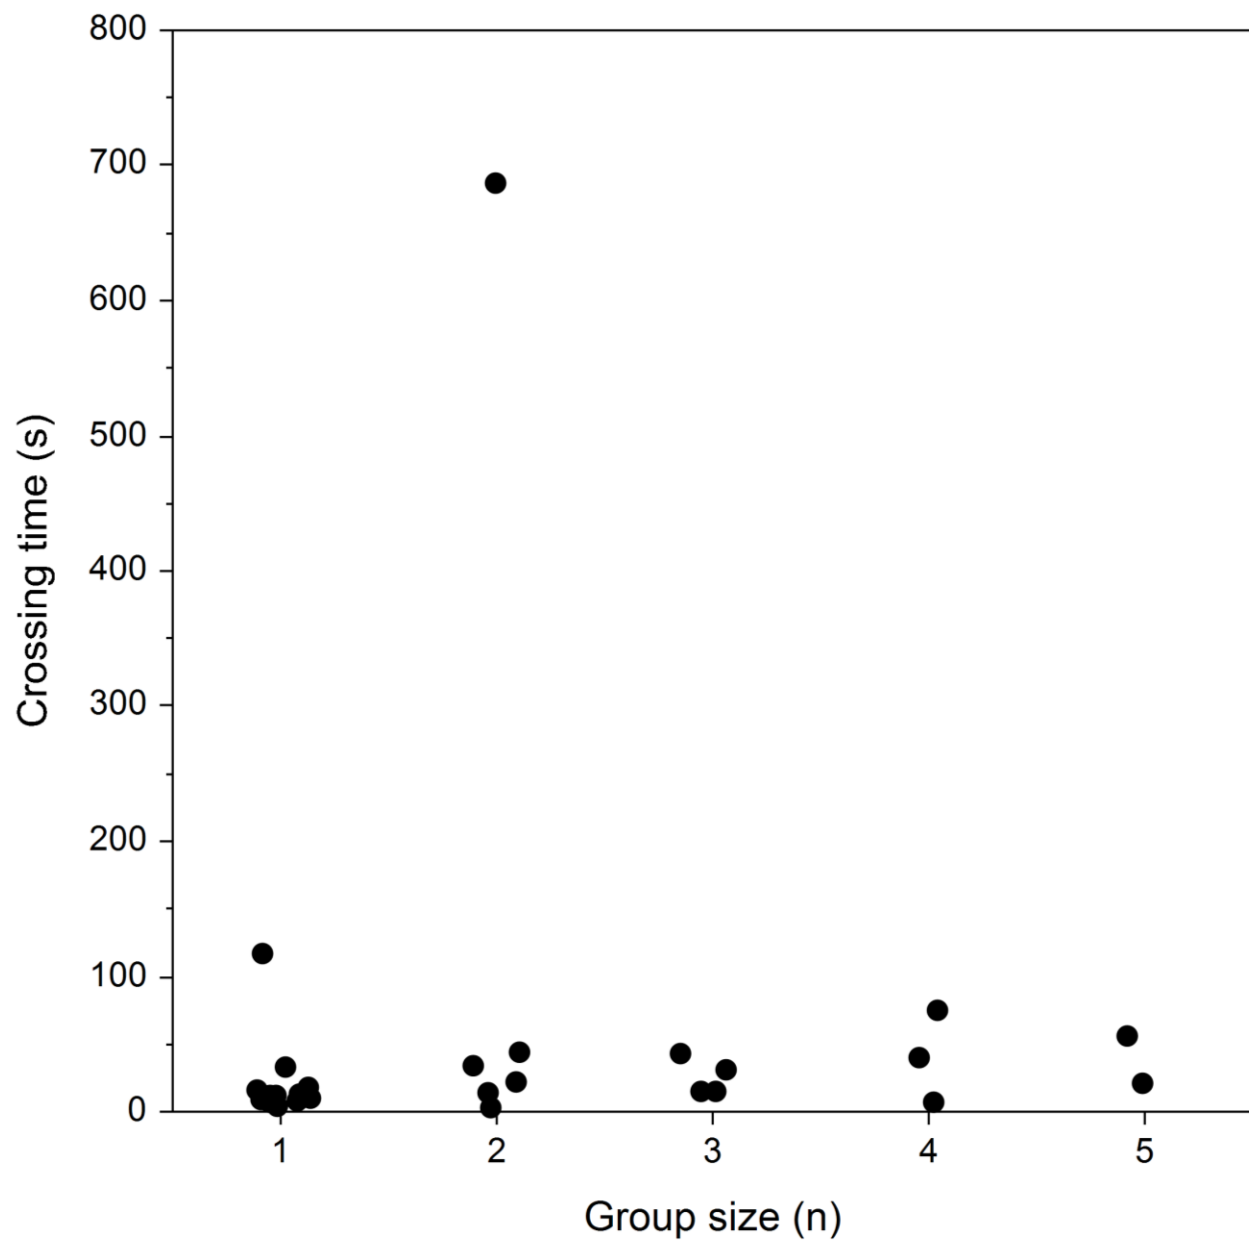
The average group size for deer was 2.15 animals (SD = 1.32, N = 27, Median = 2). The average crossing time for a deer group was 50.59 seconds (SD = 129.62, N = 27, Median = 16) (Figure 15). No obvious correlation between the size of the deer group and the crossing time for a group was apparent. In two cases, there were extremely long group-crossing times. These long group crossings occurred when traffic was absent. Only two groups of elk were observed, and no group size analysis was conducted.

Figure 15. The Crossing Time for Deer Groups Depending on the Group Size.

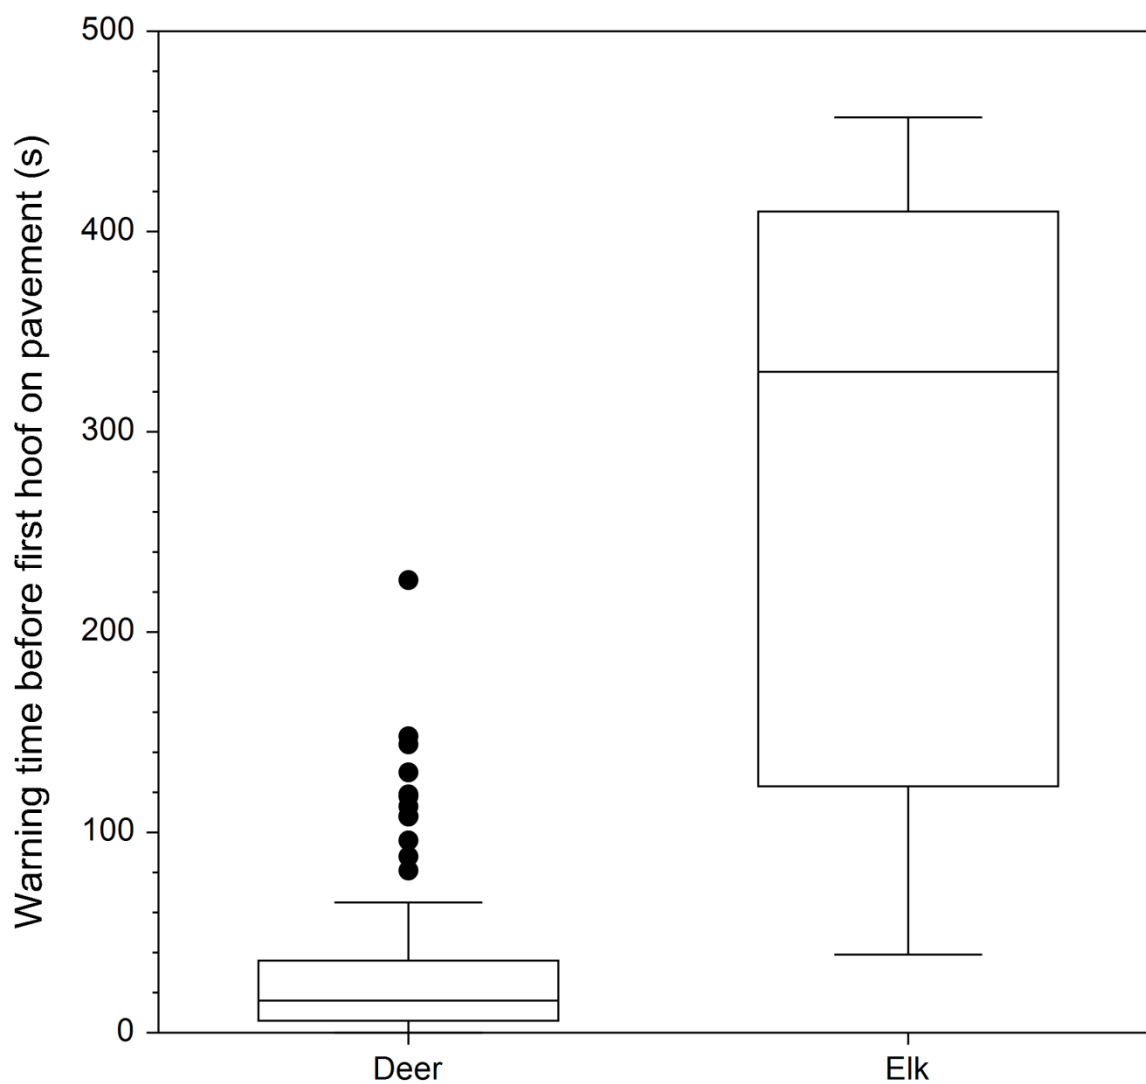
The average time between detecting a deer and that deer setting its first hoof on the pavement was 35.35 seconds (Figure 16; Table 8). For elk, the average time was 268.44 seconds (Figure 16; Table 8). For fifty percent of deer crossings, drivers had a warning time of at least 15.5 seconds (Figure 17).

Figure 16. The Warning Time Before Deer or Elk Set First Hoof on the Pavement.

area. Given the actual time that passed between detecting a deer and that deer setting its first hoof on the pavement (Figure 16), between 58.1 and 67.9 percent of the deer were detected sufficiently early for northbound drivers. For southbound drivers to receive the warning in time, the warning signs needed to be activated between 3.2 (near edge) and 7.5 seconds (far edge) before a large animal entered the pavement in the detection area. Given the actual time that passed between detecting a deer and that deer setting its first hoof on the pavement (Figure 16), between 70.4 and 85.0 percent of the deer were detected sufficiently early for southbound drivers.

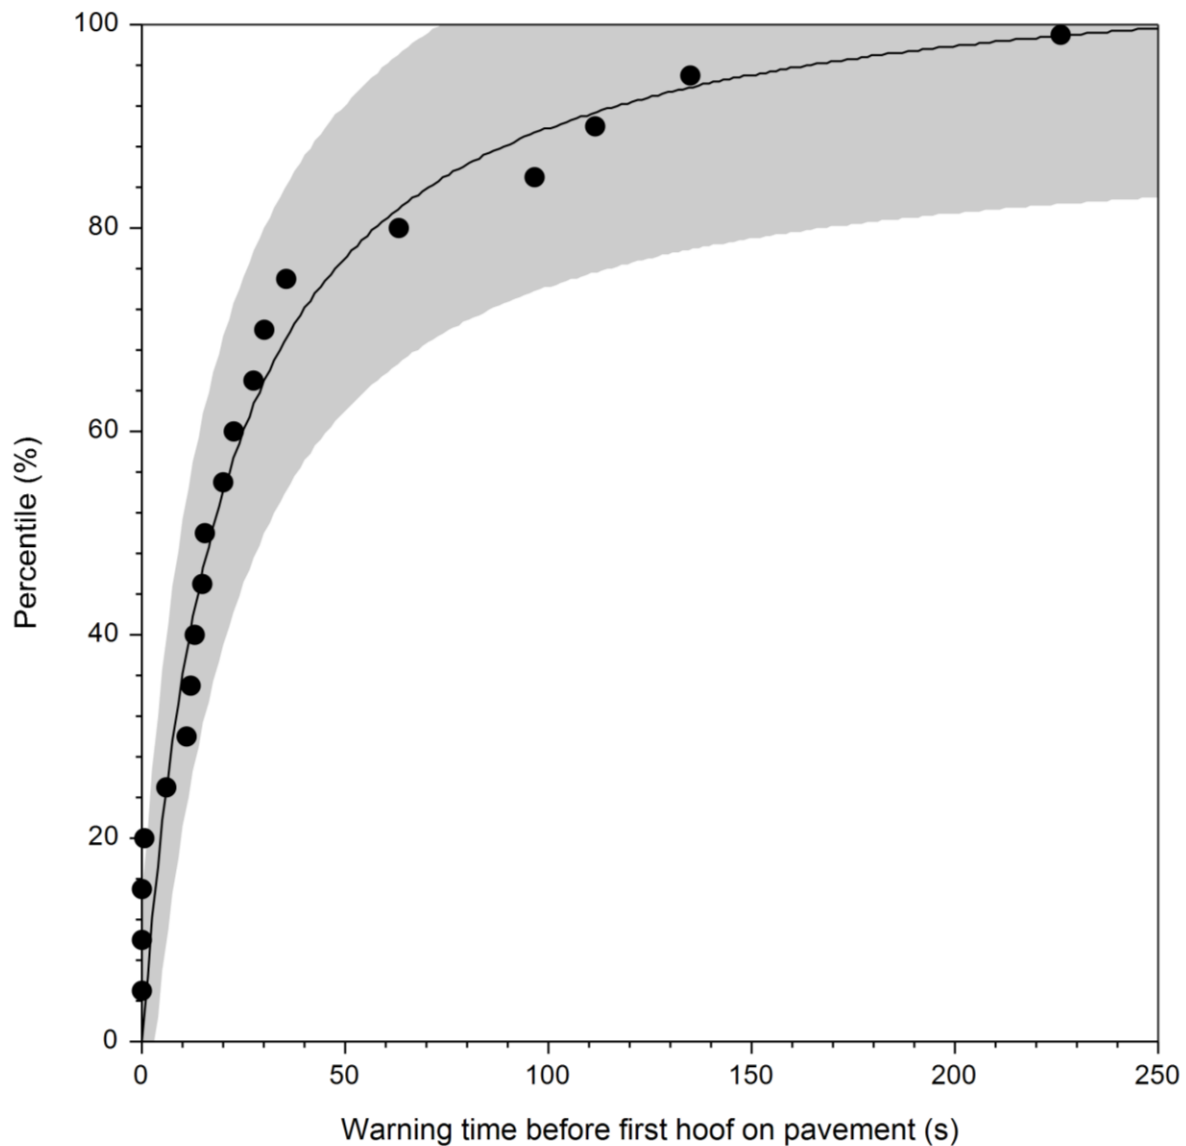
Note: Percentile = $107.56482 \cdot \text{Warning_Time} / (19.76350 + \text{Warning_Time})$, $R^2 = 0.94844$. The shaded area adjacent to the curve represents the 95 percent confidence interval.

Figure 17. The Percentile of the Warning Time before Deer Set First Hoof on the Pavement.

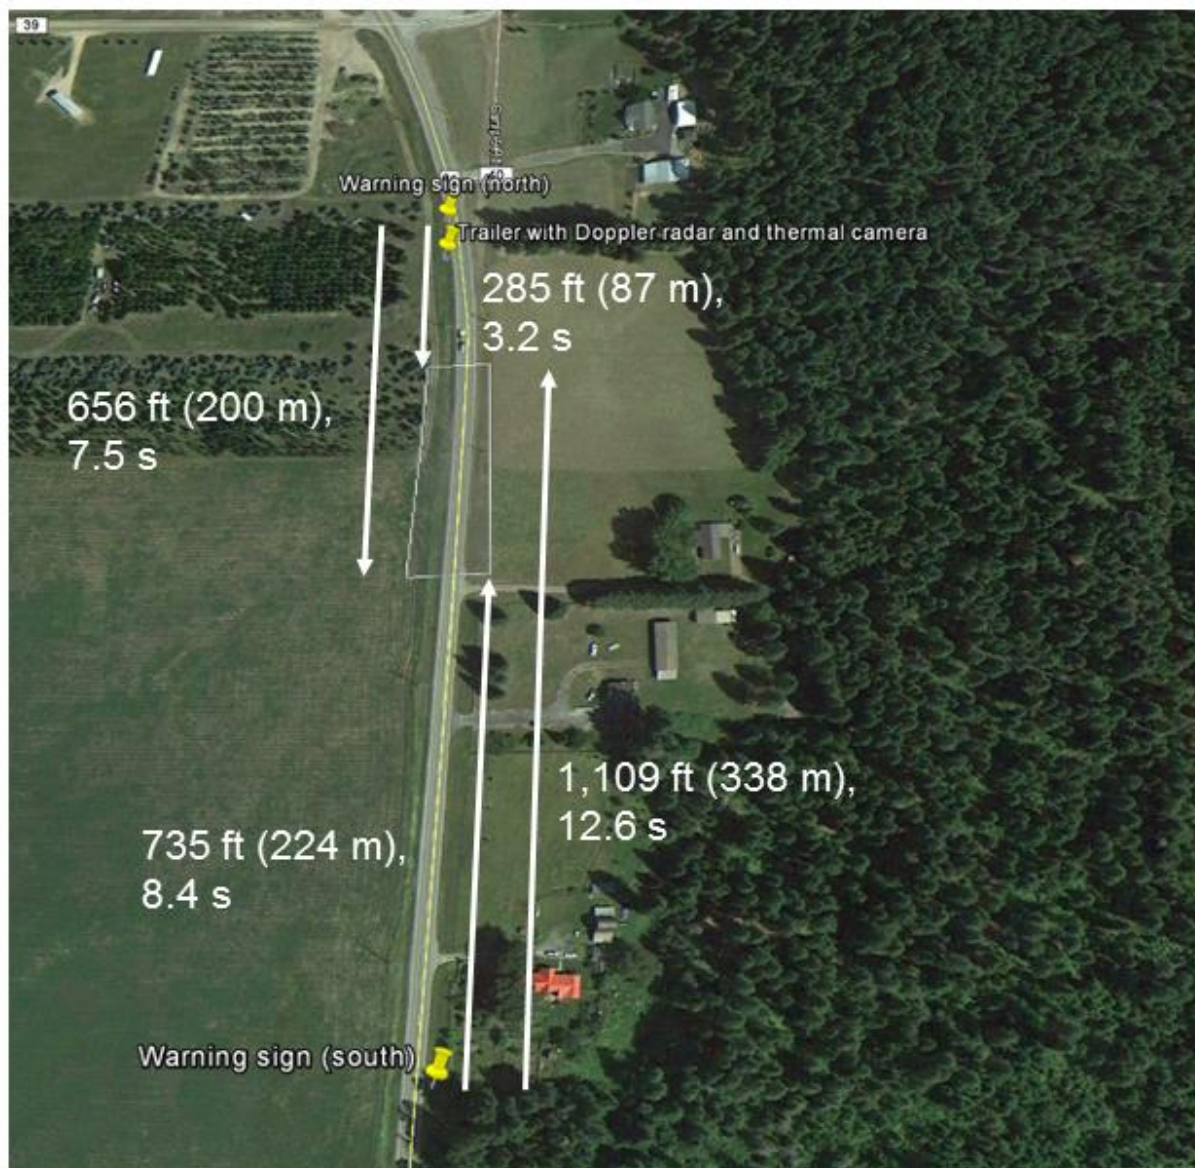
Note: Also shown are the detection area covered by the Doppler radar (delineated by the white line) and the location of the two warning signs.

Figure 18. Distances and Travel Times Between Warning Signs and the Outer Edges Detection Area.

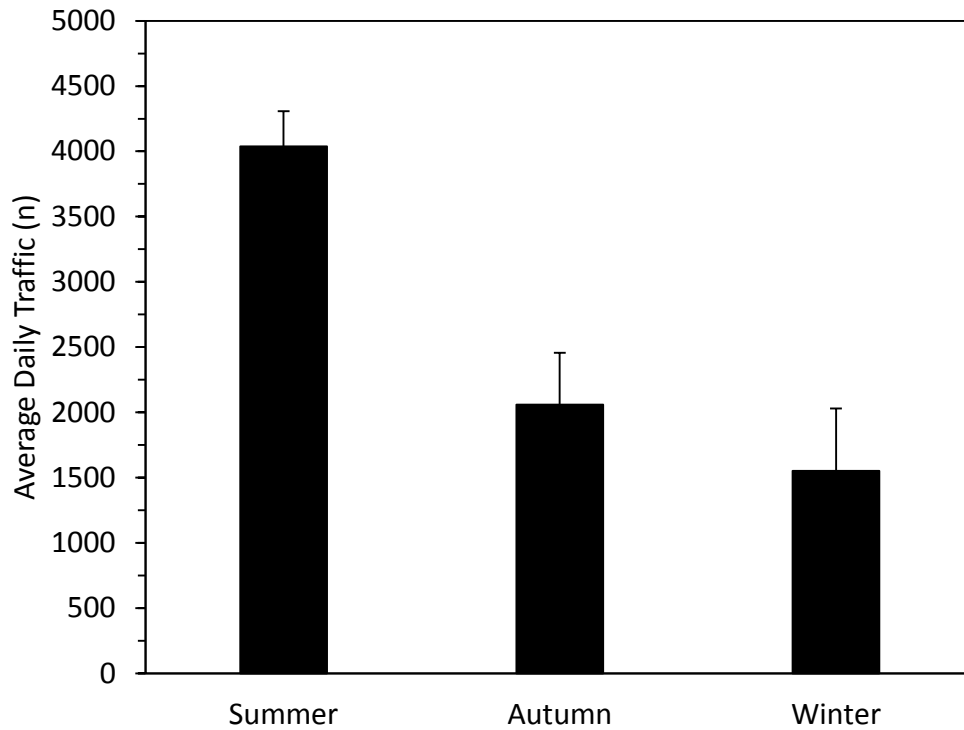
The speed radars also measured traffic volume. Traffic volume was much higher in summer (n=4,039) than in autumn (n=2,059) and winter (n=1,551) (Figure 19).

Note: The data relate to the number of vehicles per day for both travel directions combined (and standard deviation) for the ten consecutive speed trial days in the three seasons at the central radar.

Figure 19. Average Daily Traffic for the Three Seasons.

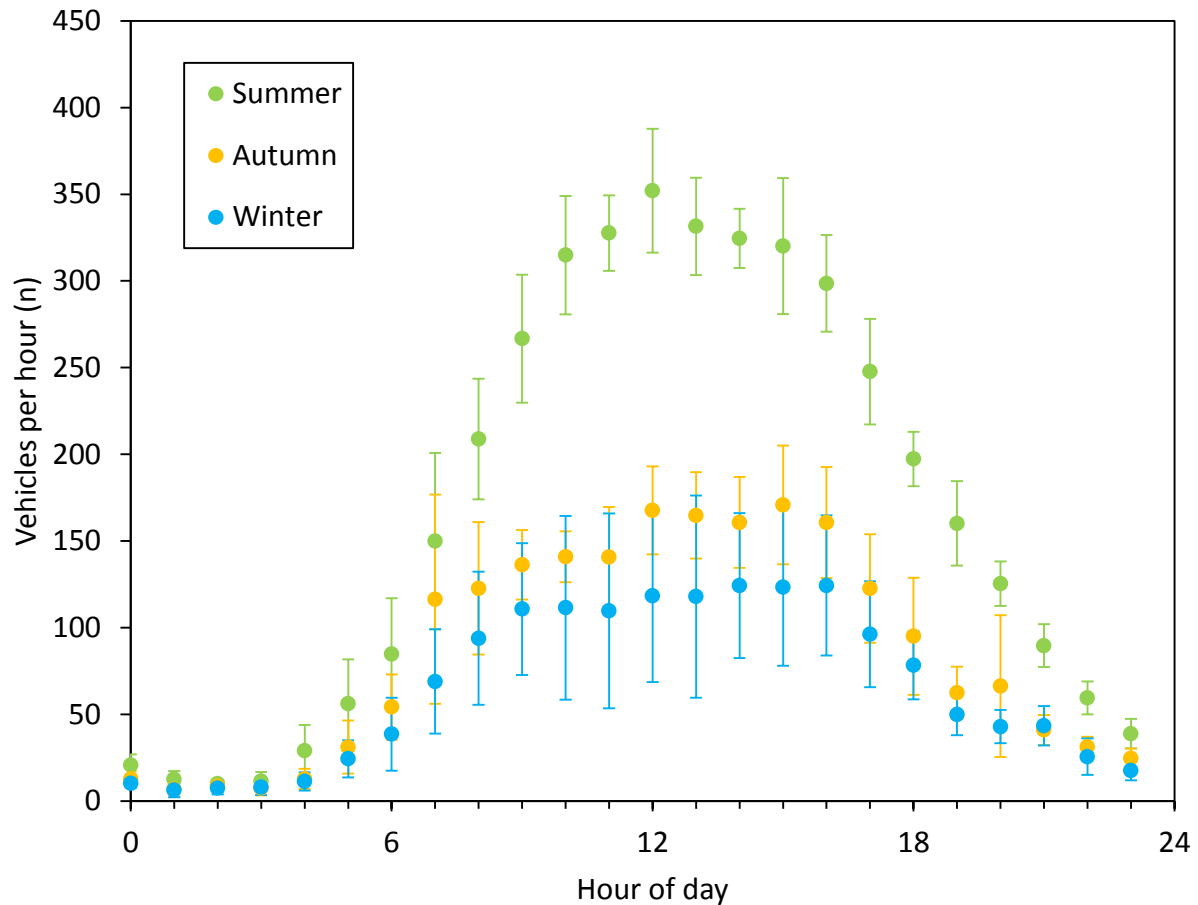
Traffic volume was highest between 9:00 and 17:00 (between 9 a.m. and 5 p.m.), with around 100 to 350 vehicles per hour (Figure 20). Traffic volume was lowest between 1:00 and 4:00 (between 1 a.m. and 4 a.m.) with 6 to 13 vehicles per hour.

Note: The data relate to ten consecutive speed trial days at the central radar. 6 = Between 6 and 7 A.M., etc.).

Figure 20. Average Traffic Volume per Hour and Associated Standard Deviation in the Three Seasons.

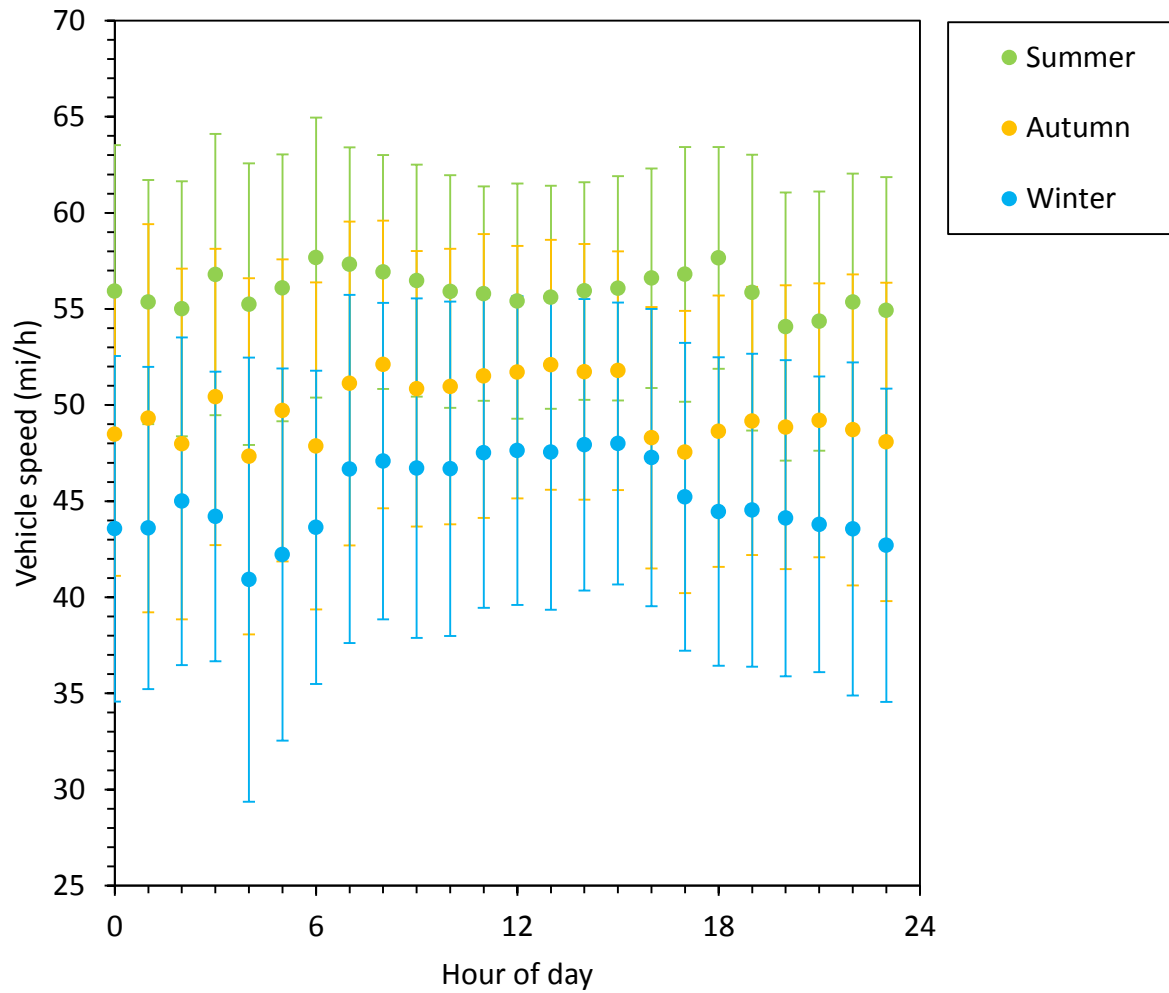
Vehicle speed was highest in summer and lowest in winter (Figure 21). In general, vehicle speed was highest during the day and lowest during the night.

Note: The data relate to the ten consecutive speed trial days in the three seasons. 6 = Between 6 and 7 A.M., etc.).

Figure 21. Average Vehicle Speed per Hour and Associated Standard Deviation for the Three Seasons.
