RP 247

The Reliability and Effectiveness of a Radar-Based Animal Detection System

Idaho Transportation Department
Research Program, Contracting Services
Division of Engineering Services

September 2017

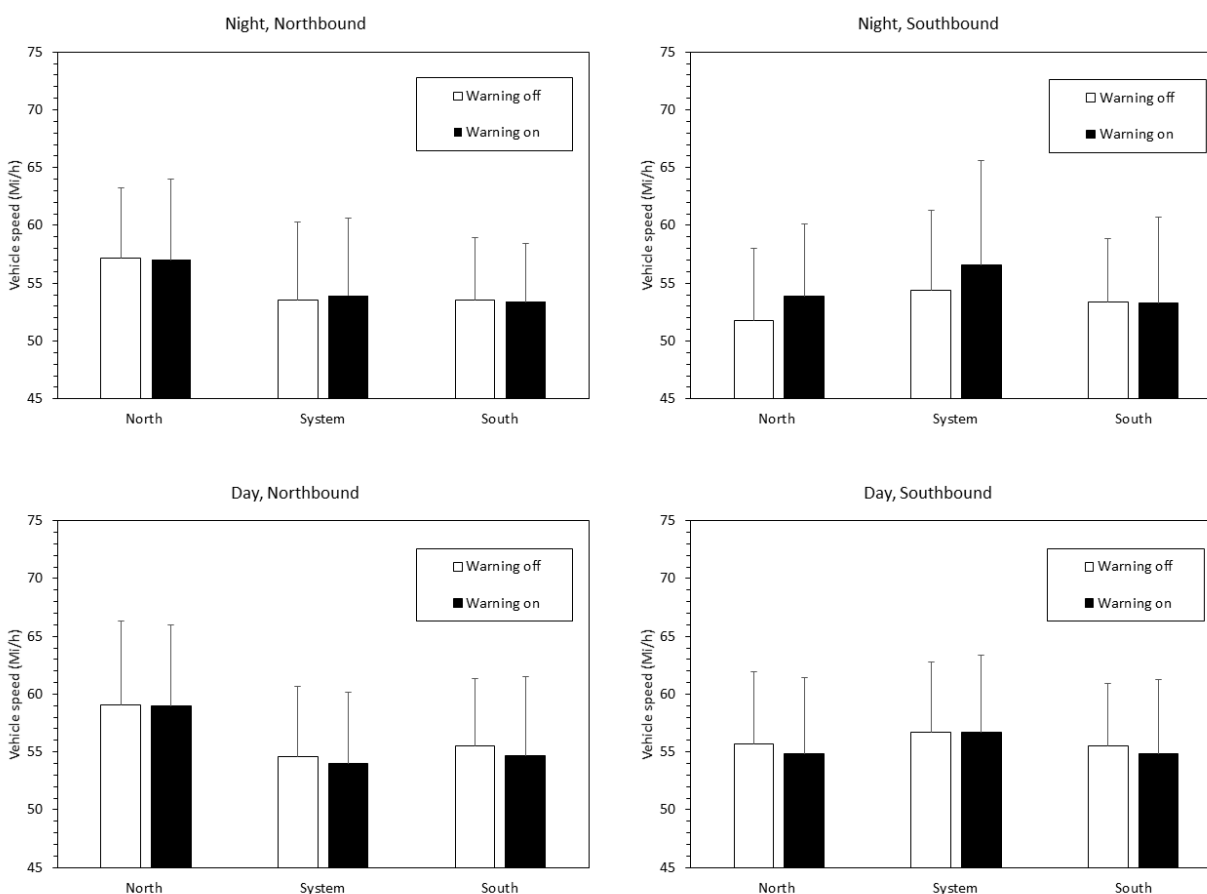
The average vehicle speed in summer was calculated and broken down by treatment (warning signs off vs. warning signs on), light conditions (day vs. night), and for travel direction (northbound vs. southbound) (Figure 22).

Note: The data relate to vehicle speed with warning signs off and warning signs on, during day and night, and for northbound and southbound traffic.

Figure 22. Average Vehicle Speed and Associated Standard Deviation) in Summer.

In summer, travel direction (northbound vs. southbound) and light (day vs. night) had a significant effect on vehicle speed at the location of the system (main effects) (Tables 12, 13). The effect of treatment (warning signs off vs. warning signs on) on vehicle speed was also significant, but the effect depended on the light conditions (day vs. night) (Table 13). At night, vehicle speed was 1.32 mi/h higher with warning signs on than with warning signs off. During the day, vehicle speed was 0.30 mi/h lower with warning signs on than with warning signs off.

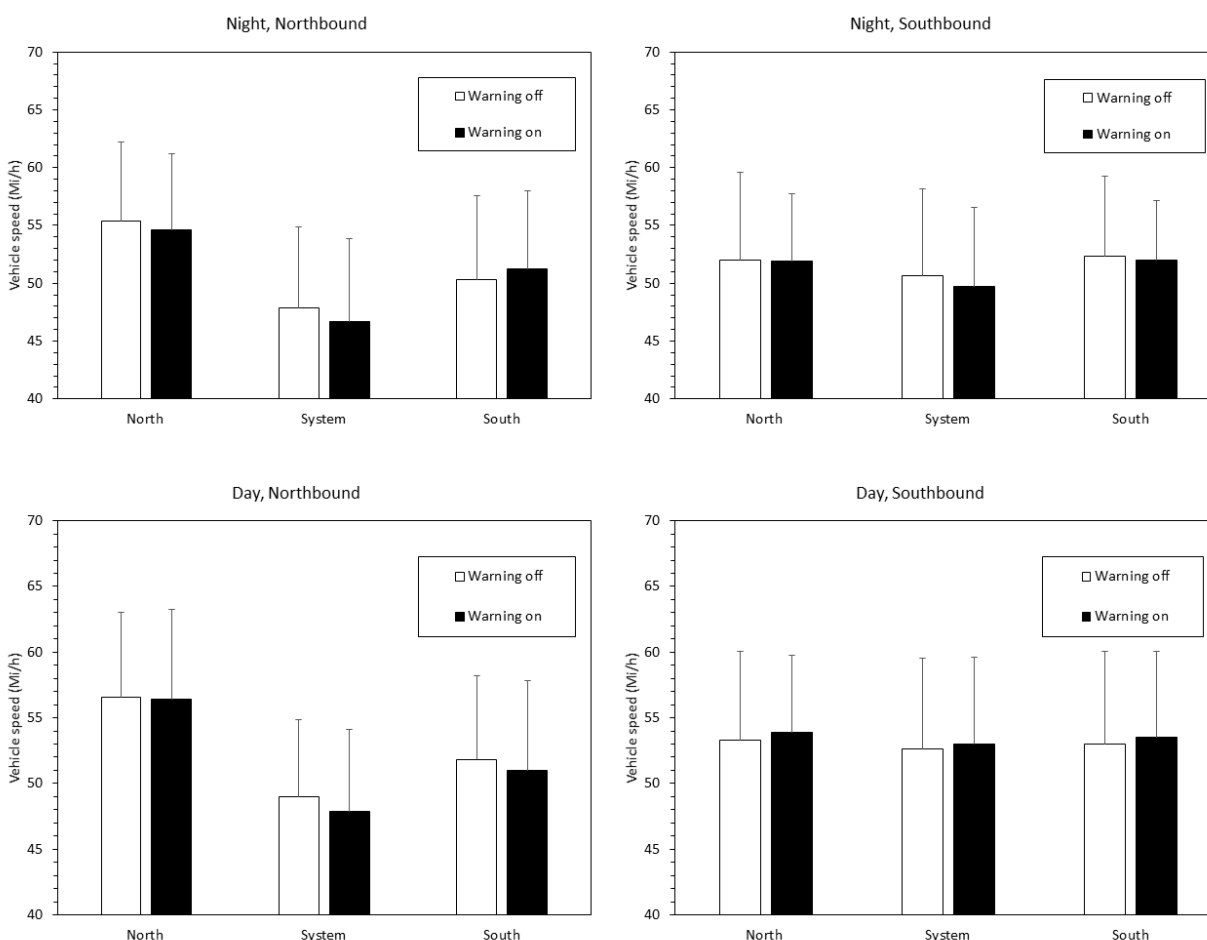
The average vehicle speed in autumn was calculated and broken down by treatment (warning signs off vs. warning signs on), light conditions (day vs. night), and for travel direction (northbound vs. southbound) (Figure 23).

Note: The data relate to vehicle speed with warning signs off and warning signs on, during day and night, and for northbound and southbound Traffic.

Figure 23. Average Vehicle Speed and Associated Standard Deviation in Autumn.

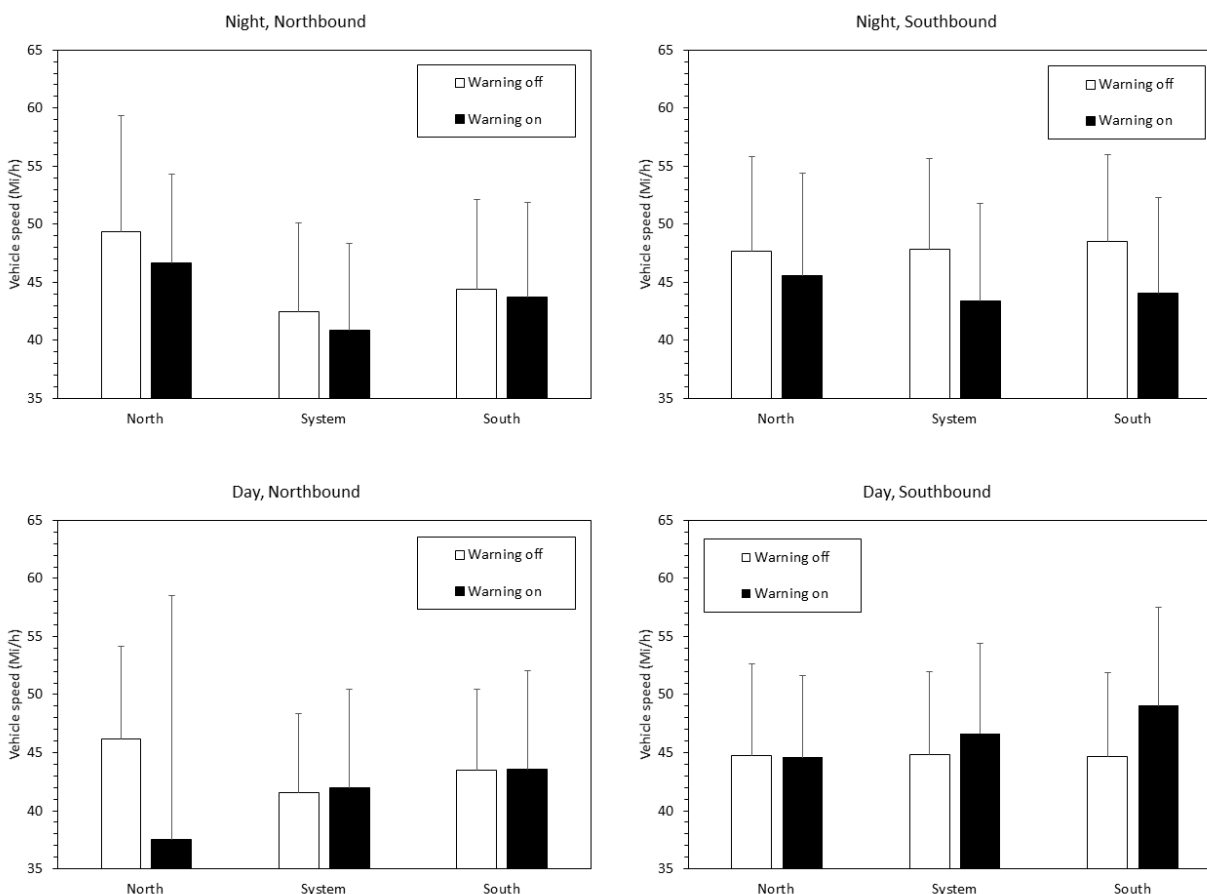
The average vehicle speed in winter was calculated and broken down by treatment (warning signs off vs. warning signs on), light conditions (day vs. night), and for travel direction (northbound vs. southbound) (Figure 24).

Note: The data relate to warning signs off and warning signs on, during day and night, and for northbound and southbound traffic.

Figure 24. Average Vehicle Speed and Associated Standard Deviation in Winter.

In winter, travel direction (northbound vs. southbound) had a significant effect on vehicle speed at the location of the system (main effect) (Tables 16, 17). The effect of treatment (warning signs off vs. warning signs on) on vehicle speed was also significant, but the effect depended on the light conditions (day vs. night) (Tables 16, 17). At night, vehicle speed was 3.01 mi/h lower with the warning signs on than with warning signs off. During the day, vehicle speed was 1.08 higher with warning signs on than with warning signs off (Table 17). The effect of treatment (warning signs off vs. warning signs on) on vehicle speed was also significant in interaction with travel direction (northbound vs. southbound) and light conditions (day vs. night) (Table 16). During the night, vehicle speed was lower (1.59 mi/h for northbound traffic, 4.43 mi/h for southbound traffic) with warning signs on than with warning signs off

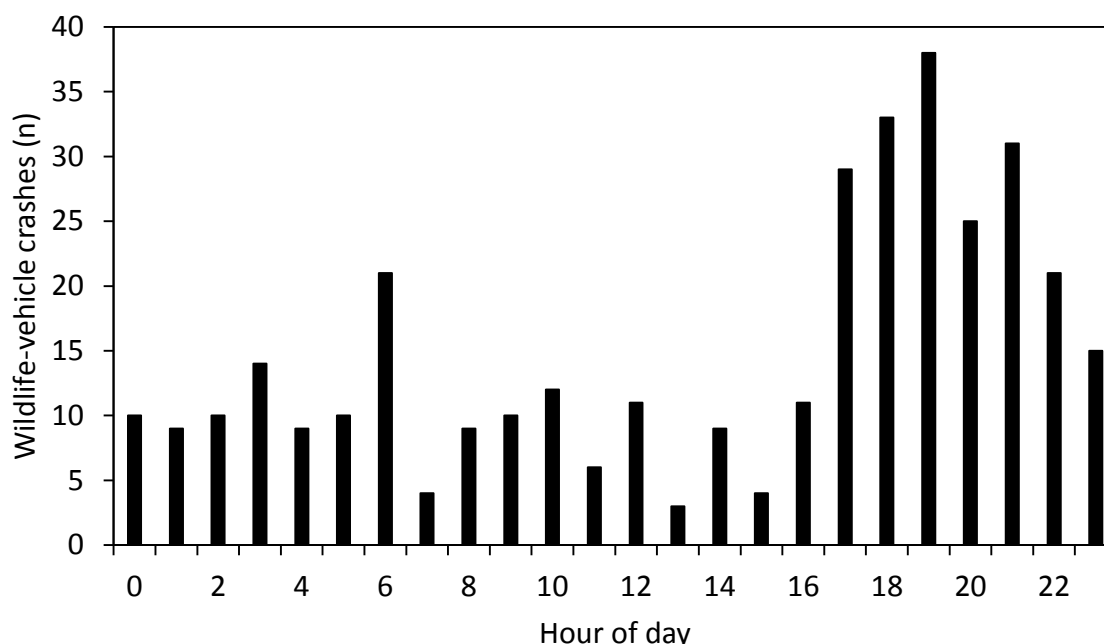
Most wildlife-vehicle crashes occurred in the late afternoon until midnight (Figure 26). A smaller peak in crashes occurred in the early morning. Most crashes (74.01 percent) occurred during the night, only 25.99 percent occurred during the day.

Note: The data relate to U.S. Hwy 95 (between mile reference posts 510 and 538).

Figure 26. The Distribution of Wildlife-Vehicle Crashes over the Hours of the Day.
