Evaluation of Effectiveness and Cost-Benefits of Woolen Roadside Reclamation Products: Field Tests

Task 4 Report

December 2016

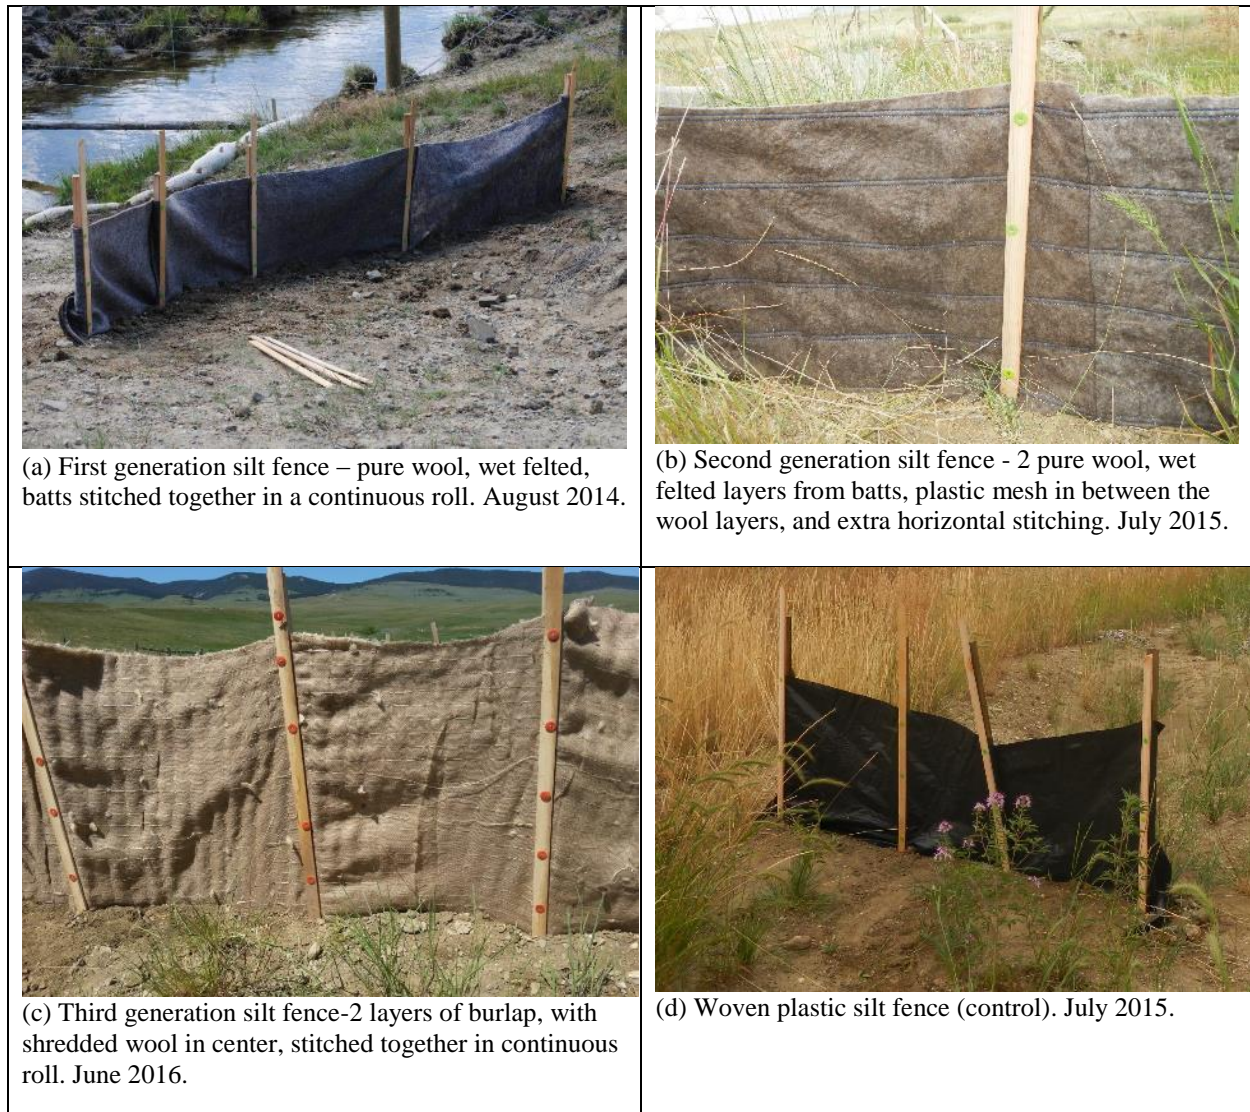
Figure 2. Three generations of wool silt fence and the standard woven plastic silt fence tested in field trials, 2014 – 2016.

There were four field tests of the first generation of silt fence, which consisted of 100% biodegradable 244 g/m² (7 oz/yd²) wet felted wool batts. The silt fence was manufactured by Sugar Loaf Wool Carding Mill. Each rectangular wool batt was approximately 106.7 cm (42 in) by 91.4 cm (36 in), and was subsequently sewed together by Custom Canvas Design of Bozeman, MT into a continuous roll of wool silt fence 106.7 cm (42 in) wide. The silt fence was installed at the field site on August 28, 2014 (Table 1). The four locations were selected because erosion was visually observed indicating it would provide adequate conditions to test the product's ability to capture sediment, withstand surface runoff volumes typical of MDT roadsides, and endure through the winter and spring conditions. All wool silt fence was installed consistent to standard geotextile silt fence fabric and similar to MDT specifications (see drawing 208-30, Supplemental to the MDT Standard Specifications for Road and Bridge Construction, 2016). A six inch, v-shaped ditch was dug to bury and backfill the bottom six inches of the wool fabric. The above-ground portion of wool silt fence was stapled to 1.2 m (4 ft) tall wood stakes placed at approximately 1 m (3 ft) spacing for support (Figure 2a). The first generation silt fence was monitored in October 2014 and January 2015.

The second generation silt fence included stitching to increase strength and longevity of the product. Custom Canvas Design of Bozeman, MT stitched at 10 cm (4 in) intervals into two layers of 140 g/m² (4 oz/yd²) felted wool silt fence (Figure 2b). A plastic mesh net was stitched between the two layers of felted wool to increase strength of the resultant fence. Two second generation silt fences and one plastic geo-textile silt fence (control) were installed in July 2015 at locations 2, 3, and 1, respectively (Table 1). The second generation silt fence was monitored in October 2015 and June 2016.

previous generation felted wool silt fence. This final version of silt fence for this project could also potentially be used in automated silt fence installation machinery currently used for woven plastic silt fence (control) installation. The third generation silt fence wool / burplap product was installed at locations 2 and 3 in June 2016 (Figure 2c) and was monitored in July 2016.

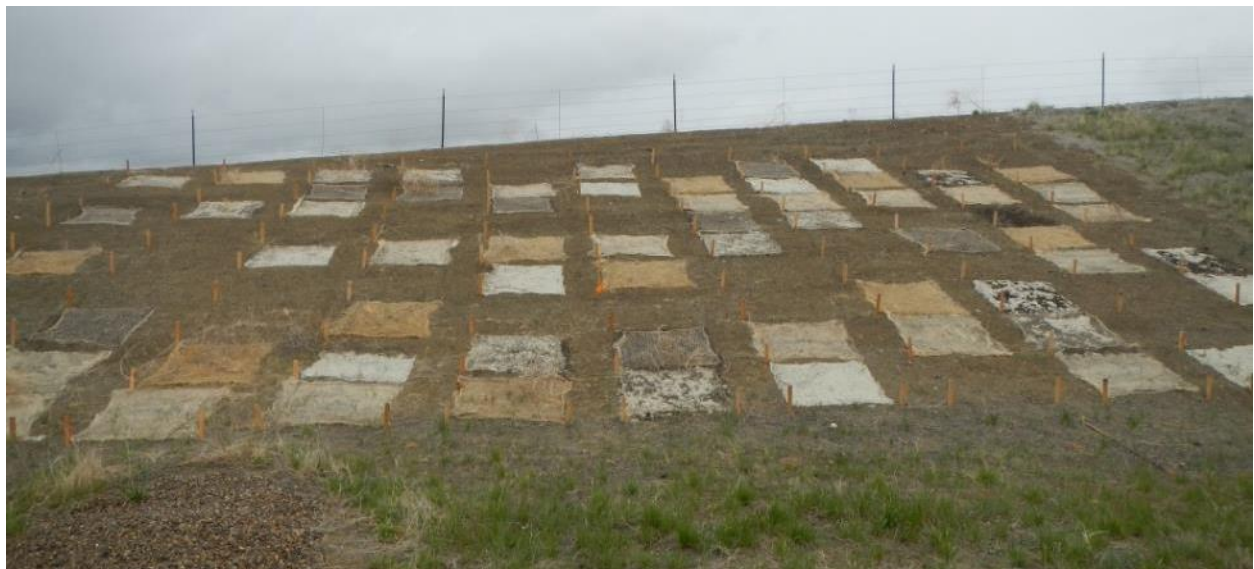
Figure 3. Experimental layout of eleven treatments with eleven replications at the Highway 287 field site, October 2014 (treatments installed in 2015 not pictured).

Treatments, except for treatments 10 and 11 (Table 2), were arranged in a randomized complete block design with eleven replications of each treatment (Table 3; Figure 3). The eleven replications of treatments 10 and 11 were added to the north end of the field site because the material arrived at a later date and was not part of the original experimental design. The treatment installation dates varied due to delays in product manufacturing and shipping. Treatments 1, 2, 5, 6, 7, 8 and 9 were installed October 17, 2014. Treatment 3 was installed on November 5, 2014, and treatments 4, 10 and 11 were installed on May 7, 2015. Treatment plots were 1 m² (10.2 ft²) with 0.5 m (1.6 ft) spacing between plots. Each treatment plot was held in place using a 1 x 1 cm (0.4 in) gauge biodegradable coconut netting and secured with steel sod staples. Seeding took place at the time of treatment installation using a standard MDT seed mix (Table 4). Glacier Gold® compost was used and the compost with wool was weighed and mixed by the research team. The compost and compost with wool was applied at a 1.3 cm (½ in) depth as recommended by a previous MDT research project (Ament et al. 2011).

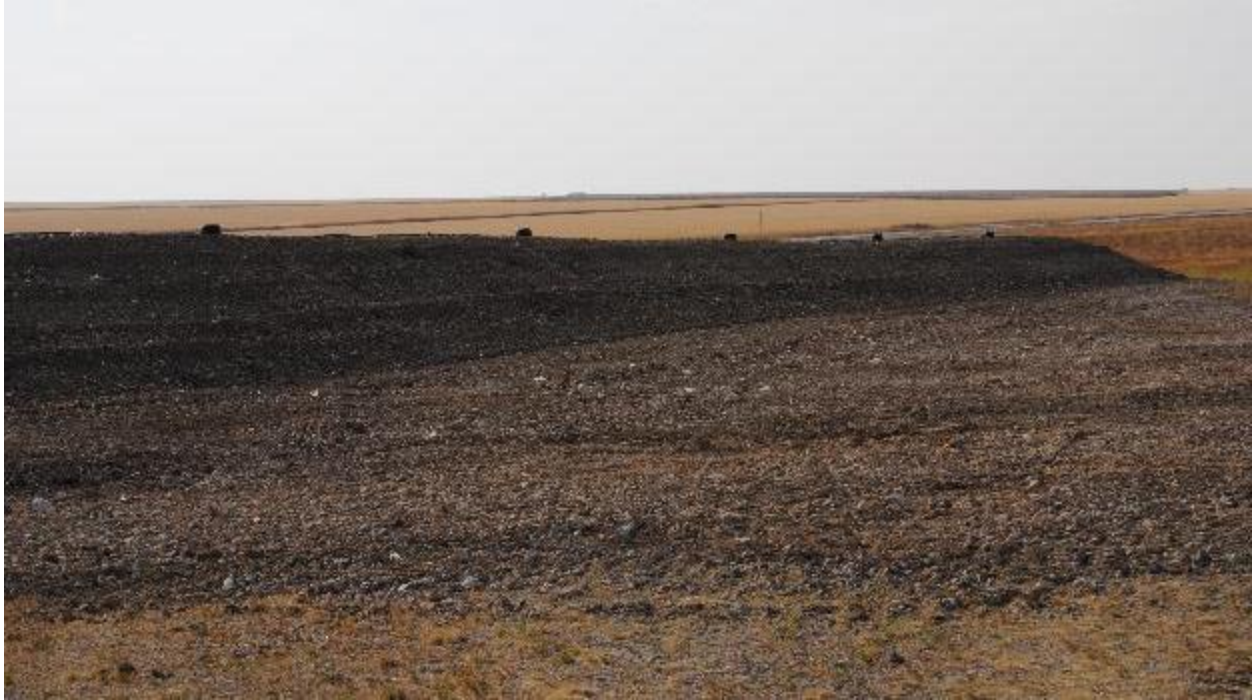
Figure 4. Test slope (2H:1V) constructed at Transcend, a WTI-MSU experimental station in Lewistown, MT.

A constructed test slope at WTI's Transcend test facility located near Lewistown, MT (Lat. 47°01'48.19" N, Long. 109°28'15.75" W) was used as a second field test site for evaluating the wool / straw ECBs and the straw / coconut ECB as the control (Figure 4). The test slope at Transcend is a 2H:1V (2 horizontal:1 vertical) slope and is comprised of local subsoil. The slope dimensions are 100 m (328 ft) long and 5 m (16.4 ft) high. Soils were tested for nutrient content after construction of the test slope in 2013.

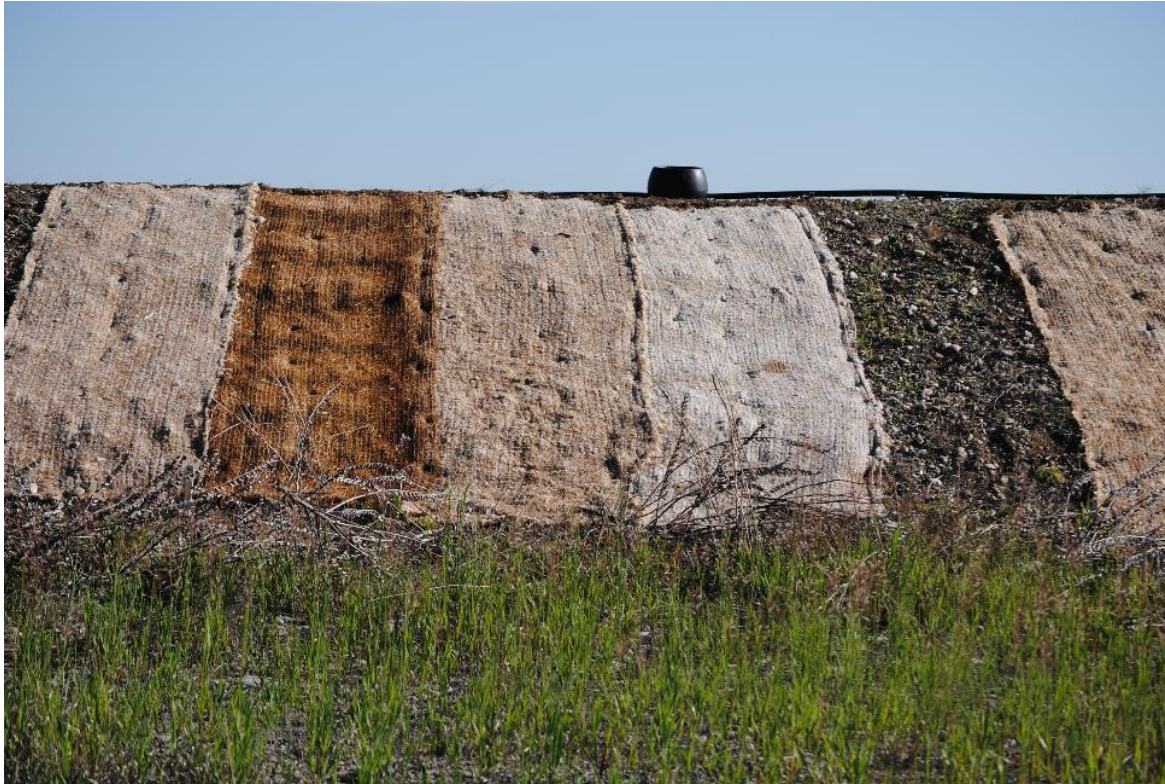
Figure 5. One replication of the six treatments at the Transcend test slope.

Prior to plot establishment, the entire slope was sprayed twice (May and early June 2015) with a 6% glyphosate (Roundup®) solution to remove all existing vegetation. The test site was then hand-weeded and raked prior to seeding and installing the ECBs. On June 23 and 24, 2015, the slope was seeded using the standard MDT seed mix (Table 4) and six ECB treatments were installed on the test slope (Table 5 and Figure 4). Treatments were arranged in a randomized block design with ten replications. Each treatment plot was 1.5 m wide by 5 m long to cover the height of the slope (Figure 5). Treatment plots were placed on the south facing slope (azimuth 180 degrees).

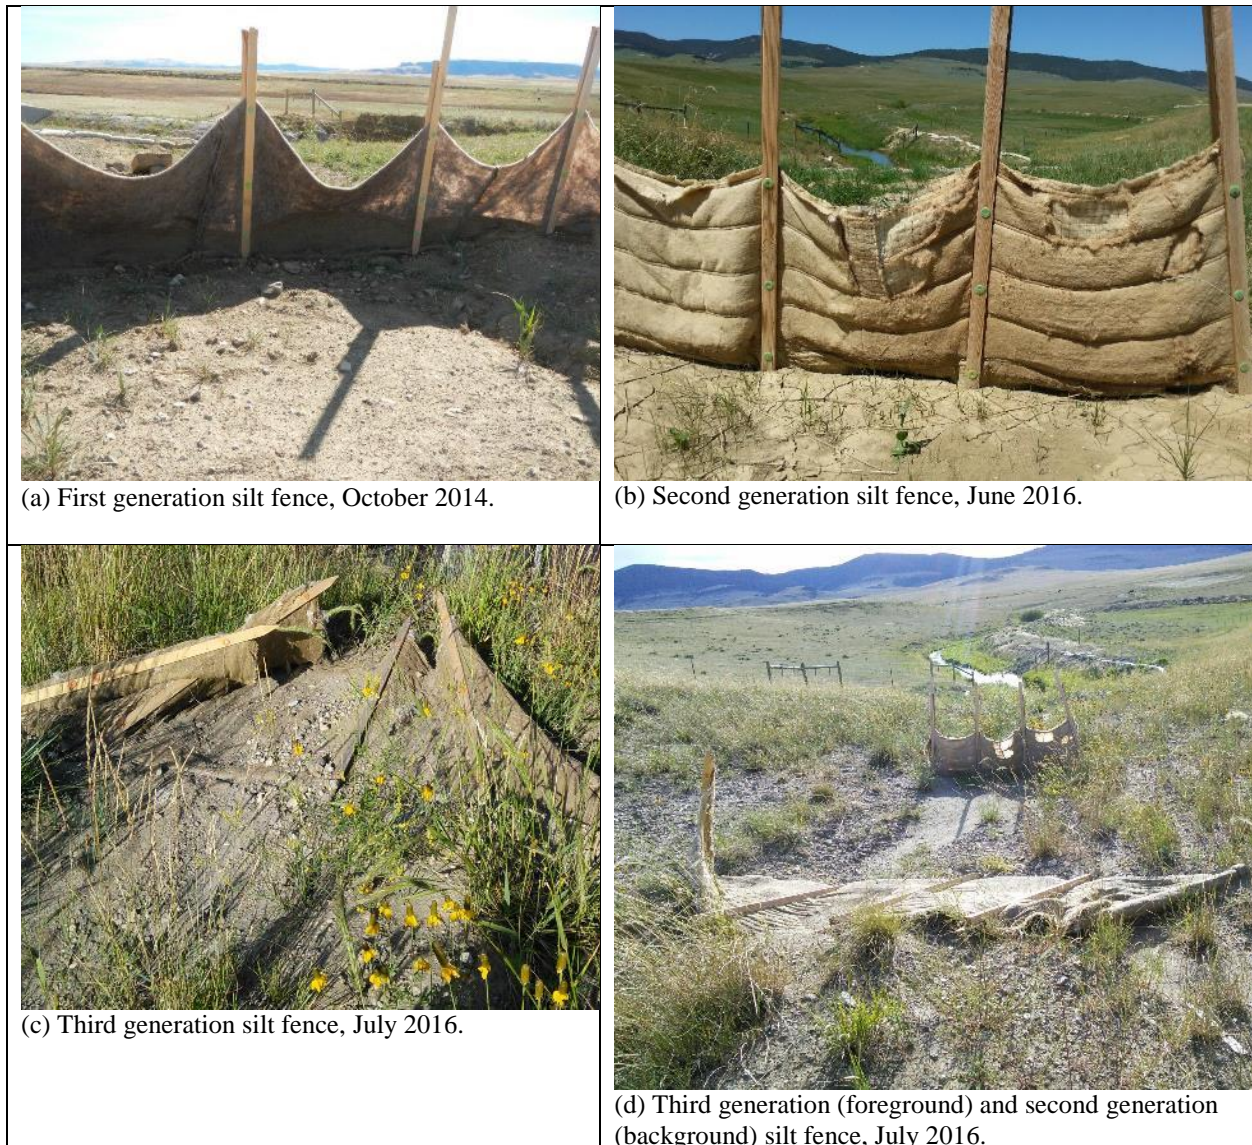
Figure 6. Photo monitoring the three generations of wool silt fence developed and tested in field trials along U.S. Highway 12, 2014 – 2016.

The October 2014 observation of first generation silt fence found that it was able to capture sediment and filter water (Figure 6a). However, all four locations of the first generation wool silt fence were beginning to lose form – sagging, small holes – probably due to wetting events. This was a pure wool fence which was felted, thus had no additional strengthening materials. It appeared that it would not be able to survive intact, and fully functional, for two years. It indicated that future wool silt fence products needed additional inputs – stitching, mesh, etc. – to increase tensile strength and longevity. The first generation silt fence was removed in June 2015.

The second generation silt fence maintained its form one year after installation (Figure 6b). The additional stitching and mesh netting reinforcement strengthened the wool silt fence and extended its functional life. After enduring several summer thunderstorm events in 2015, there was visual evidence it was fully successful in filtering water and containing sediment. However, parts of the second generation silt fence were beginning to biodegrade one year after installation, exposing mesh netting or creating small holes in the fabric, indicating that it could function as a short-term roadside reclamation product. This version of wool silt fence lacked the durability needed for multi-year roadside projects.

The two locations where the third generation silt fence was installed were monitored one month after installment. These burlap and wool silt fences were found lying on the ground with signs of a heavy rain and storm event that covered the fence with sediment and debris (Figure 6c and 6d). While the third generation silt fence did not withstand the storm event, the two remaining second generation silt fences remained in place and were functioning. It appears two layers of burlap and a layer of wool may be too restrictive to water flow during storm events. It appears that this product, although easily produced with existing ECB manufacturing equipment, will need further development that adjusts the amounts of burlap and wool content.
