Improving Safety for Pedestrians and Cyclists at the Entrance to Don Edwards San Francisco Bay National Wildlife Refuge: A Description of the Process and Results of a Road Safety Audit

April 2014

Newark, CA

August 6-7, 2013

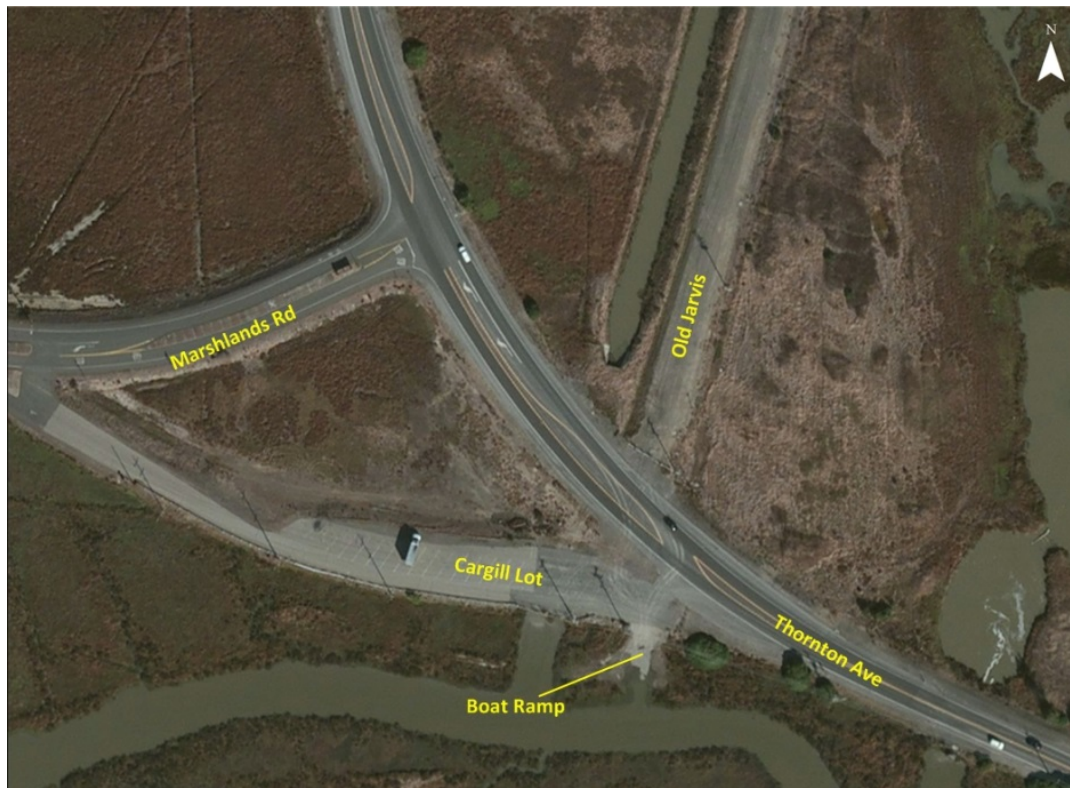
Figure 3: Intersection #2 - Thornton Avenue at Marshlands Road/Cargill Lot

Intersection #2: Thornton Avenue at Marshlands Road/Cargill Lot includes two intersections that provide access to the Refuge (Figure 3). The intersection of Thornton Avenue at Marshlands Road serves as the main entrance to the Refuge, and includes signage designating it as such. The EB approach of Thornton Avenue features a shared through/right lane. The WB approach features a through lane and a left-turn lane. The NB approach of Marshlands Road features a shared left/right lane. Approximately 500 feet east of the Thornton Avenue/Marshlands Road intersection is the entrance to a paved parking area termed the Cargill Lot, thus named because it is owned by Cargill, Inc. The intersection of Thornton Avenue and the Cargill Lot entrance serves as an informal secondary access point for the Refuge.

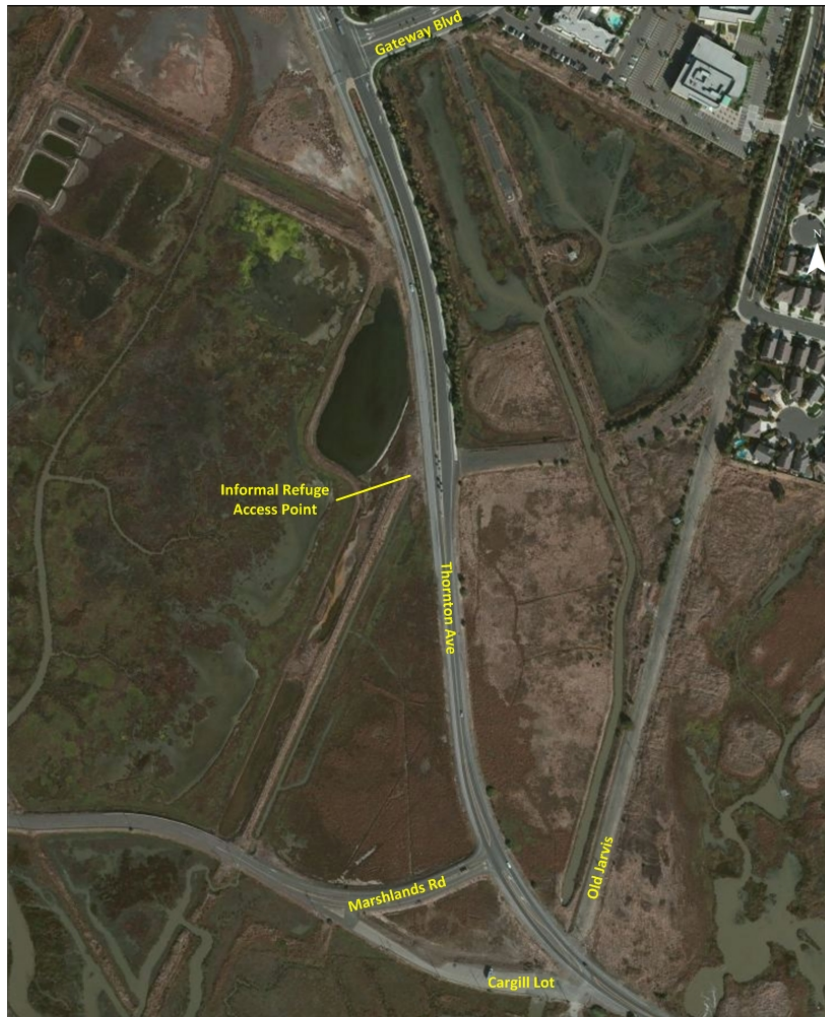
Figure 4: Segment #1 - Thornton Avenue between Gateway Boulevard and Marshlands Road

Segment #1: Thornton Avenue between Gateway Boulevard and Marshlands Road includes the western portion of the study area, and features sharply contrasting roadway characteristics (Figure 4). A sidewalk and a marked bike lane are located on the north side of Thornton Avenue. Thornton Avenue is divided in this section, with 2 WB lanes and 1 EB lane. The ped/bike facilities and median end approximately ¼ mile east of Gateway Boulevard, where Thornton Avenue becomes an undivided two-lane roadway, with undeveloped land on both sides of the roadway.

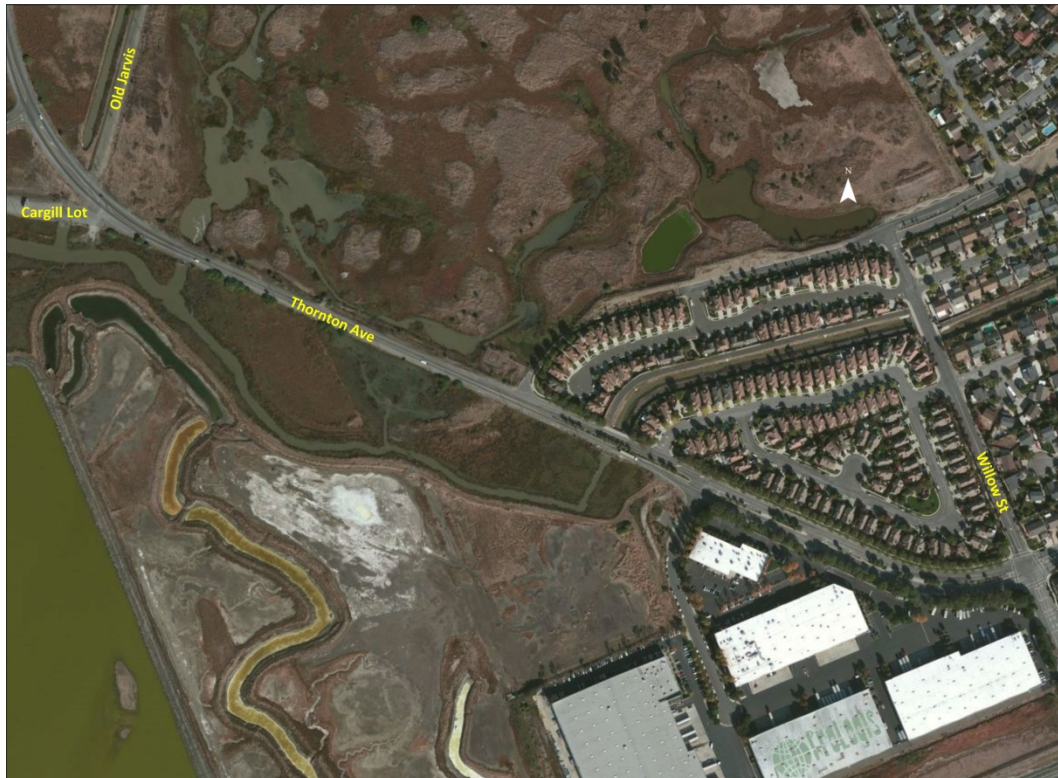
Figure 5: Segment #2 - Thornton Avenue between Marshlands Road and Willow Street

Segment #2: Thornton Avenue between Marshlands Road and Willow Street includes the eastern portion of the study area, and also features varied roadway characteristics, with more urban/suburban development and amenities – including a buffered sidewalk on the north side of the roadway – at the eastern end of the study area (Figure 5). Thornton Avenue is a divided four-lane roadway in this section. The portion of the segment that lies closer to Marshlands Road and that borders the Refuge is a two-lane undivided roadway and has a considerably more open character, with no development and no bike/ped accommodations on either side of the roadway.

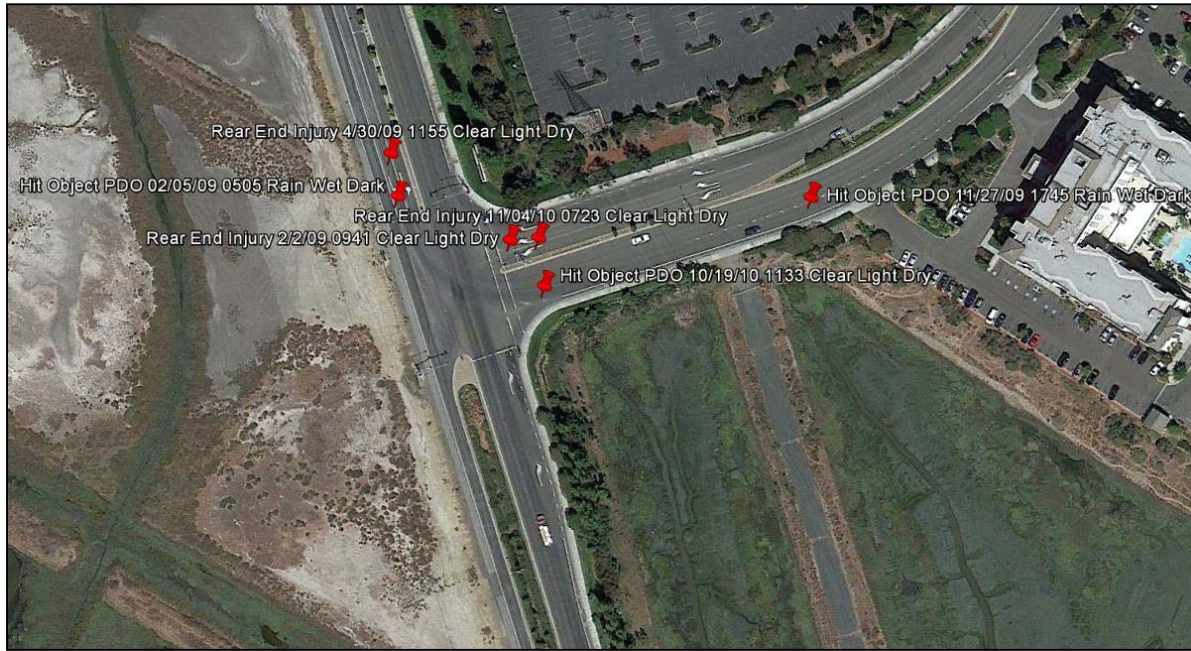
Figure 6: Crash Locations in the Vicinity of Thornton Avenue at Gateway Boulevard (2009-2011)

Figure 6, Figure 7, and Figure 8 show the locations of reported crashes in the study area, along with information about time, date, roadway conditions, and lighting conditions.

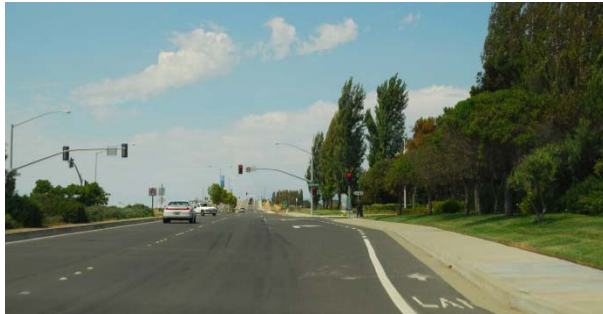
percent to 85 percent as vehicle speed increases from 20 mph to 40 mph.¹ Motor vehicle lane widths and surrounding land use may contribute to motor vehicle speeds in the study area.²

Wide lanes on the WB approach to the Thornton/Gateway intersection.

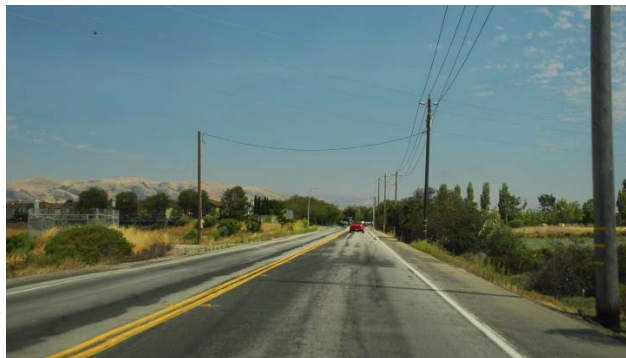
Lack of connectivity of existing ped/bike facilities. As mentioned previously, the study area does include some bicycle and pedestrian facilities, located at either end of the corridor. However, these facilities end abruptly at the edge of the developed portions of the study area, causing pedestrians and bicyclists to navigate difficult conditions in order to travel Thornton Avenue or reach the Refuge entrance. There is also no marked crossing on Thornton Avenue in the vicinity of Marshlands Boulevard. The nearest marked crossing is at Thornton Avenue and Willow Street approximately 1.2 miles away, but a lack of pedestrian facilities on the south side of Thornton Avenue precludes safe access to the Refuge for pedestrians who may use this marked crossing.

A section of Thornton Avenue with no designated ped/bike facilities.

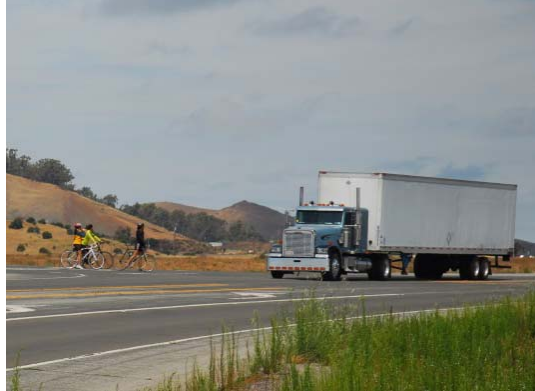
Heavy truck traffic. Thornton Avenue is a designated truck route and provides a connection between SR 84 freeway and industrial areas to the south and east of the study area. Heavy truck traffic can make for a hostile setting for pedestrians and bicyclists, particularly in the sections of Thornton Avenue that lack ped/bike facilities.

Bicyclists exiting the Refuge wait for a gap in traffic as a tractor trailer passes on Thornton Avenue.

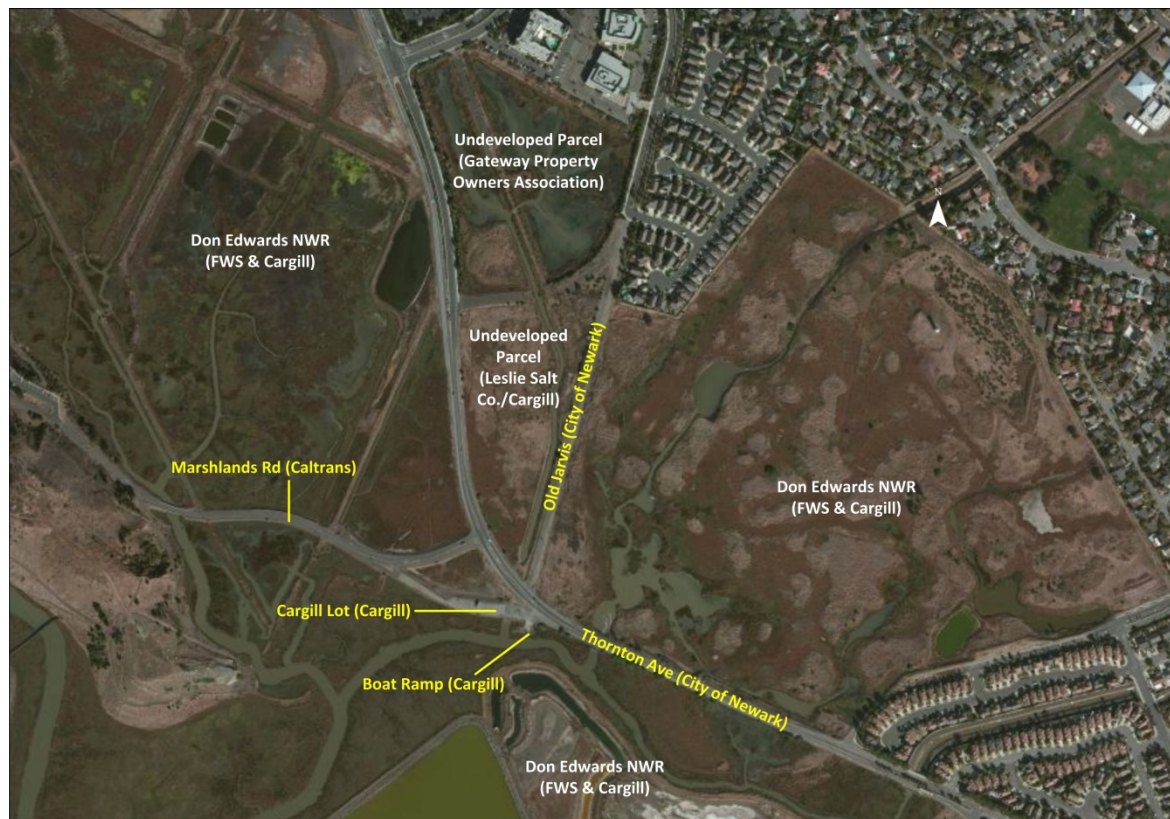
Figure 10: Land and Transportation Facility Ownership in the Study Area

The relative complexity of the ownership status of the various facilities and landholdings will make **outreach to stakeholders** particularly critical to efforts to improve Thornton Avenue, Marshlands Road, and the Cargill Lot. FWS, the City of Newark, Caltrans, and Cargill will need to work closely to align planning efforts and implement improvements in a consistent and coordinated fashion.

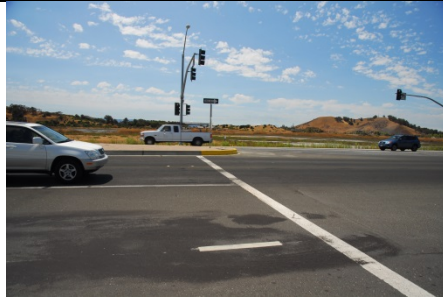
NO.	ISSUE/CONCERN	EXAMPLE OF ISSUE	POTENTIAL IMPROVEMENTS TO BE CONSIDERED
1a	<p>No marked crossing across Thornton Avenue</p> <p>– While there is a marked crosswalk and pedestrian signal across Gateway Boulevard on the east leg of the intersection, there are no pedestrian accommodations for crossing Thornton Avenue. The only formal crossing in the study area is located at Thornton Avenue and Willow Street, which is 1.2 miles from the Thornton/Gateway intersection.</p>

<p><i>The south leg of the intersection of Thornton Avenue and Gateway Boulevard. Both the north leg and south leg of the intersection lack a marked crossing and pedestrian signals.</i></p>	<p>Intermediate – Consider installing a marked crosswalk and pedestrian signals across Thornton Avenue on the south leg of the intersection. Crosswalk and ped signal installation should be considered in conjunction with potential receiving facilities on west side of Thornton Avenue, including a two-way pedestrian facility (a sidewalk or path separated from the roadway) on the south/west side of Thornton Avenue. See item 1b. See also the section on potential corridor-wide improvements.</p>

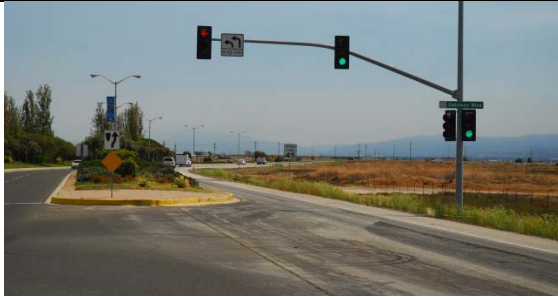
1b	<p>No receiving facilities on west side of Thornton Avenue – There currently are no separated pedestrian facilities on the west side of Thornton Avenue in the vicinity of the Thornton Ave./Gateway Blvd. intersection. Ideally, two-way facilities for pedestrians should be provided if a formal crossing is installed.</p>

<p><i>This view, looking southbound/eastbound on Thornton Avenue, shows the absence of bike/ped facilities on the south/west side of Thornton Ave.</i></p>	<p>Intermediate – Consider installing accessible landing area and connecting pedestrian facilities on west/south side of Thornton Avenue. Installation of landing area and ped/bike facilities should be considered in conjunction with a potential marked crosswalk and pedestrian signals on south leg of the intersection as well as a two-way pedestrian facility on the south/west side of Thornton Avenue. See item 1a. See also the section on potential corridor-wide improvements.</p>

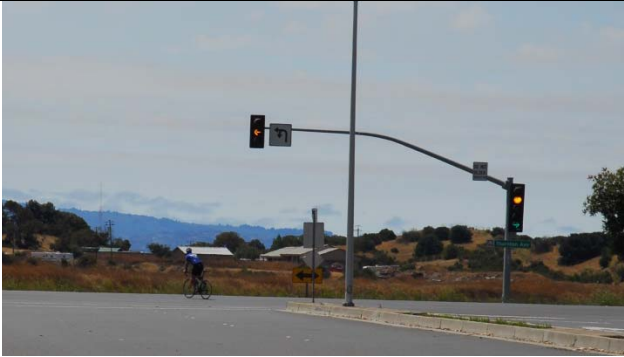
NO.	ISSUE/CONCERN	EXAMPLE OF ISSUE	POTENTIAL IMPROVEMENTS TO BE CONSIDERED
2	<p>Green time for WB left-turning bicyclists – Bicyclists turning left from WB Gateway Blvd. onto SB/EB Thornton Ave. may not have sufficient green time to move through the intersection and complete their turn. As a result, bicyclists may face conflicts with SB/EB vehicles, which may receive a green signal while the bicyclist is still completing his or her turn.</p>

<p><i>A cyclist is only partway through his left turn onto SB/EB Thornton Avenue as the signal turns yellow.</i></p>	<p>Short-term – Work with the City of Newark to review whether current signal timing allows for WB left-turns for bicyclists at the intersection.</p>

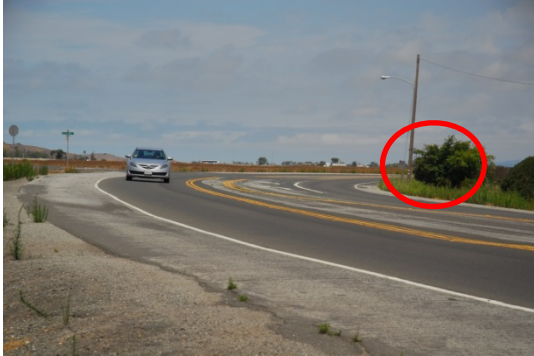
NO.	ISSUE/CONCERN	EXAMPLE OF ISSUE	POTENTIAL IMPROVEMENTS TO BE CONSIDERED
1	Limited sight distance – Sight distance is limited for vehicles, bicyclists and pedestrians exiting the Refuge due to the curvature of Thornton Avenue and due to vegetation.

<p><i>Roadway curvature and vegetation limit sight distance for vehicles, cyclists and pedestrians exiting the Refuge at either Marshlands Road or the Cargill Lot.</i></p>	Short-term – Consider removing vegetation along inside of curve in vicinity of Thornton Ave./Marshlands Rd. intersection to increase sight distance.
2	Intended use of Cargill Lot – The undefined nature of the Cargill lot results in uses that lead to conflicts between motorists, cyclists and pedestrians, both in the lot and at the access to Thornton Avenue. The lot currently is used for Refuge access/egress by bicyclists and occasionally by motorists; for boat ramp access; and for parking (including overnight parking).

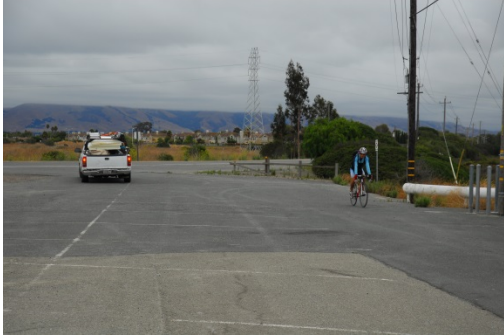
<p><i>A cyclist enters the Refuge via the Cargill Lot as a pickup truck exits the lot onto Thornton Avenue. The faded striped parking spaces are visible in the photo.</i></p>	Short-term – Restrict left turns out of the Cargill lot. Remove gap in centerline pavement markings on Thornton Avenue. Existing gap in centerline permits vehicles to turn left out of Cargill Lot onto WB Thornton Avenue. See item 4. Short-term – Install a stop sign at the Cargill lot exit. Intermediate – Consider restricting access to the Cargill Lot from Thornton Avenue. Consider eliminating motor vehicle access to the lot from Thornton Avenue, but allowing for bicycle egress from the lot onto EB Thornton Avenue. See item 4. Intermediate – More clearly designate parking

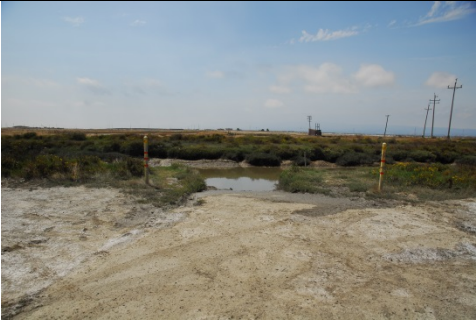
<p><i>The boat launch at the southeast corner of the Cargill Lot.</i></p>	<p>lot use in conjunction with potential closure of lot access from Thornton Avenue.</p> <p>Intermediate to Long-term – Coordinate with Cargill to transfer Cargill Lot land to FWS.</p>
3	<p>Crossings to and from Old Jarvis – Pedestrians and bicyclists use the decommissioned road opposite the Cargill Lot – termed “Old Jarvis” for the purposes of this report – to access the Refuge. In doing so, pedestrians and bicyclists must cross Thornton Avenue using the unmarked crossing at Marshlands Road, which is located on a curve with high vehicle speeds and limited sight distance.</p>

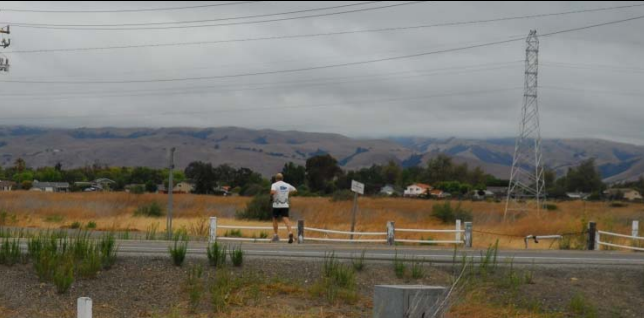
<p><i>A jogger crosses Thornton Avenue to enter Old Jarvis after exiting the Refuge.</i></p>	<p>Short-term – Conduct a study to determine the appropriate traffic control – e.g. pedestrian hybrid beacon (HAWK) or full signal – for the intersection of Thornton Avenue and Marshlands Road based on existing volumes (AADT was 11,759 vpd in 2012). Based on ADT and ped/bike volumes, a marked crossing without significant traffic control may create a condition that places crossing peds/bikes at higher risk. See Appendix A for a table of recommendations for installing marked crosswalks at uncontrolled locations.</p>

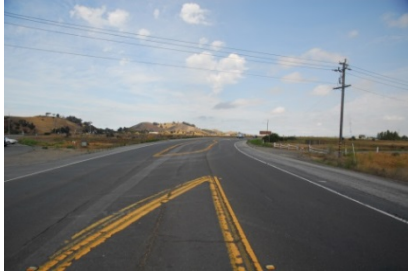
NO.	ISSUE/CONCERN	EXAMPLE OF ISSUE	POTENTIAL IMPROVEMENTS TO BE CONSIDERED
	<p>Road, although motorists were observed using the Cargill Lot for right turns onto EB Thornton Avenue. The Refuge's multiple access and egress points lead to confusion and conflicts among motorists, bicyclists and pedestrians, particularly since motorists on Thornton Avenue may not be expecting two access points located within such close proximity to one another.</p>	<p><i>turning and right-turning vehicles.</i></p>

<p><i>Pavement markings on Thornton Avenue include a marked left turn out of the Cargill Lot (on the left).</i></p>	<p>Intermediate – Consider restricting access to the Cargill Lot from Thornton Avenue. Consider eliminating motor vehicle access to the lot from Thornton Avenue, but allowing for bicycle egress from the lot onto EB Thornton Avenue. See item 2.</p> <p>Intermediate – Consider repurposing lanes to create narrower motor vehicle lanes and a buffered 6' bike lane on both sides of the roadway for one-way bike travel for sections of Thornton Avenue that do not currently have designated bike facilities.</p> <p>Intermediate – Consider installing two-way pedestrian facilities on south side of Thornton Avenue, per recommendations in Corridor-Wide Issues section.</p>

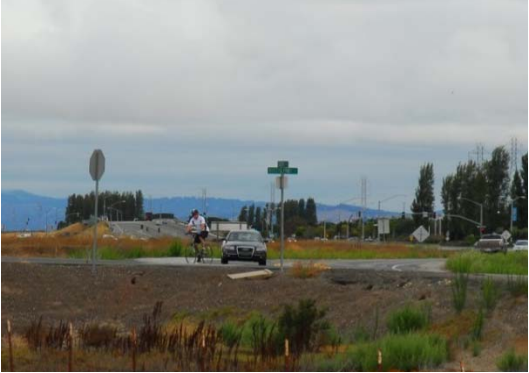
5	<p>Bikes riding the wrong way on Thornton Avenue to enter Refuge – Currently, WB bicyclists often cross Thornton Avenue in advance of the Refuge entrance and then ride the wrong way along Thornton Avenue in order to enter the Refuge via the Cargill Lot.</p>

<p><i>A bicyclist enters the Refuge after having ridden against traffic on Thornton Avenue.</i></p>	<p>Intermediate – Include safety messages on maps showing designated bicycle facilities.</p>

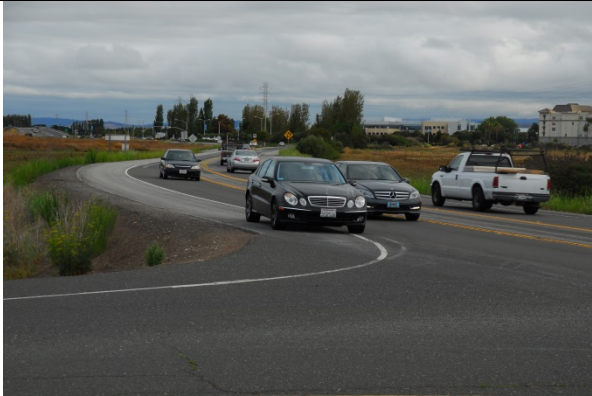
NO.	ISSUE/CONCERN	EXAMPLE OF ISSUE	POTENTIAL IMPROVEMENTS TO BE CONSIDERED
6	<p>Conflicts at right-turn from EB Thornton – Currently, EB right-turning motorists use a portion of the shoulder of Thornton Avenue as an informal turning lane as they decelerate to enter the Refuge at Marshlands Boulevard. This puts them in conflict with bicyclists riding on the shoulder, as well as with through vehicles on Thornton Avenue, as the limited shoulder width does not allow for right-turning vehicles to move fully out of the travel lane.</p>

<p><i>A vehicle turning right to enter the Refuge uses the shoulder to decelerate, while another vehicle passes on its left.</i></p>	<p>Short-term – Consider installing bicycle warning signs with Share the Road plaques in the vicinity of the Refuge entrance.</p> <p>Intermediate – Consider repurposing lanes to create narrower motor vehicle lanes and a buffered 6' bike lane on both sides of the roadway for one-way bike travel for sections of Thornton Avenue that do not currently have designated bike facilities.</p> <p>Intermediate to Long-term – In coordination with repaving of Thornton Avenue, consider shifting and narrowing motor vehicle lanes to accommodate a buffered 6' bike lane on both sides of the roadway and to create a right turn lane on EB Thornton at Marshlands Road.</p>

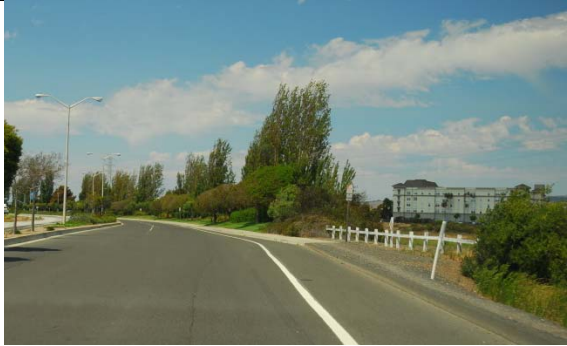
NO.	ISSUE/CONCERN	EXAMPLE OF ISSUE	POTENTIAL IMPROVEMENTS TO BE CONSIDERED
1	<p>Lack of continuity of bicycle/pedestrian facilities – There is a sidewalk and a bike lane on the north/east side of Thornton Avenue in the vicinity of the intersection at Gateway Boulevard. However, these facilities end abruptly approximately ¼ mile east/south of the intersection. This lack of continuity of bike/ped facilities means that bicyclists must ride and pedestrians must walk in the shoulder for much of the section between the Thornton/Gateway intersection and the Refuge entrance. There are no bike/ped facilities on the south/west side of Thornton Avenue.</p>

<p><i>This view of Thornton Avenue east/south of the intersection at Gateway Blvd. shows the transition from no bike/ped facilities to a sidewalk and marked bike lane.</i></p>	<p>Short-term – Install bike warning signs with Share the Road plaques in the section of Thornton Avenue with no designated bike/ped facilities.</p> <p>Intermediate – Consider repurposing lanes to create narrower motor vehicle lanes and a buffered 6' bike lane on both sides of the roadway for one-way bike travel for sections of Thornton Avenue that do not currently have designated bike facilities.</p> <p>Intermediate – Consider installing two-way pedestrian facilities on south side of Thornton Avenue, per recommendations in Corridor-Wide Issues section.</p>

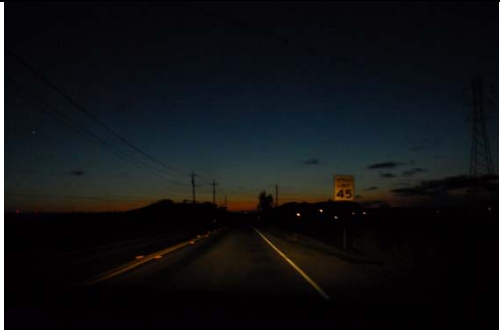
3	<p>Signage – Signs along Thornton Avenue lack retroreflectivity, making them difficult to see at night. There is also a “Divided Highway Ends” sign on EB Thornton Avenue that is upside down.</p>

<p><i>A speed limit sign along Thornton Avenue lacking retroreflectivity.</i></p>	<p>Short-term – Replace current signs with retroflective signs.</p> <p>Short-term – Reinstall “Divided Highway Ends” sign so that it is oriented properly.</p>

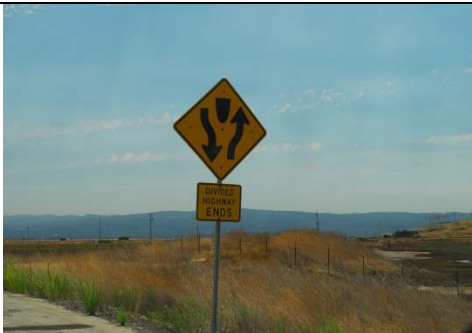
<p data-bbox="793 597 1402 667"><i>A “Divided Highway Ends” sign on EB Thornton Avenue is oriented upside down.</i></p>	
4	<p data-bbox="142 699 737 797">Limited lighting – There is limited lighting along Thornton Avenue in this section of the study area, leading to poor visibility in dark conditions.</p>

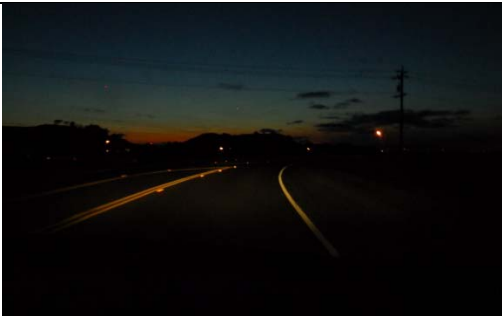
<p data-bbox="783 1015 1415 1084"><i>Limited lighting along Thornton Avenue results in low nighttime visibility.</i></p>	<p data-bbox="1457 699 1976 971">Short-term - Undertake an education campaign to increase motorist awareness of pedestrians and bicyclists in the study area, including recommendation on wearing retroreflective clothing or using a light. For more detail, see possible short-term improvements in the Corridor-Wide Issues section.</p>

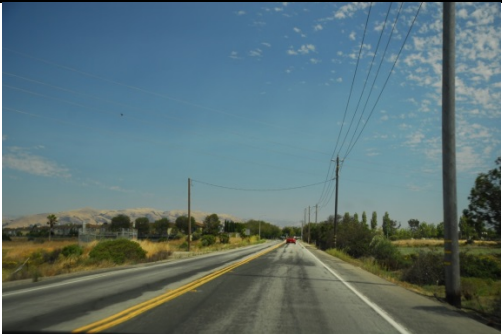
NO.	ISSUE/CONCERN	EXAMPLE OF ISSUE	POTENTIAL IMPROVEMENTS TO BE CONSIDERED
1	<p>Narrow shoulder, drop off – The shoulder on the south side of Thornton Avenue is 4 feet wide at its narrowest point, and is not wide enough to safely accommodate pedestrians or bicyclists. This lack of accommodation is exacerbated by a 4- to 5-inch drop off on the south side of the roadway.</p>

<p><i>The narrow shoulder on the south side of Thornton Avenue (right side in the photo) increases travel risk for pedestrians and bicyclists.</i></p>

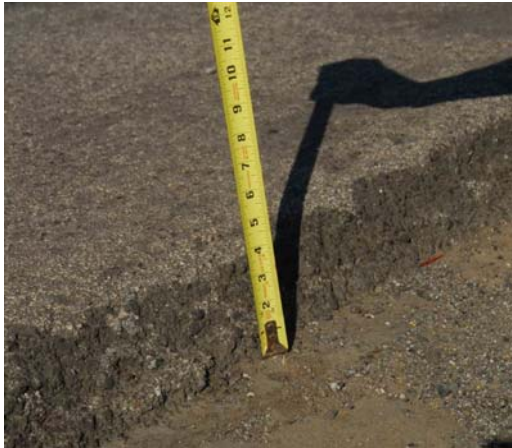
<p><i>The drop off on the south side of Thornton Avenue measures between 4 and 5 inches.</i></p>	<p>Intermediate – Consider restriping lanes to provide wider shoulder.</p> <p>Intermediate – Install a safety edge to create a tapered roadway edge and eliminate the drop off.</p> <p>Intermediate – Consider widening shoulder as part of scheduled repaving of Thornton Avenue.</p>

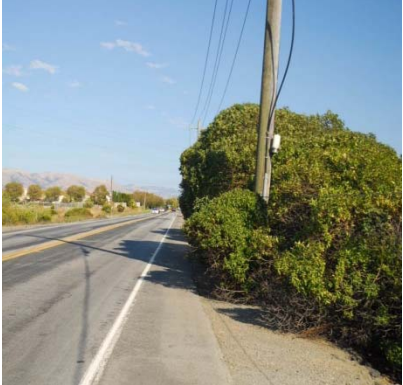
NO.	ISSUE/CONCERN	EXAMPLE OF ISSUE	POTENTIAL IMPROVEMENTS TO BE CONSIDERED
2	Overhanging vegetation – Vegetation overhanging the roadway further narrows the effective width of the shoulder and makes it impassable for pedestrians and bicyclists, who must walk or ride in the travel lane to get past the overgrowth.

<p><i>Vegetation overhanging the shoulder on EB Thornton Avenue.</i></p>	Short-term – Trim vegetation on south side of Thornton Avenue to two feet from the edge of the shoulder.
3	Lack of continuity of bicycle/pedestrian facilities – There is a sidewalk on the north side of Thornton Avenue in the vicinity of the intersection at Willow Street. However, the sidewalk ends approximately 4/10 mile west of the intersection. This lack of continuity of pedestrian facilities means that pedestrians must walk along an informal path (a.k.a. “goat trail”) for much of the section between the Thornton/Willow intersection and the Refuge entrance. There are no bicycle facilities in this section of the study area, and there are no pedestrian facilities on the south side of Thornton Ave.

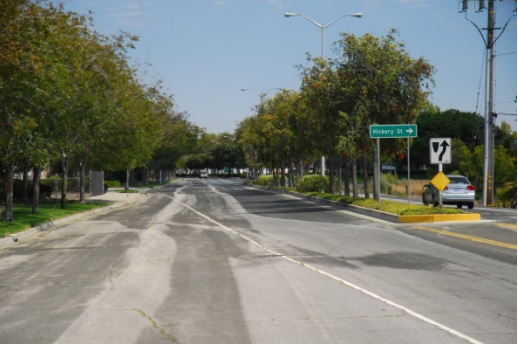
<p><i>The end of pedestrian facilities at the east end of the study area is accompanied by a dropped lane on WB Thornton Avenue.</i></p>	<p>Short-term – The travel lanes are wide – in excess of 16 feet – in both directions on Thornton Avenue near Willow Street, with wide shoulders in addition to the wide lanes. Consider striping bike lanes on both sides of the roadway at the eastern end of the study area.</p> <p>Short-term – Install bike warning signs with Share the Road plaques in the section of Thornton Avenue with no designated bike/ped facilities.</p> <p>Intermediate – Consider repurposing lanes to create narrower motor vehicle lanes and a buffered 6’ bike lane on both sides of the roadway for one-way bike travel for sections of Thornton Avenue outside of the suburban roadway cross-section.</p> <p>Intermediate – Consider installing two-way</p>

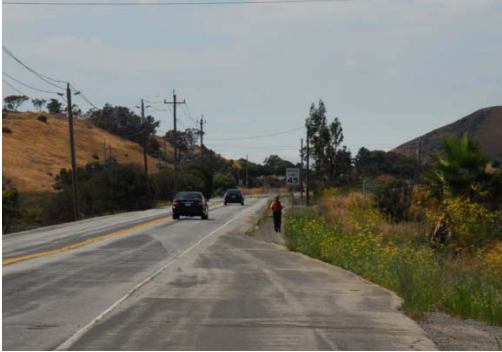
<p><i>A pedestrian walks with her back to traffic along the goat trail on the north side of Thornton Avenue.</i></p>	<p>Short-term - Undertake an education campaign to increase motorist awareness of pedestrians and bicyclists in the study area, including information on increased risk to pedestrians from walking with their back to traffic. For more detail, see possible short-term improvements in the Corridor-Wide Issues section.</p> <p>Intermediate – Consider installing two-way pedestrian facilities on south side of Thornton Avenue, per recommendations in Corridor-Wide Issues section.</p>
