# Road Safety Audit for the Lincoln Memorial Circle

September 2014

*This document was prepared for the Federal Transit Administration and National Park Service  
by the Paul S. Sarbanes Transit in Parks Technical Assistance Center*

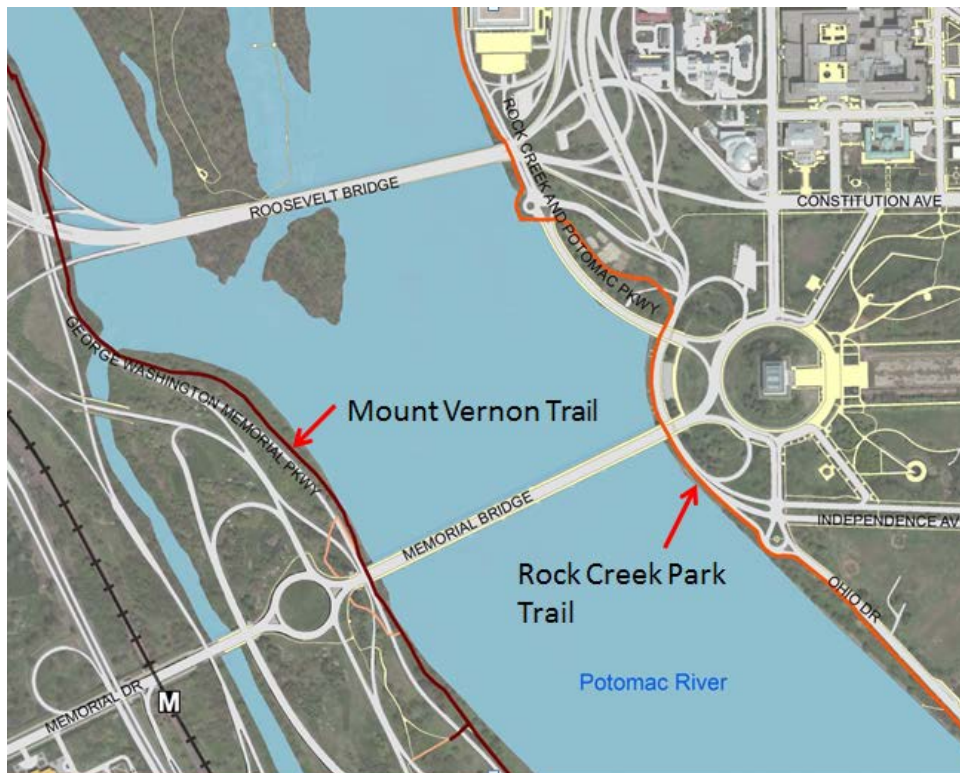
*Figure 2: Rock Creek Park Trail & Mount Vernon Trail (Image courtesy of Dan Nabors)*

The Lincoln Memorial is located at the western end of the National Mall in Washington D.C. and is one of the most visited tourist sites in the city with approximately 6.2 million annual visitors (2). The Lincoln Memorial Circle (LMC), which surrounds the Lincoln Memorial, is a crossing point for vehicles using Rock Creek Parkway, George Washington Memorial Parkway (GWMP), I-66, the Arlington Memorial Bridge, and several other arterials. Non-motorized users may pass through the LMC when connecting from the Mount Vernon Trail to the Rock Creek Park Trail via the Arlington Memorial Bridge (Figure 2).

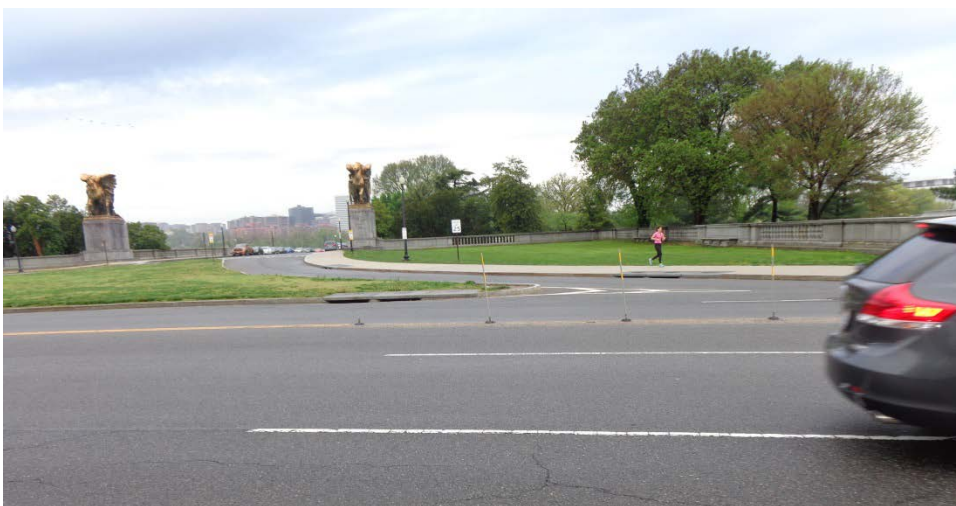
**Figure 4: Delineators**

*Delineator installation date:* At the east end of the Arlington Memorial Bridge, just prior to where the roadway diverges to follow the circle in either direction, there are delineators in between the opposing directions of travel (Figure 4). Jim Burton indicated that the delineators were installed at the end of 2012.

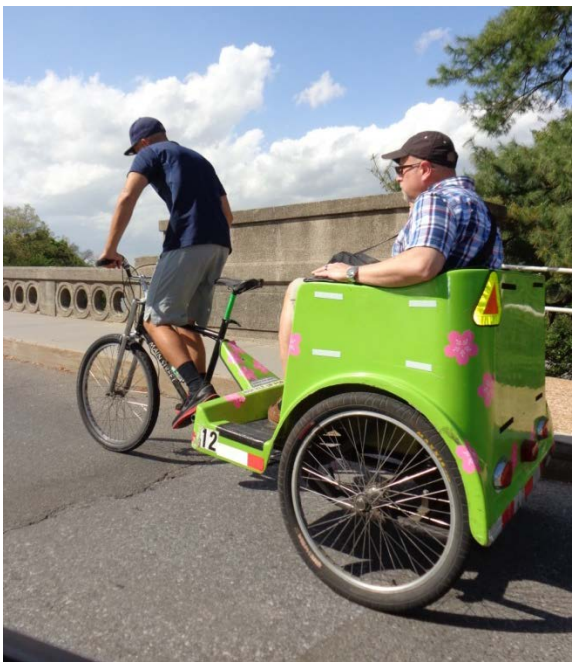
**Figure 11: Pedicab**

- There is a concern regarding the rapid expansion of the offering of "pedicabs" (Figure 11), which occupy a lane of traffic. As shown in the Figure 11, pedicabs are bicycles with trailers that carry pedestrians. Washington D.C. issues permits for pedicab operations, and NAMA issues Commercial Use Authorizations (CUA) as well.

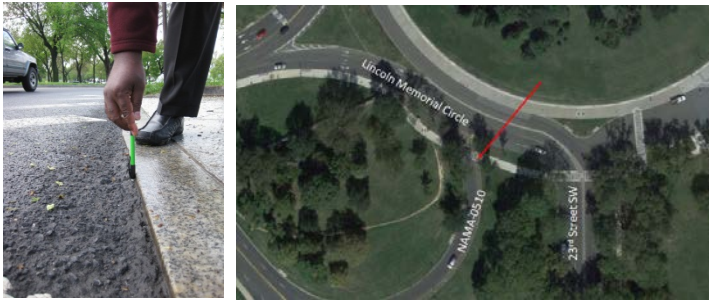
*Figure 12: Gap between roadway and curb ramp from trail (Photo credit: Norah Ocel) (1)*

The RSA Team observed a gap between the roadway and trail (Figure 12) as the trail crossed NAMA-0510 (off-ramp from Arlington Memorial Bridge to Ohio Drive) that can be problematic to bicycle tires.

**Curb Ramps:** Many curb ramps in the study area are significantly narrower than the crosswalks (Figure 14) and often have a gap between them and the pavement (Figure 12), which can be problematic for bicyclists, people with mobility restrictions, or those pushing strollers.

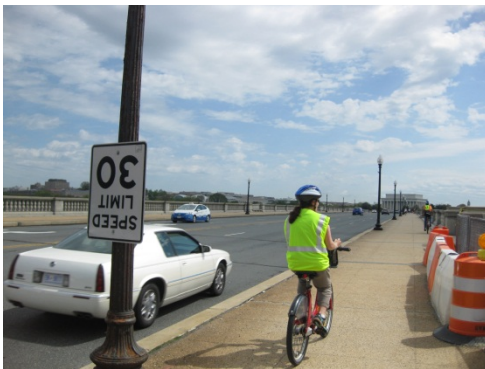
*Figure 15: Sign in need of repair (Photo credit: Norah Ocel)*

**Signs:** Throughout the study area, there are locations where 1) signs could be considered, 2) the current signage was not compliant with the Manual on Uniform Traffic Control Devices (MUTCD), 3) there are conflicts between the existing signs, and 4) signs needed to be repaired/replaced (Figure 15). Therefore, one general recommendation is to perform a comprehensive signage study for pedestrians, bicycles and vehicles. In 2011, Hunt Design Associates completed the National Mall Wayfinding Plan, which will likely serve as a good basis when developing a comprehensive signage study. The following sections will identify specific signage issues based on the location.

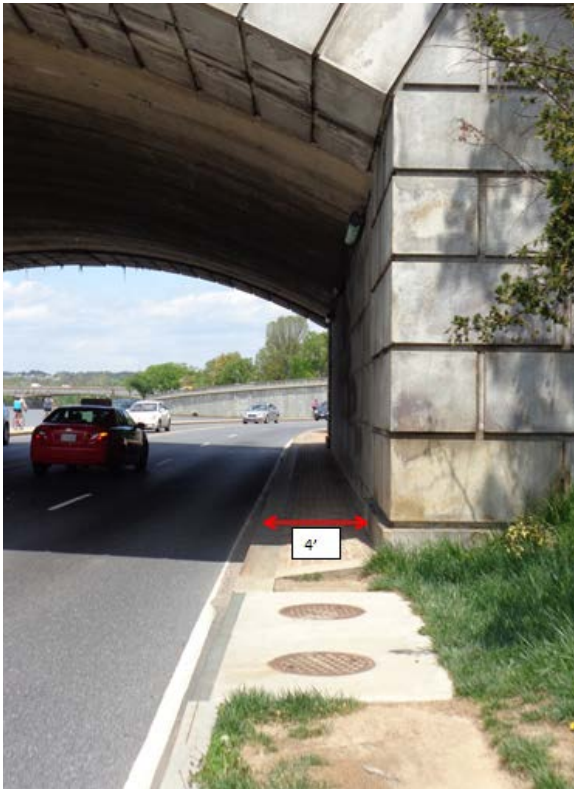
*Figure 19: Narrow walkway under Arlington Memorial Bridge*

If additional space could be reallocated from the roadway to this path, a bicycle route could be installed here. However, discussions during the RSA indicated that this pathway was created from minimal space during a more recent construction project on Ohio Drive. Therefore, another potential option that could be considered is a floating boardwalk on the west side. This concept is shown by the dashed line in Figure 17. Figure 20 shows a photo of a boardwalk on water at the Rocky Mountain Arsenal National Wildlife Refuge near Denver, Colorado; this image is only provided for conceptual purposes. A potential drawback with providing the connection on the west side of Ohio Drive (i.e. a boardwalk) is that locations where a bicyclist could cross Ohio Drive on the north and south side of the Arlington Memorial Bridge would have to be identified.

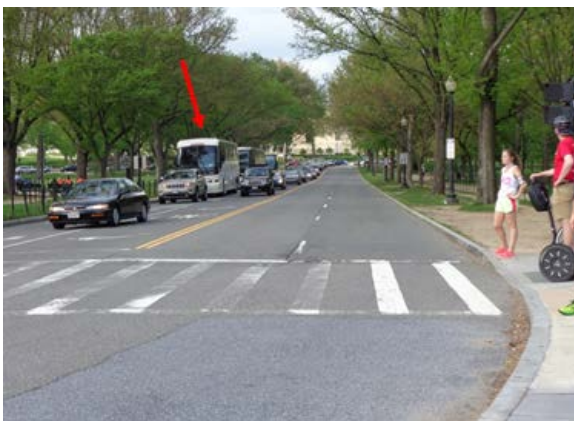
*Figure 21: Henry Bacon Drive, PM Peak*

**Parked Buses:** The photo in Figure 21 was taken within the peak period, which shows buses parked in a traffic lane. Enforcement can help remedy the problem.

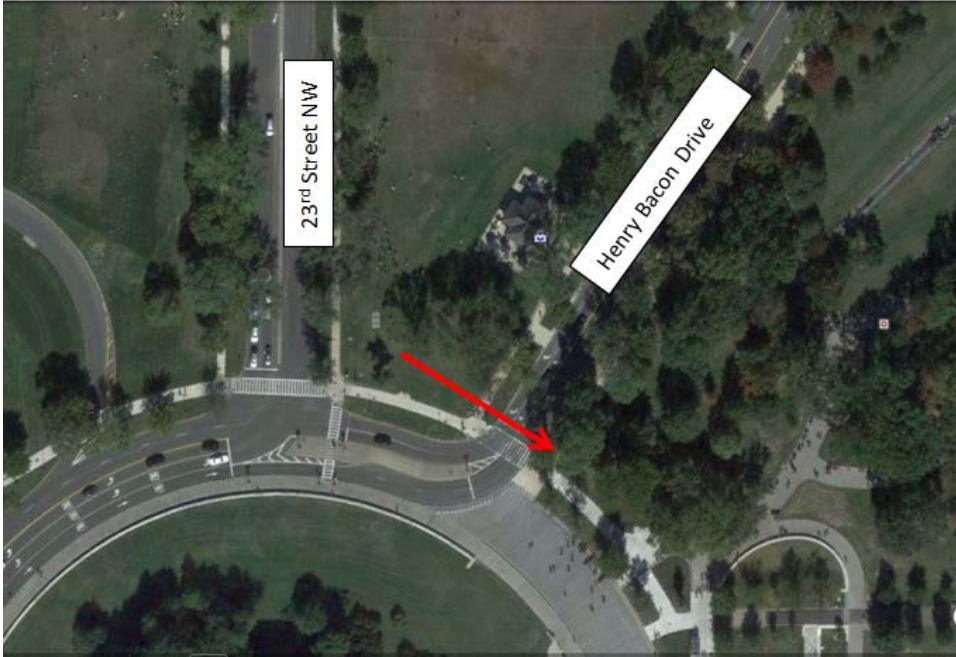
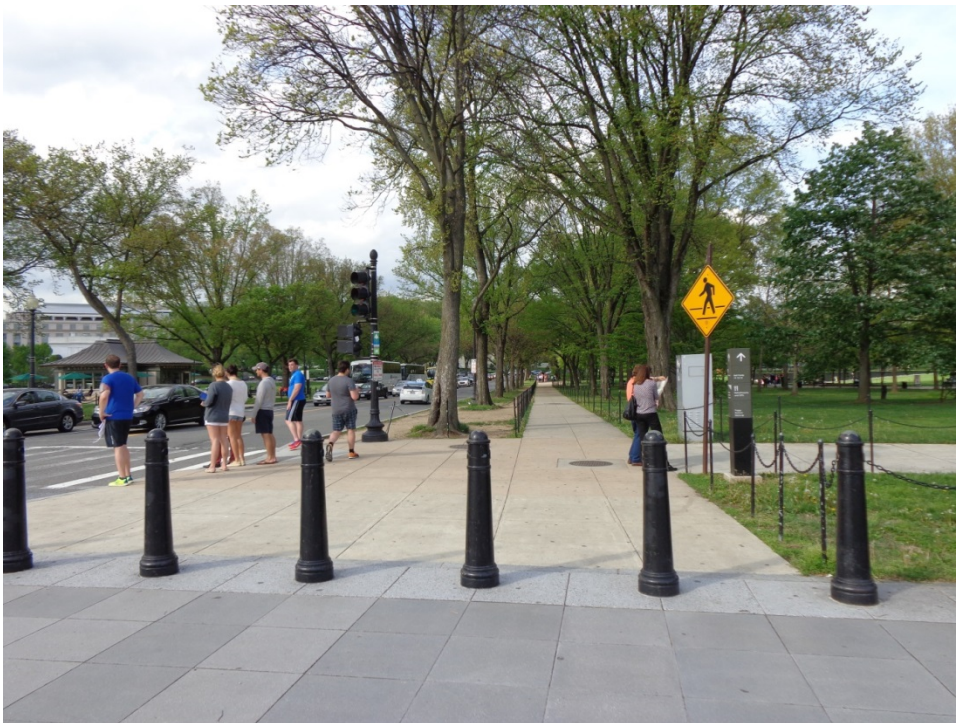
*Figure 22: Henry Bacon Drive, Location of Pedestrian Sign (1)*

**Pedestrian Sign:** The arrow in Figure 22 shows the approximate location of the pedestrian sign shown in Figure 23. This sign should be removed as the purpose of this sign is unclear.

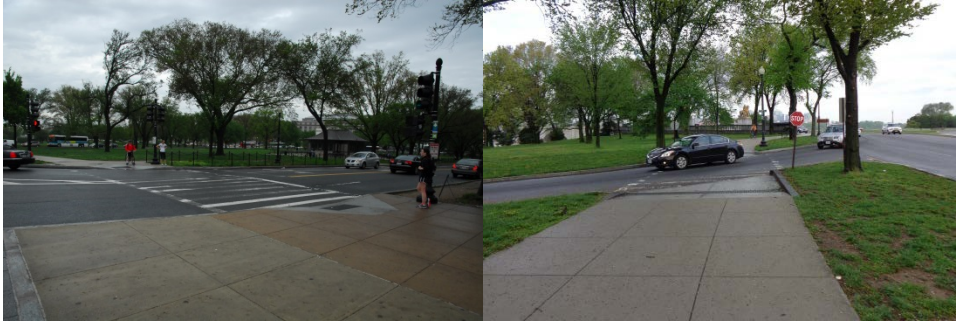
*Figure 24: Henry Bacon Drive, Curb Ramps, Left: Existing, Right: Recommended (Left Photo credit: Dan Nabors)*

**Curb Ramps:** The existing curb ramps at Henry Bacon Drive shown in Figure 24 (left) do not correspond well with the provided crosswalk space. As an alternative, they could be widened like the one shown in Figure 24 (right) so that the curb ramp width coincides with the crosswalk width.

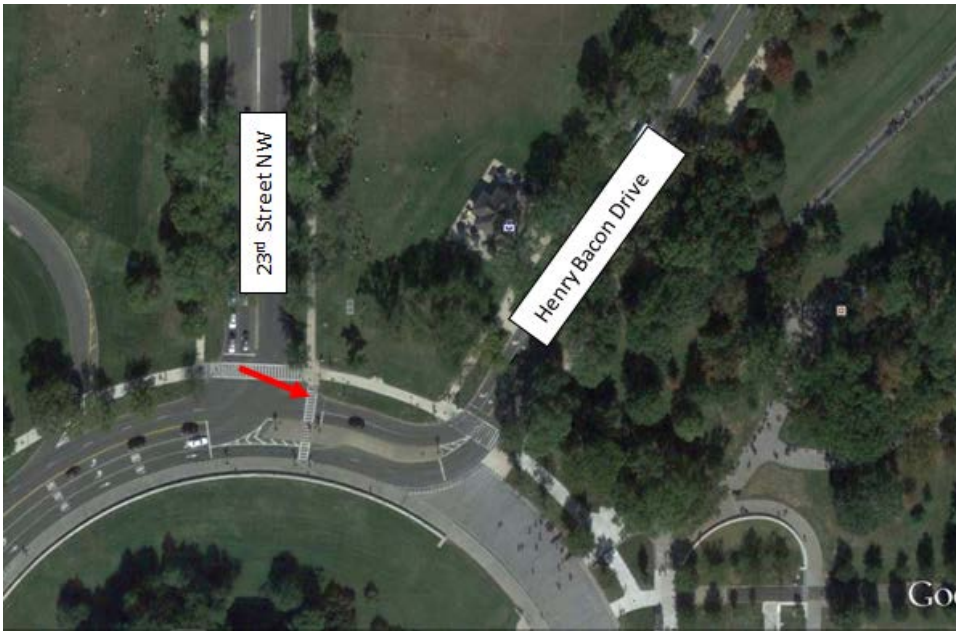
*Figure 25: 23<sup>rd</sup> Street NW, Crosswalk (1)*

**Signals:** The signal for the crosswalk shown in Figure 25 has a short duration during which pedestrians are allowed to cross. However, there appears to be additional time that can be utilized without conflict to vehicular movements. Therefore, the signals at this location should be investigated to determine if additional time can be provided for pedestrians to cross within the current timing configuration.

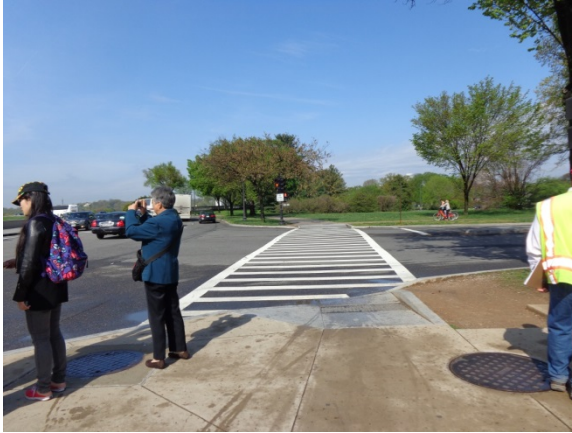
*Figure 26: 23<sup>rd</sup> Street NW, Existing Curb Ramp*

**Curb ramp:** The curb ramps at 23<sup>rd</sup> Street NW are narrow and do not match up well with the painted crosswalks (Figure 26). Pedestrian and bicyclist demand in the area utilizes all of the defined space. Therefore, considerations should be made for providing a curb ramp that spans the same width as the identified crosswalk.

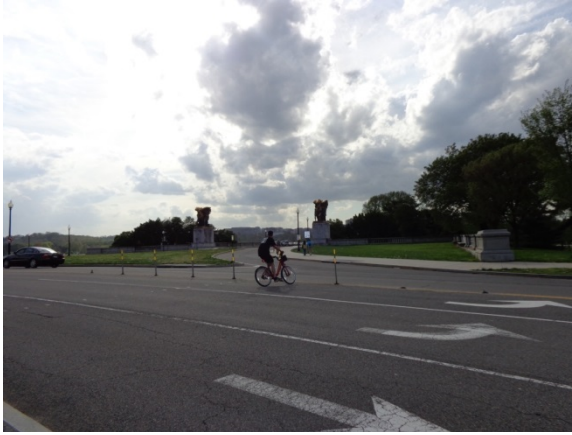
*Figure 28: Existing Northern Delineator Installation*

The RSA Team recommends extending the northernmost installation to 23<sup>rd</sup> Street NW (Figure 28), as shown by the dashed red line. Furthermore, the delineators should be installed no more than 2 to 3 feet apart. In addition, as experience has shown with the existing installation of delineators, a plan is needed to identify who will replace the damaged delineators and how often it will occur.

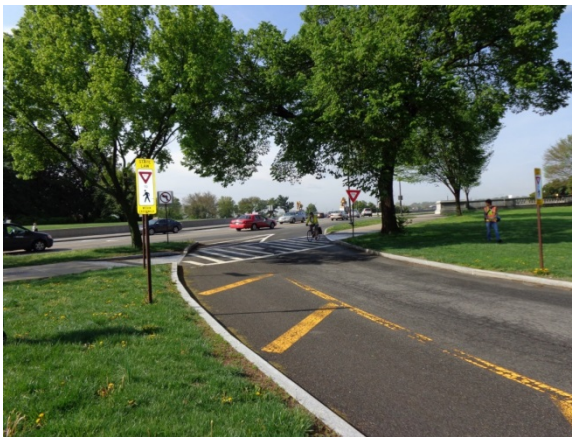
*Figure 29: NAMA-0509 approach to the LMC*

**Yield Signs:** There are two recommendations related to the yield signs for access to the LMC from NAMA-0509. First, the trees may be partially obstructing the yield signs (Figure 29).

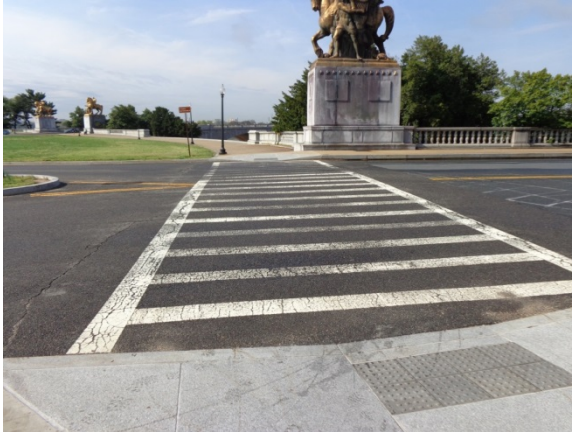
*Figure 31: Parkway Drive crosswalk markings*

**Pavement Markings:** The existing crosswalk markings on Parkway Drive just prior to the entrance to the LMC are faded, as shown in Figure 31. They should be restriped according to DDOT standards. Additionally, the park should consider installing pavement markings indicating "PED XING" on the westbound approach prior to the crosswalk.

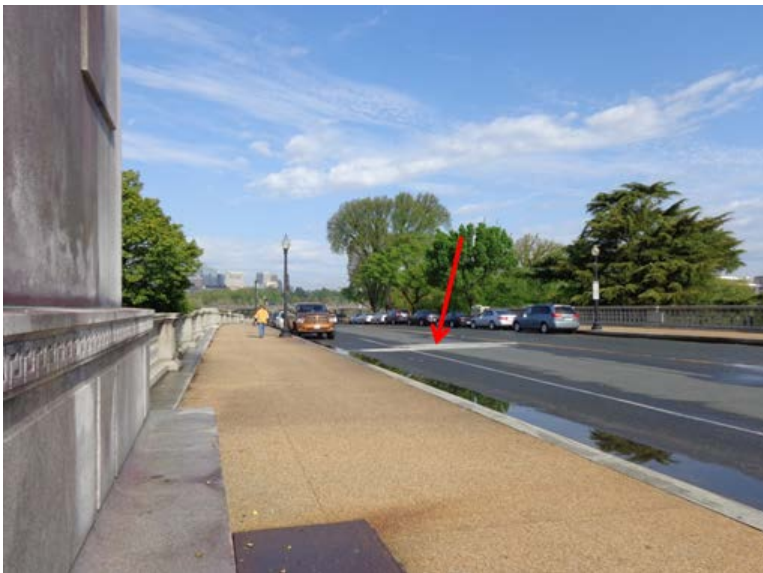
*Figure 32: Parkway Drive rumblestrips*

Rumblestrips: Prior to the crosswalk on Parkway Drive before the LMC there are remnants of rumblestrips. These rumblestrips need to be replaced and installed to current standards, taking into consideration the speed of motorists, the need for snow removal, and ensuring that they are designed to accommodate bicyclists. A project that is being implemented in the near future should be considered for replacing the rumblestrips.

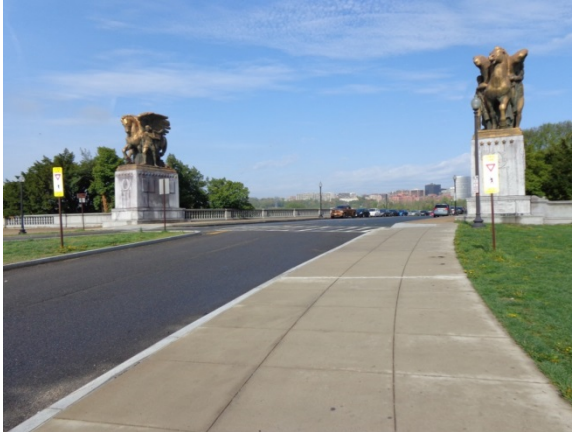
*Figure 33: Parkway Drive looking west*

Refuge Island: The existing lanes for Parkway Drive connecting to the LMC are wide and have gentle radii, which enables vehicles to travel at higher speeds. The installation of a median island, which can be achieved by narrowing the lanes (Figure 33), can help calm the traffic and create a refuge area for crossing pedestrians and bicycles.

**Pedestrian Signs/U-turn Signs:** The existing pedestrian crosswalk signs for westbound traffic (Figure 33) are not the standard signs for pedestrian crosswalks. They should be replaced with DDOT's R1-6a sign (not including fine information) (Figure 30). In addition, there are no advance pedestrian warning signs for the eastbound approach. Two signs should be installed on the eastbound approach, one on the north side and one on the south side. Furthermore, NPS should consider installing DDOT's R1-6a and W16-7P signs (Figure 30) for both approaches at the crosswalk.

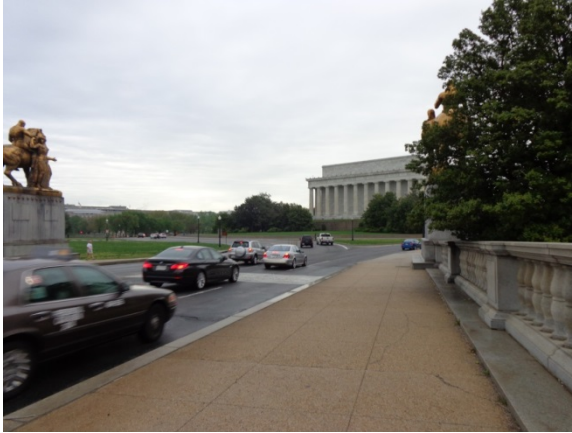
*Figure 34: Rumblestrips on the Arlington Memorial Bridge*

**Rumblestrips:** The existing, raised transverse rumblestrips are ineffective (Figure 34), as they have been worn down. They should be replaced. However, considerations should be taken with regard to why the rumblestrips are currently ineffective. There is the potential that they have been worn down as a result of snowplow operations. Therefore, designs that can provide the function of warning the driver while at the same time remain effective over time should be implemented. One potential approach would be to have a plan with regard to maintaining any installed rumblestrips. Because the rumblestrips are located on a bridge, it is not recommended that the rumblestrips be grooved into the pavement.

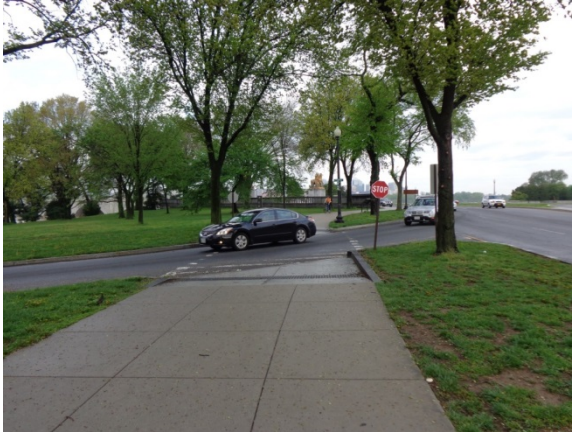
*Figure 35: NAMA-0510 Pedestrian/Bicycle Pathway Stop Signs*

**Stop Signs:** The current design has both stop signs for the bicycle/pedestrian pathway and regulatory signs for motorists that indicate they are required to stop for bicycles/pedestrians. These two regulatory sign configurations contradict each other. Observing traffic, the majority of vehicles stop for crossing pedestrians/bicyclists. Therefore, to avoid the contradictory signs, it is recommended that the stop signs along the bicycle/pedestrian pathway be removed (Figure 35).

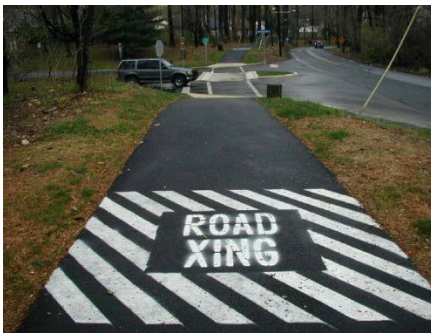
*Figure 36: Loudoun County “ROAD XING” Markings (13)*

In addition, the park may want to consider some kind of warning for trail users about vehicles crossings. One example that the park may want to consider is including a pavement marking that says, “ROAD XING” on each approach to the crossing (Figure 36). Additional design details can be found in Section 8.1 and Section 8.2 of the Loudoun County Pedestrian and Bicycle Design Toolkit (13).

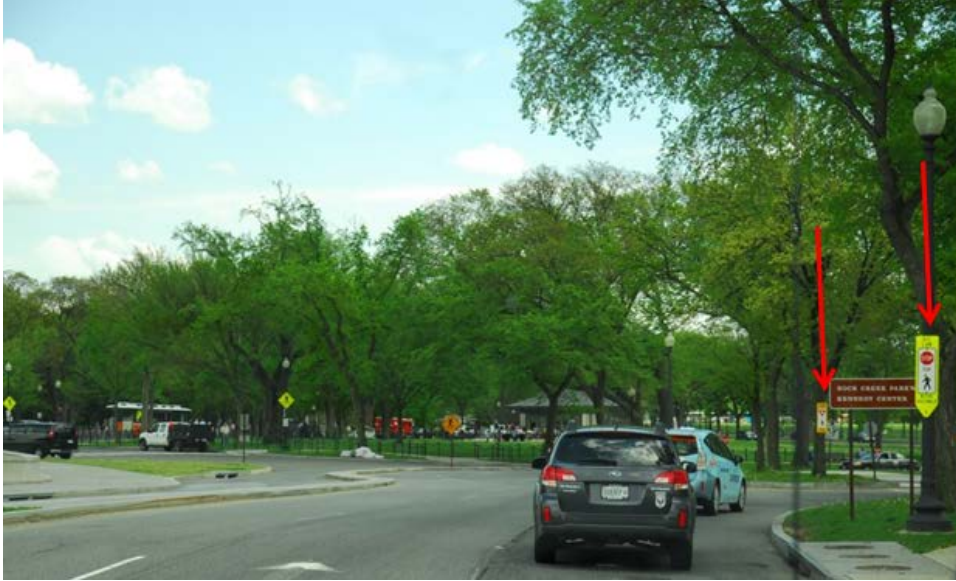
**Figure 37: Pedestrian Crosswalk**

Pedestrian signs: There are several on-road pedestrian crossing signs. However, they contradict each other (Figure 37).

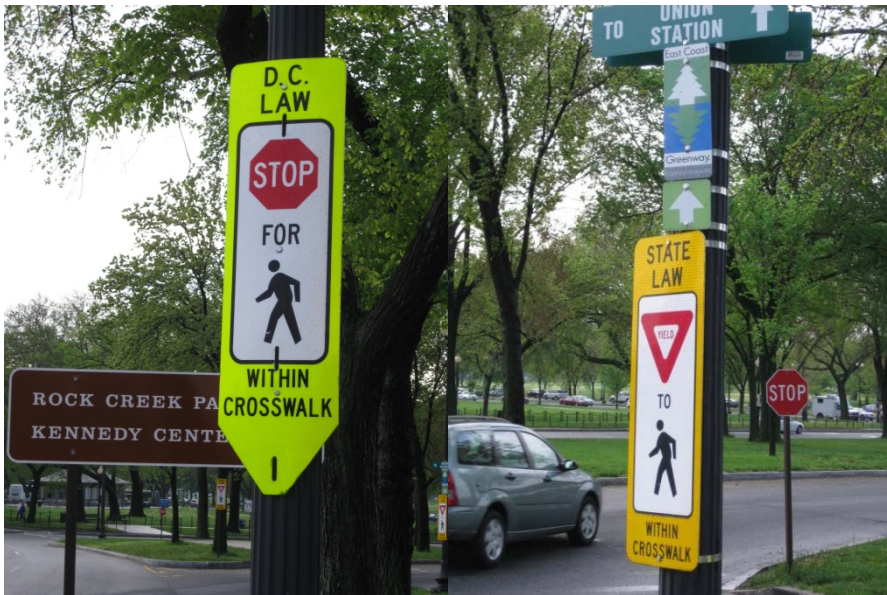
**Figure 38: Contradictory Signs (Photo credit: Norah Ocel)**

One sign indicates that the motorists should yield to pedestrian/bicyclists; however, another sign indicates that motorists should stop for pedestrians/bicyclists. Figure 38 shows a close-up of the warning signs for motorists.

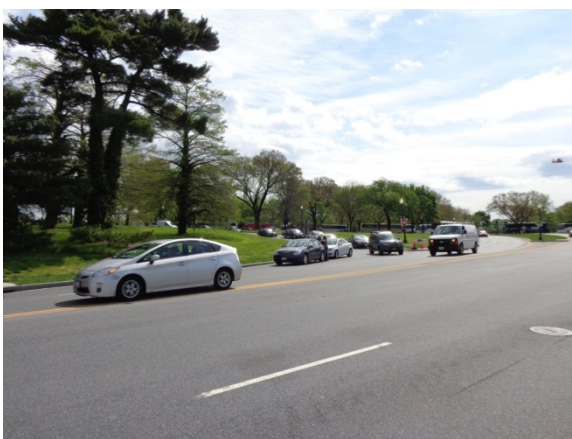
*Figure 40: Crash at merge from NAMA-0510 to Ohio Drive*

Merge: At the merge from NAMA-0510 to Ohio Drive, the team observed many conflicts between vehicles. In fact, during the RSA field visit, a crash was observed (Figure 40). Therefore, the geometry of this merge area should be investigated to determine if a better acceleration area can be provided.

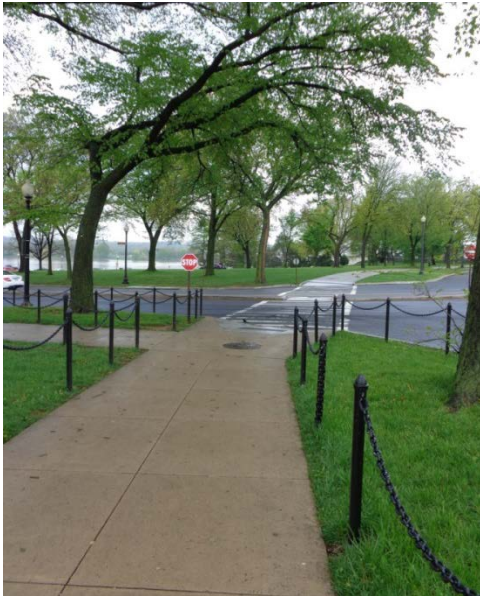
*Figure 41: Stops signs on pathway crossing 23<sup>rd</sup> Street SW*

Stop Signs: Similar to the recommended removal of the stop signs on the pathway at NAMA-0510, the stops signs along the pathway crossing 23<sup>rd</sup> Street SW should be removed (Figure 41). In addition, the park may want to consider some kind of warning for trail users regarding vehicles crossings, as was recommended for NAMA-0510.

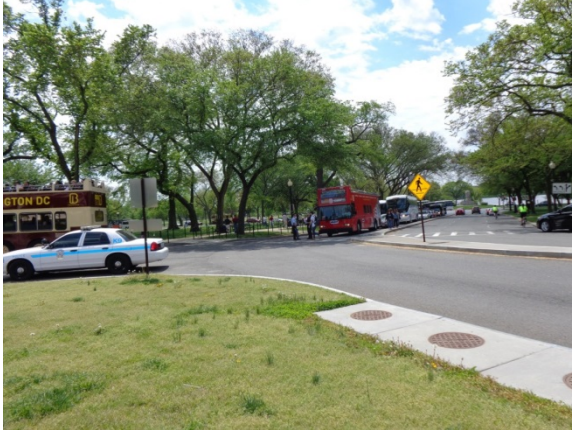
*Figure 42: Buses on 23<sup>rd</sup> Street SW*

Buses: Buses on 23<sup>rd</sup> Street SW often stack up and block the pedestrian/bicyclist pathway crossing (Figure 42). Enforcement should focus on ensuring that the buses are not blocking these crossings and that there is a set-back to ensure that pedestrians/bicyclists are visible.

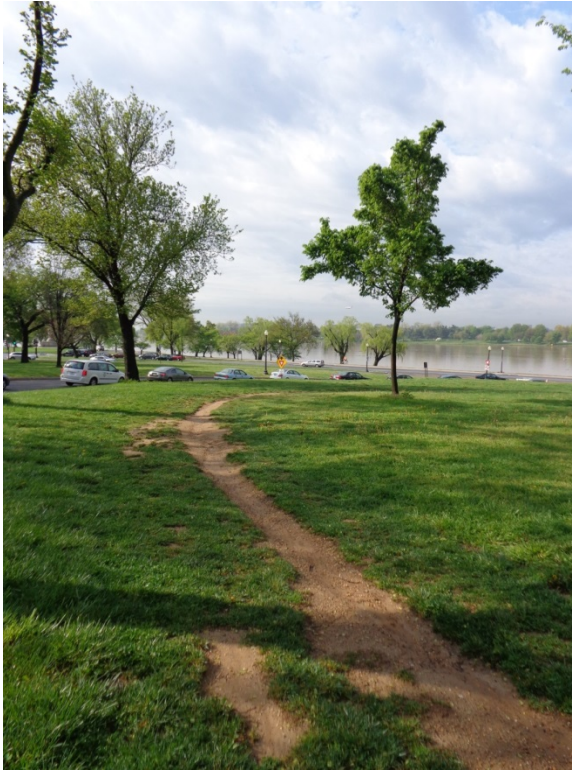
*Figure 44: Existing Social Trail*

The recommendation is to construct a hard surface for the existing social trail (Figure 44). During the Ohio Dive reconstruction, a four foot walkway was created beneath the Arlington Memorial Bridge (Figure 19). The team observed that this walkway is being

utilized by some on foot, and therefore, constructing a hard surface trail is desirable. However, prior to constructing the hard surface, NAMA should ensure that connectivity is provided on the opposite side and that the surface underneath the bridge, which is currently cobblestone, can be traversed by the intended users (i.e. handicapped accessible, traversable by bike).

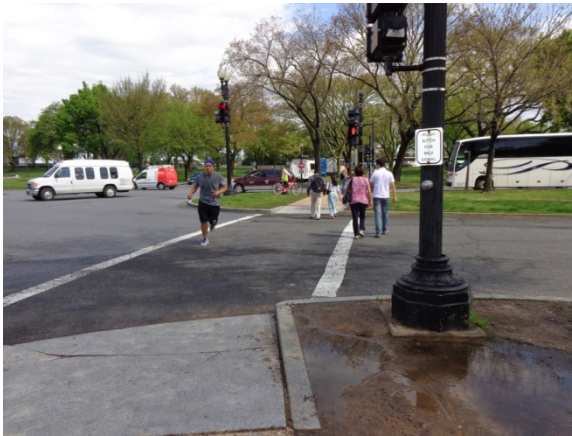
*Figure 46: Signal delay at Independence and 23<sup>rd</sup> Street SW*

As a result, users disregard the pedestrian crossing indications (Figure 46). Therefore, the team recommends a reconfiguration of the timing for this crosswalk.

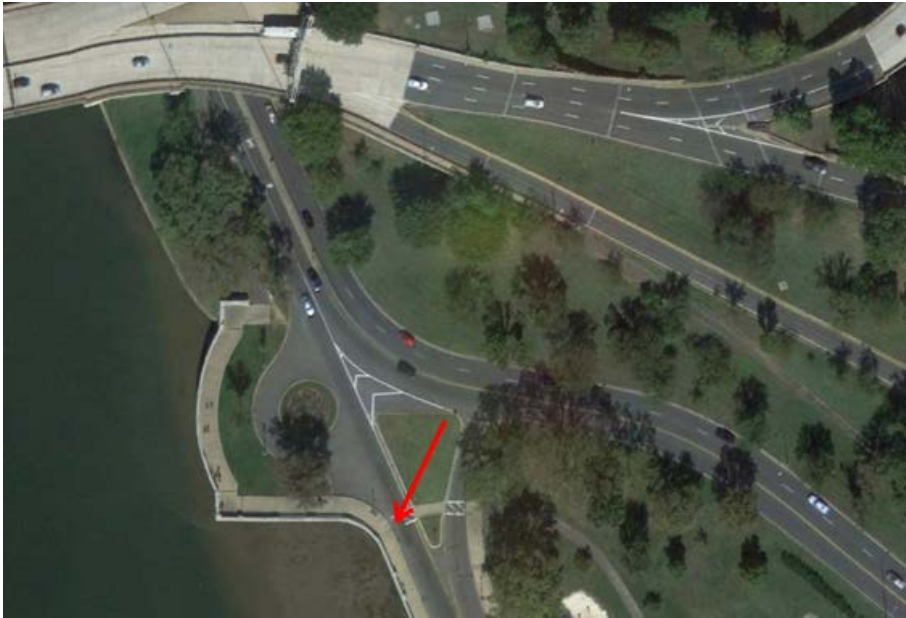
*Figure 47: Parkway Drive & Rock Creek Parkway Wayfinding (1)*

**Wayfinding:** The current wayfinding from Rock Creek Park to the Lincoln Memorial is limited. Therefore, improvements to the wayfinding are necessary. NAMA is currently participating in a study by DDOT that is working to improve the wayfinding in this area, although it is specific to bicycles. Figure 47 shows a decision point, where a non-motorized

user would want to cross to head towards Hains Point or continue straight to head to the Lincoln Memorial.

**Pedestrian/Bicyclist Crossings:** The pedestrian/bicycle crossing on Parkway Drive shown in Figure 47 near the arrow does not have any vertical signage to identify the crossing to motorists. DDOT's R1-6a and W16-7P (Figure 30) could be used at this location.

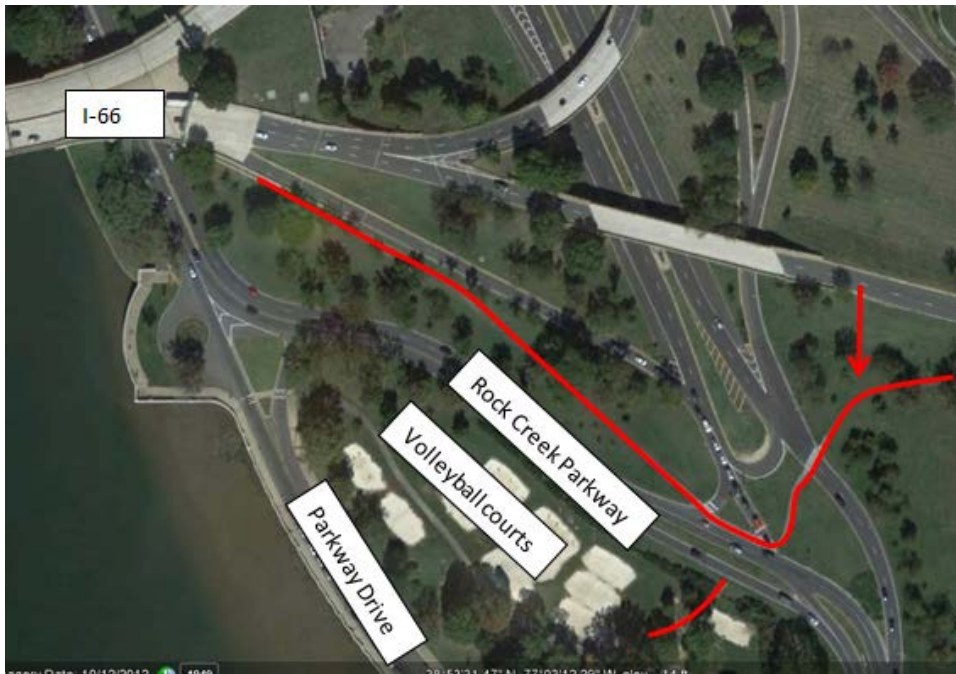
**Figure 49: Trails around I-66 (1)**

**Discontinuity of Trail Across I-66:** The top red line shown in Figure 49 is an established hard-surfaced trail that continues east to the intersection of 23<sup>rd</sup> Street NW and Constitution Avenue. It appears as if the majority of users of this trail then cross Rock Creek Parkway to access Rock Creek Trail or the volleyball courts. However, bike share users have been observed following this trail all the way to the I-66 bridge. Once they follow the bridge to the other side of the river, the trail unexpectedly stops. Therefore, one recommendation is to provide information at the location identified by the arrow regarding the discontinuity of the trail.

**Rock Creek Park Crossing:** A social trail currently exists as identified by the lower red line in Figure 49. People making use of this trail are likely either accessing the Rock Creek Trail or the volleyball courts. The feasibility of creating a defined, protected crossing should be investigated.
