# George Washington Memorial Parkway Traffic and Safety Context Sensitive Solutions Assessment

March 2021

| <b>4. TITLE AND SUBTITLE</b><br><br>George Washington Memorial Parkway: Traffic and Safety Context Sensitive Solutions Assessment | | | | <b>5a. CONTRACT NUMBER</b> DTFH71-13-D-00002L | |

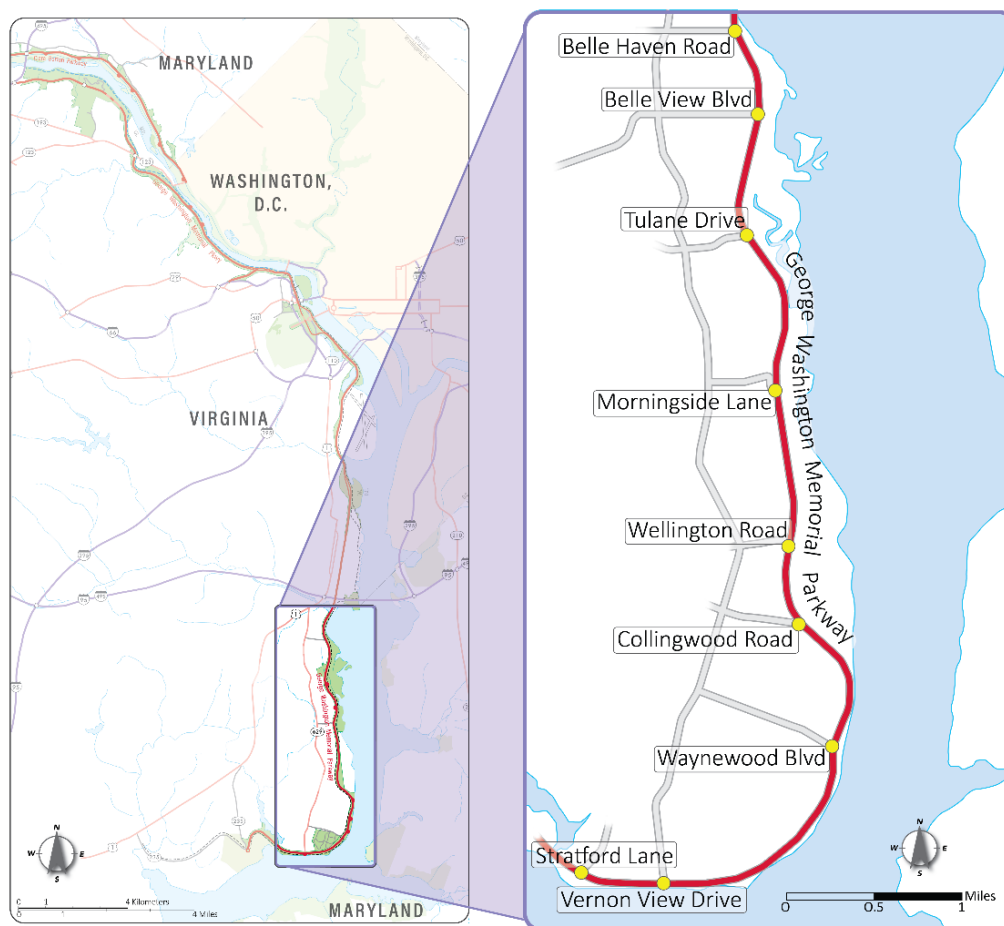
Figure 1: Map of the nine study intersections along the Parkway.

The George Washington Memorial Parkway (Parkway) was established as a recreational and environmental conservation area. A parkway is an attenuated (narrow) park with a road through it, but a park, nonetheless. The road serves as a means for the visitor to experience the park, much as a trail is the means to experience the mountains. On the National Register of Historic Places, the Parkway is a scenic and historic roadway that runs along the south bank of the Potomac River between Mount Vernon and I-495. This study is a traffic and safety assessment, focusing on the following intersections located in the southern segment (approximately 6.3 miles) between the City of Alexandria and Mount Vernon (Figure 1):

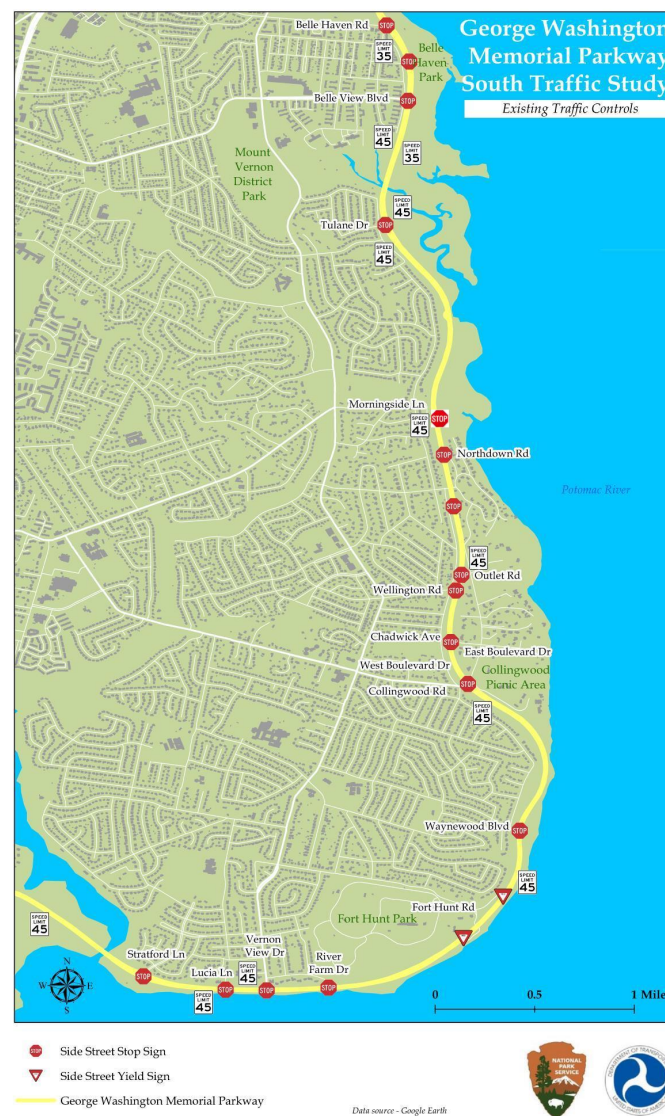
Figure 2: Study Corridor: Traffic Controls and Speed Limits

A study area map, with the traffic control from each approach and posted speed limits identified, is shown in Figure 2.

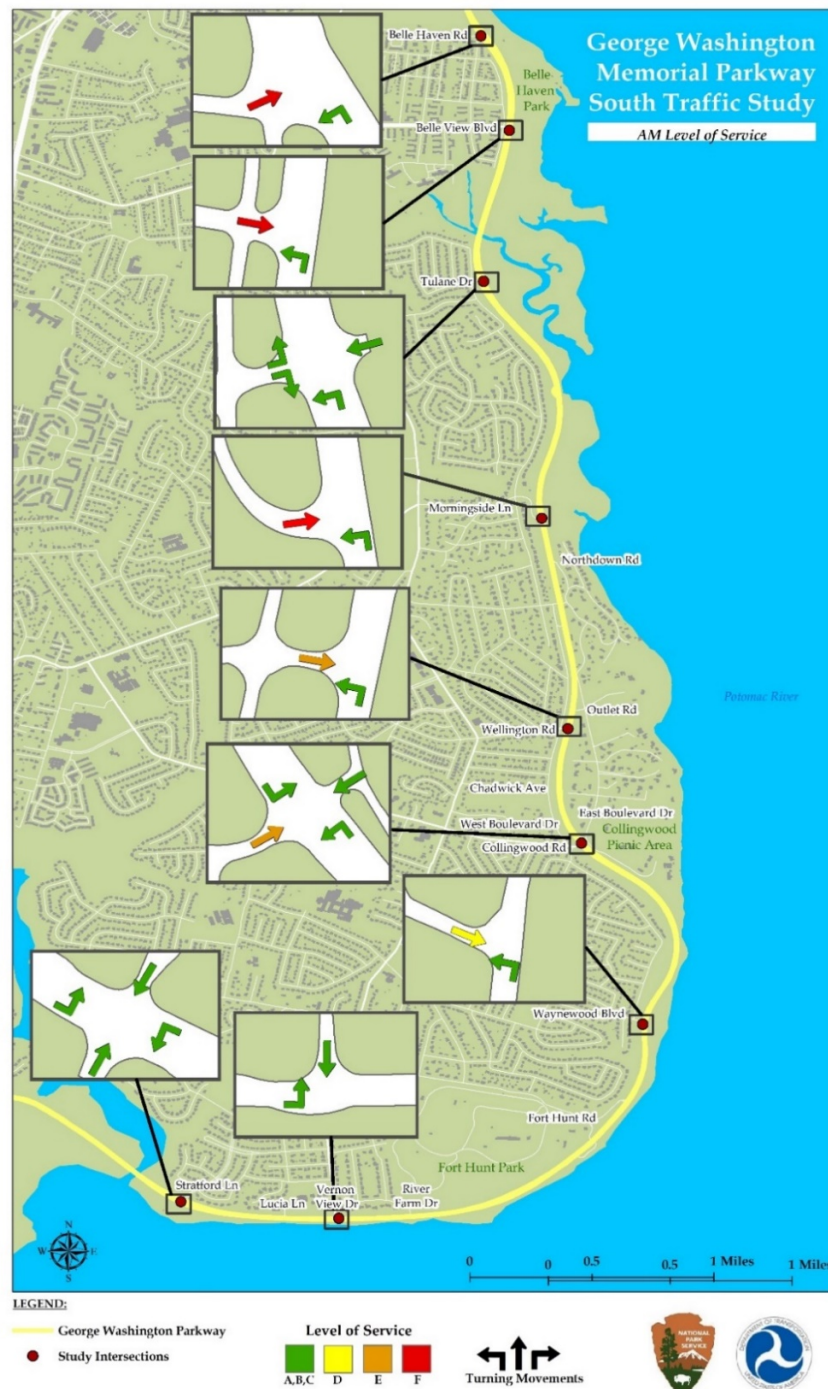
Figure 7: AM Peak Level of Service per Lane at Study Intersections

*Delay (Control delay)* is the portion of delay attributed to traffic signal operation for signalized intersections or stop/yield signs for stop or roundabout-controlled intersections. Control delay (overall delay) can be categorized into deceleration delay, stopped delay, and acceleration delay. Figure 7 and Figure 8 show the LOS for each movement at each study intersection on a map view for AM Peak and PM Peak respectively. During the AM Peak, the approach from Belle Haven Road, Belle View Boulevard, and Morningside Lane all experienced an LOS F (Figure 7). Wellington Road and eastbound Collingwood Road experienced an LOS E (Figure 7). The Waynewood Boulevard approach experienced an LOS D (Figure 7). During the PM Peak, the situation became more congested at Belle Haven Road, with the left-turn from the Parkway to Belle Haven Road experiencing an LOS F (Figure 8). The Belle View Boulevard and Morningside Lane approaches remained consistent in the PM Peak to that in the AM Peak with an LOS F (Figure 8). The Wellington Road, eastbound Collingwood Road, and Waynewood Boulevard approaches all improved during the PM Peak, with an LOS D; LOS A, B, C; and LOS A, B, C; respectively (Figure 8).

- Belle Haven Road – LOS F during AM and PM peak hour
- Belle View Boulevard – LOS F during AM and PM peak hour
- Morningside Lane – LOS F during AM and PM peak hour
- Collingwood Road – LOS E during AM peak hour

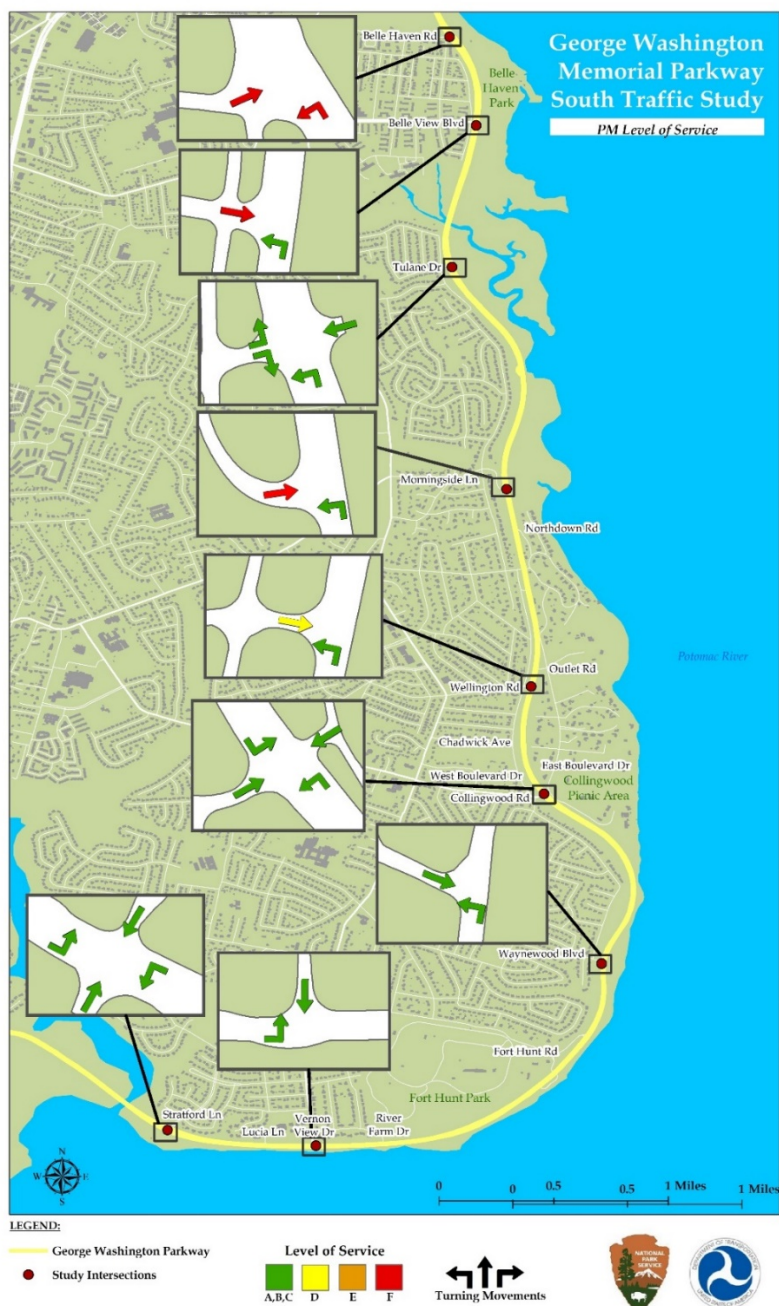
Figure 8: PM Peak Level of Service per Lane at Study Intersections

grades delays of greater than 50 seconds (about half of what drivers approaching the Parkway on Belle View Boulevard experience) as failing level of service for stop signs. Lowering the delay threshold can help reduce the variability in waiting time that motorists currently experience at stop signs when trying to find an adequate gap to safely enter traffic.

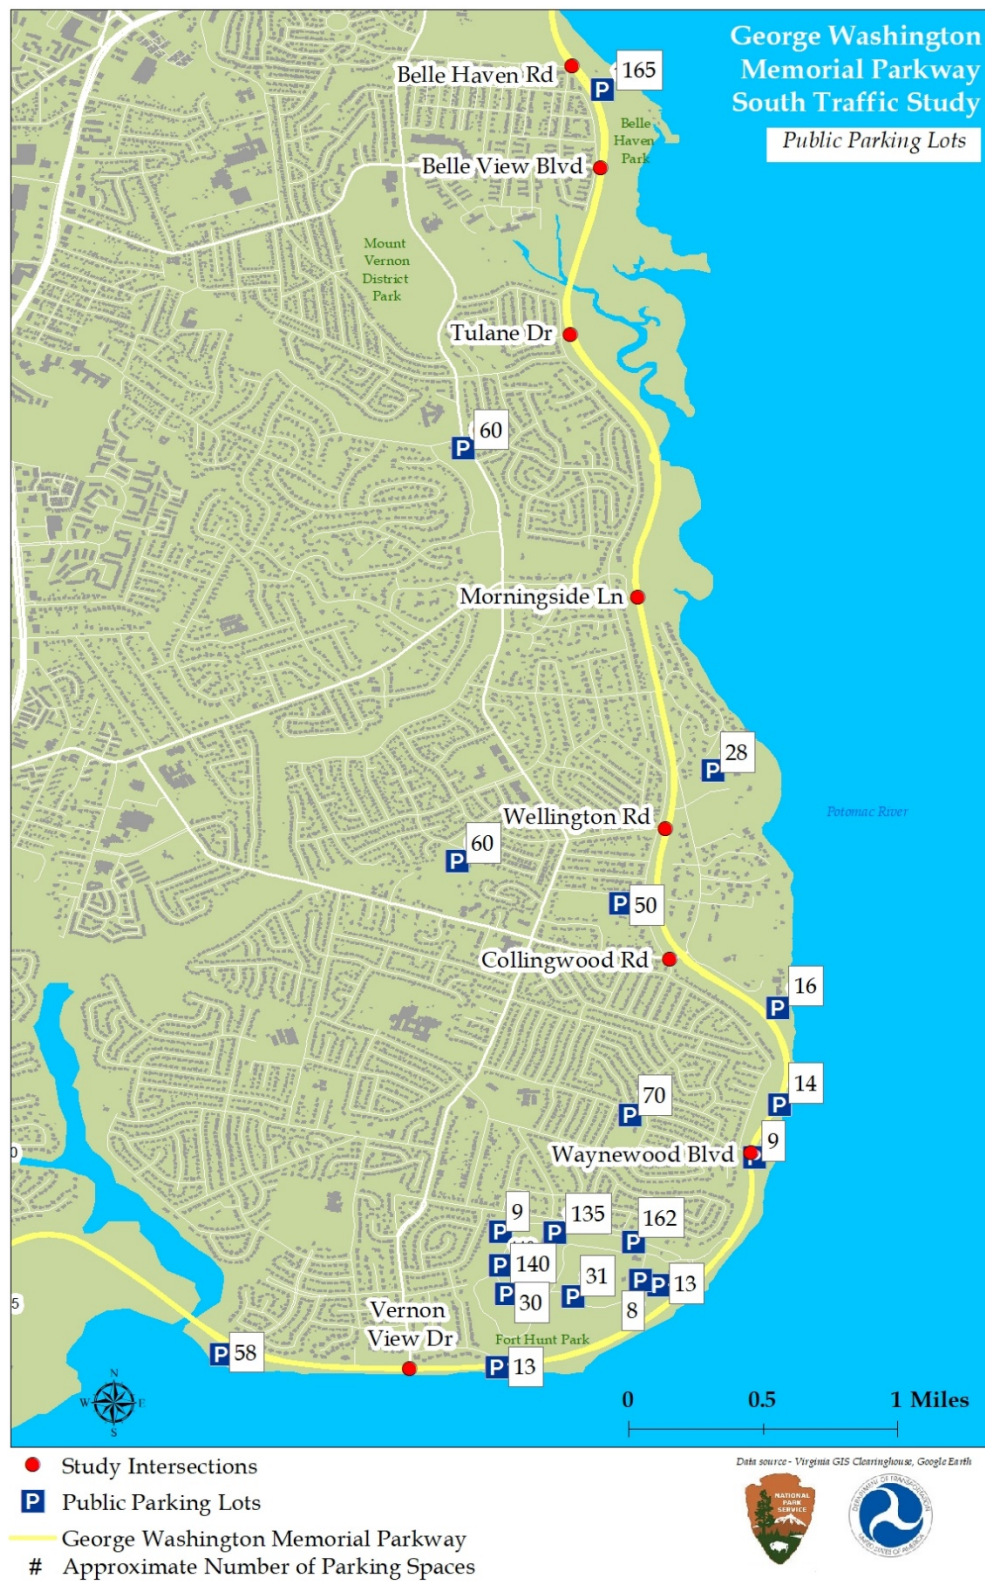
Figure 11. Existing Parking Lots

The research team performed an inventory and utilization survey of selected parking lots in March 2019 to evaluate visitor activity. Figure 11 illustrates the parking lot locations. The largest parking lot is located near Belle Haven Road, followed by Stratford Lane. Overall, no parking lot was found to be more than approximately 50% utilized in any weekday time period. Table 15 and Figure 11 summarize the parking lot capacity and utilization data.

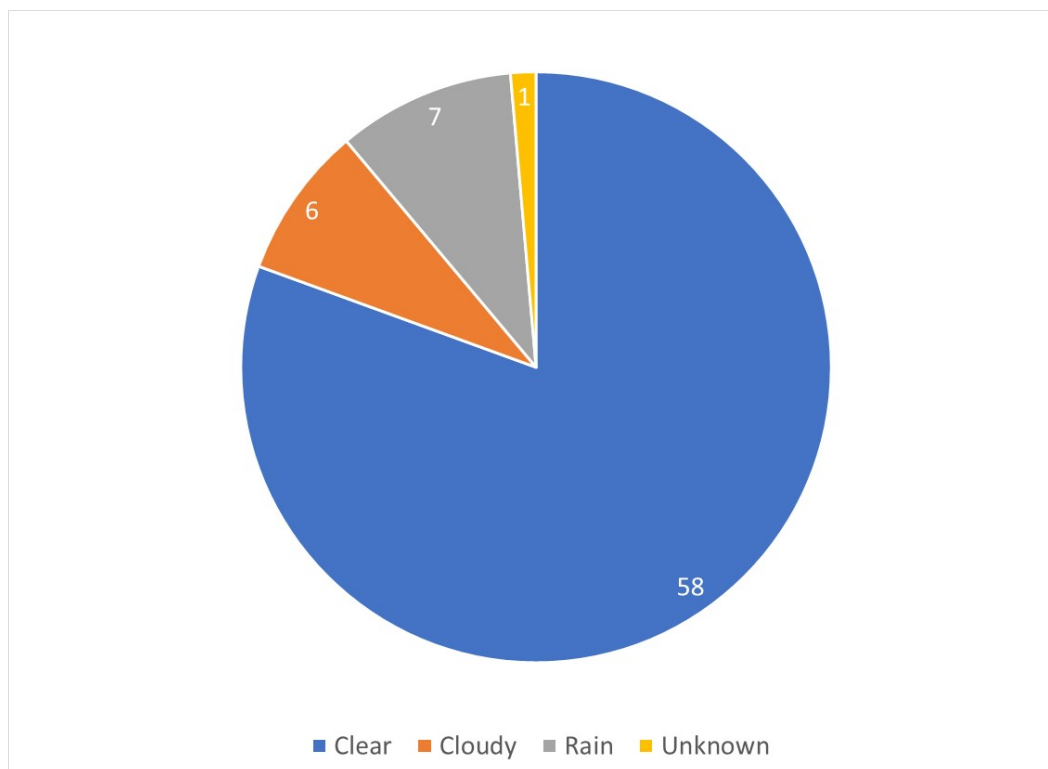
Figure 18: The Parkway & Belle Haven Road, Weather

With regard to weather, the majority of the crashes (**fifty-eight**) occurred during “Clear” periods; therefore, weather does **not** appear to be a factor contributing to crashes (Figure 18).

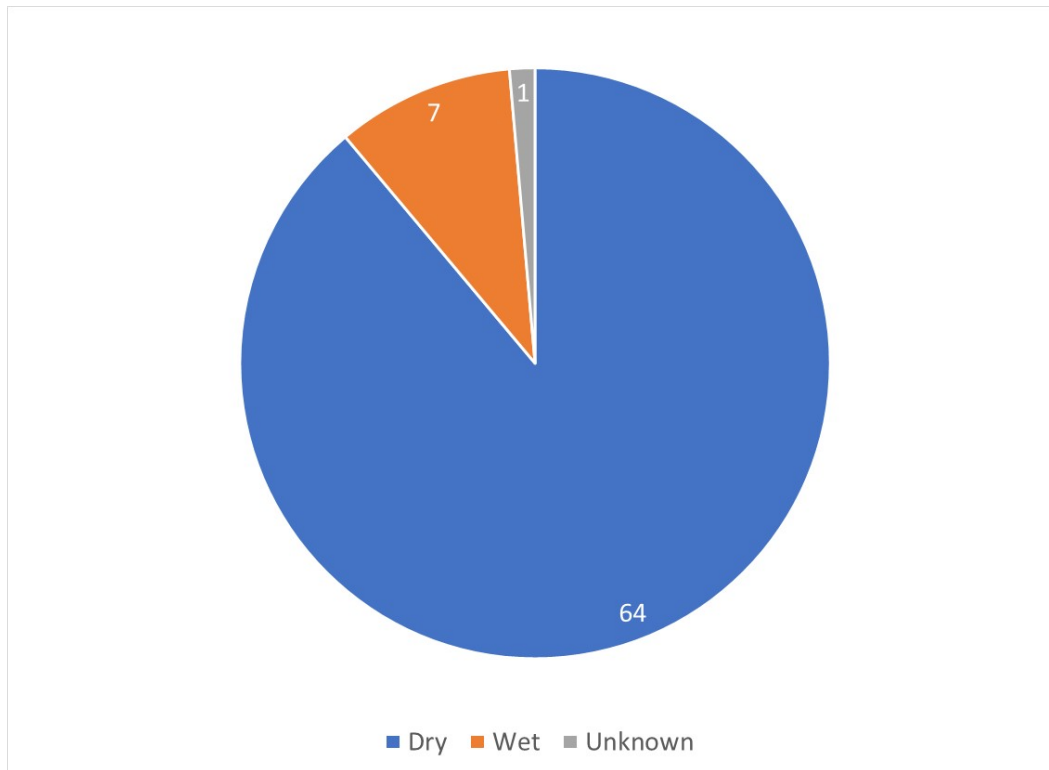
*Figure 19: The Parkway & Belle Haven Road, Surface Condition*

The majority of crashes (**sixty-four**) occurred when surface conditions were “Dry,” which suggests that surface condition is unlikely to be an issue (Figure 19).

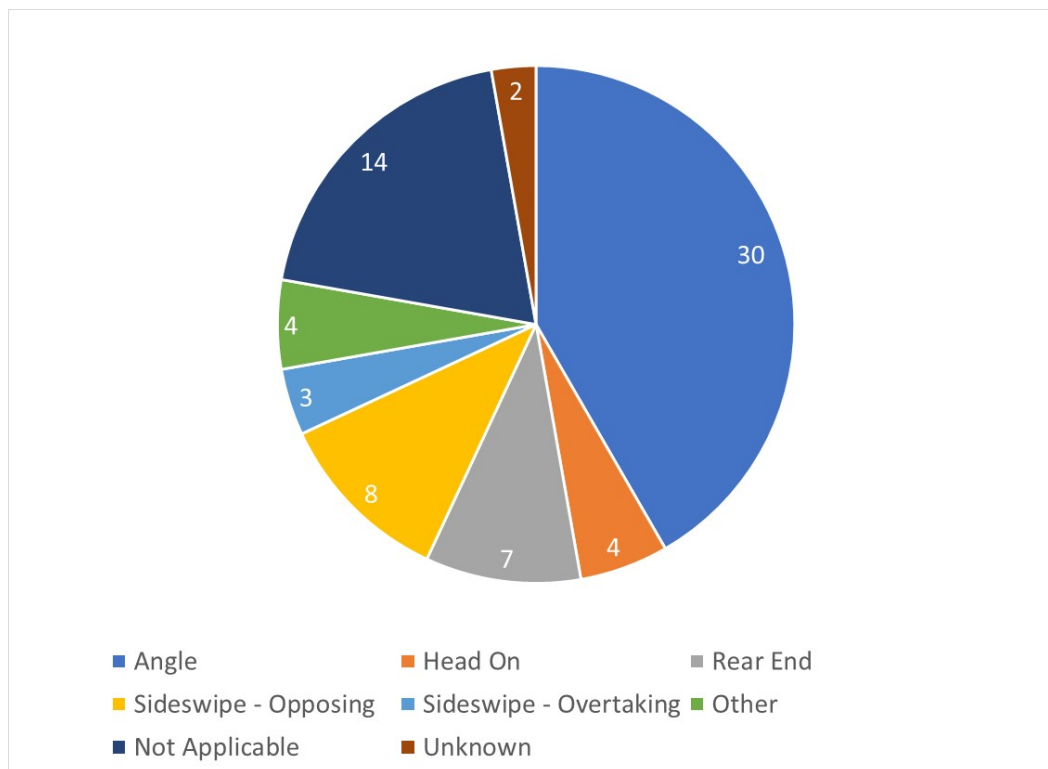
Figure 20: The Parkway & Belle Haven Road, Crash Type

One category of the tabular data provided information about the vehicle collision type. “Angle” was the most common crash type (**thirty**) (Figure 20).

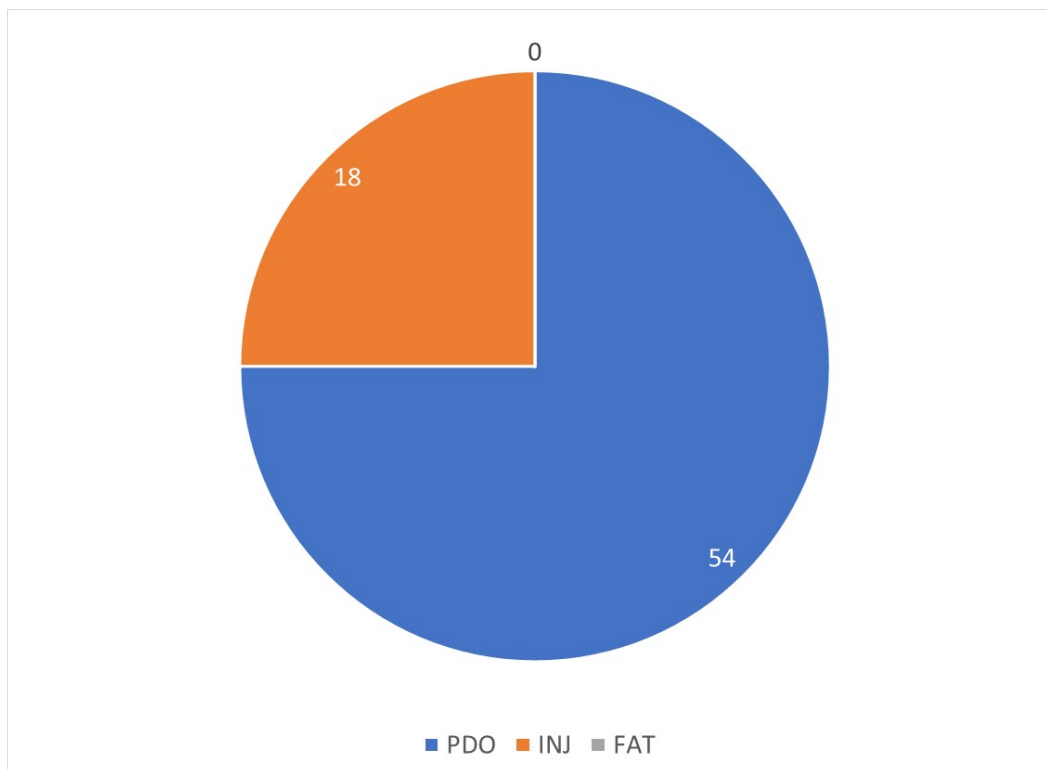
Figure 22: The Parkway & Belle Haven Road, Crash Severity

This section identifies the number of property damage only (PDO), injury (INJ) and fatal (FAT) crashes. The majority of crashes (**fifty-four**) that are occurring at the intersection are PDO crashes; no fatal crashes were reported at the intersection (Figure 22).

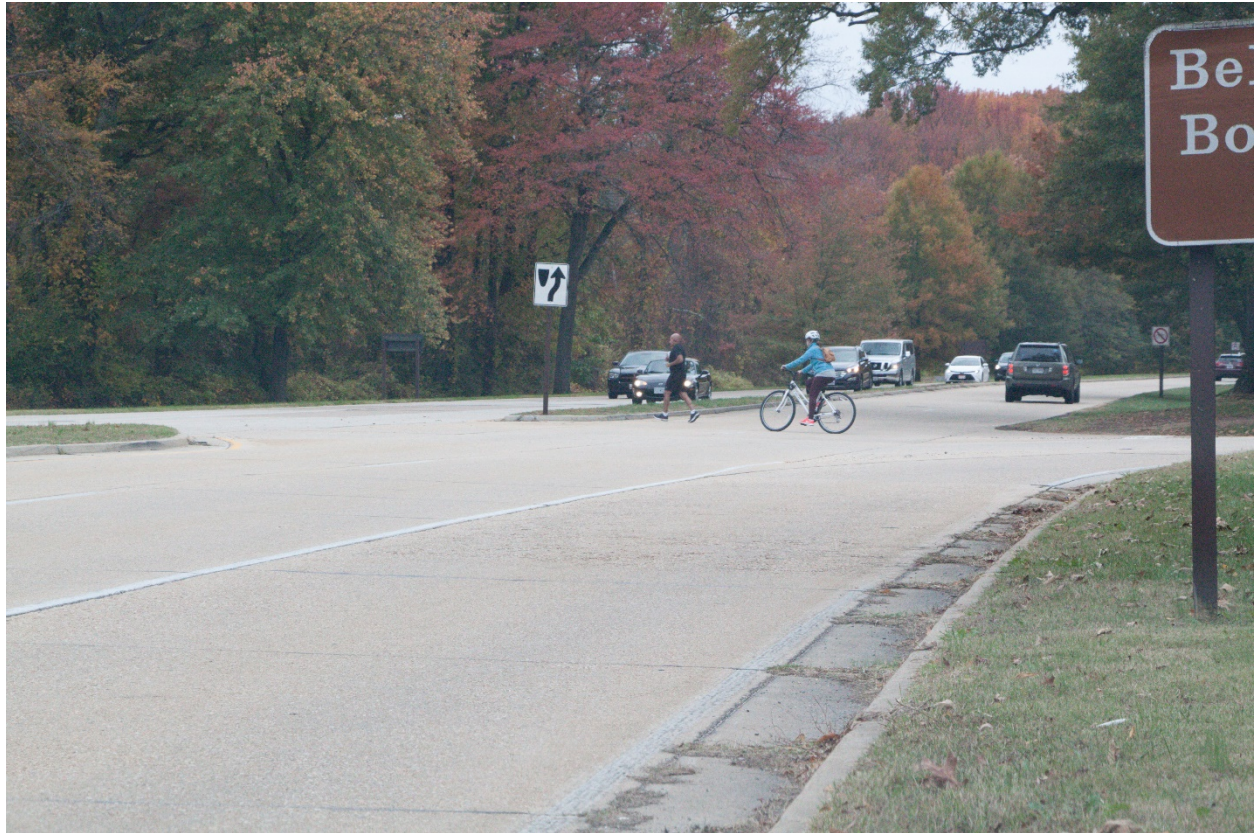
*Figure 28: Pedestrian, Bicyclist & Vehicle at the Parkway & Belle View Boulevard*

One of many photos taken of bicyclists/pedestrians at this intersection can be found in Figure 28. Finally, in the southbound direction of the Parkway there is a right-turn lane. This lane can potentially obstruct a driver's view who is looking to turn northbound from eastbound on Belle View Boulevard. In addition, there is the potential for confusion if someone in the right-turn lane does not commit to turning right.

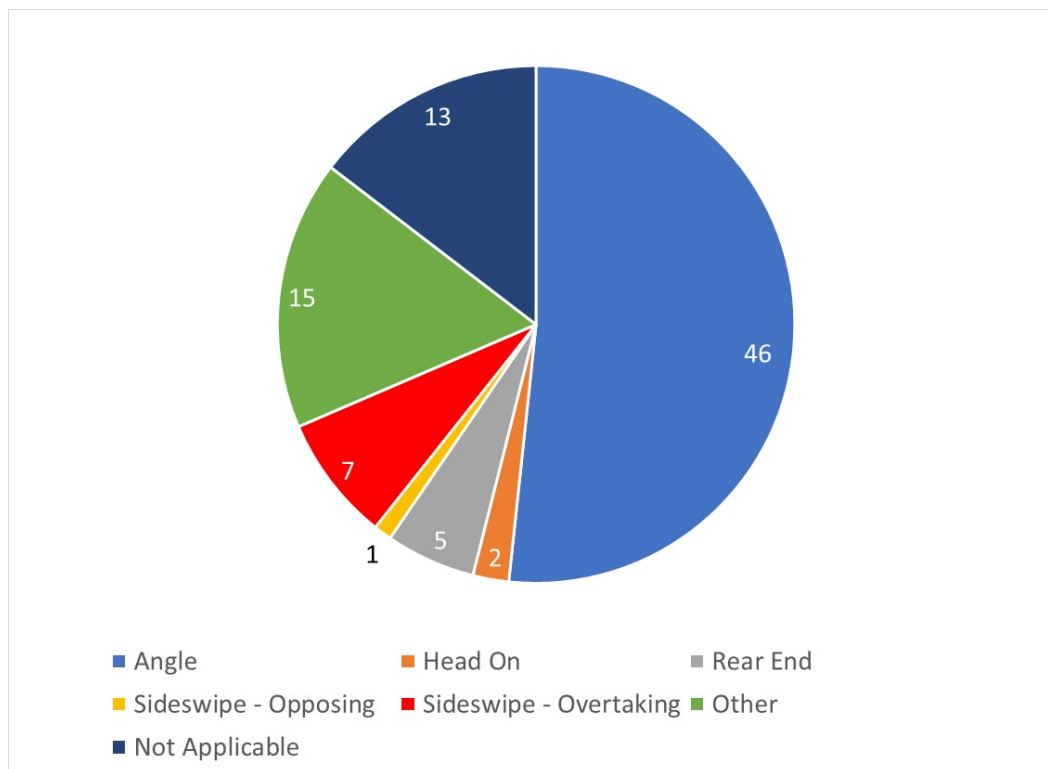
Figure 36: The Parkway & Belle View Boulevard, Crash Type

One category of the tabular data provided information about the vehicle collision type. “Angle” was the most common crash type (**forty-six**) (Figure 36).

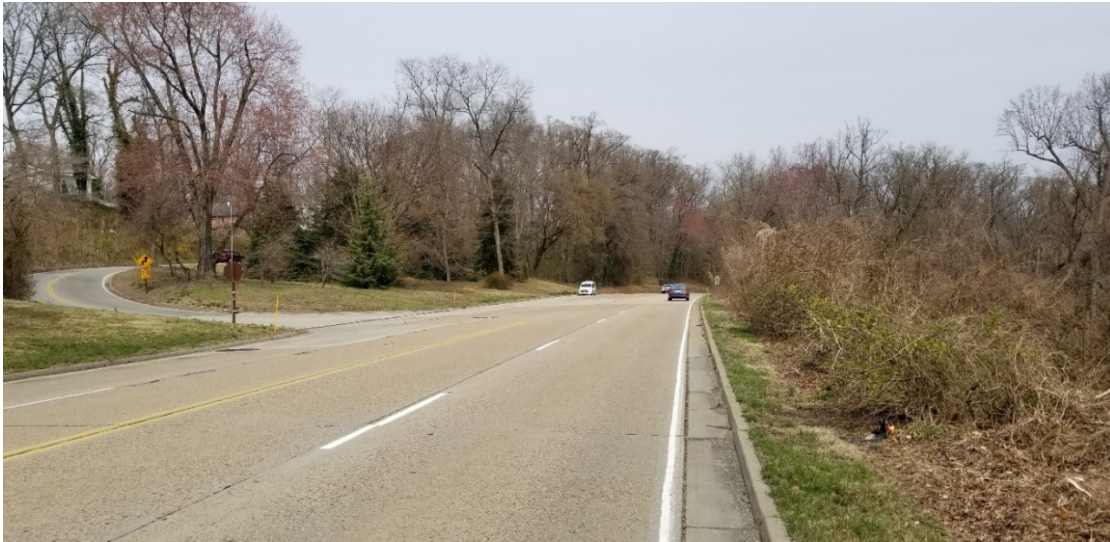
*Figure 59: The Parkway & Morningside Lane, Looking north*

Morningside Lane is stop-controlled. Morningside Lane itself seems to be slightly down-sloped (Figure 59); there is a right-turn lane in the southbound direction on the Parkway turning onto Morningside Lane (Figure 60).

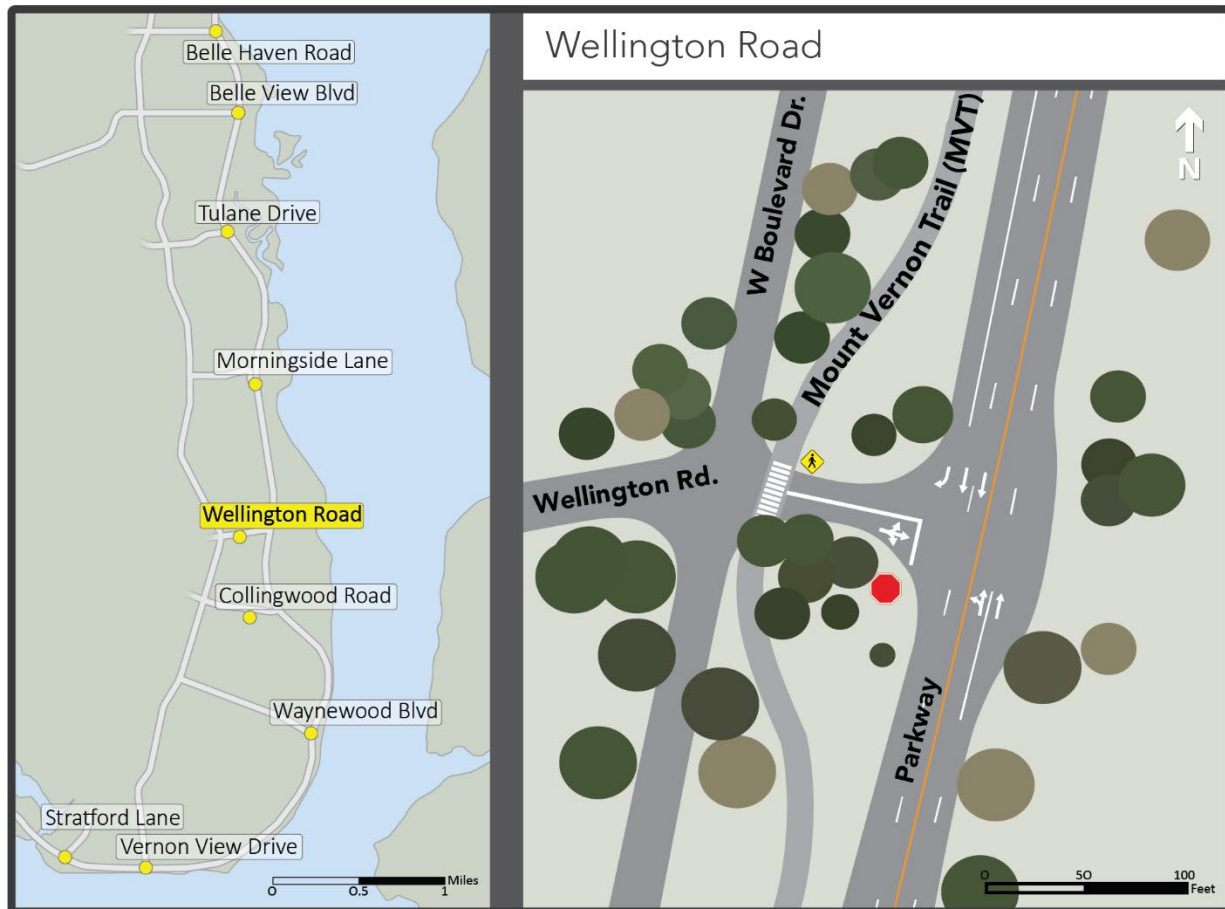
Figure 75: The Parkway & Wellington Road

Figure 75 shows the orientation of the Parkway and Wellington Road, a three-legged intersection.

Notice the close proximity between the Parkway and the parallel roadway (West Boulevard Drive) and to the MVT. There is no advance warning to motorists traveling southbound and turning right that the MVT is present. A pedestrian warning sign (W11-2 from the Manual on Uniform Traffic Control Devices (MUTCD) (USDOT/FHWA, 2017)) is just east of the crossing.

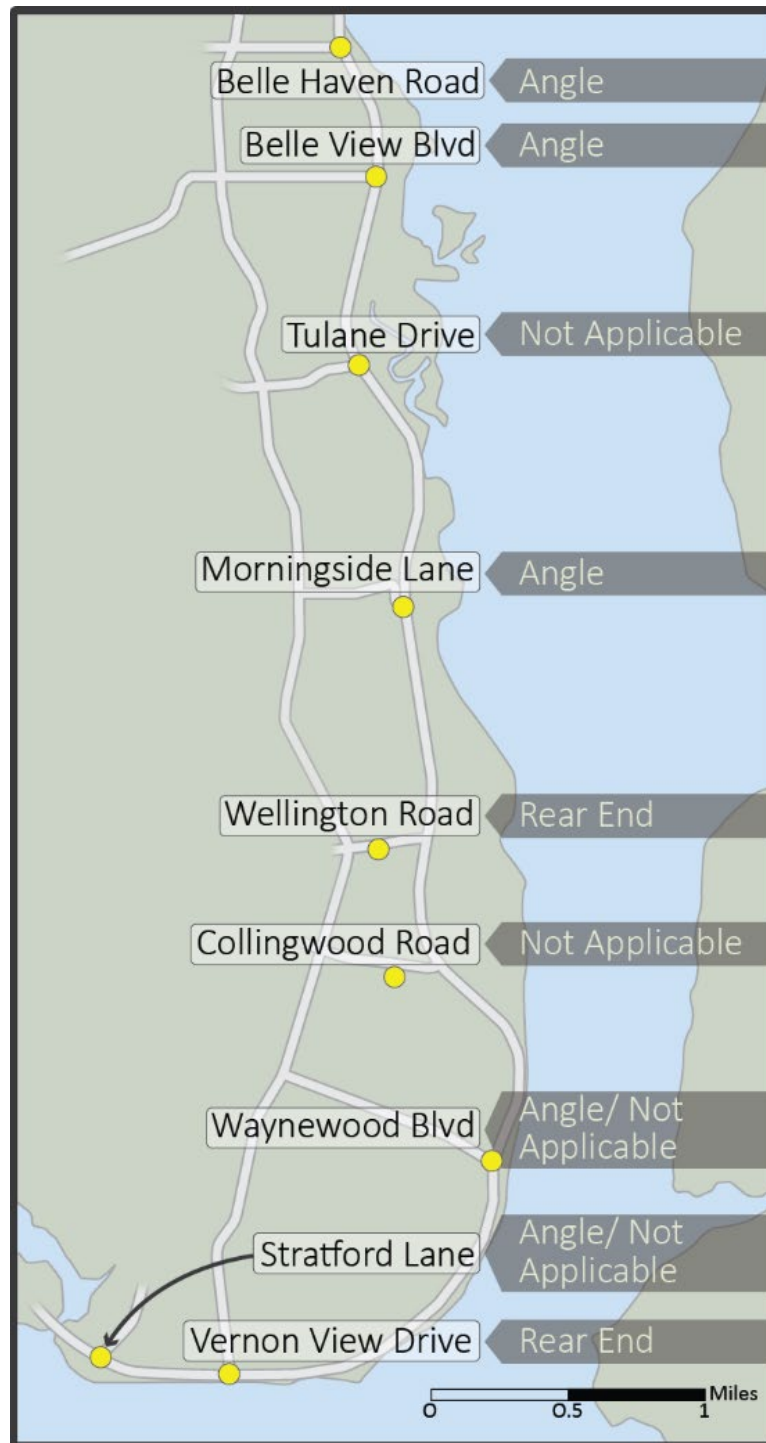
Figure 160: The South Parkway Corridor, Crash Type

“Angle” and “Not Applicable” crashes are the most common reported crash types (Figure 160). Most angle crashes are between vehicles, whereas the latter are with trees/shrubs, animals, and other roadside objects (e.g. drainage structures, signs). Implementing measures that will keep vehicles on the roadway (e.g. slower speeds, more forgiving roadside) can help to mitigate these crashes.

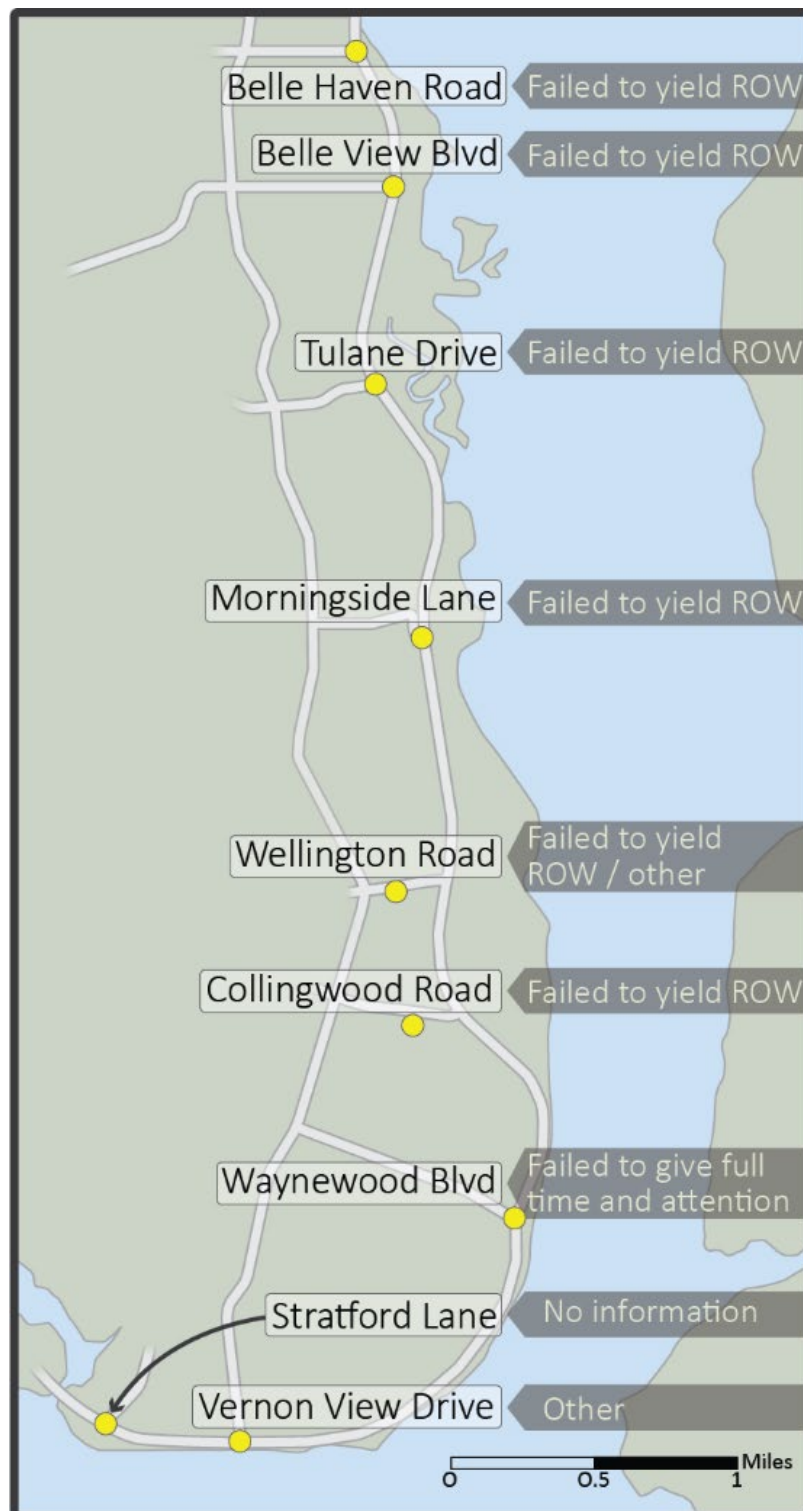
Figure 163: The South Parkway Corridor, Primary Cause

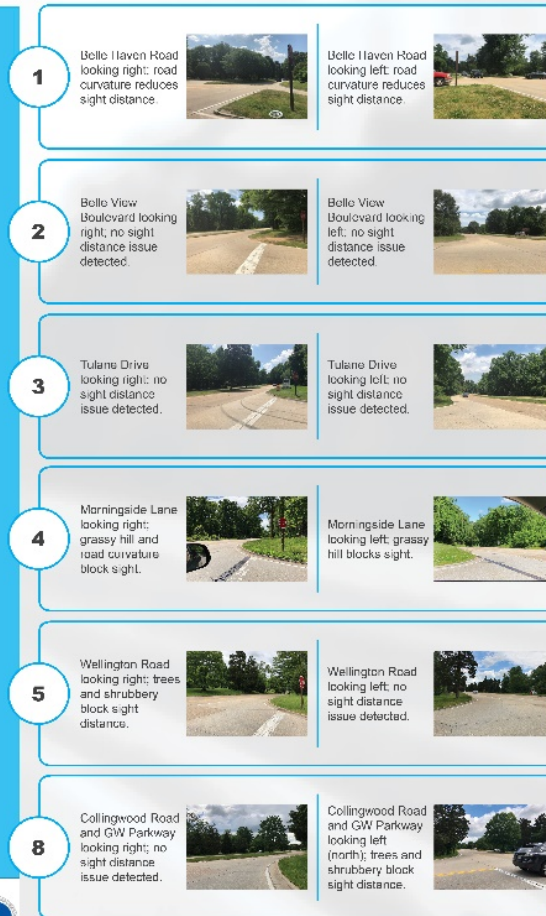
Figure 166: Driver's Line of Sight at Study Intersections

Table 48 summarizes field observations regarding sight distances. The results compare the available line of sight for stopping and for crossing maneuvers, based on the required stopping sight distance using the prevailing roadway speeds. For example, a vehicle traveling at 50 mph (prevailing speed) requires about 425 feet to stop on a level terrain. Making a left turn from a stop onto the Parkway when vehicles on the Parkway are traveling at 50 mph requires a minimum of 555 ft of sight distance, and 480 ft if making a right turn (AASHTO, 2018). For left-turns, for each lane that the turning vehicle has to traverse, an additional 0.5 seconds of delay must be added, resulting in 590 to 625 feet (less if they turn into the near lane, more if they turn into the far lane) needed to safely allow the turning vehicle to enter the Parkway. As can be seen from the table, drivers traveling along the Parkway have an adequate stopping sight distance when traveling at the prevailing speeds. At intersecting streets, road curvature and vegetation present sight obstructions for drivers turning left or right when merging onto the Parkway. Also, changes in slopes, skewed intersecting angles, and vegetation present sight obstructions at most of the intersections including: Belle Haven Road, Tulane Drive, Morningside Lane, Wellington Road, Collingwood Road, Waynewood Boulevard, Vernon View Drive, and Stratford Lane. Figure 167 includes photographs of obstructions for vehicles entering the Parkway from side streets.

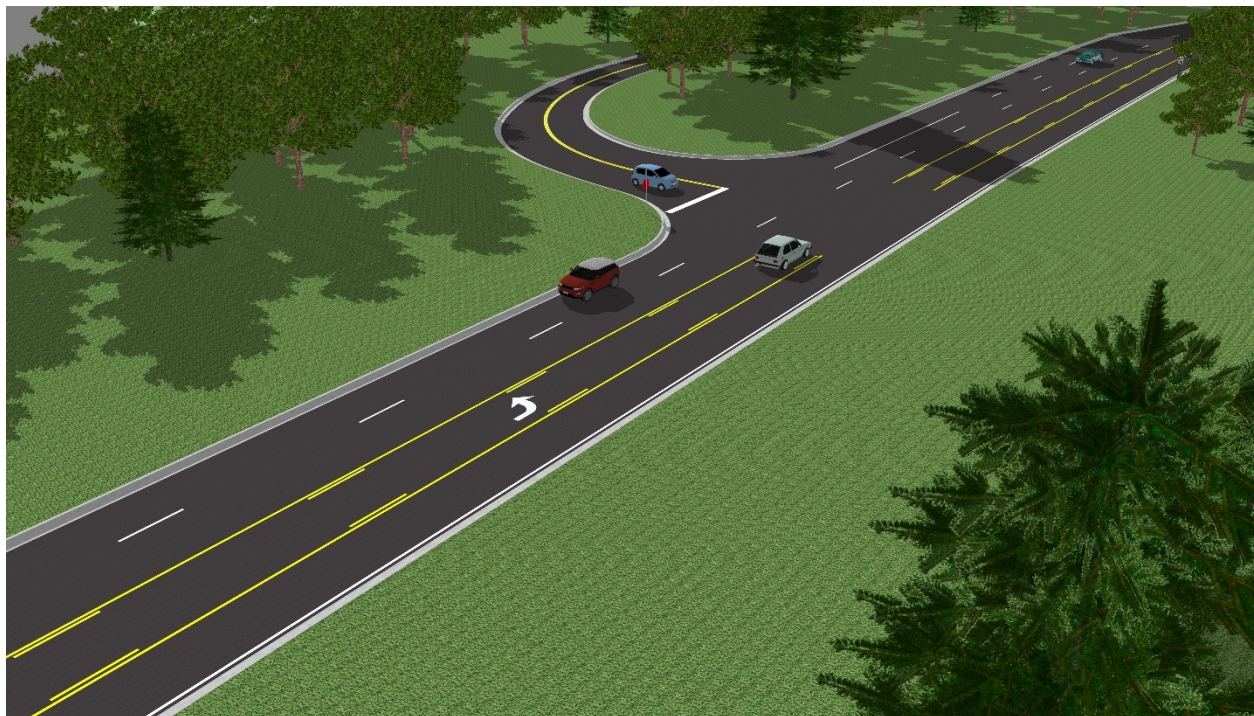
*Figure 185: Rendering of Option 2 Road Diet at Morningside Lane*

A rendering of a road diet treatment for Option 2 at Morningside Lane is shown in Figure 185.

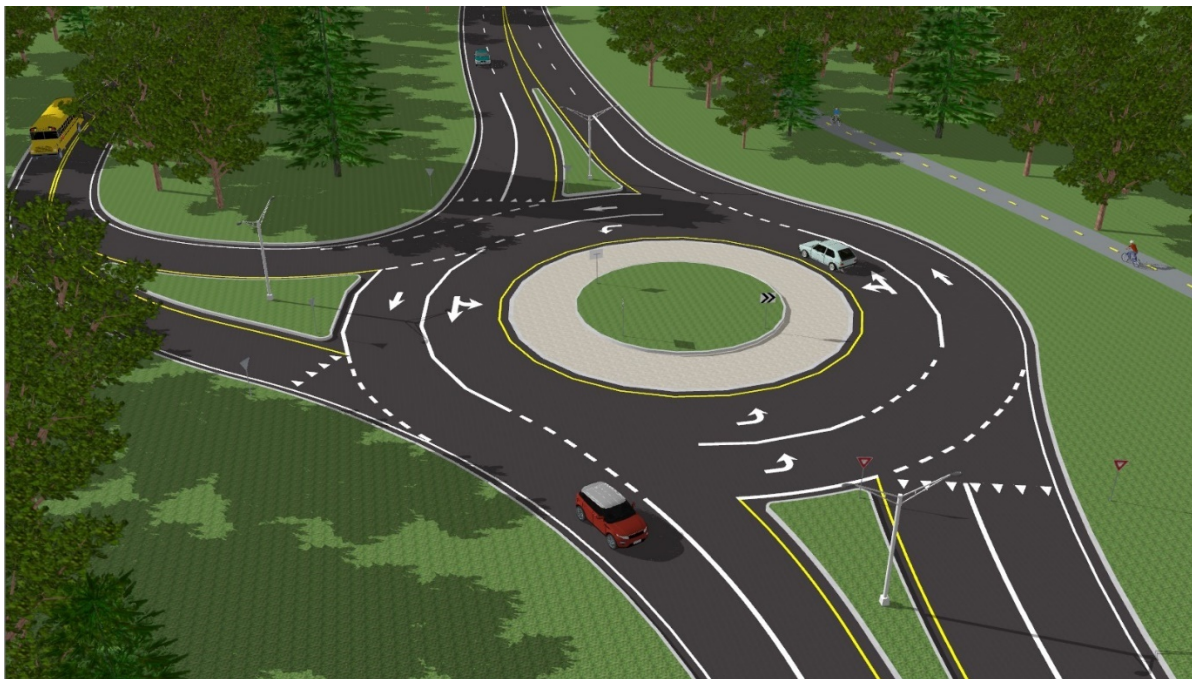
*Figure 191: Roundabout Rendering at Morningside Lane*

A rendering of the roundabout at Morningside Lane is shown in Figure 191.

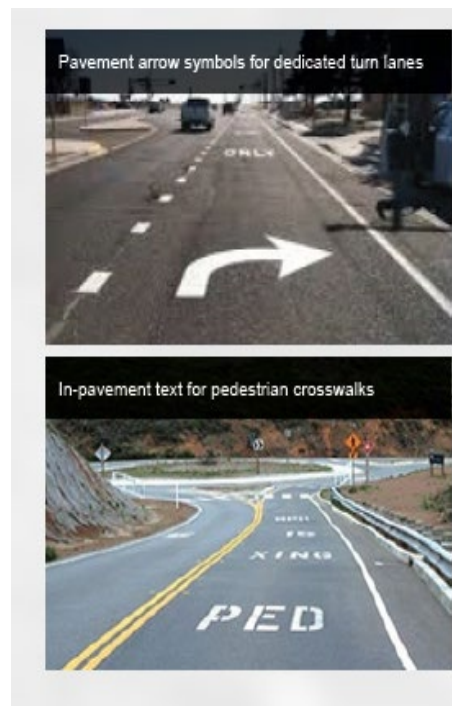
Figure 195: Examples of Pavement Symbols for Dedicated Turn Lanes & Pedestrian Crosswalks (Street views from Google Maps)

Upgraded signing and pavement markings are key to providing guidance to motorists at decision points along the Parkway such as intersections, MVT (bicycle/pedestrian) crossings and entering and exiting auxiliary lanes (Figure 195). Ensuring that signing is updated with current MUTCD standards such as W1-2 intersection warning signs, W11-15 (U.S. Department of Transportation (USDOT), 2017) trail crossing signs and advisory speed subplates will provide additional positive guidance to all motorists, especially park visitors.

Pavement markings similarly could be refreshed routinely and enhanced for visibility using high retro-reflectivity grade tape and contrast tape to maximum conspicuity. Supplemental markings for auxiliary lanes including left and right turn lane arrows and ‘only’ text could be included to inform drivers of auxiliary lane usage.

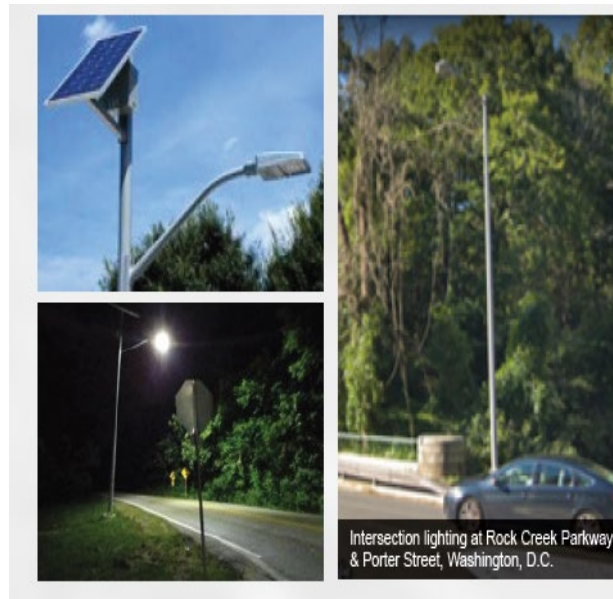
Figure 196: Intersection Lighting, At Night & with Solar Power (Street views from Google Maps)

Intersection lighting refers to devices that illuminate the intersections at night. It does not include traffic signals. Pole-mounted intersection lighting provides appropriate illumination levels during dark hours for all conflict points within an isolated intersection to enhance visibility for motorists, pedestrians and bicyclists (Figure 196).

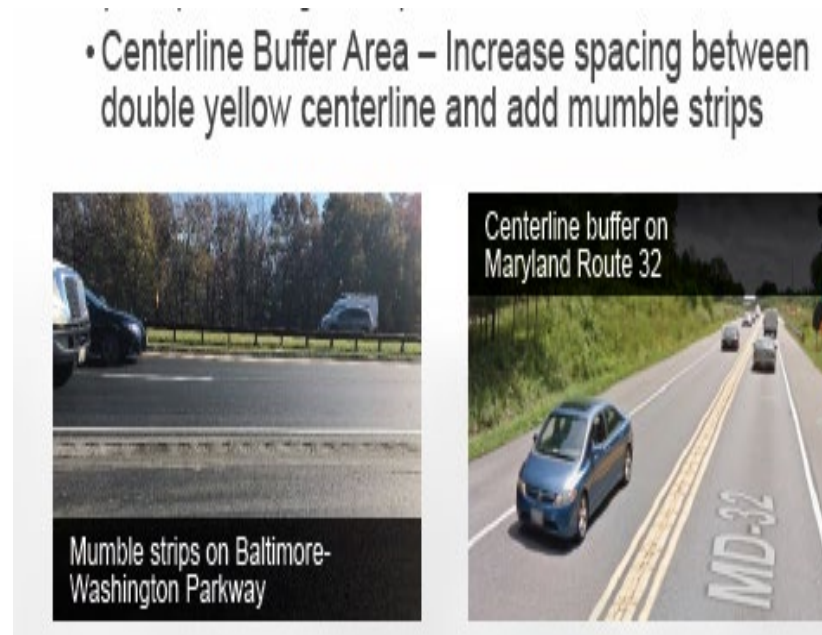
Figure 197: Centerline Buffer Area (Street views from Google Maps)

restrictions or of the edge of the road, and provide positive guidance to avoid lane departures. Rumble strips can also be used in the center of the roadway in coordination with a double yellow centerline to make drivers aware if they start encroaching in the opposite direction of travel. Mumblestrips are still a relatively new treatment, as they have evolved from rumblestrips with the intent of retaining the safety benefits while reducing the noise impacts. Figure 197 shows mumblestrips on asphalt.

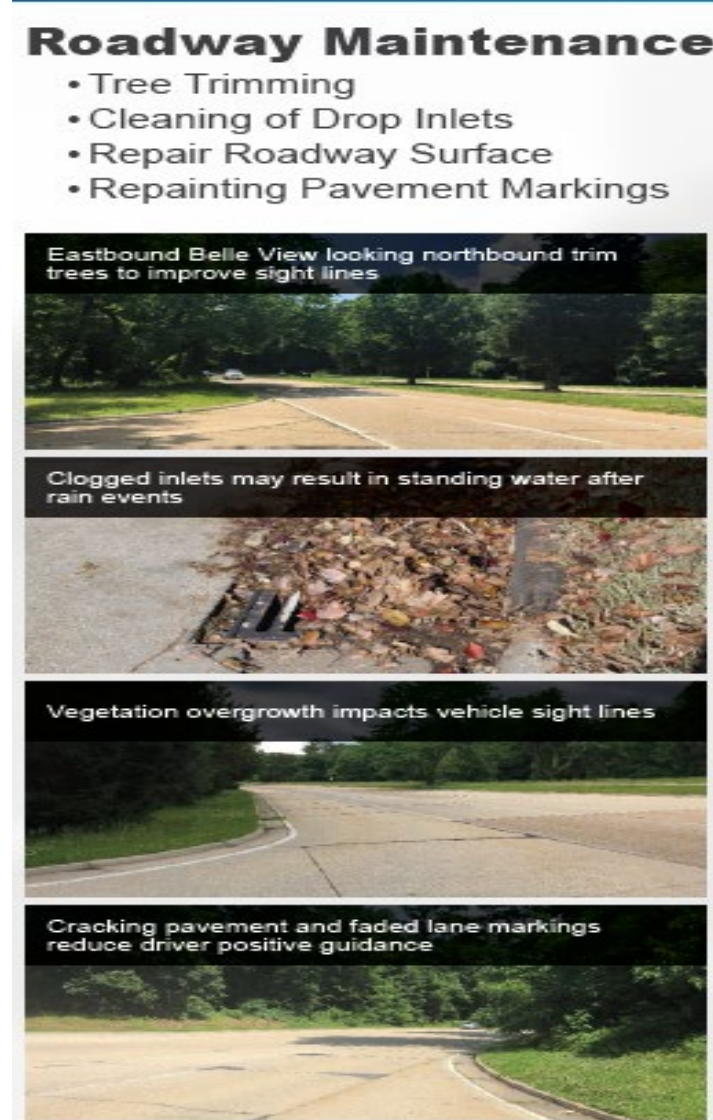
Roadway maintenance plays a key role in improving traffic safety. Important measures for improving traffic safety on the Parkway (Figure 198) include providing:

- routine maintenance of vegetation to maintain intersection sight lines,
- clearing of storm drain inlets from debris to maintain storm water runoff and reduce standing water,
- repairing roadway surfaces such as potholes, and
- refreshing faded pavement markings.

Figure 198: Roadway Maintenance Examples (Street views from Google Maps)

Specifically, maintenance activities could provide a sight distance of at least 590 feet, which corresponds to vehicles traveling at 50 mph to accommodate intersection sight distance for prevailing vehicle speeds. (Note: This can be reduced as engineering and enforcement solutions are implemented to assist with traffic calming (e.g. speed reduction).)
