**Ecological impacts of new and upgraded dirt roads in
Cabeza Prieta National Wildlife Refuge and avoidance,
mitigation and compensation strategies**

A report prepared for the
U.S. Fish & Wildlife Service,
Headquarters Office, Transportation Branch,
5275 Leesburg Pike, Falls Church, VA 22041

15 December, 2021

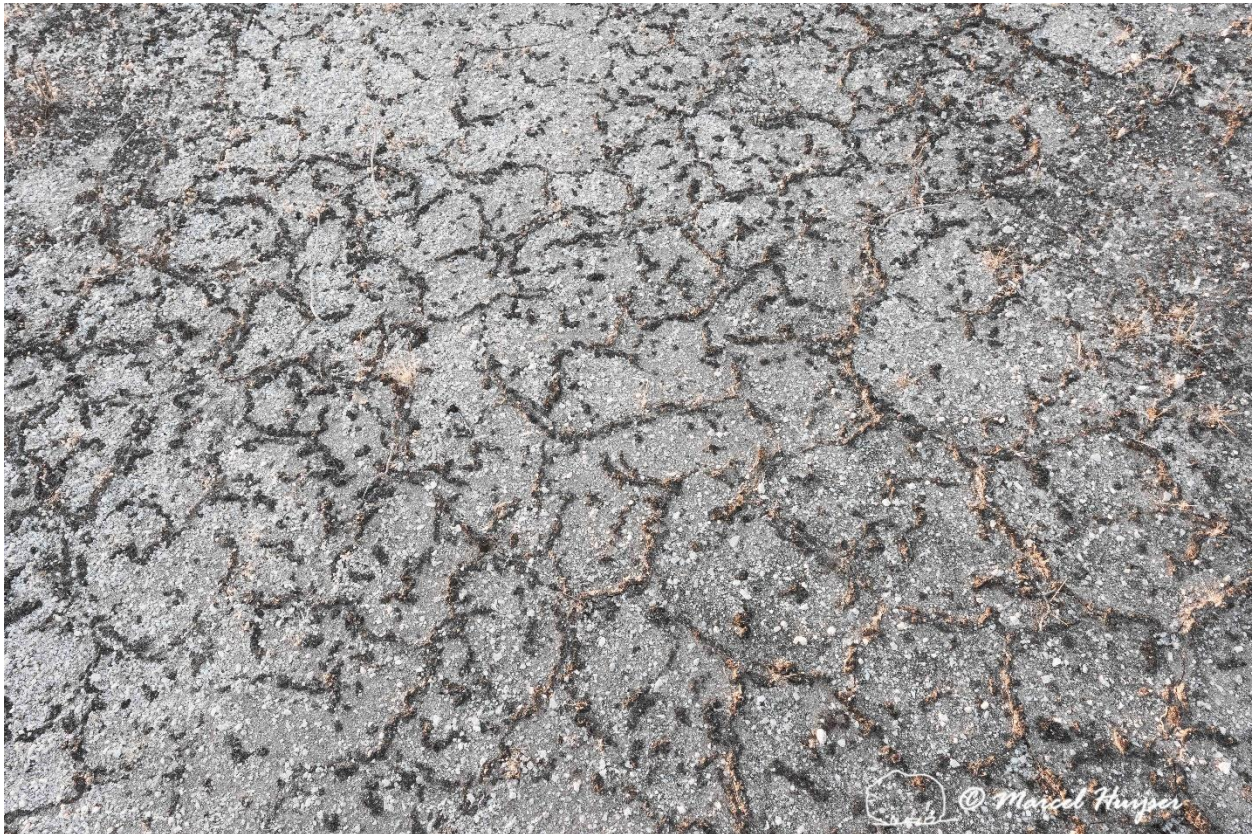
Cryptobiotic soil or biological soil crust, Barry M. Goldwater Air Force Range or Barry M. Goldwater Range (BMGR), North of Tinajas Altas, Arizona.

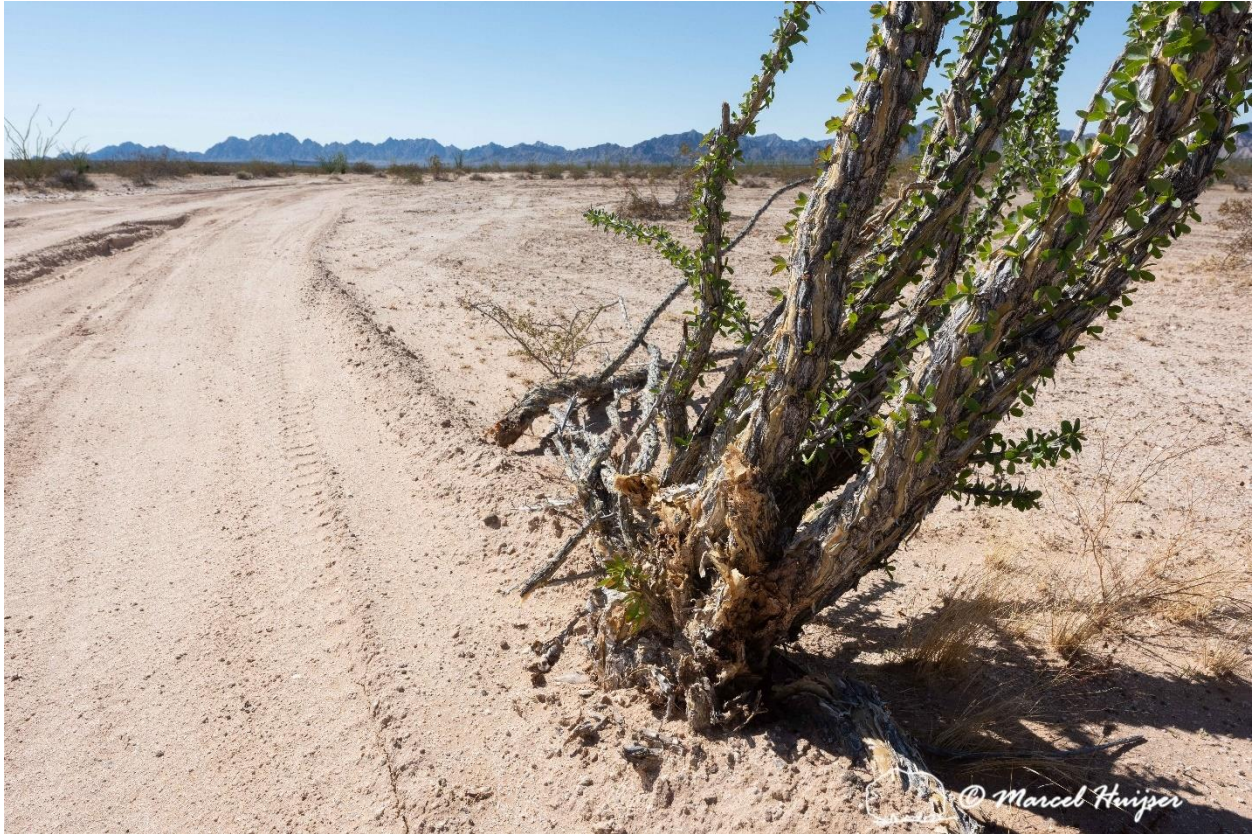
Ocotillo (*Fouquieria splendens*) damaged by vehicles, South Tordillo road looking south from El Camino del Diablo, about 4.6 miles east of the western boundary, Cabeza Prieta National Wildlife Refuge, Arizona (32°15'22.764" N 113°53'22.001" W).

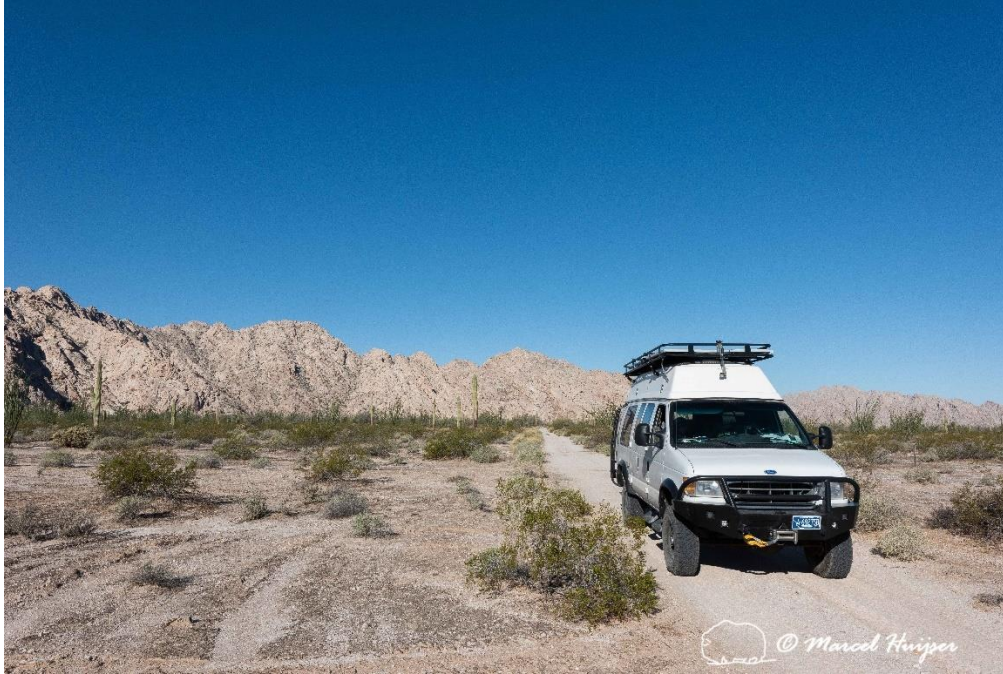
"Old" section of dirt road just west of the actual El Camino del Diablo, about 1.1 mile south-east of Tinajas Altas, Barry M. Goldwater Range (BMGR), Arizona ($32^{\circ}18'22.812''$ N $114^{\circ}1'53.916''$ W). This is the closest remaining "reference" for the "old" El Camino del Diablo west of Cabeza Prieta National Wildlife Refuge (CPNWR).

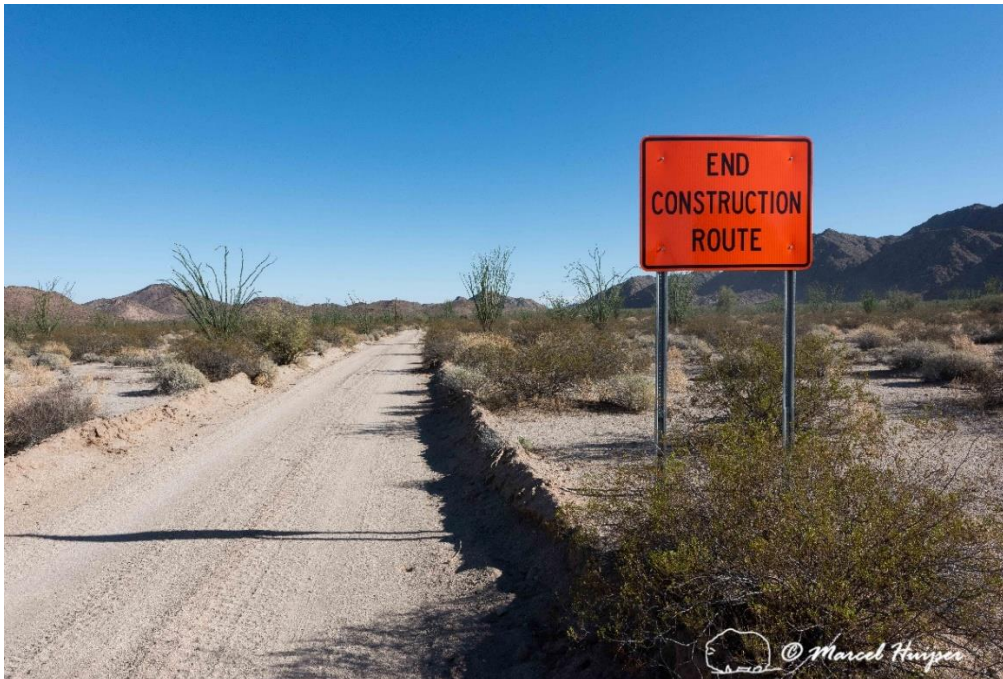
"Old" section of El Camino del Diablo just east of the junction with Tule Extension road, east of Tule Well, Cabeza Prieta National Wildlife Refuge (CPNWR), Arizona ($32^{\circ}11'55.584''$ N $113^{\circ}43'36.863''$ W). This is the closest remaining "reference" for the "old" El Camino del Diablo east of the widened road section.

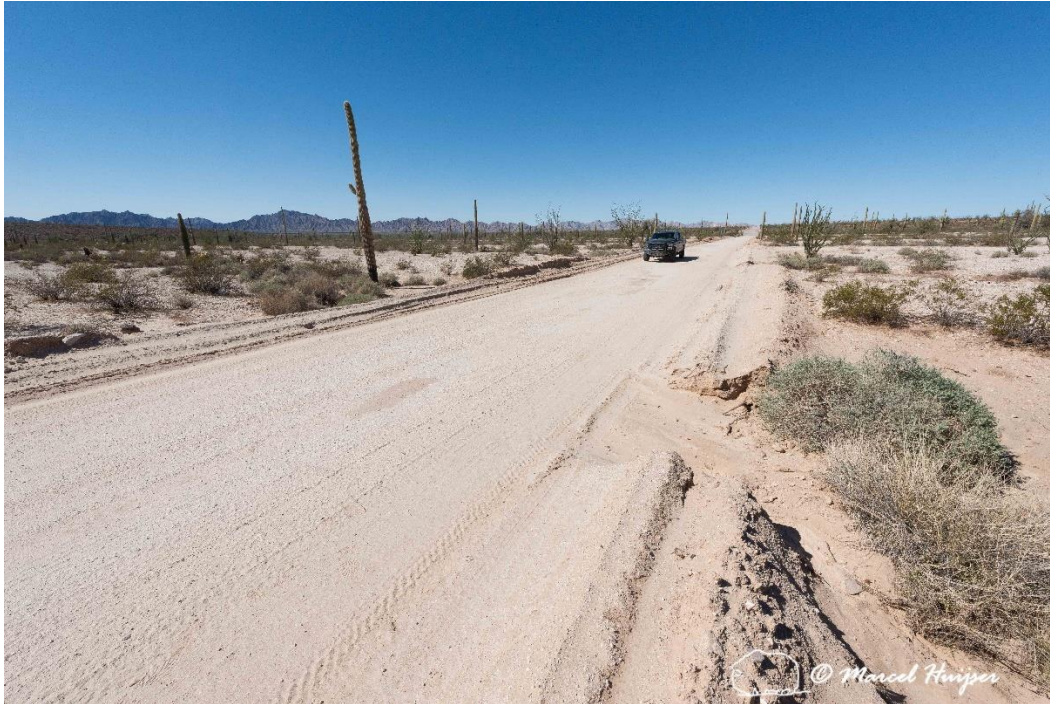
A widened section of El Camino del Diablo, about 5.5 miles east of the western boundary, Cabeza Prieta National Wildlife Refuge, Arizona ($32^{\circ}15'5.039''$ N $113^{\circ}52'30.413''$ W).

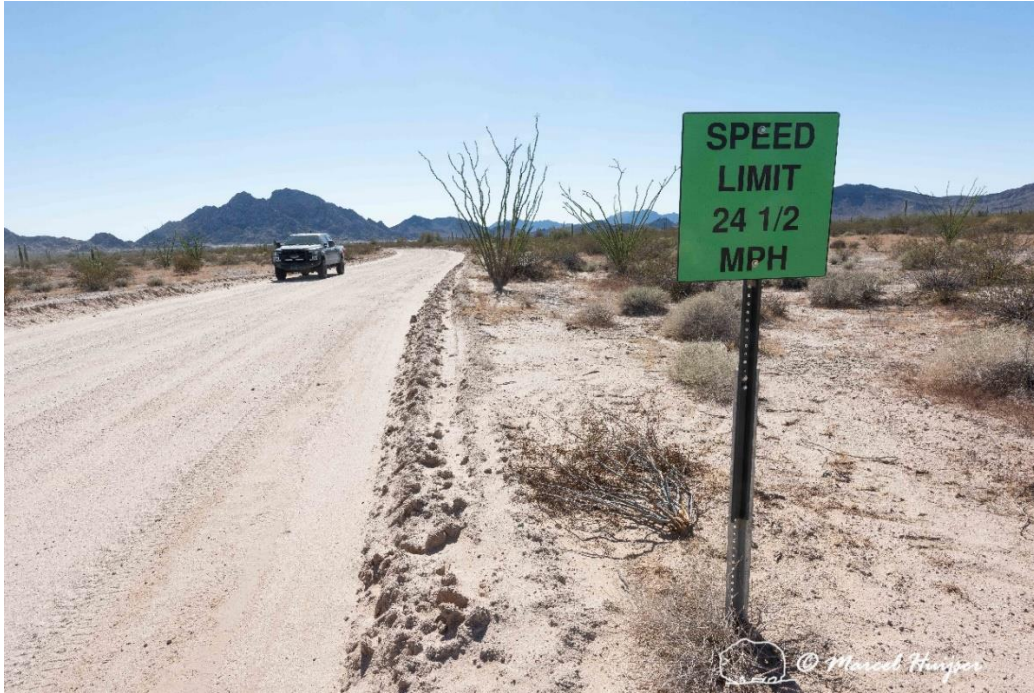
O-5 road looking south from El Camino del Diablo west of Tule Well, about 11.8 miles east of the western boundary, Cabeza Prieta National Wildlife Refuge, Arizona ($32^{\circ}13'9.041''$ N $113^{\circ}46'50.712''$ W). Similar to sections of El Camino del Diablo, this road section was also widened.

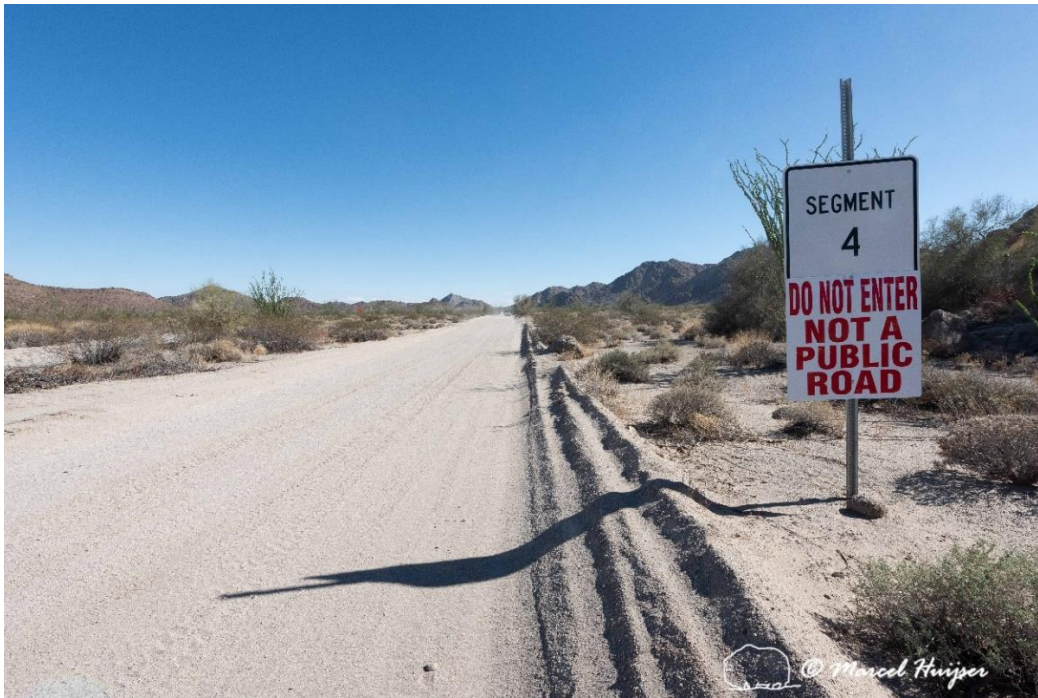
Tule Extension road looking south from El Camino del Diablo east of Tule Well, about 16.0 miles east of the western boundary, Cabeza Prieta National Wildlife Refuge, Arizona ($32^{\circ}11'57.876''$ N $113^{\circ}43'41.136''$ W). Similar to sections of El Camino del Diablo, this road section was also widened.

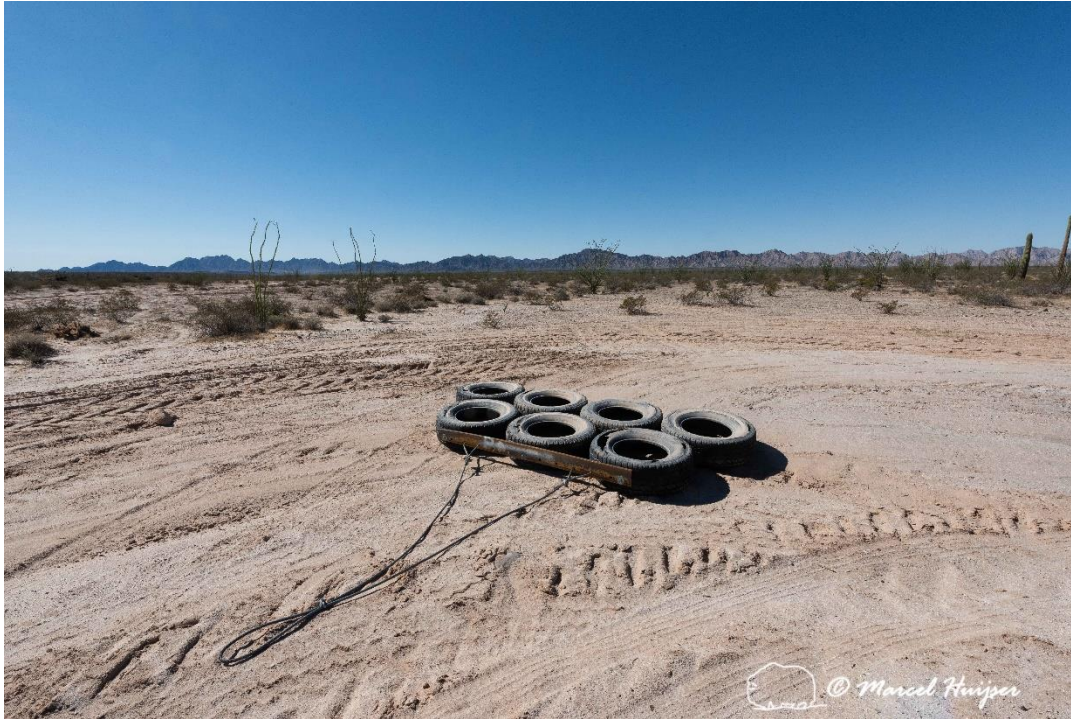
A pull-out associated with the widened El Camino del Diablo, at the junction with the South Tordillo road, about 4.6 miles east of the western boundary, Cabeza Prieta National Wildlife Refuge, Arizona ($32^{\circ}15'23.37''$ N $113^{\circ}53'22.338''$ W). Note: when in use, the tires are dragged behind a border patrol vehicle to be able to track people who may have crossed the border.

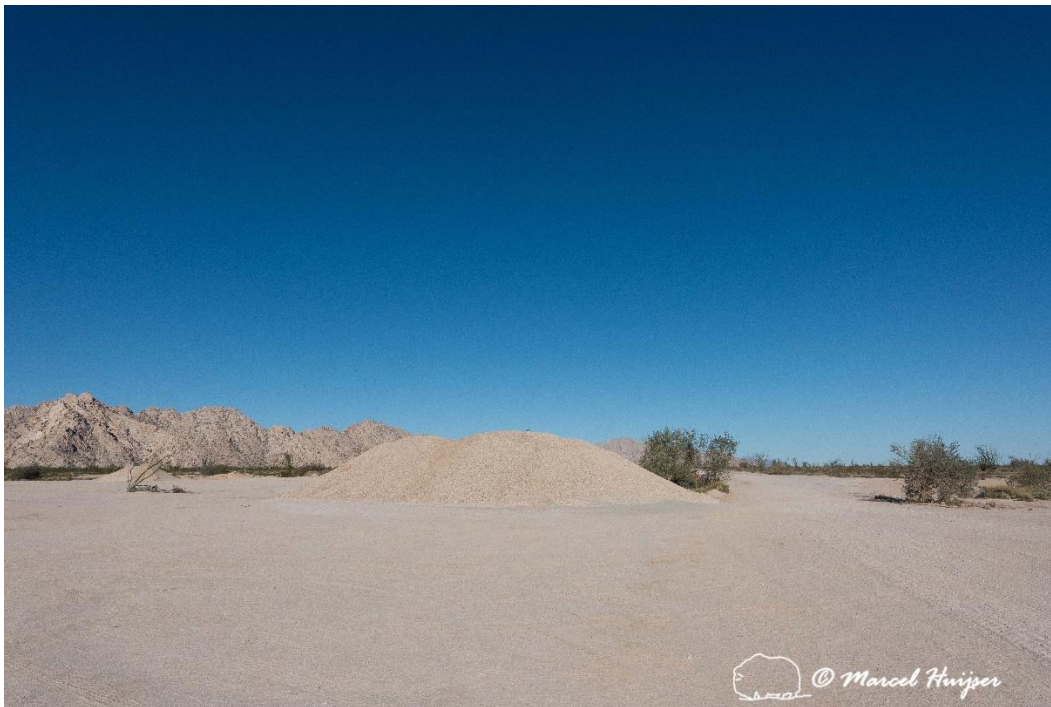
Example of a staging area for materials and equipment along a widened section of El Camino del Diablo, about 1.8 miles south-east of Tinajas Altas, Barry M. Goldwater Range West (BMGR-W), Arizona ($32^{\circ}18'8.519''$ N $114^{\circ}1'11.91''$ W).

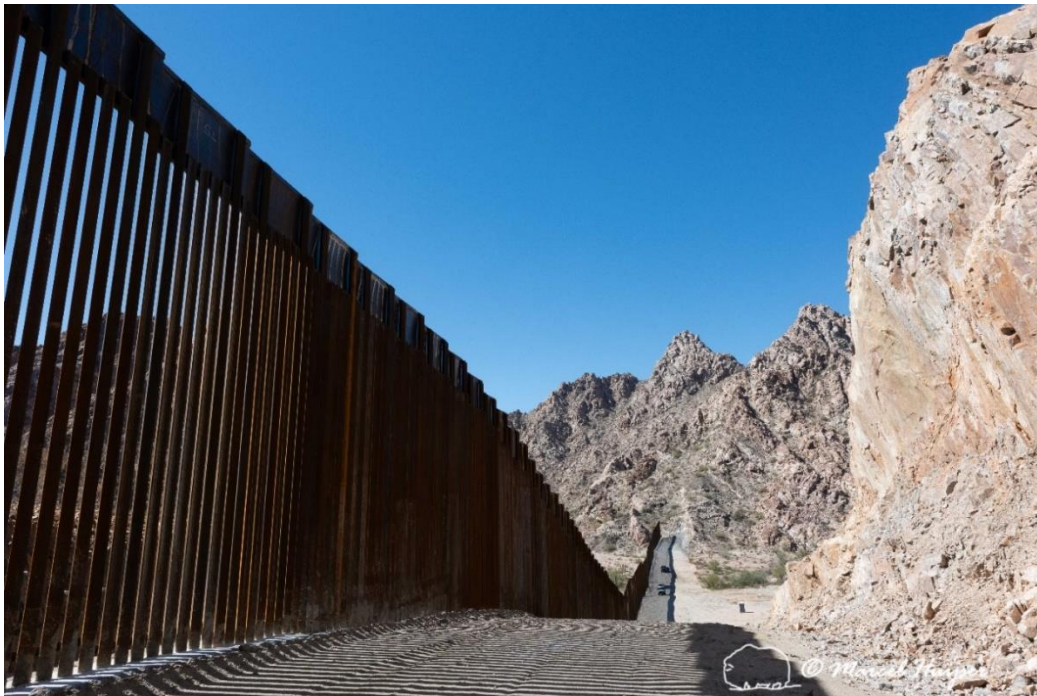
Border wall and road, south of Tule Well, at the southern end of the O-5 road, adjacent to Cabeza Prieta National Wildlife Refuge, Arizona. The Roosevelt Reservation is a 60 ft wide strip of federal land along the border that is not part of the refuge ($32^{\circ}10'46.925''$ N $113^{\circ}46'58.985''$ W), but the activities and infrastructure along the border do impact the ecology of the adjacent refuge.

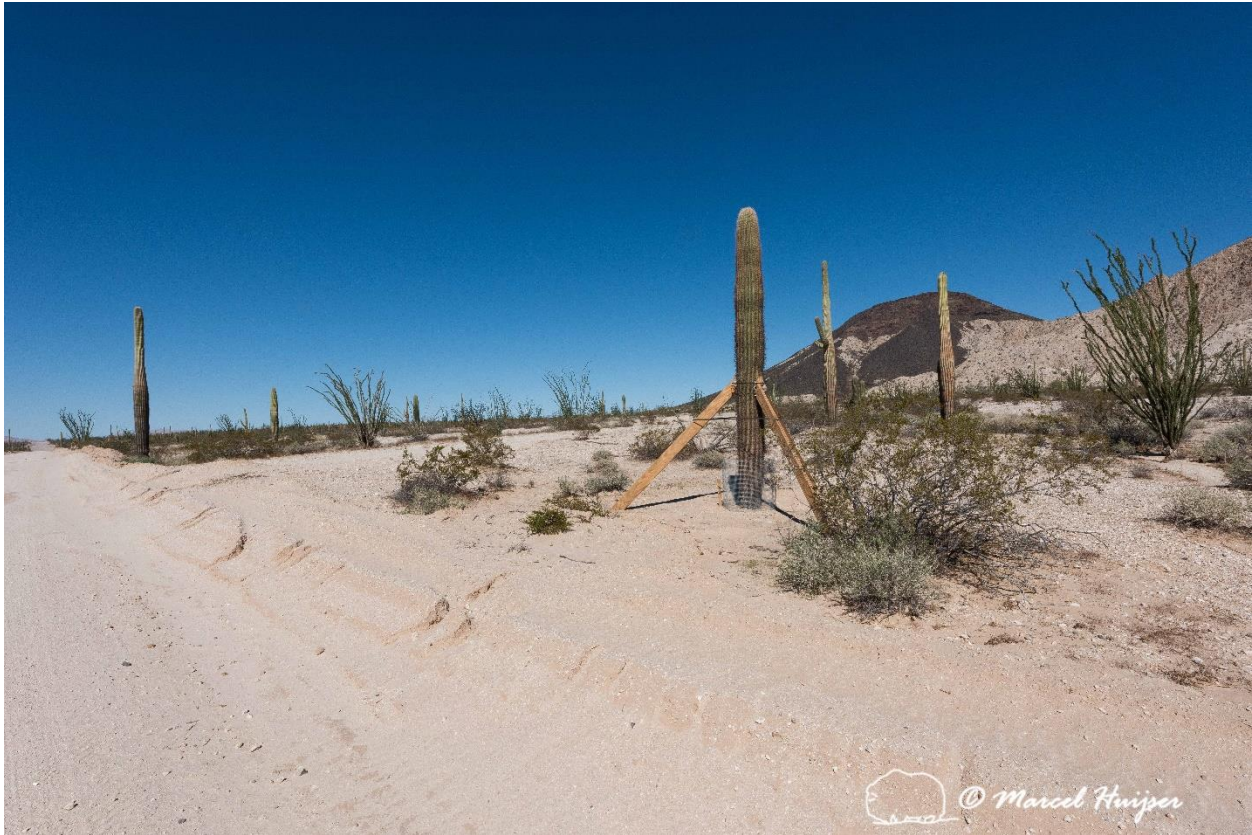
A transplanted saguaro (*Carnegiea gigantea*) that was in the path of a widened section of El Camino del Diablo east of Tinajas Altas, Cabeza Prieta National Wildlife Refuge, Arizona.

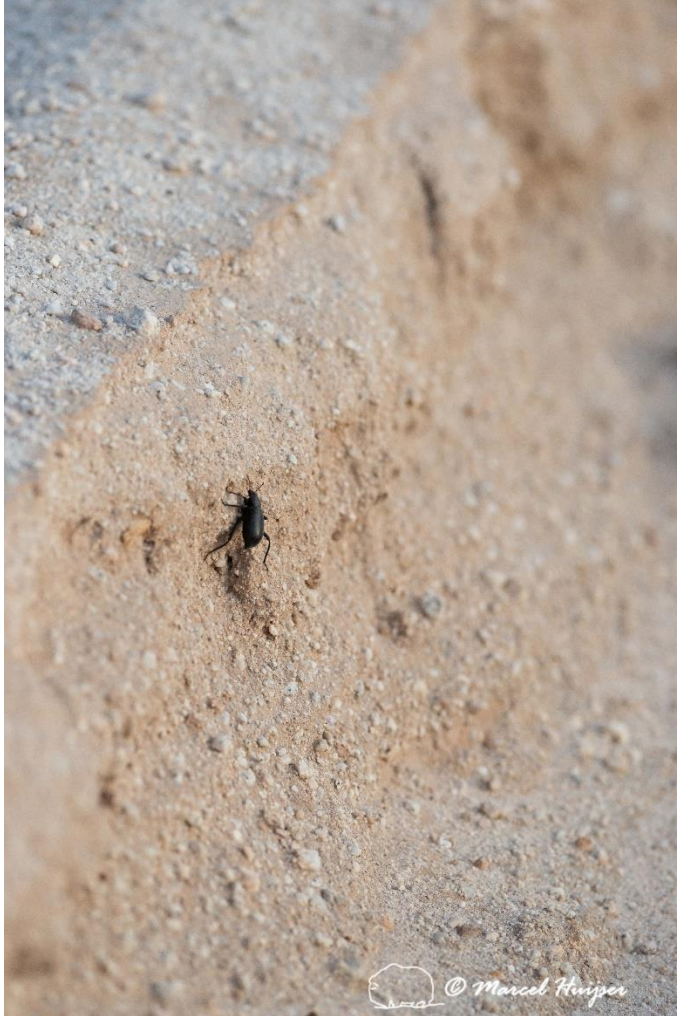
Pinacate beetle (*Eleodes* sp.) scaling a near vertical sand berm along dirt road after walking alongside the berm for several meters, El Camino del Diablo este, about 6.4 miles north of Tinajas Altas, Barry M. Goldwater Range West (BMGR-W), Arizona (32°24'9.234" N 114°4'22.134" W).

The berms are partly the result of grading the dirt road (for the widening itself and for maintenance), and partly the result of erosion as water collects on the road and then flows down the road instead of in being transported in desert washes. Berms caused by grading stick out both above the road and above the surrounding landscape. Berms caused by erosion stick about above the road, but are mostly level with the surrounding landscape, indicating that soil has been “removed” from the roadbed. In some instances, berms caused primarily by one activity or process are exacerbated by the other. Note that there are also berms along the “old” El Camino del Diablo in some sections, mostly because of erosion. While erosion occurs along sections of both the old and the widened El Camino del Diablo, grading is restricted to the widened sections, and since grading is applied along the entire length of these road sections, the berms are present nearly everywhere along the widened road, over great lengths.

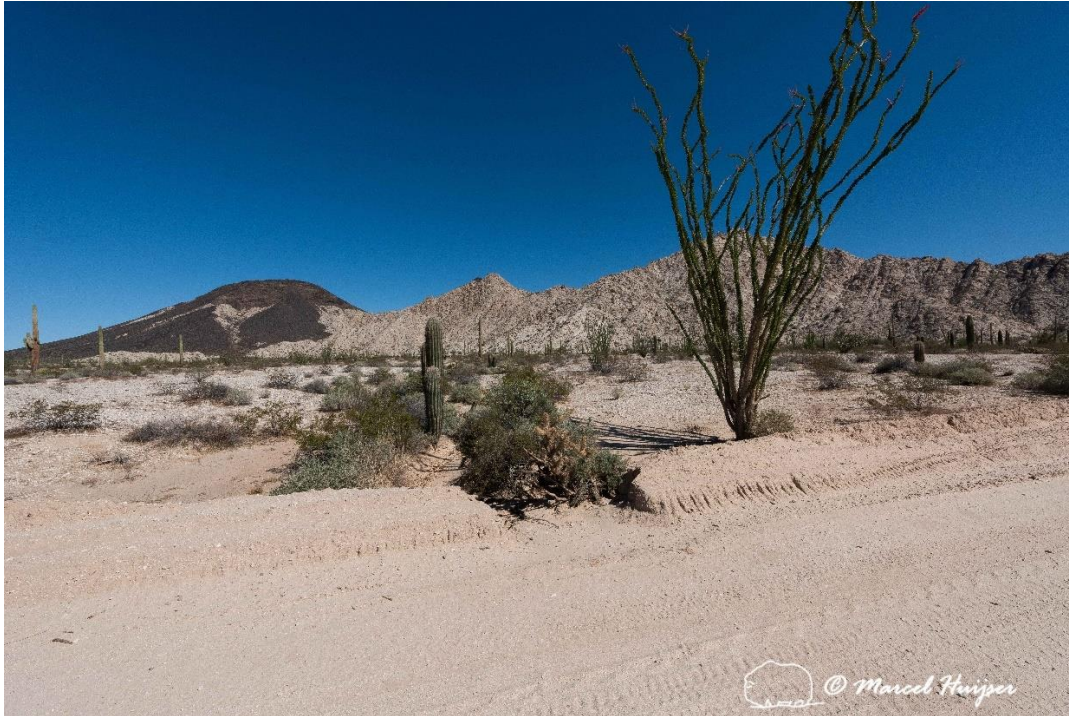
Berm (1-2 ft tall), primarily caused by grading, along a widened section of El Camino del Diablo, about 5.5 miles east of western boundary, Cabeza Prieta National Wildlife Refuge, Arizona ($32^{\circ}15'4.506''$ N $113^{\circ}52'29.273''$ W).

Another strategy aimed at reducing the footprint of the road, reducing the barrier effect of the road, and restoring sheet flow, is to address the berms caused by grading. Berms from grading stick up above the road surface and above the surrounding landscape. In some areas these berms are more than a foot wide, and they can be more than a foot high as well. If the berms only stick out above the roadbed and not above the landscape, then the berms are caused by erosion and would require a different treatment.

Berms caused by grading can be flattened to be level with the roadbed and surrounding areas. However, simply flattening these berms, without associated habitat restoration, would effectively widen the road surface. Combining restoration (see next section) with the effort to flatten berms can reduce the overall footprint of the road as the area formerly occupied by the berms would become natural habitat. The purpose of this tactic is to “bring the desert to the edge of the road”. Of course, this is only possible if there will be no future grading or grading-associated berms.

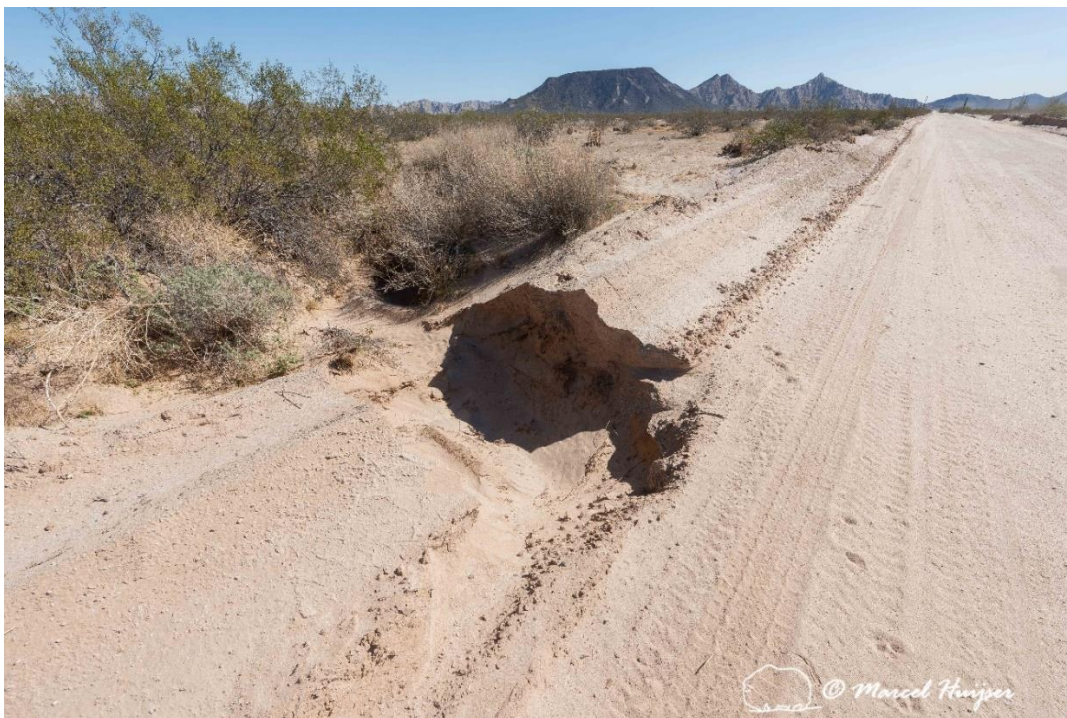
Berm (1-2 ft tall), primarily caused by grading, with runoff eroding across the berm, along a widened section of El Camino del Diablo about 3.1 miles from western boundary, Cabeza Prieta National Wildlife Refuge, Arizona ($32^{\circ}15'53.004''$ N $113^{\circ}54'42.503''$ W).

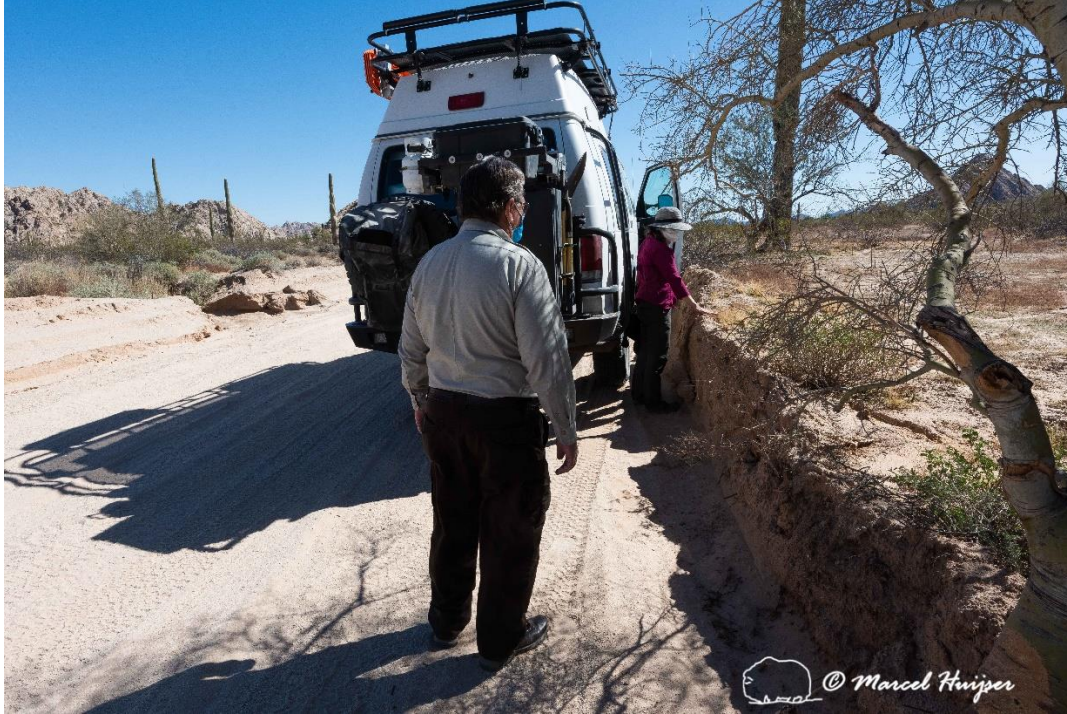
Berm (about 2.5 ft tall), primarily caused by erosion, along a widened section of El Camino del Diablo, about 7.3 miles from western boundary, Cabeza Prieta National Wildlife Refuge, Arizona ($32^{\circ}14'48.906''$ N $113^{\circ}50'47.453''$ W).

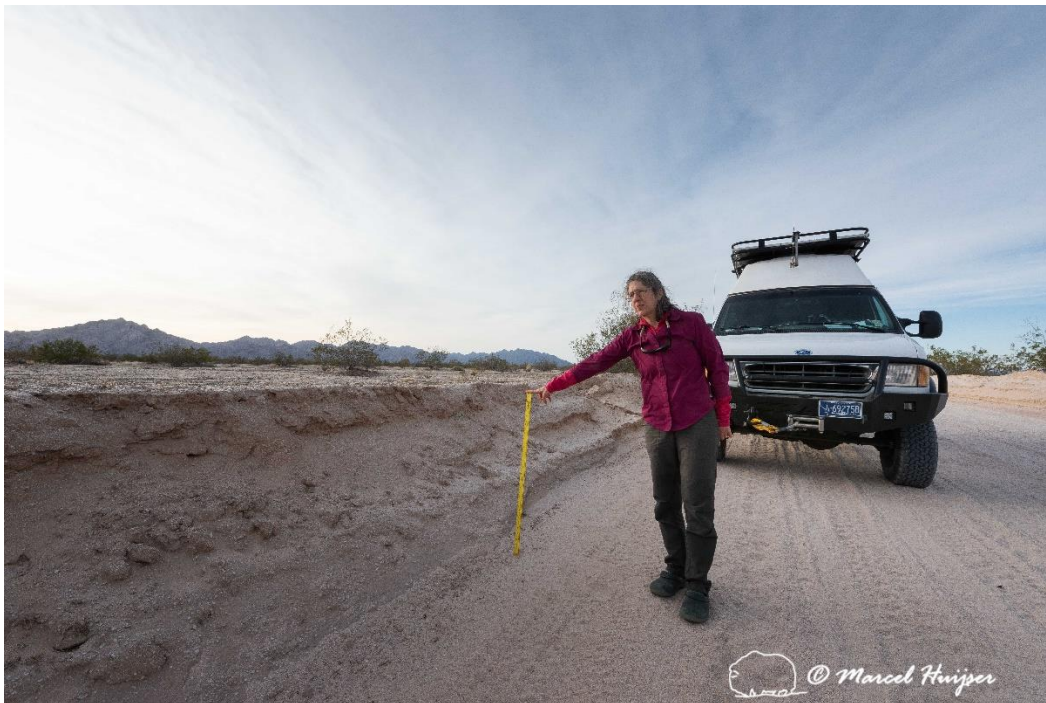
Berm (over 3 ft tall), primarily caused by erosion, but initiated by grading, along a widened section of El Camino del Diablo, about 10.3 miles north of Tinajas Altas, Barry M. Goldwater Range West (BMGR-W), Arizona ($32^{\circ}27'14.837''$ N $114^{\circ}5'57.467''$ W).

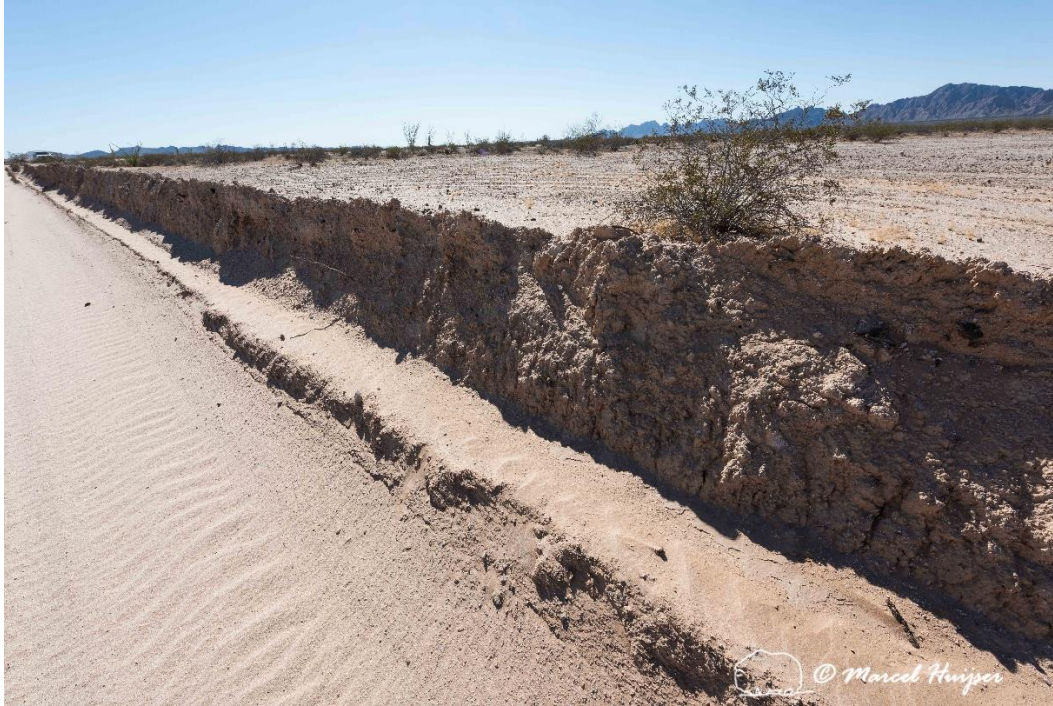
Berm, primarily caused by erosion, but initiated by grading, along a widened section of El Camino del Diablo, about 2.0 miles from western boundary, Cabeza Prieta National Wildlife Refuge, Arizona ($32^{\circ}16'15.09''$ N $113^{\circ}55'45.827''$ W).

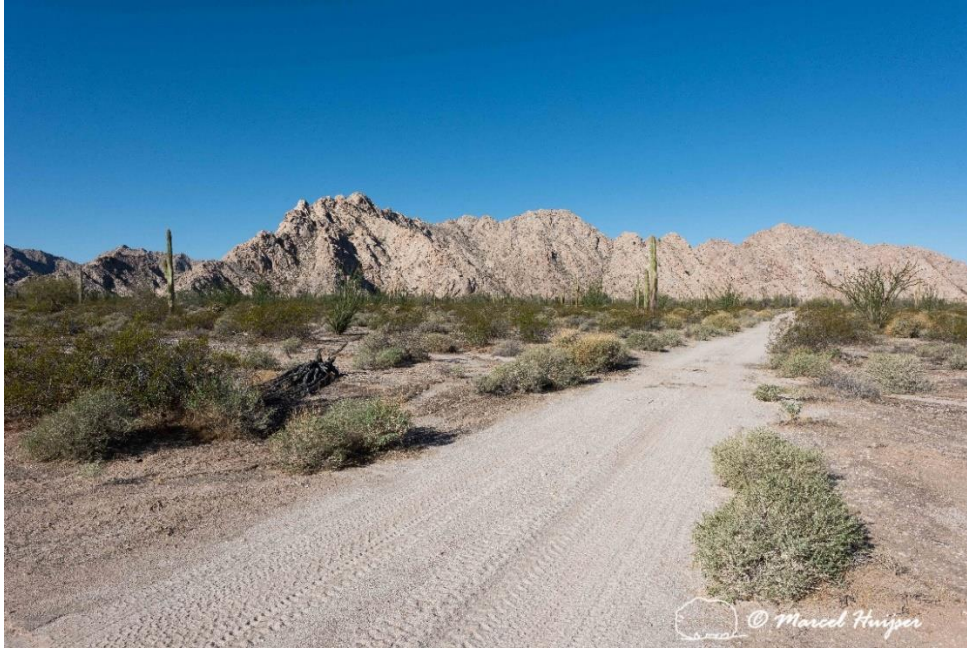
"Old" section, just west of El Camino del Diablo, about 1.1 mile south-east of Tinajas Altas, Barry M. Goldwater Range West (BMGR-W), Arizona ($32^{\circ}18'23.267''$ N $114^{\circ}1'54.749''$ W). This is the closest remaining "reference" for the "old" El Camino del Diablo west of Cabeza Prieta National Wildlife Refuge (CPNWR). Sheet flow crosses the road, no or little water flows down the road, no or little erosion.

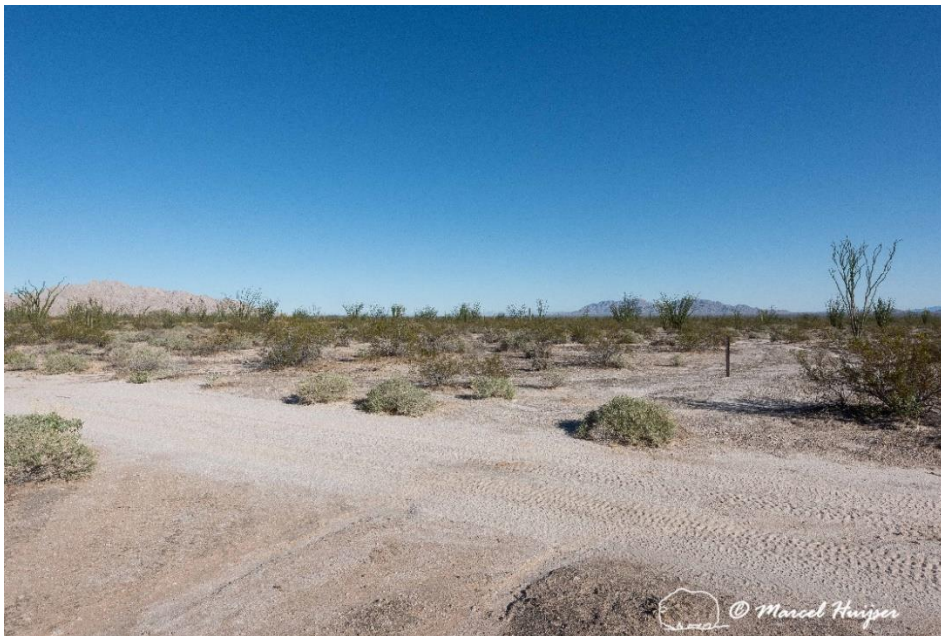
"Old" section, just west of El Camino del Diablo, about 1.1 mile south-east of Tinajas Altas, Barry M. Goldwater Range West (BMGR-W), Arizona ($32^{\circ}18'22.997''$ N $114^{\circ}1'54.851''$ W). This is the closest remaining "reference" for the "old" El Camino del Diablo west of Cabeza Prieta National Wildlife Refuge (CPNWR). A small desert wash crosses the road, no or little water flows down the road, no or little erosion.

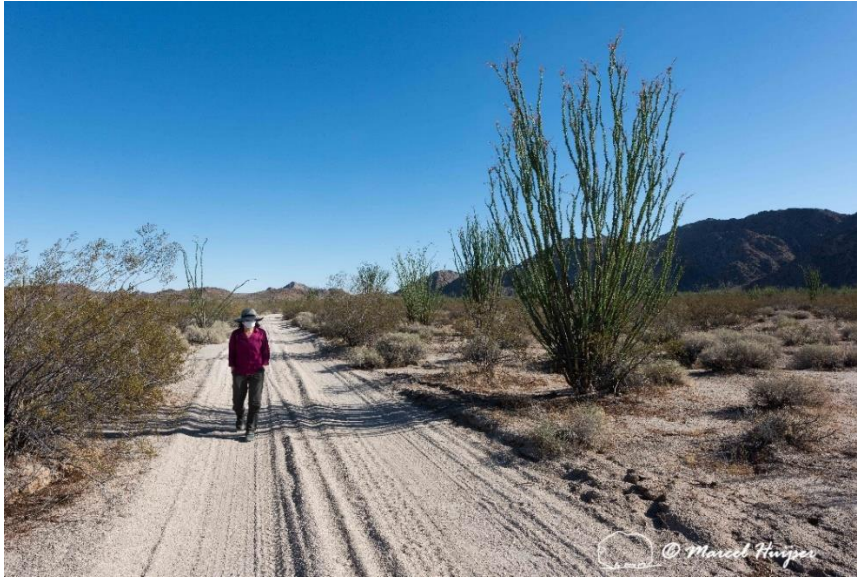
“Old” section of El Camino del Diablo east of Tule Well, about 0.4 miles south-east of the junction with the Tule Extension road, Cabeza Prieta National Wildlife Refuge (CPNWR), Arizona. This is the closest remaining “reference” for the “old” El Camino del Diablo east of the widened section of El Camino del Diablo ($32^{\circ}11'47.231''$ N $113^{\circ}43'22.59''$ W). Sheet flow crosses the road, no or little water flows down the road, no or little erosion.

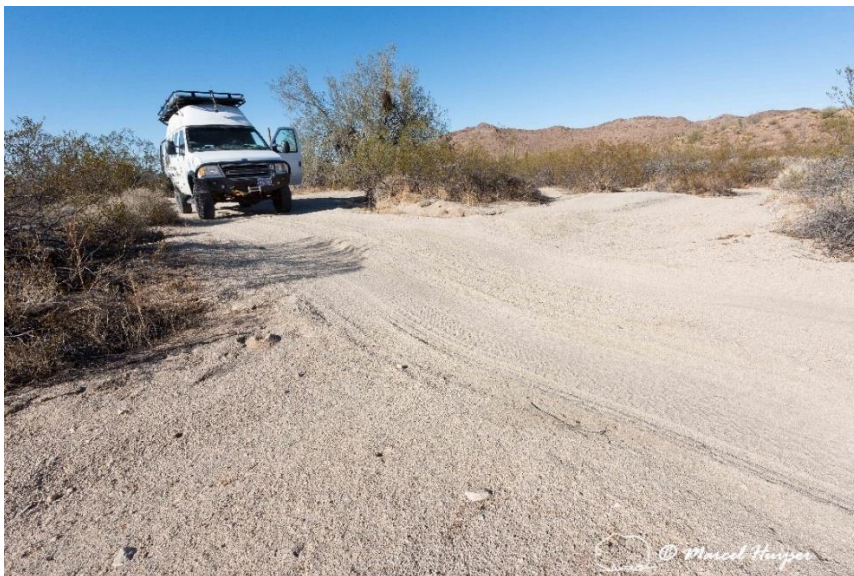
Rolling dip (possibly natural topography rather than constructed) along the "old" section of El Camino del Diablo east of Tule Well, about 1.0 mile south-east of the junction with the Tule Extension road, Cabeza Prieta National Wildlife Refuge (CPNWR), Arizona ($32^{\circ}11'26.58''$ N $113^{\circ}42'54.149''$ W). This allows water to cross the road rather than flow down the road. It minimizes the connection between the road system and the hydrological system. It results in no or minimal flooding and erosion on the road and it has minimal impact on natural hydrology, erosion, and sedimentation processes. This is the closest remaining “reference” for the “old” El Camino del Diablo east of the widened section of El Camino del Diablo.

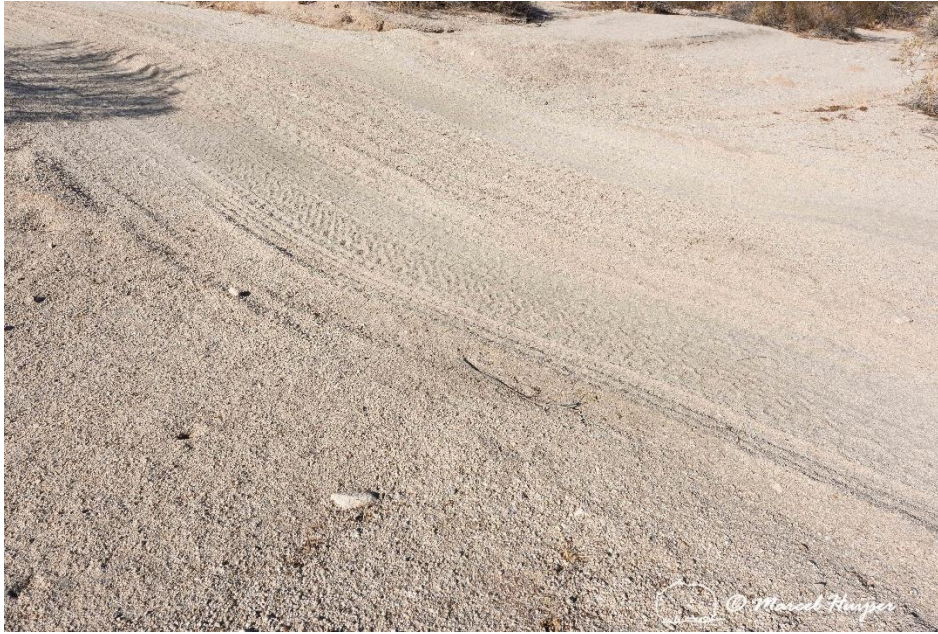
Detail of a rolling dip (possibly natural topography at the wash crossing rather than constructed) along the "old" section of El Camino del Diablo east of Tule Well, about 1.0 mile south-east of the junction with the Tule Extension road, Cabeza Prieta National Wildlife Refuge (CPNWR), Arizona ($32^{\circ}11'26.573''$ N $113^{\circ}42'54.144''$ W).

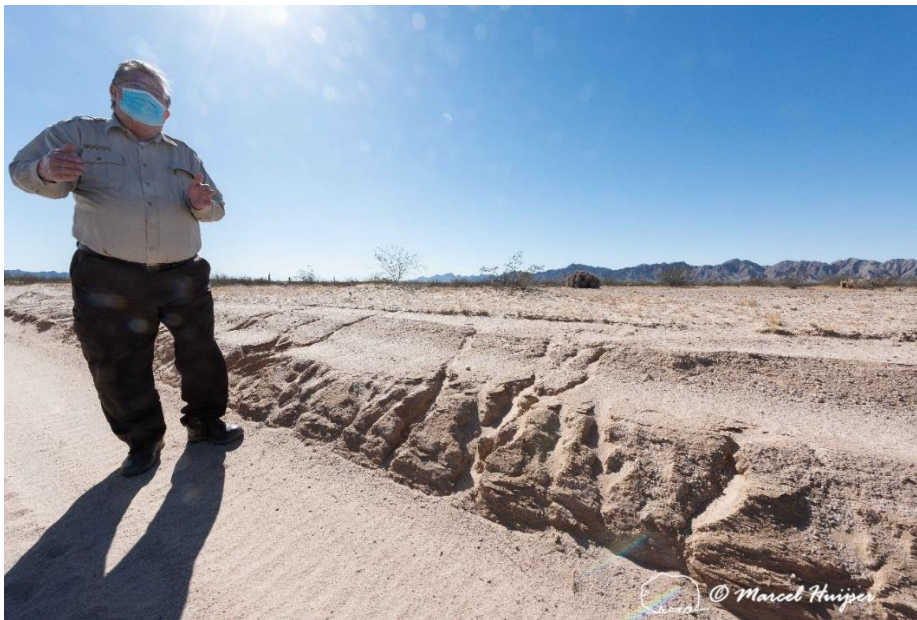
Berm with evidence of sheet flow entering the lower roadbed, primarily caused by grading, along a widened section of El Camino del Diablo, about 1.1 mile from the western boundary, Cabeza Prieta National Wildlife Refuge, Arizona ($32^{\circ}16'32.286''$ N $113^{\circ}56'36.048''$ W). Ideally the sheet flow should continue on the other side of the road. Because the road is incised (because of a combination of grading and erosion), this can no longer happen. Instead the water concentrates on the road until it breaks through the berm on the other side and forms a small or large desert wash. Other areas on the "downslope side" of the road no longer receive sheet flow.

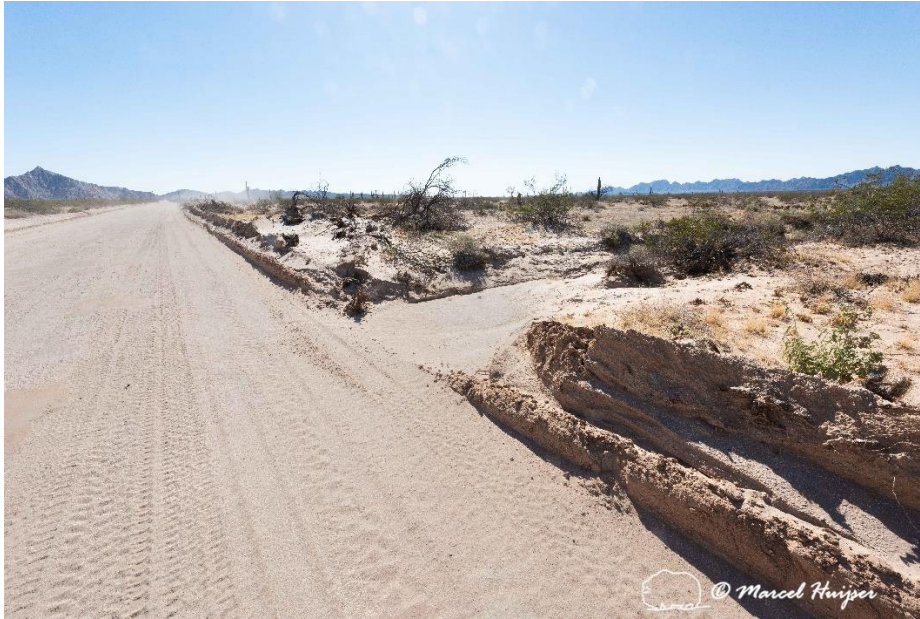
A small desert wash enters the roadbed, along a widened section of El Camino del Diablo, about 3.1 miles from the western boundary, Cabeza Prieta National Wildlife Refuge, Arizona ($32^{\circ}15'52.896''$ N $113^{\circ}54'42.785''$ W). Ideally, the wash should exit the road on the other side and not somewhere else down the road.

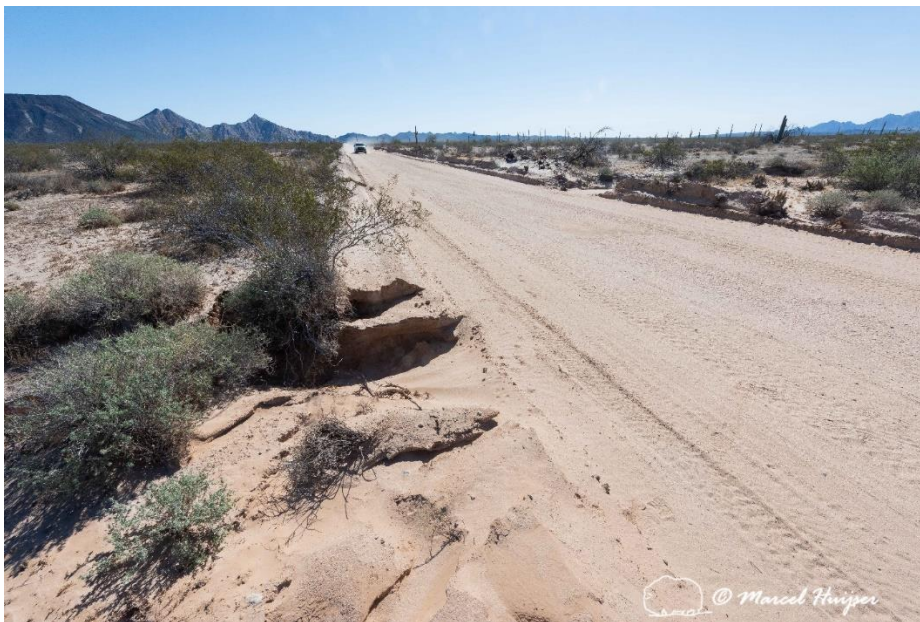
Water has left the road by eroding through a berm (primarily caused by grading) along a widened section of El Camino del Diablo, about 3.1 miles from the western boundary, Cabeza Prieta National Wildlife Refuge, Arizona ($32^{\circ}15'53.261''$ N $113^{\circ}54'43.038''$ W). This results in new desert washes on the downslope side, and other areas on the downslope side no longer receive sheet flow. The original wash also no longer receives the same amount of water on the downstream side of the road.

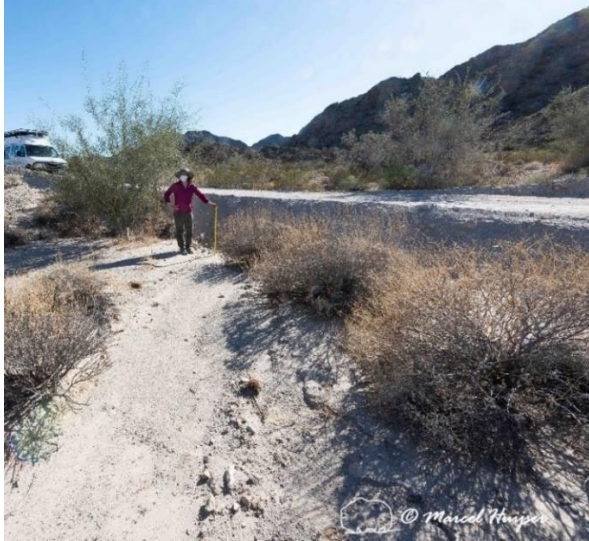
Desert wash blocked by a roadbed that is more than 3 ft above the wash bottom along a widened road section, Tule Extension road, about 1.9 miles south-east of the junction with El Camino del Diablo, Cabeza Prieta National Wildlife Refuge, Arizona (32°10'43.314" N 113°42'23.165" W). The roadbed and associated fill blocks the natural flow of water in the desert wash, acting as a dam across the wash. With large rain events, the wash may saturate and blow out the roadbed material. This threatens the integrity and functionality of the road, and has the potential to completely block access if the road fails completely at this point. Alternately, deep channels could cut through the roadbed creating a safety hazard for unsuspecting drivers.

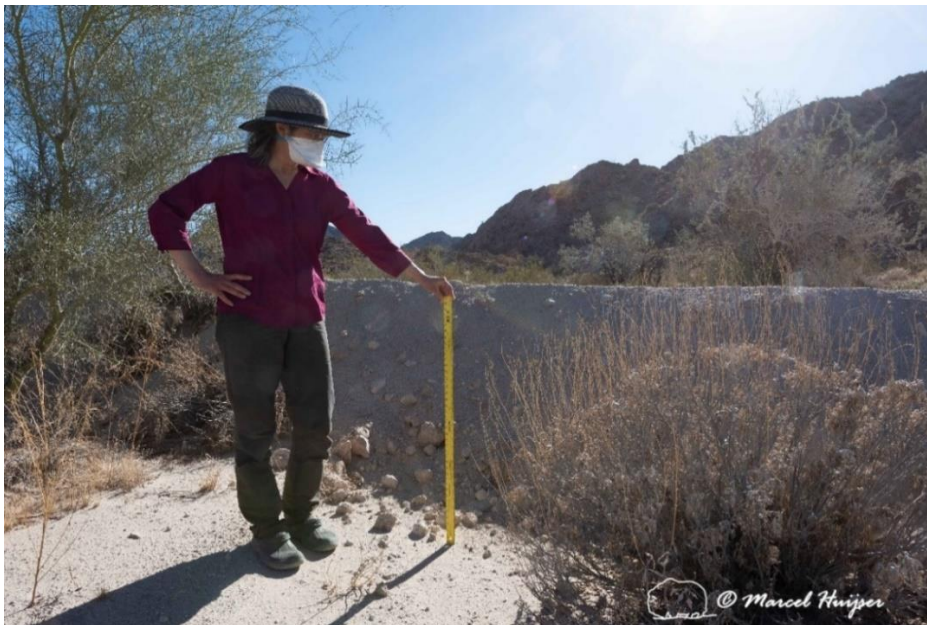
Desert wash blocked/dammed by a roadbed over 3 ft tall, widened road section, Tule Extension road, about 1.9 miles south-east of the junction with El Camino del Diablo, Cabeza Prieta National Wildlife Refuge, Arizona (32°10'43.164" N 113°42'23.184" W). This is a detail of the previous image.

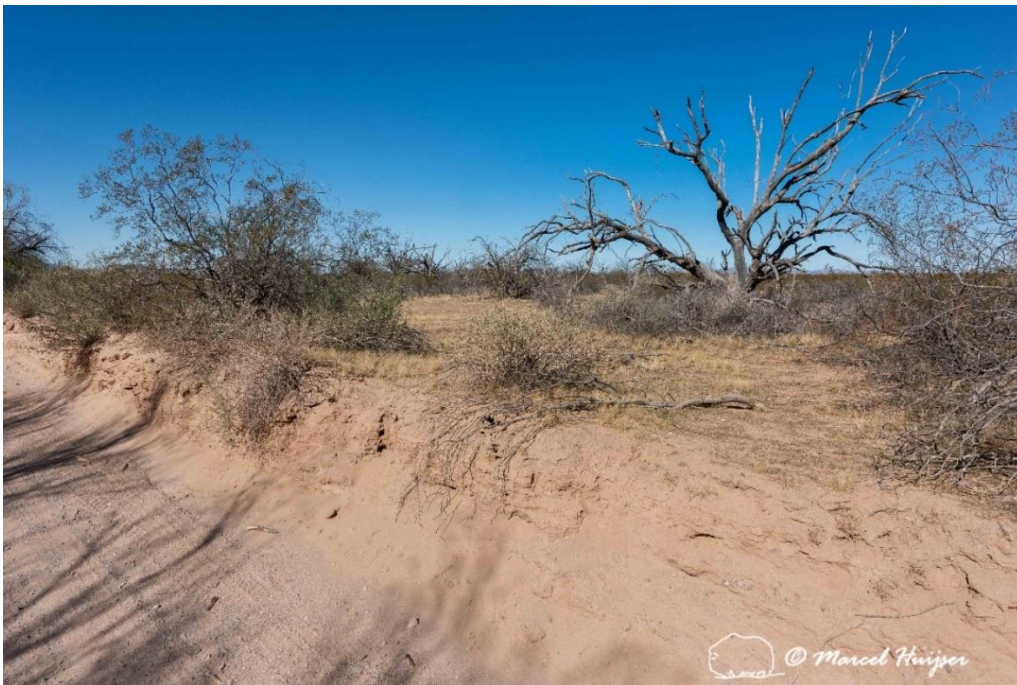
Deeply eroded and incised road, collecting sheet flow and starving the downslope vegetation from water (dead trees), along Bates-Well road, Organ Pipe Cactus National Monument, Arizona (32°8'39.63" N 113°2'49.319" W).
