**Ecological impacts of new and upgraded dirt roads in
Cabeza Prieta National Wildlife Refuge and avoidance,
mitigation and compensation strategies**

A report prepared for the
U.S. Fish & Wildlife Service,
Headquarters Office, Transportation Branch,
5275 Leesburg Pike, Falls Church, VA 22041

15 December, 2021

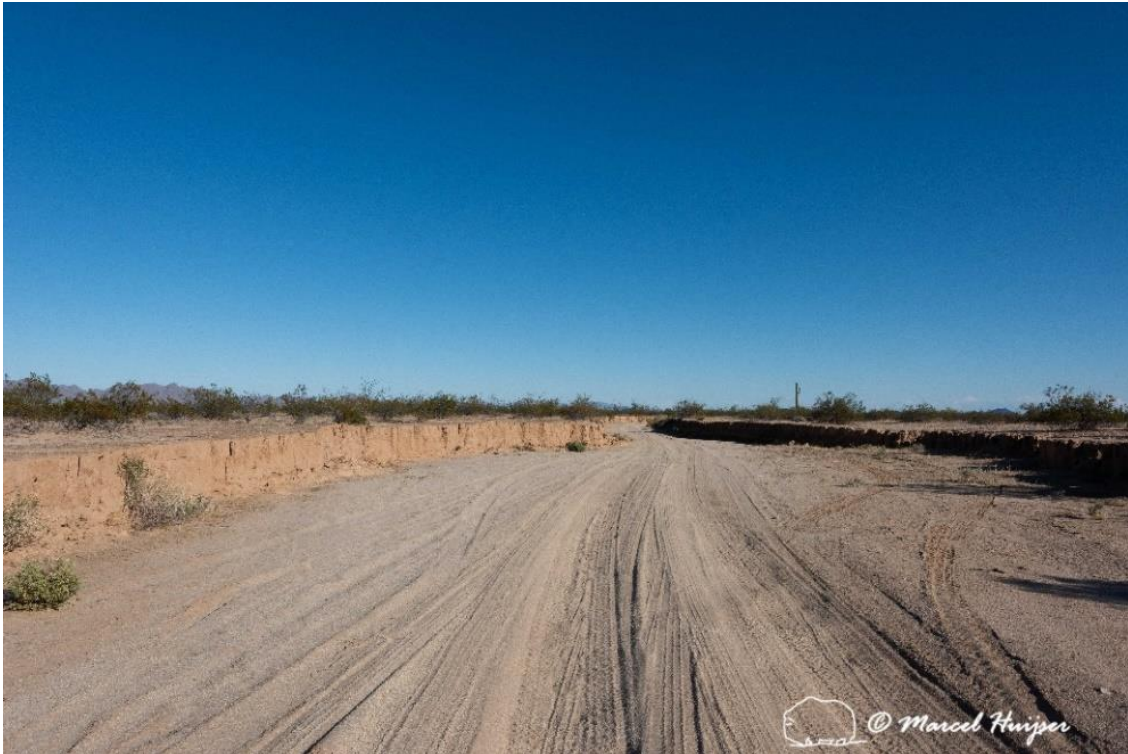
Heavily eroded section of the "old" section of El Camino del Diablo east of Tule Well, about 7.3 miles south-east of the junction with the Tule Extension road, Cabeza Prieta National Wildlife Refuge (CPNWR), Arizona (32°9'23.58" N 113°37'23.082" W). Water enters the road somewhere "upslope" flows down the road, and causes heavy erosion of the road, leaving the roadbed several feet (around 3 ft) lower than the surrounding area. As time passes and more rain events occur, the erosion and incision worsen, and the incision deepens and widens, also causing a widening footprint of the road. Flooding and erosion threaten the integrity of the road and likely encourage people to drive around, avoiding the inundated road section. This results in a "braided" road corridor with an ever-increasing footprint of the road corridor (increasing width), erosion, and disruption of the natural hydrology and erosion and sedimentation processes.

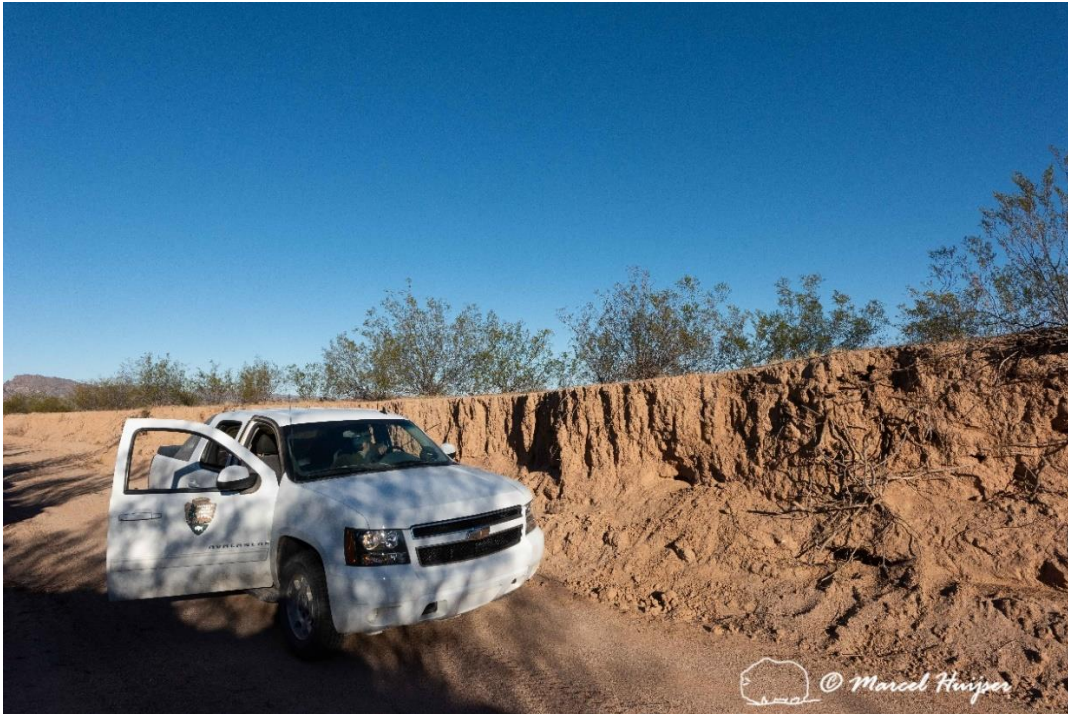
Deeply eroded and incised road (over 6 ft) near Cuerda de Leña and Kuakatch wash. Organ Pipe Cactus National Monument, Arizona (32°12'1.764" N 112°52'1.968" W).

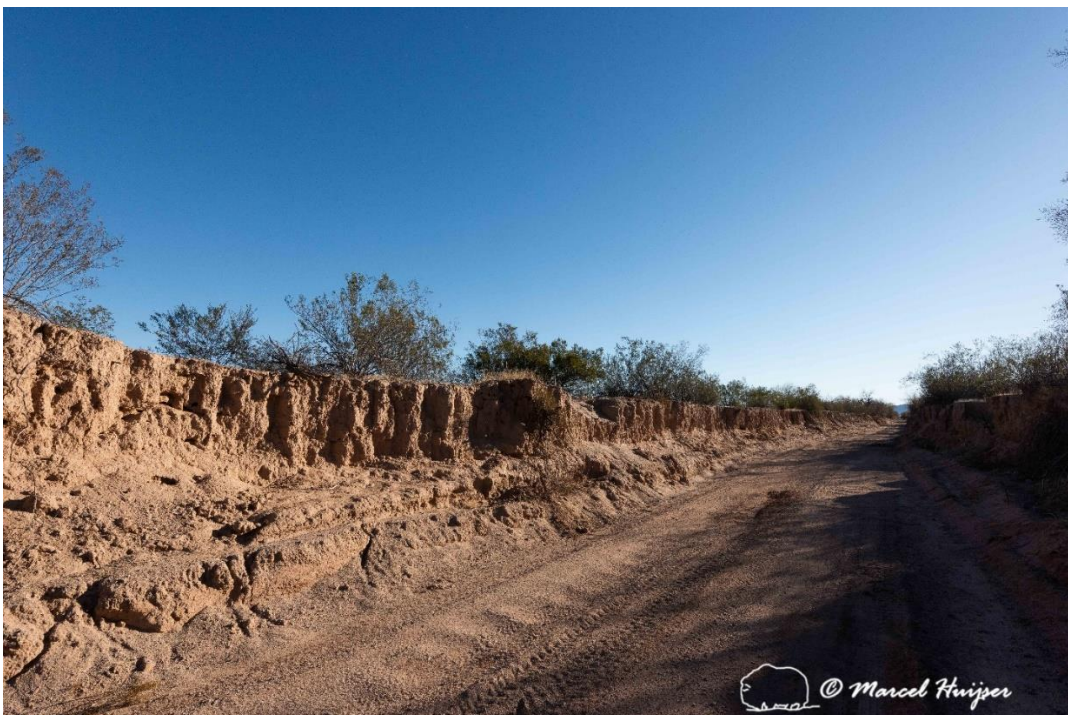
Deeply eroded and incised road (over 6 ft) near Cuerda de Leña and Kuakatch wash. Organ Pipe Cactus National Monument, Arizona (32°12'1.847" N 112°52'2.088" W).

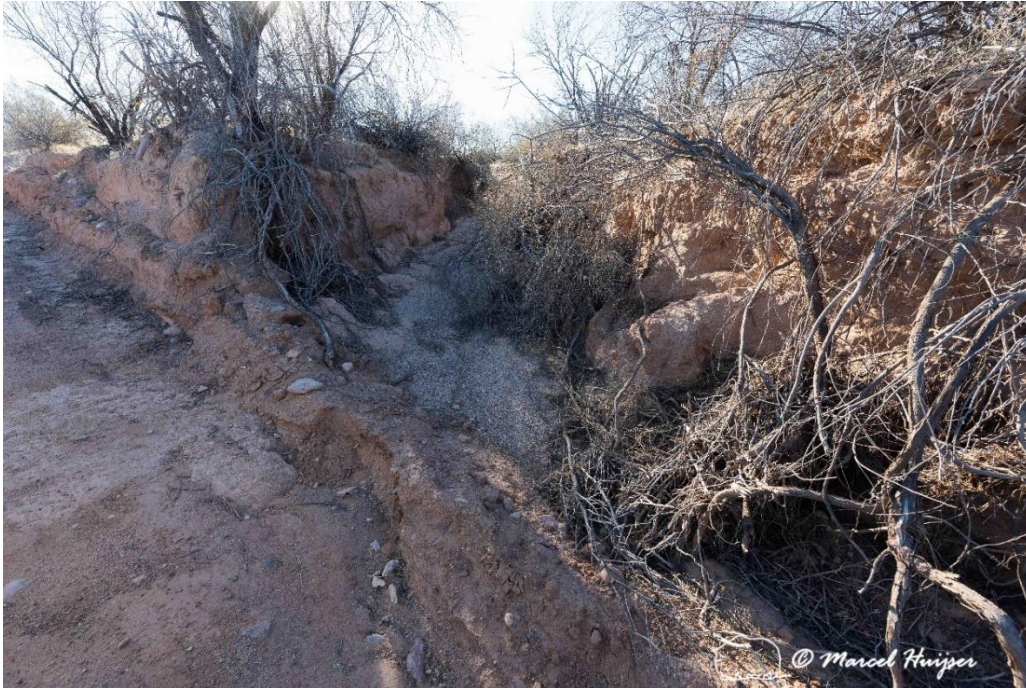
Deeply eroded side channel funneling water into incised road near Cuerda de Leña and Kuakatch wash. Organ Pipe Cactus National Monument, Arizona ($32^{\circ}12'1.836''$ N $112^{\circ}51'39.059''$ W). The incised road and the side channel get wider over time, and the side channels eat further and further into the area adjacent to the road.

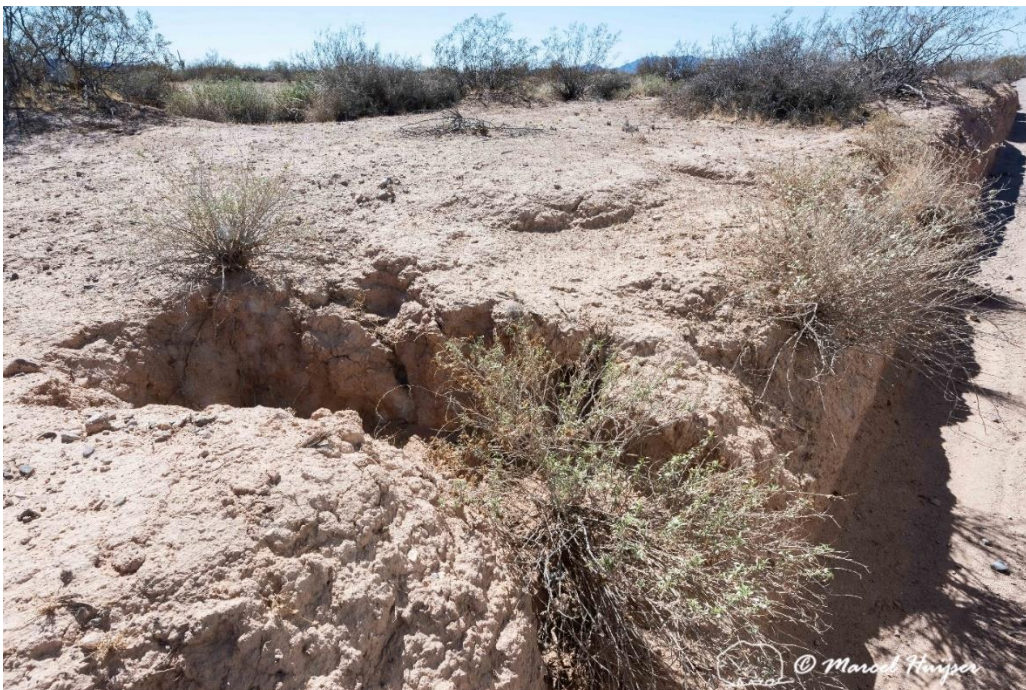
A side channel forms along heavily eroded and incised road, along Bates-Well road, Organ Pipe Cactus National Monument, Arizona ($32^{\circ}8'58.097''$ N $113^{\circ}2'6.245''$ W). The side channel will progress further and further from the road, while also widening and deepening.

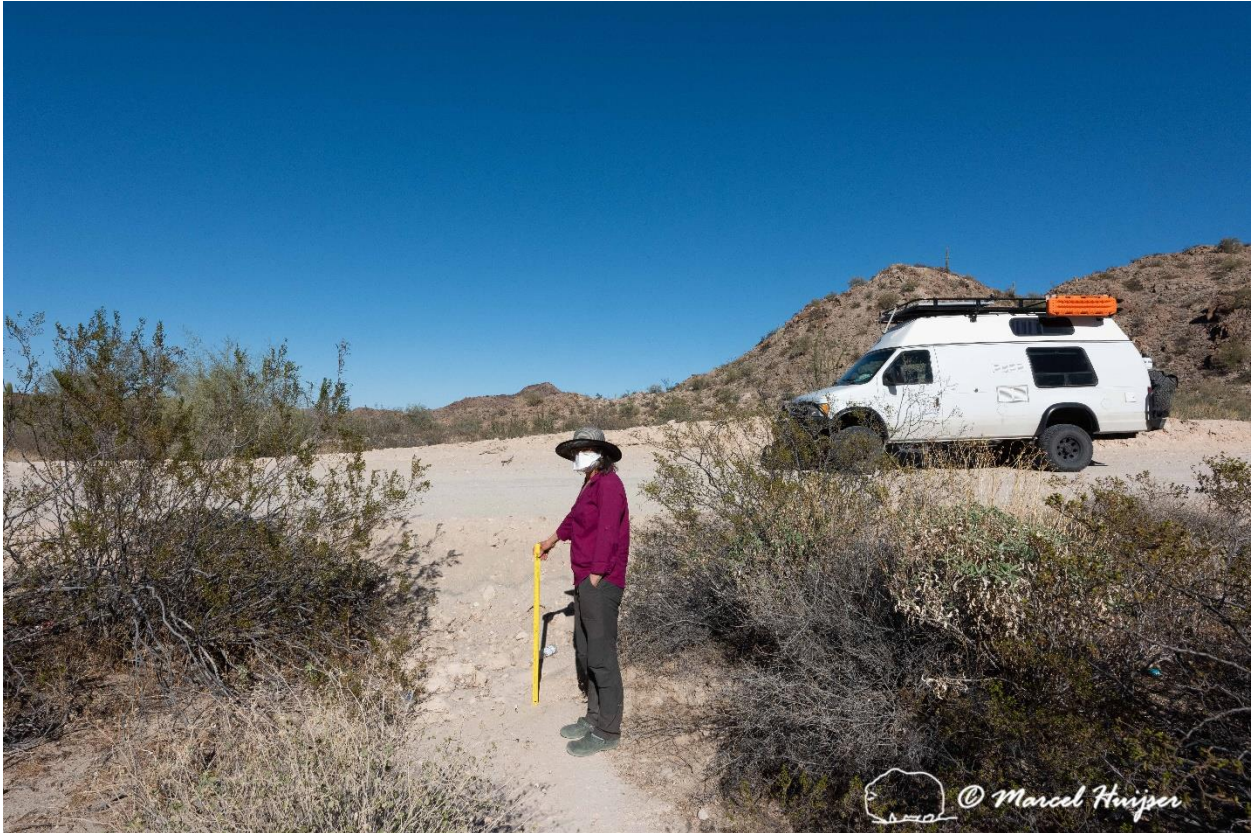
6. Potential for deep channels to form during and just after rain events where the roadbed has filled a wash. When this happens, it is likely a safety hazard for unsuspecting drivers.

Desert wash blocked by a roadbed over 3 ft tall along a widened road, Tule Extension road, about 1.9 miles south-east of the junction with El Camino del Diablo, Cabeza Prieta National Wildlife Refuge, Arizona ($32^{\circ}10'42.474''$ N $113^{\circ}42'23.531''$ W). The road blocks the natural flow of water in the desert wash. With large rain events, the wash may saturate and blow out the roadbed material. This threatens the integrity and functionality of the road, and deep channels that cut through the roadbed could be a safety hazard for unsuspecting drivers.

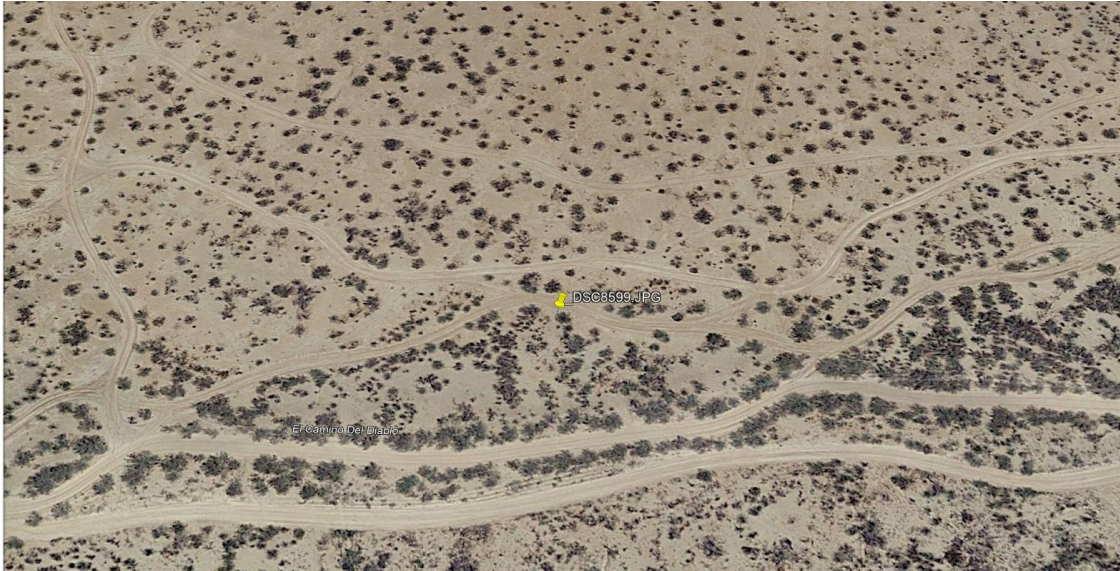
Braided road corridor in the Las Playas area (pin is at $32^{\circ}5'38.513''$ N $113^{\circ}26'49.722''$ W). Drivers take different paths in response to loose sand, giant desiccation cracks, flooding events, and mud. This resulted in an ever-increasing width of the travel corridor. Here, the width of the braided road system is about 250 ft (only the major tracks, excluding minor tracks).

8. The road surface may erode to the point that it becomes difficult or impossible to drive on (deep ruts, rocks, loose silty sand) This results in people driving around these rough sections, resulting in an ever-widening braided road corridor (e.g. hundreds of yards wide), which results in increased habitat loss and increasing impacts on hydrology and erosion processes.

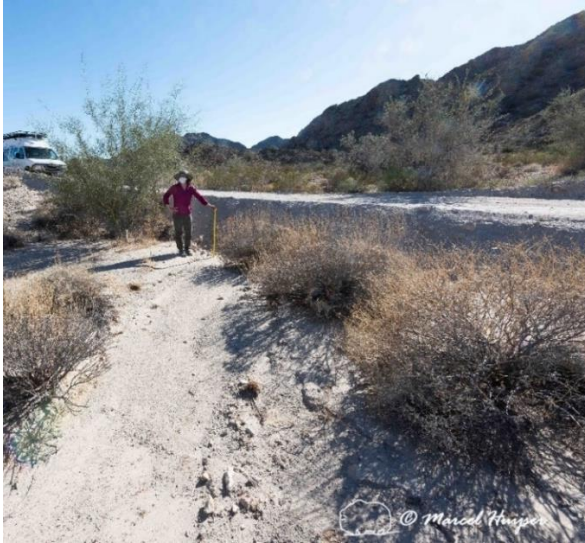
Desert wash blocked by a roadbed that extends more than 3 ft above the wash on a widened road, Tule Extension road, about 1.9 miles south-east of the junction with El Camino del Diablo, Cabeza Prieta National Wildlife Refuge, Arizona ($32^{\circ}10'43.314''$ N $113^{\circ}42'23.165''$ W). The fill blocks the natural flow of water in the desert wash. With large rain events, the wash may saturate and blow out the roadbed material. This threatens the integrity and functionality of the road, and deep channels that cut through the roadbed could be a safety hazard for unsuspecting drivers. This road/wash crossing is highly unlikely to be sustainable (hydrology, erosion, integrity and functionality of the road, road safety).

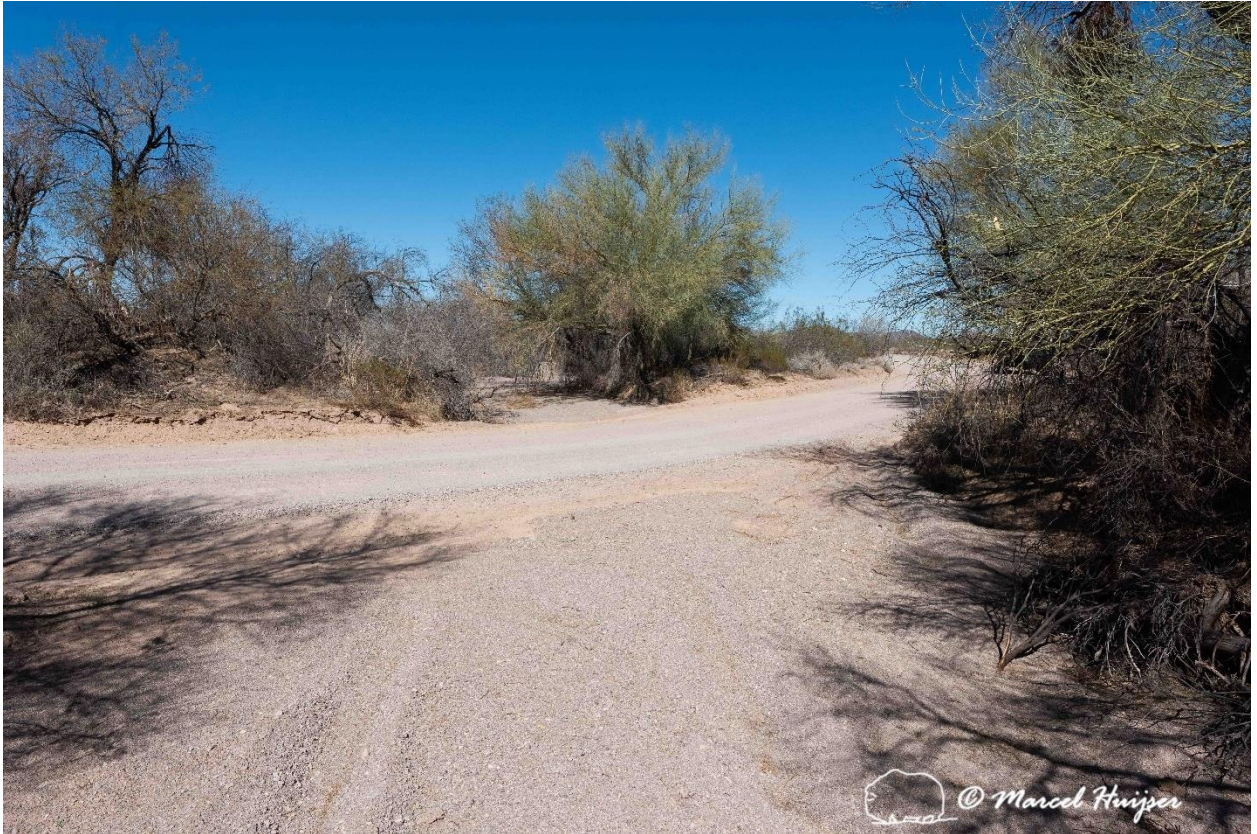
Desert wash crosses the road with higher areas on either side of the wash, Bates -Well road, Organ Pipe Cactus National Monument, Arizona ($32^{\circ}13'18.353''$ N $112^{\circ}53'36.174''$ W).

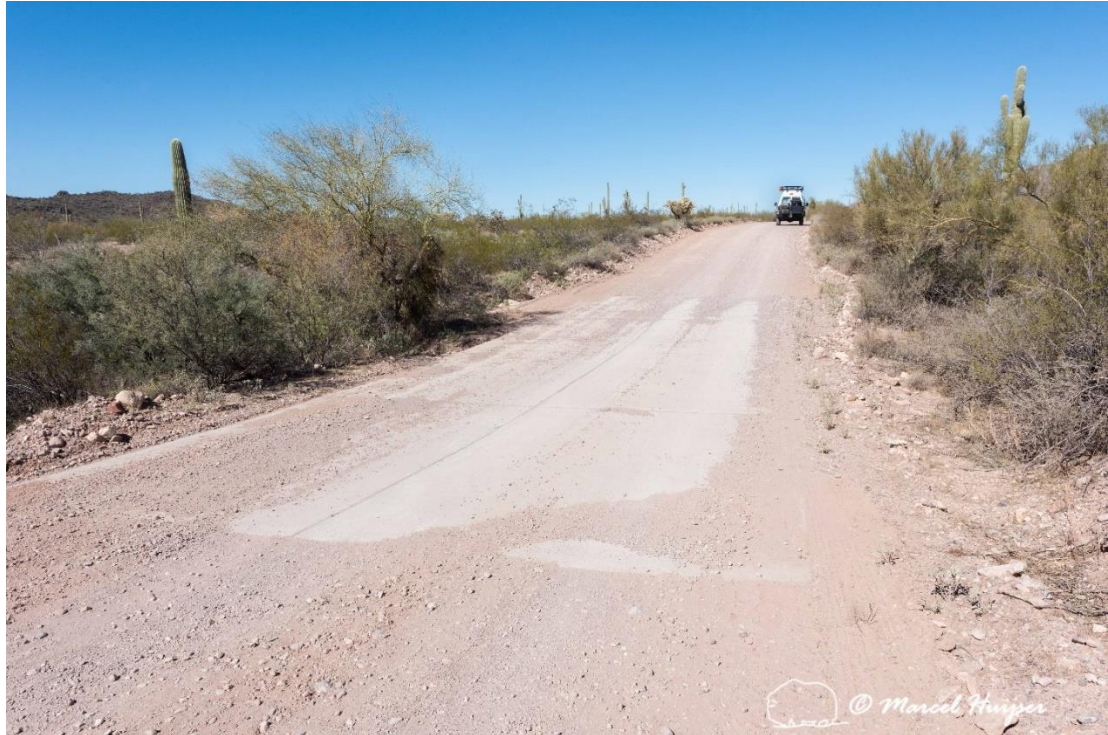
Road crosses a desert wash, Organ Pipe Cactus National Monument, Arizona. The road surface is paved where the road crosses the wash to reduce erosion (31°58'22.637" N 112°46'27.641" W).

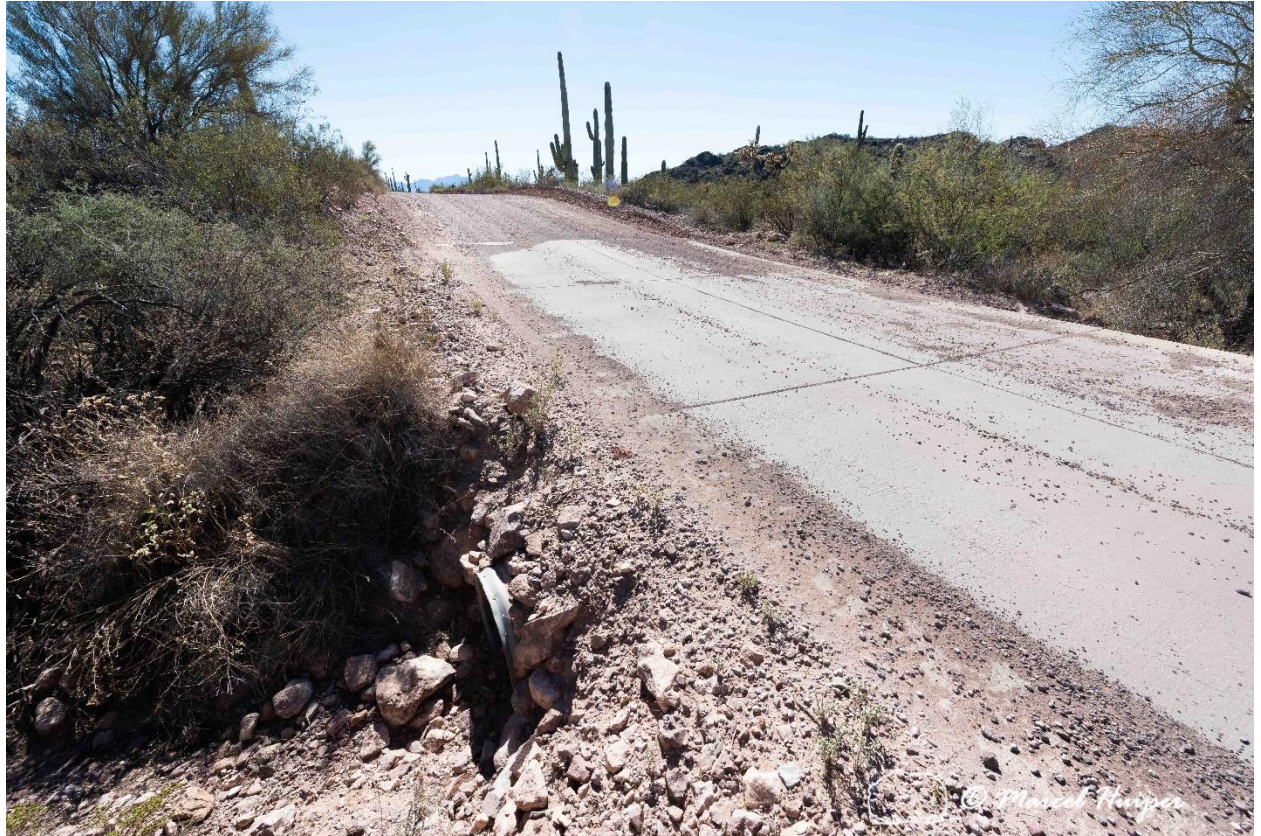
Road crosses desert wash (culvert and dip), Organ Pipe Cactus National Monument, Arizona. The road surface is paved where the road crosses the wash to reduce erosion (31°58'23.172" N 112°46'27.443" W).

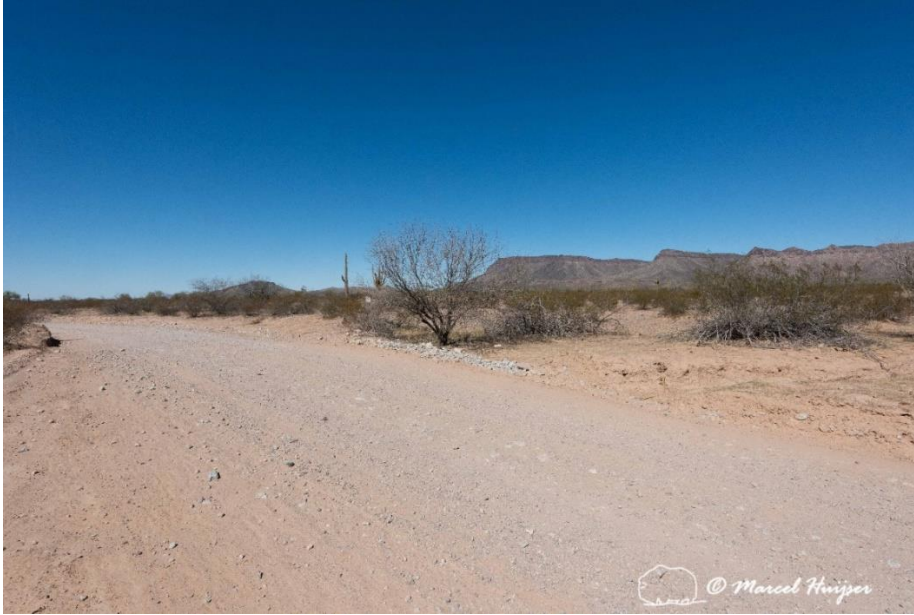
Constructed rolling dip (rock base), along Bates-Well road, Organ Pipe Cactus National Monument, Arizona ($32^{\circ}9'47.088''$ N $112^{\circ}59'55.98''$ W). The length of the rise is one car length, and the slopes are half a car length of either side (total length is approximately two car lengths) (Pers. Communication, Rijk Morawe, Resources Management Chief, Organ Pipe Cactus National Monument).

Sheet flow can enter the roadbed almost anywhere. If it cannot cross or exit the road, it will concentrate and flow downslope on the road, with increasing volume and speed, creating more severe flooding and erosion as a consequence. Therefore, it is good practice to create regular drainage structures to disperse concentrated water and move it from one side of the road to the other. Following the direction of the water flow, a “dip” is created in the roadbed, angling towards where the water should go (Figure 4). A “rise” is created just after the dip, increasing the functionality of the dip in guiding water off the road and preventing water to continue to flow along the roadbed.

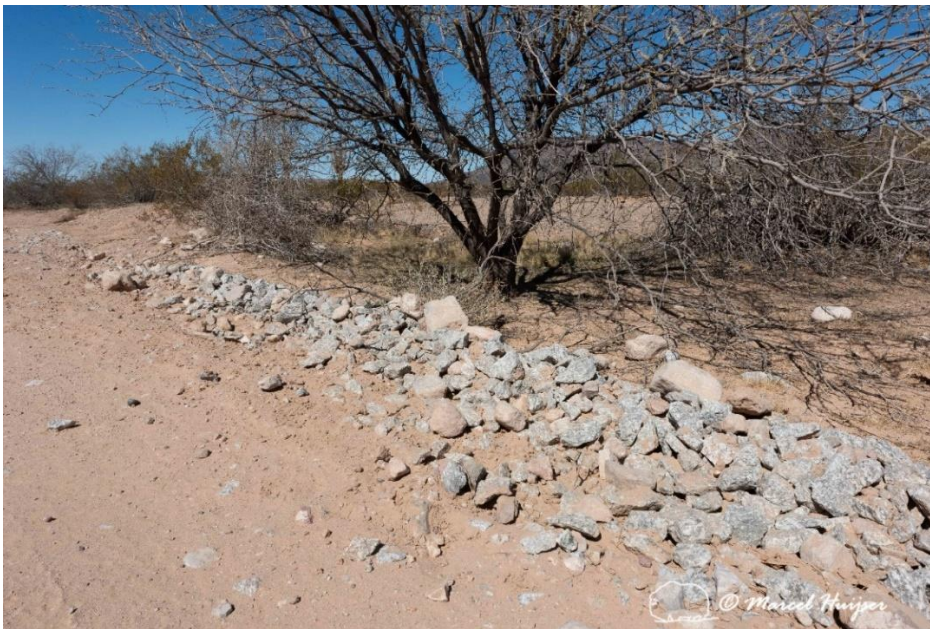
Detail of a constructed rolling dip (rock base), along Bates-Well road, Organ Pipe Cactus National Monument, Arizona ($32^{\circ}9'47.315''$ N $112^{\circ}59'56.124''$ W). These rises were constructed with 4 inch rocks, aggregate base, and soil, and compact (with water) (Pers. Communication, Rijk Morawe, Resources Management Chief, Organ Pipe Cactus National Monument).

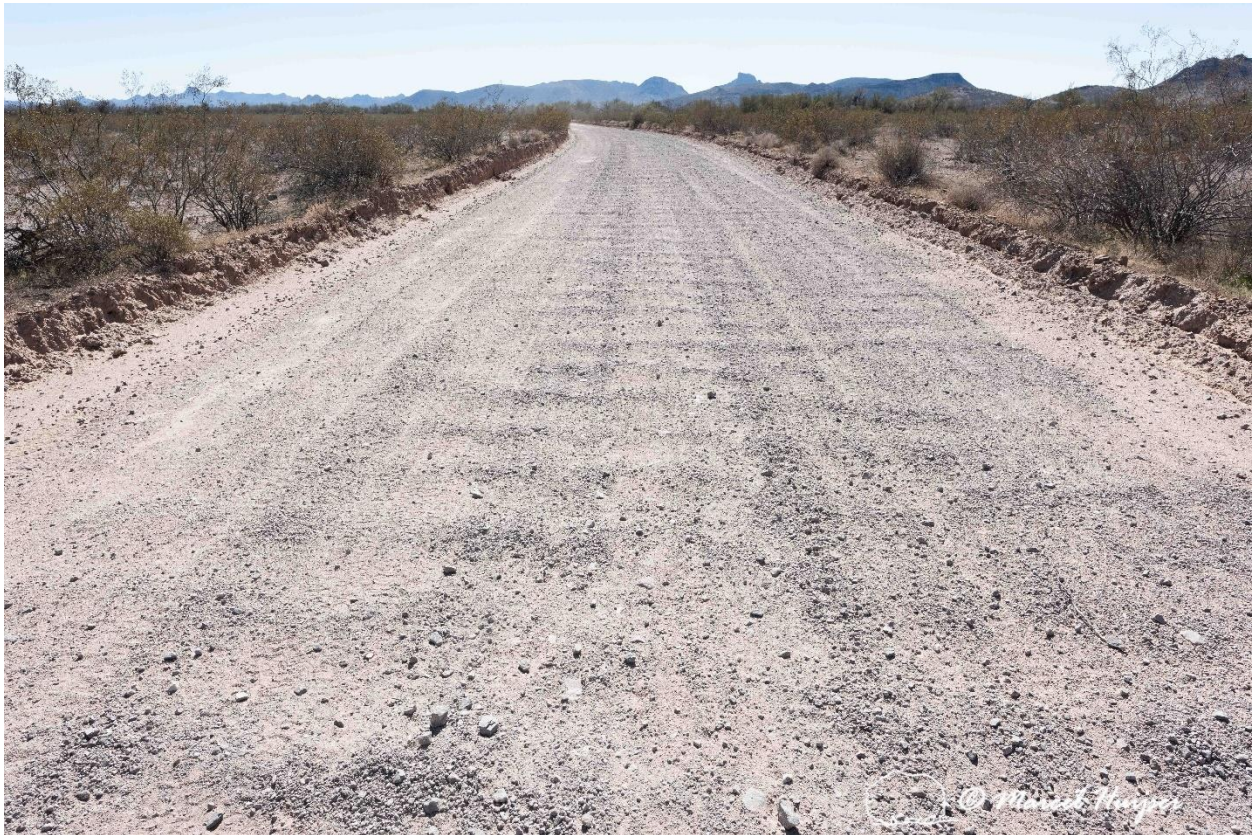
Washboards, Bates -Well road, Organ Pipe Cactus National Monument, Arizona (near 32°13'18.353" N 112°53'36.174" W).

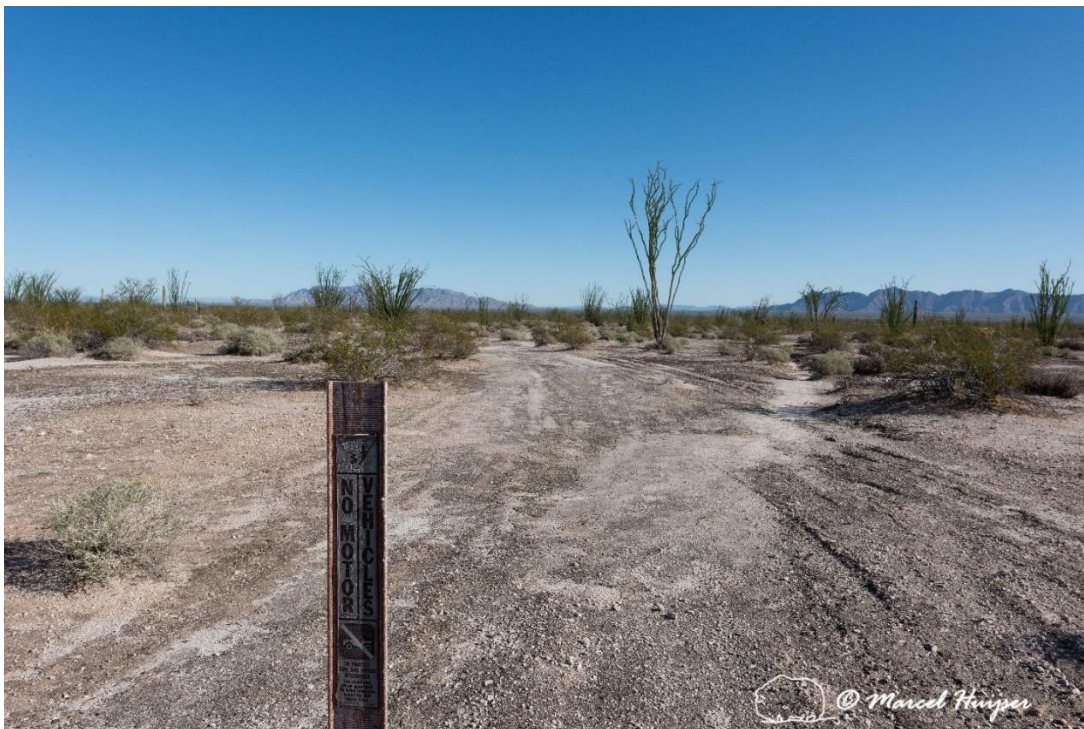
Desert wash, closed to vehicles, but there is vehicle use evidence anyway, about 1.1 miles southeast of Tinajas Altas, Barry M. Goldwater Range West (BMGR-W), Arizona (32°18'23.478" N 114°1'54.689" W).

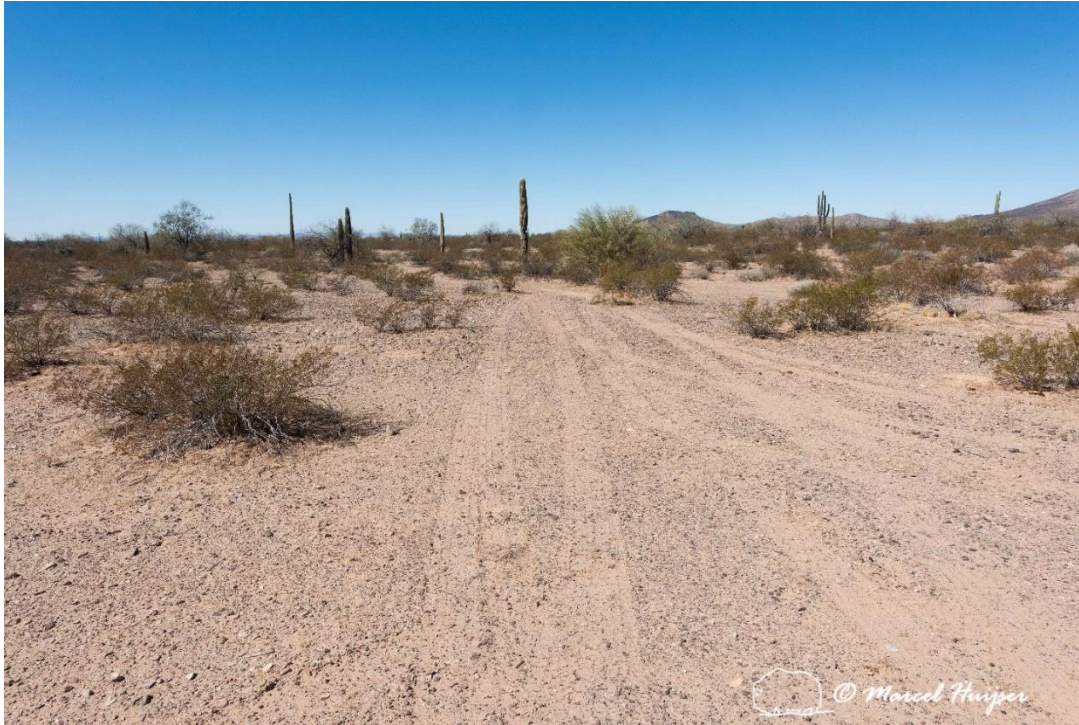
Evidence of off-road driving, along Bates-Well road, Organ Pipe Cactus National Monument, Arizona ($32^{\circ}9'49.949''$ N $112^{\circ}59'38.946''$ W).

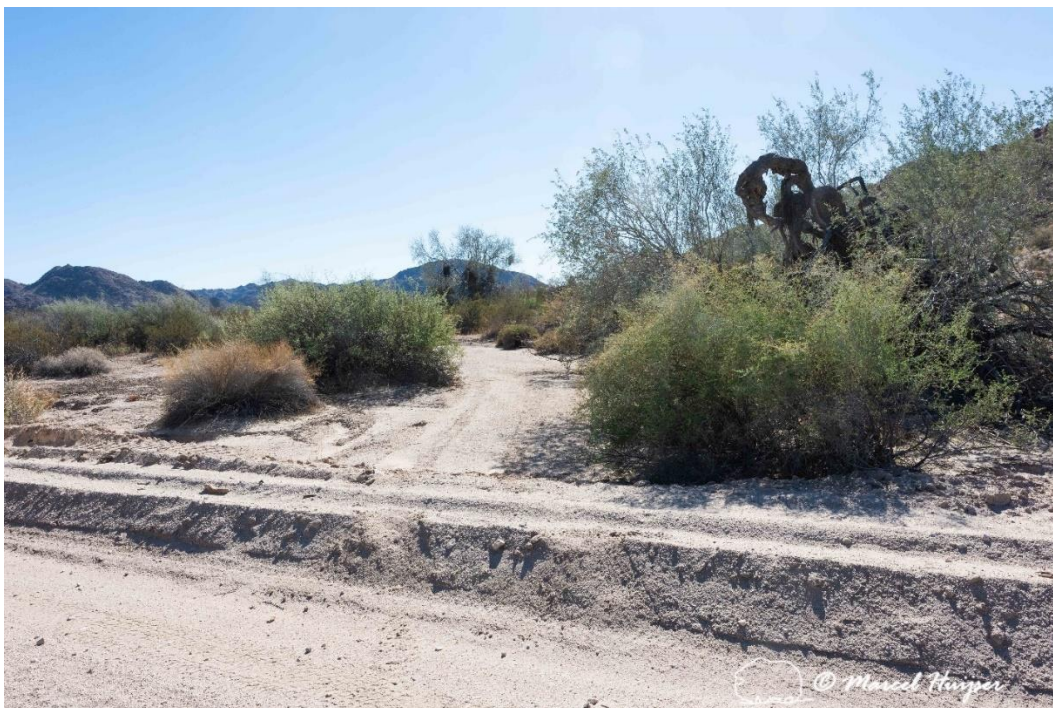
Desert wash that has been driven on by an ATV, off El Camino del Diablo east of Tinajas Altas, Cabeza Prieta National Wildlife Refuge, Arizona ($32^{\circ}12'50.124''$ N $113^{\circ}44'28.115''$ W).

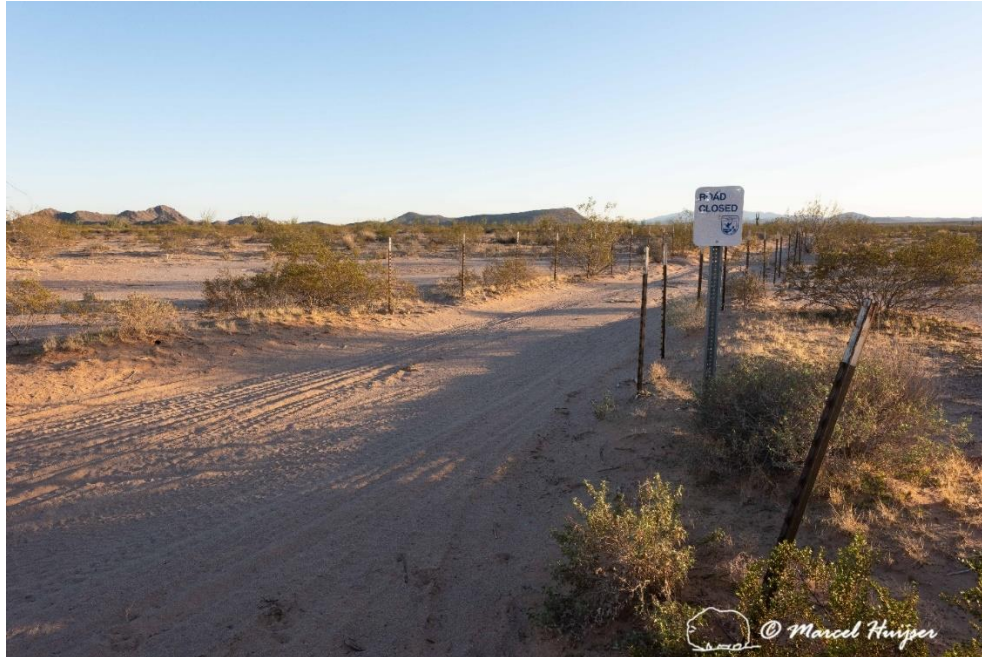
Management road closed to the public off El Camino del Diablo, Las Playas area, Cabeza Prieta National Wildlife Refuge, Arizona ($32^{\circ}5'28.811''$ N $113^{\circ}24'15.083''$ W). Note the fence posts that encourage drivers to keep their vehicles on the road.

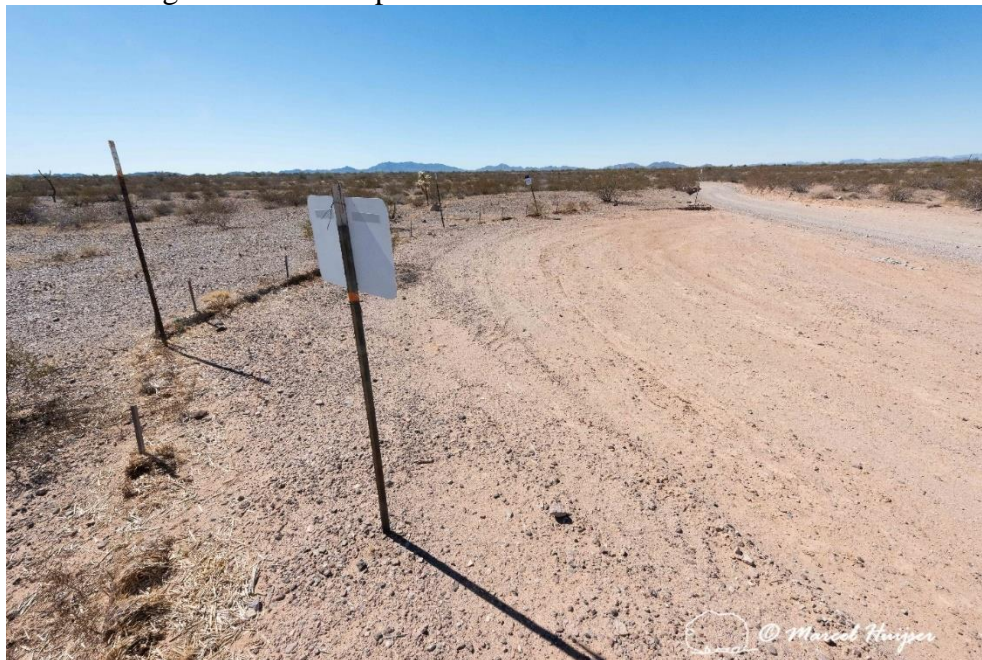
Pull out, boundary staked with fence posts, along Bates-Well road, Organ Pipe Cactus National Monument, Arizona ($32^{\circ}9'32.334''$ N $113^{\circ}0'56.621''$ W). Note the tracks on the lower left that indicate a vehicle drove over the erosion control roll.

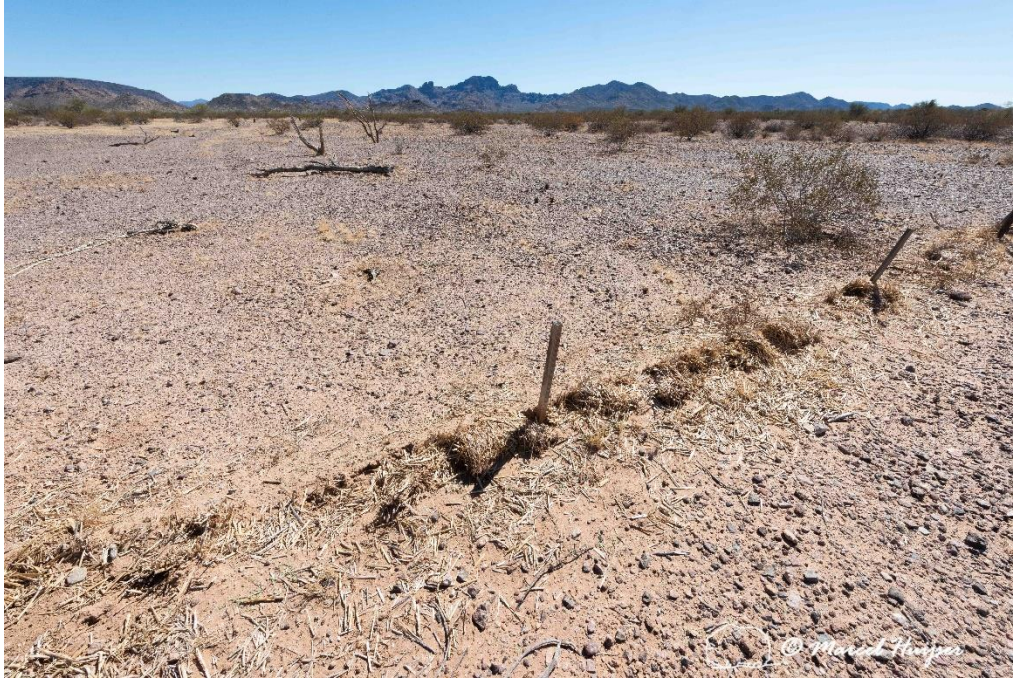
Evidence of a vehicle driving off road across erosion control measures, at a pull out with boundary staked with fence posts, along Bates-Well road, Organ Pipe Cactus National Monument, Arizona ($32^{\circ}9'32.364''$ N $113^{\circ}0'56.717''$ W).

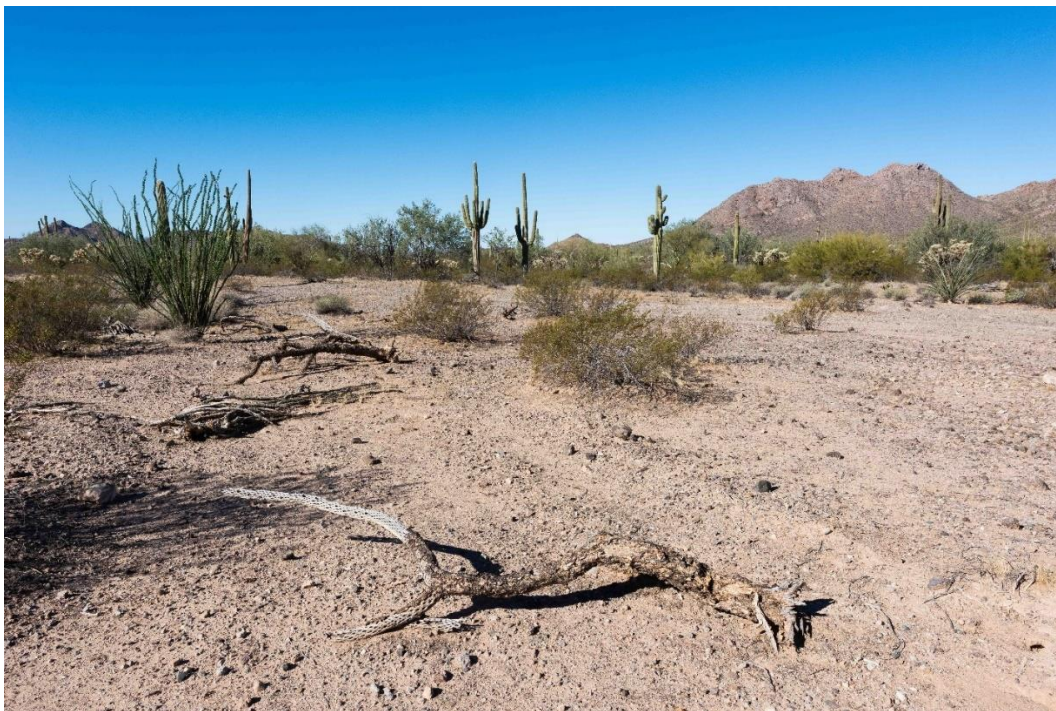
Habitat restoration to restore impact of off-road driving, along Bates-Well road, Organ Pipe Cactus National Monument, Arizona ($32^{\circ}10'49.775''$ N $112^{\circ}56'47.285''$ W). Note the use of dead cacti and branches to discourage driving in the area.

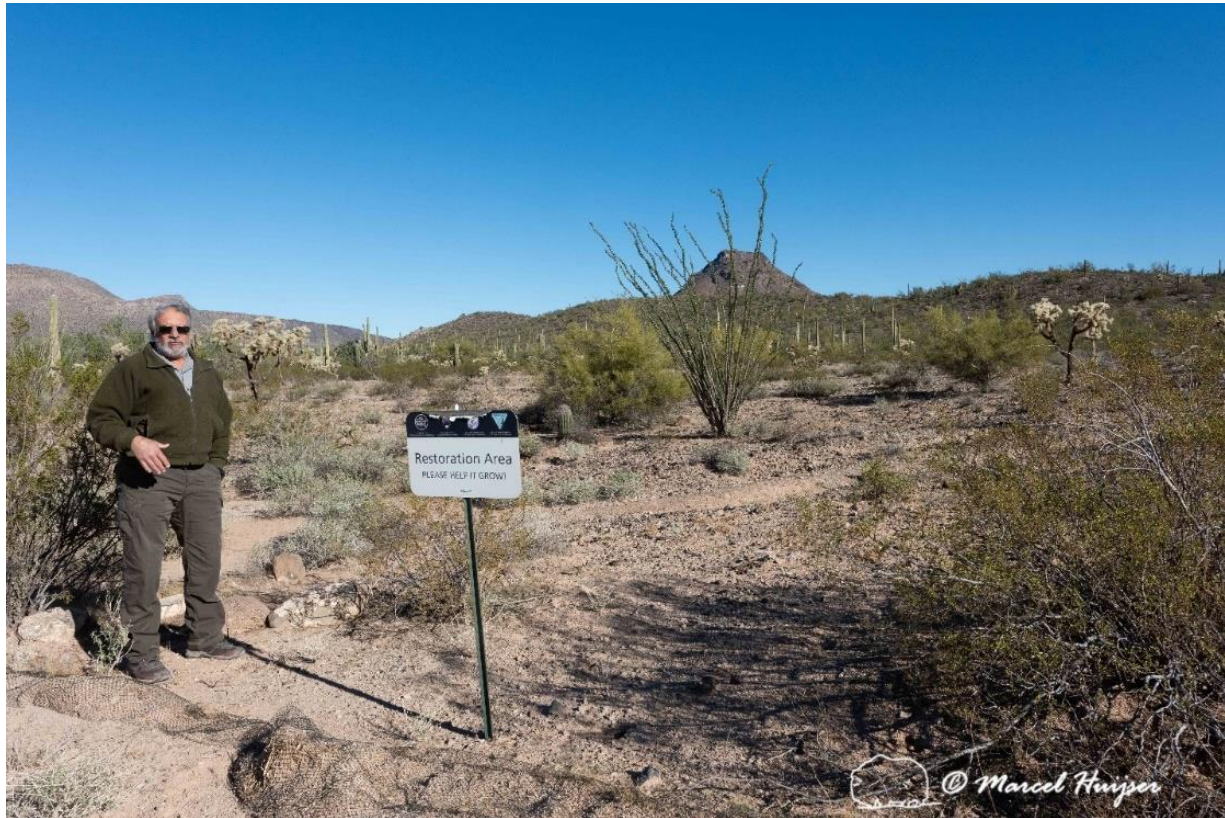
Habitat restoration to restore impact of off-road driving, along Bates-Well road, Organ Pipe Cactus National Monument, Arizona (32°11'6.408" N 112°56'8.579" W).

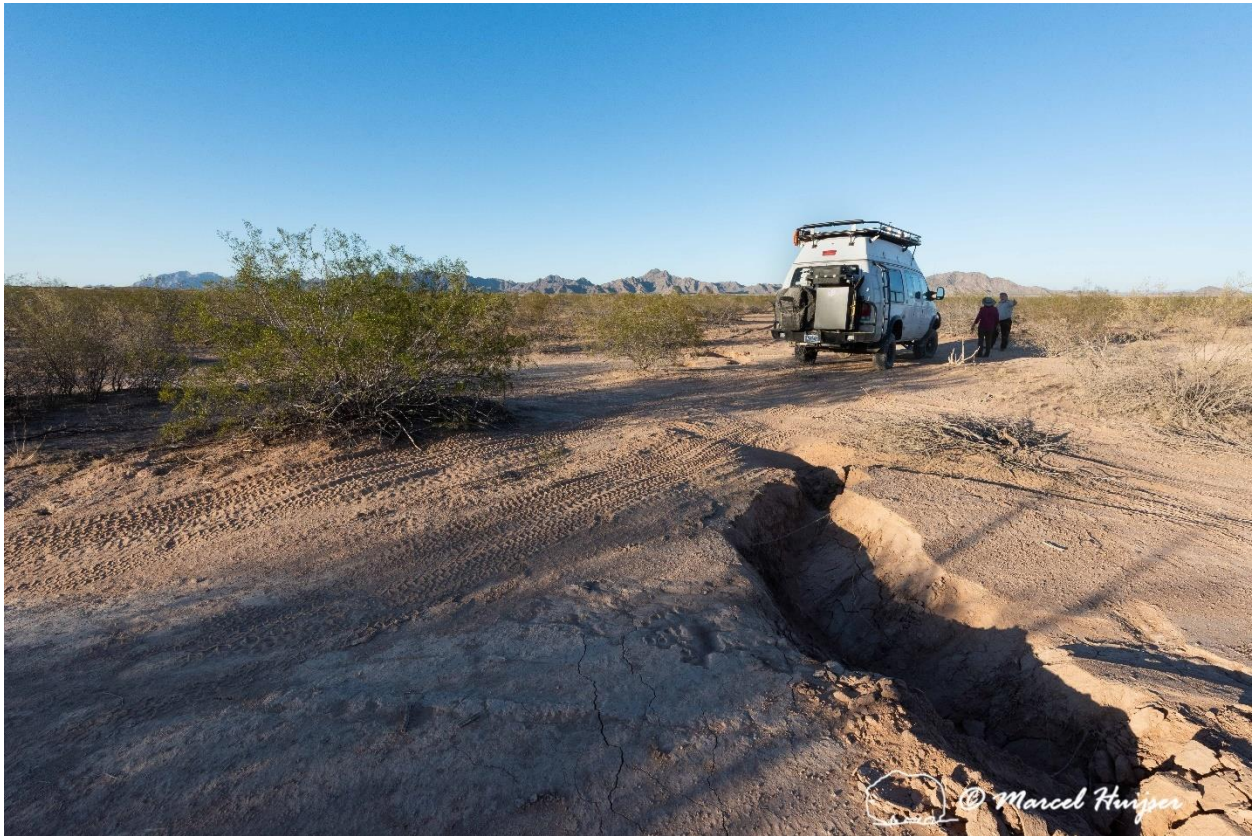
The El Camino del Diablo in the Las Playas area, Pinta Sands, is a braided set of roads rather than one “road”. Loose silty sand, erosion, and occasional flooding and mud cause drivers to seek alternate routes to avoid the obstacles in this area. Giant desiccation cracks are a particular hazard in this area. Giant desiccation cracks are mud cracks or large soil cracks, but they occur on a very large scale. Our measurements showed that the holes and cracks in this area can be over 3 ft deep, but there was no formal or complete survey. The giant desiccation cracks are not always visible to drivers as the “road surface” may still appear to be intact but there may be a sizeable hole or crack just underneath. It appears that there is a potential for damage to vehicles and risk to human safety, both with “visible” and “invisible” cracks as the latter may cause the surface to collapse under the weight of a passing vehicle.

Giant desiccation cracks along the El Camino del Diablo, Las Playas area, Pinta Sands, Cabeza Prieta National Wildlife Refuge, Arizona (32° 5'38.73"N, 113°26'49.66"W).

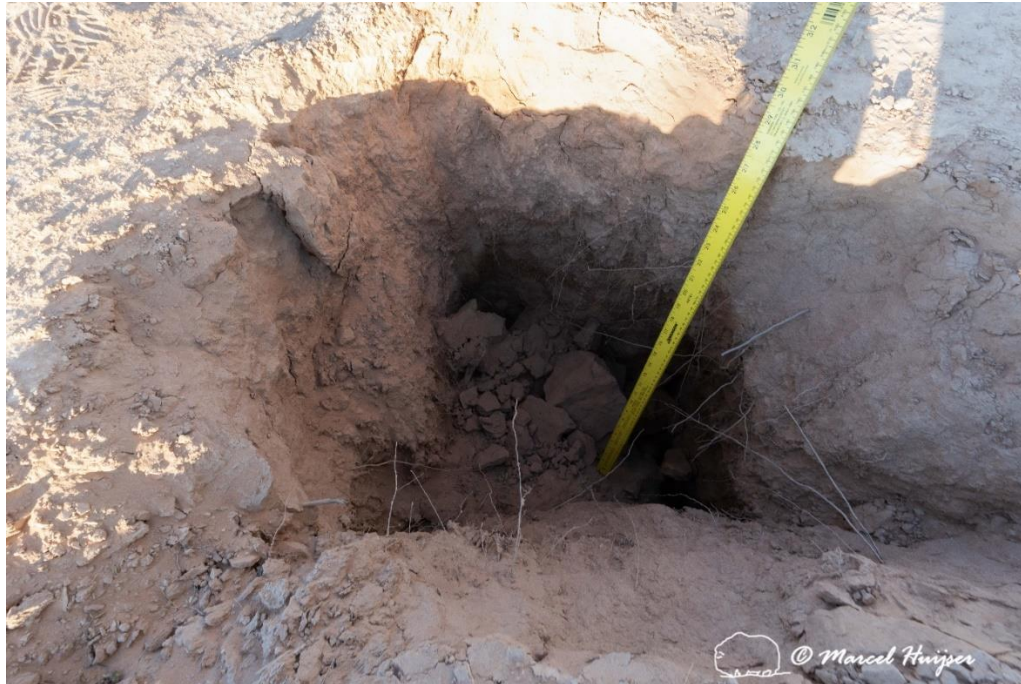
Giant desiccation cracks (here about 30 inches deep) along the El Camino del Diablo, Las Playas area, Pinta Sands, Cabeza Prieta National Wildlife Refuge, Arizona ($32^{\circ} 5'38.92''\text{N}$ $113^{\circ}26'49.37''\text{W}$).

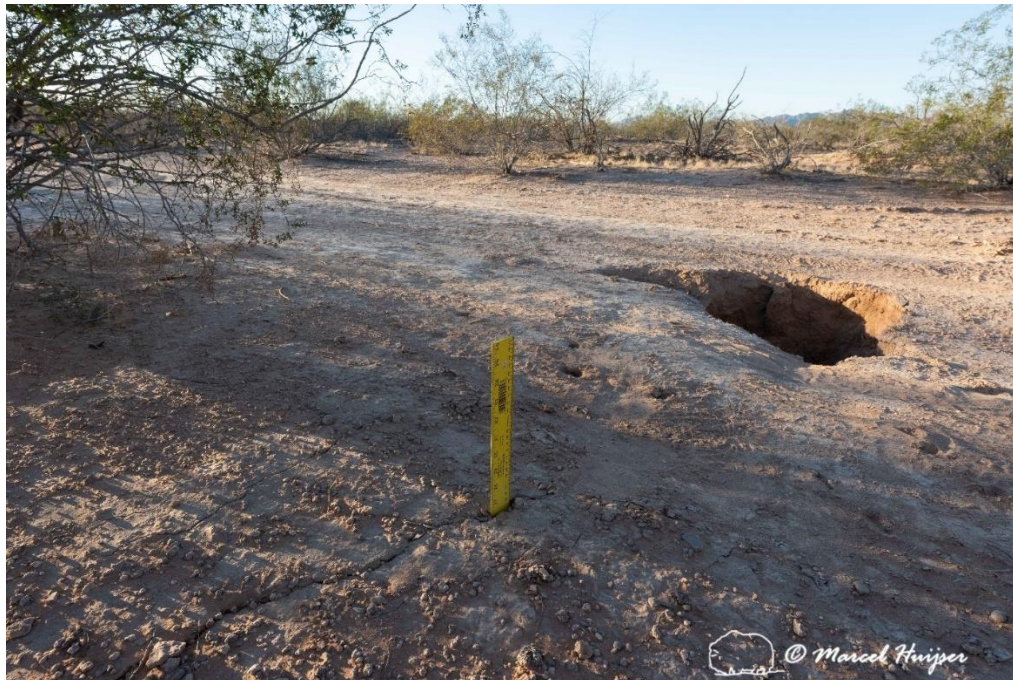
Giant desiccation cracks (at least 26 inches deep but only a tiny crack is visible on the surface) along the El Camino del Diablo, Las Playas area, Pinta Sands, Cabeza Prieta National Wildlife Refuge, Arizona ($32^{\circ} 5'38.90''\text{N}$ $113^{\circ}26'49.86''\text{W}$).

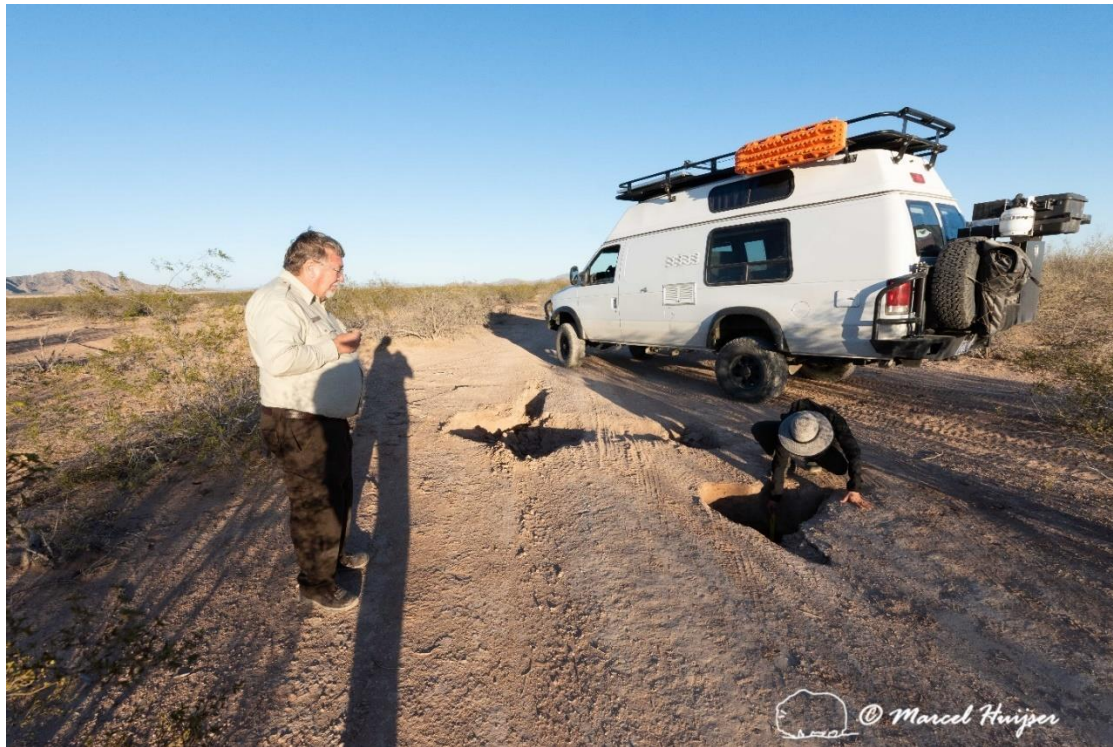
Giant desiccation cracks along the El Camino del Diablo, Las Playas area, Pinta Sands, Cabeza Prieta National Wildlife Refuge, Arizona ($32^{\circ} 5'39.00''\text{N } 113^{\circ}26'49.69''\text{W}$).
