**Ecological impacts of new and upgraded dirt roads in
Cabeza Prieta National Wildlife Refuge and avoidance,
mitigation and compensation strategies**

A report prepared for the
U.S. Fish & Wildlife Service,
Headquarters Office, Transportation Branch,
5275 Leesburg Pike, Falls Church, VA 22041

15 December, 2021

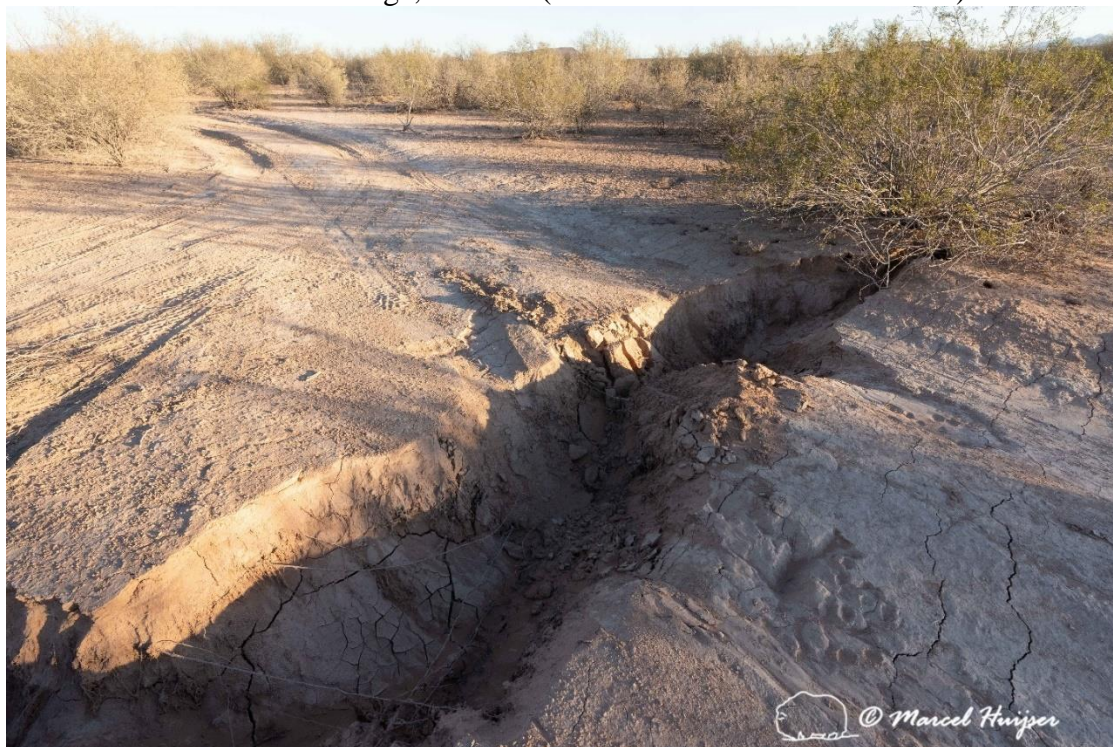
Giant desiccation cracks along the El Camino del Diablo, Las Playas area, Pinta Sands, Cabeza Prieta National Wildlife Refuge, Arizona ($32^{\circ} 5'38.73''\text{N } 113^{\circ}26'49.66''\text{W}$).

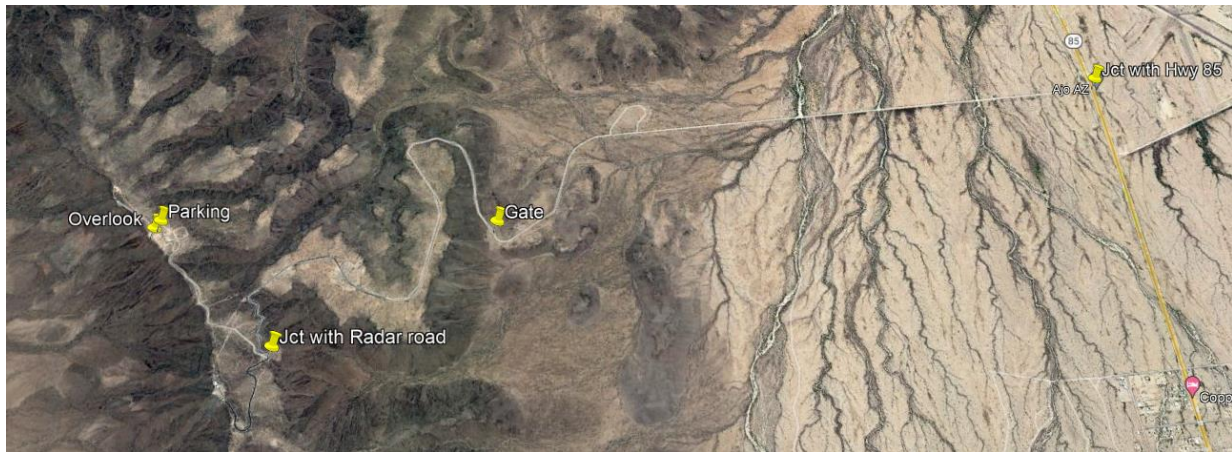
Figure 6: The road from the junction with Hwy 85 (right) to the overlook on the top of Childs Mountain (left) (total road length about 7.4 miles), Cabeza Prieta National Wildlife Refuge, Arizona.

On top of Childs Mountain, in the north east section of CPNWR, north of Ajo, a viewpoint overlooks a portion of the refuge. The road to Childs Mountain Overlook currently has a gate that is locked (Figure 6 and 7). The road up to Childs Mountain Overlook may be opened to day-use and needs to be evaluated for its potential impacts and measures to address these impacts (Pers. Communication, Sid Slone, Refuge Manager CPNWR)

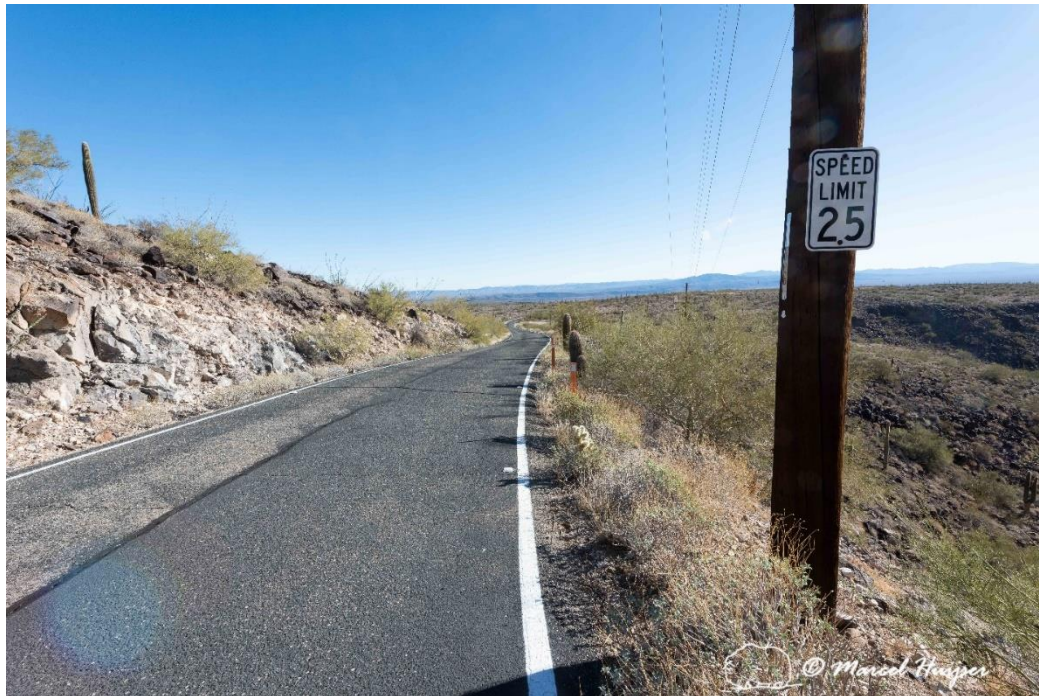
The road to the overlook is steep and windy, Childs Mountain, Cabeza Prieta National Wildlife Refuge, Arizona (32°26'15.58"N 112°56'32.97"W).

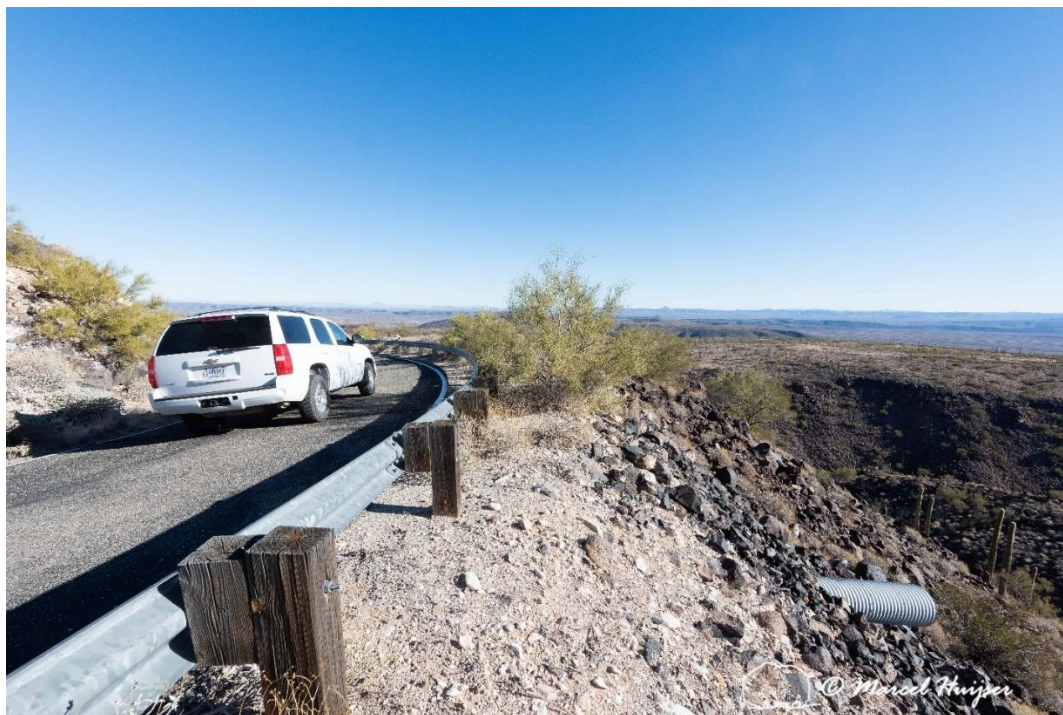
The road to the overlook is steep and windy, Childs Mountain, Cabeza Prieta National Wildlife Refuge, Arizona (32°26'7.18"N 112°56'30.33"W).

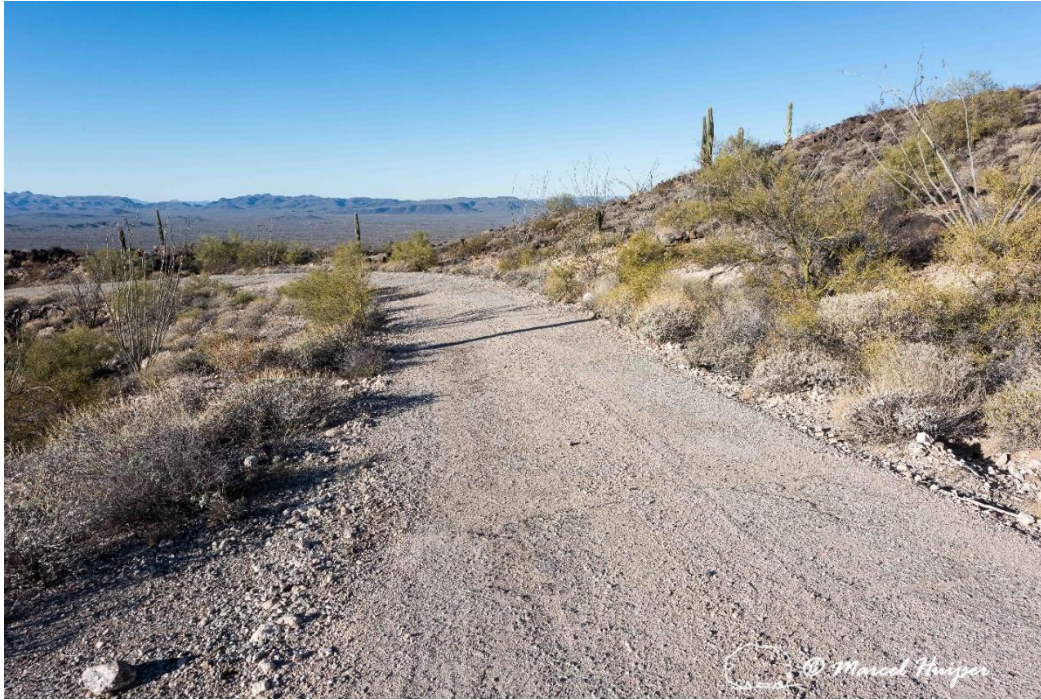
The road to the overlook is steep and windy, Childs Mountain, Cabeza Prieta National Wildlife Refuge, Arizona ($32^{\circ}26'27.36''\text{N}$ $112^{\circ}56'56.65''\text{W}$).

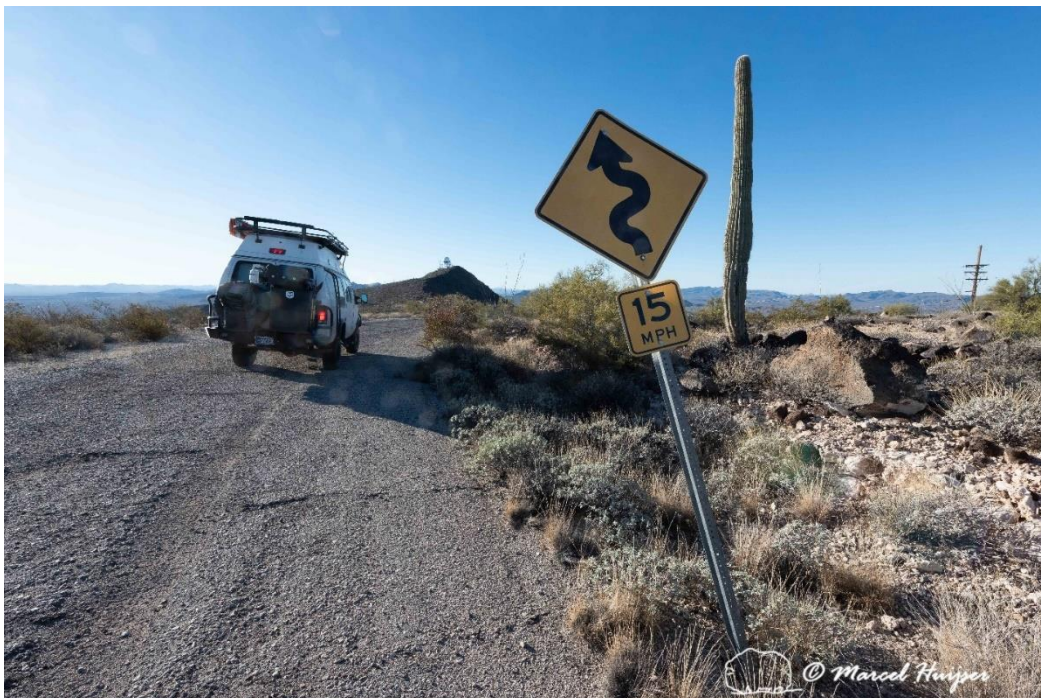
The road to the overlook is steep and windy, Childs Mountain, Cabeza Prieta National Wildlife Refuge, Arizona ($32^{\circ}26'30.69''\text{N}$ $112^{\circ}56'54.99''\text{W}$).

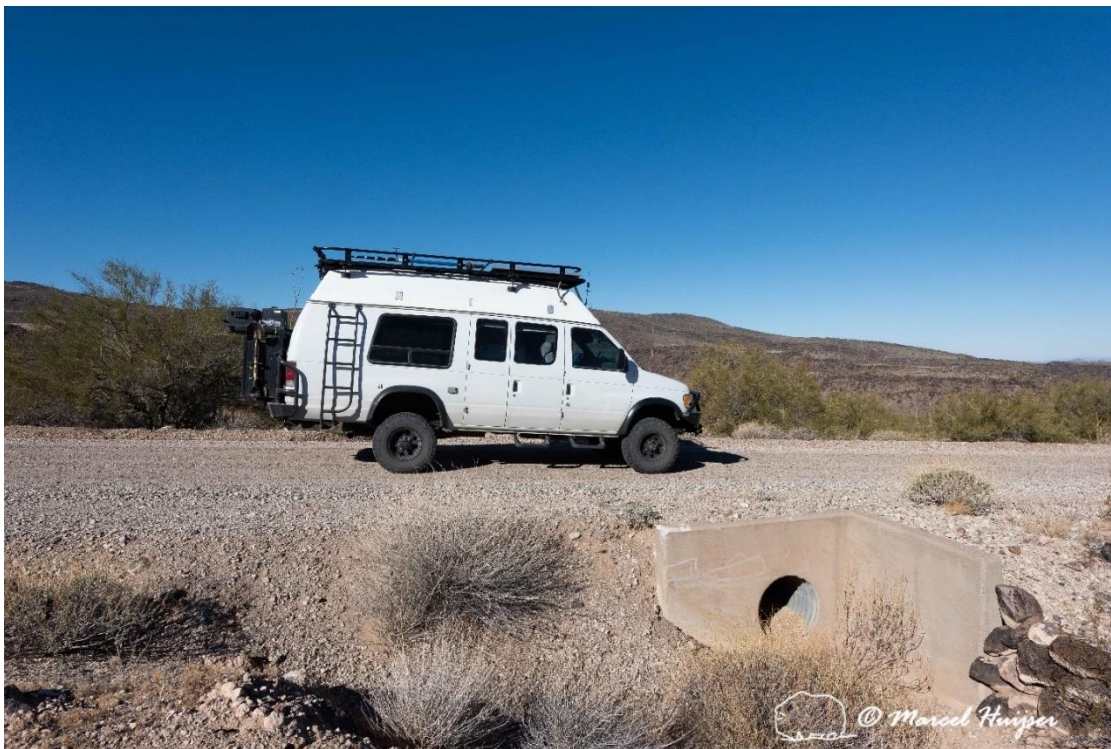
Culvert under the road to the overlook, Childs Mountain, Cabeza Prieta National Wildlife Refuge, Arizona (32°26'17.51"N 112°55'43.78"W).

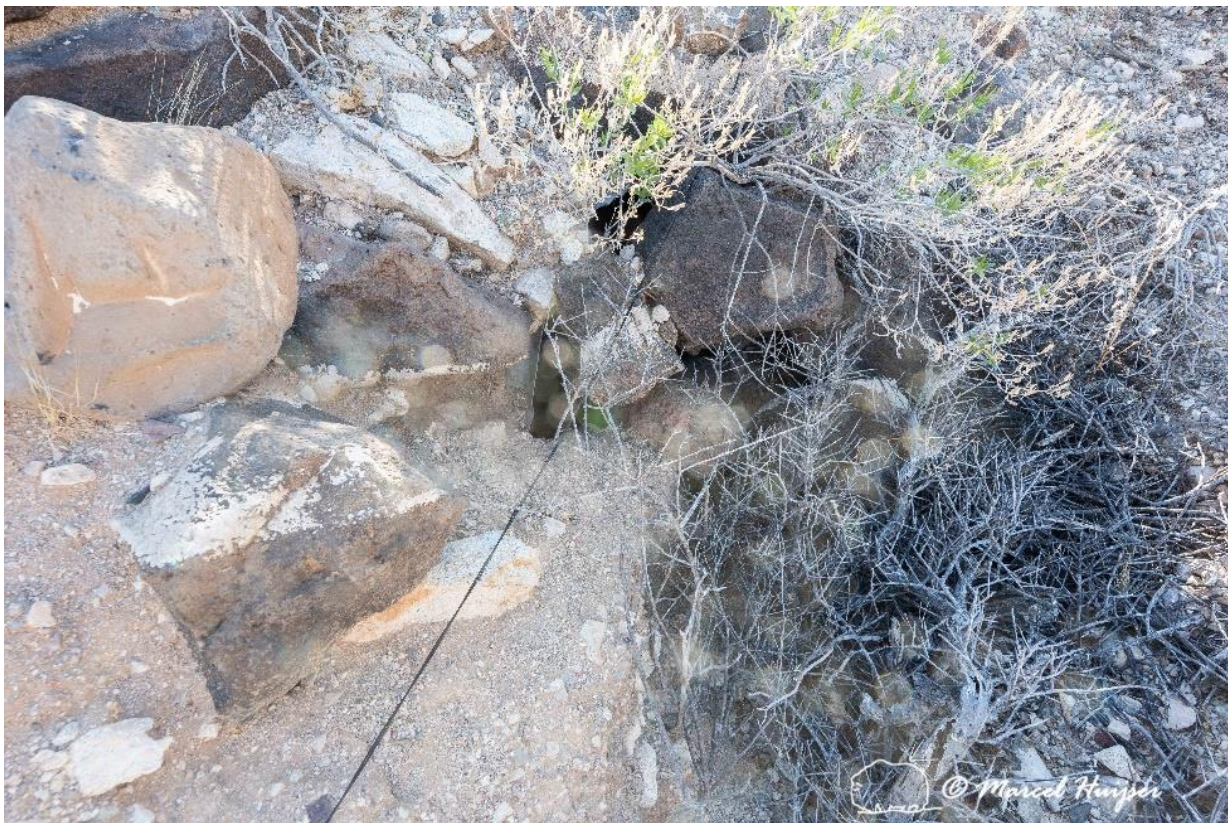
The soil is highly erodible and soil, rocks, vegetation, and other debris can clog culverts partially or fully. This can result in water building up on the upslope side of the road and eventually the water will flow over the road surface or it will saturate the roadbed and cause the road to fail and wash out.

Clogged culvert under the road to the overlook, Childs Mountain, Cabeza Prieta National Wildlife Refuge, Arizona (32°26'13.70"N 112°56'48.50"W).

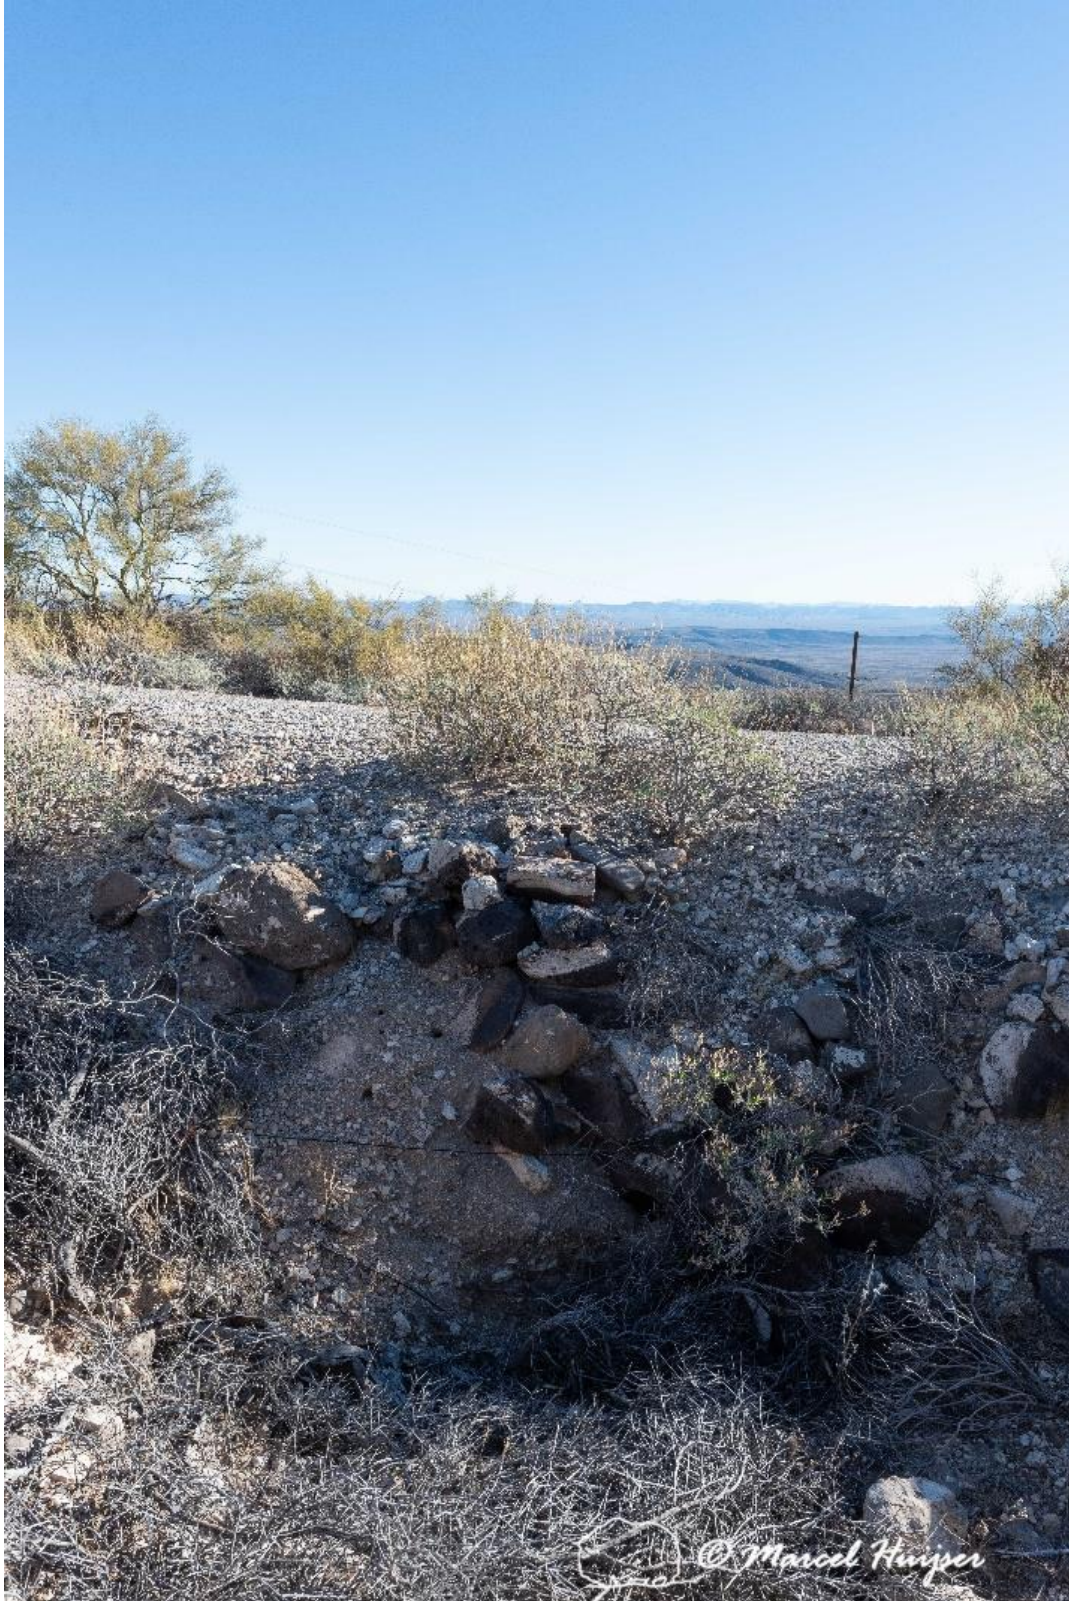
Clogged culvert under the road to the overlook, Childs Mountain, Cabeza Prieta National Wildlife Refuge, Arizona (32°26'13.85"N 112°56'48.79"W).

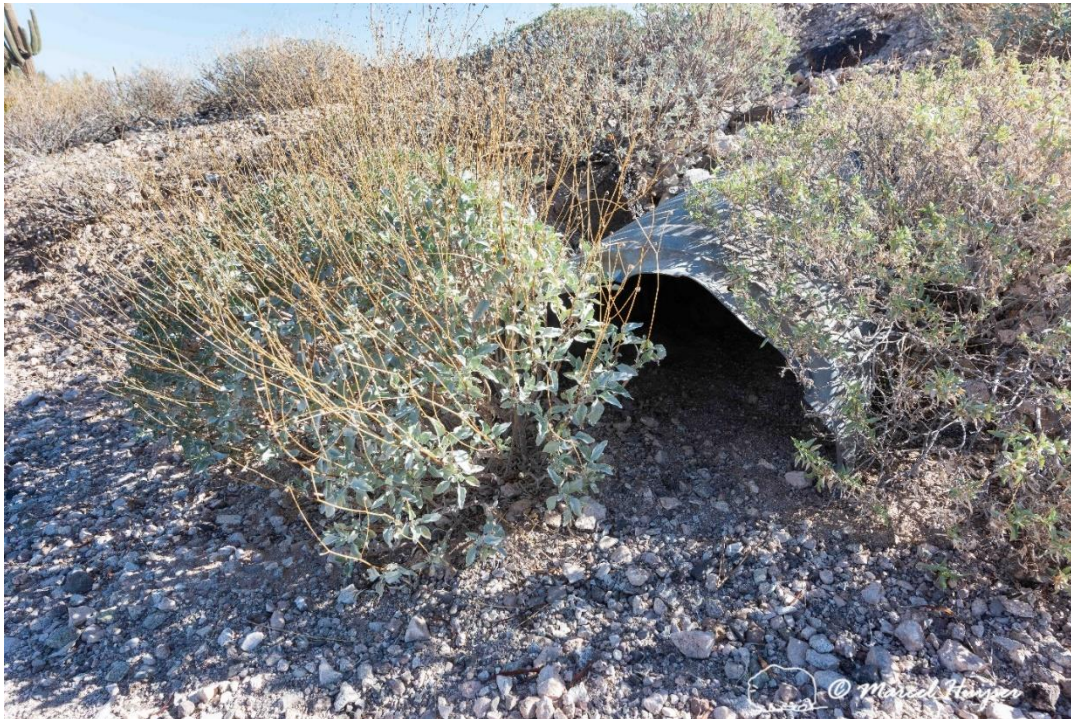
Partially clogged culvert under the road to the overlook, Childs Mountain, Cabeza Prieta National Wildlife Refuge, Arizona (32°26'34.25"N 112°55'39.26"W).

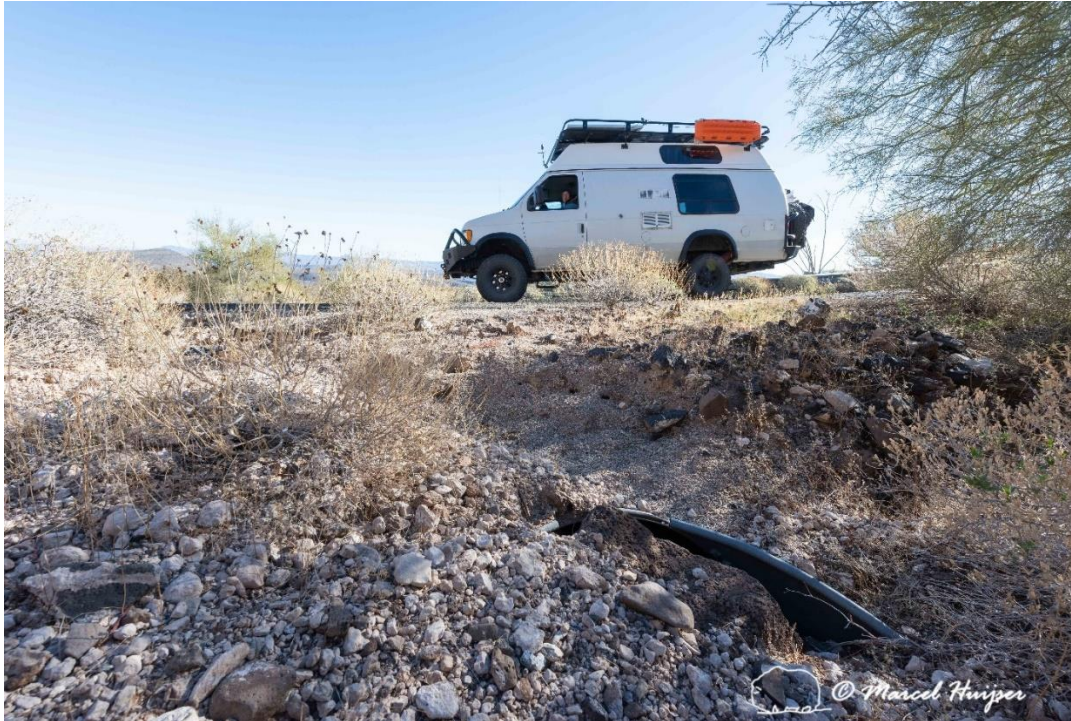
Clogged culvert under the road to the overlook, Childs Mountain, Cabeza Prieta National Wildlife Refuge, Arizona (32°26'9.14"N 112°56'32.67"W).

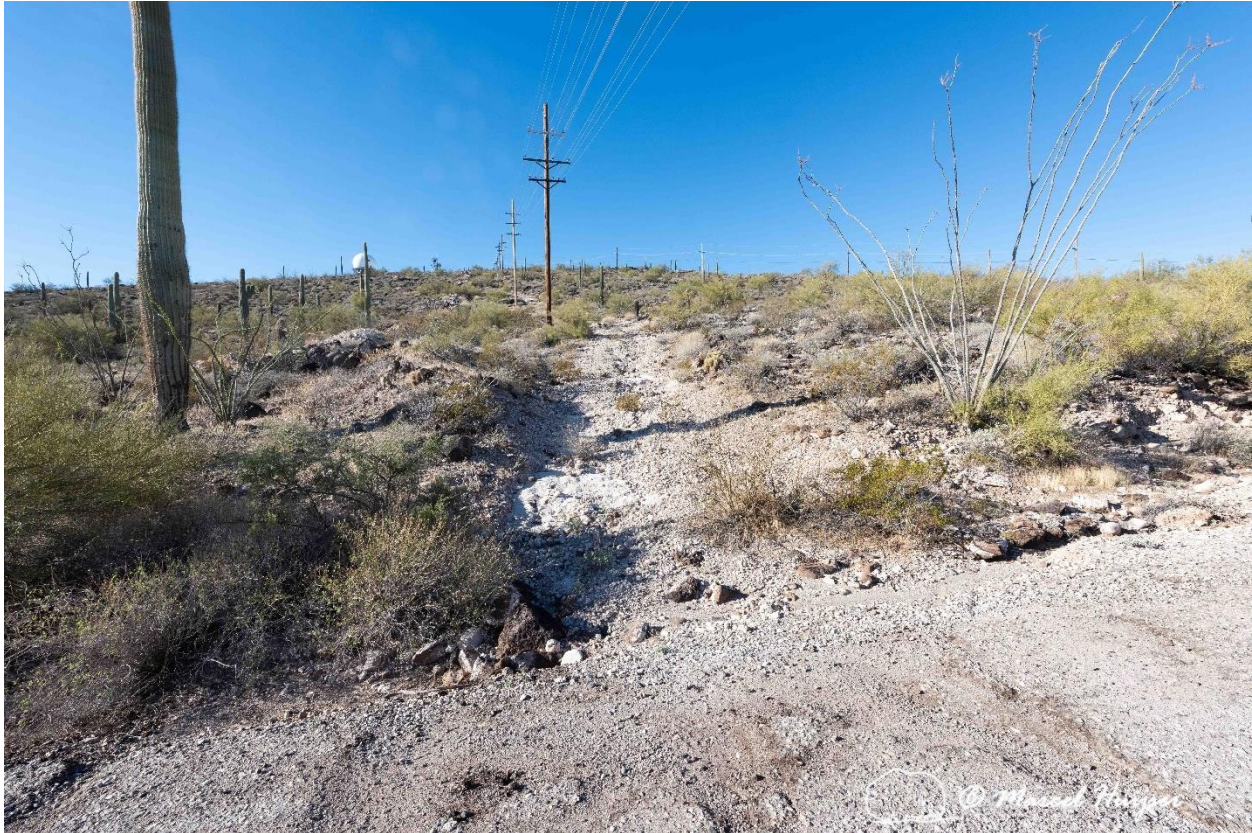
There are several points where water is concentrated onto the road, e.g. at erosion gullies or along a two-track along the powerlines. Adequate culverts are not always present. In other cases a cut slope may erode.

The two-track along the power line is eroding and is a potential threat to the road to Childs Mountain (32°26'6.24"N 112°56'38.98"W).

Reduce erosion by slowing down water velocity and creating sediment traps in the gullies. This may include placing boulders, woody debris, straw wattles (with coir netting, not nylon), and revegetation. Place adequate culverts where gullies cross the road. A steep slope that is susceptible to erosion has been stabilized with shotcrete.

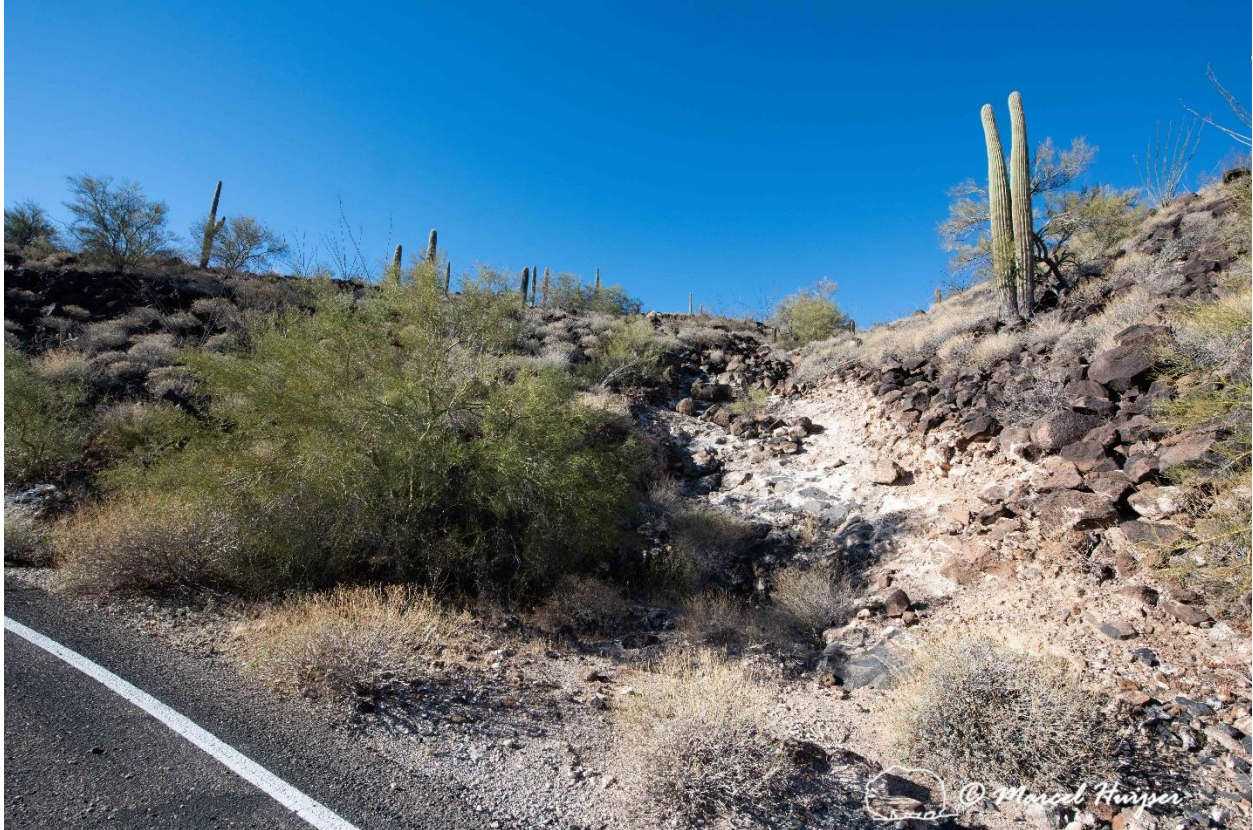
An erosion gully crosses the road to the Childs Mountain overlook (32°26'9.26"N 112°56'32.43"W).

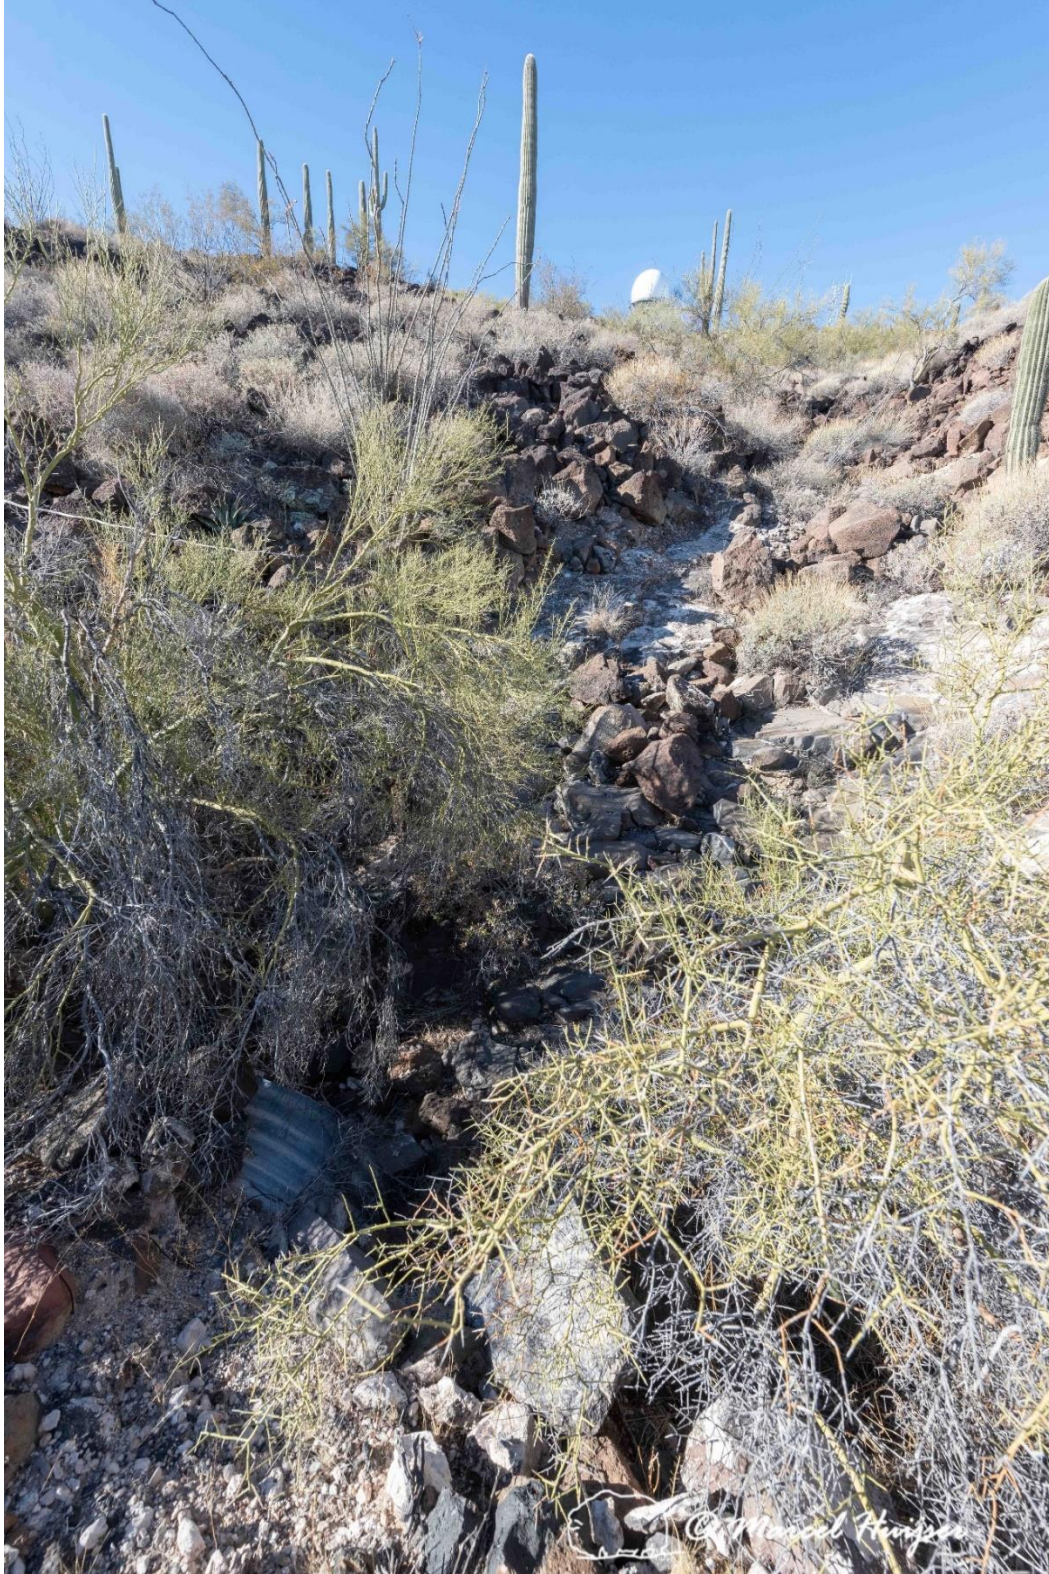
An erosion gully crosses the road to the Childs Mountain overlook (32°25'59.12"N 112°56'32.59"W).

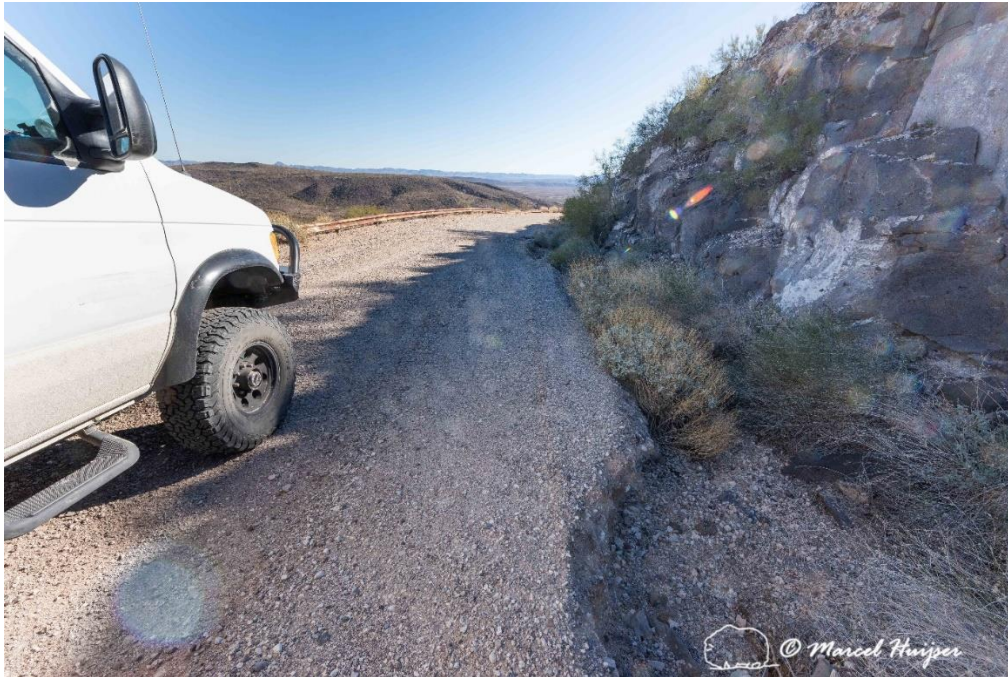
The inboard ditches and the adjacent roadbed are eroding in places.

Erosion of the roadbed into the inboard ditch along the road to the Childs Mountain overlook (32°26'53.58"N 112°55'41.10"W).

Place water bars and consider installing rolling dips to divert the water off the road at regular intervals. Regular placement of culverts is required to keep the inside ditch from eroding.

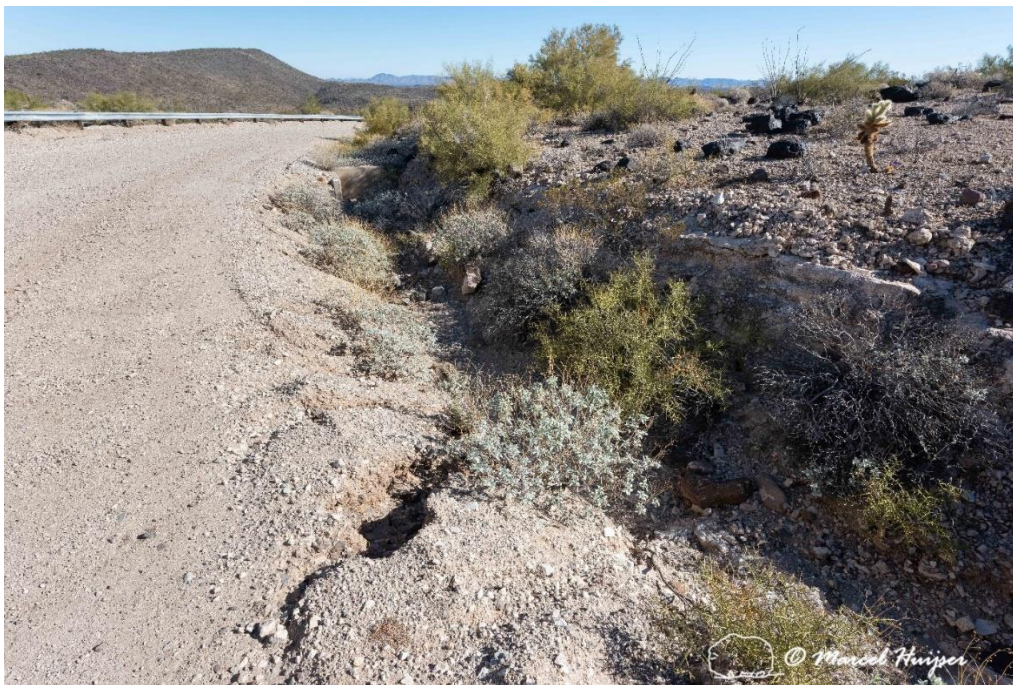
Erosion of the roadbed into the inboard ditch along the road to the Childs Mountain overlook (32°26'50.90"N 112°55'47.49"W).

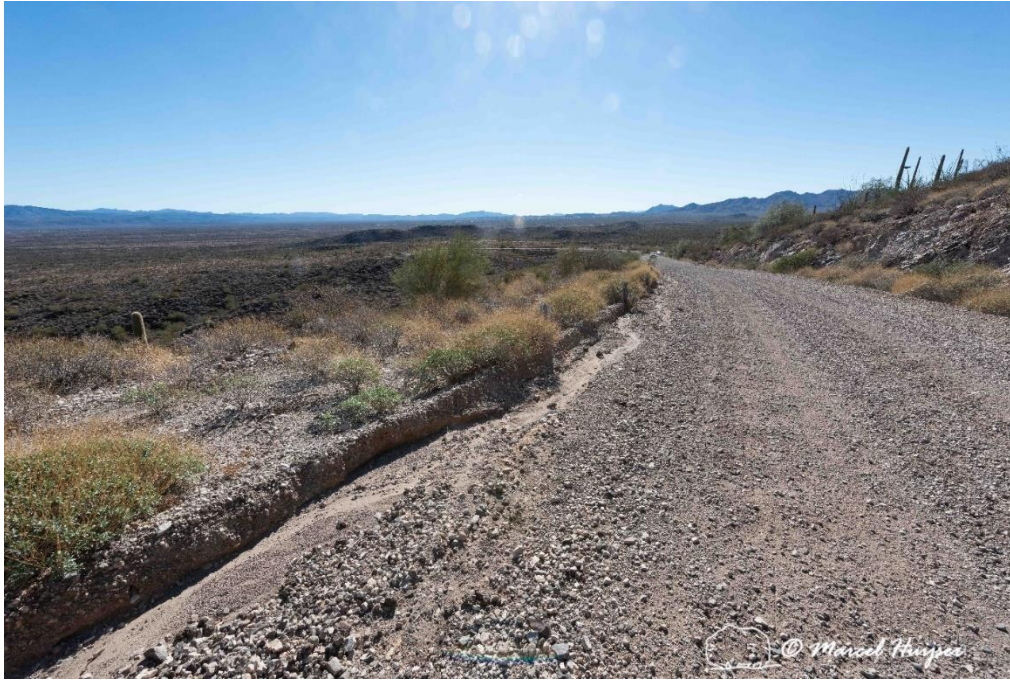
In places, the water cannot leave the road on the out-slope side. The berms along the road prevent the water from leaving the road and this can cause erosion.

The berm does not allow water to leave the road along the road to the Childs Mountain overlook ($32^{\circ}26'32.17''\text{N } 112^{\circ}55'27.72''\text{W}$).

Flatten the berm in places so that water can leave the road surface. Additional measures may include water bars and rolling dips.

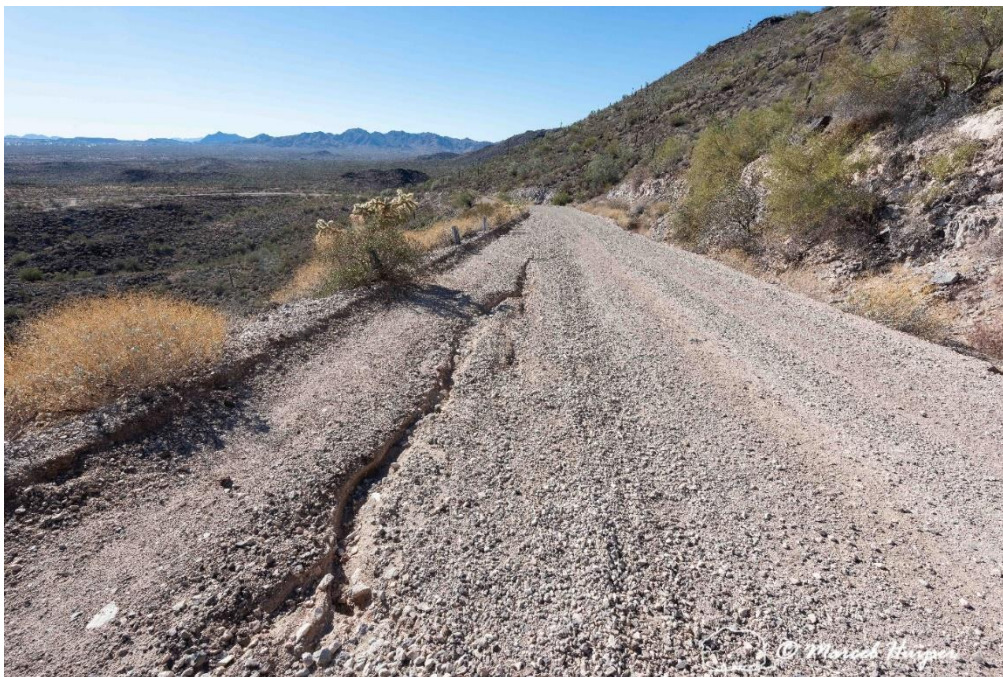
The berm does not allow water to leave the road and a channel causes the roadbed to erode, along the road to the Childs Mountain overlook ($32^{\circ}26'38.43''\text{N } 112^{\circ}55'28.40''\text{W}$).

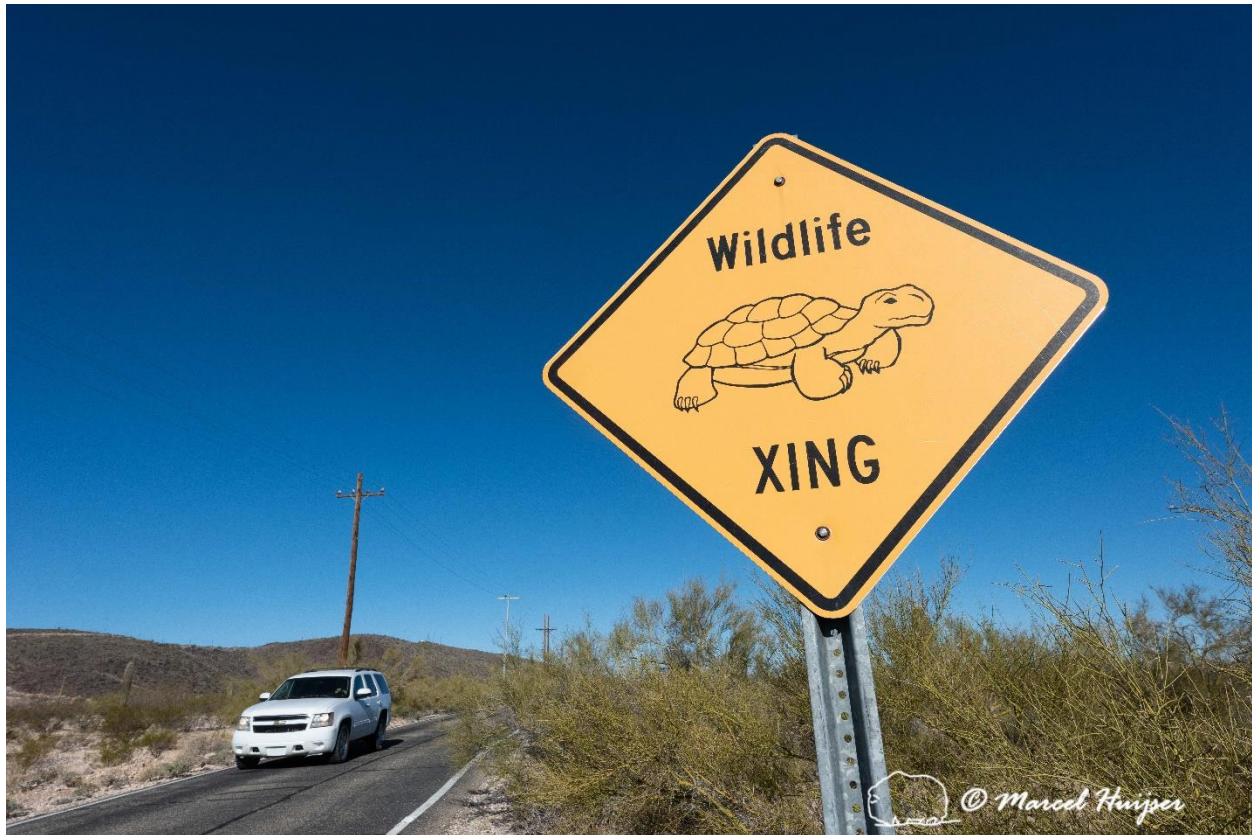
Increased use of the road may increase the likelihood of vehicles killing Sonoran desert tortoise. A sign is installed indicating that this may occur. Note that wildlife warning signs are not effective in reducing collisions with wildlife (e.g. review in Huijser et al. 2008).

Warning sign for Sonoran desert tortoise, Childs Mountain, Cabeza Prieta National Wildlife Refuge, Arizona (32°25'57.44"N 112°56'28.89"W).

A substantial reduction in road mortality of tortoises can be obtained by installing barriers (fences) along both sides of the road. Because fences alone would result in a near absolute barrier of the road for tortoises, fences are typically combined with underpasses (e.g. culverts). However, desert tortoise roadkill may or may not be an issue along this road. Monitoring of roadkill is recommended though.

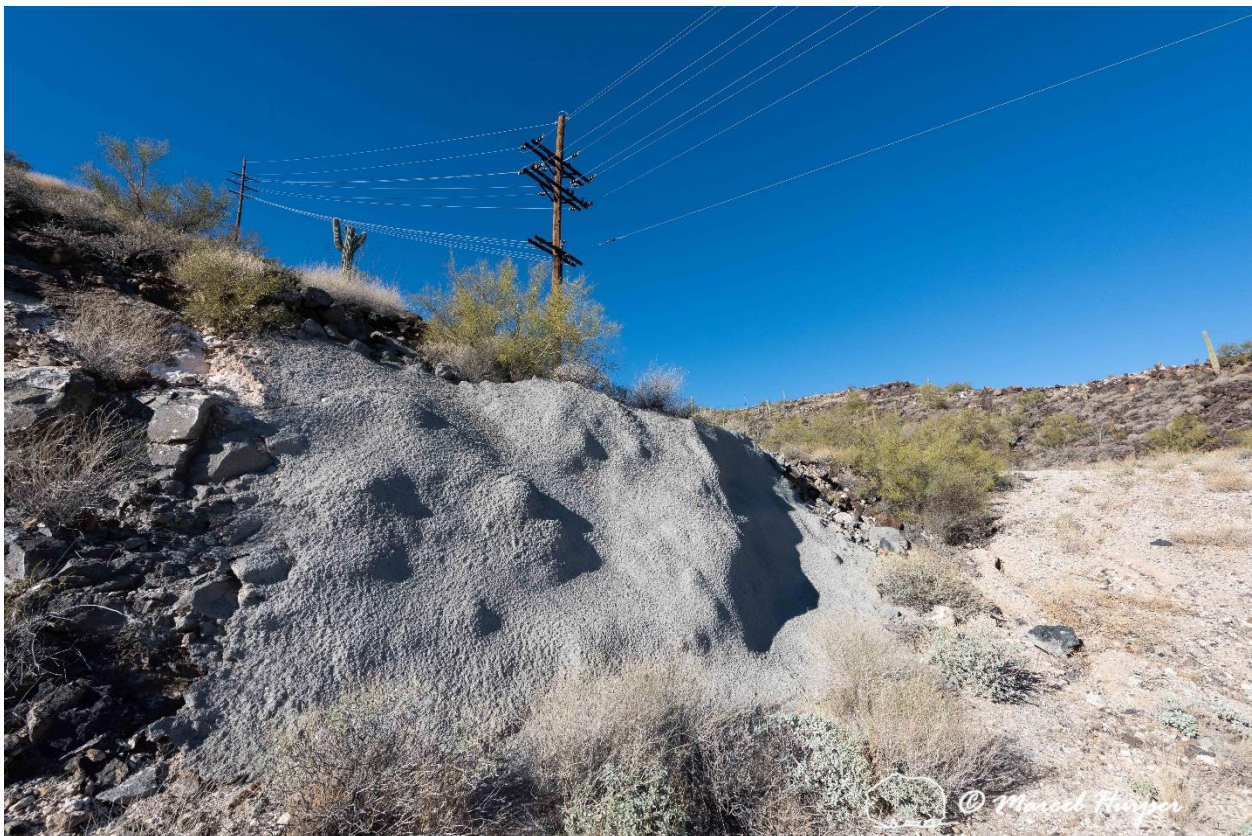
Shotcrete stabilizes a cut-slope along the road to Childs Mountain overlook (32°26'13.16"N 112°56'35.27"W).

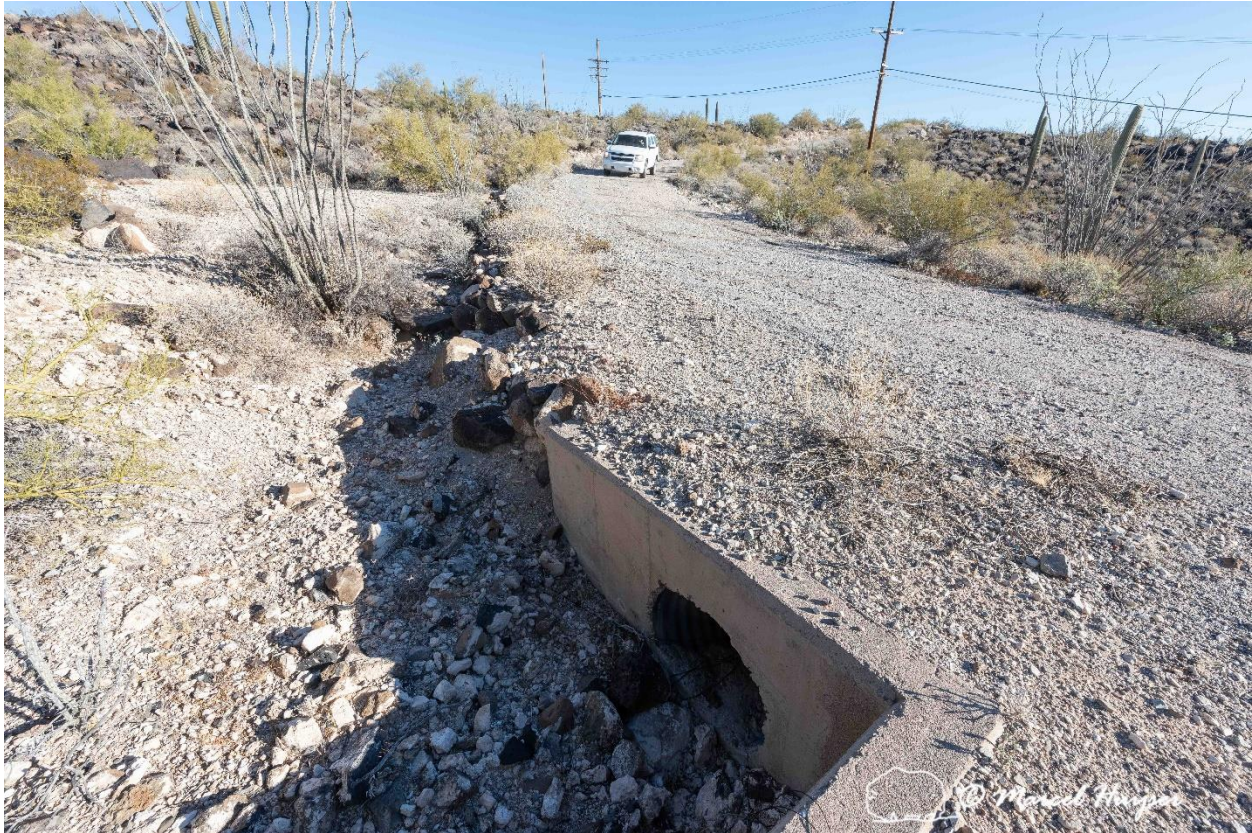
A culvert at an inboard ditch along the road to Childs Mountain overlook ($32^{\circ}26'25.73''\text{N}$ $112^{\circ}56'57.82''\text{W}$).

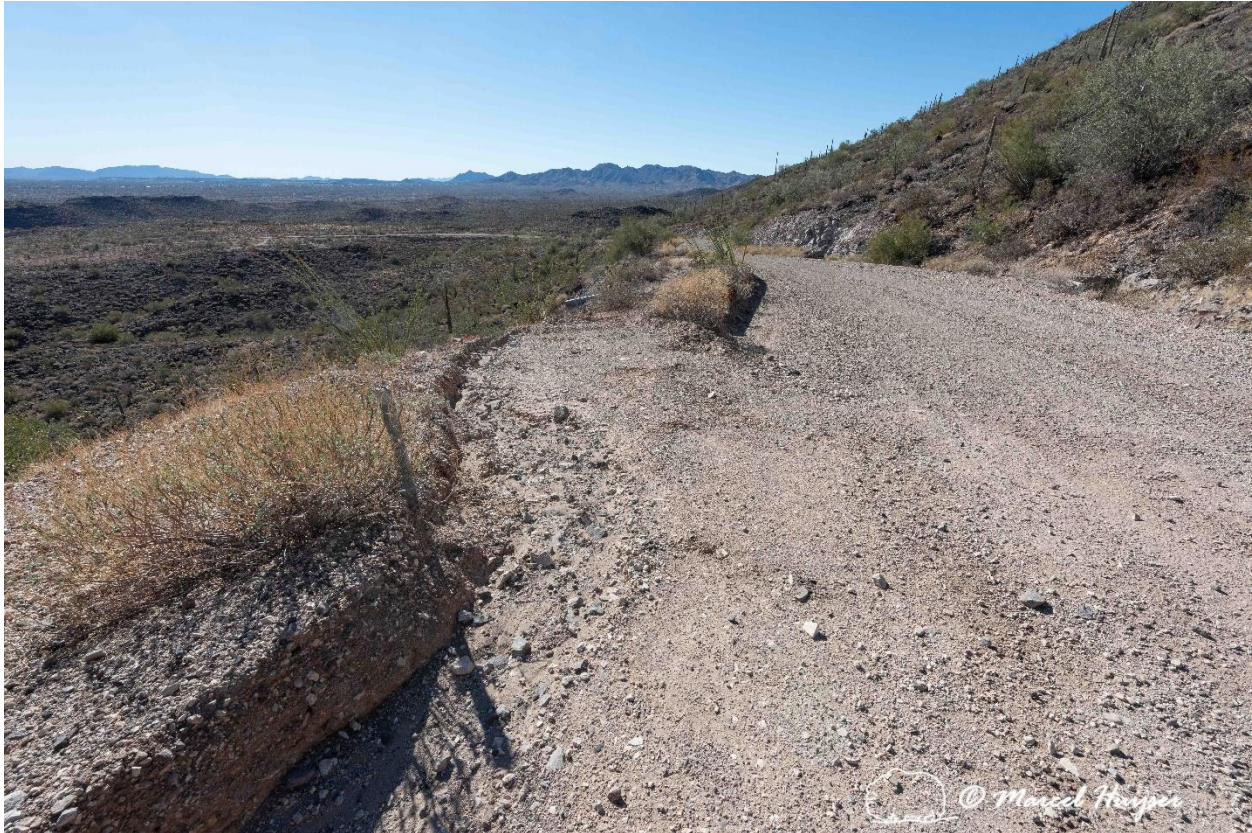
Here there is an opening in the berm allowing water to leave the road surface (32°26'35.74"N 112°55'28.39"W).
