Wildlife barriers: The effectiveness of electrified barriers to keep large mammals out of fenced road corridors

NDOT Research Report

No. 701-18-803 TO 6 Part 2

Wildlife Vehicle Collision Reduction and Habitat Connectivity Pooled Fund Study, TPF-5(358)

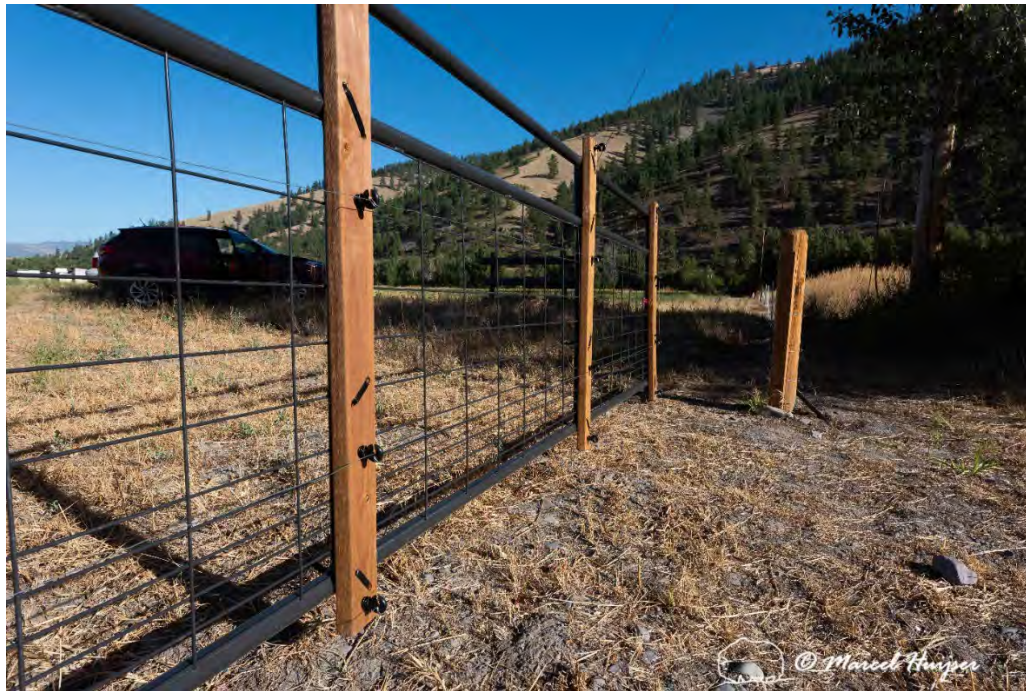
Figure 5: The electrified swing gate (16' (4.88 m) wide, 4'6" (1.37 m) tall, about 7" (18 cm) gap between ground and bottom of gate). The wires were mounted at 6" (15 cm), 1'7" (48 cm), 3'2" (97 cm), and 4'7" (140 cm) above the ground.

The researchers evaluated 5 different electrified barrier designs at 4 access points in 2020 and 2021 (Table 2, Figures 5-9). In addition, the swing gate at access point 2, and the drive-over mat at access point 3 were monitored from 23 May 2022 until 25 Sep 2022. The drive-through bump-gates were originally installed at 2 access points, but 1 of them was modified in 2020. The drive-over wires barrier was replaced by a drive-over mat in 2021 (Table 2).

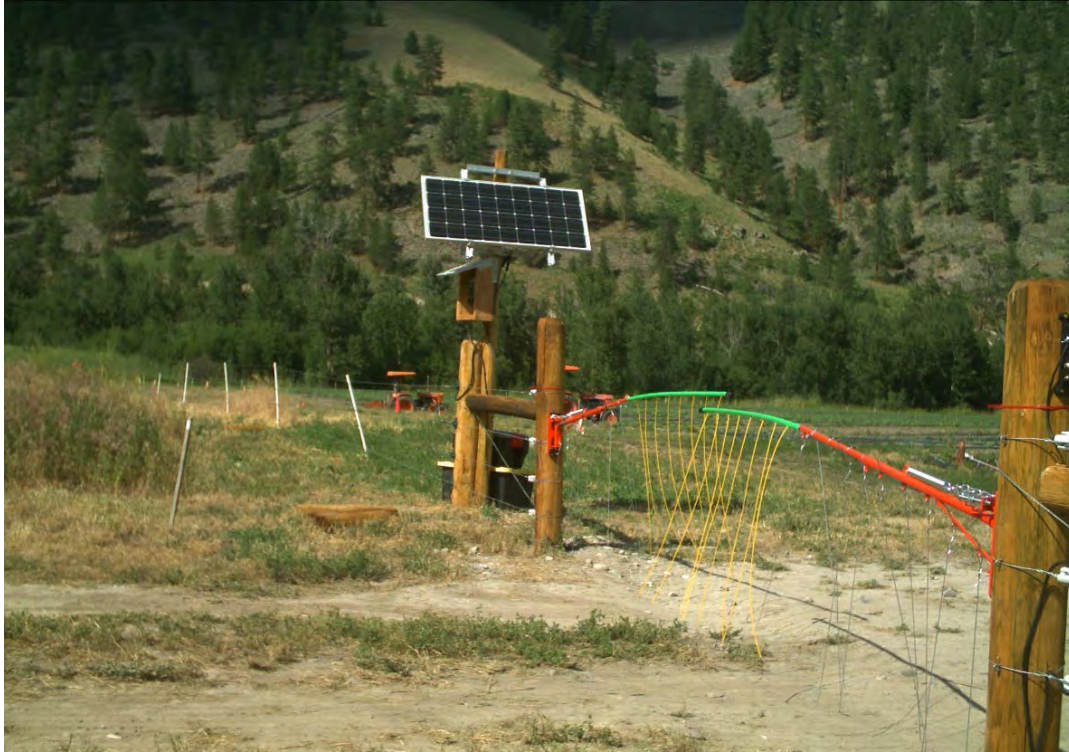
Figure 6: A drive-through bump gate (not modified) (about 16' (4.88 m) wide, about 3' (91 cm) tall), with vertical electrified wires. The orange horizontal pole is metal and carries current. The green horizontal part is fiberglass and does not carry current.

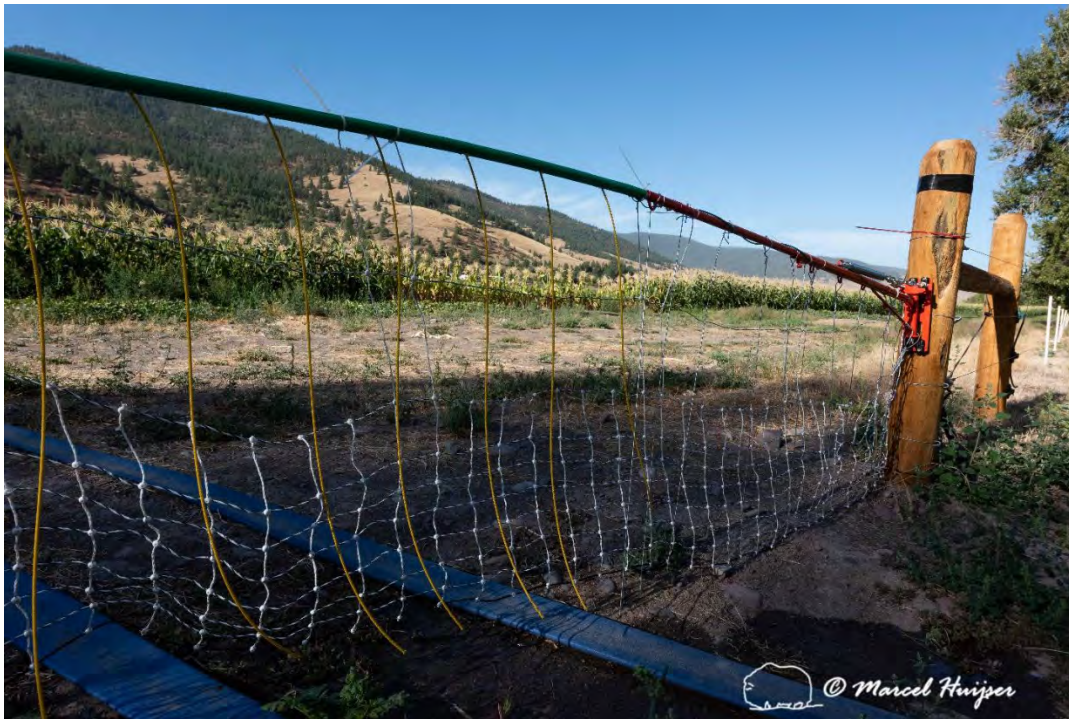
Figure 7: A modified drive-through bump gate (with conductive netting) (about 16' (4.88 m) wide, about 3' (91 cm) tall), with vertical electrified wires and custom conductive netting (about 2' (61 cm) high) attached.

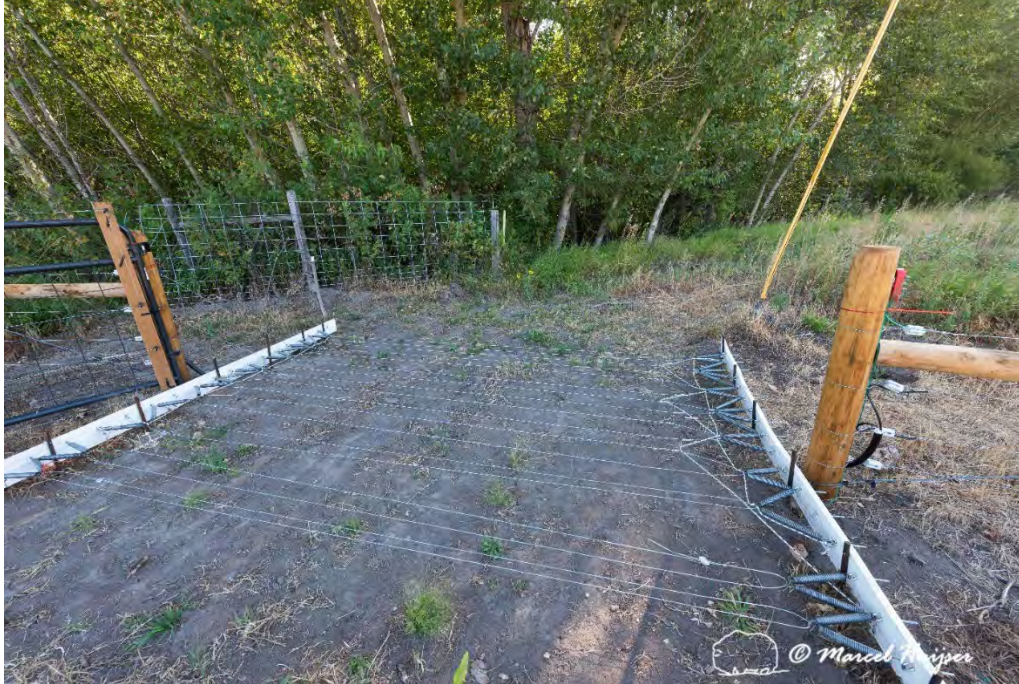
Figure 8: The drive-over wires, about 14'3" (4.34 m) wide (post-post) and 10'2" (3.10 m) long. The 18 drive-over wires are about 7" (18 cm) above the ground and the gaps between the wires vary between 5-12" (13-30 cm). There are "side-board" wires that angle toward the ground from the post along the sides of the barrier to reduce the likelihood of an animal bypassing the drive-over wires. However, these "side-boards" do not cover the full length of the barrier.

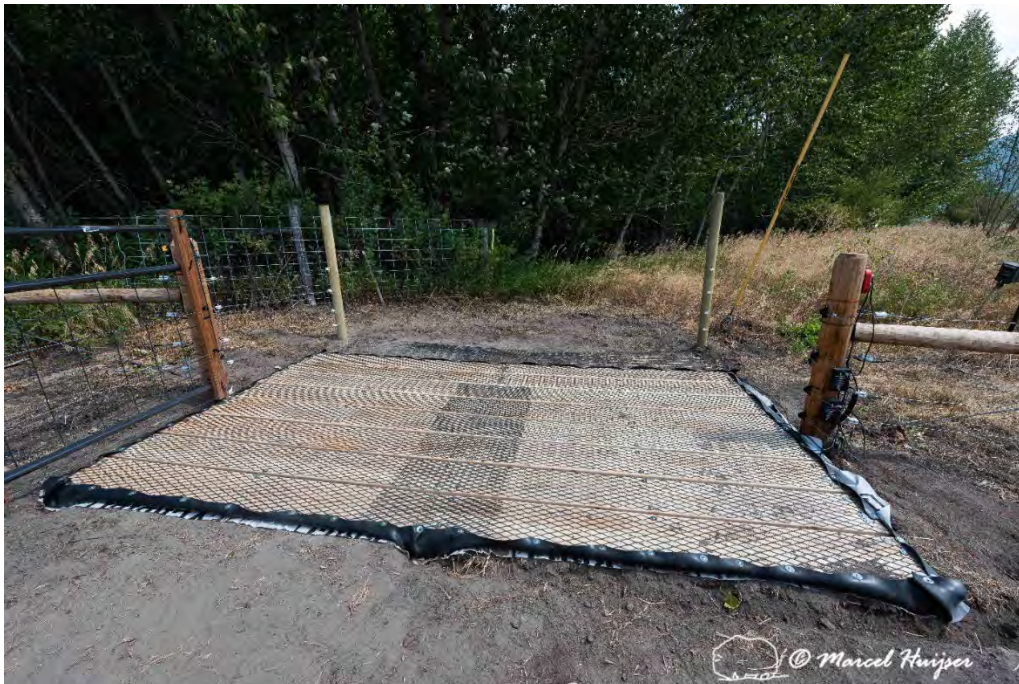
Figure 9: The drive-over mat about 14'3" (4.34 m) wide (post-post) and about 10' (3.05 m) long. On the far side, the habitat side, there is metal mesh on the ground, connected to a grounding rod (about 2 ft (61 cm) wide). This is followed by 8 sections of 10-11" (25-28 cm) wide expanded metal sheeting (alternating positive and negative (ground)) mounted on wooden planks. This drive-over mat is powered by its own solar panel, battery and energizer.

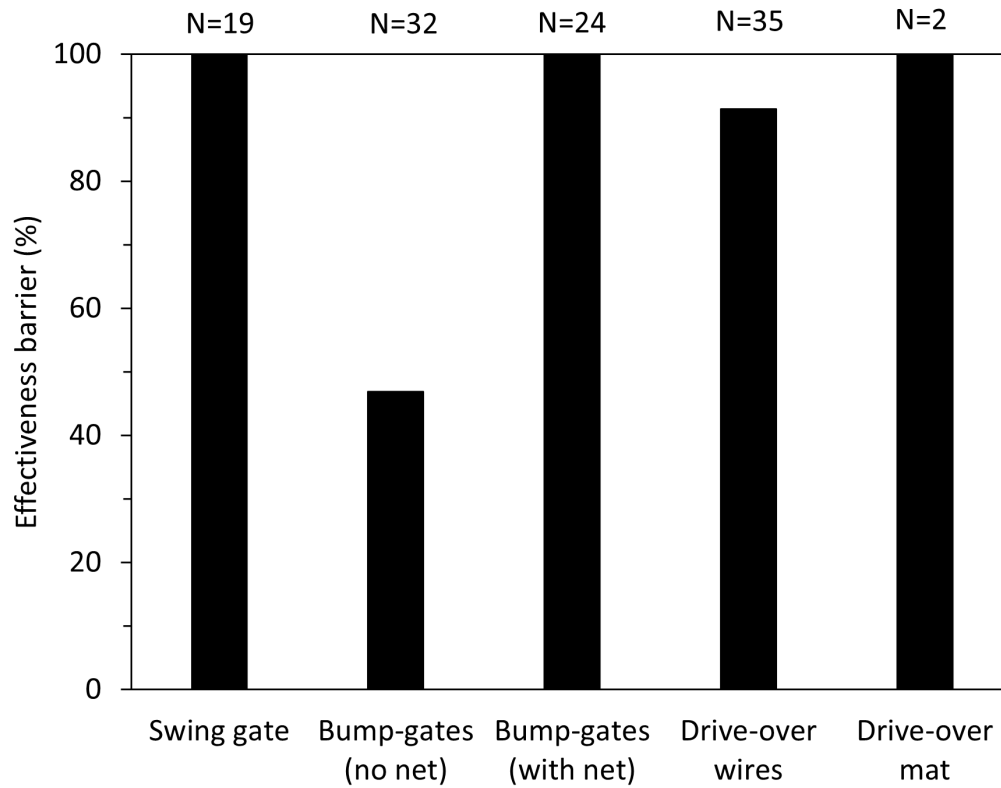
Figure 12: The effectiveness of the different barrier types in keeping black bears out of the melon patch.

All the bears that were recorded were black bears; there were no observations of grizzly bears. All the black bear events related to single animals; there were no events involving multiple black bears (e.g. a sow and cubs). Four out of the 5 electrified barrier designs for access points were an absolute (100%) or near absolute barrier (91.4%) for black bears (Figure 12). However, the bump-gates that were originally designed for cattle were a poor barrier for black bears (46.9%). Based on the images from the cameras, the bears usually passed in between the vertical electrified strands, and thus minimized contact with the wires (Figure 13). After conductive netting was attached to a bump gate, the bears no longer passed through the bump gate (100% barrier) (Figure 12) and they did not even touch the electrified barrier. The same was true for the swing gate, drive-over wires, and drive-over mat; most bears that approached the barriers did not touch the electrified components at all. Three out of 35 black bears passed the drive-over wires

above the ground (Figure 12). All 3 intrusions involved a bear bypassing most of the wires by coming in or leaving from the side (Figures 14-16).

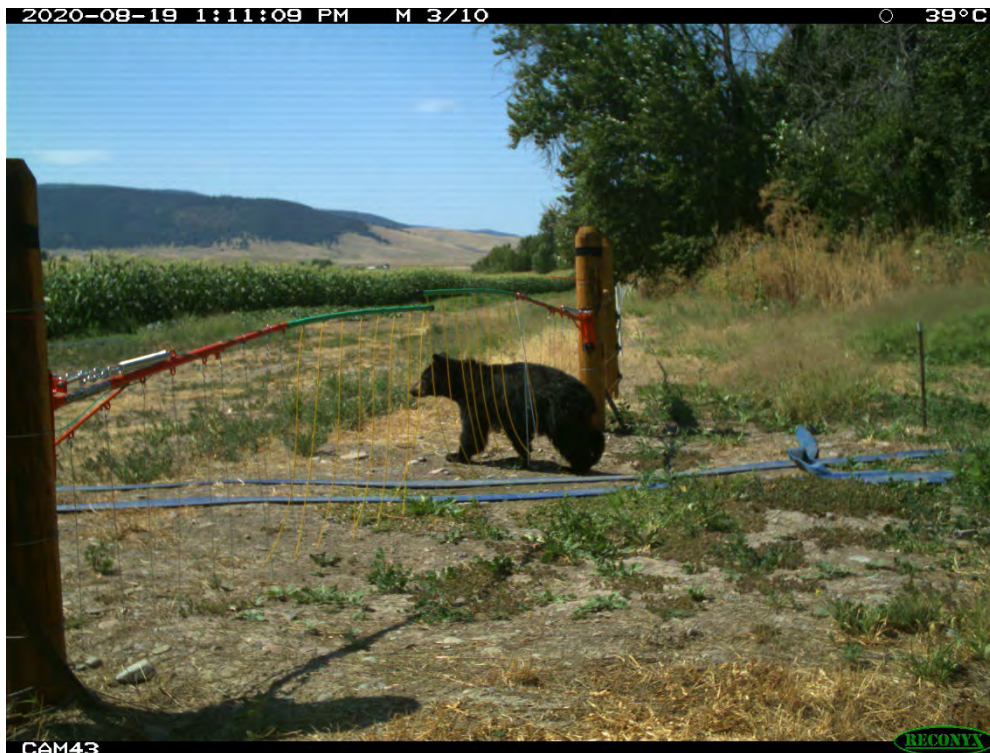
Figure 13: Black bear accessing the melon patch at a bump gate at access point 4, entering in between the vertical electrified wires. The black bears tended to choose the location where the space between the vertical wires was widest, at the transition of the orange and green parts of the horizontal pole.

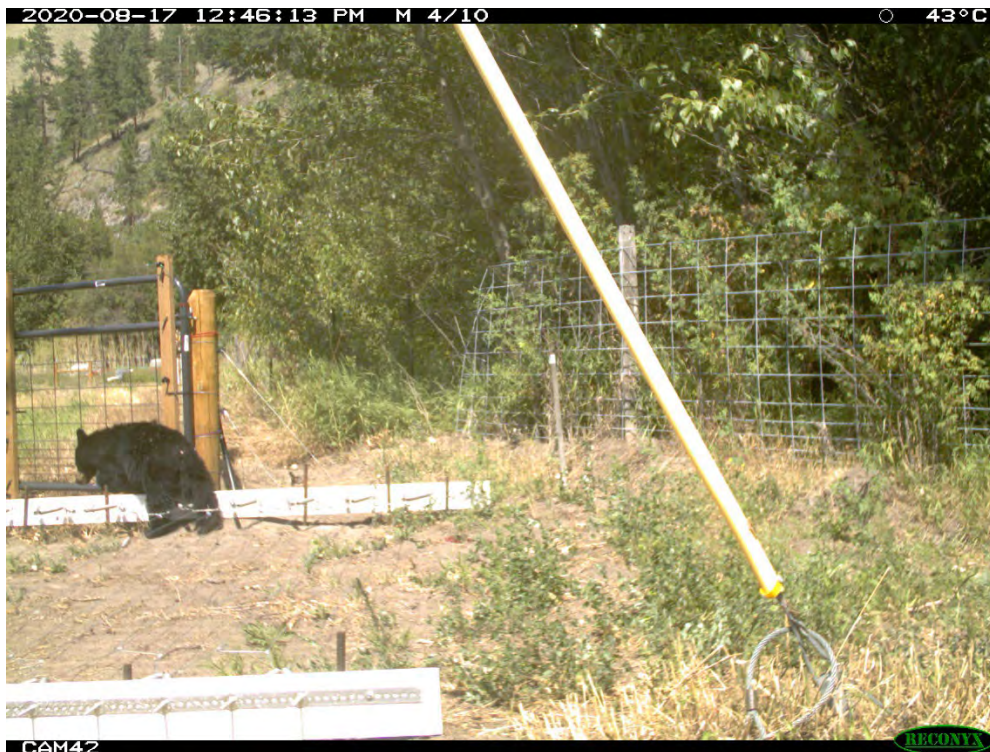
Figure 14: Black bear bypassing most of the wires above the ground and taking advantage of the space between the wires and the electrified gate on the side (1st out of 3 intrusions). Note that the electric wires on the side of the barrier (to the right of the bear) only cover the side partially.

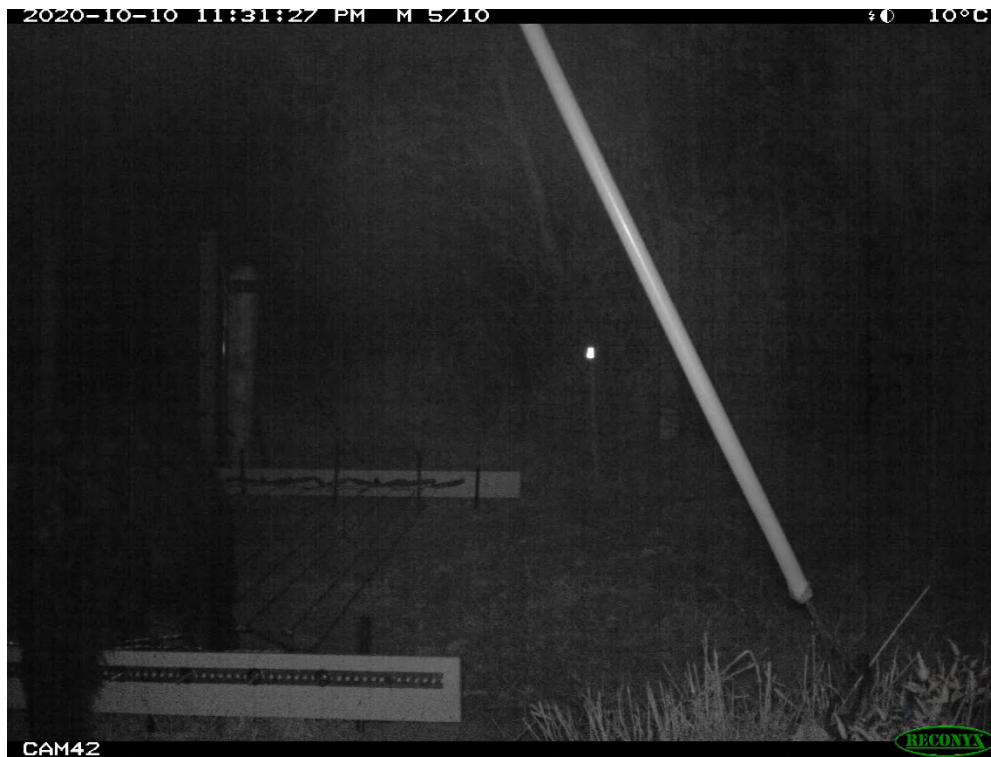
Figure 15: Black bear bypassing most of the wires above the ground by taking advantage of the partial electric fence on the side of the barrier (2nd out of 3 intrusions).

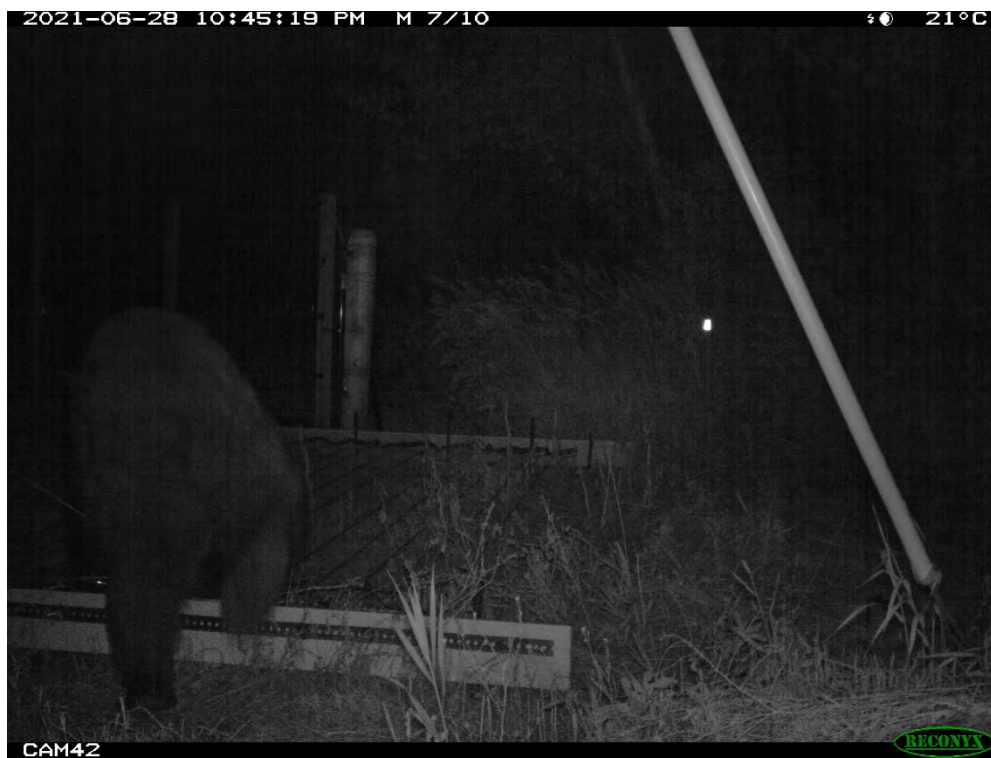
Figure 16: Black bear bypassing most of the wires above the ground by taking advantage of the partial electric fence on the side of the barrier (3rd out of 3 intrusions).

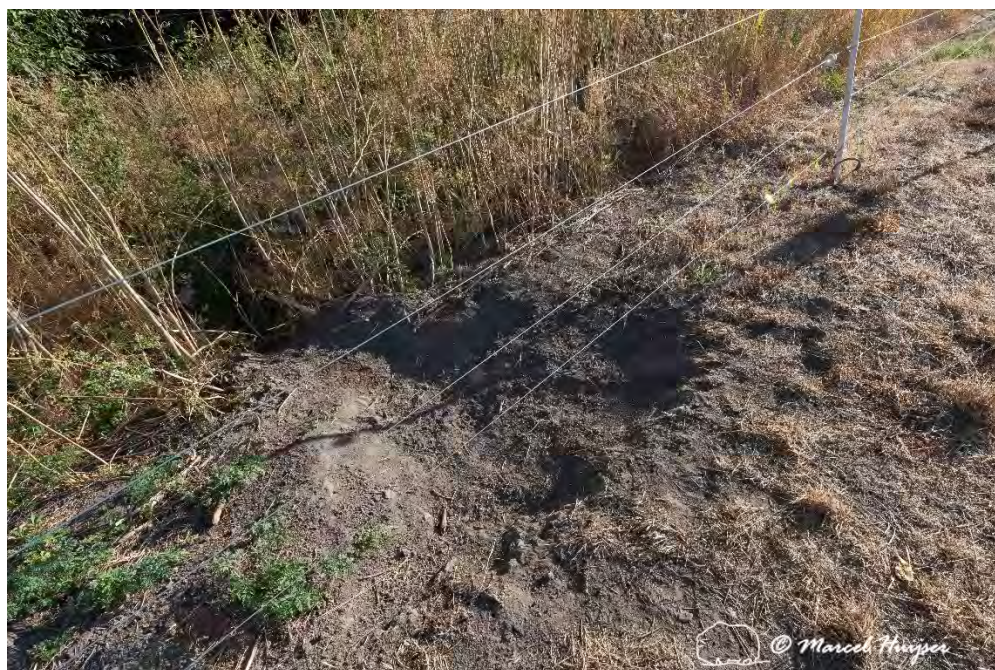
Figure 18: In some places black bears dug under the fence.

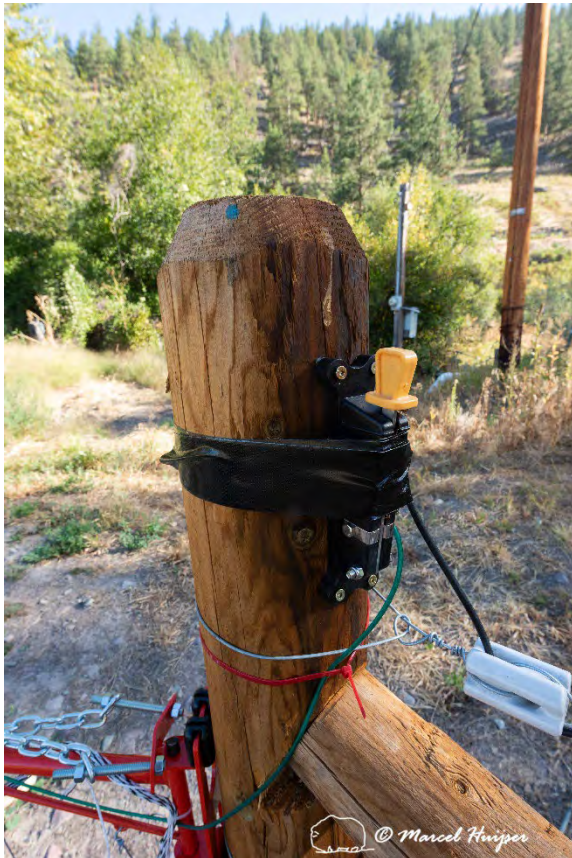
Figure 22: Switch at a bump gate taped in the permanently “on” position. Also note the adjustment bolts and nuts for the chain (lower left in image) that allows for the alignment of the horizontal pole.

All 4 vehicle access points had manual switches allowing farm personnel to walk through the electrified barriers without shocking themselves. However, shortly after the electric barriers were activated, the farmer realized that the switches were sometimes accidentally left in the “off” position. From 29 August 2020 onwards, all switches were permanently taped in the “on position” (Figure 22). While relatively inexpensive, the bump gates required custom conductive netting to become a substantial barrier to black bears. The netting is subject to tearing and needs to be adjusted and reattached regularly (e.g. zip-ties). In addition, there are tensioners for the 2 horizontal poles of the bump gates (Figure 22). These also need to be adjusted on a regular basis to ensure that the two horizontal poles align and do not leave a gap in the middle. The horizontal poles are also subject to breaking; one of the poles broke after it got stuck in a bumper or wheel well of a pickup truck (Figure 23).

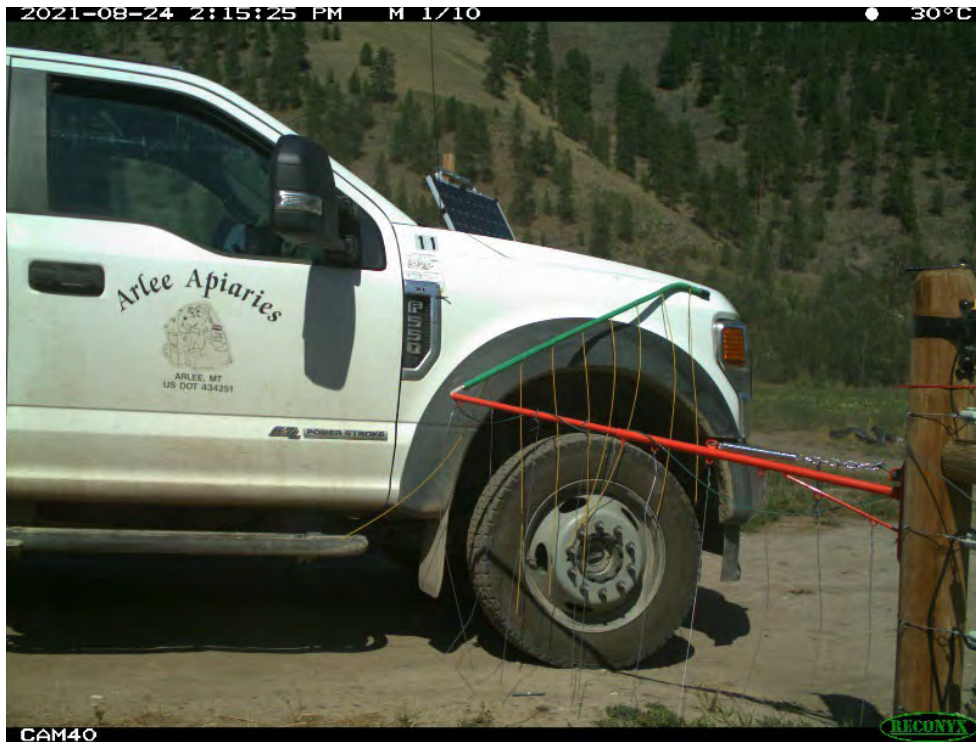
Figure 23: Broken horizontal pole of a bump gate because of a vehicle passing through.

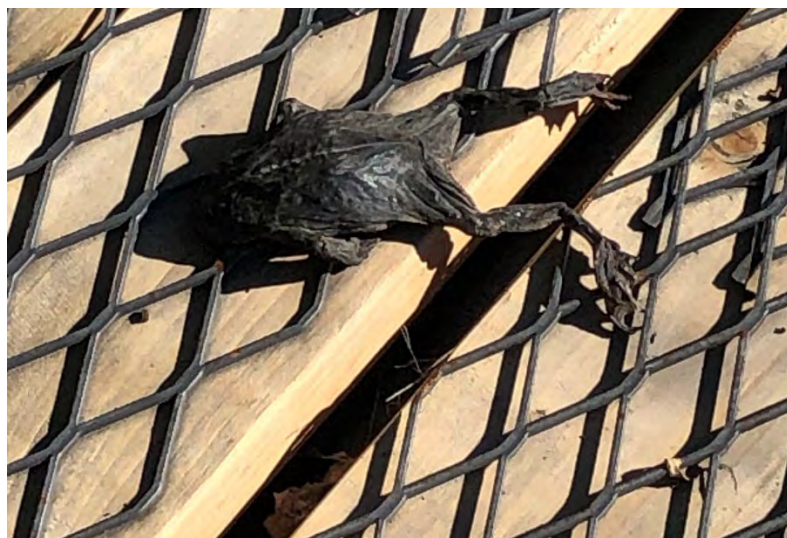
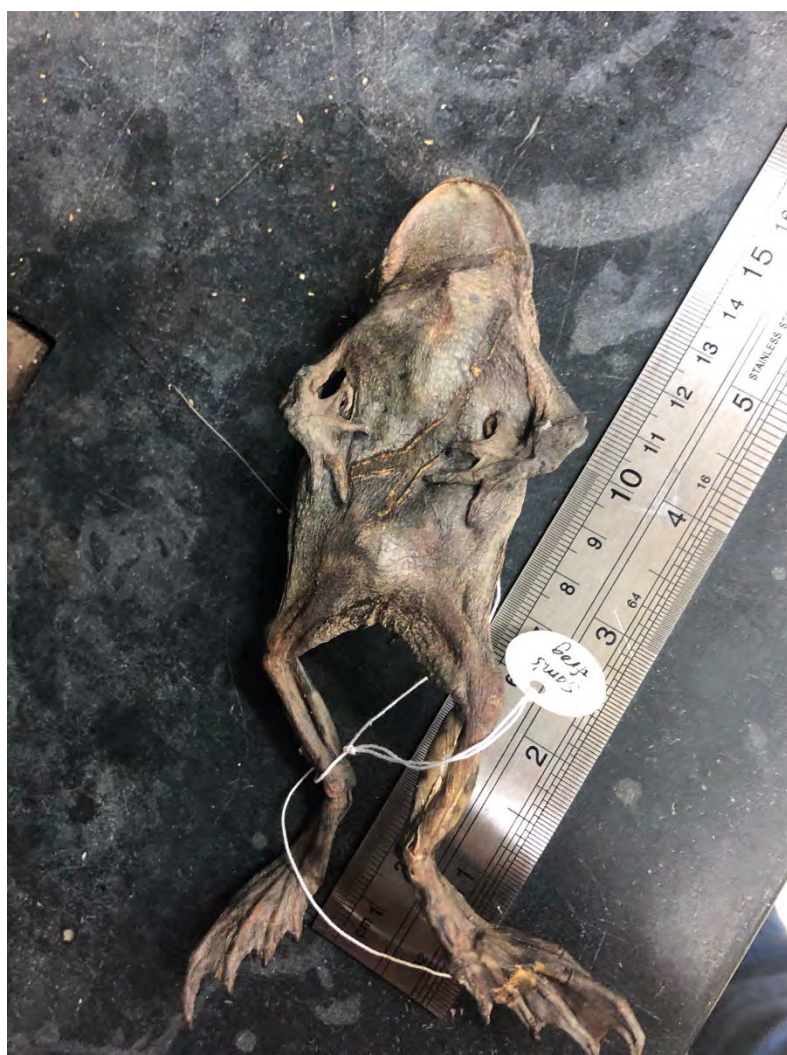
Figure 24: A. Western toad (*Anaxyrus boreas*), presumably electrocuted, on the electrified drive-over mat (Crosstek™). B. Same animal with burn marks from the mat. (Copyright: Samantha Getty).

There were no operation or maintenance issues with the electrified swing gate. A design problem of the drive-over wires barrier was that the side fences were too short. All three intrusions for black bears bypassed most of the wires above the ground by accessing or leaving the barrier from one of the sides. Barriers or “side-fences” that run tight along the full length of the barrier would address this issue and force bears, if they try to access the crop, to walk on top of or in between the wires above the ground for the full length of the barrier. In contrast, the drive-over mat has side barriers that have a tight connection to the mat, and they do run the full length of the mat. Here, no large mammals were able to bypass the mat by coming in from or leaving at one of the sides. The researchers did observe that the drive-over mat may kill amphibians and small mammals. Between 6 August 2021 and 21 November 2021, the researchers found one dead toad and one dead mouse on the mat (Figure 24, 25).

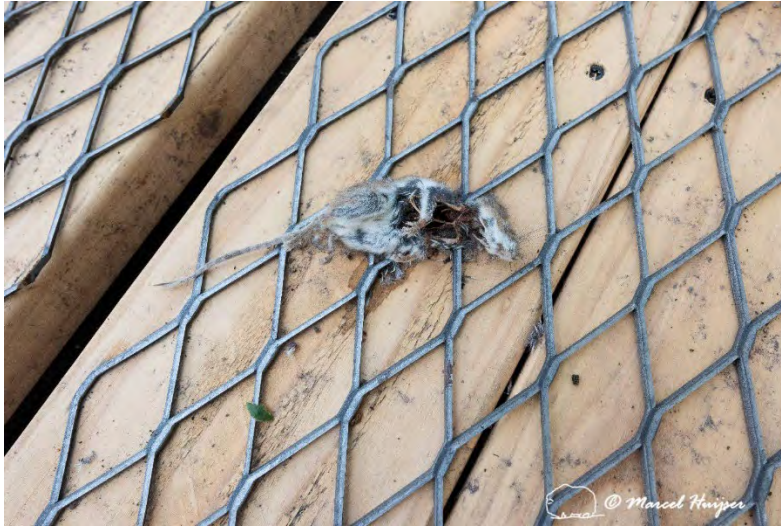
Figure 25: Deer mouse (*Peromyscus maniculatus*), presumably electrocuted, on the electrified drive-over mat (Crosstek™).

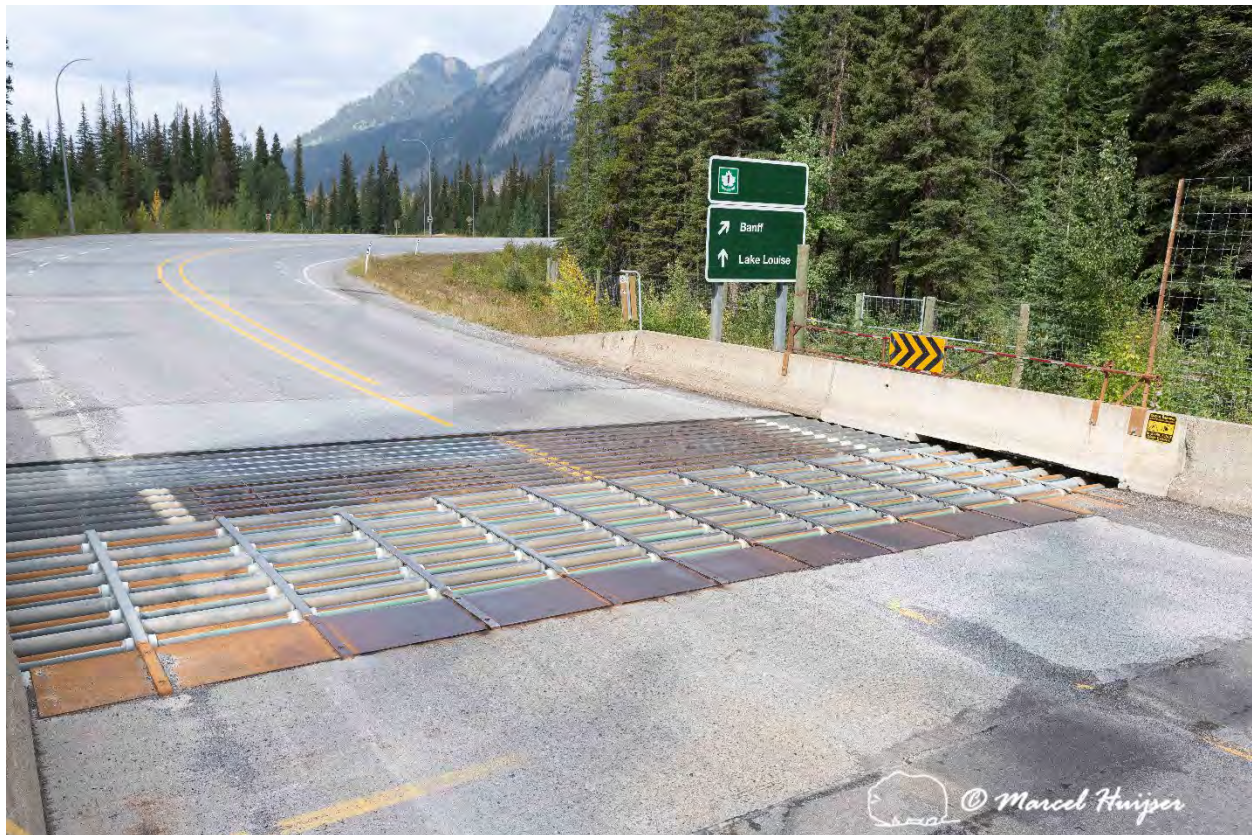
Figure 26: Electrified barrier, Sunshine Road, Banff National Park, Canada.

1. The grounding plate with strips to protect it from snowplows. This is the metal plate in front of the barrier, this is the habitat side where the animals would be approaching from.
2. A section with alternating positive (n=5) and negative (n=5) round bars. The positive bars have white insulators.
3. A section (far side in image, this is the highway side)) with flat bars (n=11, not electrified).

The barrier was briefly fully operational 8-20 October 2020, but a snowplow damaged the grounding plate as the protective strips had not been installed yet. After that, the damaged grounding plate was removed which meant that the animals were less likely to receive a full shock (variable conductivity of the pavement) or they would only be delivered a full shock after making contact with both a positive and negative bar. The grounding plate was reinstalled (with protective strips) at the end of September 2021 (personal communication Dan Rafla, Parks Canada).

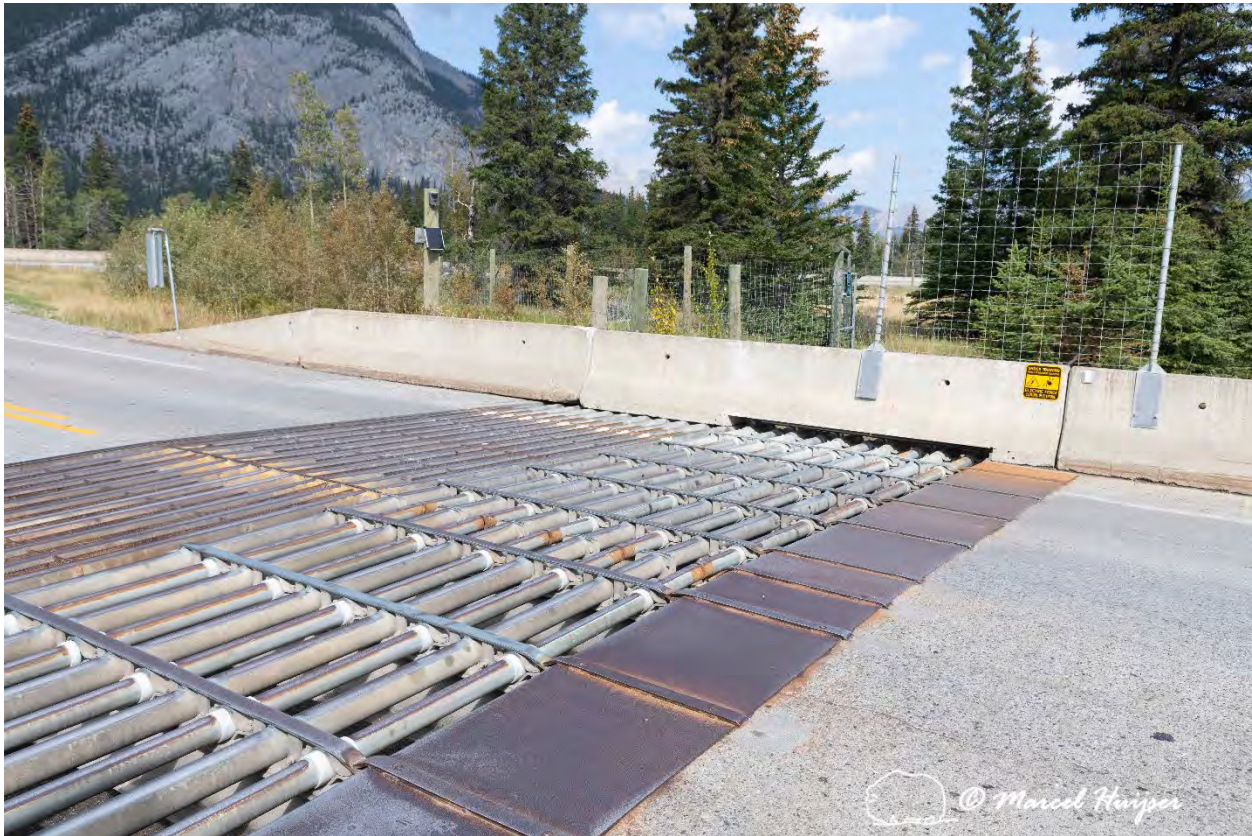
Figure 27: Electrified barrier, Compound Road, Banff National Park, Canada.

The barrier at Compound Road is constructed similar to the one at Sunshine Road (Figure 27). This barrier did not receive a grounding plate (with protective strips) until the end of September 2021 (personal communication Dan Rafla, Parks Canada).

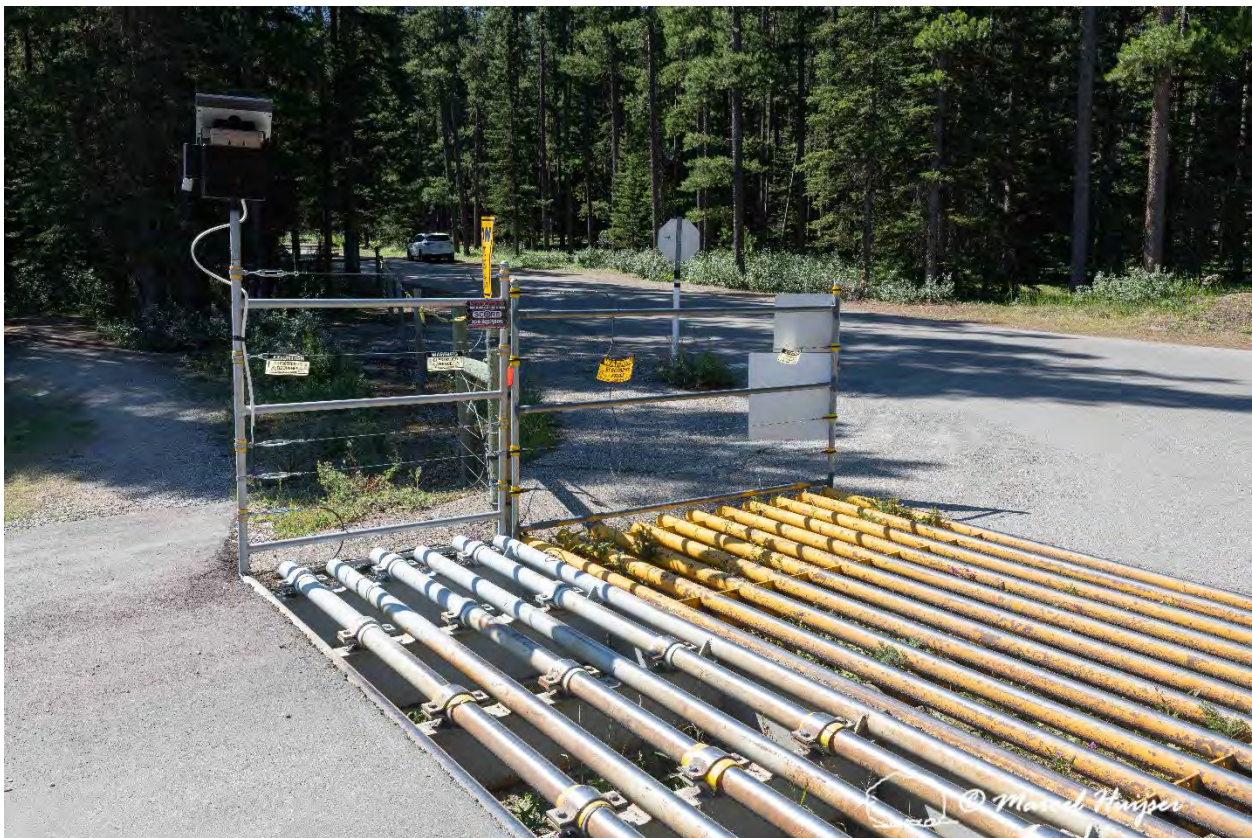
Figure 28: Electrified barrier, Lake Louise Campground, Lake Louise, Canada.

This barrier does not have a grounding plate. This barrier has been operational, but the electricity is turned off in winter when most bears are inactive.

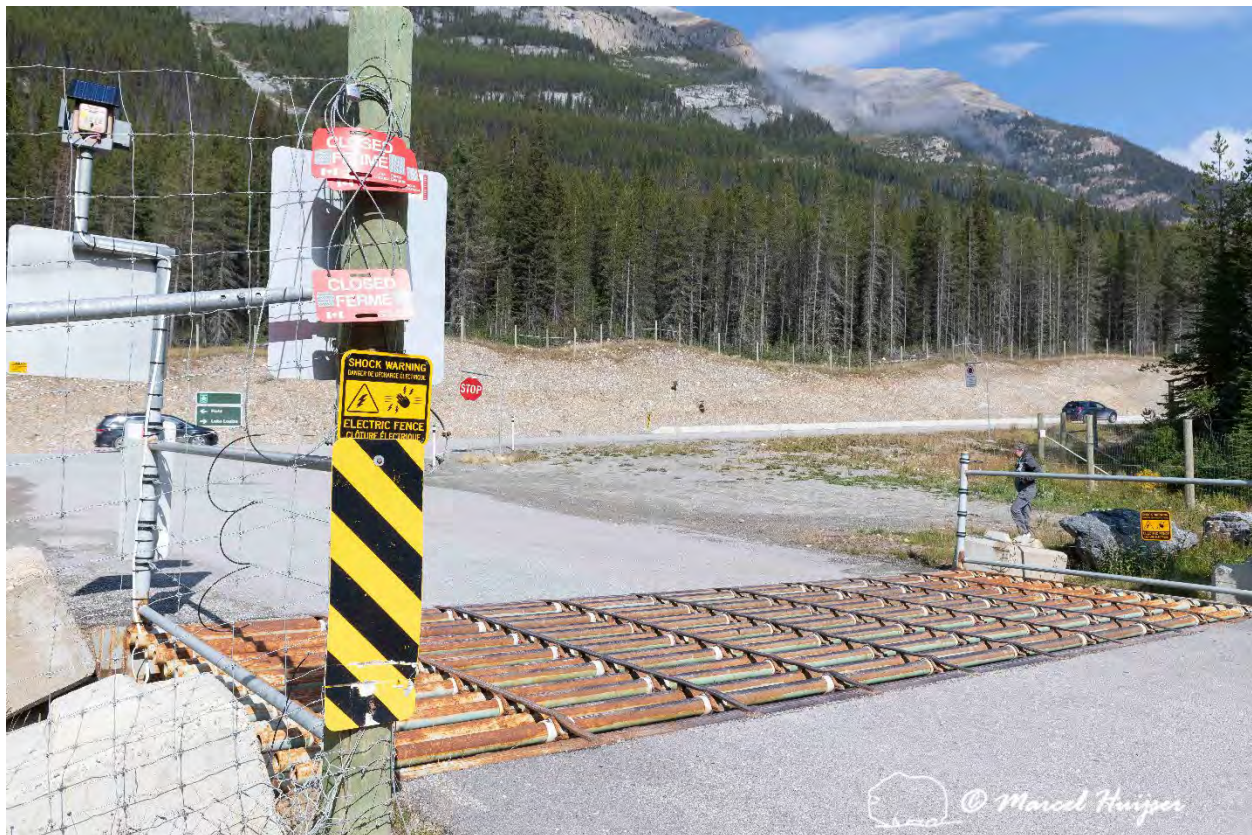
Figure 29: Electrified barrier, Lake O'Hara exit, Yoho National Park, Canada.

1. A section with alternating positive ($n=7$) and negative ($n=7$) round bars. The positive bars have a white insulator.

This barrier does not have a grounding plate. The Trans-Canada Highway is in the far side of the image. The foreground is the habitat side. This barrier does not have a grounding plate. This barrier has been operational, but the electricity is turned off in winter when most bears are inactive.

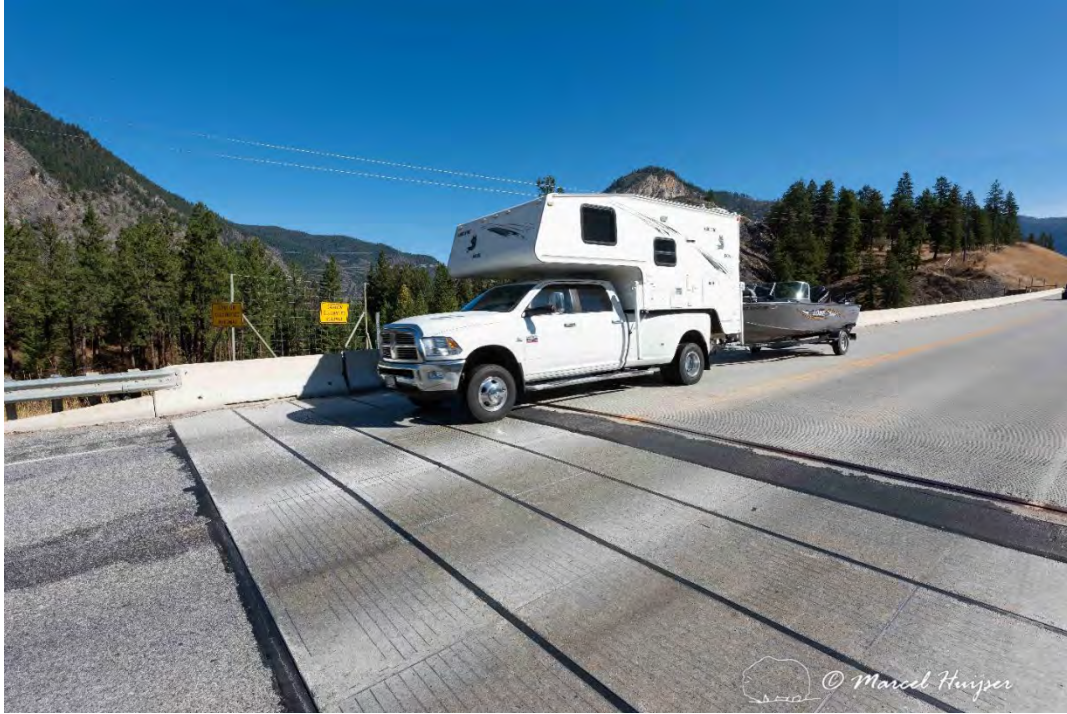
Figure 31: The electrified barrier at the west fence-end. Note that the bridge directly connects to the electrified barrier.

ZapCrete™ consists of concrete, conductive materials and insulation materials. The power source is a solar battery system. The dimensions of the electrified barriers are 40 ft x 12 ft (12.2 x 3.7 m) (west end) and 33 x 12 ft (10.1 x 3.7 m) (east end) (personal communication Tim Hazlehurst, CrossTek™ Wildlife Solutions) (Figure 31-34). Each mat is solar-powered and consists of metal strips embedded in concrete. There are 2 pushbuttons at each mat, one for each travel direction. These buttons are for pedestrians and other non-motorized traffic that may be at risk of receiving an electric shock (around 10kV). After the button has been pushed, the power turns off. After about 1 minute the power turns back on automatically. The total cost for two mats across 2 lanes was approximately US\$ 247,000, including materials and labor (about US \$ 123,500 per mat).

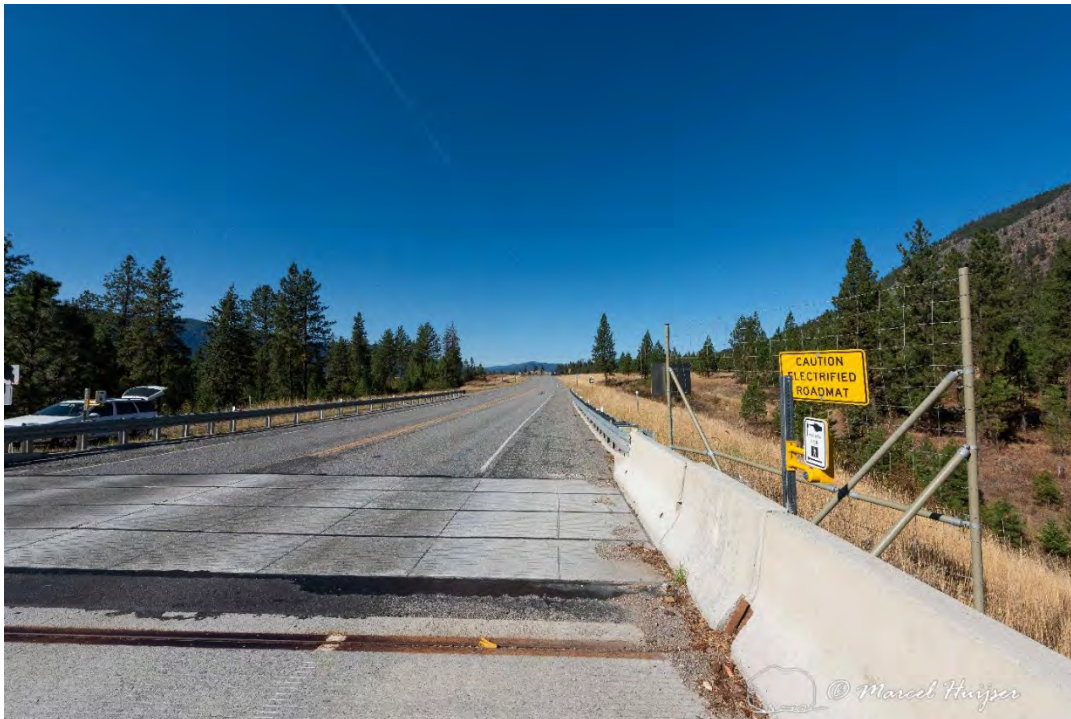
Figure 32: The electrified barrier at the west fence-end. Note that the bridge directly connects to the electrified barrier.

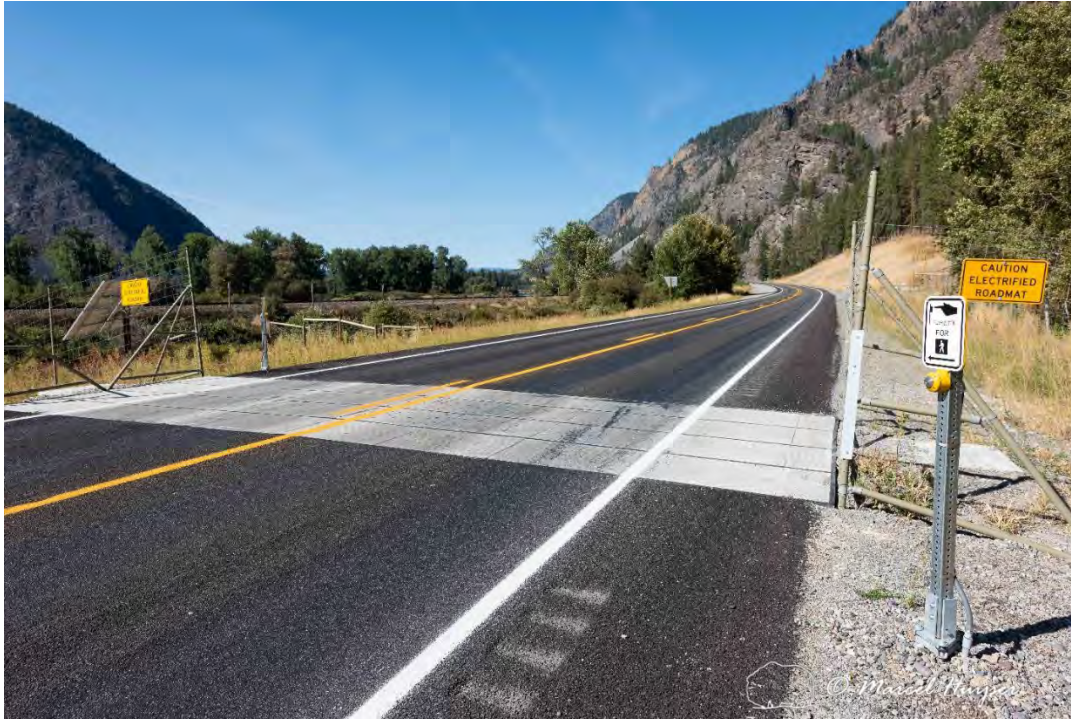
Figure 33: The electrified barrier at the east fence-end.

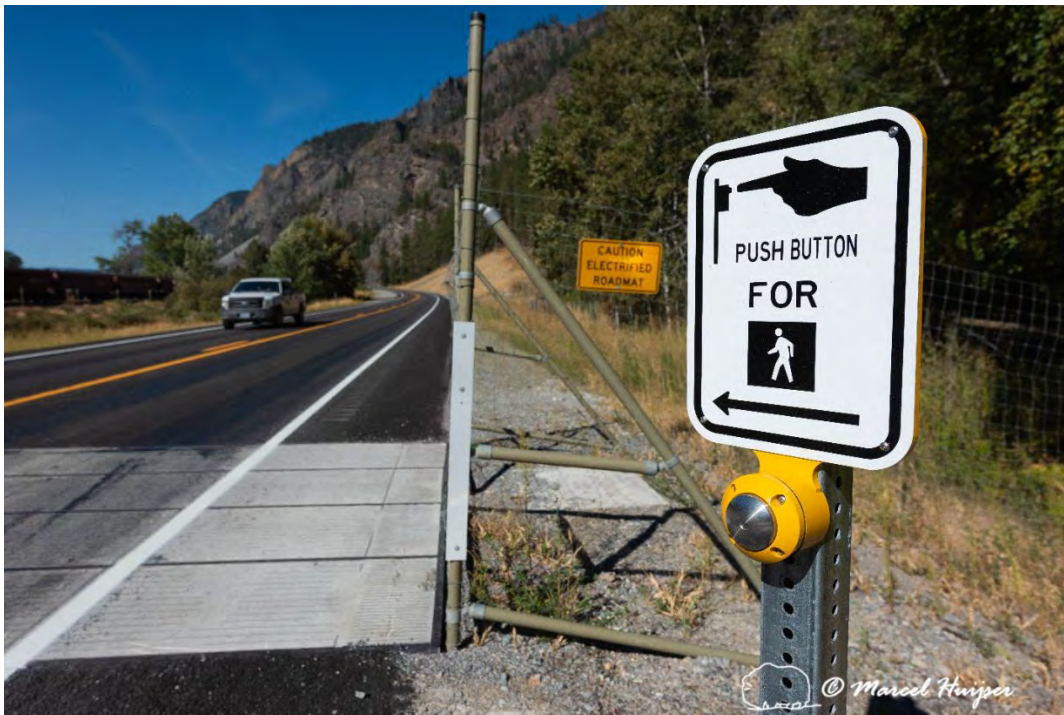
Figure 34: One of the push buttons for pedestrians at the electrified barrier at the east fence-end. There are 2 push buttons; one for each travel direction.

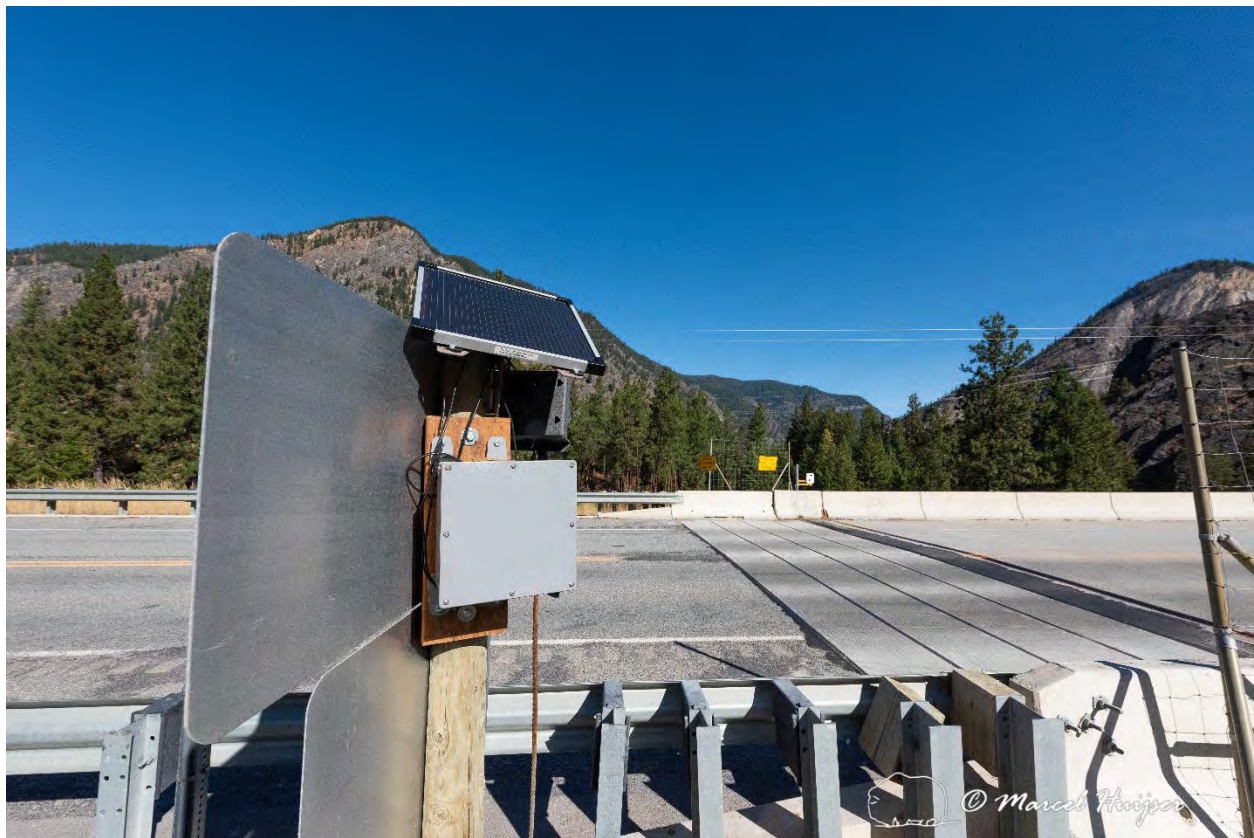
Figure 35: The camera, battery box and solar panel installed on a sign post behind the sign at the western electrified barrier.

The west and east electrified barrier each had a trail camera installed (HyperFire 2 Professional Covert IR) (Figures 35, 36). To accommodate the heavy use of the cameras associated with the traffic volume (about 2,000 potential camera triggers per day on average), the cameras were customized with an external power. This allowed the cameras to be powered through a solar panel and associated battery. In addition, high-capacity memory cards (64 GB) were used. The cameras were checked, and the memory cards were exchanged about once a month. The camera at the west fence-end was installed 30 September 2020. The camera at the east fence-end required a new post for which a right-of-way encroachment permit was obtained from MDT on 8 October 2020. The post and camera were installed on 27 October 2020.
