Wildlife barriers: The effectiveness of electrified barriers to keep large mammals out of fenced road corridors

NDOT Research Report

No. 701-18-803 TO 6 Part 2

Wildlife Vehicle Collision Reduction and Habitat Connectivity Pooled Fund Study, TPF-5(358)

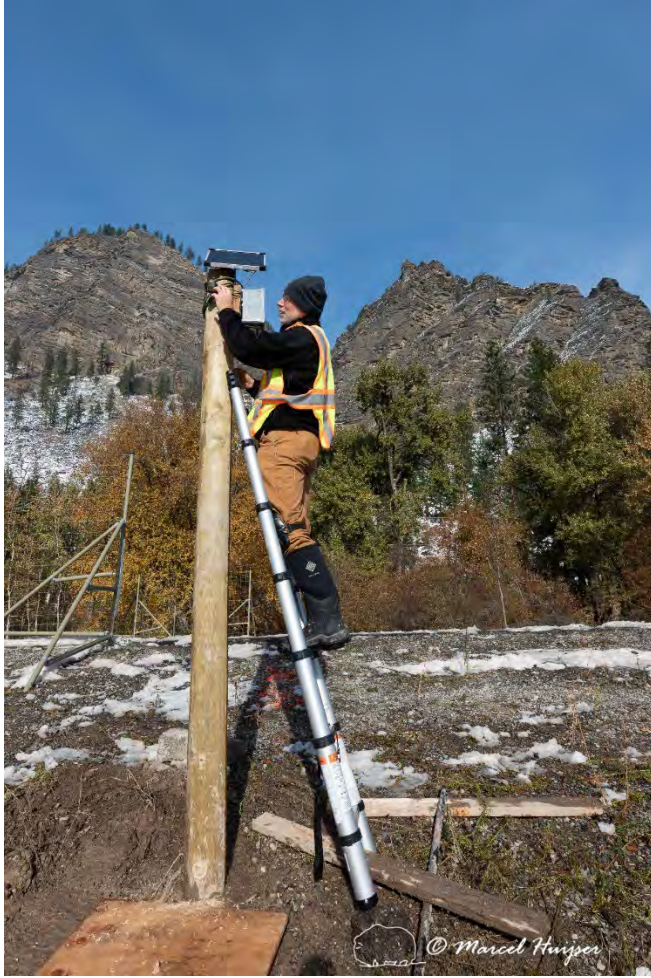
Figure 36: The camera, battery box and solar panel installed on a designated newly installed post at the eastern electrified barrier.

The west and east electrified barrier each had a trail camera installed (HyperFire 2 Professional Covert IR) (Figures 35, 36). To accommodate the heavy use of the cameras associated with the traffic volume (about 2,000 potential camera triggers per day on average), the cameras were customized with an external power. This allowed the cameras to be powered through a solar panel and associated battery. In addition, high-capacity memory cards (64 GB) were used. The cameras were checked, and the memory cards were exchanged about once a month. The camera at the west fence-end was installed 30 September 2020. The camera at the east fence-end required a new post for which a right-of-way encroachment permit was obtained from MDT on 8 October 2020. The post and camera were installed on 27 October 2020.

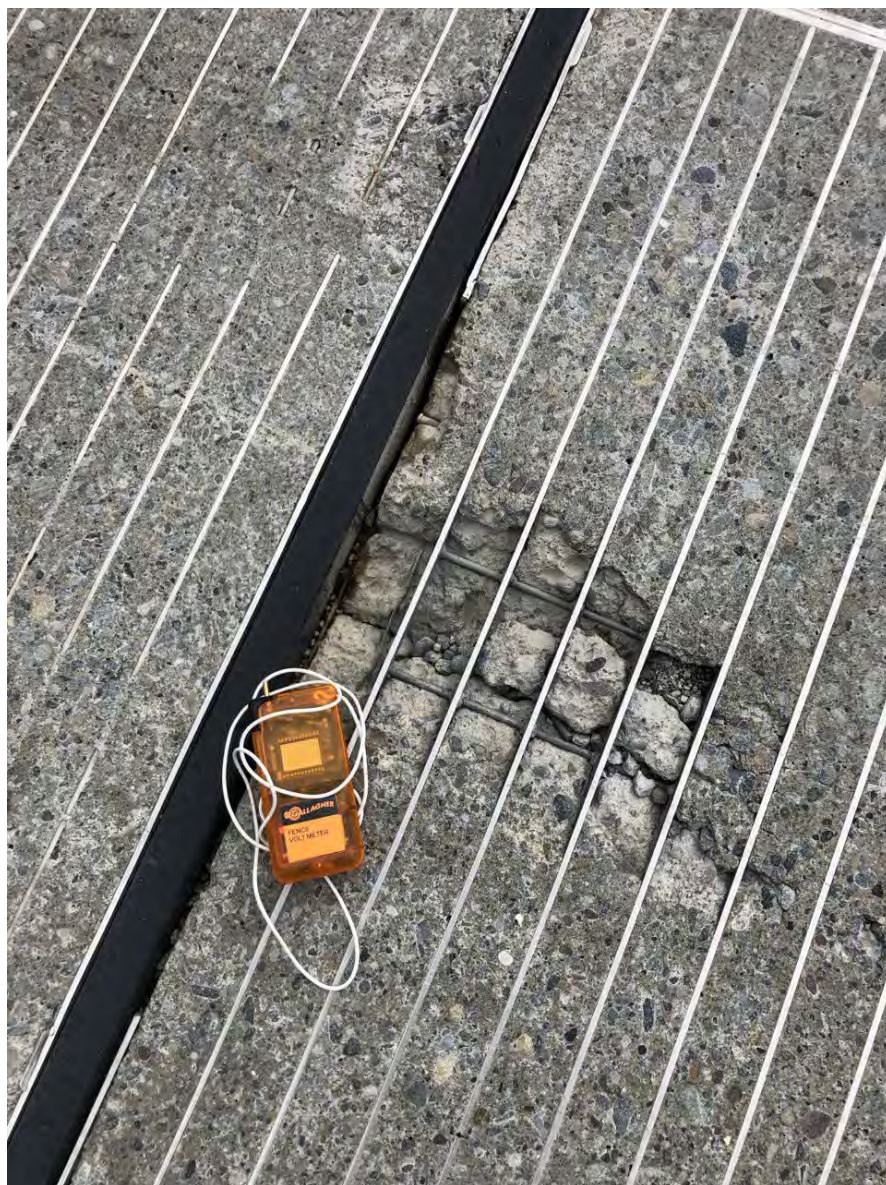
Figure 37: Crumbling concrete at the western electrified barrier, presumably associated with a change in slope after the bridge abutment settled (image Samantha Getty).

- Both mats were disabled by MDT in Nov 2021. The concrete between the metal strips at the western mat was crumbling, presumably because the bridge abutment has settled, and there is now a change in slope where the bridge connects to the electrified mat. This causes vehicles to exercise excessive stress on the pavement (Figure 37-38). There is no evidence that the material associated with the electric mat is more fragile than standard concrete.

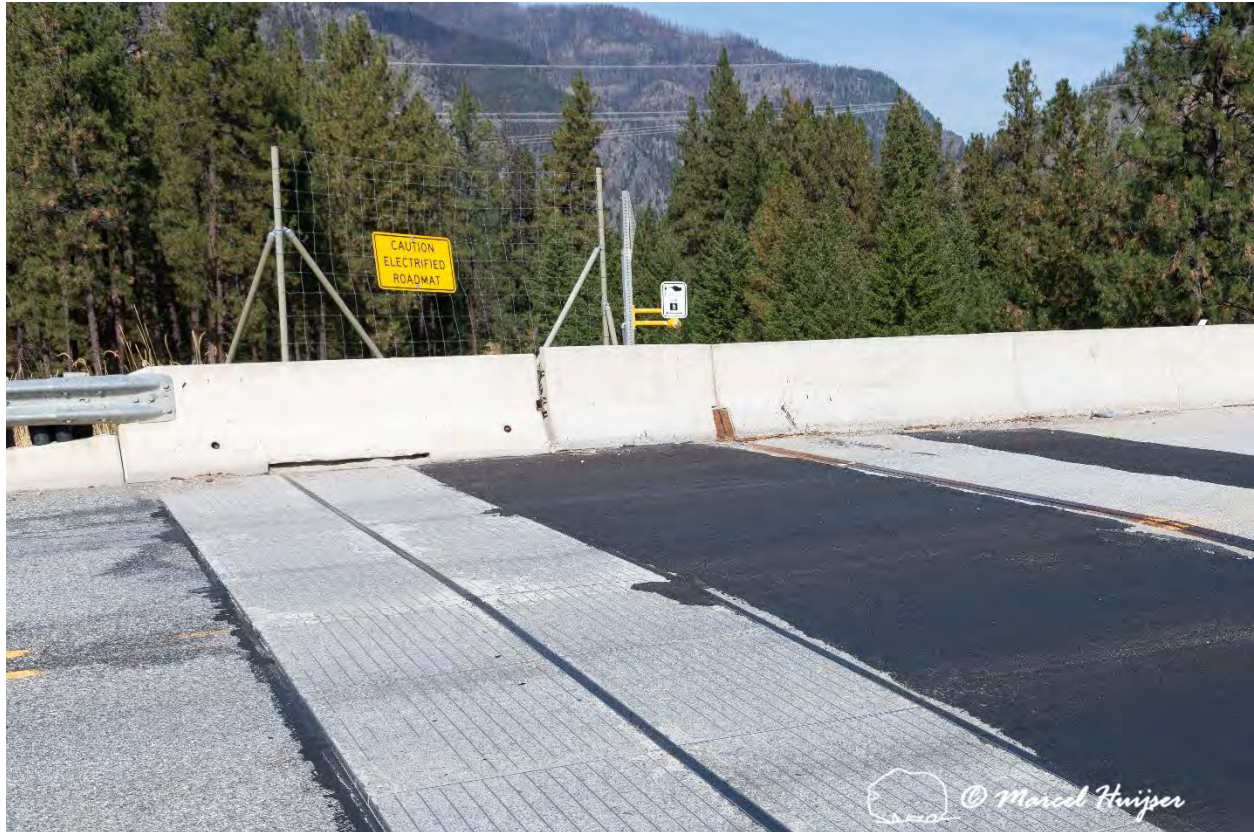
Figure 38: The crumbling concrete at the western electrified barrier was covered in asphalt.
