Wildlife barriers: Modified jump-outs for white-tailed deer and mule deer

NDOT Research Report

No. 701-18-803 TO 6 Part 1

Wildlife Vehicle Collision Reduction and Habitat Connectivity Pooled Fund Study, TPF-5(358)

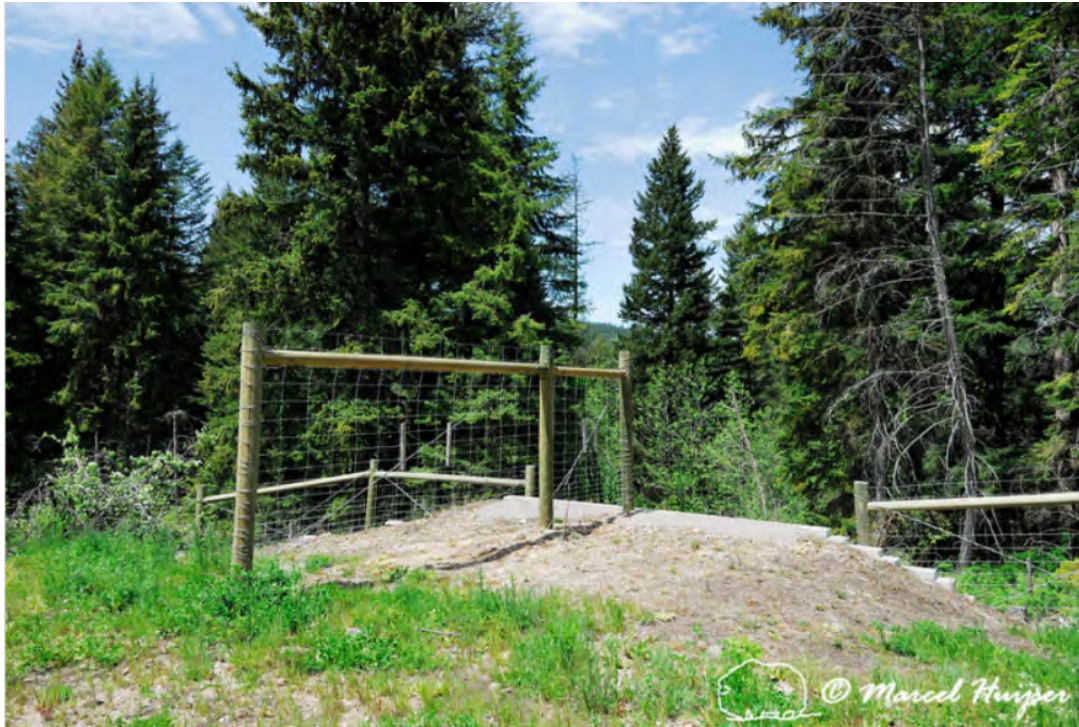
Figure 2: An unmodified jump-out in the Evaro area. The mount allows the animals to walk up to an opening in the fence, with a drop of around 6 ft (1.83 m) to the habitat side of the jump-out.

Between 2008-2015, 52 jump-outs or escape ramps were monitored using tracking beds on top and on the bottom of the jump-outs (Huijser et al. 2016) (Figure 2 and 3). Most of these jump-outs were about 6-7 ft (1.83-2.13 m) high and had a width (i.e., gap in the fence) of about 5 m (15 ft). Only 13.84% of the deer that were tracked on top (white-tailed deer and mule deer combined) were estimated to have jumped down. None of the deer that passed by on the habitat side of the jump-out were estimated to have jumped up into the fenced road corridor (Huijser et al. 2016). More detailed monitoring with wildlife cameras (2014-2016) of 10 of these jump-outs (varying in height 1.75-2.04 m (5.7-6.7 ft)) showed that only 6.88% of the white-tailed deer and 32.35% of the mule deer detected on the top of the jump-outs jumped down to the safe side of the fence (Huijser et al. 2016). None of the deer that passed by on the habitat side of the jump-outs were observed jumping up into the fenced road corridor (Huijser et al. 2016). Note that “a deer” may eventually jump-down, but especially white-tailed are not likely to do so on their first attempt and the deer spend more time inside the fenced road corridor than most would consider desirable. Alternatively, a deer escapes the fenced road corridor at a wildlife guard at an access road, or where the fenced road corridor ends (at a fence-end).

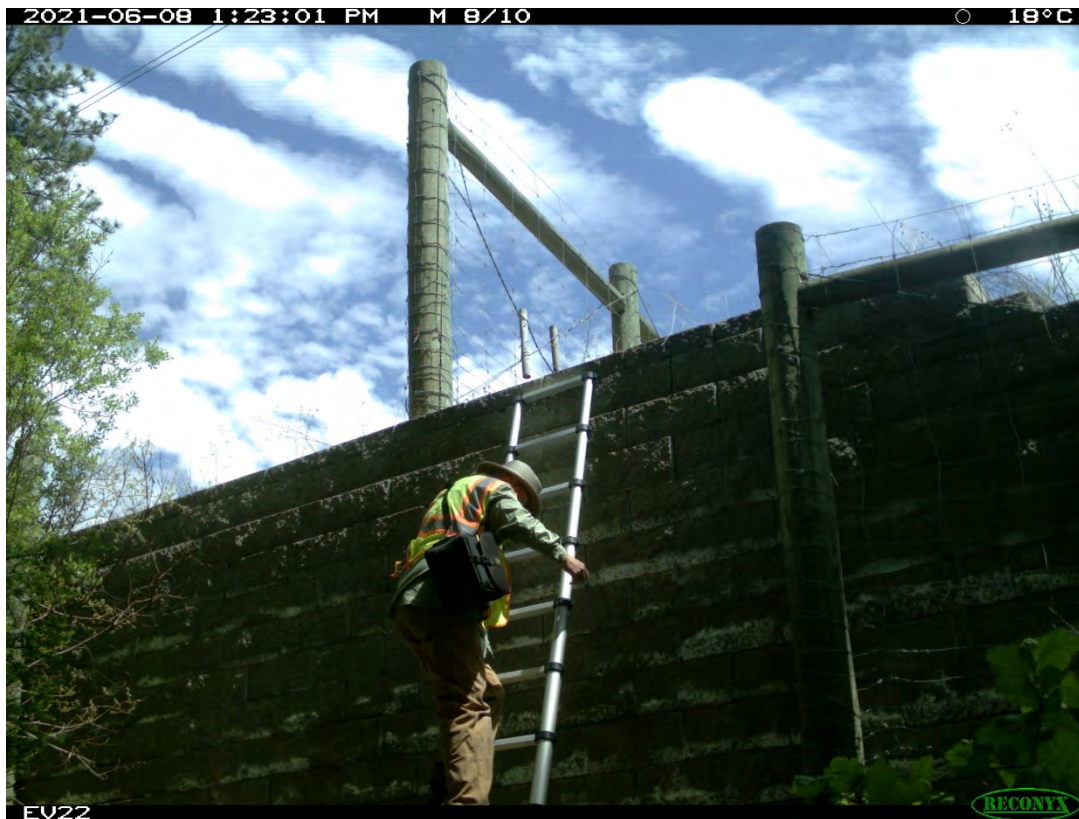
Figure 3: Some of the unmodified jump-outs are extremely high.

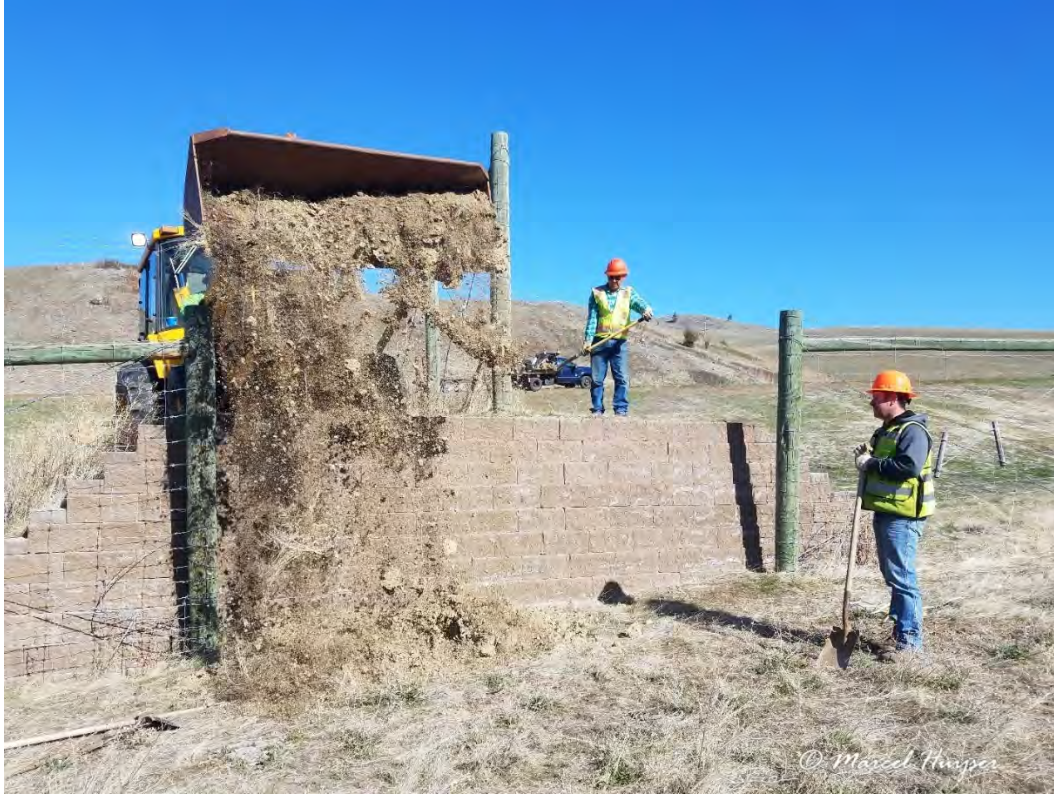
Figure 4: The Montana Department of Transportation assisted with the lowering of 10 jump-outs. After removing concrete blocks of the face, soil from the top was deposited at the bottom for the landing area.

- Lower height to exactly 5 ft (1.52 m). This was accomplished by removing soil from the top and removing one or multiple rows of the concrete blocks from the face (the wall) (Figure 4). The top blocks are 3 inches (7.6 cm) tall, and the standard blocks are 7 inches (17.8 cm) tall. The jump-outs in the Ravalli Hill area were lowered on 21 April 2021. The jump-outs in the Evaro area were lowered on 4 May 2021.
- The soil that was removed from the top was deposited at the bottom of the jump-outs to level the landing area up to about 6-7 ft (2 m) out from the vertical face of the jump-outs. This resulted in a consistent height of 5 ft (1.52 m) for vertical face of the jump-outs.
- Removal of tall vegetation on top and on the road-facing slopes of jump-outs, and the landing area.
- Adding a bar on top of the jump-out above the ground level.

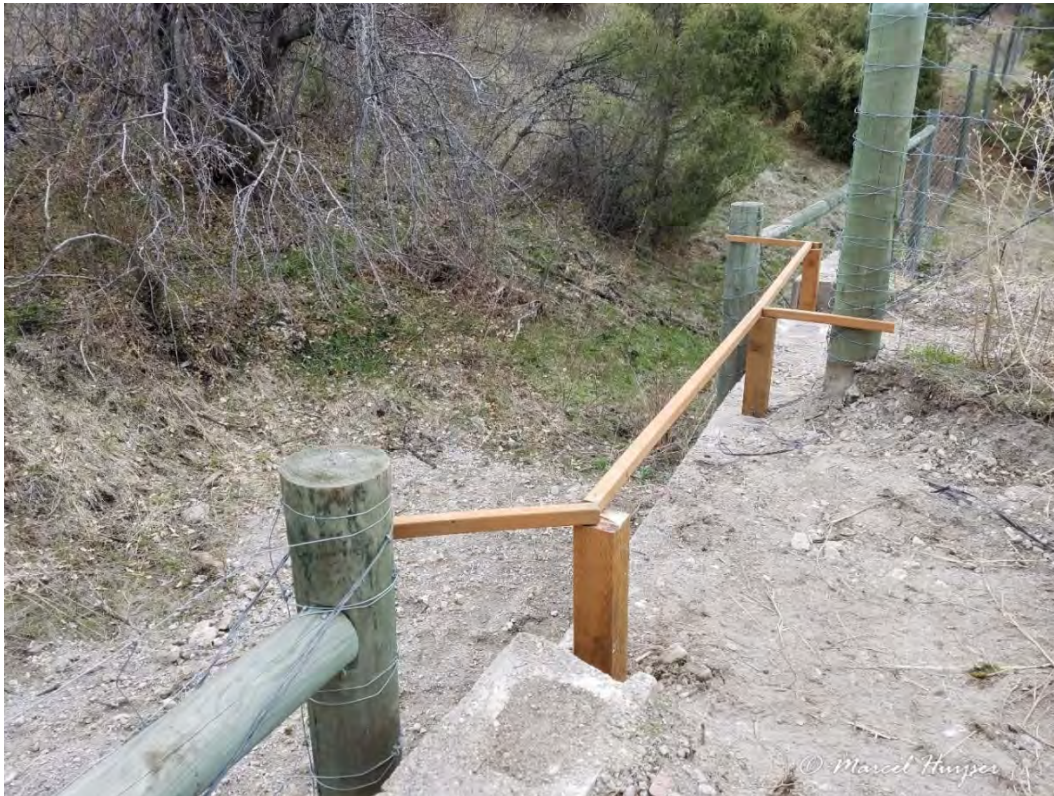
Figure 5: The prototype for the “bar” made from “2x2” inch and “4x4” inch treated lumber.

A prototype of the “bar” was made from treated lumber (“2x2” inch (5x5 cm) and “4x4” inch (10x10 cm)) (Figure 5). The 4x4 inch (10x10 cm) posts sat on the top of the concrete blocks. More permanent “bars” were made from rebar (grade 60, 1/2-inch (1.25 cm) diameter) (Figure 6). The rebar was bent into giant “staples” that measured 60 inches (152 cm) horizontal and 42-inch (1.07 m) legs. The 42-inch legs allowed the “staples” to go deep into the soil of the mount for stability, and they also allowed for height adjustments (higher or lower above the ground on top). L-shaped 36-inch (91 cm) swing arms (with 42-inch legs) were used to connect the bar to the fence posts at each side of the jump-out (Figures 7-9). The legs of the “staples” and L-shape corner elements were connected with metal wire twisted around both legs to increase rigidity.

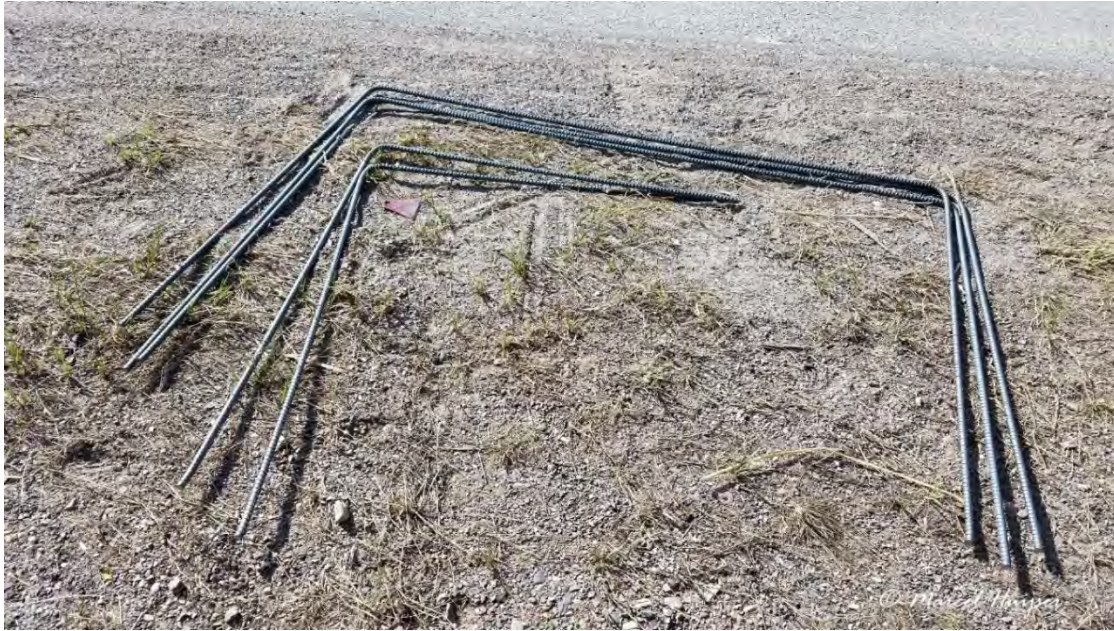
Figure 6: Several of the “staples” (60-inch horizontal, 42-inch legs) the L-shaped corner elements (36-inch swing arms, 42-inch legs).

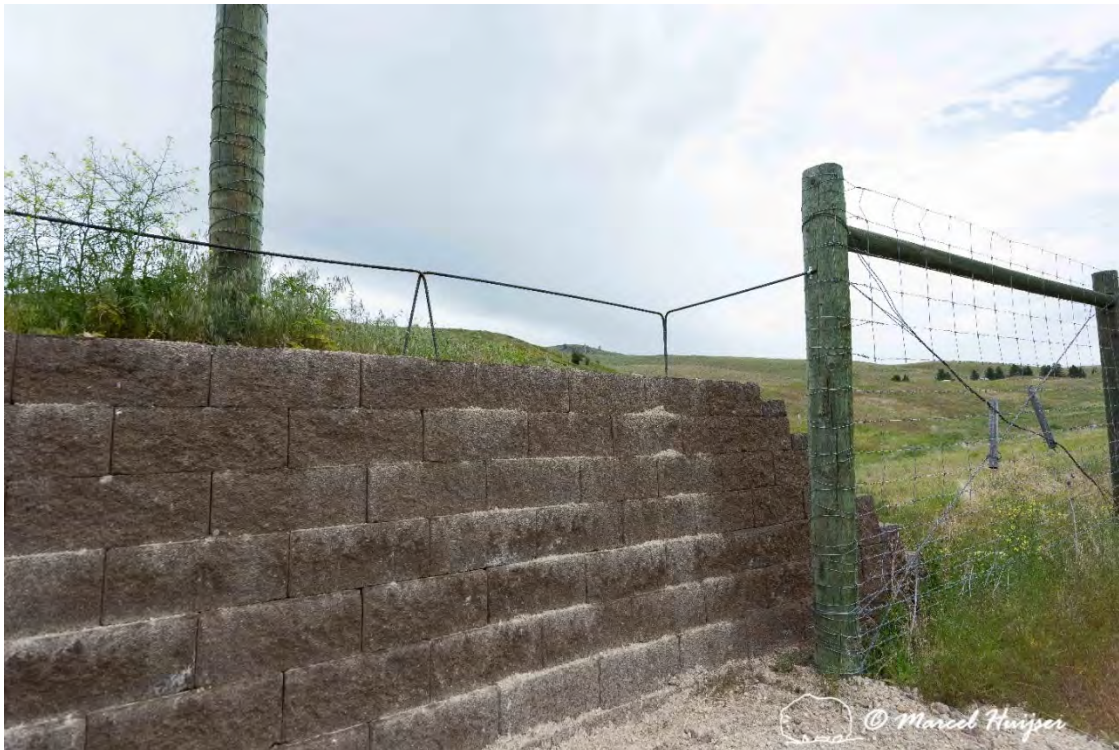
Figure 7: The rebar installed with the L-shaped corner elements connected to the fence post.

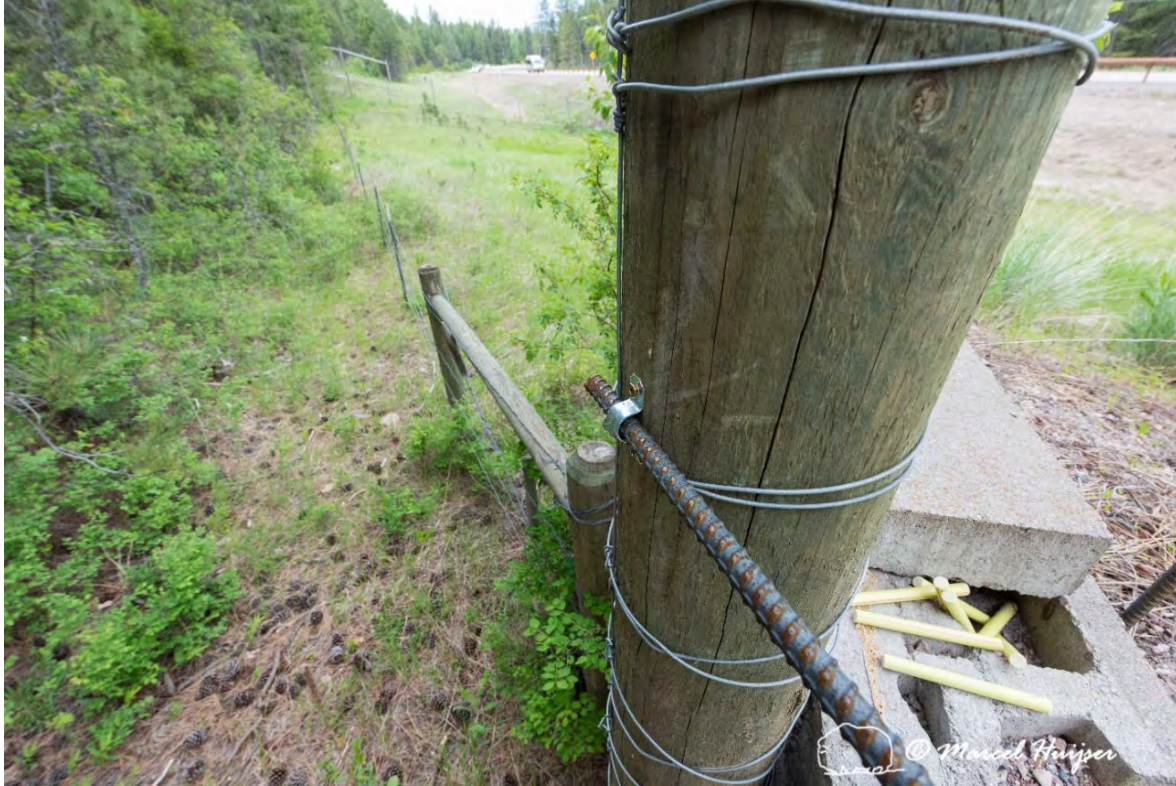
Figure 8: The L-shaped corner elements were connected to the fence posts with brackets and screws.

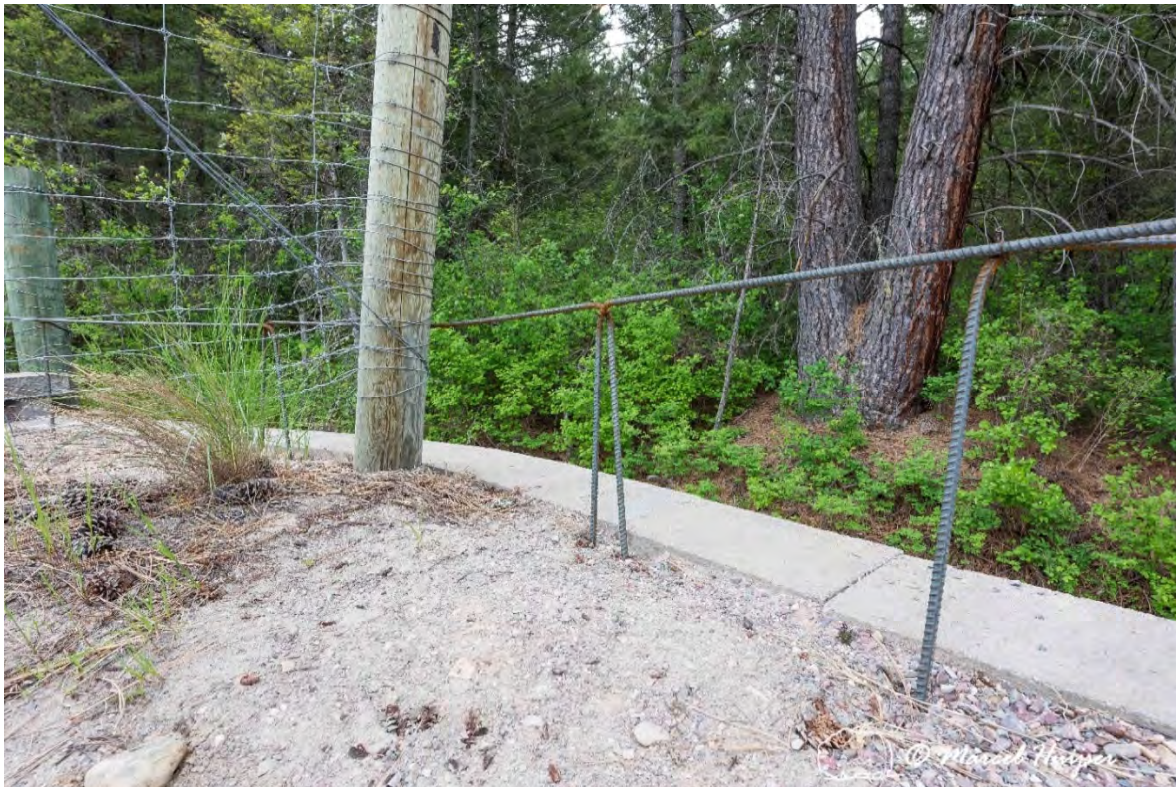
Figure 9: The legs of the “staples” and L-shaped corner elements were connected with metal wire.

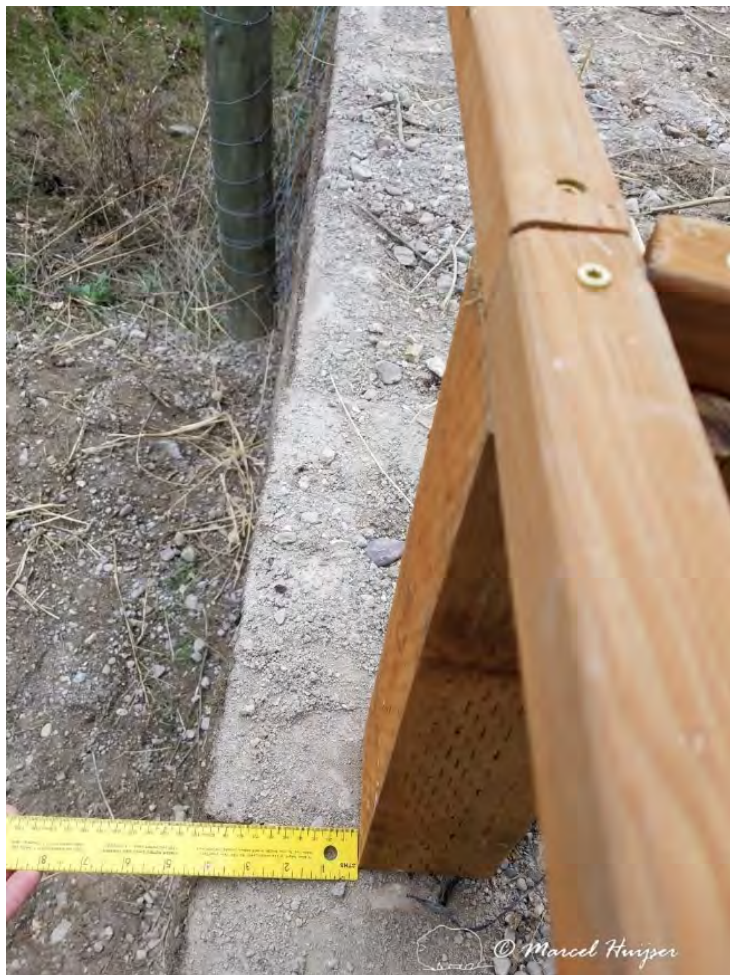
Figure 10: The wooden prototype had a setback of 4 inches (10 cm).

The top of the wooden prototype of the bar was 18 inches (46 cm) above the surface of the jump-out and had 4 inches (10 cm) setback from the wall (Figure 10). The bars made from rebar were initially also 18 inches above the surface of the jump-out. However, they had to be positioned behind the concrete blocks that formed the wall and therefore they had an initial setback of 12 inches (30 cm) (Figure 11). Based on the initial results with the prototype, 4 inches setback appeared to be insufficient to allow the deer to step over the bar with their front legs and take advantage of the low height of the jump-out (Figure 12). Because the deer jumped the bar going down the effective height for the animals jumping down was 5 ft (1.52 m) plus an additional 18 inches (46 cm): 6½ ft (1.98 m) total height. Additional data from the rebar design (height 18 inches, setback 12 inches) showed an increase in mule deer jumping down compared to the wooden prototype, but the performance was still marginal and similar to the use of the unmodified jump-outs; less than 10% of the white-tailed deer and only 30-40% of the mule deer that were recorded on top of the jump outs jumped down. Therefore, further modifications were initiated to the bars. The height was reduced, and the setback was increased in 3-inch increments (Figure 13, Table 2).

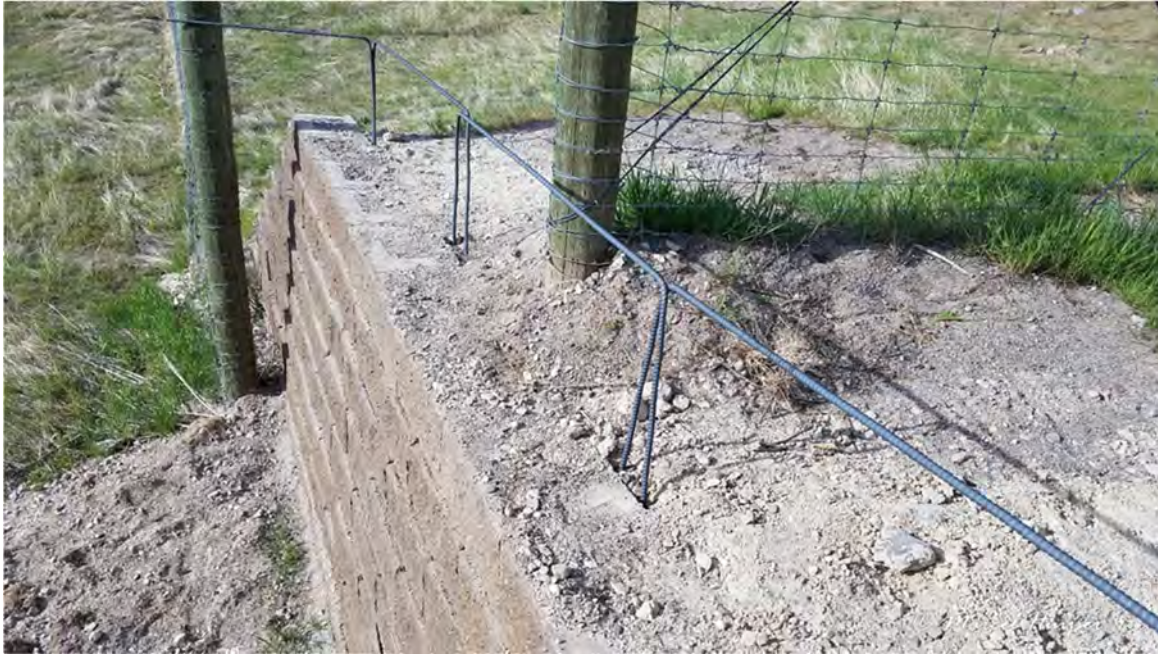
Figure 11: The rebar had a minimum setback of 12 inches (30 cm) as the legs had to be positioned behind the concrete blocks of the face of the jump-out.

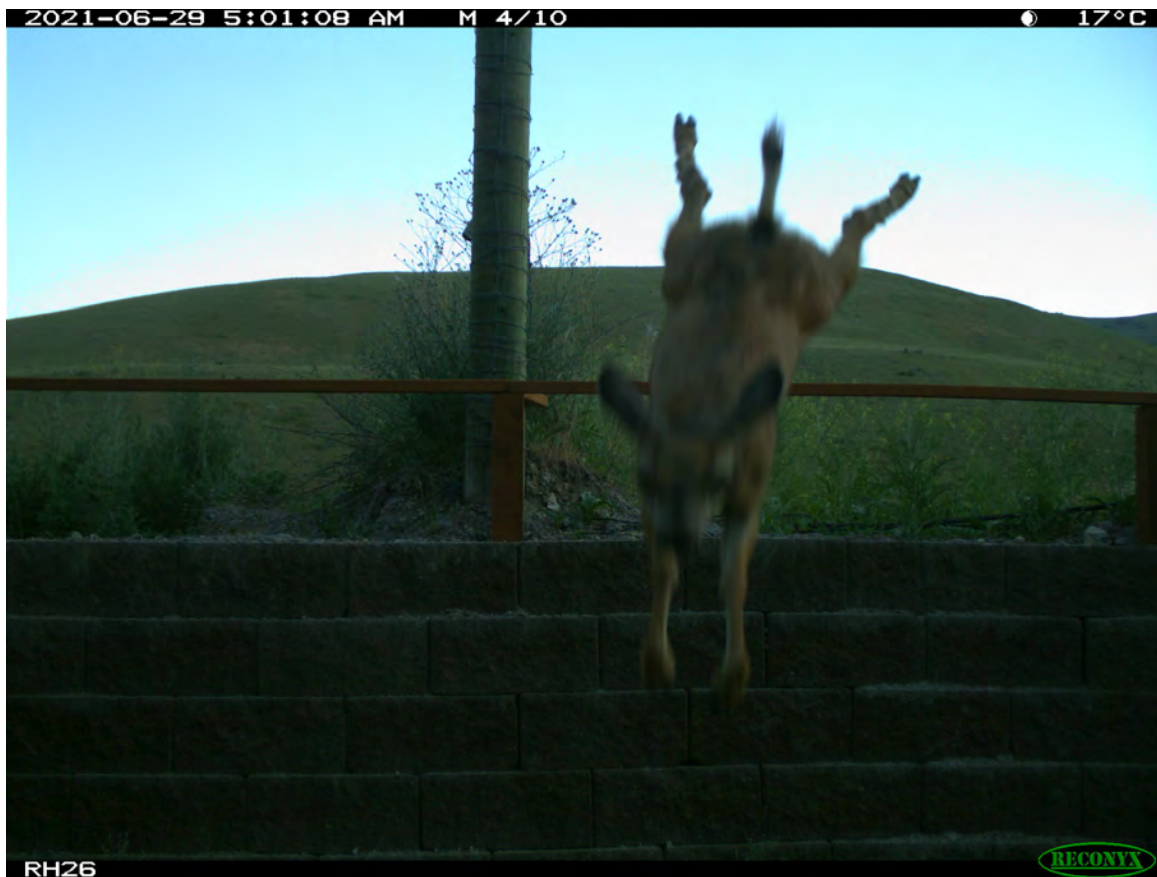
Figure 12: A mule deer jumps down the jump-out with the prototype (height 18 inches, setback 4 inches). The animal starts the jump from behind the bar and does not step over the bar first before jumping down.

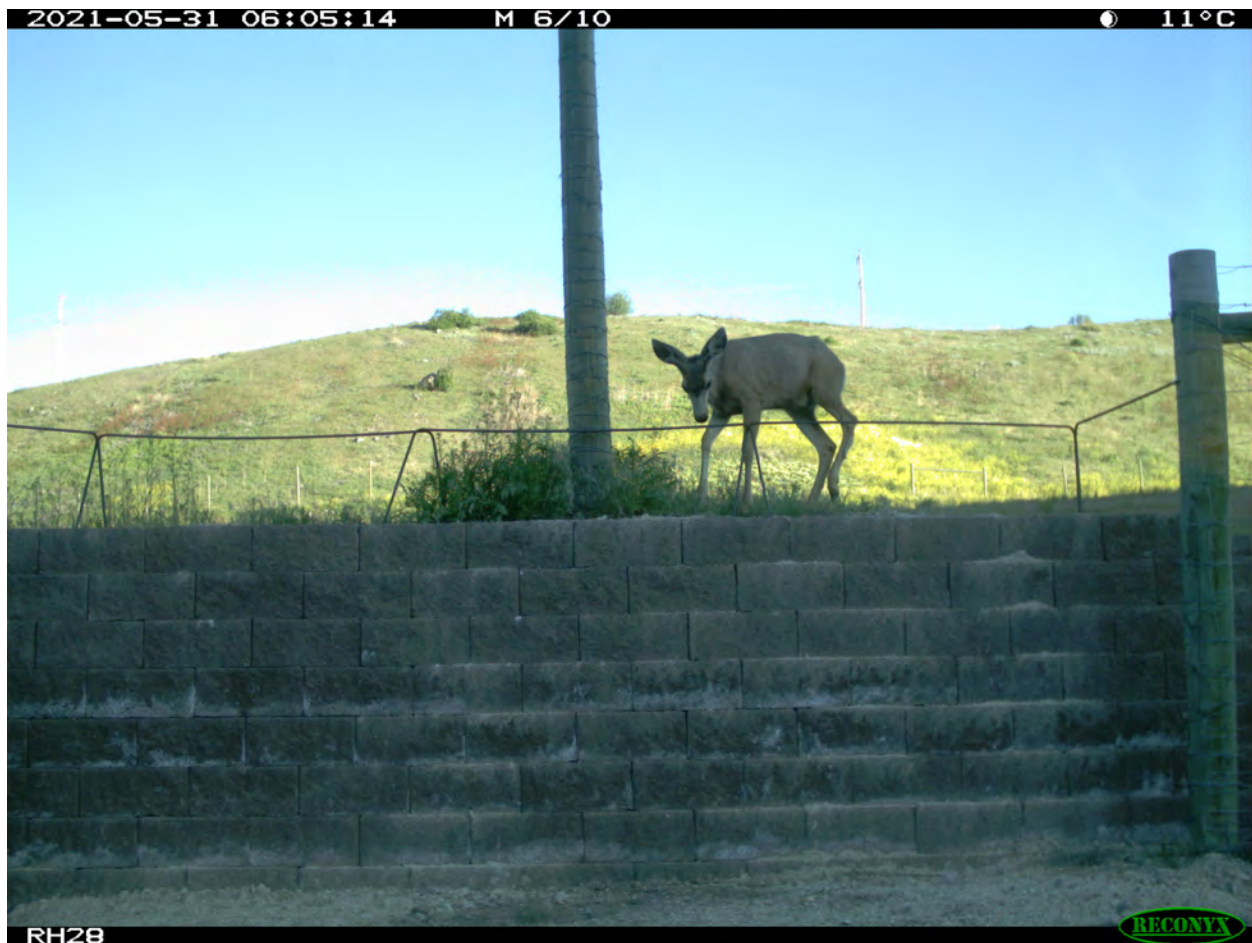
Figure 14: The typical view of the cameras allowing the researchers to see animals both on top and at the bottom of the jump-outs. Mule deer contemplates jumping down to the habitat side of the fence.

All 10 jump-outs had research cameras (Reconyx PC900 HyperFire) installed on 28 May 2021. The cameras were typically positioned on the habitat (safe) side of the fence, looking at the face of the jump-outs. This allowed the researchers to observe animals that appeared on the top of the jump-out and see animals that passed by on the safe side of the jump-out (Figures 14 and 15). In some cases, a camera needed to be installed on one of the fence posts at the edges of the jump-out because of the topography, vegetation, or land ownership. In all cases, a clear view of potential animals on top of the jump-outs was prioritized over a clear view of potential animals on the habitat side of the jump-out. The researchers analyzed the images from the cameras. The researchers identified the species, evaluated whether the animals came within 2 m (6.6 ft) of the face of the jump-out (on top and at the bottom of the jump-outs), noted if they showed interest in jumping up or down, and evaluated whether the animals ultimately jumped up or down. The researchers observed and counted the behavior of individual animals, regardless of whether they occurred in a group. Of the deer that jumped down to the habitat side of the jump-outs, the researchers also noted if the deer first stepped over the bar, and if so, with how many legs.

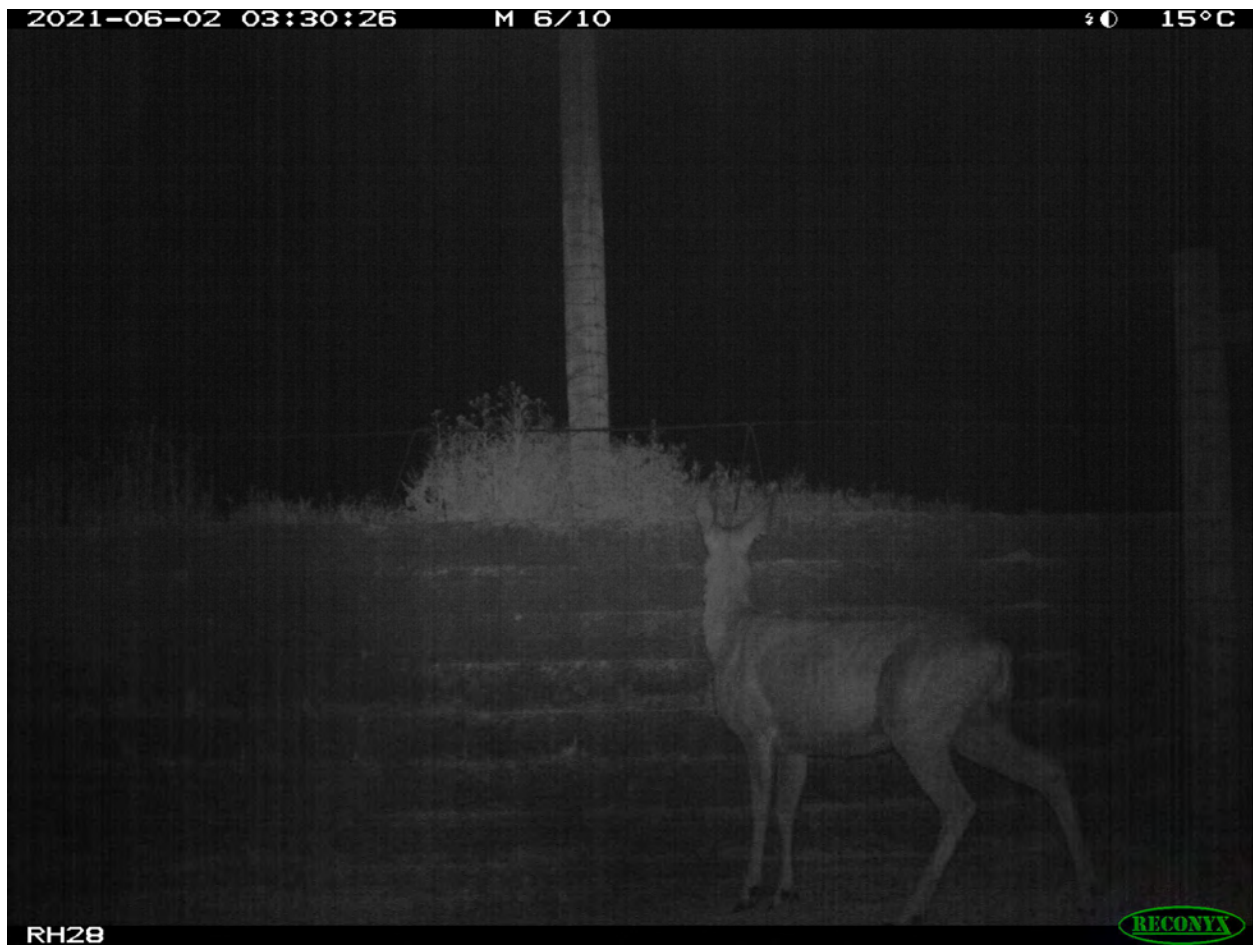
Figure 15: The typical view of the cameras allowing the researchers to see animals both on top and at the bottom of the jump-outs. Mule deer contemplates jumping up into the fenced road corridor.

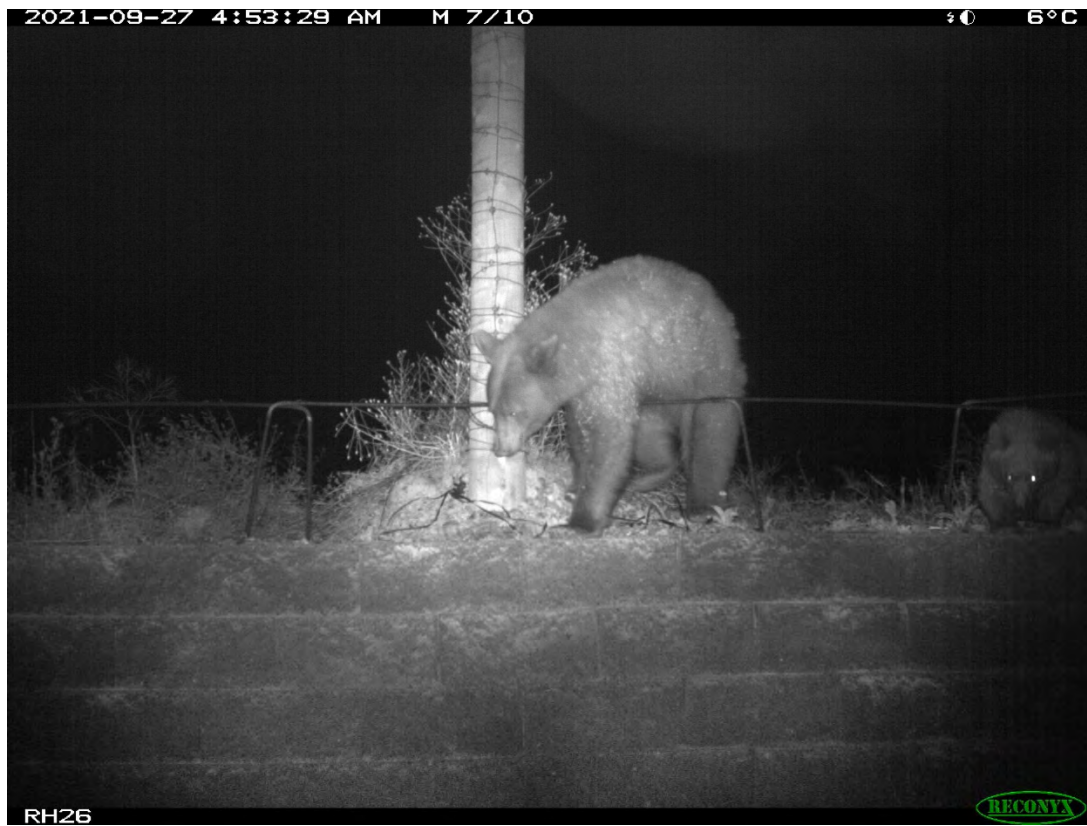
Figure 16: Some black bears first stepped over the bar; others crawled under.

Besides the two deer species, other mammal species greater or equal to a raccoon were also evaluated for their behavior at the jump-outs (Table 4, Figures 16-20). However, due to small sample sizes no distinction was made between the different treatments for the bar. Black bear, bobcat, elk, mountain lion and wolf usually jump down to the safe side of the jump-out (>50%), whereas coyote and red fox occasionally jump down ($\leq 50\%$). Bobcat and mountain lion always jumped up (100%), whereas black bear occasionally climbed up the face into the fenced right-of-way (12.5%), and coyote, elk, and moose were never observed jumping up.

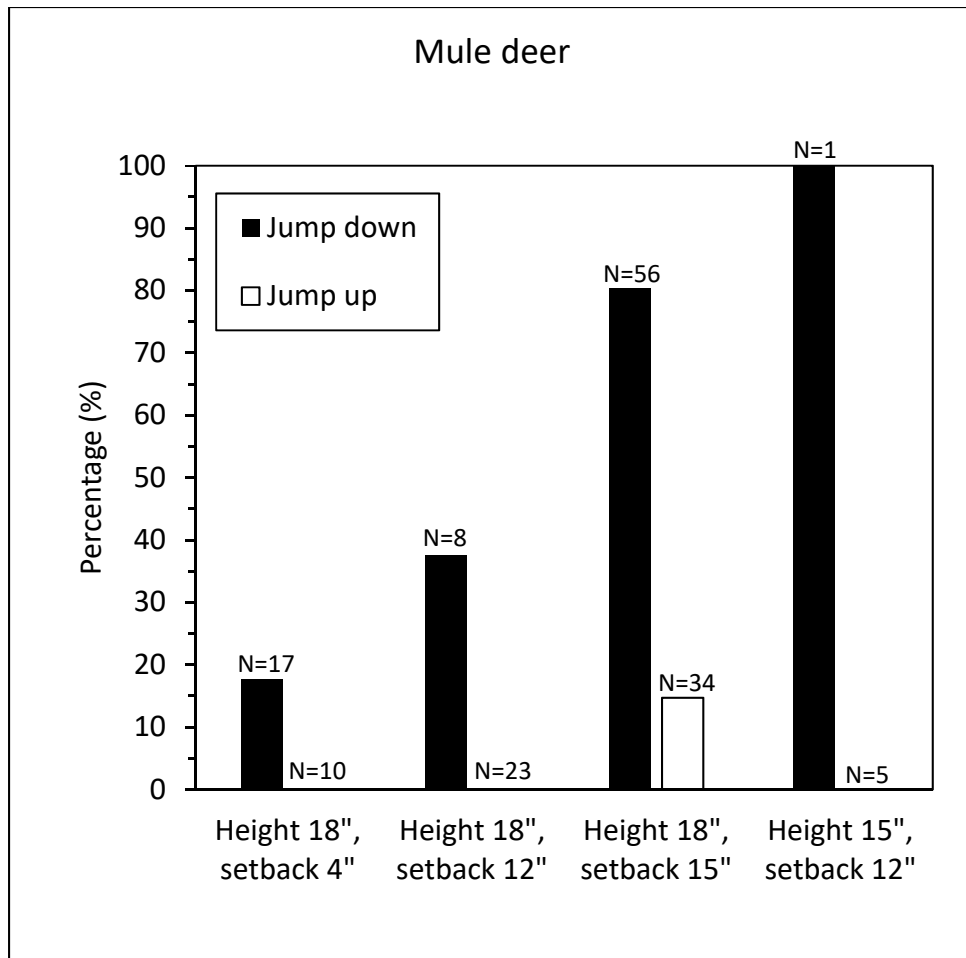
Figure 22: The percentage of mule deer that jumped down (desired behavior) and that jumped up (undesired behavior) for the different treatments. N is the sample size for each treatment.

Regardless of how close the animals came to the face of the jump-out, and regardless of the treatment, white-tailed deer barely jumped down (10% or less) to the habitat side of the fence (Figure 21). No white-tailed deer jumped up into the fenced road corridor for any of the treatments. Regardless of how close the animals came to the face of the jump-out, and regardless of the treatment, mule deer jumped down much more readily (17.7-100.0%) than white-tailed deer (Figure 22). The treatment with a height of 18 inches and a setback of 15 inches had 80.4% of all mule deer that were observed within the right-of-way jump down to the habitat side of the jump-outs (Figure 23). At the same time, this treatment allowed 14.7% of the mule deer that were observed on the habitat side of the jump-out to jump up into the fenced road corridor (Figure 24). While the treatment with a height of 15 inches and a setback of 12 inches also seemed to perform well, it suffered from low sample size.

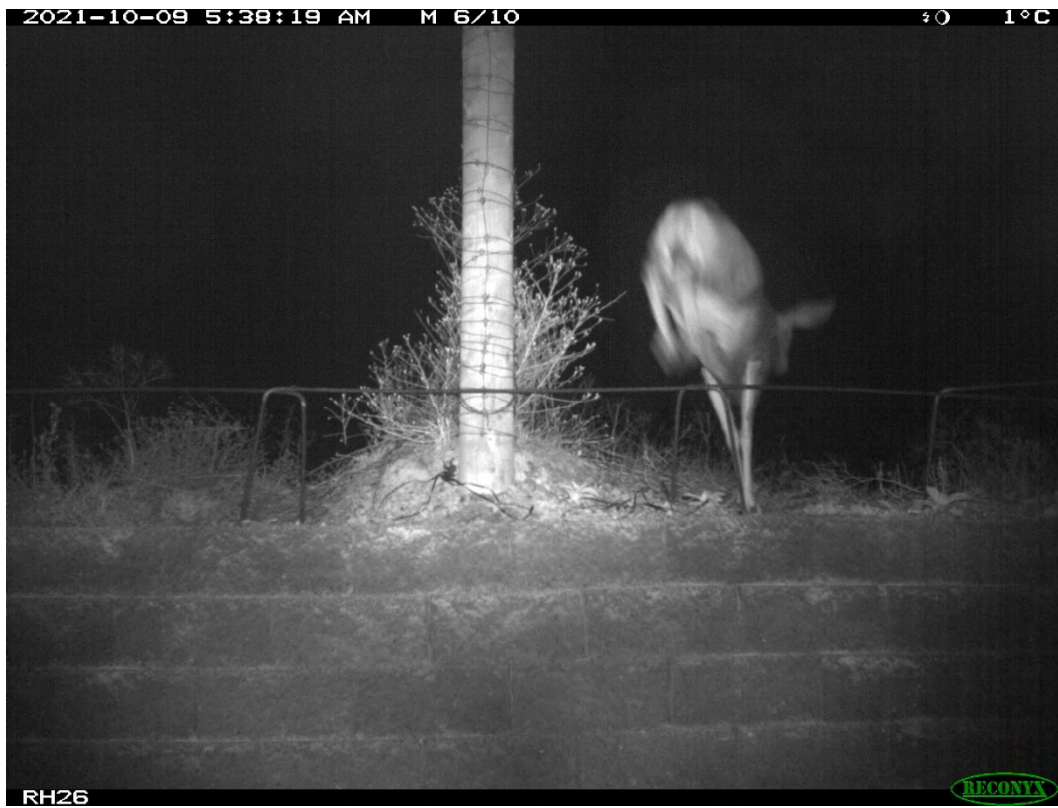
Figure 24: A mule deer jumps up into the fenced road corridor, clearing the bar (undesired behavior).

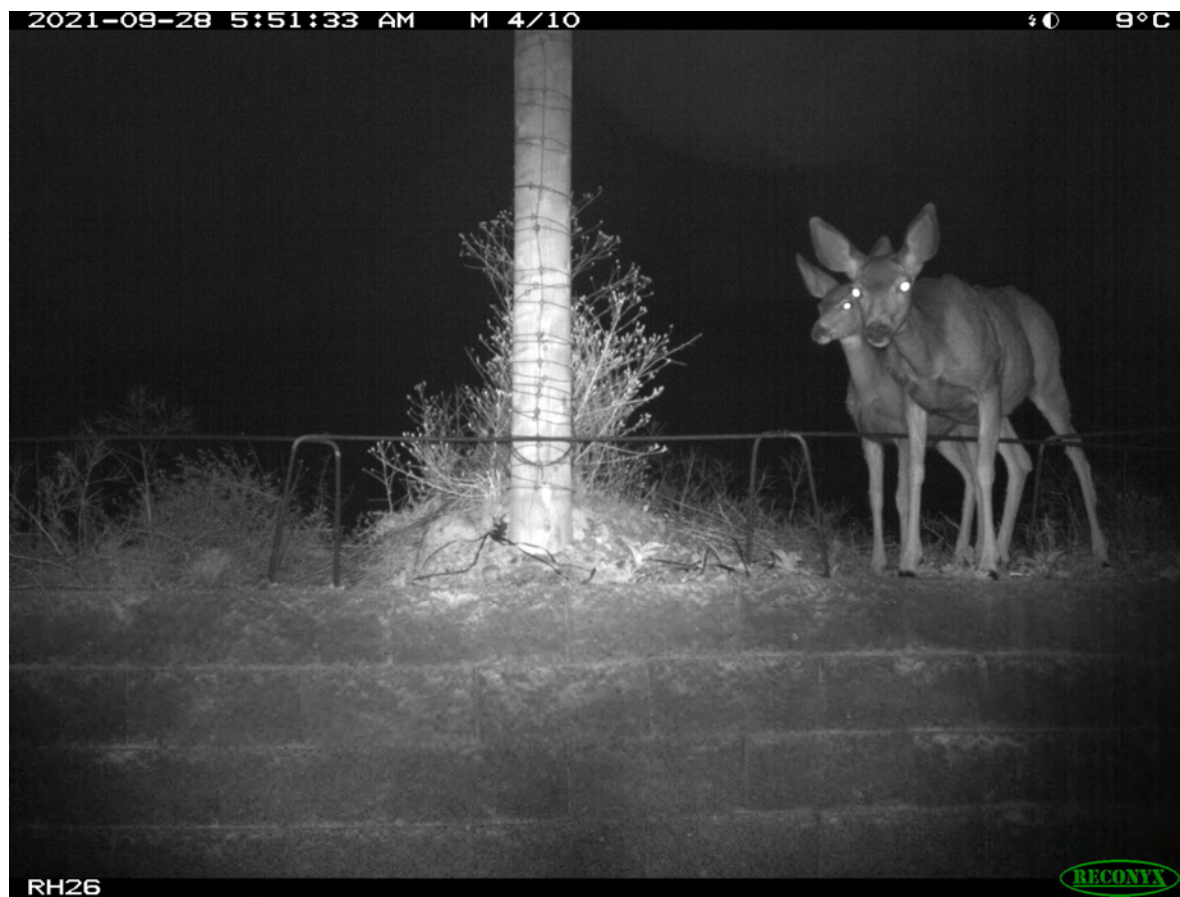
Figure 25: A mule deer steps over the bar with both its front legs before jumping down (desired behavior).

There was only 1 white-tailed deer for which the images showed if and with how many legs the animal first stepped over the bar before jumping down (Table 5). However, the white-tailed deer for which this behavior was recorded, first stepped over the bar with 2 legs (the front legs). Mule deer jumped down through jumping over the bar (without first stepping over it) as well as through first stepping over the bar with one or more legs (Table 5). However, most of the mule deer that jumped down stepped over the bar with at least 1 leg, most often 2 legs (front legs), before jumping down (Figure 25). One mule deer stepped over with all 4 legs before jumping down. The jump-outs with the greatest setback (15 inches) received most of the successful jump downs and most of the mule deer that jumped down stepped over the bar with their two front legs before jumping down.
