# **Electrified Barriers Installed on Top of Wildlife Guards to Help Keep Large Wild Mammals Out of a Fenced Road Corridor**

Marcel P. Huijser, PhD  
Samantha C. Getty, BSc

Western Transportation Institute  
Montana State University

December, 2023

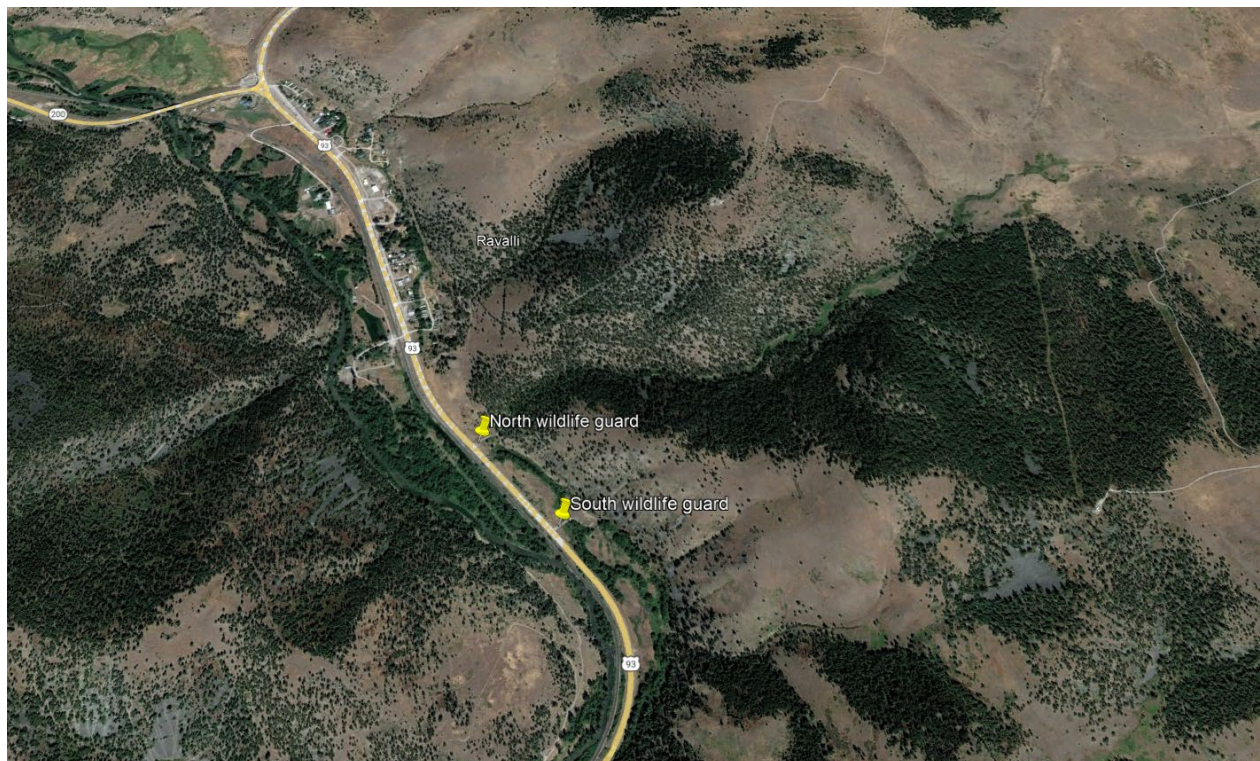
Figure 1: The two locations selected for the installation of an electrified mat on top of an existing wildlife guard, just south of Ravalli, Montana. Note that these are the same two sites that were part of the study by Allen et al. (2013).

Two locations were selected for the installation of electrified barriers on top of existing wildlife guards (Figure 1). These two locations meet the following criteria:

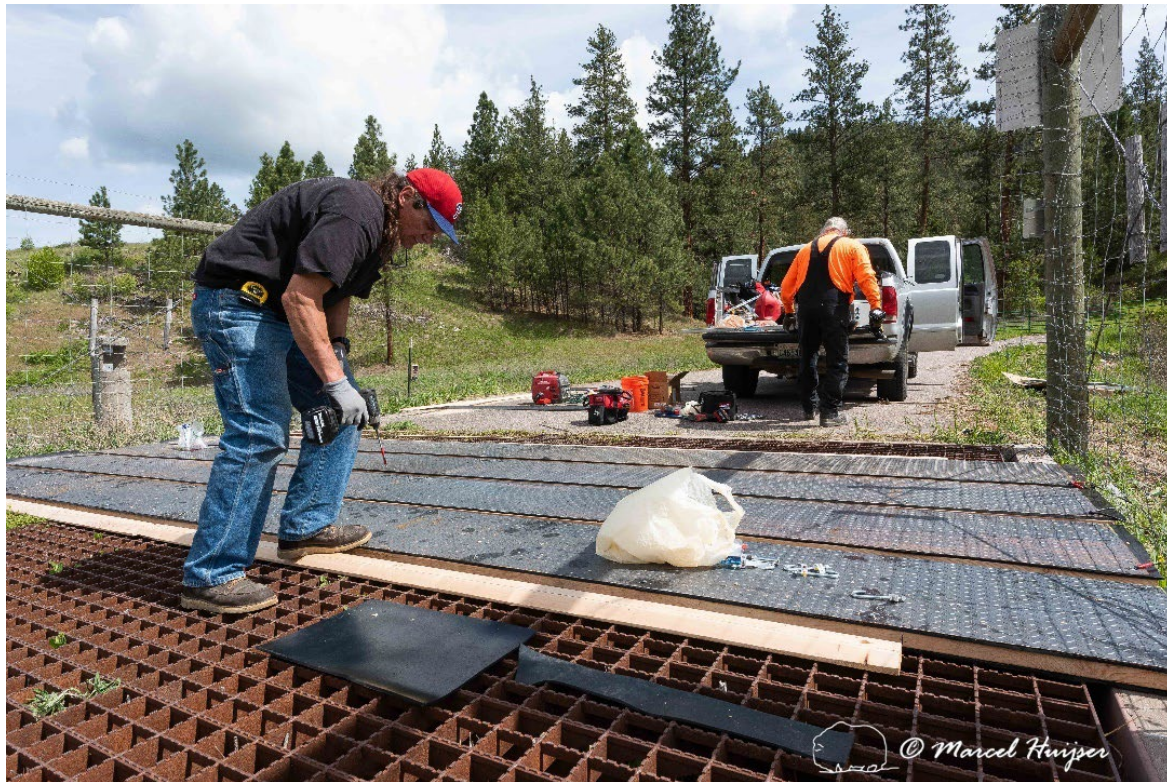
Figure 2: The installation of the electrified mat by Crosstek at the north wildlife guard, US Hwy 93, south of Ravalli, Montana.

- North wildlife guard: Crosstek, installed 20-23 May 2022 (Figure 2, 3). This barrier was 8 ft wide and consisted of 2 pairs of alternating positive and negative plates. Costs, including installation: US\$ 11,250.
- South wildlife guard: BS Fabrications, installed 6 November 2021 (Figure 4, 5). This barrier was 4 ft wide and consisted of one positive plate in two parts. Costs, including installation: US\$ 11,260.

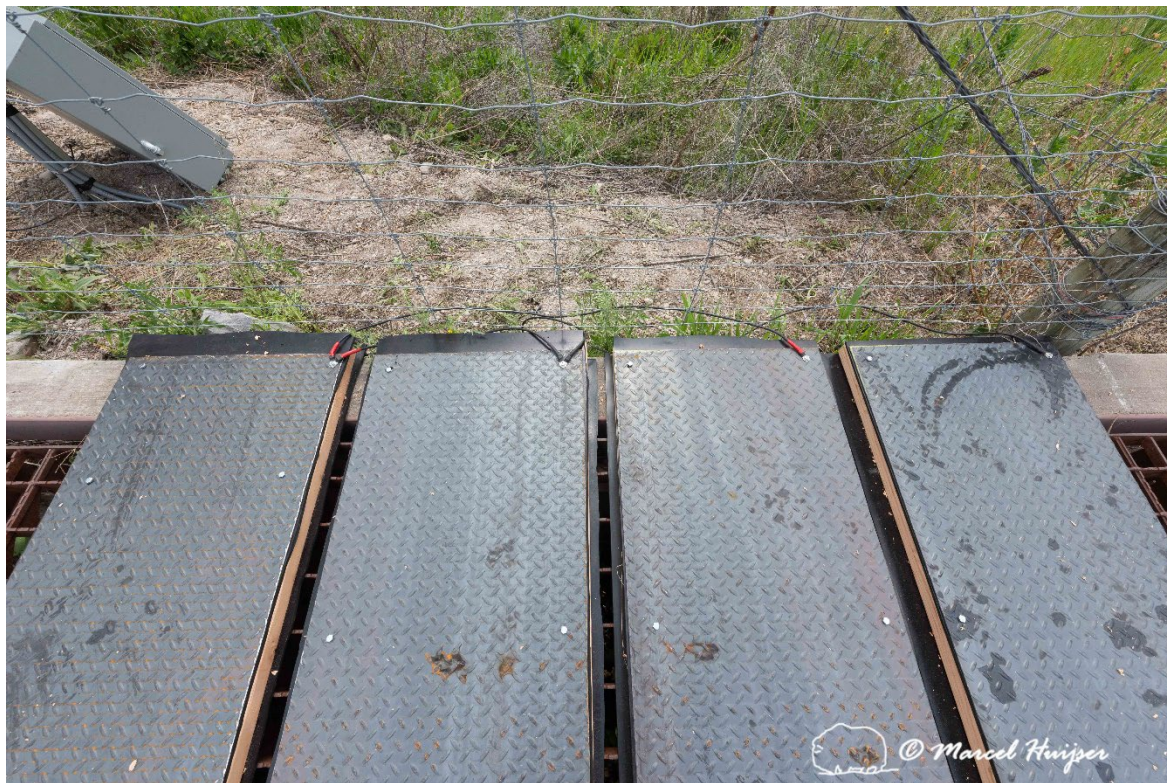
Figure 3: The electrified mat by Crosstek covers the concrete edge around the pit, at the north wildlife guard, US Hwy 93, south of Ravalli, Montana.

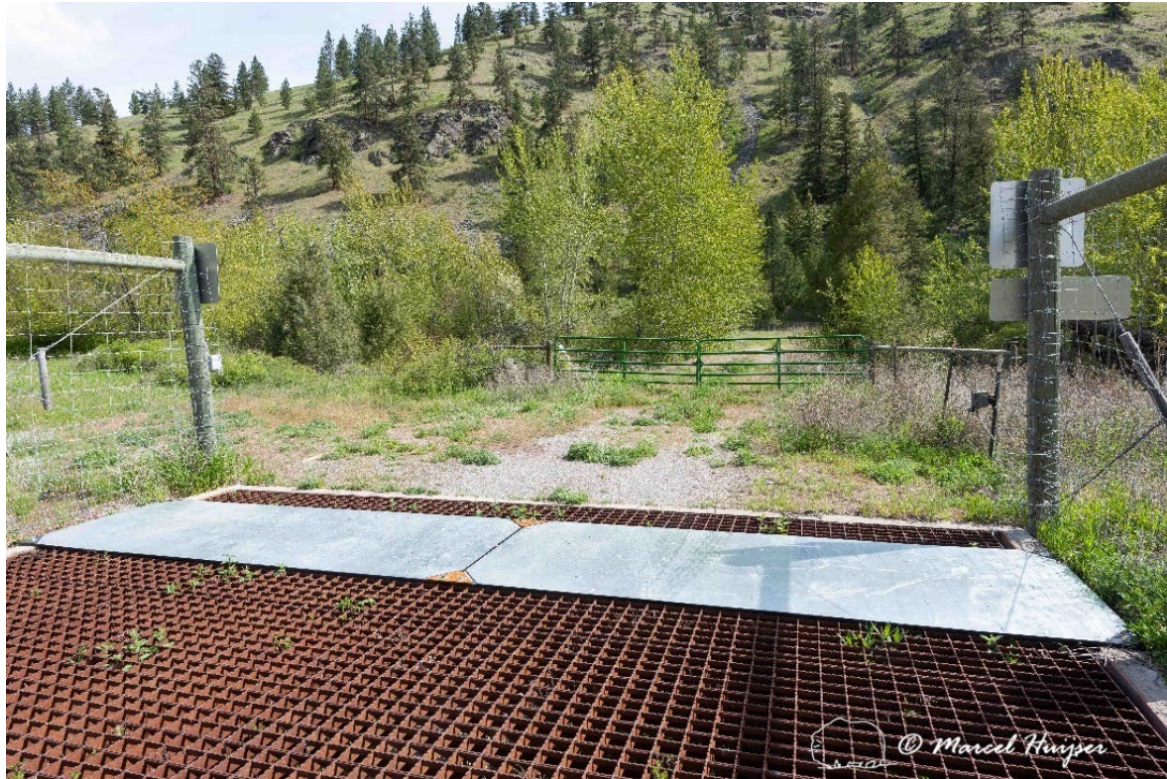
Figure 4: The electrified mat installed by BS Fabrications at the south wildlife guard, US Hwy 93, south of Ravalli, Montana.

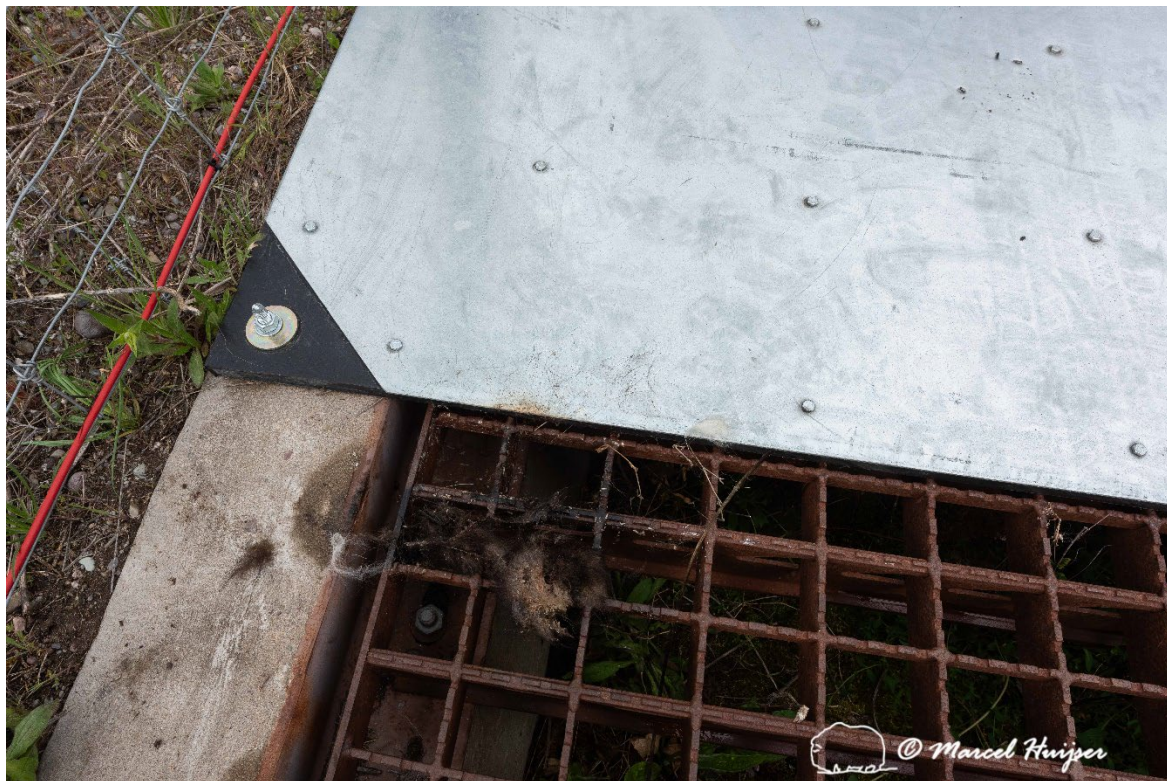
Figure 5: The electrified mat by BS Fabrications covers the concrete edge around the pit, at the north wildlife guard, US Hwy 93, south of Ravalli, Montana.

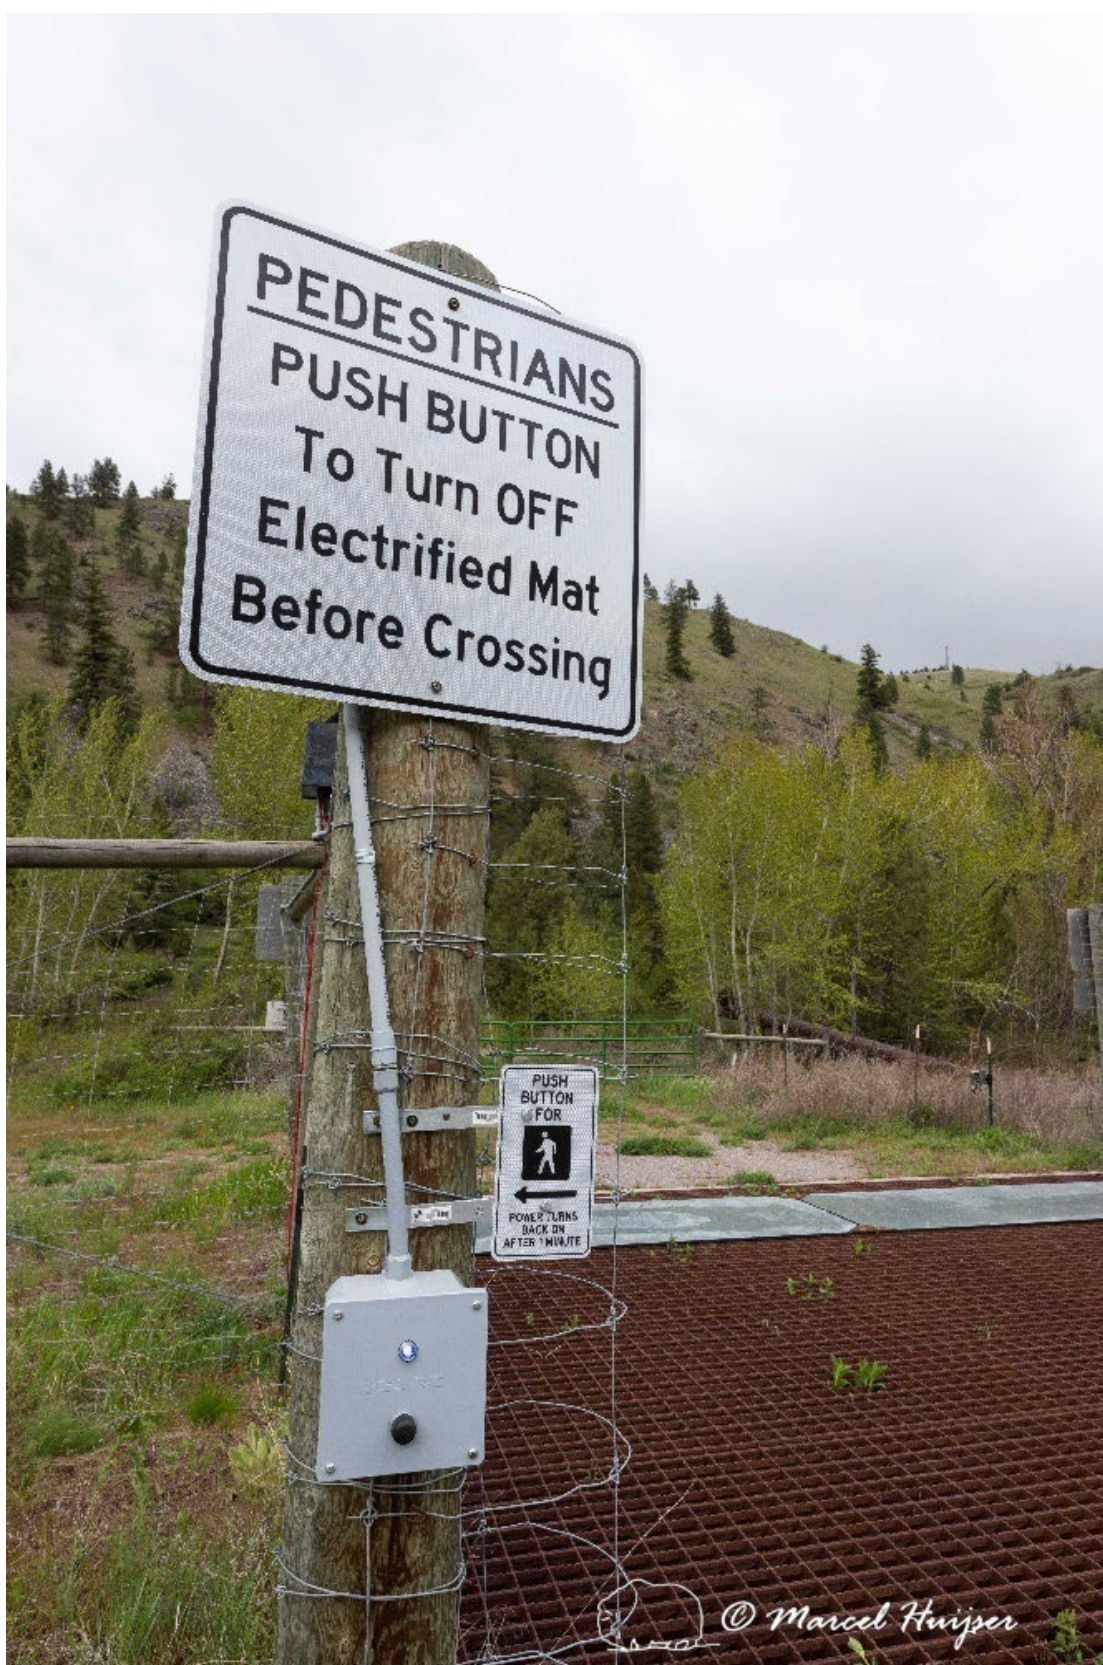
Figure 6: Push button for pedestrians to temporarily (about 1 minute) turn off the power.

Both mats had the exact same signs informing the public and road maintenance crews about the mat and they also had a push button that temporarily deactivated the mat (i.e., electricity turned off after pushing the button) (Figure 6, 7, 8). After about 1 minute the electricity came back on again. The signs and push buttons were on both the habitat and roadside of the wildlife barriers.

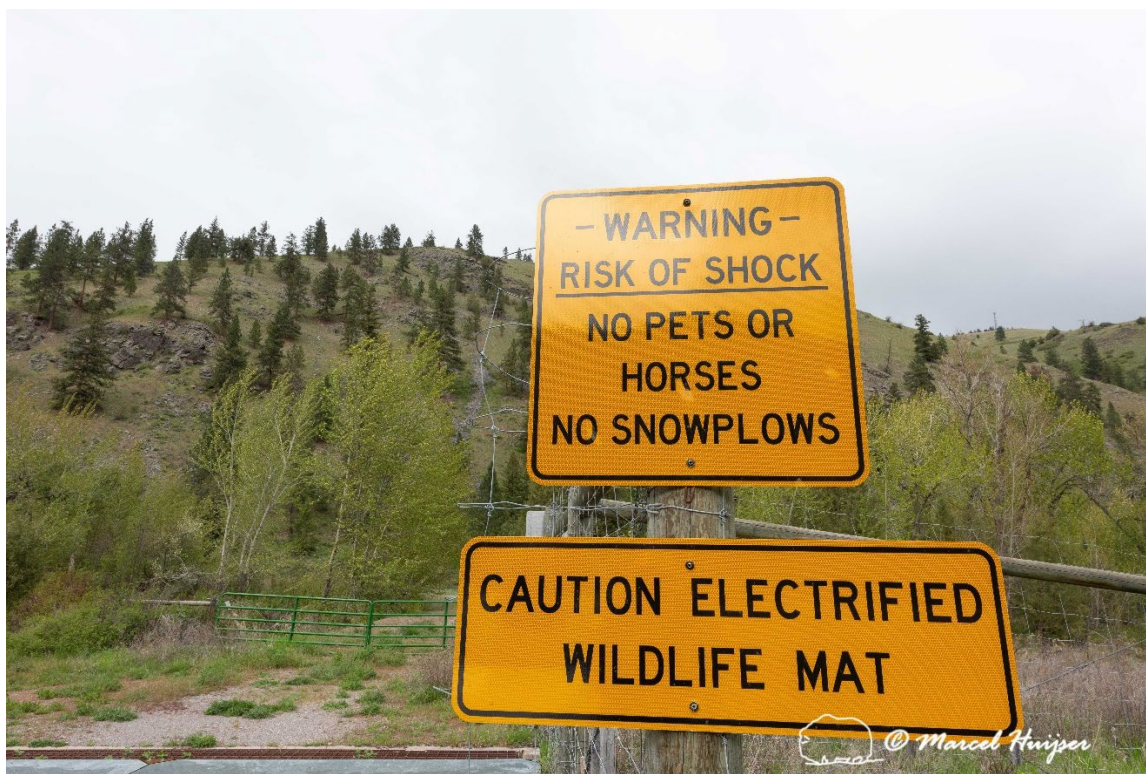
Figure 7: Warning signs at the electrified mats for pets, horses, and snowplows.

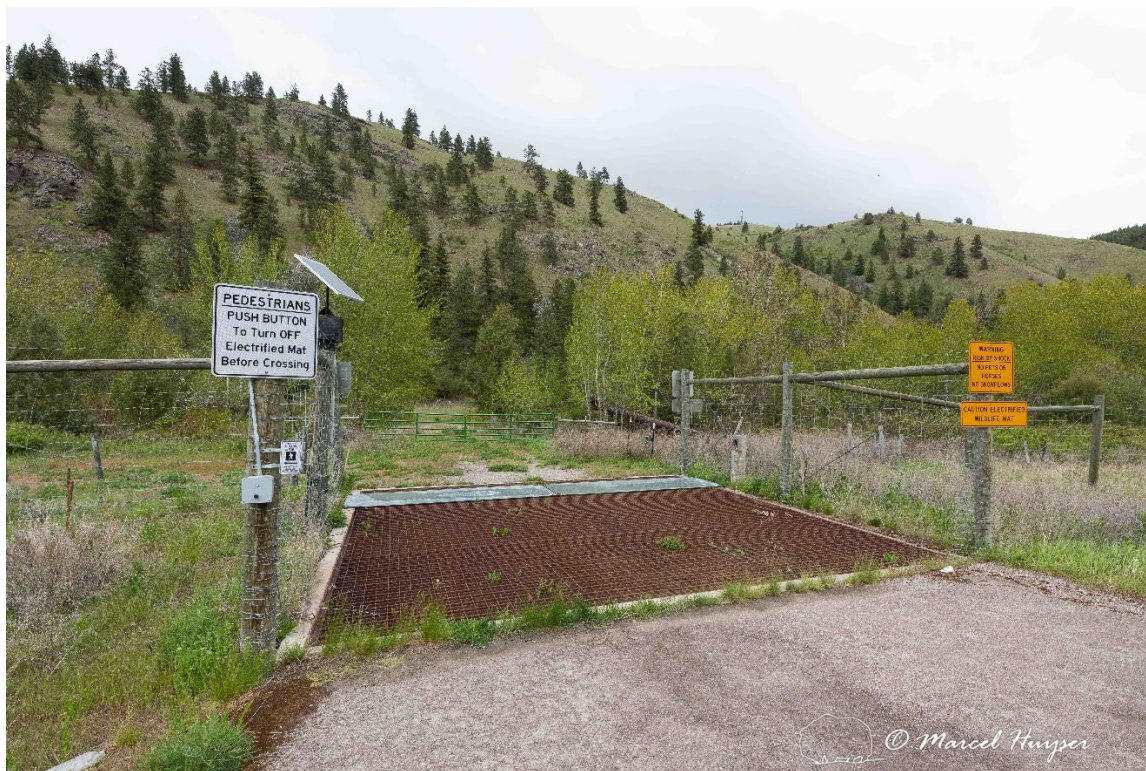
Figure 8: The signs associated with an electrified mat on top of a wildlife guard. There is a set of signs on both the habitat side and the roadside.

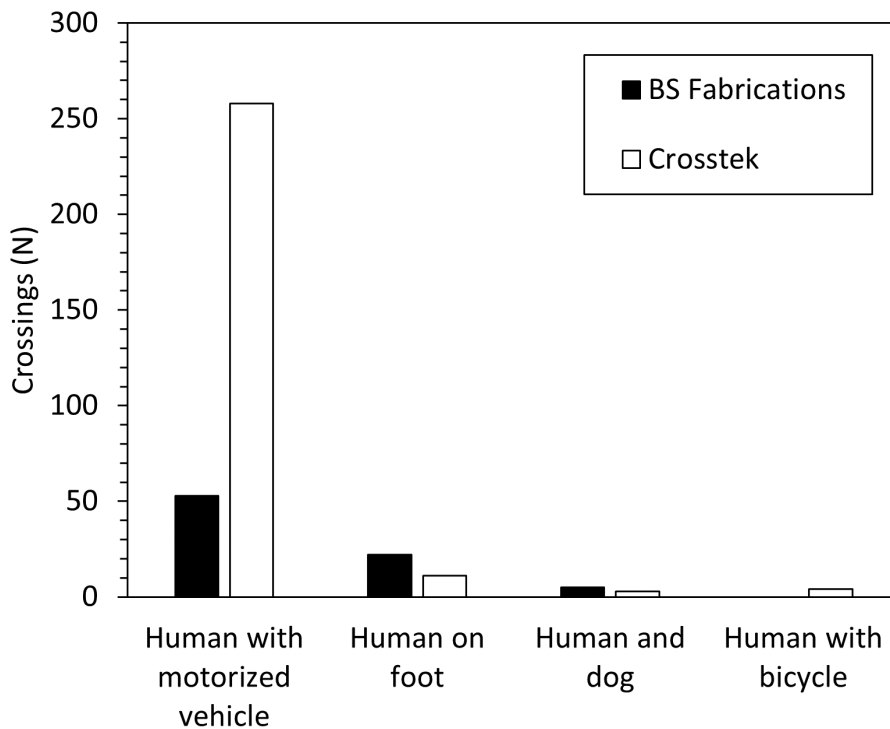
Figure 9: The number of detected barrier crossings by humans (excluding researchers), regardless of whether they left or entered the fenced road corridor.

In the 282 days that the two wildlife guards and electrified barriers were monitored, humans crossed the barriers predominantly by vehicle (Figure 9). The northern barrier (Crosstek, average of 0.91 crossings per day) received higher traffic volume than the southern barrier (BS Fabrications, average of 0.19 crossings per day). Humans not associated with a motorized vehicle were frequently seen using the push buttons that temporarily turned off the power to the electrified mats.

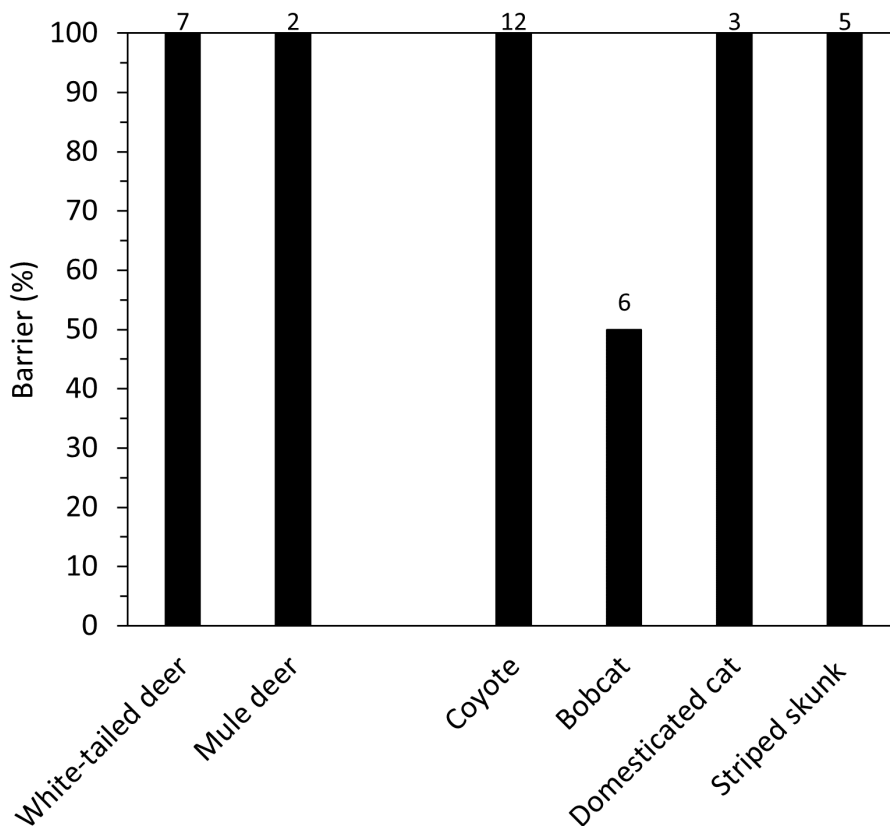
Figure 10: The barrier effect (%) for the different ungulate species (left) and species with paws (right) that approached the wildlife guard (without an electrified barrier) within 2 meters on the habitat side. The numbers on top of the bars are the sample size (i.e., the total number of animals that approached the wildlife guard on the habitat side and that came within 2 m of the wildlife guard).

None of the white-tailed deer and mule deer that approached the wildlife guard on the habitat side and that came within 2 m of the wildlife guard crossed into the fenced road corridor (Figure 10). The wildlife guard was also an absolute barrier for coyotes, domesticated cats, and striped skunks. However, 50% of the 6 bobcats that approached the wildlife guard entered the fenced road corridor. All three bobcats that entered the fenced road corridor did so by walking on the exposed concrete edge of the pit (Figure 11).

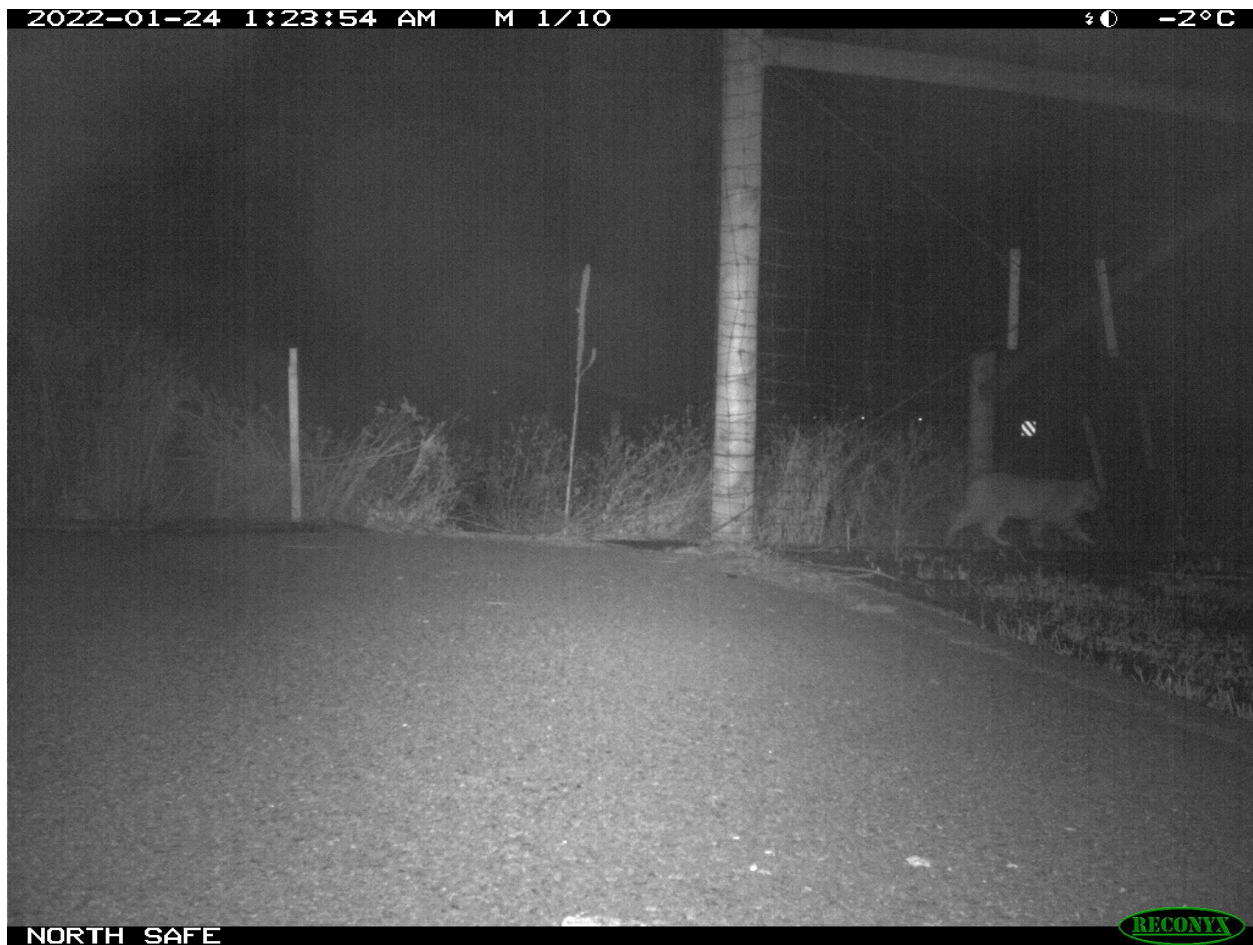
*Figure 11: A bobcat enters the fenced road corridor by walking on the accessible concrete edge of the pit under the grate of the wildlife guard. There is no electrified barrier installed yet at the time of the event.*

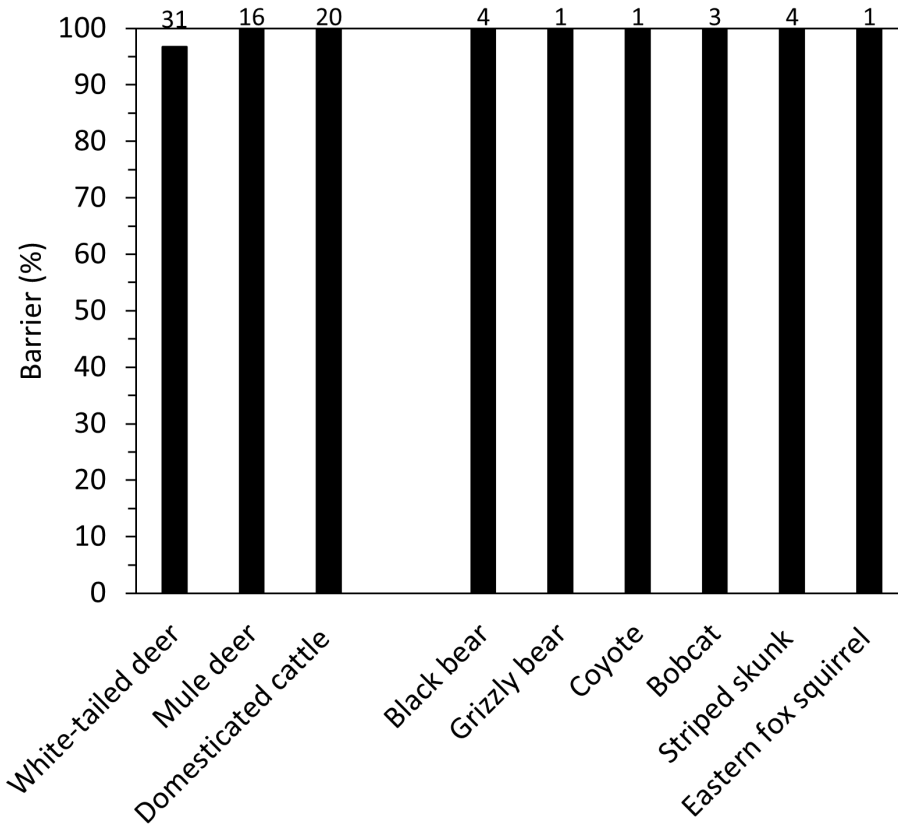
Figure 12: The barrier effect (%) for the different ungulate species (left) and species with paws (right) that approached the two wildlife guards and electrified mats (both Crosstek and BS Fabrications combined) within 2 meters on the habitat side. The numbers on top of the bars are the sample size (i.e., the total number of animals that approached the two wildlife guards and electrified mats on the habitat side and that came within 2 m of the edge of the wildlife guard).

One of the 31 white-tailed deer but none of the 16 mule deer that approached the 2 wildlife guards on the habitat side and that came within 2 m of the electrified wildlife guards crossed into the fenced road corridor (Figure 12) (96.8% barrier for white-tailed deer, 100% barrier for mule deer, 97.9% barrier for the 2 deer species combined). The northern barrier (Crosstek) had 7 white-tailed deer and 2 mule deer approach the wildlife guard on the habitat side within 2 m. None of these animals crossed into the fenced road corridor (100% barrier for both deer species). The southern barrier (BS Fabrications) had 24 white-tailed deer and 14 mule deer approach the wildlife guard on the habitat side within 2 m. One white-tailed deer but none of the mule deer crossed into the fenced road corridor (95.8% barrier for white-tailed deer, 100% barrier for mule deer). Based on the images, the one white-tailed deer that entered the fenced road corridor still got shocked, but there seems to have been a delay because of the snow, likely contributing to the animal jumping forward rather than backing off (Figure 13).

The electrified wildlife guards were an absolute barrier (100%) for domesticated cattle, black bears, grizzly bears, coyotes, bobcats, striped skunks, and eastern fox squirrel. Based on the images, at least 2 of the 4 black bears were shocked (Figure 14), and the one grizzly bear was also shocked (Figure 15). There was one additional black bear on 25 April 2022 (outside of the formal evaluation period) that started crossing the wildlife guard with an electrified mat by BS Fabrications. Based on the images, this black bear was shocked as well and ran back to the habitat side. Thus, if it was not for the electrified barriers, likely at least 3 black bears and 1 grizzly bear would have crossed into the fenced road corridor where they would have been exposed to vehicles.

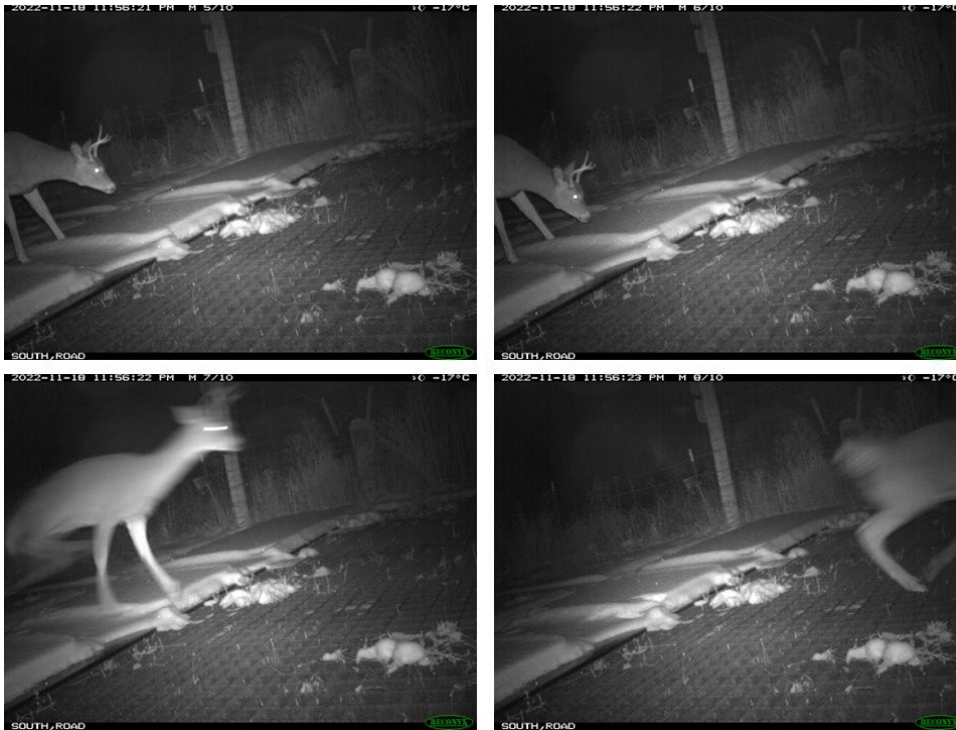
Figure 13: The white-tailed deer that did cross over the wildlife guard and electrified barrier (BS Fabrications) did so on 18 November 2022 at 11:56 pm with several inches of snow present on the mat and at  $-17^{\circ}\text{C}$  ( $1^{\circ}\text{F}$ ). Based on the images, this animal still appears to have been shocked, but with a bit of a delay after it already had both of its front hoofs on the snow on top of the mat. After the shock the animal jumped forward into the fenced road corridor. Note that this was an exception; only 1 out of 31 white-tailed deer that approached, crossed the combination of the wildlife guards and electrified barriers.

and that was when the electrified mat was covered in snow. Based on the images, a shock was delivered to the animal, but potentially later than normal, causing the animal to leap forward rather than turn back. If an electrified barrier is designed for year-round operation, larger solar panels, larger capacity batteries, and snow removal from the electrified mat and wildlife guard would need to be considered. Note that the current design of the electrified mats makes the mats stick out above the grate of the wildlife guard. Therefore, snowplows would likely cause substantial damage to the electrified mats. Low profile electrified mats, or electrified mats that are integrated in the pavement are likely a better design in situations where traffic volume is high and where the electrified barrier needs to be operational throughout the winter. Note that such designs are likely to come at a substantially higher cost, which was important to avoid for the application at the current locations (Huijser & Getty 2022). Longer term deployment at low volume roads, even in summer only would benefit from replacing the wooden “ramps” at the two sides of the Crosstek barrier with composite ramps (Pers. com. Tim Hazlehurst, Crosstek) (see also Appendix A). The electrified barrier by BS Fabrications experienced a problem with the bridging wire between the two plates, and cracked bolts because of differences in expansion and contraction of the metal and isolation material (Pers. com. Brady Stone, BS Fabrications) (Appendix B). The problem associated with expansion and contraction was addressed, but the design of the bridge between the 2 plates would still need to be addressed for higher traffic volumes and snow removal.

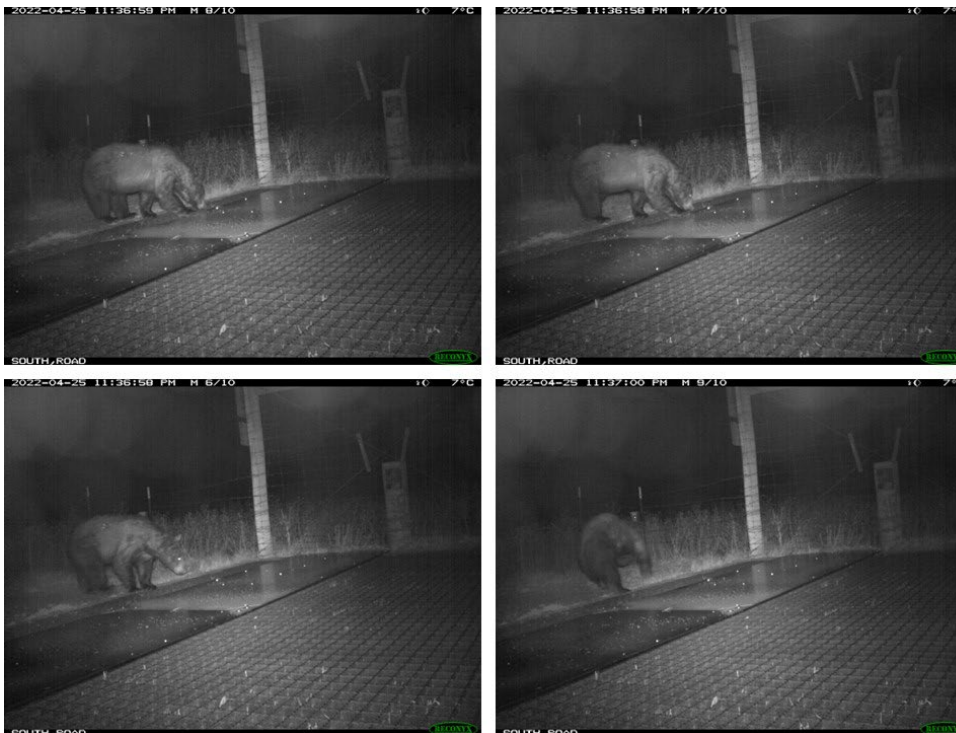
Figure 14: A black bear approached the wildlife guard and electrified barrier (BS Fabrications). Based on the images, this animal was shocked and ran back to the habitat side.

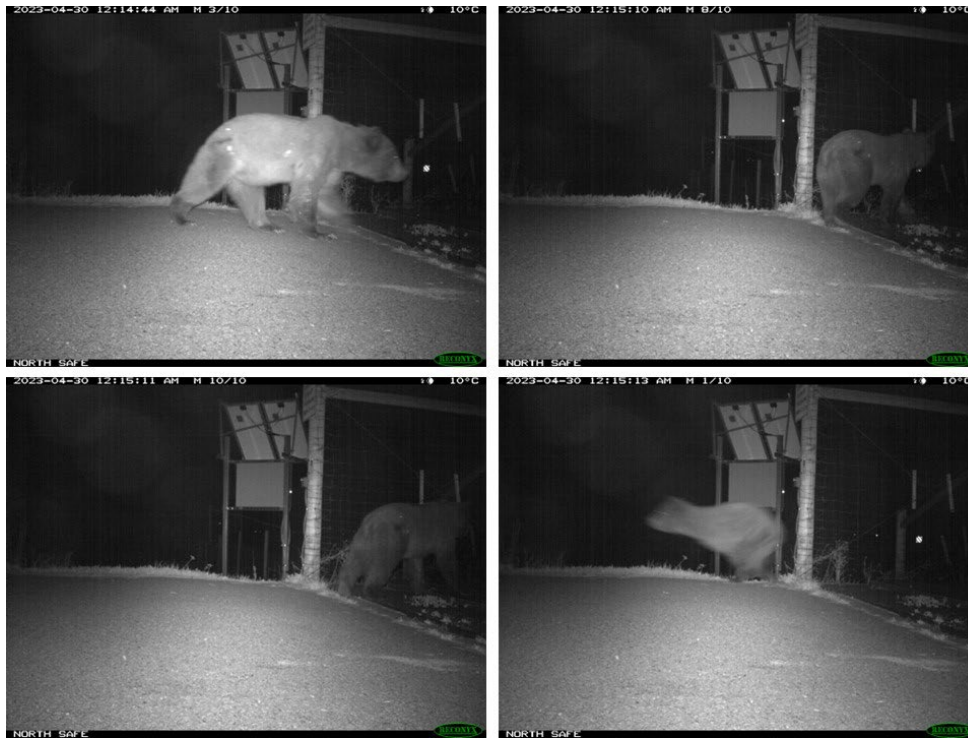
*Figure 15: A grizzly bear approached the wildlife guard and electrified barrier (Crosstek). Based on the images, this animal was shocked and ran back to the habitat side.*

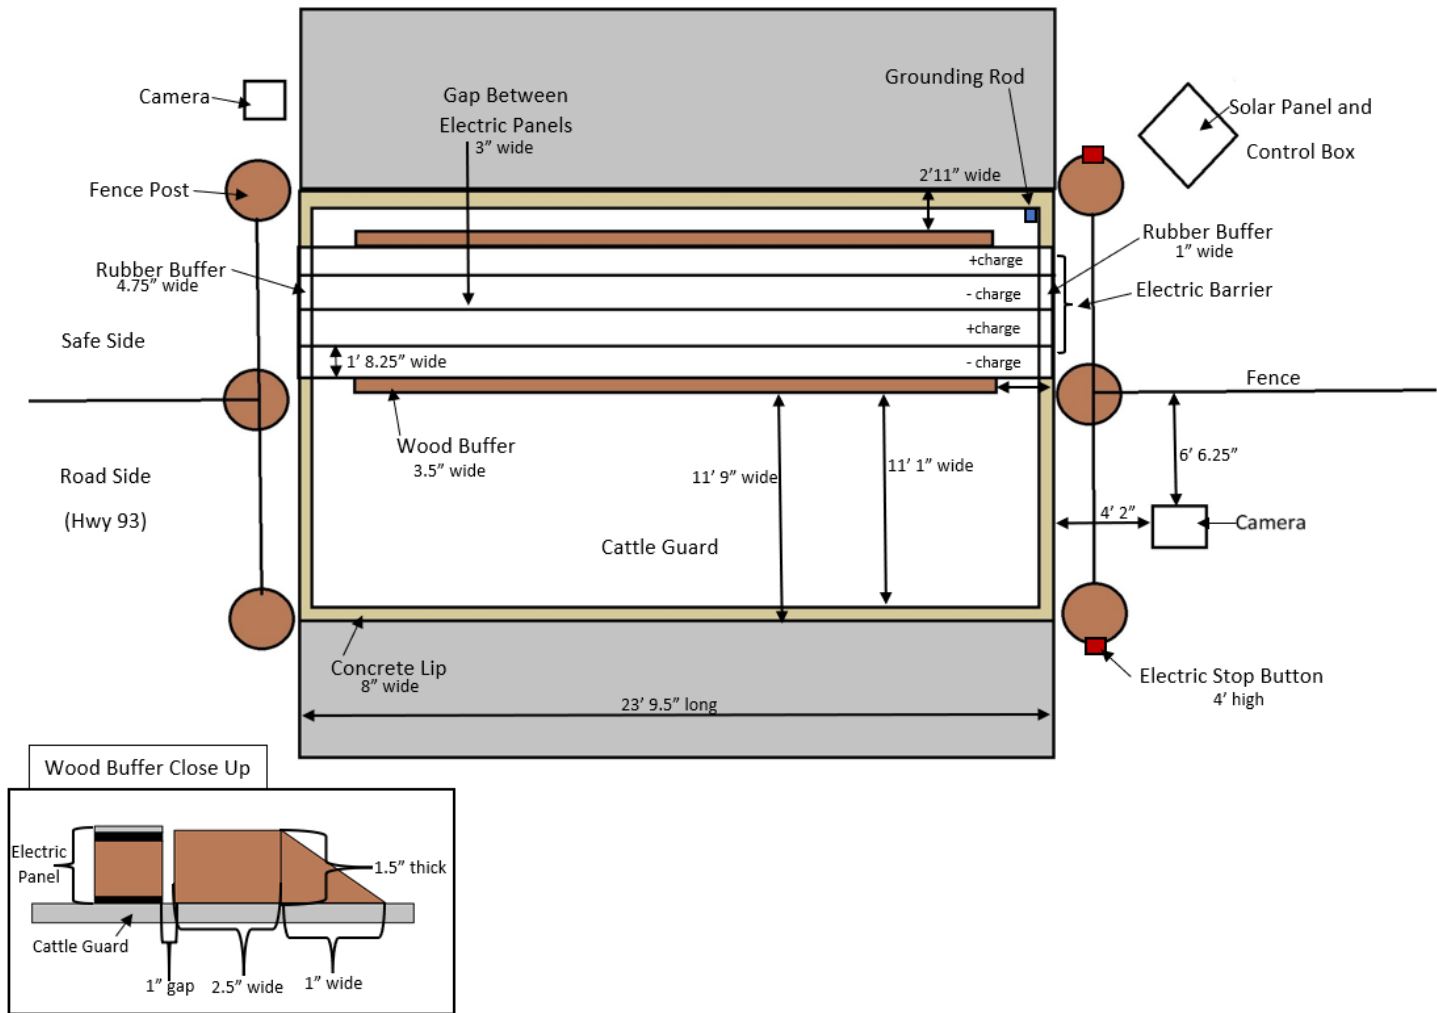
Figure 16: Technical drawing of the Crosstek electrified mat. Note: for "proof of concept" for this project, CrossTek determined inclusion of wood materials was adequate given the expected short study length and low traffic volume. CrossTek uses a variety of very long life and highly durable materials including composites and concrete where necessary, designed for and matched to individual site conditions.

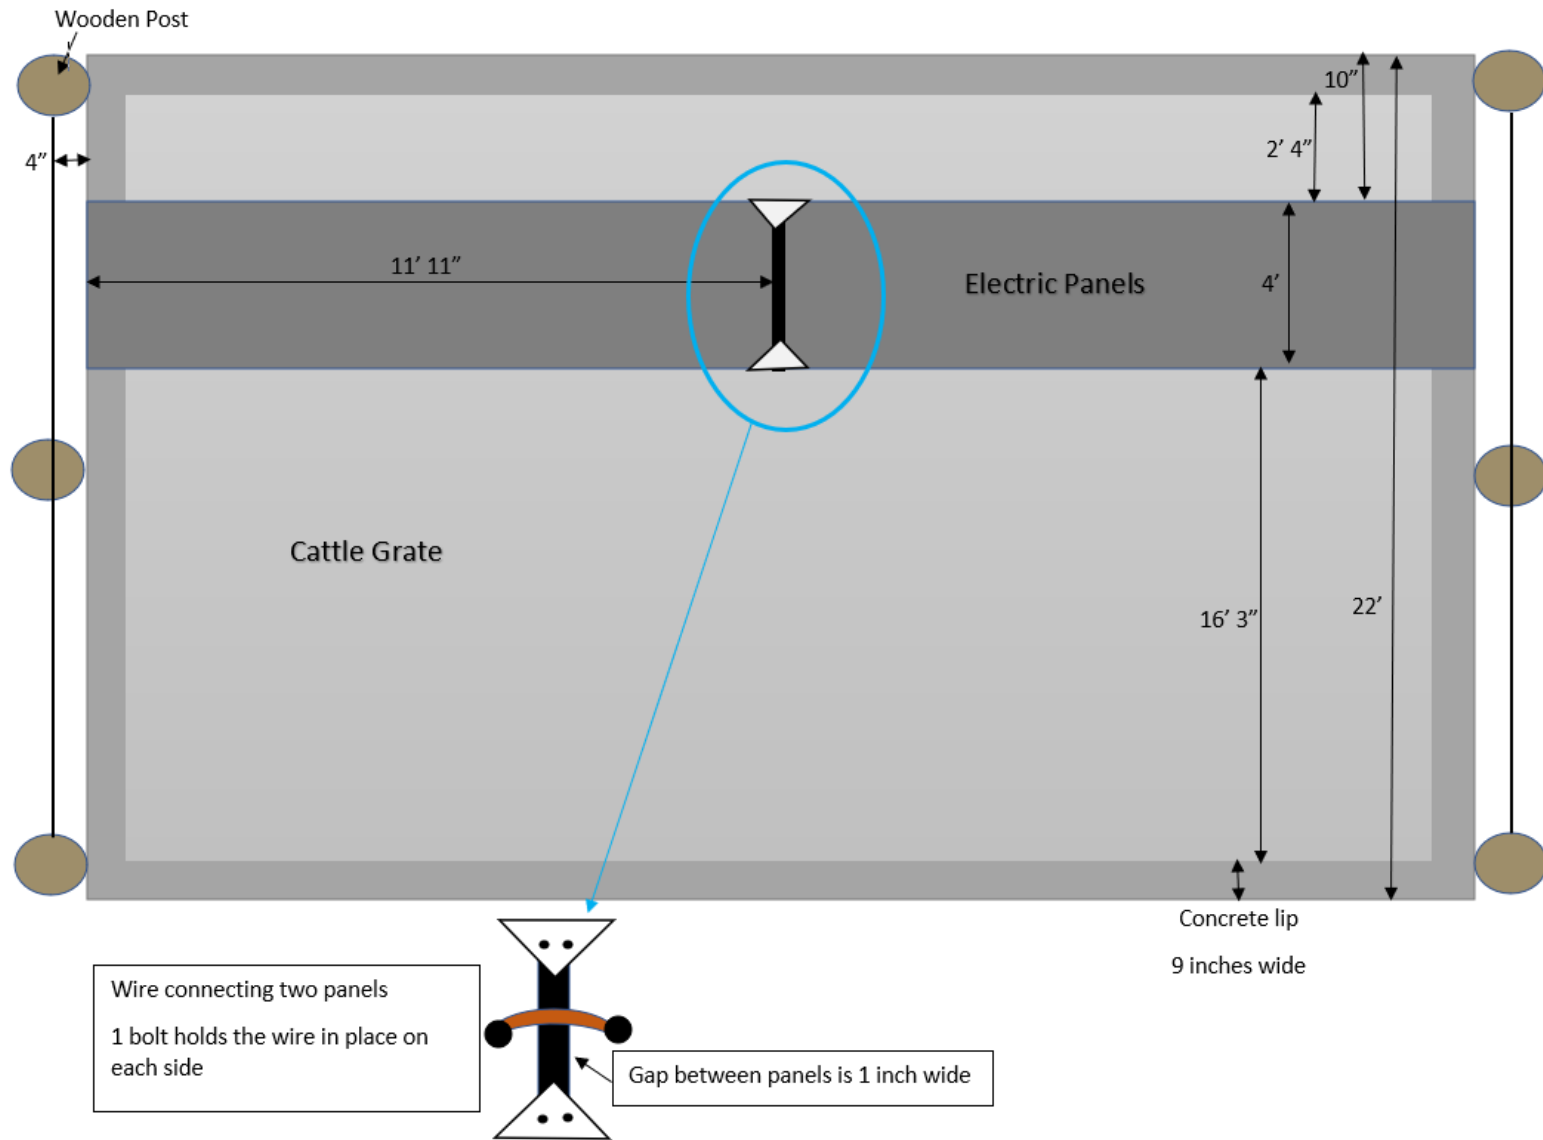
Specifications electrified mat by BS Fabrications (Figure 17)

Figure 17: Technical drawing of the BS Fabrications electrified mat.
