# TRAILBLAZER: A Data-Driven Trail Condition Assessment Methodology

a report by the  
**Western Transportation Institute  
Montana State University**

prepared for the  
**National Park Service  
Transportation Branch  
1849 C Street Washington, DC**

February, 2023

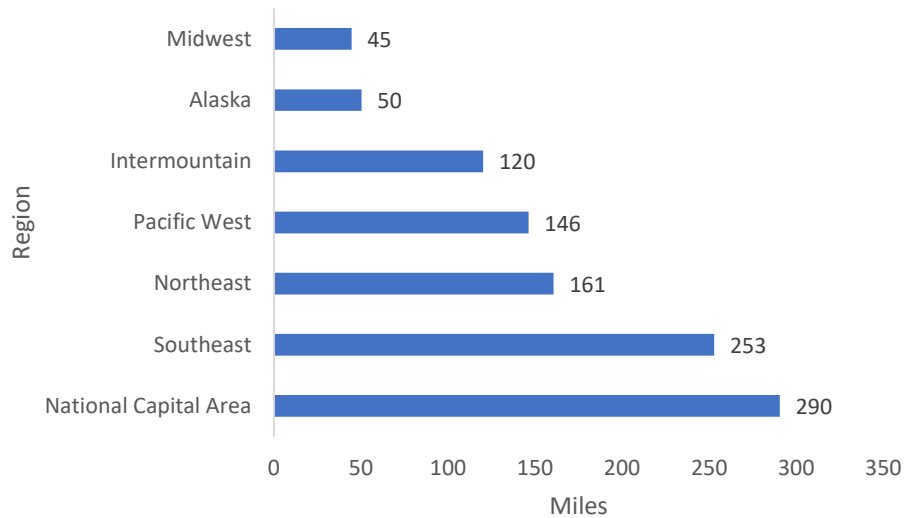
A total of 1,065 miles of NPS transportation trails have been inventoried as of August 2022 (Volpe Center, 2022). Figure 1 shows the transportation trail mileage by NPS region. The National Capital region contains 290 miles of NPS transportation trails, followed by the Southeast Region with 253 and the Northeast region with 161 miles.

**Figure 1: NPS transportation trail miles by NPS region (Volpe Center, 2022)**

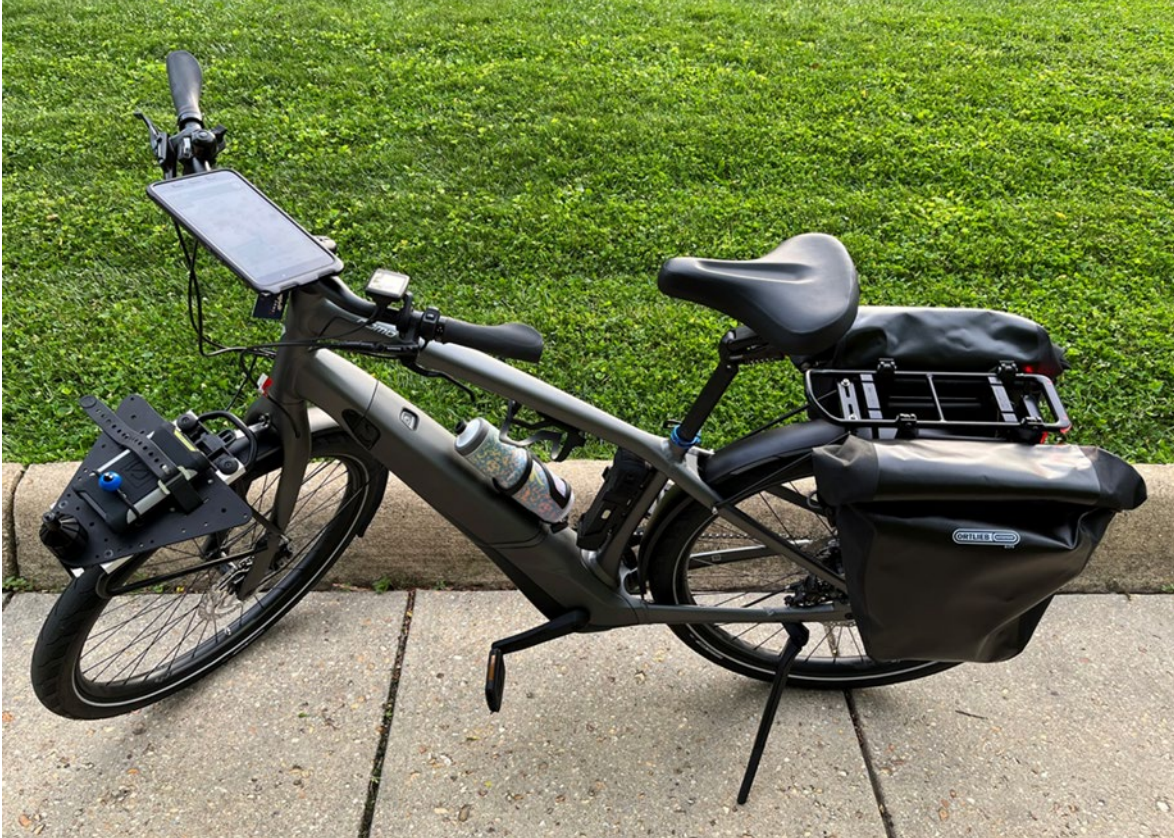
Figure 3: Specialized Como 4.0 650b ebike with accessories.

Ebikes have a wide range of pricing. They rarely cost less than \$1,000 and some models cost over \$10,000. The team researched and tested a variety of models, determining that none of the bikes that met the project team's requirements cost less than \$3,000. Related research projects in Minnesota and Iowa used ebikes that cost \$5,000 or more. More information on these related research projects can be found in the Literature Review section of this report. Based on the considerations discussed above, the Specialized Como 4.0 650b ebike was selected for this research. The Specialized Como 4.0 650b aluminum frame ebike (Figure 3) has 8 traditional gears, 3 levels of electrical assist, and in 2022 the listed base price was \$3,750.

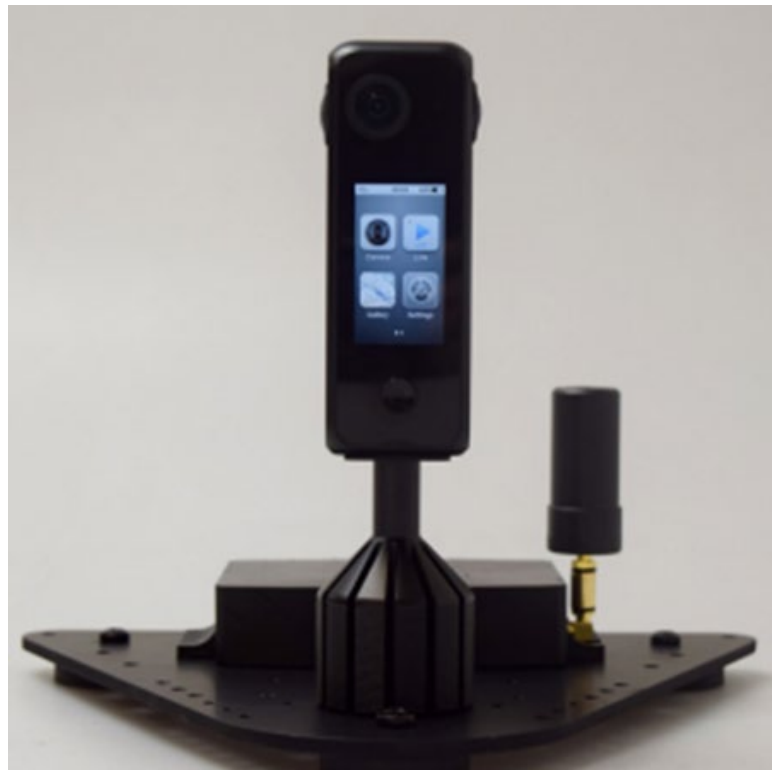
**Figure 4: Smart Delta SmartPano MMS 8k Camera.**

the team decided to use a pre-designed platform for data synchronization and management. However, many products that collect all the desired data types are designed to be mounted on vehicles and are too large for bikes. Other reasonably sized products that are designed for bikes collect some, but not all the desired data types (i.e., a camera with a GPS, but no accelerometer). Through their research, the team identified the Smart Delta SmartPano MMS 8k camera (Figure 4), which collects all desired data types, synchronizes them, and provides software for real-time streaming, visualization, and post-collection data management. This product also has a built-in Wi-Fi hotspot that allows it to transmit data to a tablet in real-time, which streamlines data management and allows for real-time data visualization.

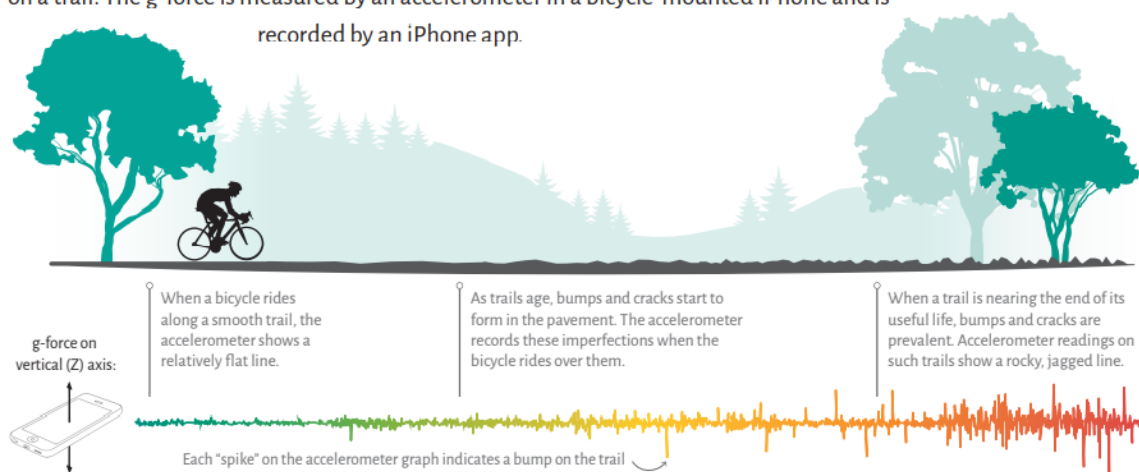
The Trail Roughness Index (TRI) measures the variation in g-forces felt by a bicyclist riding on a trail. The g-force is measured by an accelerometer in a bicycle-mounted iPhone and is recorded by an iPhone app.

**Figure 5: Trail Roughness Index (Parks and Trails Council of Minnesota, 2019).**

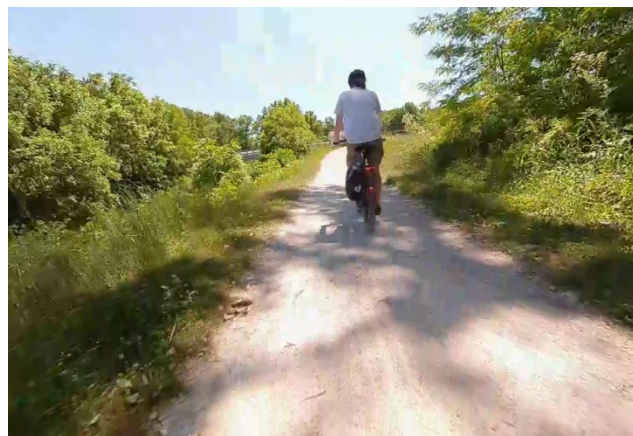
**Figure 11: A crushed limestone trail surface.**

Figure 10, Figure 11, Figure 12, and Figure 13 are screenshots from a 360-degree viewer, where the user can pan around the photograph horizontally and vertically.

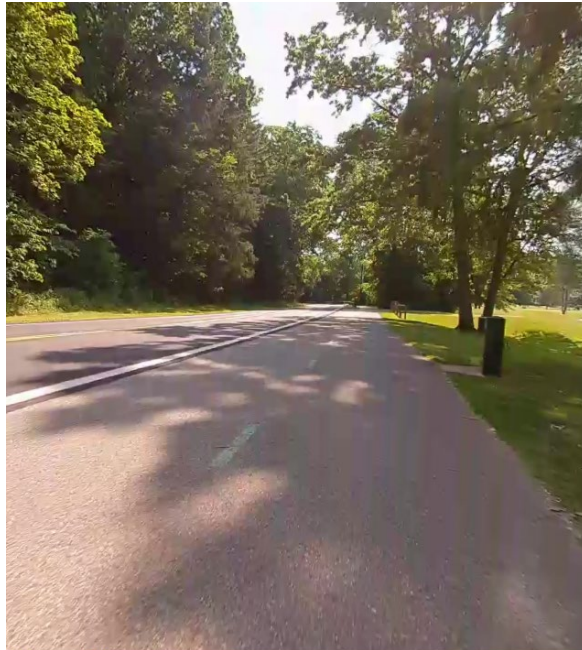
**Figure 12: A paved trail surface.**

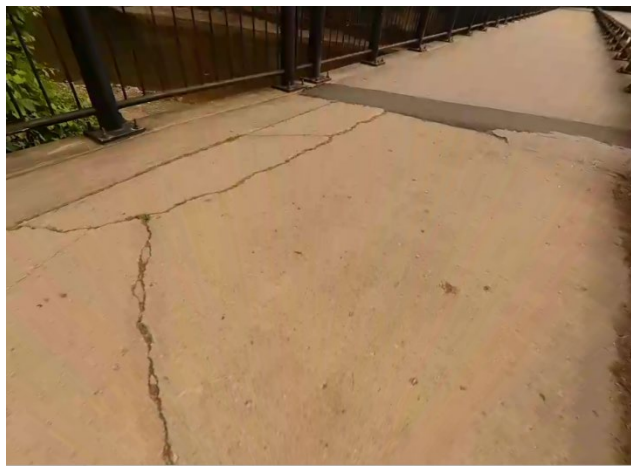
**Figure 13: Heavy cracking on concrete trail surface.**

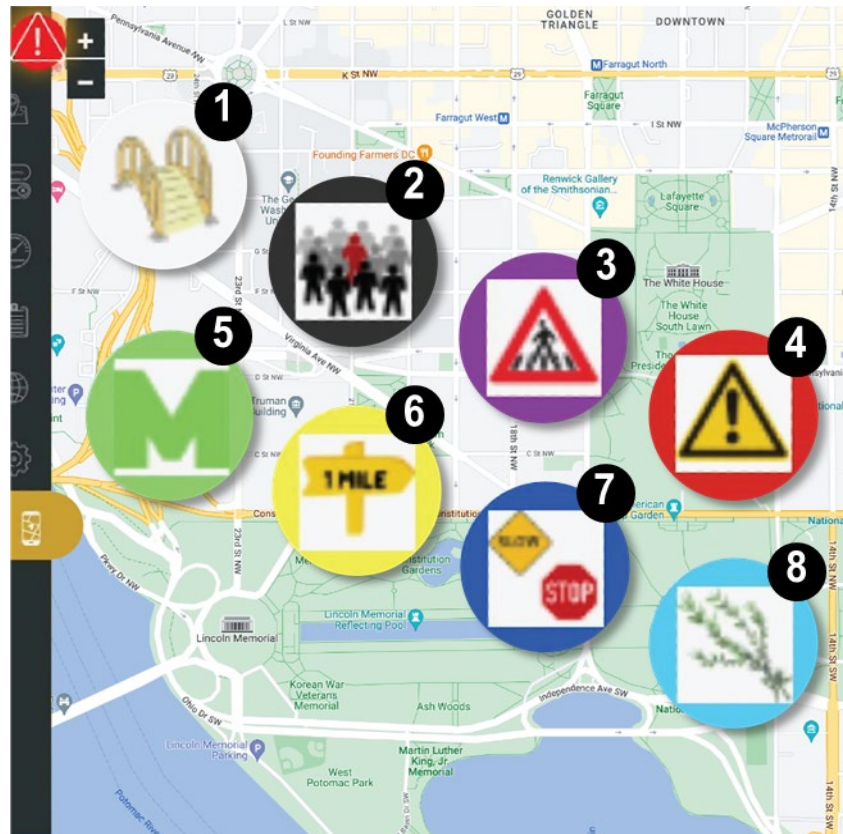
custom annotation interface displayed in Figure 14 was developed by Smart Delta, the company that produced the SmartPano cameras, for the purpose of this project.

**Figure 14: Smart Delta user interface with map and annotations. The numbered icons are: 1) bridge, 2) congestion, 3) crosswalk, 4) hazard, 5) trail surface material change, 6) milepost, 7) slow/stop, and 8) vegetation.**

This interface allows the project team to create custom annotation buttons that can be tailored to record the specific information desired by different trail managers. For example, the Chesapeake and Ohio Canal National Historical Park was interested in documenting the location of trail mileposts, so the project team added a ‘milepost’ annotation.

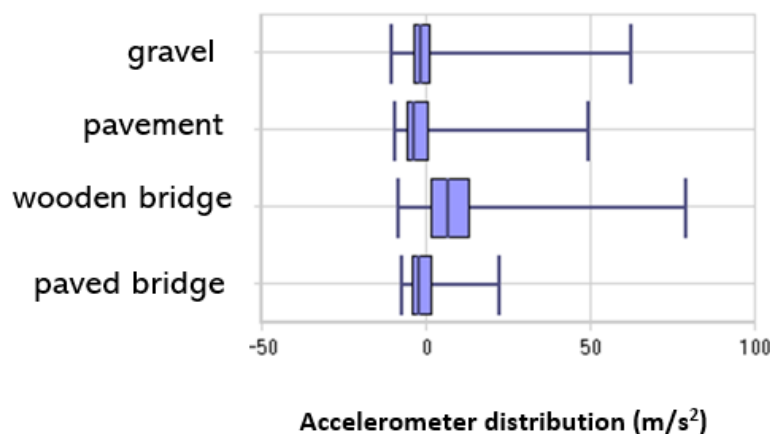
Figure 20 shows the accelerometer distributions (along the x-axis) for different trail materials (along the y-axis). As discussed previously, negative  $9.8 \text{ m/s}^2$  indicates a smooth surface. This figure shows that pavement and paved bridges tend to be relatively smooth, with average accelerometer readings close to negative  $9.8 \text{ m/s}^2$ . Wooden bridges are rougher with average accelerometer readings of approximately  $10 \text{ m/s}^2$ , while gravel surfaces have accelerometer readings slightly less than  $0 \text{ m/s}^2$ , indicating they tend to be rougher than pavement, but smoother than wooden bridges.

Figure 20: Distribution of baseline roughness data by trail material.

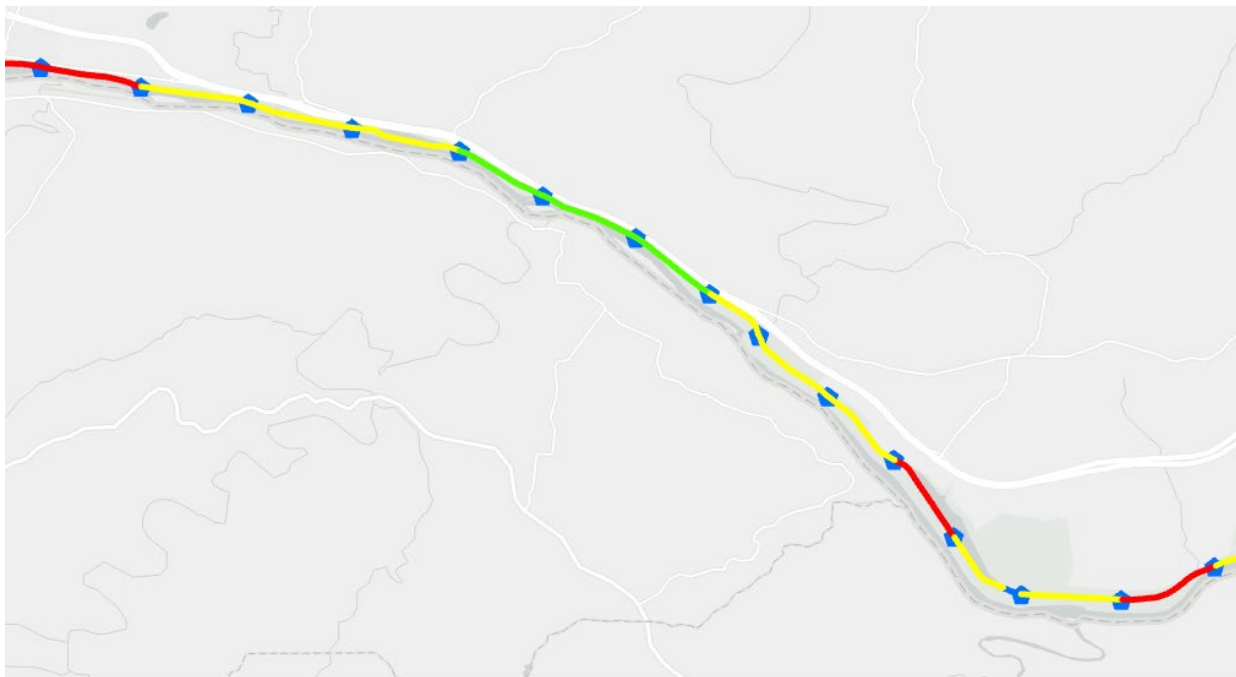
Figure 29: CHOH baseline data averaged by mile with milepost annotations.

The NPS National Capital Region Transportation Program and the staff at CHOH were interested in the Trailblazer project team pinpointing the milepost locations along the 185-mile CHOH trail. Figure 29 demonstrates the customizable nature of the annotation function, showing the location of mileposts collected by the project team as well as the average baseline accelerometer data averaged by mile.

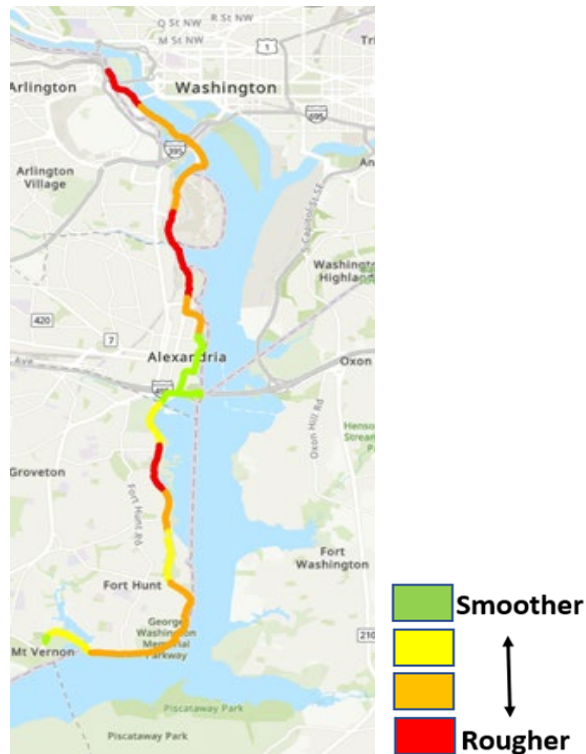
Figure 32: GWMP baseline roughness data averaged by mile.

Figure 30 shows the baseline roughness data from the Mount Vernon Trail, Figure 31 shows trail roughness averaged by half mile, and Figure 32 shows trail roughness averaged by mile. (NOTE: a small amount of data in the Alexandria area was collected on paved roads that serve as a bike route but are not on the Mount Vernon trail.)

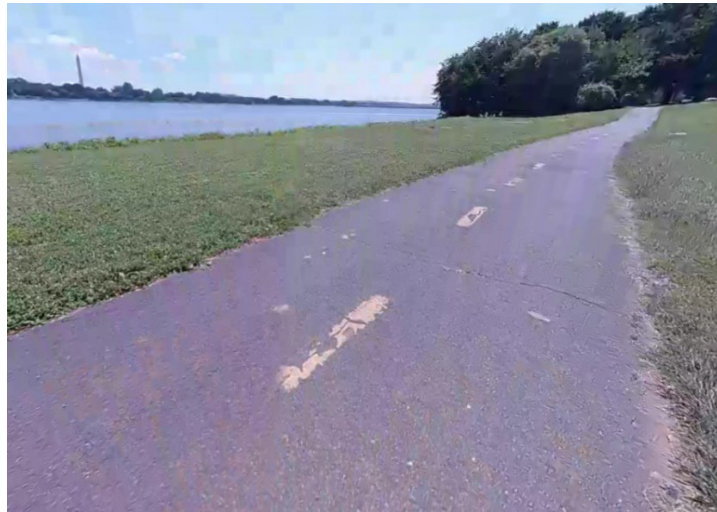
**Figure 33: A rough section of Mount Vernon Trail near the Arlington Memorial Bridge.**

Figure 33 is an image taken from the ArcGIS 360-degree image viewer that shows a rough section of the Mount Vernon Trail.

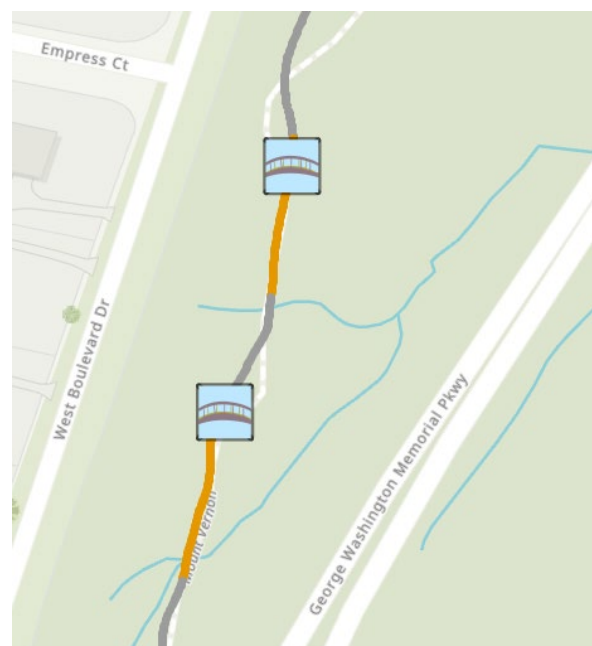
**Figure 34: example of bridge annotations and trail surface material layer.**

Figure 34 provides an example of the utility of annotations, in this case ‘bridge’ annotations, in creating a trail surface material map. The annotations serve as a reference for the project team to examine these locations and codify segments of trail as either pavement or wooden bridge.

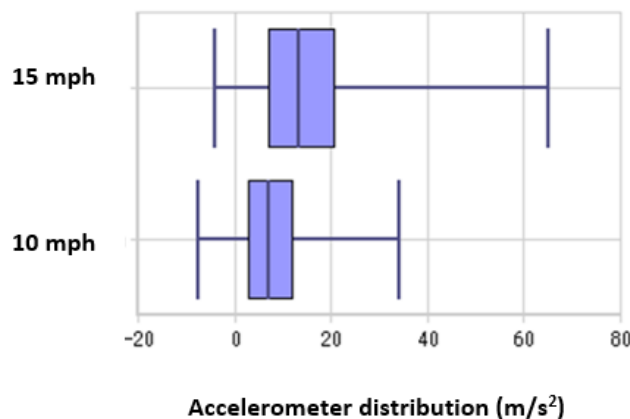
Speed is an important variable to consider when conducting an assessment. The project team tested the impact of speed and weight on accelerometer data. The findings suggest that the faster the ebike is moving, the higher the accelerometer values are compared to accelerometer data collected on the same section of trail at a slower speed. The data displayed in Figure 35 was collected by the same rider going the same direction on the same wooden bridge, where the ‘fast’ speed was 15 mph and the ‘slow’ speed was 10 mph.

Figure 35: The effect of speed on baseline roughness data.

These findings suggest that maintaining a consistent speed is critical for the integrity of roughness data. Understanding this, the project team tried to maintain a constant speed of 15 mph for all data collection, with a margin of +/- 2 mph. The target speed can be adjusted for future use of the Trailblazer methodology, but maintaining a consistent speed is critical (the electrical assist function of the ebike is essential for this). Furthermore, the project team would mark the ‘slow/stop’ annotation in areas where the target speed was not met, such as a congested area, for review after data collection.

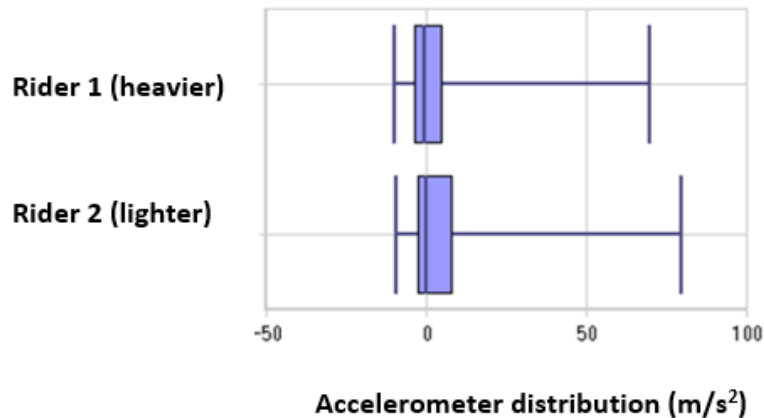
**Figure 36: The effect of weight differential on baseline roughness data distribution**

Figure 36 shows the distribution of baseline accelerometer data collected by a heavier rider (top) and a lighter rider (bottom). This data suggests that the less a rider weighs, the broader the total distribution of baseline roughness data will be, as bumps register higher accelerometer values. To address variability in weight, it is important to label datasets with rider information, and not to compare accelerometer data between two riders with significantly different weights. Keeping this in mind, the project team only used one project team member's accelerometer data for the roughness analysis on any given trail.

Weight, like speed, is also an important variable to consider when conducting a trail condition assessment. Weight also has a major effect on accelerometer data, and, like speed, it is important to keep the combined weight of the rider and ebike consistent for the duration of data collection on any given trail. The project team compared the effects of an approximately 50 lb. weight differential on accelerometer data between two riders travelling at the same speed on the same section of trail.

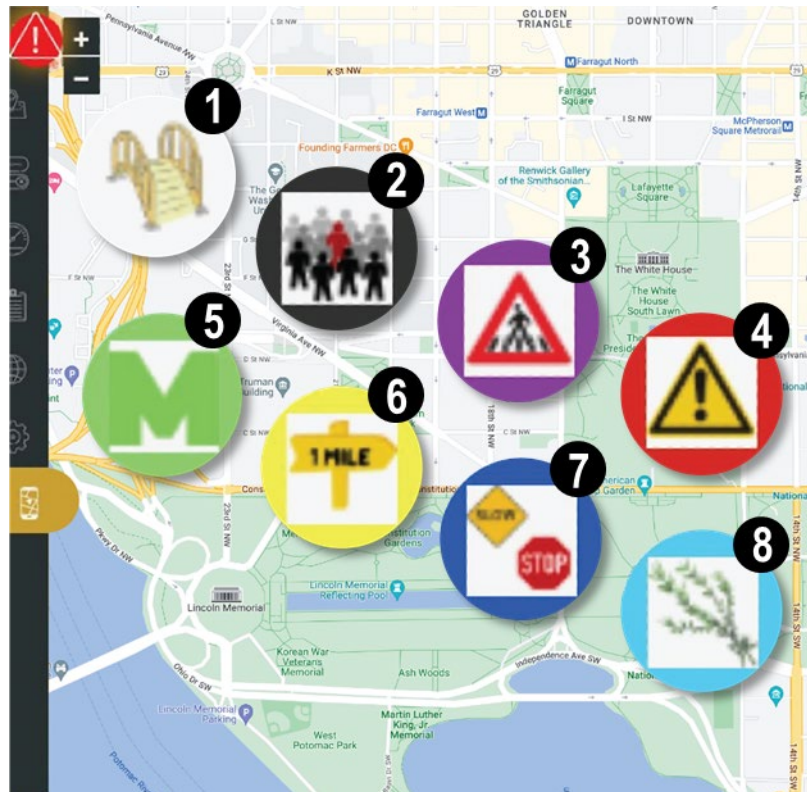
2.
  - iii. Above: screenshot of the tablet's screen featuring an offline map and annotation buttons
  - iv. Attach tablet to tablet mount on handlebars
  - v. Plug into battery pack, ensure tablet is charging
- d. Saddlebags
  - i. Attached full saddlebags to ebike
