# **The effectiveness of electrified barriers to keep large mammals out of a fenced road corridor and a campground**

Marcel P. Huijser, PhD

Parks Canada Agency

20 June 2024

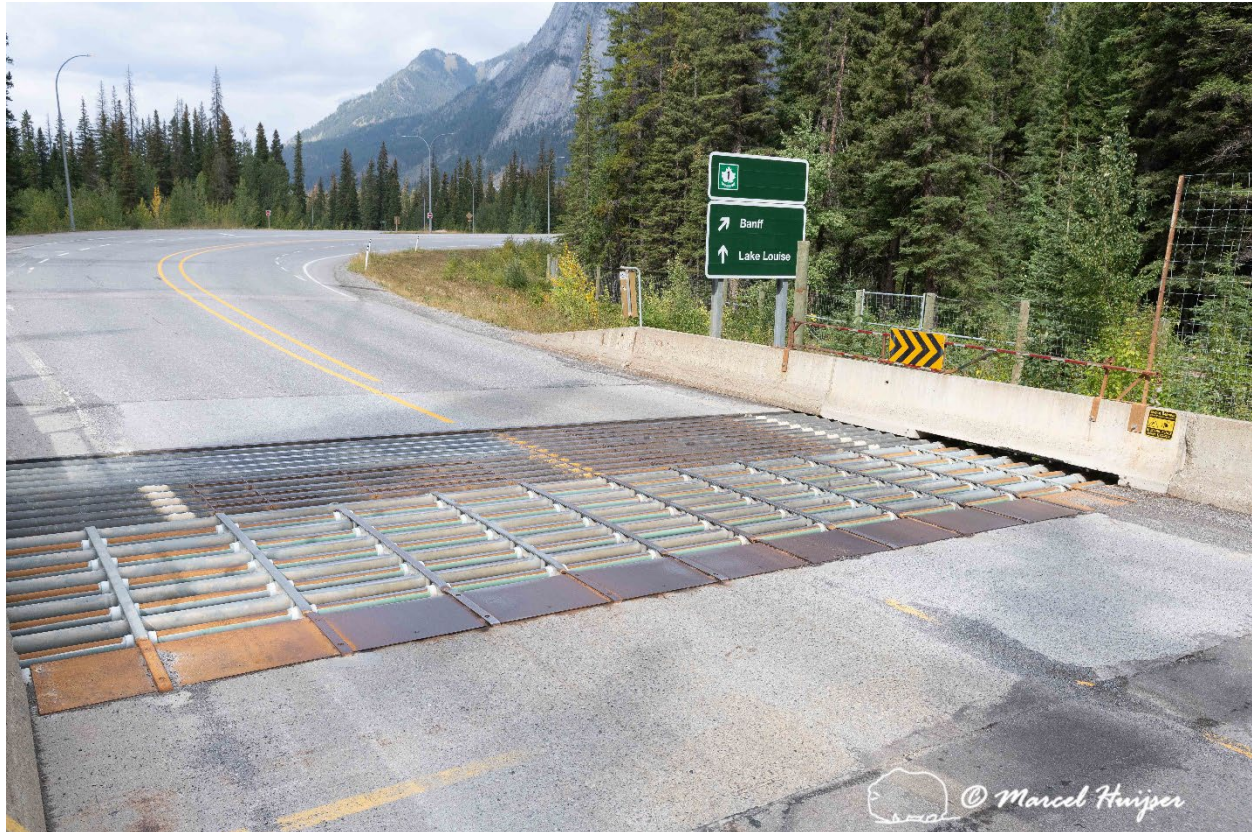
At this location, a non-electrified wildlife guard (5.0 m long, 10.8 m wide) was first installed in the 1980s (personal communication Trevor Kinley, Parks Canada). In August 2020, a partially electrified barrier was installed. It consists of 3 sections (Figure 1):

1. The grounding plate (approximately 50 cm wide) with strips to protect it from snowplows. This is the metal plate in front of the barrier, on the habitat side where the animals would be approaching from.
2. A section (approximately 2.2 m wide) with alternating positive (n=5) and negative (n=5) round bars. The positive bars have white insulators.
3. A section (approximately 2.2 m wide) (far side in Figure 1, this is the highway side)) with flat bars (n=11, not electrified).

**Figure 1: Electrified barrier, Sunshine Road, Banff National Park, Canada**

The barrier was briefly fully operational 8-20 October 2020, but a snowplow damaged the grounding plate as the protective strips had not been installed yet. After that, the damaged grounding plate was removed which meant that the animals were less likely to receive a full shock (variable conductivity of the pavement) or they would only be delivered a full shock after making contact with both a positive and negative bar. The grounding plate was reinstalled (with protective strips) between 23-25 September 2021 (personal communication Dan Rafla, Parks Canada). The electrified components were hard-wired and thus “on” all the time. However, in winter, voltage measurements were usually zero or “low” (up to about 3-4 kV rather than 9 kV or higher), presumably because of shorting caused by snow and road salt (personal communication Dan Rafla, Parks Canada).

### 1.1.1 Sunshine Road, near Banff, Banff National Park, Alberta

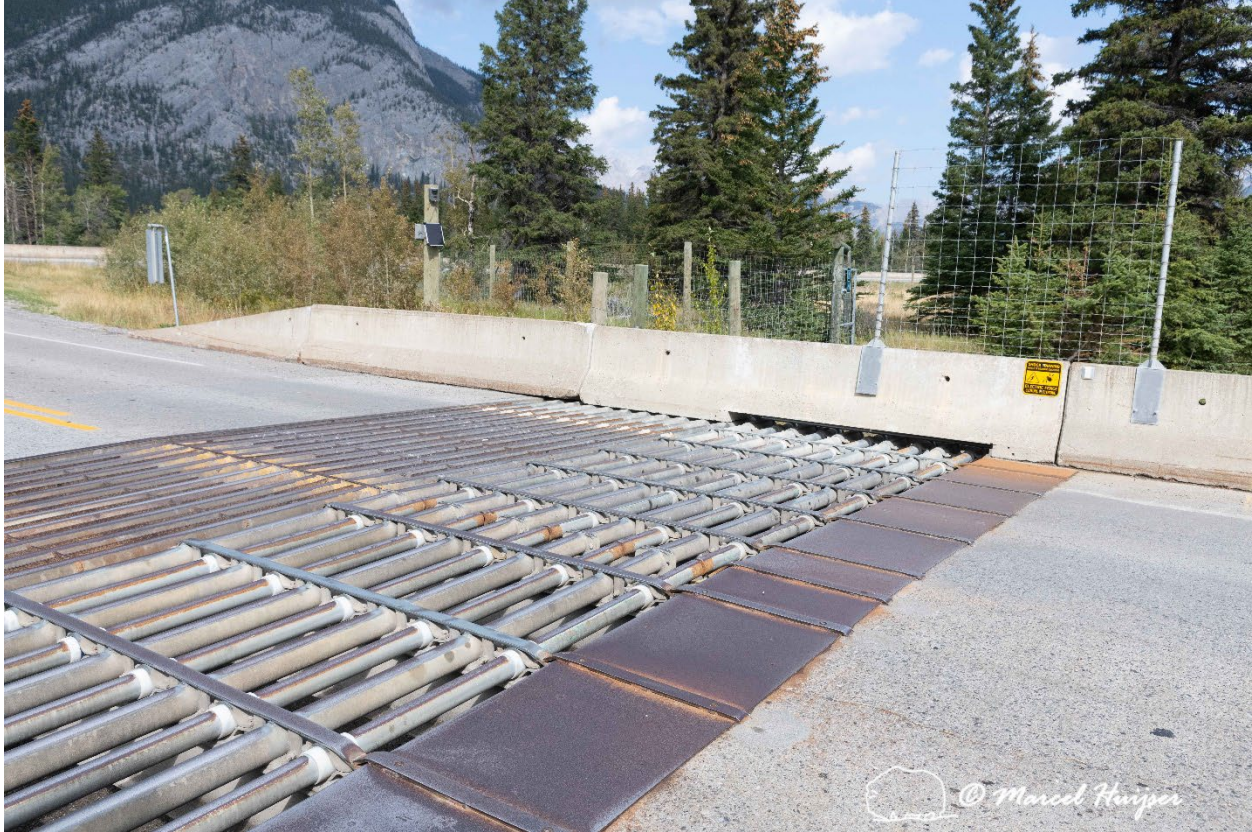
The barrier at Compound Road has similar sections and dimensions to the one at Sunshine Road (Figure 2). This barrier did not receive a grounding plate (with protective strips) until 27 September 2021 – 1 October 2021 (personal communication Dan Rafla, Parks Canada). The electrified components were hard-wired and thus “on” all the time. However, in winter, voltage measurements were usually zero or “low” (up to about 3-4 kV rather than 9 kV or higher), presumably because of shorting caused by snow and road salt (personal communication Dan Rafla, Parks Canada).

**Figure 2: Electrified barrier, Compound Road, Banff National Park, Canada**

At this location, a non-electrified wildlife guard (5.0 m long, 9.9 m wide) was first installed in the 1980s. An electrified mat was added in 2016, which was replaced with a partially electrified wildlife guard in 2020 (personal communication Trevor Kinley, Parks Canada).

### 1.1.2 Compound Road, near Banff, Banff National Park, Canada

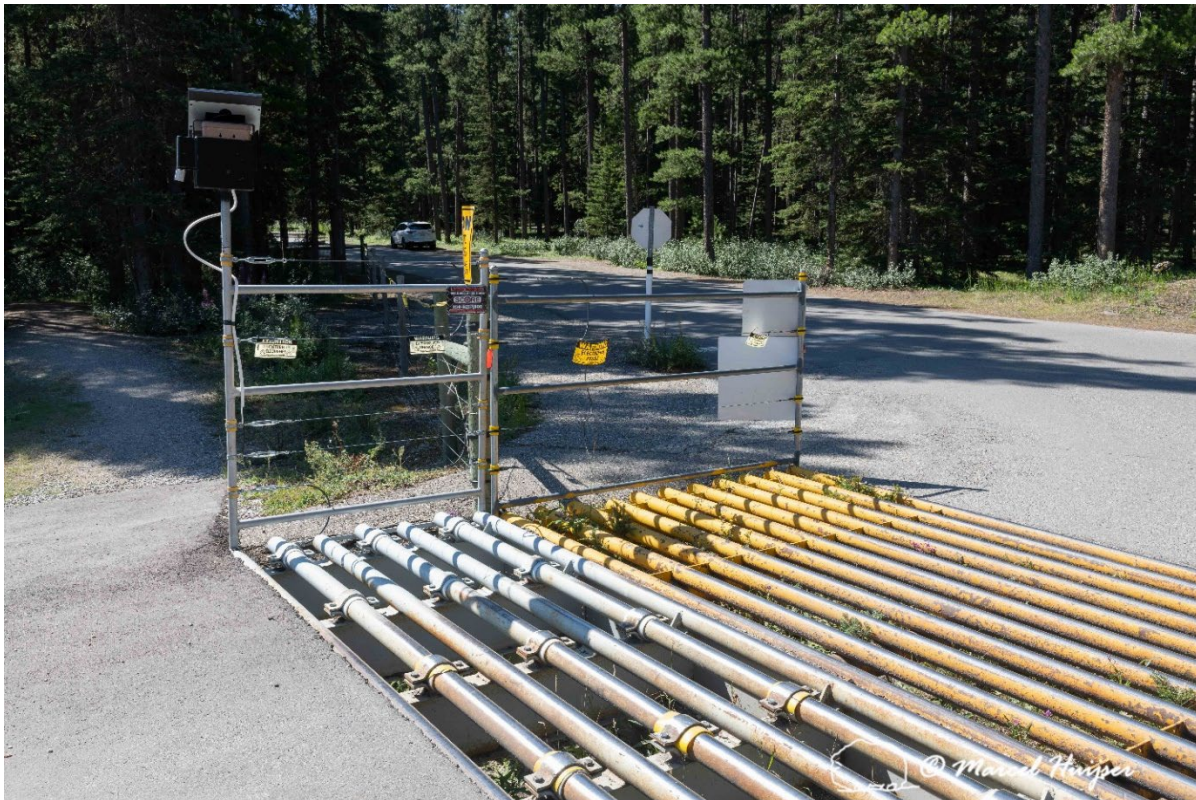
The barrier that was evaluated consists of 2 sections (Figure 3):

1. A section (approximately 2 m wide) with alternating positive (n=3) and negative (n=3) round bars. The positive bars have a yellow insulator.
2. A section (approximately 1.8 m wide, far side in image, this is the campground side)) with yellow round bars (n=11, not electrified).

Figure 3: Electrified barrier, Lake Louise Campground, Lake Louise, Canada

This barrier does not have a grounding plate. This barrier has been operational, but the electricity was likely only turned on when the campground was operational in the summer months when bears are active (personal communication Saundi Stevens, Parks Canada). Note that the connecting fence is designed for black bears and grizzly bears and not for ungulates. Ungulates can jump this fence and enter or leave the campground anywhere, regardless of whether the electricity is turned on or off.

### 1.1.3 Lake Louise Campground, Lake Louise, Banff National Park, Canada

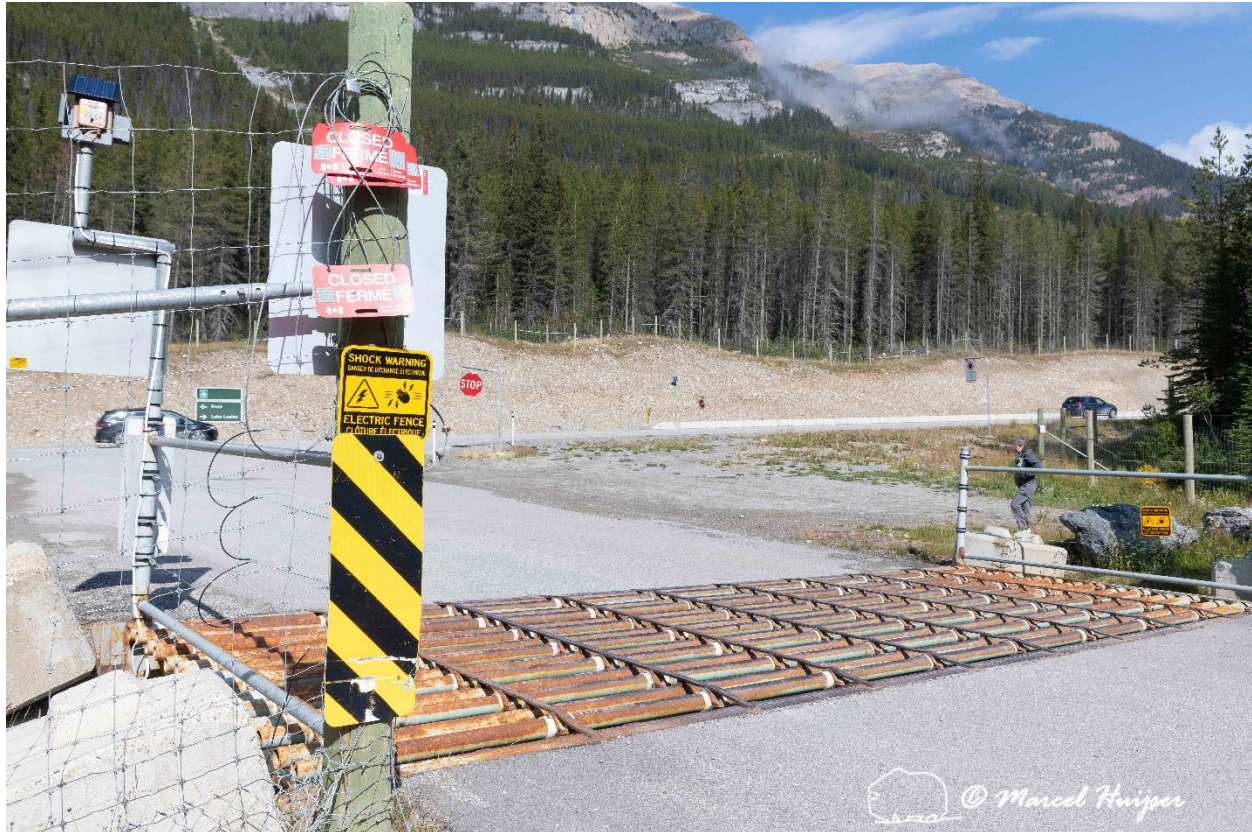
No wildlife guard was installed prior to 2018. The electrified barrier (3.5 m long, 9.0 m wide) was installed in 2018 and consists of 1 section (personal communication Trevor Kinley, Parks Canada) (Figure 4):

1. A section with alternating positive (n=7) and negative (n=7) round bars. The positive bars have a white insulator.

The Trans-Canada Highway is in the far side of the image (Figure 4). The foreground is the habitat side. This barrier does not have a grounding plate. This barrier has been operational, but the electricity is turned off in winter when most bears are inactive. Each year, the system is likely to have been turned on sometime in April and turned off in either October or November.

**Figure 4: Electrified barrier, Lake O'Hara exit, Yoho National Park, Canada**

### 1.1.4 Lake O'Hara Road, Yoho National Park, Canada

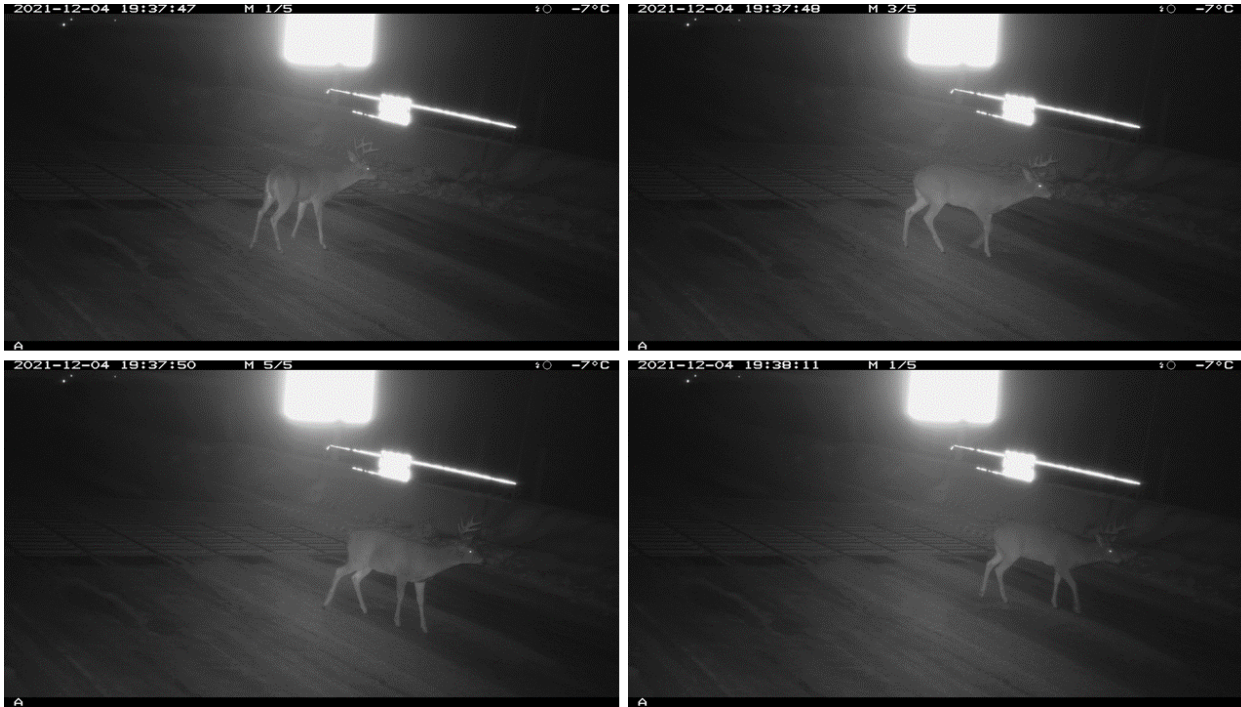
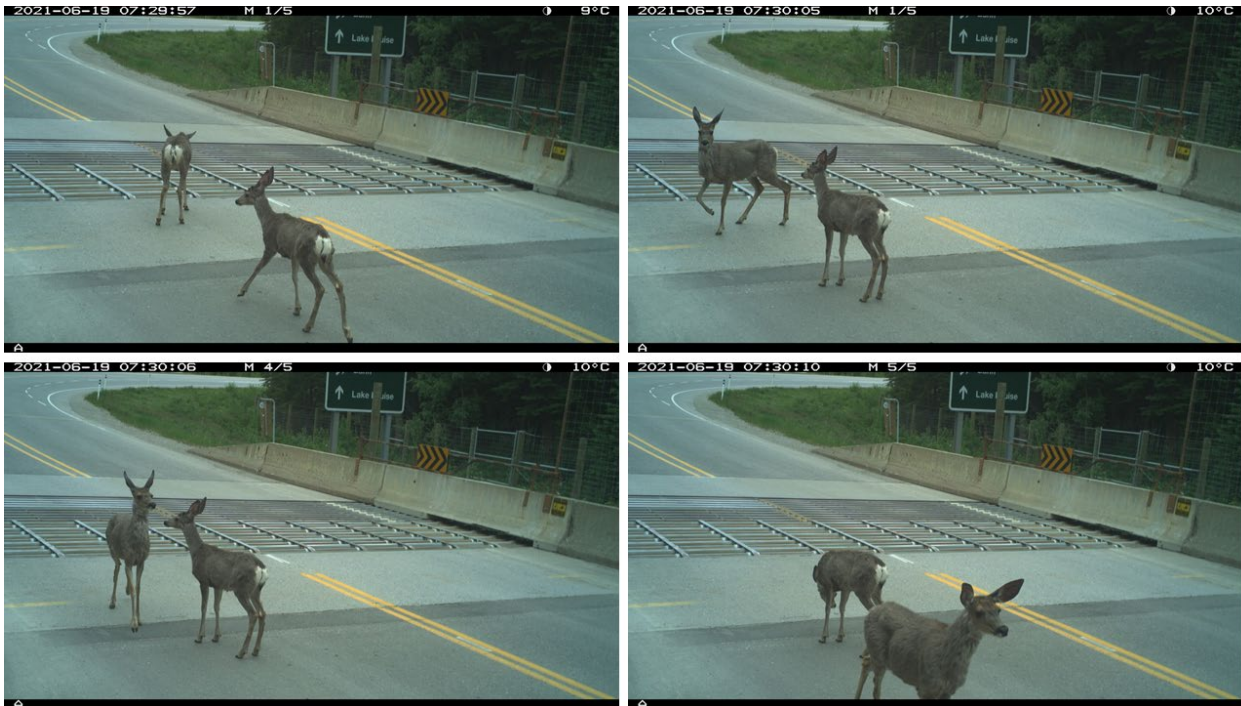
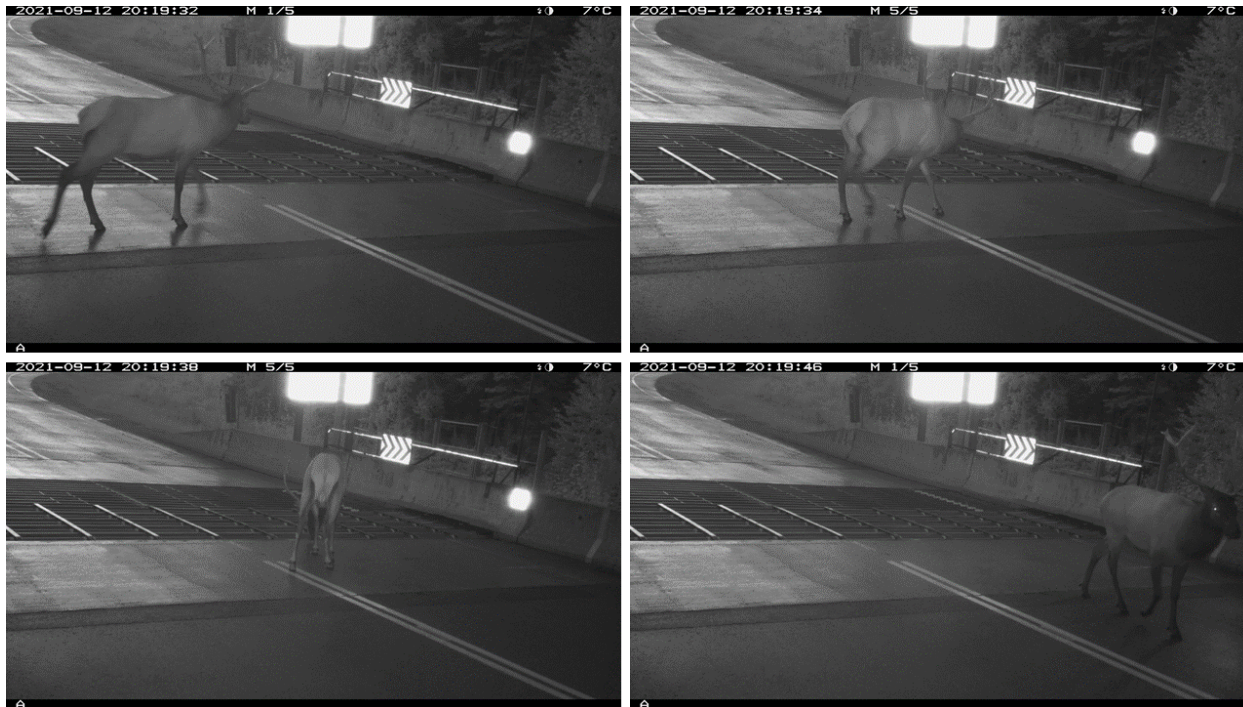
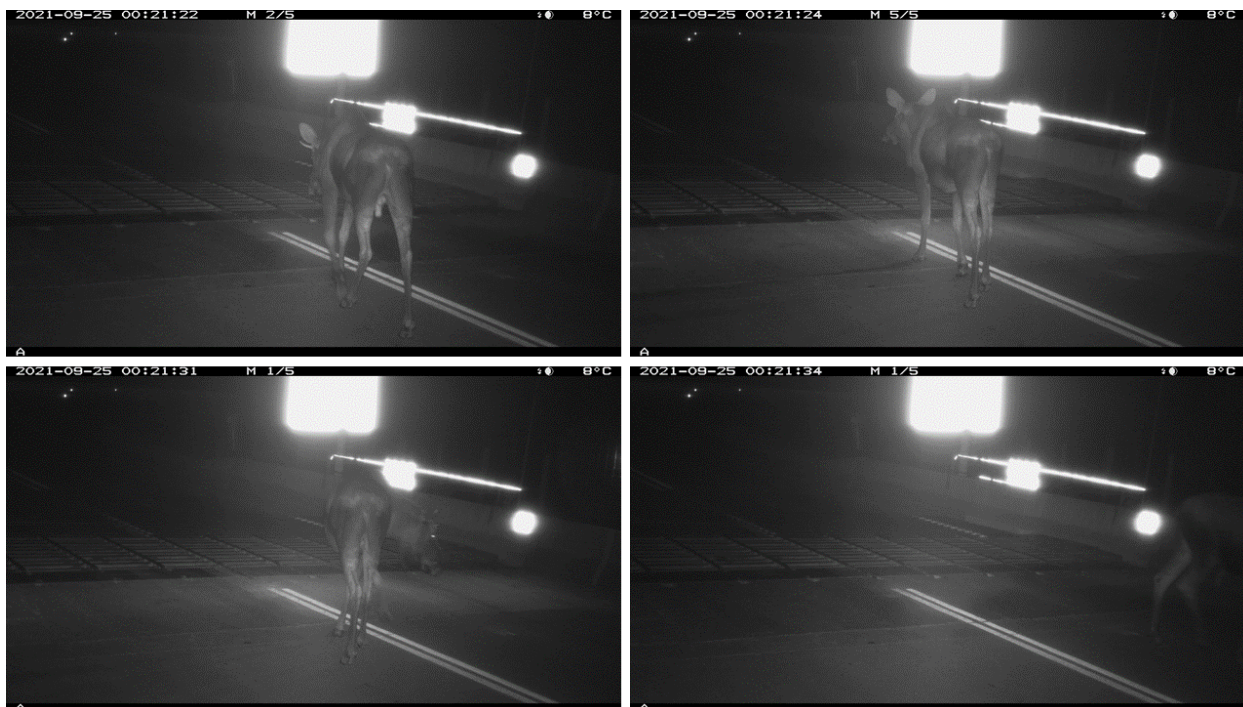
Most animals that approached the electrified barriers stopped and turned around without making any physical contact with the barrier (Figure 5, Figure 6, Figure 7, Figure 8, and Figure 9). Only one animal, a grizzly bear, appears to have received an electric shock when attempting to cross into the fenced road corridor at Lake O’Hara Road (Figure 10).

Figure 5: White-tailed deer approaches electrified barrier at Sunshine Road and turns back

Figure 6: Mule deer approach electrified barrier at Sunshine Road and turn back

Figure 7: Elk approaches electrified barrier at Sunshine Road and turns back

Figure 8: Moose approaches electrified barrier at Sunshine Road and turns back

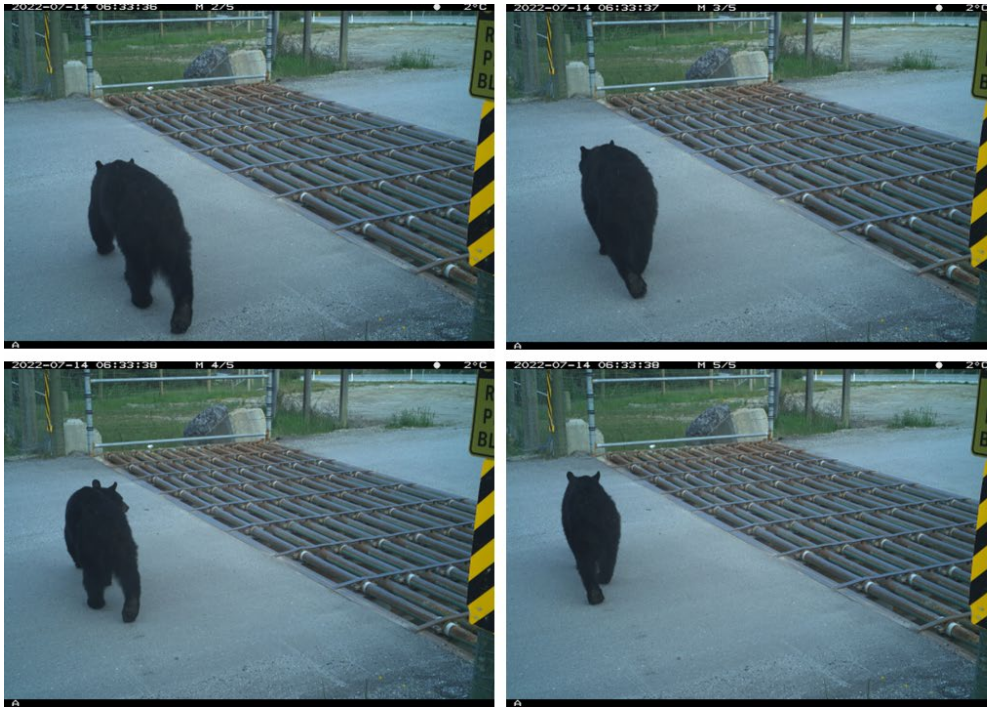
Figure 9: Black bear walks by electrified barrier at Lake O'Hara Road and glances at the barrier

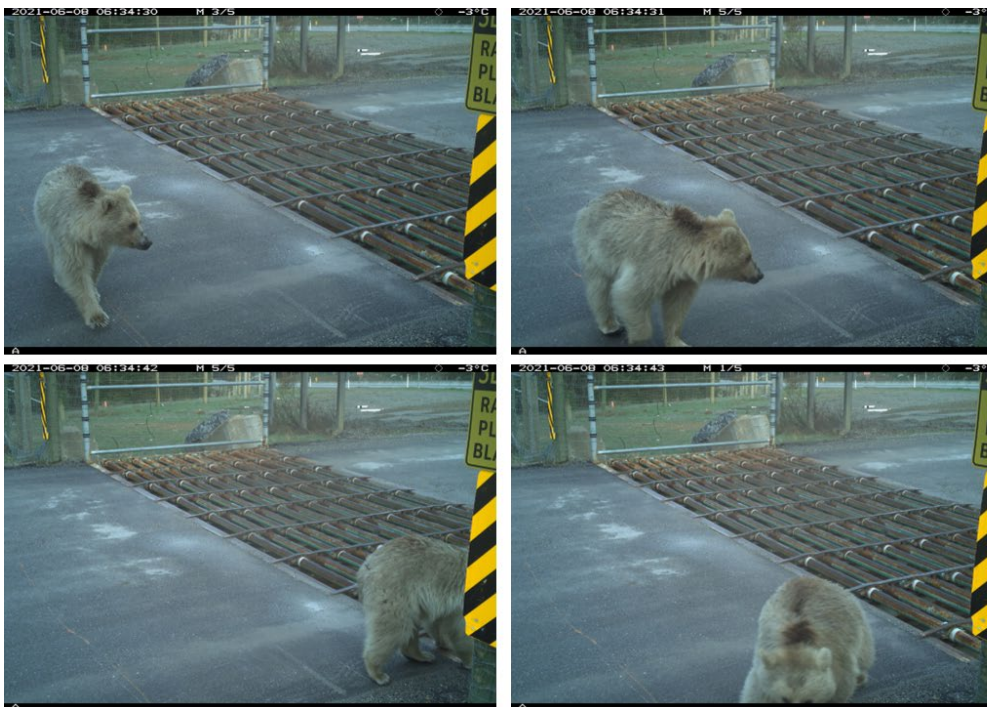
Figure 10: Grizzly bear receives an electric shock when attempting to enter the fenced road corridor at Lake O'Hara Road

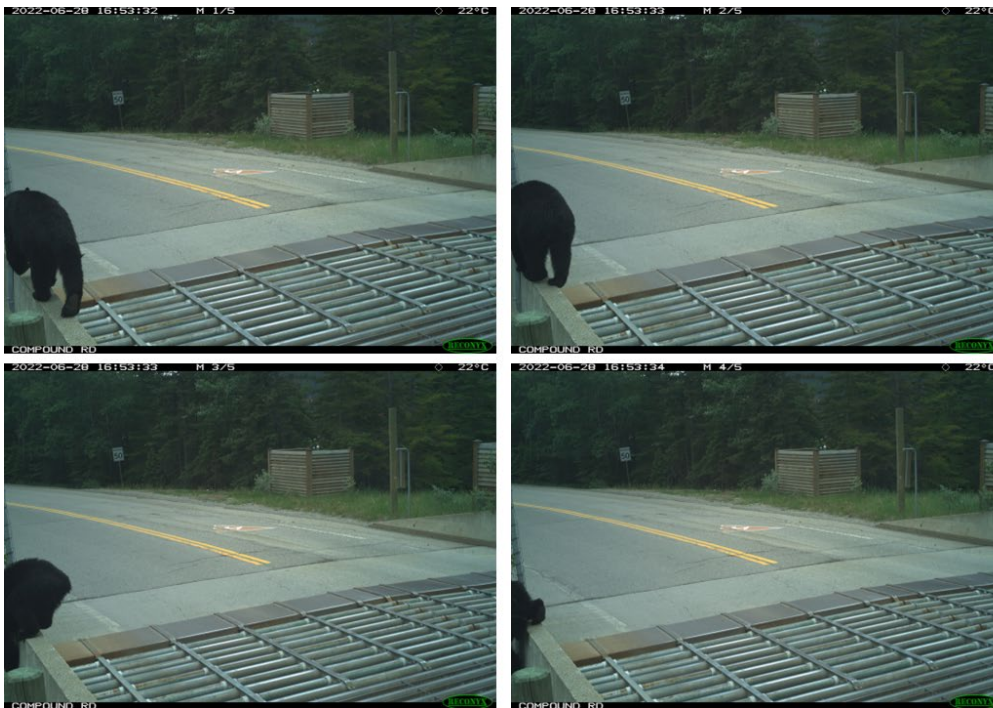
**Figure 11: Black bear at Compound Road failing to exit the fenced road corridor**

A black bear attempting to exit the fenced road corridor failed to cross to the habitat side of the electrified barrier. Two red foxes and one wolverine did exit the fenced road corridor to the habitat side of the electrified barrier, but these three crossings were all in winter when the voltage was likely compromised because of snow and road salt (usually between zero and 3-4 kV). In addition, crossings to the habitat side can be considered acceptable as they improve human safety on the main highway and keep the animals from being hit by vehicles.

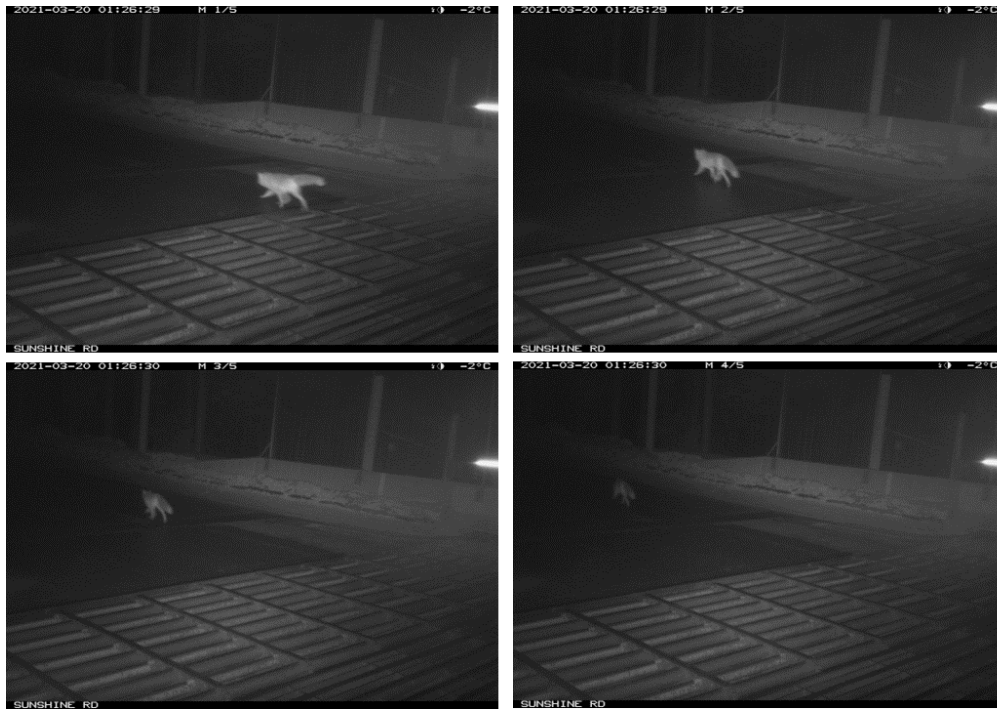
Figure 12: Red fox at Sunshine Road, having crossed the barrier from the road side to the habitat side

Of the 109 animals that were observed in total, 4, split in 4 groups, were interpreted to have crossed the barriers from the road side to the habitat side. These animals were not first observed on the road side of the barrier as the cameras were oriented to the habitat side of the barrier. Therefore, these animals were first observed on the barrier or on the habitat side of the barrier, but the direction of their movement and their speed was interpreted as indicating that these animals were moving from the road side to the habitat side of the barrier. A black bear attempting to exit the fenced road corridor failed to cross to the habitat side of the electrified barrier but tried to do so using the Jersey barrier (Figure 11). Two red foxes and one wolverine were interpreted as having exited the fenced road corridor to the habitat side of the barrier while running (Figure 12, Figure 13, and Figure 14). These last three crossings were all in winter when the voltage was likely compromised because of snow and road salt (usually between zero and 3-4 kV). Note that there was 1 animal, a red fox, for which it was unclear in which direction it moved and whether it had crossed the electrified barrier.

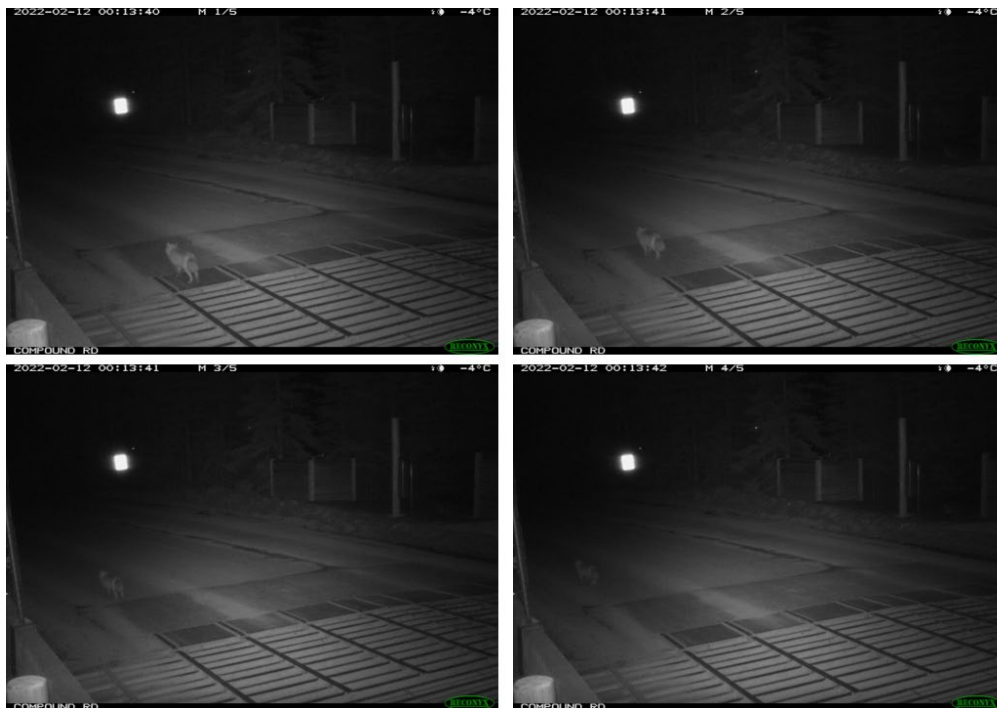
Figure 13: Red fox at Compound Road, having crossed the barrier from the road side to the habitat side

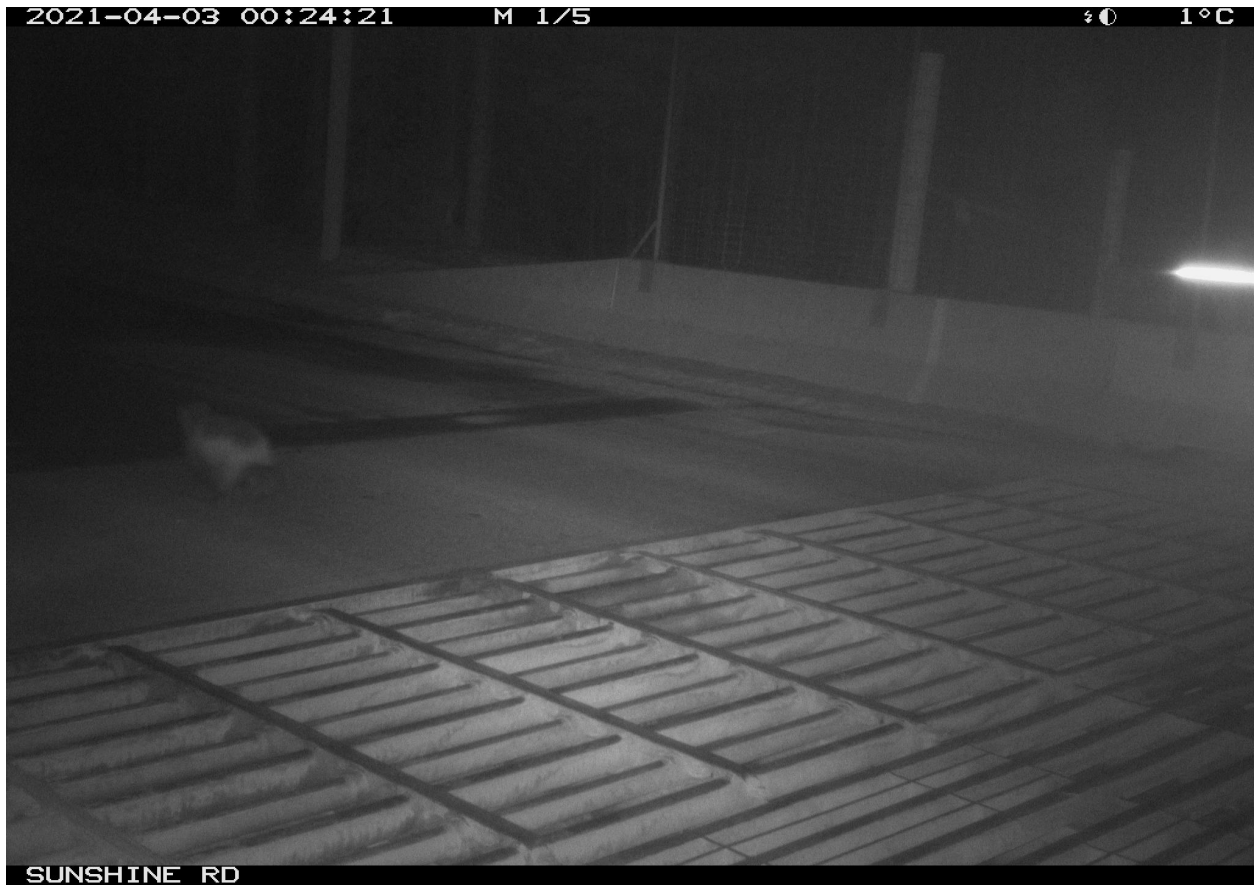
**Figure 14: Wolverine at Sunshine Road, having crossed the barrier from the road side to the habitat side**

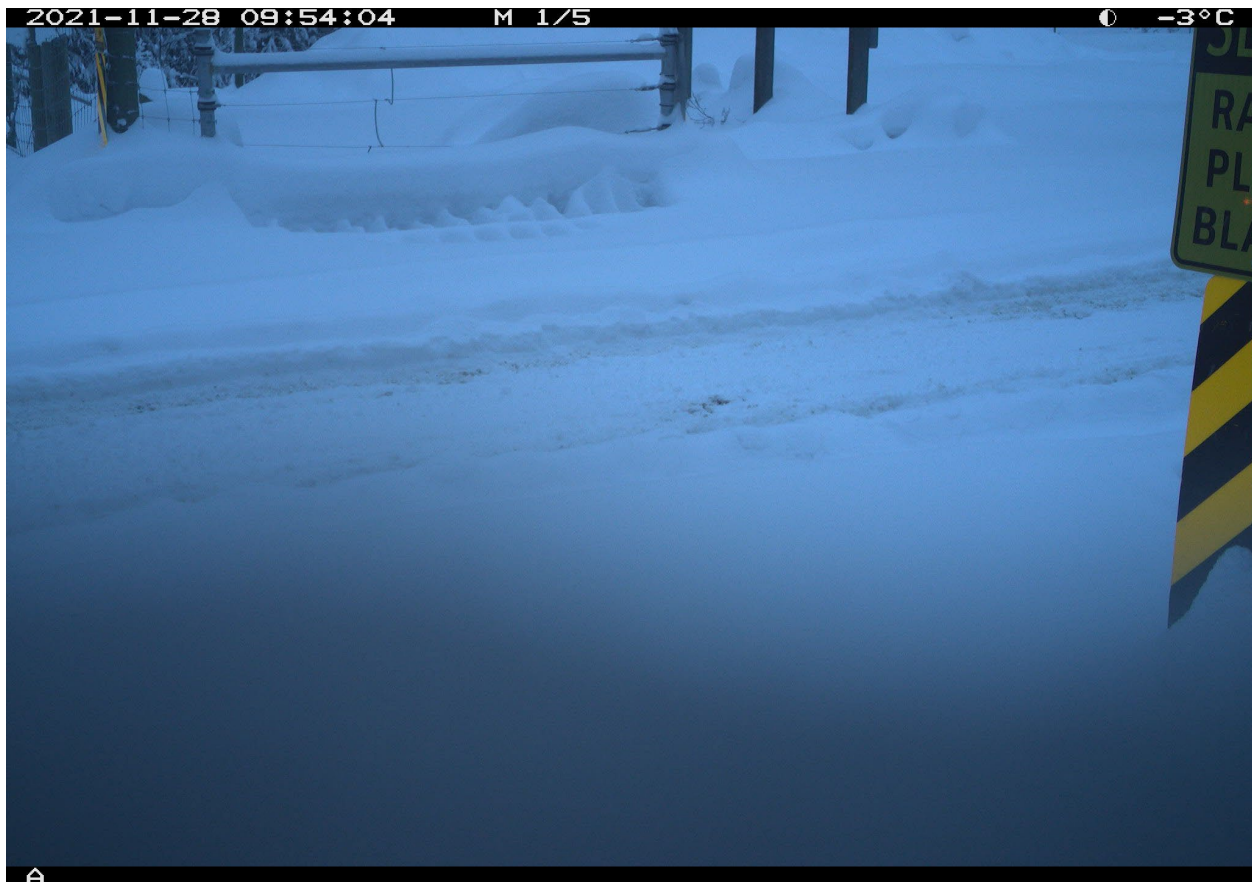
- Snowplows or front loaders carefully maneuvered at the barriers, clearing the snow as much as possible. This does require more time and skill compared to not having a barrier in place.
- Protective strips for the grounding plates and the insulators are important; snowplows can otherwise easily damage the grounding plate, insulators, or the individual bars. The protective strips seemed to hold up through the winter.
- Some of the barriers filled up with snow in winter, making them not functional, as expected (Figure 15).

**Figure 15: Snow fills up the barrier at Lake O'Hara Road, making it no longer a barrier to large wild mammals**

- Road salt was applied to some of the barriers to melt the snow and ice between the bars and under the bars.
- “The accumulation of snow, salt, gravel, etc. between the negative and positive charge cause it to short in winter and may cause voltage drop, or the guard can be completely covered by snow (Personal communication Dan Rafla, Parks Canada).
- During the winter, the wiring was not able to withstand the vibrations from vehicles and gravel/salt that fell between the pipes. The wiring had to be redone to a more robust standard (Personal communication Dan Rafla, Parks Canada).
- Some barriers were “washed” with a hose from a water truck after the winter.
- Keep a detailed log with dates and times of what the status of the barriers is (e.g. electricity on or off), and what the operation and maintenance issues are that may be encountered.
