EVALUATING CONCRETE BRIDGE DECK PERFORMANCE

FHWA/MT-06-006/8156-002

Final Report

prepared for
THE STATE OF MONTANA
DEPARTMENT OF TRANSPORTATION

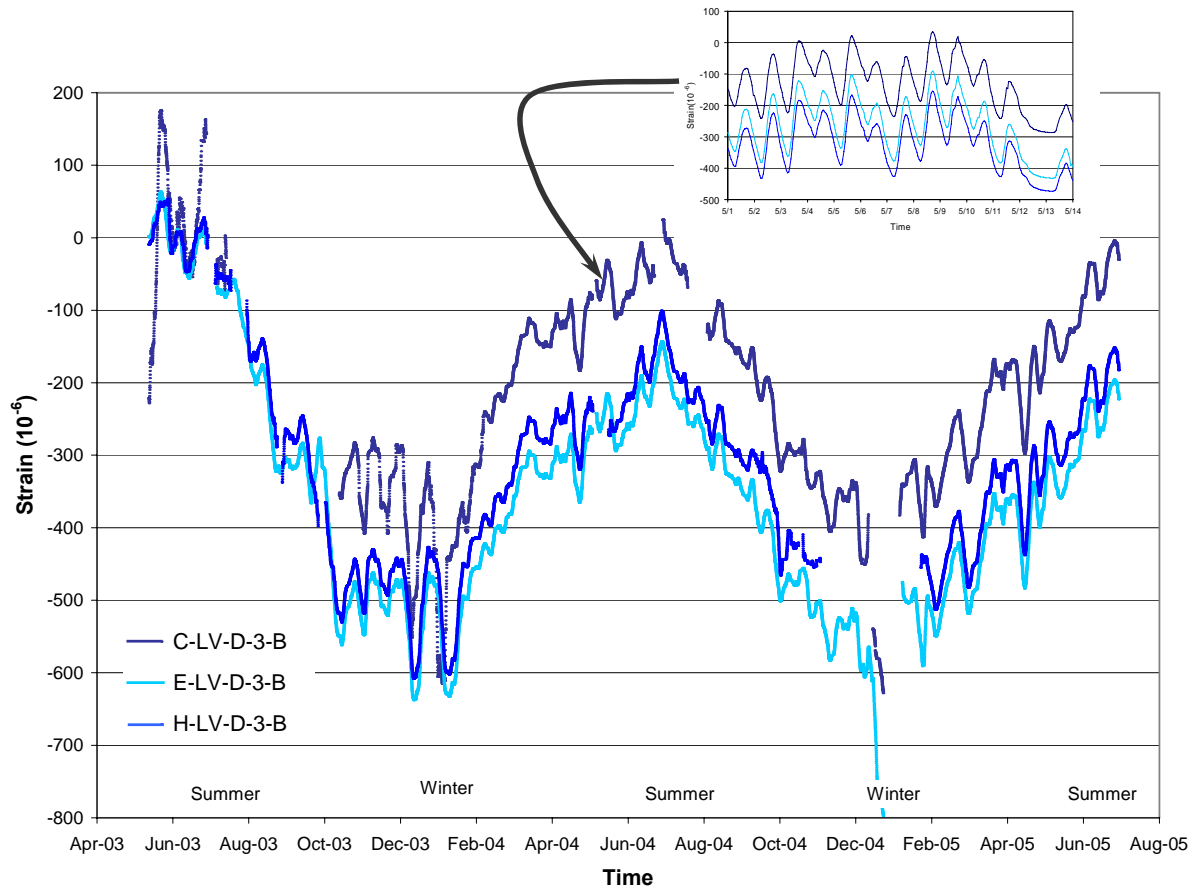
Figure 91: Strain History All Three Decks Longitudinal Gage Location LV-D-3-B (Smoothed)

The typical longitudinal strain response in the interior of the decks between the girders (specifically, at Gage Location LV-D-3-B) is shown in Figure 91. Once again, the diurnal cycles have been filtered out of the primary traces, so that the average response of the three decks is more readily apparent. As mentioned above, thermal movements in the decks in the longitudinal direction were expected to be influenced by their composite connection to the girders, the constraint offered by the integral abutments, and the conditions at the transverse cracks over the bents. These factors could easily vary between the decks, which would affect their relative strain response. In this case, referring to Figure 91, the overall response of all three bridges is very similar to that seen in the transverse direction (see Figure 90), consisting of diurnal temperature cycles superimposed on the strain changes associated with broader seasonal temperature changes, which are further superimposed on the fundamental drying shrinkage in the concrete. In this case, however, the lowest mean strains are observed in the Conventional deck (recall that in the transverse direction, the lowest mean strains were seen in the HPC deck). The mean strains in the Conventional deck furthermore were noticeably lower in magnitude than the longitudinal strains seen in this deck in the transverse direction. This reduction in strain level could result from a difference in the longitudinal restraint in this deck relative to situation in the Empirical and Conventional decks. Additional information presented below on the longitudinal response of the decks indicates that the transverse crack over the bents is structurally more severe in the Conventional deck relative to the HPC and Empirical decks. Thus, the presence of this crack could also be influencing the longitudinal response at this location in the Conventional deck.

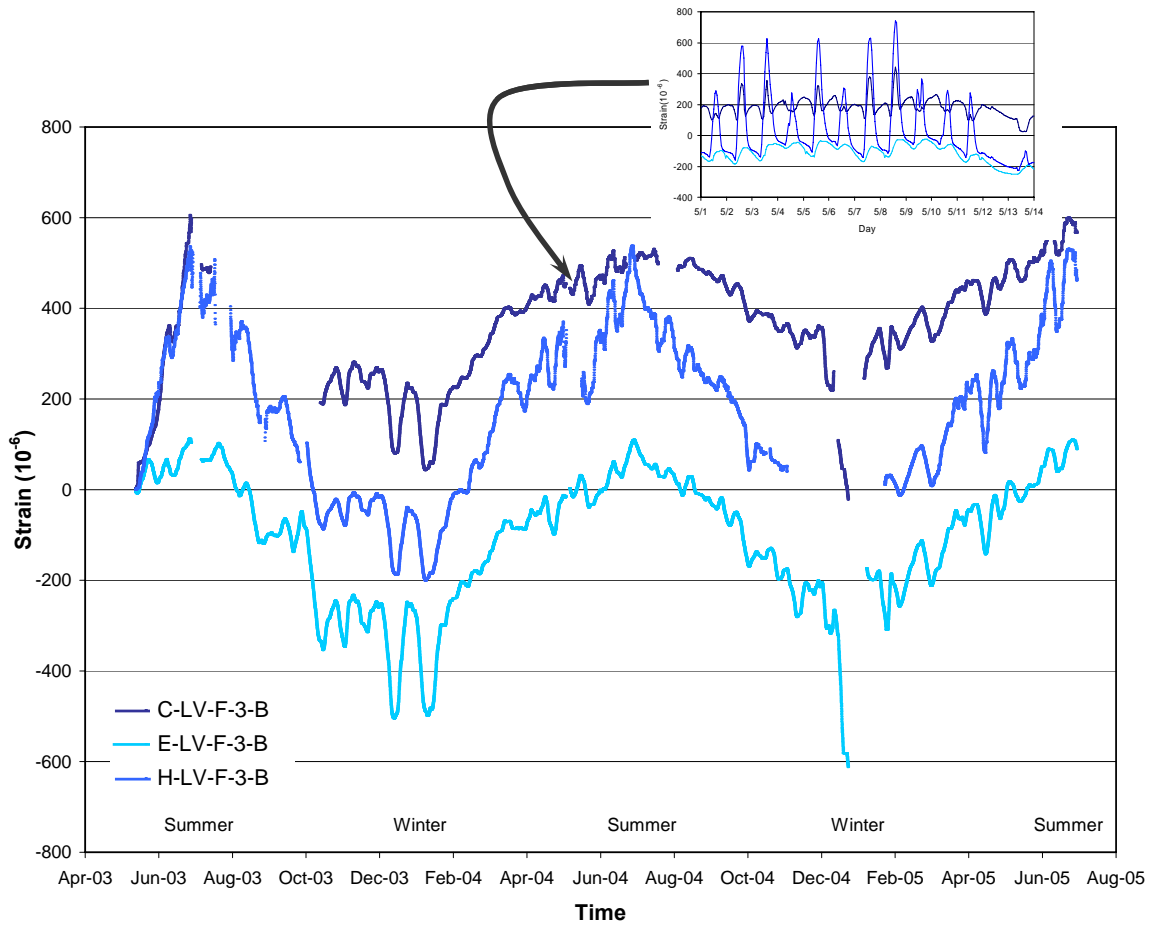
Figure 92: Strain History All Three Decks Longitudinal Gage Location LV-F-3-B (Smoothed)

Reported in Figure 92 is the longitudinal strain response at Gage Location LV-F-3-B. These gages are in the immediate area of the cracks in the decks over the bents, and as expected, their behavior is somewhat difficult to understand due the abrupt interruption in the structure that these cracks create. Despite the presence of the cracks, the decks generally shrank in the winter and expanded in the summer at this location. While early in the record the seasonal temperature variations were superimposed on an overall shrinkage in the decks, the magnitude of the mean shrinkage slowly decreased with time. In the case of the HPC deck, the mean response actually became expansive (tensile) in nature in the second year of the record. This gradual shift could be related to crack growth, and increasingly independent action of the two now separate deck slabs on either side of the bent. The diurnal strain response at the bents also differs between the bridges, as is evident in the inset in Figure 92. The strain cycles in the Conventional deck are out of phase with the cycles in the HPC and Empirical decks, which in turn are in phase with the temperature cycles. This behavior is consistent with the crack over the bent in the Conventional deck being more fully formed than those in the HPC and Empirical decks. The crack in the Conventional deck is functioning at a diurnal level as a joint, allowing the deck to expand and contract as two separate pieces on either side of the crack. While the diurnal cycles in the

Empirical and HPC decks are in phase (and in phase with the temperature cycles), the magnitude of the diurnal cycles in the Empirical deck are much smaller than in the HPC deck, which is indicative that the crack in the Empirical deck is more fully formed than that in the HPC deck.

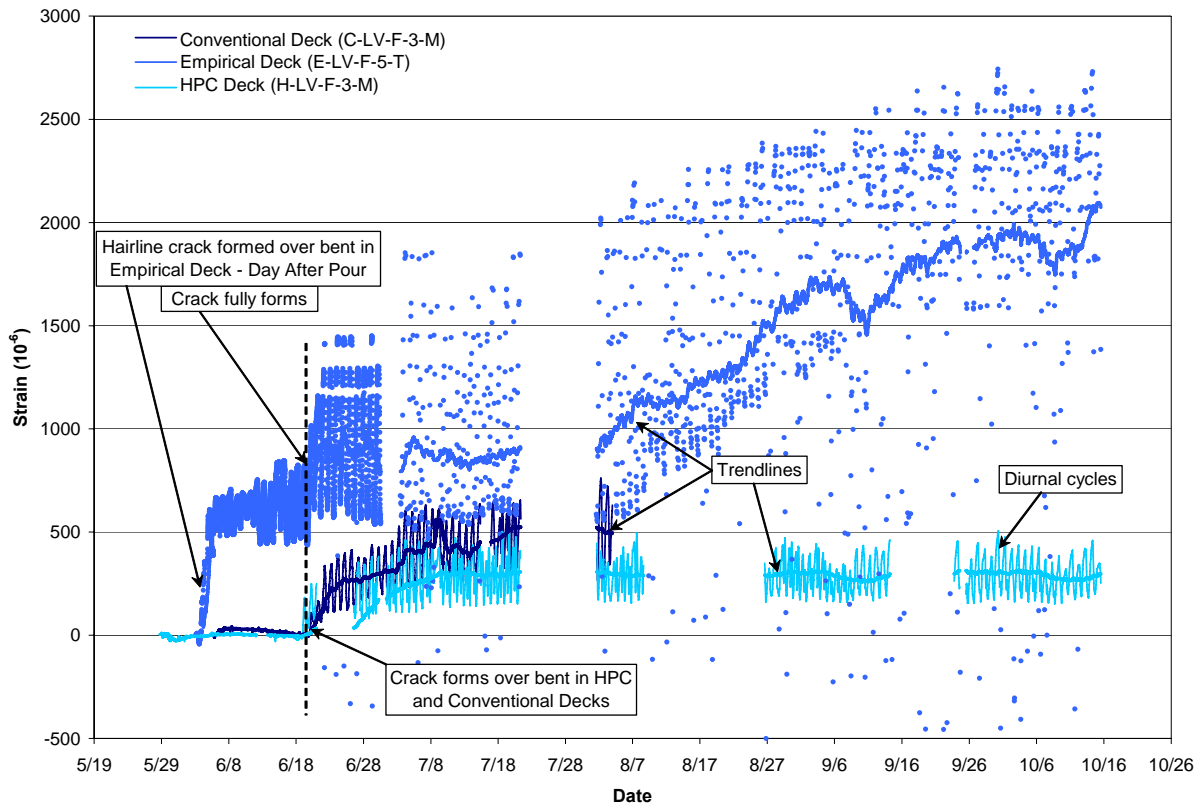
Figure 93: Long Term Data Showing the Formation of Cracks in All Three Decks.

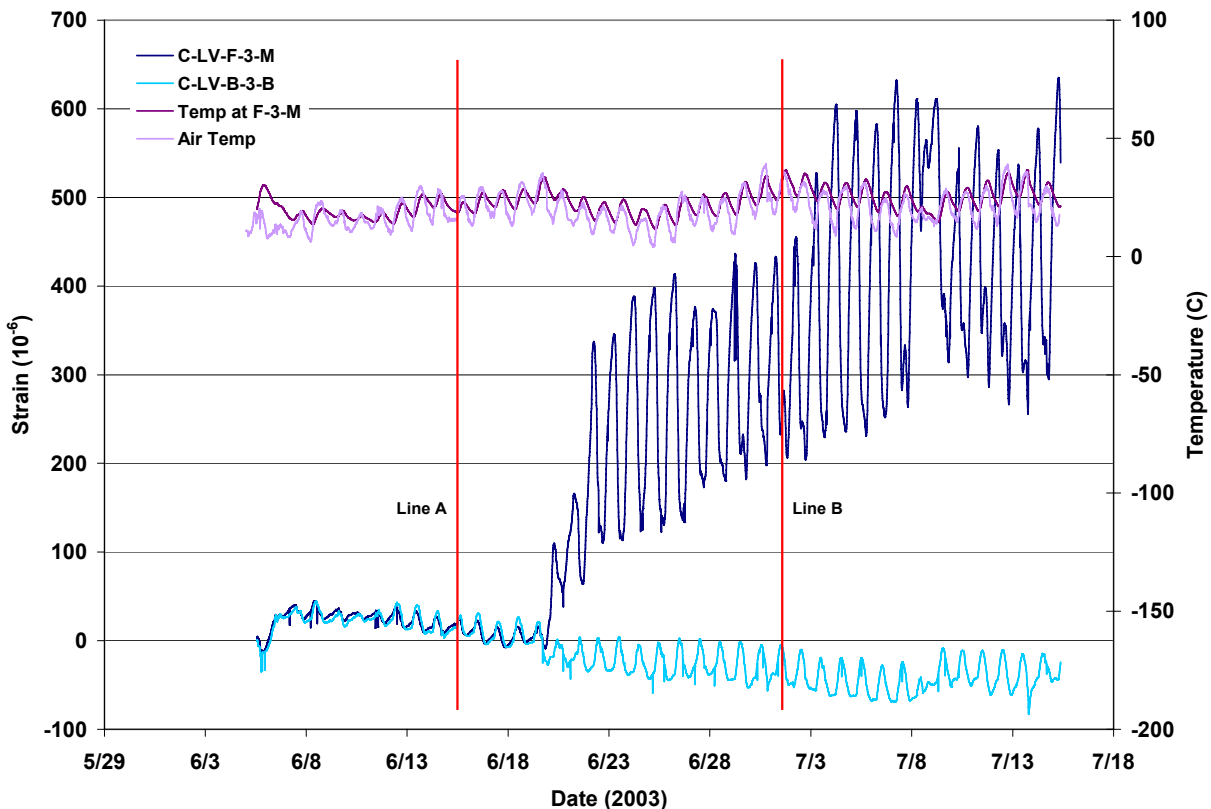
Figure 95: Comparison of Cracked and Non-cracked Position in the Conventional Deck.

The formation and presence of a crack can clearly be seen in the data from the Conventional deck presented in Figure 95. In this case, longitudinal strains collected over the interior bent (Gage Location F-3) and over the intermediate diaphragm (Gage Location B-3) are compared. Prior to cracking, strains in these two locations are almost identical, simultaneously fluctuating based on daily temperature oscillations. Notably, prior to crack formation, lower temperatures caused decreases in strain indicating thermal compression. Conversely, higher temperatures produced increases in strain (Line A, Figure 95).

On the evening of June 19th, strains over Bent #2 (Gage Location F-3) noticeably began to deviate from those at Gage Location B-3. This deviation is most certainly because a crack formed over the bent and intercepted the vibrating wire gage installed at that location. Following the formation of the crack at position F-3, two effects can be observed, 1) diurnal strain fluctuations increased in magnitude at the crack location, and 2) the mean level of strain at the crack location increased in magnitude and became tensile in nature due to deck concrete shrinkage on either side of the crack. First, daily changes in temperature produced higher strain values over the bent since the bridge deck concrete was essentially separated at that point. This separation caused contractive strains from each section of deck to be realized as increased strains across the crack. Therefore, what used to be decreasing strains over the bents before the crack occurred now became increasing strains. Moreover, the lowest temperatures during the day now produced the highest strains over the bents (Line B, Figure 95). Strains at Gage Location B-3, however, retained their original cyclic behavior.

Shrinkage of the deck concrete can also be observed using these same two locations. Average strain at both positions is decreasing slightly over time until the crack forms over the bent. At that time, the average strain at position B-3 continued to decrease, but average strain at position F-3 began to increase. In the body of the deck (B-3), the concrete shrank, placing the

gage in compression. Conversely, as the "slabs" on either side of the crack shrank, they drew away from the crack, placing the gage at the crack in tension. Possible reasons for the higher rate of increase of the mean strains at the bents (F-3) relative to the body of the slab (B-3) are that 1) strains across the crack represent a concentration of the shrinkage strain effects that are distributed across the adjacent "slabs", and/or 2) ratcheting of the crack is occurring as small concrete particles hold it increasing open after each cycle of expansion.

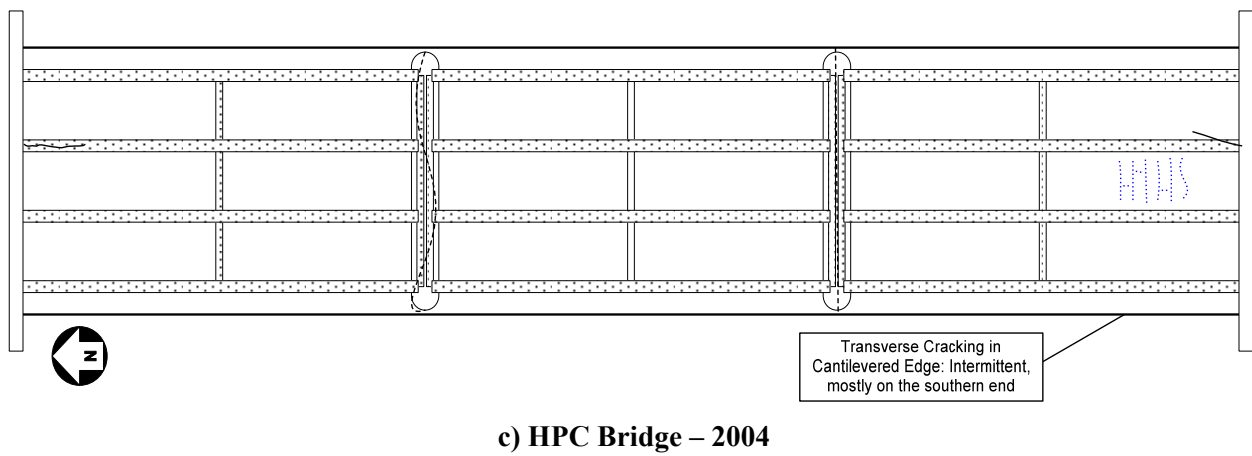
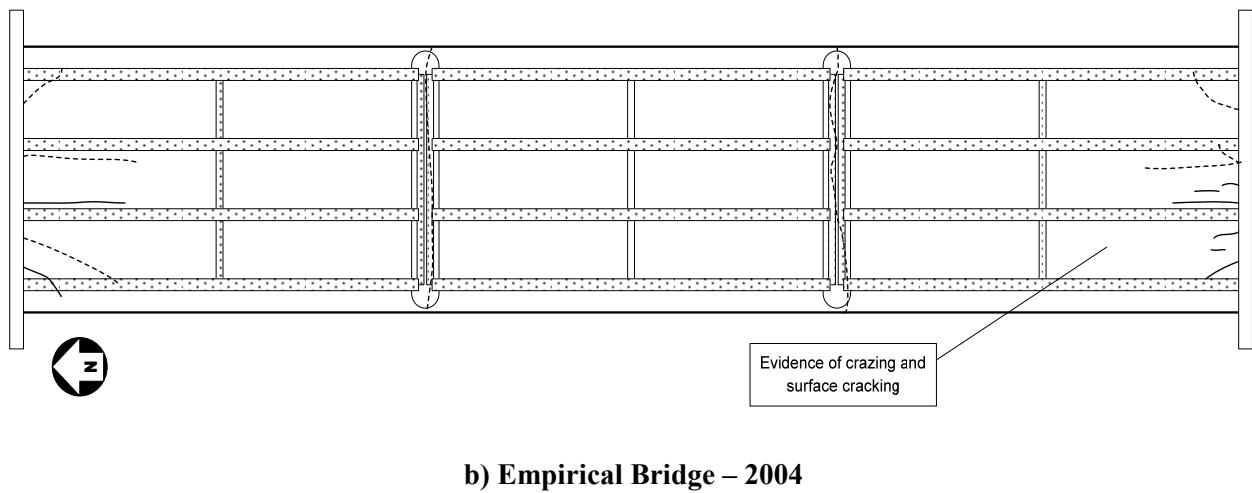
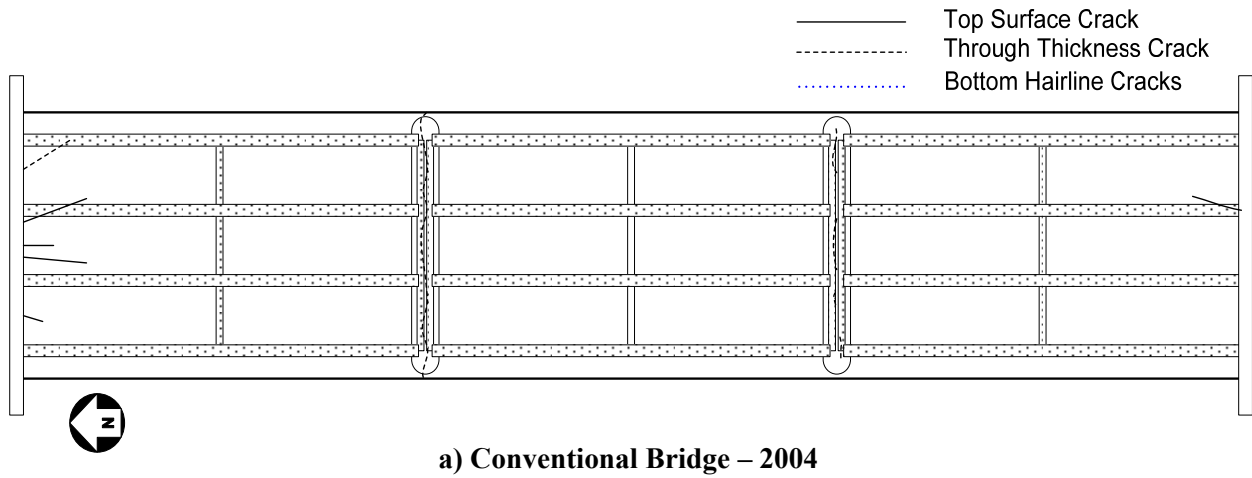
Figure 103: Distress Survey Maps of the Saco Bridges – 2004

Evidence of crazing and
surface cracking

Transverse Cracking in
Cantilevered Edge: Intermittent,
mostly on the southern end

Extensive surveys of the decks during site visits in July of 2004 and 2005 revealed top-surface and full-depth cracking near the bridge abutments. Top-surface cracks are those which are detectable from the top surface of the deck only, while full-depth cracks were detected and extended from both the top and bottom surfaces. In some cases, white precipitate had formed around cracks on the underside of the deck indicating that they were full-depth.   The Conventional deck had three sizable cracks on the north end, one of which was a full-depth crack. Only one top surface crack was detected near the south end. Many more top surface cracks were revealed during the visual distress survey conducted on the Conventional deck in 2005, most of which were small or hairline in nature. Throughout this evaluation the Empirical deck performed well, but showed more distress than the Conventional and HPC bridges. There were six sizeable, full-depth cracks and several smaller surface cracks on both ends of the Empirical deck in 2004. Fewer new cracks were revealed during the 2005 survey of the Empirical deck than in the Conventional and HPC decks. The HPC deck showed the least distress near the ends of the deck, having only one small crack on each end in 2004. Cracking near the north abutment had somewhat increased by summer 2005. Examples of top surface cracking near the northwest corners of each of the bridges are shown in Figures 108, 109 and 110. Note – cracks in most of the photographs were highlighted with a black marker to make them more visible.

Many of the cracks near the abutment radiate diagonally from the centerline of the bridges. This phenomenon is most prevalent in the Conventional and Empirical bridges, and was noticed early-on (March 2004) in the Empirical deck. Several of these diagonal cracks extend through the full depth of the concrete and, at times, into the abutment itself (Figures 111 and 112 for the Conventional and Empirical decks, respectively). A study conducted by Schmitt and Darwin (1995) concluded that bridges with integral abutments were approximately two to three times more likely to have these types of cracks near the abutment when compared to pin-end girders. This type of cracking often indicates inadequate design near the abutments which instigates flexural and drying shrinkage cracking.

Full-depth transverse cracking of the cantilevered edges (i.e., east and west overhangs) was first noticed in the HPC deck during the July 2004 site visit. These randomly spaced cracks were concentrated mostly on the southern end of the bridge and did not extend beyond the outer edge of the outside stringers. Edge cracking was not discovered in the Conventional and Empirical decks in 2004, but by July 2005, edge cracking was common in all three decks. The HPC and Conventional decks exhibited this type of cracking along both edges, while the Empirical deck only had a few cracks on the west edge and showed less edge cracking overall. Spacing of these cracks in the HPC deck is approximately 60 to 100 cm. Interestingly, edge cracking in all three decks was generally more pronounced on the east side of the deck when compared to the west. This phenomenon could be caused by differential solar heating effects in the two sides of the deck as the sun traverses the sky in the east-west direction relative to the north-south orientation of the decks.

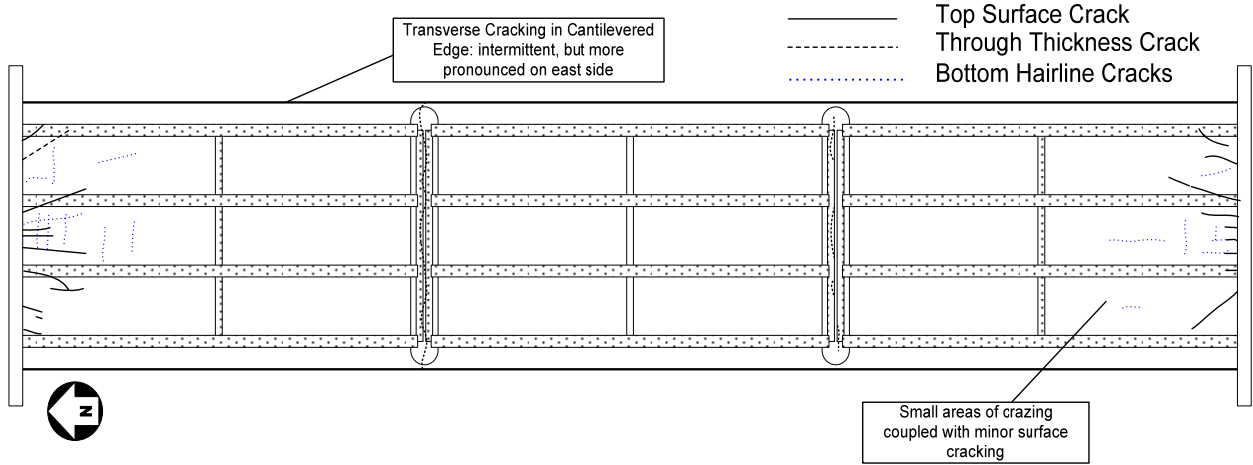
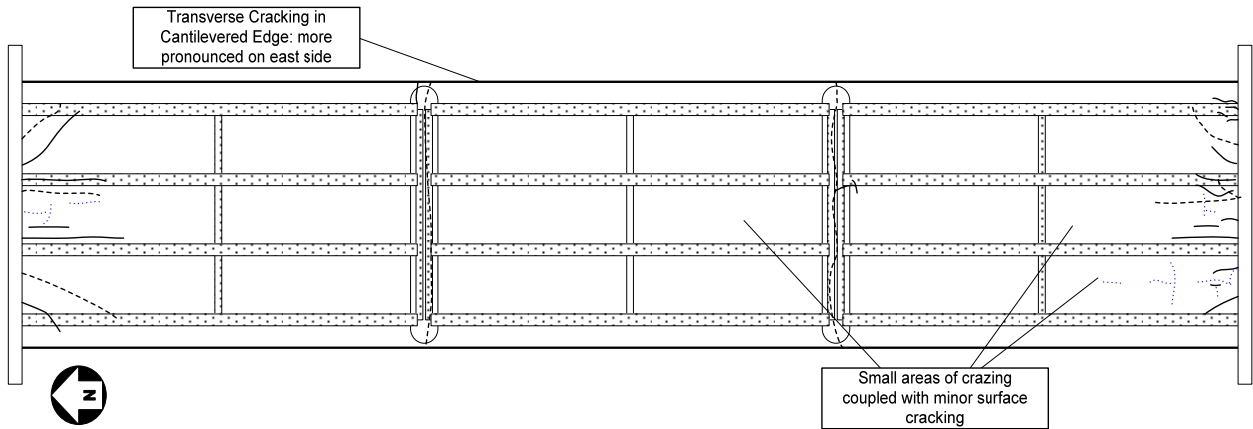
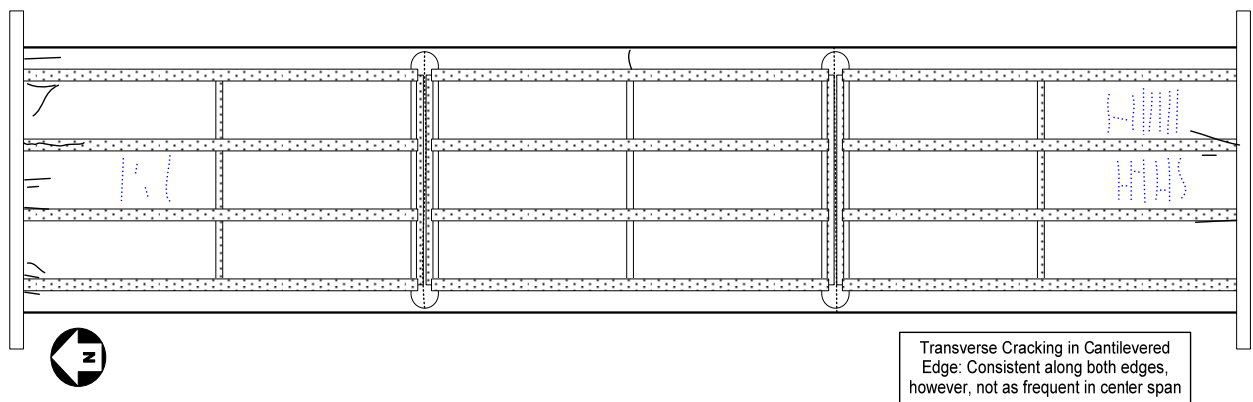
Figure 104: Distress Survey Maps of the Saco Bridges – 2005

Notable differences were seen in the strain response between bridges and between years at locations where the bridges experienced visible distress, that is, in the cracked zones near the abutments, and over the bents (corresponding to gage lines A and F). Typical longitudinal strains measured in the bottom of the decks in the 2005 live load tests near the abutment end of the span (location A-3, ST-T test) are presented in Figure 70. Unlike the strains reported in Figure 69 for the interior of the span (location D-3), the strains measured in the three decks at this location varied significantly in magnitude. The greatest strains were observed in the Conventional deck, with peak values of approximately -28 and 32 microstrain in compression and tension, respectively. Conversely, the peak compressive strains in the Empirical and Conventional decks were approximately 11 and 7 microstrain, respectively. This ordering of the strain magnitudes is consistent with the degree of local distress visually observed in each deck in 2005. That is, the Conventional deck had a pronounced diagonal crack in the top surface at gage location A-3 (see Figure 104a). The Empirical deck experienced less severe but more numerous cracks then the Conventional deck at gage location A-3 (see Figure 104b). Finally, the HPC deck was uncracked in and around location A-3 (see Figure 104c).

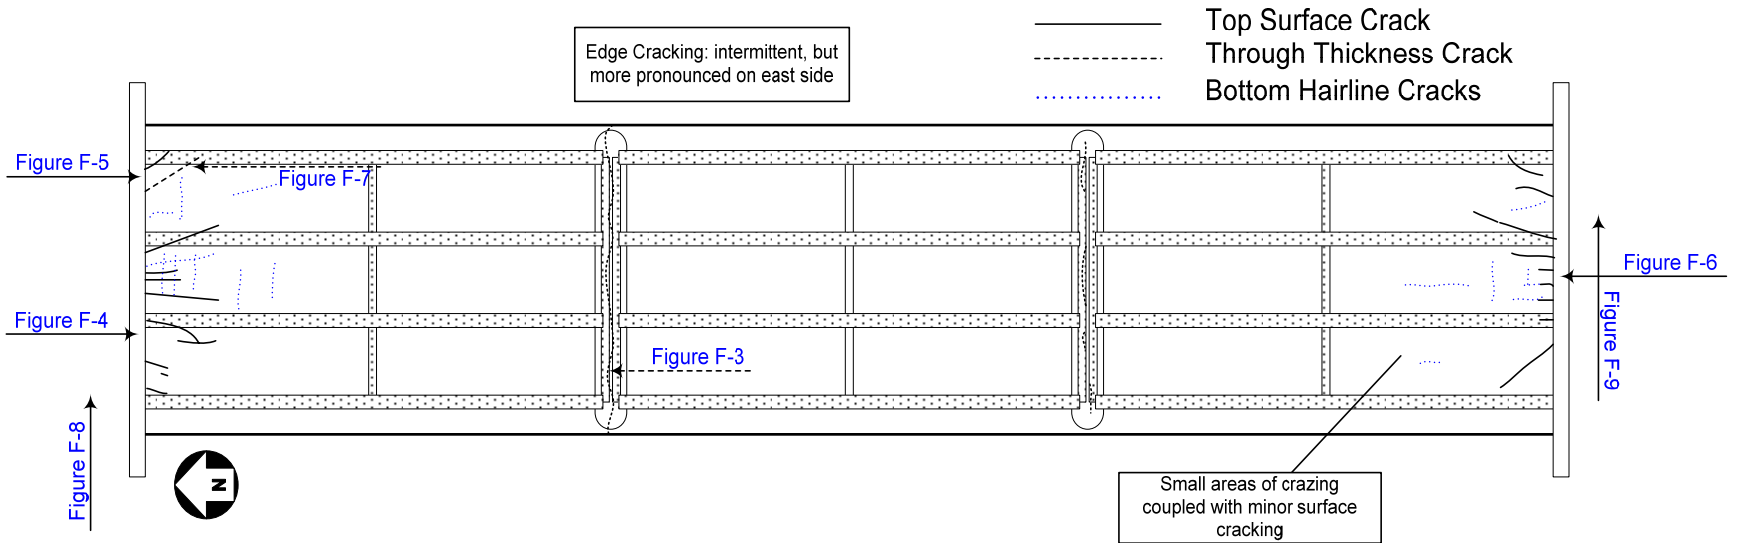
coupled with minor surface
cracking

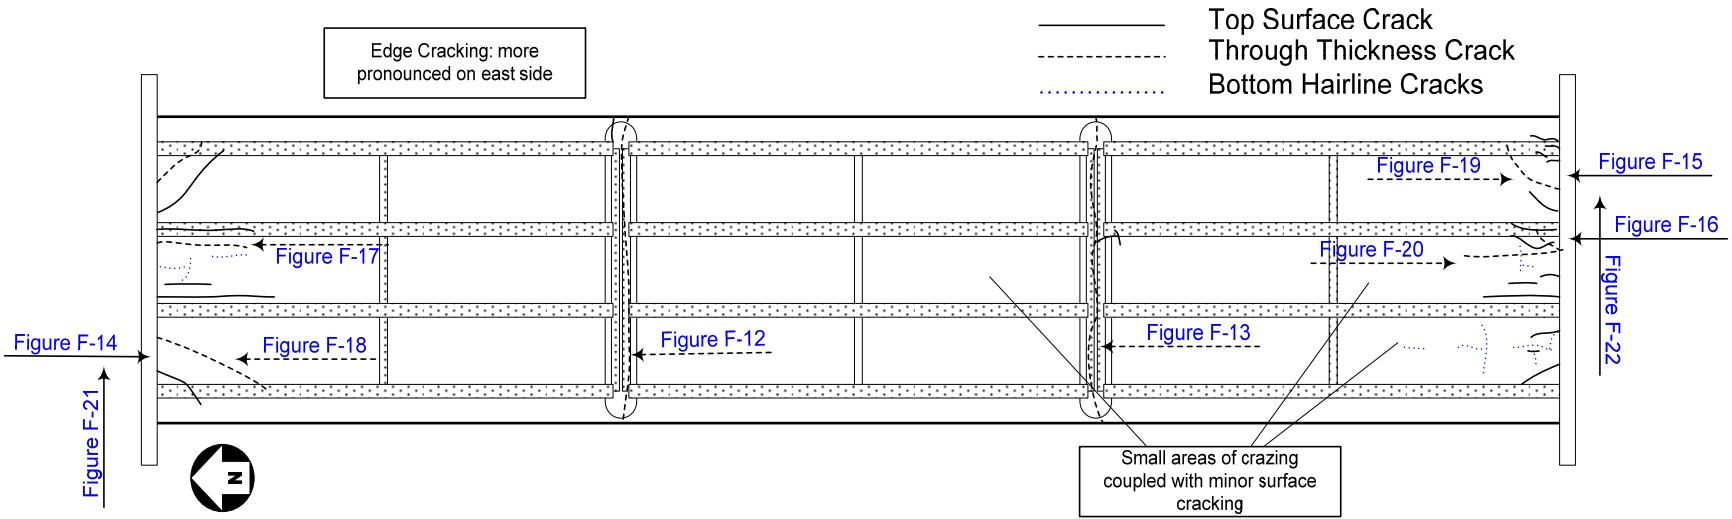
Small areas of crazing coupled with minor surface cracking
