Culvert Data Collection Guide

Civil Engineering Department

Montana State University

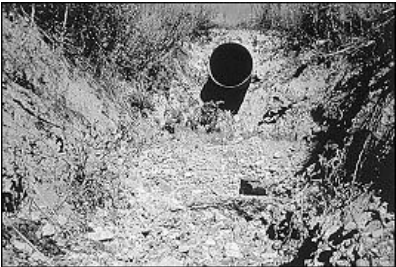
| 26 | Perched Outlet | Determine if invert of outlet lies notably above downstream channel <i>(YES or NO)</i> | Perched outlets inhibit fish passage and also contribute to scour effects. Example photo of extreme case: |
