Rehabilitation Techniques for Stripped Asphalt Pavements

Final Report

Stripped Asphalt Final Report

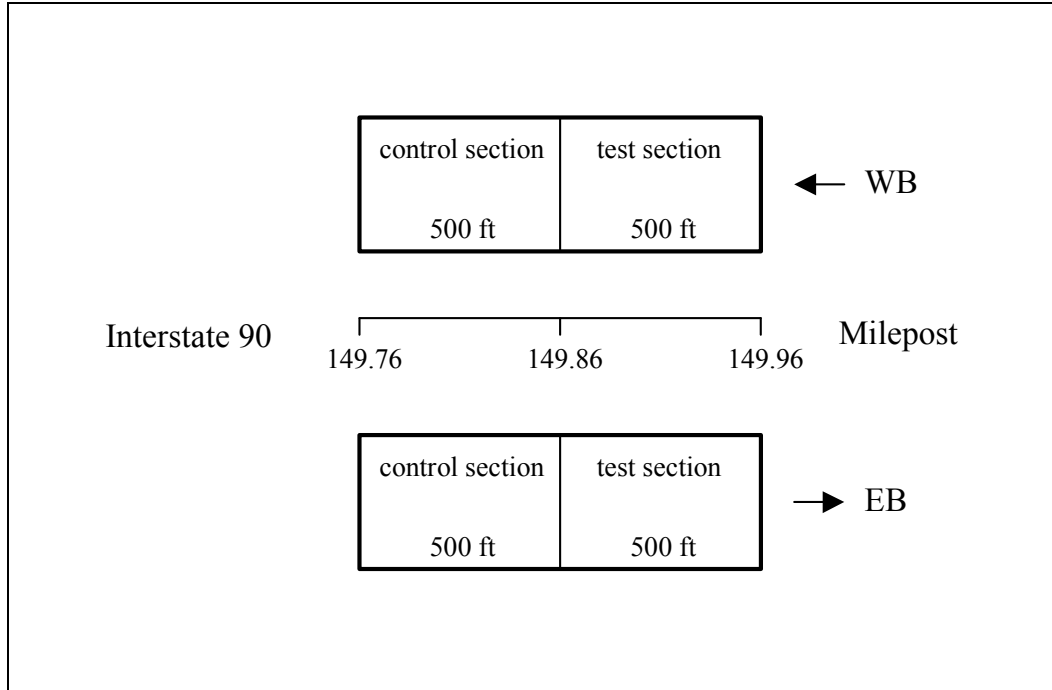
The Bearmouth-Drummond test site is located on Interstate 90 in Granite County, just west of Drummond, Montana. The site includes both a control and a test section in each of the eastbound and westbound lanes, as shown in Figure 2. Each control section is west of each test section. Each control section is 500 feet long, starting at milepost 149.76 (STA 842+81.9) and ending at milepost 149.86 (STA 847+81.9). Each test section is also 500 feet long, starting at milepost 149.86 (STA 847+81.9) and ending at milepost 149.96 (STA 852+81.9). A one-inch diameter steel rod was placed at the beginning and end of the control and test sections on the north side of the westbound lane, along the right-of-way fence.

Figure 2. Layout of the Test Site at Bearmouth-Drummond

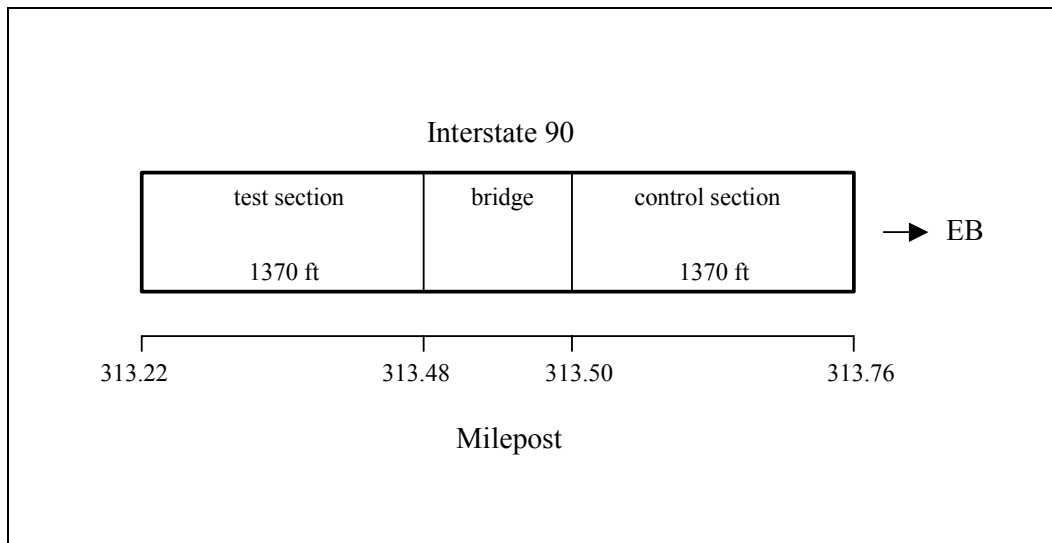
The Rocky Canyon test site is located on Interstate 90 in Gallatin County, just east of Bozeman, Montana. Both the control and test sections are in the eastbound lane, separated by the bridge at the Bear Canyon Interchange (Figure 3). The test section is west of the bridge, while the control section is east of the bridge. The test section is 1370 feet long, starting at milepost 313.22 (STA 218+77.3) and ending at milepost 313.48 (STA 232+47.7). The control section is also 1370 feet long, starting at milepost 313.50 (STA 233+60.7) and ending at milepost 313.76 (STA 247+30.7). A one-inch diameter steel rod was placed at the beginning and end of the control and test sections on the south side of the eastbound lane, along the right-of-way fence.

Figure 3. Layout of the Test Site at Rocky Canyon

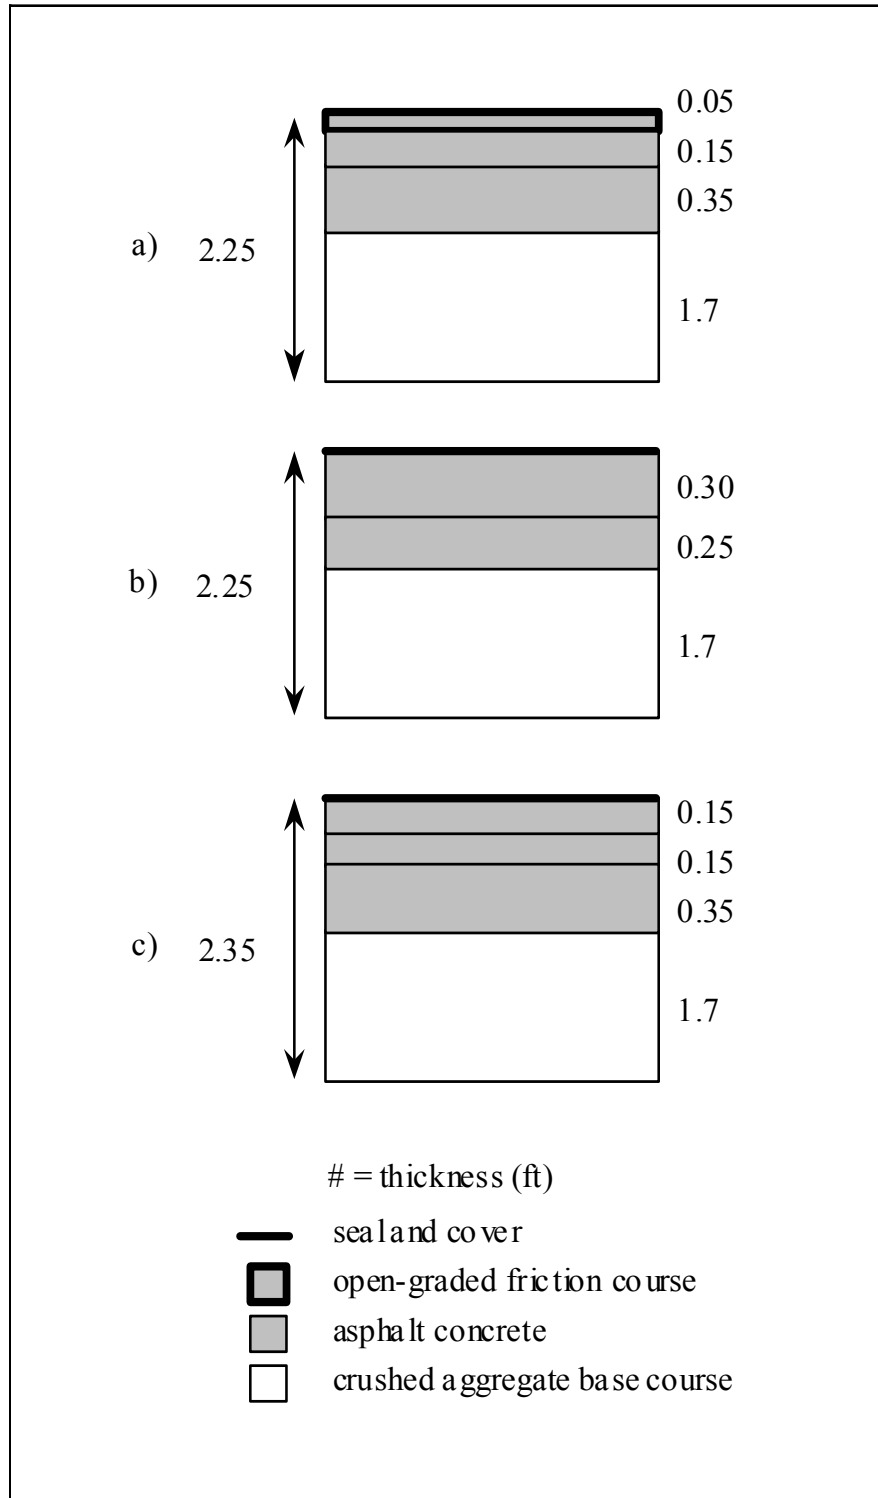
Figure 7. Pavement Cross-Sections at Bearmouth-Drummond:
a) original pavement, b) control section, and c) test section

The control section at Bearmouth-Drummond did not involve an increase in pavement thickness above subgrade, relative to the original pavement structure (Figure 7). The MDT design personnel did not feel an increase in structural capacity was necessary at this site. The final thickness of the control section at Rocky Canyon was the same as the original structure, but the structural capacity was increased through stabilization (Figure 8). The control sections at Lincoln Road-Sieben, Custer County Line West, and Tarkio-East involved increases in thickness above subgrade of 0.5, 5, and 2 inches, respectively (see Table 8 and Figures 9, 10, and 11).

The structural capacities of the test sections at all sites were increased relative to the original pavement structures. Milling was only deep enough to remove the OGFC, so all overlay lift thicknesses were greater than the depth of removed material. Increases in total thickness above subgrade for the test sections ranged from 1 to 4 inches, as shown in Table 8 and Figures 7 through 11.

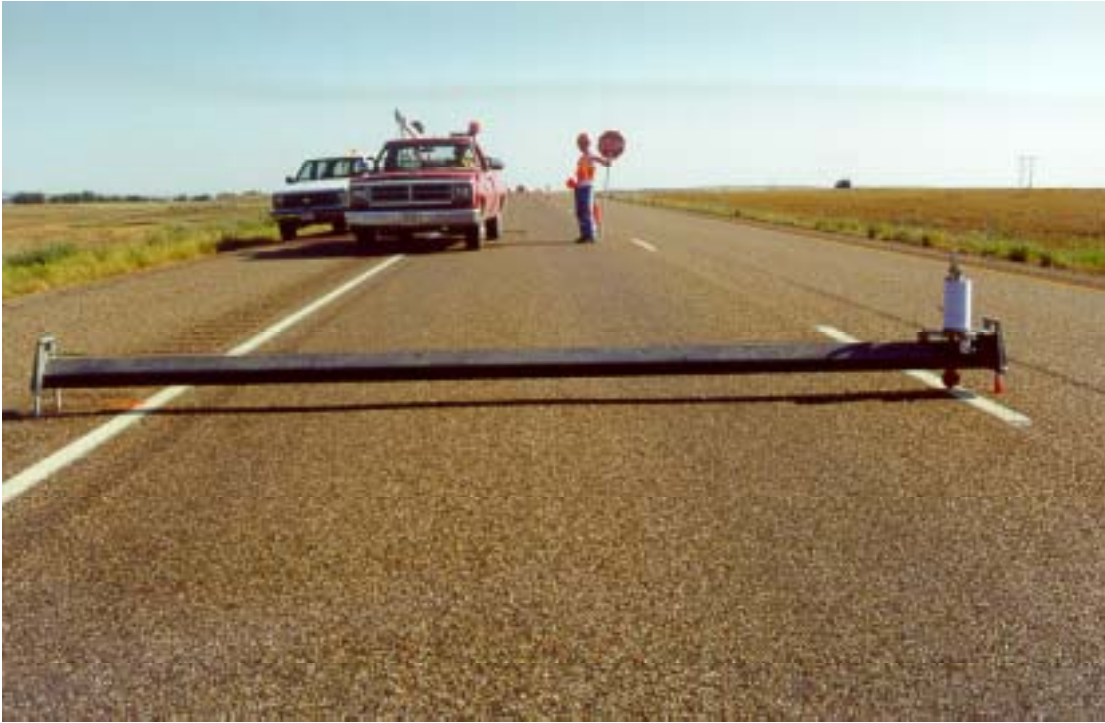
During the last two years of roughness and rut depth monitoring (1999 and 2000), the Rainhart Profilograph was used to measure rut depth because it had demonstrated the ability to supply accurate and reliable data during other recent MDT research studies. The Rainhart Profilograph differs fundamentally from the South Dakota Profilometer because it measures ruts by purely mechanical means. This profilograph consists of a rigid beam, which is supported above the pavement surface by rigid legs. Typically, the beam is positioned transverse to a roadway lane (Figure 13). Upon the beam rests a barrel to which a pen and lined graph paper are attached. As the barrel is moved across the beam, a wheel that rides on the pavement surface transcribes changes in elevation on the paper (Figure 14). The profilograph is placed at discrete locations along the pavement and the surface elevation measurement wheel is moved from one side of a lane to the other. For this research, the wheel was first moved from the shoulder to the centerline. The marking pen was then moved slightly and a second profile of the same station was made from the centerline to the shoulder. Scaling ratios were set so that surface roughness was drawn with a 1:12 ratio (paper:pavement) horizontally and a 1:1 ratio vertically.

Figure 13. Rainhart Profilograph

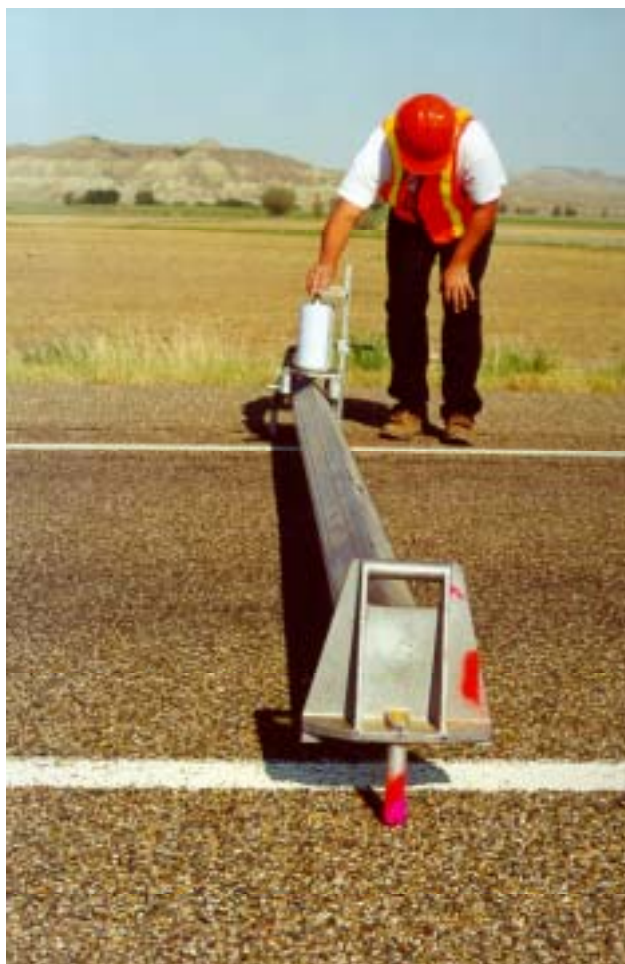
Figure 14. Moving the Rut-Transcribing Mechanism Across the Rainhart Profilograph

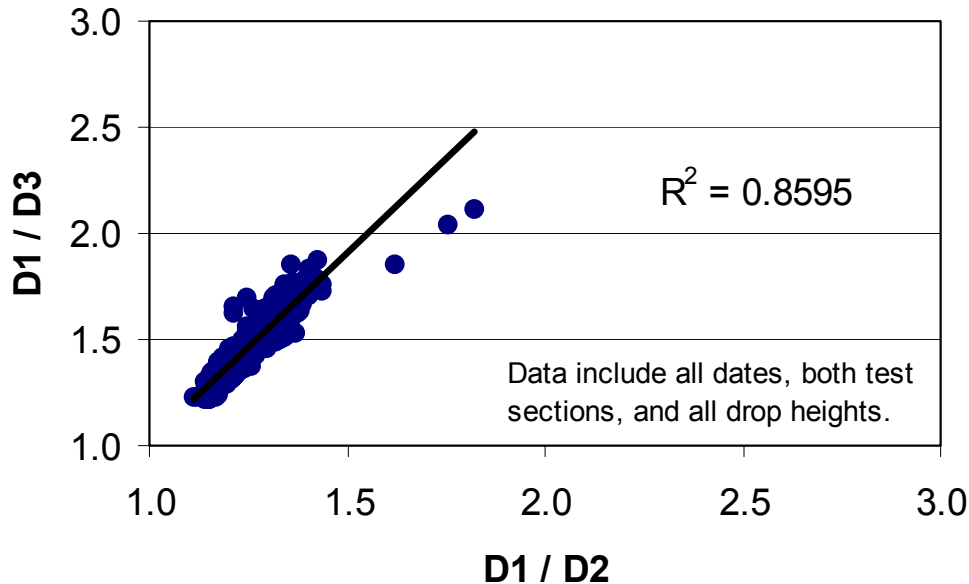
The Lincoln Road data was used to develop a routine of data analyses. Only one of the basin curvature parameters was found to be necessary because they were highly correlated with a Pearson correlation coefficient equal to 0.927 (see Figure 15). The D1/D3 parameter was chosen because its use is popular and well documented (e.g. Rohde 1990). Further references to basin curvature will imply the D1/D3 parameter.

Figure 15. Correlation of Basin Curvature Parameters for Lincoln Road-Sieben Site

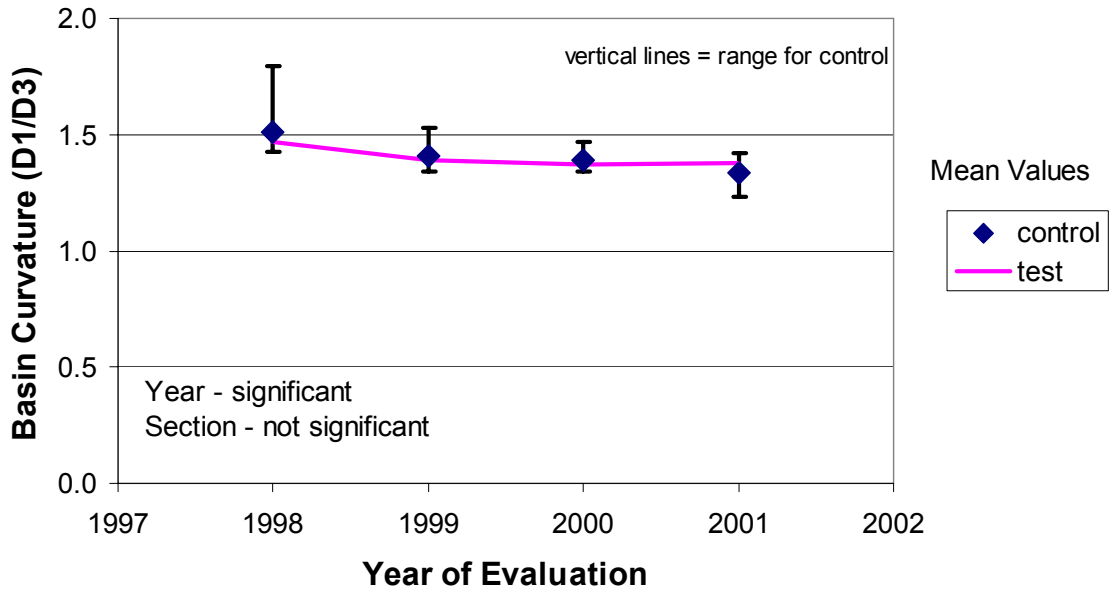
Figure 22. Basin Curvature at Bearmouth Drummond, Westbound Lane

Similarly, basin curvature generally changed significantly over time. In most cases, the trend was toward increasing pavement stiffness (see Figures 22 through 27). Custer County was the only test site where curvature increased over time, indicating a weakening of near-surface pavement layers (see Figure 26). This weakening was consistent with ISM results. Differences between control and test sections were not significant.

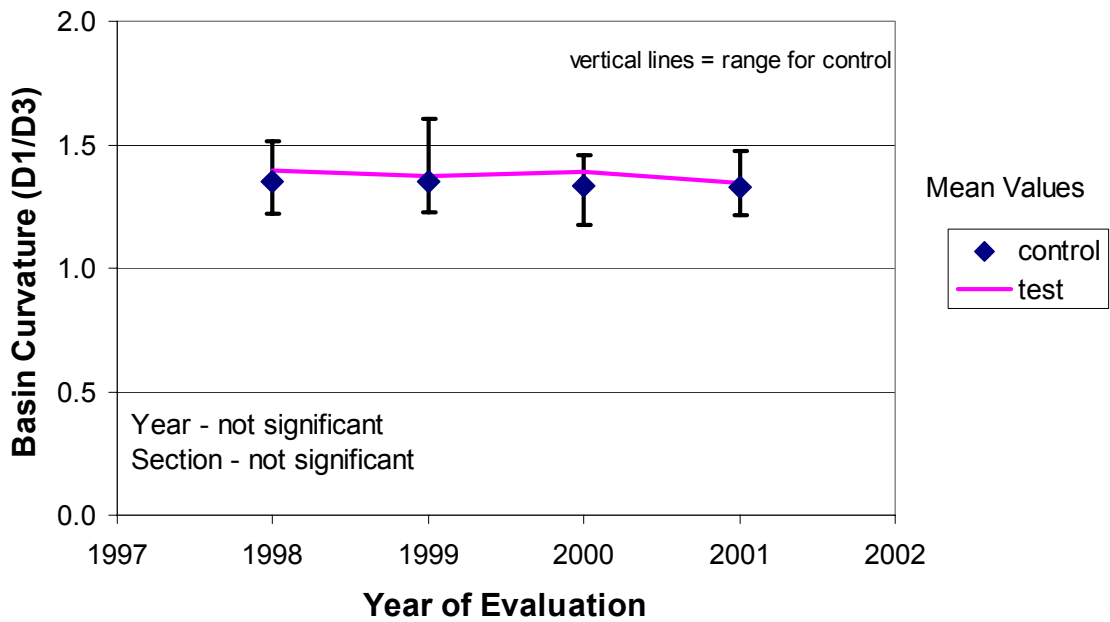
Figure 24. Basin Curvature at Rocky Canyon

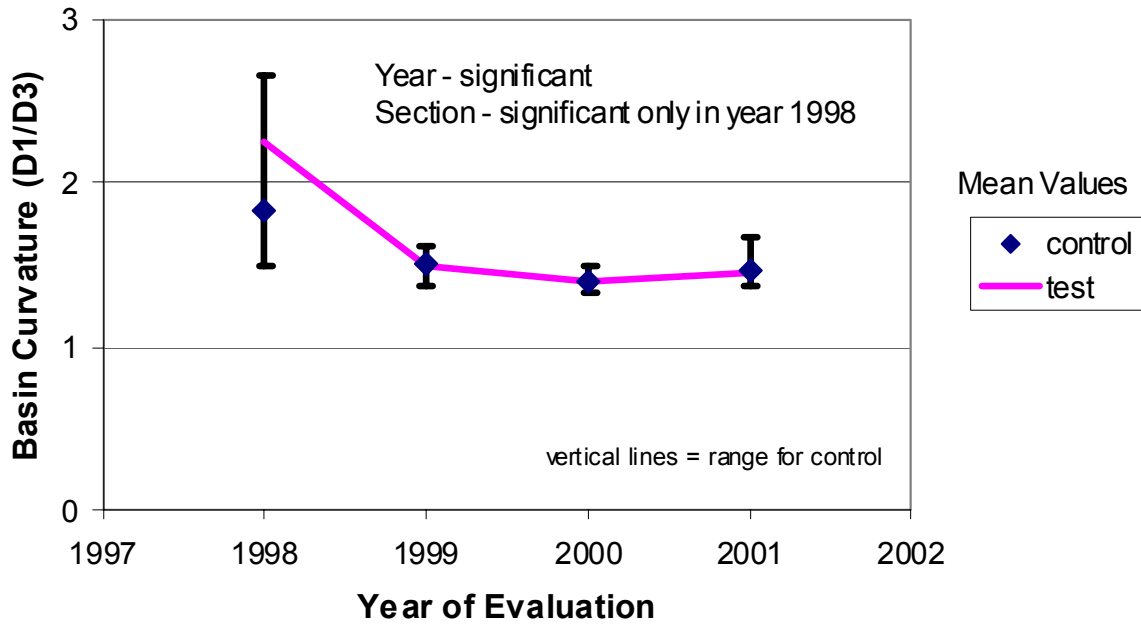
Figure 28. Basin Curvature at Traffic Edge

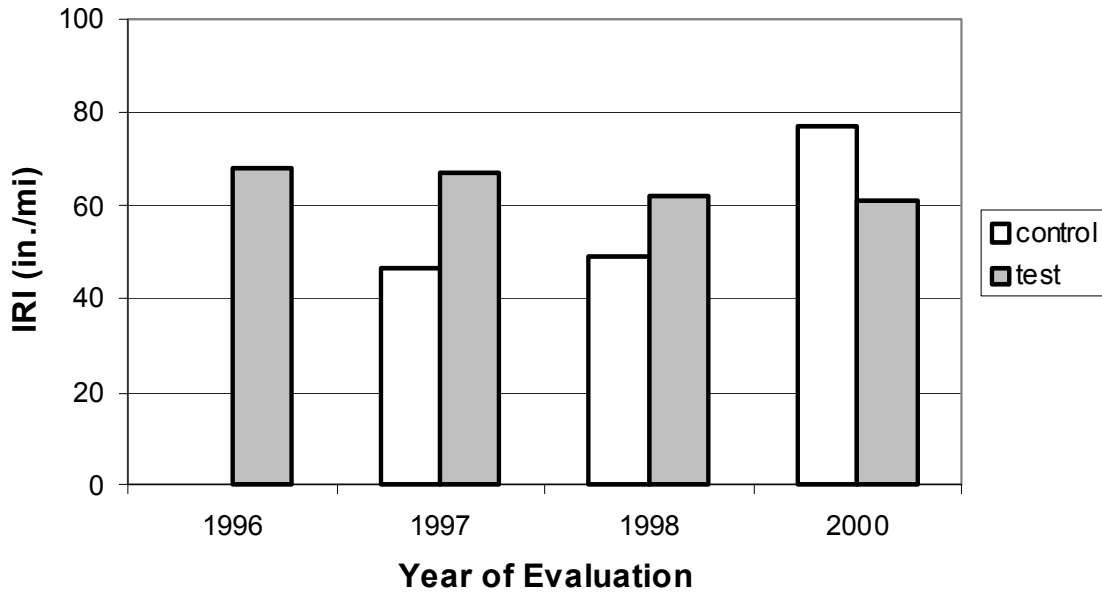
Figure 29. International Roughness Index at Bearmouth Drummond, Eastbound Lane

The experimental pavement sections began their service with roughness values (IRI) of approximately 40 to 100 inches per mile (see Figures 28 through 33 and Appendix D), which correspond to MDT qualitative rankings of good to fair (see Table 9). The IRI, soon after construction, were similar for the control and test sections at Rocky Canyon, Lincoln Road-Sieben, and Custer County Line West (see Figures 30 through 32). The IRI for these sites generally increased with time, slightly more so for the test sections than the control sections. At Bearmouth-Drummond (Westbound) and Tarkio-East, the IRI were higher for the test sections than for the control sections on all evaluation dates (see Figures 28 and 33). At Bearmouth-Drummond (Eastbound), the test section had a higher IRI in 1997, but by 2000 the control section had a higher IRI (see Figure 29).

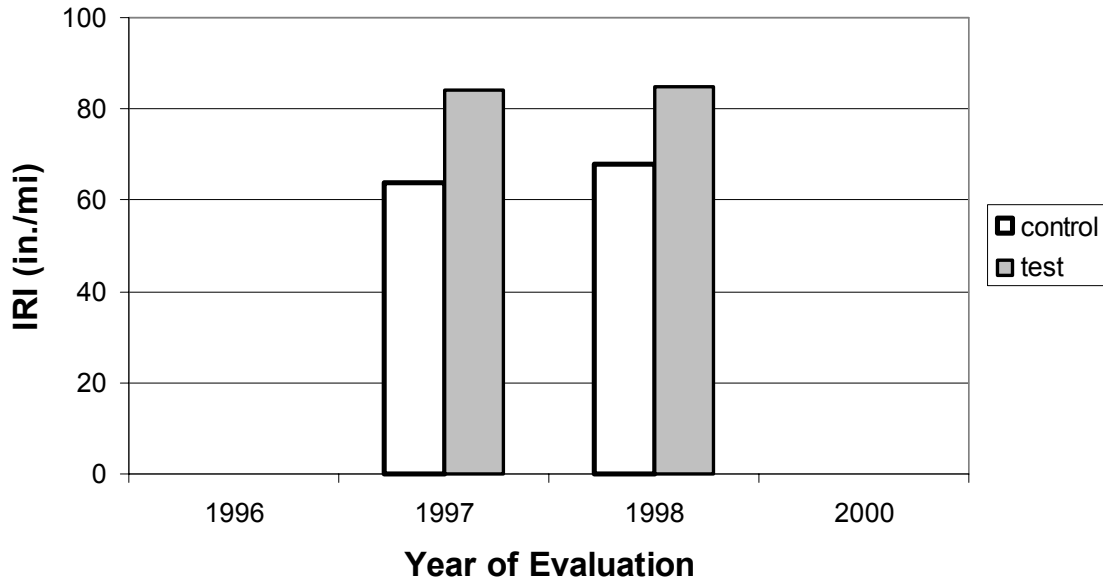
Figure 33. International Roughness Index at Tarkio East

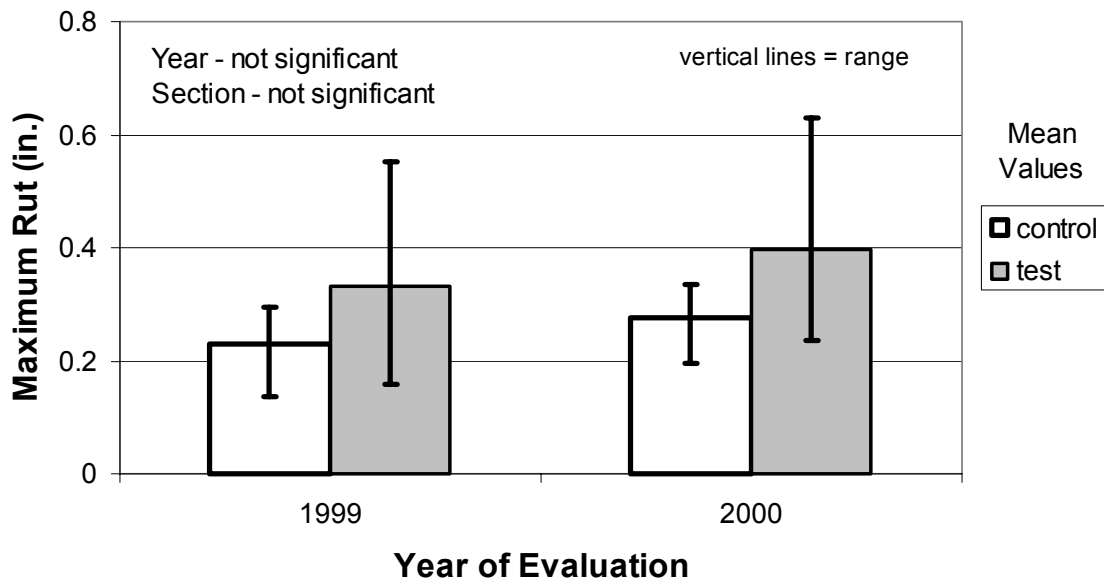
Figure 35. Rutting (Rainhart Profilograph) at Bearmouth Drummond, Eastbound Lane

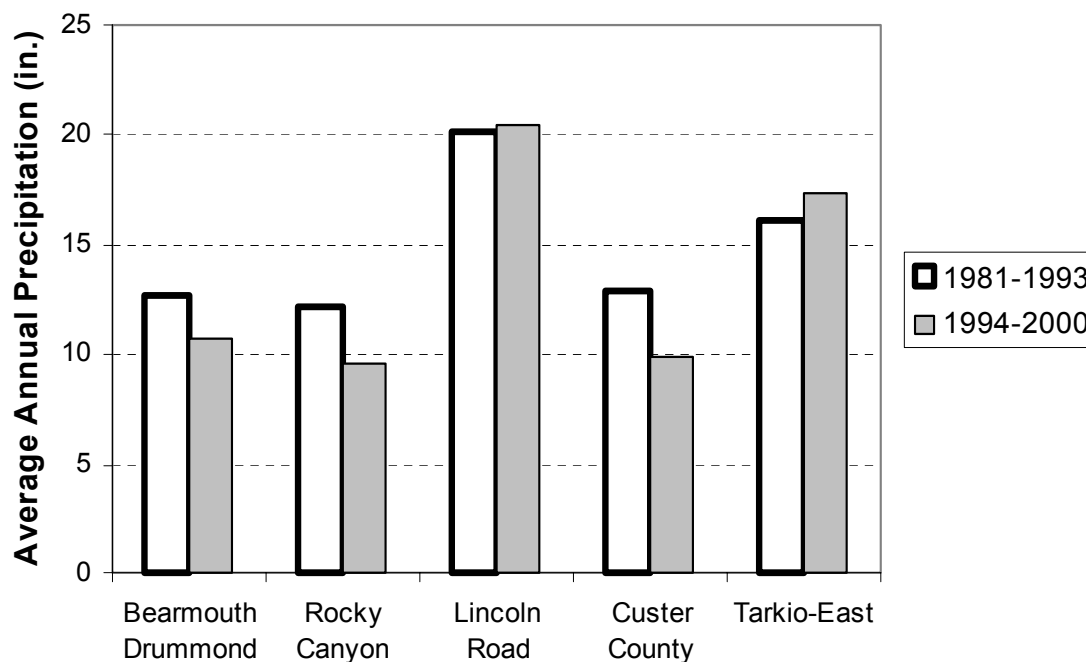
Figure 43. Average Annual Precipitation Near Test Sites During the Experiment

Therefore, it would appear that lack of normal moisture should not have skewed the research results at Tarkio or Lincoln Road. However, lower-than-normal rainfall is a factor that should be taken under consideration when analyzing the results for Bearmouth Drummond, Rocky Canyon, and Custer County. In summary, it does not appear that the reduced precipitation in Montana in recent years should have a substantial effect on this asphalt stripping experiment.
