USE OF HIGHWAY CROSSING STRUCTURES BY KIT FOXES

PREPARED FOR THE CALIFORNIA DEPARTMENT OF TRANSPORTATION

August 2007

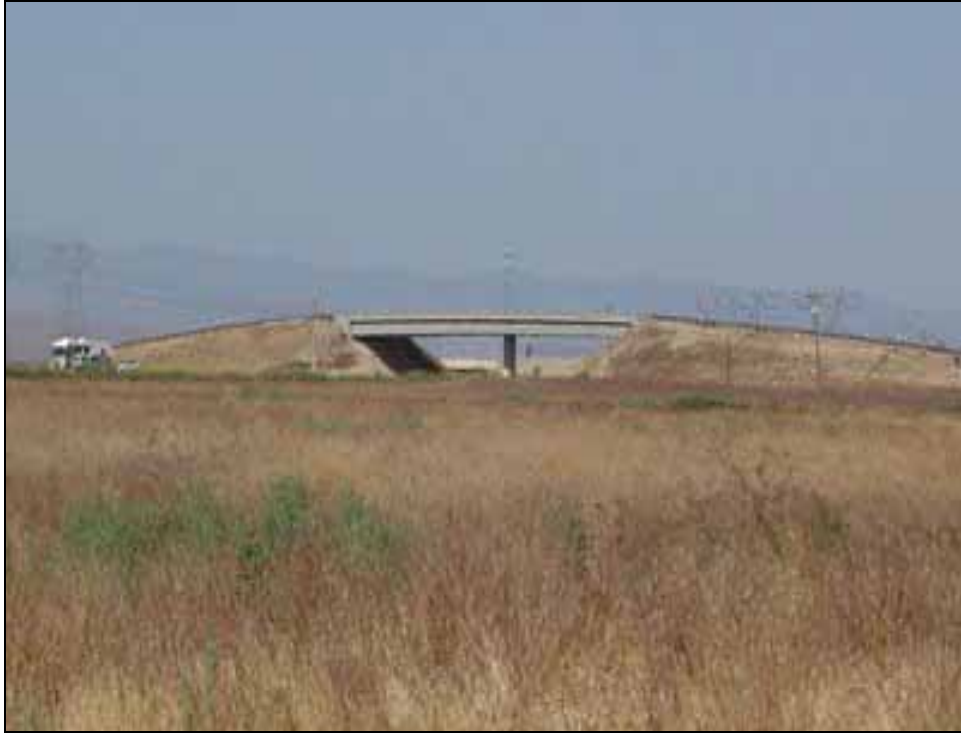
Figure 5. Two-lane overpass crossing structure over Interstate 5.

Crossing structures at the I-5 site included two overpasses and six culvert underpasses (Figure 5 and Figure 6). Specifications of the six culverts are shown in Table 1. All culverts on this stretch of I-5 had a median break. No median barrier was present at this study site. Culverts were extremely overgrown at the start of the study period (Figure 7 and Figure 8). Entrances were often difficult to locate until extensive vegetation clearance was undertaken. In several cases, the original dimensions of the culvert had been considerably reduced due to soil build-up within the culvert (Figure 9).

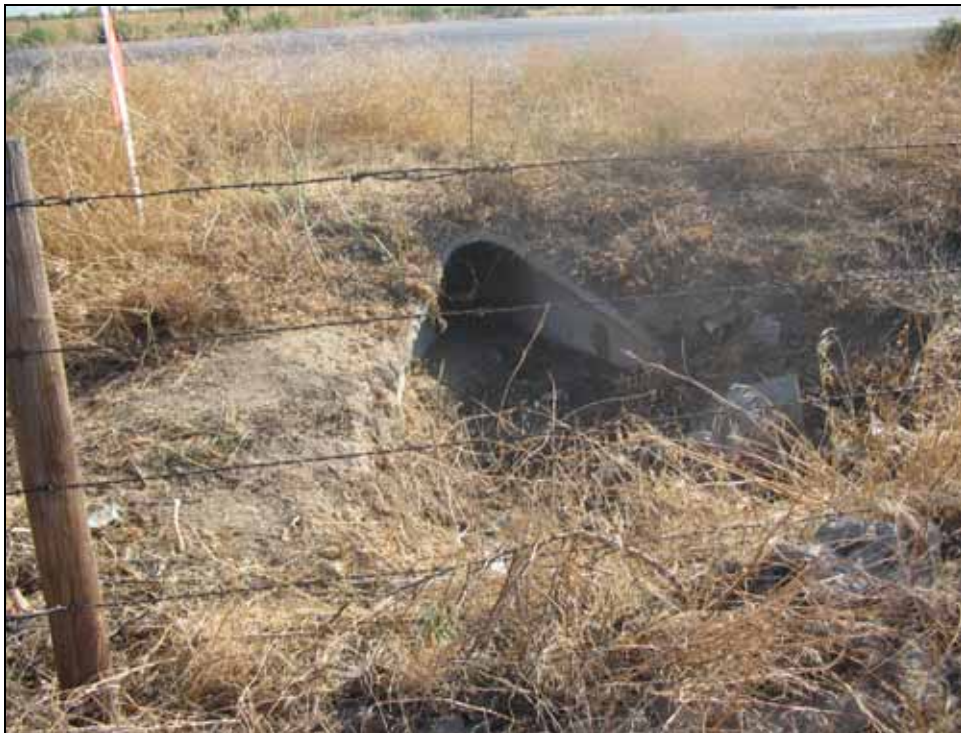
Figure 6. Example of a concrete circular culvert under Interstate 5.

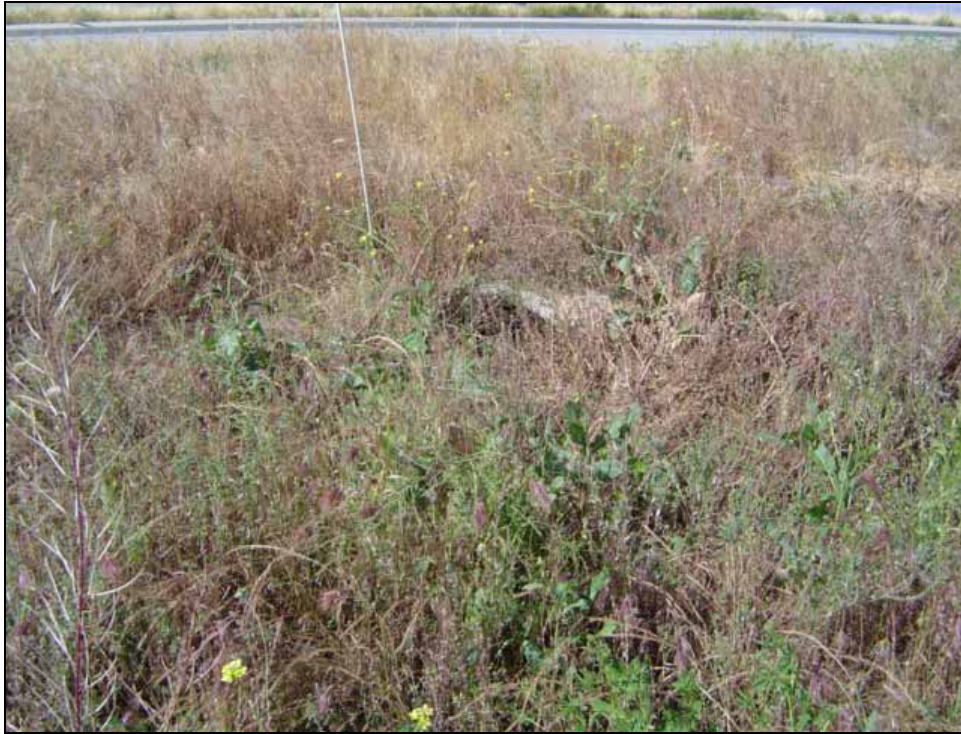
Figure 7. Example of an overgrown culvert under Interstate 5.

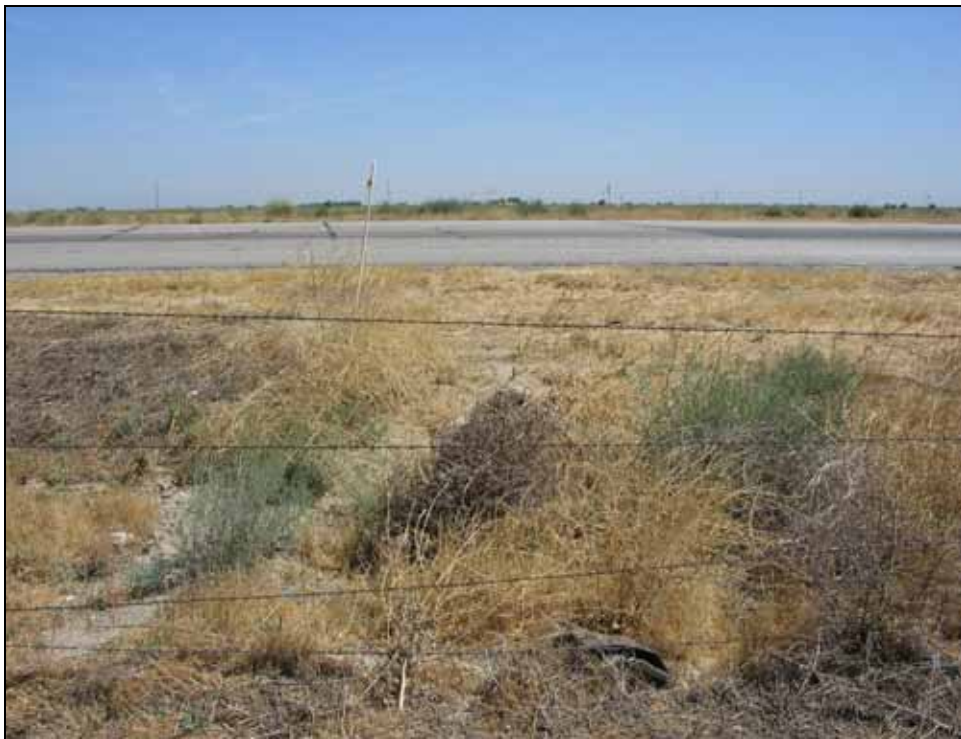
Figure 8. Example of an overgrown culvert under Interstate 5.

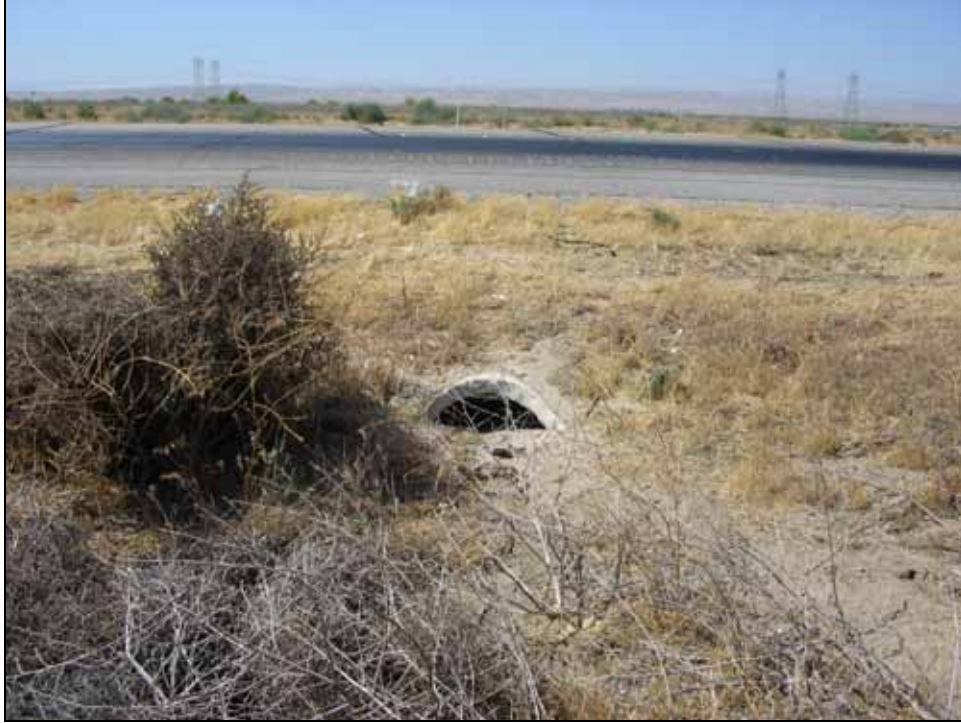
Figure 9. Example of a soil filled culvert under Interstate 5.

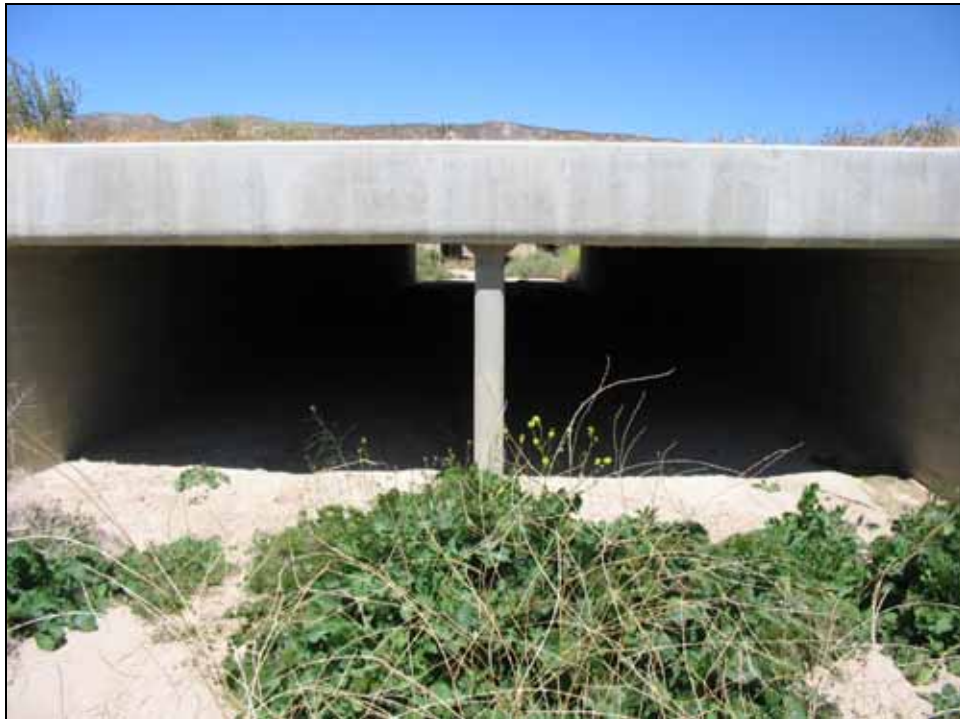
Figure 11. Two-x box-culvert crossing structure with median break at the Route 14 study site.

The concrete box structures consisted of either 2 or 6 adjoining box structures of varying heights (Figure 11 and Figure 12). A median break was incorporated at each of the box structures. No median barrier was present at this study site.

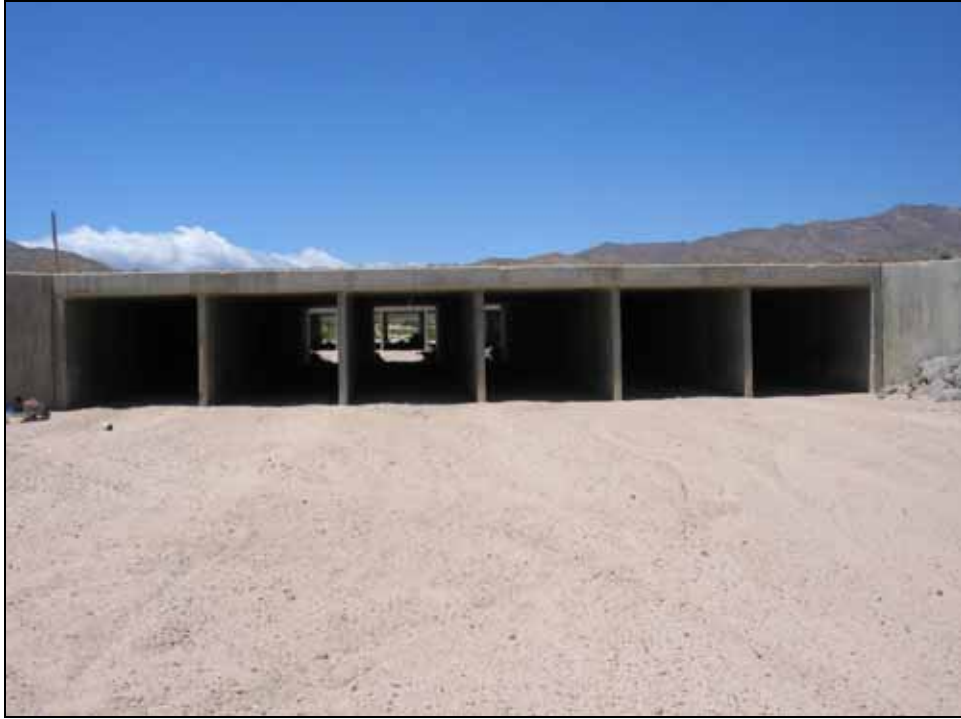
Figure 12. Six-x box-culvert crossing structure with a median break at the Route 14 study site.

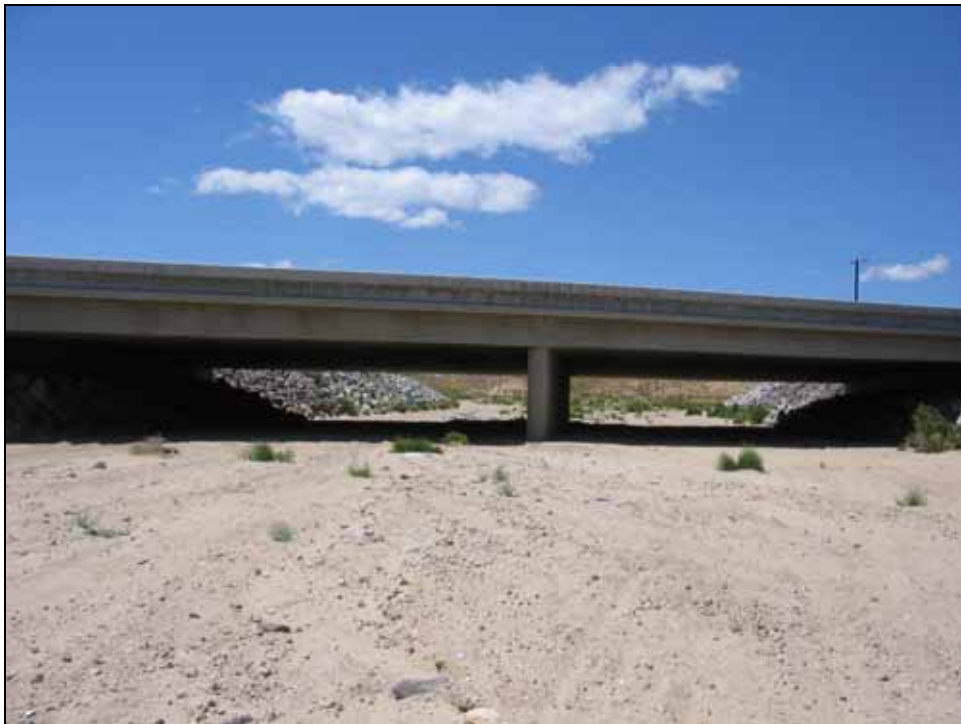
Figure 13. Bridge style crossing structure with solid wall supports at the Route 14 site.

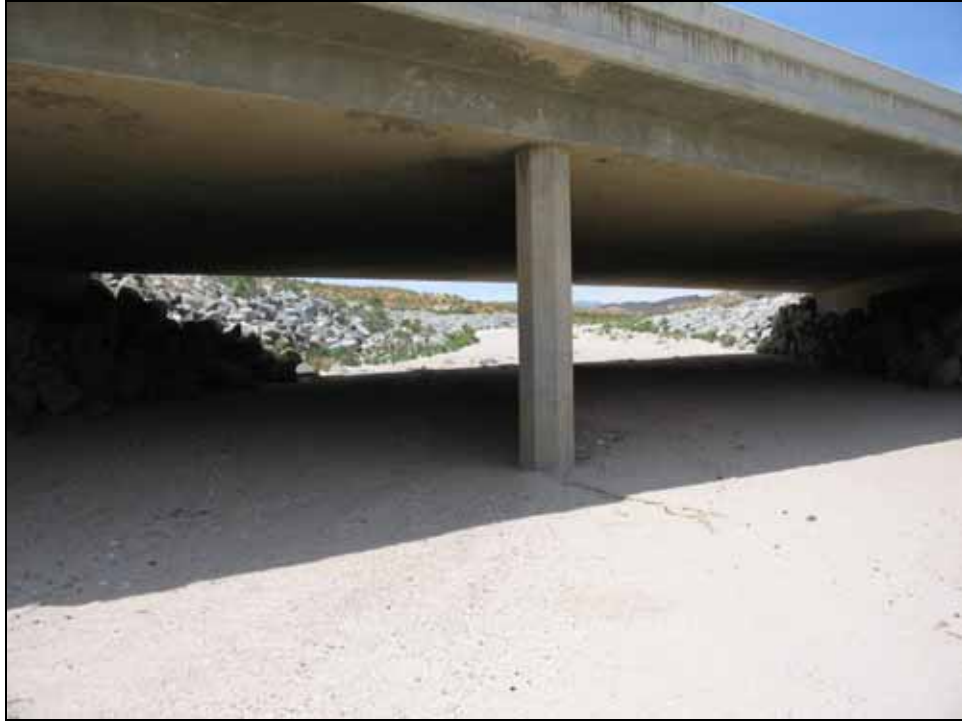
Figure 14. Bridge style crossing structure with double post supports at the Route 14 site.

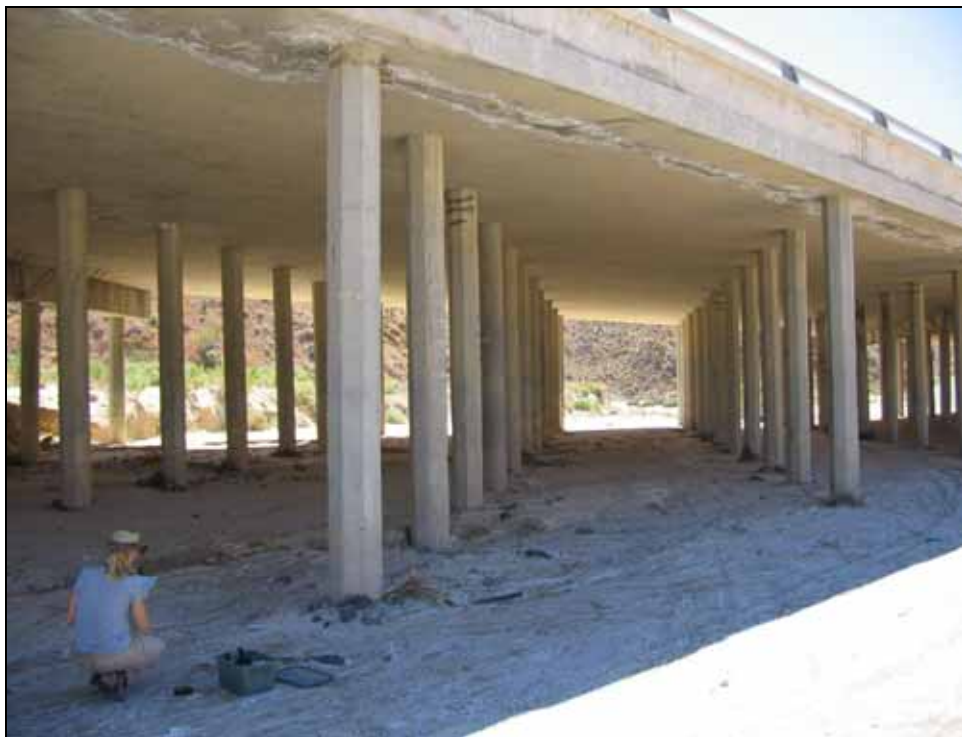
Figure 15. Bridge style crossing structure with multiple post supports at the Route 14 study site.

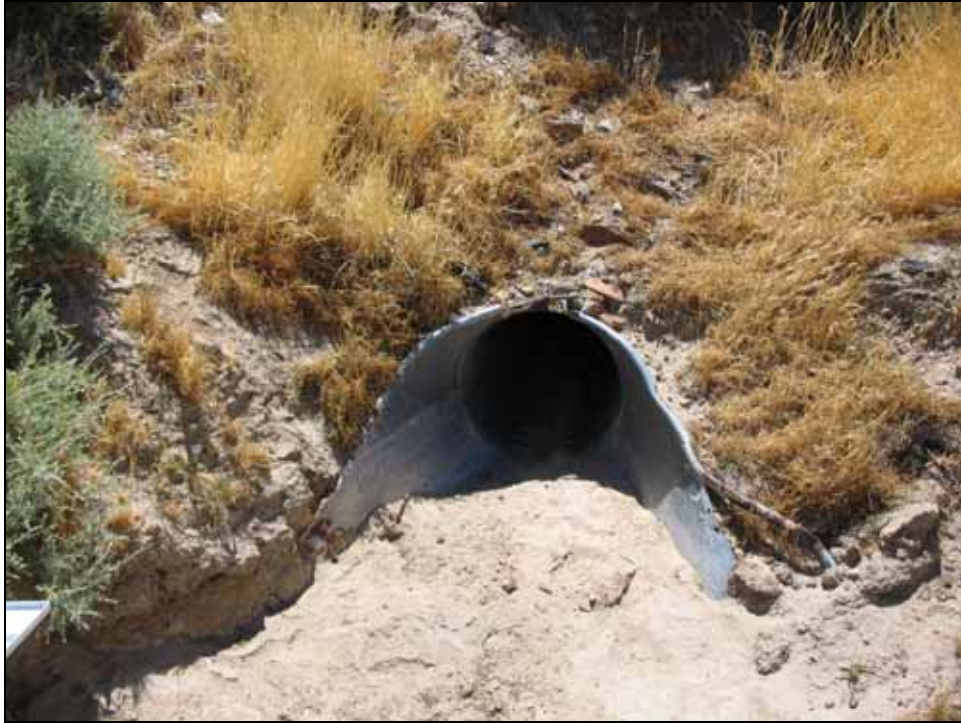
Figure 16. Example of a metal culvert at the Route 14 site.

None of the metal culverts had a median break (i.e., each culvert started on one side of the highway and traversed directly through to the other side). All culverts were constructed from ridged metal pipe (Figure 16) and ranged in size from 47 cm high x 21 cm wide to 94 cm high x 188 cm wide. The majority of these culverts had a sand base created by rain run-off flowing through the pipe (Figure 17). The depth of the sand base varied across culverts and also throughout the duration of the study depending on weather conditions. Therefore, the amount of space available for an animal to pass through the culvert crossing structures varied over time.

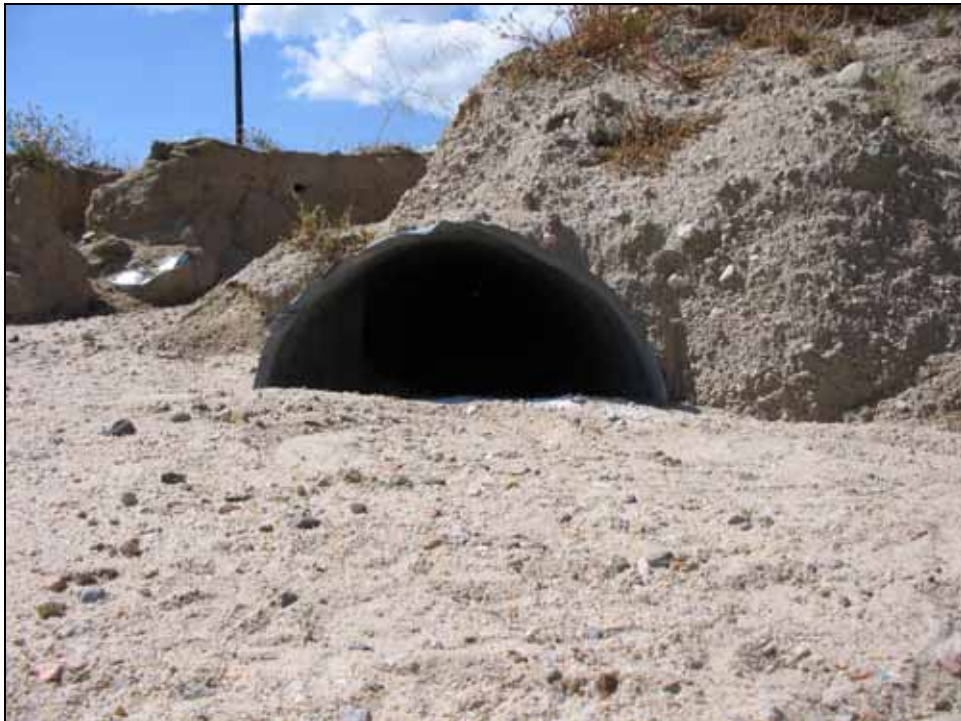
Figure 17. Sand base in a metal culvert crossing structure at the Route 14 site.

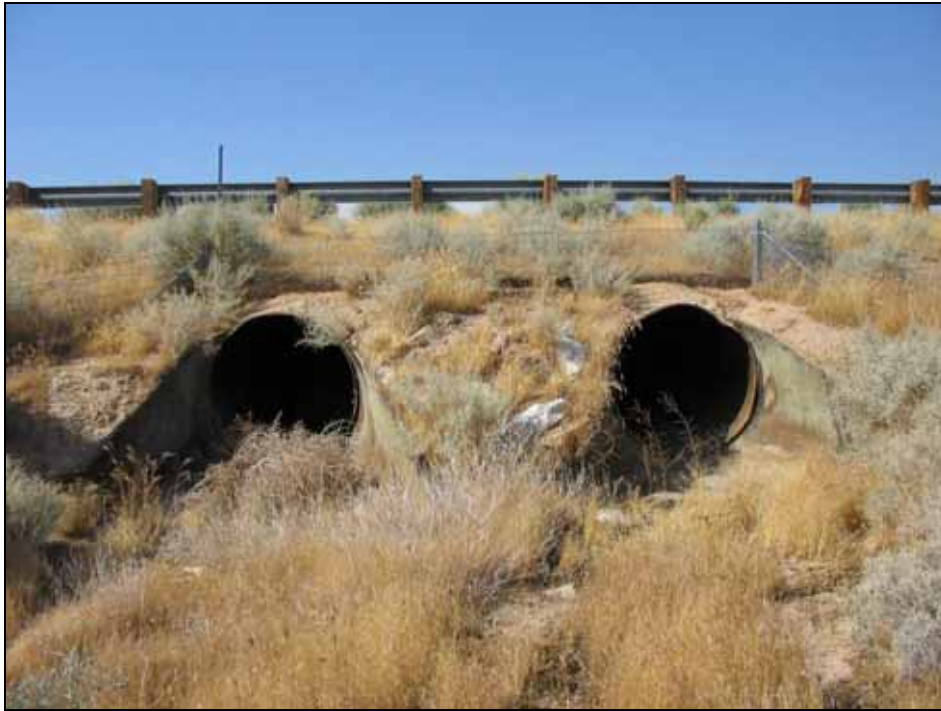
Figure 19. Unlined double metal culvert crossing structure on Hwy 58.

Crossing structures along this section of Hwy 58 comprised single or double metal pipe culverts (some of which were lined with a bituminous coating used to prevent corrosion of the corrugated metal pipe; Figure 19 and Figure 20), single or double concrete box structures (Figure 21), and concrete bridge structures supported by either one concrete support wall or three rows of support columns (Figure 22 and Figure 23). Round metal culverts and concrete box culverts did not have a median break in them, but the larger concrete bridge structures did have a median break. No median barrier was present along this stretch of Hwy 58. Details of the structures are shown in Table 3.

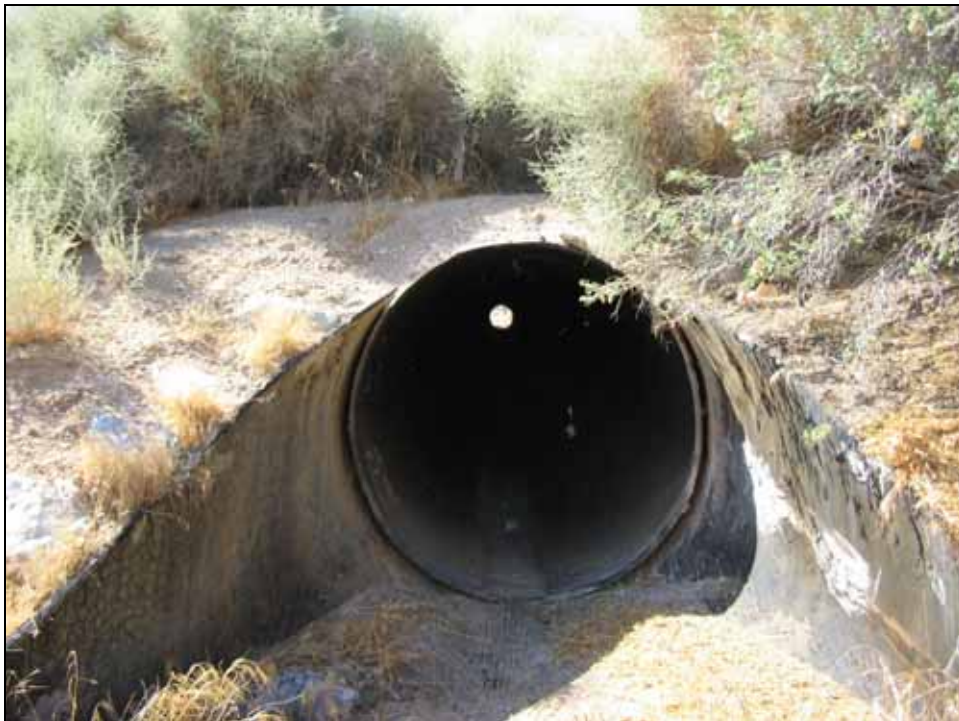
Figure 20. Lined single metal culvert crossing structure on Hwy 58.

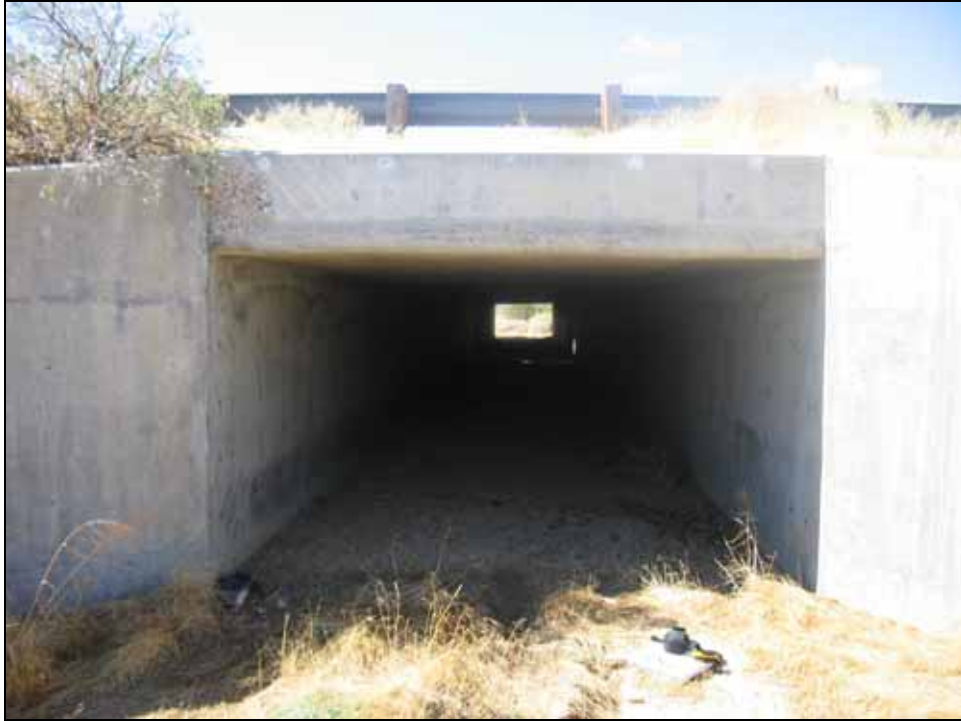
Figure 21. Single box culvert crossing structure on Hwy 58.

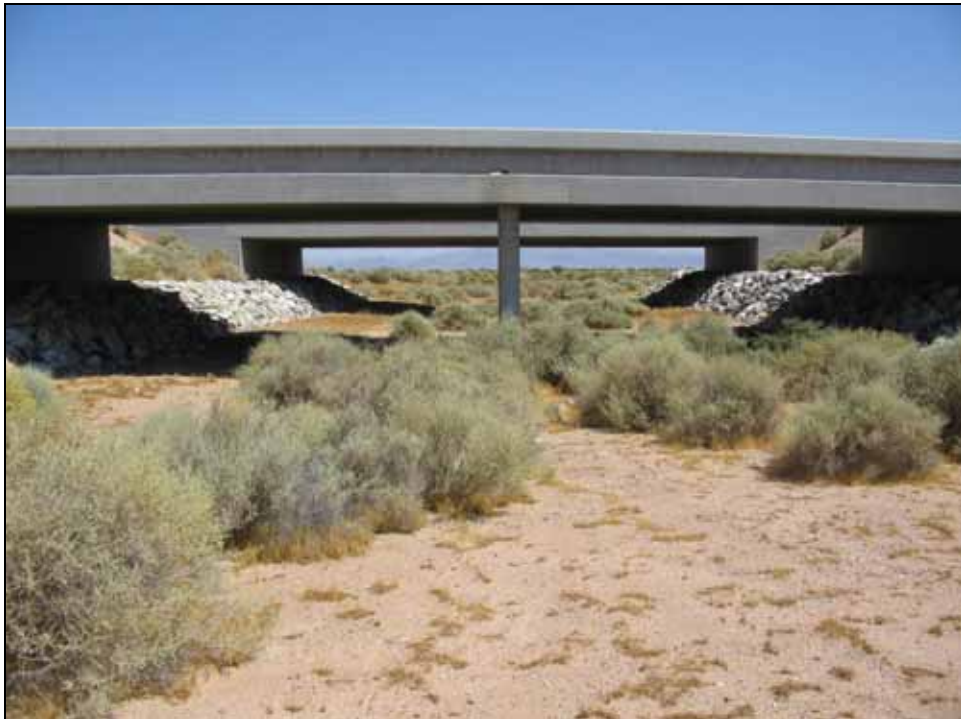
Figure 22. Concrete bridge crossing structure with one support wall on Hwy 58.

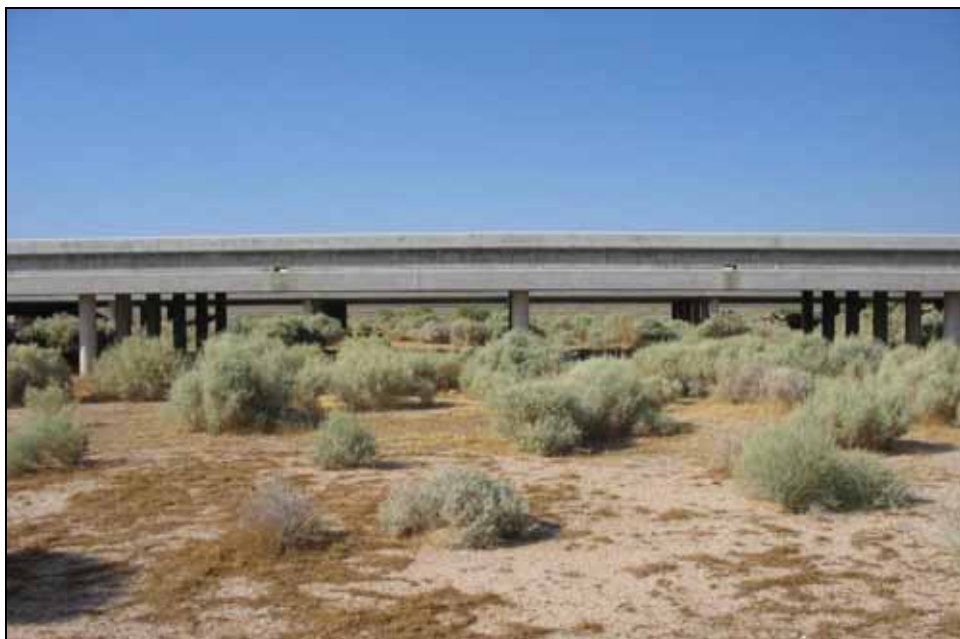
Figure 23. Concrete bridge style crossing structure with three rows of support columns on Hwy 58.

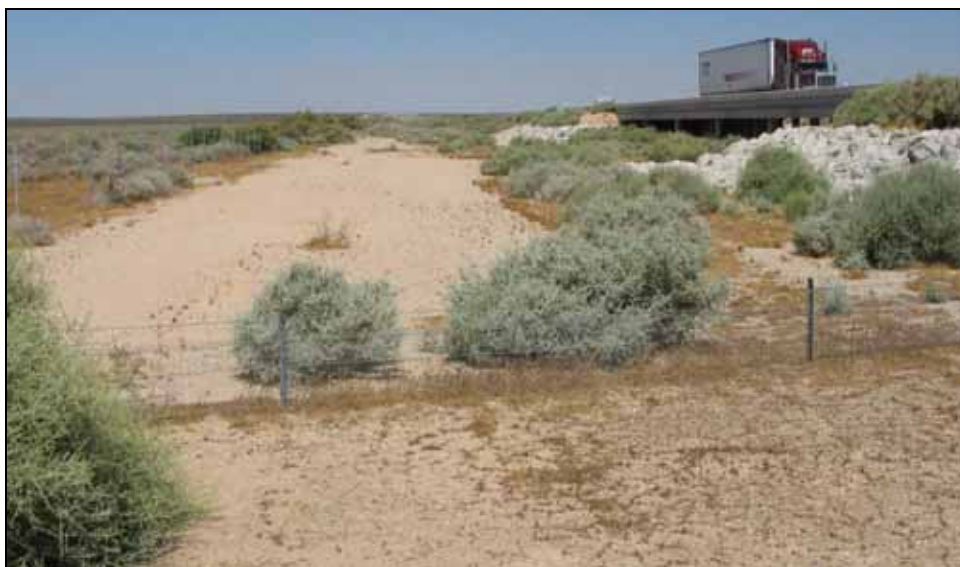
Figure 24. Drift fencing installed to guide desert tortoise to underpasses.

Drift fencing was present along this section of Hwy 58 (Figure 24) from a study conducted on Desert Tortoise (*Gopherus agassizii*; Boarman and Sazaki 1996). While this fencing may have facilitated in guiding kit foxes towards the crossing structures, it was not of an adequate height to prevent them from passing over the fence and crossing via the road. Drift fencing was not present at the median breaks in the bridge style crossing structures. It is probable that the slopes of the median break would be inaccessible to a desert tortoise, but a kit fox would likely be able to access the roads from these median breaks. Therefore, the drift fencing present on this site was not considered as affecting the fox's choice of whether to cross via a crossing structure or pass over the road surface.

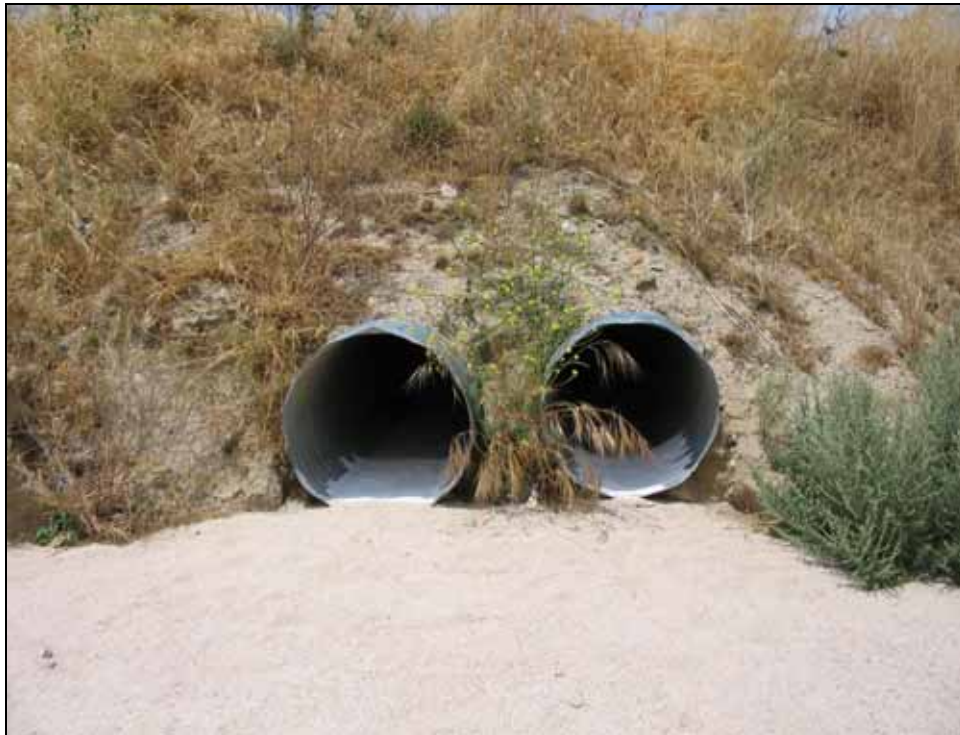
Figure 25. Example of a diatomaceous earth track station.

Track stations consisted of a layer of diatomaceous earth (DE) spread out at the entrance of each end of the pipe culverts (Figure 25). The area covered by the DE was large enough to ensure that at least one kit fox track would be captured within the tracking medium should a fox pass over the station. The DE was smoothed down using a soft rubber mat to ensure that any tracks would be clearly visible. Prior to setting the track station, any debris was removed from the culvert entrance. Sand-based track stations were also set at the box culverts on Rte 14. These culverts encompassed too large an area to cover using DE, and therefore the sand at these sites was raked to remove stone and other debris, and then covered with a layer of finely sifted sand (Figure 26).

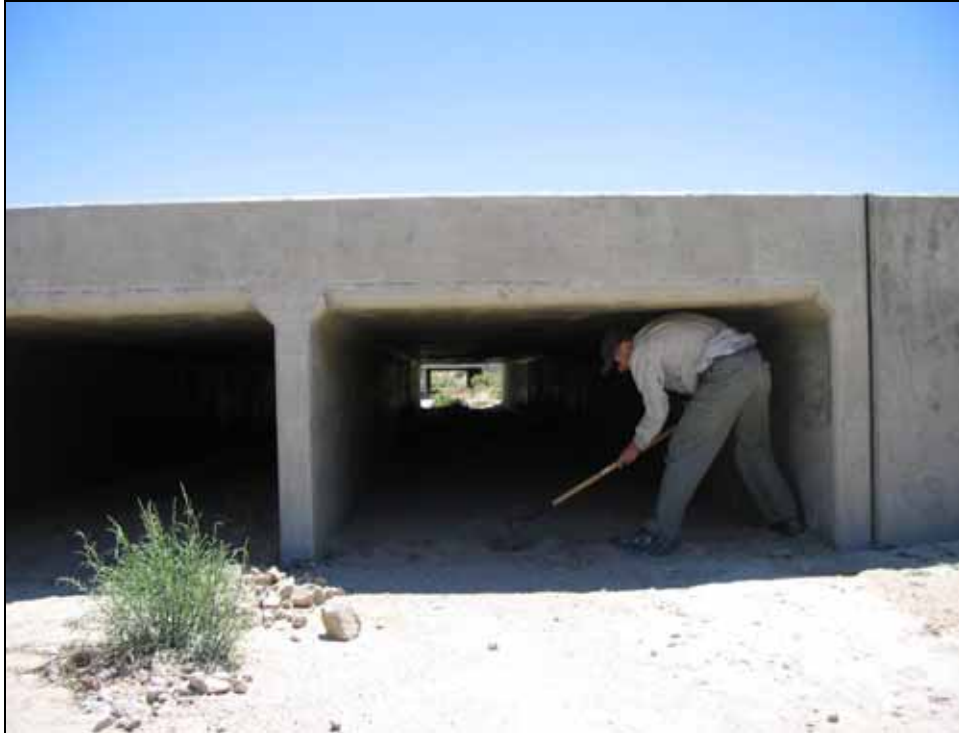
Figure 26. Sand-based track stations at box culverts on Route 14.

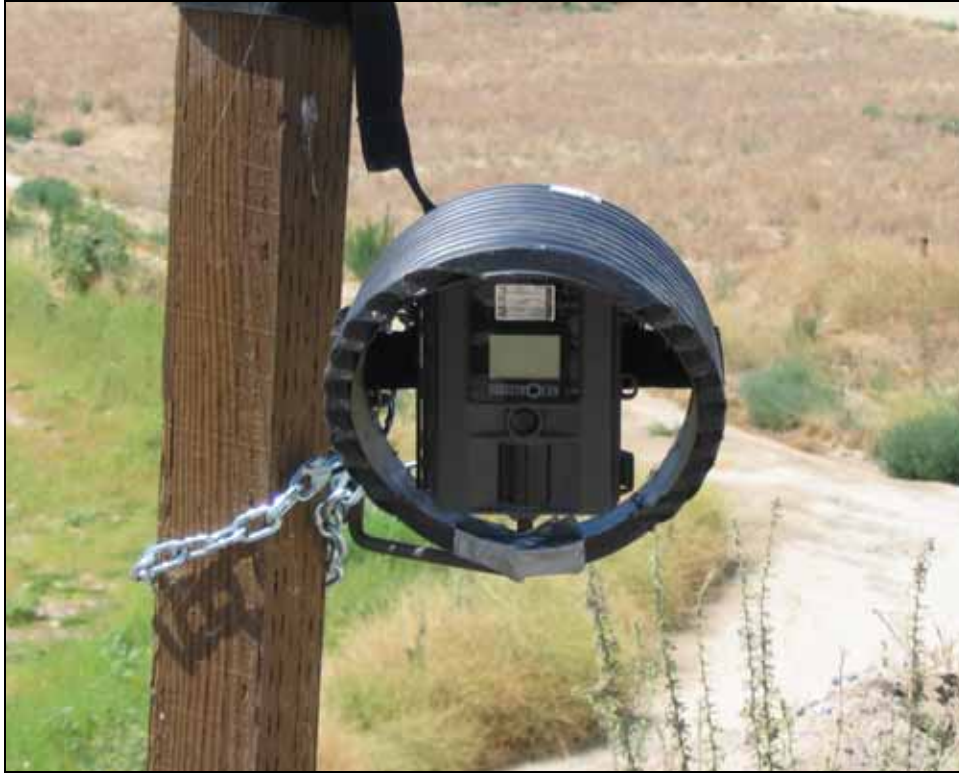
Figure 27. Stealthcam DIGRC-XV motion detector camera with shade at the Interstate 5 study site.

Overpass crossing structures on Rte 14 were monitored using remote, motion-activated digital cameras. Two 1.3-megapixel digital scouting Stealthcam (DIGRC-XV) cameras were set on each overpass, one at either end of the structure. Plastic structures were constructed to protect the cameras both from excessive sunlight, and from being moved during strong winds (Figure 27). The cameras were attached to posts present at either end of the overpasses with straps or mounts that were part of the camera package and secured using a heavy duty chain and padlock. A smaller padlock was used to lock the camera body to prevent the memory card from being removed.

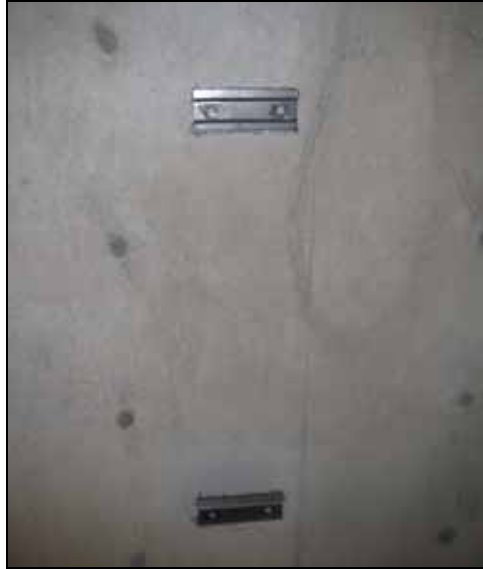
Figure 28. Hat plates for camera security boxes attached to the culvert wall using epoxy.

Camera stations were set up at seven box culverts along Hwy 58 using Cuddeback 3.0 megapixel scouting cameras. Due to the high probability of human disturbance at each of these sites the cameras were placed in security boxes designed and constructed for this project. Each box was mounted to the culvert wall by 'hat plates' epoxied to the wall (Figure 28). Struts were bolted to the hat plate (Figure 29), and the box attached to the struts using security bolts (Figure 30 and Figure 31). A complete description of this camera security box system can be found in Fiehler et al. (2007).

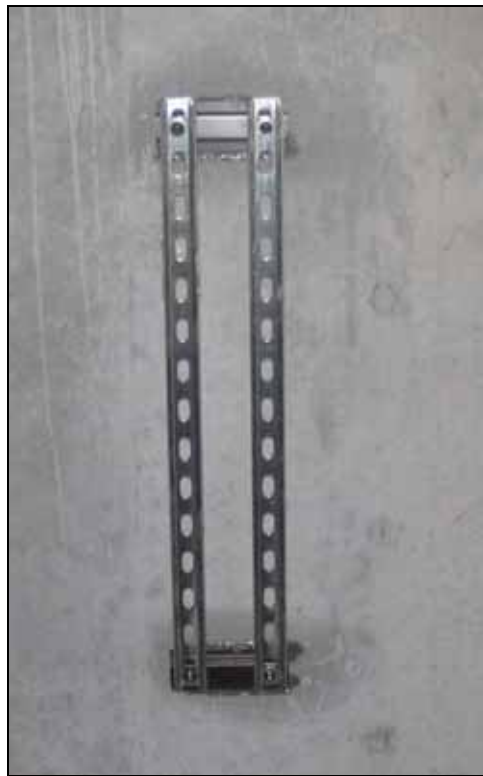
Figure 29. Struts for camera security boxes bolted to the hat plates.

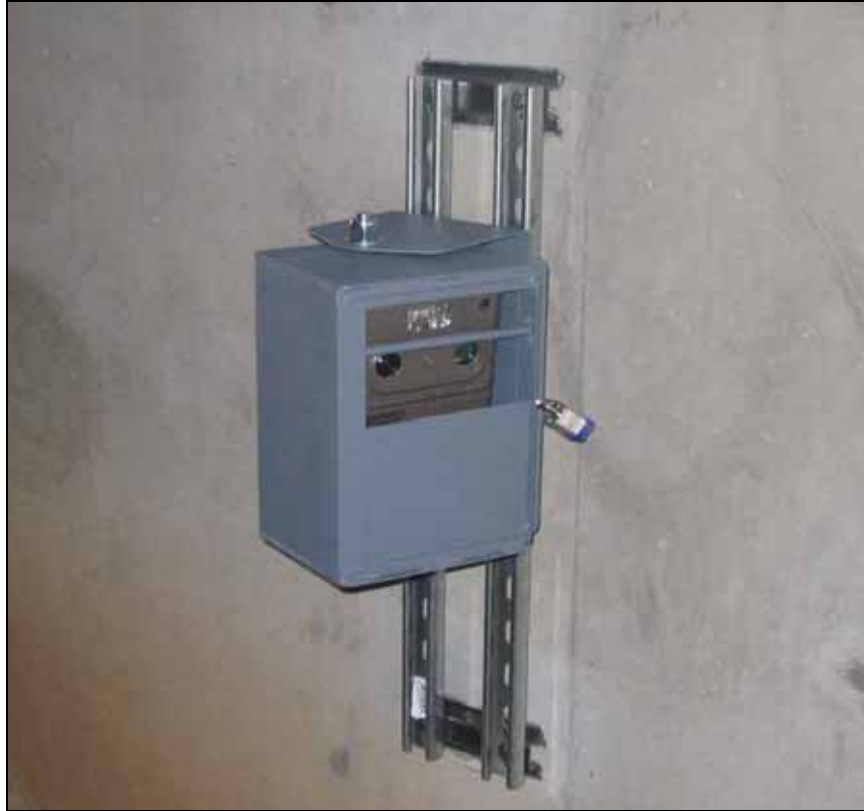
Figure 30. Camera box containing Cuddeback camera – front view.

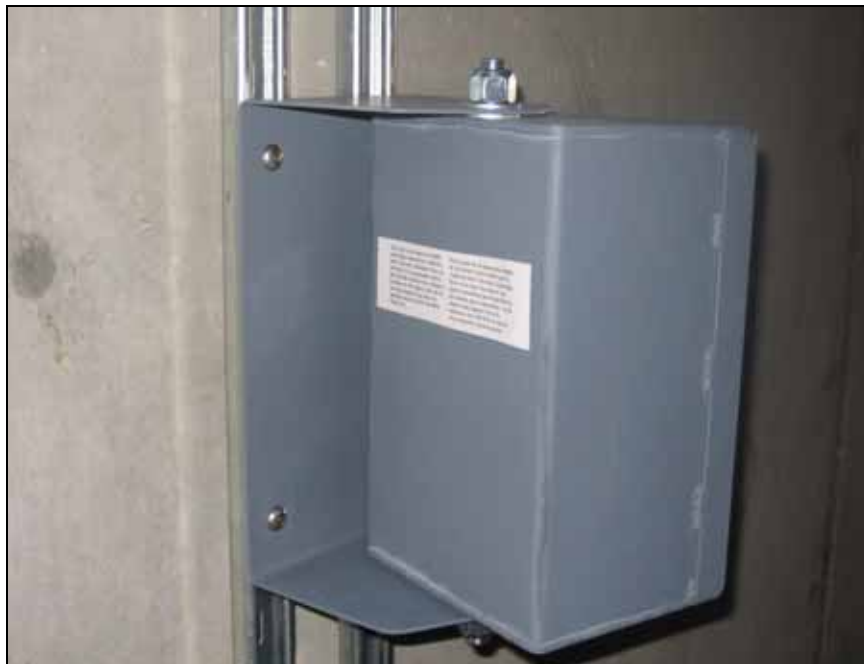
Figure 31. Camera box attached to the struts - back view.

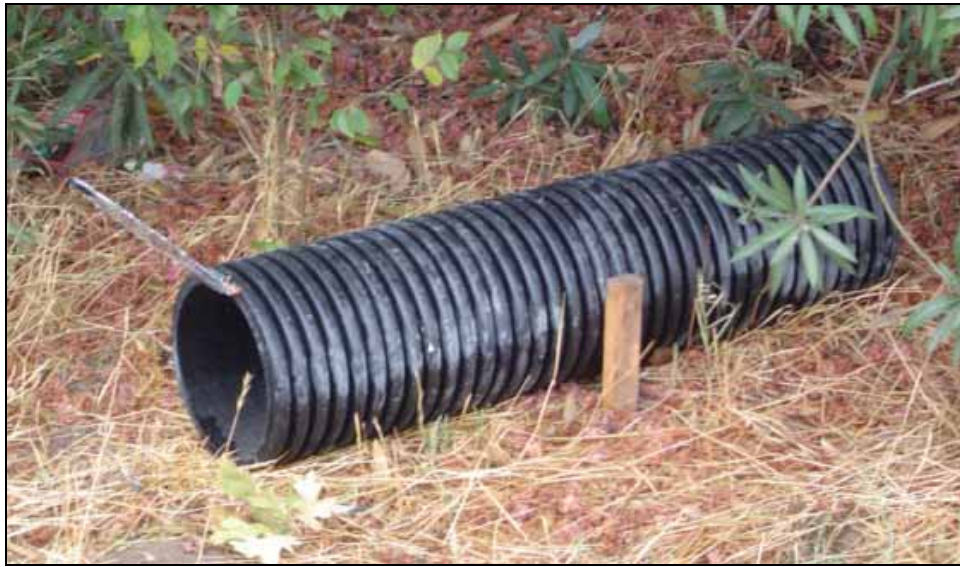
Figure 32. Single-sample hair snare device designed for use on kit foxes.

A single-sample hair collection device had previously been designed and tested for collecting hair DNA samples from San Joaquin kit fox (Figure 32; Bremner-Harrison et al. 2006). Hair traps were set at the I-5 and Hwy 58 sites. At the I-5 site, traps were set every 0.2 miles on both the east and west sides of the highway. Traps were set from the base of the southern overpass and extended north of the northern overpass into the Conservation Area of the Kern Waterbank (Figure 33). Due to an area of consistent flooding a gap of ca. 1 mi existed between trap 6a and 7a on the east side of I-5. At the Hwy 58 site, hair traps were set on the north and south sides of the highway at 0.5-mile intervals. The traps ran from station Hwy58-01 to Hwy58-22.

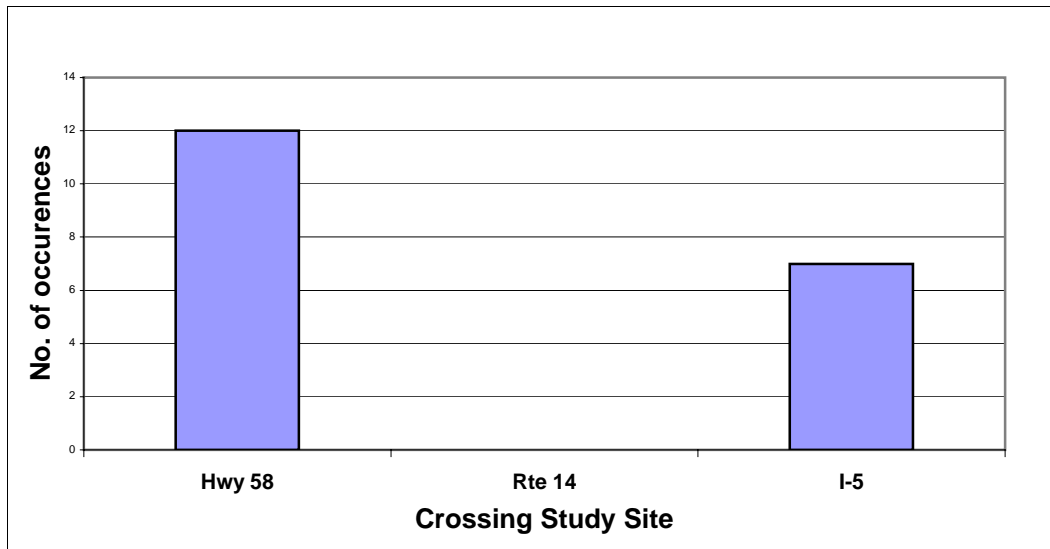
Figure 35. Number of occurrences of kit fox tracks detected in track stations across the three study sites.

Kit fox tracks were observed in track stations a total of 19 times across the three study sites. Tracks were detected at both the Hwy 58 and I-5 sites but not the Rte 14 site (Figure 35). In addition, the presence of species other than kit foxes was recorded across all three study sites (Figure 36).

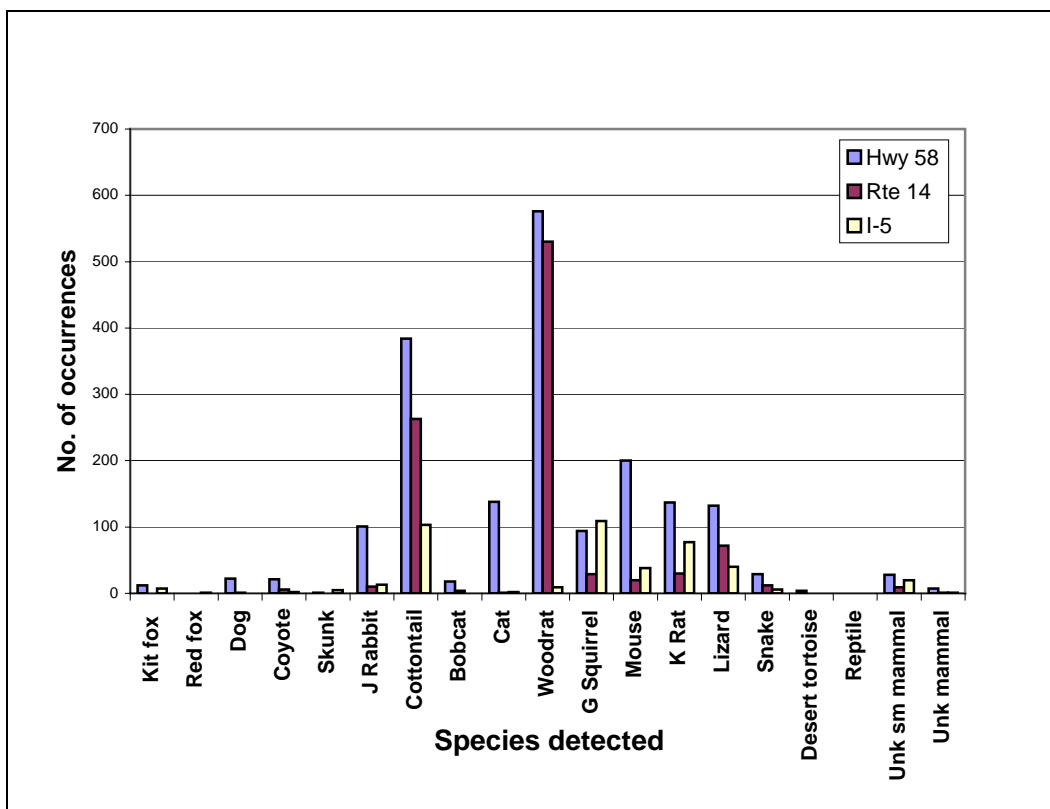
Figure 36. Number of visits by all species recorded in track stations across the three study sites.

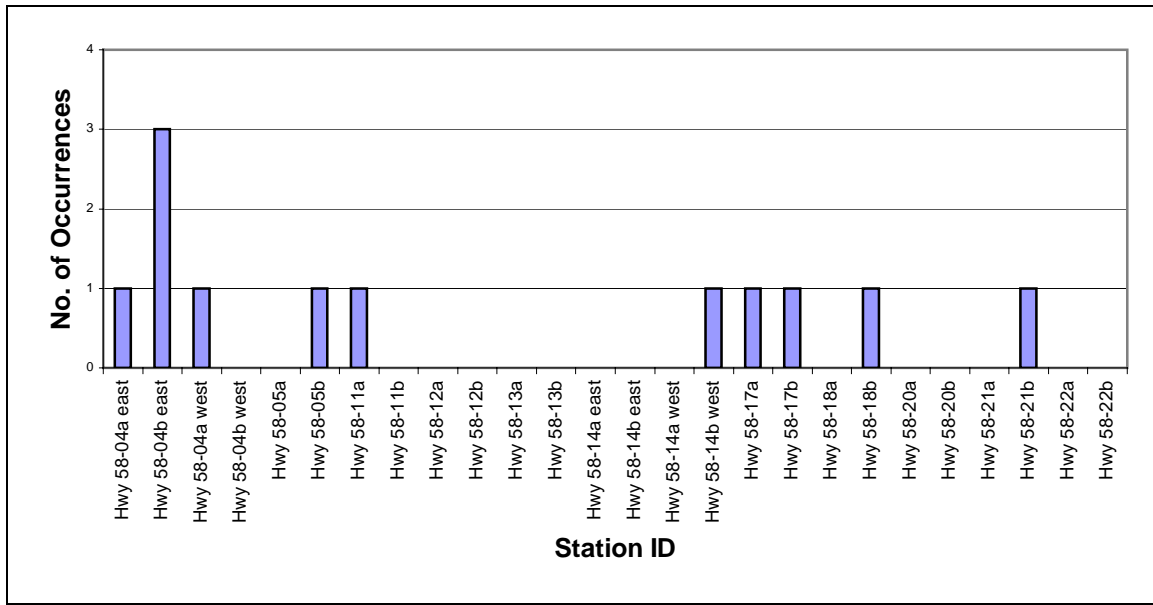
Figure 37. Number of occurrences of kit fox tracks at individual culverts at the Highway 58 site.

Kit fox tracks were observed a total of 12 times in track stations at eight different pipe culvert crossing structures at the Hwy 58 site (Figure 37). However, none of these occurrences indicated that foxes had passed through the crossing structures as in each instance tracks were only found at one end of the structure. At each of these eight crossing structures and in additional structures, tracks were observed from animals larger or of a comparable size to kit foxes (Figure 38). In several instances, tracks from these larger species were found at each end of the culvert suggesting that the animal had passed through the culvert. Table 8 depicts visits by kit foxes and comparably-sized species at each of the crossing structures, and whether these species had passed through the culvert or only were detected at one end. In the majority of cases where species had not passed

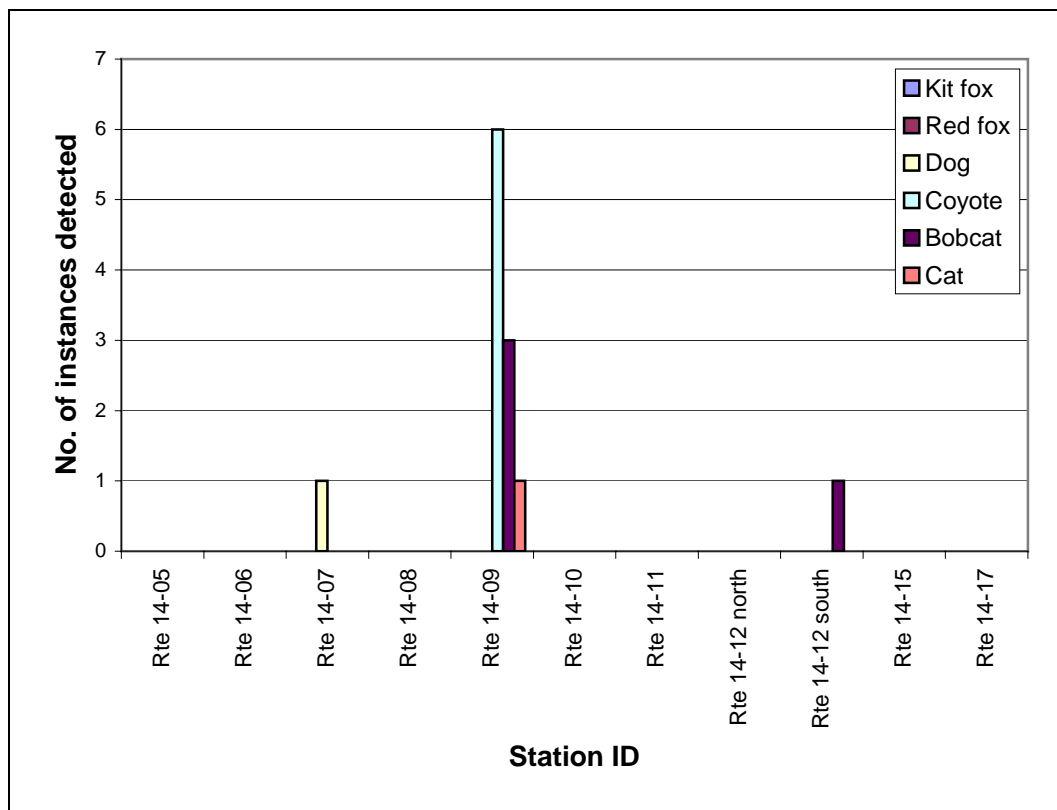
Figure 39. Number of instances of kit foxes and species of comparable or larger size detected in track stations at the Route 14 study site.

Kit fox tracks were not observed in any of the track stations at the Rte 14 site. Tracks from animals larger or of a comparable size to kit foxes were observed at several of the stations (Figure 39). Again, on several occasions tracks from these larger species were found at each end of the culvert, suggesting that the animal had passed through the culvert. Table 9 shows a breakdown of the presence of species of comparable size to kit fox at each of the crossing structures, and whether these species had passed through the culvert or were detected at one end. In the majority of cases where species had not passed through the crossing structures, tracks were found on both sides of the road, but on different dates.
