USE OF HIGHWAY CROSSING STRUCTURES BY KIT FOXES

PREPARED FOR THE CALIFORNIA DEPARTMENT OF TRANSPORTATION

August 2007

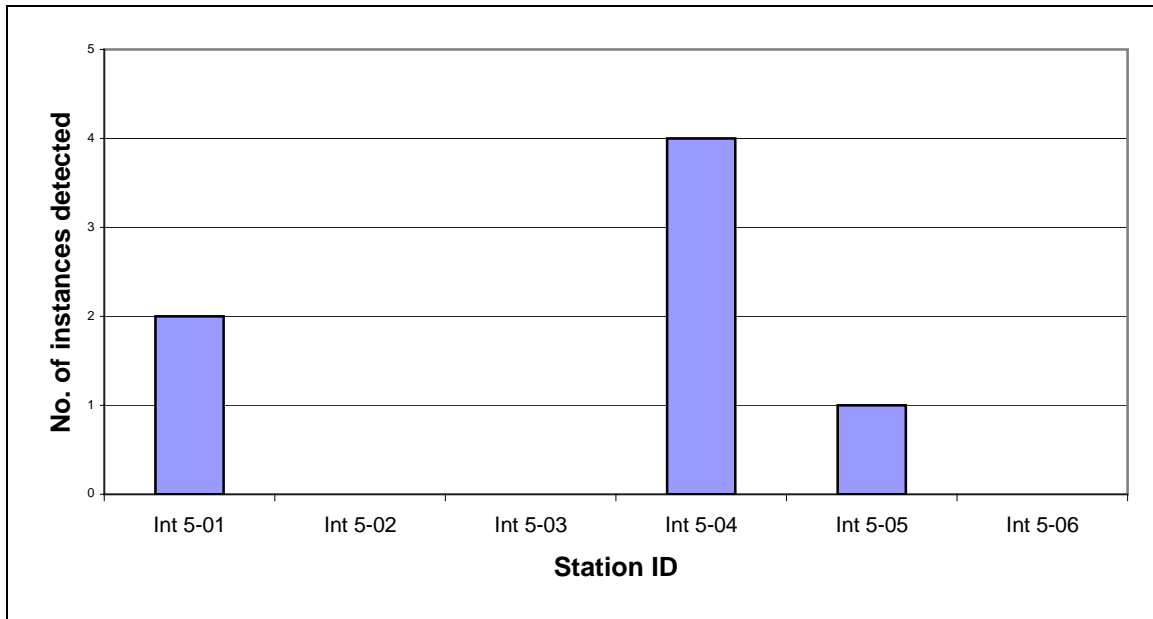
Figure 40. Number of occurrences of kit fox tracks at individual culverts at the Interstate 5 site.

Kit fox tracks were observed a total of 7 times in track stations at three different pipe culvert crossing structures at the I-5 site (Figure 40). Again, none of these occurrences indicated that foxes had passed through the crossing structures as tracks were only found at one end of the structure in each instance. At two of these three crossing structures, tracks from animals larger or of a comparable size to kit foxes were observed (Figure 41). None of these tracks indicated that the animals had passed through the crossing structures (Table 10). In the majority of cases where species had not passed through the crossing structures, tracks were again found on both sides of the road, but on different dates.

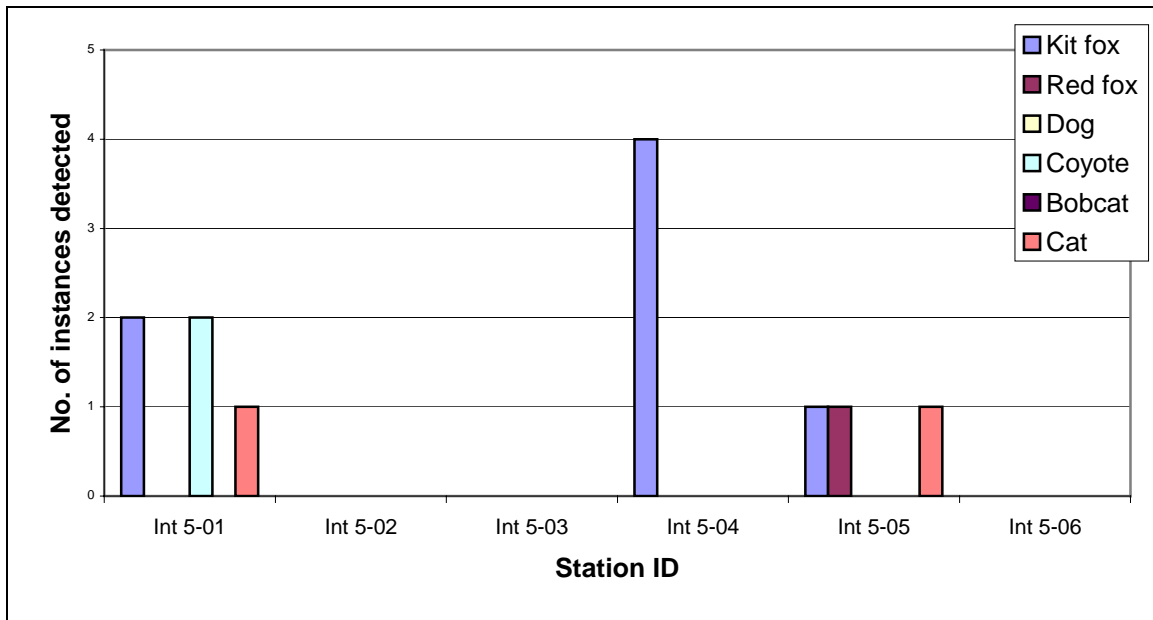
Figure 41. Number of instances of kit foxes and species of comparable or larger size detected in track stations at the Interstate 5 study site.

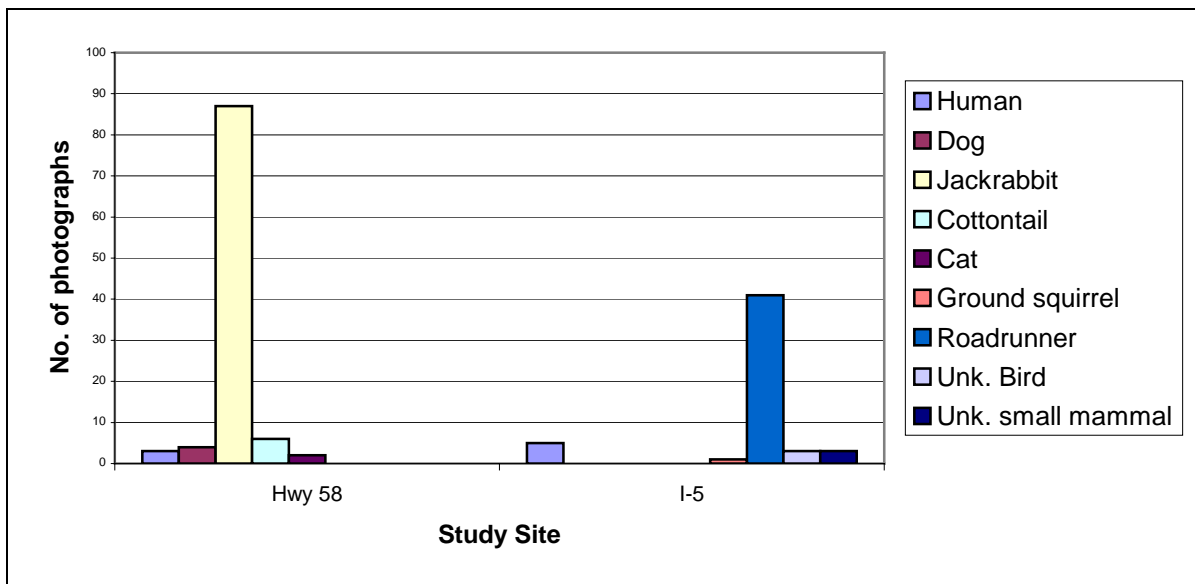
Figure 43. Number of photographs of species other than kit foxes obtained from the Highway 58 and Interstate 5 study sites

There were no instances of kit foxes recorded on camera from either of the two study sites where cameras were deployed. The species captured on camera at each site is shown in Figure 43. Visits to each station by species is shown in Figure 44 for Hwy 58 and Figure 45 for I-5. A large number of blank photographs were obtained from each site. Of the total number of photographs obtained from the cameras at the I-5 site, 86% were blank. Of the 135 photographs taken at the Hwy 58 site, 23% were blank. Cameras at the I-5 site were set on overpasses utilized on a regular basis by the landowners, the Kern Water Bank. Of the 4,134 photographs obtained from these two crossing structures, 537 (13%) were of vehicles. Vehicular crossings also likely contributed to the high percentage of blank photographs from the cameras set at the I-5 site (i.e., vehicles triggered the cameras but passed out of view before a picture was taken).

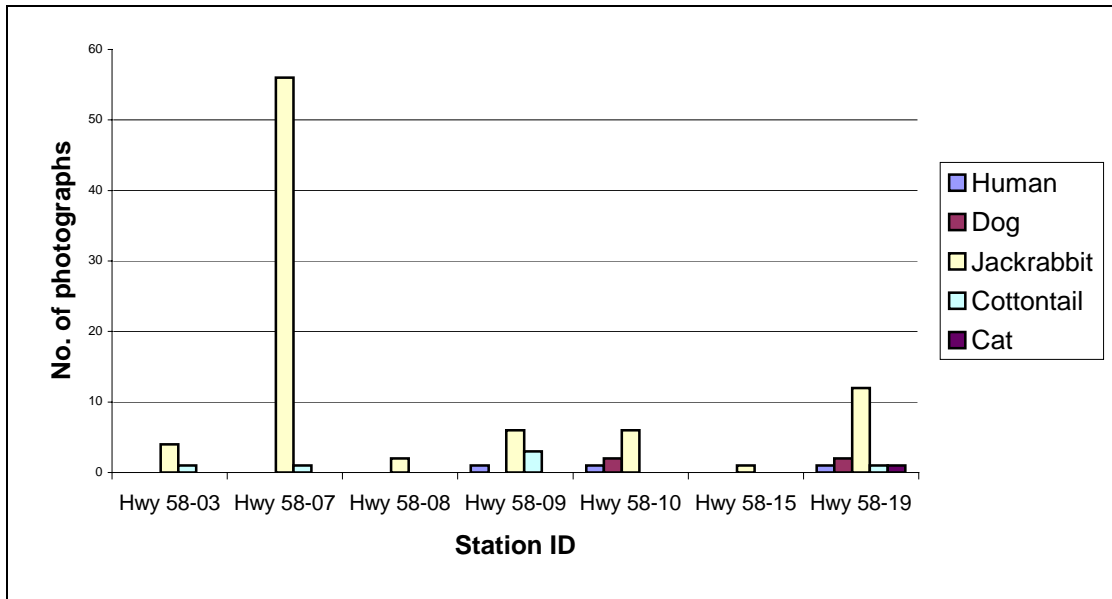
Figure 44. Number of photographs of species other than kit foxes obtained from the Highway 58 study site by individual station.

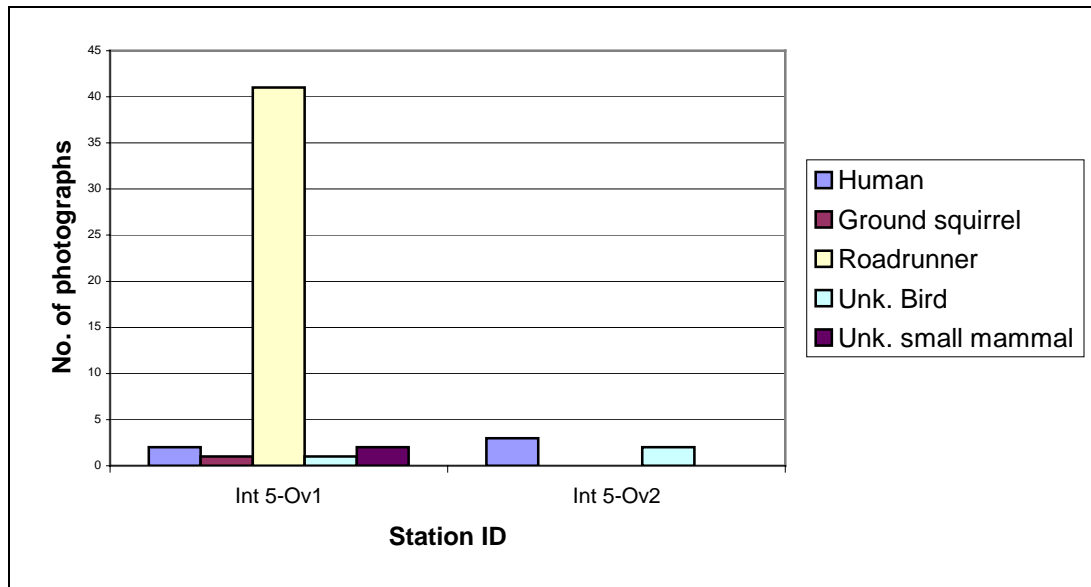
Figure 45. Number of photographs of species other than kit foxes obtained from the Interstate 5 study site by individual station.
