1. REPORT NUMBER CA13-1750	2. GOVERNMENT ASSOCIATION NUMBER	3. RECIPIENT'S CATALOG NUMBER
4. TITLE AND SUBTITLE Automated Safety Warning Controller Final Report	5. REPORT DATE March 22, 2013	6. PERFORMING ORGANIZATION CODE

Automated Safety Warning Controller

Final Report

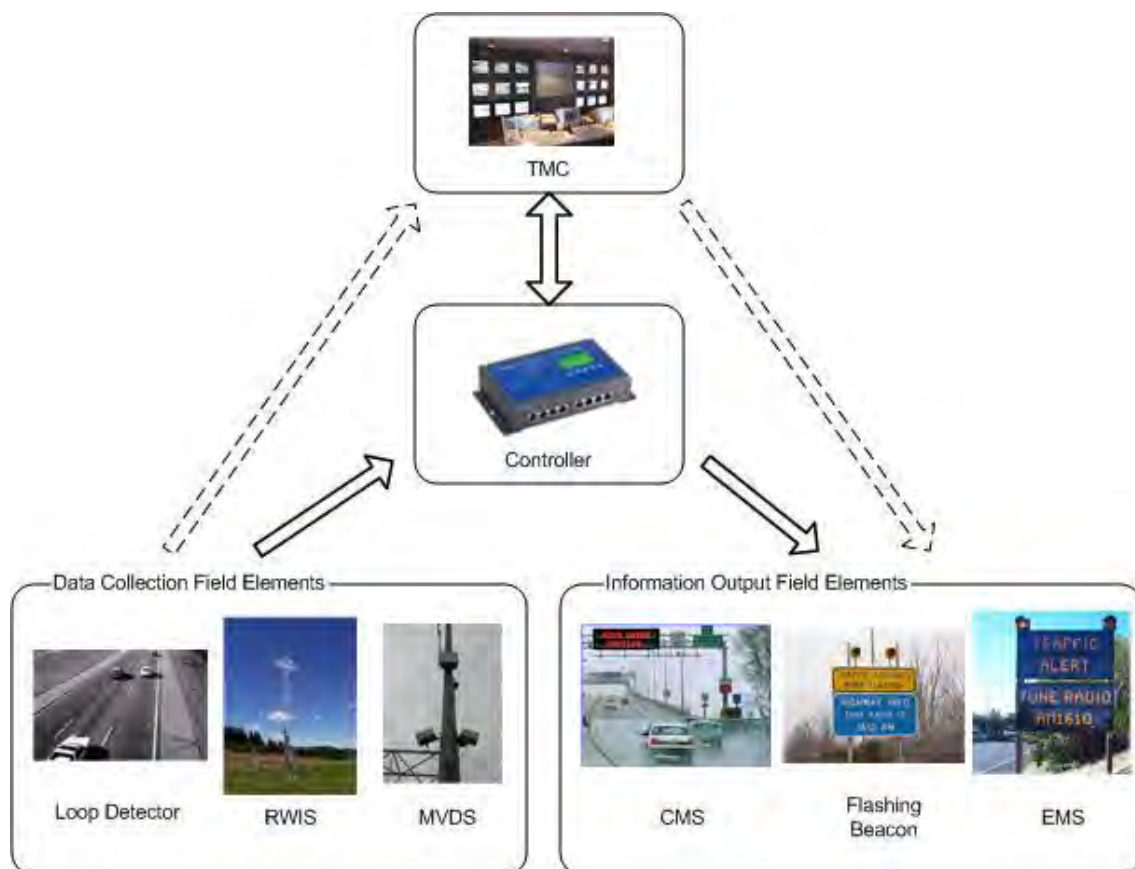
The goal of this project was the development of a system that frequently and automatically monitors field element data and determines, according to best practice algorithms, if a warning should be activated. The automated warning controller device would be installed near the warning devices it controls, so the system could continue to work even if communication with the RTMC is disrupted. The controller can also poll field elements much more frequently than a RTMC operator and quickly and automatically make the decision whether to activate a warning based on the retrieved information. Another goal of this project was to develop a standardized system that is versatile enough to be used at any location, with any number and type of field elements from which to draw data. Figure 1 shows an early conceptual diagram of the system.

Figure 1: Controller Interaction with TMC and Field Elements

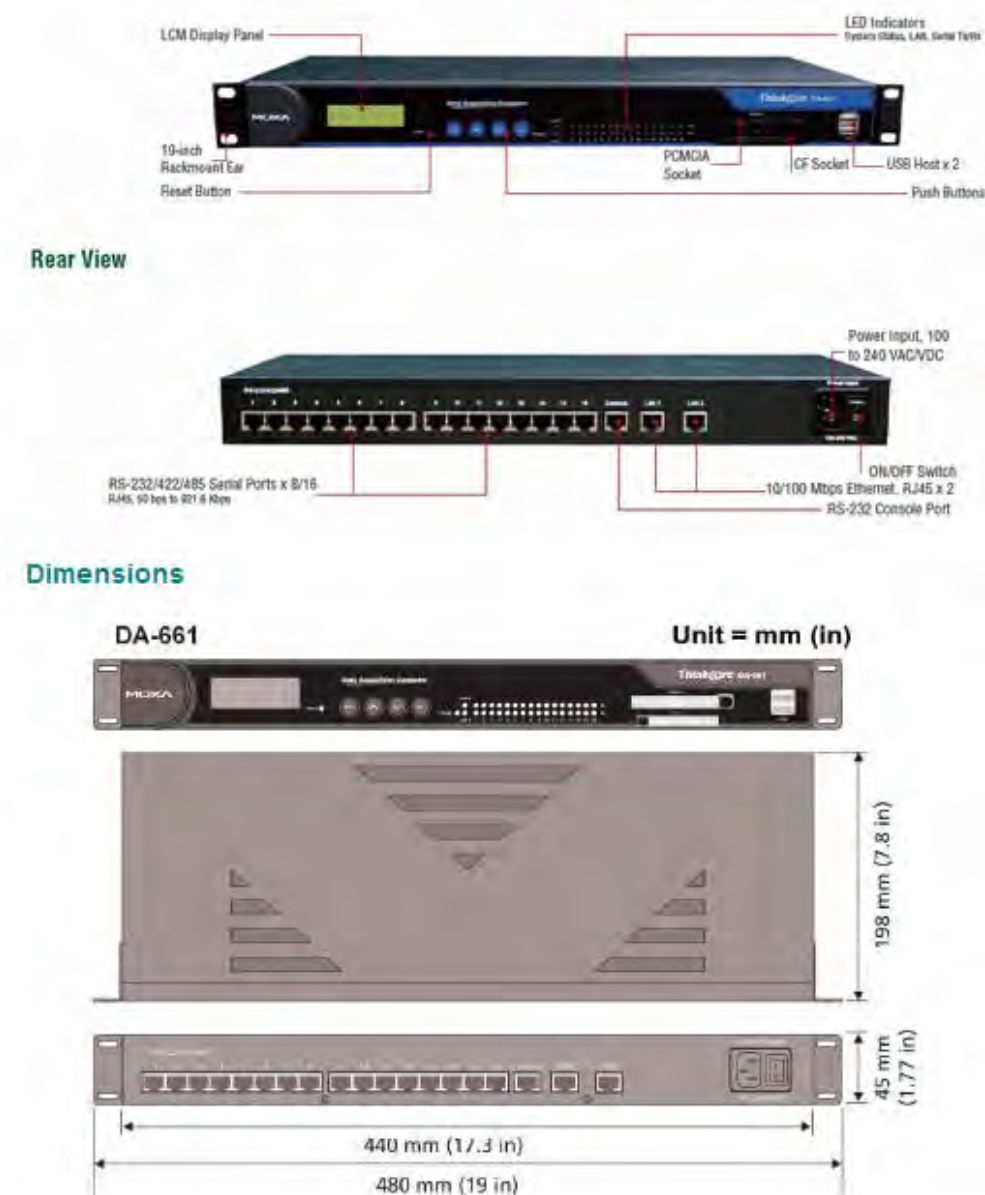
For this phase of the project, Caltrans requested the use of a rack mount device consistent with Caltrans roadside network equipment mounting. The Moxa DA-661 was selected due to its compatibility with the UC-7420 used in Phase 1. Figure 2 shows the Moxa DA-661.

Figure 2: Moxa DA-661 Embedded Computer (image courtesy of Moxa)

The main difference between the UC-7420 used in Phase 1 and the DA-661 is the size of the display and number of front panel buttons. Improving the front panel interface was one of the items identified from Phase 1, modifying it for the fewer buttons and smaller display size of the DA-661 added to the challenge of making an informative and intuitive interface. The front panel interface was re-done to be easy to understand and use for the occasional user such as a field

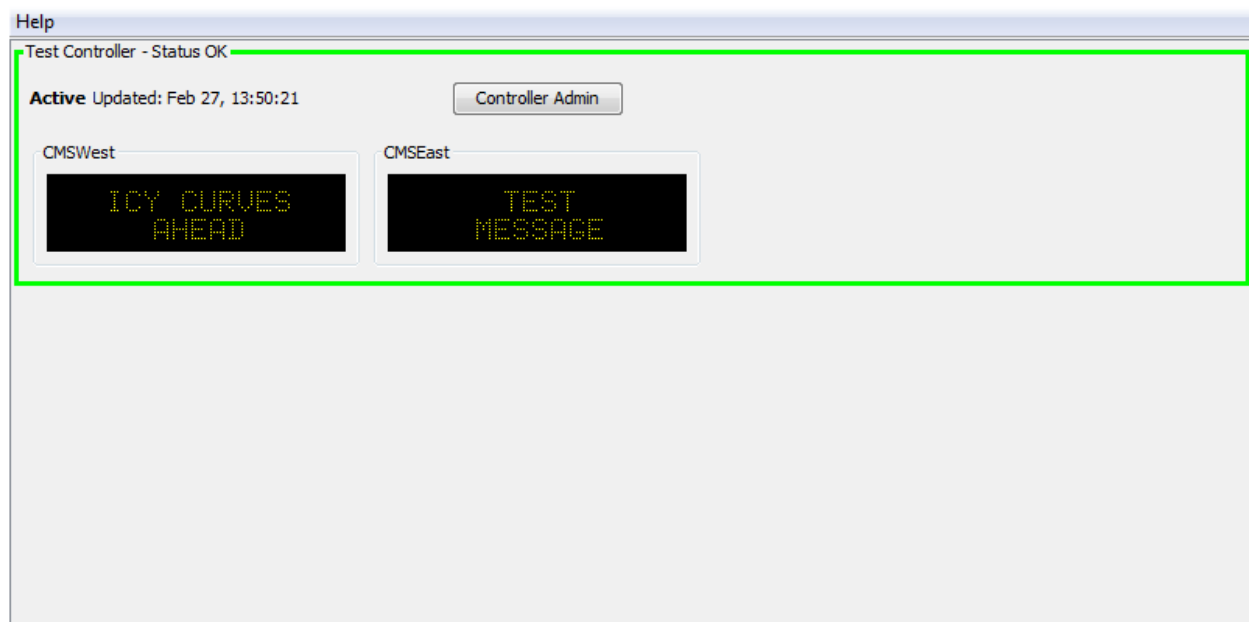
The SOCCS ASWC user interface was implemented as a Java applet running on a PC browser and served up by a separate TMC housed server. The SOCCS ASWC user interface was implemented as a summary screen and administrative screen. Multiple ASWCs can be configured and will be listed on the summary screen. The summary screen gives a quick look at the status and CMS message(s) for the configured ASWC, see Figure 3. The summary screen establishes an unauthenticated connection with the ASWC, retrieves the status and CMS message data, and then closes the connection. The update interval is configurable to optimize the usage of dialup lines. The administrative screen is accessed by demand and requires a username/password combination to establish an authenticated connection with the ASWC. The administrative screen gives operator and supervisor level access to the ASWC as defined in the Automated Safety Warning Controller System Concept and Requirements Specification (3). This screen allows the user to view detailed status of the running modules, view log messages, view values of input module sensors, and add a message to the CMS.

Figure 3: SOCCS ASWC Summary Screen

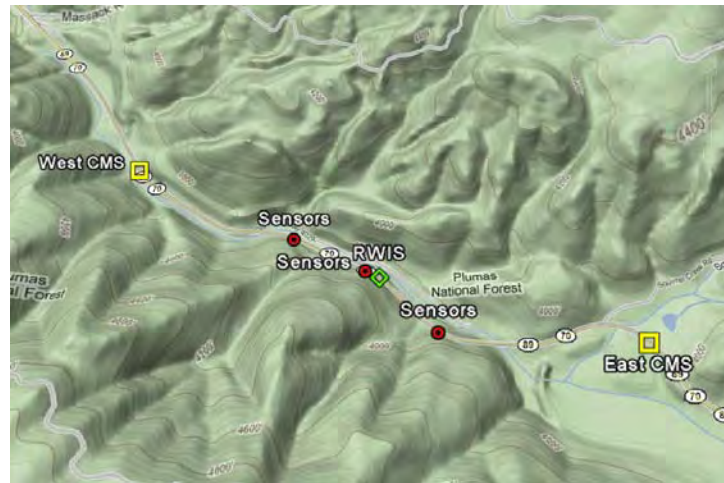
There is an RWIS at the Spring Garden with six in-pavement surface sensors deployed at three locations spanning approximately one-half mile. The West CMS is one-half mile west of the first surface sensor and the East CMS is a little over one-half mile east of the last surface sensor.

Figure 5: Spring Garden Field Element Configuration

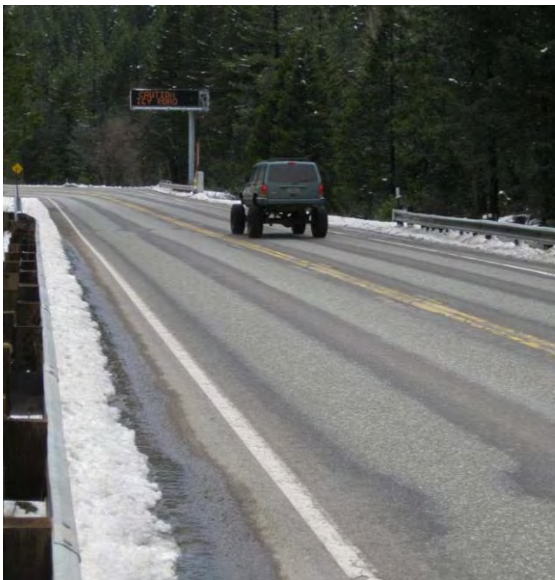
Figure 6: Eastbound CMS (photo by Ian Turnbull)

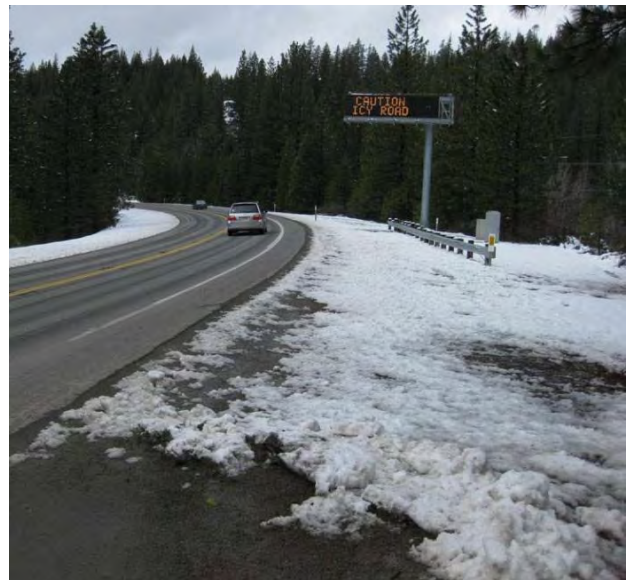
Figure 7: Westbound CMS (photo by Ian Turnbull)

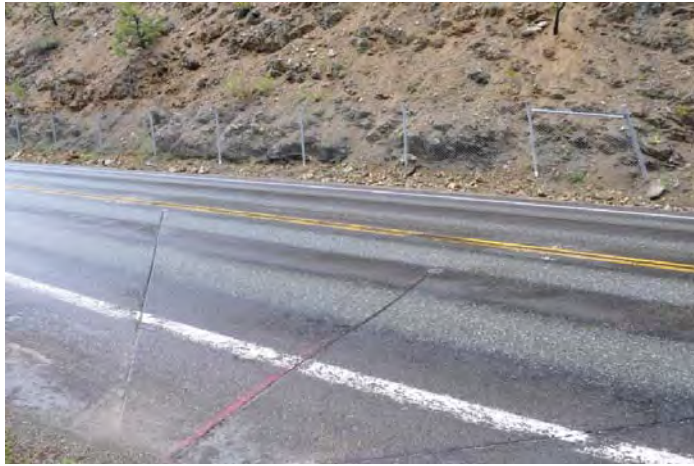
Figure 8: Pavement Surface Sensors

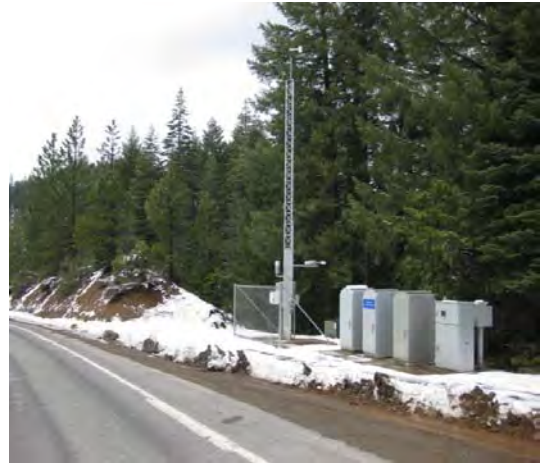
Figure 9: Spring Garden RWIS (photo by Ian Turnbull)

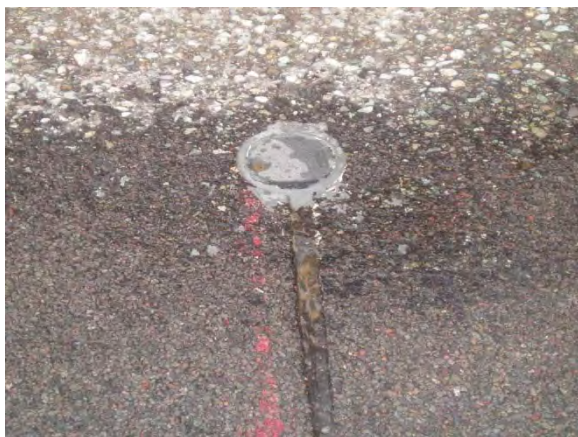
Figure 10: Pavement Surface Sensor

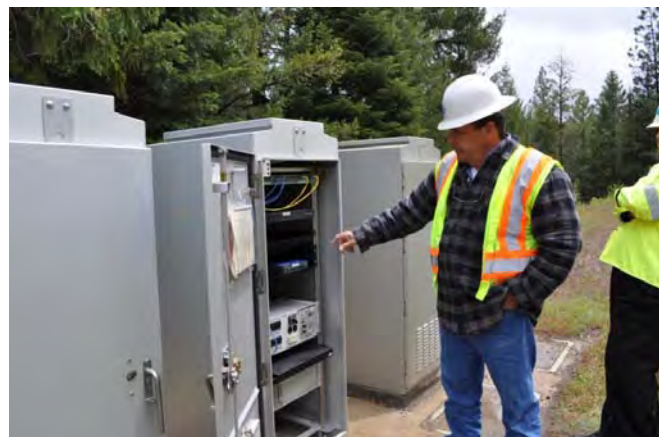
Figure 11: ASWC in Spring Garden ITS Cabinet, as shown by Ian Turnbull

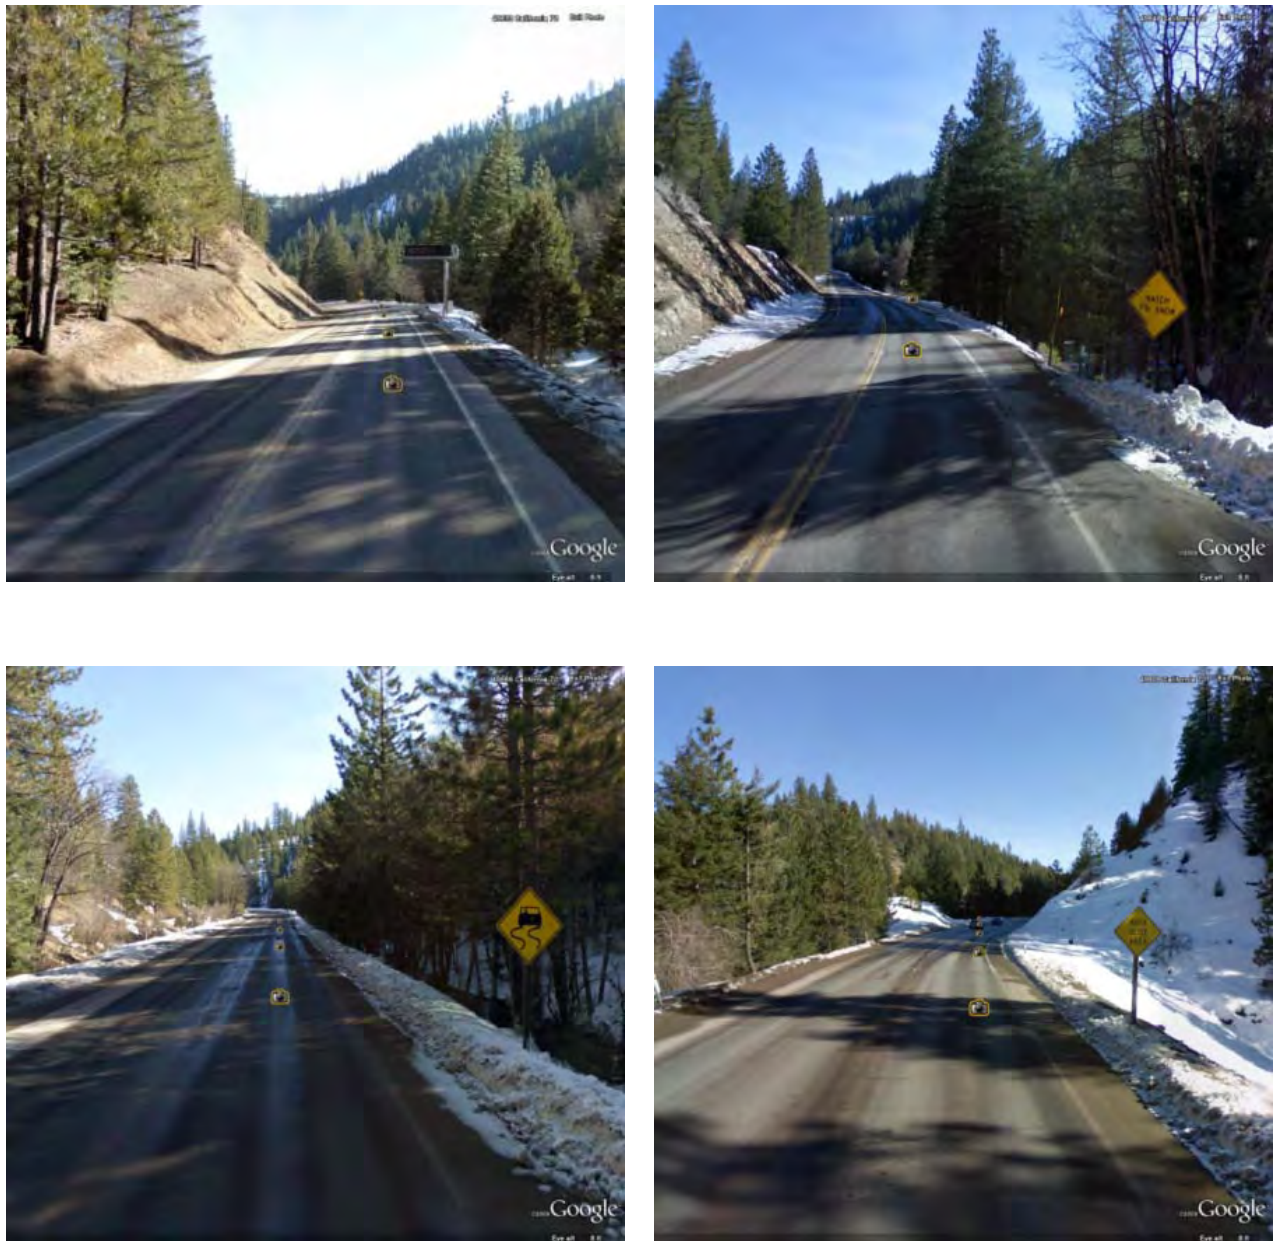
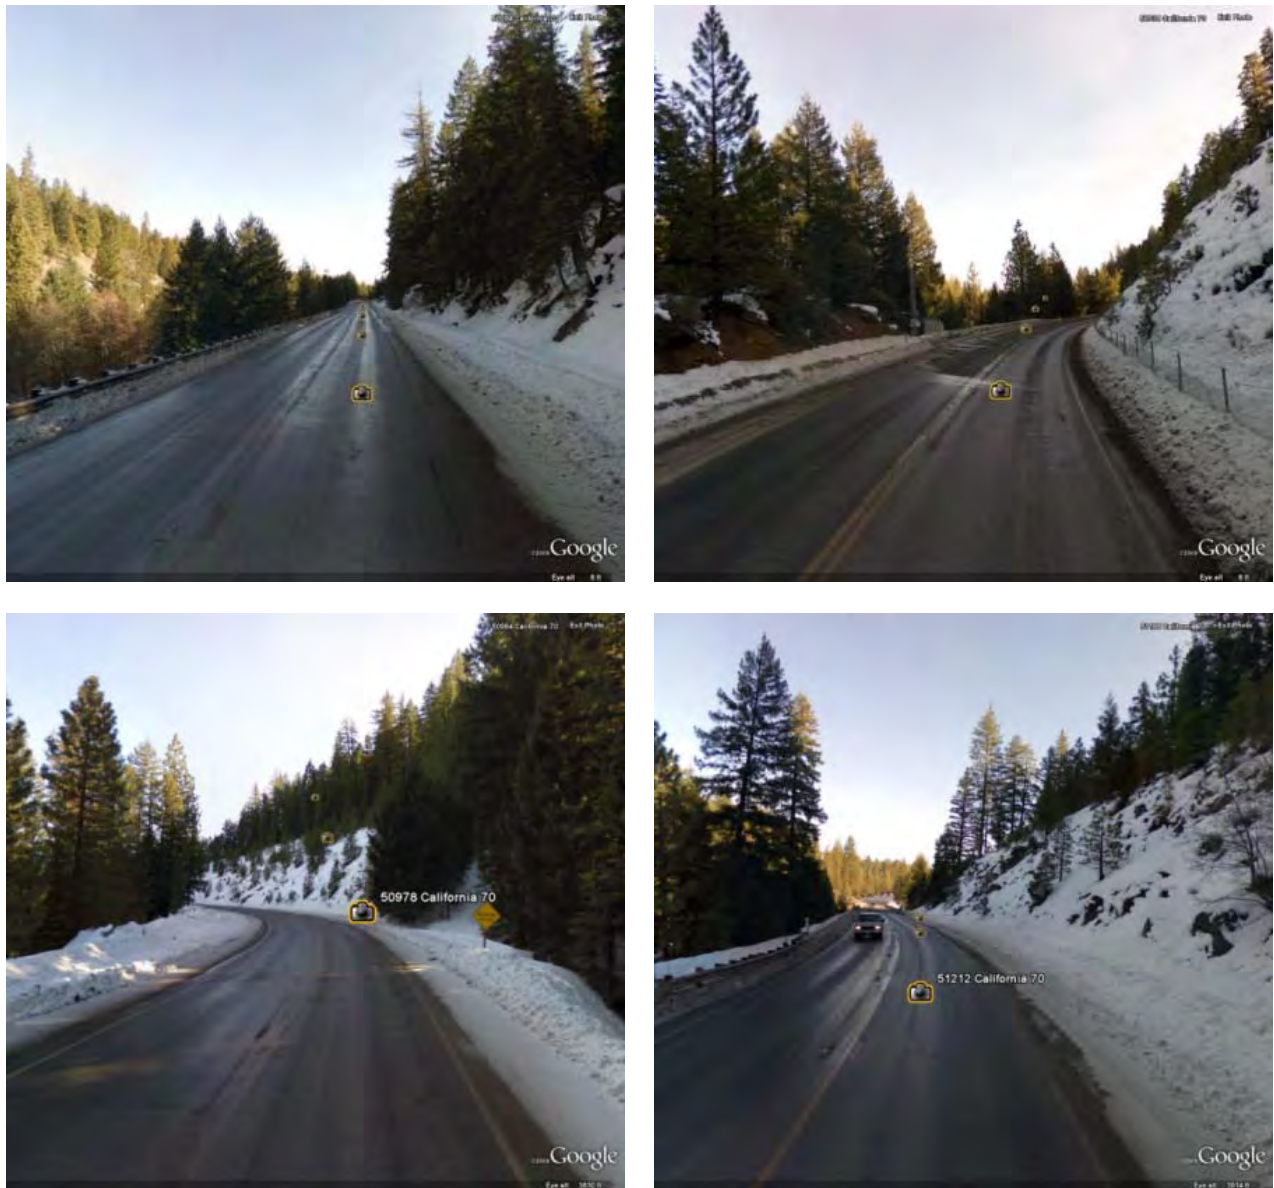
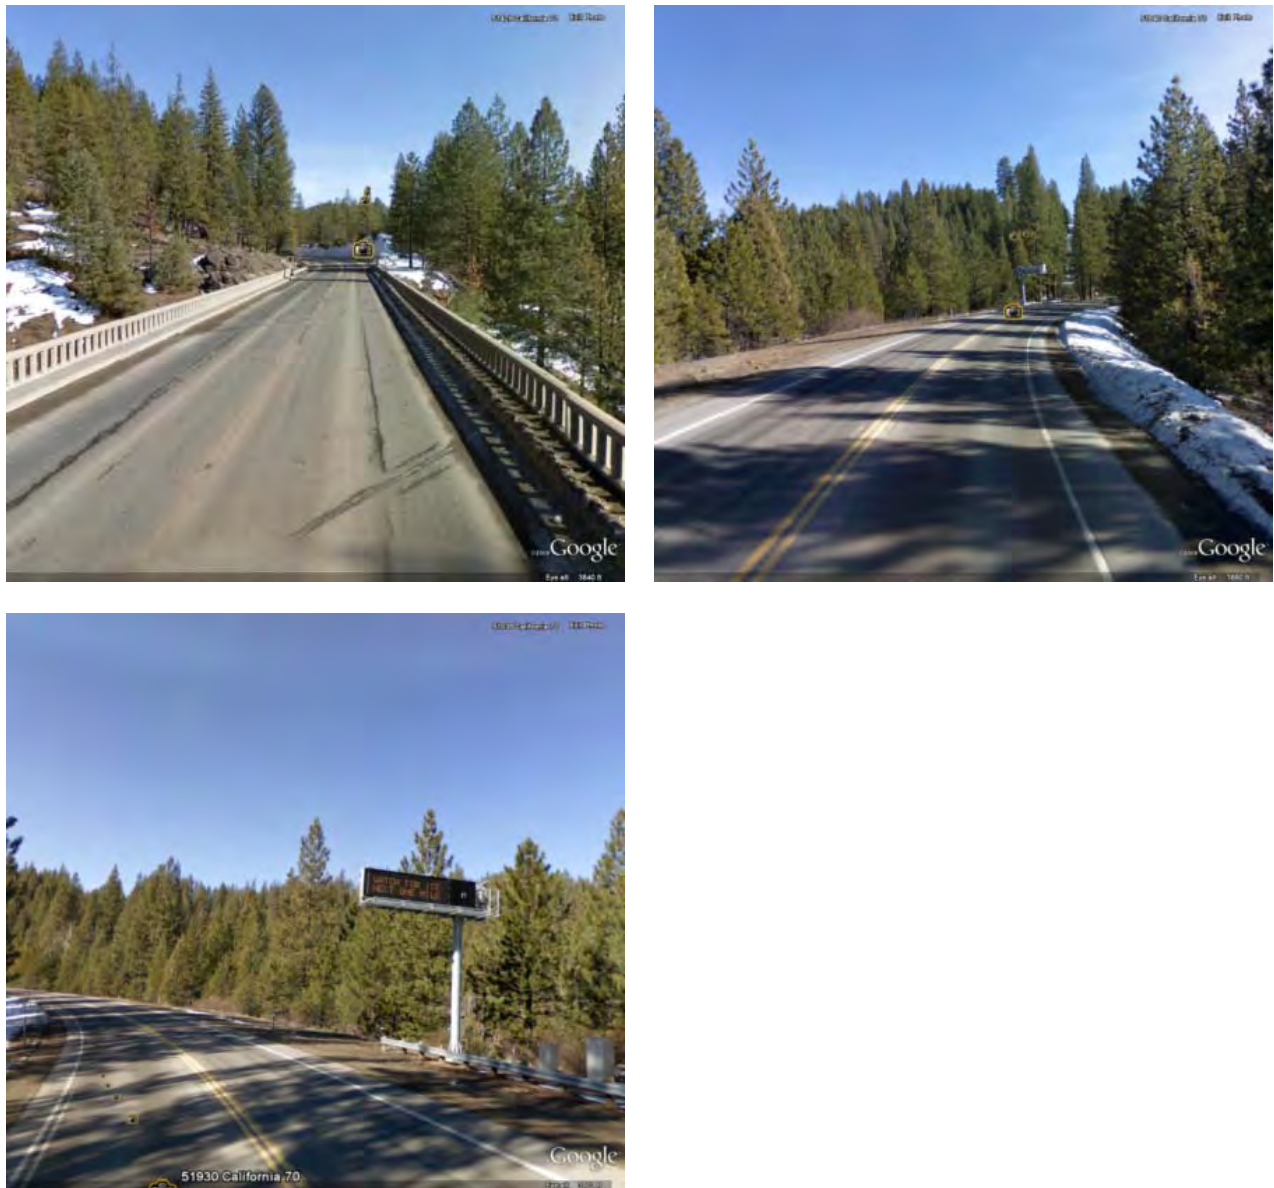
An ice warning alert was implemented at this site using the ASWC to warn drivers from either direction of ice on the road in the section covered by the surface sensors, which is generally shaded and along a slope where runoff occurs. The roadway prior to this section may be bare and dry while this section has ice due to runoff and cooler temperatures.

The following photos from Google Street View from February 2009 traverse this segment from West to East, and demonstrate this condition, with a bare and dry roadway preceding and following the segment and apparent ice on the segment.

Figure 12: Google Street View Images of Spring Garden ASWC Ice Warning Area (Part 1)

Figure 13: Google Street View Images of Spring Garden ASWC Ice Warning Area (Part 2)

Figure 14: Google Street View Images of Spring Garden ASWC Ice Warning Area (Part 3)

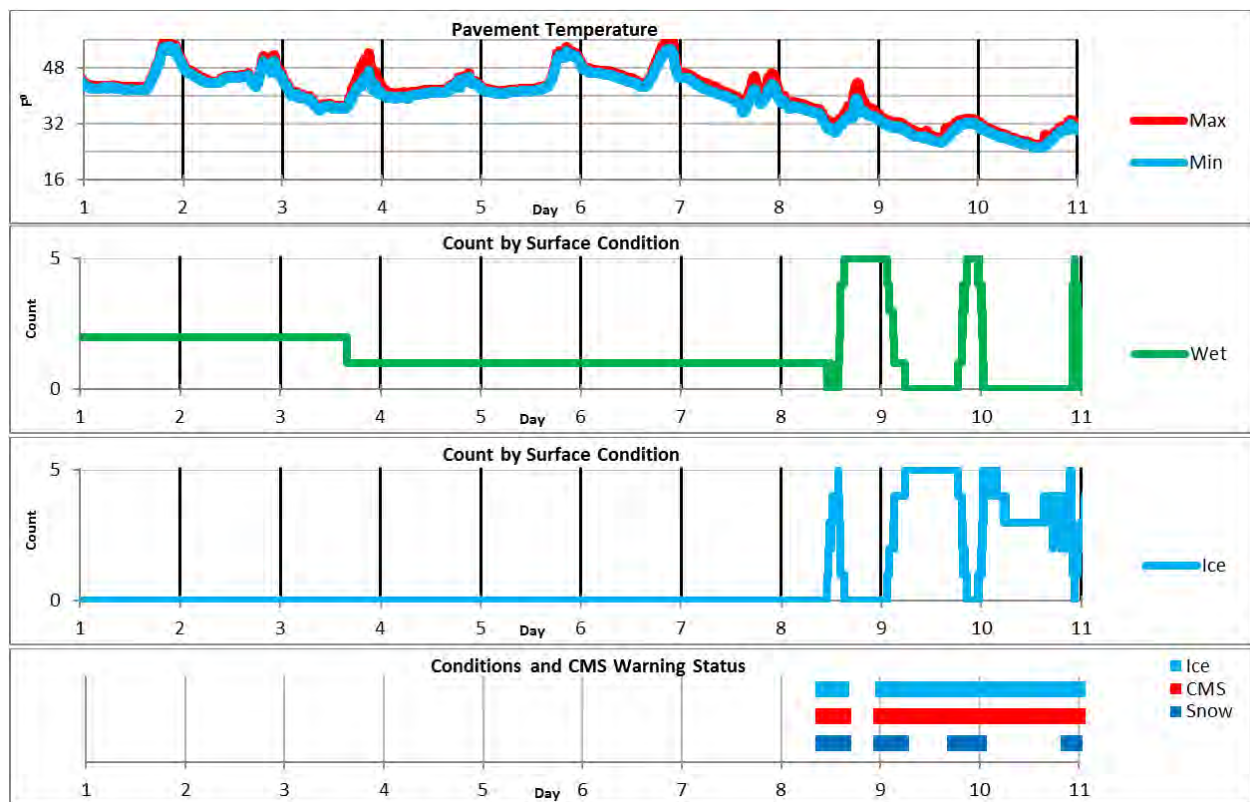
During the first seven days, no warning messages were displayed. Although several of the sensors detected “Wet” condition, temperatures were above freezing. On the 8th through 10th days, the warning message was triggered due to primarily to Ice conditions (Ice Warning, Ice Watch or Frost). When temperatures rose above freezing, the warning message was taken off the sign. At the end of the 8th day and throughout the entire 9th and 10th days Ice conditions were present and the warning message was displayed. Note that the “Snow” condition, which corresponds to “Wet” and temperature below 32.5 degrees was intermittent during this time. Ice conditions were reported on as many as 5 of the sensors during this time. Note further that one of the surface sensors was reported invalid values, so these summaries only include five of the surface sensors.

Figure 16: Conditions and Warning Status for 2012-12-01 through 2012-12-10 GMT (pavement temperatures in °F, “Count” is the number of sensors reporting the given conditions)

The project team examined in detail the operation of the ASWC throughout December 2012 to verify that warning messages were invoked during conditions matching the alert logic. The following plots show this analysis and confirm correct operation of the ASWC. Note that times and day breakdowns correspond to GMT.

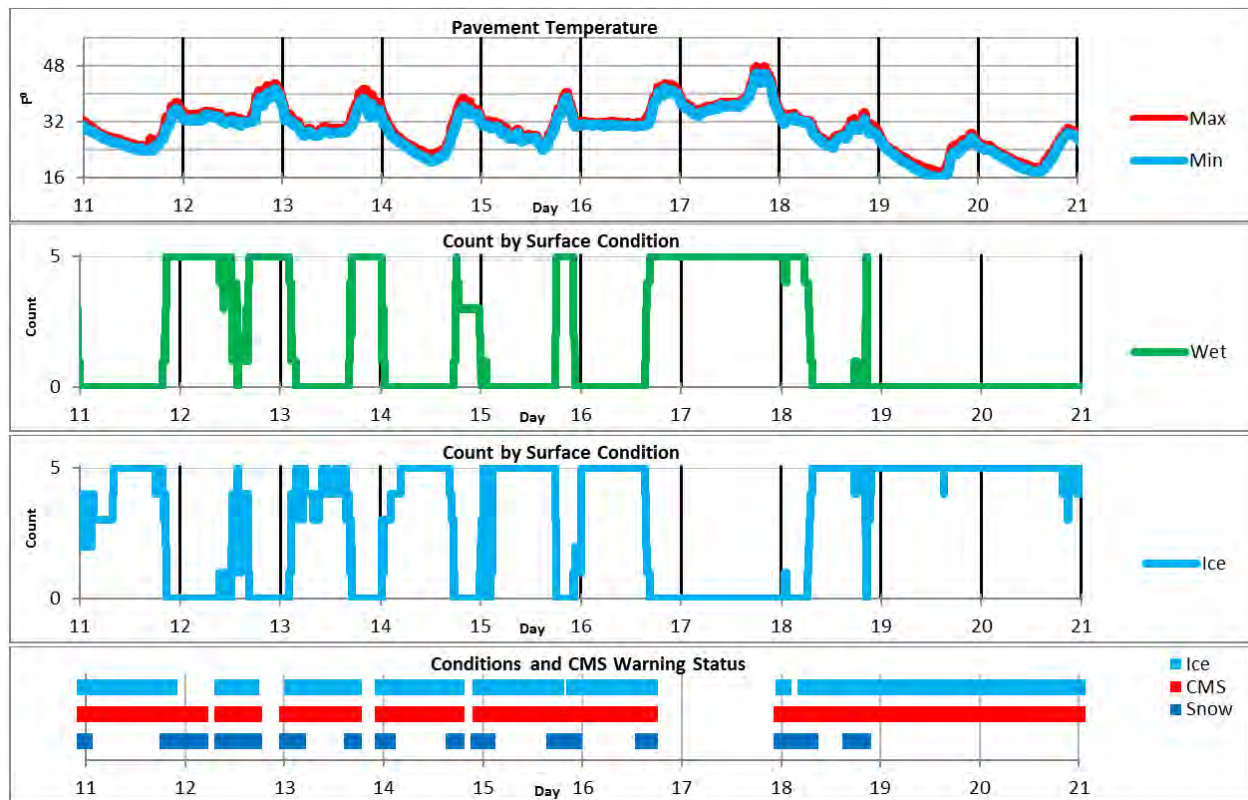
Warning messages were invoked over most of the 11th through 20th days, with the exception of most of Day 17, when temperatures were above freezing. Note that several times, particularly at the end of day 11 and the beginning of Day 12, Ice conditions were not present but snow conditions were. During days 15 and 18, Snow conditions caused the warning message to remain on the signs during short periods in which ice conditions were not reported.

Figure 17: Conditions and Warning Status for 2012-12-11 through 2012-12-20GMT (pavement temperatures in °F, “Count” is the number of sensors reporting the given conditions)

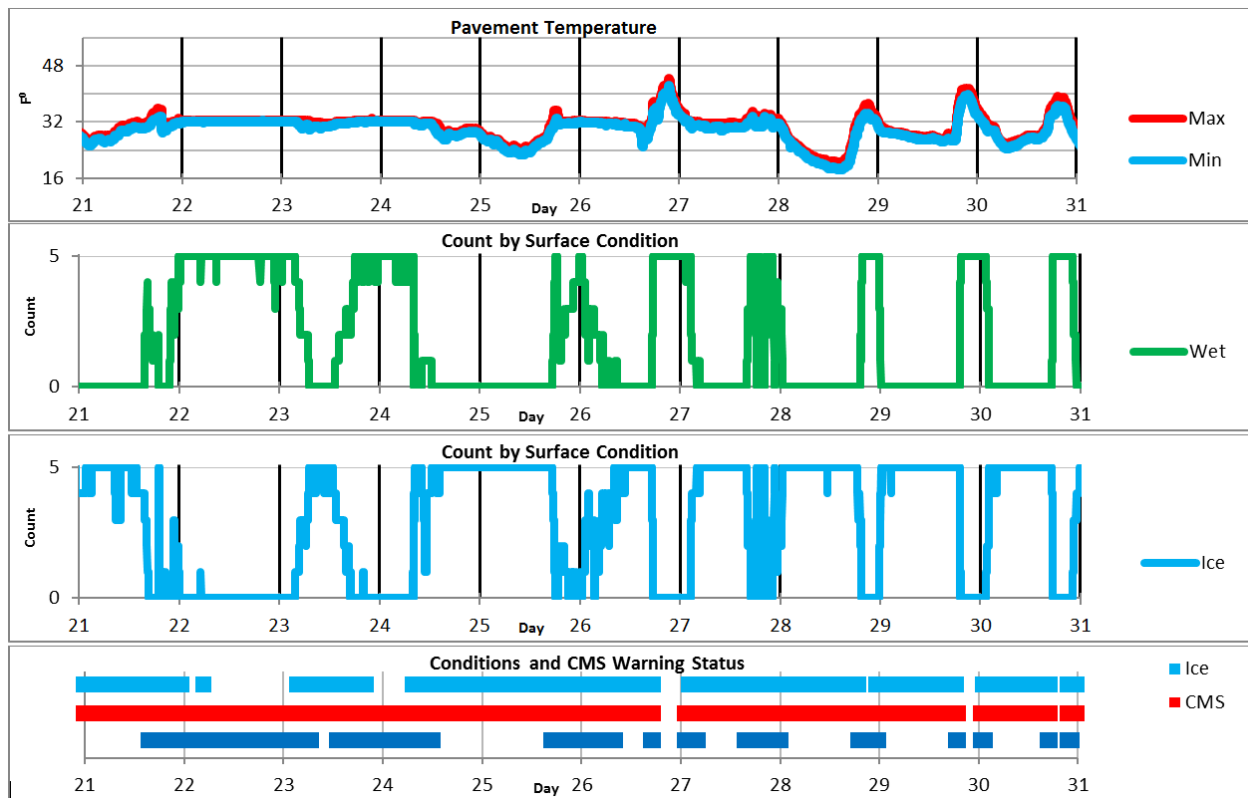
Days 21 through 30 showed similar behavior, with warning messages active for all but a short interval on Day 26, another on Day 29, and a very short time on Day 30.

Figure 18: Conditions and Warning Status for 2012-12-21 through 2012-12-30GMT (pavement temperatures in °F, “Count” is the number of sensors reporting the given conditions)
