1. REPORT NUMBER CA13-1750	2. GOVERNMENT ASSOCIATION NUMBER	3. RECIPIENT'S CATALOG NUMBER
4. TITLE AND SUBTITLE Automated Safety Warning Controller Final Report	5. REPORT DATE March 22, 2013	6. PERFORMING ORGANIZATION CODE

Automated Safety Warning Controller

Final Report

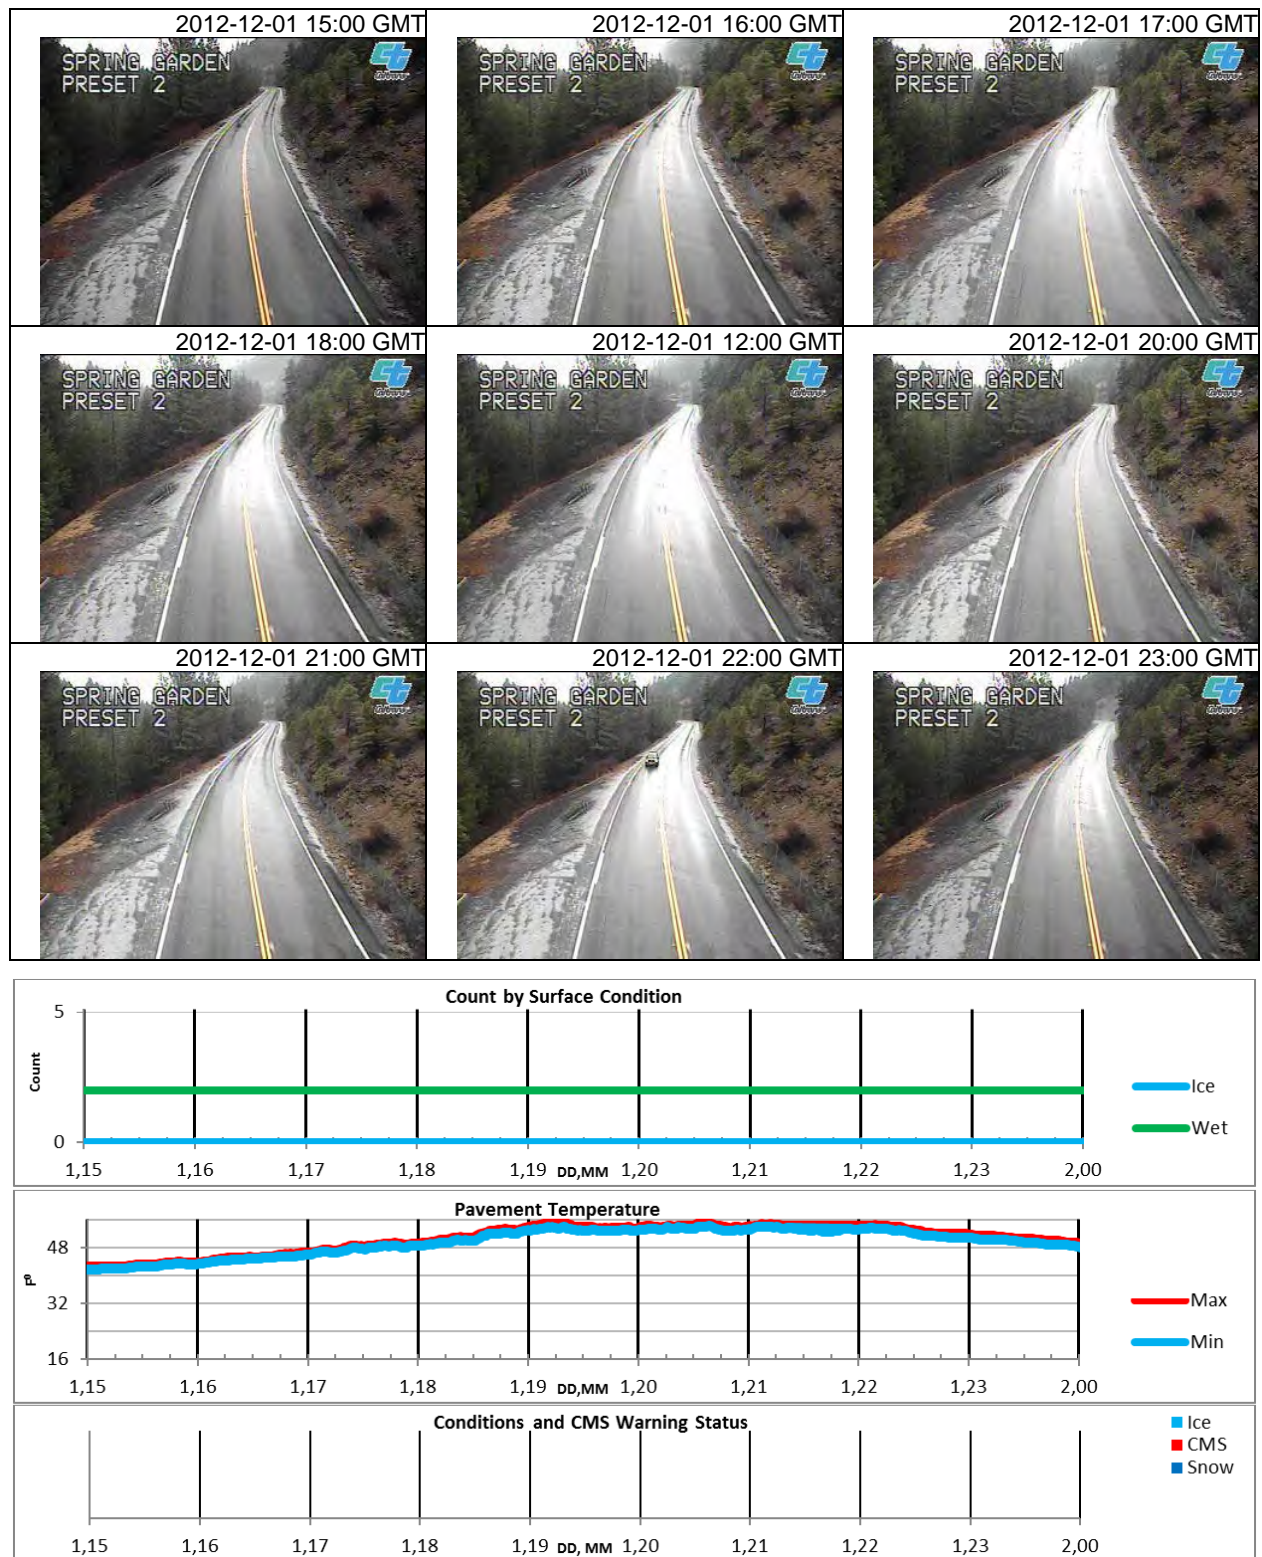
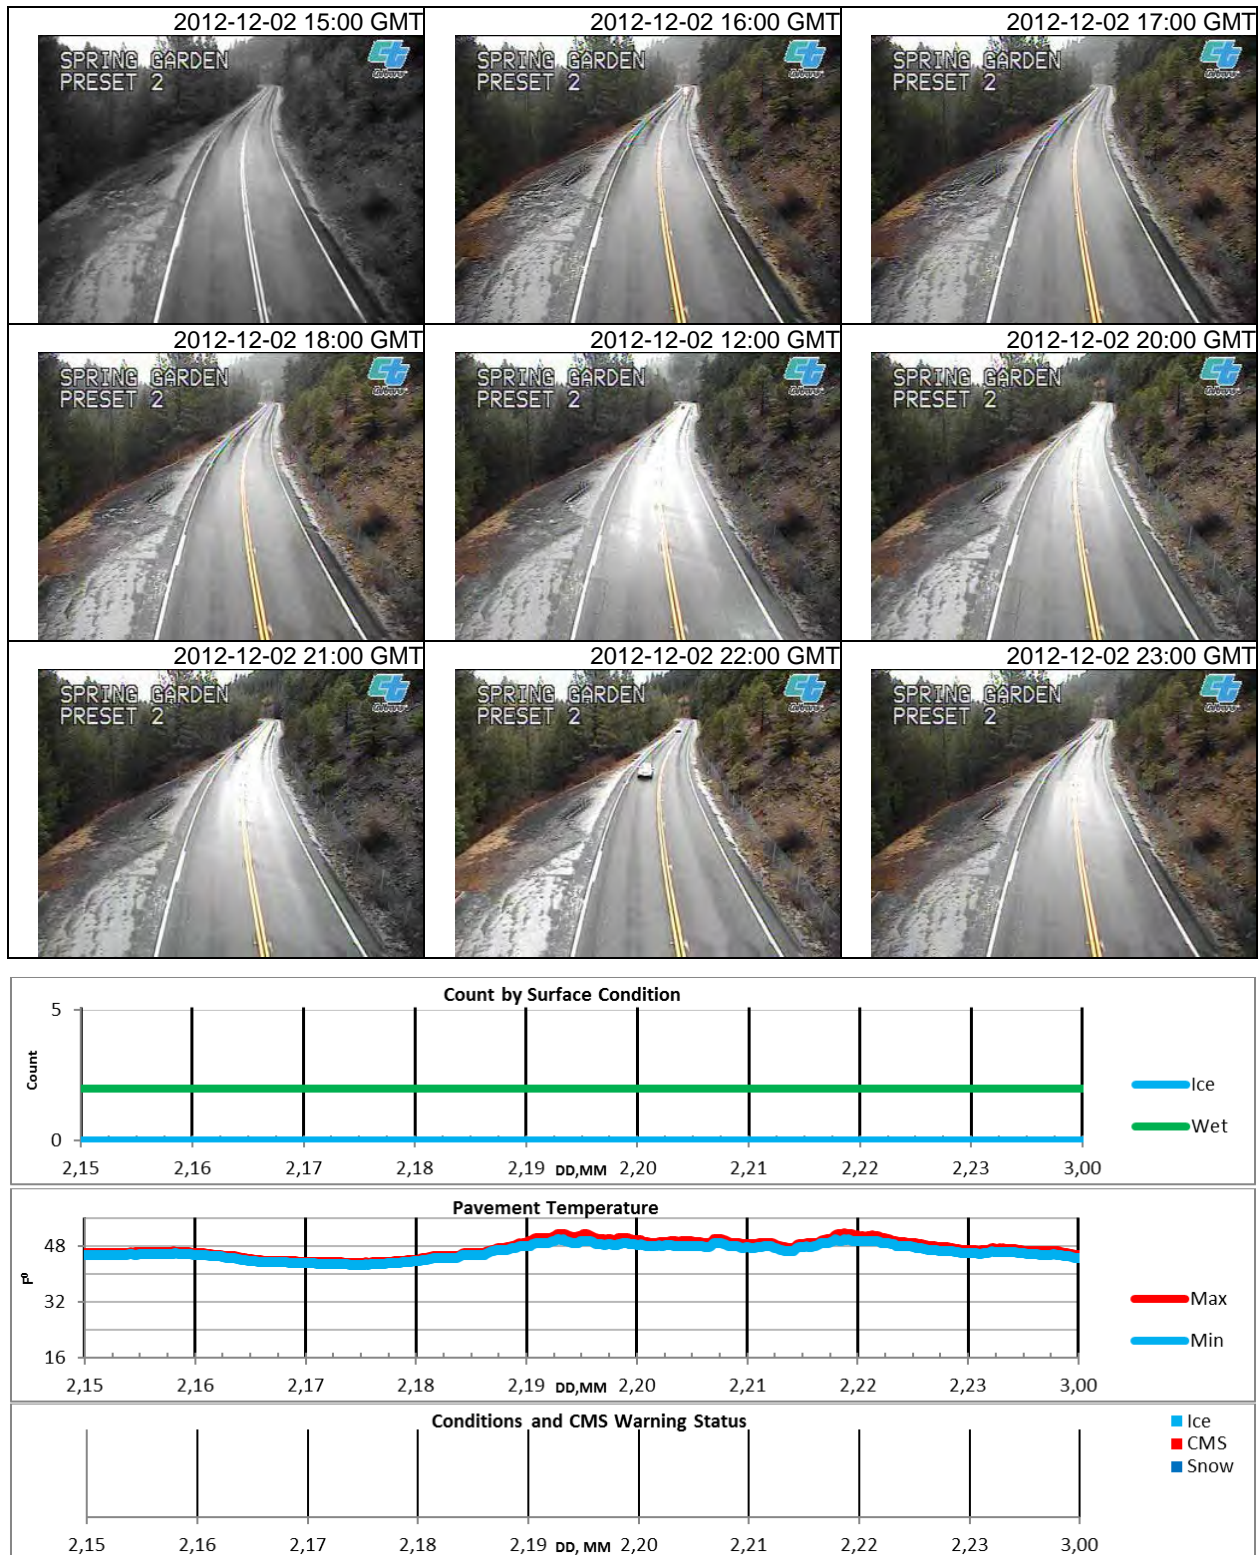
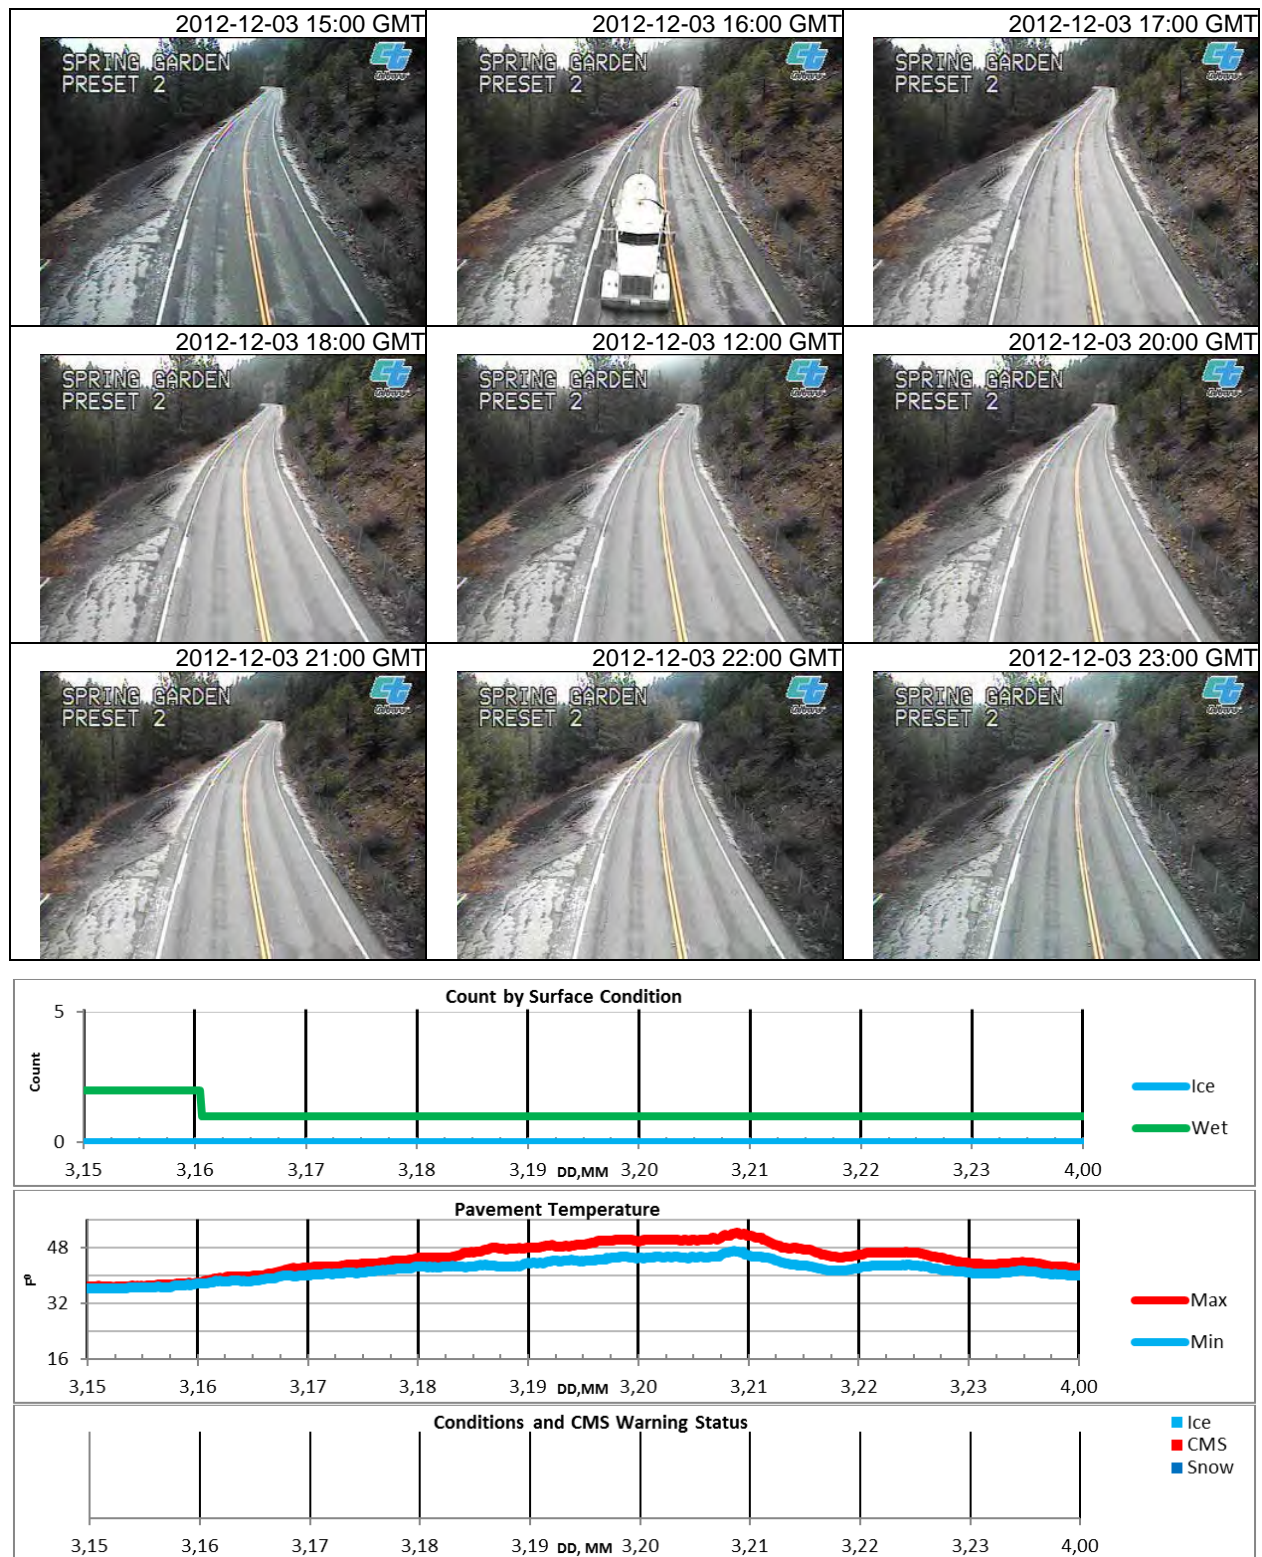
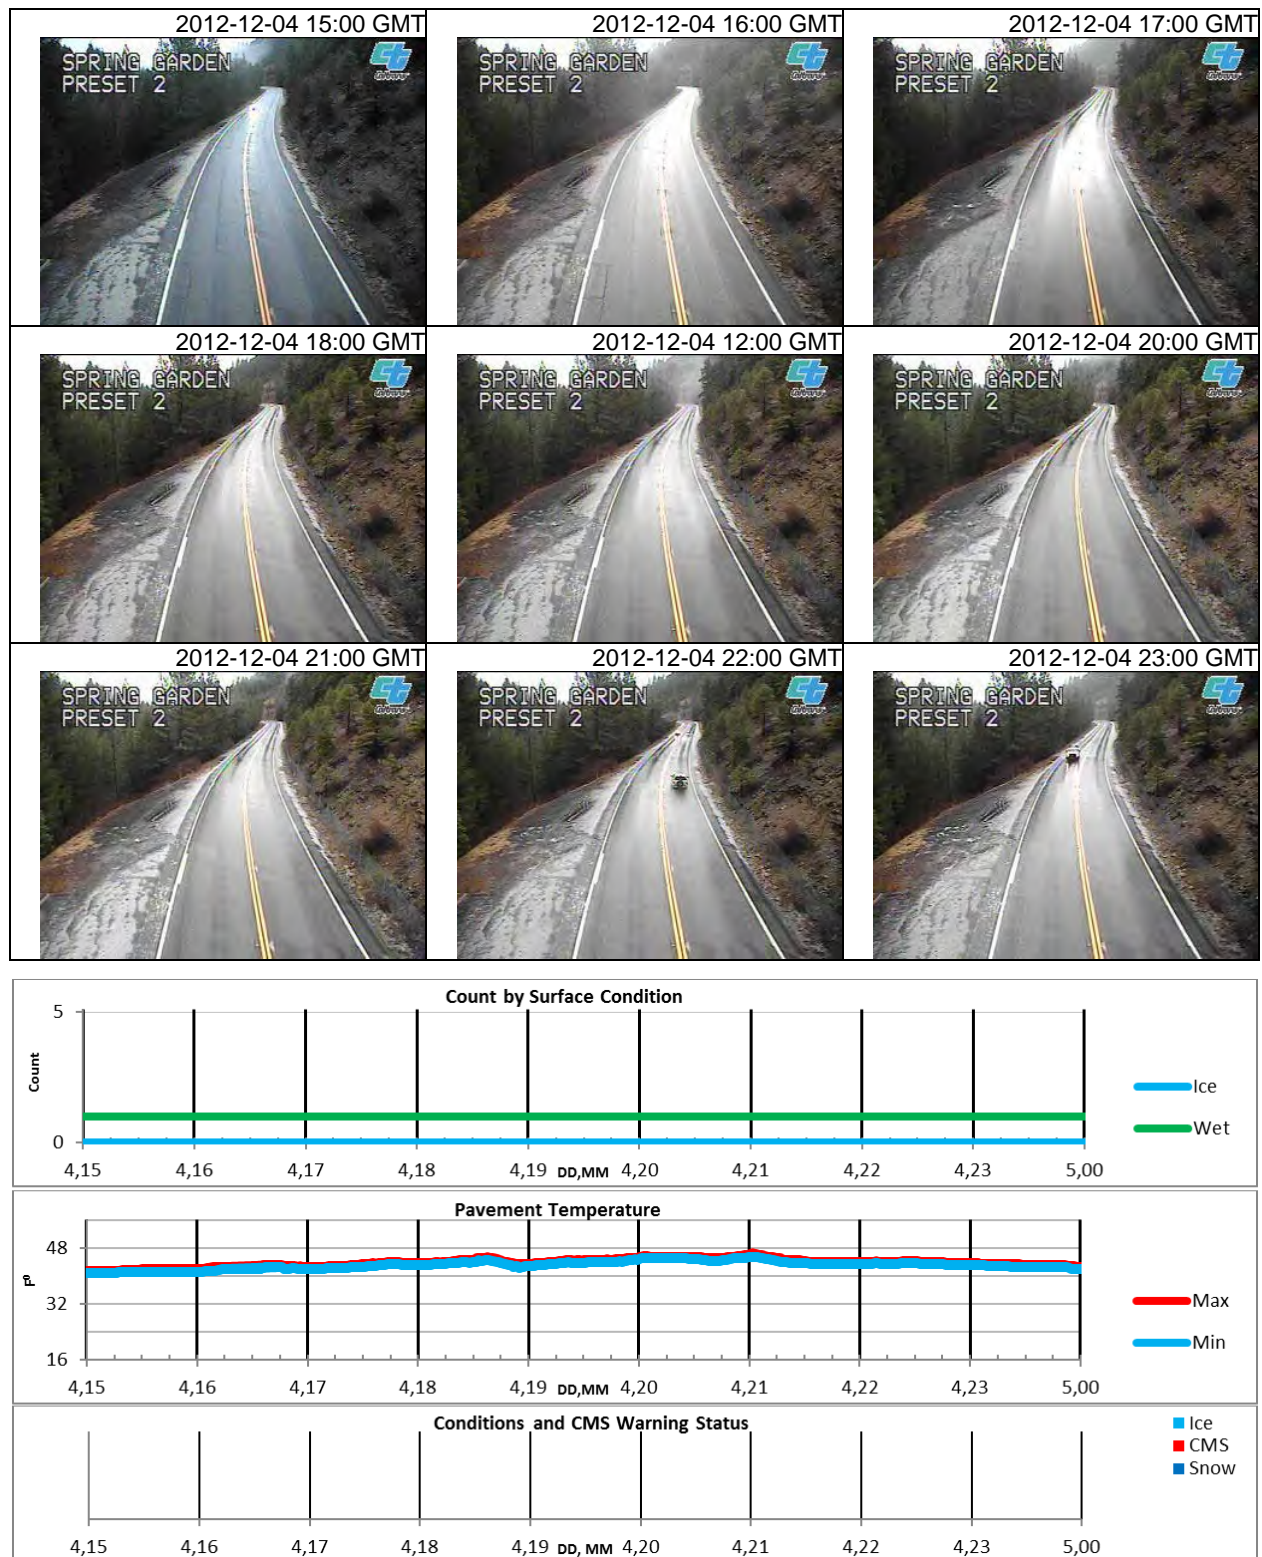
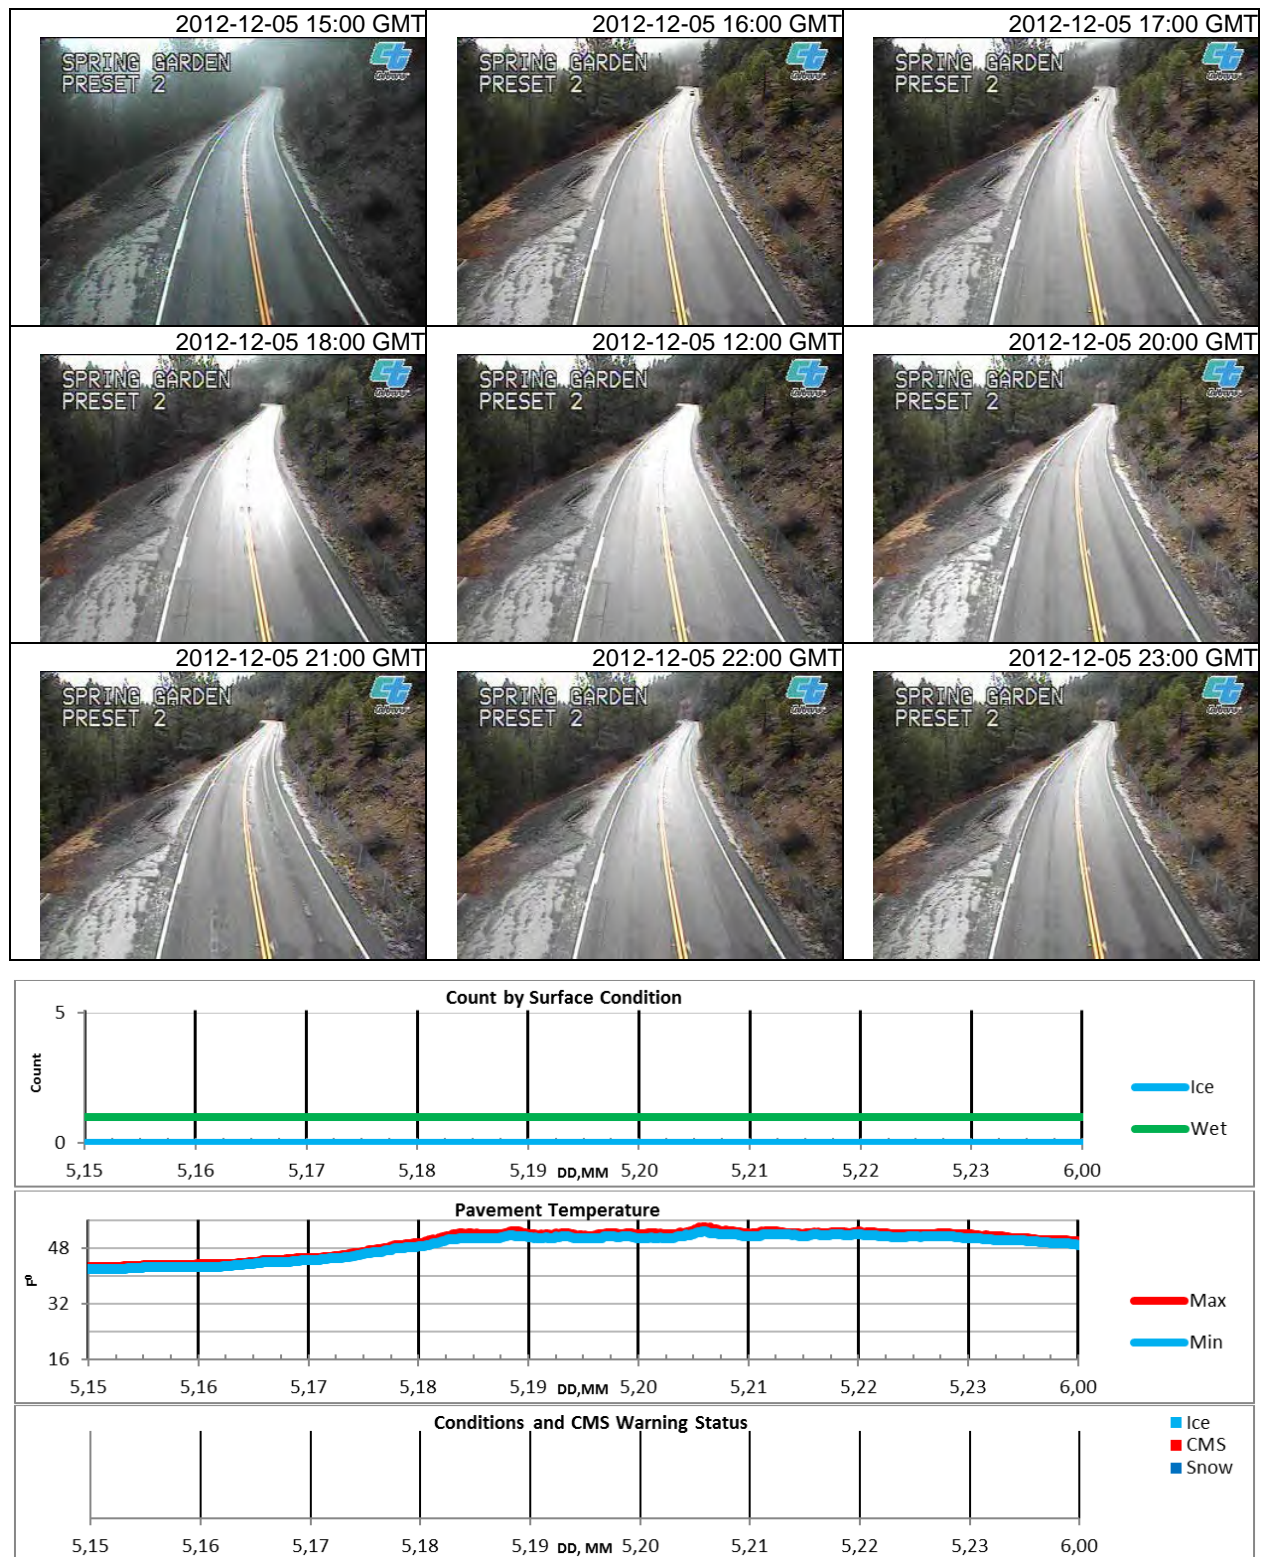
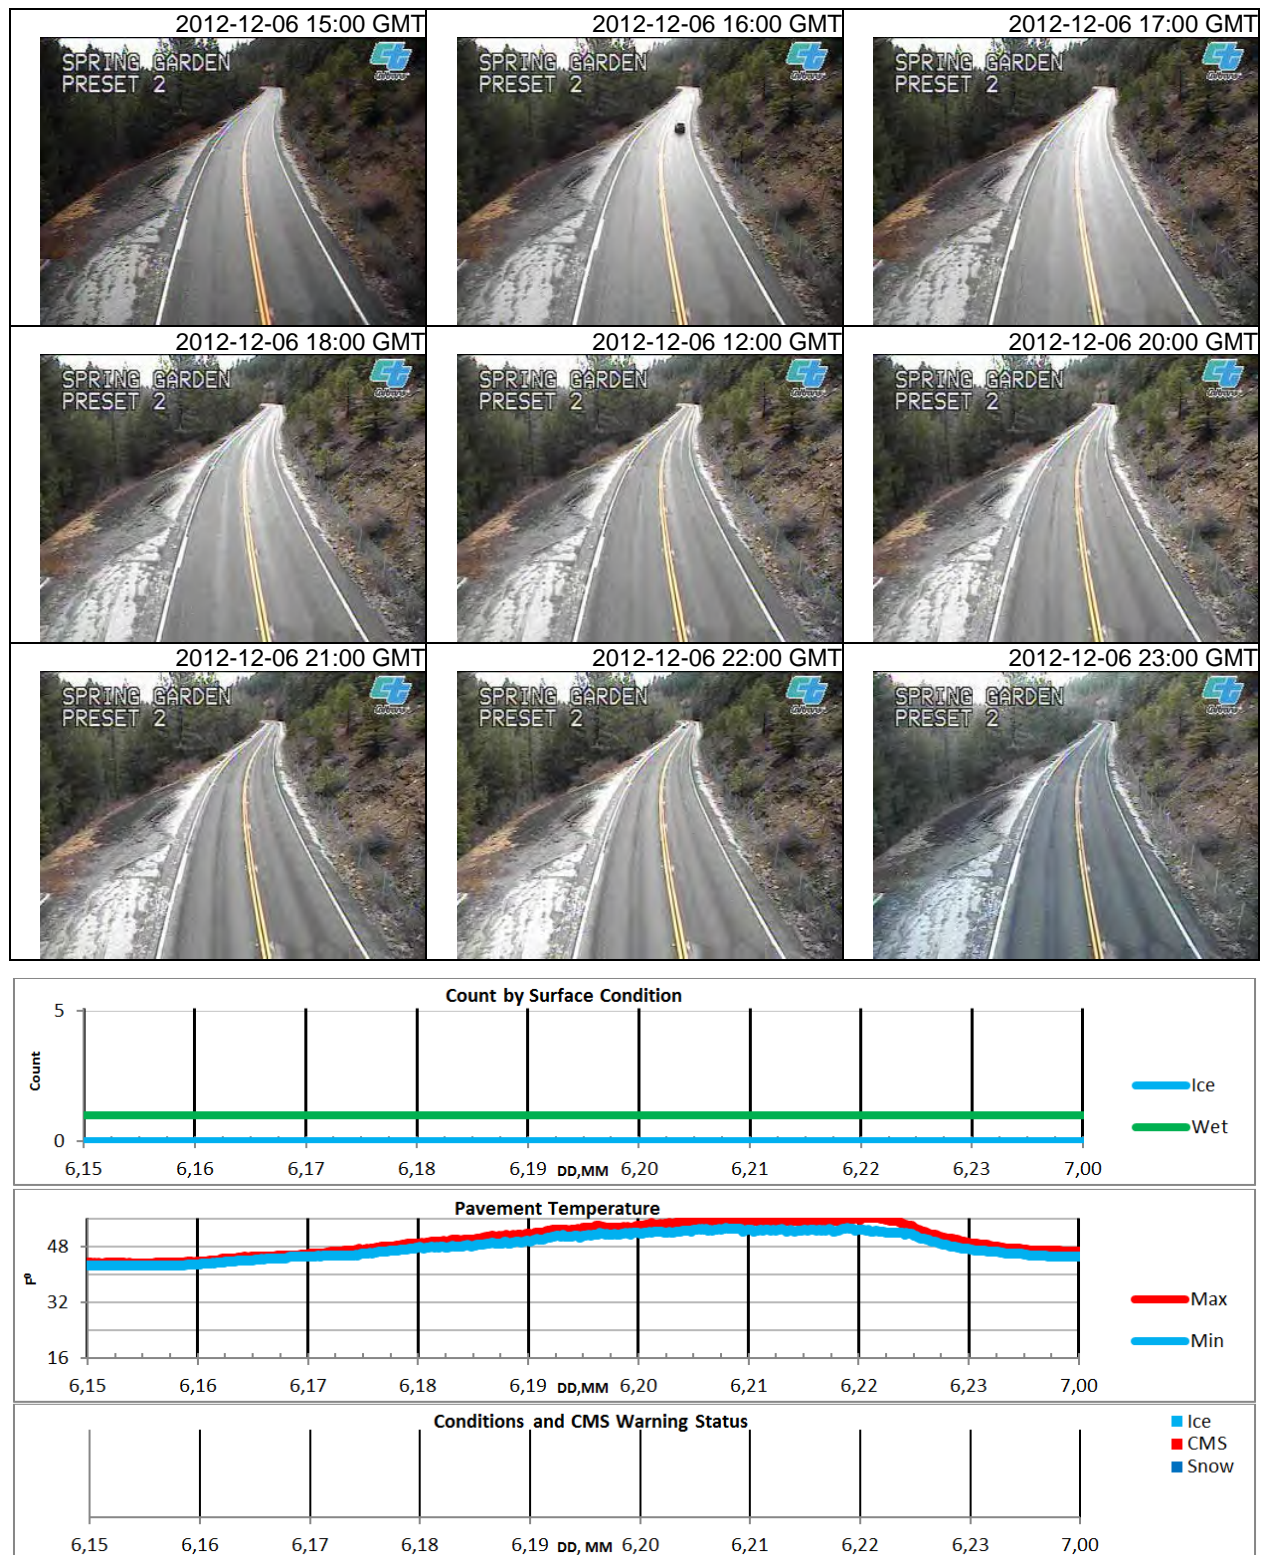
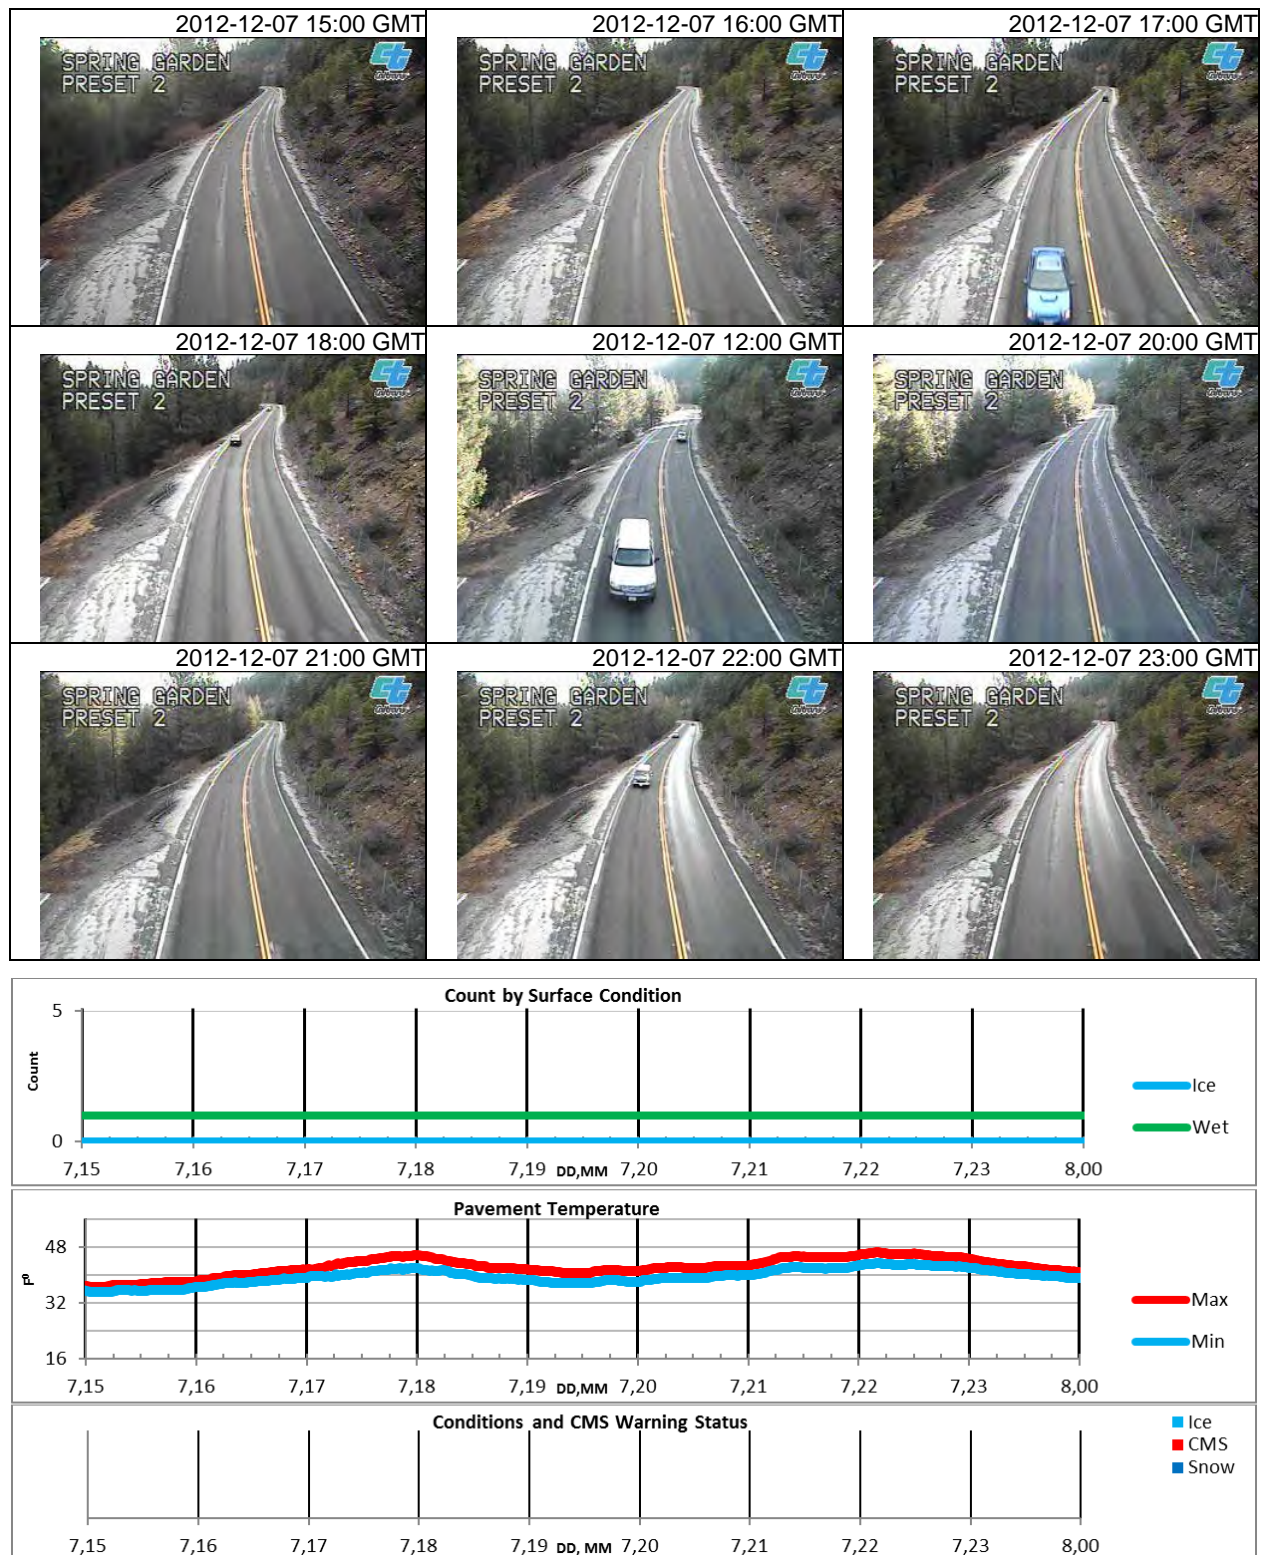
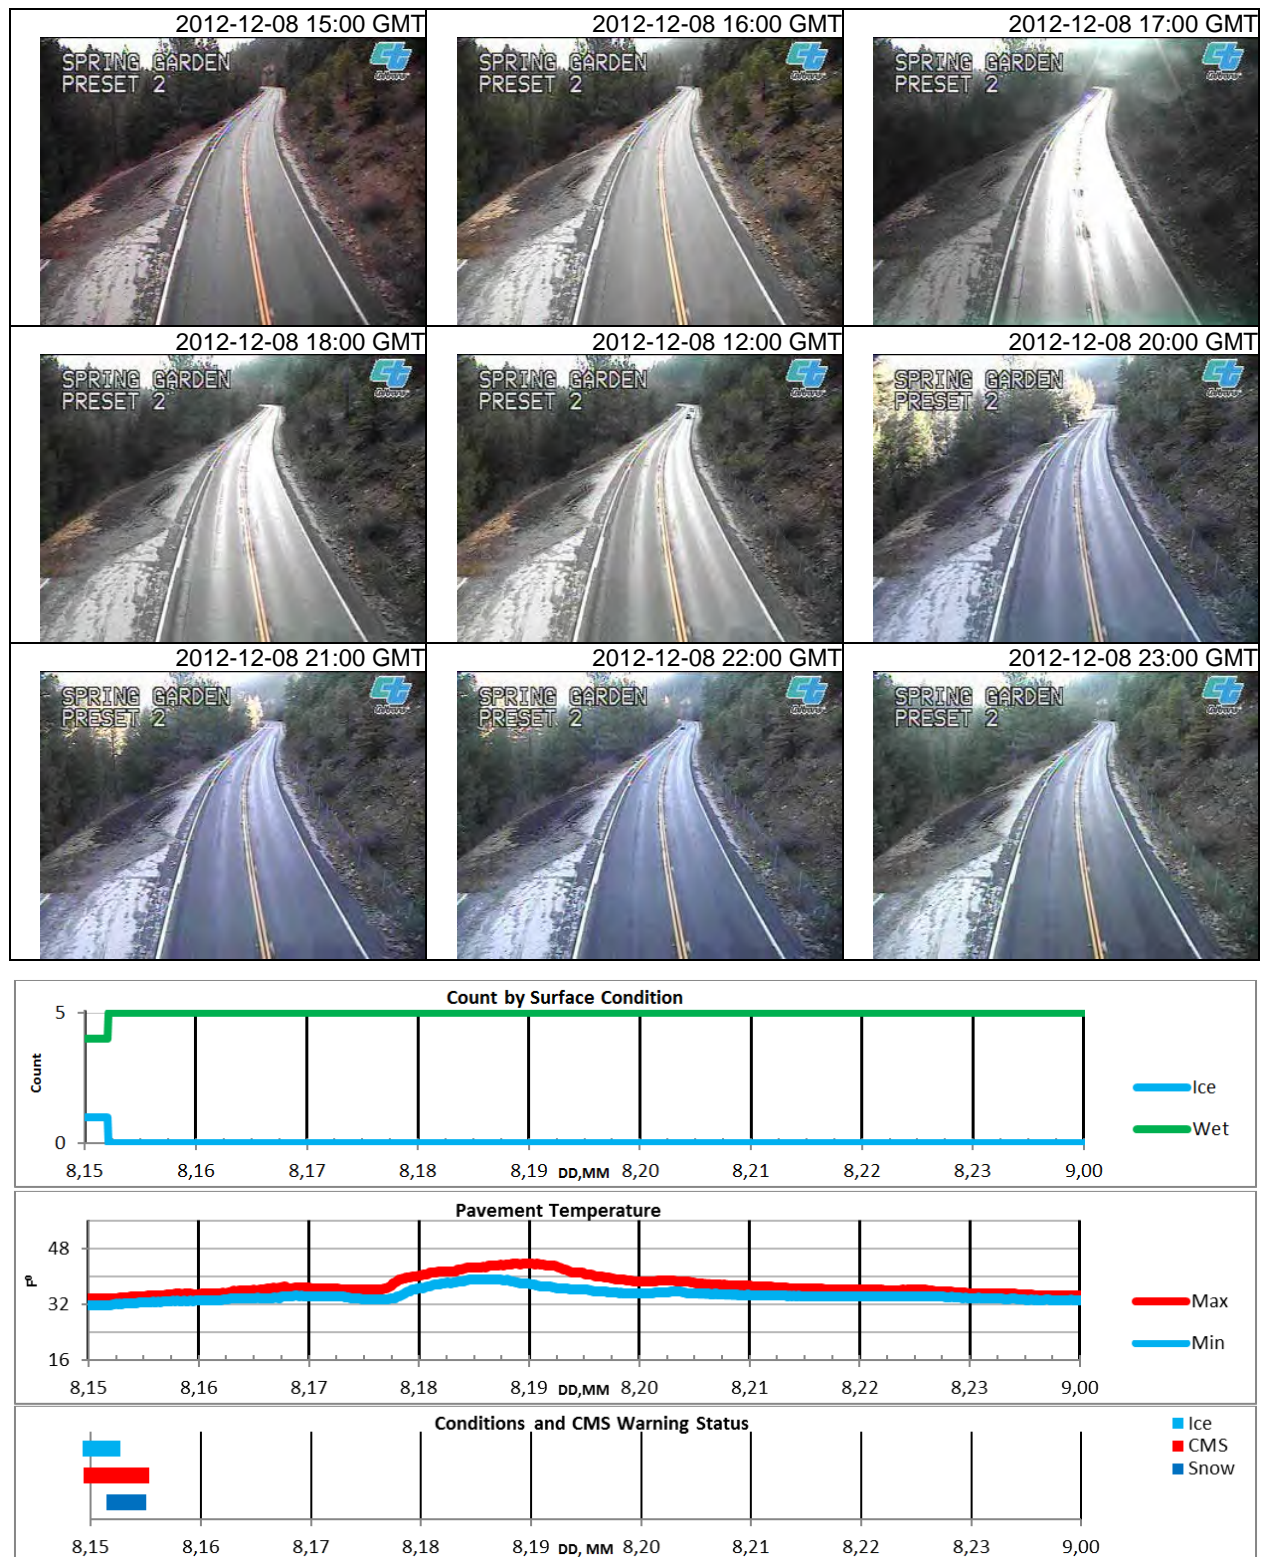
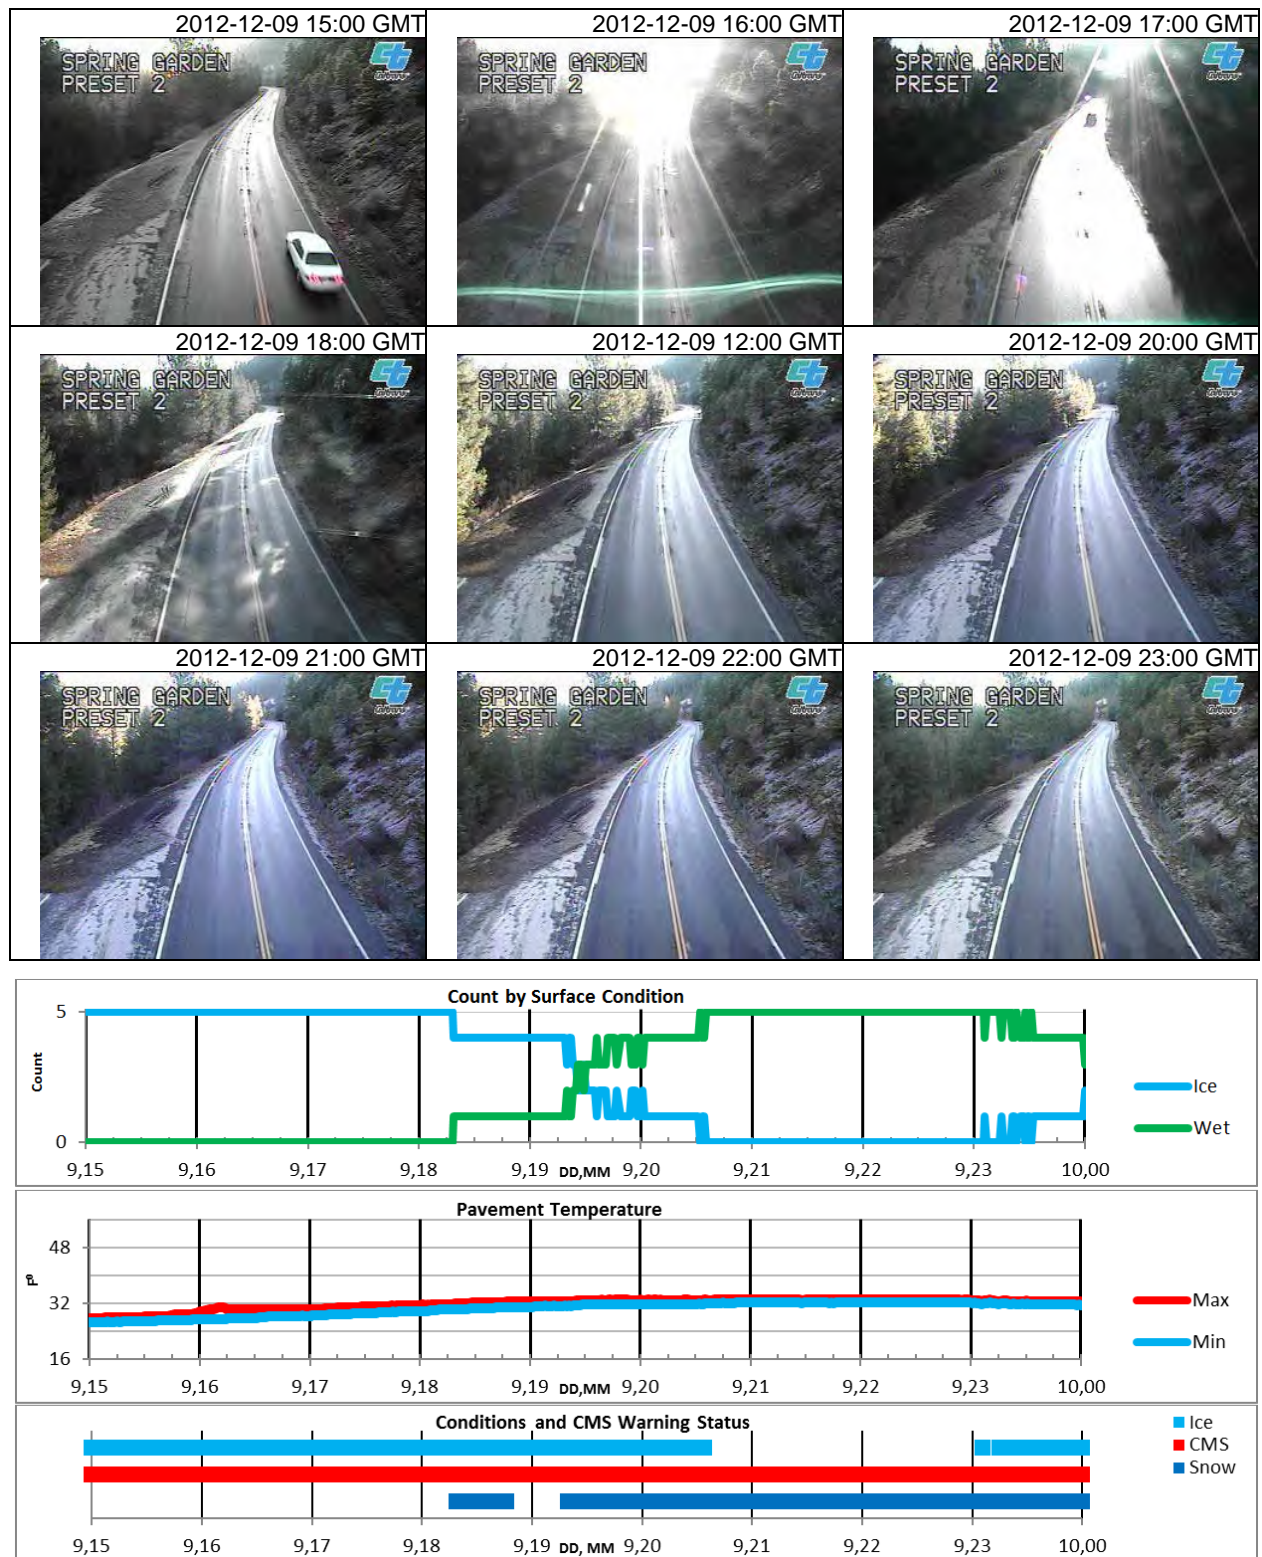
The following CCTV images and graphs corresponding to daylight hours and allow for visual confirmation of the conditions at Spring Garden. Generally the CCTV images confirm the conditions, although it is difficult at times to determine from the images alone whether there is ice on the roadway. It is particularly interesting to observe the times in which conditions were changing from Ice to Wet and versa, including times when there is snow on the road, but ice conditions are not detected. For the latter, the additional logic used by Caltrans District 2 to represent “Snow” conditions appear to be merited, particularly during transition times which might otherwise result in no warning messages.

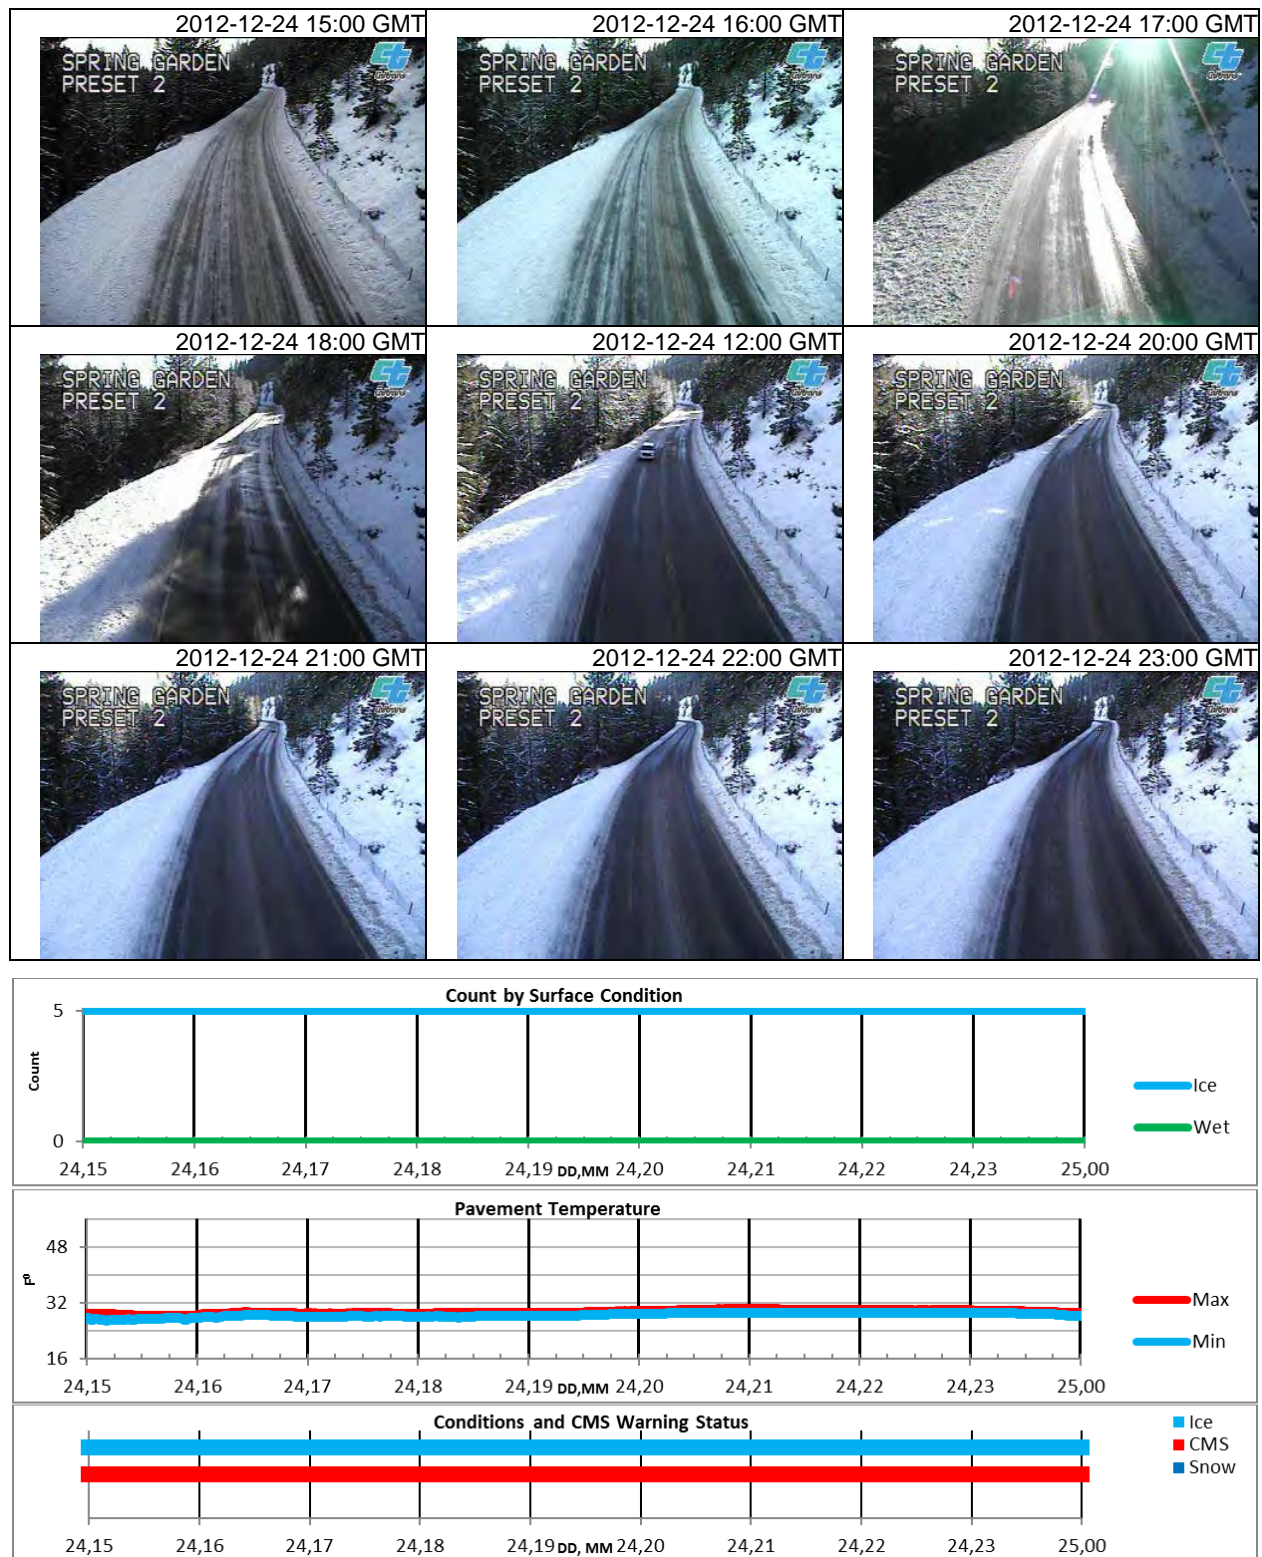
Figure 42: Conditions and Warning Status for 2012-12-24 GMT (pavement temperatures in °F, “Count” is the number of sensors reporting the given conditions)

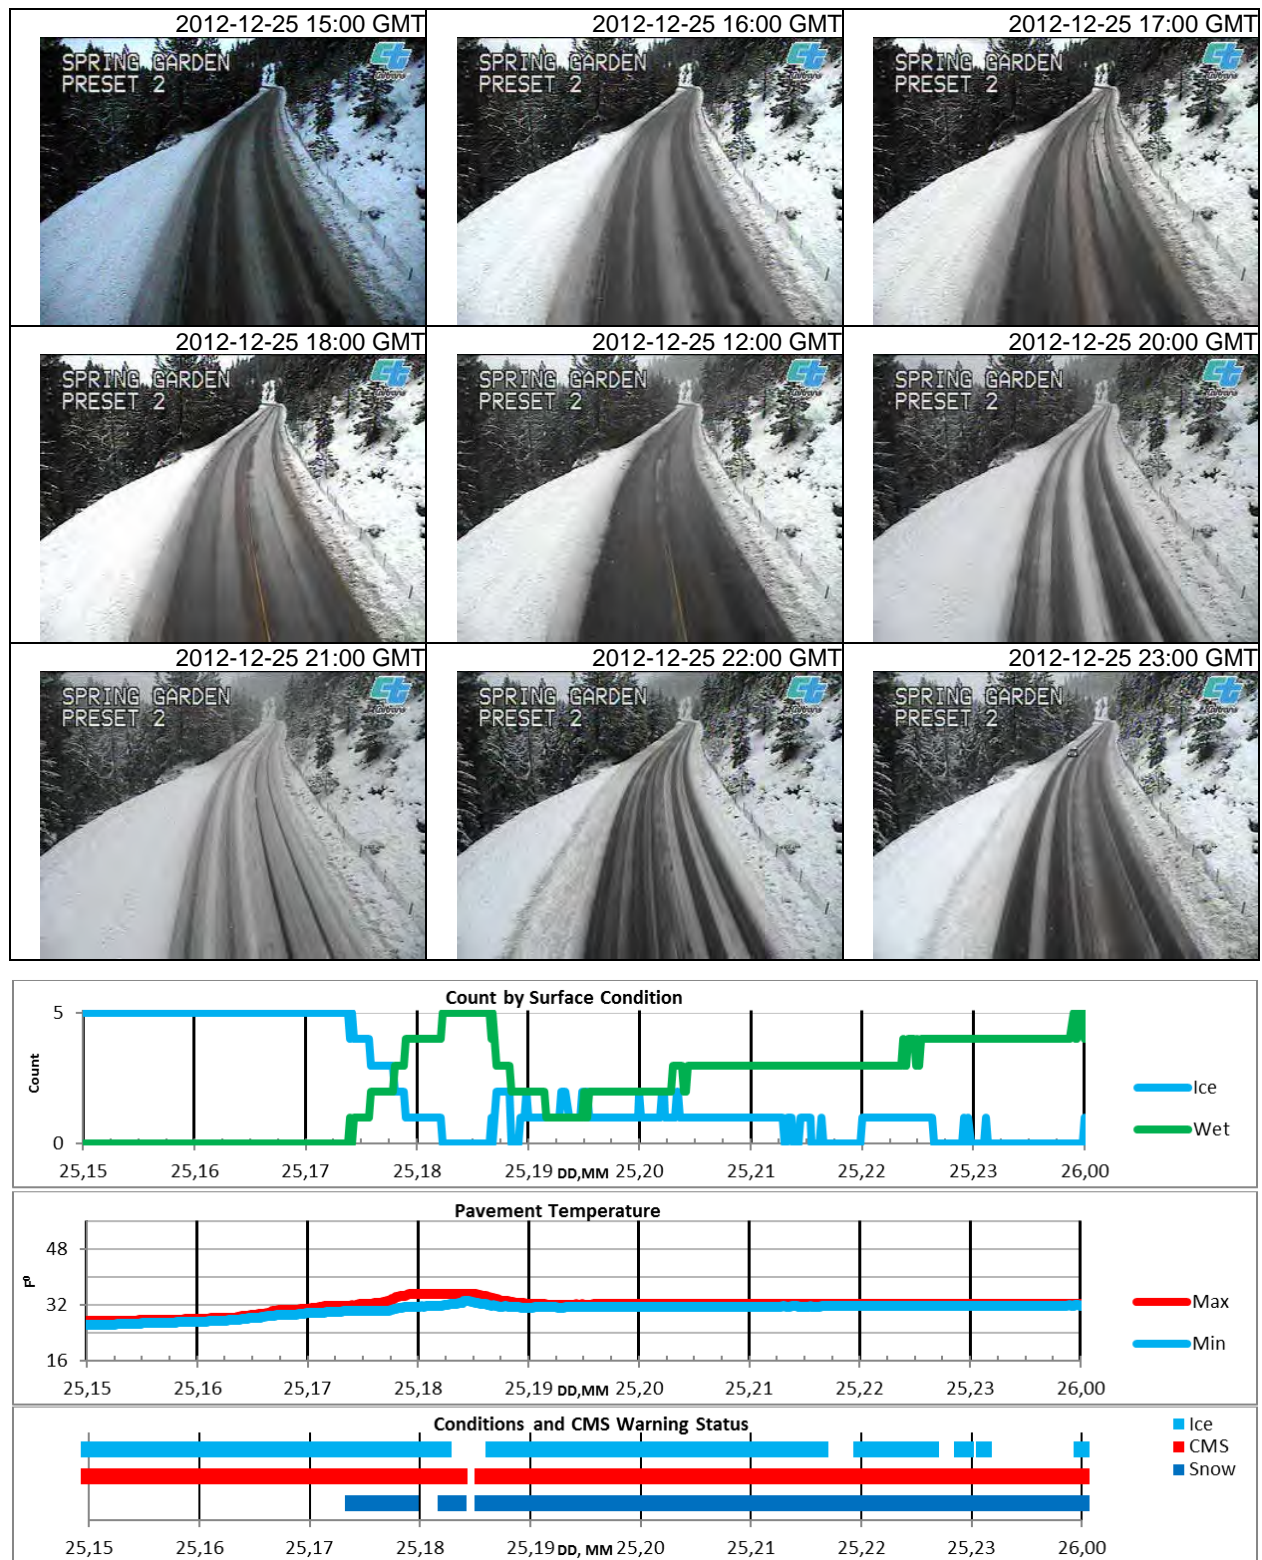
Figure 43: Conditions and Warning Status for 2012-12-25 GMT (pavement temperatures in °F, “Count” is the number of sensors reporting the given conditions)
