1. REPORT NUMBER CA13-1750	2. GOVERNMENT ASSOCIATION NUMBER	3. RECIPIENT'S CATALOG NUMBER
4. TITLE AND SUBTITLE Automated Safety Warning Controller Final Report	5. REPORT DATE March 22, 2013	6. PERFORMING ORGANIZATION CODE

Automated Safety Warning Controller

Final Report

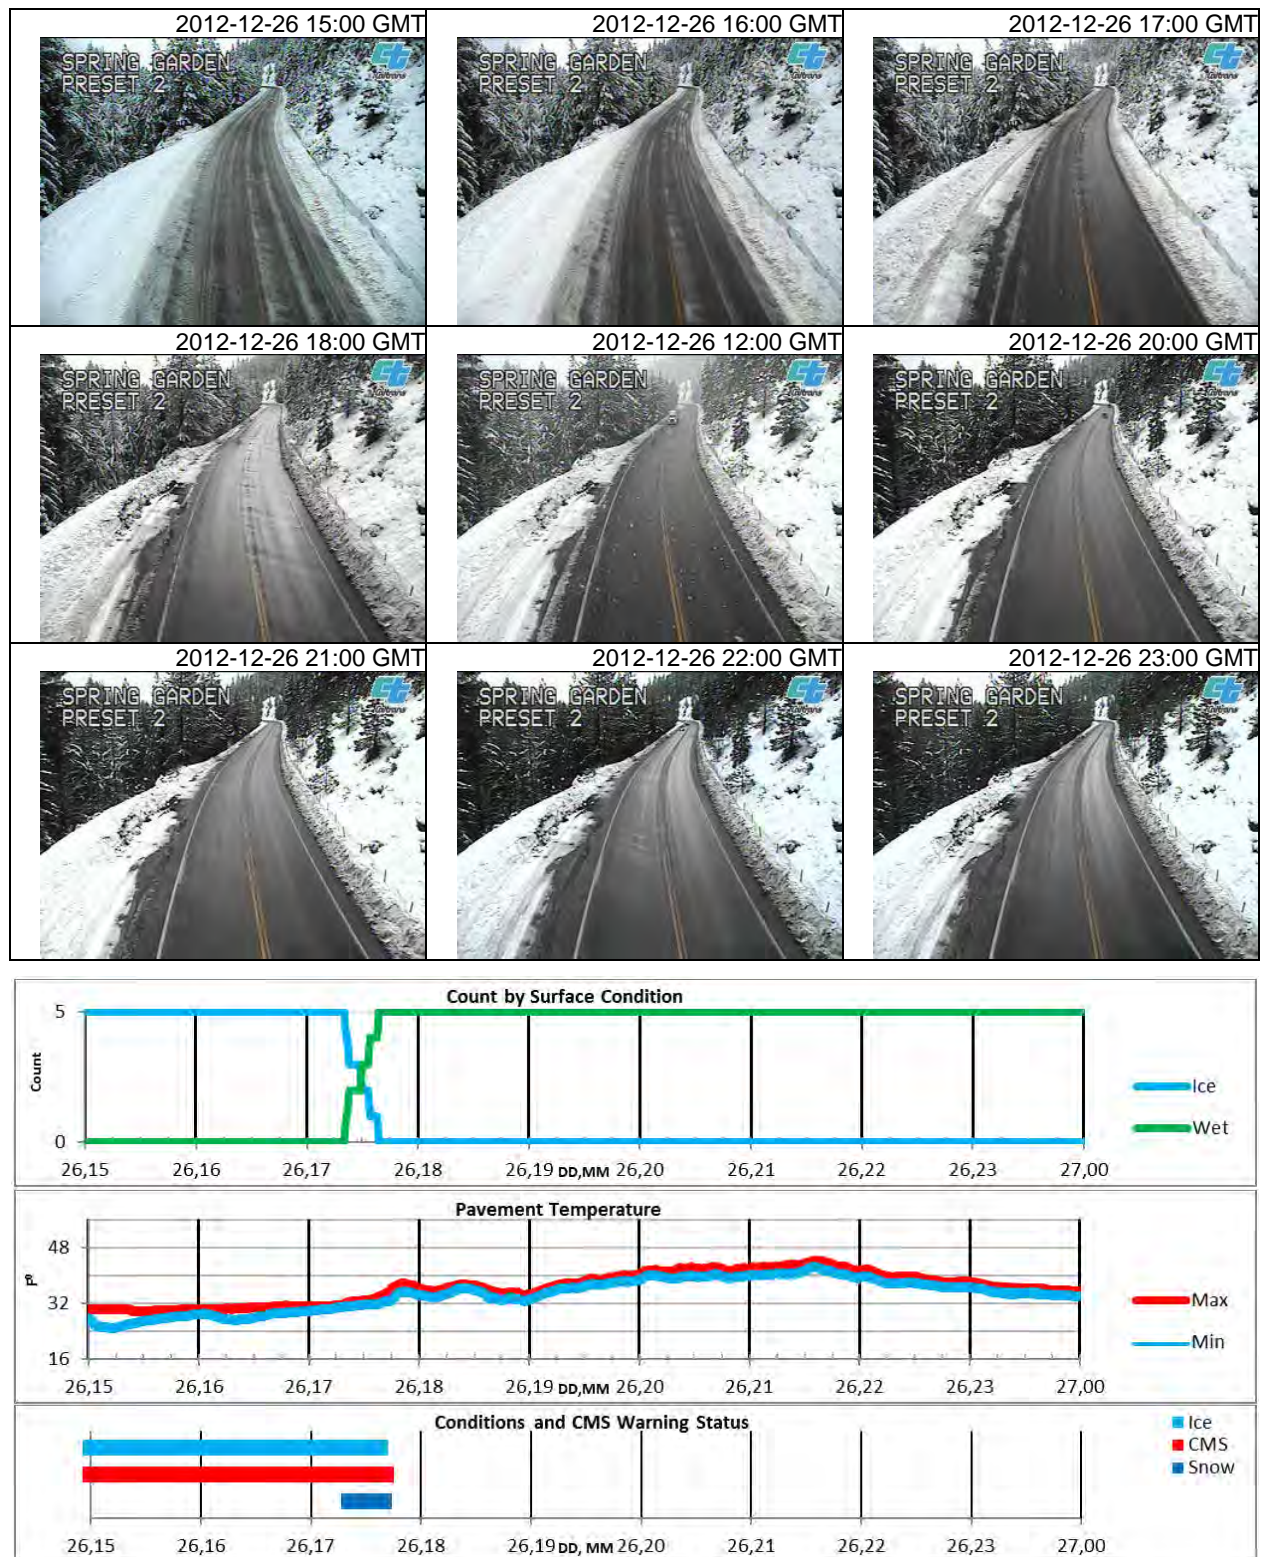
Figure 44: Conditions and Warning Status for 2012-12-26 GMT (pavement temperatures in °F, “Count” is the number of sensors reporting the given conditions)

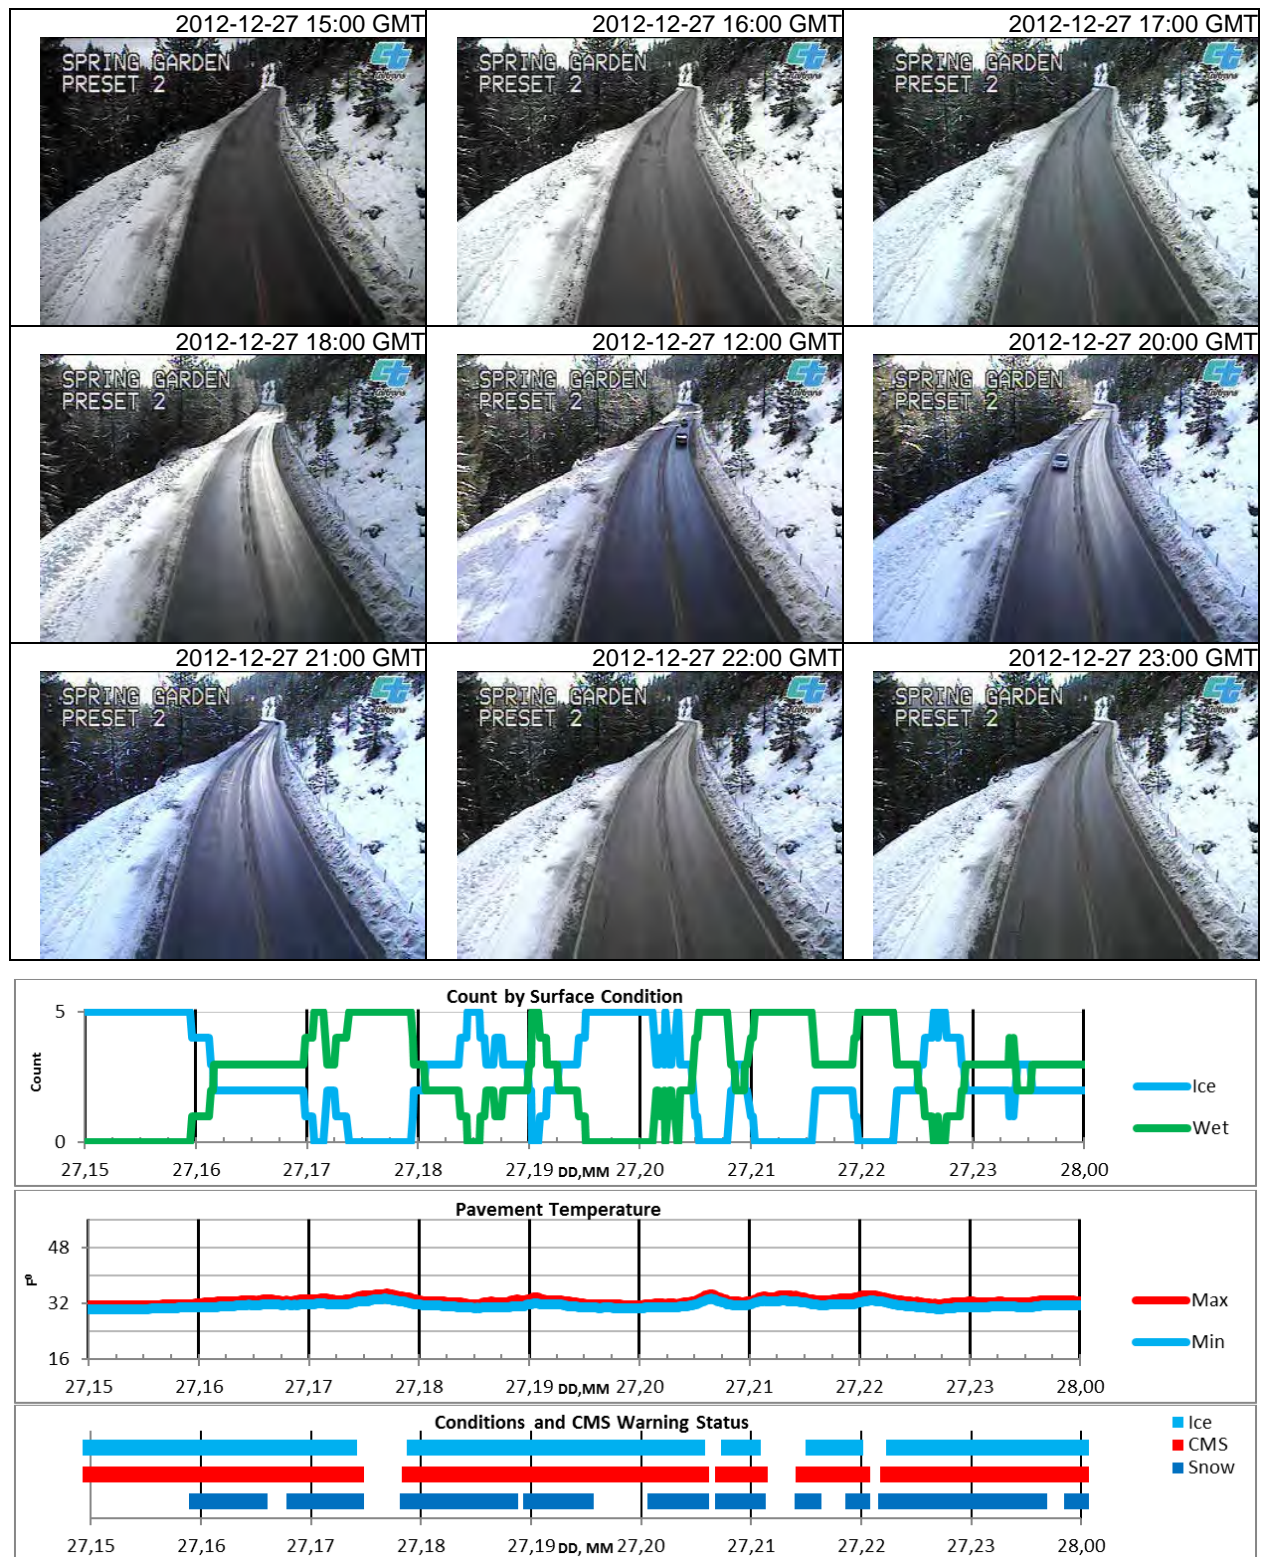
Figure 45: Conditions and Warning Status for 2012-12-27 GMT (pavement temperatures in °F, “Count” is the number of sensors reporting the given conditions)

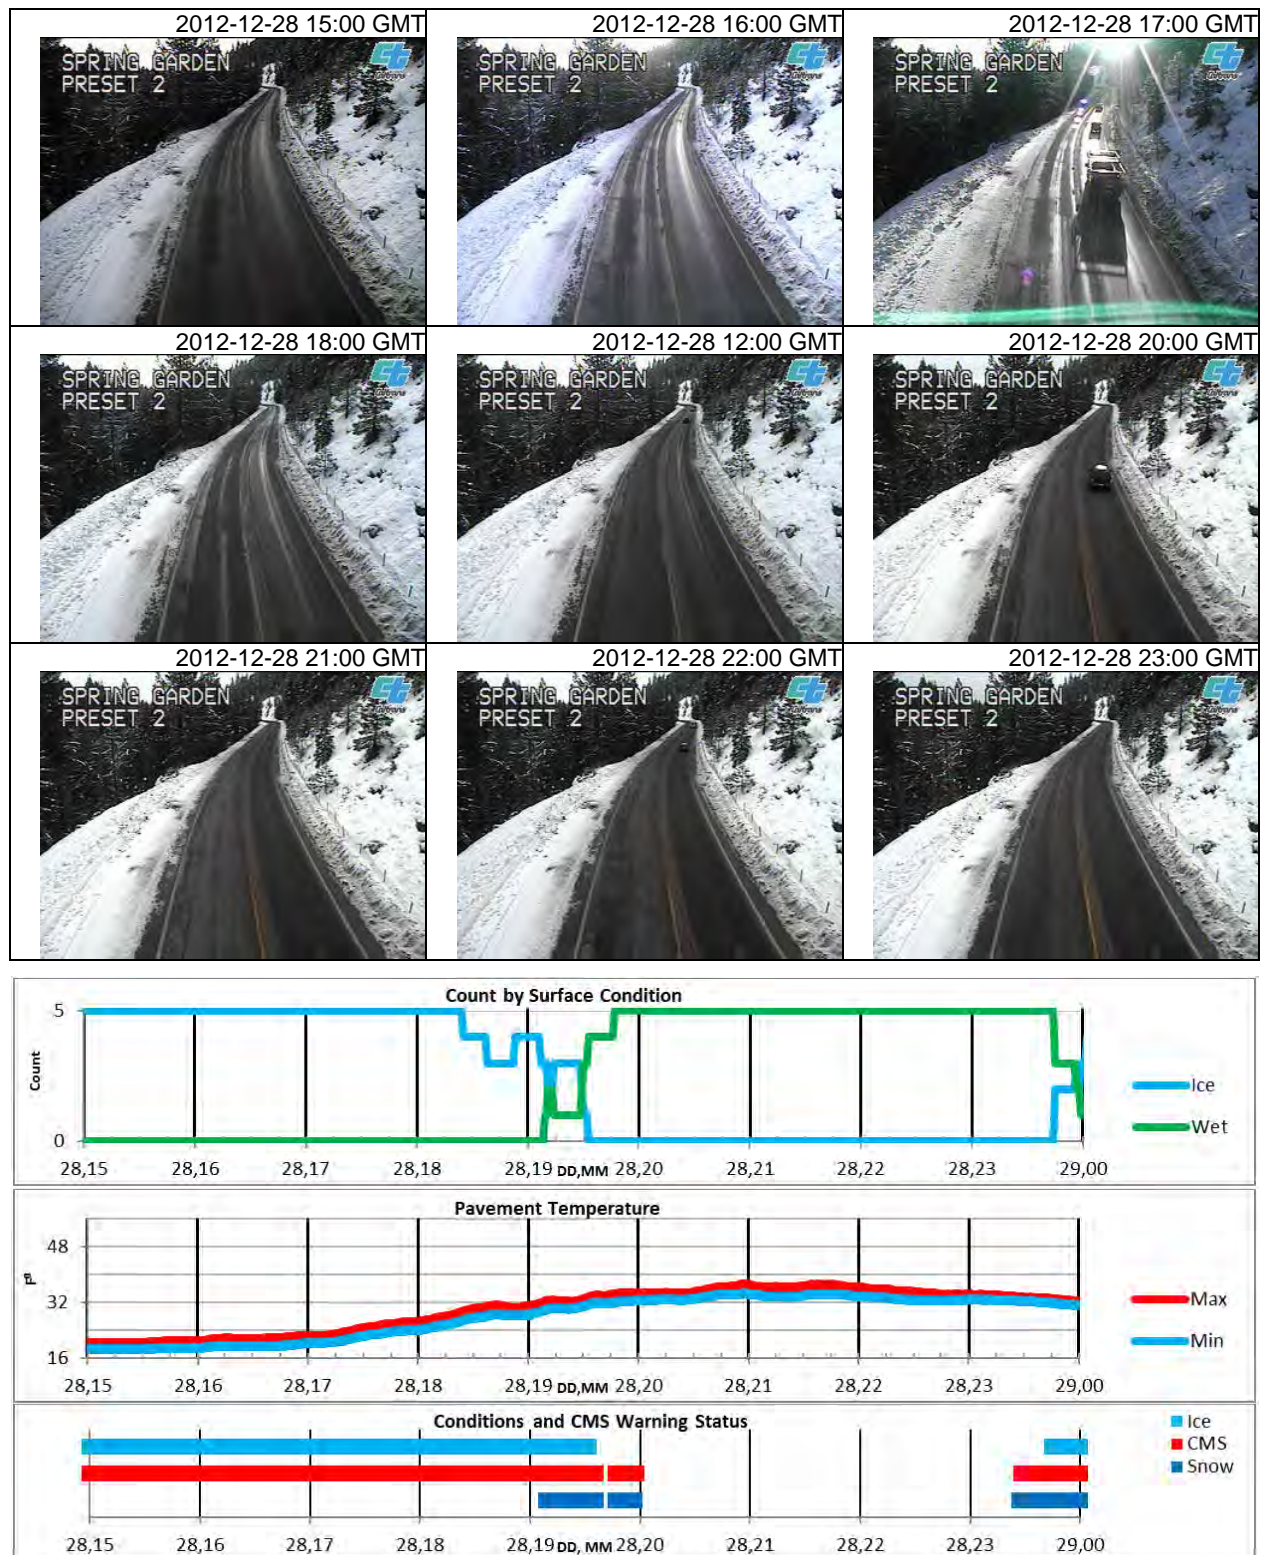
Figure 46: Conditions and Warning Status for 2012-12-28 GMT (pavement temperatures in °F, “Count” is the number of sensors reporting the given conditions)

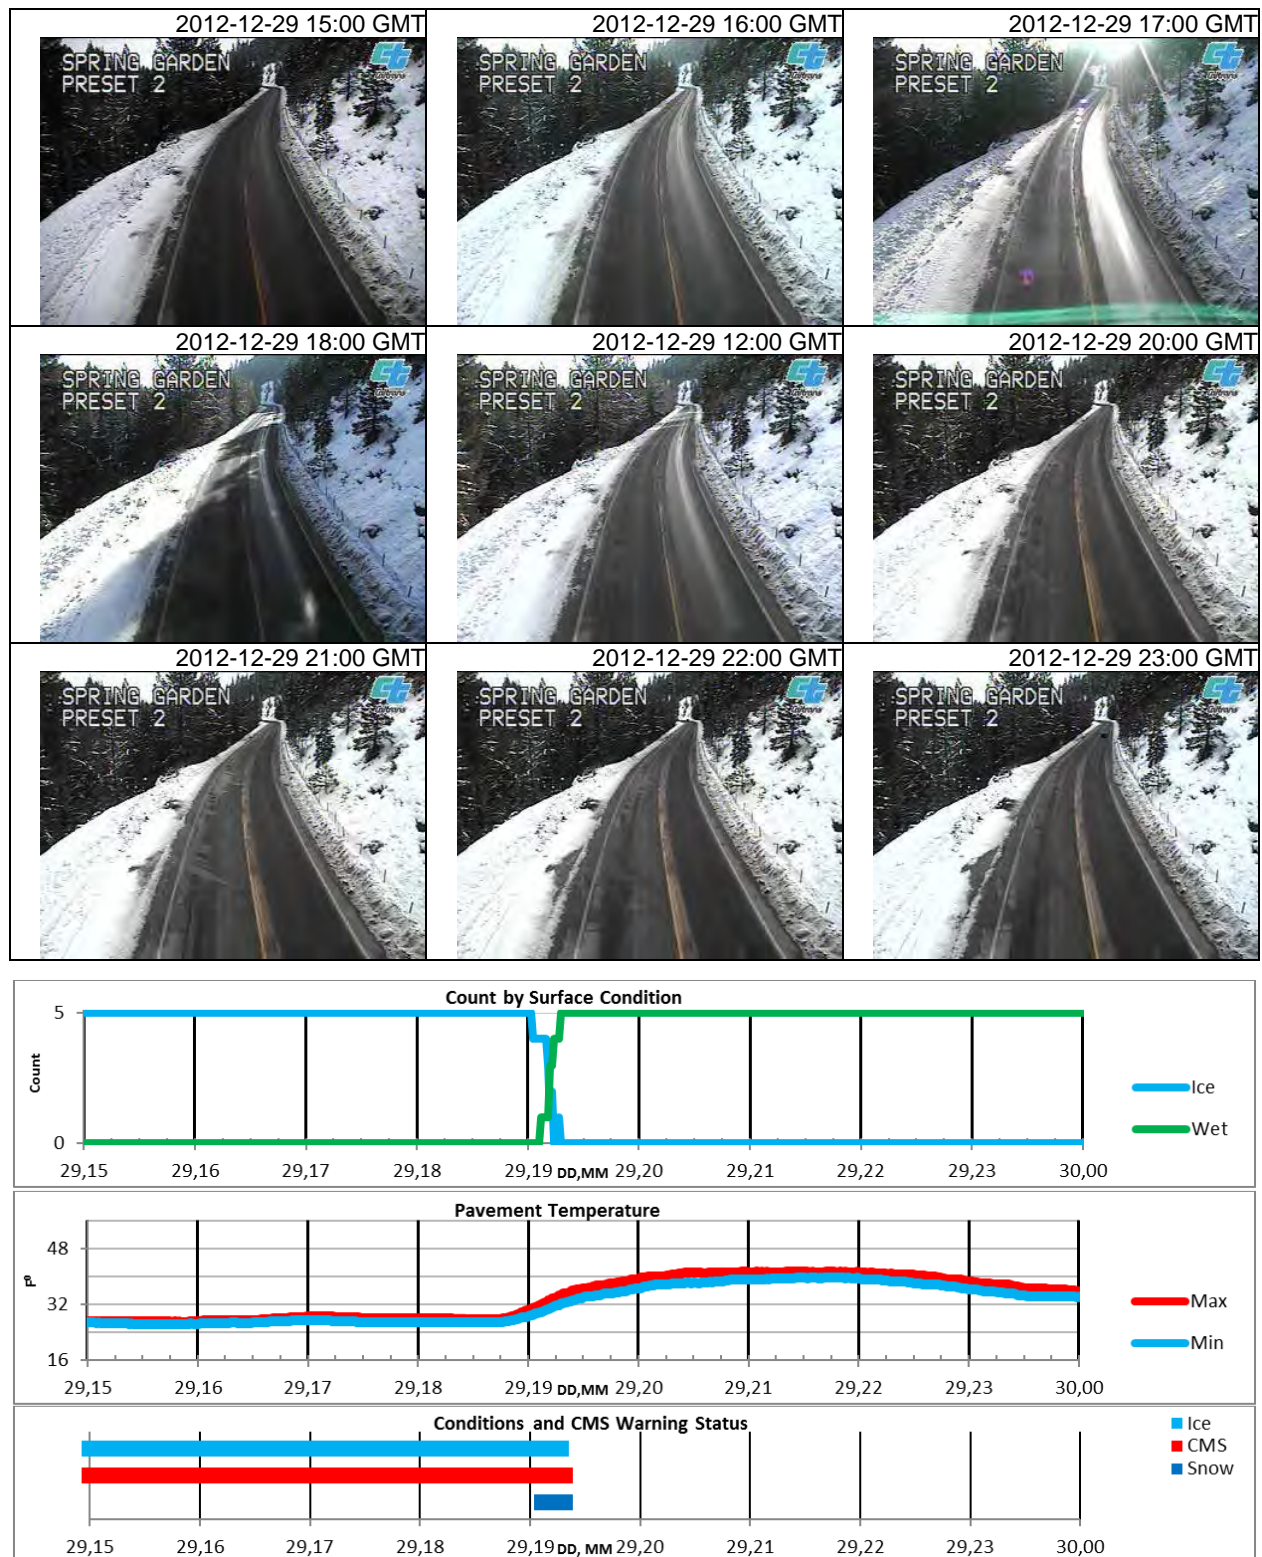
Figure 47: Conditions and Warning Status for 2012-12-29 GMT (pavement temperatures in °F, “Count” is the number of sensors reporting the given conditions)

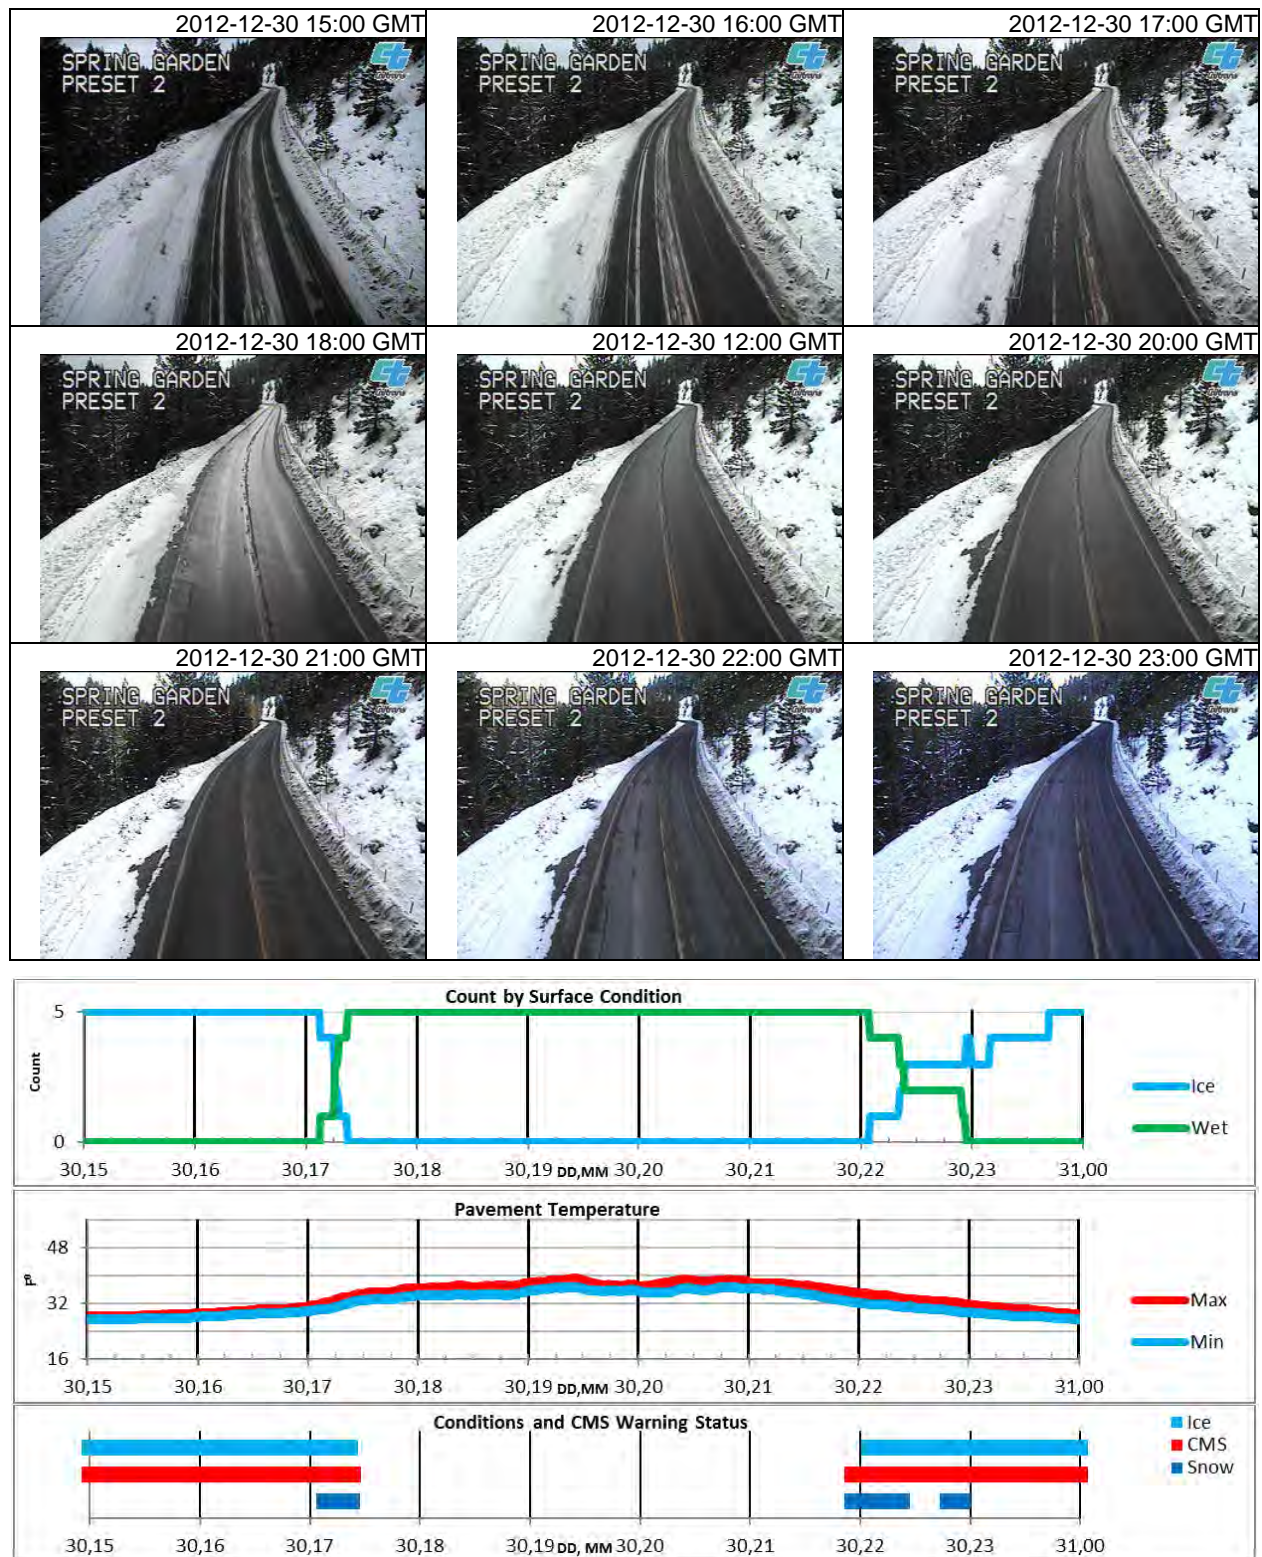
Figure 48: Conditions and Warning Status for 2012-12-30 GMT (pavement temperatures in °F, “Count” is the number of sensors reporting the given conditions)

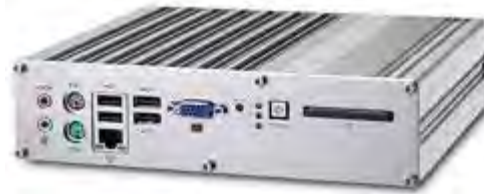
MXE-1005:

- Intel Atom N270 CPU @ 1.6 GHz
- 1 GB RAM
- Fanless
- **No LCD or buttons**
- One 10/100/1000Mbps Ethernet
- Four USB ports
- Two RS-232 serial ports, two RS-232/422/485 serial ports
- One VGA video out port
- CompactFlash slot, SATA port
- No documented installed OS, supports Linux and Windows
- Operating temperature: 14° to 140° F (-10° to 60° C),
-4° to 158° F (-20° to 70° C) optional
- Price: N/A
- Source: http://www.adlinktech.com/PD/marketing/Datasheet/MXE-1000Series/MXE-1000Series_Datasheet_en_1.pdf

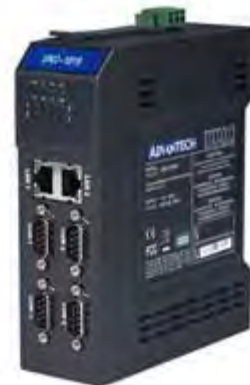
UNO-1019:

- Marvell XScale ARM-5 CPU @ 200 MHz
- 64 MB RAM
- Fanless
- **No LCD or buttons**
- Two 10/100 Mbps Ethernet
- **No USB**
- Two RS-232 serial ports, two RS-232/422/485 serial ports
- No video out port
- CompactFlash slot
- Windows CE 5.0, optional µClinux
- **Operating temperature: 32° to 158° F (0° to 70° C)**
- Price: \$425.00
- Source: http://downloadt.advantech.com/ProductFile/Downloadfile4/GF-X1LP/UNO-1019_DS.pdf

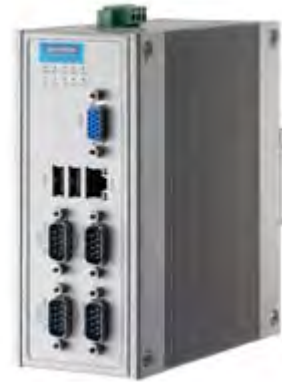
UNO-1140:

- Advantech 486SX CPU @ 150 MHz
- 64 MB RAM
- Fanless
- **No LCD or buttons**
- One 10/100 Mbps Ethernet
- Two USB ports
- Four RS-232/485 serial ports
- One VGA video out port
- CompactFlash slot
- Optional Windows CE.NET 6.0, DOS, Linux
- Operating temperature: -4° to 167° F (-20° to 75° C)
- Price: \$365
- Source: http://downloadt.advantech.com/ProductFile/PIS/UNO-1140/Product%20-%20Datasheet/UNO-1140_DS20110706140617.pdf

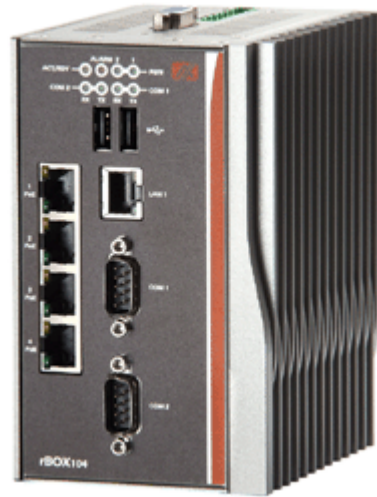
Axiomtech**rBox104:**

- Intel Atom CPU @ 1.1 GHz
- Up to 2 GB RAM
- Fanless
- **No LCD or buttons**
- One 10/100/1000 Mbps Ethernet
- Two USB ports
- Two RS-232/422/485 serial ports
- One VGA out port
- CompactFlash slot, optional SD card slot
- Two watchdog timers, alarm contact, user defined alarm LED
- Supports WinCE, Linux, Windows® 7
- Operating Temperature: -40° to 158° F (-40° to 70° C)
- Price: N/A
- Source: <http://us.axiomtek.com/Download/Spec/rbox104.pdf>

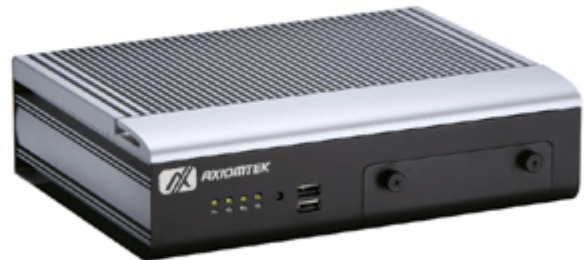
**tBox311-820-FL:**

- Intel Atom CPU @ 1.1 GHz
- Up to 2 GB RAM
- Fanless
- **No LCD or buttons**
- Two 10/100/1000 Mbps Ethernet
- Four USB ports
- No serial ports
- Two VGA video out ports
- One SATA drive bay, one CompactFlash slot
- Watchdog timer, 4 programmable LEDs
- Supports WinCE, Linux
- Operating Temperature: -40° to 149° F (-40° to 65° C)
- Price: N/A
- Source: <http://us.axiomtek.com/Download/Spec/tbox311-820-fl.pdf>

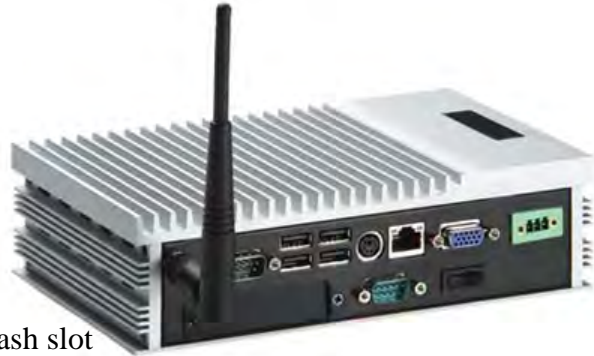
BSI**EMS6503:**

- Intel Atom @ 1.1 GHz
- Up to 2 GB RAM
- Fanless
- **No LCD or buttons**
- One 10/100/1000 Mbps Ethernet
- Four USB ports
- Two RS-232 serial ports
- One VGA video out port
- One SATA drive bay, one CompactFlash slot
- Watchdog timer
- Supports Windows XPE
- Operating temperature: -4° to 149° F (-20° to 65° C)
- Price: \$805
- Source:
http://www.bsicomputer.com/new/embedded_computer/ems6503/ems6503_embedded_computer.htm

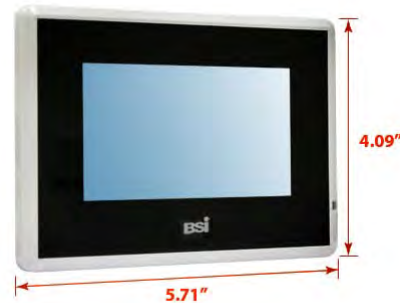
**IOVU-430M:**

- Intel XScale RISC CPU @ 416 MHz
- 128 MB RAM
- Fanless
- Touch sensitive LCD
- One 10/100 Mbps Ethernet
- One USB port
- One RS-232/422/485 serial port
- miniSD card slot
- Windows CE 5.0
- Operating temperature: -4° to 140° F (-20° to 60° C)
- Price: N/A
- Source:
http://www.bsicomputer.com/new/panel_PC/iovu430m/iovu430m_touch_panel_pc.htm

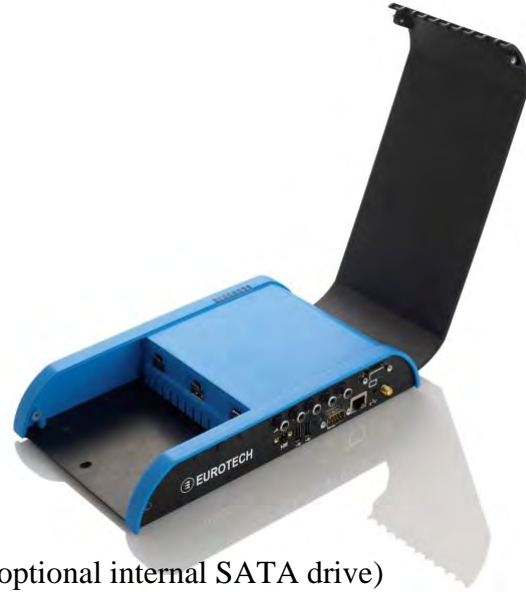
Helios:

- Intel Atom @ 1.1 GHz
- 512 MB RAM
- Fanless
- **No LCD or buttons**
- One 10/100/1000 Mbps Ethernet
- Five USB ports (3 inside bay)
- One RS-232/485 serial port
- Optional multimedia card for video out
- 2 GB CompactFlash card (optional SD card, optional internal SATA drive)
- Eight programmable LEDs, one software readable push button
- Wind River Linux 3.0, Windows CE 6.0
- Operating temperature: -40° to 185° F (-40° to 85° C)
- Price: N/A
- Source:
http://www.eurotech.com/DLA/datasheets/Products_Eurotech/HeliosPlatform_sf.pdf

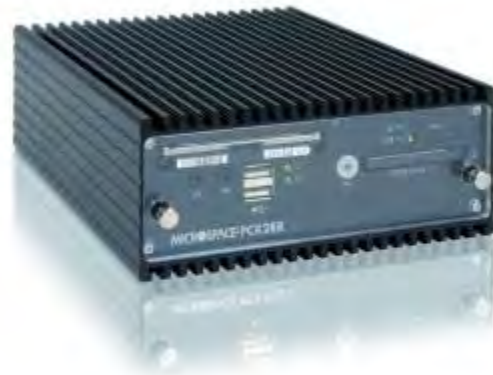
MICROSPACE MPCX28R:

- Intel Atom CPU @ 1.6 GHz
- 1 GB RAM
- Fanless
- **No LCD or buttons**
- Two 10/100 Mbps Ethernet
- Five USB ports
- Two RS-232/422/485 serial ports
- One DVI video out port, VGA optional
- One SATA bay, optional CompactFlash
- Compatible with Windows or Linux
- Operating temperature: -4° to 158° F (-25° to 70° C)
- Price: N/A
- Source:
<http://us.kontron.com/etc/scripts/download/getdownload.php?downloadId=MTEzNDY=>

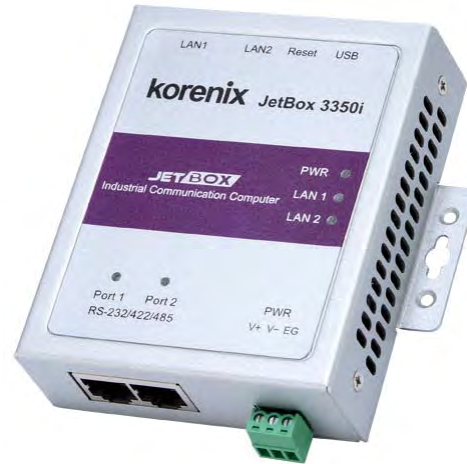
Korenix**JetBox 3350i-w:**

- Atmel ARM CPU @ 180 MHz
- 64 MB RAM
- Fanless
- **No LCD or buttons**
- Two 10/100 Mbps Ethernet
- Two USB ports
- Two RS-232/422/485 serial ports
- No video out port
- One microSD slot
- Watchdog timer
- Linux
- Operating temperature: -40° to 176° F (-40° to 80° C)
- Price: N/A
- Source: <http://www.korenix-usa.com/pdfs/JetBox3350i-w-low.pdf>

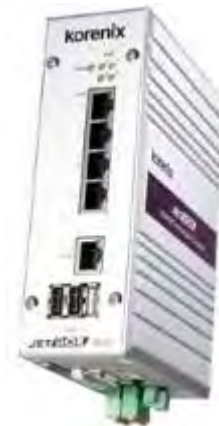
**JetBox 9430-w:**

- Intel XScale IXP435 RISC CPU @ 667 MHz
- 128 MB RAM
- Fanless
- **No LCD or buttons**
- Five 10/100 Mbps Ethernet
- Three USB ports
- No serial ports
- No video out port
- One SD card slot, one CompactFlash card slot
- Watchdog timer
- Linux 2.6.20
- Operating temperature: -40° to 176° F (-40° to 80° C)
- Price: N/A
- Source: <http://www.korenix-usa.com/pdfs/JetBox9430-w-low.pdf>

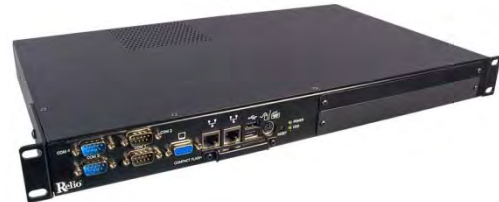
Relio R4300:

- AMD Geode CPU @ 500 MHz
- 1 GB RAM
- Fanless
- **No LCD or buttons**
- Two 10/100 Mbps Ethernet
- Two USB ports
- Two RS-232/422/485 serial ports, two RS-232 serial ports
- One VGA video out port
- One optional internal hard drive, one CompactFlash slot
- Watchdog timer
- Windows and Linux compatible
- Operating temperature: **32° to 122° F (0° - 50° C)** (Extended temperature options available)
- Price: \$999
- Source: <http://www.sealevel.com/store/computing-hmi/industrial-computers/expandable-rackmount/r4300-relio-r4300-500mhz-amd-geode-lx800.html>

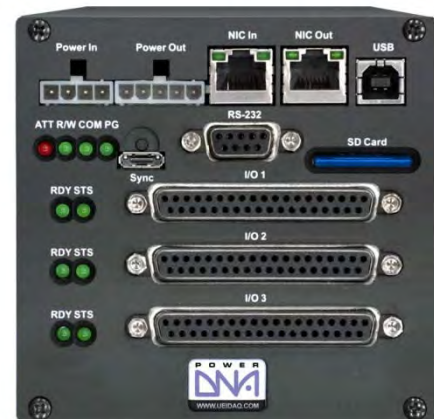
**United Electronic Industries****DNA-PPCx:**

- Freescale MPC5200 CPU @ 400 MHz
- 128 MB RAM
- Fanless
- **No LCD or buttons**
- Two 10/100 Mbps Ethernet
- **No USB host ports**
- One RS-232 serial port
- No video out port
- 128 MB internal flash, SD card slot
- Windows and Linux compatible
- Operating temperature: -40° to 185° F (-40° to 85° C)
- Price: \$995
- Source: <http://www.ueidaq.com/media/catalog/product/pdf/datasheet/dna-ppcx.pdf>

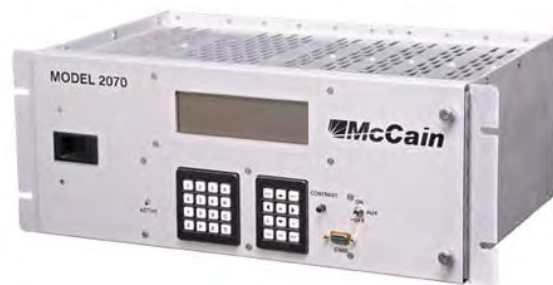
- 256MB DDR memory expansion
- Optional modules
- Various modems (2070 form factor)
- GPS module

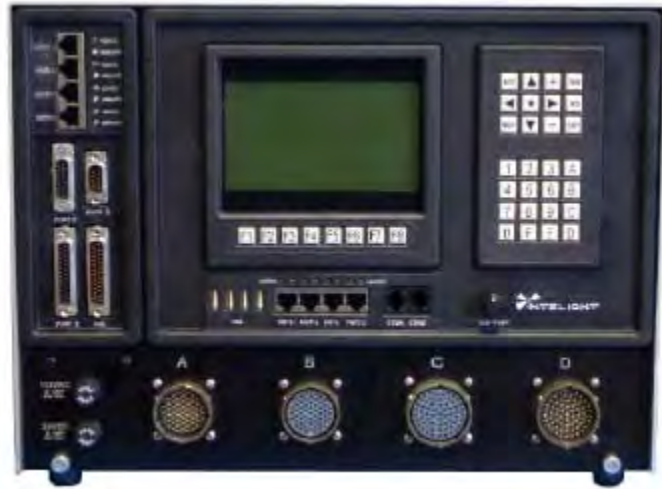
Intelight**NEMA TS2 Type 1 & 2 Advanced Transportation Controller (ATC)**

- Compliant with current NEMA TS2 and ATC 5.2b standards
- Open Architecture Embedded Linux Multi-Processing Operating System
- 4 Standard 10/100 Mbit Ethernet Ports
- 2 Quad 4 Port Integral Ethernet Switches
- 4 USB Ports
- 2 Keypads & 8 Programmable Special Function Keys
- ATC 5.2b Compliant Engine Board CPU
- ATC Standard API for third party application support
- Two ATC/2070 Type Communications/Modem Slots
- 16 Line X 40 Character (240 X 120 Graphics) LCD Display
- 7 configurable Serial Ports (5 are SDLC capable)
- 14 3/4" W X 7 3/4" D X 10 1/2" H
- Power 95 - 250 VAC 50/60 Hz Auto Sensing
- -40 to +80° C operating environment
- 64MB Flash / 64MB DRAM memory / 1MB SRAM

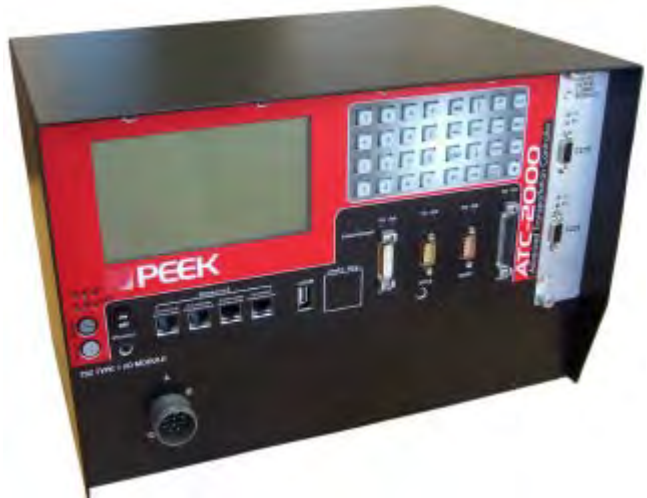
- 16MB SDRAM memory (standard)
- 32MB and 64MB available as upgrade options
- 1MB SRAM
- Dimensions: 14¾" Wide × 10½" Deep × 10¼" Tall (375mm × 267mm × 261mm)

- Power requirements 95 to 135VAC 60Hz ± 3 Hz
- Environment: -35°F to + 165°F -37°C to + 74°C
- 0-95% relative humidity

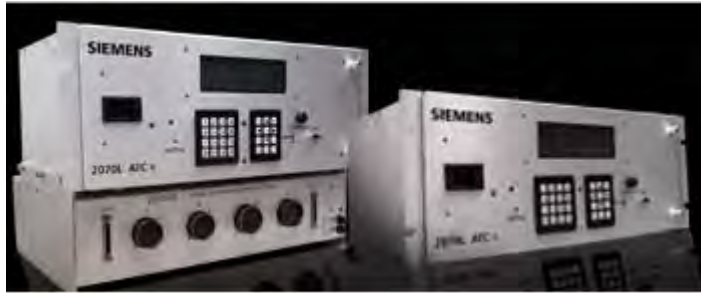
- Multitasking - each 2070ATC unit can control multiple applications
- Multiprocessing - each 2070ATC unit can accommodate multiple CPUs
- High speed serial communications to CPU

- Designed and built for unattended operation in harsh environments
- Built-in 10 Base-T Ethernet with IP address on 2070-1B (2070L models)

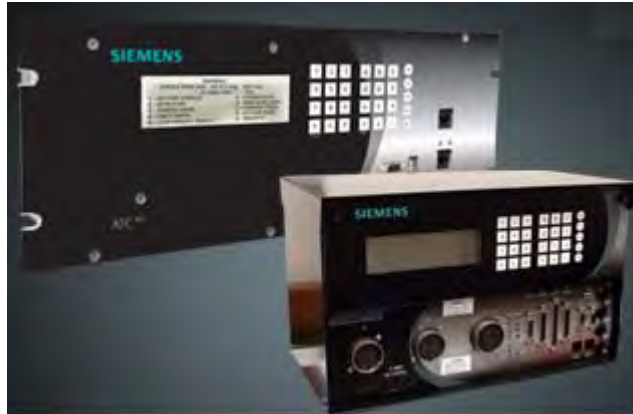
SITRAFFIC® Sphere ATC

Freescape Power Quicc II Pro microprocessor w/ e200 core, running at 500MIPs with E200 core 266 MHz processor

- 36MB flash memory
- 64 MB DRAM
- 2 MB SRAM
- Linux operating system using gLibc w/ C++ support libraries
- Multi-line alpha-numeric backlit display
- Durable front coating
- Runs multiple-concurrent applications
- Lightweight, injection molded, high-impact poly-carbonate case (rack mount)
