## PILOT PROJECT

# Dynamic Warning Systems to Alert Motorists to the Presence of Bicyclists

## FINAL REPORT

- **Prepared by:**  
The Western Transportation Institute at  
Montana State University
- **Prepared for:**  
The Federal Highway Administration
- **DECEMBER 2021**

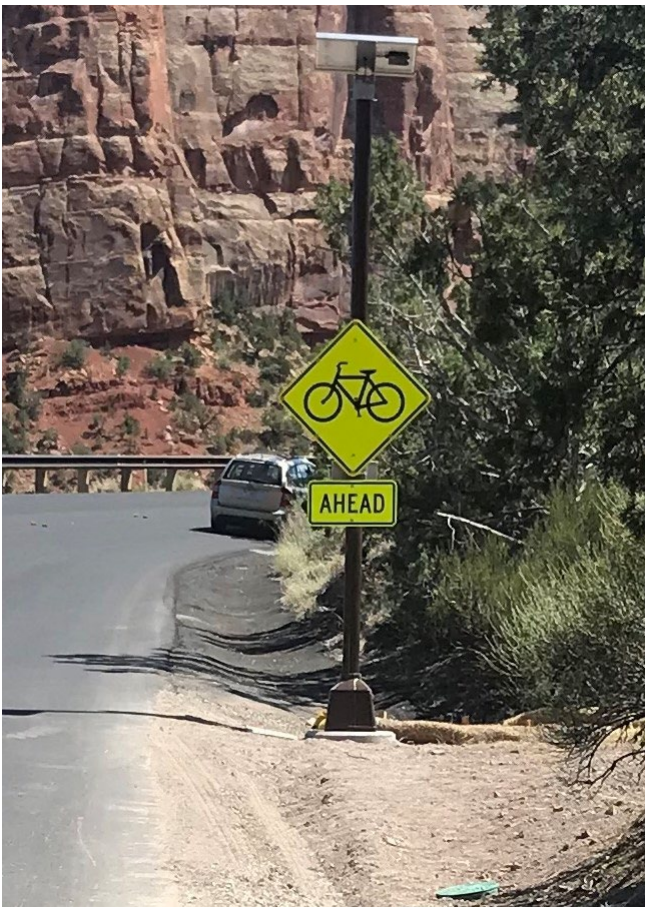
**Figure 1: Colorado National Monument warning sign 1 with bicycle blinker panel (photo: WTI)**

One warning system was placed in the westbound lane of Rim Rock Drive, 0.7 miles from the east entrance station. This location is just before the first hairpin turn and was selected to warn drivers of bicyclists ahead where the road is curvy with blind corners and short sight distances. The second sign was placed further up the east hill near the south entrance to the tunnel, 2.4 miles from the east entrance station. This location was selected to warn drivers of bicyclists ahead in the tunnel and curvy sections of road beyond. Both systems were installed for traffic heading west (uphill), because the inductive loop detection is more accurate when there is a speed differential between bicycles and motor vehicles. Both locations receive ample sun for the solar panels. This section of road has a substantial amount of commuter traffic that travels between Glade Park and Grand Junction and is a popular cycling route. The speed limit is 25 miles per hour.

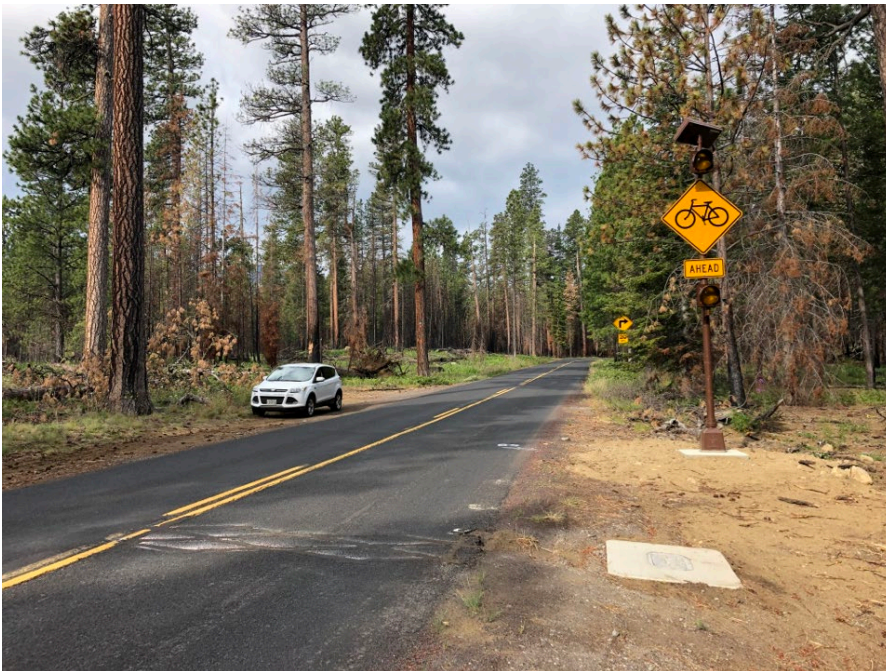
Figure 2 shows the warning sign approximately seven miles west of Sisters, Oregon, with the concrete pull box and inductive loops in the foreground.

**Figure 2: Hwy 242 warning sign near Milepost 84 with dual amber beacons near Sisters, Oregon (photo: WTI)**

A dual amber beacon system was selected for the Oregon sites. Based on experience with amber beacon systems, ODOT preferred beacons (rather than a bicycle sign panel with lights integrated into the panel) for its durability and consistency with other ODOT signs.

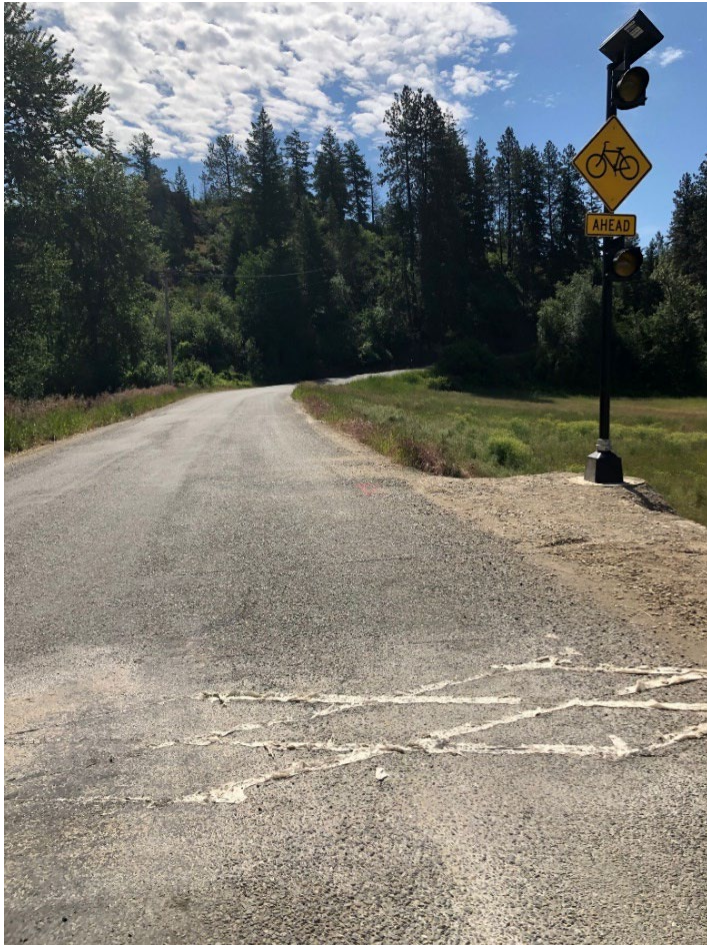
**Figure 3: Riverside Road (west) warning sign, Boundary County, Idaho (photo: WTI)**

Two dynamic warning systems were installed on Riverside Road: one on the east side of Ambush Rock, viewable by westbound drivers heading out of town. The other sign is on the west side of Ambush Rock, viewable by eastbound drivers heading into town as shown in Figure 3. This section of road was selected because of the limited site distance and constrained road conditions imposed by rock outcroppings.

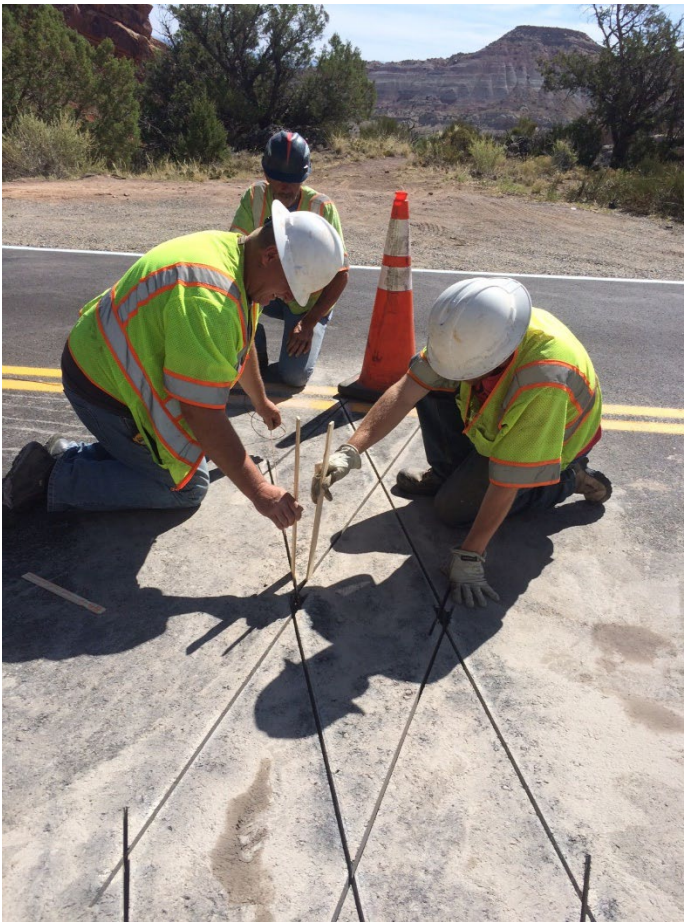
**Figure 4: Contractor installing inductive loops for bicycle detection at Colorado National Monument (photo: WTI)**

In early June 2018, WTI staff met a Grand Junction area contractor on-site to oversee the pavement saw cuts and inductive loop installation as shown in Figure 4. While this contractor had installed inductive loops to detect motor vehicles, they had not installed loops to detect bicycles. There is a specific method for the sawcut and inductive loop configuration that is required for the system to function properly for bicycle detection. Eco-Counter provides training on this method to ensure proper installation. These saw cuts were approximately 3/8 inches wide and two inches deep near the road centerline and two and a half inches deep near the edge of the road to enable to wires from the loops near the centerline to connect to the counter. Loop wires were tightly wrapped, and inductance tests showed 130 and 150 microhenries, which confirmed proper functioning prior to sealing.

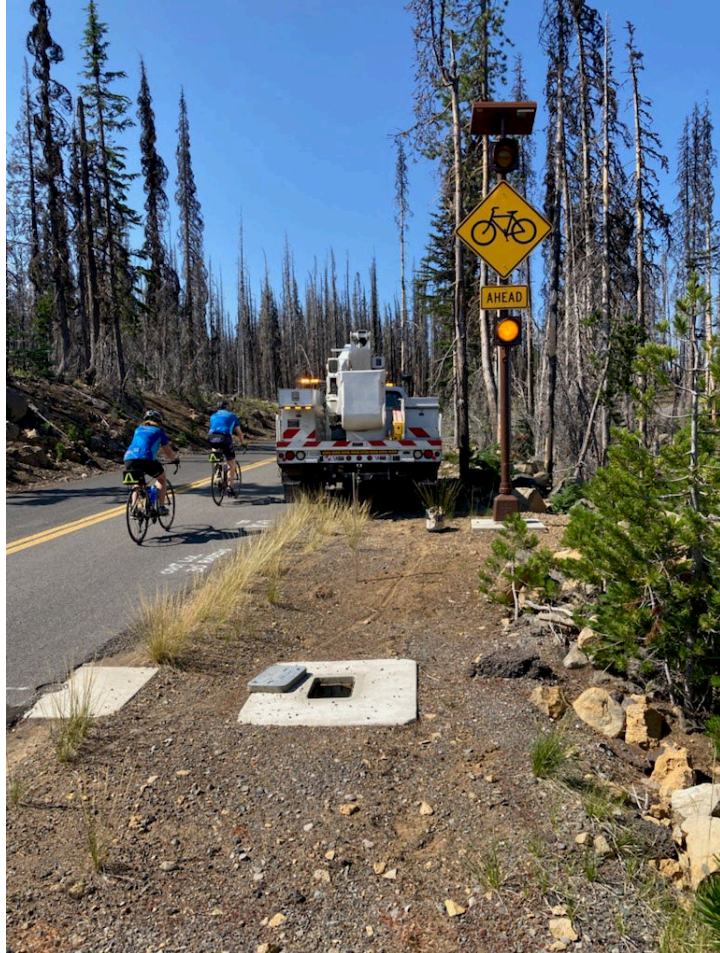
**Figure 6: Oregon HWY 242 dynamic warning sign near Milepost 78 and concrete junction box (photo: ODOT)**

Figure 5 shows the upper warning sign near milepost 78.78 with the concrete pull box in the foreground. A 2 feet deep trench was dug to contain the 2-inch conduit that holds the wires between the data logger and warning sign.

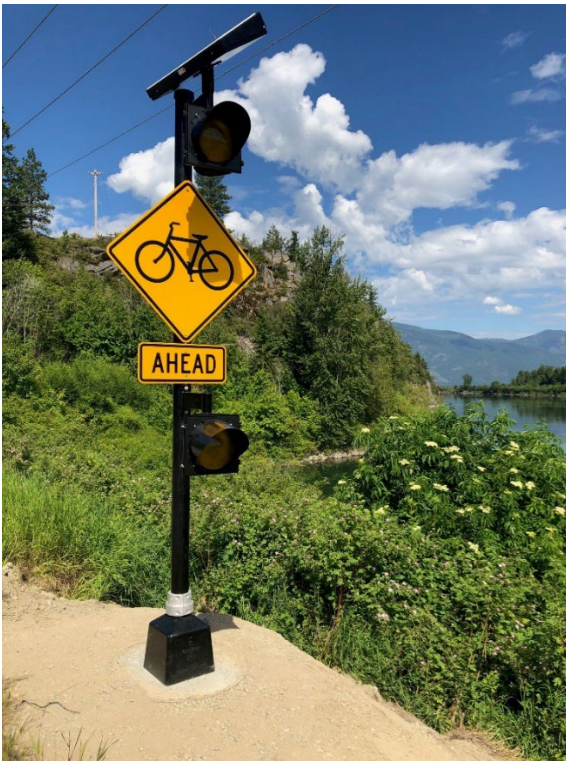
**Figure 8: Riverside Road (east) warning sign, Boundary County, Idaho (photo: Boundary County)**

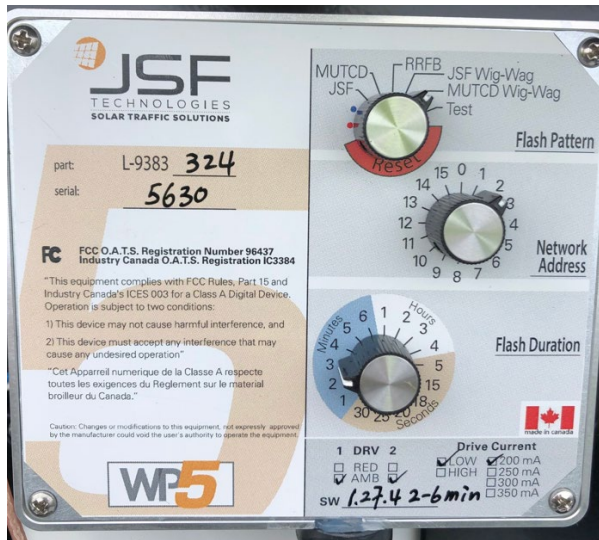
**Figure 9: JSF control panel dials for the Idaho warning systems (photo: Boundary County)**

with Oregon warning signs, Connex boards were ordered ahead of time for these systems and the controller was programmed by JSF to include flash durations specific to this location, ranging from 1-6 minutes as shown in Figure 9. However, the process to install the Connex boards and connect the sign to the bicycle counter was still challenging and took quite a bit of time. Figure 10 shows the Boundary County Road crew working on the JSF control panel, for the west sign. Notice a bucket truck provides access to the control box which is integrated with the solar panel at the top of the sign. After installation, it was realized the Eco-Counter was not working properly. Boundary County staff worked with Eco-Counter and were able to replace some damaged parts in a timely manner, after which the system functioned properly. Figure 11 shows the inside of

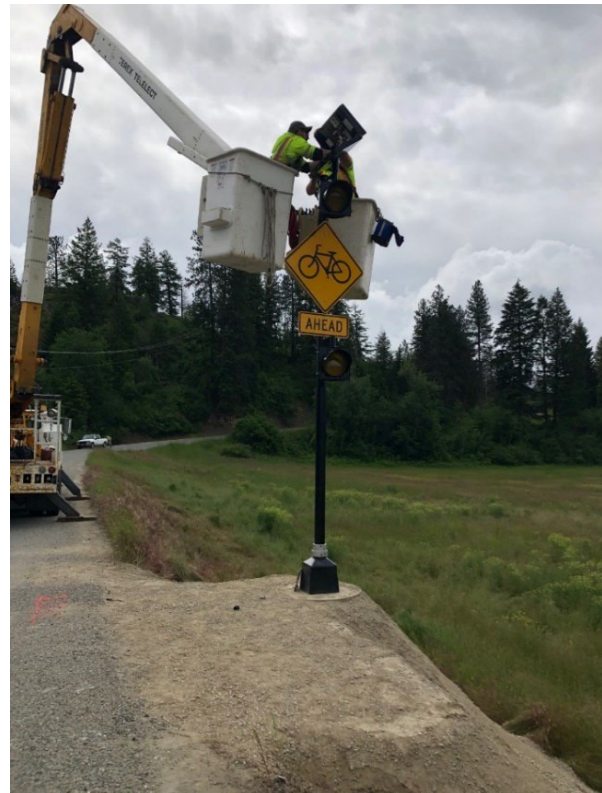
**Figure 10: Boundary County crew working on Riverside Road (west) sign (photo: Boundary County)**

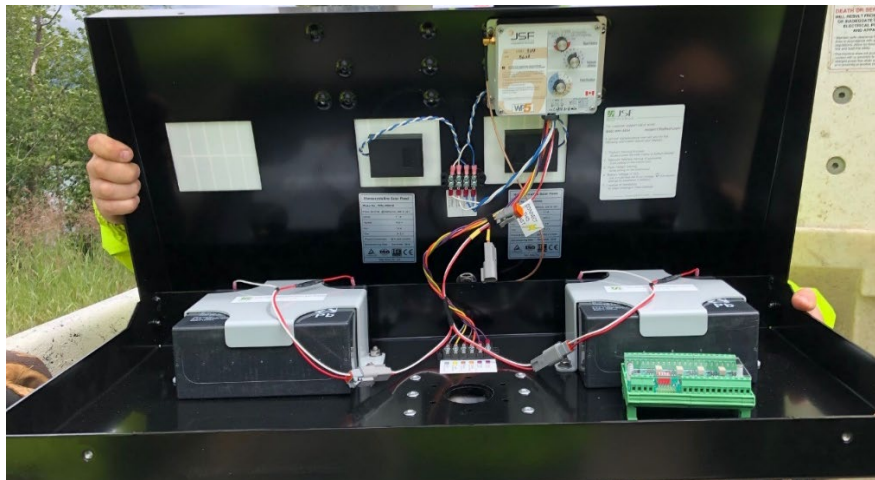
**Figure 11: JSF solar and control box (photo: Boundary County)**

the JSF control box. Notice the green Connex board in the front of the box, which has not yet been connected in this photo.

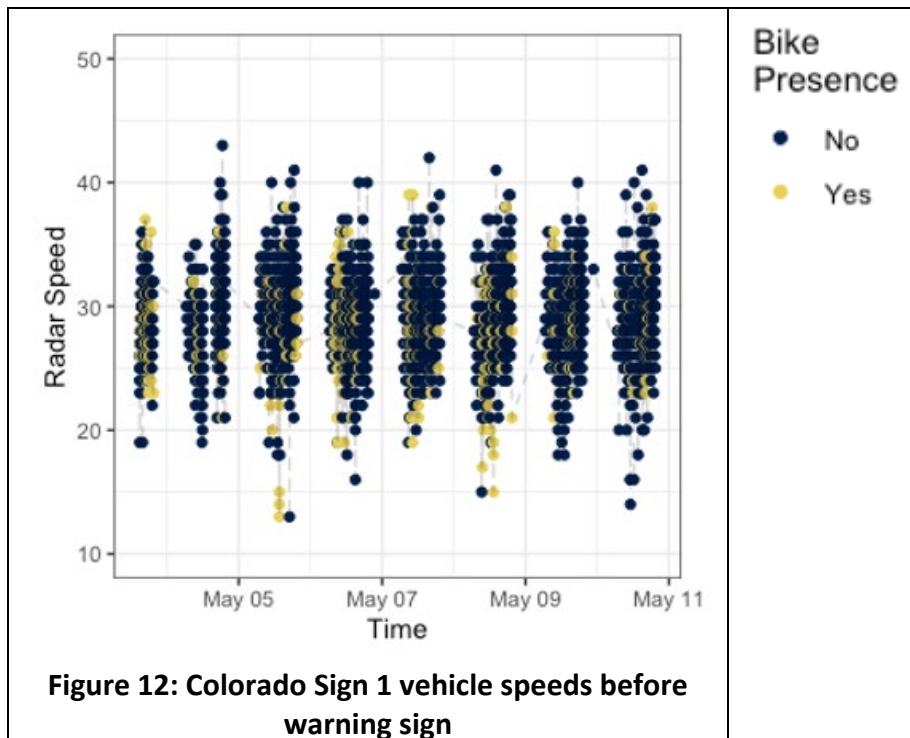
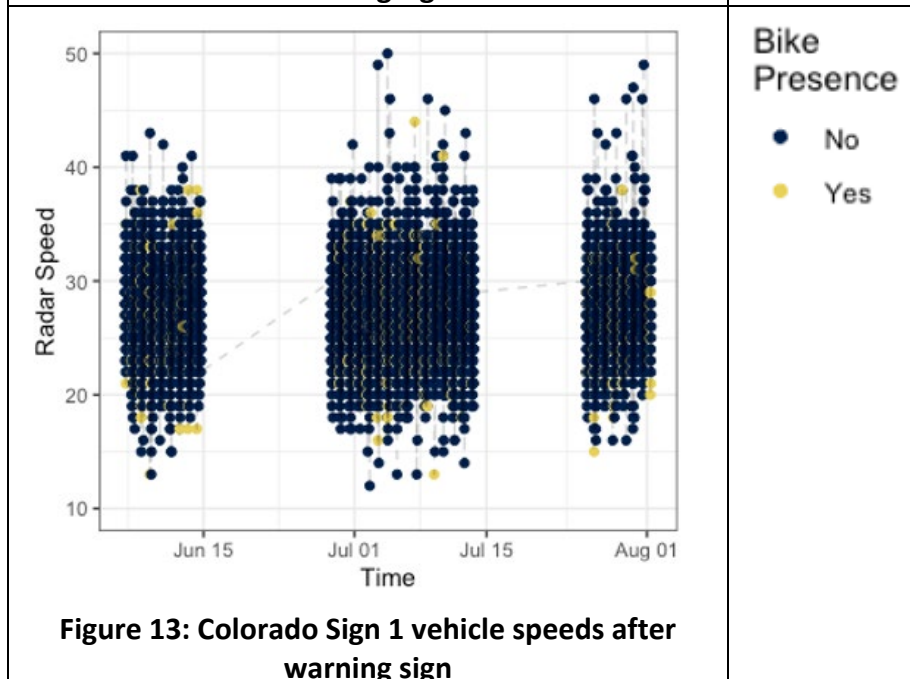
Figures 12 and 13 show radar speeds near Colorado Site 1 in miles per hour (mph). Figure 12 shows speeds for Before-Sign/Bikes Present and Before-Sign/Bikes Absent groups. Figure 13 shows speeds for After-Sign/Bikes Present and After-Sign/Bikes Absent groups. The yellow dots represent vehicle speed for the Bikes-Present groups and the blue dots represent vehicle speed for the Bikes Absent groups.

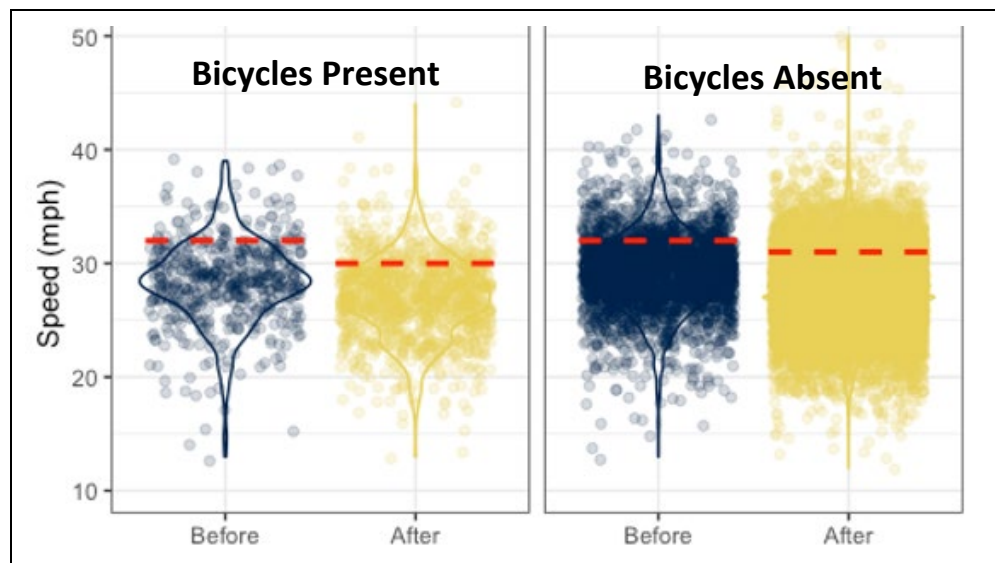
**Figure 14: Colorado Sign 1 association between vehicle speed and bicycle presence/absence**

The median speeds are similar before warning sign 29 mph (with or without bikes) but decrease after the warning sign by 1 mph and 2 mph without and with a bike respectively. Figure 14 shows vehicle speed data graphically with the 85<sup>th</sup> percentile denoted with a red dashed line.

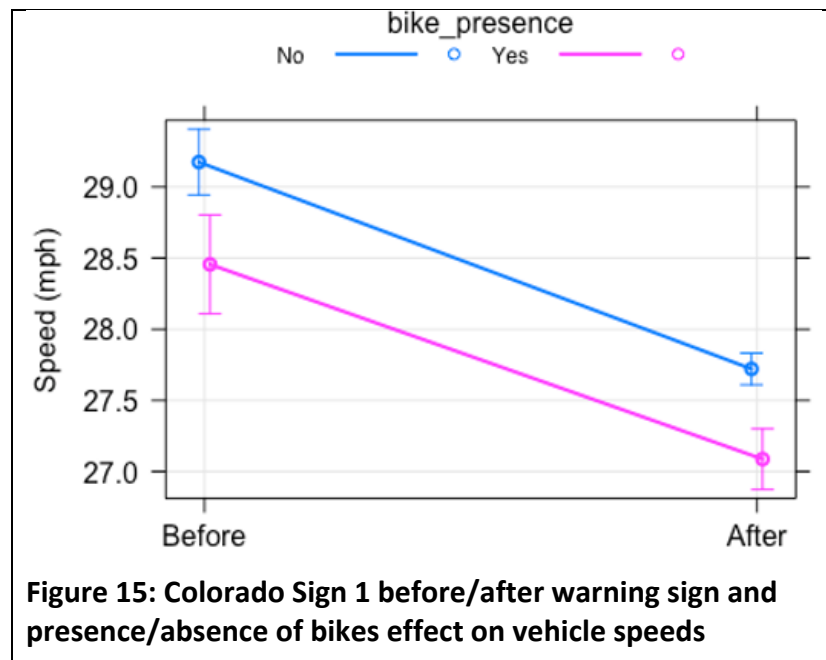
Adjusted for day-to-day variation, there is weak evidence that the average speed difference between vehicles before and after the warning sign depends on whether or not a bike was present ( $t = 0.445$ , on  $df = 18260$  with  $p\text{-value} = 0.656$ ). The  $p\text{-value}$  is a measure of the probability that the observed difference could have occurred by random chance. The lower the  $p\text{-value}$ , the greater the statistical significance or evidence of the observed difference. This model estimates a drop in mean speed of 1.37 mph when bikes were present and a drop of 1.45 mph when bikes were absent after the warning signs were installed versus before. Thus, there is a slightly smaller drop in mean speed when bikes were present as compared to when they were absent after the sign was installed ( $1.37 - 1.45 = -0.085$  mph). The model shows with 95% confidence that this difference in mean vehicle speed when bikes were present versus absent ranges between a 0.289 mph decrease to an increase of 0.459 mph. These results are visualized in the effects plots shown in Figure 15. As expected, the average speed is lower after the warning sign was installed. However, the lines are relatively parallel suggesting that this relationship is similar with or without the presence of bicycles, hence there is limited interaction between the warning sign and bike presence.

The overall explanatory power of the model is relatively modest, with only 2.70% of the variation in vehicle speed explained by the dynamic warning system, presence/absence of a bike and their interaction in the model (based on the  $R^2$  *marginal* coefficient of determination, which describes the proportion of the variance explained by the fixed factors). Likewise, only 3.34% of the variation in vehicle speed is explained by the interaction between the

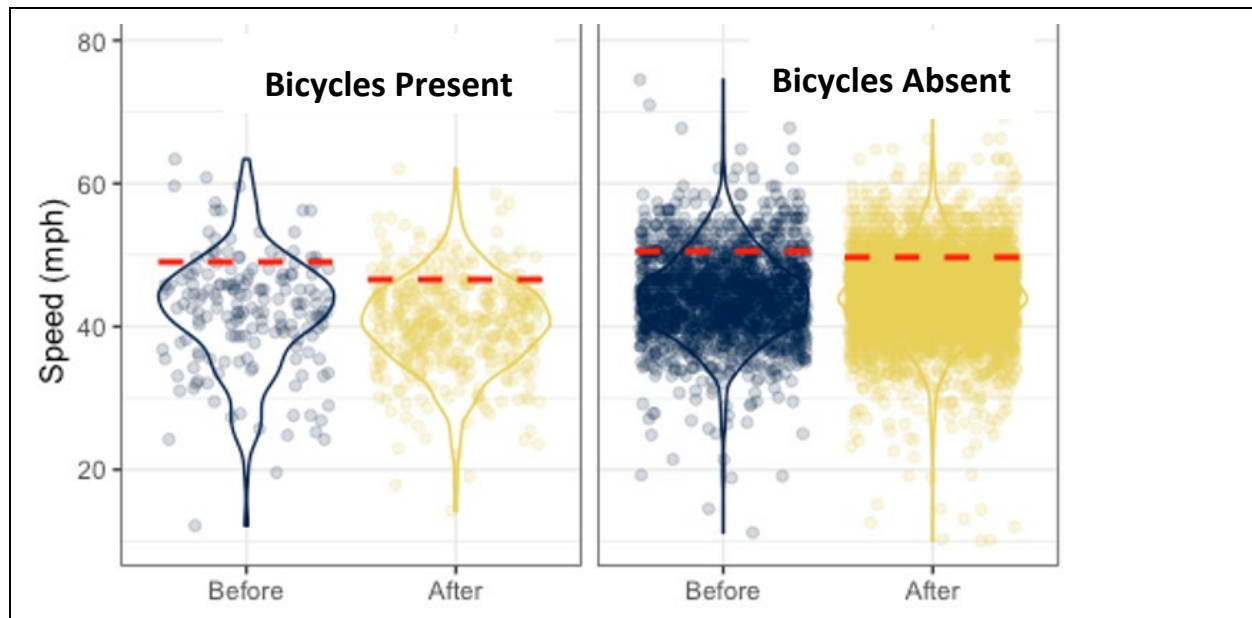
**Figure 18: Oregon MP 84 Association between vehicle speed and bicycle presence/absence**

Figure 18 shows vehicle speed data graphically with the 85<sup>th</sup> percentile denoted with a red dashed line.

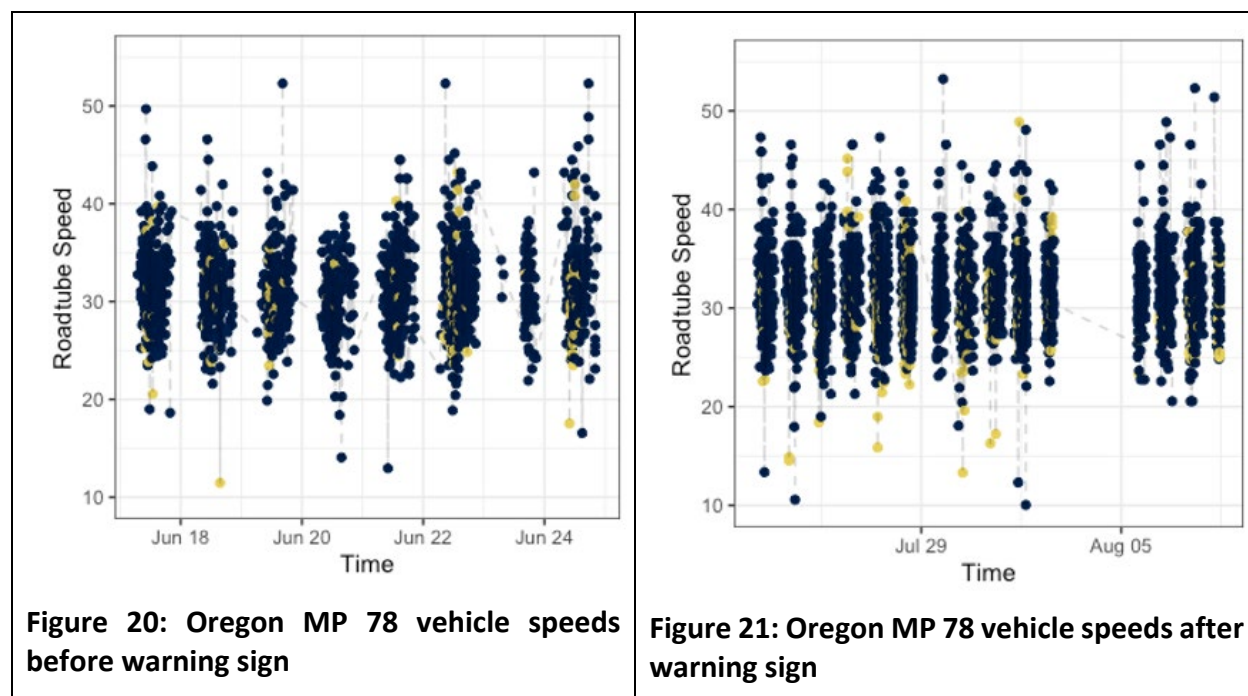
Figure 20 and 21 show road tube speeds near MP 78 in mph. Figure 16 shows speeds for Before-Sign/Bikes Present and Before-Sign/Bikes Absent groups. Figure 17 shows speeds for After-Sign/Bikes Present and After-Sign/Bikes Absent groups. The yellow dots represent vehicle speed for the bicycle present group and the blue dots represent vehicle speed for the bicycles absent group.

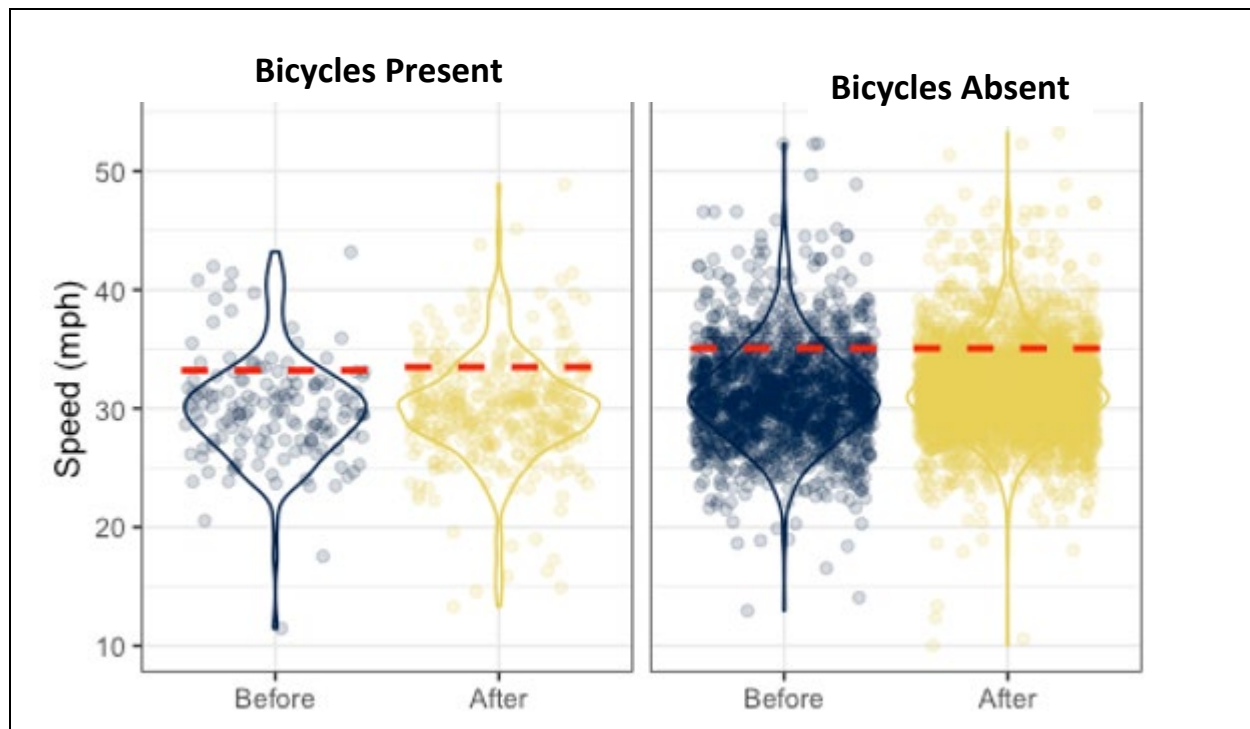
**Figure 22: Oregon MP 78 association between vehicle speed and bicycle presence/absence**

Figure 22 shows vehicle speed data graphically with the 85<sup>th</sup> percentile denoted with a red dashed line, demonstrating that the 85<sup>th</sup> percentile speed is higher when bicycles are absent both before and after the warning signs were installed. This suggests people tend to drive somewhat slower when they are near a bicycle.

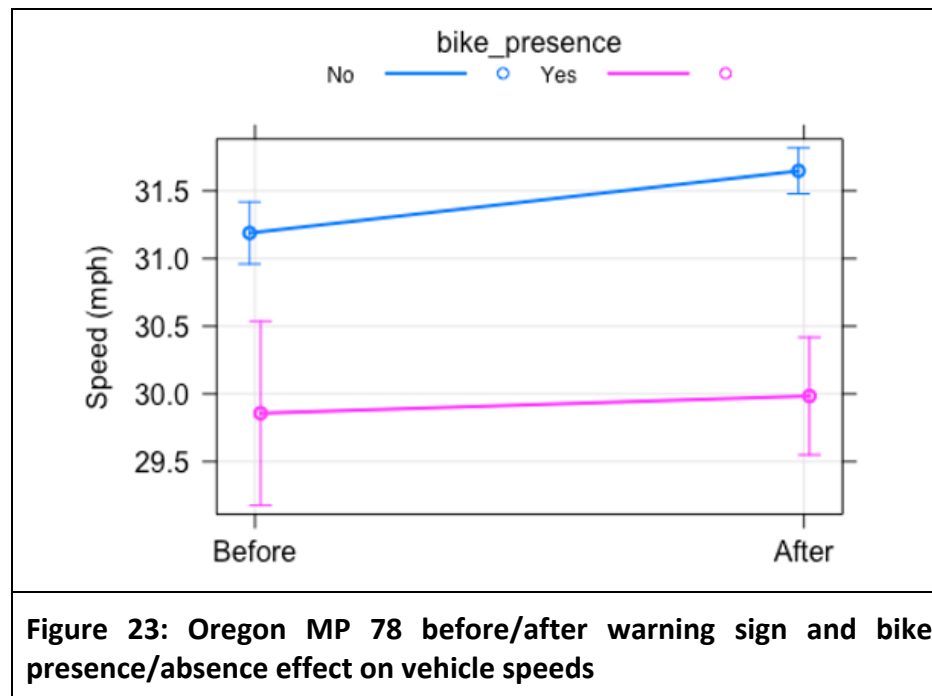
The overall explanatory power of the model is relatively modest, with only 1.5% of the variation in vehicle speed explained by the dynamic warning system, presence/absence of a bike and their interaction in the model (based on the  $R^2$  *marginal* coefficient of determination, which describes the proportion of the variance explained by the fixed factors). Likewise, only 1.6% of the variation in vehicle speed is explained by the interaction between the dynamic warning system and presence/absence of bikes, their marginal effects and day-to-day variability in the model (based upon the  $R^2$  *conditional* coefficient of determination, which describes the proportion of variance explained by both the fixed and random factors). These results are visualized in the effects plots shown in Figure 23.

As expected, the average speed is lower when a bike is present compared to when there is no bike present. However, surprisingly, average motor vehicle speed increased slightly after the warning sign was introduced compared to before regardless of whether a bike was present or not.

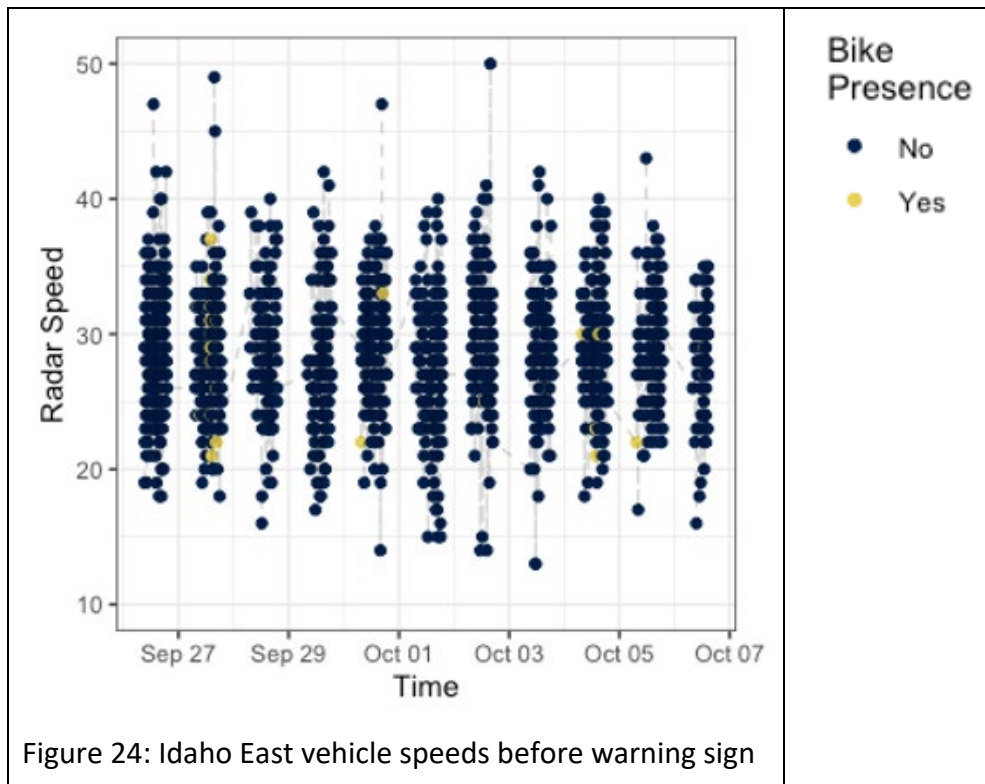
Figure 24: Idaho East vehicle speeds before warning sign

Figure 24 and Figure 25 show radar speeds near the Idaho East sign in mph. Figure 20 shows vehicle speeds for Before Sign Bikes Present and Absent groups. Figure 21 shows speeds for the After Sign Bikes Present and Absent groups. The yellow dots represent vehicle speeds when bikes are present, and the blue dots represent vehicle speeds when bikes are absent.

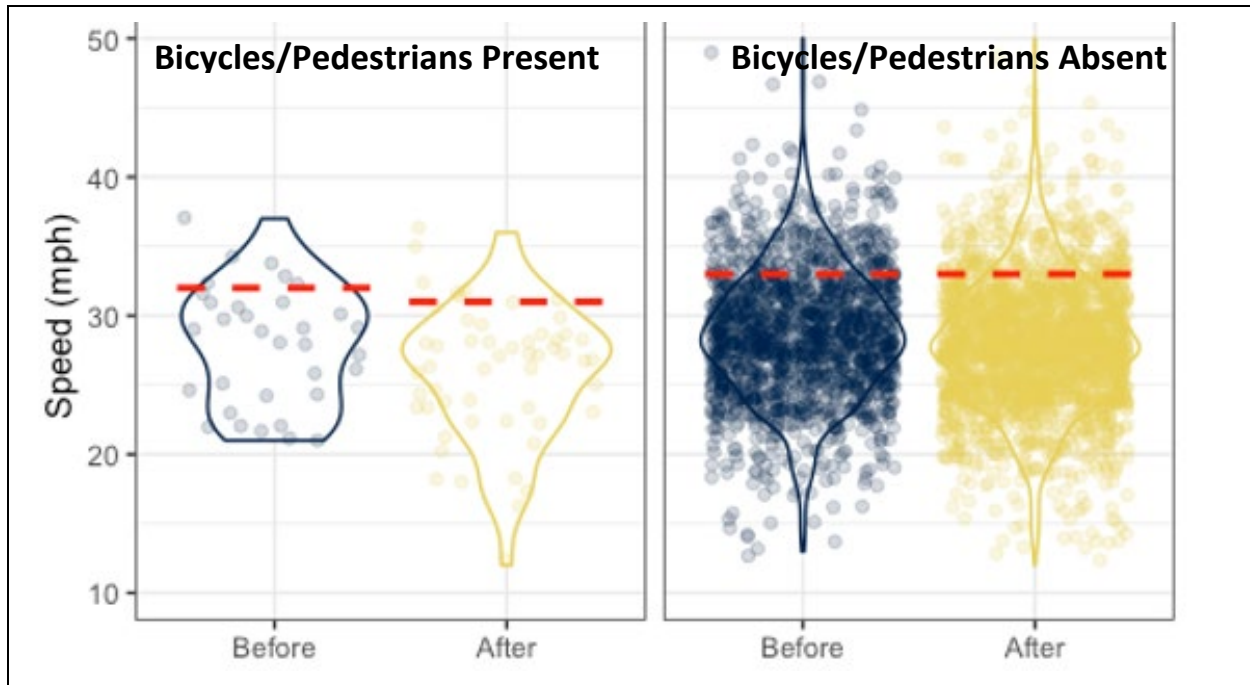
**Figure 26: Idaho East association between vehicle speed and bicycle/pedestrian presence and absence**

Figure 26 shows vehicle speed data graphically with the 85<sup>th</sup> percentile denoted with a red dashed line. The image on the left shows there are relatively few vehicles present when bikes/pedestrians are on the roadway and vehicle speeds tend to be lower after the warning sign was installed. The figure on the right shows there are many more vehicles when there are no bikes on the road and their speeds appear relatively consistent before and after the warning sign was installed. It also shows the 85<sup>th</sup> percentile speeds (red dashed line) tend to be higher when there are no bikes/pedestrians present in the westbound lane.

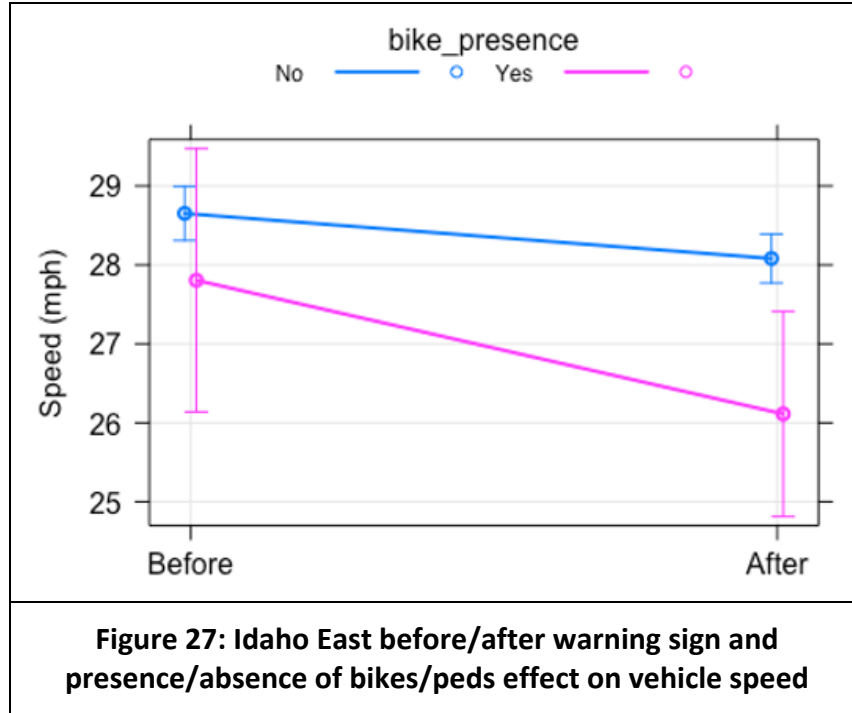
A mixed effect model was used to assess day-to-day speed variation. Bicycle/pedestrian presence was interacted with before/after the warning system was installed as the fixed effects and date as the random intercept. Adjusted for day-to-day variation, there is weak evidence that the average speed difference between vehicles before and after the warning sign depends on whether or not a bike or pedestrian was present ( $t = -1.045$ , on  $df = 3853.6324$  with  $p\text{-value} = 0.2960$ ). The  $p\text{-value}$  is a measure of the probability that the observed difference could have occurred by random chance. The lower the  $p\text{-value}$ , the greater the statistical significance or evidence of the observed difference. This model estimates a decrease in mean speed of 1.69 mph when bikes/peds were present and a decrease of 0.57 mph when bikes/peds were absent after the warning signs were installed versus before. Thus, mean speed decreases more when bikes/peds were present as compared to when they were absent after the sign was installed ( $1.69 - 0.57 = 1.21$ ). mph). The model shows with 95% confidence that this difference in mean vehicle speed when bikes were present versus absent ranges between a 3.24 mph decrease to an increase of 0.97 mph. These results are visualized in the effects plots shown in Figure 27.

variability in the model (based upon the  $R^2$  conditional coefficient of determination, which describes the proportion of variance explained by both the fixed and random factors). As expected, we see that the average speed is lower after the warning sign compared to before its installment. However, the lines are relatively parallel suggesting that this relationship is similar with or without the presence of bicycles/pedestrians, hence there is limited interaction between the warning sign and bike/pedestrian presence.

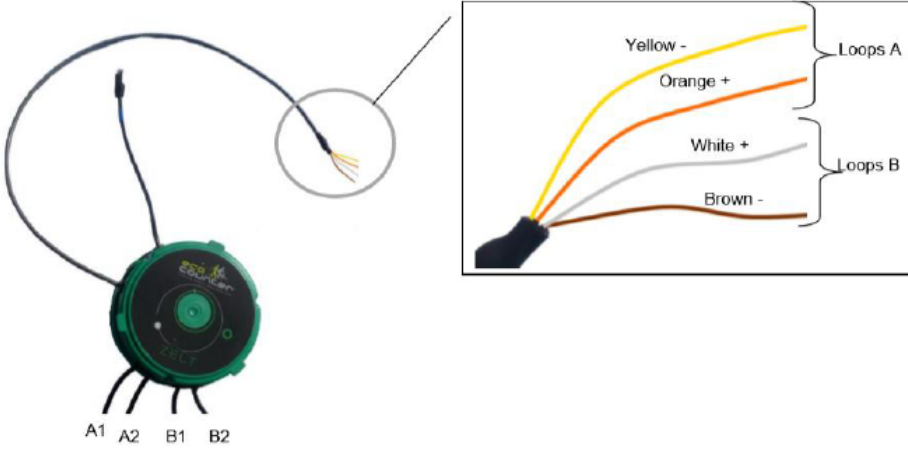
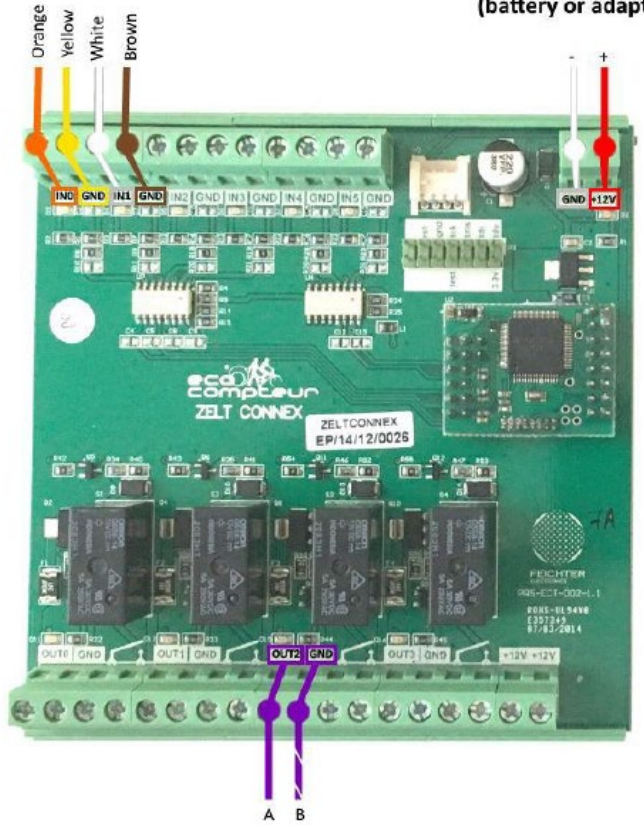
### A.3 Eco-Counter Zelt Sensor Wires and Connex Board Wiring Diagram

<p><b>DRY CONTACT OUTPUTS</b></p> <p>If you have ordered a ZELT System with dry contact output, your ZELT Sensor looks like this:</p> <ul style="list-style-type: none"> <li>Systems with one to four loops:</li> </ul>

<p><b>To Eco-Counter Sensor</b></p> <p><b>12 V DC Power Supply (battery or adapter)</b></p>

<p><b>To JSF Flashing Sign Control</b></p>
<p>Eco-Counter Zelt Sensor with wiring</p>	<p>Eco-Counter Connex Board Wiring with JSF solar powered flashing beacons (courtesy of Eco-Counter)</p>

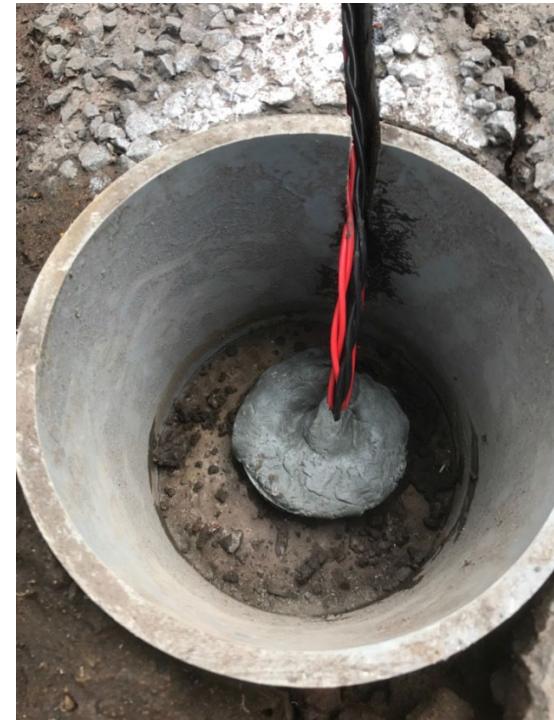
## A.5 ODOT Sand Pocket Loop Wire Entrance Detail (DET4428) and Photo

Photo of sand pocket before the sand and cold mix is added. Notice the pavement cut near the top of the picture where the wires come in from the roadway.
