# NARROWS OVERSIZED VEHICLE IDENTIFICATION SYSTEM (NOVIS)

# TECHNICAL MEMORANDUM 2: TEST-BED EVALUATION OF WIDTH DETECTORS

Western Transportation Institute College of Engineering Montana State University

July 2005

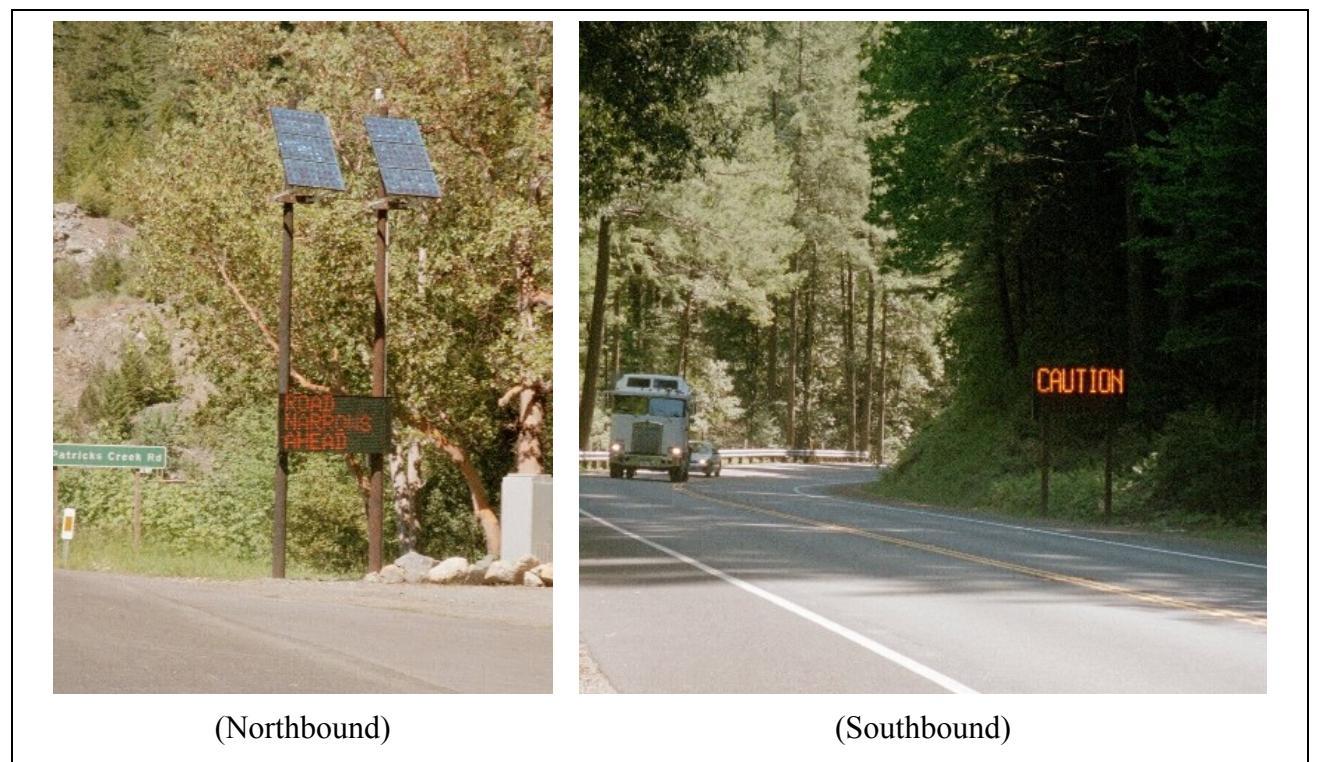
Figure 1-2: CMS Installation During Phase One

Two CMS were installed, shown in Figure 1-2, that read "CAUTION ROAD NARROWS AHEAD" to provide static warnings to motorists about the narrow widths in this area and therefore to increase driver awareness of the potential for vehicle conflicts. Evaluation of these signs in summarized in the NOVIS Phase 1 report (2).

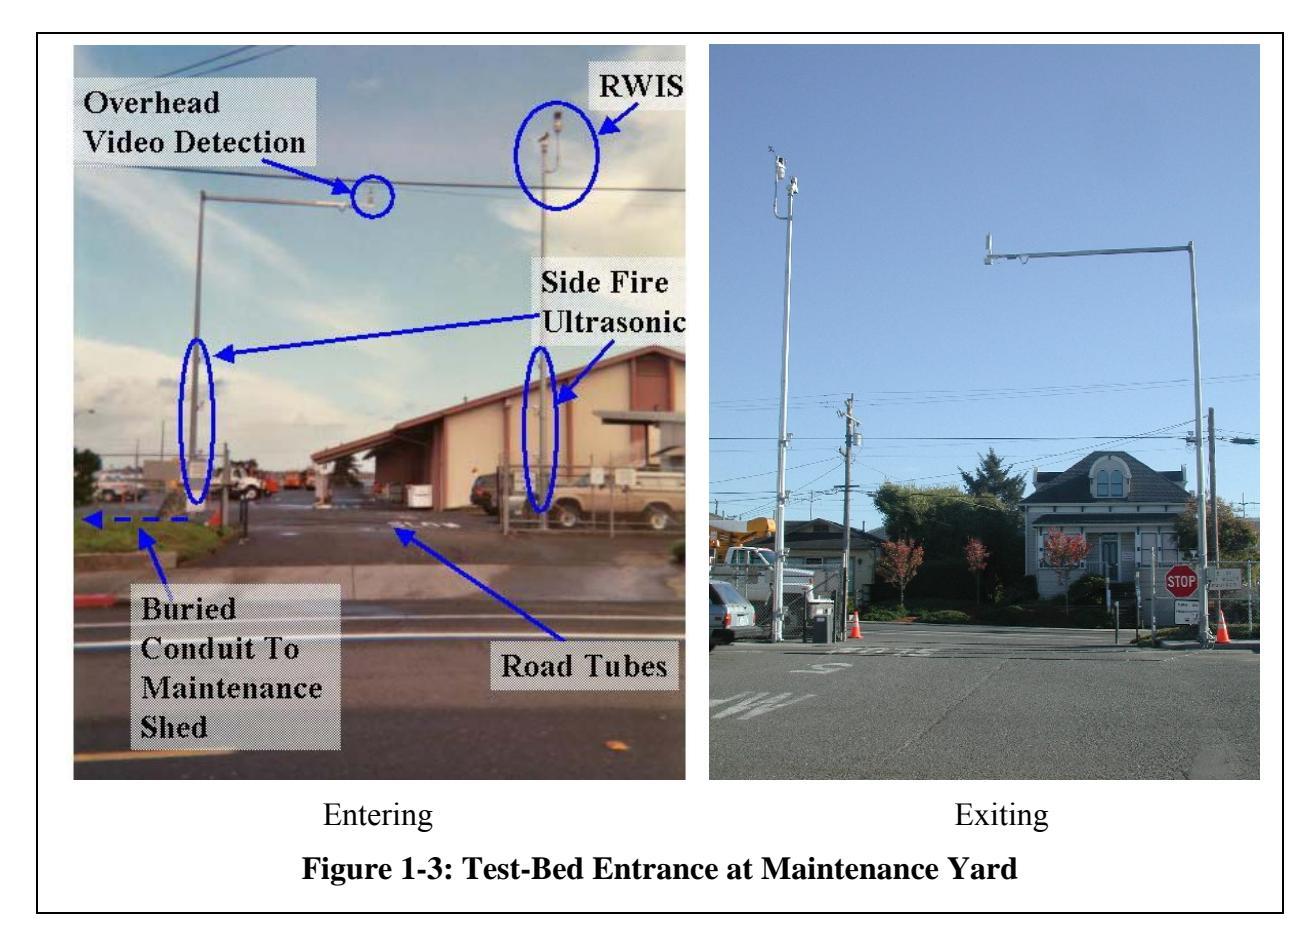
Figure 1-3 shows the entrance to the maintenance yard where the width detectors were placed. For the test-bed, two poles were installed at the entrance with appropriate conduit and wiring. A functioning Road Weather Information System (RWIS) and Closed Circuit Television (CCTV) were installed on the top of the right pole. The RWIS and CCTV are Caltrans equipment, not directly part of this project. They will remain after the test-bed is removed. The left pole includes a mast arm for overhead instruments at a height of 30 feet. In this picture only the video camera for the video detection system is installed on the mast arm. The overhead ultrasonic was also installed on the mast arm but removed for reasons discussed later in this report. Each pole has the required mounting for four side-fire ultrasonic detectors. Buried conduit for power and communications runs from each of these poles to the control cabinet located inside a maintenance shed to the left of the entering view in Figure 1-3.

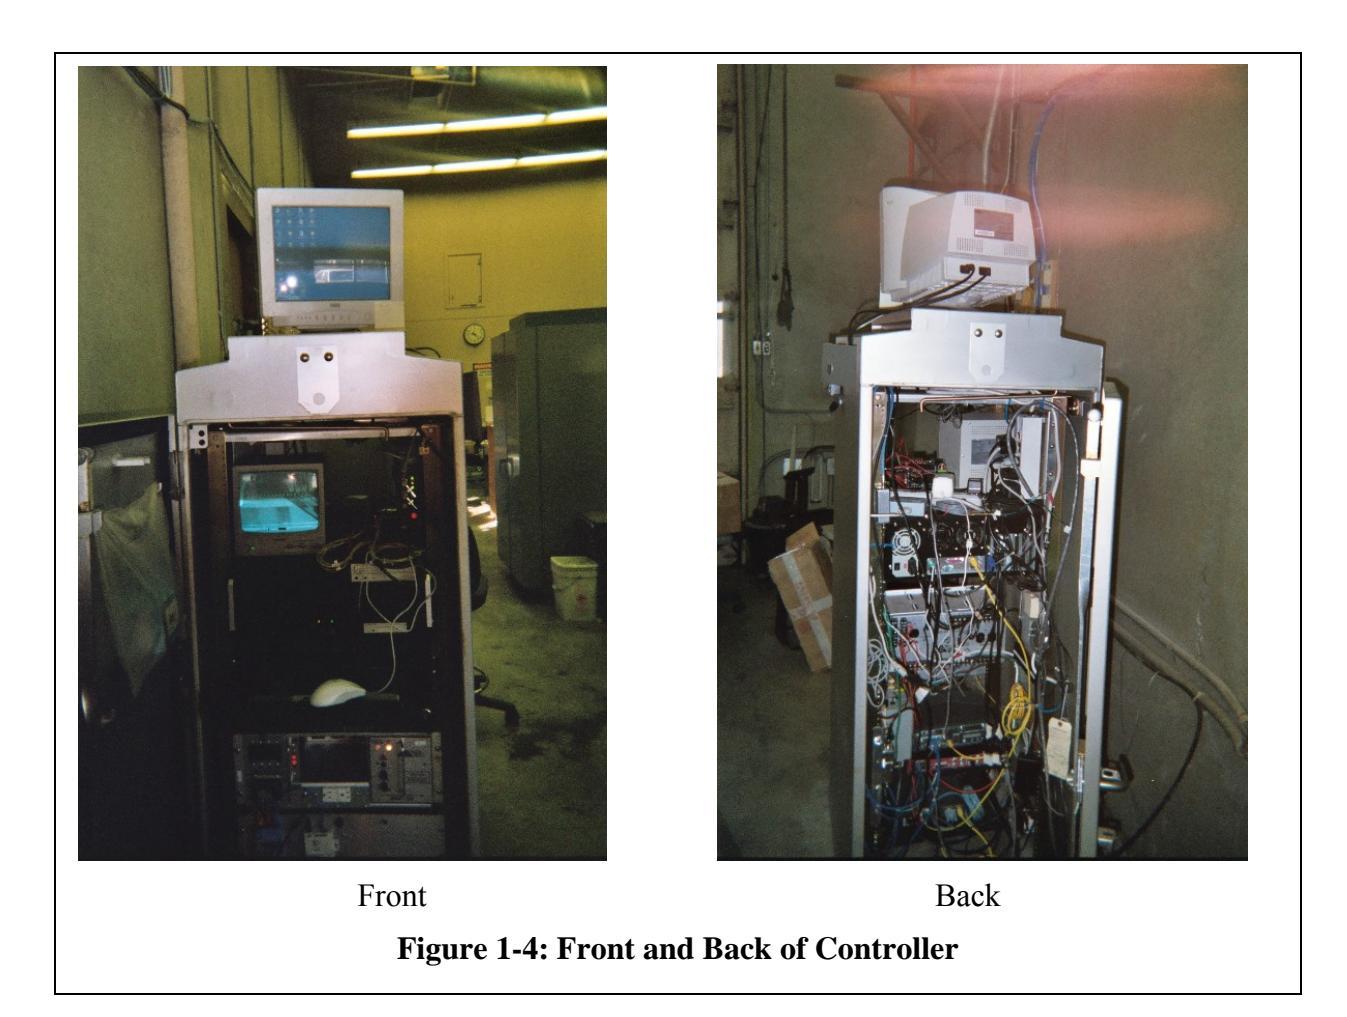
Caltrans District 1 allowed space for the NOVIS project equipment in one of their controller cabinets on site. The cabinet is shown in Figure 1-4. On the top of the cabinet, you can see the monitor for the NOVIS computer. On the top shelf are the video monitor, Iteris controller, and programmable logic controller (PLC) for the video detection system. The NOVIS computer is located on the next shelf down. The remainder is equipment not related to NOVIS with the exception of a cable router on the bottom shelf. Equipment related to specific width detection systems will be described later in this report. Equipment that is part of the testbed "backbone" and common to all systems is discussed here.

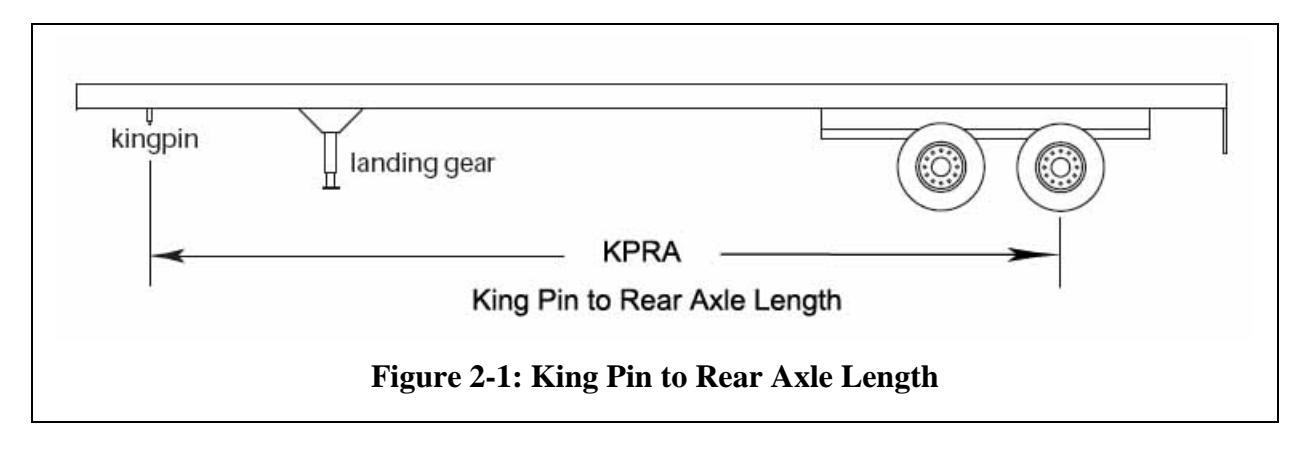
The basis for measurements in California is as follows. Kingpin to rear axle (KPRA) length is measured from the center of the king pin to the center of the rearmost axle (Figure 2-1). KPRA length is more important than total vehicle length (i.e., bumper to bumper) because it determines the amount of off-tracking when the vehicle rounds a curve. Width is defined as the total outside width of the vehicle or its load. Height is measured from the surface on which the vehicle stands to the top of the load/vehicle.

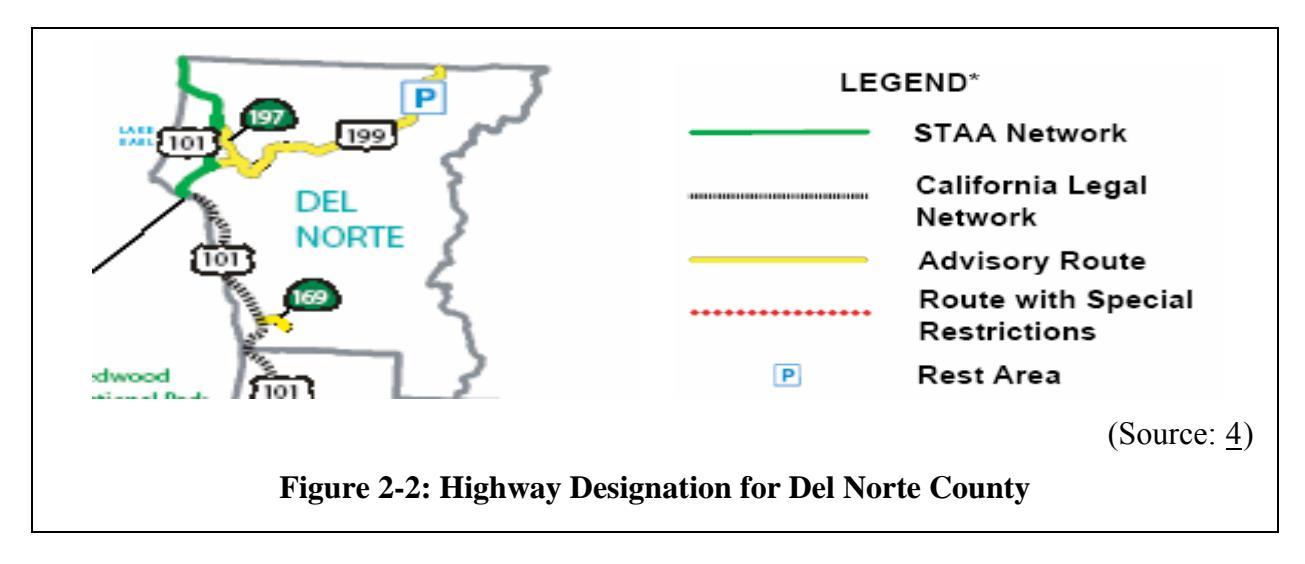
As shown in Figure 2-2, the Narrows on US Route 199 is an Advisory Route. This indicates that trucks wishing to use this facility are restricted by STAA, California requirements and additional advisories. The advisory for this route is for vehicles with KPRA lengths of 30 feet.

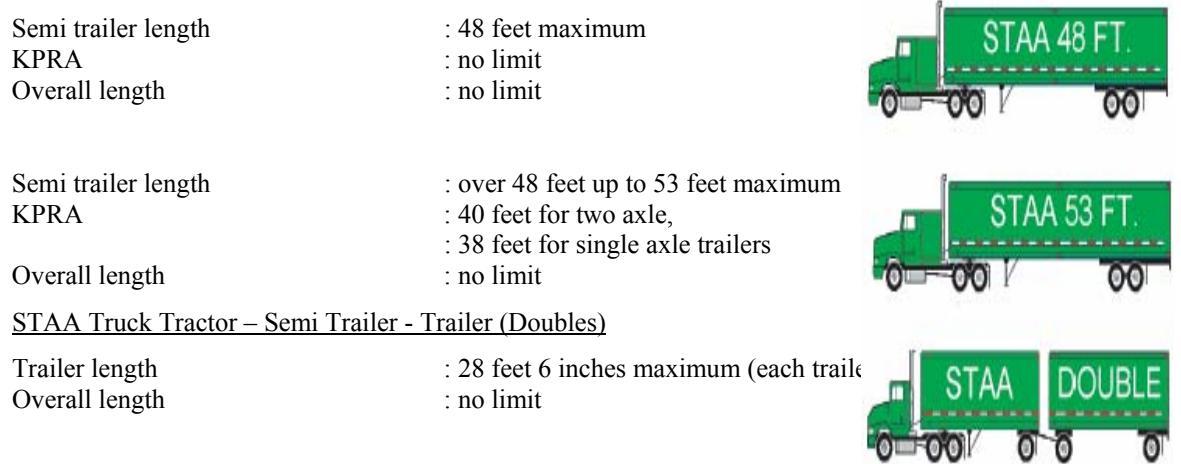
STAA Truck Tractor - Semi Trailer

The Surface Transportation Assistance Act (STAA) requires states to allow larger trucks on the "National Network," which is comprised of the Interstate system plus the non- Interstate Federalaid Primary System. The STAA requirements are listed below as a reference so the change in requirements can be quantified.

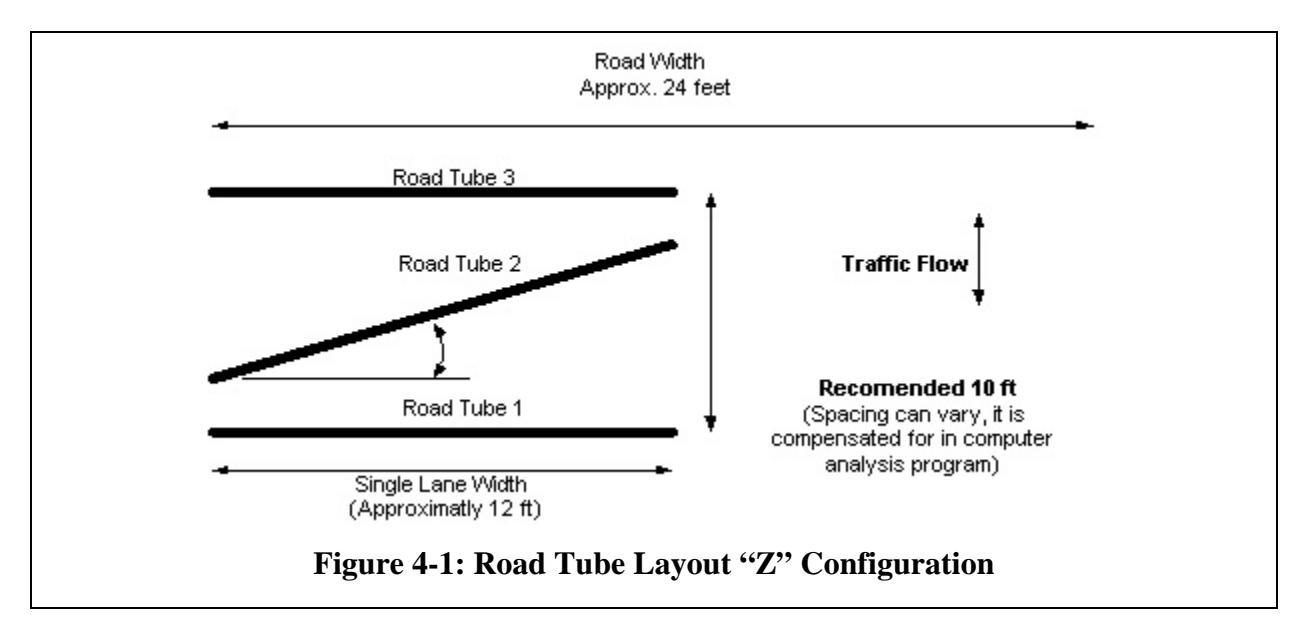
The time-tagged event data is downloaded to a PC with a serial cable. Prior to development of additional software by Timemark, Inc., the data could be analyzed to provide vehicle information including the time the vehicle was recorded, direction, speed, number of axles, axle spacing, and gap. Width analysis was added to the classifier through the development of the Timemark software, and the development of new road tube layouts. The initial road tube layout proposed was in a "Z" configuration as shown in Figure 4-1.

The use of a 30-degree angle was expected to minimize the discrepancy for dual tires and avoid simultaneous hits by tandem axles of most trucks and trailers. Manufacturer analysis indicated that this angle would provide widths at the tires within a maximum error of 2.9 inches at 60 mph assuming a fixed tire width. Any speeds slower than 60 mph will result in higher accuracy. Following more detailed analysis and testing, the development of a more accurate and reliable "X" layout shown in Figure 4-2 was recommended and implemented.

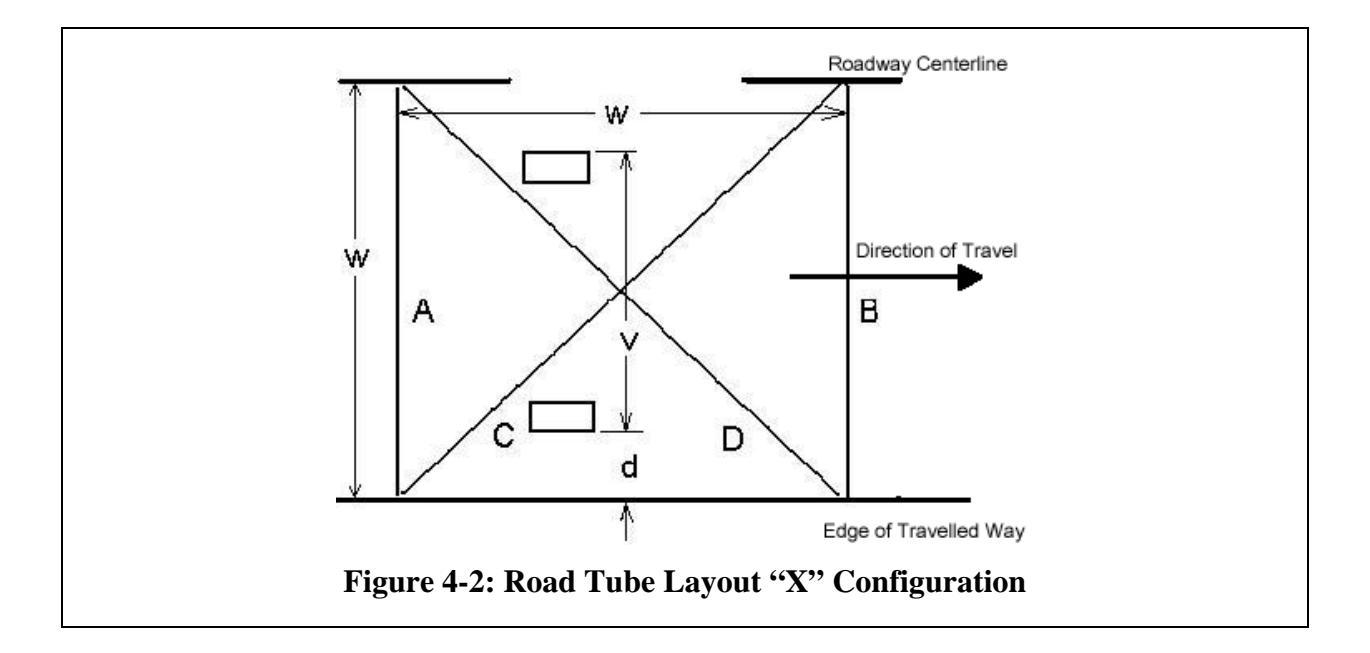
The X layout is intended to be a square of width and length w. Based on the known geometry of this layout and the raw data information from all four tubes the vehicle width v can be calculated. This layout requires vehicles to travel straight across the tube layout in order to be calculated correctly.

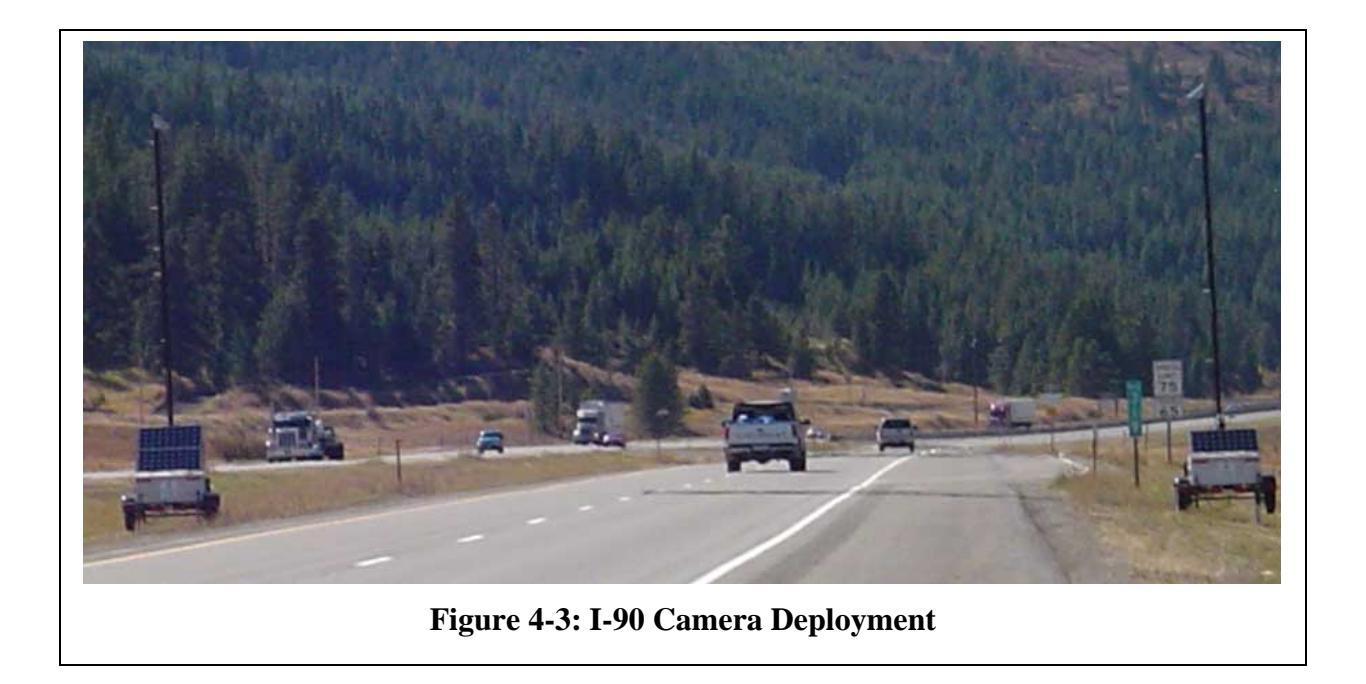
Due to the constraints at the test-bed location, the deployment of this system was relocated to a more appropriate test location on Interstate 90 (I-90) westbound at milepost 319.4 on the Bozeman Pass in Montana. This section of roadway is a straight and level section providing the optimal situation for vehicle entering the test area. I-90 is a two lane rural interstate with an average annual daily traffic (ADT) of approximately 12,800 vehicles, and a posted speed limit of 75 mph ( $\underline{6}$ ). Road tube setup was completed between October 5, 2004 and October 7, 2004. Without a known vehicle fleet being used to test the system, width validation as a measure of accuracy was completed using video data. Video camera trailers were set up at the test location to record during the testing. The video was later used to obtain vehicle widths and subsequently measure road tube accuracy. This camera deployment is shown in Figure 4-3.

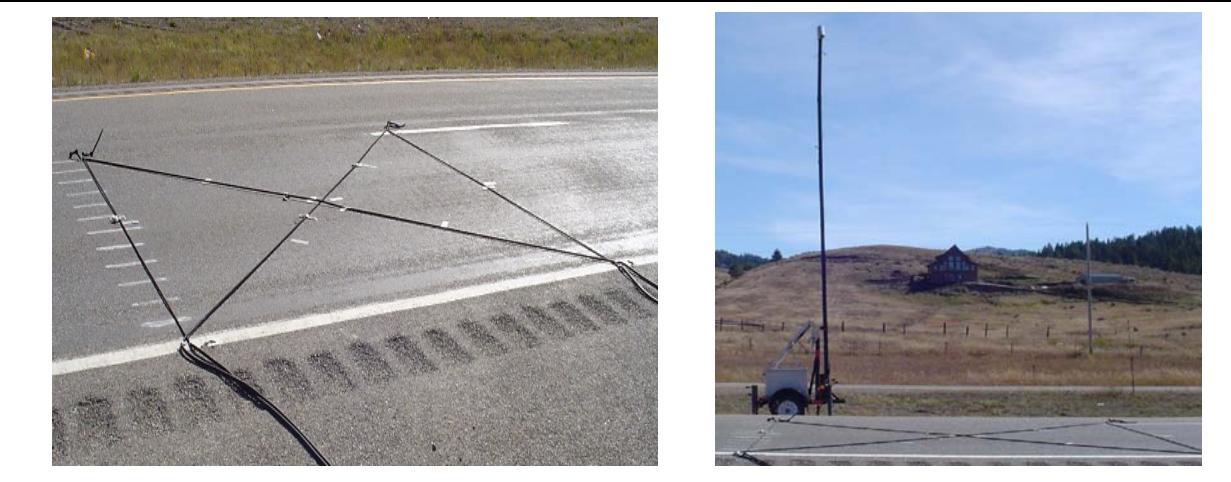
Figure 4-4: I-90 Road Tube Layout and Width Markers

The road tubes were deployed in the same location and can be seen in Figure 4-4 as line crossing perpendicular to the direction of travel in the shoulder lane. Width markers on the roadway were used during video evaluation to determine vehicle offsets from the edge of traveled way and centerline. These can be seen along the left road tube in Figure 4-4.

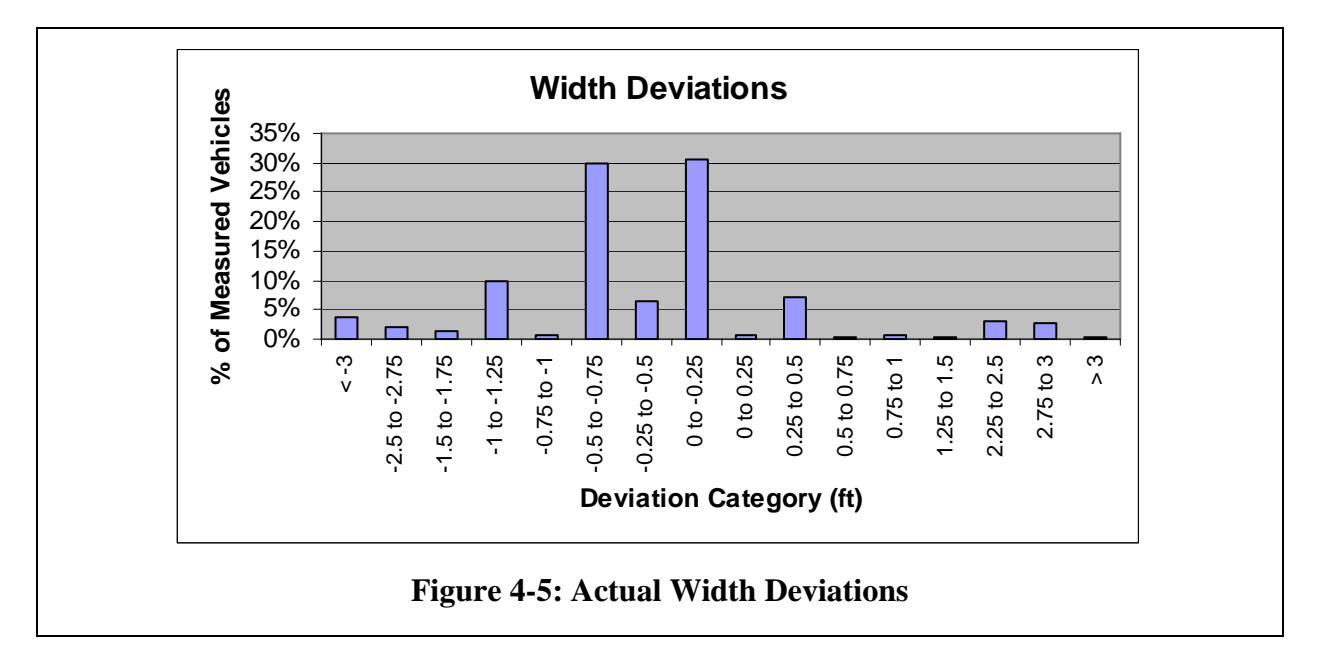
For the I-90 site, researchers compared the width and offset calculations from the Timemark VIAS software, the raw road tube data, and widths measured from video. The offset refers to the distance from the edge of the traveled way (i.e., white stripe) to the edge of the nearest tire, which is used to calculate the width. Due to data errors, widths could not be determined from the VIAS software, or the raw data. In place of widths, offsets were used for evaluating accuracy instead. This correlation provides a measure of accuracy for the system based on the data available. In this case, for the vehicles that were identified, a distribution of the actual difference between measured distances from edge of traveled way (based on video data) and the width extracted from the Timemark data is presented in Figure 4-5.

This distribution shows the 252 vehicles of the 346 vehicles that could be measured. It can be seen from this distribution that the majority of vehicles measured are measured within one foot. Of those vehicles that are measured to within one foot, the large majority are underestimated. Of the vehicles measured, 84 percent of the vehicles were measured as having an edge line offset less than the actual offset. Of that percentage, 31 percent of the vehicles were identified to within an accuracy of 0.25 feet.

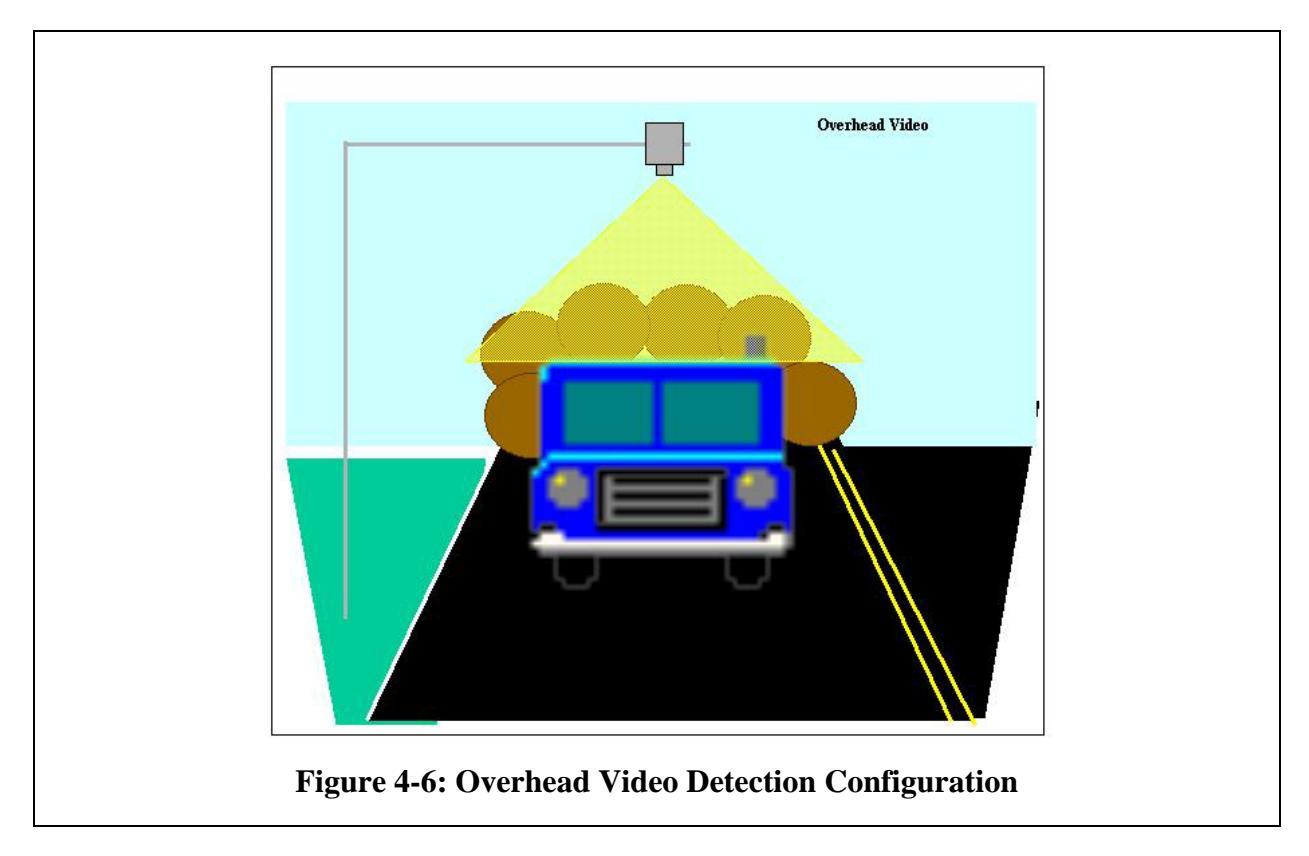
WTI selected the overhead deployment of the Iteris camera system, which involves positioning cameras directly over the lane of travel of vehicles to be measured. The video camera was mounted at a height of 30 feet in the center of the travel lane. This approach targets the top of the vehicle as it approaches or passes underneath the camera. The system makes use of the powerful algorithm already developed to detect a vehicle presence in a predefined zone.

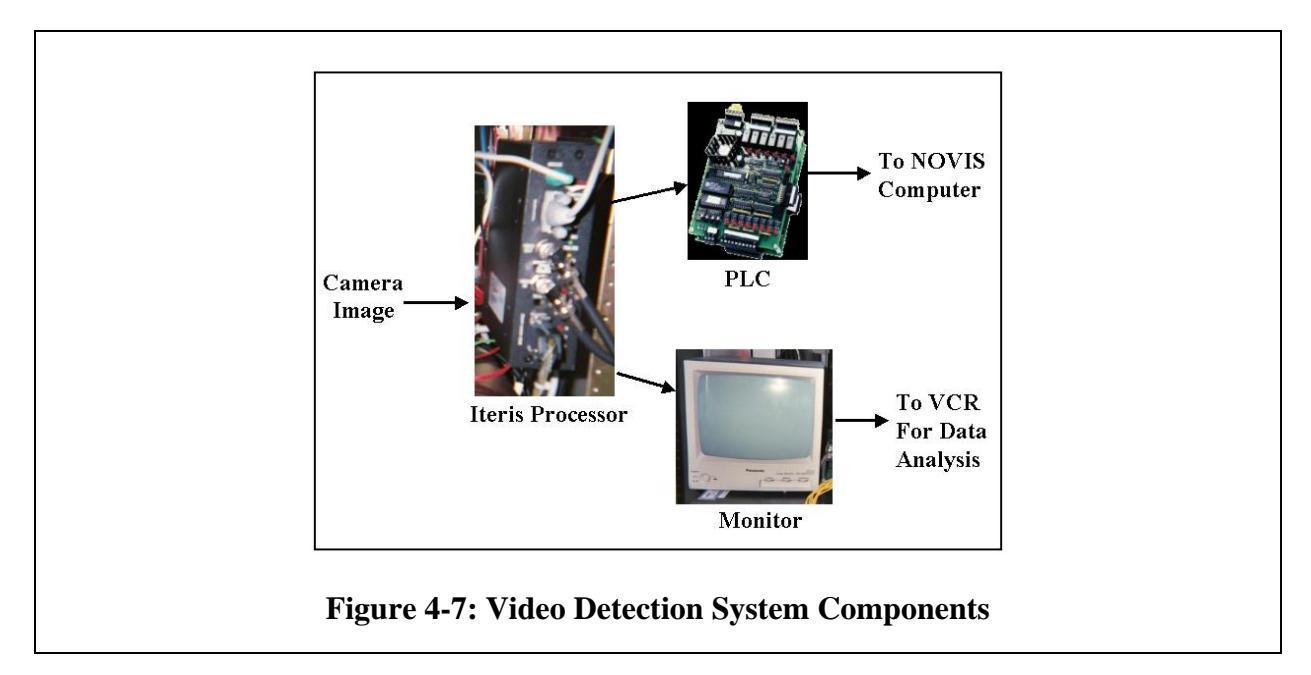
The major components for the video detection system are shown in Figure 4-7. The image comes from the camera to the Iteris image processor. The image processor analyzes the video image and, depending on the settings, will output up to eight alarms. In a typical situation, these alarms would be sent to a signal controller (as loop detection alarms) or another such device. However, in order to capture the time and data of these alarms we used a programmable logic controller (PLC), which would send times and alarm numbers to the NOVIS computer to be recorded for analysis. The monitor is used to view the video image to ensure the camera is functioning. For use during setup, a mouse can be plugged directly into the Iteris controller and the detection zones can be manipulated.

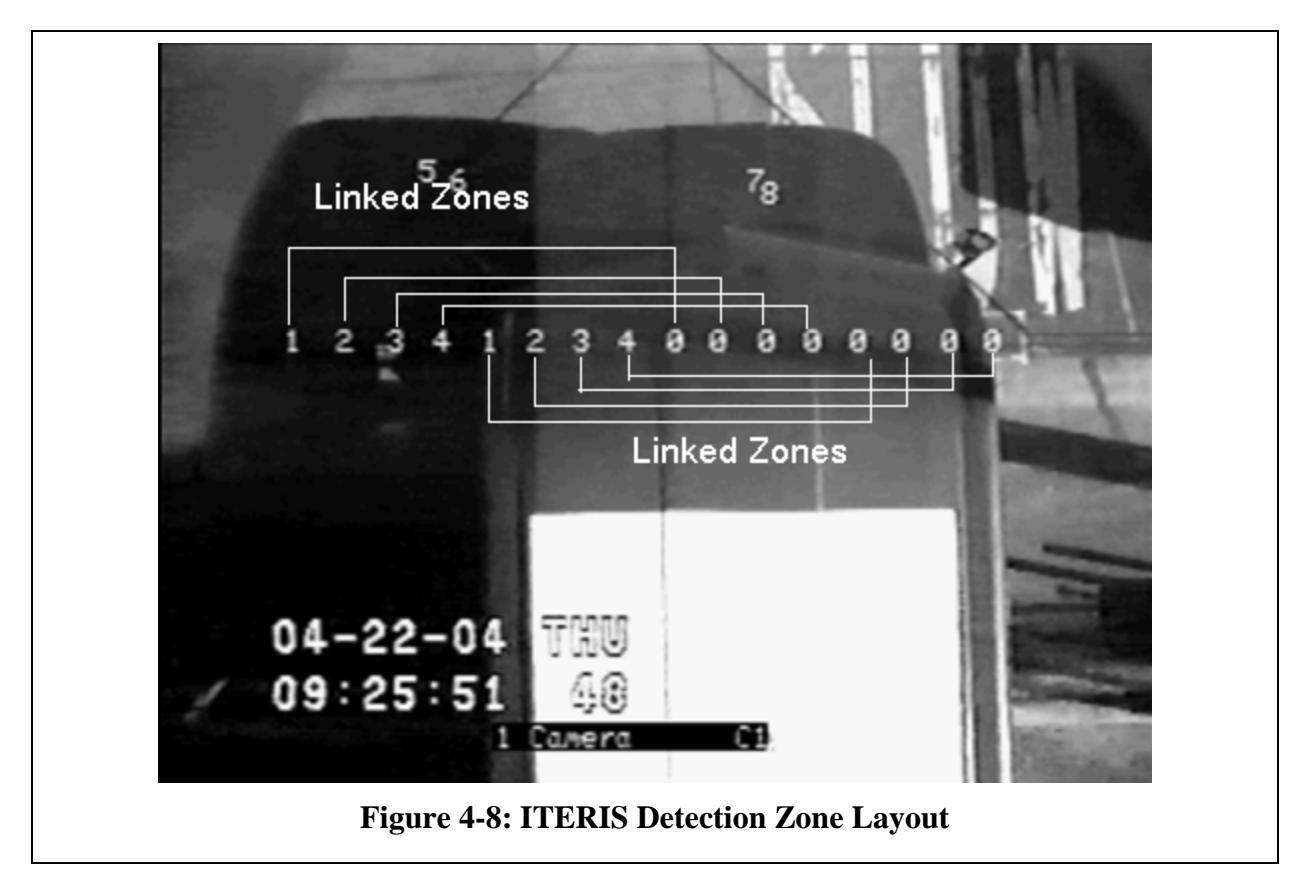
Detection zones are created by the operator of the system, and can be moved or changed based on the needs of the system. In this deployment a total of 16 one-foot wide zones were created in a single line across one lane of travel. In order to utilize all 16 detection zones, the outputs were linked, thus if two detection zones eight feet apart are triggered then an alarm will be generated and an over-width vehicle has been detected. This allows the identification of width to 2 ft accuracy. This layout can be seen in Figure 4-8.

In this layout it can be seen that alarms one through four are repeated, meaning that an alarm will sound on channel 1 if zones one and nine or zones five and thirteen are triggered. This allows alarms five through eight to identify the direction of travel for a vehicle.

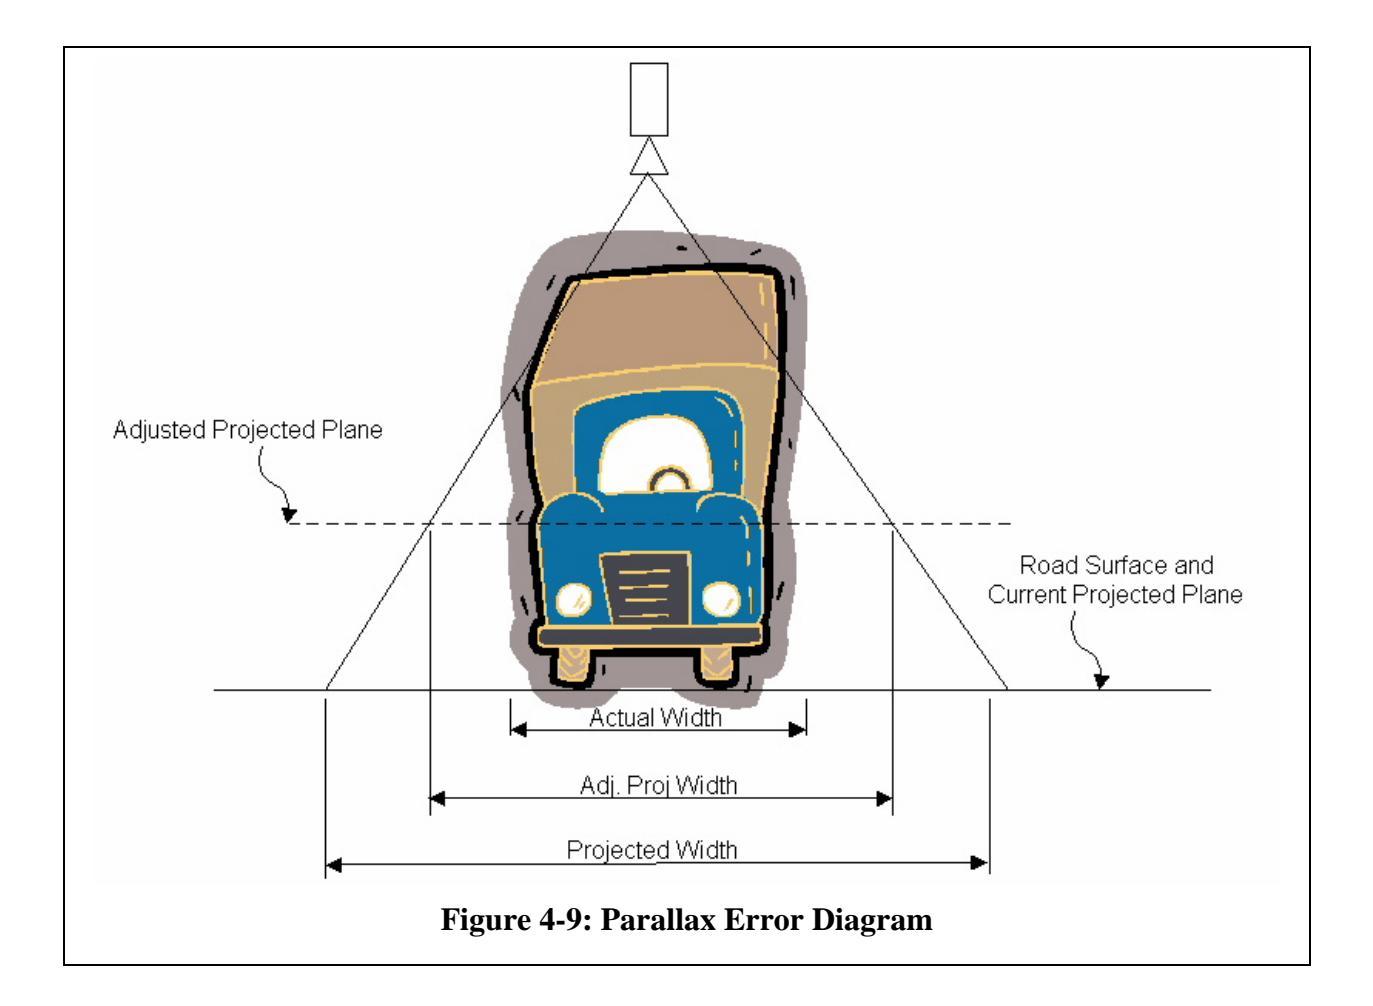
Implementation of the basic system components was relatively simple. Some additional programming and configuration was required in order to record the alarms from the system (i.e., the PLC installation), however, this was fairly straightforward. The major problems arose from the actual data collection ability of the system. When using this system, parallax error from the camera perspective is an issue. The distance between the camera and the projected plane is different for different vehicle heights, and will change as the vehicle travels through the zone. The zone sizes are based on one-foot width on the ground. When the vehicle image is projected onto the ground, it appears much larger than the actual size. The parallax problem is shown graphically in Figure 4-9.

To fix the parallax problem, the critical width of a vehicle could be set based on height and width combinations as shown in Table 4-1. The dimensions are averages taken from the AASHTO Green Book ( $\underline{8}$ ) and a camera height of 30 ft. As can be seen, finding a critical width that identified the 8.5-foot wide vehicles, but not the 8 ft wide vehicles, would be problematic. Adjusting the plane of the projected image can reduce the parallax error; however, the difference in height of oversized loads (i.e., flatbeds vs. trailers) may cause problems with this approach. The parallax error could be adjusted reliably if we knew the distance to the vehicle by the equations developed by Tian, et al (9). However, this would require a rangefinder and an additional algorithm (likely programmed into the PLC), which would take some development to resolve timing errors between the rangefinder and the image processor.

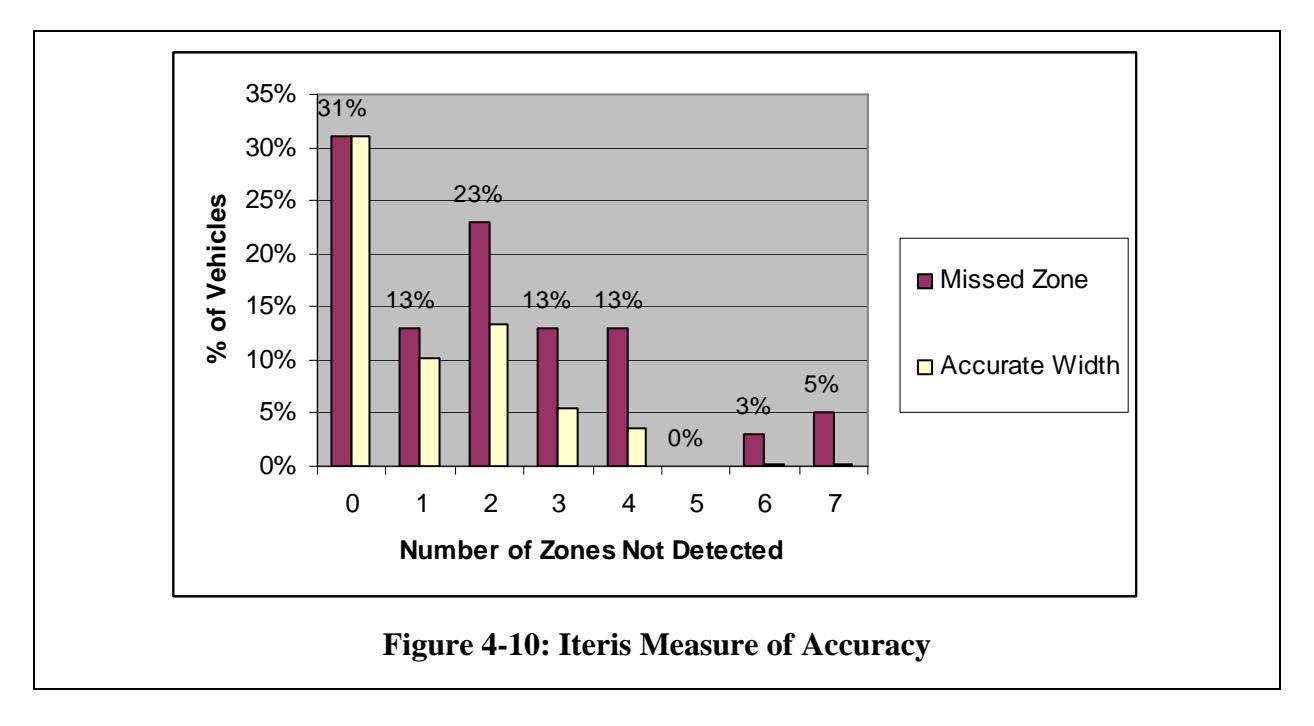
Accuracy of the system is compromised by many different issues: the vehicle color, shadows, difference in height as vehicles pass under the system, and the way detection boxes are linked. The most influential of these variables are the changes in height as vehicles pass, and the way alarms require the detection zones to be linked. Since the accuracy was completely compromised by the issue of parallax, a surrogate measure of accuracy identified was the number of zones that were improperly not detected against percent of vehicles entering the detection zone.

Figure 4-10 shows that the system correctly detected all one-foot zones for 31 percent of all vehicles that entered. Although this is a measure of accuracy for detection, it does not account for width detection. Ignoring the parallax error and assuming alarms for detected zones were sent simultaneously, the width of a vehicle would only be correctly measured if the two zones on either edge of the vehicle were triggered. For this example, zones 1 and 9 would need to be triggered at the same moment for the vehicle to be identified as over eight feet. Assuming an over-wide vehicle would pass through nine zones and the probability of the edge zone being a

missed zone is not any different than that of a middle zone, an estimate of the accuracy in detecting over-wide vehicles can be determined. For example, the system missed one zone for 13% of the vehicles. The probability of the one missed zone not being an edge zone is 0.778 (seven ninths). This estimates that 10.1% (0.778 \* 13%) of the vehicles had one zone missing but still would have an accurate width detected as shown by the second series in Figure 4-10. With these assumptions, we estimate the system would detect oversized vehicles accurately, 64 percent of the time.

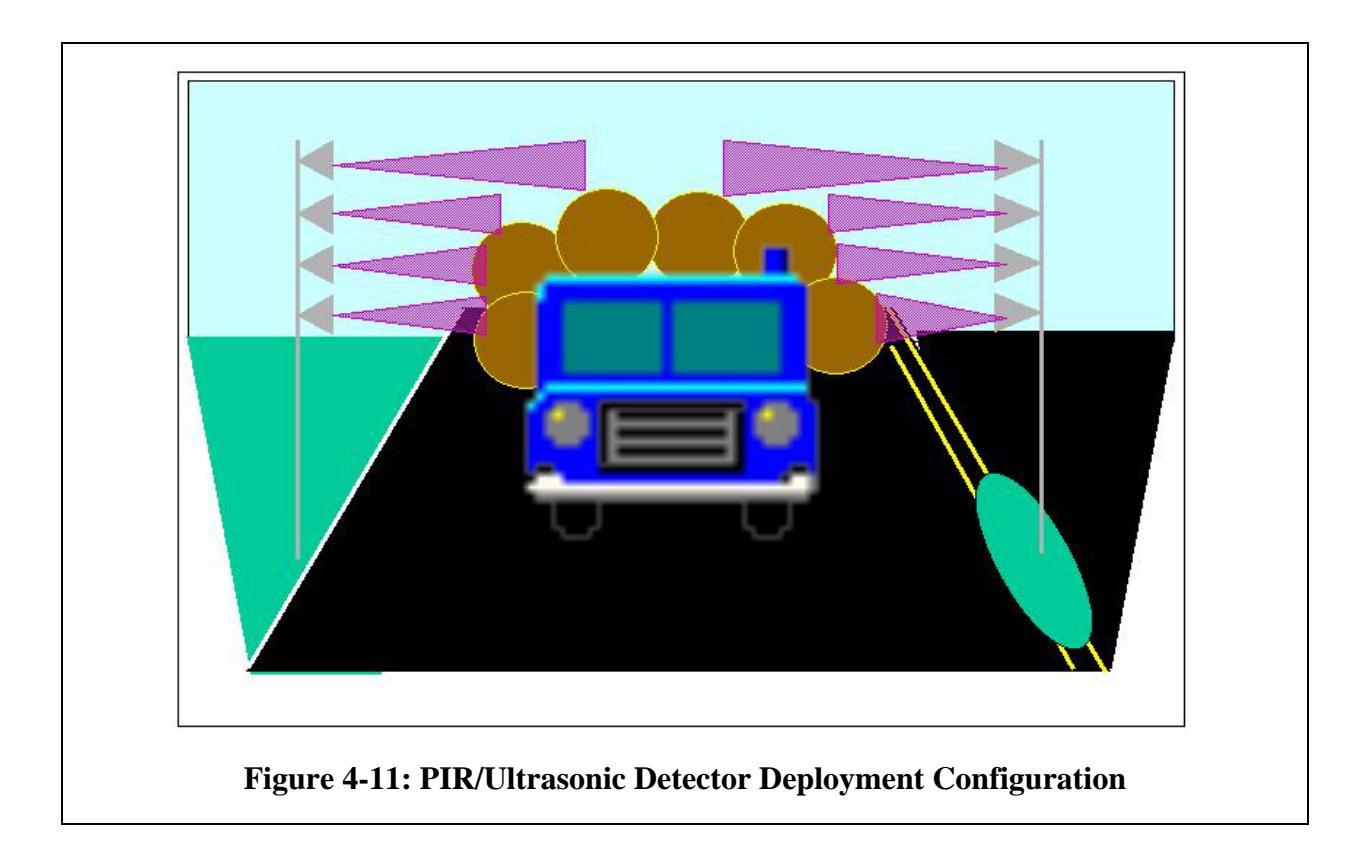
The side of roadway deployment configuration was selected for this project and involves deployment of dual Passive Infrared (PIR) and ultrasonic detectors along both sides of the roadway (Figure 4-11). A series of four detectors were installed one above the other on a pole on each side of the roadway. Detectors on opposite sides of the roadway would be oriented toward one another and perpendicular to approaching vehicles. Vehicles passing through the PIR detectors' fields of view are detected and initiate measurement by the ultrasonic detectors that is located in the same housing as the PIR detectors. The ultrasonic detector emits a series of acoustic signal bursts (beyond audible frequencies). The acoustic signals are reflected off the sides of the vehicle moving through the detector zone and used for measurement. The time required for the reflected signal to return to the detector determines the distance (and hence in this case, the width) of the vehicle being measured.

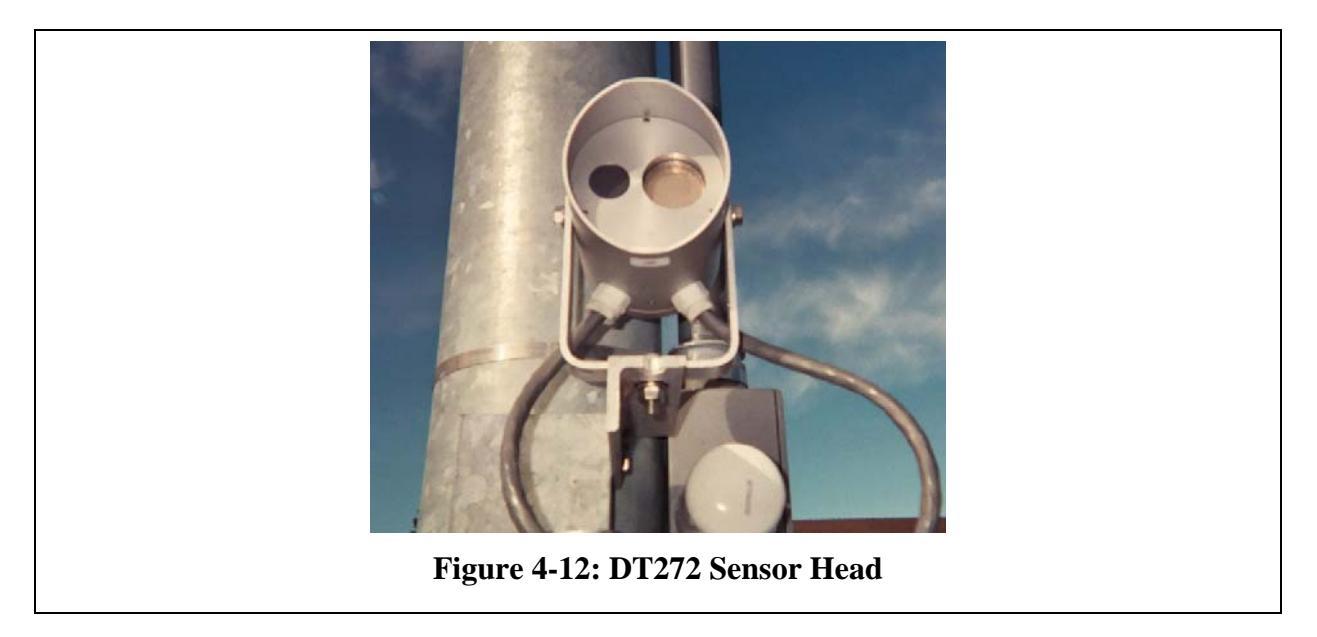
portion is both a transmitter and receiver, used for vehicle measurement. The specifications for these sensors are detailed in the appendix.

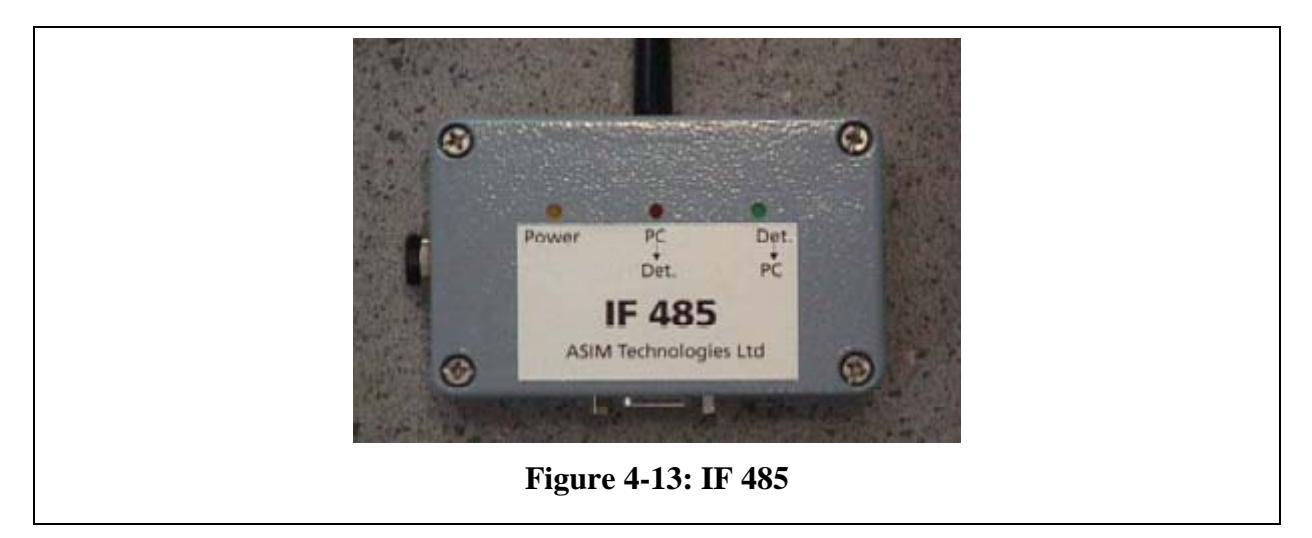
These devices require a background distance to be set for all the sensor heads. If a distance greater than this background distance is measured, it is ignored. To avoid interference from sensors on the opposite side of the road, the background distance must be less than half the distance between the two poles. A buffer distance is also set so that the sensors ignore distances measured that are extremely close to the sensor (for example, within 2 feet). When a sensor detects an object and measures a distance greater than the buffer distance and less than the background distance, it sends this distance to the main processor. In this case, the main processor is the NOVIS computer. In order to avoid the signals sending messages at the same time, a slave/master relationship is set up with one sensor designated as the master. The master sensor communicates with the NOVIS computer through a data bus utilizing the IF 485 shown in Figure 4-13. The IF 485 is also used when the sensor settings (i.e., buffer and background distance) are updated by the computer.
