# NARROWS OVERSIZED VEHICLE IDENTIFICATION SYSTEM (NOVIS)

# TECHNICAL MEMORANDUM 2: TEST-BED EVALUATION OF WIDTH DETECTORS

Western Transportation Institute College of Engineering Montana State University

July 2005

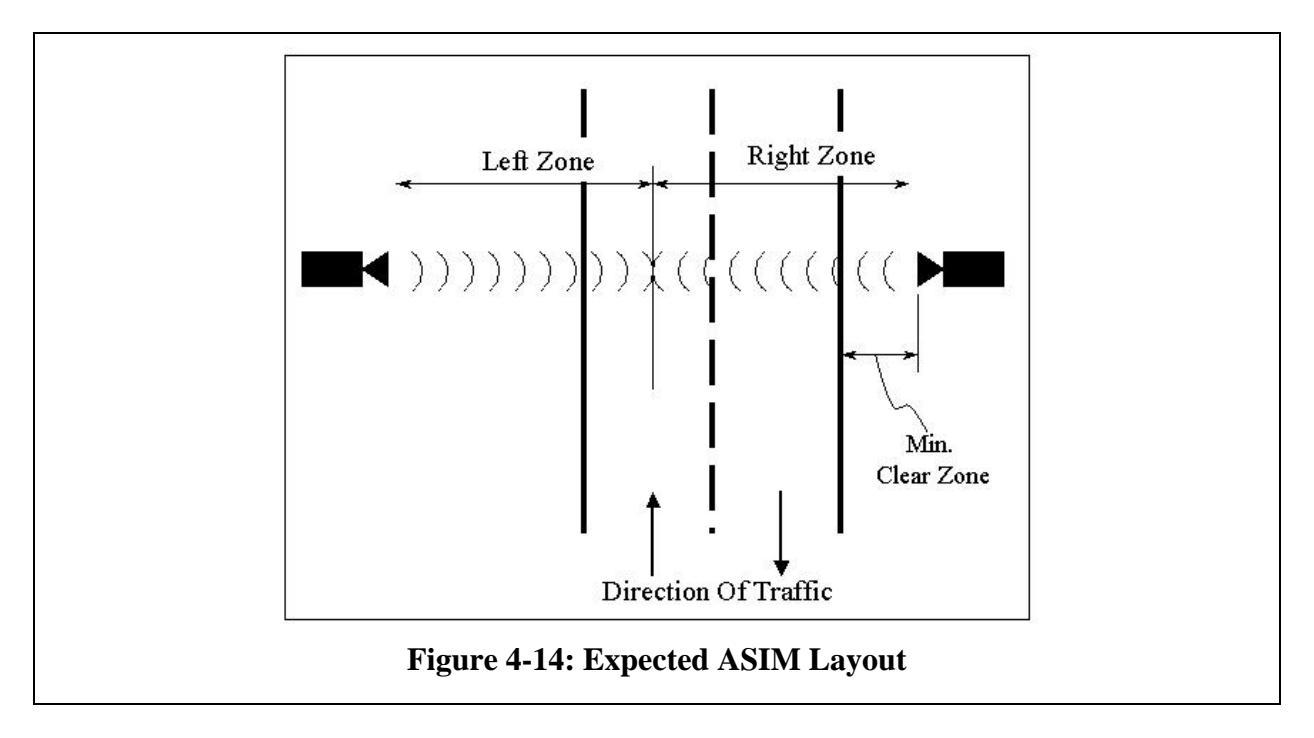
Some limitations of this system are inherent to the setup method and positioning of sensors. The background distance setting requires a vehicle to cross the middle of the detection zone or a width cannot be calculated. Even though the test-bed had bi-directional traffic, most vehicles were centered as they passed through the detection zone due to the lack of channelization. However, for a two-lane highway, a separate set of poles would be required for each lane. As shown in Figure 4-14, for a given lane the far pole would need to be placed a distance equal to 1.5 lane widths plus clear zone from the center of the lane (e.g. 18+30 ft) which may be out of range for the sensor. Due to the nature of sound propagation, these sensors are limited in their range (about 35 ft according to the vendor). Also, these distance constraints may not be feasible in an area such as the Narrows with restrictive topography since the right and left zones in Figure 4-14 must be equal length. There might be a solution to this problem if the sensors on one side used a different frequency than those of the other, however, this would require additional development and testing.

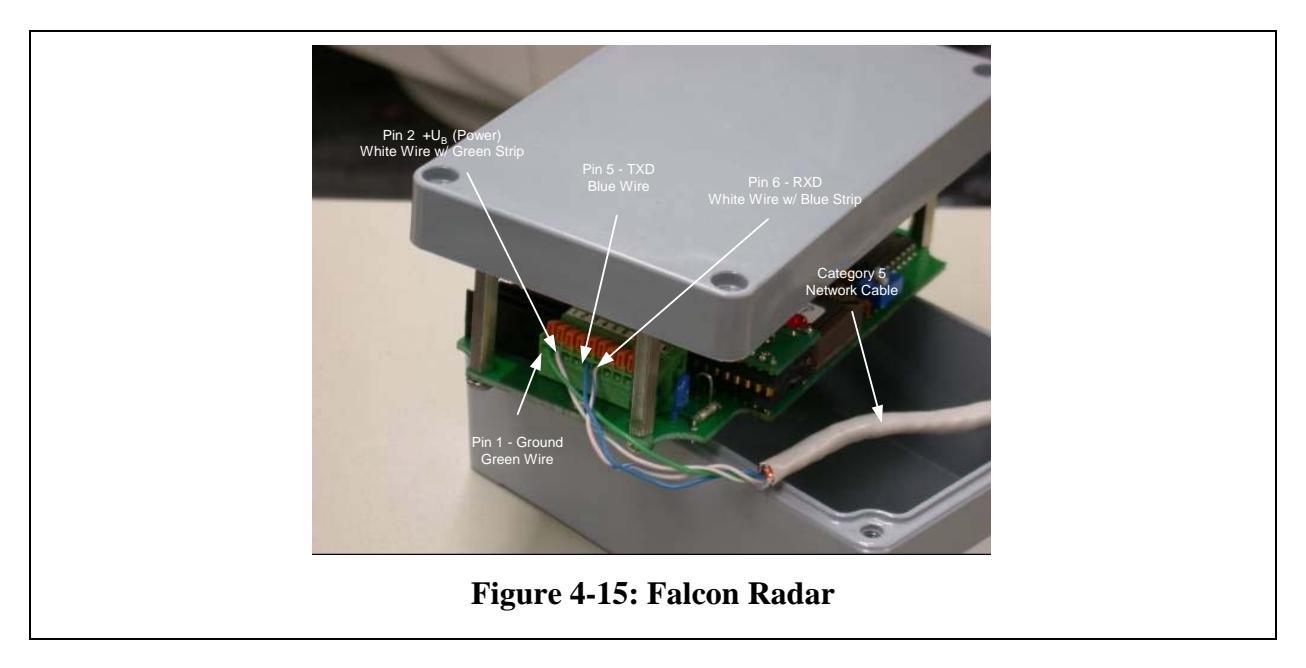
Falcon radar, shown in Figure 4-15, uses a direction sensing Doppler radar to calculate vehicle speeds. The vendor also claims it can determine length, but the primary reason for the installation was to determine the vehicle speeds for data analysis. The radar would be placed above the road surface and angled to record vehicle speeds as they approach the sensors. Vehicle speeds could be displayed, but we were unable to get the device to record speeds for future analysis. This issue could not be resolved since the vendor, for proprietary reasons, would not provide necessary information on how the speeds were coded.

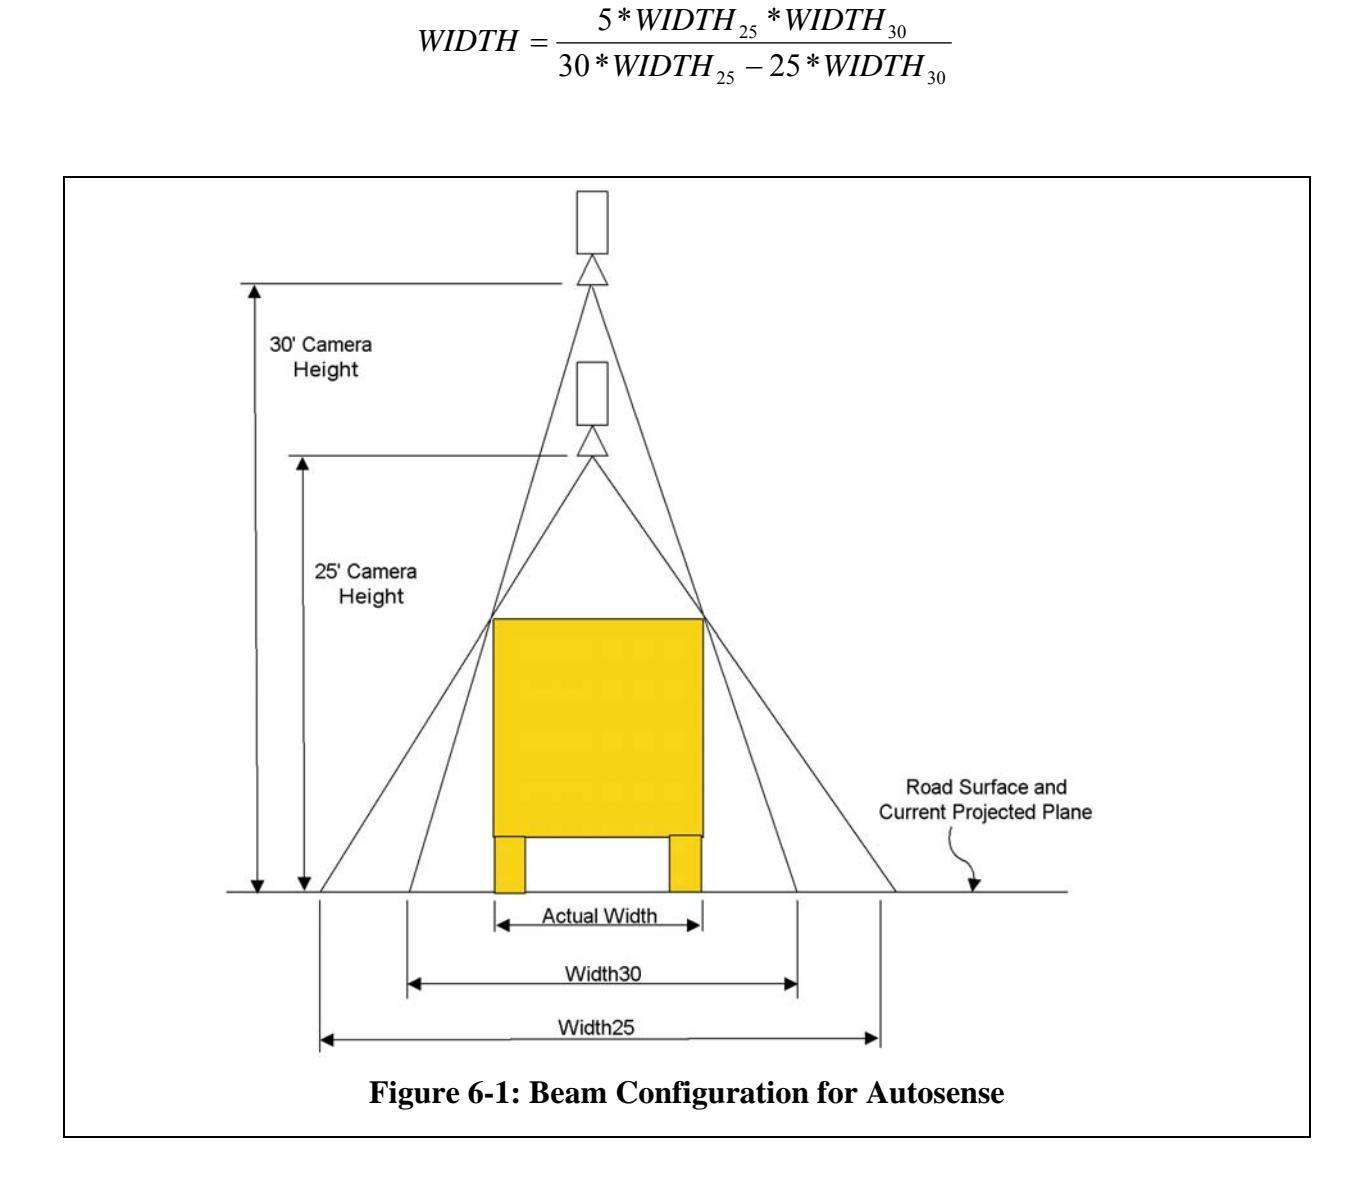
following relationship where  $Width_{25}$  is the width measured by a camera mounted 25 feet high, and  $Width_{30}$  is the width measured by the camera mounted 30 feet high as shown in Figure 6-1.

Due to the issue with one-foot accuracy, the two measured widths can be rounded up or down yielding four possible widths. The error depends on the actual dimensions of the vehicle and how the widths are rounded. The four possible calculated widths are shown in Table 6-1 for common vehicle types taken from the AASHTO Green Book (). Due to the potential error of this approach, it is not recommended. However, the authors wanted to mention it since this option was discussed previously with the steering committee.

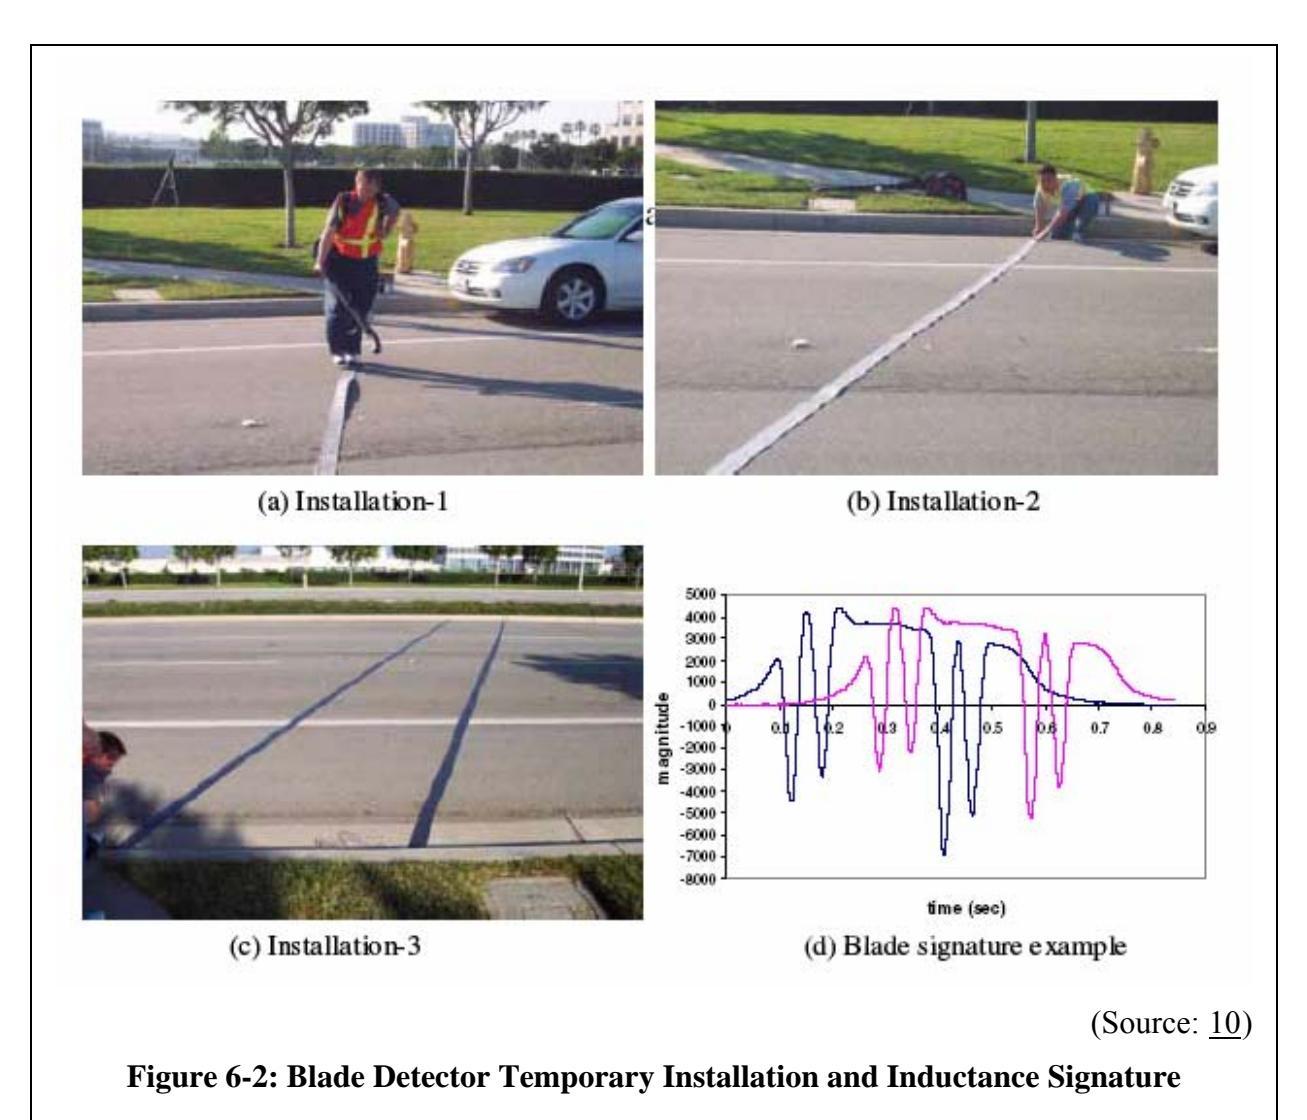
The reason why a Blade detector might work as well as a piezo-electric system is that the inductive signatures in most cases clearly indicate the location of the wheels. Metal passing over the detector will cause inductance. The more metal and the closer it is to the detector, the higher the inductance. Since wheels are closer to the pavement than the rest of the vehicle, a higher inductance is measured. The four downward spikes in the vehicle signature in Figure 6-2 represent the four wheels of a passenger car.

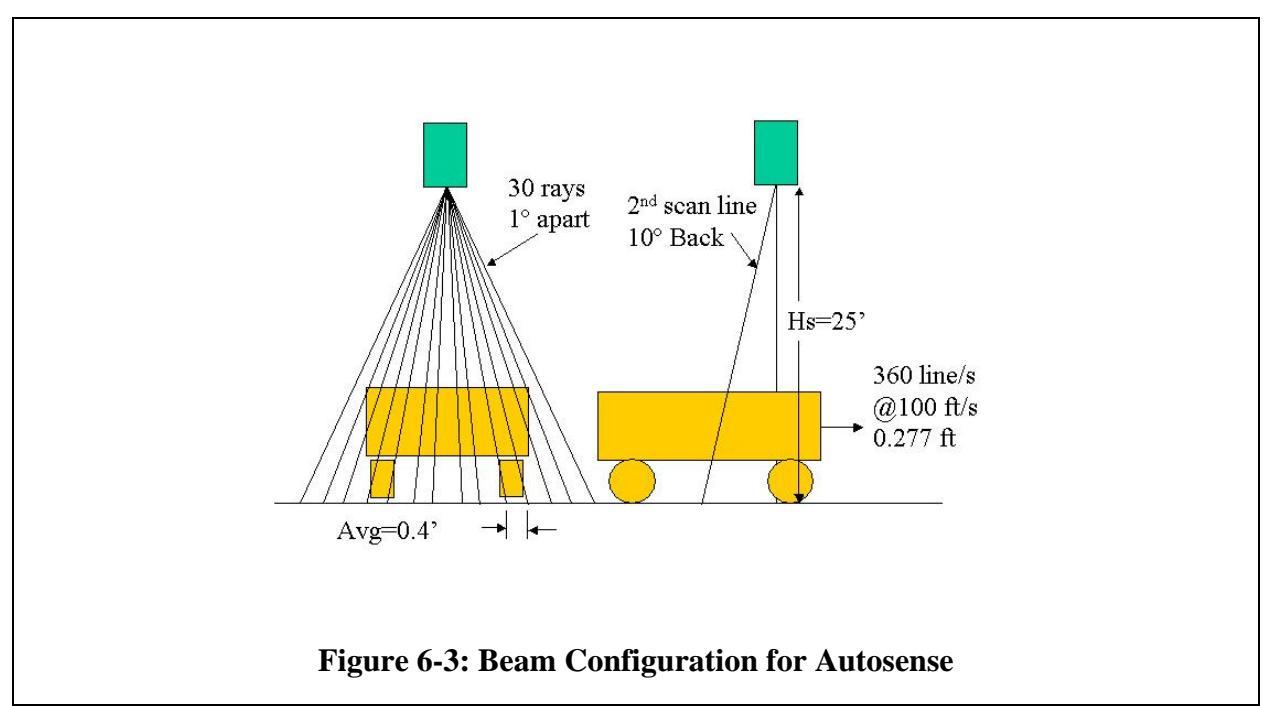
Developed by Schwartz Electro-Optics, the AutoSense unit was built for overhead vehicle classification. It has been used for several tolling and truck inspection applications. Two "scanlines" of laser beams are fired onto the pavement. For each beam, the range to the nearest object is reported to the detector. For the AutoSense 625, the scan lines each contain 30 beams, each 1-degree apart, as shown in Figure 6-3. The AutoSense 815 has 90-beam scan lines each two thirds of a degree apart. The first scan line lies in a vertical plane perpendicular to the vehicle. The second scan line is at a 10-degree angle and is used to calculate speed.

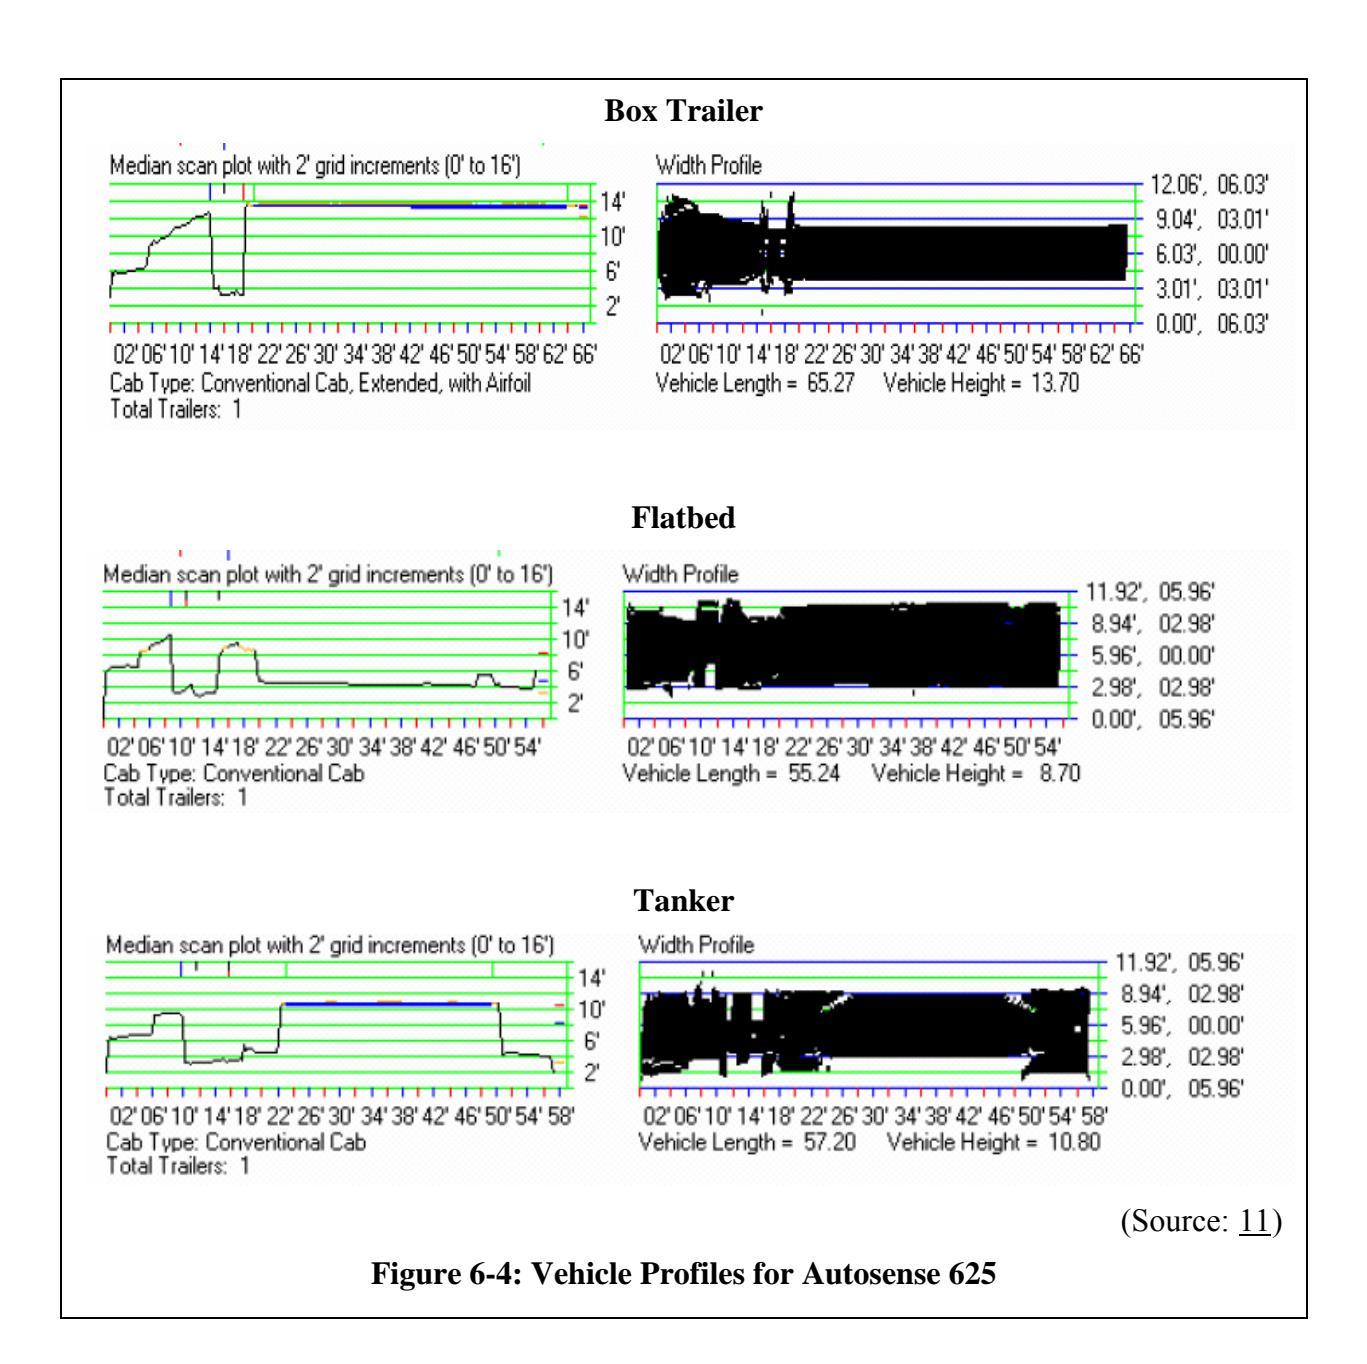
Figure 6-4 shows some width and height profiles for three types of trucks as measured by the Autosense 625. As can be seen, the width profile seems very good for box trailers, but somewhat erratic for flatbeds, tankers and cabs.
