Exploration of Opportunities to Address the Impacts of Roads and Traffic on Wildlife Around Rocky Flats National Wildlife Refuge

FINAL REPORT

Prepared by Marcel P. Huijser, PhD James S. Begley, MSc Western Transportation Institute Montana State University

November, 2023

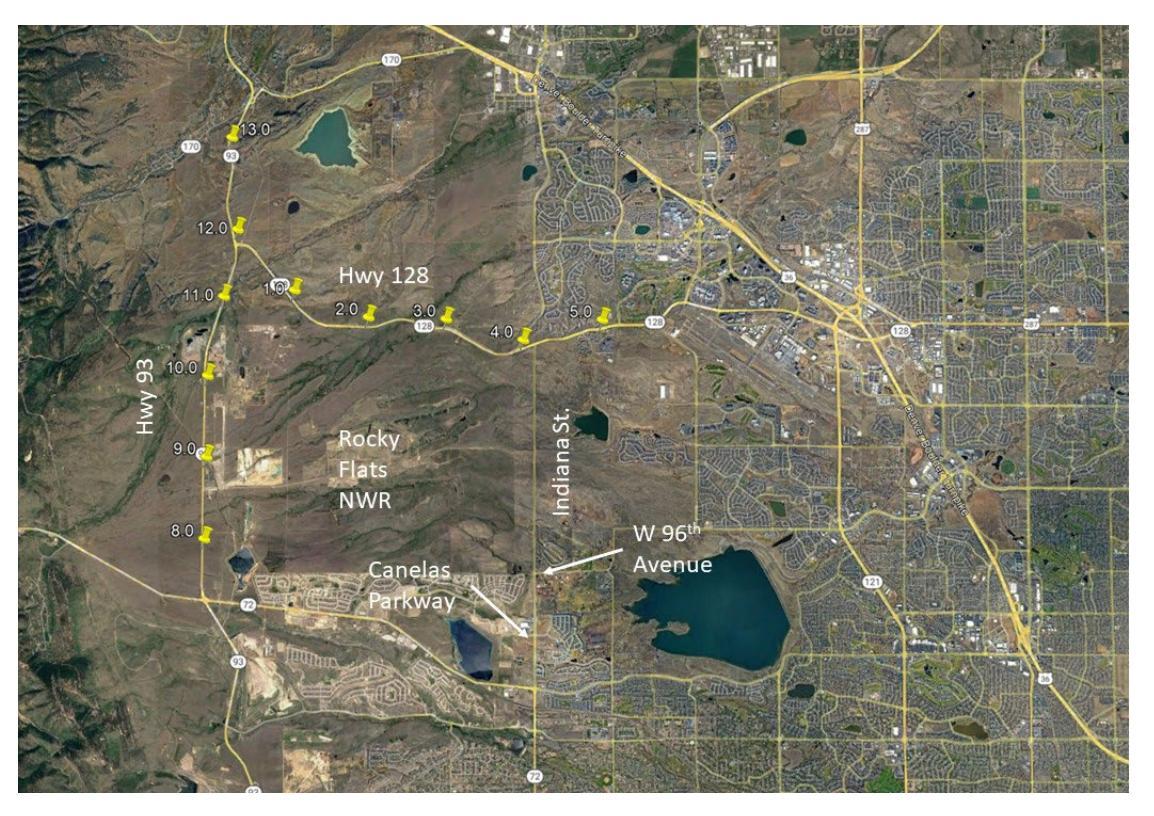
Figure 2: The highway sections with mile reference posts and crossroads included in the animal-vehicle crash data analyses.

- 1. Hwy 93
 - a. Start mile reference post: 7.2 (Junction with Hwy 72, Coal Creek Canyon Rd.).
 - b. End mile reference post: 11.9 (Junction with Hwy 128).
 - c. Length: 4.7 miles.
- 2. Hwy 128
 - a. Start mile reference post: 0.0 (Junction with Hwy 93).
 - b. End mile reference post: 4.2 (Junction with Indiana St.).
 - c. Length: 4.2 miles.
- 3. Indiana St. (no mile reference posts present, description based on crossroads)
 - a. Start: Junction with Hwy 128.
 - b. End: Junction with Canelas Parkway.
 - c. Length: 3.5 miles.

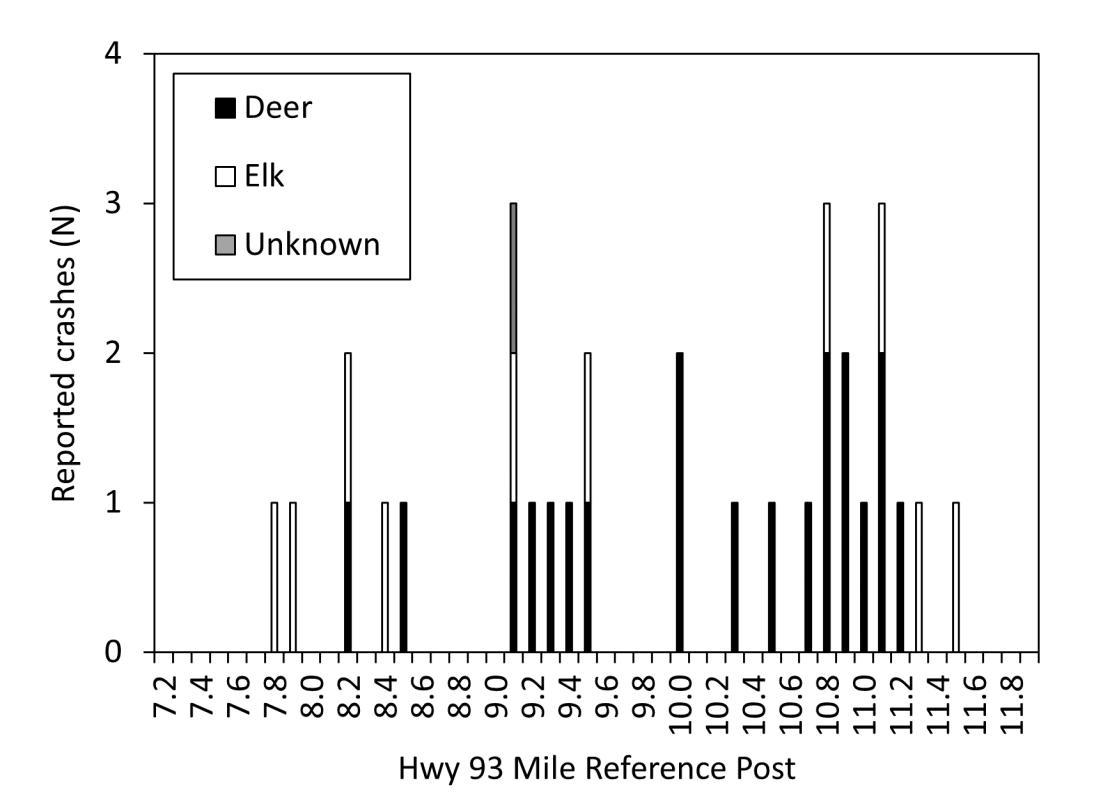
Figure 3: The number of reported crashes with animals along Hwy 93 between mile reference post 7.2 (Junction with Hwy 72, Coal Creek Canyon Rd.) and 11.9 (Junction with Hwy 128).

Along Hwy 93, deer and elk crashes were most abundant between mile reference posts 9.1-9.5 and between 10.7 and 11.3 (Figure 3). Along Hwy 128, deer and elk crashes were most abundant at mile reference post 2.0 and 3.9 (Figure 4). Along Indiana St., deer and elk crashes were most abundant south of the junction with Hwy 128 (Figure 5).

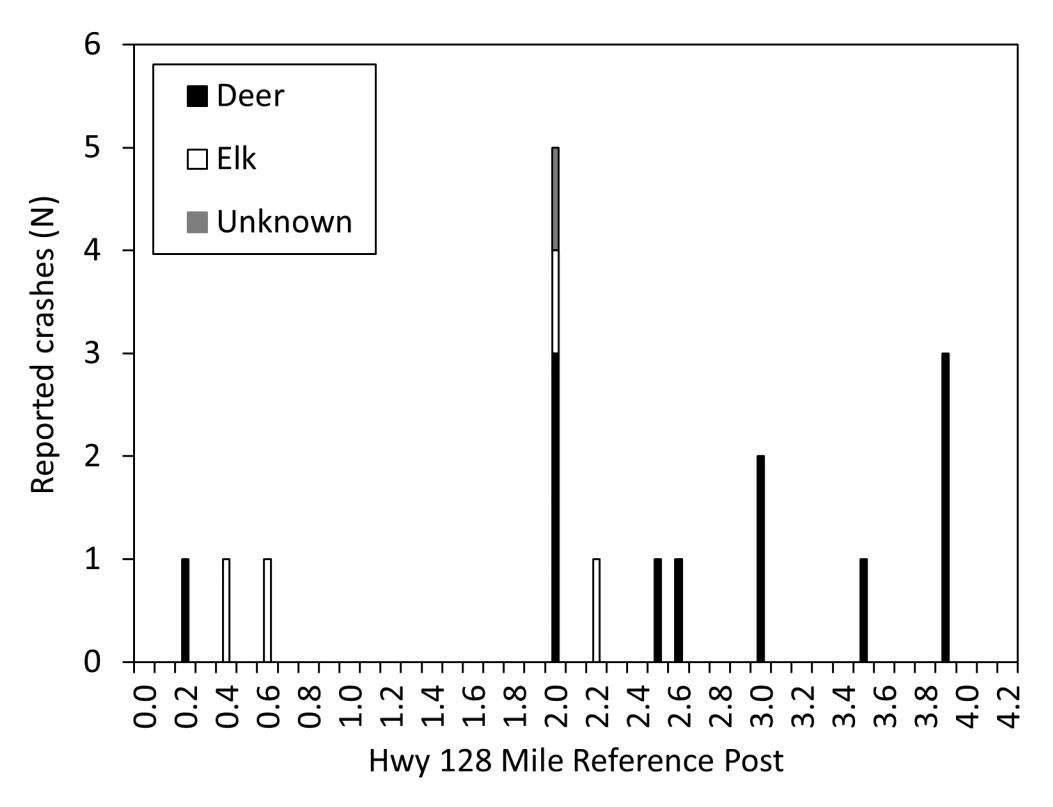
Figure 4: The number of reported crashes with animals along Hwy 128 between mile reference post 0.0 (Junction with Hwy 93) and 4.2 (Junction with Indiana St.).

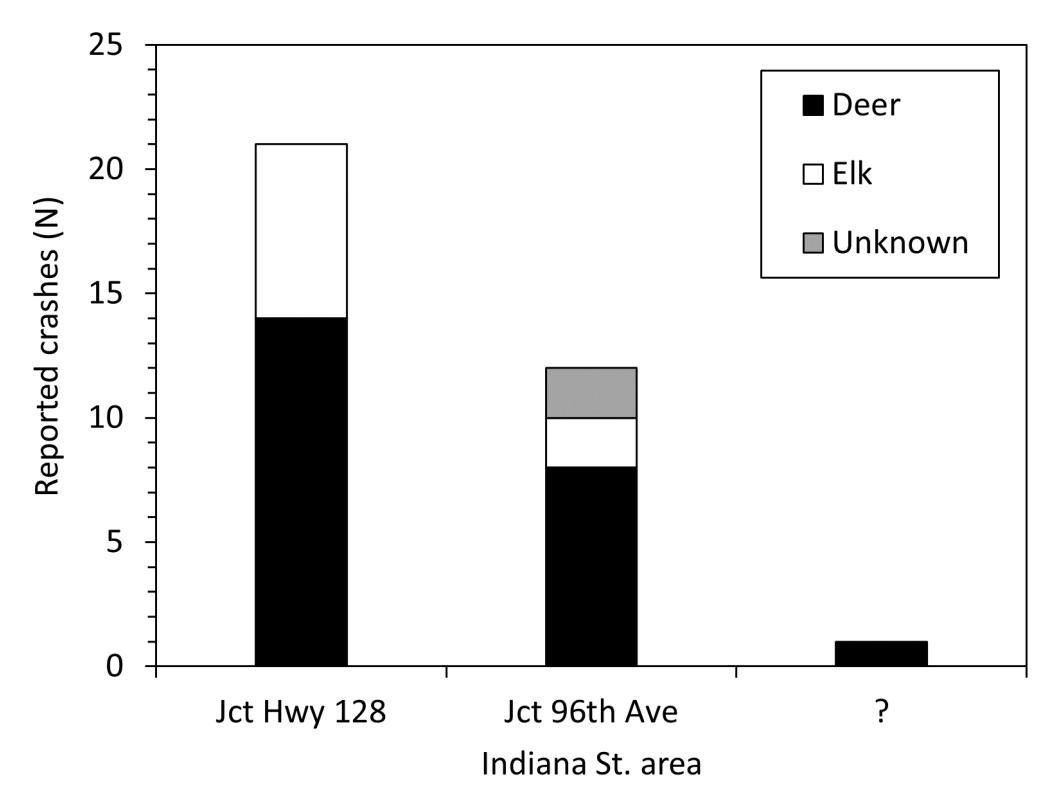
Figure 5: The number of reported crashes with animals along Indiana St. in 2 areas: South of Junction with Hwy 128 (north end), and around the Junction with W 96th Avenue (south end).

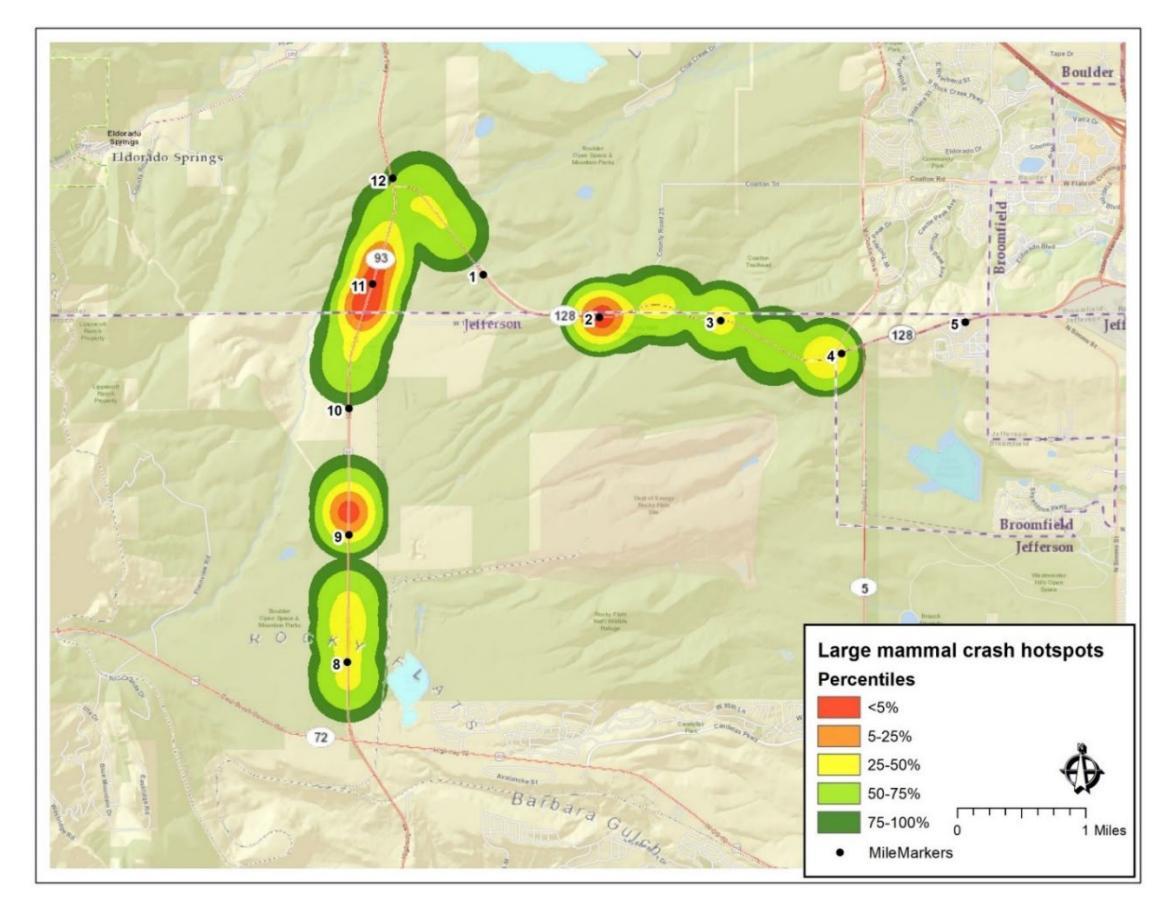
Figure 6: Kernel density hotspot percentiles for large mammal-vehicle crashes for Hwy 93 and Hwy 128 (2011–2020).

We investigated where the highest concentrations of large mammal-vehicle crashes were along Hwy 93 and Hwy 128 through a hotspot analysis. Large mammal-vehicle crashes along Indiana St. could not be included as the location of the observations was not spatially precise. The hotspot analysis was based on a Kernel density analysis using ArcGIS 10.6.1 (ESRI 2018) for point features of large mammal-vehicle crash locations using a 25 m cell size (82 ft \times 82 ft). A 25 m cell size is relatively fine scale but still accommodates for some spatial inaccuracies in GPS coordinates. The Kernel density analysis calculates the density of crashes in a neighborhood around each cell and is based on the quartic kernel function described by Silverman (1986). We set the neighborhood search radius at 1,000 m (0.62 mi). On a straight road this means that large mammals crashes that are up to about 1,000 m away are included in the density analysis for each cell. To help interpret the results of the Kernel density analyses and identify hotspots, we displayed the raster output using a heat map classification with varying densities of crashes. We used percentage breaks to create five categories (<5%, 5-<25%, 25-<50%, 50-<75%, and 75-100%) that display the areas with the highest densities of crashes (<5%) to areas with the lowest densities (75-100%). The highest concentrations of large mammal-vehicle crashes were just north of mile reference posts 9 and 11 along Hwy 93, and around mile reference post 2 along Hwy 128 (Figure 6).

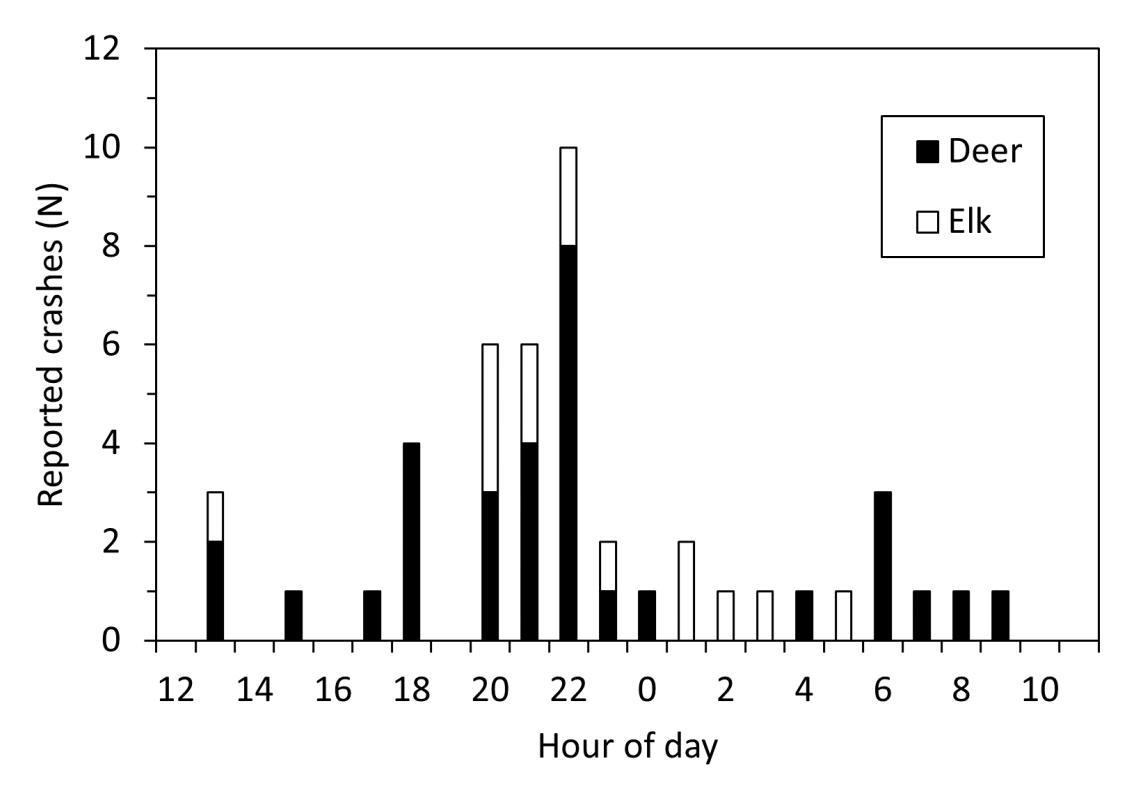
Figure 7: Deer and elk crashes by the hour of day (2011–2020). 20 = between 8 and 9 pm.

Deer and elk crashes predominantly occurred during the dark hours, especially between 8 and 11 pm (Figure 7).

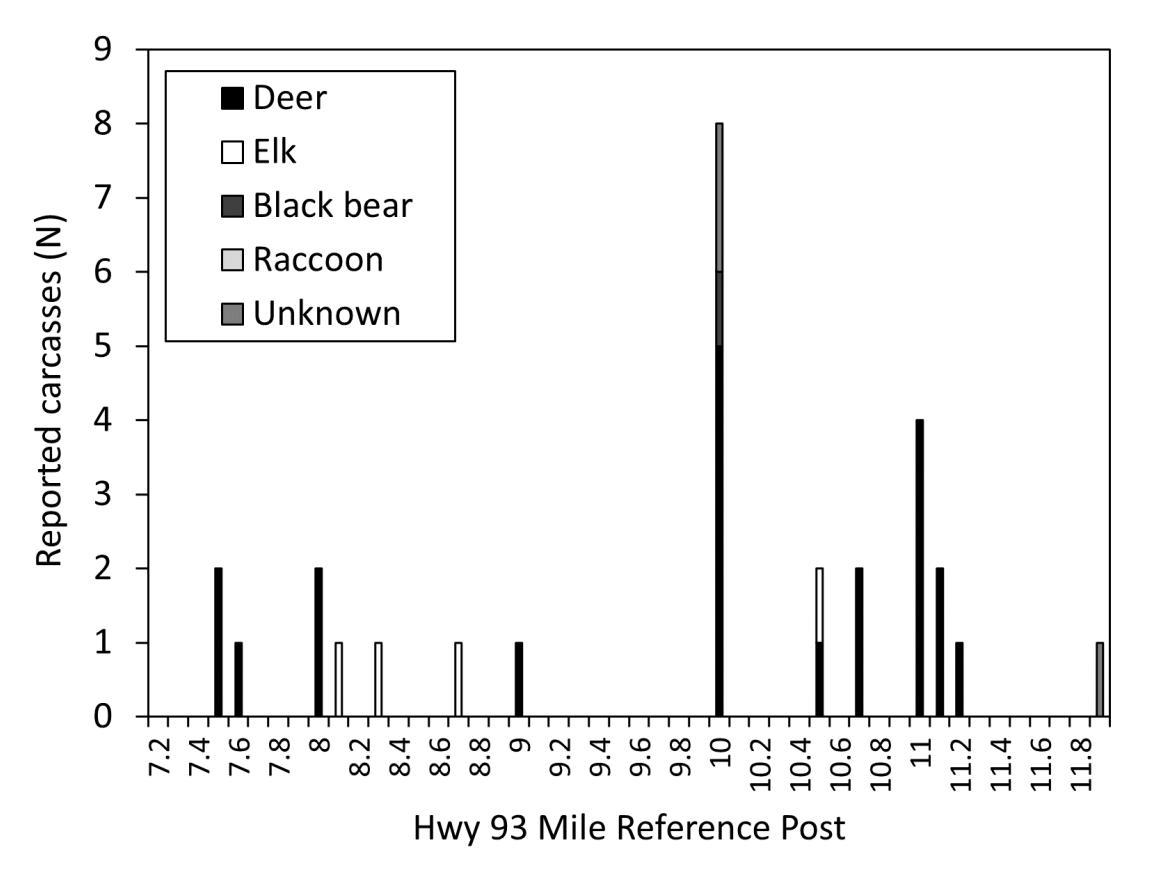
Figure 8: The number of reported carcasses with animals along Hwy 93 between mile reference post 7.2 (Junction with Hwy 72, Coal Creek Canyon Rd.) and 11.9 (Junction with Hwy 128).

Along Hwy 93, deer and elk carcasses were most abundant at mile reference post 10.0 and between 11.0 and 11.2 (Figure 8). Along Hwy 128, the number of recorded carcasses was low and deer and elk crashes did not have a particular concentration (Figure 9).

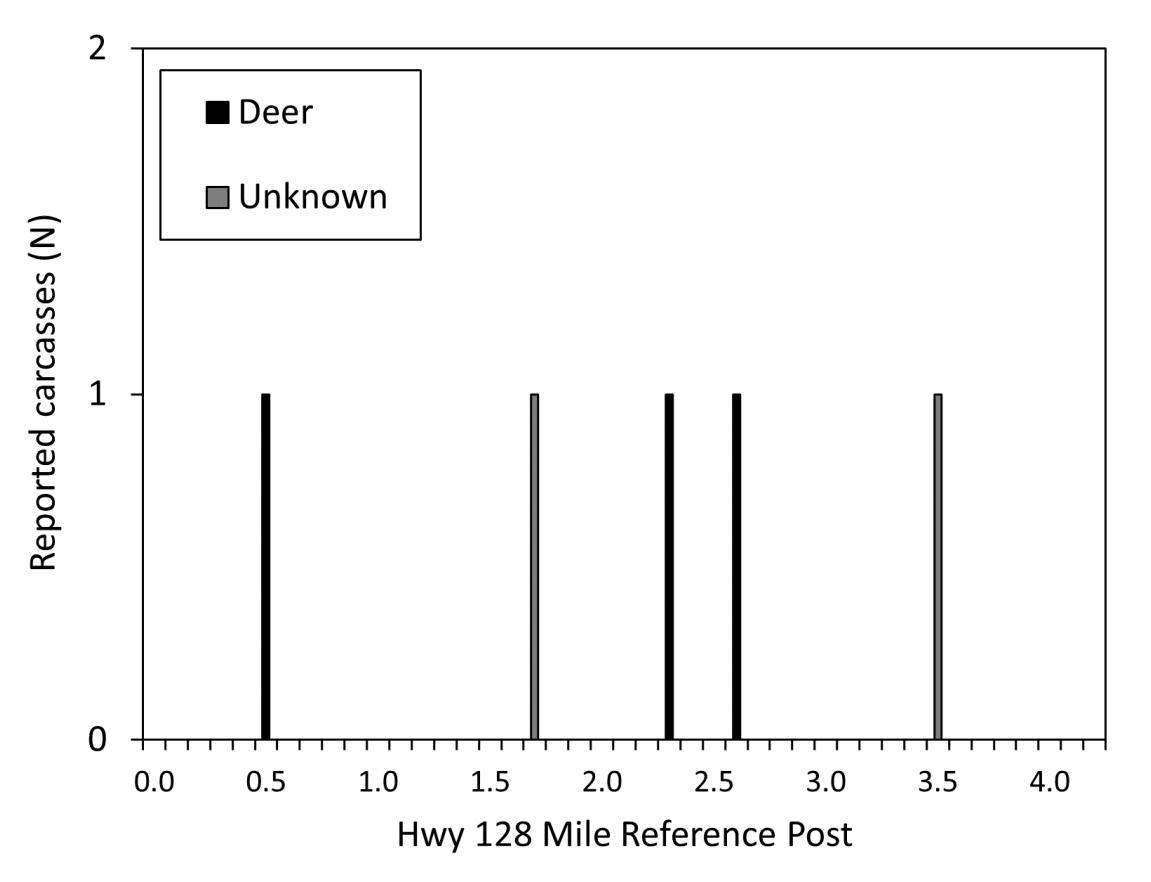
Figure 9: The number of reported carcasses with animals along Hwy 128 between mile reference post 0.0 (Junction with Hwy 93) and 4.2 (Junction with Indiana St.).

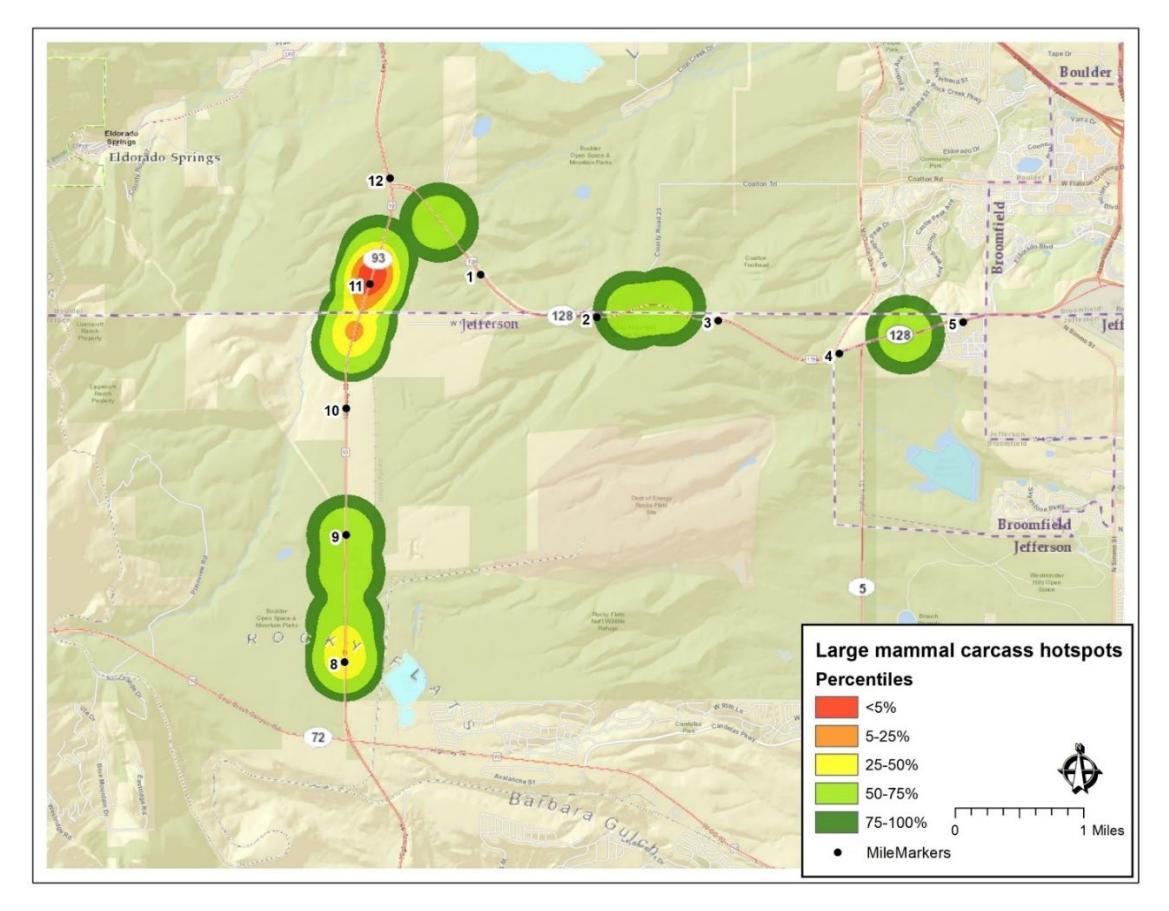
Figure 10: Kernel density hotspot percentiles for large mammal carcasses for Hwy 93 and Hwy 128 (2002–2022).

We investigated where the highest concentrations of large mammal-vehicle carcasses were along Hwy 93 and Hwy 128 through a hotspot analysis, similar to the analysis described for crashes. Large mammal-vehicle carcasses along Indiana St. were not available. The highest concentration of large mammal carcasses was along Hwy 93 from just south to just north of mile reference post 11.0 (Figure 10).

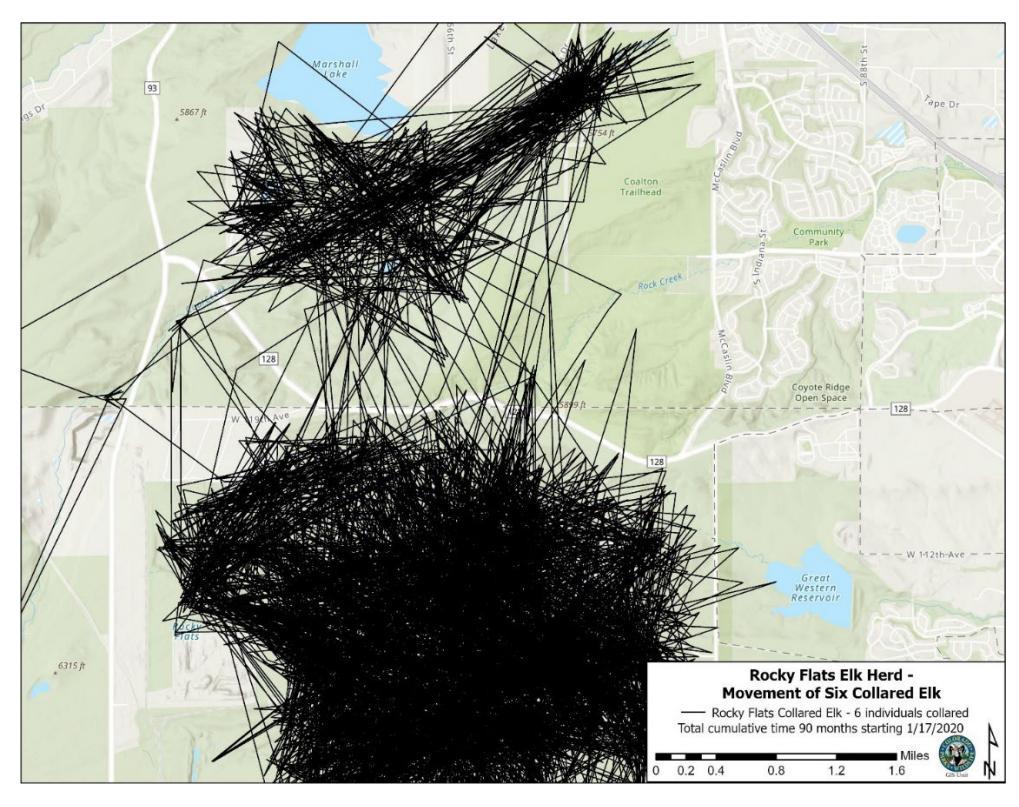
Figure 12: Locations and movements of GPS-collared elk from the Rocky Flats National Wildlife Refuge herd (Source: Joe Halseth, Colorado Parks and Wildlife).

GPS-collared elk from the herd that resides mainly in the Refuge cross Hwy 128 regularly, but cross Hwy 93 only occasionally (Figure 12). GPS-collared elk from the herd that resides mainly west of Hwy 93 (Plainview herd) were not observed crossing Hwy 93 into the Refuge or into the area north of Hwy 128 (Figure 13). These movement data suggest that elk mostly stay away from the main roads; they are mostly confined to the meshes within the road network with the highways being partial or near complete barriers. The elk also seem to spend most of their time on the legacy site in the center of the Refuge where the public is not allowed and where human disturbance is lowest.

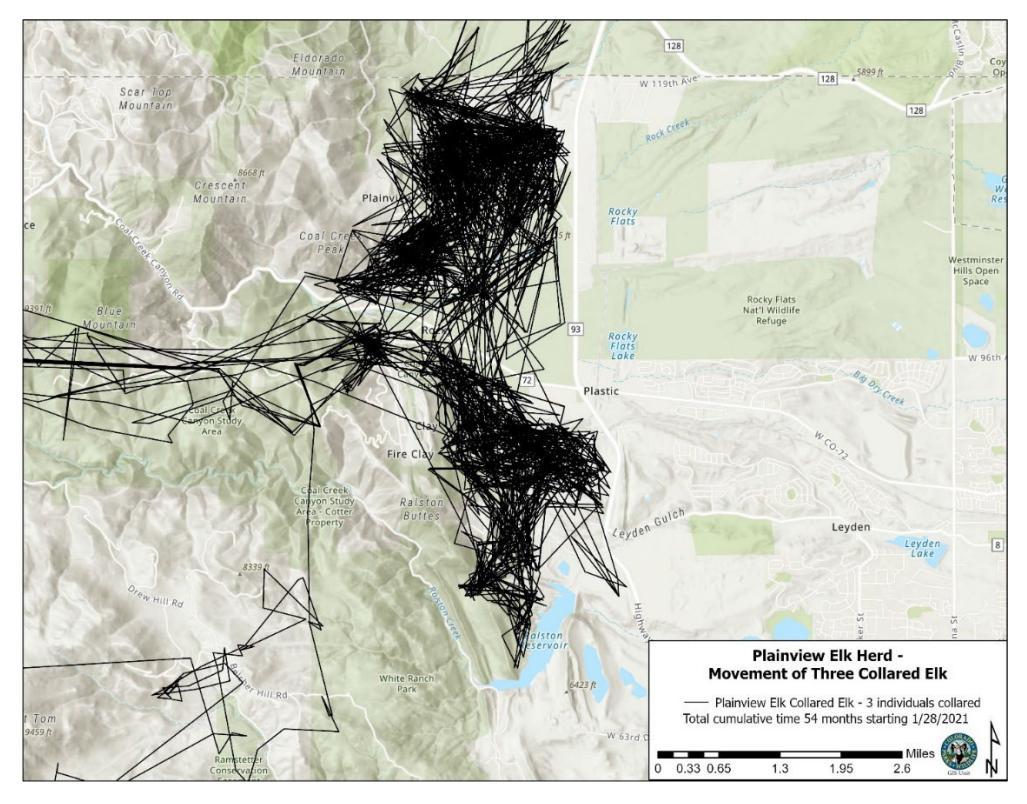
Figure 13: Locations and movements of GPS-collared elk from the Plainview herd (Source: Joe Halseth, Colorado Parks and Wildlife).

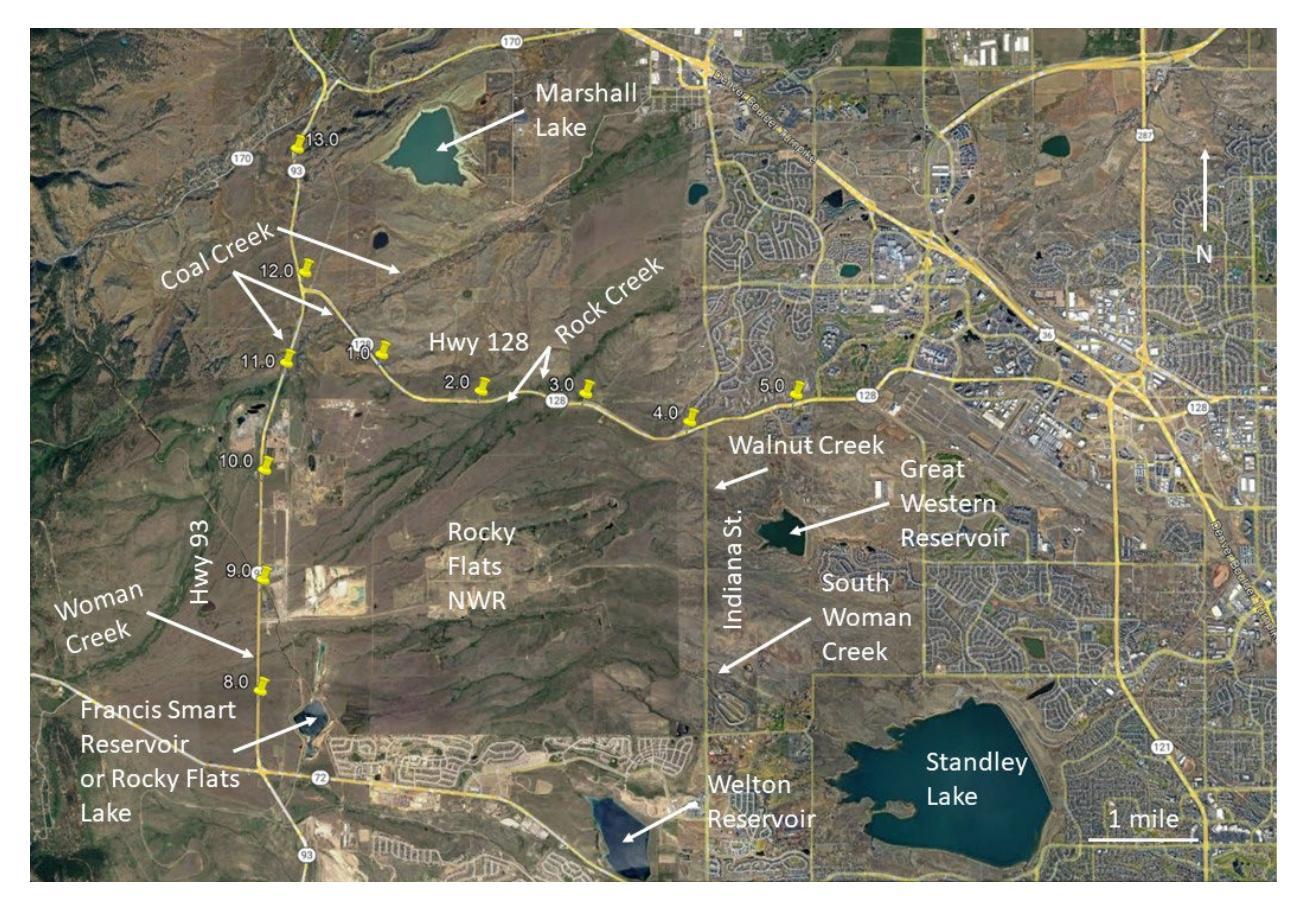
Figure 14: Map of Rocky Flats National Wildlife Refuge showing highways and associated mile reference points, creek crossings and water bodies.

The Refuge is surrounded by roads to the west, north, and east, and has developments just beyond its southern boundary (Figure 14). Hwy 93 has an estimated Annual Average Daily Traffic Volume (AADT) of about 18,000 vehicles, Hwy 128 about 4,200 vehicles, and Indiana St. about 7,000 vehicles (Michael Baker International 2016, CDOT 2023). There are several water bodies in the area that are likely important to ungulates, especially during the dry summer months (Figure 14). The area mostly consists of dry grassland with some shrubs and trees along some of the creeks (Figure 15, 16).

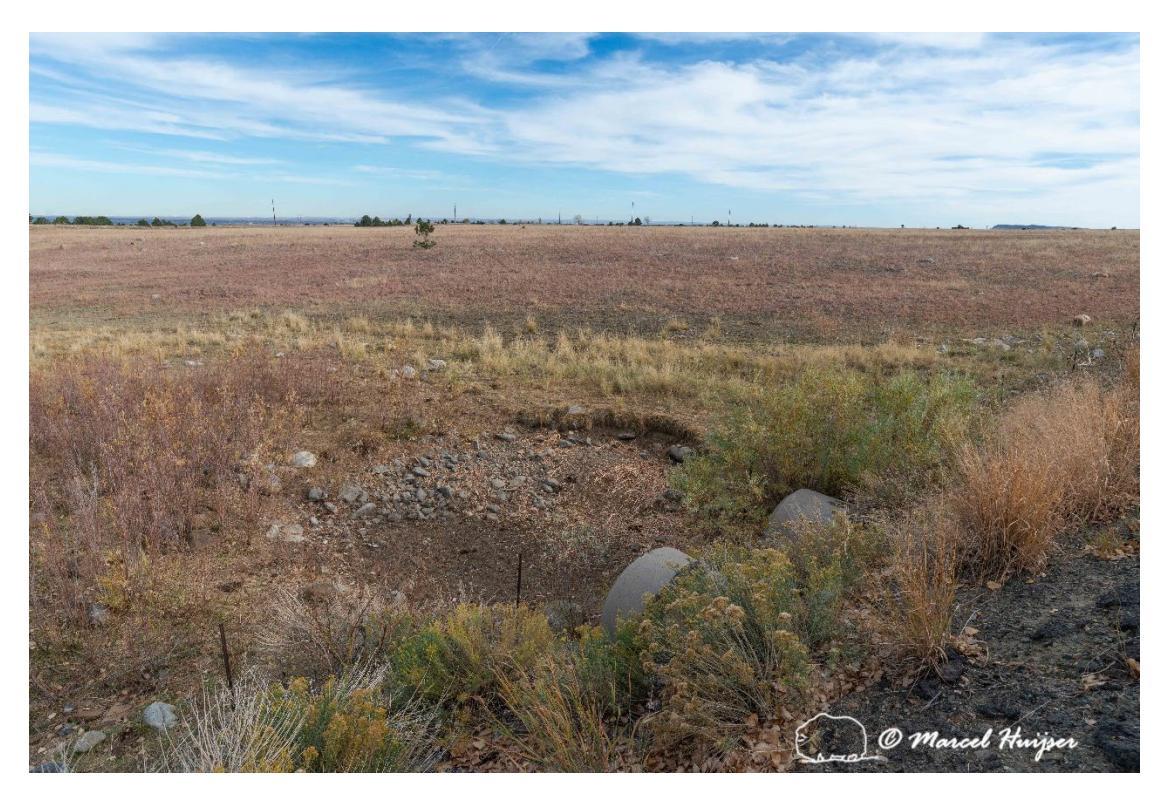
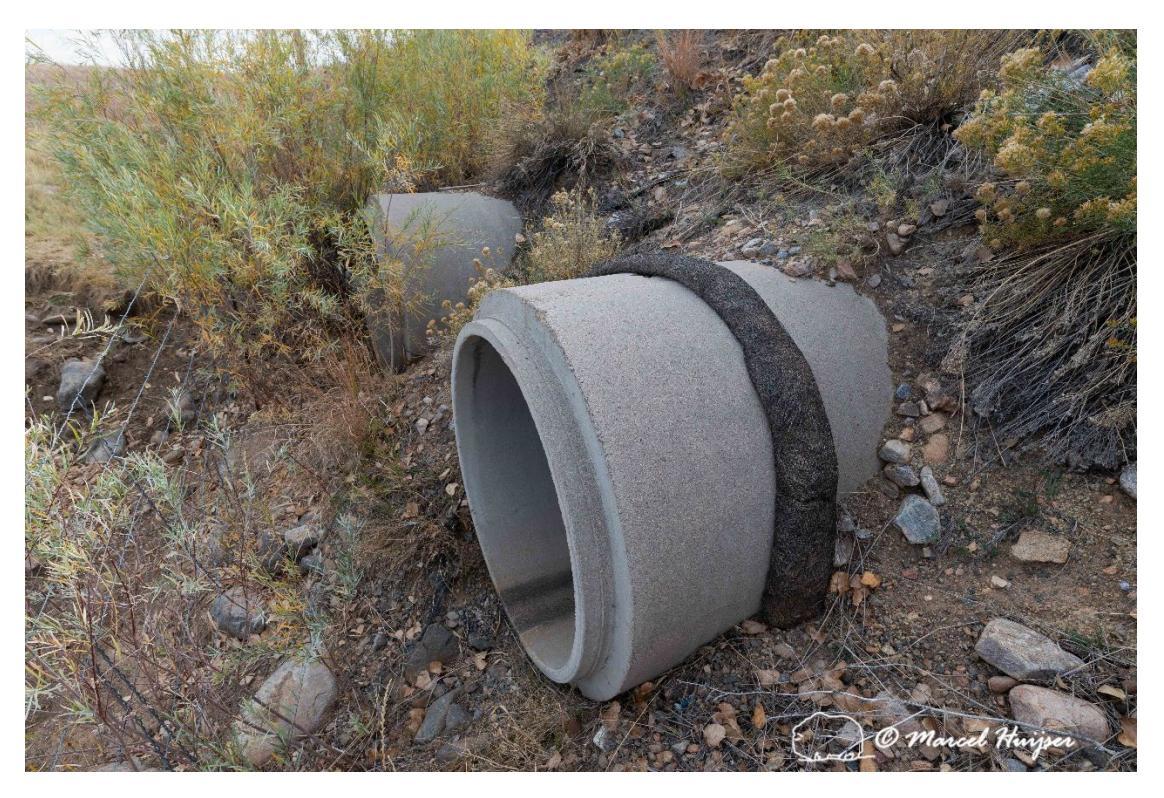
Figure 17: Double culvert, Woman Creek (Hwy 93, mile reference post 8.40), east side, outflow.

Figure 18: Double culvert, Woman Creek (Hwy 93, mile reference post 8.40), east side, outflow.

The crossing for Woman Creek along Hwy 93 (mile reference post 8.40) consists of a double culvert (Figure 17, 18).

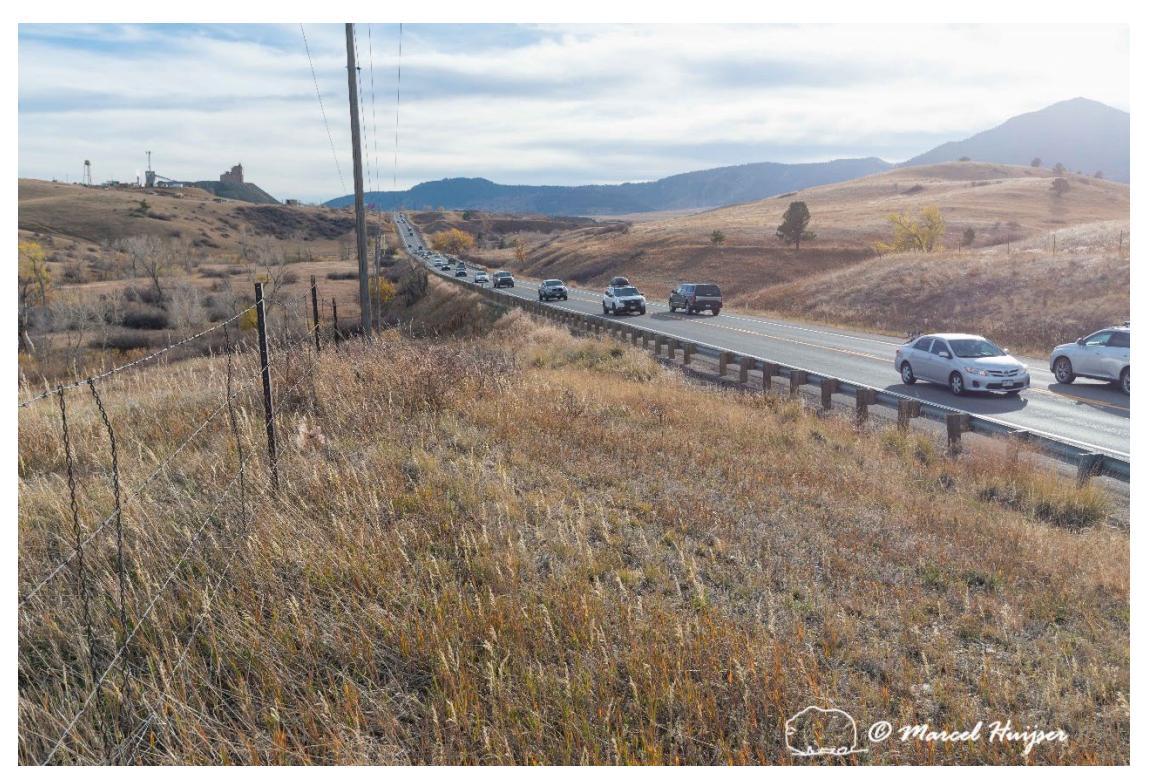
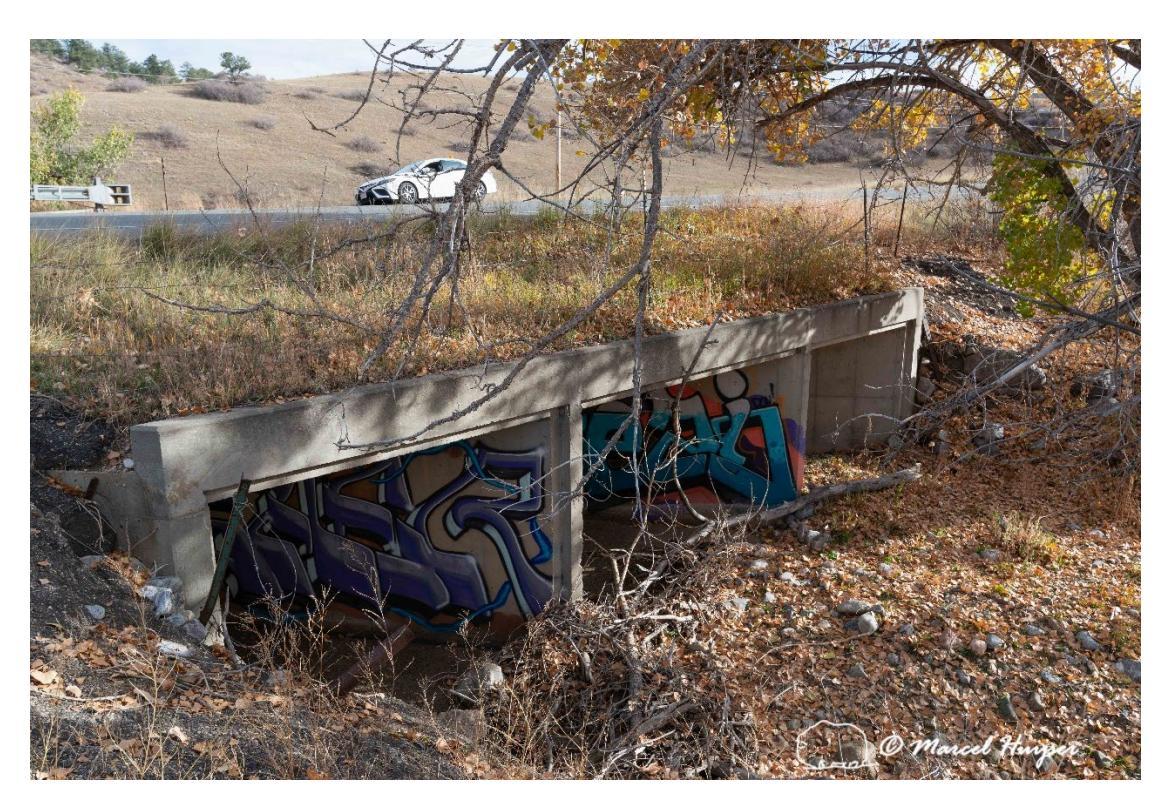
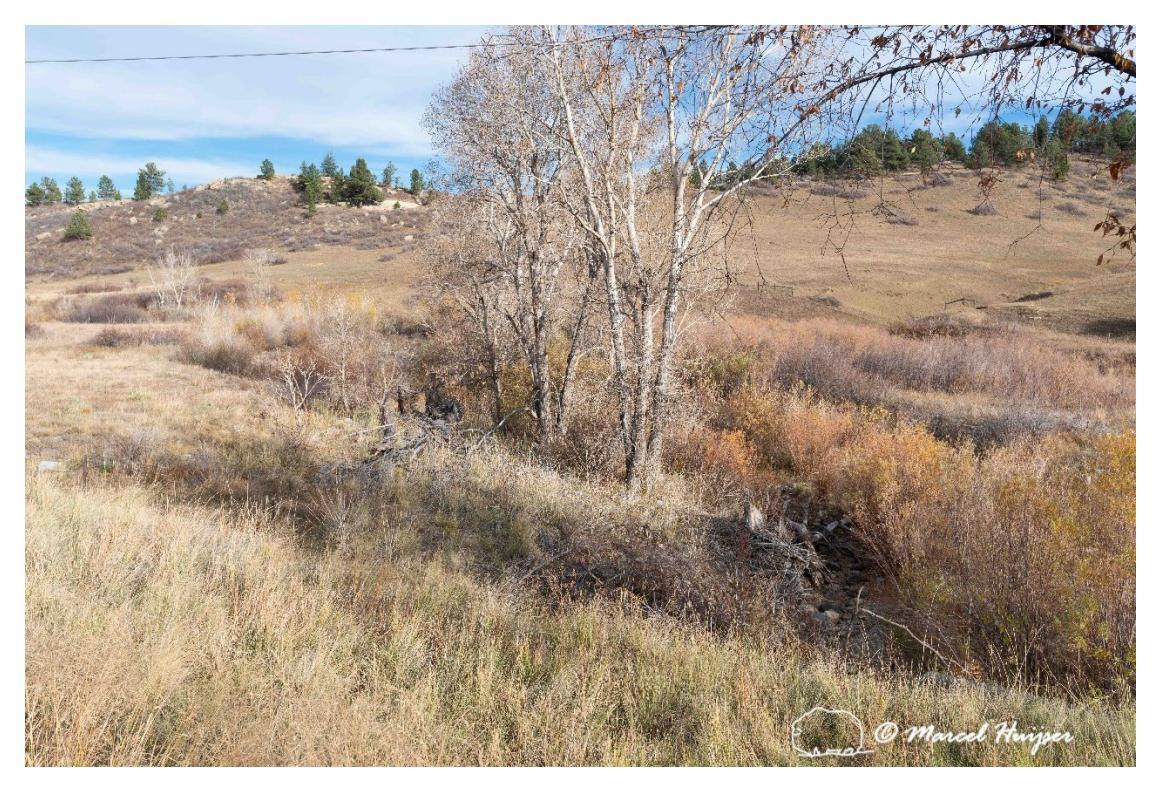
Figure 19: Surroundings, Coal Creek (Hwy 93, mile reference post 10.95), east side, looking south.

Figure 20: Divided box culvert, Coal Creek (Hwy 93, mile reference post 10.95), west side, inflow.

Figure 21: Surroundings, Coal Creek (Hwy 93, mile reference post 10.95), east side, outflow.
4.2.3 Coal Creek (Hwy 128, mile reference post 0.47)

The crossing for Coal Creek along Hwy 93 (mile reference post 10.95) consists of a divided box culvert (Figure 19, 20, 21).

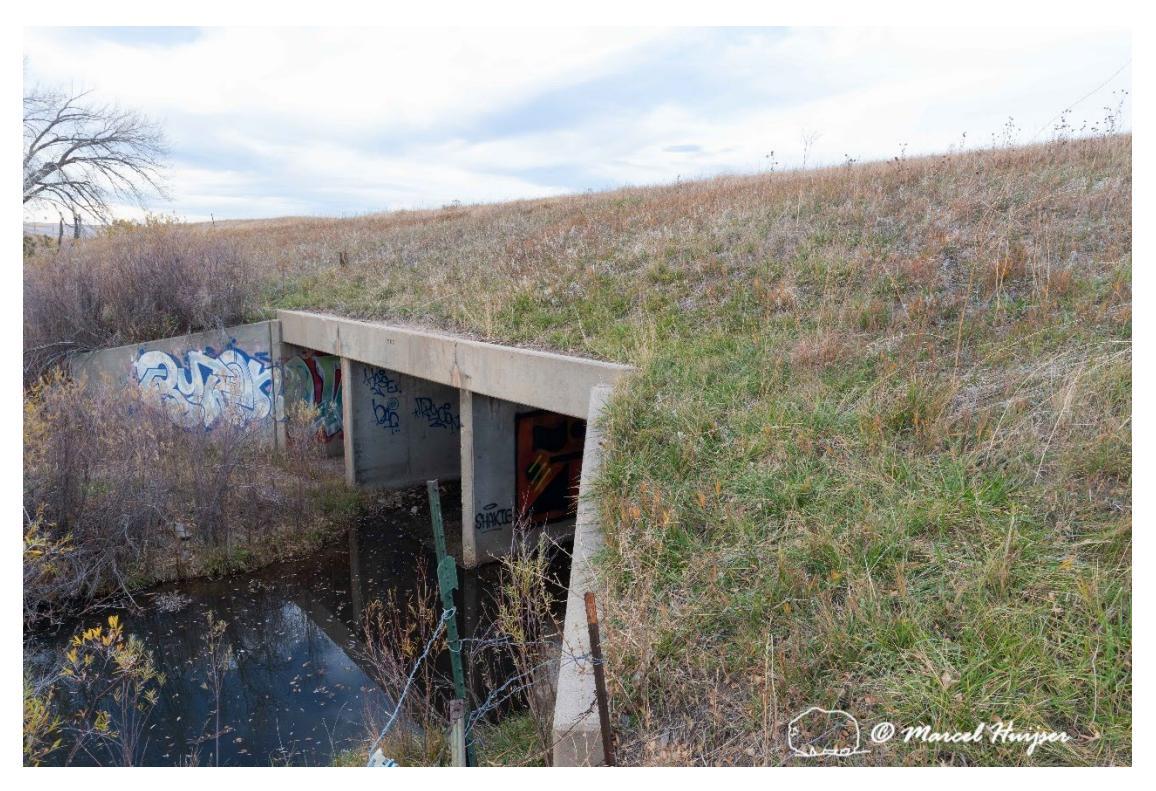
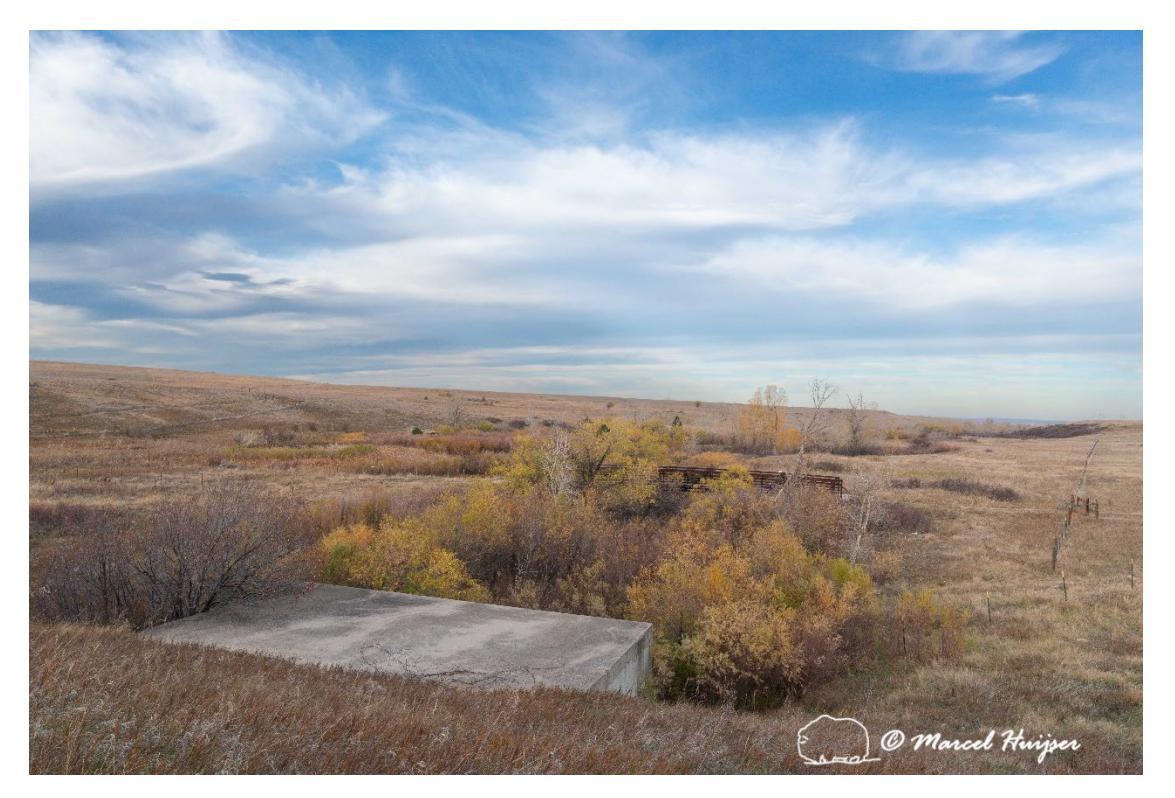
Figure 22: Divided box culvert, Coal Creek (Hwy 128, mile reference post 0.47), south side, inflow.

Figure 23: Divided box culvert, Coal Creek (Hwy 128, mile reference post 0.47), north side, outflow.

The crossing for Coal Creek along Hwy 128 (mile reference post 0.47) consists of a divided box culvert (Figure 22, 23).

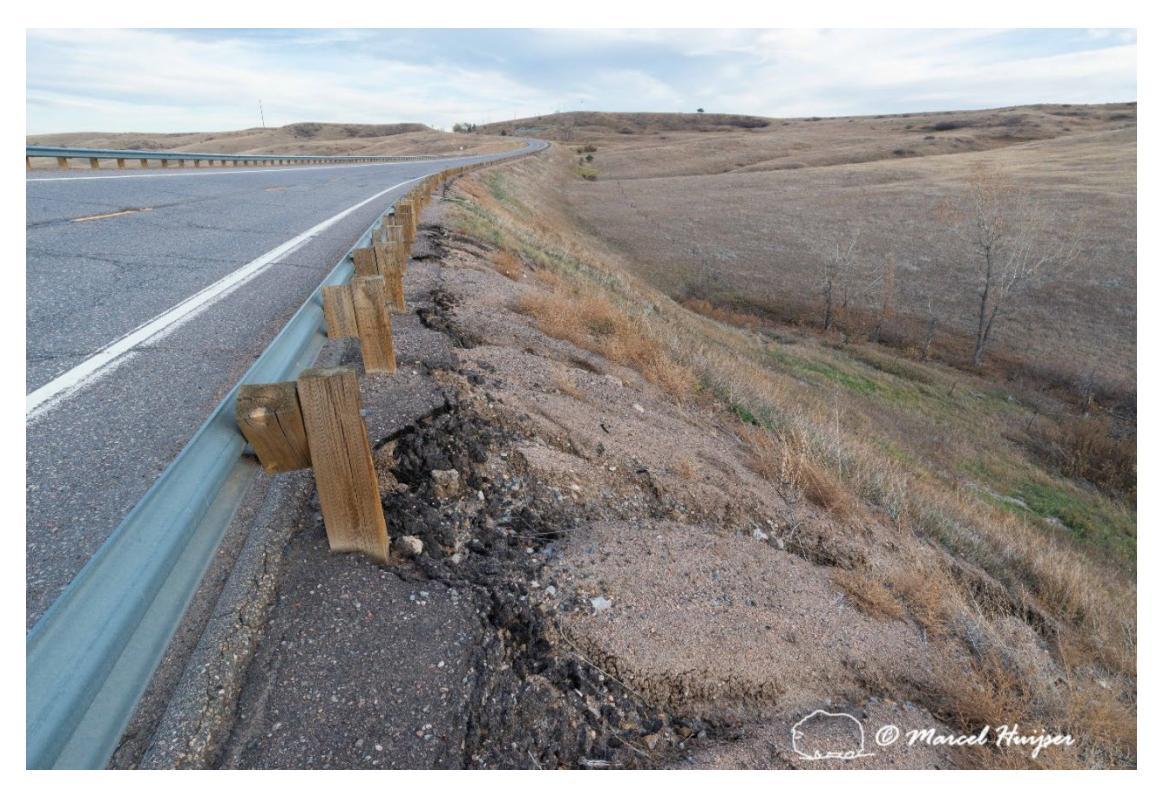
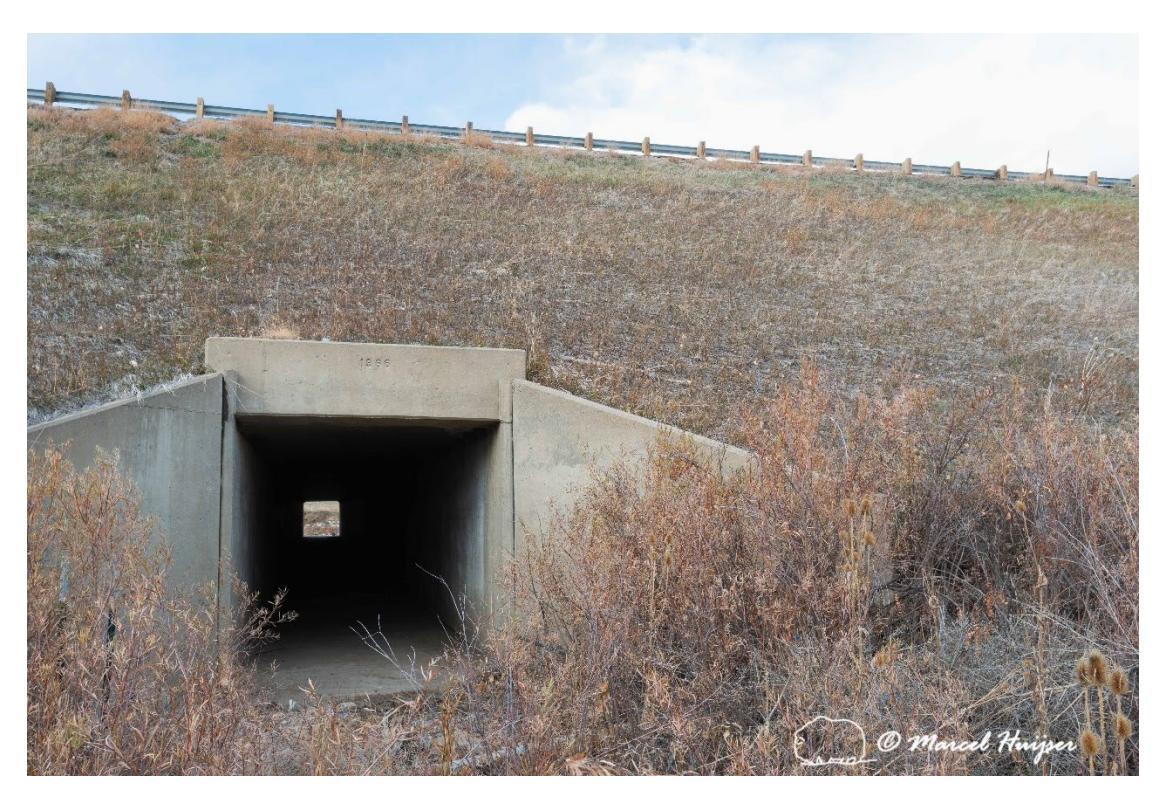
Figure 24: Surroundings, Rock Creek (Hwy 128, mile reference post 2.54), south side, looking east.

Figure 25: Surroundings, Rock Creek (Hwy 128, mile reference post 2.54), south side, inflow.

The crossing for Rock Creek along Hwy 128 (mile reference post 2.54) consists of a box culvert (Figure 24, 25).
