Exploration of Opportunities to Address the Impacts of Roads and Traffic on Wildlife Around Rocky Flats National Wildlife Refuge

FINAL REPORT

Prepared by Marcel P. Huijser, PhD James S. Begley, MSc Western Transportation Institute Montana State University

November, 2023

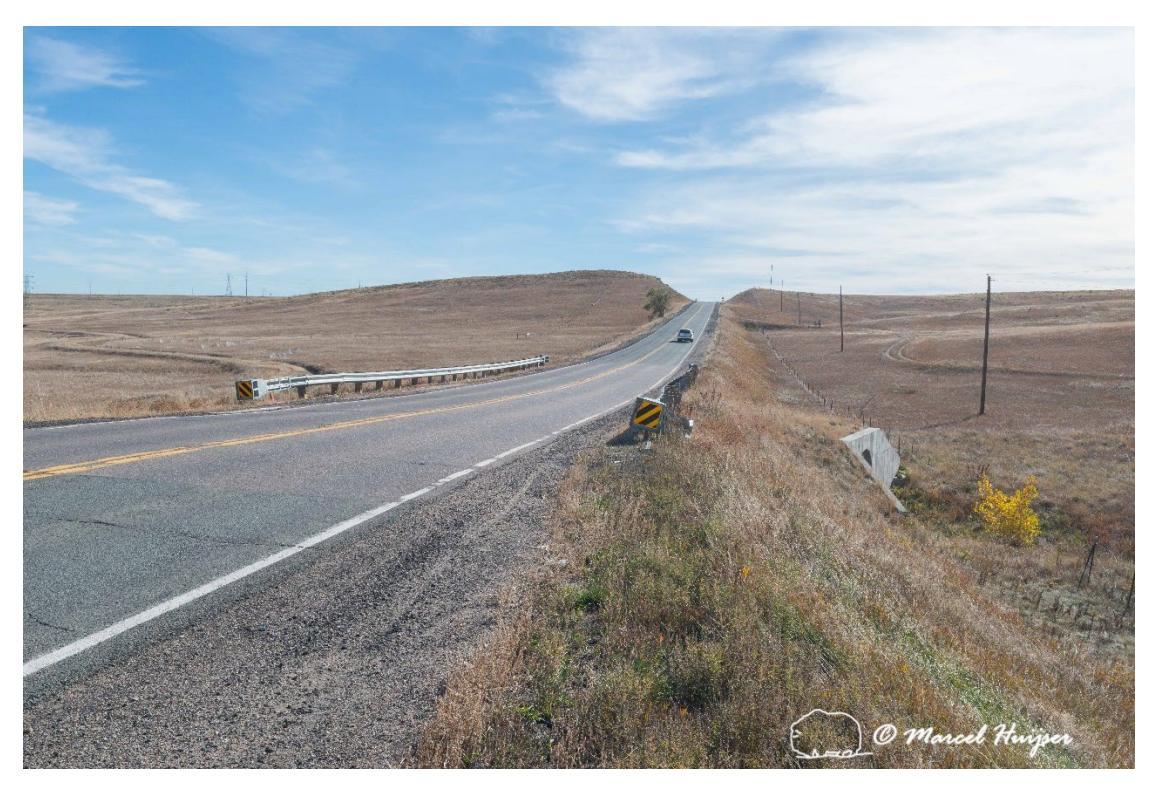
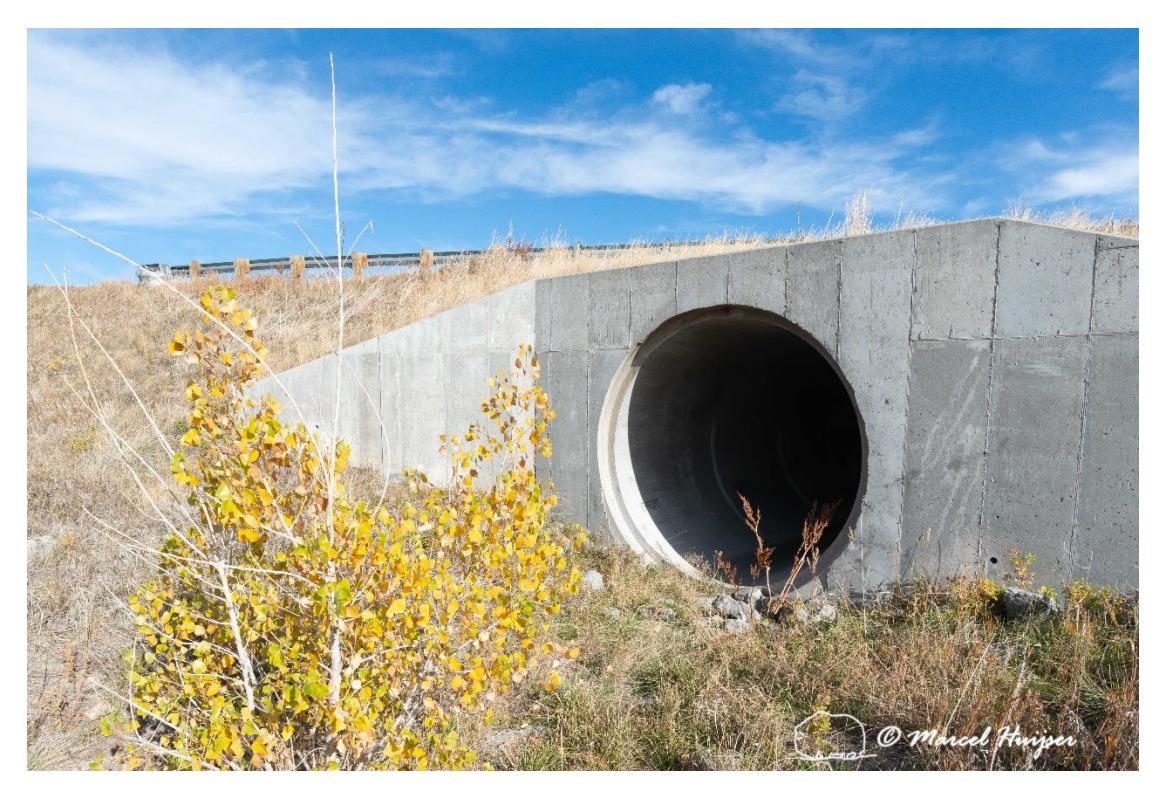
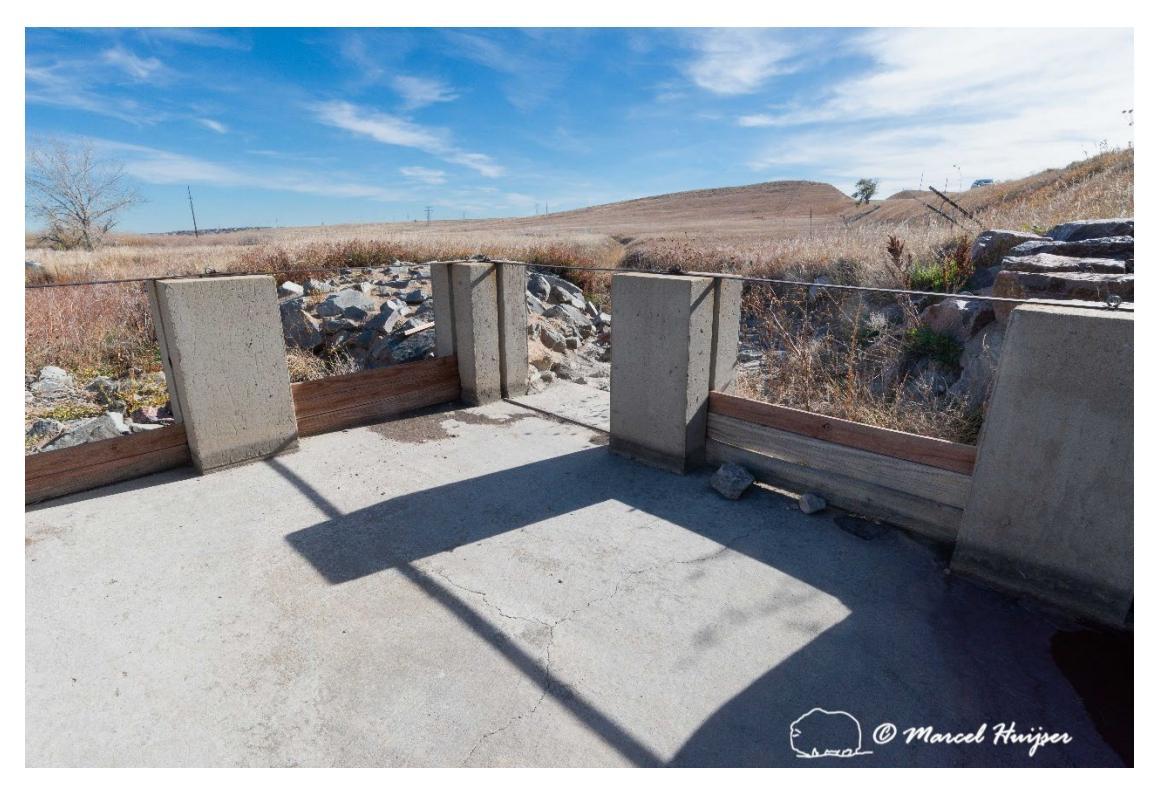
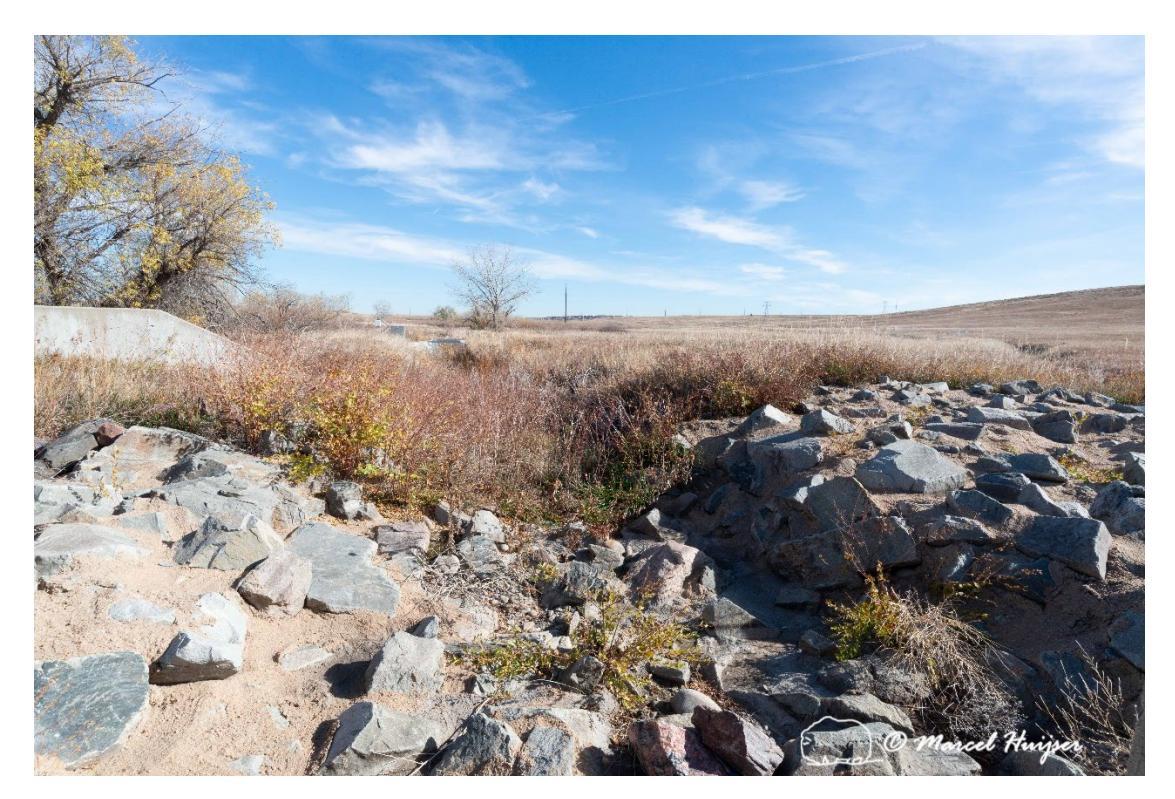
Figure 26: Surroundings, Walnut Creek (Indiana St., 0.62 mile south of junction with Hwy 128), west side, looking south.

Figure 27: Surroundings, Walnut Creek (Indiana St., 0.62 mile south of junction with Hwy 128), west side, inflow.

Figure 28: Outflow structures, Walnut Creek (Indiana St., 0.62 mile south of junction with Hwy 128), east side, outflow.

Figure 29: Riprap at outflow, Walnut Creek (Indiana St., 0.62 mile south of junction with Hwy 128), east side, outflow.

The crossing for Walnut Creek along Indiana St. (0.62 mile south of junction with Hwy 128) consists of a round culvert (Figure 26, 27, 28, 29).

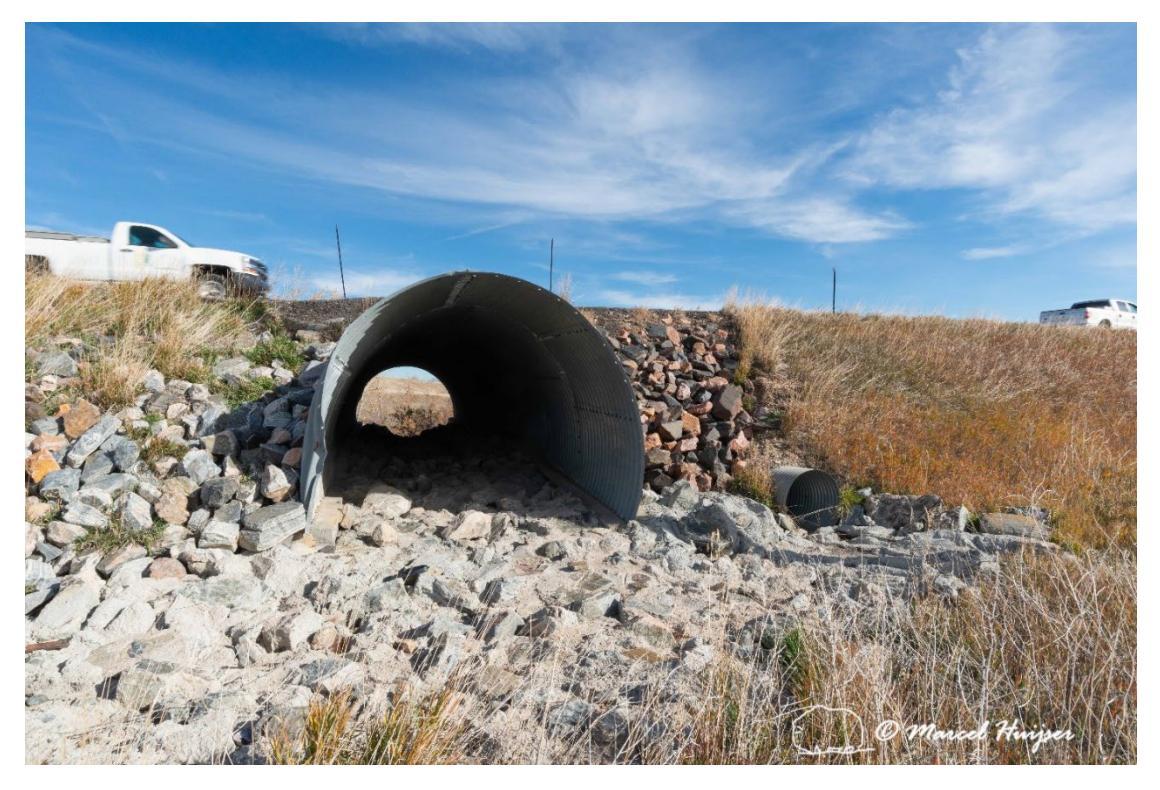
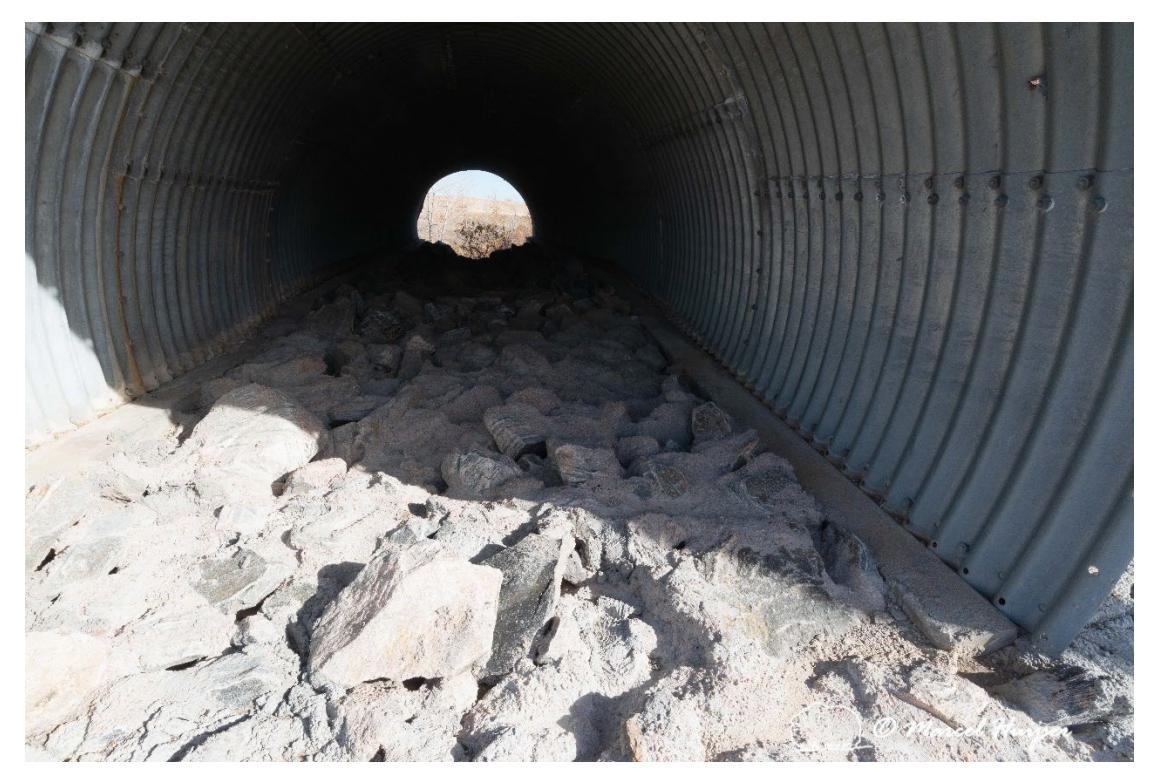
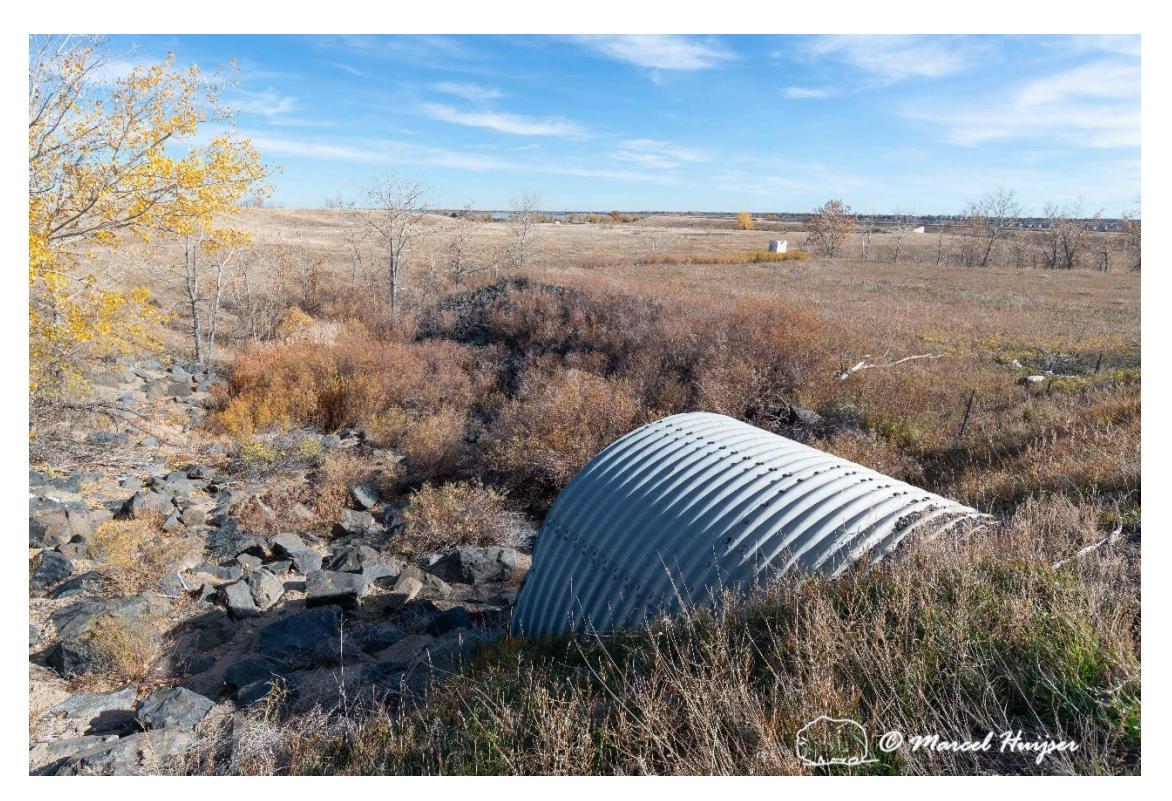
Figure 30: Riprap at inflow, South Woman Creek (Indiana St., 2.25 mile south of junction with Hwy 128), west side, inflow.

Figure 31: Riprap inside culvert, South Woman Creek (Indiana St., 2.25 mile south of junction with Hwy 128), west side, inflow.

Figure 32: Riprap at outflow, South Woman Creek (Indiana St., 2.25 mile south of junction with Hwy 128), east side, outflow.

The crossing for South Woman Creek along Indiana St. (2.25 miles south of junction with Hwy 128) consists of a round culvert (Figure 30, 31, 32).

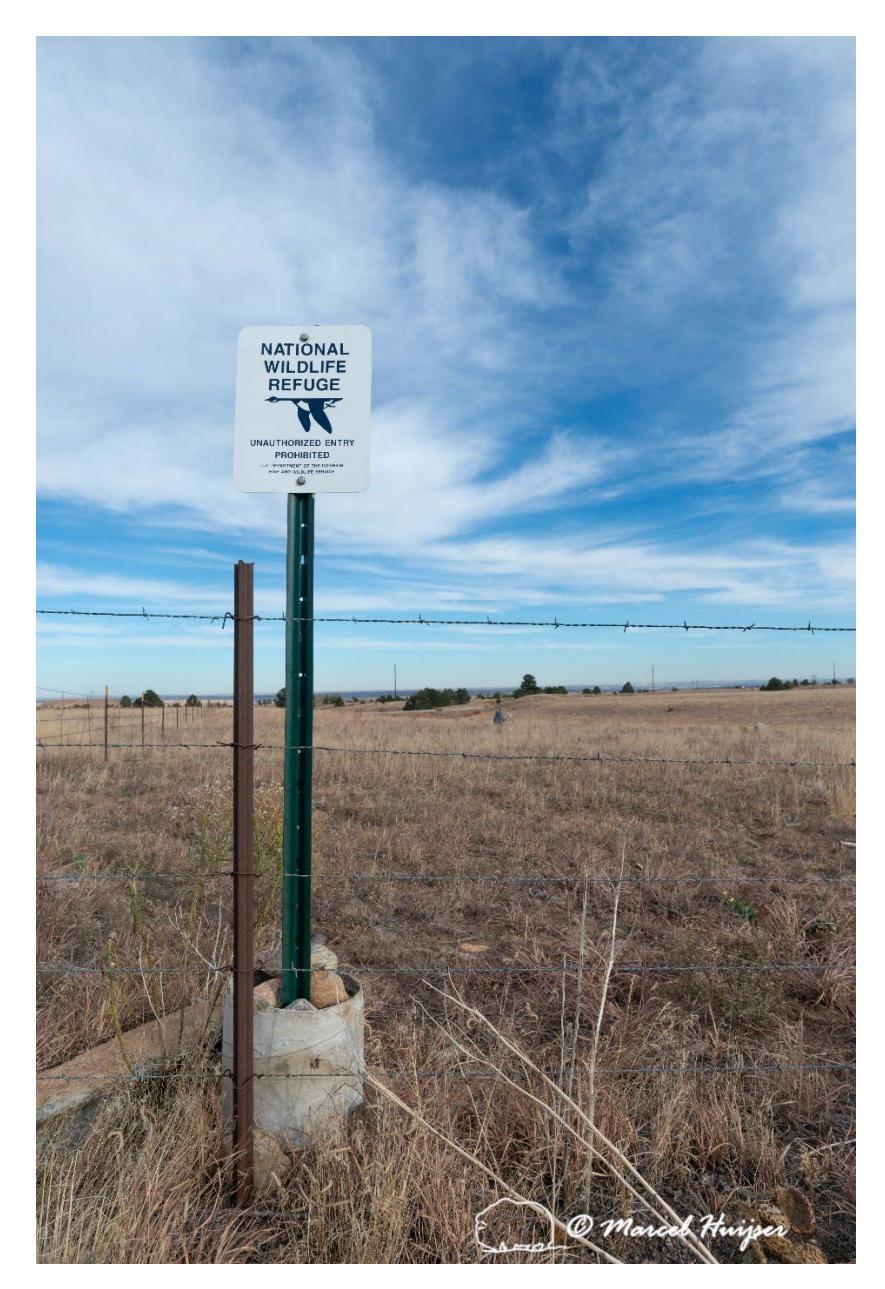
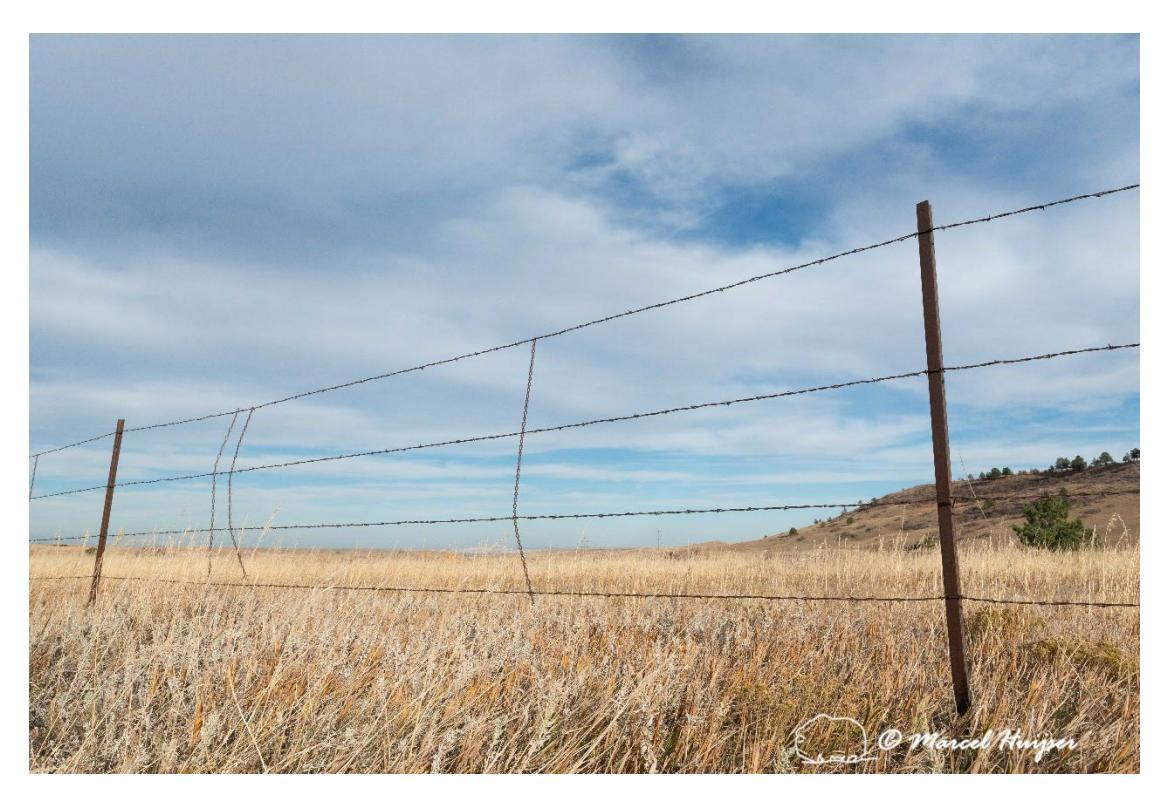
Figure 33: Right-of-way fence, Hwy 93, east side, near mile reference post 8.4.

Figure 34: Right-of-way fence, Hwy 93, east side, near mile reference post 11.3.

There are right-of-way fences or livestock fences along the highways, both on the side of the Refuge, and the other side of the highways (Figure 33, 34). These fences are not designed to keep large wild ungulates off the highway, but they can cause injuries, and even entanglement or death of large wild ungulates. Should the fences be required to keep livestock off the road, then they are likely more detrimental to wildlife then needed as wildlife friendly livestock fence designs are available (see e.g., Paige 2015).

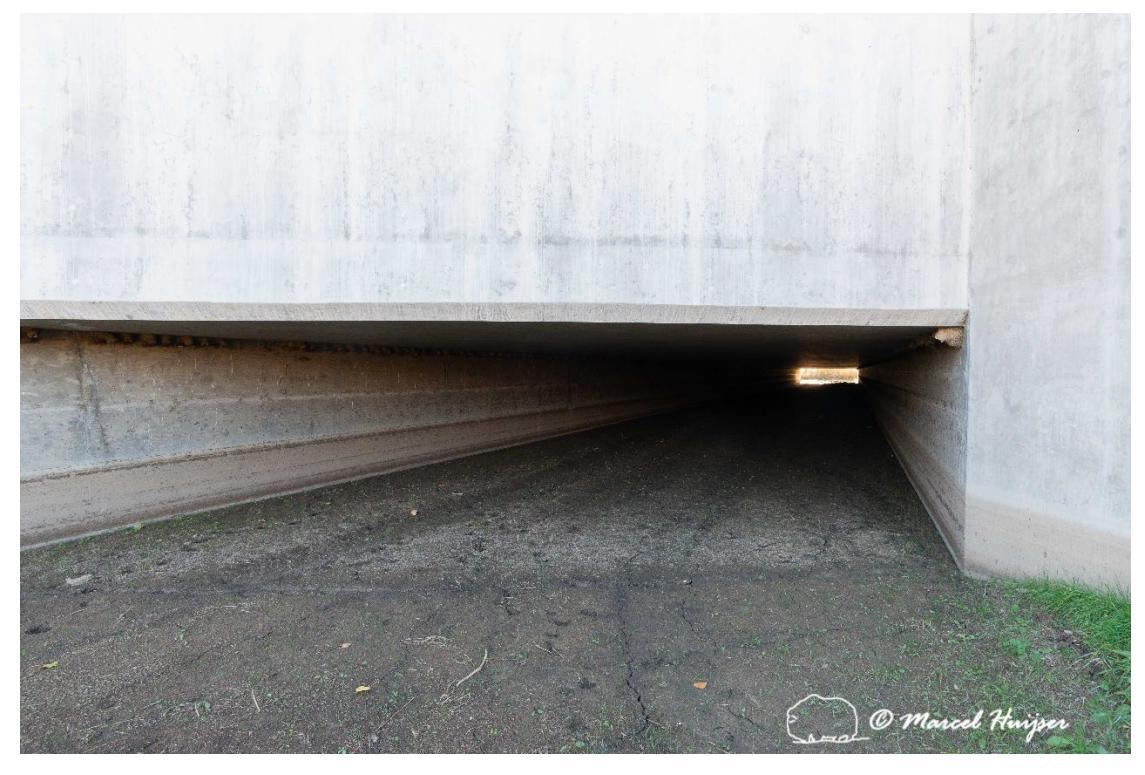
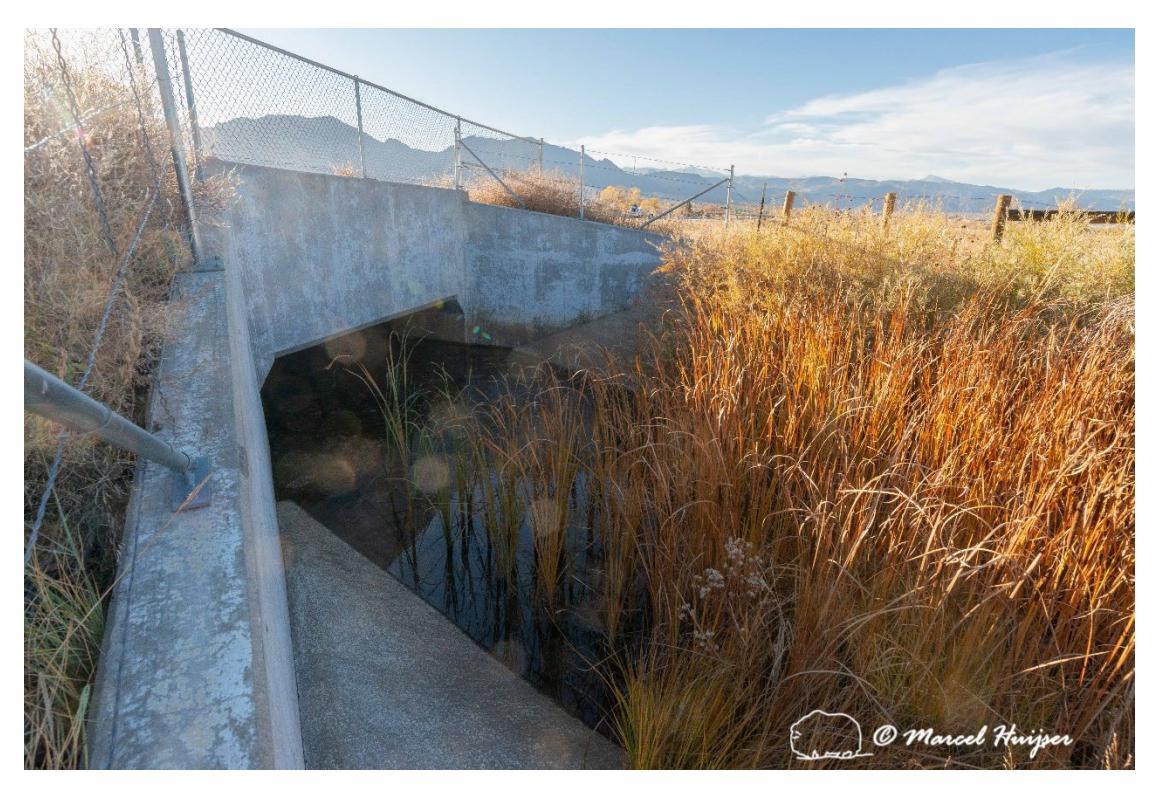
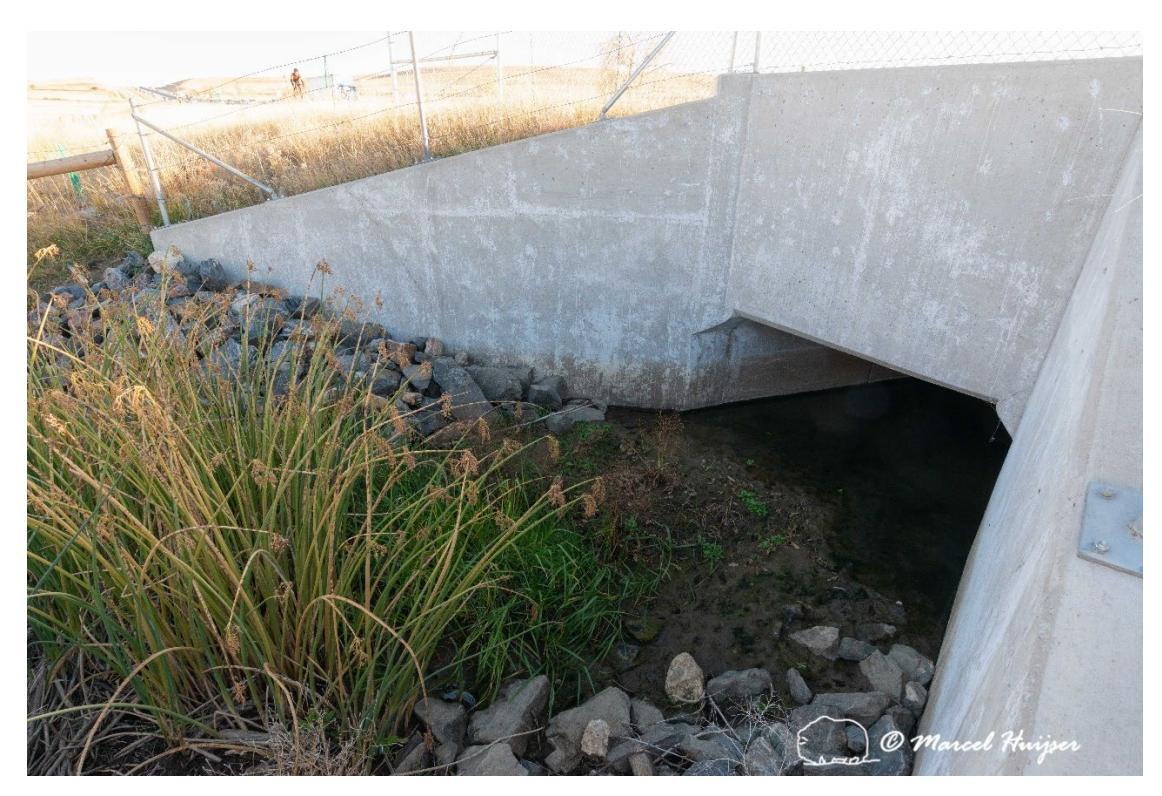
Figure 38: Culvert at Davidson Ditch (Hwy 36, mile reference post 40.8).

Figure 39: Culvert at Goodhue Ditch (Hwy 36, mile reference post 41.2).

Figure 40: Culvert at Marshallville Ditch (Hwy 36, mile reference post 41.5).

Crossing structure specifications for culverts at three ditches that were also intended to provide connectivity for Preble's meadow jumping mouse were based on engineering plans from the Colorado Department of Transportation (repository in Huijser & Gunson, 2019). The culverts are shown in Figure 38, 39, and 40. As for as the authors of this report know, there are no data on use or potential effectiveness of these structures for Preble's meadow jumping mouse. However, from the images it is evident that there is no cover, let alone live vegetation inside these culverts. Much larger structures (greater width and height) that would allow light and moisture to come in the underpasses would likely result in riparian vegetation, at least near the entrances of the underpasses.

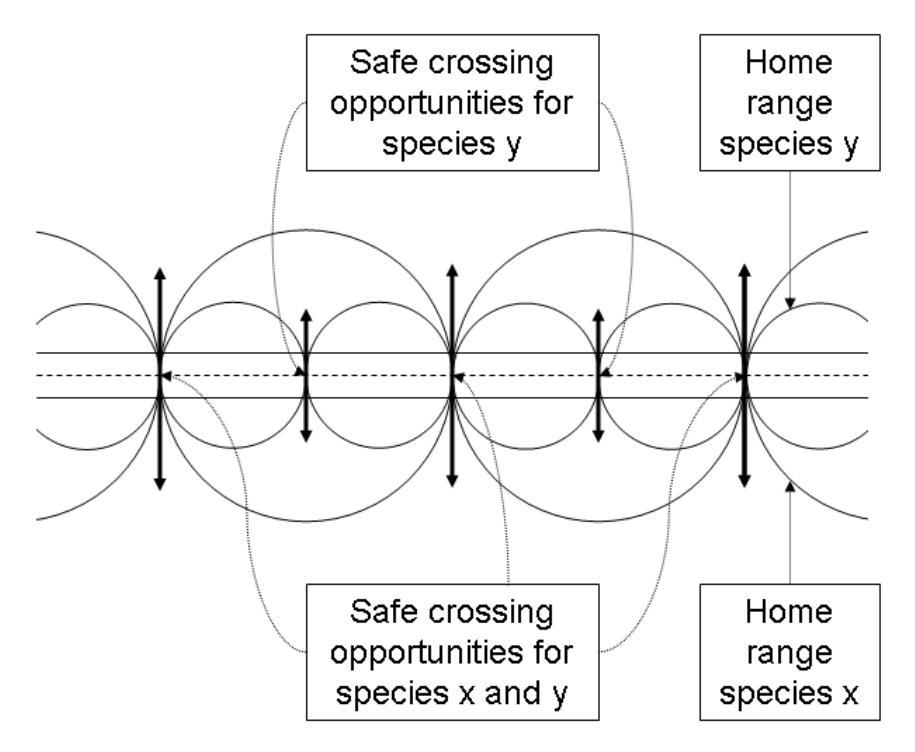
Figure 41. Schematic representation of home ranges for two theoretical species projected on a road and the distance between safe crossing opportunities (distance is equal to the diameter of their home range).

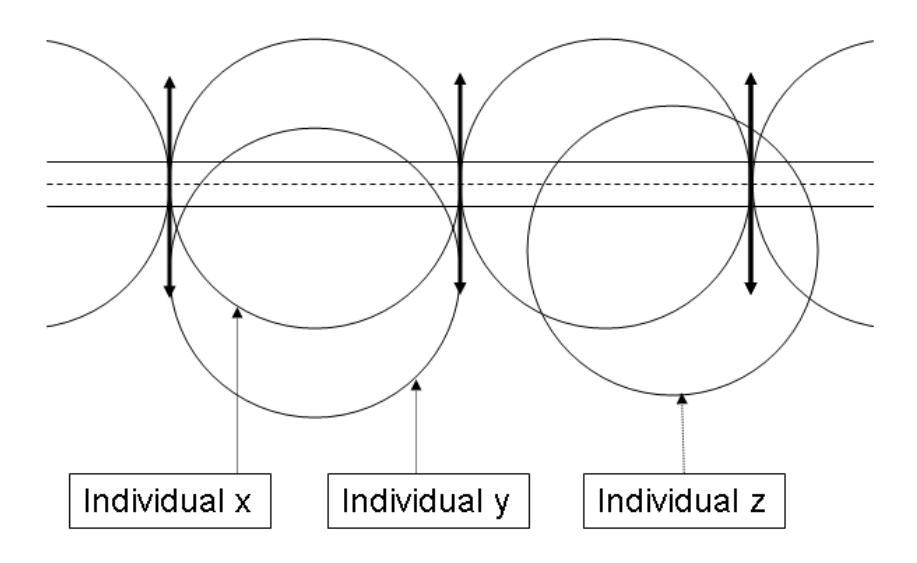
Figure 42. Schematic representation of home range for an individual (x) that has the center of its home range on the center of the road (access to two safe crossing opportunities), an individual (y) that has the center of its home range slightly off the center of the road exactly in between two safe crossing opportunities (no access to safe crossing opportunities), and an individual (z) that has the center of its home range slightly off the center of the road but not exactly in between two safe crossing opportunities (access to one safe crossing opportunities).

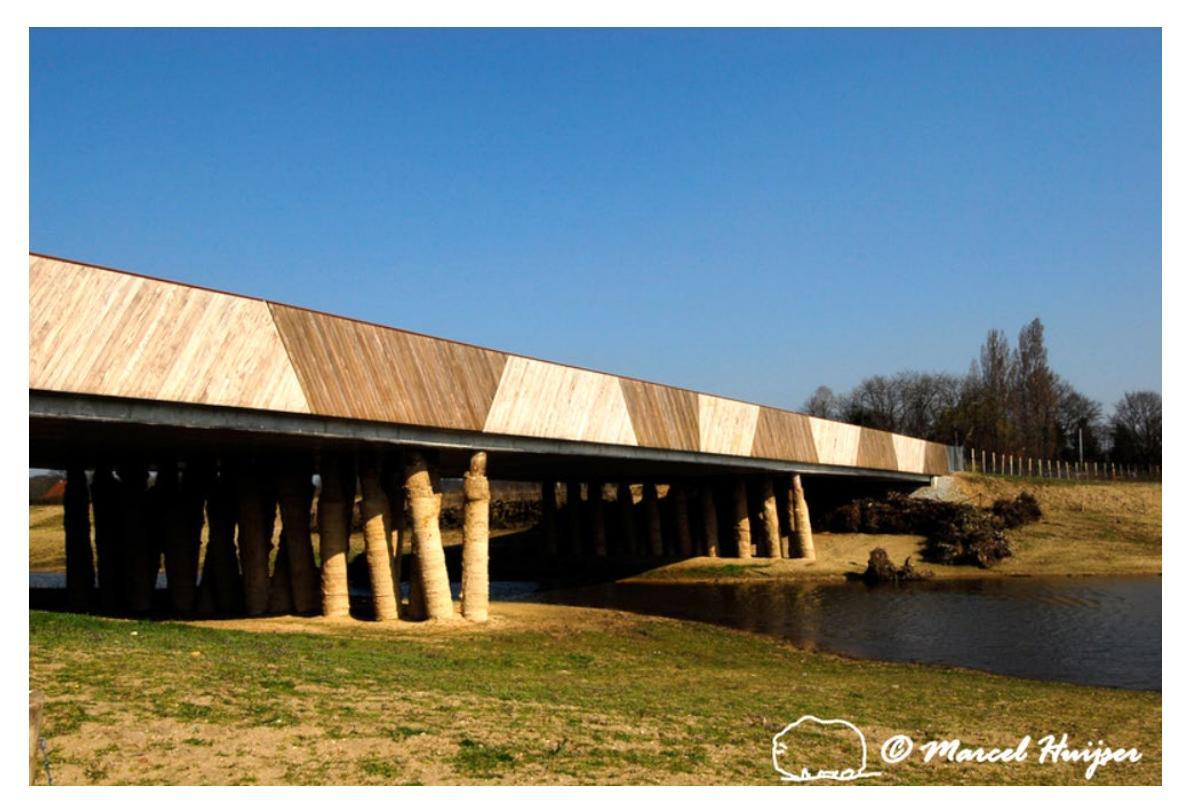
Figure 43. Multifunctional underpass, The Netherlands. The underpass is for hydrology and wildlife.

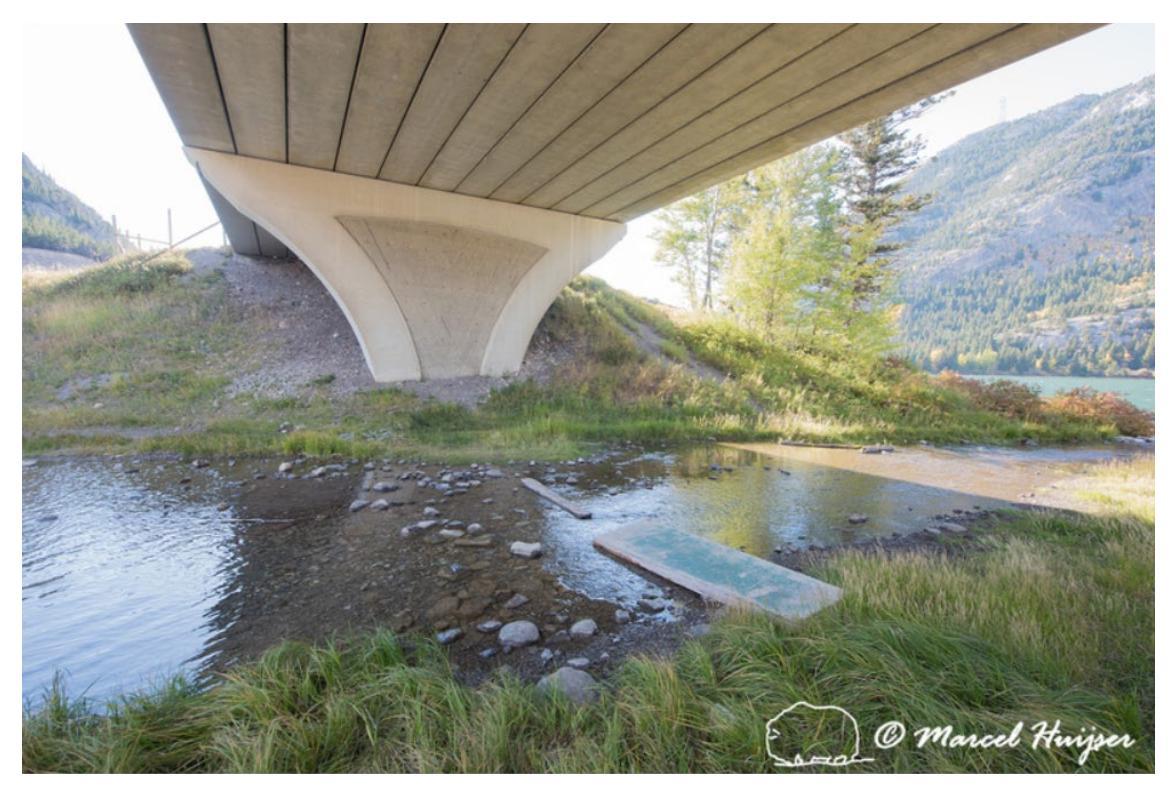
Figure 44. Multifunctional underpass, Hwy 3, Crowsnest Pass, Alberta, Canada. The underpass is for hydrology and wildlife. Note how the substrate and stream dynamics are unaffected by the structure and how light and moisture reaches the entire area under the bride allowing for natural vegetation in the riparian and terrestrial zones.

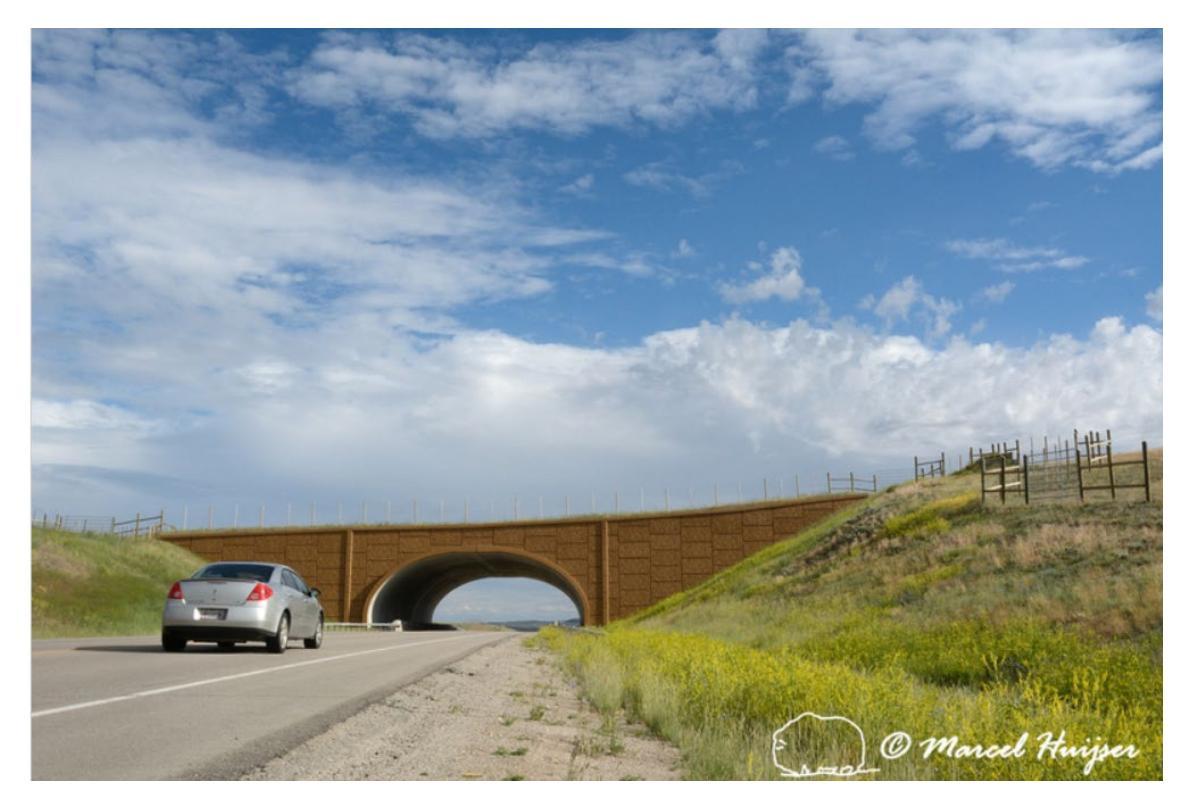
Figure 45. Wildlife overpass, primarily for pronghorn (Antilocapra americana) (46 m (150 ft) wide), on the Path of the Pronghorn, Trapper's Point, US Hwy 191, near Pinedale, Wyoming, USA.

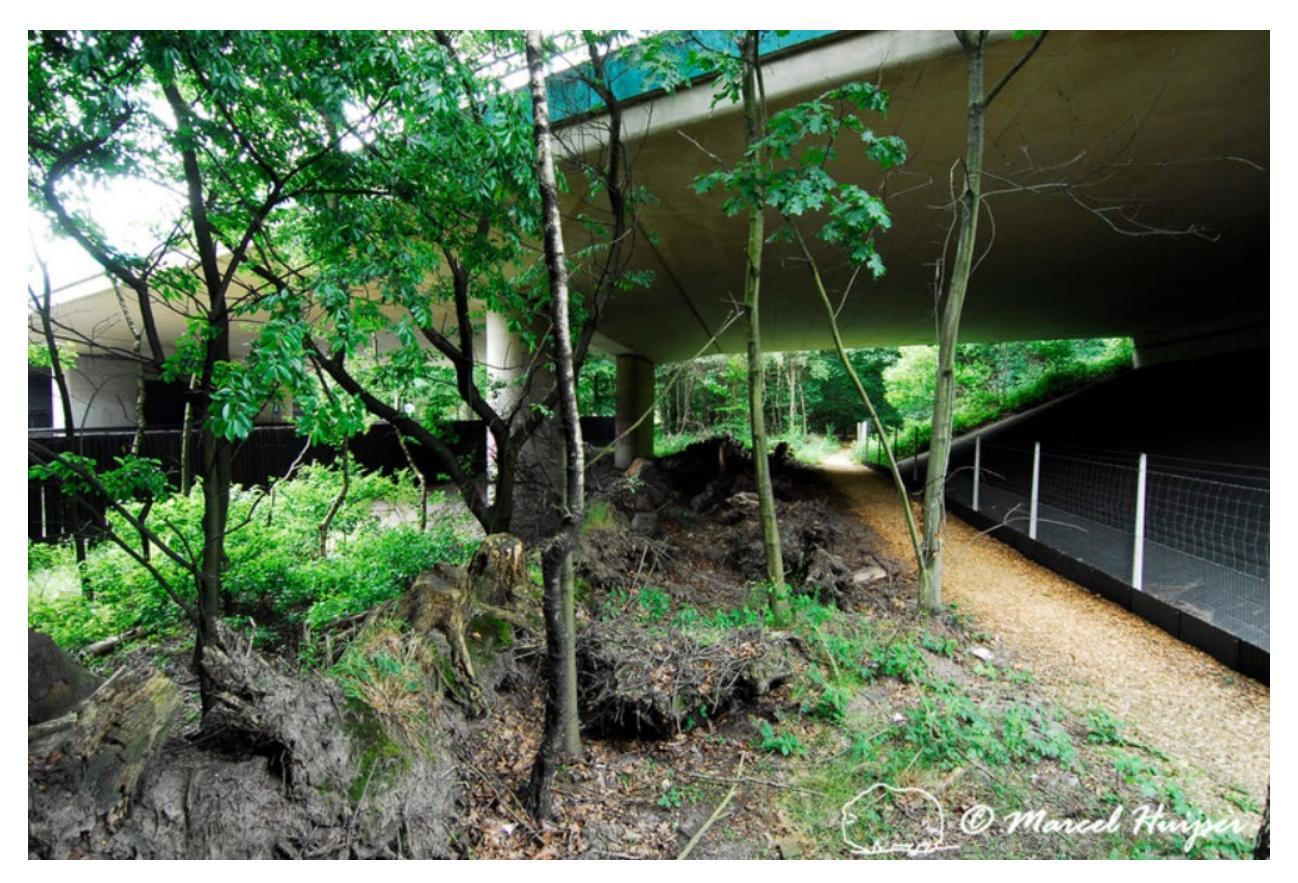
Figure 50. Multifunctional underpass under A28 motorway near Hilversum, The Netherlands. The trail for non-motorized human use is on the far-right side. A berm with root wads, small trees and shrubs in the center separates the trail from the wildlife zone further to the left. Beyond the black screen on the far left there is a 2-lane road.

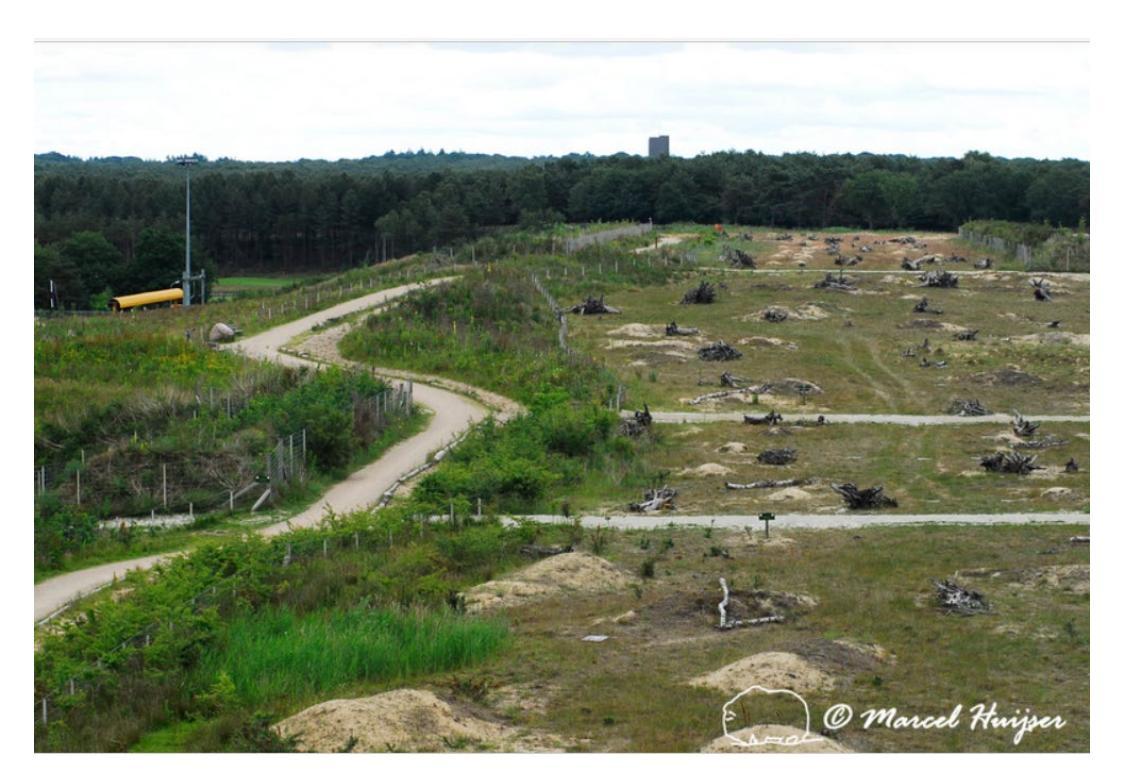
Figure 51. Multifunctional overpass across a 2-lane road and railroad tracks with a trail for non-motorized recreation on the left side, Natuurbrug Zanderij Crailoo, The Netherlands. The trail has a berm with trees and shrubs to reduce human presence and disturbance in the wildlife zone that is further to the right. The habitat on top of the overpass is dry and sandy grassland and heathland.

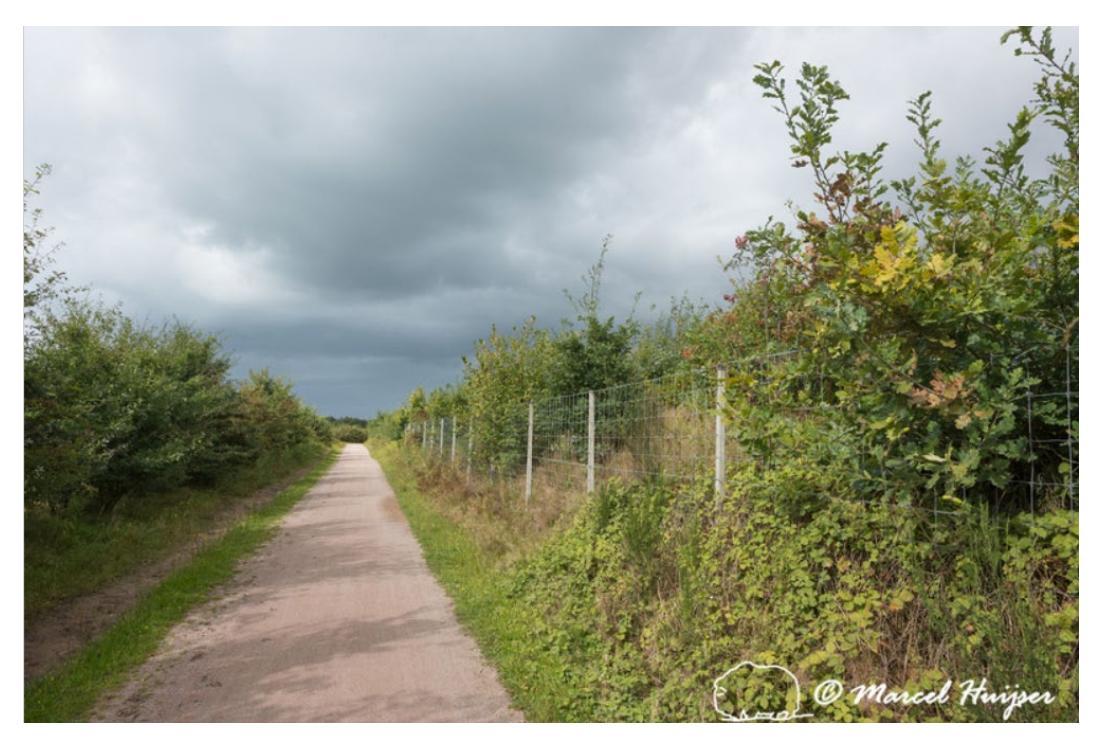
Figure 52. Multifunctional overpass across a 2-lane road and railroad tracks with a trail for non-motorized recreation, Natuurbrug Zanderij Crailoo, The Netherlands. The trail has a berm with trees and shrubs on the left-hand side to reduce human presence and disturbance in the wildlife zone that is further to the left. There is also a berm with trees and shrubs to the right of the trail, reducing visual and noise disturbance from vehicles towards the trail.

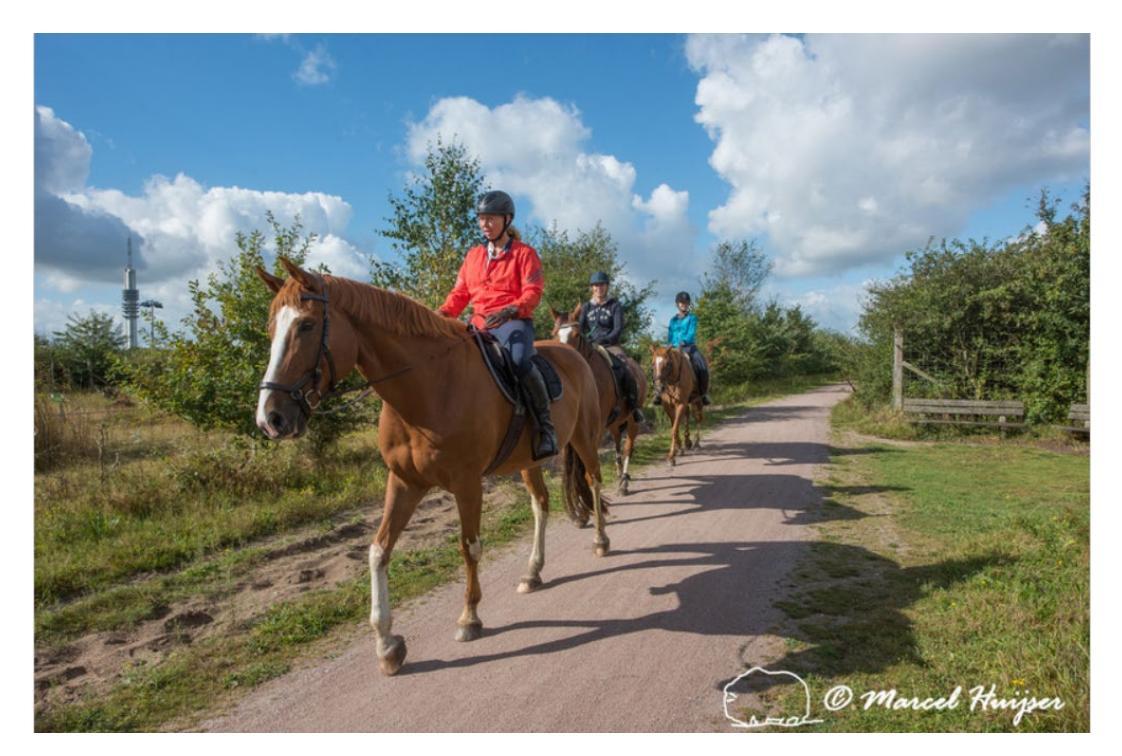
Figure 53. Horseback riders on a trail on a multifunctional overpass across a 2-lane road and railroad tracks. The trail is for non-motorized recreation. Natuurbrug Zanderij Crailoo, The Netherlands. The trail has a berm with trees and shrubs on the right-hand side to reduce human presence and disturbance in the wildlife zone that is further to the right. There is also a berm with trees and shrubs to the left of the trail, reducing visual and noise disturbance from vehicles towards the trail.

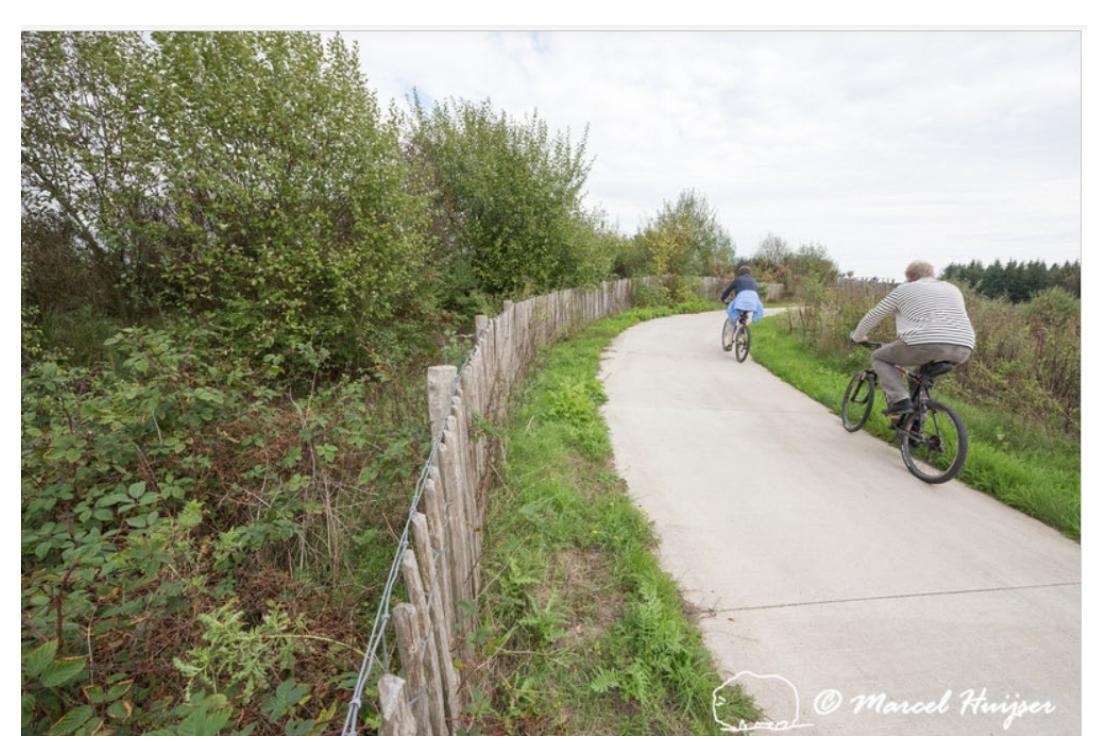
Figure 54. Bicyclists on a trail on a multifunctional overpass. The trail is for non-motorized recreation. Soest, The Netherlands. The trail has a fence and a berm with trees and shrubs on the left-hand side to reduce human presence and disturbance in the wildlife zone that is further to the left.
In the case of the Refuge, elk have somewhat adapted to human presence and disturbance by concentrating in the center of the Refuge where the public does not have access. Most of the elk (and mule deer) crashes occur at night (see Chapter 2), further indicating that road crossings already happen predominantly at night. In this context, multifunctional overpasses for elk and people may be an option as moving connectivity for large ungulates towards the dark hours has already happened given the human presence and disturbance in the area. The combined interests of wildlife connectivity and a safer and better-connected network of non-motorized trails could increase public support and associated funding for the construction of multifunctional crossing structures. An overpass for a non-motorized trail has already been suggested across Indian St. around mile reference post 1.3 (City and County of Broomfield 2016, FHWA 2023). This connector would be important to the local network of trails as well as the Rocky Mountain Greenway (RMG) that would connect the Refuge, Rocky Mountain Arsenal National Wildlife Refuge, Two Ponds National Wildlife Refuge in Arvada, and Rocky Mountain National Park (City and County of Broomfield 2016). This location would likely also be suited for a wildlife overpass for elk (see earlier).
