COST-EFFECTIVENESS OF CRACK SEALING MATERIALS AND TECHNIQUES FOR ASPHALT PAVEMENTS

Final Report

April 2004

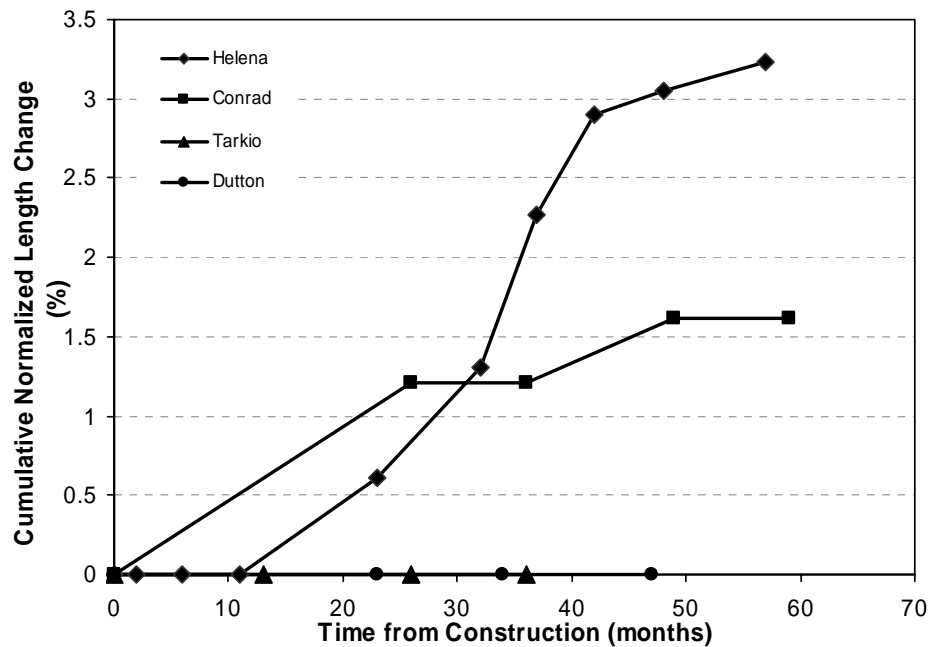
Figure 3: Comparison of Transverse Crack Propagation

Comparisons between the test sites showed that the highest cumulative, normalized percentage of transverse crack formation (3 percent) was at the Helena site (Figure 3). Neither Tarkio nor Dutton experienced transverse crack formation during their respective evaluation periods.

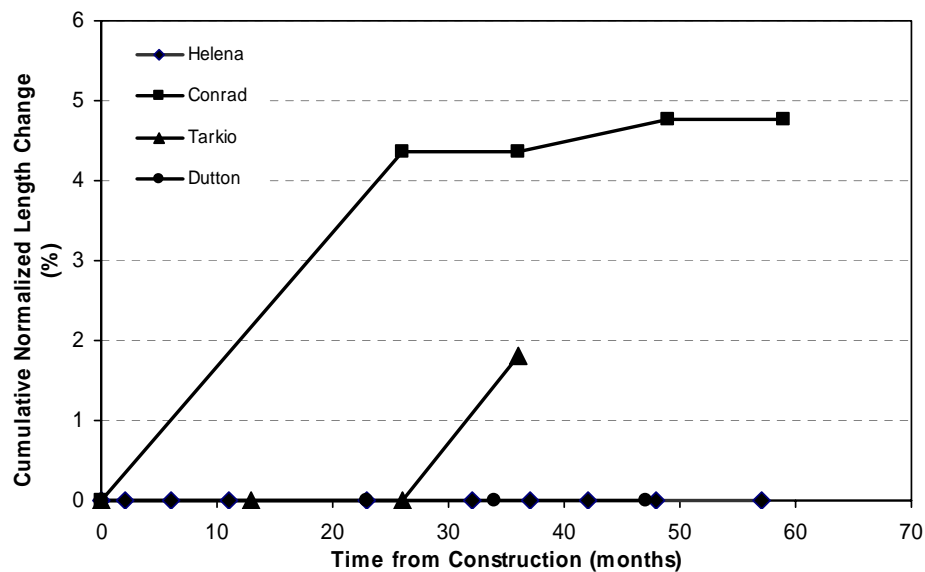
Figure 4: Comparison of Longitudinal Crack Propagation

Longitudinal crack formation/propagation was greatest at the Conrad test site. Longitudinal crack development did not occur at the Dutton or Helena sites. Longitudinal crack development occurred at the Tarkio site only between the last two site investigations. Figure 4 shows longitudinal crack development for all the test sites.

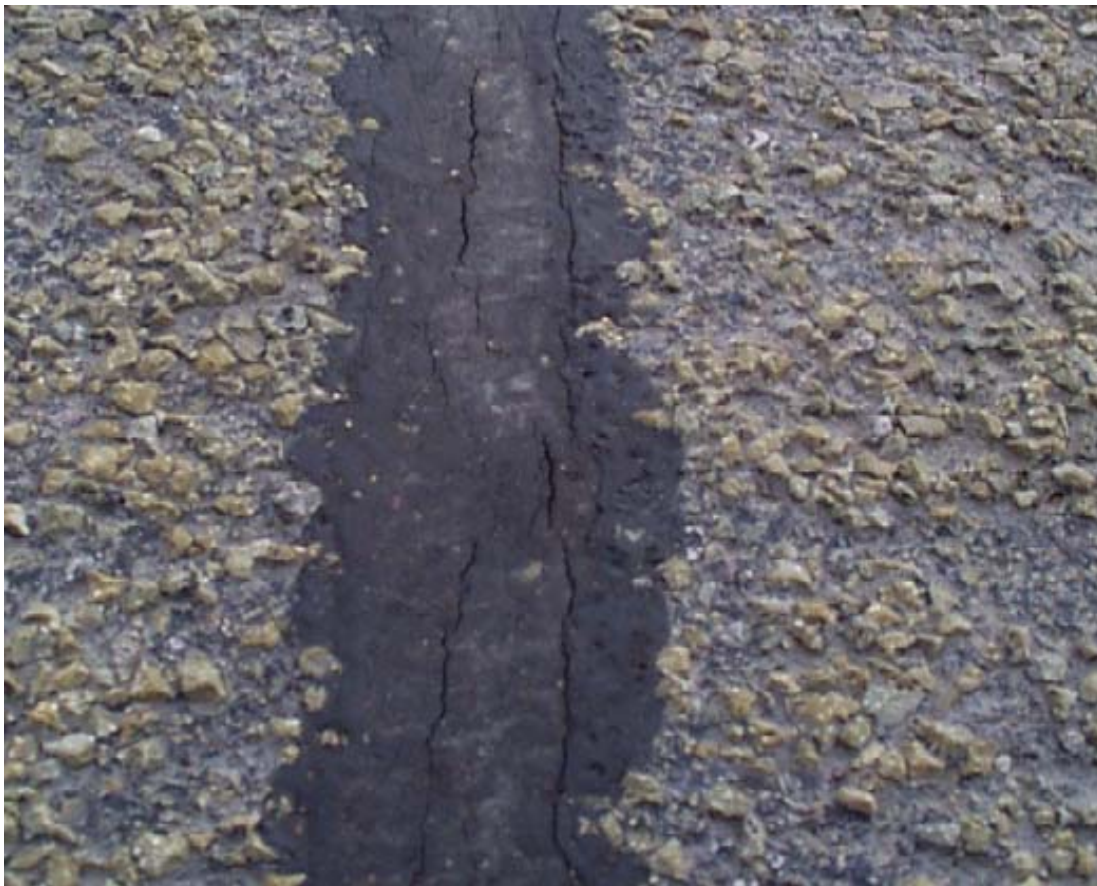
Figure 5: Example of Double Adhesion Failure Associated with the Shallow and Flush Technique

After approximately two years of service, adhesion failure was seen on both walls of a crack in a single reach (Figure 5) at the Helena site. In some cases, if more than half of the length of a crack was experiencing dual adhesion failure, the percent failure will be greater than 100. When calculating the total material failures the overlap will be accounted for, resulting in a value less than or equal to 100 percent. Dual adhesion failure of this type was seen in significant quantities in both of the Maxwell products as well as the Deery material. It is believed that failure of this type is likely to be the result of poor low-temperature resiliency. The combination of colder temperatures and pavement contraction causes internal stresses in the sealant to increase. If the sealant material does not have sufficient resiliency to resist these stresses, failure will ensue. In the past, stress relief had been provided through either cohesion or adhesions failures. Techniques that seem to be most prone to this behavior were the Square Reservoir and Flush, Square Reservoir and Band-Aid, and the Shallow Reservoir and Flush methods.

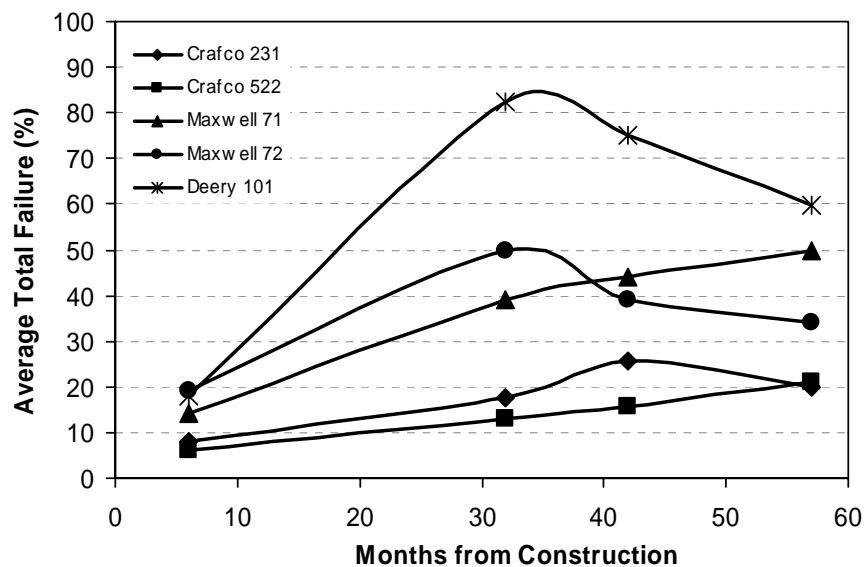
Figure 6: Average Total Failure of Sealant Materials Independent of Fill Technique for Helena

A comparison between the various materials and techniques was made that considered only total failures after the winter season. To do this, the total failures for a particular material were averaged irrespective of the technique used when filling the crack. Similarly, the total failures for a particular technique were averaged irrespective of the material used to fill the crack. Figures 6 and 7 show the average total failure for the materials only and techniques only, respectively. Results show that the Crafcro 522 material and the Shallow and Flush technique performed the best overall, while the Deery 101 material and the Band-Aid technique performed worst.

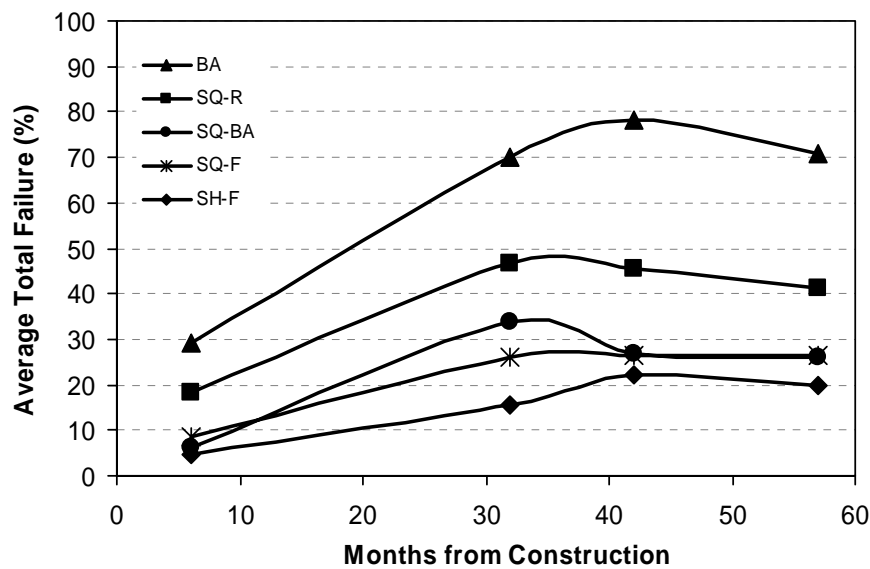
Figure 7: Average Total Failure of Fill Technique Independent of Sealant Materials for Helena

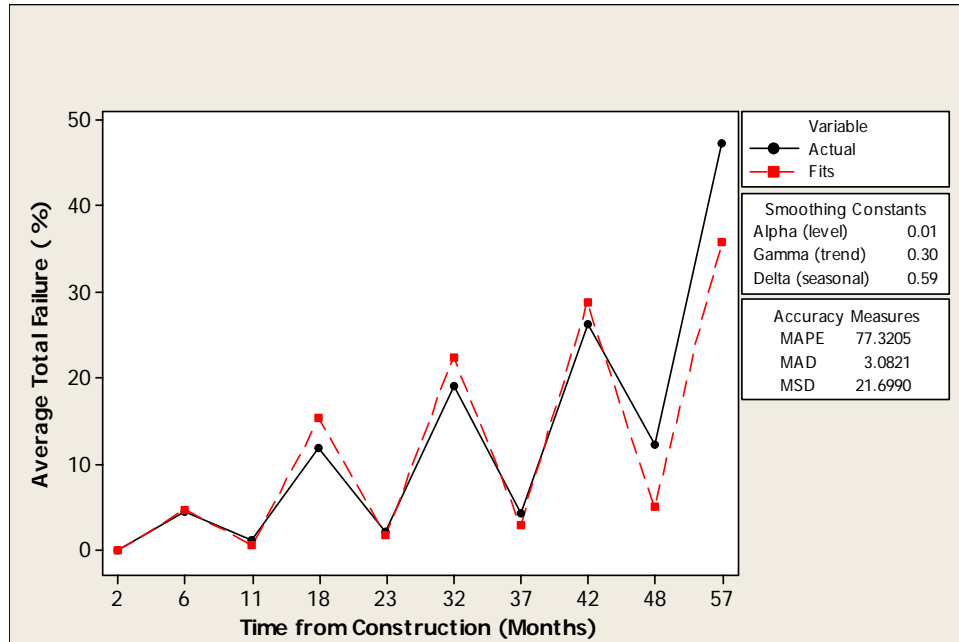
Figure 8: Winter's Seasonal Exponential Smoothing for Crafcro 522, BA

The average total failure from the summer (determined from evaluations conducted at 2, 11, 23, 37, 48 months from construction) and winter (determined from evaluations conducted at 6, 18, 32, 42, 57 months from construction) seasons were used as the inputs into the Winter's forecasting model. This forecasting model used three smoothing constants to reduce analytical errors: alpha (level), gamma (trend) and delta (seasonal). These three variables, which have a value between 0 and 1, were optimized to minimize Mean Absolute Percentage Error (MAPE), Mean Absolute Deviation (MAD), and Mean Squared Deviation (MSD). An example of the results of the Winter's analysis for the Crafcro 522 material combined with the Band-Aid technique is shown in Figure 8.

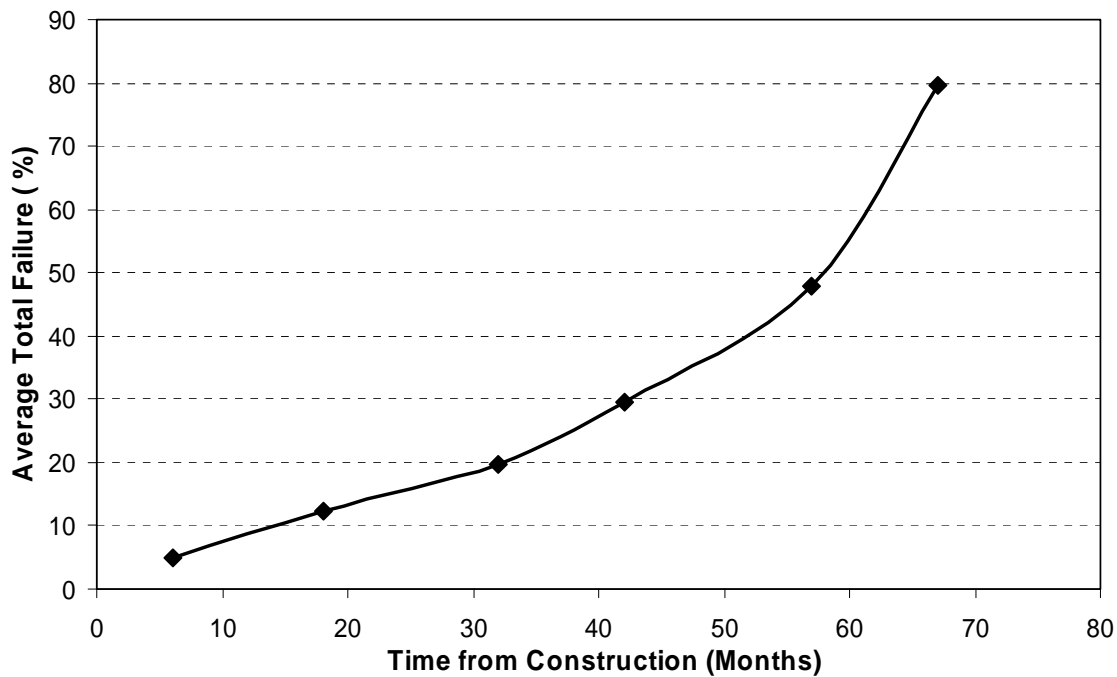
Figure 9: Eclectic Forecasting Results for Crafc0 522, BA

The forecasted values for the winter season from the Winter's model were averaged with the results of the exponential model. Using this method, predictions of useful life were determined by the first season that a particular material/technique combination reached 50 percent failure. Figure 9 shows the final output of the eclectic model which averages the results from the Winter's forecasting model with those from the exponential model for the Crafcro 522 and Band-Aid combination. Similar results to those found in Figures 8 and 9 for all the material/combinations used at the Helena test site are provided in Appendix M.

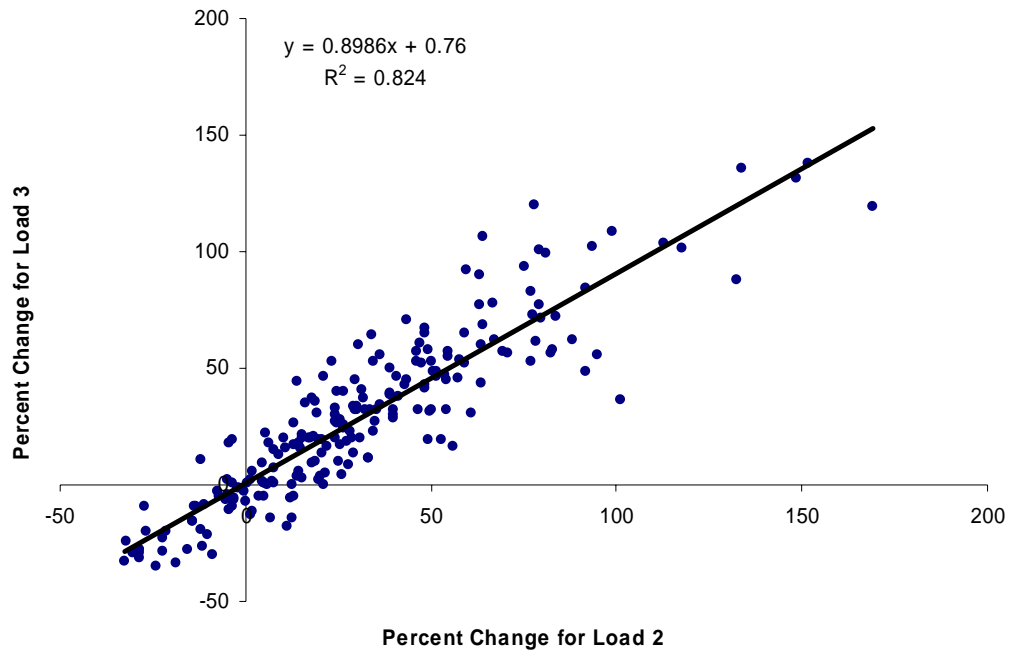
Figure 12: Percent Change in Asphalt Concrete Modulus from Initial Test Date

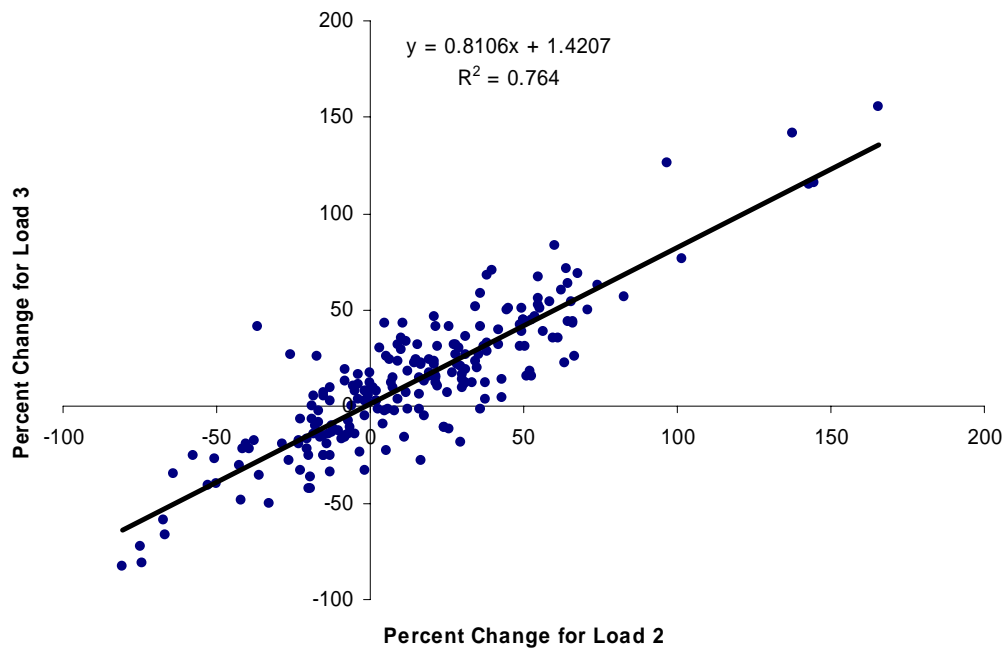
Figure 13: Percent Change in Base Course Modulus from Initial Test Date

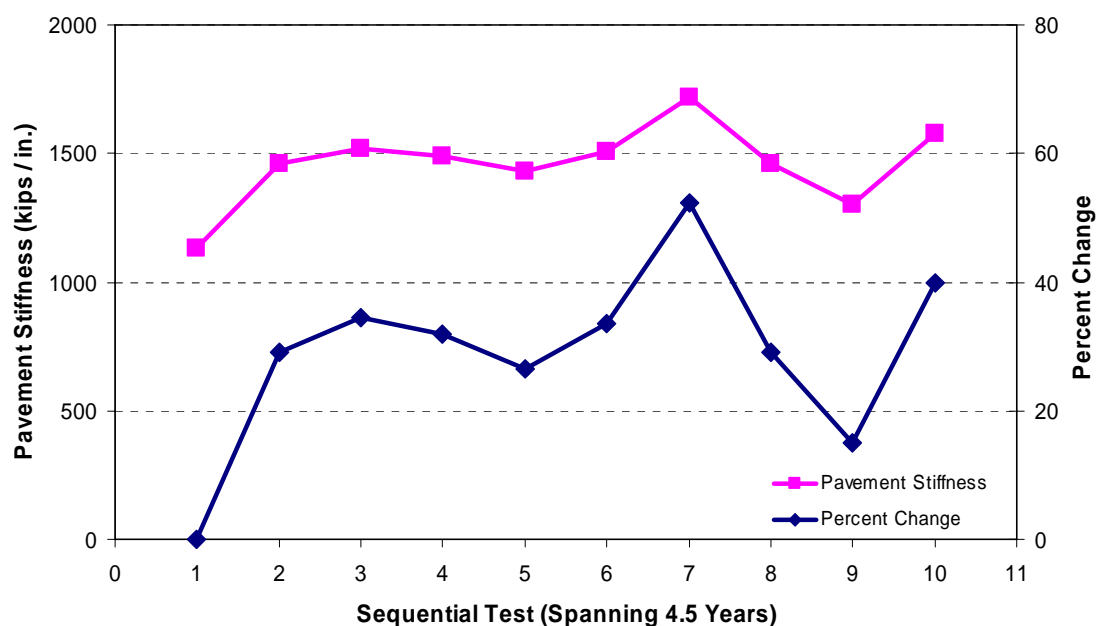
Figure 15: Pavement Stiffness over Time for the Unsealed Control Pavement (Control Section)

Fluctuations in pavement stiffness over time can also be partially correlated with changing pavement surface temperatures at the time of conducting FWD analyses (see Figure 19). For example, temperatures for evaluations 5 and 9 were relatively high, while the temperature for evaluation 7 was relatively low. As such, measured pavement stiffnesses for evaluations 5 and 9 were low relative to the pavement stiffness measured for evaluation 7 (see Figure 15).

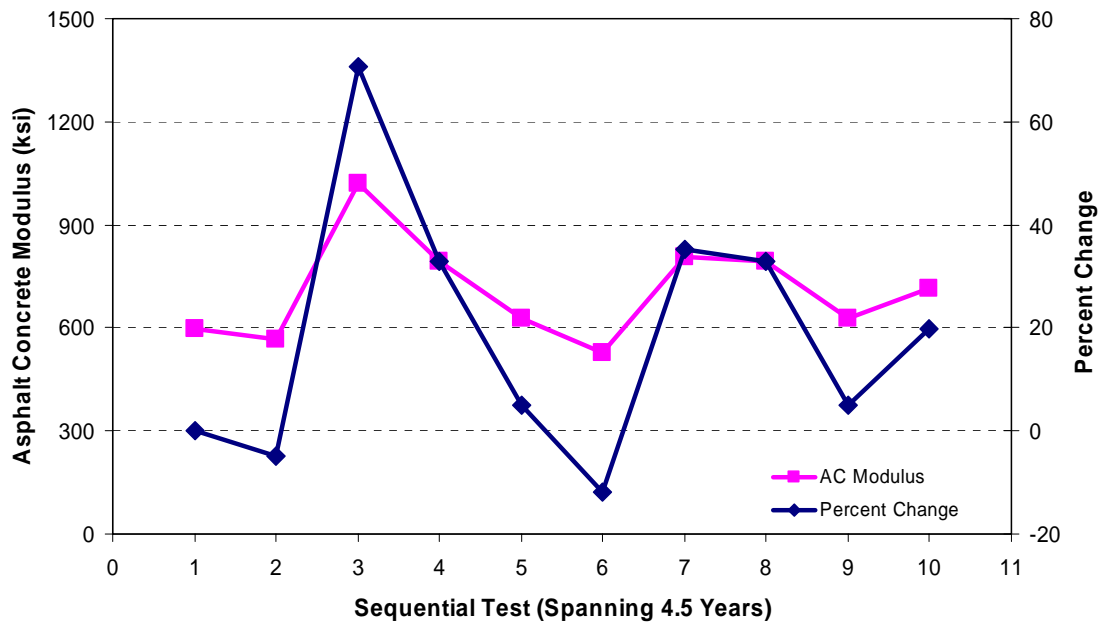
Figure 16: AC Modulus over Time for the Unsealed Control Pavement (Control Section)

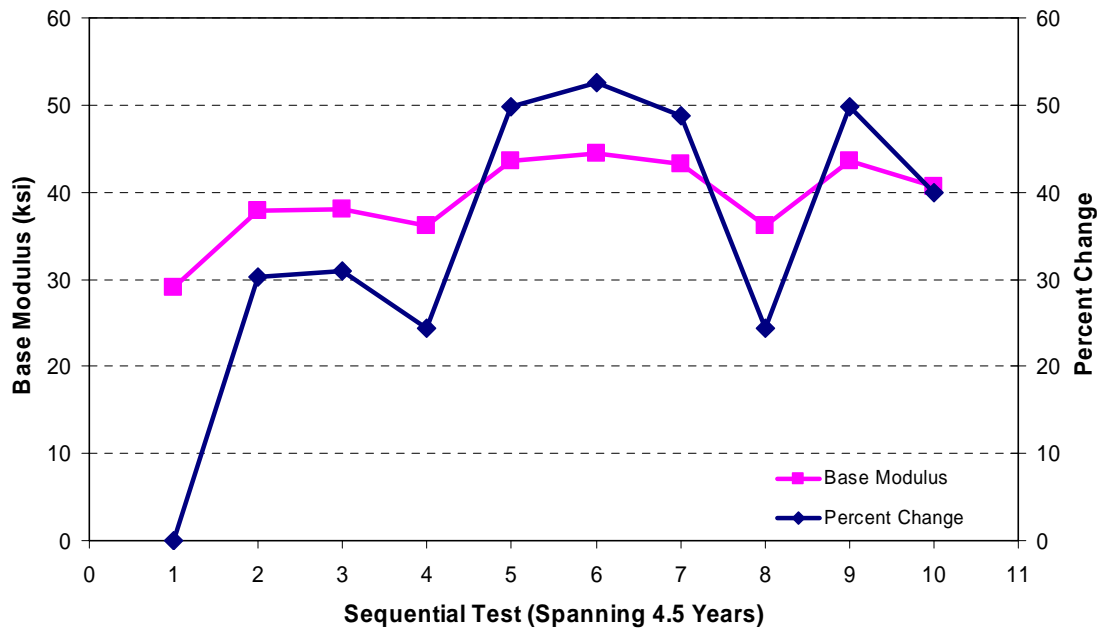
Figure 17: Base Course Modulus over Time for the Unsealed Control Pavement (Control Section)

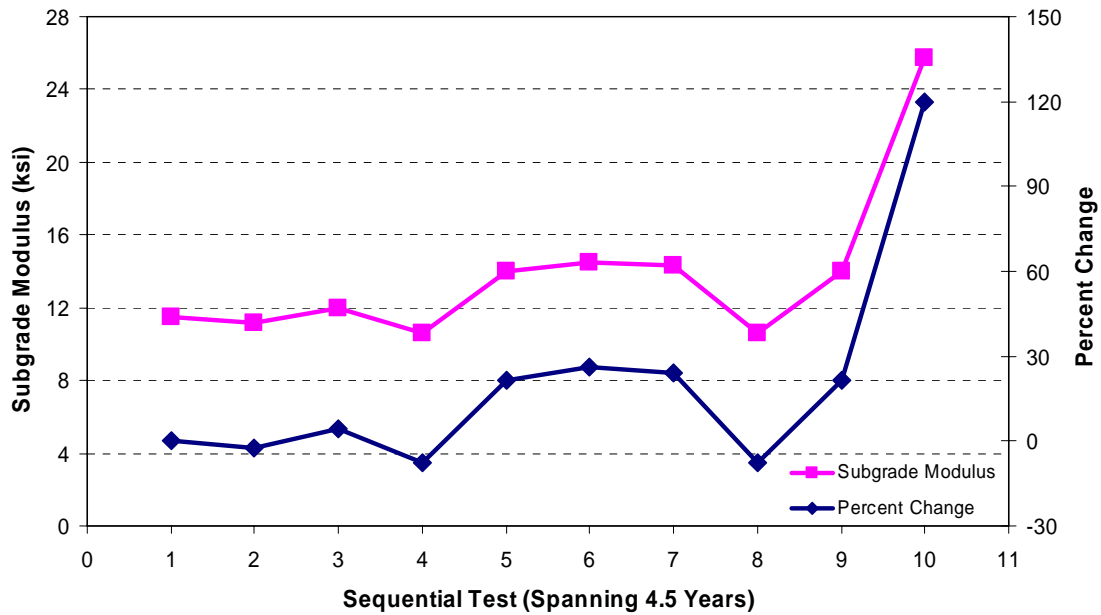
Figure 18: Subgrade Modulus over Time for the Unsealed Control Pavement (Control Section)

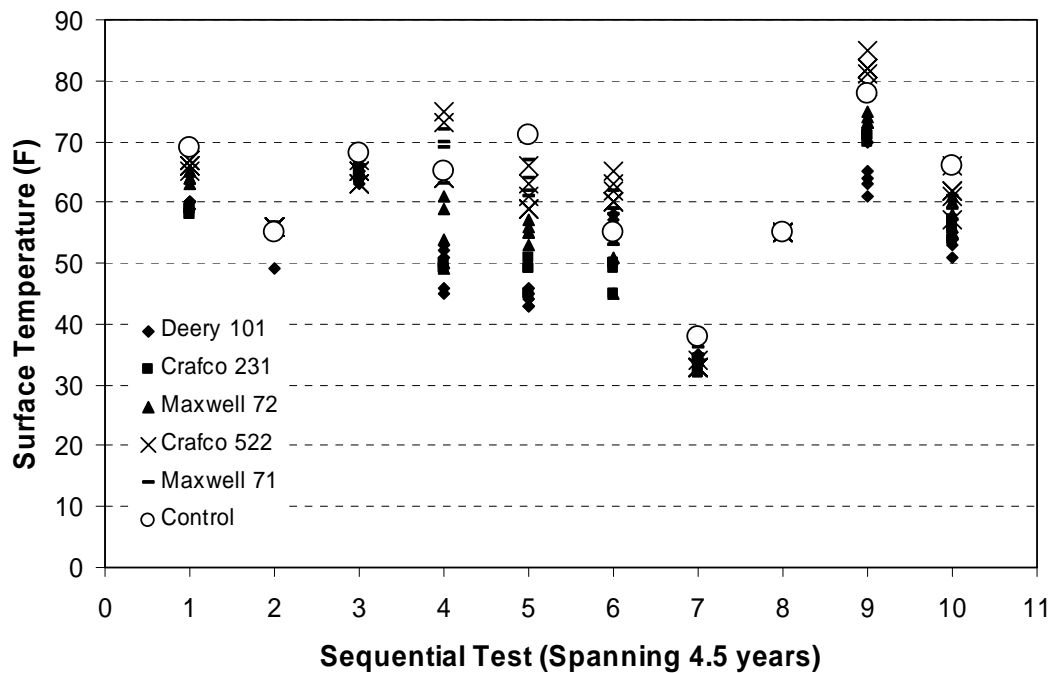
Figure 19: Average Pavement Surface Temperatures

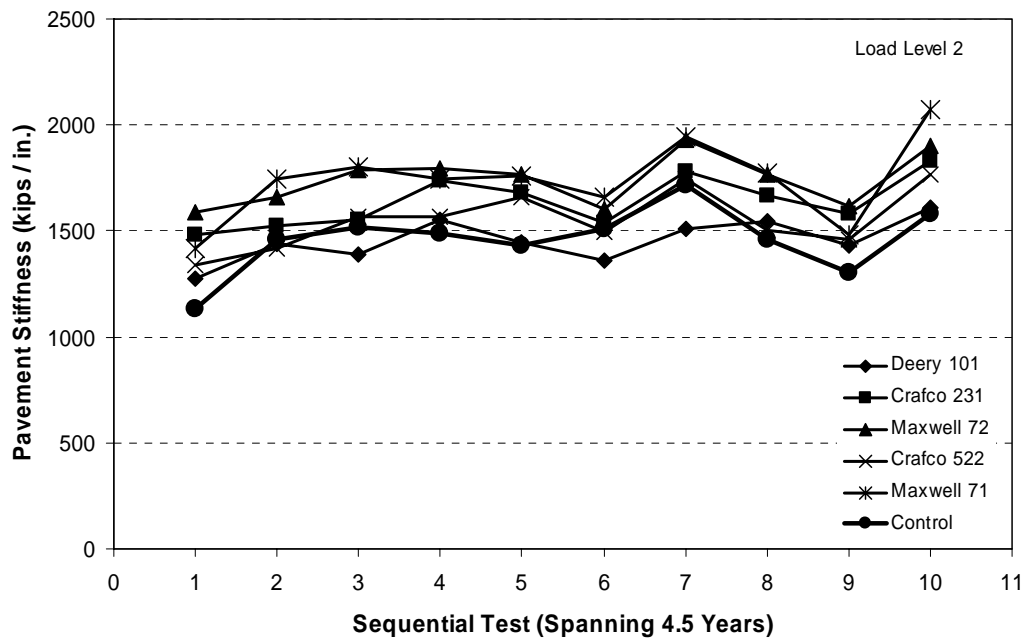
Figure 20: Pavement Stiffness over Time for the Sealed and Unsealed Test Sections

The measured values for the FWD parameters over time for sealed sections are shown in Figures 20 through 23 (responses for the unsealed Control section, Section F, are included for comparison purposes). The sealed and unsealed (i.e. control) sections are similar in that overall pavement stiffness and asphalt concrete modulus generally increased over time (see Figure 11). For example, the percent increases in overall pavement stiffness at the time of the last analysis (i.e., May 2003) for the sealed sections are commensurate with that found for the unsealed section: 20 to 50 percent versus 40 percent.

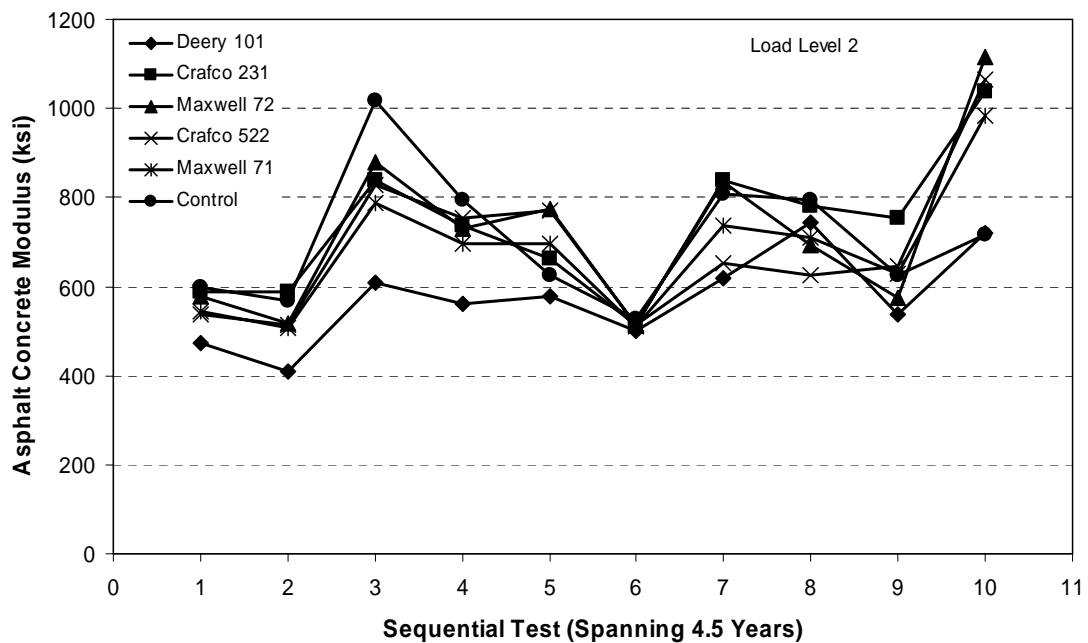
Figure 21: Asphalt Concrete Modulus over Time for the Sealed and Unsealed Test Sections

Asphalt concrete moduli generally increased over time for all pavement sections. Temperature fluctuations over time caused the asphalt concrete moduli to fluctuate between 400 and 1000 ksi. At the time of the last analysis (i.e., May 13, 2003), the modulus of the unsealed control section had increased 20 percent relative to the initial test date (September 17, 1998) and the sealed section moduli had increased 50 to 150 percent (see Figure 21). As expected, AC becomes more brittle over time thereby showing greater modulus. Nevertheless, it is not known why there was less increase in modulus in the control section.

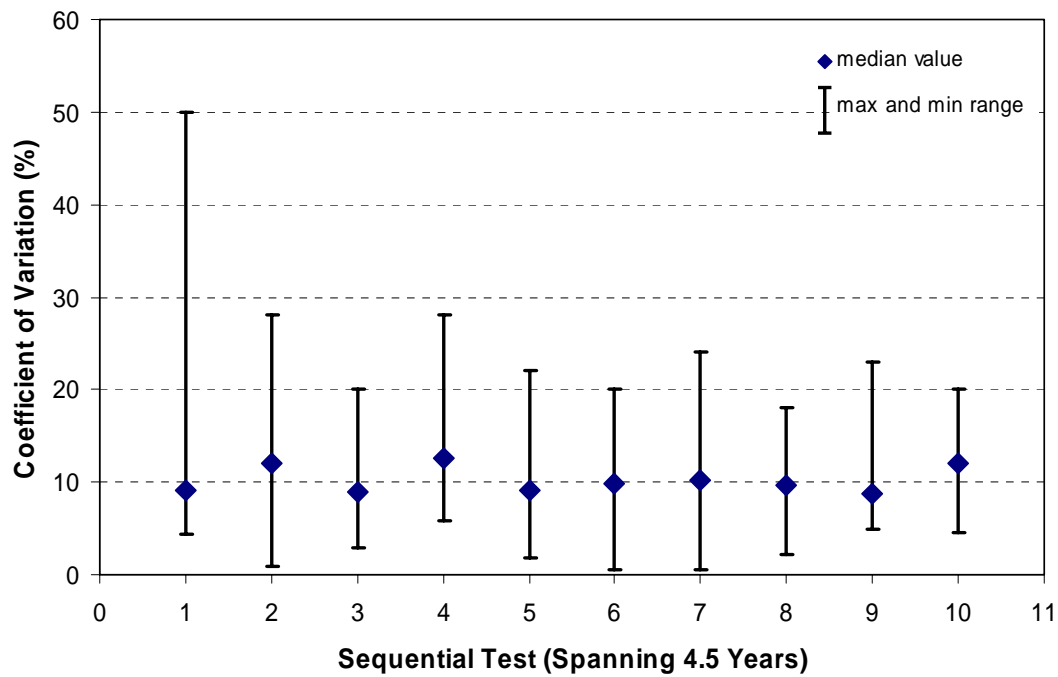
Figure 24: Variability in Pavement Stiffness between Tests within Test Sections.

5. The variability in back-calculated moduli, as measured between the different test locations in each test section, were particularly high for the last test date (see Figures 24 through 27). High variability between measurements necessitates relatively large differences in mean values in order for the differences to be considered statistically significant.

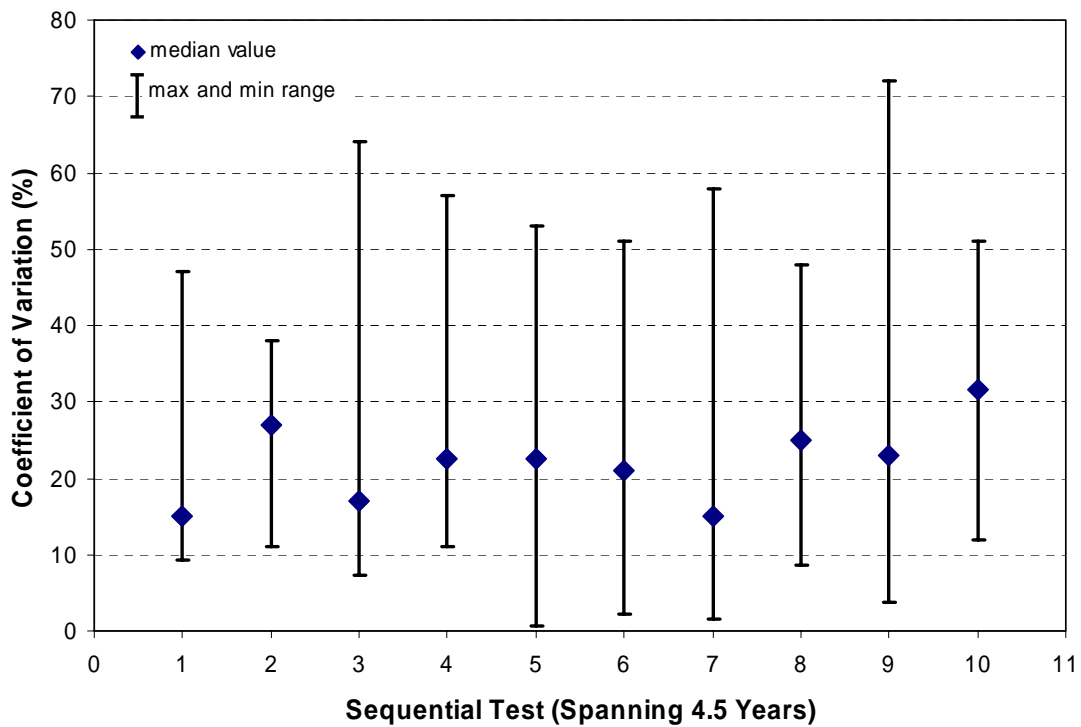
Figure 25: Variability in Asphalt Concrete Modulus between Tests within Test Sections.

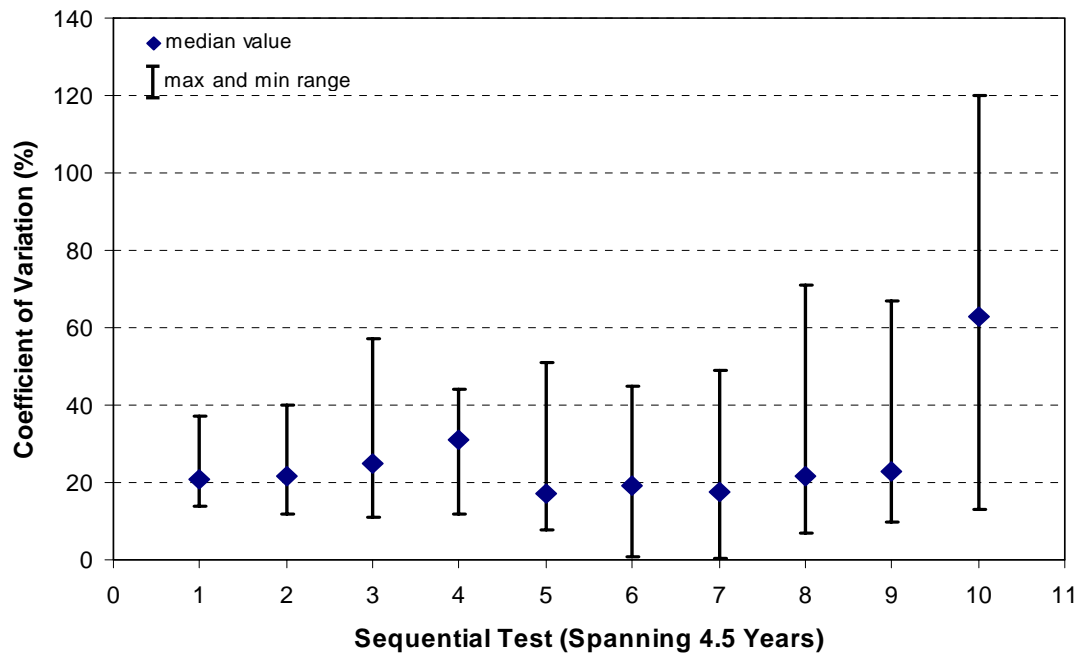
Figure 26: Variability in Base Course Modulus between Tests within Test Sections.

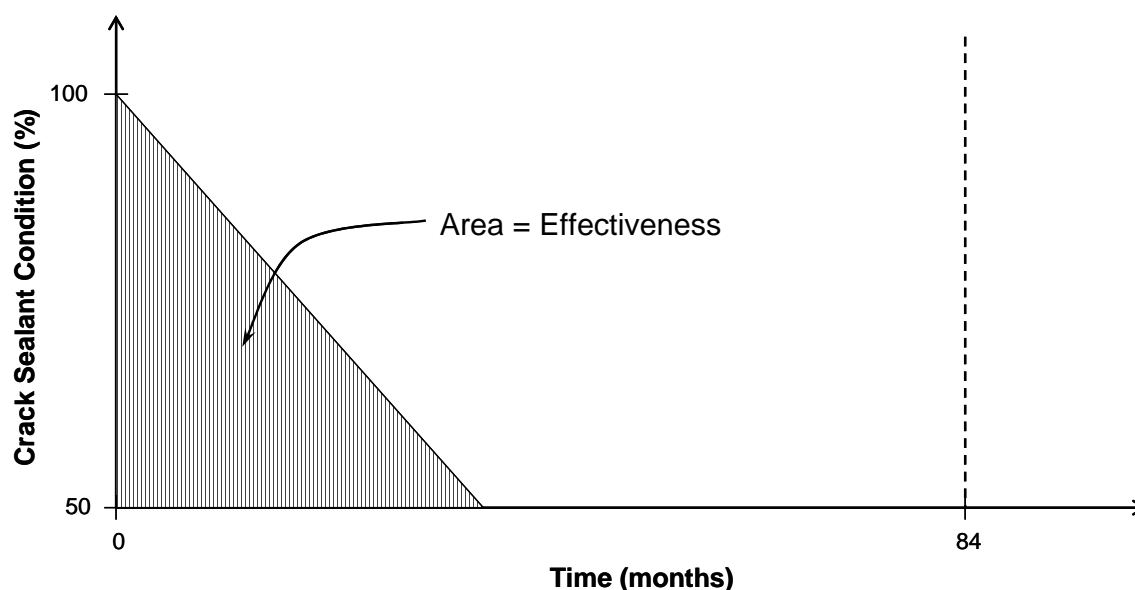
Figure 31: Example of Assumed Crack Sealant Performance Curve (Method A)

A cost-effectiveness analysis was conducted to determine which of the crack sealing materials and techniques was most cost-effective assuming that they will eventually enhance pavement performance. In this analysis the effectiveness was defined as the area under the crack sealant's performance curve. The performance curve was generated by plotting the condition of the crack sealant with respect to time. Two methods were employed to estimate crack sealing performance: Method A and Method B. The simplest method (Method A) used the forecasted life of a particular material/technique combination to estimate performance. For this method, a triangular area is formed, assuming that crack sealant performance decays linearly over time, as illustrated in Figure 31. Even though crack sealant does not typically decay linearly, this assumption provides a reasonable estimate of relative cost-effectiveness, and is less complicated to compute.

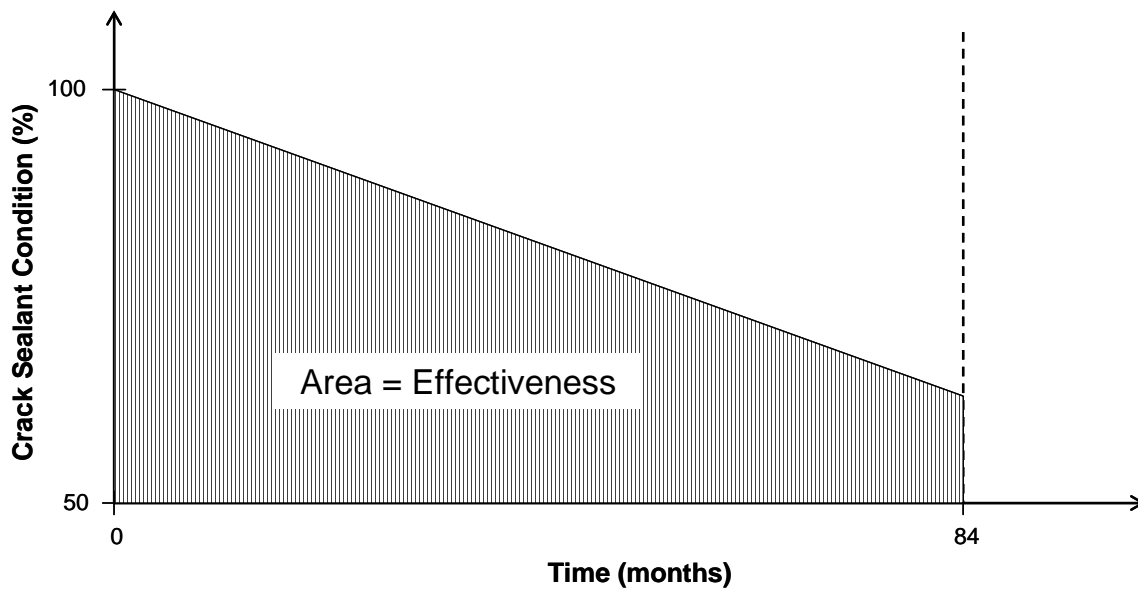
Figure 32: Example of Performance Curve for Crack Sealant Lasting Greater Than 84 Months

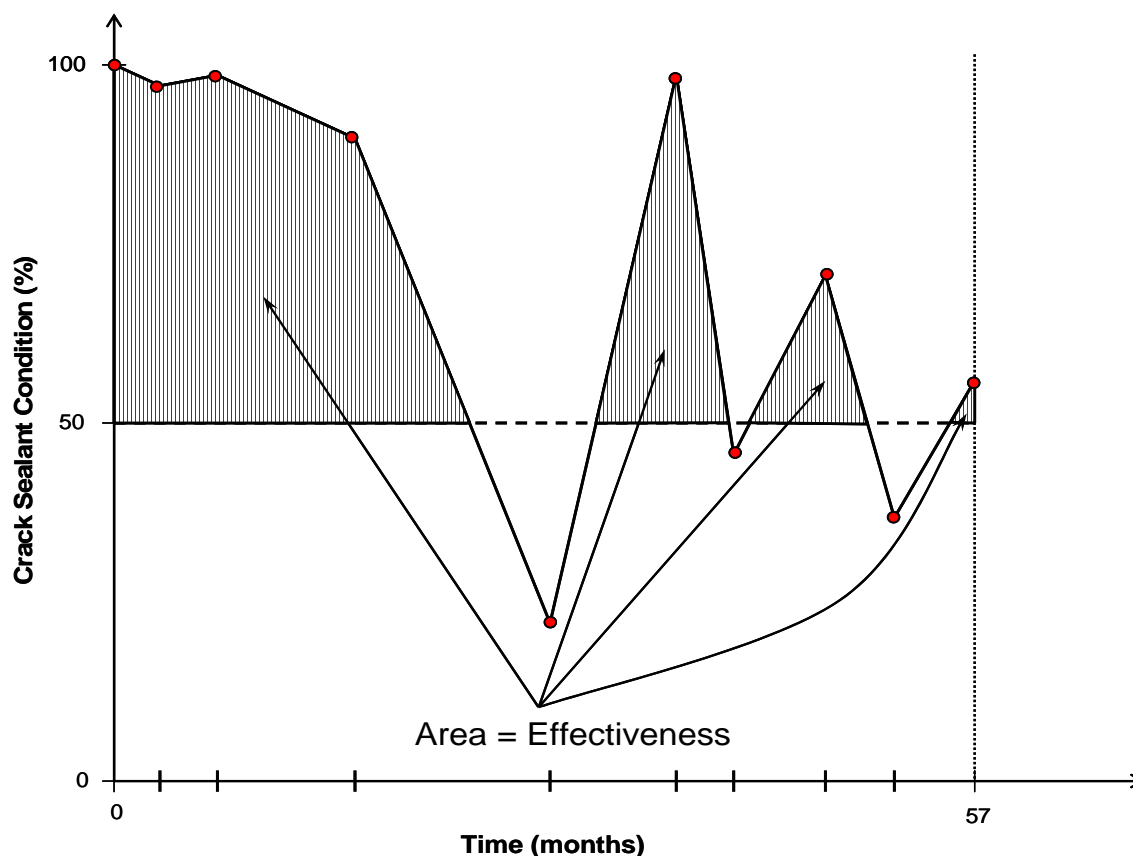
Figure 33: Example of Actual Crack Sealant Performance Curve (Method B)

Method B was created because the exponential portion of the forecasting technique used to estimate useful life of crack sealing was sensitive to fluctuations in the distress data. As such, this method used measured performance conditions collected from the Helena test site at specific time intervals. An example of the performance over time is illustrated in Figure 33. The effectiveness of crack sealing was only determined for the 57 month period during which data were collected. As in Method A, Method B defines the minimum acceptable level of service of crack sealing to be when its condition = 50 percent, i.e., when water is able to penetrate 50 percent of the sealed crack's length. Only areas formed above this line are considered in the effectiveness calculation. This method provides a more accurate estimate of the effectiveness of crack sealing material/technique combinations since it considers real performance values over time rather than an estimated performance derived from estimates of useful life.

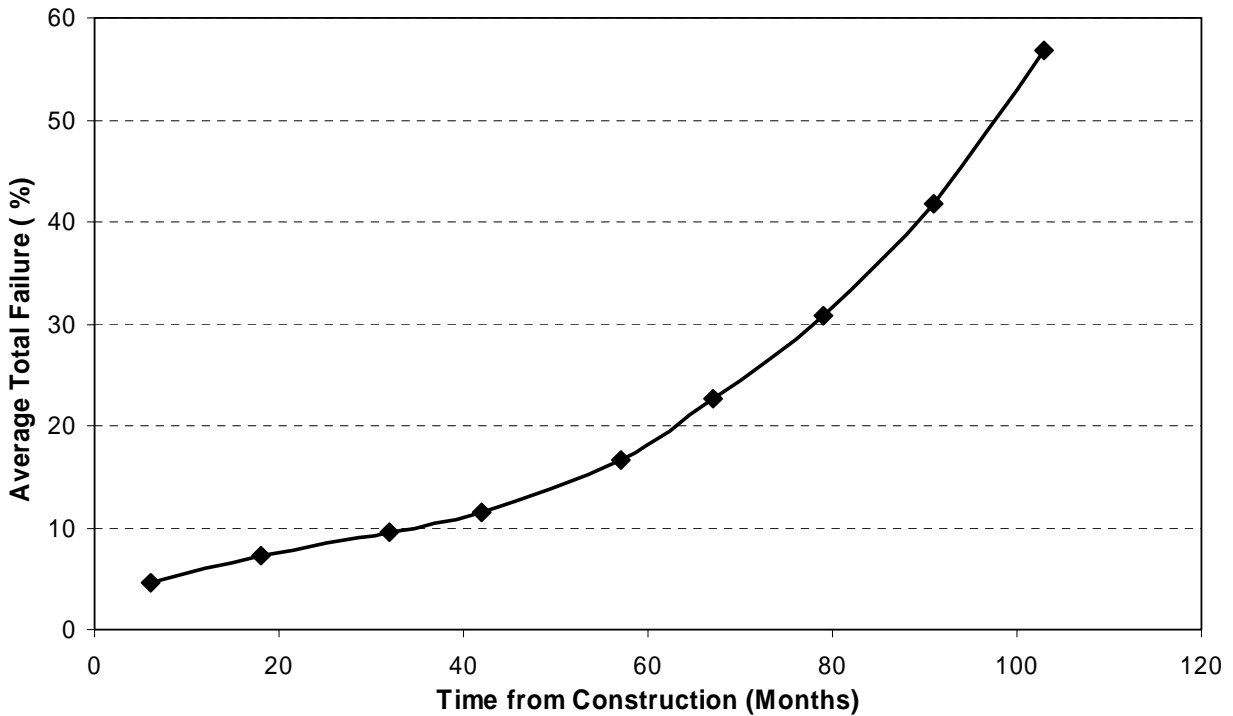
Figure 24: Eclectic Forecasting Results for Maxwell 71, SH-F
