# **Improving the Ecological Function of the Upper Bow River: Bow Lake to Kananaskis Dam**

Technical Report #4  
June 2008

By: Matt Blank and Tony Clevenger

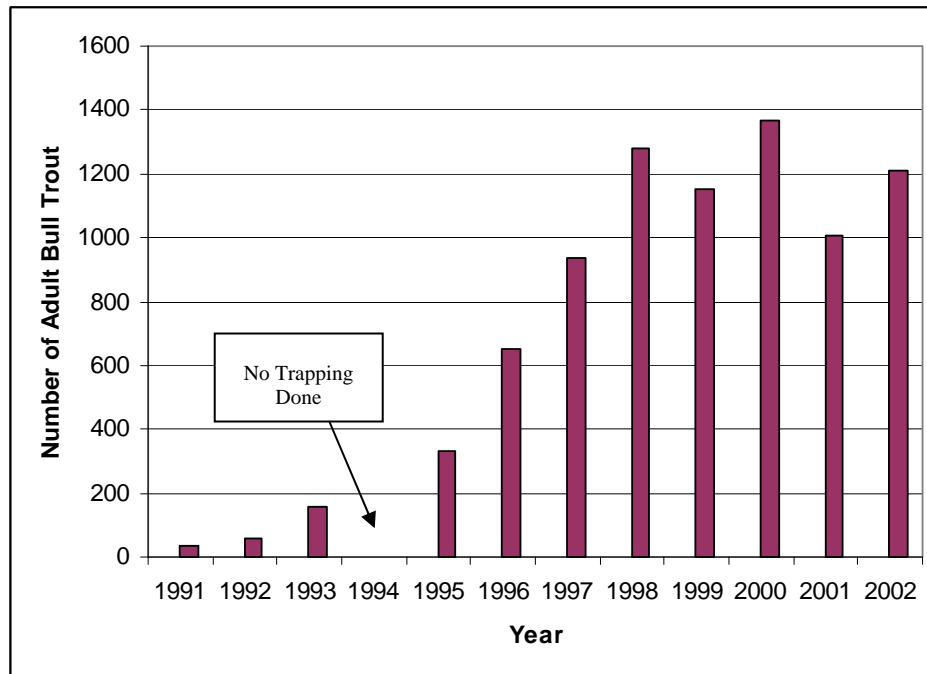
**Figure 4: Number of bull trout captured in a weir trap in Smith-Dorrien Creek.** Data from the Province of Alberta.

An example of the effect of over-harvest and the subsequent positive effects of changes to fishing regulations is shown by the population dynamics of bull trout in the Lower Kananaskis Lake. Before 1992, Alberta's sport fishing regulations allowed the harvest of bull trout over 40 cm in length. Many adults from the adfluvial population of bull trout in Lower Kananaskis Lake spawn in Smith-Dorrien creek, and in 1991, the spawning population was estimated at 60 adults. New regulations imposed in 1992 included a catch-and-release requirement, bait restrictions and the closure of angling in Smith-Dorrien Creek. Over the next several years, the number of spawning adults returning to Smith-Dorrien Creek clearly showed a dramatic increase (Mushens et al. 2001). Figure 4 shows the number of adult bull trout captured in a weir trap in Smith-Dorrien Creek before and after the regulation changes.

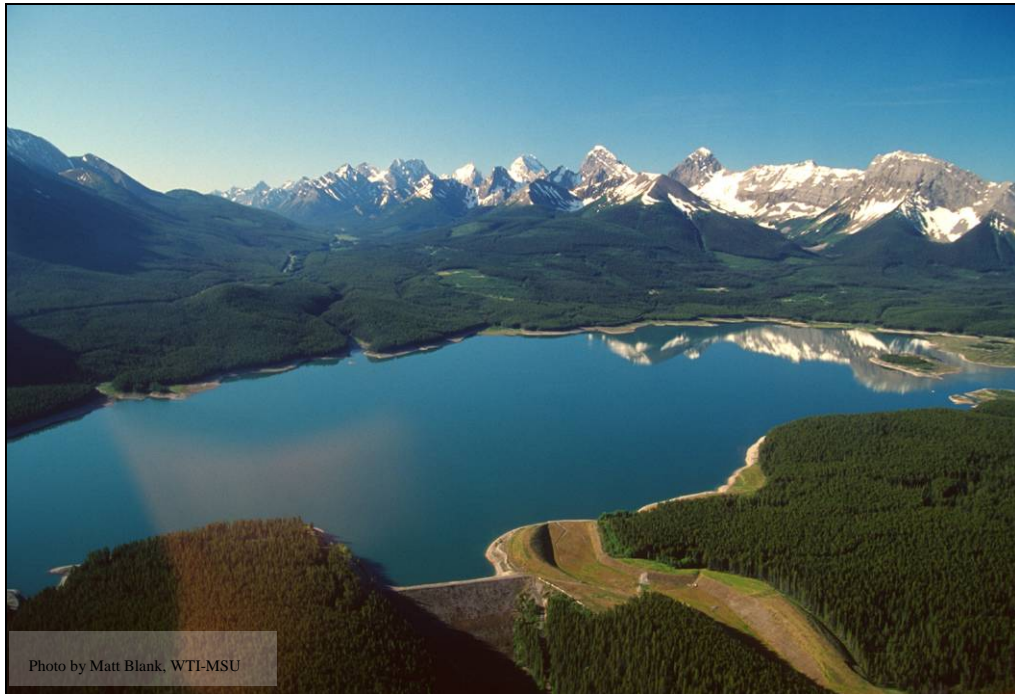
**Figure 9: Canyon Dam located on the Spray River System, a major tributary watershed to the Bow River in Reach 3. Prior to construction, the Spray River flowed through the channel outlined in the foreground. Currently, 75% of the water is directed toward Canmore.**

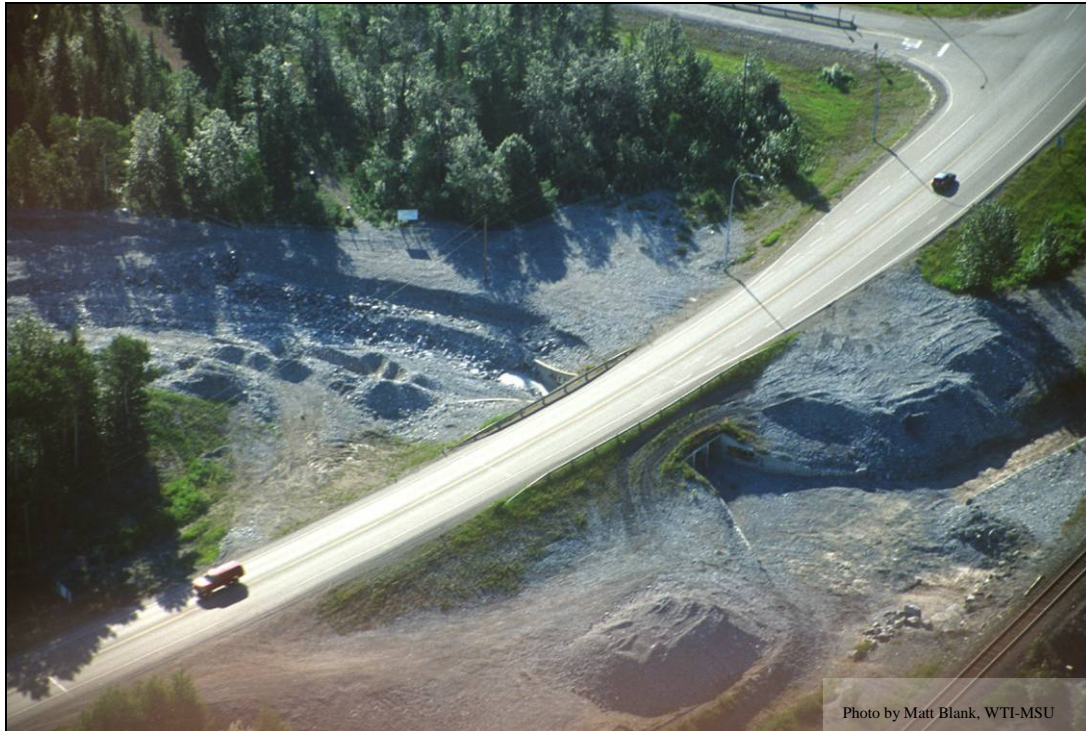
**Figure 10: An alluvial fan interruption by Highway 1A and CP Railway**

Impacts to the watershed in this Reach from transportation infrastructure include changes to natural geomorphic and hydrologic processes, reduced aquatic connectivity through barrier culverts, and changes to water quality from highway and railway runoff. A specific example that shows the effect of a road on geomorphic and hydrologic processes is Cougar Creek (Figure 10). The road crossing at Cougar Creek is too small and interrupts the natural flow of sediment, debris and water from upstream to downstream across the highway. This disruption starves the downstream aquatic habitat of necessary and important inputs from upstream.
