# DEEP PATCH REPAIR

## Phase 1: Analysis and Design

1. Report No. FHWA-WFL/TD-12-003	2. Government Accession No.	3. Recipient's Catalog No.	
4. Title and Subtitle  Deep Patch Repair, Phase I: Analysis and Design		5. Report Date March 2012

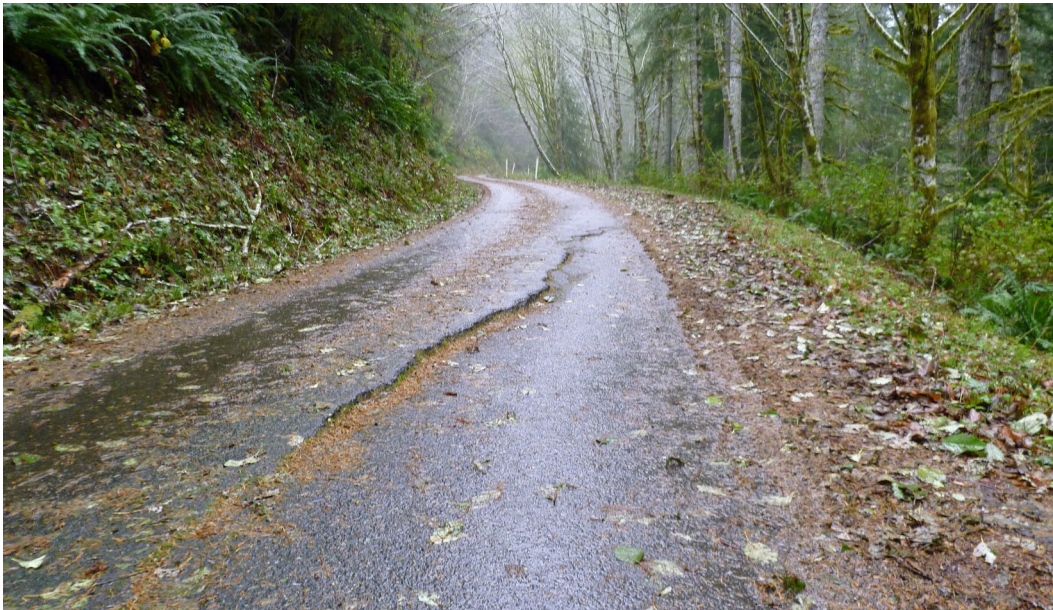
**Figure 3: Common fill slope distress on sidecast constructed road.**

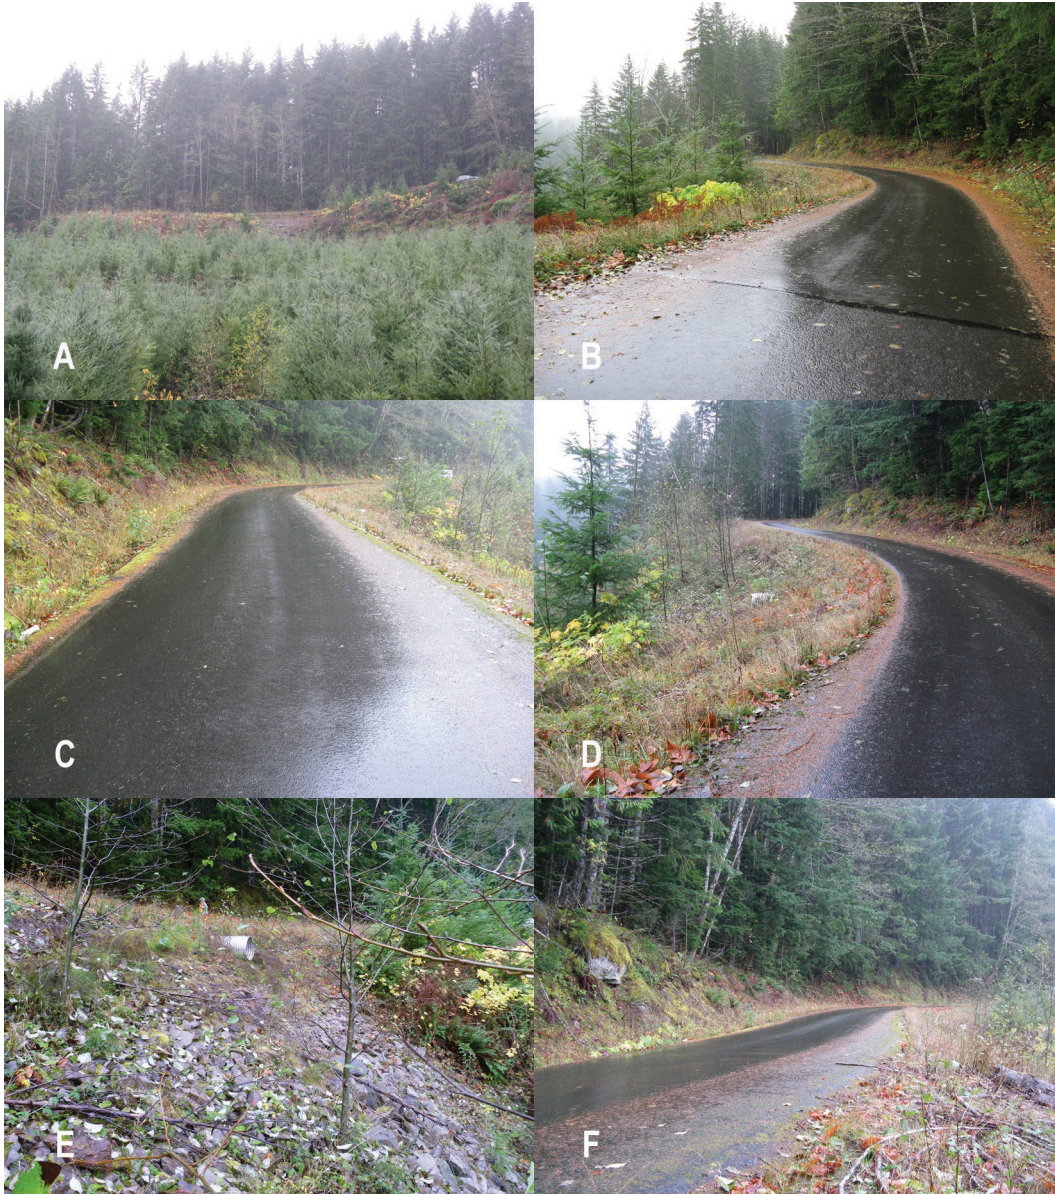
**Figure 11: Photos of Road 26, Gifford Pinchot National Forest, MP 1.1 a) distant view of site from lower road, b) layout of site from end of repair, c) road surface, d) road surface with fill slope, e) fill slope showing drainage features and protective stone facing, and f) road surface with cut slope.**

from the cut slope indicated that the soils consisted of about 20 percent fines, and classified as a clayey sand with gravel. Figure 11 shows several photos of the site when visited in November 2010.

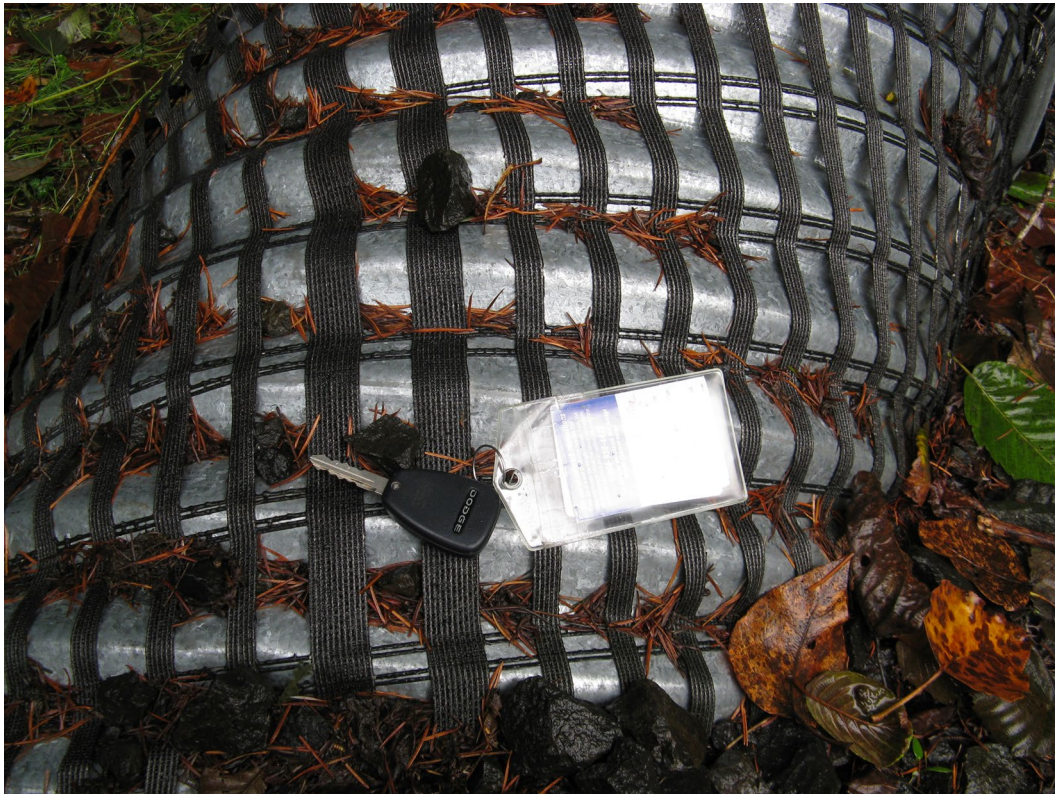
Figure 12: Photo of uniaxial geogrid used on Road 25 repairs in the Gifford Pinchot forest.

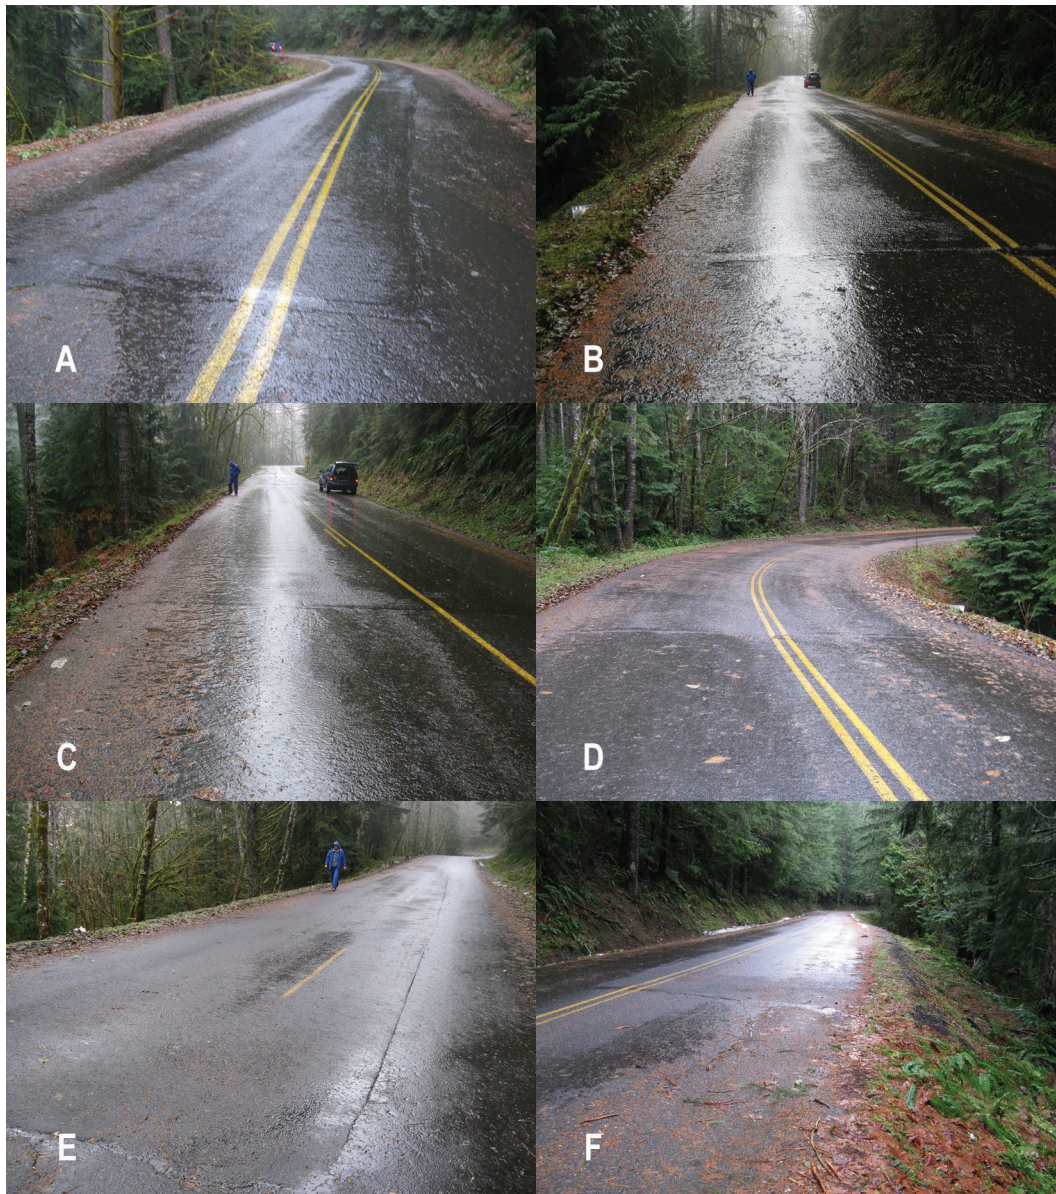
**Figure 14: Photos of Road 25, Gifford Pinchot National Forest deep patch repairs at a) MP 9.158, b) MP 9.228, c) MP 9.252, d) MP 10.032, e) MP 10.898, and f) MP 11.509.**

Deep patch repairs were constructed on Road 25 in the Gifford Pinchot forest in 2007. These repairs mainly consisted of a relatively shallow excavation in the affected area where a single layer of uniaxial woven geogrid (Figure 12) was used as reinforcement at the bottom of the subbase (schematic shown in Figure 13). Crushed aggregates were used in the subbase and base course layers and the surface was paved with hot mix asphalt. The geosynthetic extended from the termination of the excavation to the slope face. Side slopes were reconstructed at 1.5H:1V. Excavation widths (orthogonal to the direction of traffic) varied from site to site (between 23.5 and 31.5 feet at the bottom of the excavation) as tabulated in Table 1. For the most part, the widths of the asphalt patches extended past the centerline by 2 to 3 feet. One exception was the full width deep patch located at MP 10.032. The topography at that location was such that the geometry of the road resembled an embankment (all fill) rather than the traditional sidecast construction. Site visits in December 2010 by WFLHD staff showed that the sites were performing well after 3 years in service. Photos in Figure 14 provide a representative view of each of the sites.

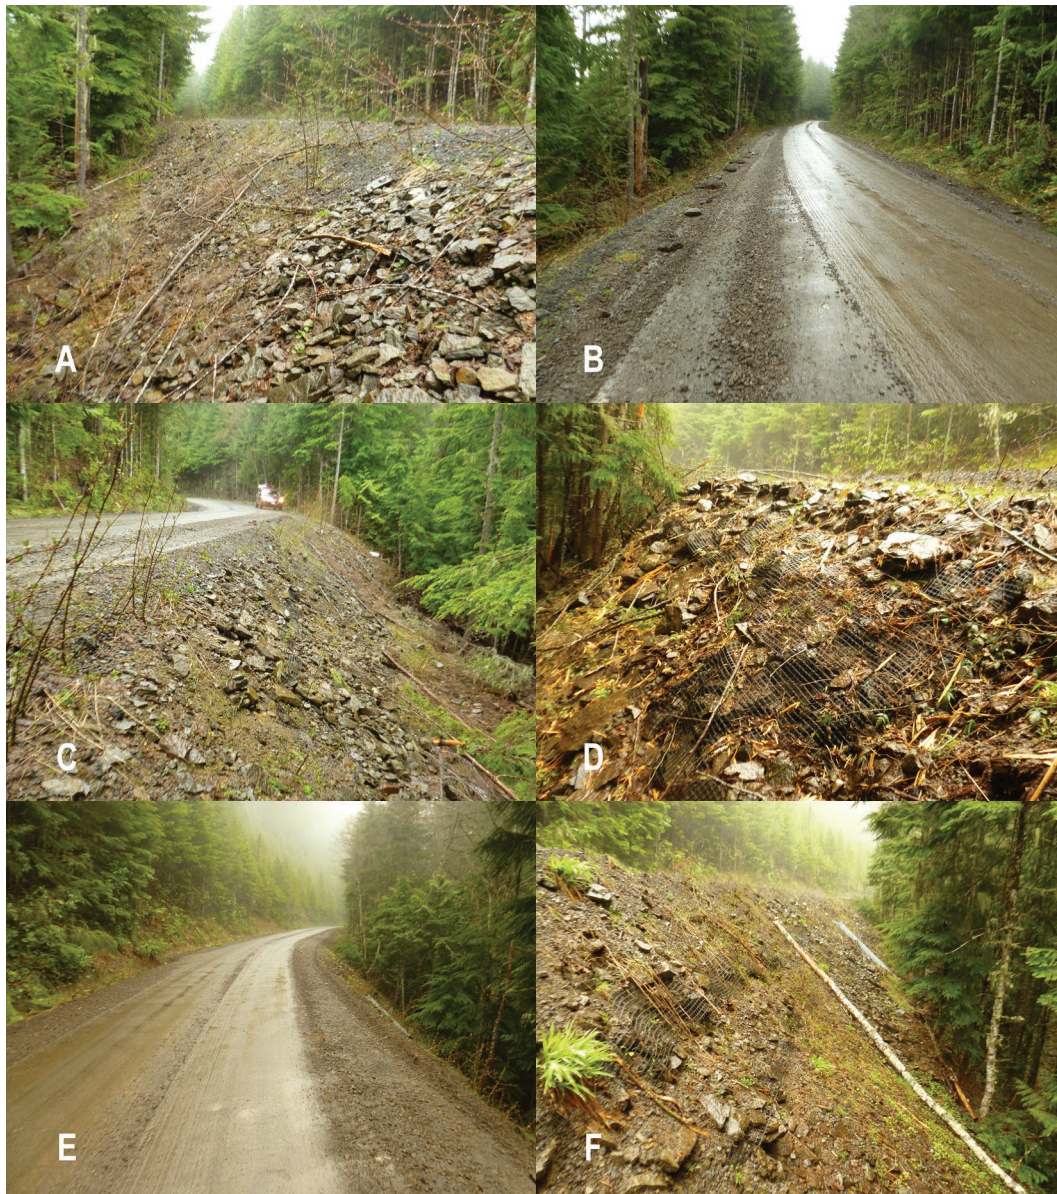
**Figure 23: Photos of Road 45, Mount Hood National Forest, deep patch repairs at MP 5.85 (a, b, c) and MP 6.76 (d, e, f).**

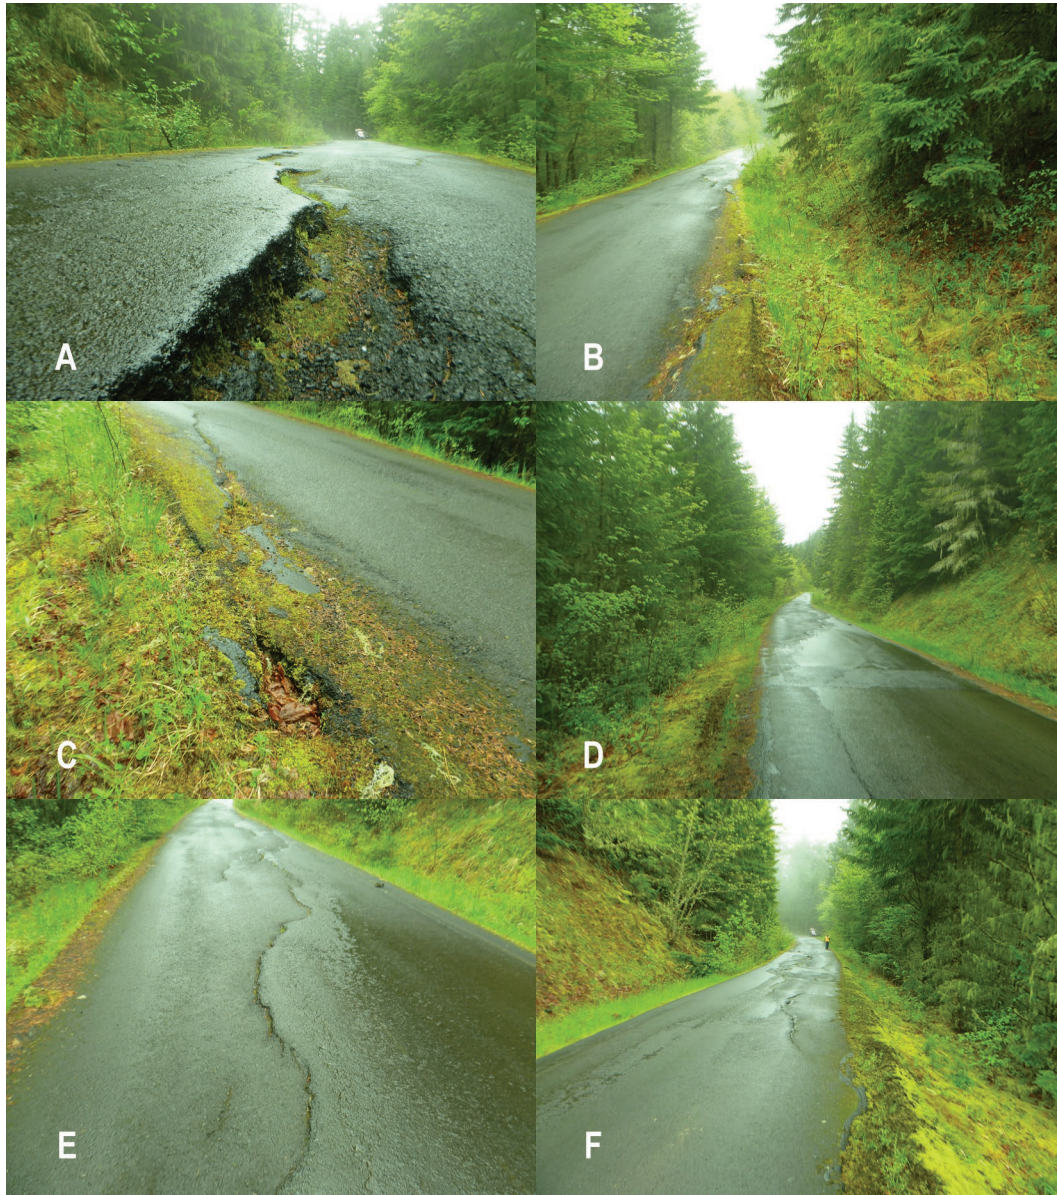
**Figure 26: Photos of distresses on Road 45, Mount Hood National Forest, MP 28.2 a) close-up of differential settlement at crack interface, b) crack extending to inside shoulder, c) close-up of crack at inside shoulder, d) general view of road surface distresses, e) surface cracking and f) general view of surface distresses.**

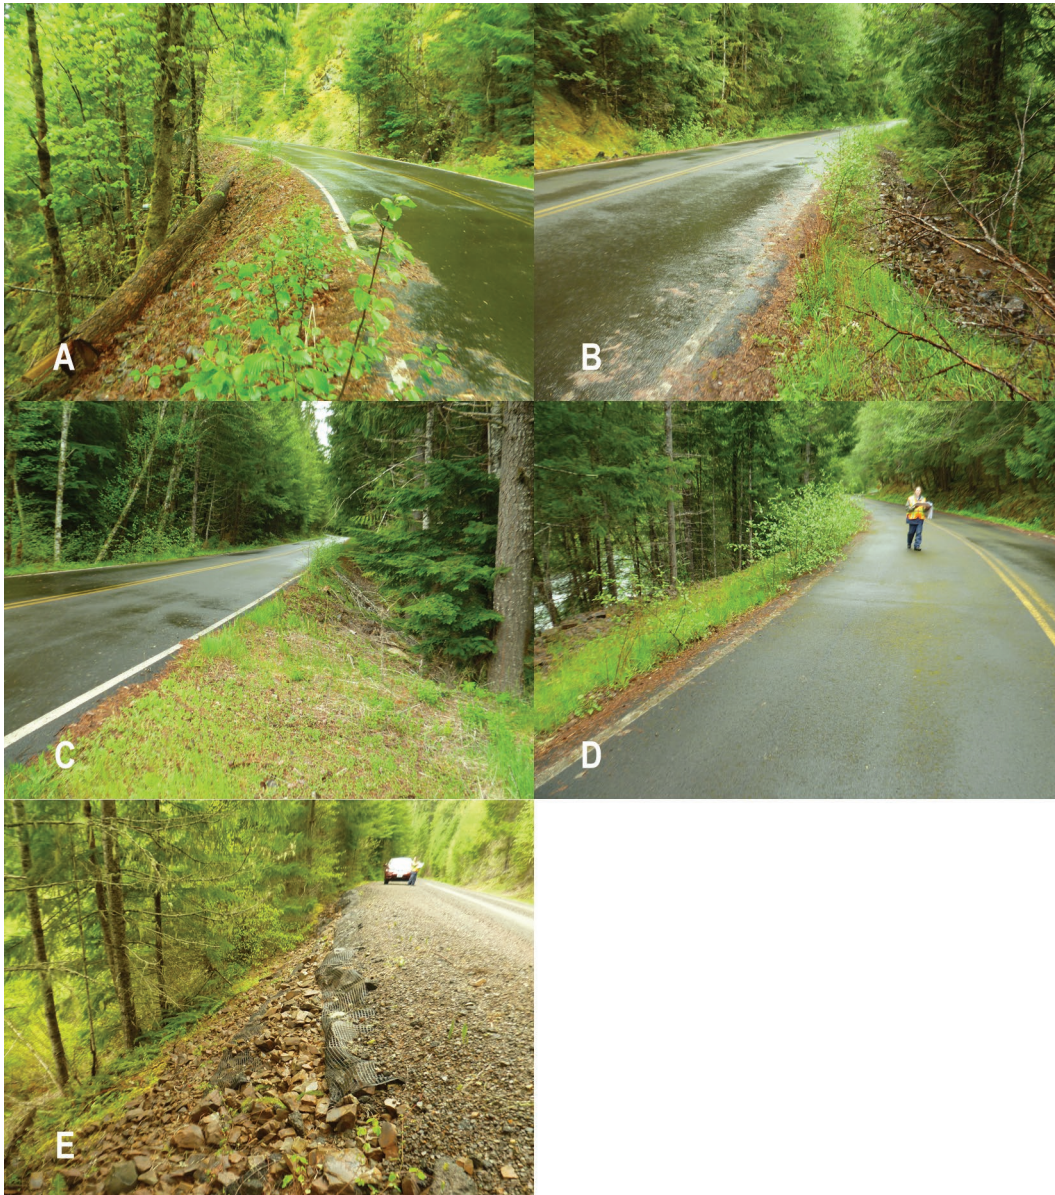
**Figure 27: Photos of deep patch repairs on Road 63, Mount Hood National Forest, at a) Sta. 20+15, b) Sta. 30+35, c) Sta. 80+68, d) Sta. 115+96, and e) Sta. 187+40.**

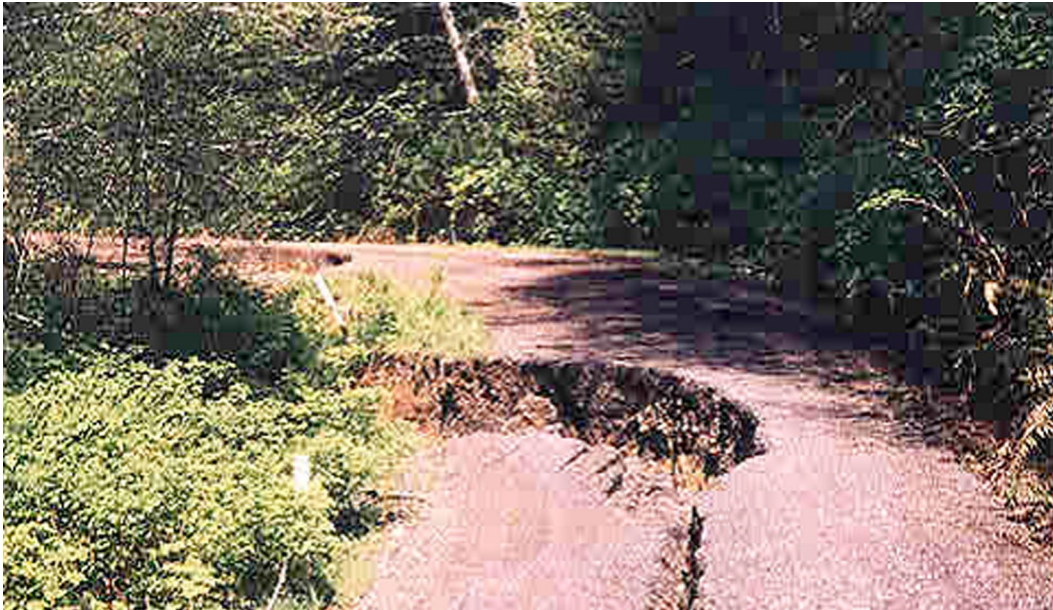
**Figure 28: Photo of slope failures on Road 58, MP 29.65, Siuslaw National Forest.**

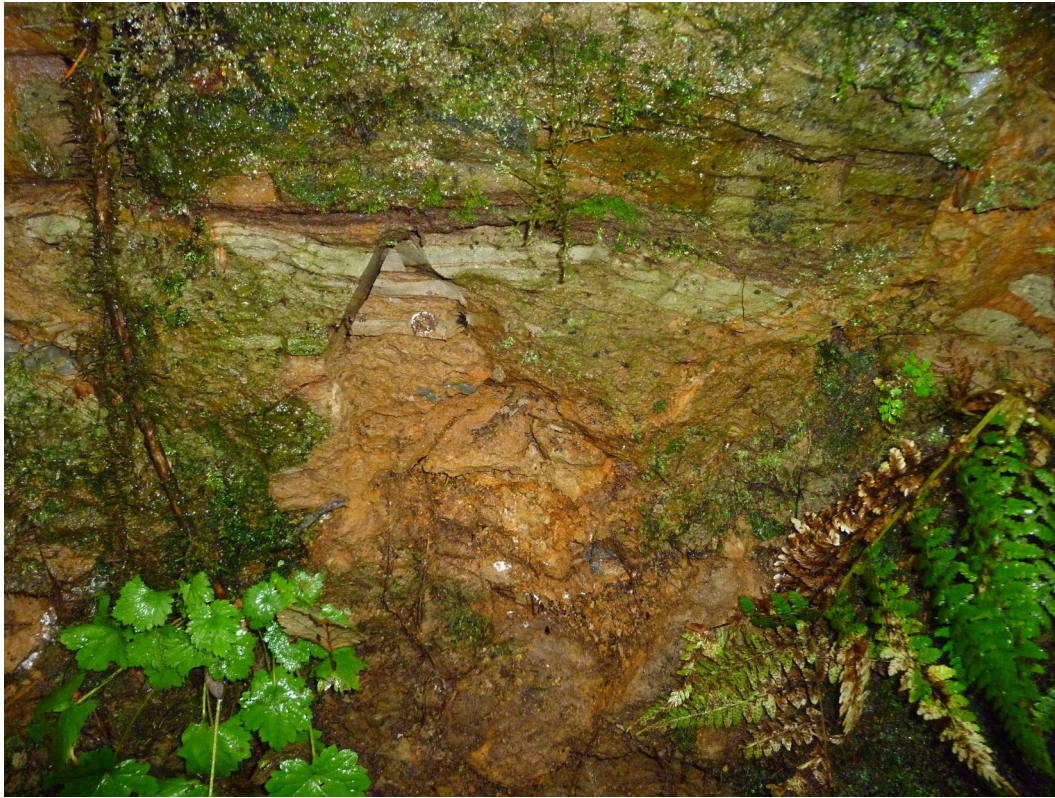
**Figure 29: Exposed soil of cut face, Road 58, MP 29.65, Siuslaw National Forest.**

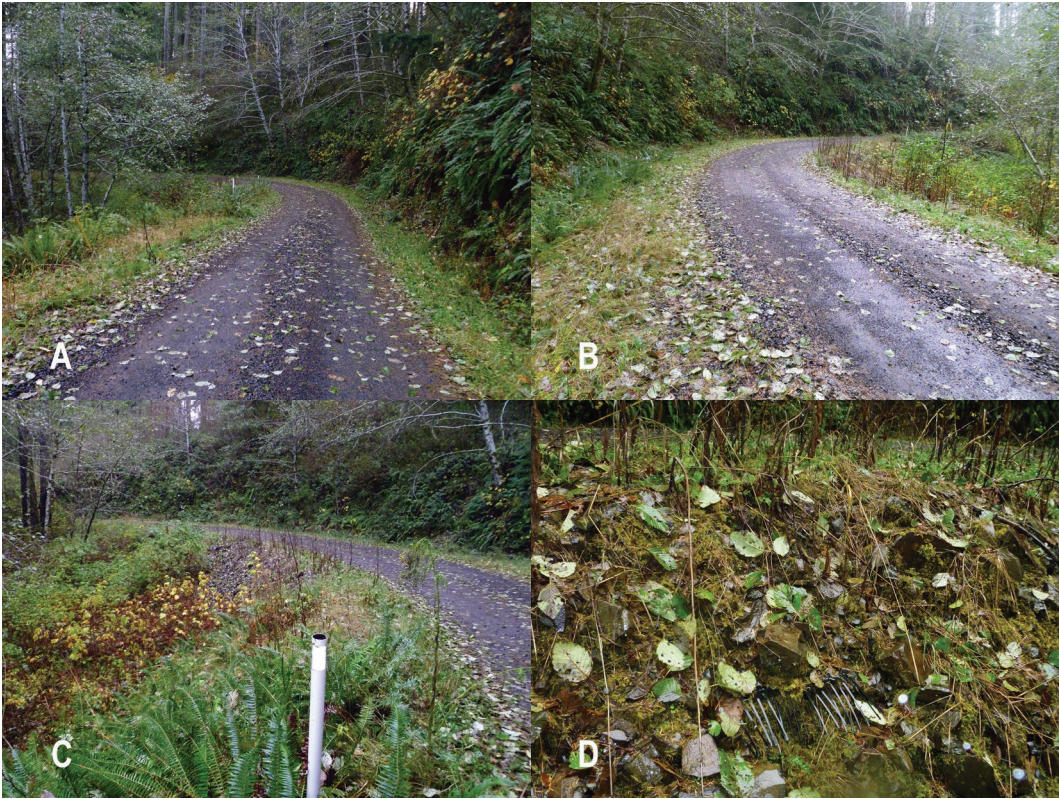
**Figure 31: Photos of deep patch repairs on Road 58, Siuslaw National Forest a) layout of site from end of repair, b) layout of site looking from other end, c) fill slope showing stone facing, and d) close-up of deep patch showing exposed geogrid.**

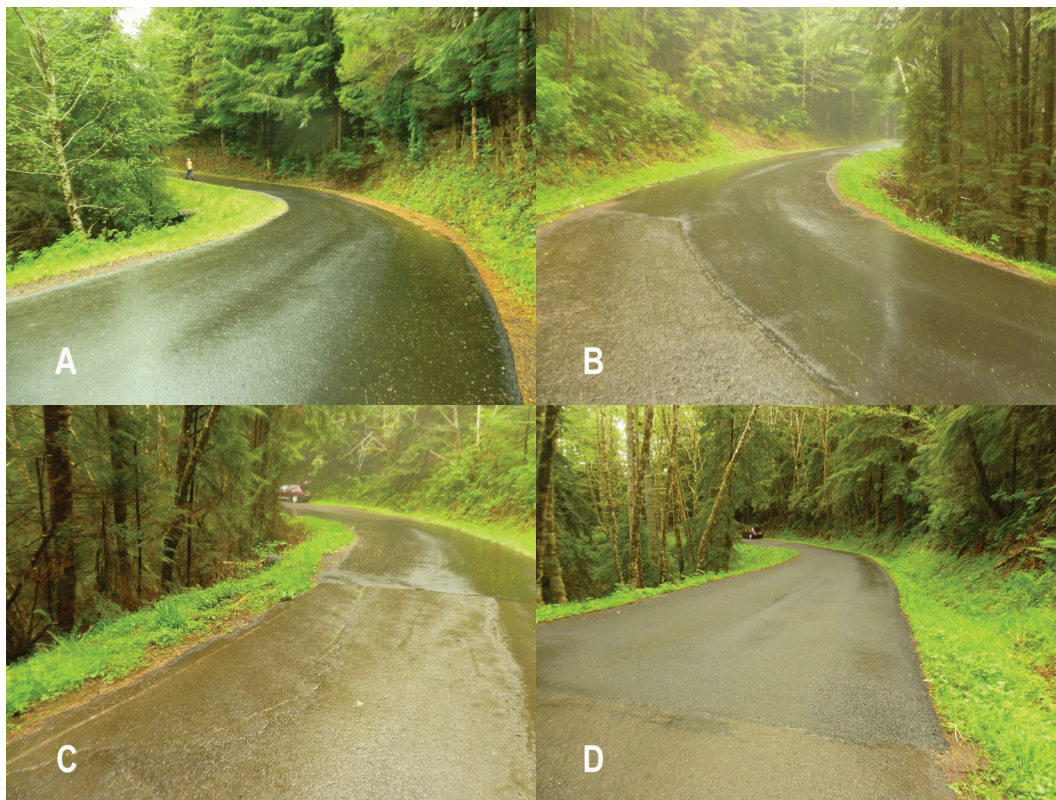
**Figure 34: Selected photos of repaired sites on Road 17, Siuslaw National Forest: a) MP 9.14, b) MP 9.39, c) adjacent distresses near repair at MP 9.39, d) MP 9.65.**

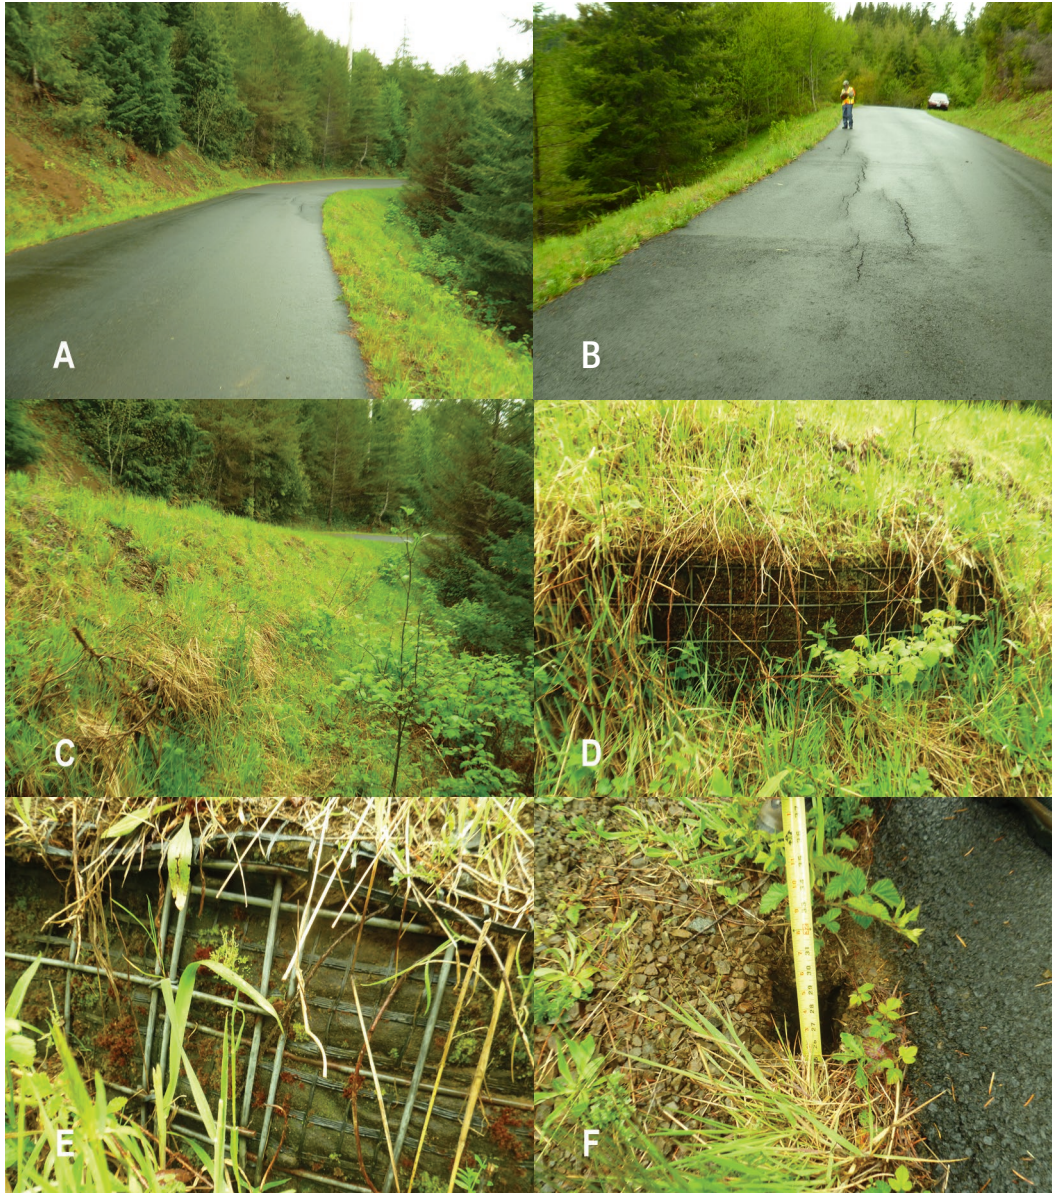
**Figure 35: Photos of deep patch repairs at milepost 7.92 on Road 17, Siuslaw National Forest showing a) layout of site from end of repair, b) layout of site looking from other end, c) fill slope showing vertical facing, d) welded wire mesh to provide vertical support of slope face, e) close-up of vertical wire mesh showing geosynthetic reinforcement and separation geotextile, and f) hole near outside edge of pavement.**

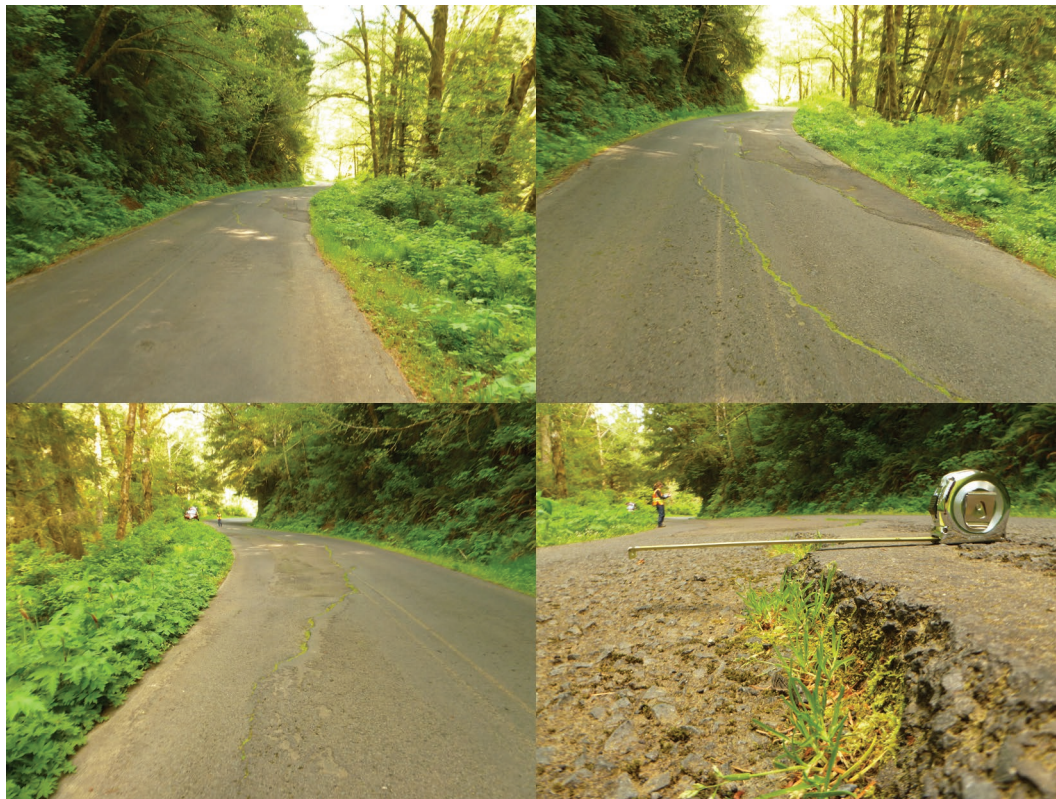
**Figure 42: Photos of distresses at milepost 2.9, Road 12, Siuslaw National Forest.**

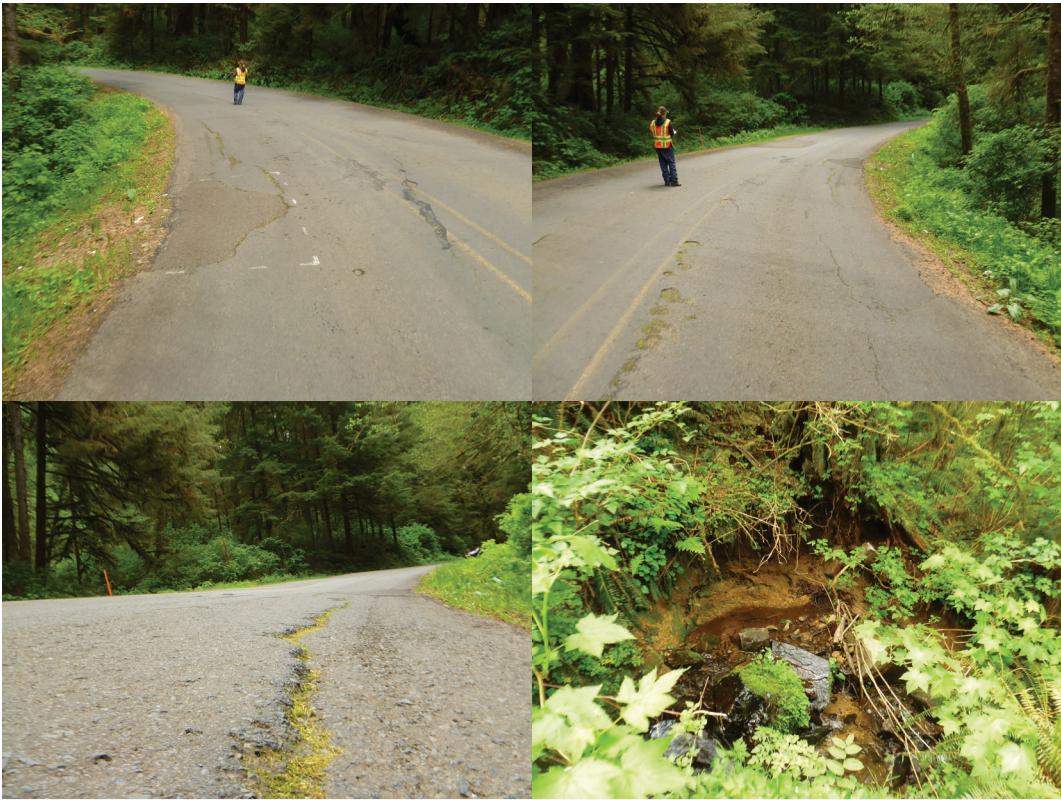
Figure 43: Photos of distresses at milepost 4.929, Road 12, Siuslaw National Forest.

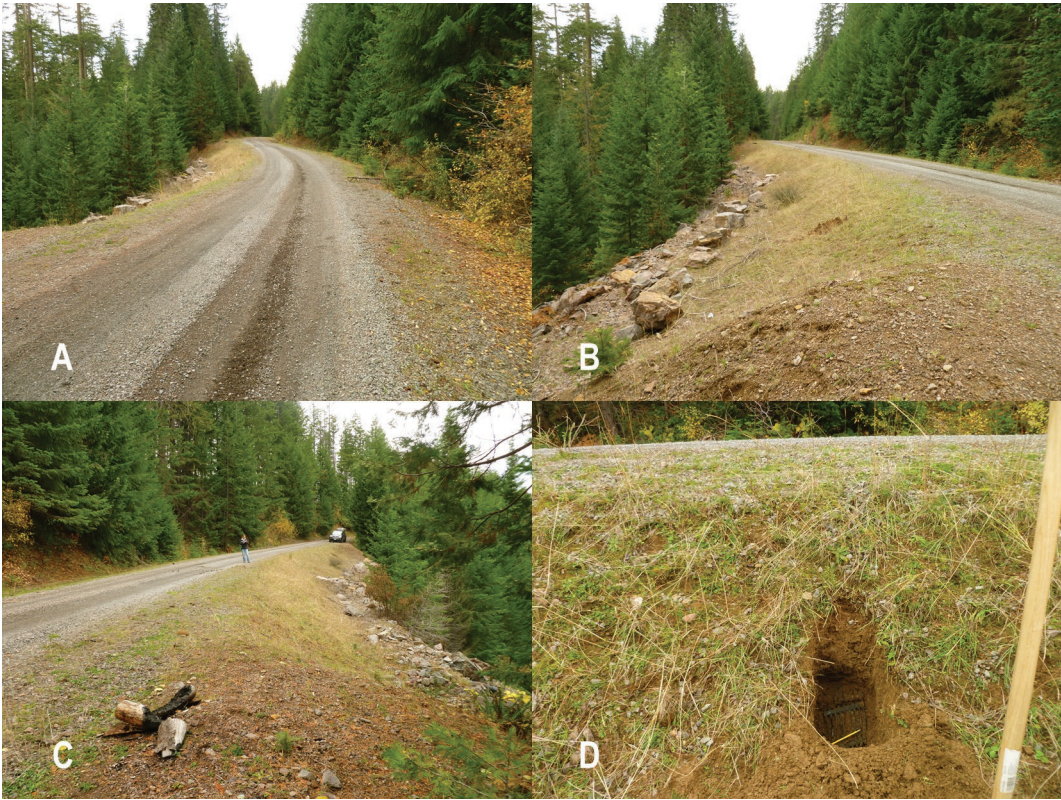
**Figure 45: Photos of deep patch repairs at Site 3 on Road 6610, Rogue River-Siskiyou National Forest showing a) layout of site and road surface, b) layout of site and embankment, c) layout of site and embankment from the other end, d) geogrid reinforcement in embankment.**

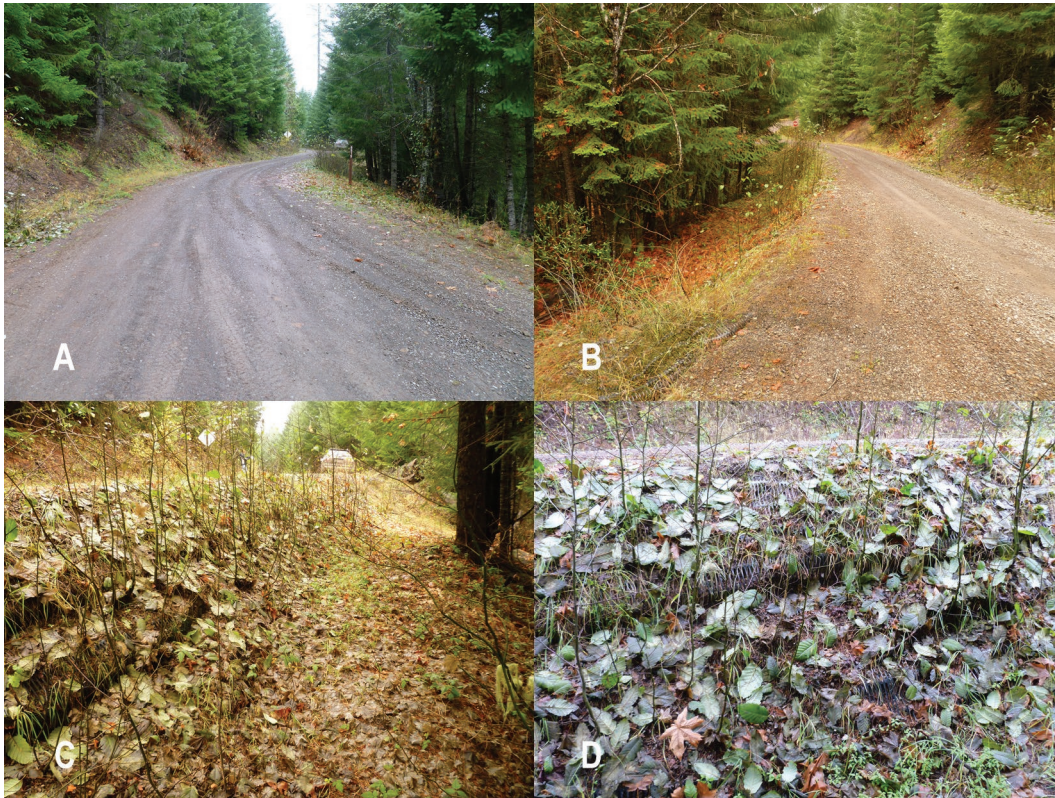
**Figure 46: Photos of deep patch repairs at Site 5 on Road 6515, Rogue River-Siskiyou National Forest showing a) general layout of site and road surface, b) layout of site from other direction (note geogrid in foreground that was unearthed by grader), c) embankment, d) exposed geogrid reinforcement in embankment.**

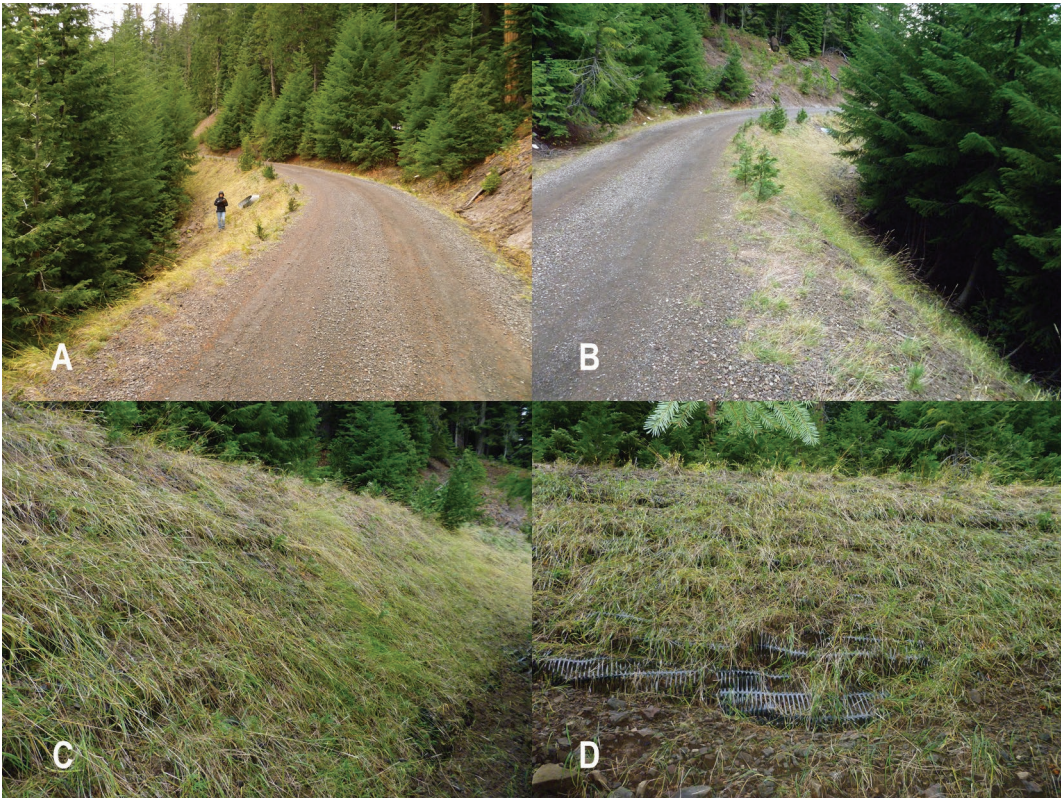
**Figure 47: Photos of deep patch repairs at Site 12 on Road 6520, Rogue River-Siskiyou National Forest showing a) general layout of site and road surface, b) layout of site from other direction, c) embankment, d) exposed geogrid reinforcement in embankment.**
