Technical Guidance: Mojave Desert Tortoise Conservation and Recovery Measures Along Roads

Mojave Desert Tortoise Transportation Ecology Task Force

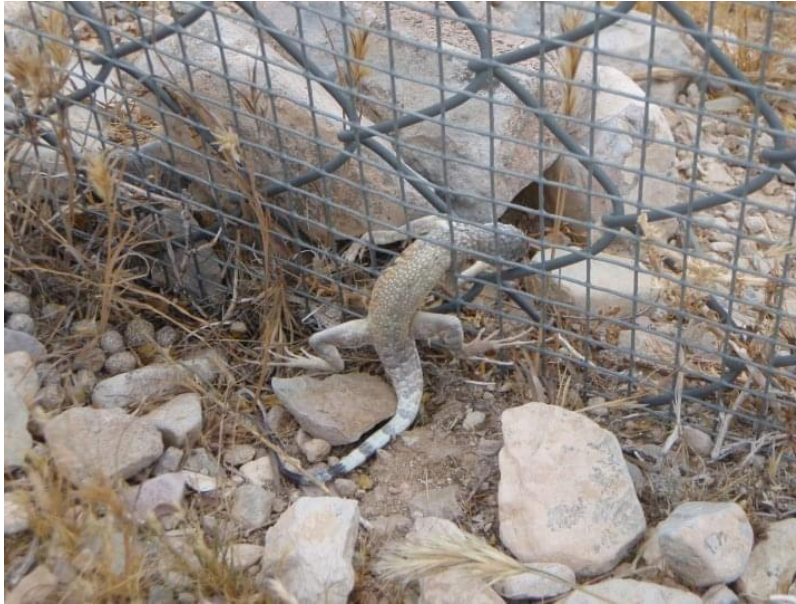
A lizard that got stuck in a fence designed for Mojave desert tortoises, and later died. The mesh size of this fence (e.g. 1 x 1 cm (0.25 x 0.25 inch) is smaller than the recommended mesh size (1 inch horizontal, 2 inches vertical). Copyright Kristi Holcomb, Nevada Department of Transportation.

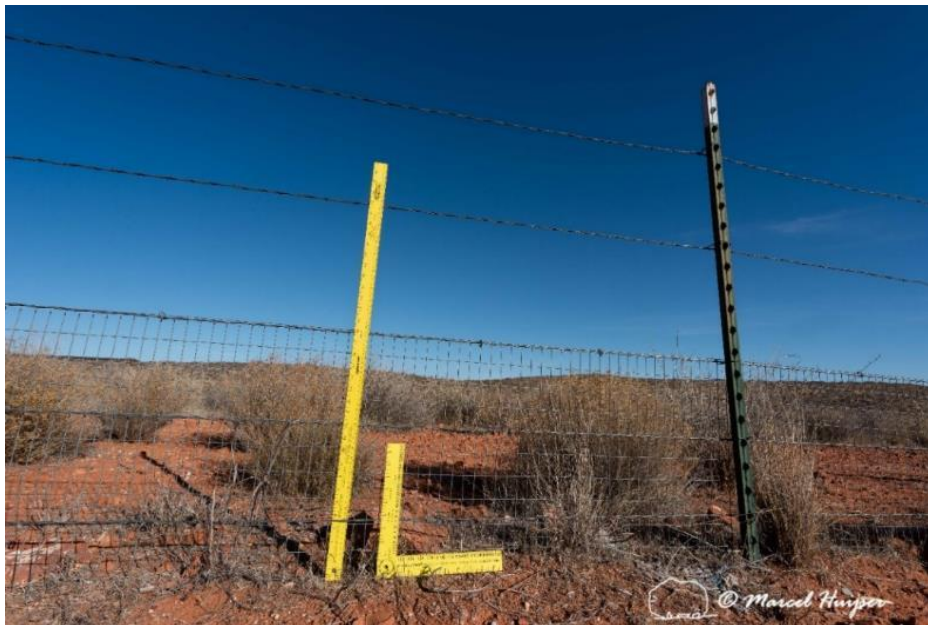
Mojave desert tortoise fencing, St. George, Utah. This fence has a mesh size that is 1 inch wide and 2 inches tall, the fence material is 20 inches above the ground, and it is attached with hog rings to three smooth strands of wire (at 4, 12, and 20 inches above the ground). There are two additional smooth wires above the fence material. Presumably, the fencing material is dug into the ground, about 16 inches deep.

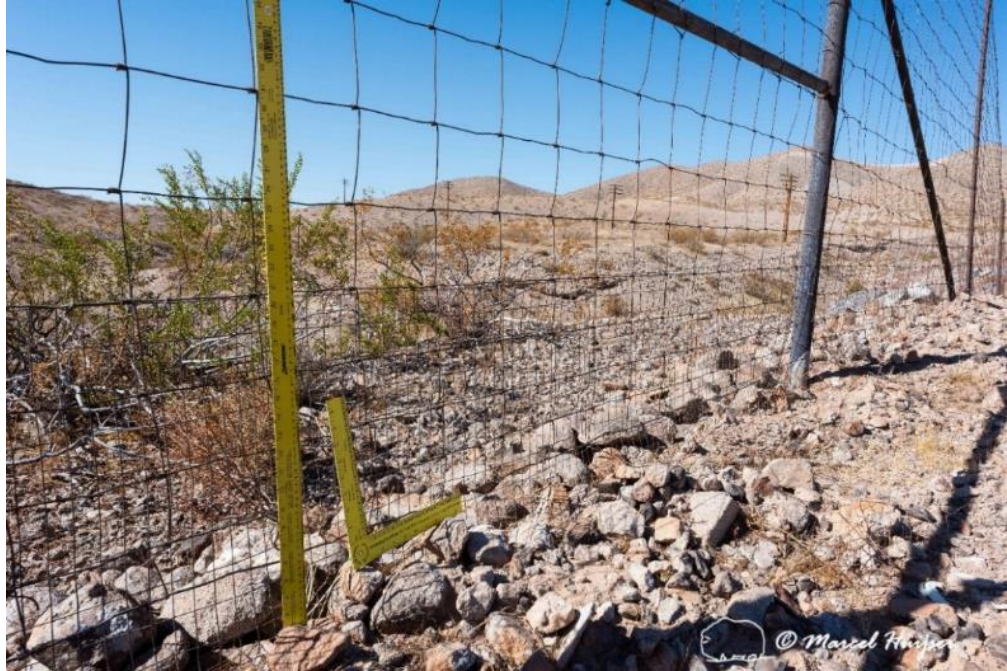
Wildlife fence (8 ft tall (2.4 m)), primarily for desert bighorn sheep (*Ovis canadensis nelsoni*), I-11, near Boulder City, Nevada. Mojave desert tortoises and bighorn sheep are known to co-occur in this area. Therefore, tortoise exclusion fencing was installed at the bottom of the bighorn sheep fencing.

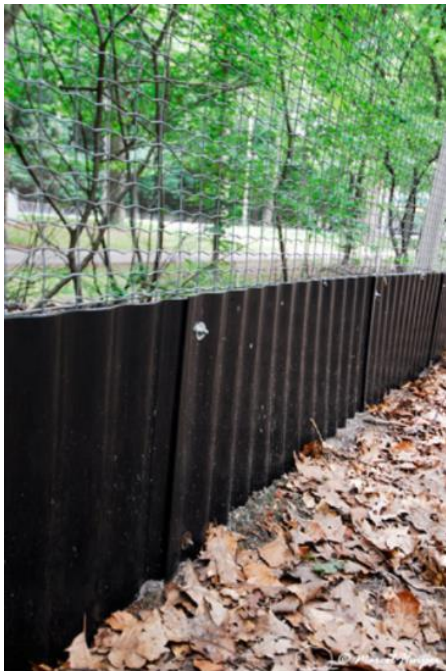
Plastic sheeting for amphibians attached to a Eurasian badger (*Meles meles*) fence, The Netherlands. Depending on the height, the sheeting may be suitable for Mojave desert tortoises. However, in arid ecosystems, erosion and sedimentation processes may be a substantial problem for this design as it is not permeable to water and fine sediments and solid barriers may also be more easily damaged by high winds.

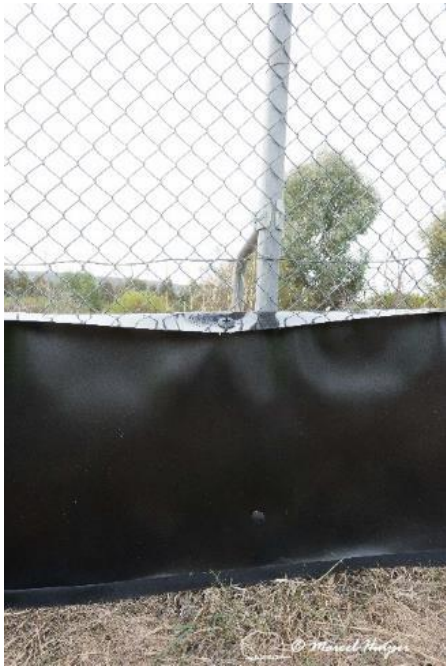
Solid plastic fencing for small animal species attached to a chain-link fence designed for larger wildlife species, M79 motorway, south of Harcourt, Victoria, Australia. However, in arid ecosystems, erosion and sedimentation processes may be a substantial problem for this design as it is not permeable to water and fine sediments and solid barriers may also be more easily damaged by high winds.

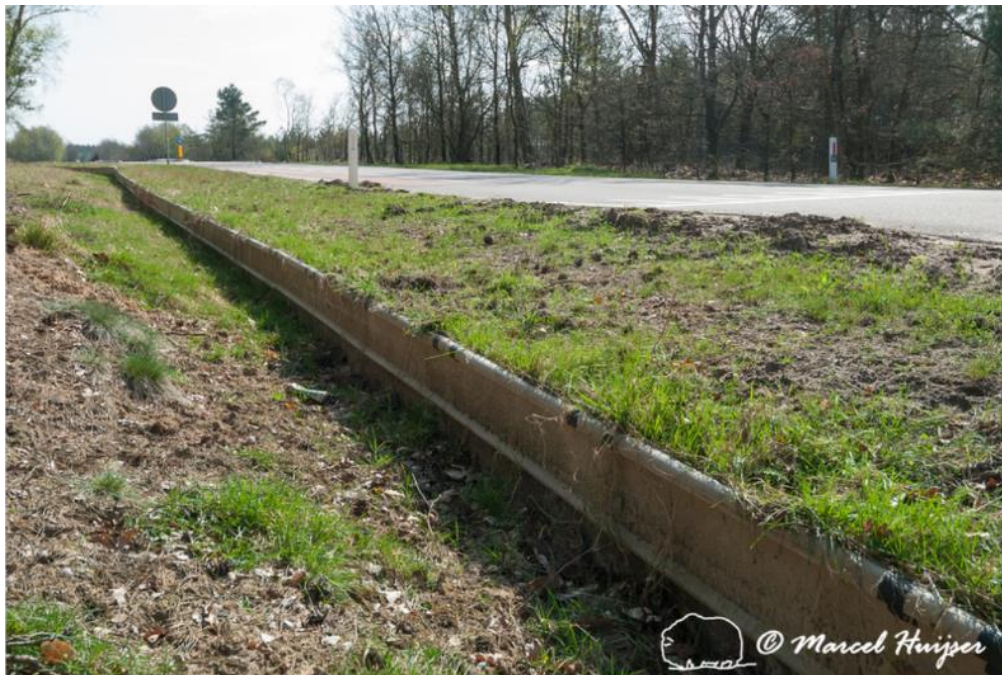
Polymer wall for amphibians integrated into the roadbed, The Netherlands. This type of barrier does not affect landscape aesthetics as experienced from the road. The design also allows for tortoises to exit the road anywhere by tumbling down the barrier. The height may have to be adjusted to prevent large adult desert tortoises from climbing over the barrier while not posing any threat of injury to tortoises that may fall over the barrier.

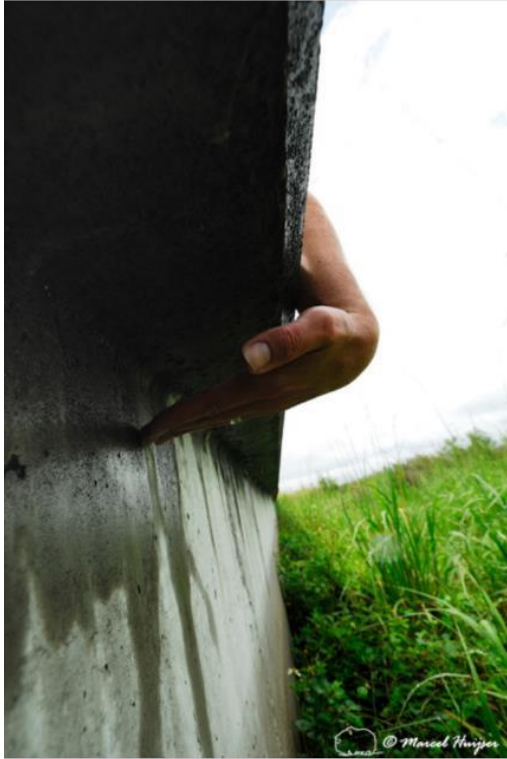
Concrete barrier wall integrated into the roadbed, with overhang, designed and implemented to keep reptiles, amphibians and small mammals off a highway, U.S. 441, Paynes Prairie Ecopassage, south of Gainesville, Florida, USA. Depending on design and construction, this type of barrier might not affect landscape aesthetics as experienced from the road.

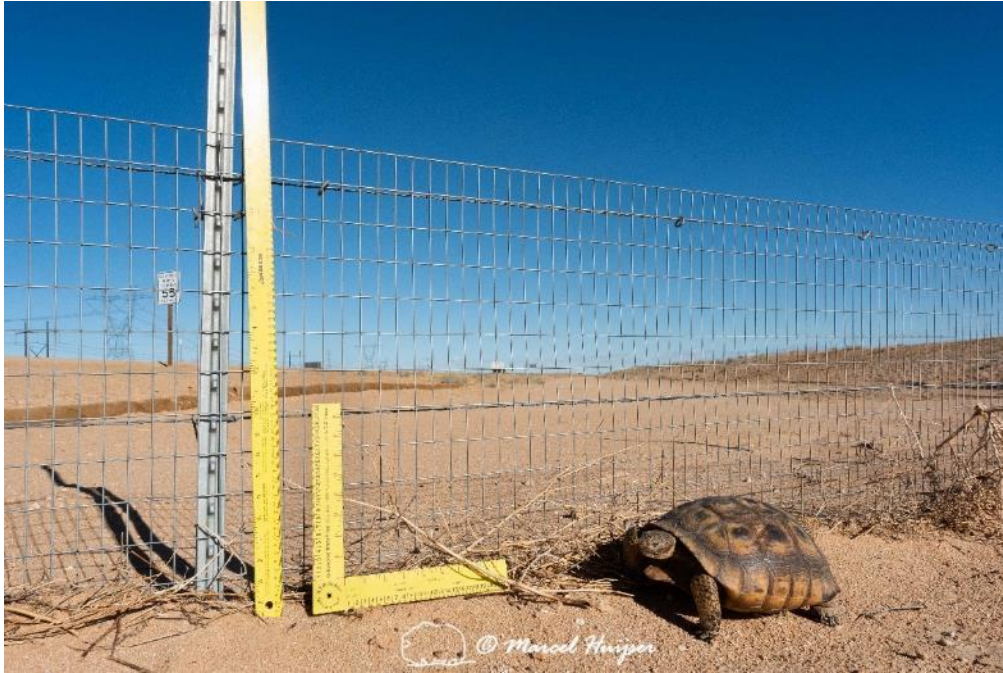
Mojave desert tortoise fence (height above ground 24 inches, presumably buried 12 inches below ground level, mesh size 1 inch wide, 2 inches tall), Hwy 58 near Kramer Junction, California. The fence material is attached to smooth wires at 10 and 22 inches above the ground.

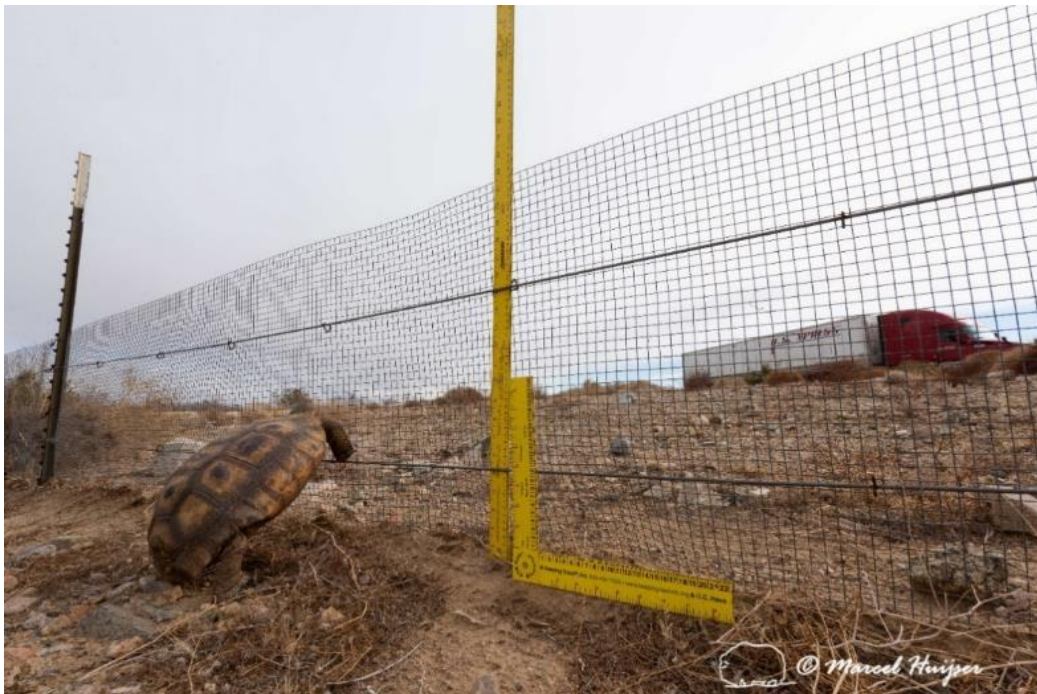
Mojave desert tortoise fence (about 21.5 inches tall, mesh size about 1x1 cm), I-15 near Barstow, California. The small mesh size may pose a greater risk to small animal species (lizards, snakes) getting stuck and dying. Small mesh sizes are

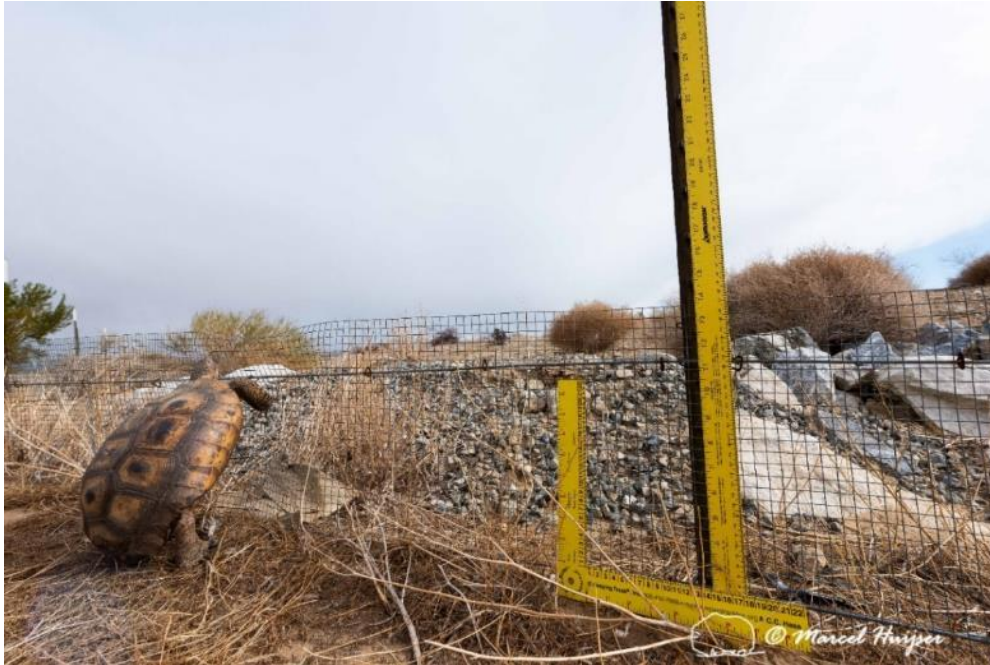
Mojave desert tortoise fence (about 14 inches tall, mesh size about 1x1 cm), I-15 near Barstow, California. The small mesh size may pose a greater risk to small animal species (lizards, snakes) getting stuck and dying. Small mesh sizes are also more likely to catch sediment. Note that this fence is too low and there is no smooth wire at the very top of the fence, making the fence less rigid.

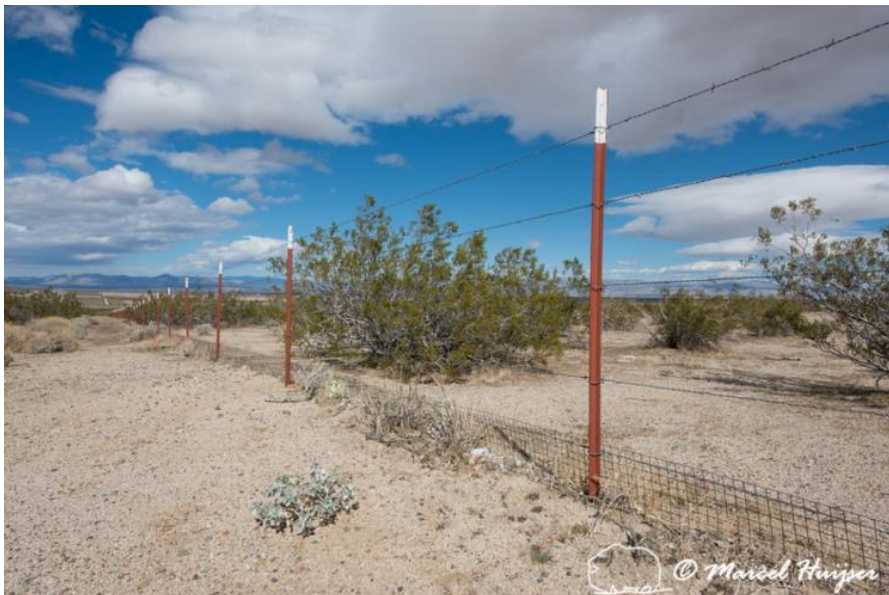
Mojave desert tortoise exclusion fence, USA Aerospace Highway (Hwy 14), near Inyokern, California. The small mesh size may pose a greater risk to small animal species (lizards, snakes) getting stuck and dying. Small mesh sizes are also more likely to catch sediment. Note that this fence is far too low (perhaps only a few inches) to be a functional barrier for Mojave desert tortoises.

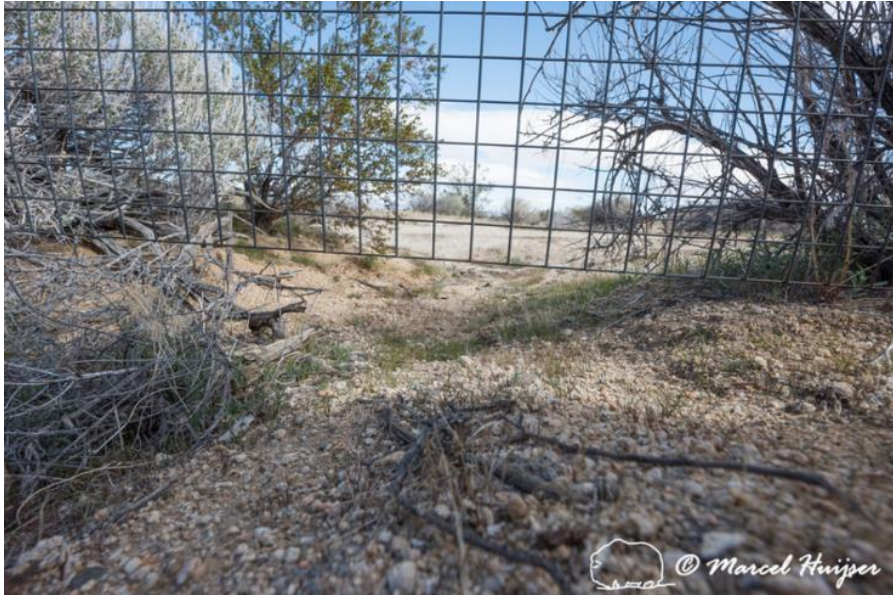
Gap under Mojave desert tortoise exclusion fence, USA Aerospace Highway (Hwy 14), near Inyokern, California. The small mesh size may pose a greater risk to small animal species (lizards, snakes) getting stuck and dying. Small mesh sizes are also more likely to catch sediment. Note that this fence is not buried at all. Mojave desert tortoise fencing should be buried at least 12 inches deep.

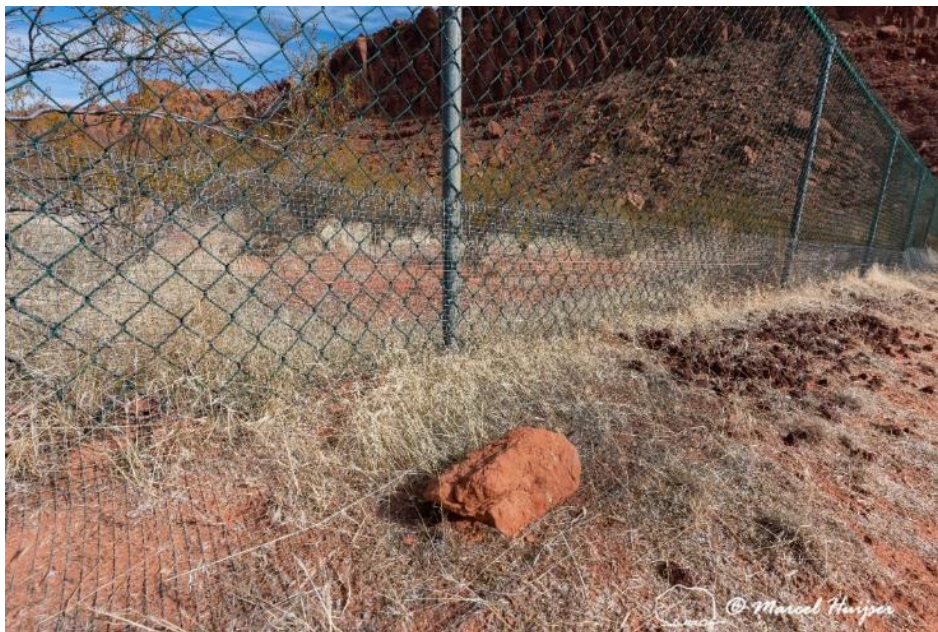
Mojave desert tortoise exclusion fence, St. George, Utah. Normally, the fence should be buried, but here it is above ground, held down by rocks. Note: the section of the fence that lies on the soil should face the safe side (habitat side) of the fence (not the roadside). Also note that the section of the fence that lies on the ground should be buried up with to 4 inches of rocks and soil on top, leaving a barrier height of 22-24 inches above the ground level.

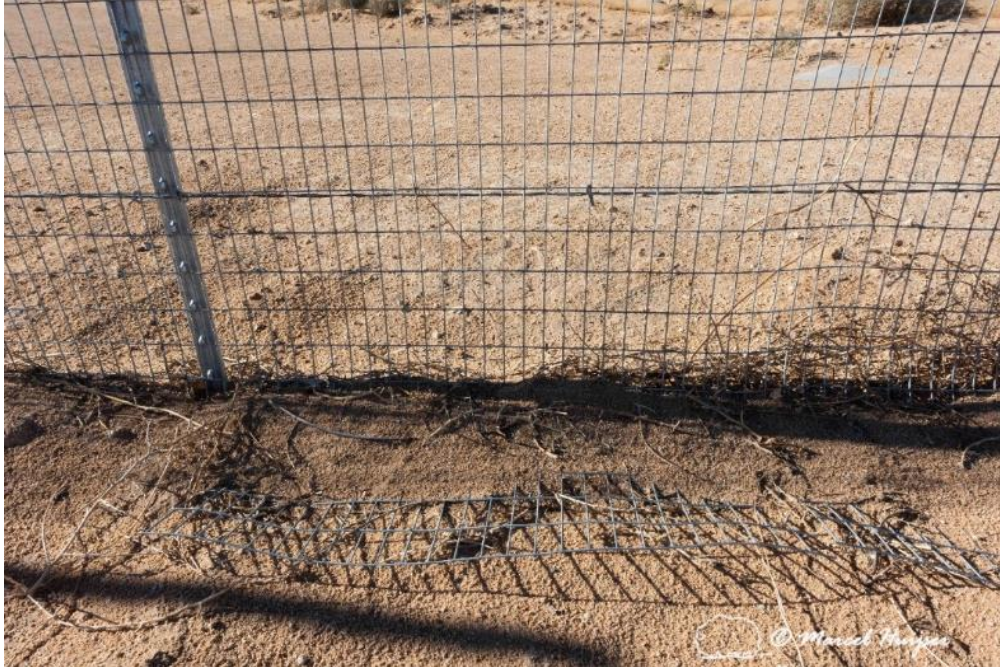
Mojave desert tortoise exclusion fence, Hwy 58 near Kramer Junction, California. Here the fence is angled towards the safe side of the fence (not the roadside), presumably because of rocky soil. Also note that the section of the fence that lies on the ground should be buried up with to 4 inches of rocks and soil on top, leaving a barrier height of 22-24 inches above the ground level.

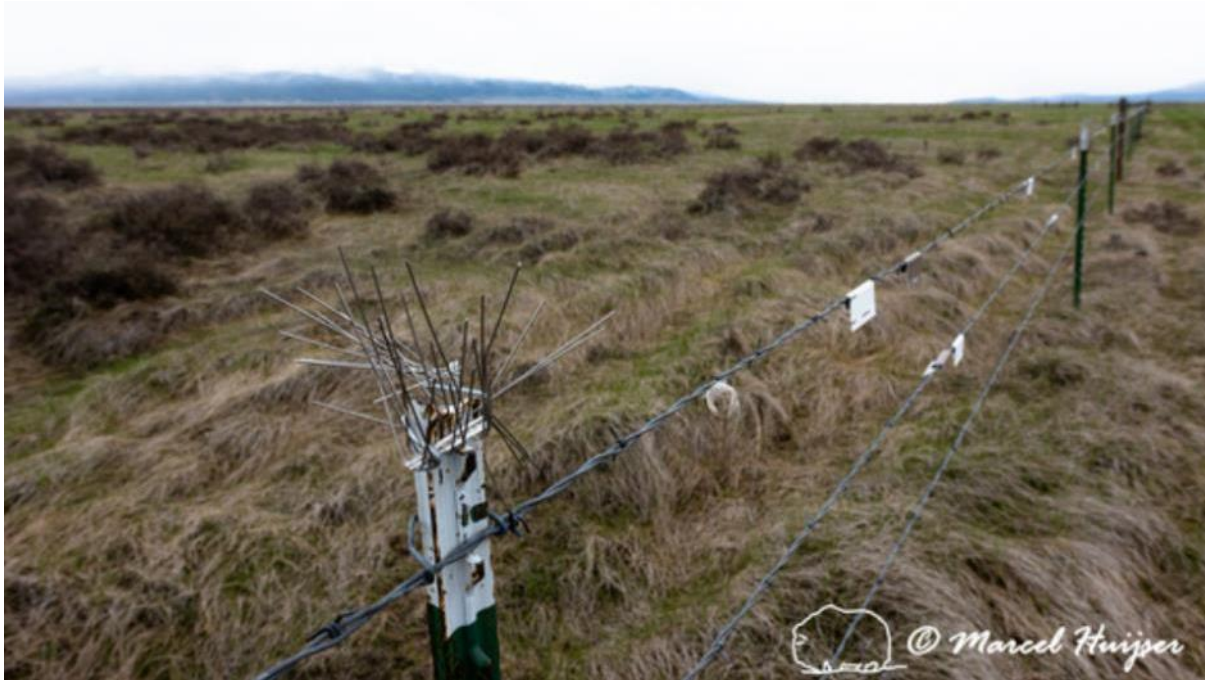
Fence markers and bird spikes on t-posts, Montana. The markers are designed to reduce the likelihood that sage grouse (*Centrocercus urophasianus*) fly into the livestock fence. The bird spikes are designed to reduce the likelihood that corvids or raptors will use the fence posts to perch and prey on sage grouse, especially the chicks. Installation of bird spikes on fence posts attached to fences in desert tortoise habitat may help reduce predation on tortoises by birds within adjacent habitat.

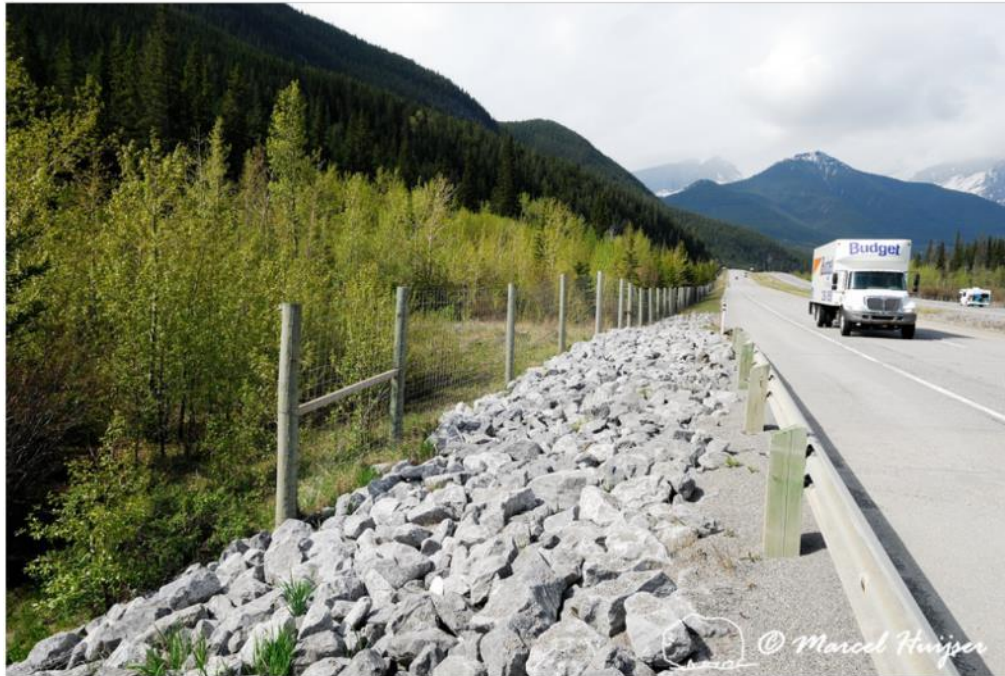
Boulder field at a fence-end, shielded through a guard rail, Alberta, Canada.

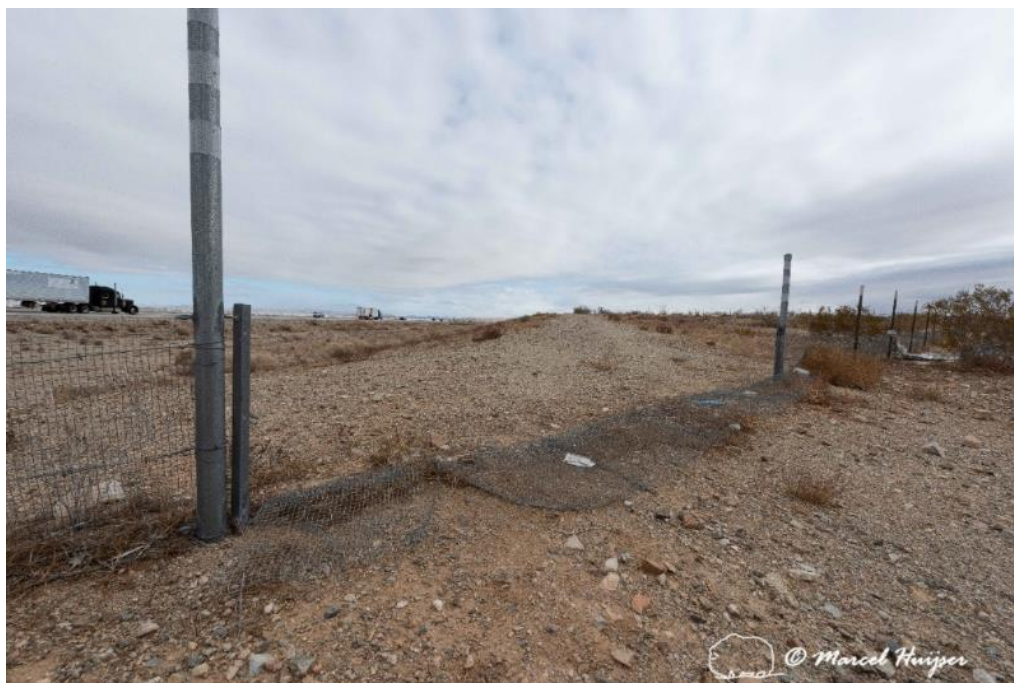
Flattened and destroyed gate at a vehicle access point associated with a Mojave desert tortoise fence, I-15 near Barstow, California. Here the fence has, or had, a gate for a dirt road, but the fence was flattened by vehicles. This suggests that gates that require people to get out of the vehicles to open

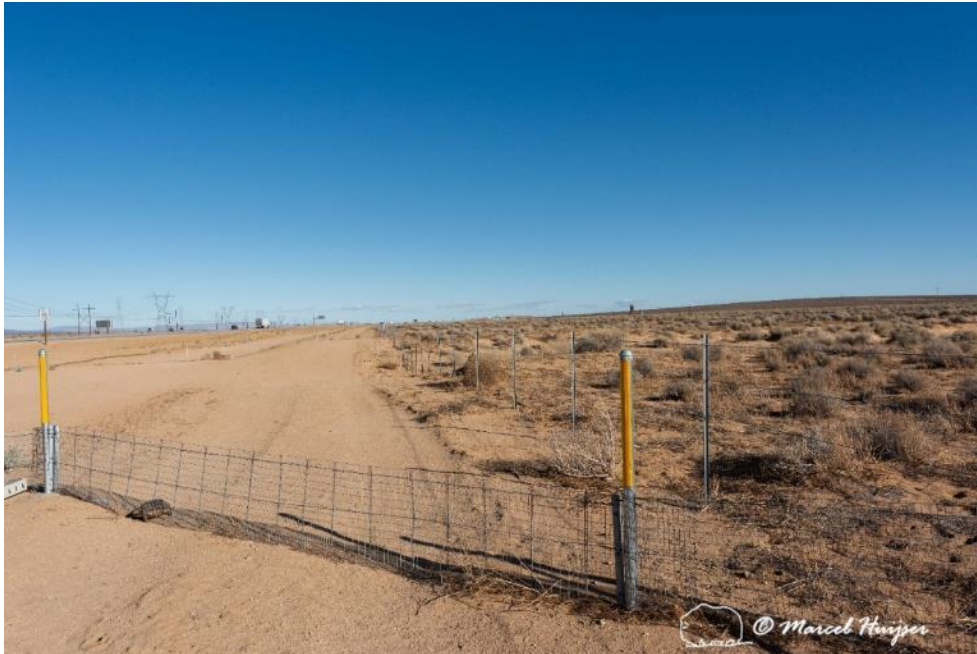
A gate associated with Mojave desert tortoise exclusion fencing, Hwy 58 near Kramer Junction, California. Note that the design of this gate resulted in gaps which affected its function as a barrier to Mojave desert tortoises (see images below).

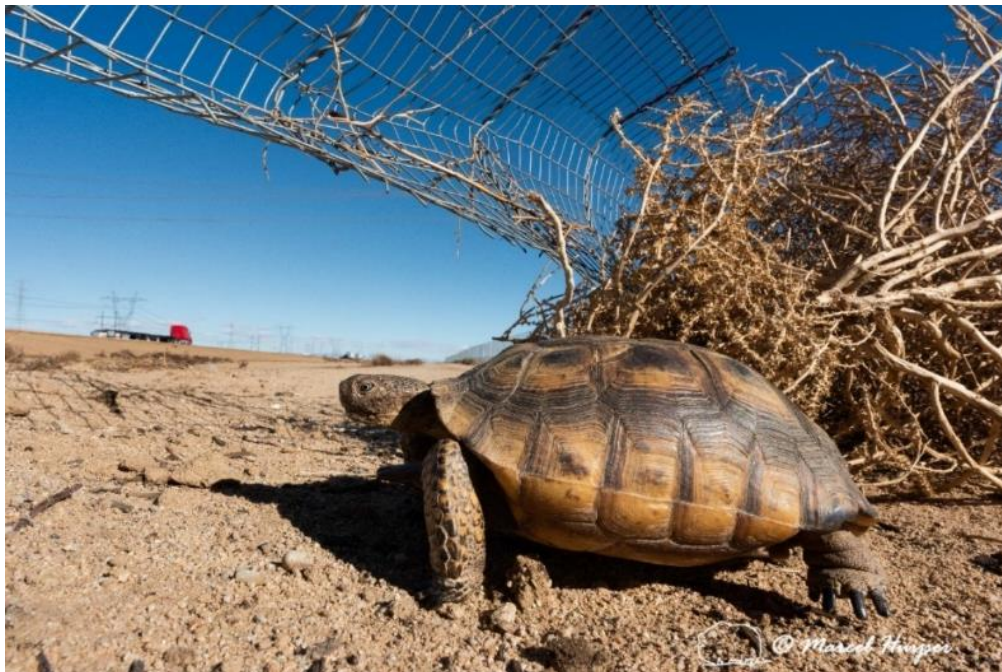
Gap under a gate associated with Mojave desert tortoise exclusion fencing, Hwy 58 near Kramer Junction, California. The gate does not have a buried component, and it had enough flex to result in permanent openings, partially as a result of tumbleweeds being blown against the fence.

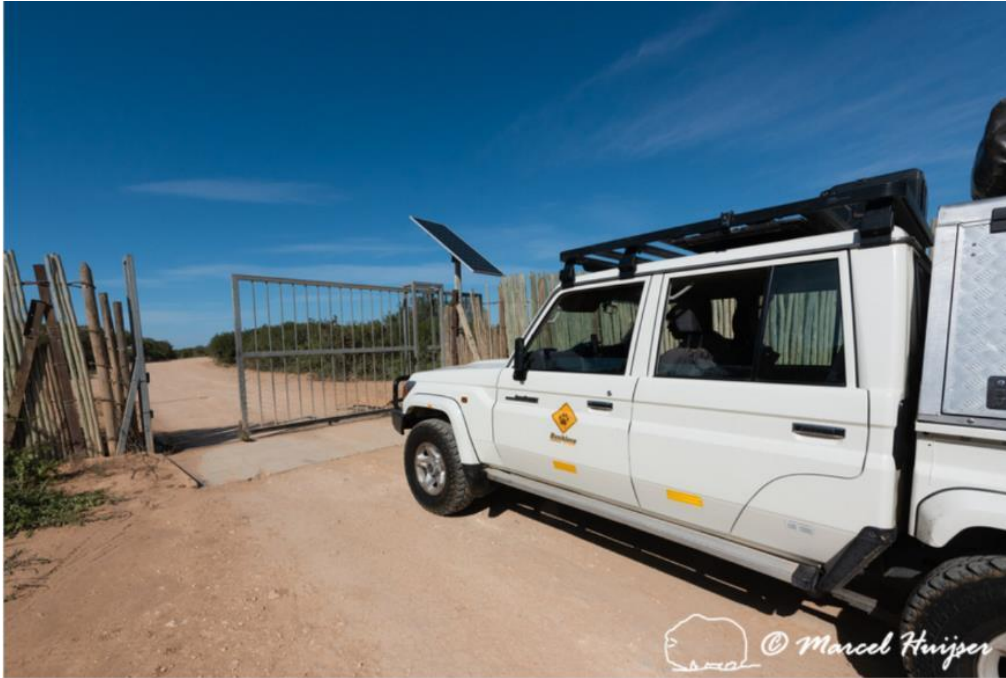
Automatic gate with a push-button to open (to the right of vehicle because of right hand driving), Addo Elephant National Park, Eastern Cape, South Africa

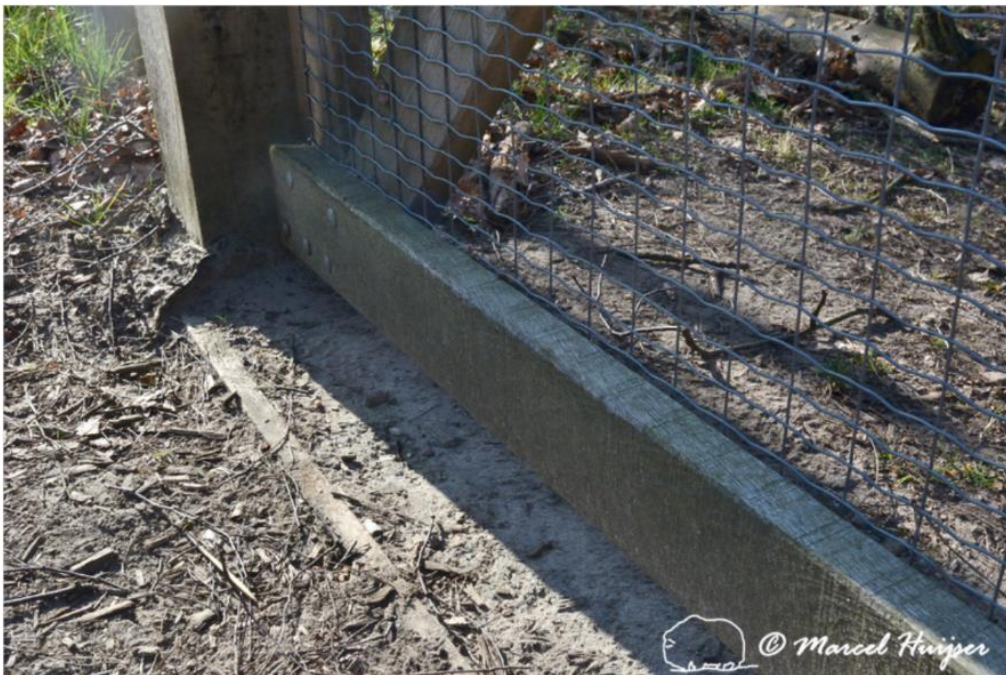
Snug fit of a gate at a wildlife fence, south of Otterlo, The Netherlands. The snug fit discourages animals from crawling under the gate.

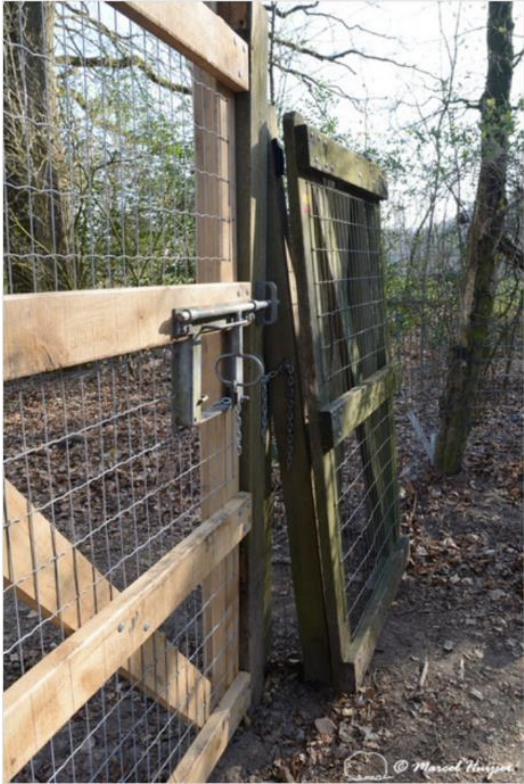
Swing gate, set at an angle so it closes through gravity, The Netherlands.

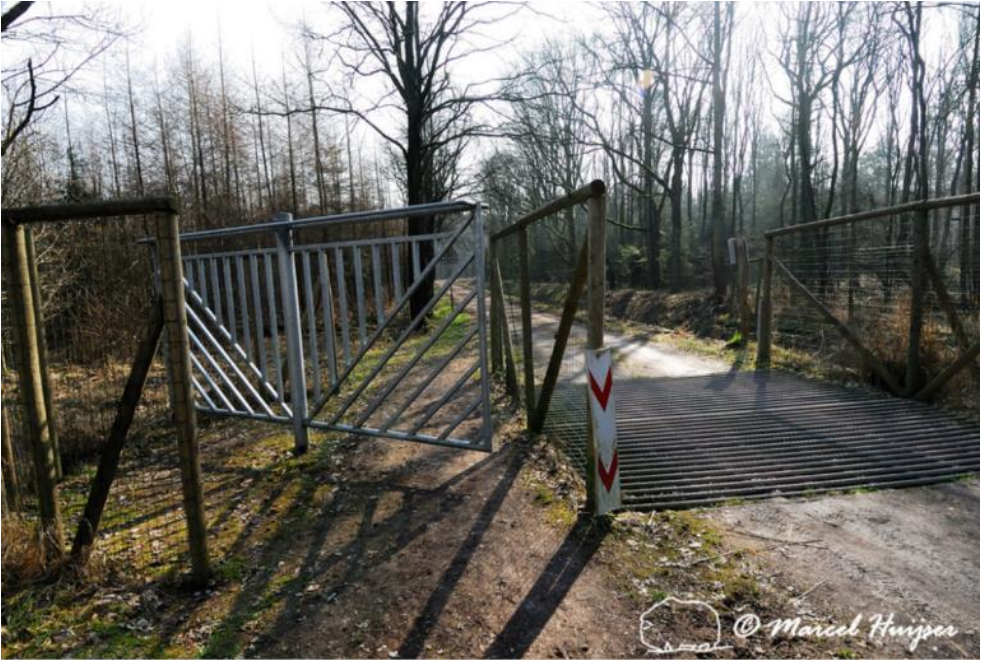
Horse swing gate, Heugterdijk, Weerterbos, near Maarheze, The Netherlands. The center of the metal swing gate is set at an angle so that gravity automatically brings the metal gate in line with the fence. Here the gate is in the process of closing.

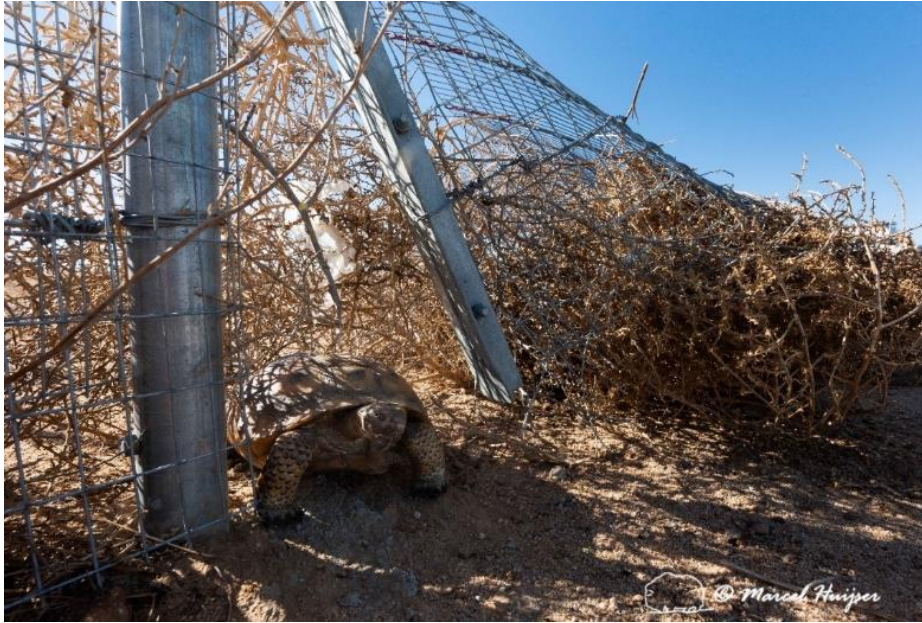
Gap at a gate associated with Mojave desert tortoise exclusion fencing, Hwy 58 near Kramer Junction, California. The gate does not have a buried component, and it had enough flex to result in permanent openings, partially as a result of tumbleweeds being blown against the fence.

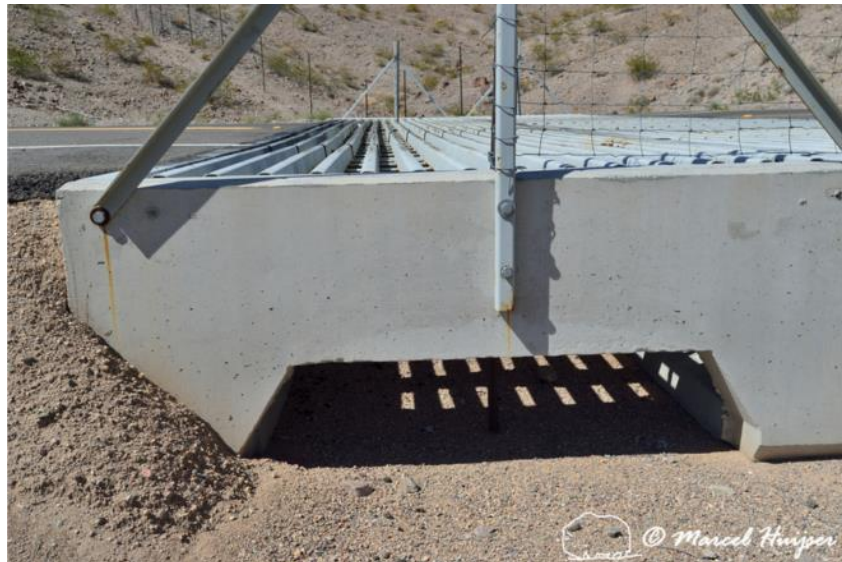
Combined drainage and escape for small animal species under a wildlife guard, Arizona, USA. While the metal bar design of this particular wildlife guard is not appropriate as a barrier for Mojave desert tortoises, the openings on the concrete walls on the side allow invertebrates, amphibians, reptiles, small mammals and other species that may fall in between the metal bars to escape to the safe side of the fence (not the roadside). For wildlife guards that have a fully enclosed pit with contiguous walls wooden planks or metal strips are sometimes attached, allowing animals to climb out of the pit. Wildlife guards are no longer recommended because Mojave desert tortoises may still cross and there may be maintenance issues if debris (e.g. tumbleweed) gets stuck in the pit (Pers. com. Kerry Holcomb, USFWS).

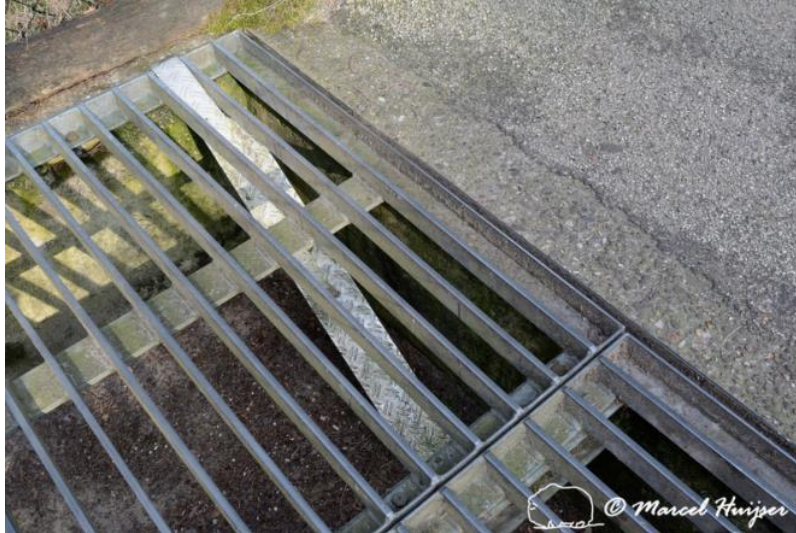
Escape ramp for small mammals, reptiles, amphibians and invertebrates from pit under wildlife guard (cattle guard), National Park Hoge Veluwe, The Netherlands. While the metal bar design of this particular wildlife guard is not appropriate as a barrier for Mojave desert tortoises, the escape ramp may allow invertebrates, amphibians, reptiles, small mammals and other species that may fall in between the metal bars to escape to the safe side of the fence (not the roadside). Note that the effectiveness of escape ramps is not tested, and their use for Mojave desert tortoises would need to be investigated before wide-spread use.

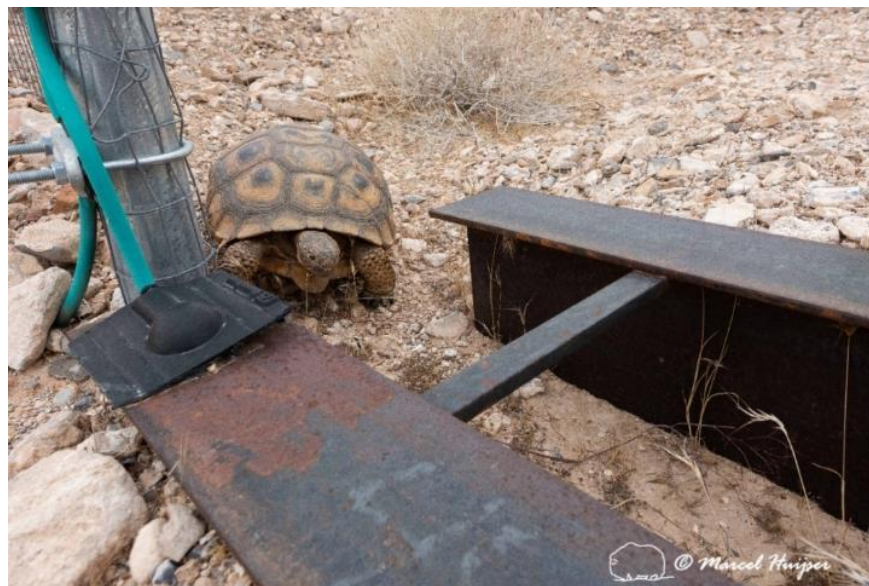
Tortoise guard consisting of two I-beams, welded together with connectors, for Mojave desert tortoise, US Hwy 93 (MP 58 NB) near Overton, Nevada. The tortoise approaches from the safe side of the fence (not the roadside). Note, that larger adult tortoises may not fit within, and may be able to gain access to the roadside across this structure. **This design is no longer recommended** because Mojave desert tortoises may still cross, and the structure does not stand up to heavy vehicles and high temperatures, and they are susceptible to erosion (Pers. com. Kerry Holcomb, USFWS; Kristina Drake, USFWS; Glen Knowles, USFWS).

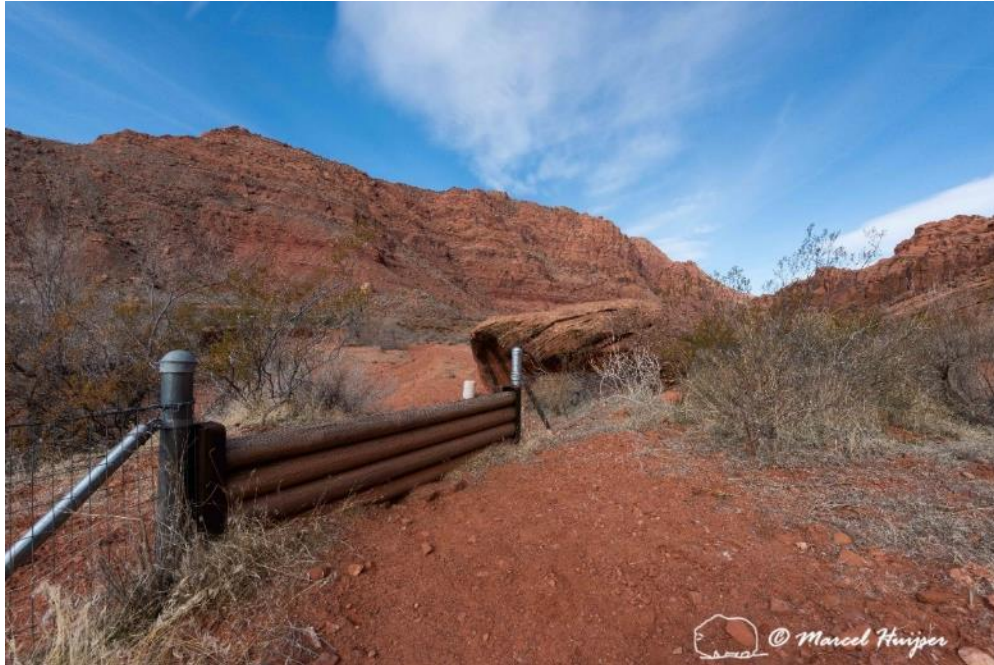
Barrier on a hiking trail, designed to keep Mojave desert tortoises out of an area, St. George, Utah. Hikers may step over this barrier to continue on the trail, while tortoises cannot gain access to the road on the other side.

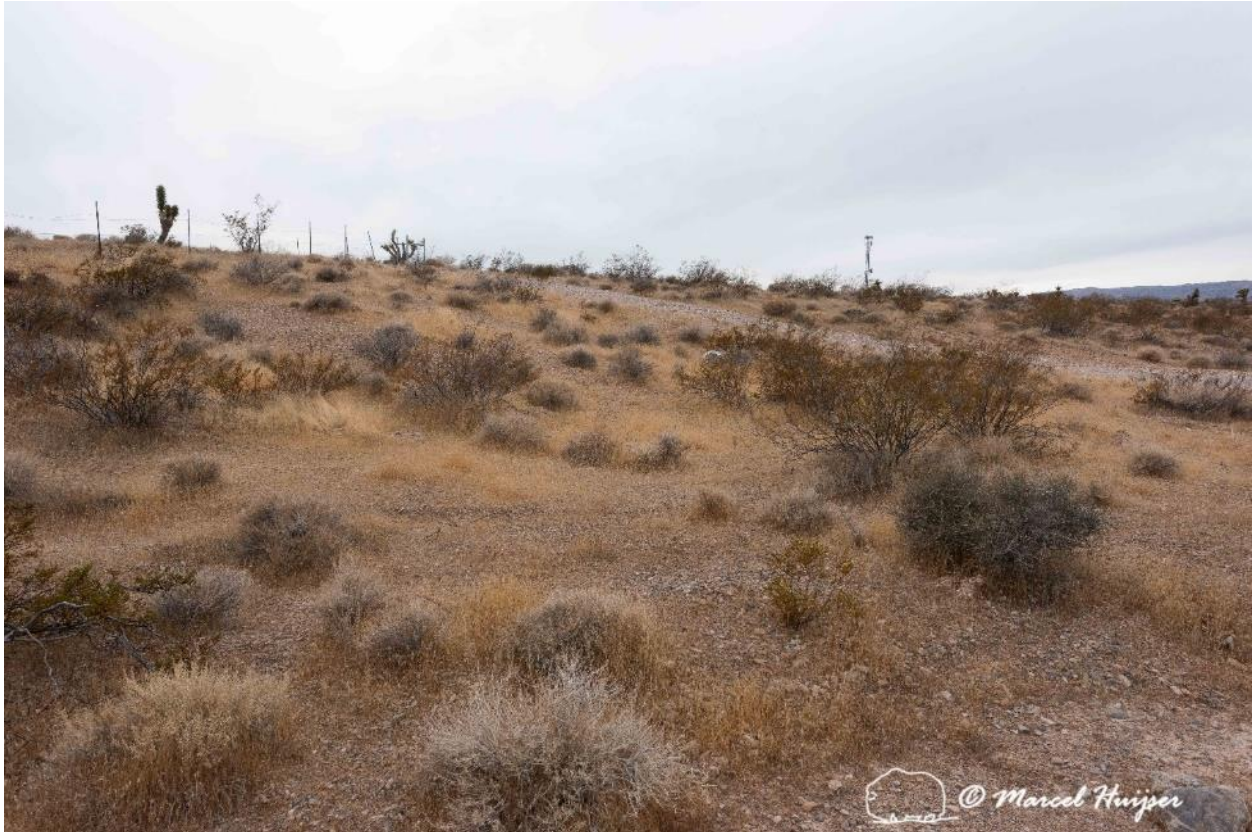
Mojave desert tortoise exclusion fence on the left, located on high ground adjacent to a desert wash leading to a culvert under US Hwy 93 (MP 58) near Overton, Nevada.

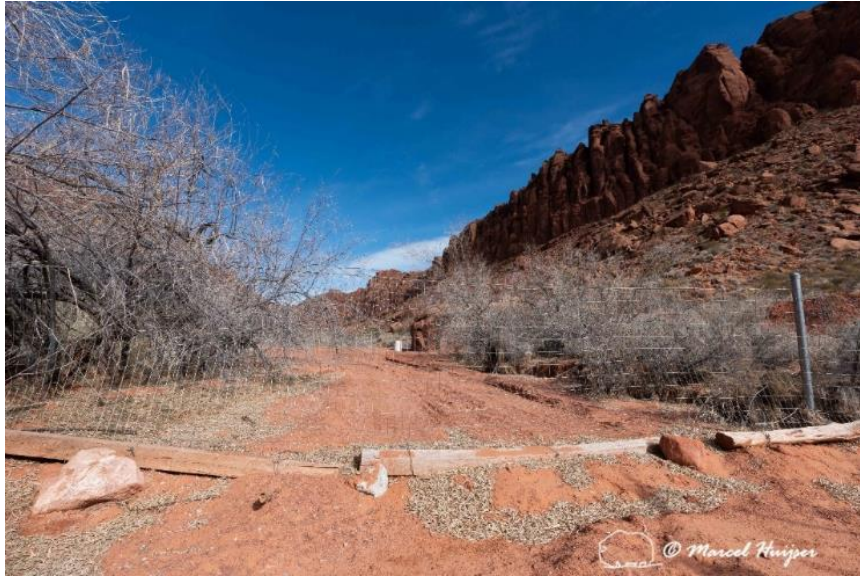
Mojave desert tortoise exclusion fencing across a desert wash, St. George, Utah. Here the fence crosses a desert wash. The cedar logs will float and lift up the fence during a flooding event. This minimizes damage to the fence because of flooding and debris.

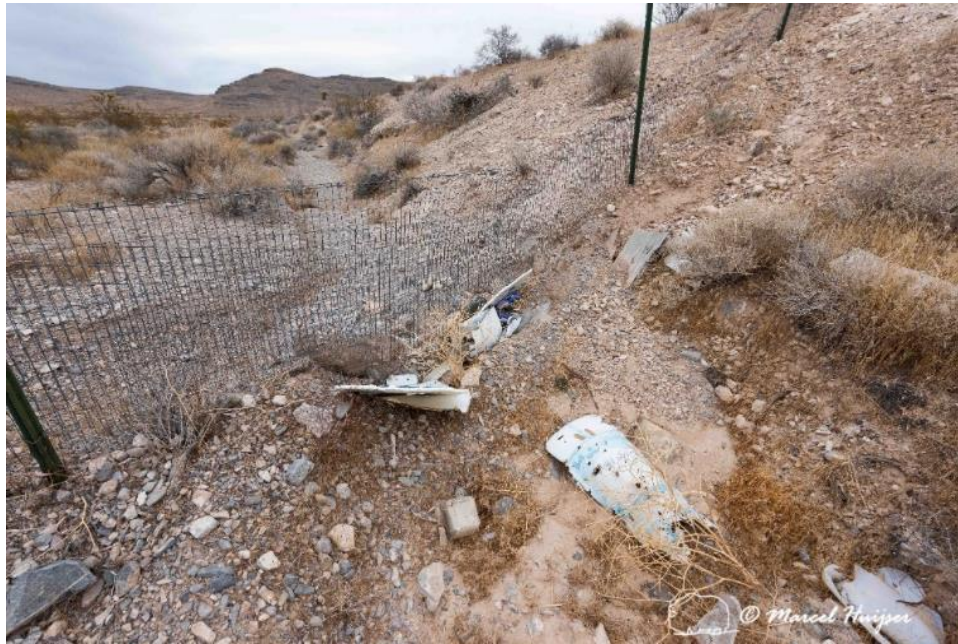
Mojave desert tortoise exclusion fencing across a desert wash with sedimentation at the fence, US Hwy 93 (MP 58 NB) near Overton, Nevada. The sedimentation reduces the effective height of the fence, and it may eventually threaten the integrity of the fence. Also note that the fence material has been cut in multiple overlapping segments to allow for the change in angle because of the change in slope (see next image for details).

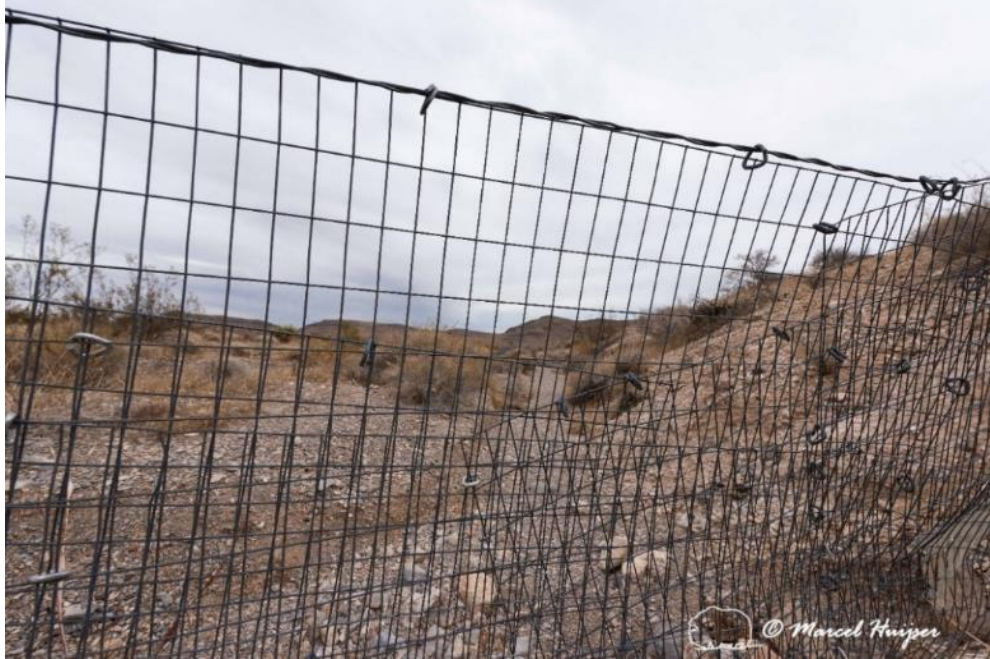
Detail of Mojave desert tortoise fencing, US Hwy 93 (MP 58 NB) near Overton, Nevada. Because of the change in slope (higher bank towards the right), the fence material was cut and installed in multiple overlapping segments.

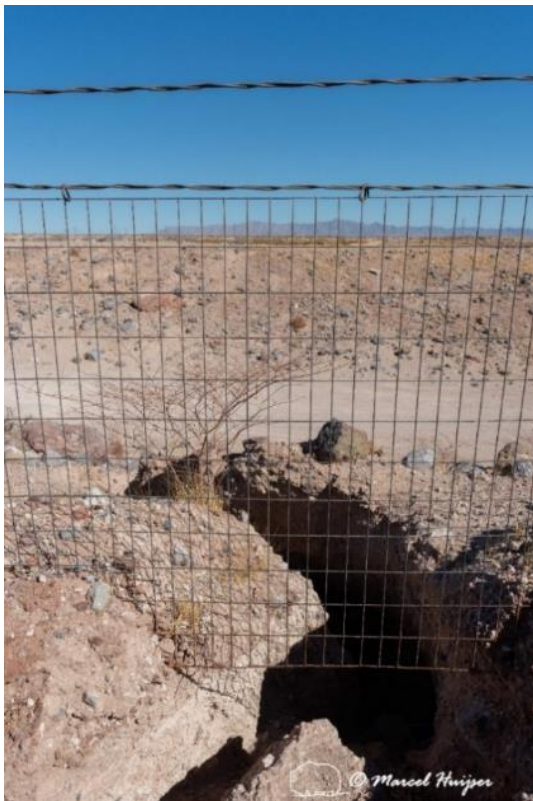
Mojave desert tortoise fencing with soil erosion, I-11, near Boulder City, Nevada. Note that the animals may now move in the erosion gully under the fence. Also note that the fence appears to have only been dug 6 inches into the ground rather than the recommended minimum 12 inches.
