Technical Guidance: Mojave Desert Tortoise Conservation and Recovery Measures Along Roads

Mojave Desert Tortoise Transportation Ecology Task Force

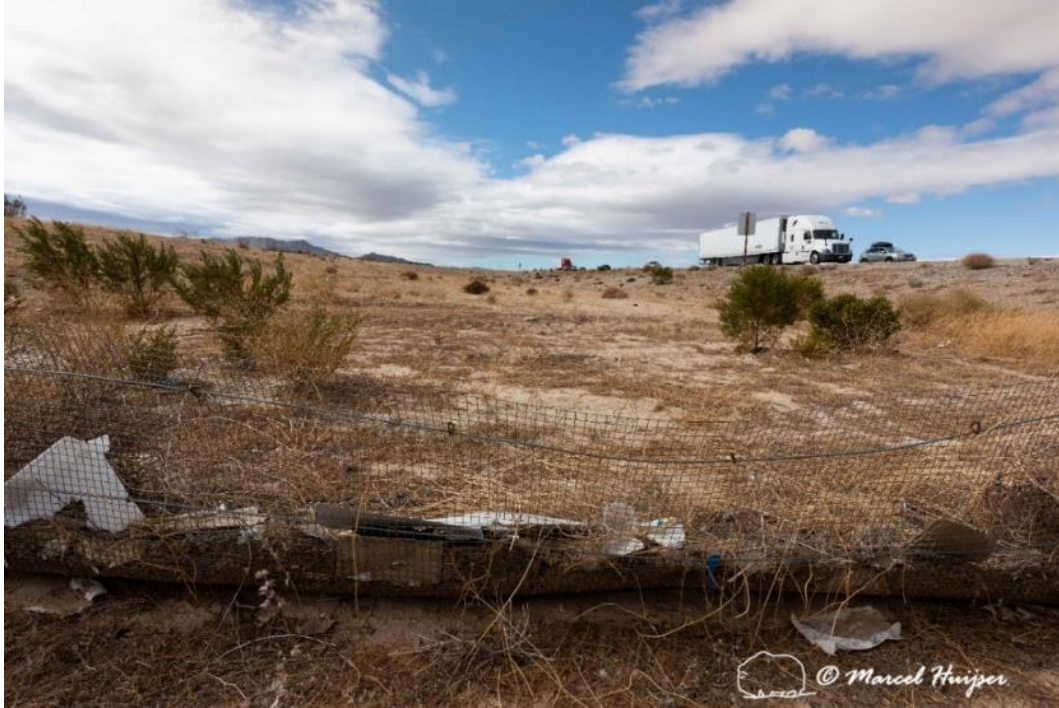
Mojave desert tortoise fencing installed across a low lying area, along I-15 near Barstow, California. Here debris (rocks, sand, garbage) has built up against the fence because water runs down the slope against the fence.

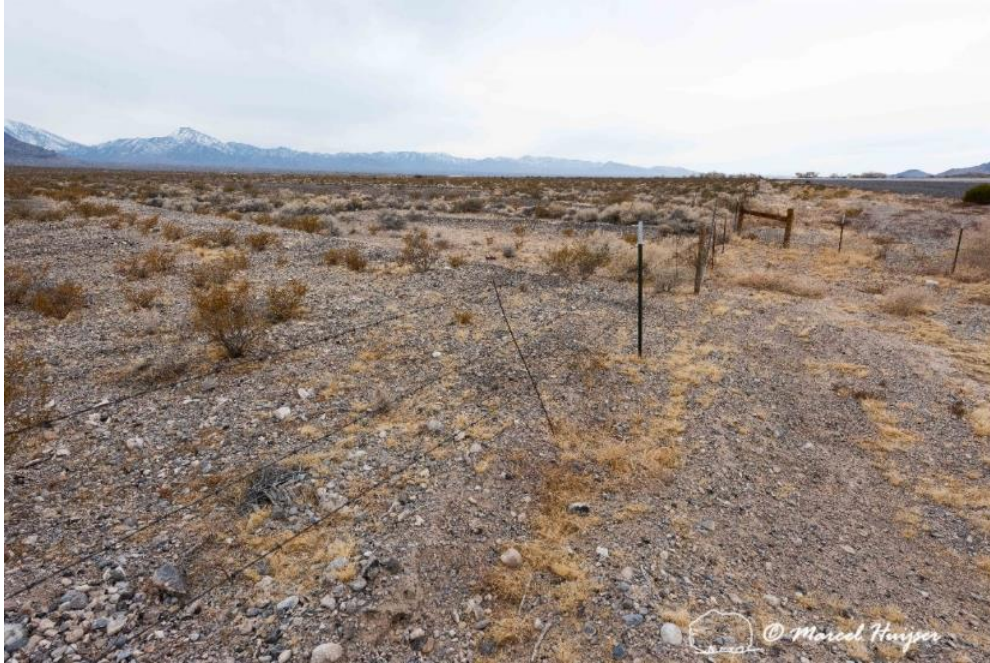
Mojave desert tortoise fencing, US Hwy 95 (MP 121.6 SB) near Indian Springs, Nevada. This is a right-of-way and cattle fence installed across the wash, intended to keep cattle from entering the culvert (which is to the right). The Mojave desert tortoise fencing (upper right) angles away from the property boundary towards the culvert.

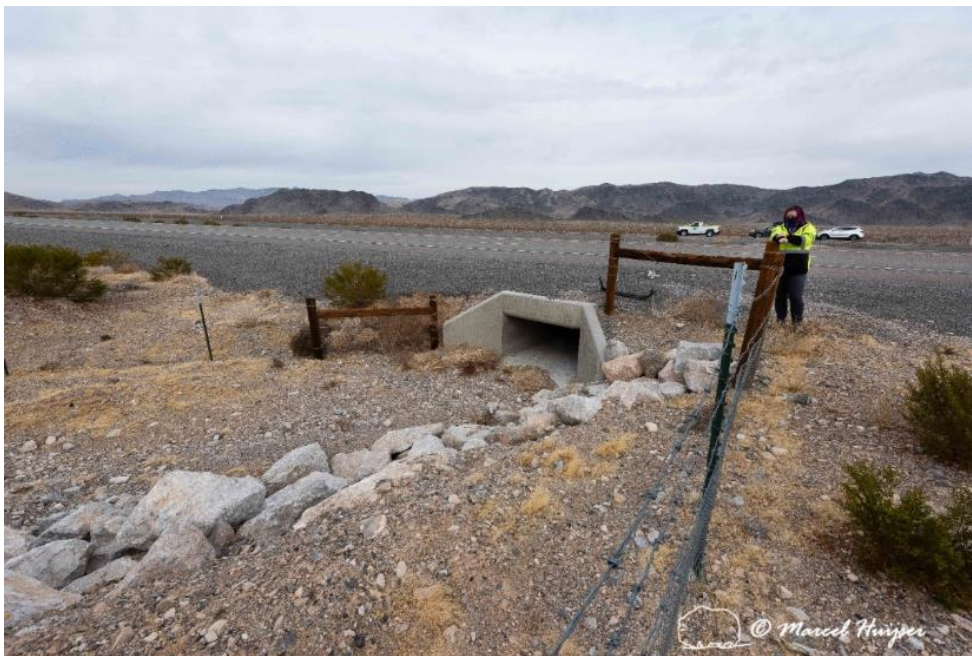
Mojave desert tortoise fencing and a concrete box culvert, US Hwy 95 (MP 127.5 SB) near Indian Springs, Nevada. Note that the fence on the near side is located on top of the bank of the desert wash, and not in the wash or on the bank.

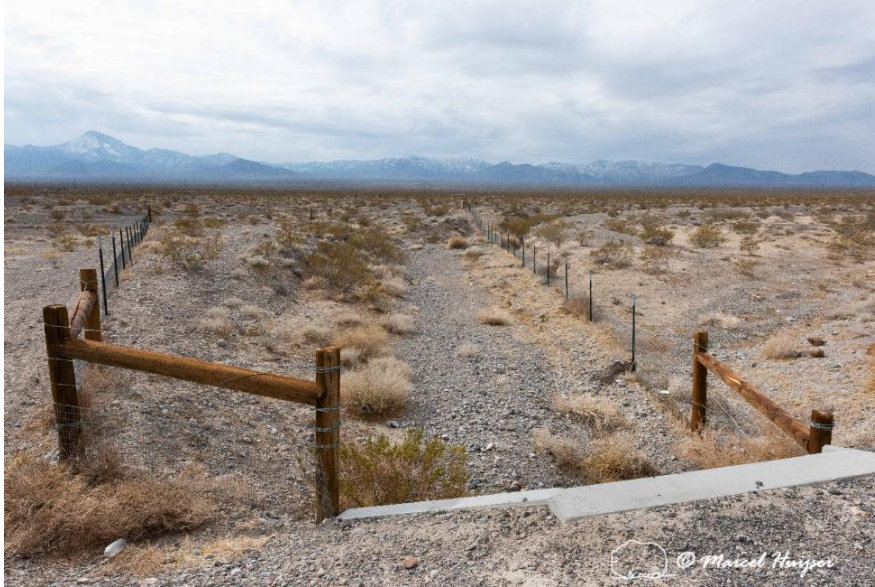
Funnel fencing for Mojave desert tortoise and a box culvert (foreground), US Hwy 95 (MP 126.5 SB) near Indian Springs, Nevada. Note that the fence on the left is on higher ground, on top of the bank of the wash, and not within the wash or on the bank.

Fences should have a tight connection to the structure or wingwalls of the structure so that Mojave desert tortoises cannot access the fenced road corridor. In some cases, it is best to **have the fence run behind and on top of the culvert** and not have any break in the fence. Do not assume large rocks or boulders are a barrier for Mojave desert tortoises and do not allow for gaps in the fence at large rocks.

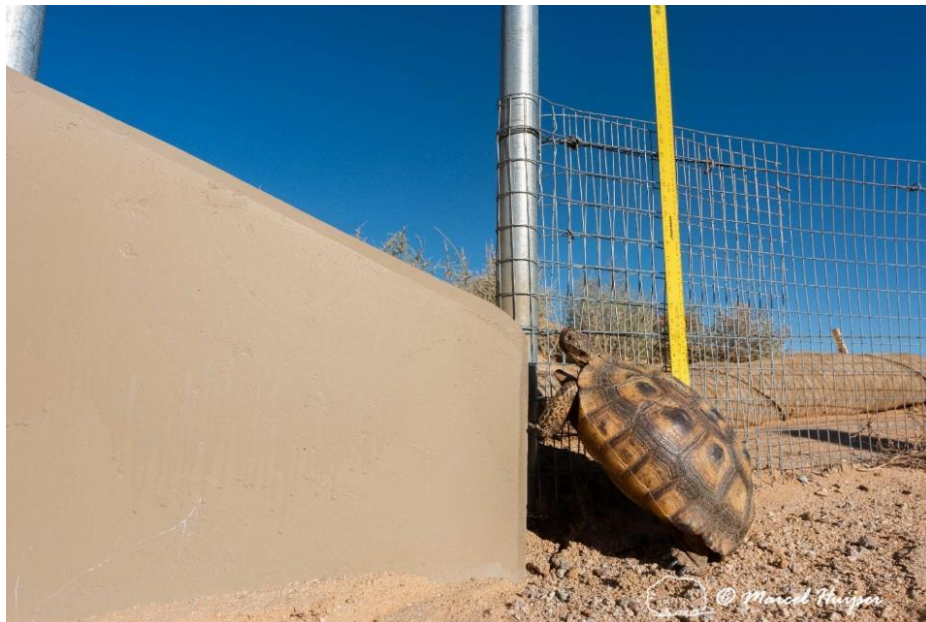
Mojave desert tortoise fencing connected to the wingwall of a culvert, Hwy 58 near Kramer Junction, California. While the connection between the fence and wingwall is tight and should not allow Mojave desert tortoises to access the fenced road corridor, the effective height at the connection is only about 11 inches instead of the recommended 22-24 inches. The fence material should have been continued until the point where the wingwall has a height of 22-24 inches.

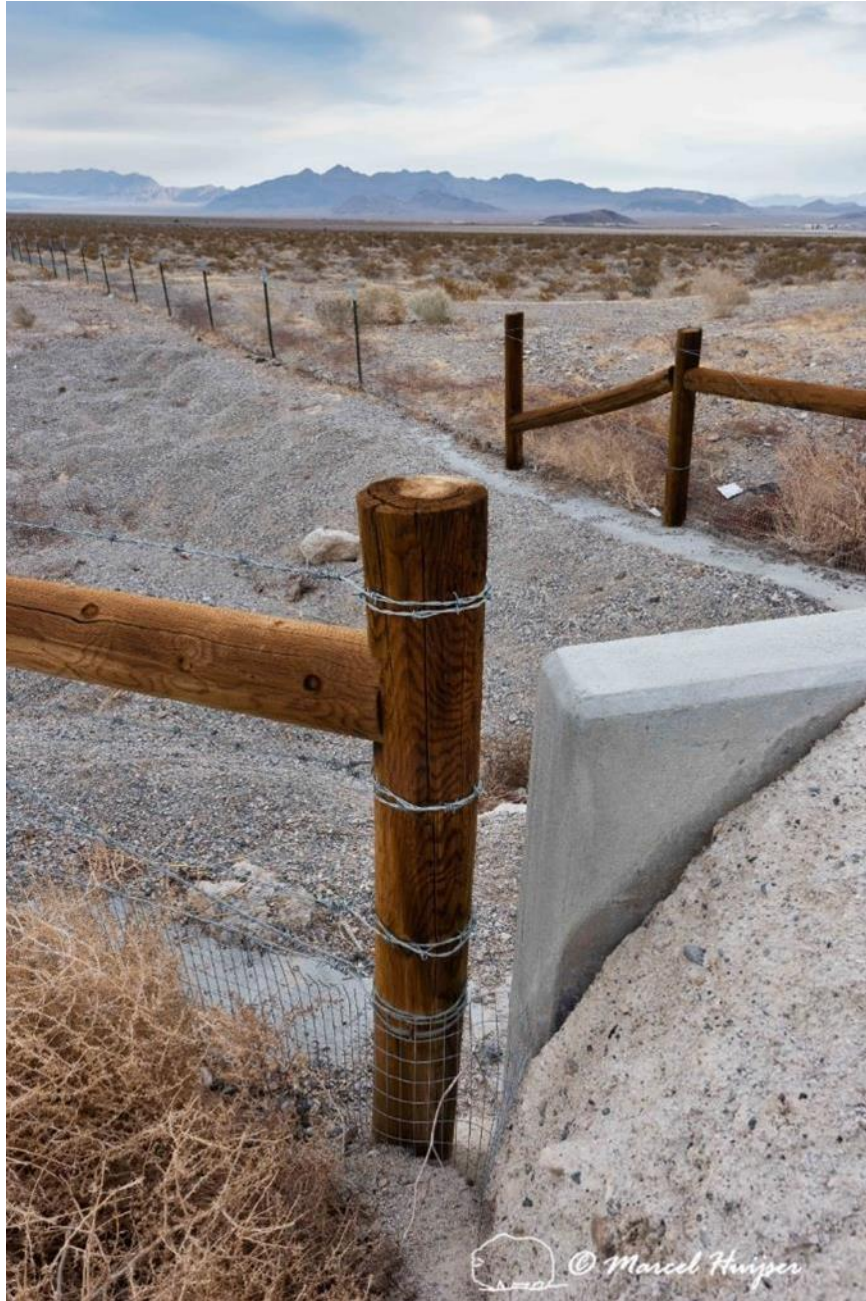
Mojave desert tortoise fencing connected to a culvert, US Hwy 95 (MP 121.6 NB) near Indian Springs, Nevada. Note concrete access paths for Mojave desert tortoises constructed along the fence.

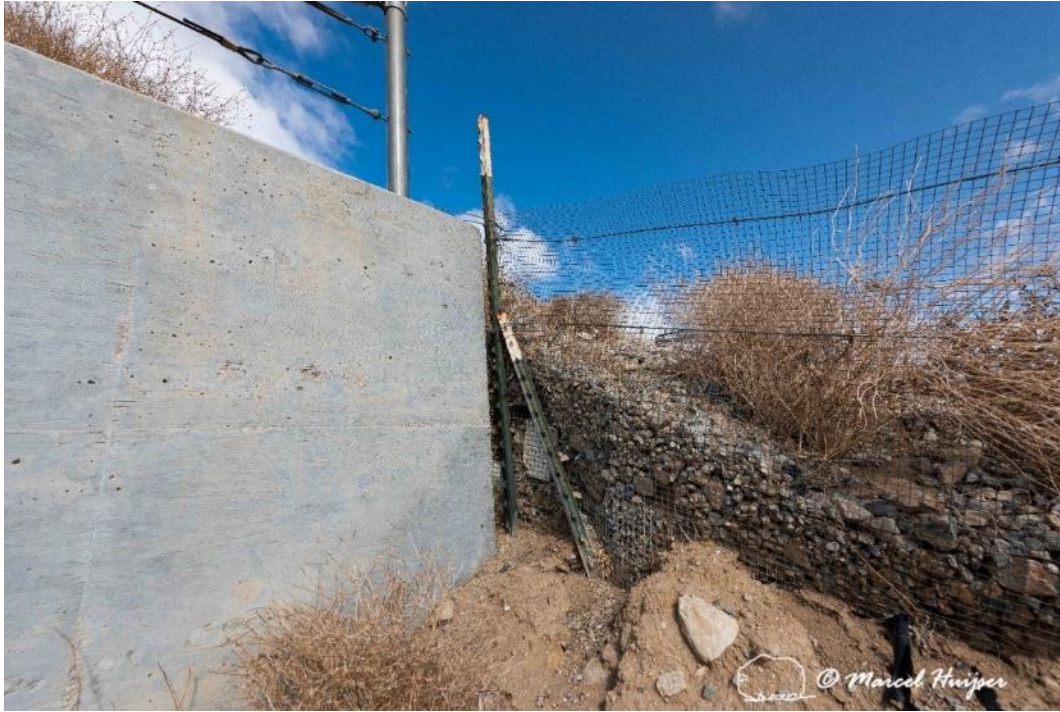
Mojave desert tortoise fencing connected to a culvert, I-15 near Barstow, California. Here debris (rocks, sand) has built up against the fence, threatening its integrity.

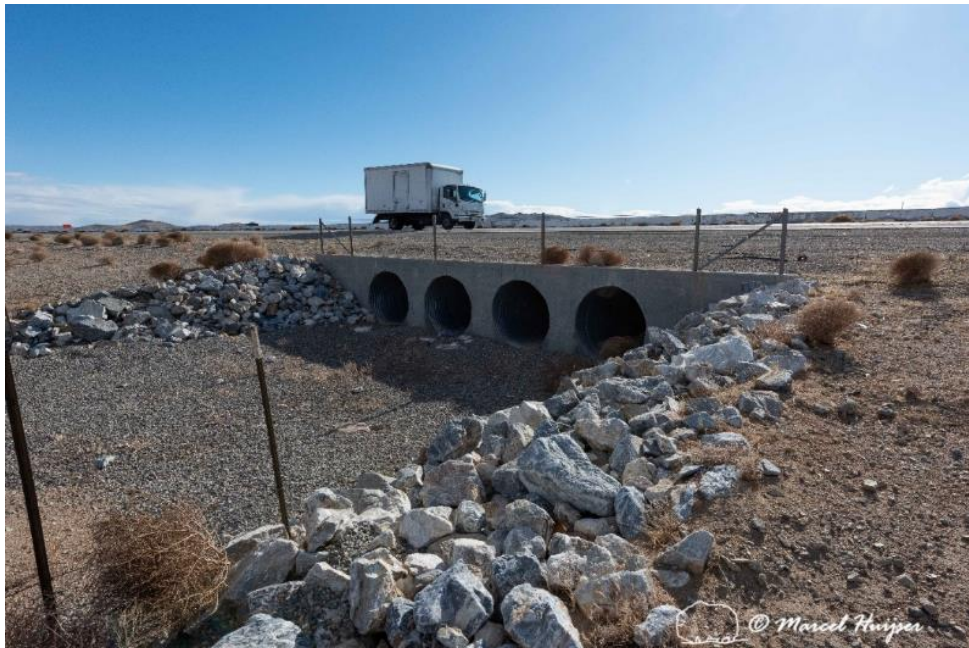
Mojave desert tortoise fencing leading up to culverts primarily designed for hydrology, I-15 near Barstow, California. Note that the fence does not physically connect to the structure and that riprap (rocks) fills the gap. However, it would have been better to leave no gap in the fence and have the fence continue on top of the bank above the boulders.

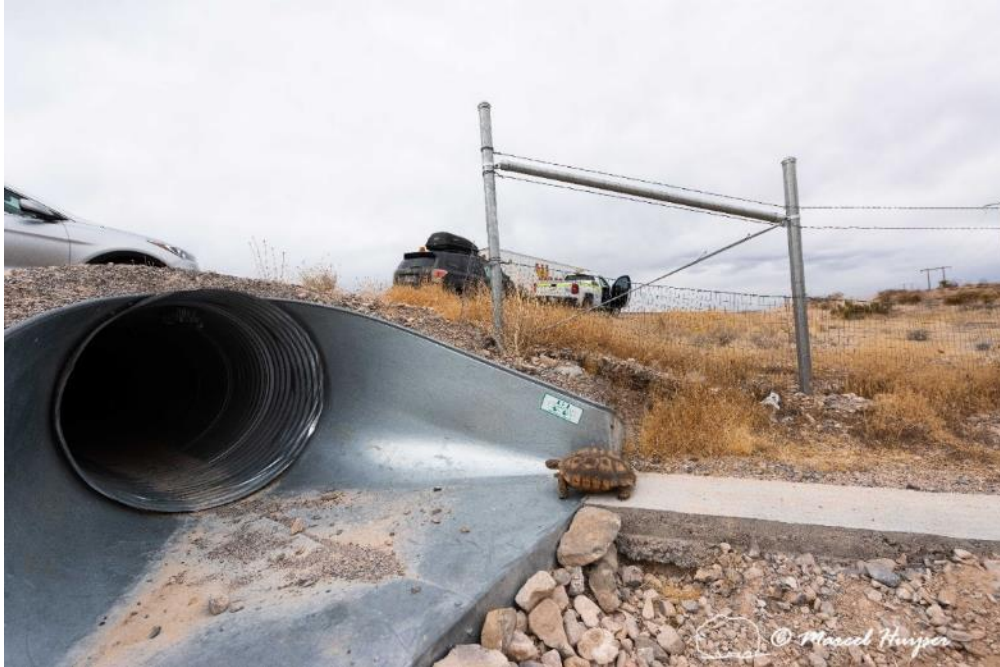
Mojave desert tortoise fencing connected to a culvert, US Hwy 93 (MP 58 NB) near Overton, Nevada. The fencing would be a more effective barrier if it was continued above the culvert without any gap in the fence.

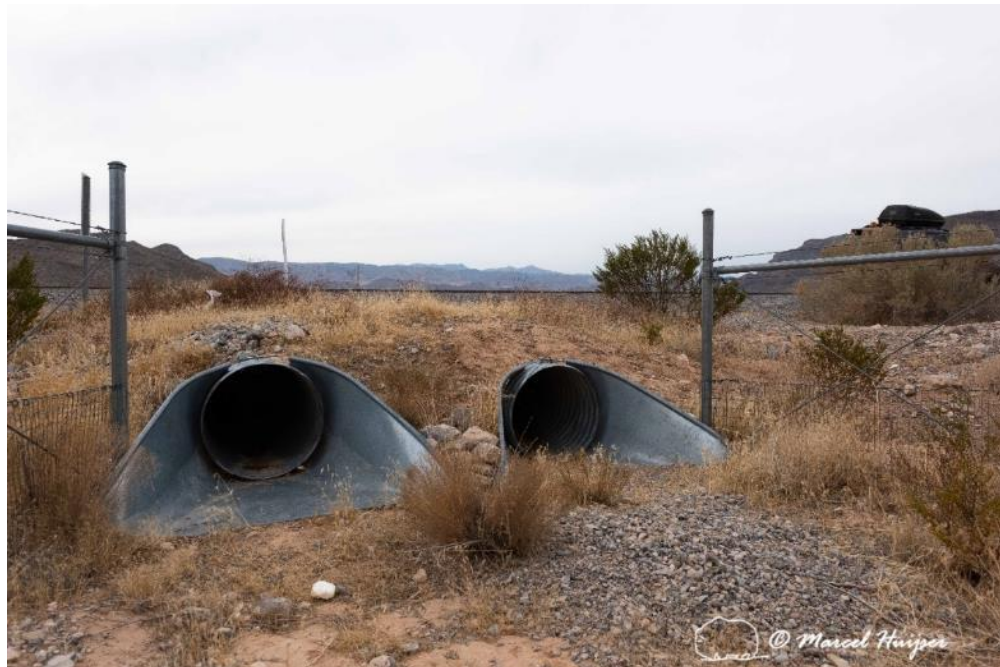
Mojave desert tortoise fencing connected to twin culverts, US Hwy 93 (MP 69.5 NB) near Overton, Nevada. The fencing would be a more effective barrier if it was continued above the culvert without any gap in the fence.

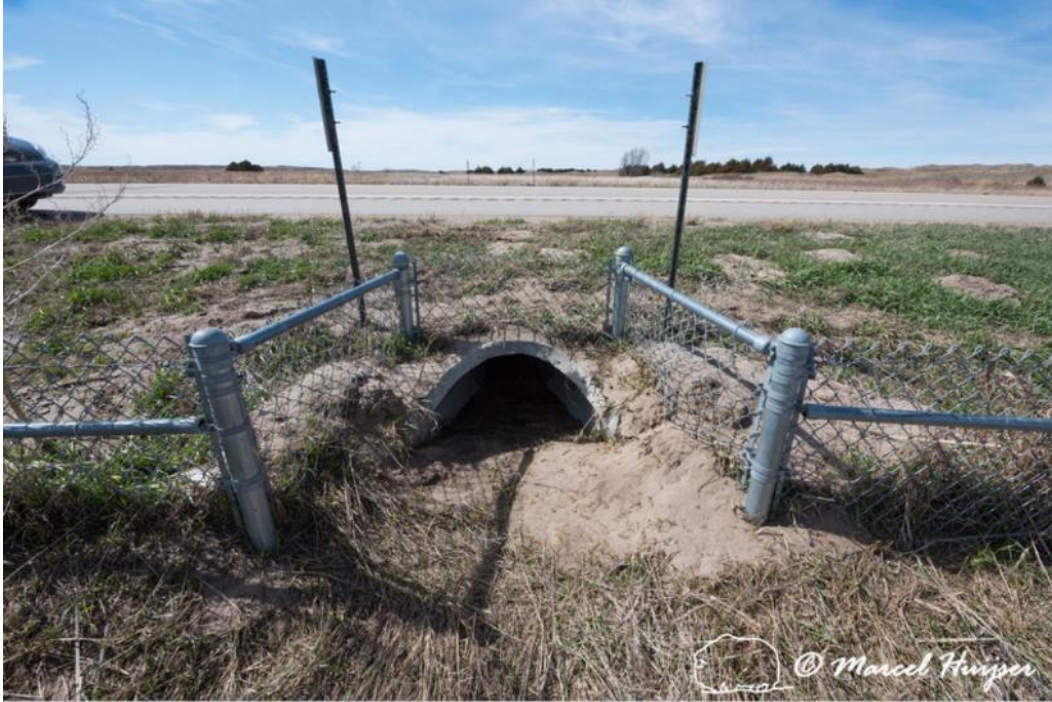
Turtle fence and a dry culvert used by turtles, Valentine National Wildlife Refuge, Ballard's South, Valentine, Nebraska, USA. This culvert is 30 inches wide, 22 inches tall. Note that this turtle fence has no gap and continues behind and on top of the culvert.

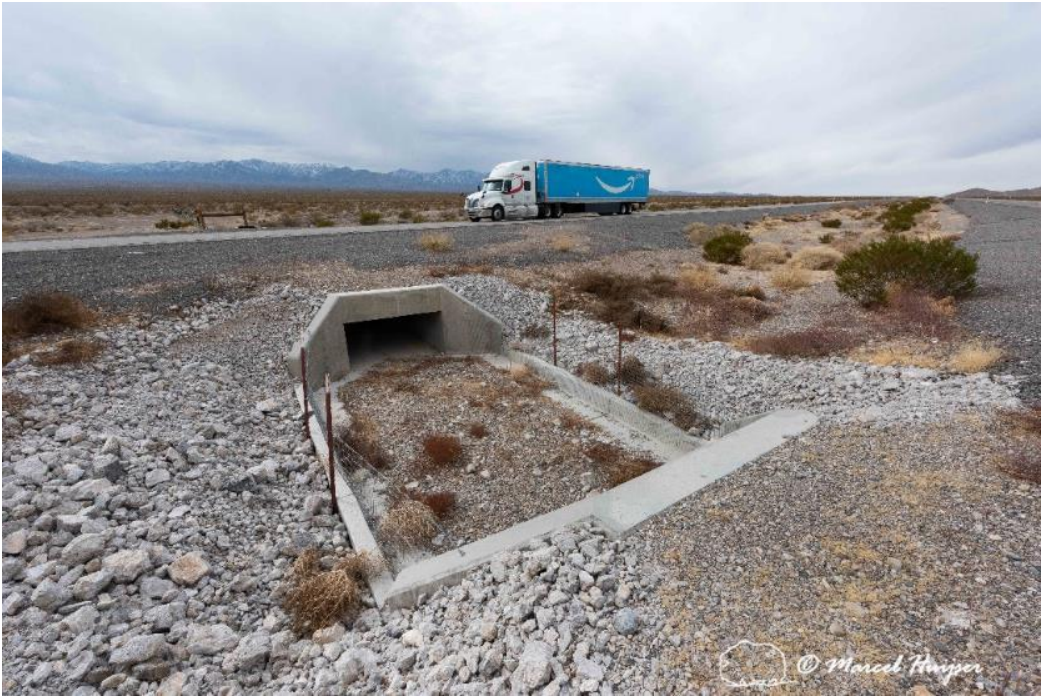
Open medians with separate crossing structures for the two travel directions should have Mojave desert tortoise fencing installed to prevent tortoises from accessing the fenced road corridor in the median.

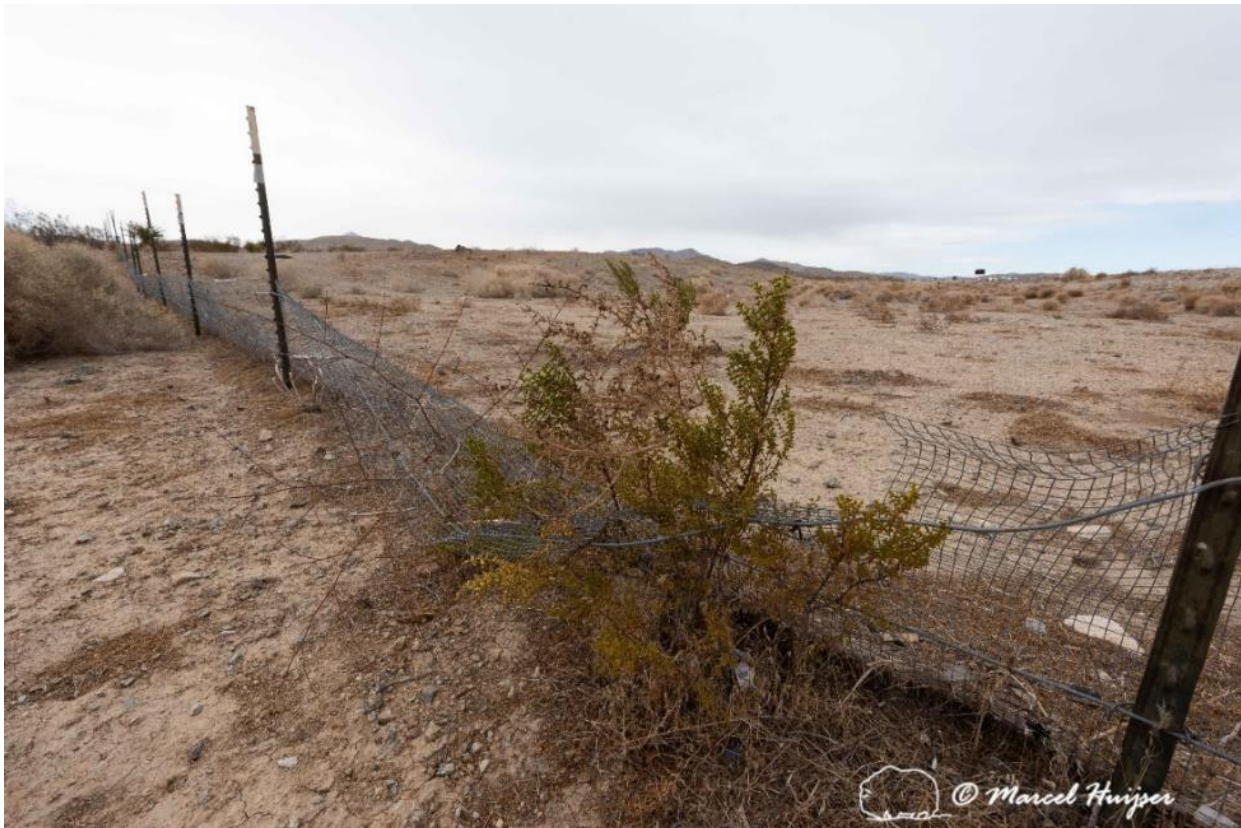
Mojave desert tortoise fencing, I-15 near Barstow, California. The fence is in disrepair and a shrub has grown through the fence, reducing its effective height.

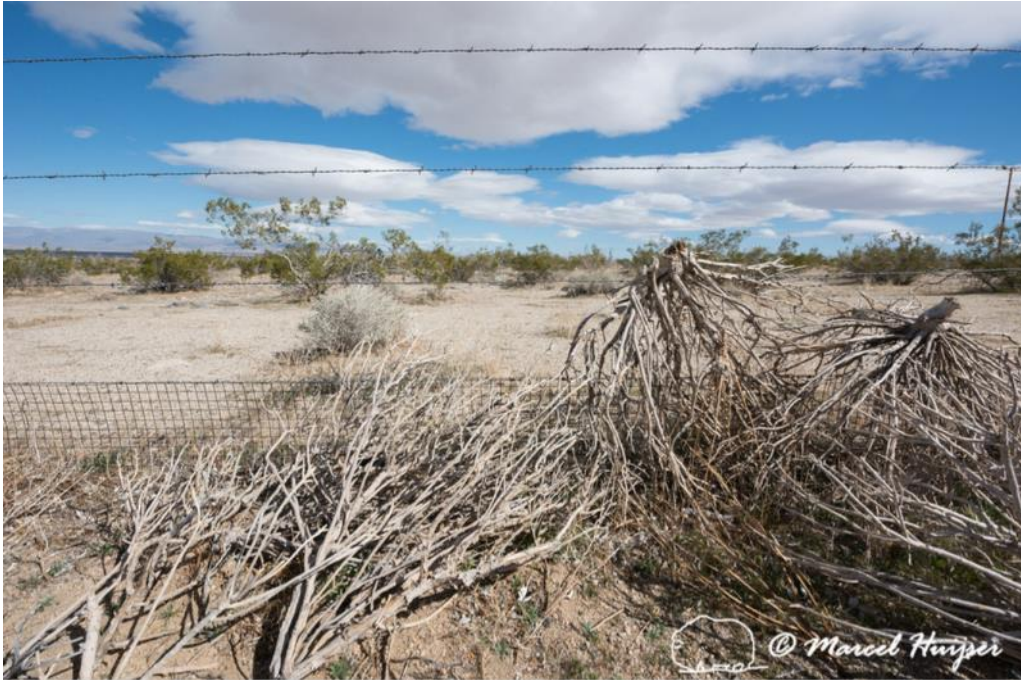
Dead vegetation has blown against the Mojave desert tortoise fence, reducing the barrier effect of the fence to keep tortoise from accessing the highway, Aerospace Hwy, Hwy 14 near Inyokern, California. Note that the height of the fence, as installed, is insufficient to begin with.

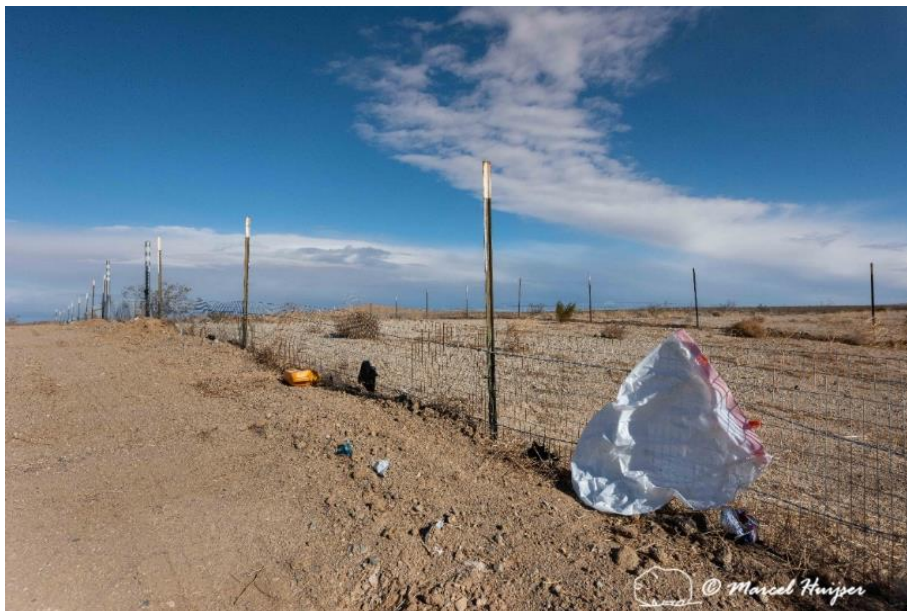
Mojave desert tortoise fencing with windblown garbage, I-15 near Barstow, California. While this garbage does not pose an immediate threat to the integrity of the fence, tortoises and other wildlife species may consume garbage with potentially lethal consequences. In addition, because fences catch windblown garbage, they make the presence of garbage more visible to people, affecting landscape aesthetics.

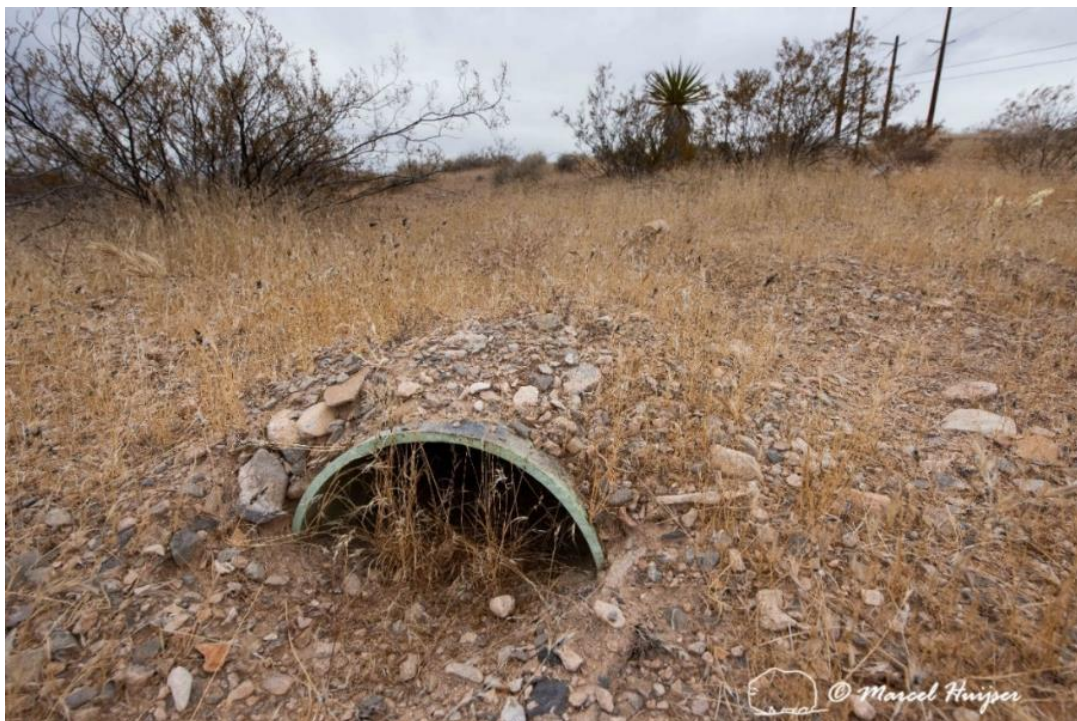
Artificial shade structure for Mojave desert tortoises, along US Hwy 93 (MP 58 NB) near Overton, Nevada.

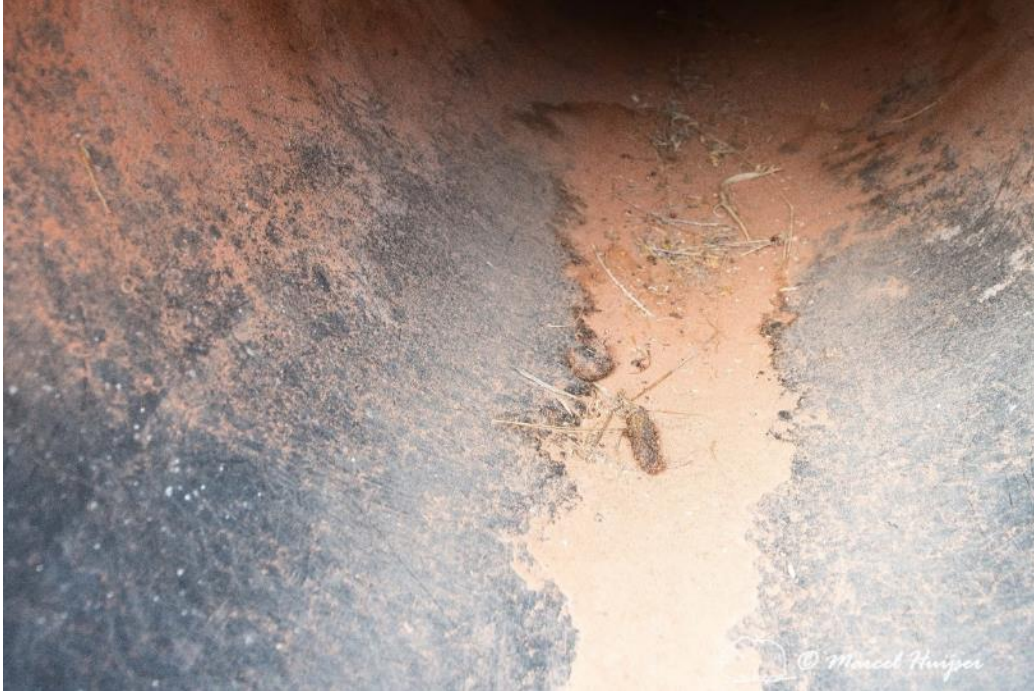
Mojave desert tortoise feces in a culvert, St. George, Utah. Culverts may resemble Mojave desert tortoise burrows and can function as a place to shelter from the sun or cold temperatures. The presence of feces indicates that a Mojave desert tortoise was present, and it may be an indication that it spent substantial time within the culvert.

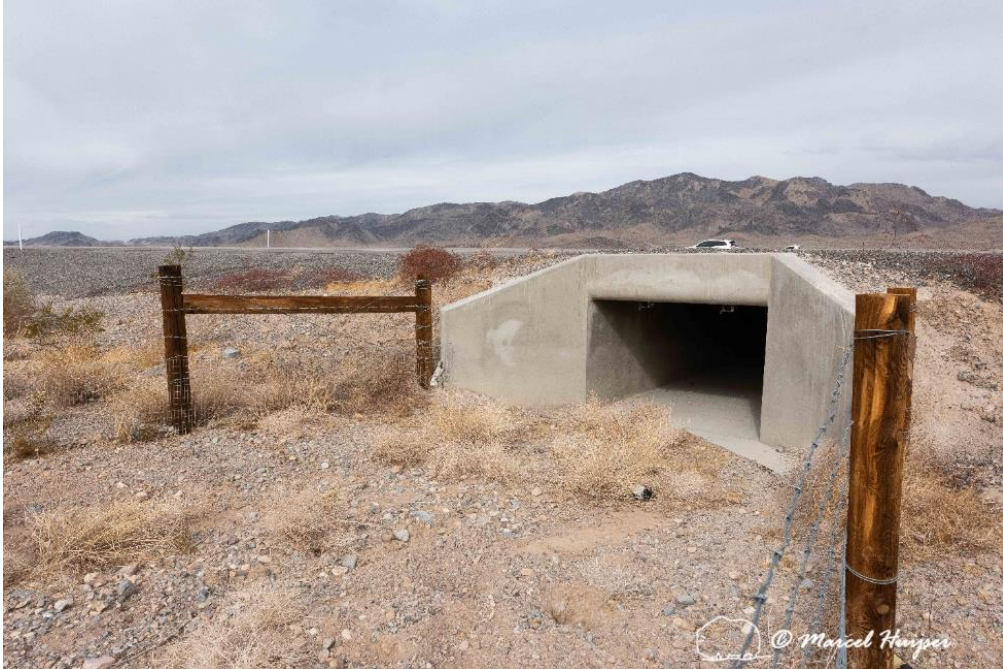
A multifunctional concrete culvert with natural substrate leading up to it, primarily designed for hydrology, but adapted for use by Mojave desert tortoises, US Hwy 95 (MP 125 SB) near Indian Springs, Nevada.

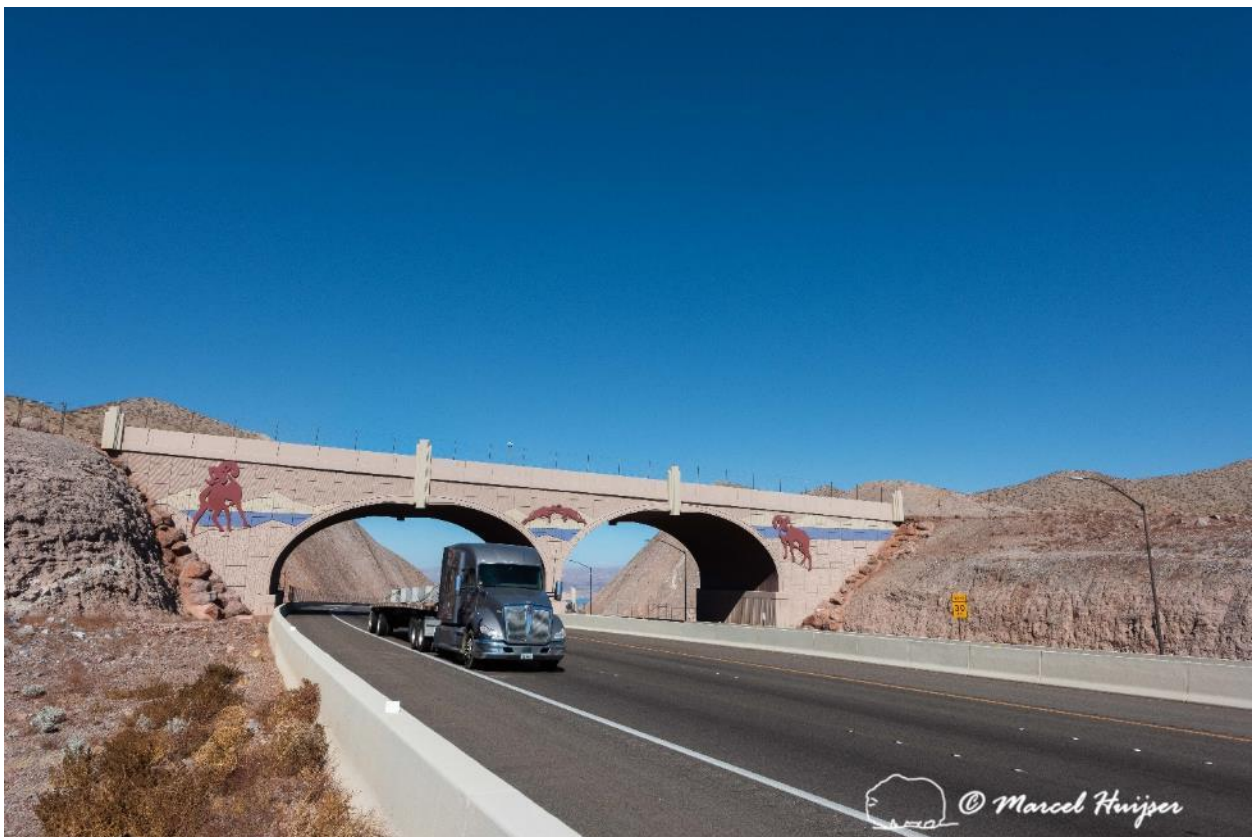
Wildlife overpass primarily designed for desert bighorn sheep, I-11, near Boulder City, Nevada.

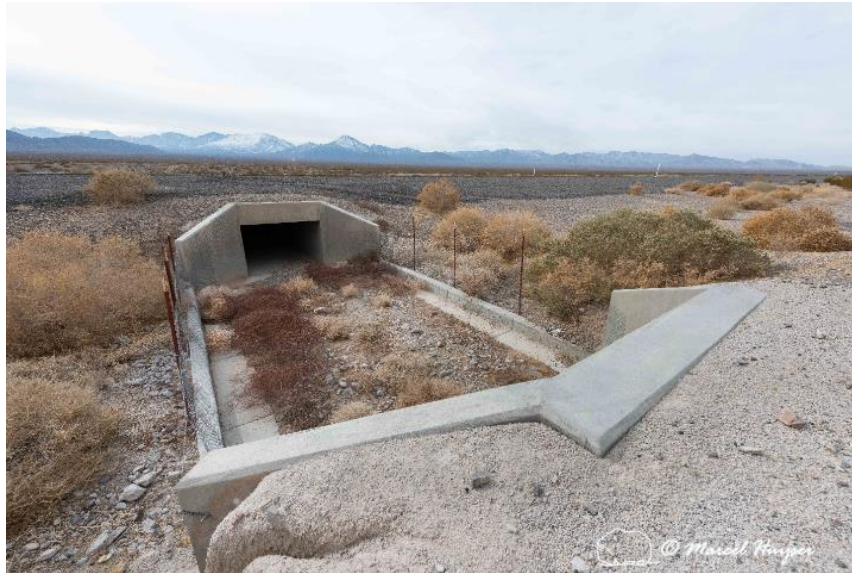
Mojave desert tortoise fencing has been installed within the open median to prevent larger tortoises from climbing over the curb and accessing the highway (US Hwy 95 (MP 125 NB) near Indian Springs, Nevada). The open median results in two separate structures (one structure for each travel direction) rather than one longer culvert structure and the fence guides the animals between the two structures. Data collected through culvert monitoring studies suggest this open median design may be conducive to enticing tortoise movement across wide four-lane highways. It is generally considered good practice to design and construct the 2 structures such that there is a direct line of sight through both of them (i.e. you can see through the 2 culverts from the west side to the east side of the road).

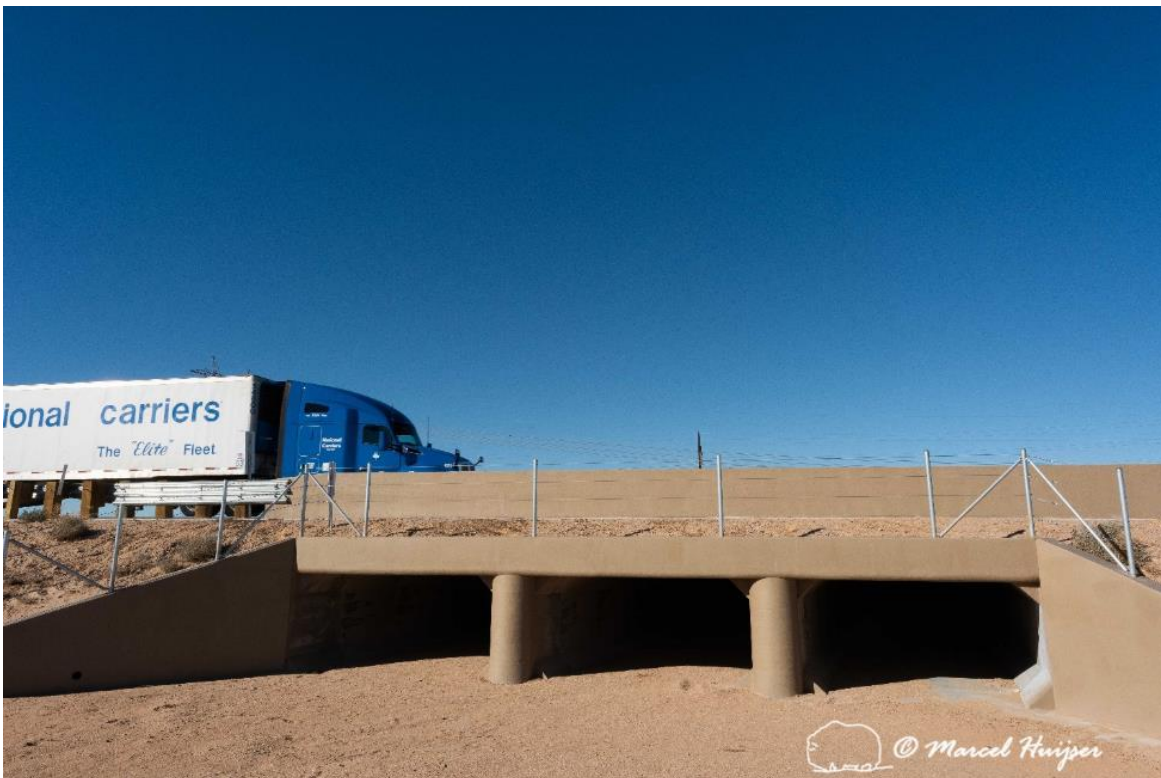
Culverts, primarily designed for hydrology, but also for Mojave desert tortoises, Hwy 58 near Kramer Junction, California. There is no erosion or sedimentation at this approach that would constitute a barrier to tortoises. However, having one open structure, not separated by dividing walls, would likely be better for wildlife use in general.

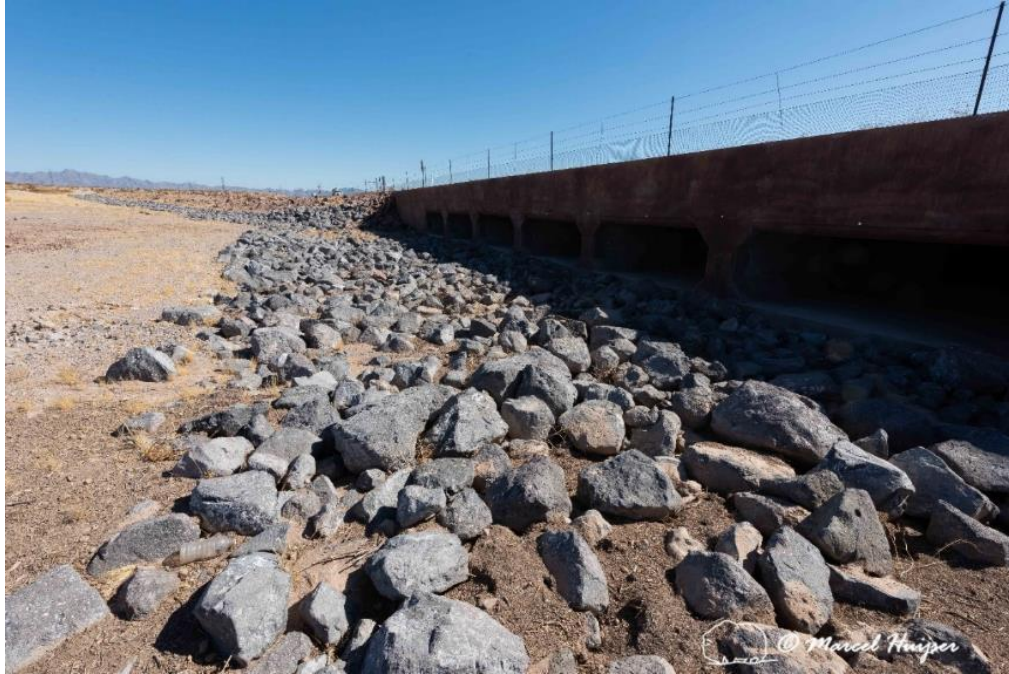
Riprap in front of culverts to reduce erosion, I-11, near Boulder City, Nevada. While beneficial to combatting erosion and sedimentation issues, the size and placement of the riprap most likely results in a substantial barrier to Mojave desert tortoises.

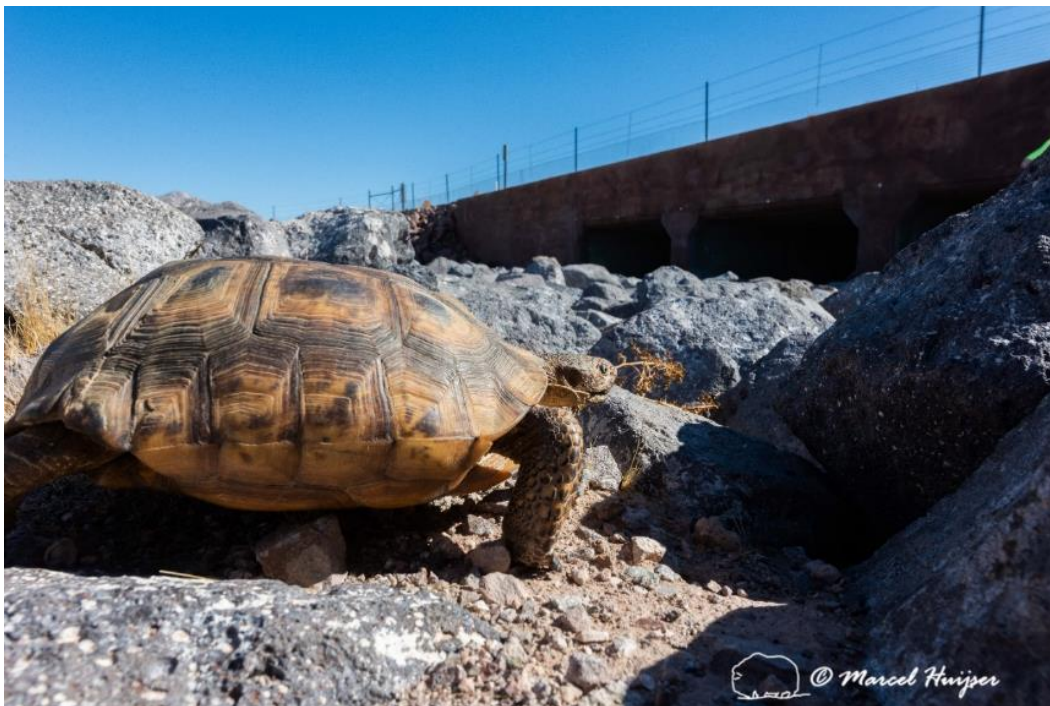
This is what the riprap field looks like from the perspective of a desert, I-11, near Boulder City, Nevada. The riprap is likely an absolute or near absolute barrier to tortoises.

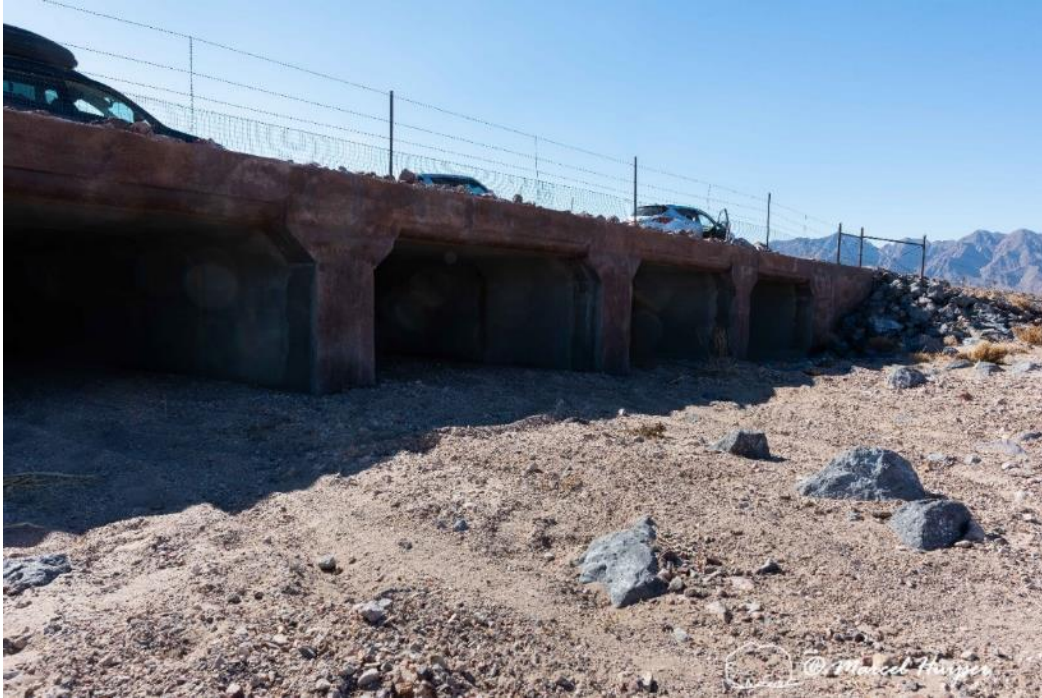
Riprap filled in with finer rocks and sand, in front of culverts to reduce erosion, I-11, near Boulder City, Nevada. This does not appear to be a barrier to Mojave desert tortoises.

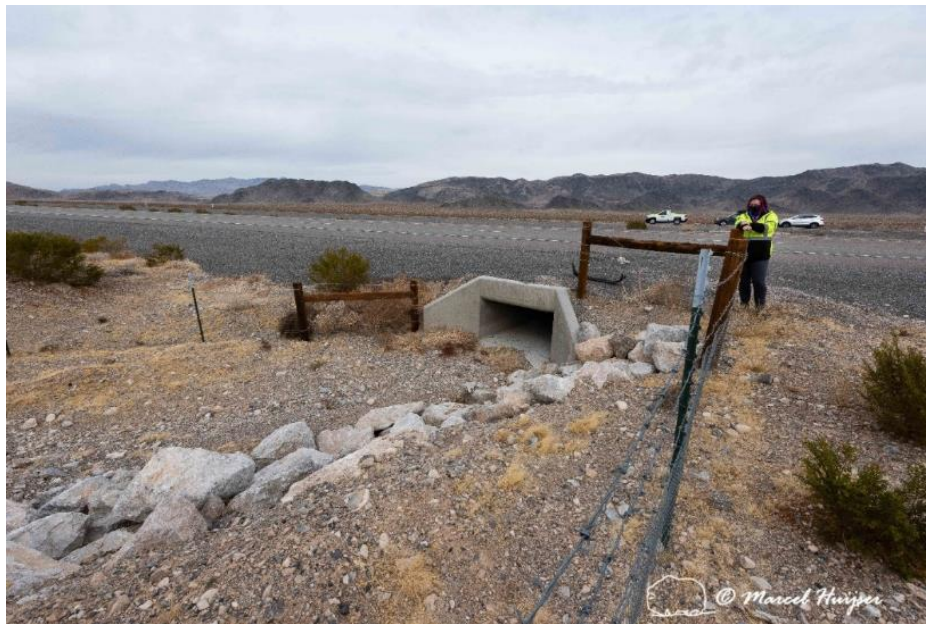
Mojave desert tortoise fence and a culvert US Hwy 95 (MP 127.5 SB) near Indian Springs, Nevada. Riprap stabilizes the slope between the fence and the culvert. Mojave desert tortoises that follow the fence cannot easily access the culvert; they would have to navigate the riprap on the slope first. Design and construction of culverts, fences, and measures aimed at erosion control should ensure that tortoises can easily access the culvert, including when they follow the fence.

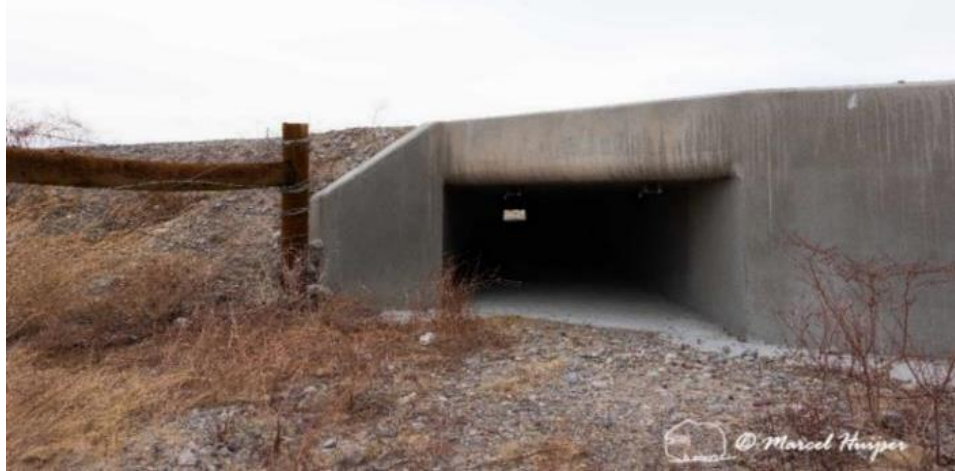
Mojave desert tortoise fence and a culvert with concrete pathways leading up to the entry, US Hwy 95 (MP 121.6 SB) near Indian Springs, Nevada. This inflow shows no noticeable erosion; Mojave desert tortoises of any size can easily access this culvert across the entire width of the culvert.

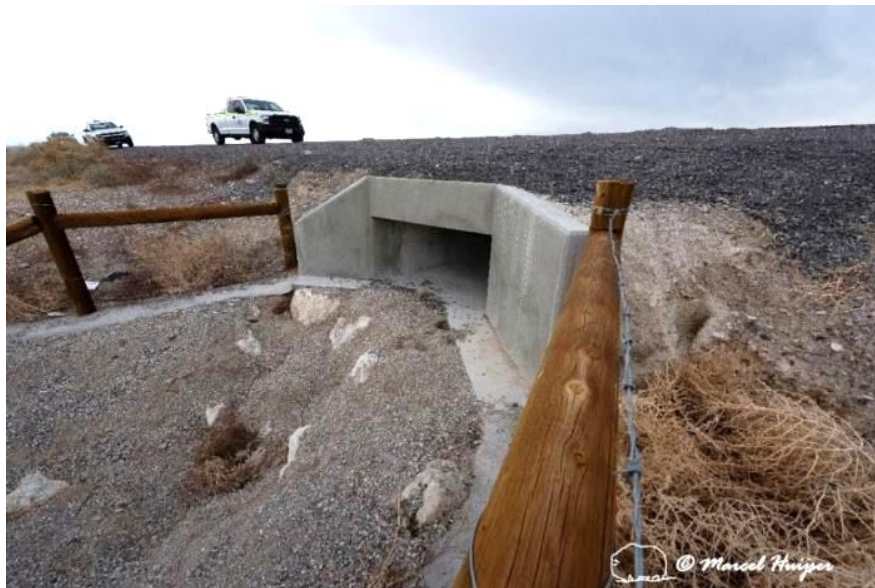
Mojave desert tortoise fence connected to a culvert with concrete pathways leading up to the entrance, US Hwy 95 (MP 121.6 NB) near Indian Springs, Nevada. A deep plunge pool was constructed to address the high water volume and velocity at this outflow. This resulted in substantial erosion and a steep slope, somewhat stabilized by large riprap. The riprap was filled in with smaller substrate to minimize the threat of entrapment of tortoise within gaps formed by the riprap. Concrete pathways were constructed to allow potential use by Mojave desert tortoises for accessing the culvert. The pathways may not be wide enough to allow larger tortoises to turn around with the risk of falling into the plunge pool and erosion is currently undermining the integrity of these pathways. Therefore, this type of culvert access design is not recommended for tortoises.

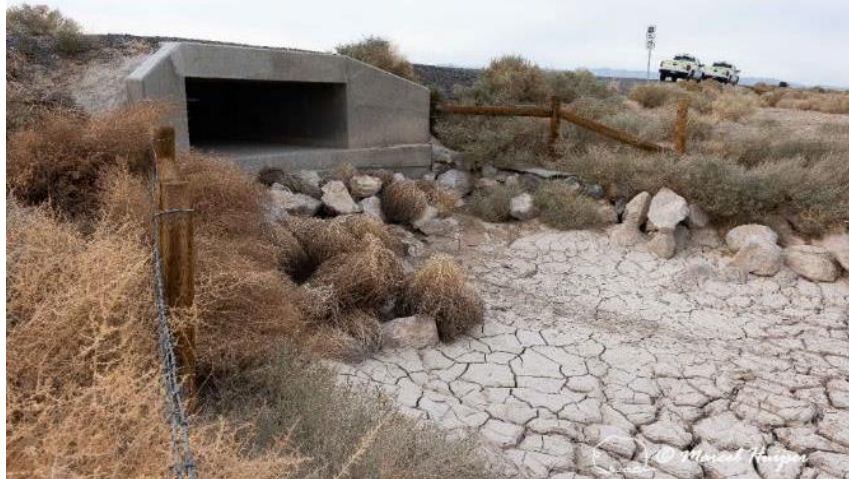
Mojave desert tortoise fence connected to a concrete box culvert with a substantial drop-off, large riprap, accumulated tumbleweed, and eroded pathways likely result in a barrier for Mojave desert tortoises, US Hwy 95 (MP 125 NB) near Indian Springs, Nevada. Drop-offs greater than 4 inches may not be accessible for most tortoises (Pers. com. Kerry Holcomb US Fish and Wildlife Service). The cracked substrate within the deep plunge pool is an indication that standing water accumulates after storm events, which may attract tortoises that are then at a risk of drowning. The tumbleweed accumulation may block or discourage use by Mojave desert tortoises and should be addressed through regular maintenance (i.e. removal of the tumbleweeds). However, access to this culvert and plunge pool was eventually blocked because it was not possible to address the safety issues for tortoises with the existing hydraulic characteristics.

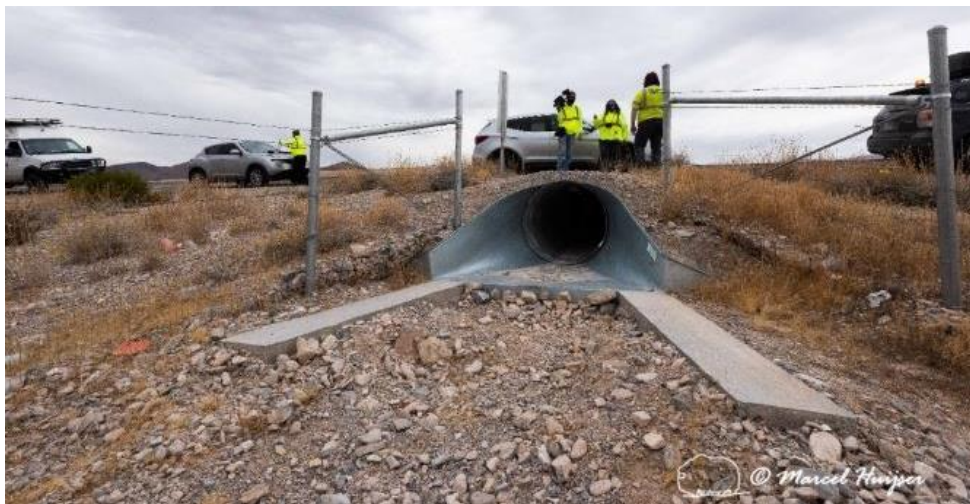
Mojave desert tortoise fence connected to a corrugated metal pipe (culvert) (CMP) with concrete pathways on both sides for Mojave desert tortoises, US Hwy 93 (MP 58 NB) near Overton, Nevada. Note that erosion resulted in a drop-off at the outflow of the culvert and this is likely a barrier to juvenile tortoises. While this culvert is passable for Mojave desert tortoises, improvements can be made by reducing the height of the drop-off.
