Technical Guidance: Mojave Desert Tortoise Conservation and Recovery Measures Along Roads

Mojave Desert Tortoise Transportation Ecology Task Force

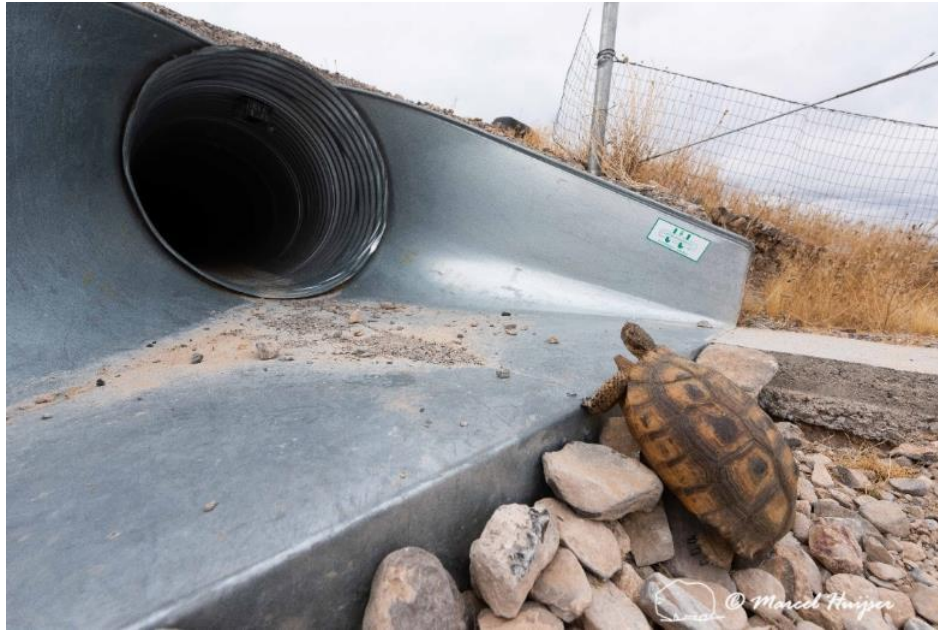
Close-up with adult tortoise model at a corrugated metal culvert (Corrugated Metal Pipe (CMP), US Hwy 93 (MP 58 NB) near Overton, Nevada. Note that the height of the drop-off at the outflow of the culvert is likely a barrier for smaller size tortoises. While adult tortoises have been observed to pass through this culvert, regular monitoring and maintenance to address the effects of erosion can help keep a culvert passable by a both adult and juvenile tortoises.

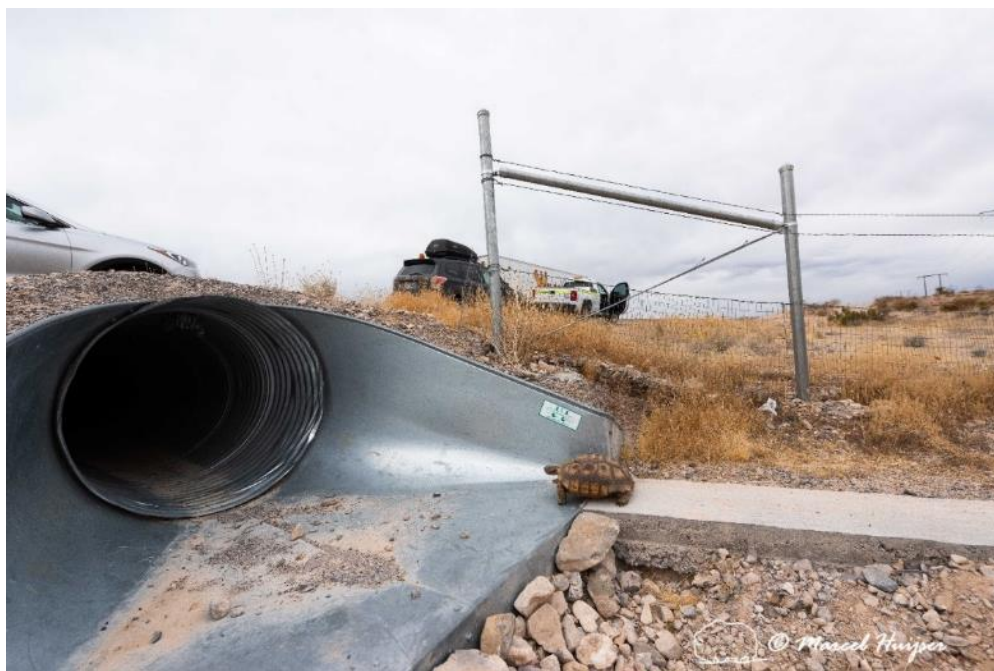
An adult tortoise model demonstrates how this concrete pathway may allow access to the culvert entrance, US Hwy 93 (MP 58 NB) near Overton, Nevada. As noted above, the drop-off at the outflow of the culvert is a potential barrier to juvenile tortoises.

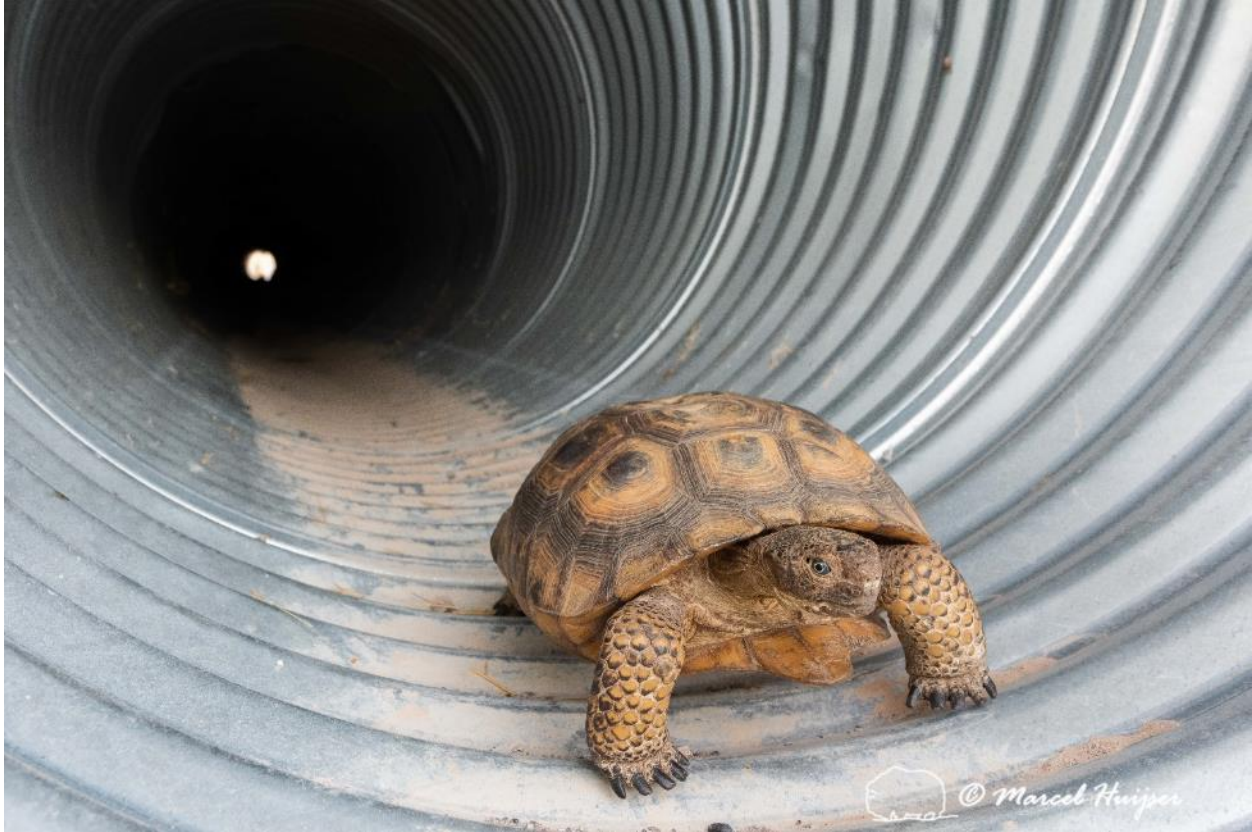
An adult tortoise model in a corrugated metal culvert (Corrugated Metal Pipe (CMP)), US Hwy 93 (MP 58 NB) near Overton, Nevada. Adult tortoises have been observed passing through these types of culvert structures, regardless of whether natural substrate was present (BLM and DCP 2022).

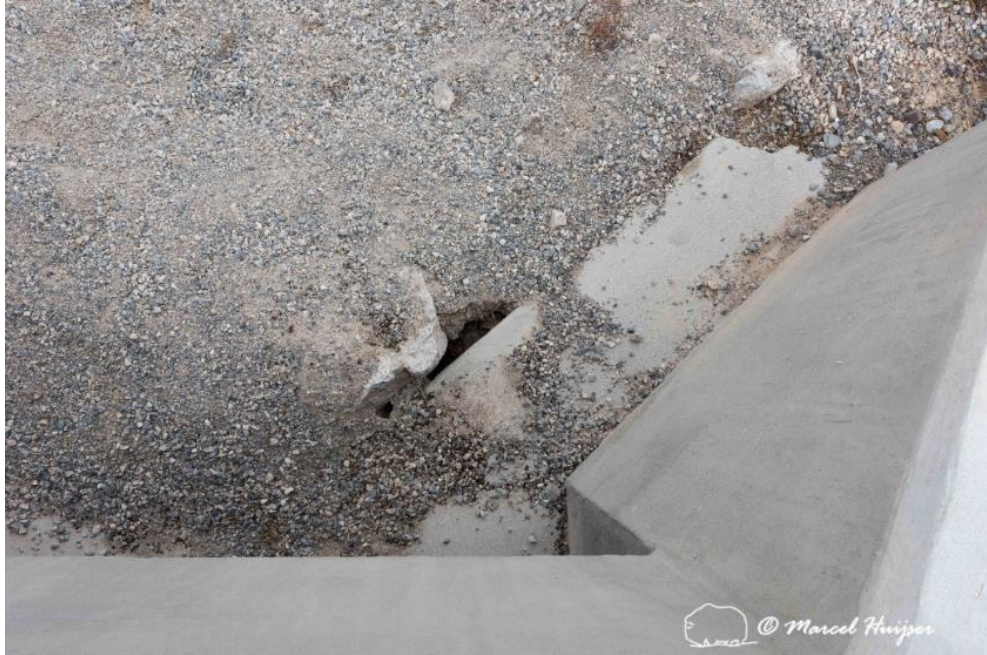
Erosion along a concrete pathway leading up to a concrete box culvert, US Hwy 95 (MP 127.5 NB) near Indian Springs, Nevada. The riprap is filled with finer sediments that allows Mojave desert tortoises to access the culvert. However, it appears that the finer sediments are washing out and resulting in cavities that could trap Mojave desert tortoises.

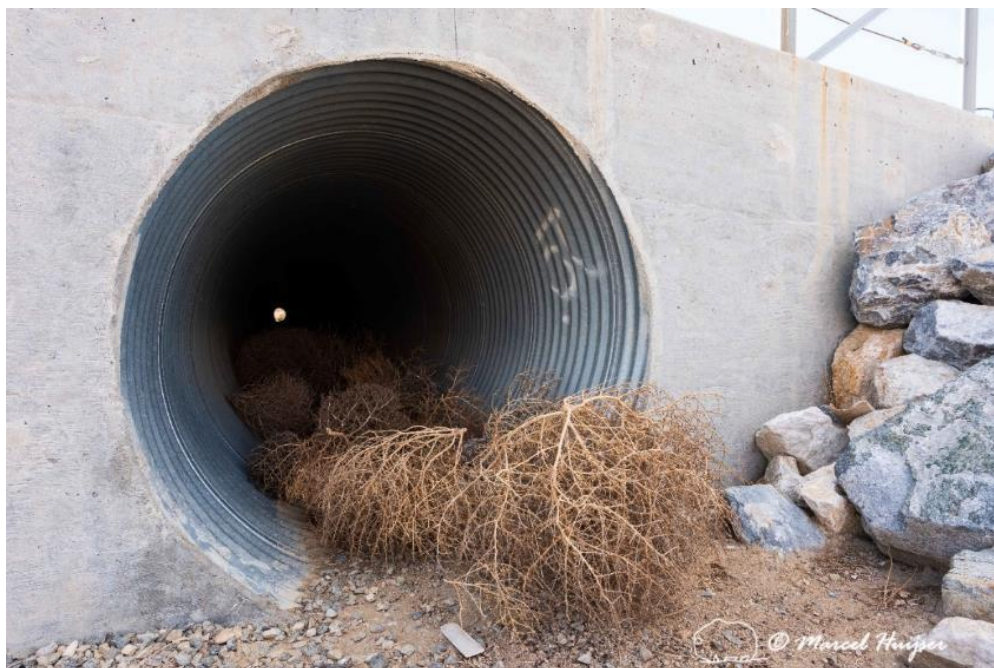
Culvert primarily constructed for hydrology, but the culvert may also allow for passage by Mojave desert tortoises I-15 near Barstow, California. However, this culvert is blocked by tumbleweed.

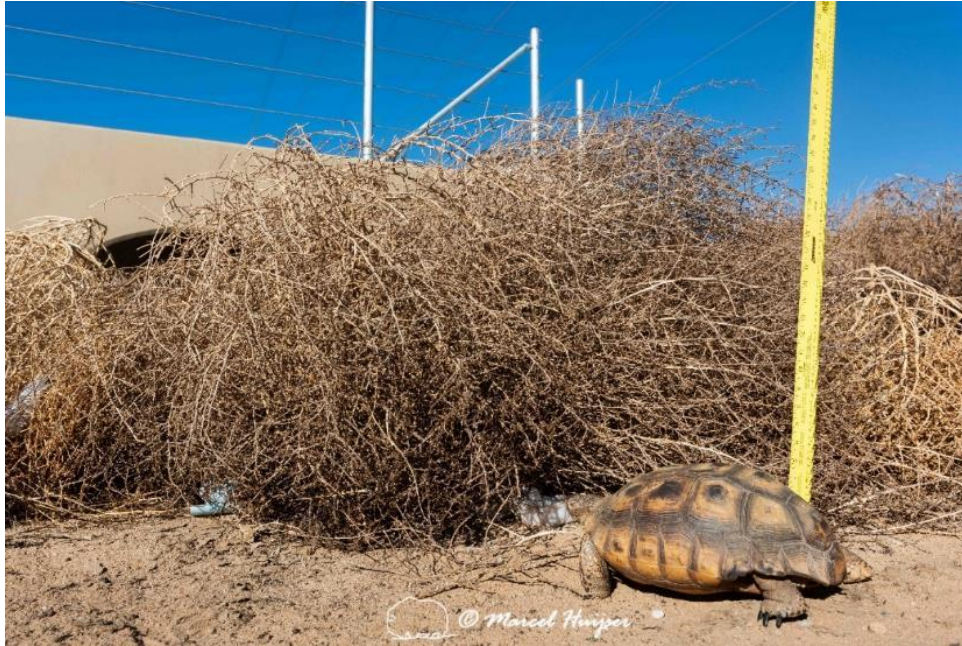
Tumbleweeds block Mojave desert tortoises approaching or leaving culverts, Hwy 58 near Kramer Junction, California.

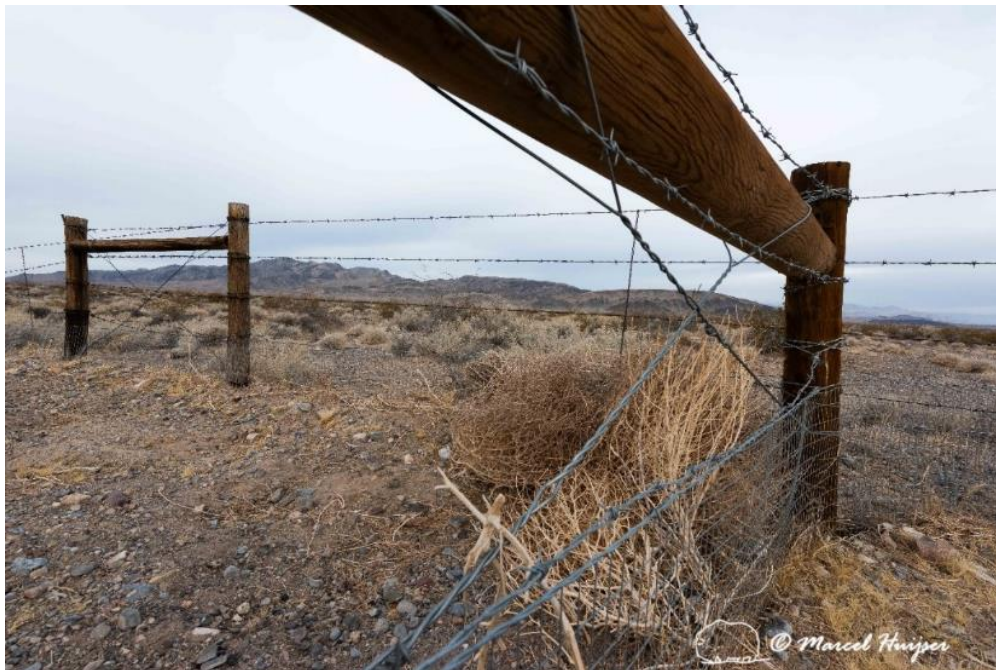
Mojave desert tortoise fence blocking access to a culvert that is considered a danger (e.g. entrapment between riprap or drowning in a deep plunge pool), US Hwy 95 (MP 125 NB) near Indian Springs, Nevada. The decision to block tortoises from accessing the culvert implies that the danger associated with accessing and using a culvert is considered greater than the benefits of potential crossings.

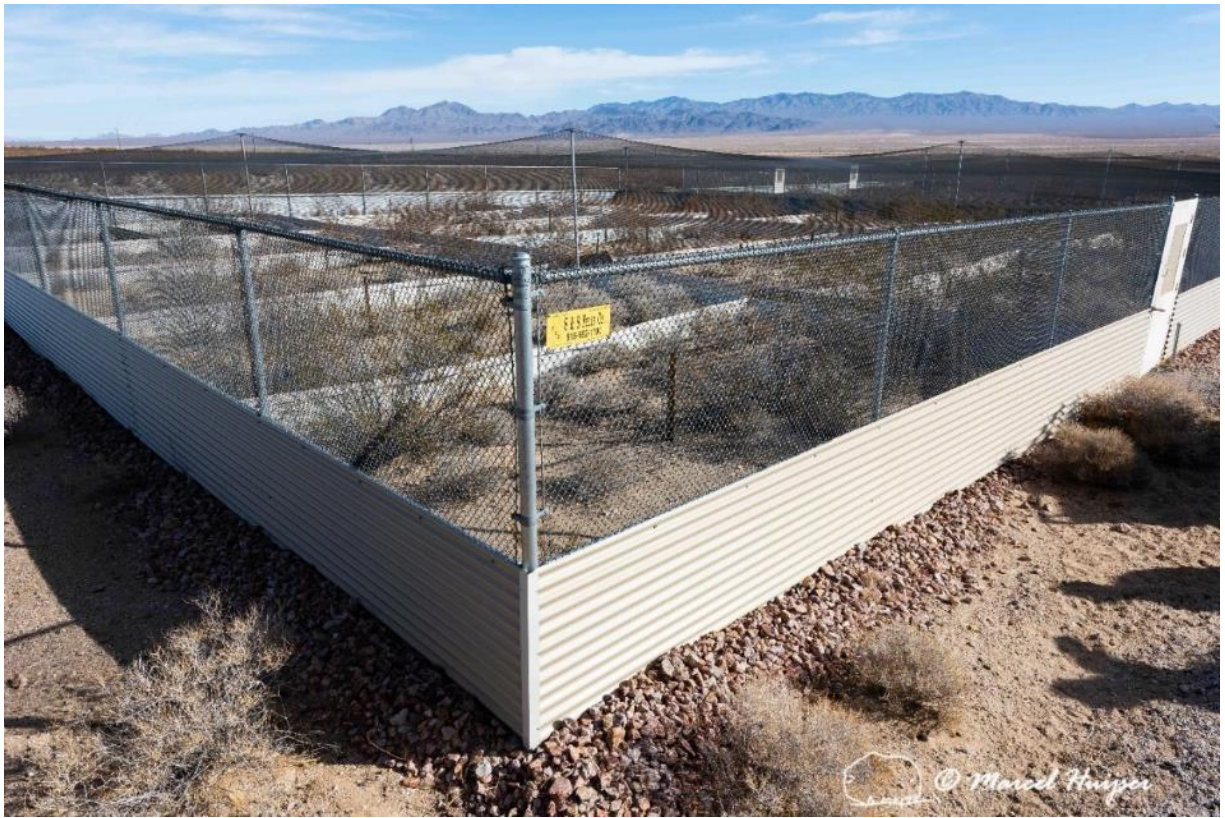
Captive breeding facility for Mojave desert tortoise, Ivanpah Desert Tortoise Research Facility, Mojave National Preserve, California. The fence and netting protect the tortoises from terrestrial and aerial predators.

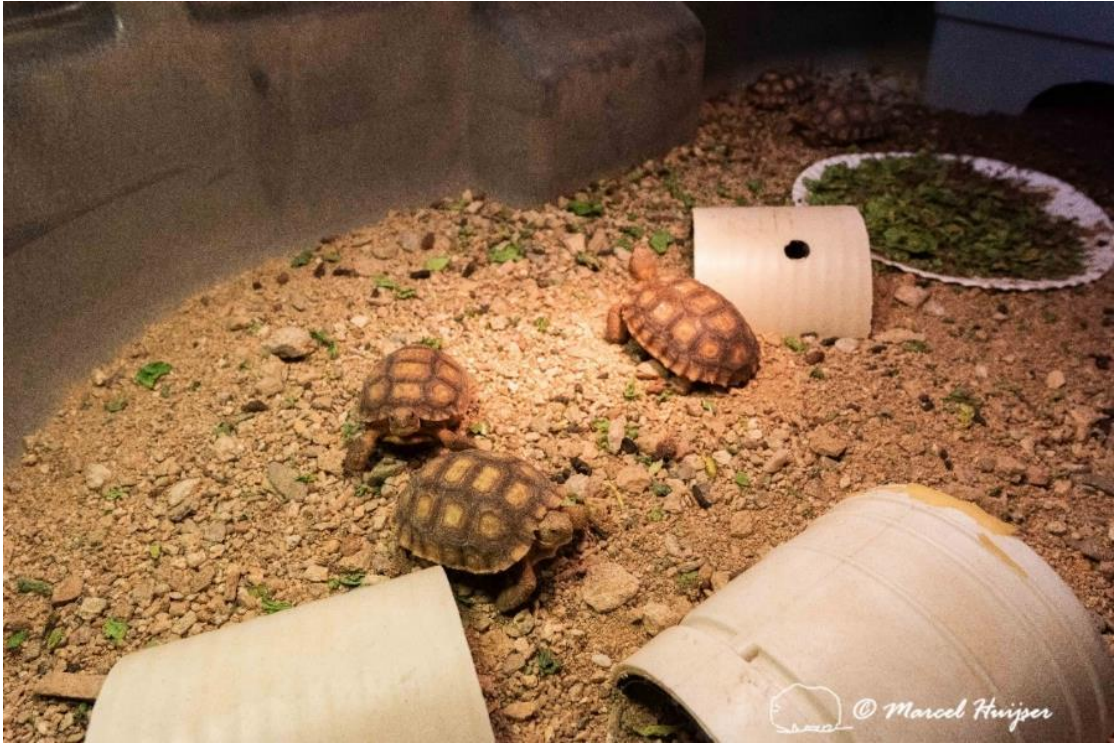
Captive breeding facility for Mojave desert tortoise, Mojave National Preserve, California.

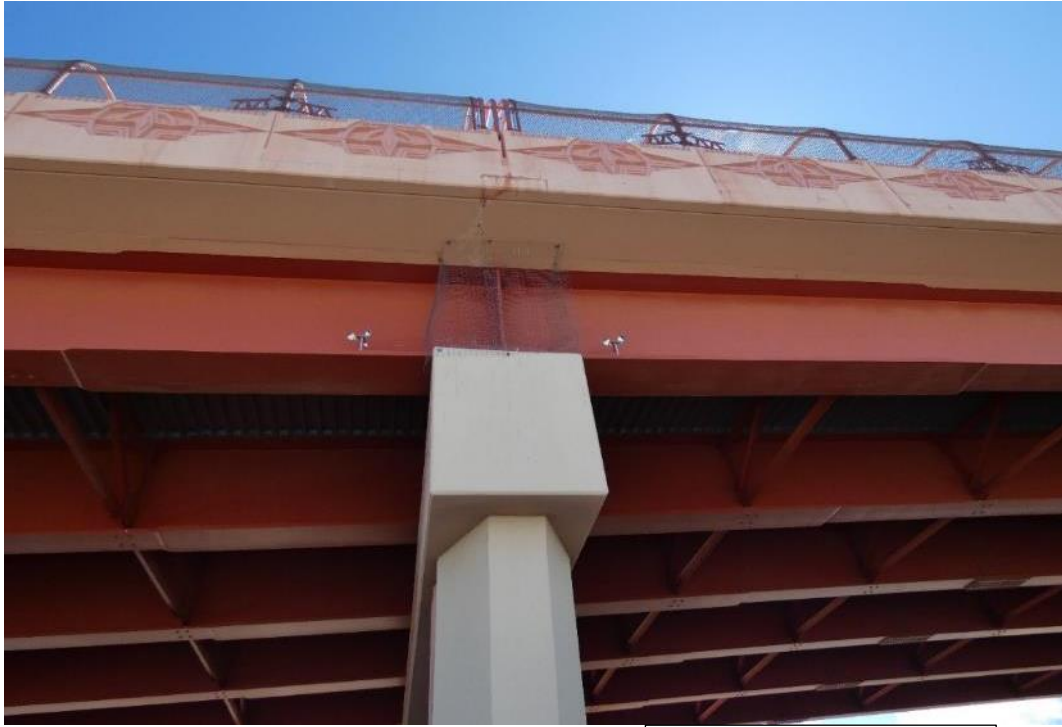
Wire mesh and metallic flashers installed to discourage raven nesting on Snow Mountain Overpass, U.S. 95, Las Vegas, Nevada.

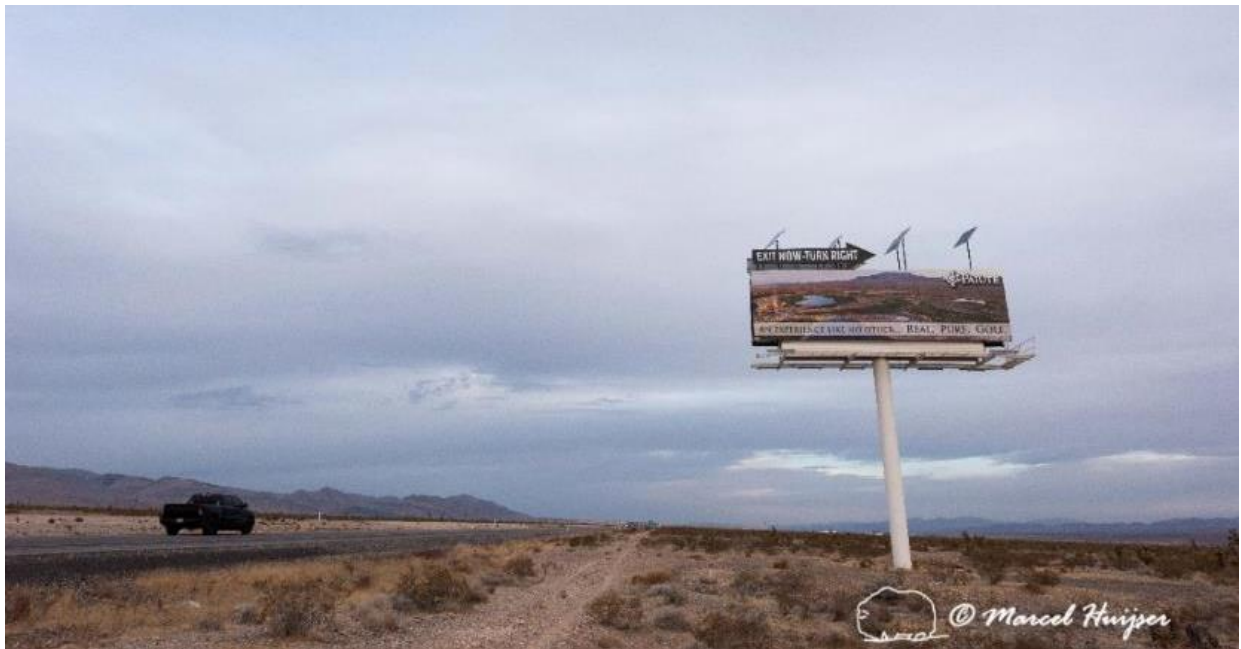
Billboards in the Mojave Desert provide nesting opportunity for ravens who then predate on juvenile Mojave desert tortoises, Las Vegas, Nevada.

- Limiting or eliminating unnatural structures that can serve as perching, roosting, or nesting sites for ravens. If unnatural structures cannot be removed, try to make them inaccessible or unsuitable (e.g., spikes (Avery & Genchi 2004, Dwyer & Doloughan 2014, Dwyer et al. 2020) or “rollers” (Vogelbescherming Nederland 2017, Dekker 2021) that make structures including signs less suitable to perching, roosting or nesting.

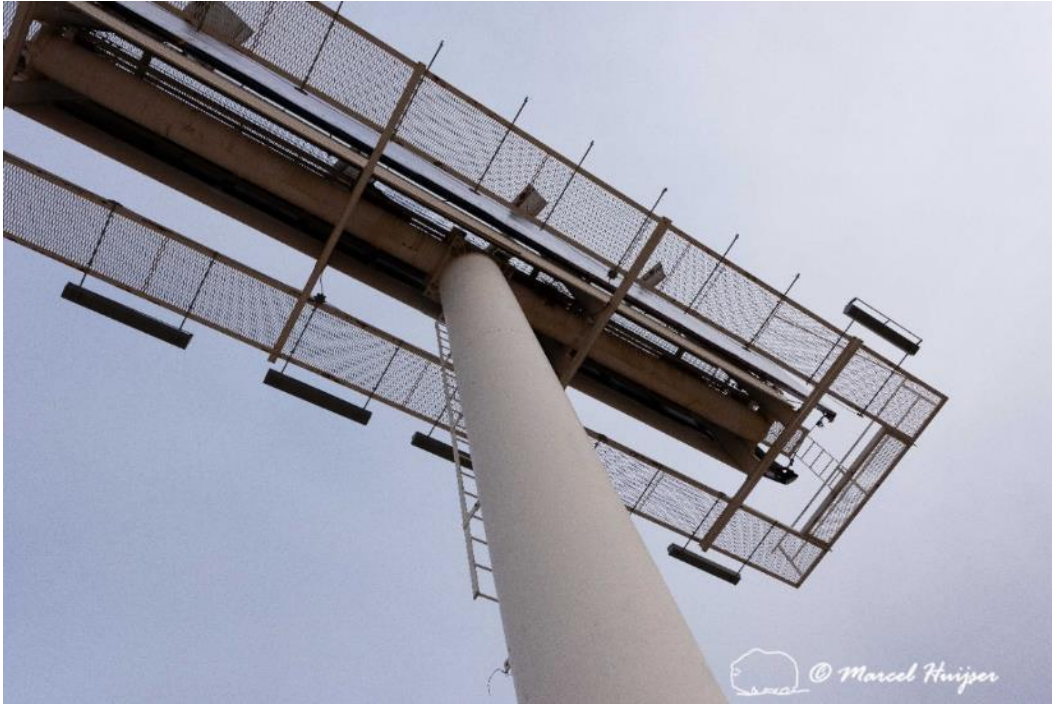
Billboards in the Mojave Desert provide nesting opportunity for ravens who then predate on juvenile Mojave desert tortoises, Las Vegas, Nevada.

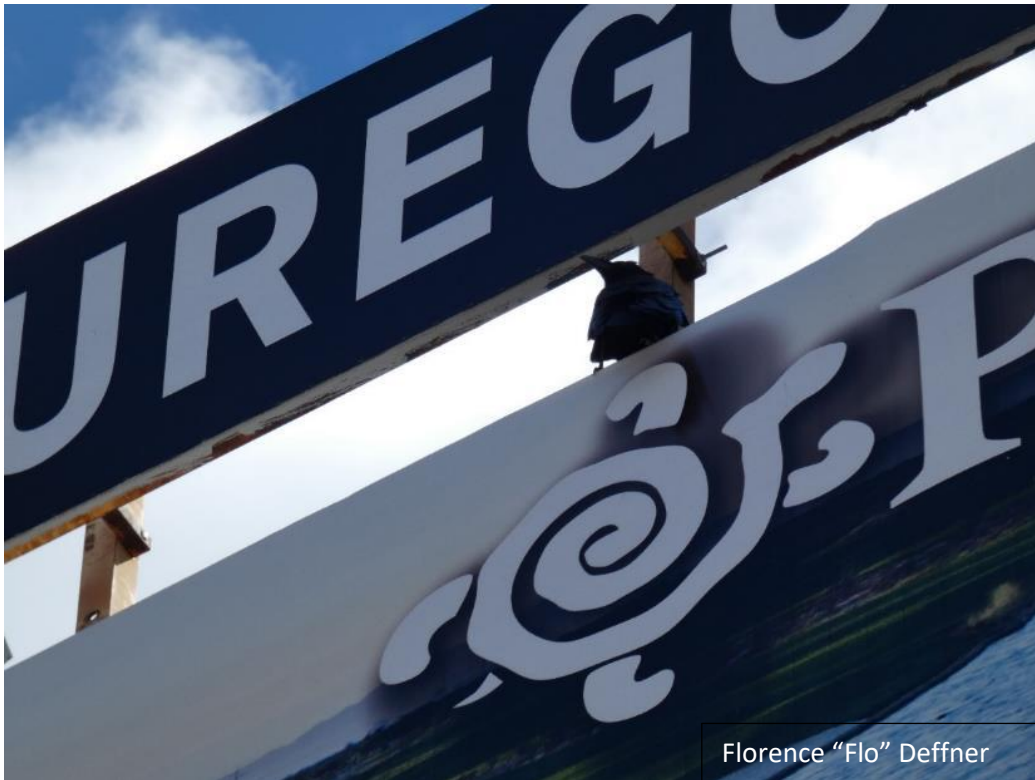
Raven roosting on billboard, U.S. 95, Las Vegas, Nevada.

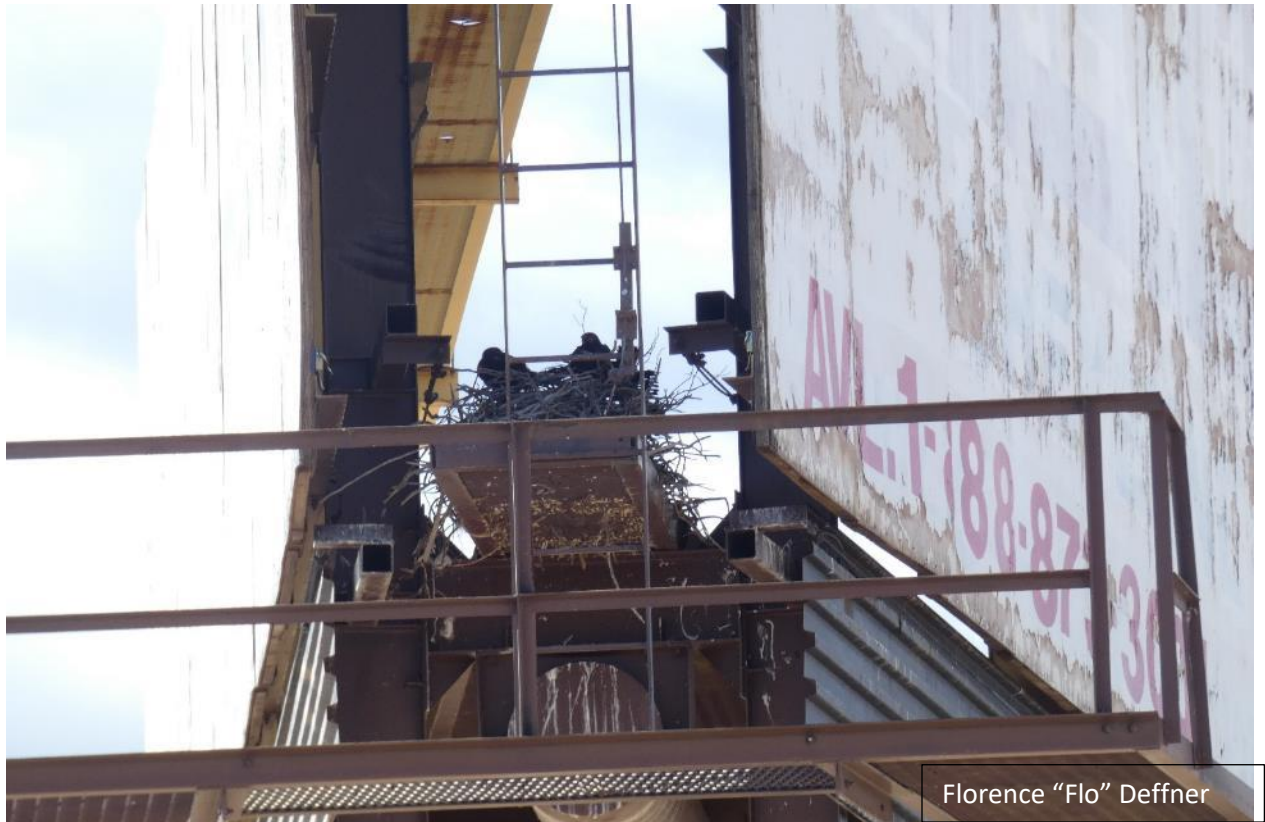
Raven nest with fledglings on billboard structure, I-15, Las Vegas, Nevada.

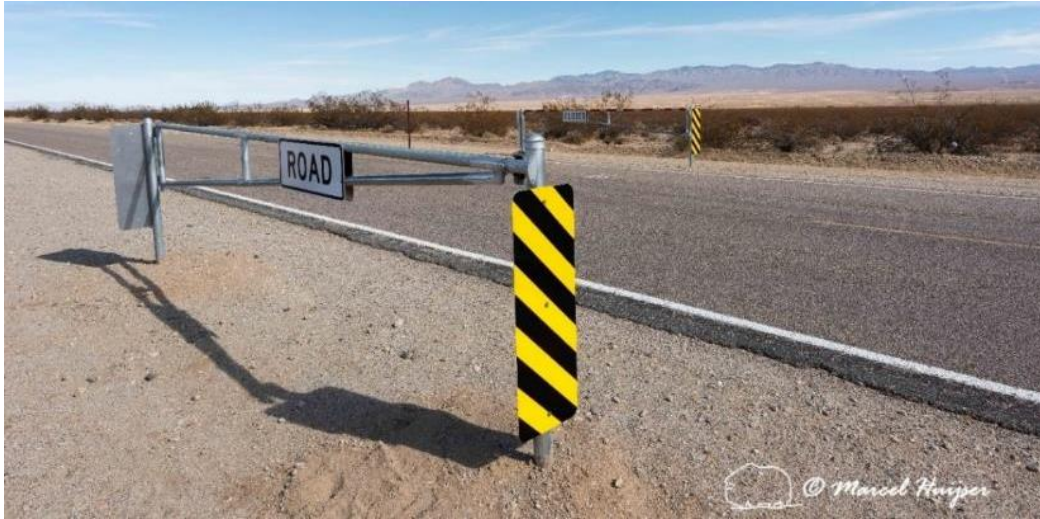
Gates for seasonal road closure to reduce road mortality of Mojave desert tortoise, Mojave National Preserve, California.

- Night-time or seasonal road closures. During periods where risk of direct road mortality is high, roads may be temporarily closed. During those closed periods, direct road mortality is eliminated.
- Speed reduction. While vehicle speed management is complex, vehicle speed may be limited through reduced legal posted speed limit and associated measures that affect the design speed

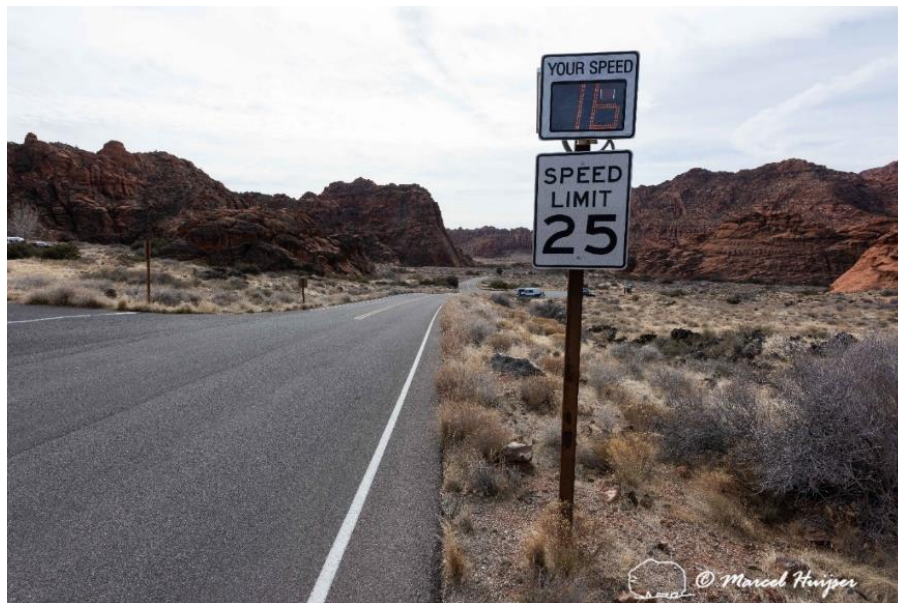
Maximum speed limit 25 MPH with speed radar to control speed, primarily for Mojave desert tortoise, St. George, Utah.

of a road (e.g., curves, narrow lanes, no road shoulder, speed bumps). However, the effectiveness of vehicle speed reduction in reducing road mortality is unknown, and it may still be ineffective for juvenile tortoises that may be too small to be noticed by drivers.

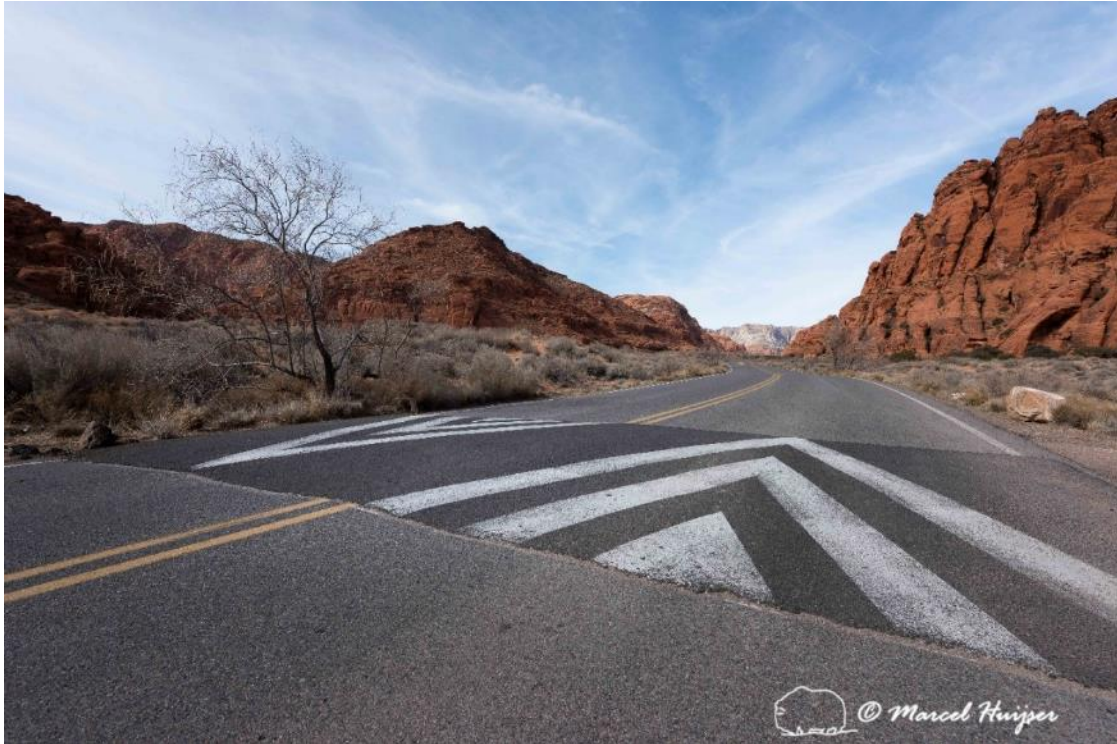
Speed bump to control speed, primarily for Mojave desert tortoise, St. George, Utah.

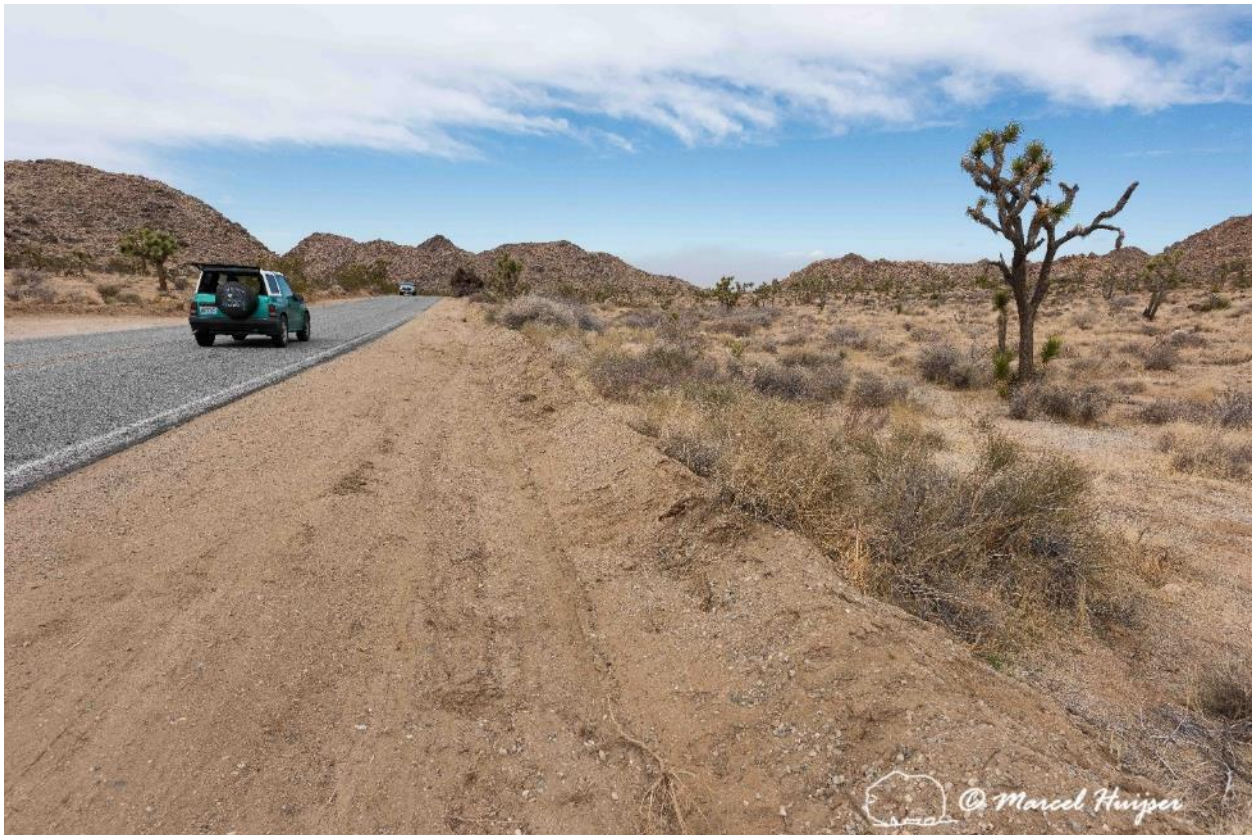
Graded road shoulder results in habitat loss and a place for vehicles to park, Joshua Tree National Park, California. Tortoises may crawl under parked vehicles for shade and are at risk of being crushed once the vehicle starts moving again.

Road shoulders allow drivers to regain control of their vehicle after departing the travel lanes. However, road shoulders also result in habitat loss as natural vegetation may no longer be present in the road shoulder. Reclaiming road shoulders through habitat restoration can reverse this habitat loss. Typically, road shoulders are made inaccessible through curbs, rocks, or other objects that discourage vehicles from leaving the road. In addition to reversing habitat loss, direct mortality of wildlife can be reduced or eliminated in the (former) road shoulder. This may be especially relevant for Mojave desert tortoises as they may crawl under parked vehicles along the road for shade. Once the vehicle starts moving again, these tortoises are at risk of being crushed.

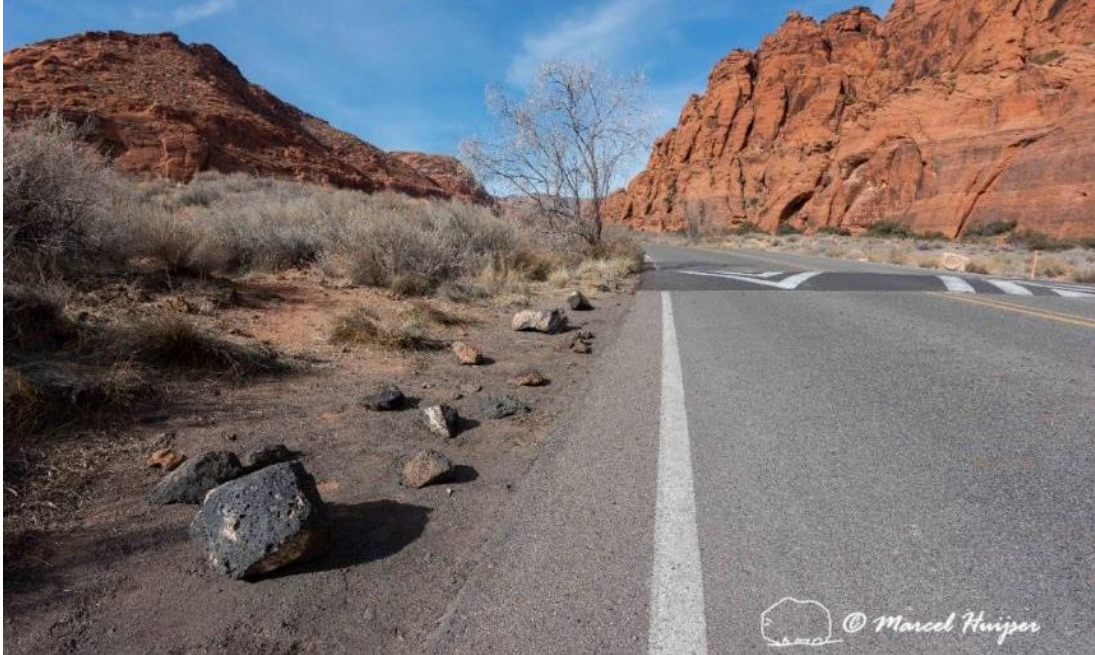
Large rocks along edge of pavement to discourage off road parking that destroys vegetation and that could kill Mojave desert tortoise, Snow Canyon State Park, St. George, Utah.

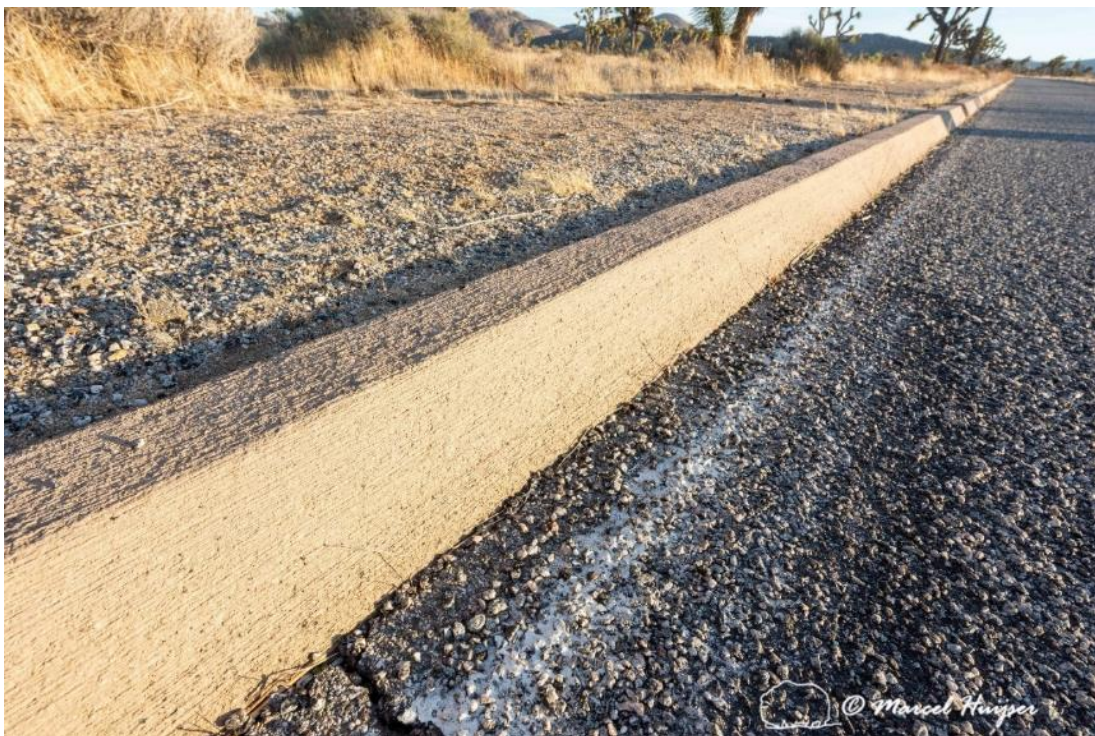
Curb to keep vehicles from leaving the pavement and parking along the roadside, Joshua Tree National Park, California. Denying vehicles access to the road shoulder can be combined with habitat restoration. The rough surface of the curb is to potentially allow Mojave desert tortoises to escape from the road.

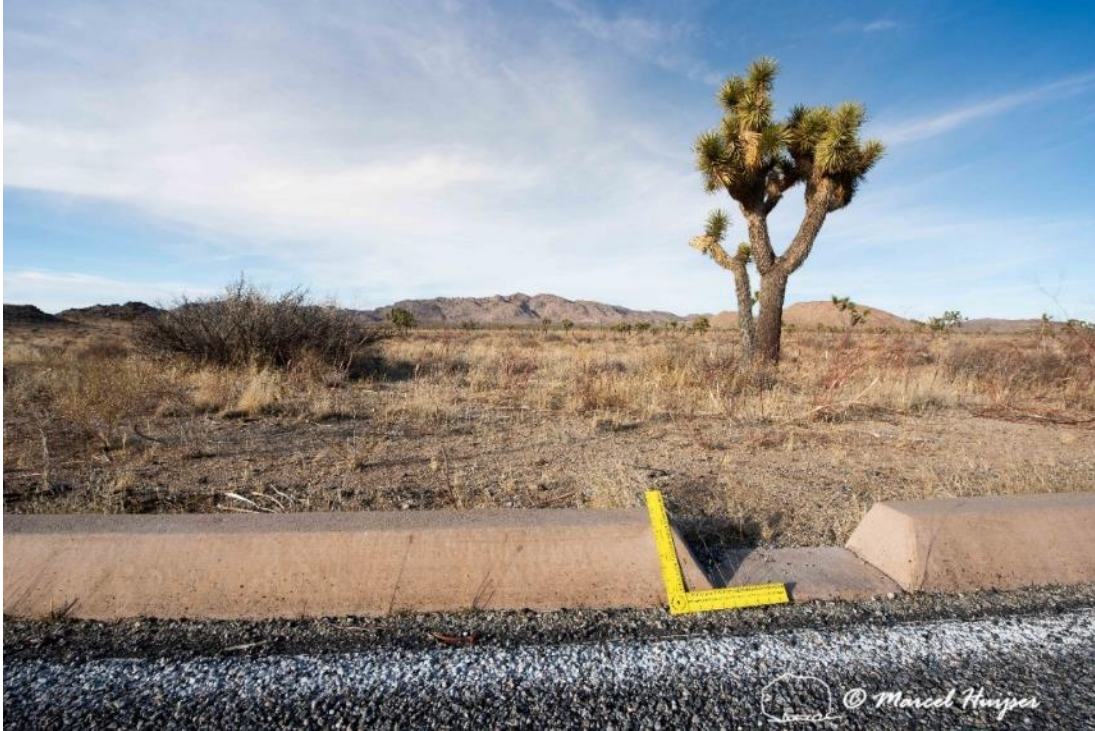
Tortoise trot, or gap in the curb, allowing Mojave desert tortoise to leave the road, Joshua Tree National Park, California.

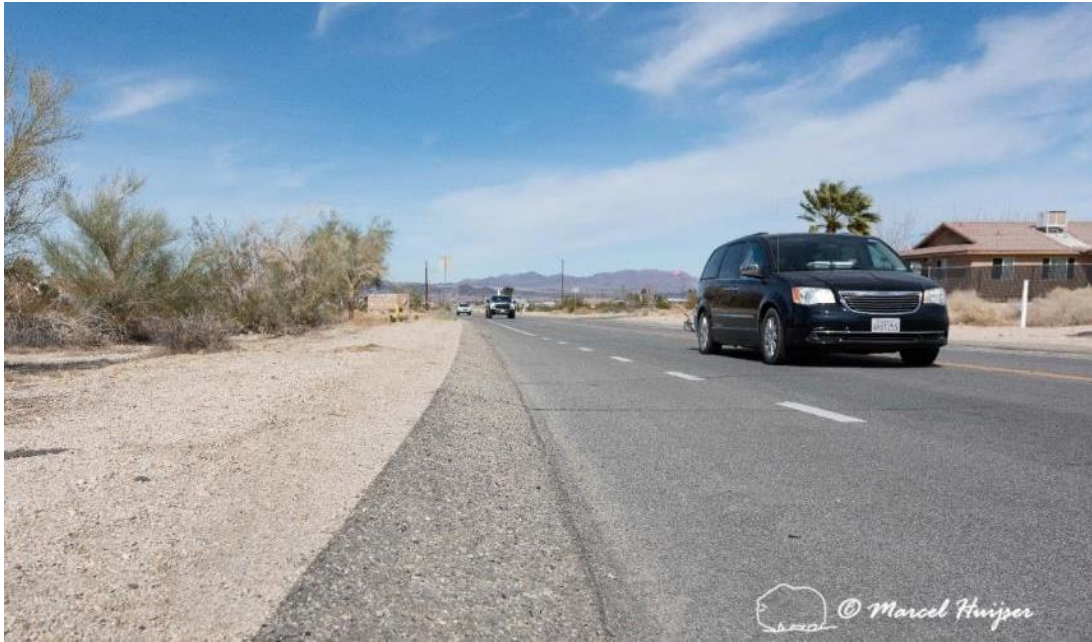
While the shoulder is still accessible to vehicles, this gentle sloped curb allows Mojave desert tortoises to leave the road, Twentynine Palms, California.
